**NIST-SP 1118 Volume I**

# **Technical Study of the Sofa Super Store Fire - South Carolina, June 18, 2007**

**Nelson P. Bryner**  
**Stephen P. Fuss**  
**Bryan W. Klein**  
**Anthony D. Putorti**

March 2011

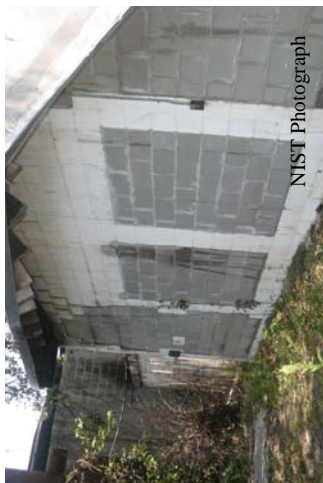
Figure 1-19. Grocery store loading dock, incinerator, and refrigeration equipment areas. Loading dock and incinerator photographs taken after warehouse was torn down and removed from site.

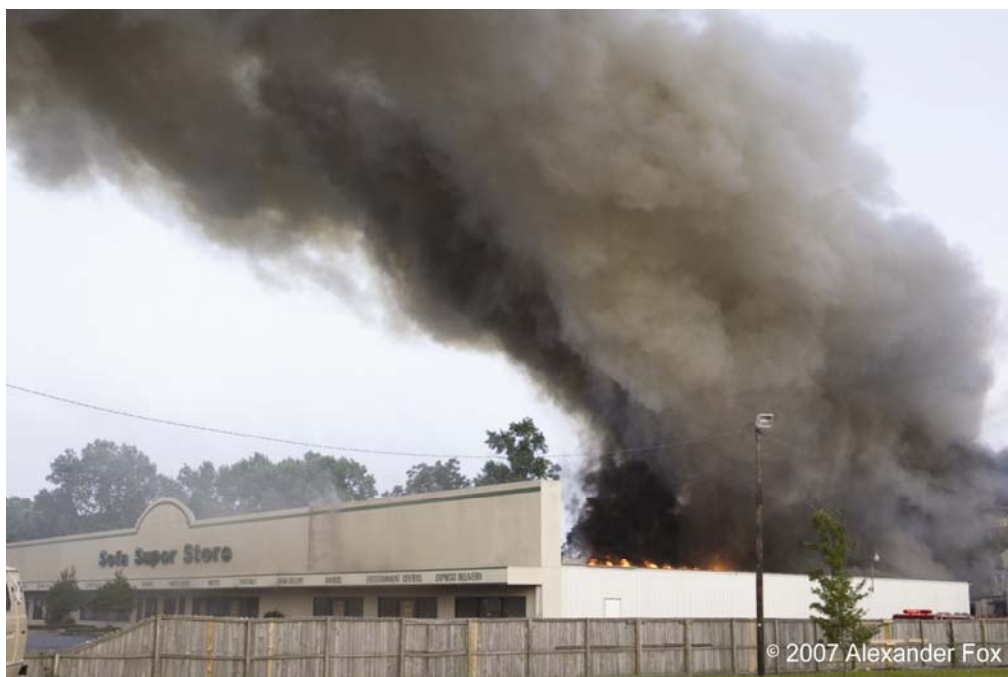
Photographs taken during the early stages of the fire show heavy smoke and flames exiting at the roof level. Figure 4-6 shows a photograph taken at 7:28:15 p.m. This photo shows heavy smoke venting from the loading dock and rear of the main showroom. Flames are also visible and appear to be coming from the roof of the main showroom. Because it was not possible to determine the exact location or size of the holes in the ceiling and roof, several holes were used in the simulations to represent the ventilation that took place. Table K-4 summarizes the ventilation conditions used in the simulations.

**Figure 4-6. Photograph showing the north and west sides of the showroom. Photo was taken at 7:28:15 p.m.**

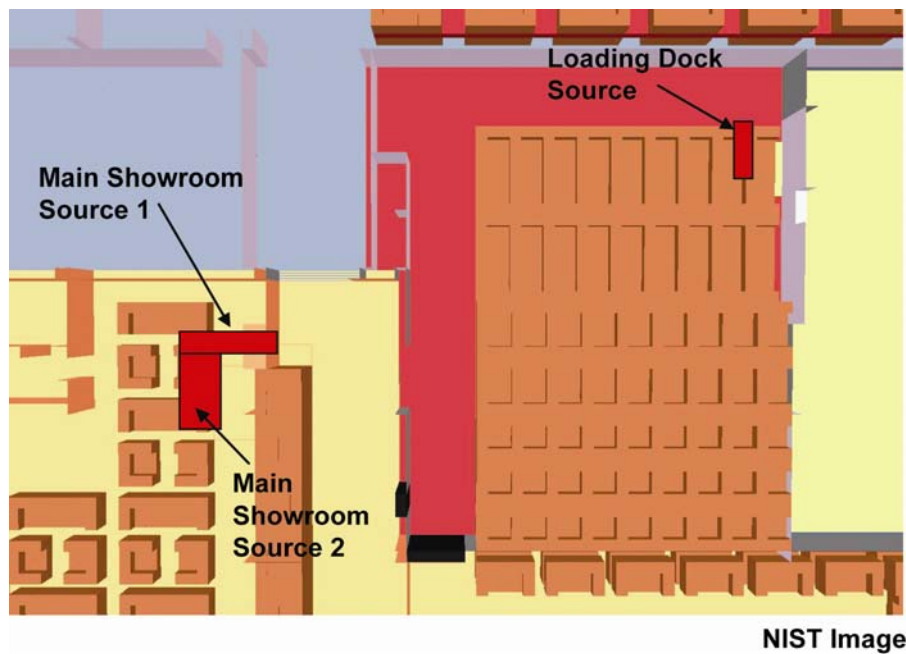
In the simulation, the fire was initiated<sup>3</sup> in the loading dock at floor level, between the door and the ventilation fan access hole. This is identified as “Loading Dock Source” in Figure 4-8 and produced a

**Figure 4-8. Diagram showing locations of initiating fire sources in the loading dock and rear of main showroom.**

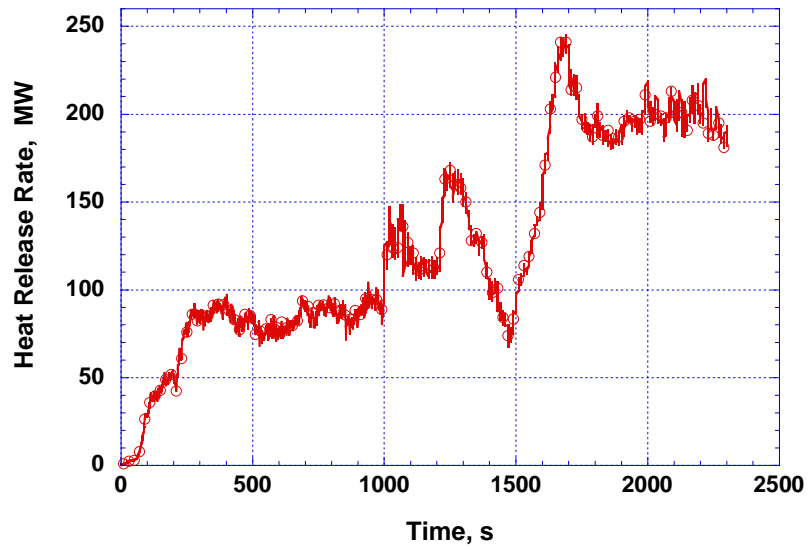
The total HRR for the fire, excluding the warehouse, is plotted as a function of time in Figure 4-9. The HRR produced by the warehouse contents dominated the total HRR in the mid and late stages of the simulation, but since the breezeway door closed early in the fire time line, there was no flow or transfer of material between these areas of the structure. In addition, the fire department did not enter the warehouse to suppress the fire there. This analysis will focus on conditions in the loading dock and showrooms.

Figure 4-9. Total heat release rate, excluding the warehouse.

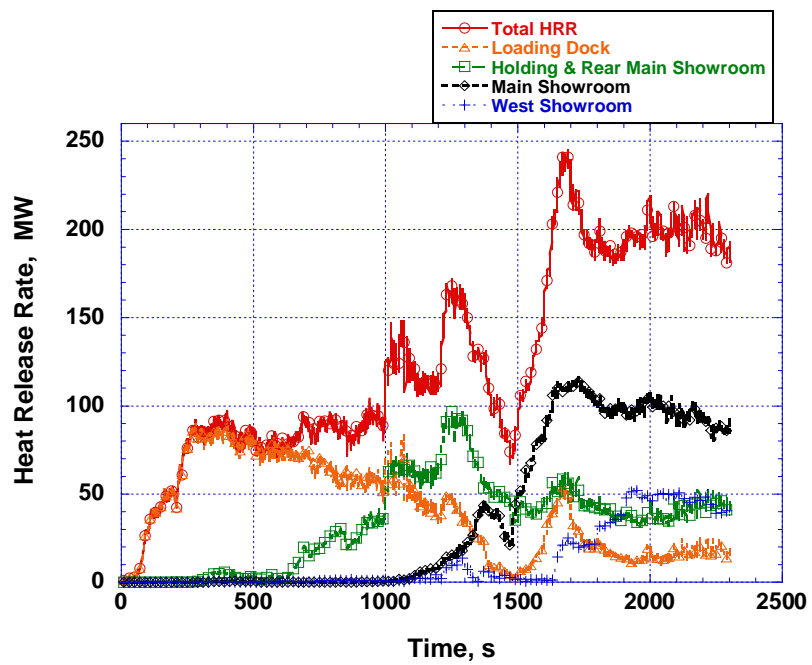
The HRR grew quickly from the initiating 700 kW fire, reaching 90 MW in 280 s as fire spread through the loading dock and into the holding area. Figure 4-10 separates the HRR events in the loading dock, holding area and rear showroom, main showroom, and west showroom. During the first 500 s, the loading dock fire dominated the HRR at about 85 MW. As the fire spread into the holding area and rear of the main showroom the HRR for the holding area and the rear of the main showroom began to increase to about 100 MW at around 1200 s. This increase in fire-spread to the holding area and main showroom was simulated by turning on Source 1 and 2 (Figure 4-8) in the computer model. As the fire spread into the rear of the main showroom, the fire became underventilated and began to decrease in HRR. The total HRR continued to decrease until about 1450 s when the removal of the windows in the main showroom, beginning at 1457 s (7:35:10 p.m.), provided a fresh influx of oxygen leading to the subsequent rapid fire

growth. The HRR of the fire grew to over 100 MW in the main showroom and 50 MW in the west showroom. The energy release rate of the holding area/rear main showroom increased slightly and then leveled out at about 40 MW. The loading dock HRR exhibited a transient peak at about 50 MW and then decreased to about 15 MW.

Figure 4-10. Component heat release rates for the loading dock, holding area, main showroom, and west showroom.

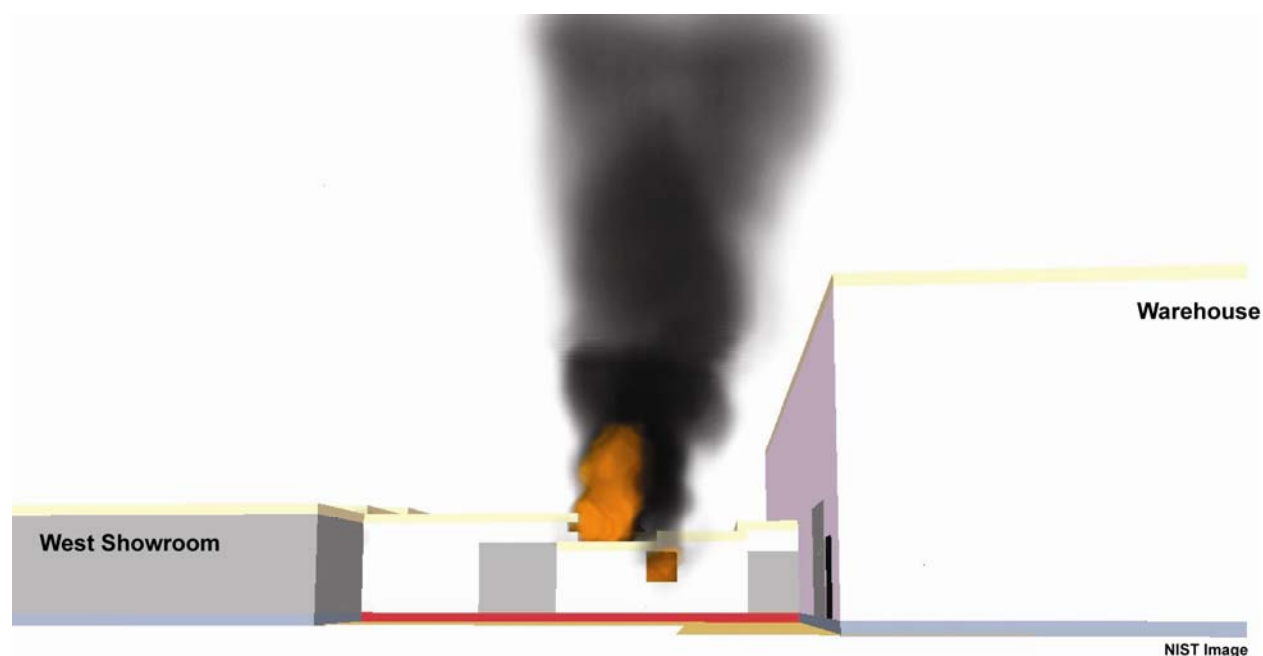
**Figure 4-11. Rendered image showing the west side of the loading dock 110 s into the simulation.**

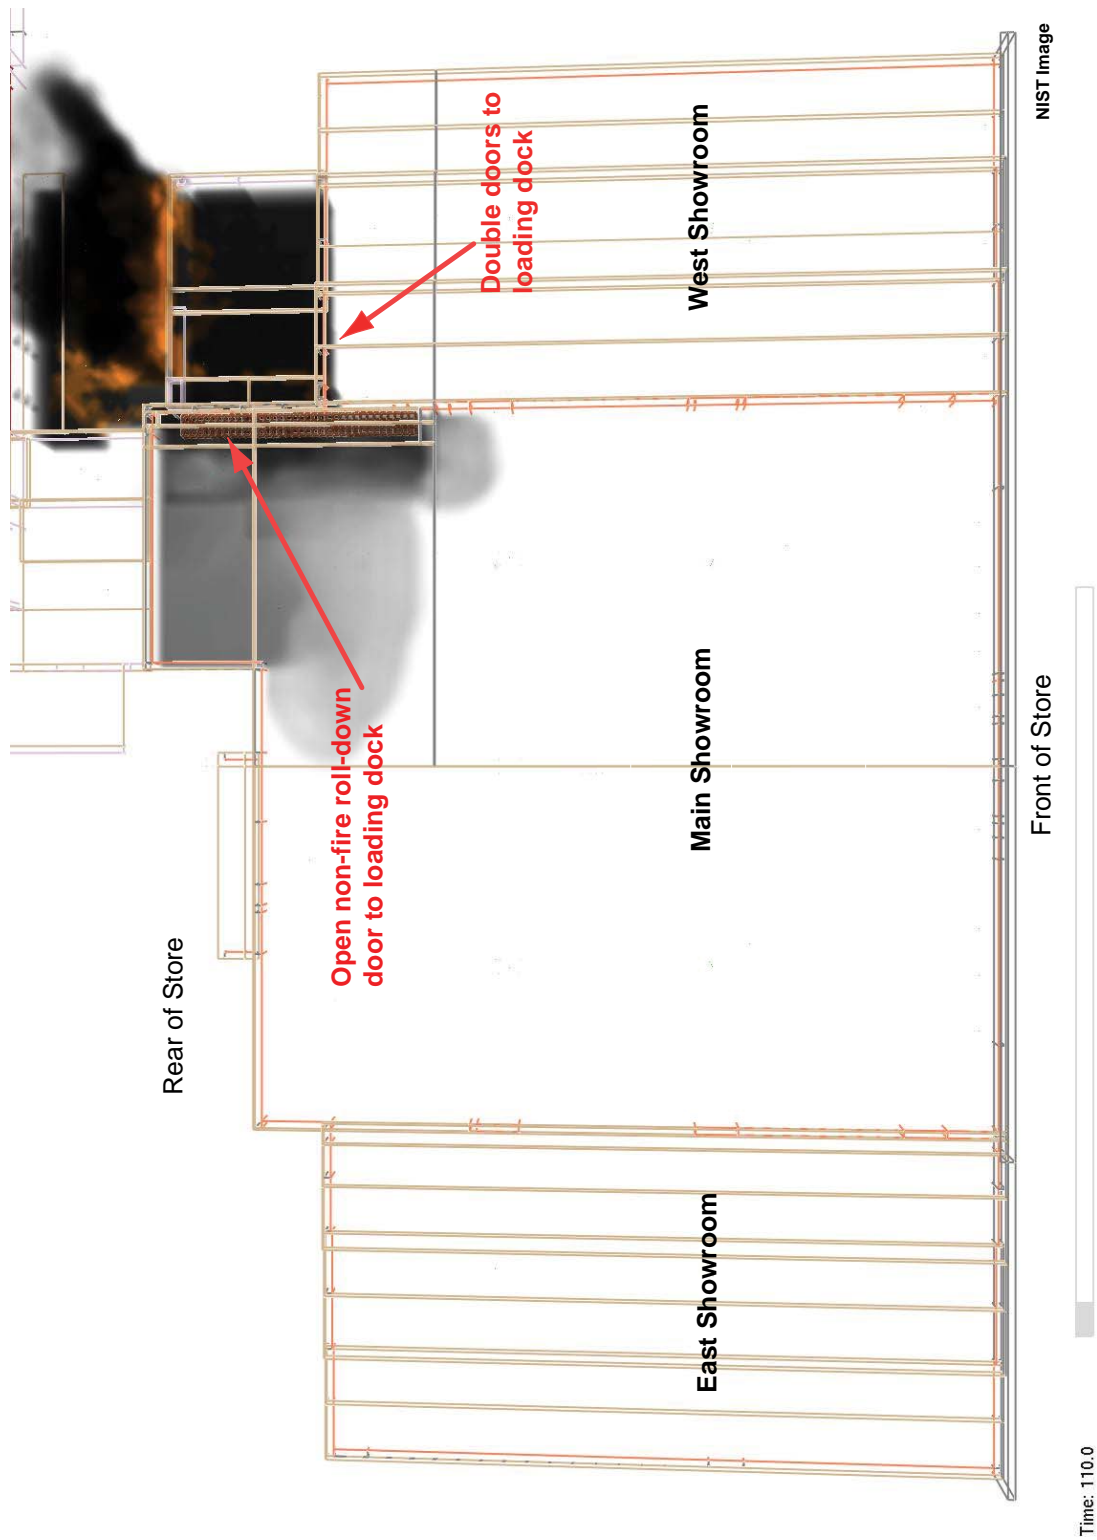
Figure 4-12. Smoke filling in void space above main showroom. Image was rendered 110 s into the simulation.

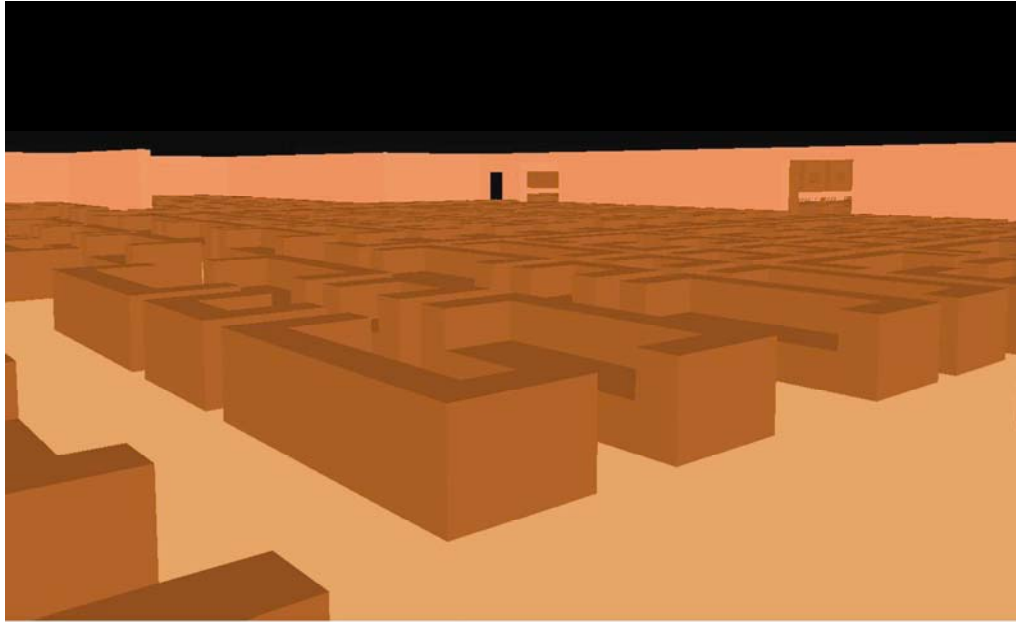
The AC and E-10 captain entered the main showroom and initially observed clear conditions. Figure 4-13 shows an image of the main showroom, from the perspective of a person standing at the front entrance and facing south west, toward the holding area. This image was rendered 80 s into the simulation (7:12:13 p.m.), approximately the time the Assistant Chief entered the showroom and observed clear conditions.

**Figure 4-13.** Image rendered 80 s (7:12:13 p.m.) into the simulation from inside the main showroom, near the entrance. View is toward the south west corner of the main showroom.

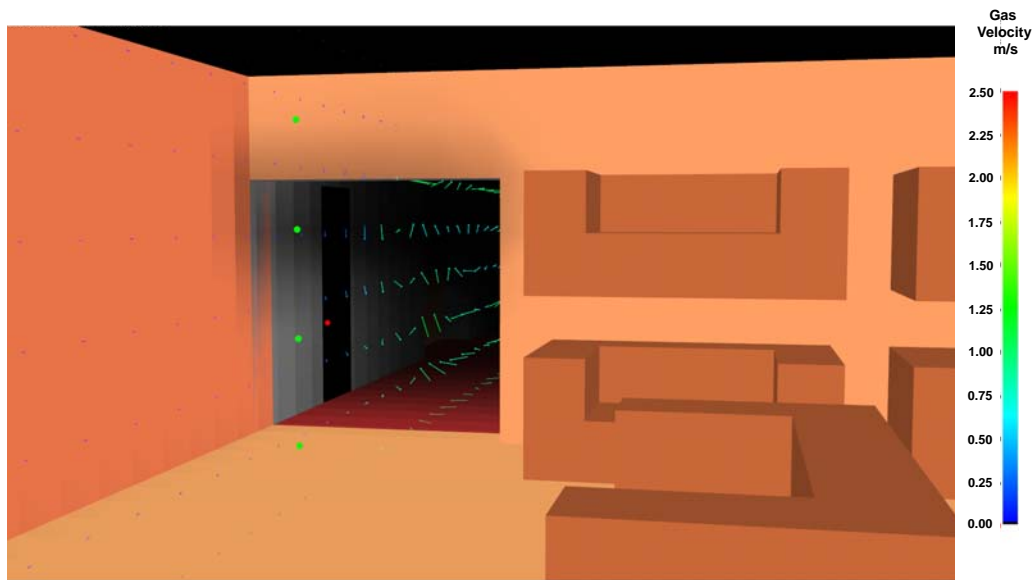
**Figure 4-14.** Image rendered 145 s (7:13:18 p.m.) into the simulation from the west showroom, near the double doors that lead to the loading dock. Arrows indicate direction and relative speed of air moving from the showroom into the loading dock (The relative speed is proportional to the length of the arrow, i.e. longer arrows indicate higher relative speeds and color scale indicates velocity magnitude).

Figure 4-15 shows a rendered image of the double doors from inside the west showroom at 145 s, 1 second after they were opened. The arrows or velocity vectors indicate that the air was flowing from the rear of the west showroom into the loading dock just after the doors were opened.

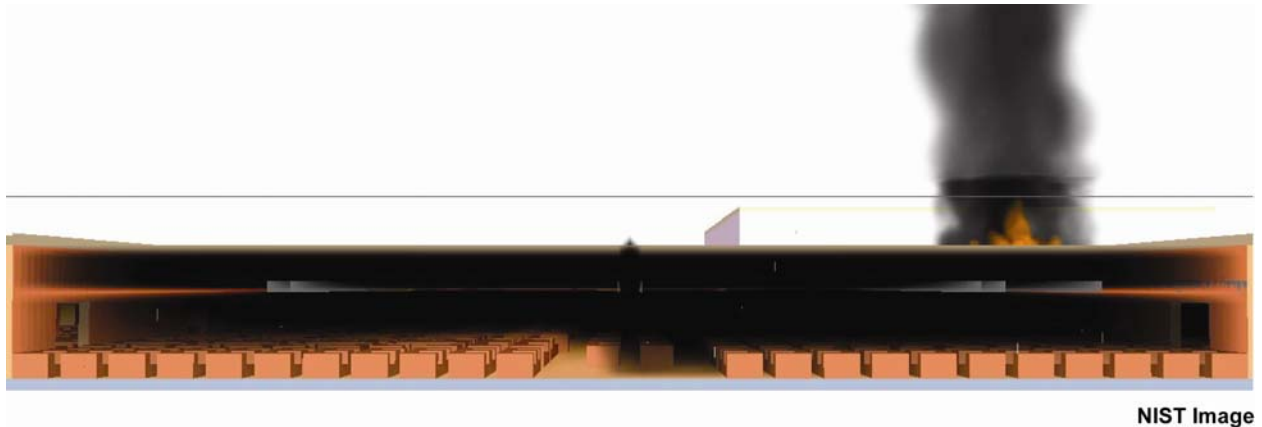
**Figure 4-16. Model rendering of view inside the front of the main showroom at 487 s (7:19:00 p.m.).**

self-contained breathing apparatus (SCBA) face pieces. Figure 4-16 shows an image of the front of the main showroom, with the front wall removed, at 487 s. This image shows that smoke had filled the void space above the ceiling and banked down to the showroom floor. Conditions on the east side, including the area near the entrance, are not as severe. However, as one progresses toward the rear and west, conditions degrade significantly.

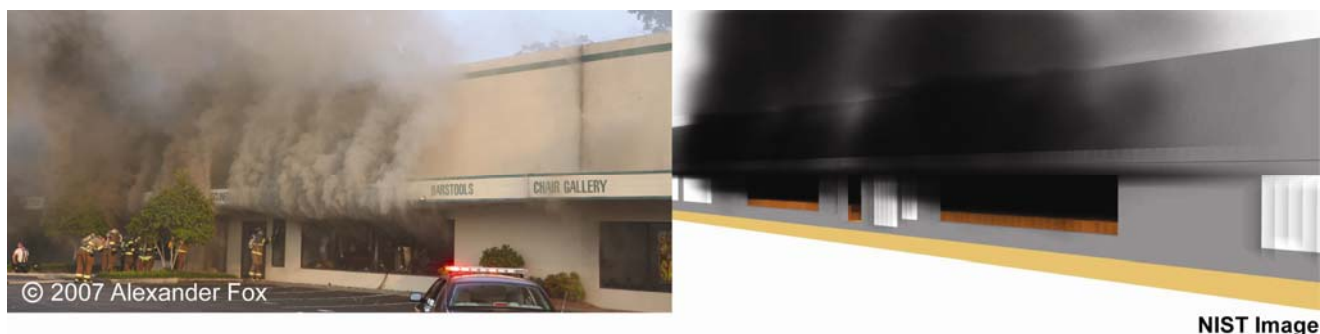
**Figure 4-21. Comparison between photo and rendered image from the simulation at 1530 s (7:36:23 p.m.). The view is of the front of the main showroom.**

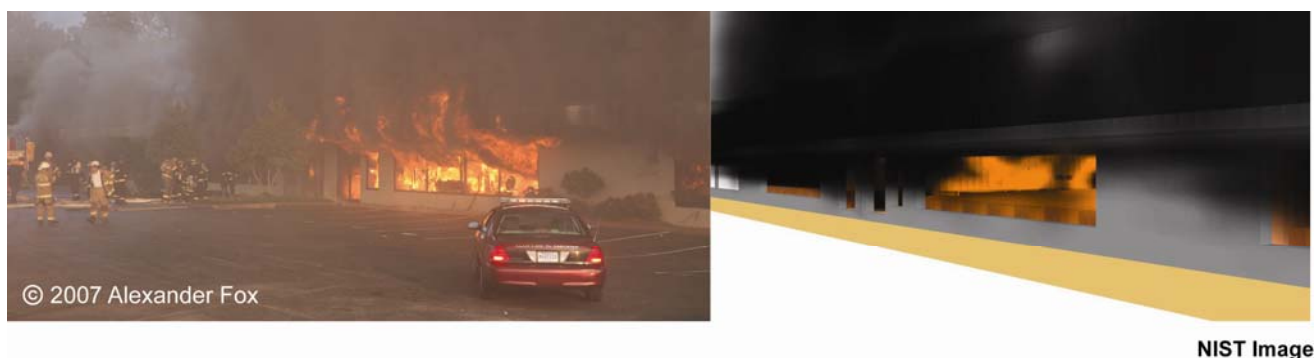
time, flames were not yet visible from the exterior through the front windows. By 1655 s (7:38:28 p.m.), shown in Figure 4-22, fire had reached the front of the main showroom and had stretched across the west side of the main showroom. At 1686 s (7:38:59 p.m.) flames were visible inside the west showroom, Figure 4-23, and the first window in this side had failed. By 1884 s (7:42:17), shown in Figure 4-24, fire had stretched across the front of the west showroom and two of the three windows were broken out.

**Figure 4-22. Comparison between photo and rendered image from the simulation at 1655 s (7:38:28 p.m.). The view is of the front of the main showroom.**

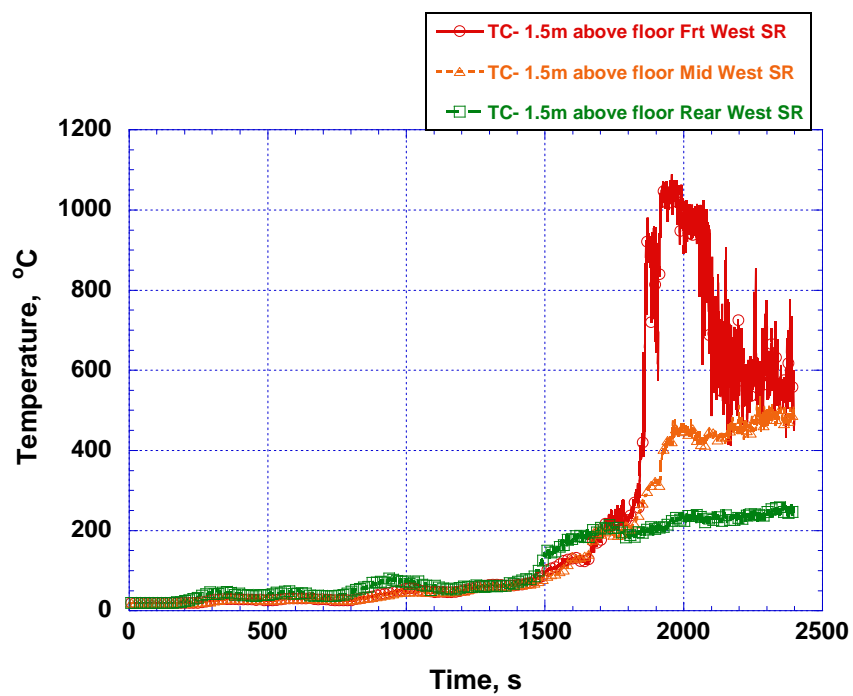
Figures 4-28 through 4-30 show charts of temperatures recorded at the locations throughout the main and west showroom as indicated in Figure 4-25. All data in these charts were recorded 1.5 m (5 ft) above the floor. Figure 4-28 shows temperatures in the west showroom. Temperatures in the west showroom remained relatively low, below 100 °C, until the fire began moving toward the front of the main showroom. The temperature at the rear sensor surpassed 120 °C at 1350 s (7:33:23 p.m.). As the fire in the main showroom continued to move forward, the temperature at the mid and front sensors reached 120 °C at 1400 s (7:34:13 p.m.)

Figure 4-28. West showroom temperatures for 1.5 m (5 ft) above floor.

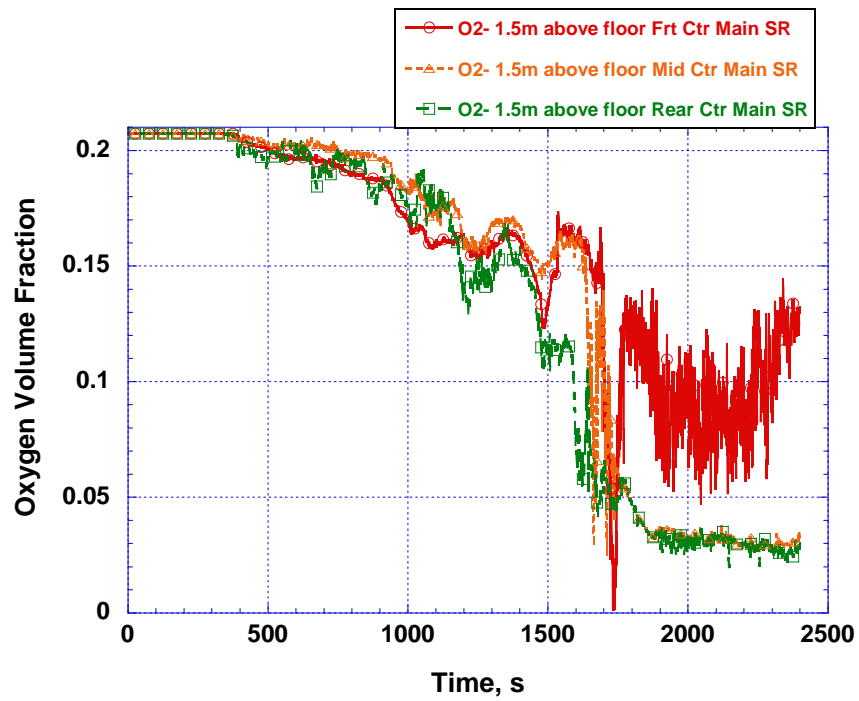
Figure 4-34. Main showroom (center) oxygen volume fractions for 1.5 m (5 ft) above the floor.

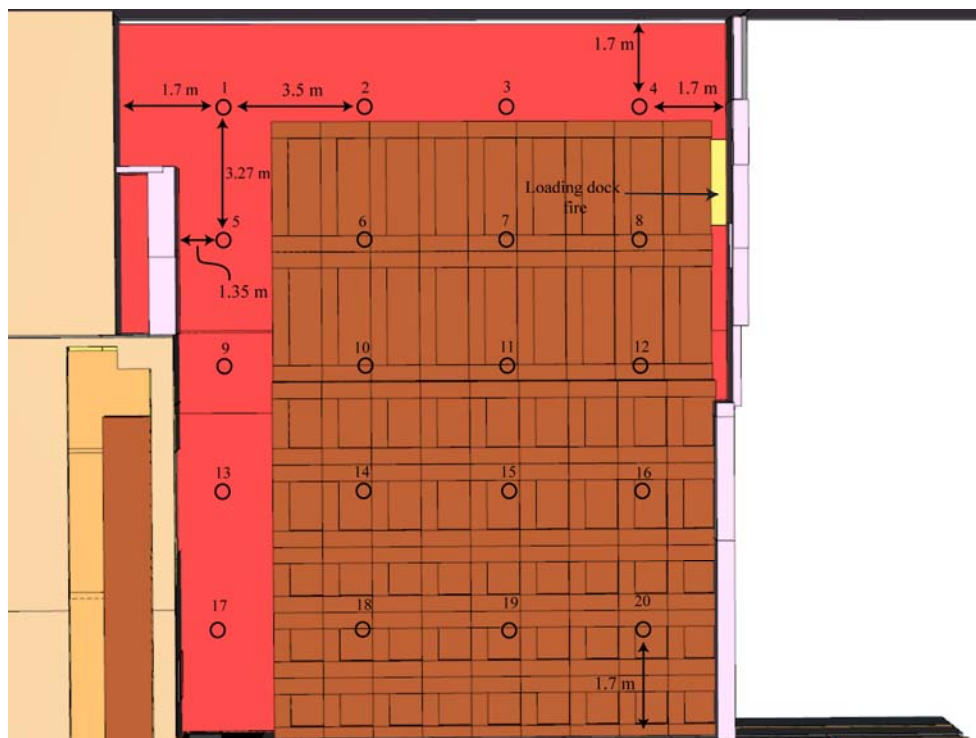
Figure 4-35. Sprinkler layout inside the enclosed loading dock.

Twenty sprinklers were placed inside the loading dock as shown by the black circles in Figure 4-35. The sprinkler specifications that were used in the simulation are detailed in Appendix K, Table K-6. In this configuration, the maximum protection area of coverage per sprinkler was approximately  $11.9 \text{ m}^2$  ( $128 \text{ ft}^2$ ) with a water density of approximately  $8.8 \text{ L min}^{-1} \text{ m}^{-2}$  ( $0.22 \text{ gpm/ft}^2$ ). Two sprinklers, labeled 4 and 8 in Figure 4-35, activated in the simulation. Sprinkler 8 was the first to activate, at 50 s, while sprinkler 4 activated at 75 s.

The sprinkler system layout was designed in accordance with NFPA 13, *Standard for the Installation of Sprinkler Systems* [17]. The system was designed as an Ordinary Hazard Group 2 wet pipe system, assuming that the enclosed loading dock area was heated. An Ordinary Hazard Group 2 sprinkler system was utilized in order to provide a more conservative estimate for the design area/water density as compared to an Extra Hazard design, for simulating the effects of sprinklers on fire conditions. The locations of the sprinklers within the enclosed loading dock are shown in Figure 4-35. Note that given the dimensions of the cells in the simulation, the locations of the sprinklers in the simulation vary up to 2 cm (0.8 in) from the layout shown. The specific locations of the sprinklers are given in the FDS input file. The sprinkler characteristics and operating parameters are given in Table K-8.

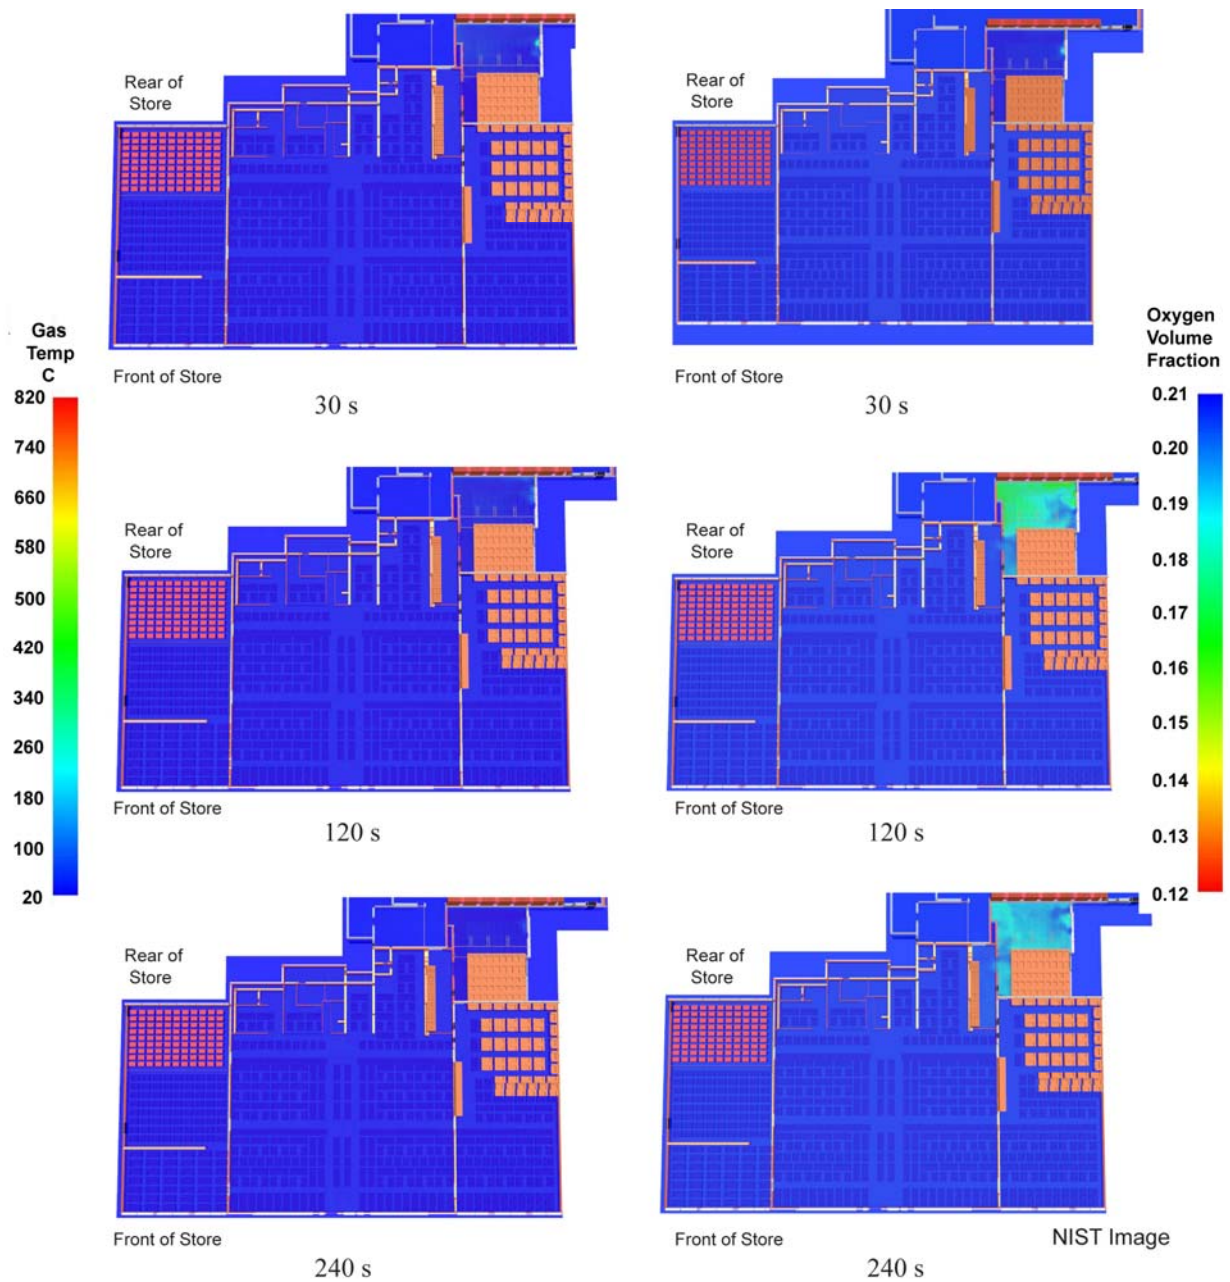
Figure 4-38 shows a series of images with a temperature slice 1.5 m (5 ft) from the floor rendered at a range of times between 30 s through 240 s. Note that the scale on these images is consistent with those in Figure 31. These images show that the area of elevated temperatures is limited to the immediate vicinity of the fire inside the loading dock.

A similar result is seen in the oxygen volume fraction data, shown in Figure 4-39. This figure shows a series of images 1.5 m (5 ft) from the floor at times between 30 s through 240 s. Depleted oxygen levels are observed in the vicinity of the holding area. The oxygen volume fraction at 1.5 m never drops below the tenability threshold of 0.12 (volume fraction). There is an increase in oxygen volume fraction between the final two images, as fresh air enters the holding area.

**Figure 4-38. Temperatures 1.5 m (5 ft) above the floor in the sprinklered simulation.**

**Figure 4-39. Oxygen volume fractions 1.5 m (5 ft) above the floor in the sprinklered simulation.**

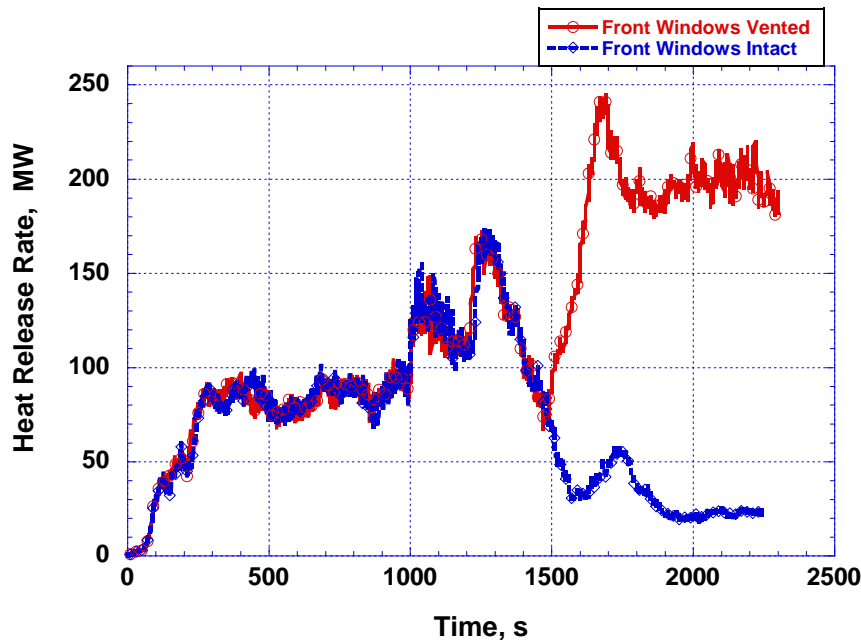
Figure 4-41 shows the change in HRR over time for this scenario and the baseline simulation. In both scenarios, HRR peaked at 120 MW at around 1300 s after which the HRR decreased. This would be consistent with the fire becoming underventilated. The venting of the front windows in the main showroom at 1457 s corresponds with the subsequent rapid increase in HRR for the base case. In the simulation with the windows intact, the HRR did not increase at approximately 1500 s, but continued to decrease until about 1600 s.

**Figure 4-41. Comparison of the heat release rate in the simulations for front windows vented and front windows intact.**

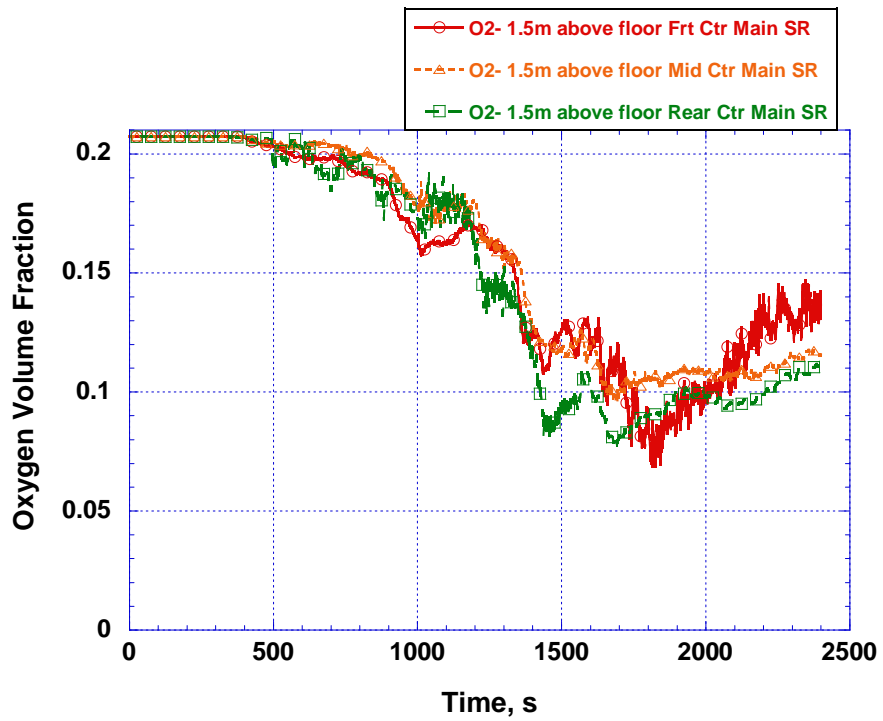
Figures 4-47 through 4-49 show oxygen volume fraction data for the front windows intact case that were recorded at the same sensor locations (Figure 4-25) as the baseline case. For the first 1000 s, the oxygen volume fraction in the west showroom (Figures 4-47 and 4-32) drops to about

0.16 for both cases. For about the next 400 s, the oxygen volume fraction decreases more slowly in both cases. By 1400 s the volume fraction drops below 0.1 for the windows intact case, but decreases to 0.15 for the base scenario. For the windows intact case, after the time when the windows would have been broken at 1457 s, the oxygen volume fraction in the rear of the west showroom begins to increase and peak at about 0.12 at 1850 s. The oxygen volume fractions in the mid and front of the west showroom decrease to 0.09 and 0.07, respectively. The oxygen volume fractions in the rear of the main showroom (Figures 4-48 and 4-33) show similar trends during the first 1300 s. For the windows intact case, the oxygen volume fraction became more steady between 0.07 and 0.09. The oxygen volume fraction for the same location in the base scenario continues to drop to less than 0.02. For the base case, after 1700 s, the oxygen volume fraction is less than 0.03 for the holding area, rear, and mid showroom. For the windows intact scenario, at about the same time, 1700 s, the oxygen volume fraction for the rear, mid, and front showroom locations are all above 0.07. Overall, the trends for both cases are similar during the early portion of the simulations, but after the time at which the windows were broken out in the base scenario, the oxygen volume fractions appear lower than in the front windows intact case for the rear holding, rear, and mid showroom locations.

Figure 4-49. Main showroom (center) oxygen volume fractions for 1.5 m (5 ft) above the floor.
