**NIST Special Publication 1164**

# **Preliminary Reconnaissance of the May 20, 2013, Newcastle-Moore Tornado in Oklahoma**

December 2013

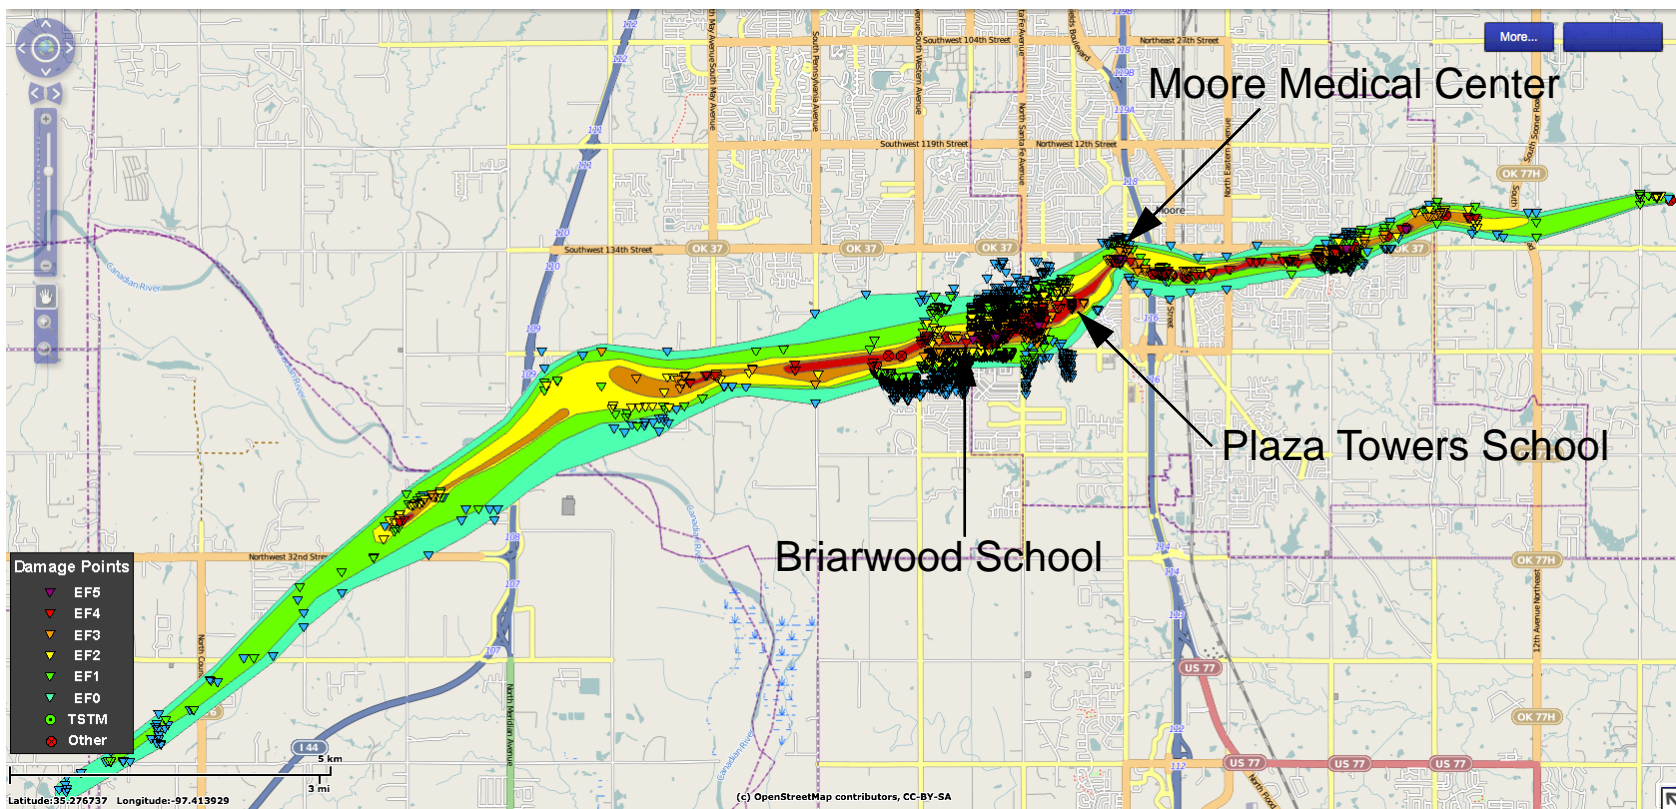
Figure 2-4. Tornado damage path map showing point estimates of EF damage at specific locations (triangles) and swaths for EF-0 (turquoise), EF-1 (green), EF-2 (yellow), EF-3 (brown), EF-4 (red) and EF-5 (purple) intensity damage (data source NOAA/NWS). The locations where damage was evaluated represents only a small percentage of the number of buildings damaged or destroyed by the tornado.

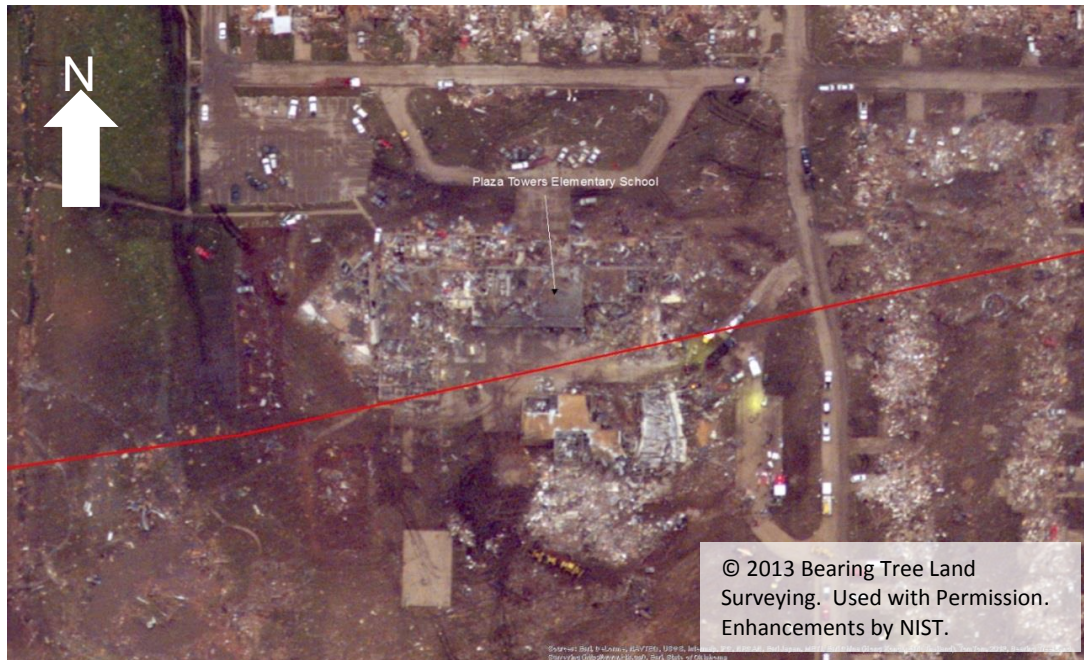
The buildings of Plaza Towers Elementary School sustained significant structural damage due to strong wind and debris impact loadings. Figures 4-4 and 4-5 show aerial views of Plaza Towers Elementary School shortly after the tornado hit. Following is a summary of the damage observed at this facility and related fatalities and injuries.

Figure 4-4. Aerial photograph of Plaza Towers Elementary School and proximity to estimated center of tornado damage path.

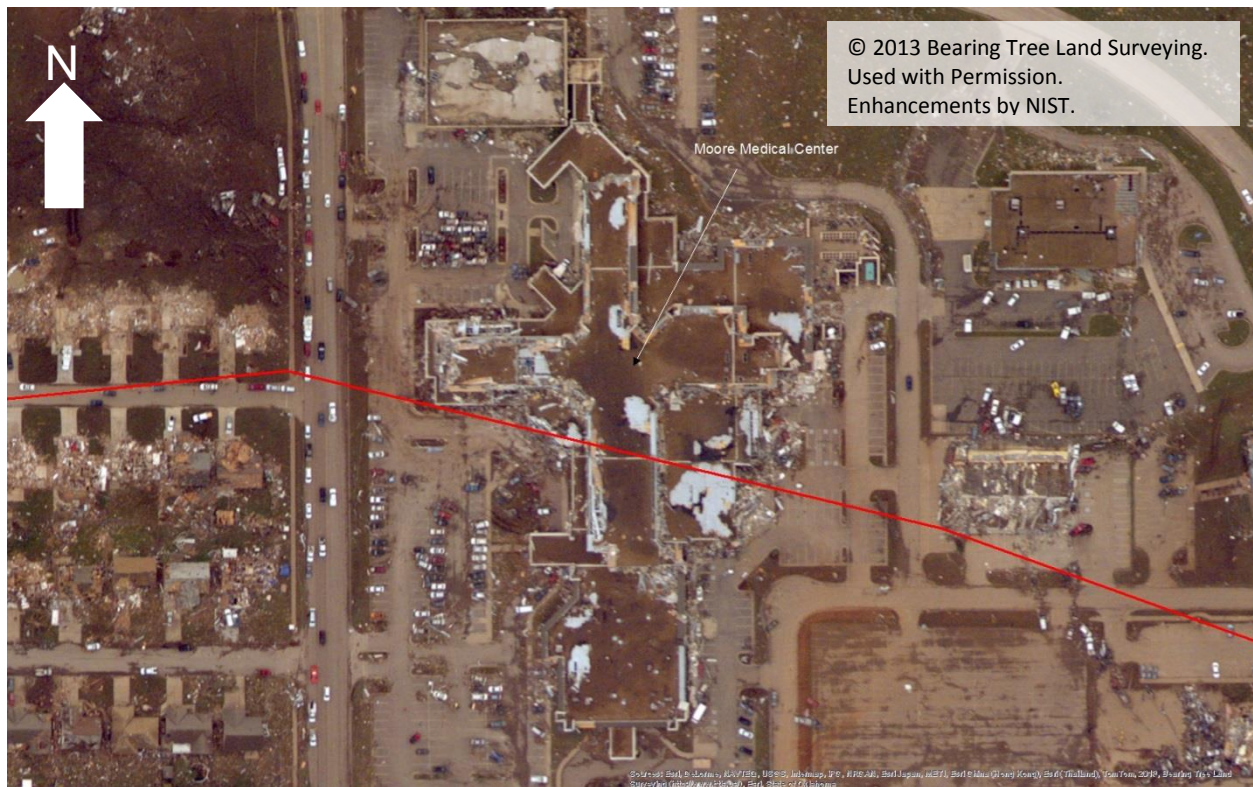
The estimated centerline of the tornado damage path passed close to the center of the facility (Figure 4- 23). The damage across the entirety of the exterior of the Moore Medical Center is shown in Figs. 4-24 through Figure 4-26. The figures show severe damage to much of the interior of the hospital and the medical office buildings. Similar to the two elementary schools discussed earlier in the report, the Moore Medical Center was also subjected to both wind and wind-borne debris impact loading; however, the structural damage to the Medical Center was minimal compared to the schools. Debris hazards included automobiles (and automobile parts) tossed against, into, and onto the building, and a large steel trash dumpster that landed on top of the second story of the west nursing wing of the hospital, damaging the roof deck and supporting bar joists (Figure 4-28).

Figure 4-23. Aerial photograph of Moore Medical Center shortly after the tornado struck, showing estimated centerline of the tornado damage path (in red).
