NIST Technical Note 1796

A Case Study of a Community Affected by the Witch and Guejito Fires: Report #2 – Evaluating the Effects of Hazard Mitigation Actions on Structure Ignitions

May 2013

This publication was a joint effort between the National Institute of Standards and Technology and the United States Forest Service (USFS).

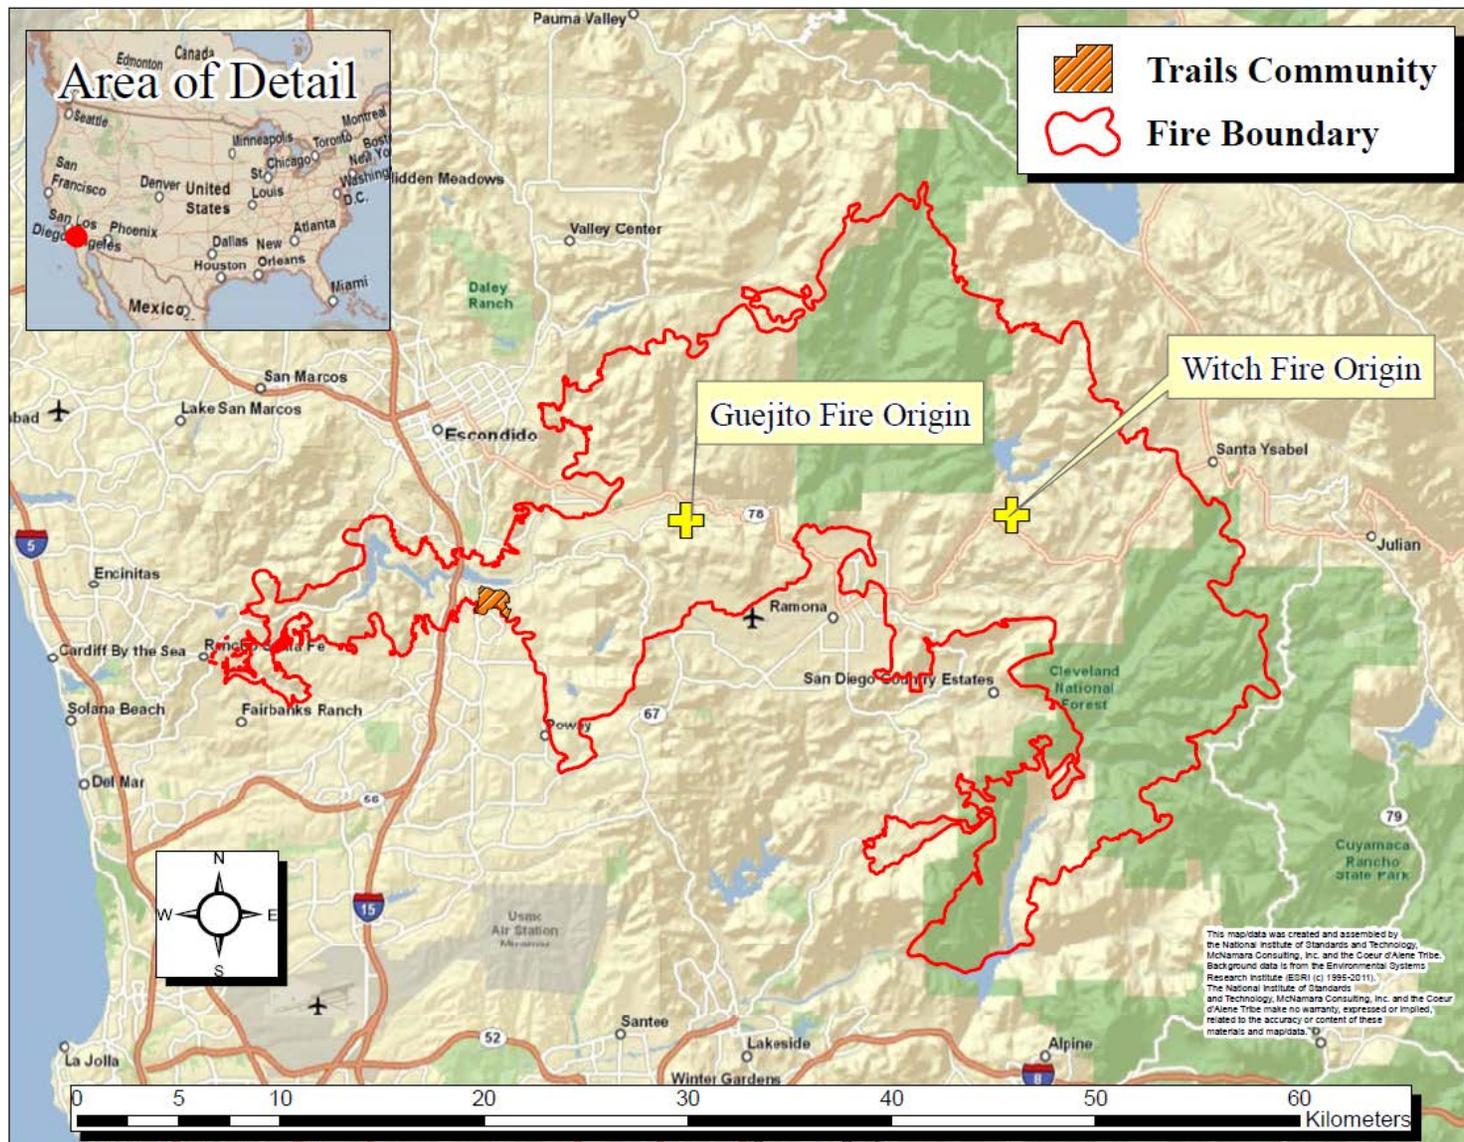
The combined perimeter of both the Witch and Guejito Fires along with the origins of each fire is shown in Figure 1. Figure 2 portrays the approach of the Witch and Guejito Fires to the Trails community.

Figure 1 Overview of the entire extent of the Witch and Guejito Fires in context with the United States. Also portrayed is the study area within the fire perimeter and the origins of the fires.

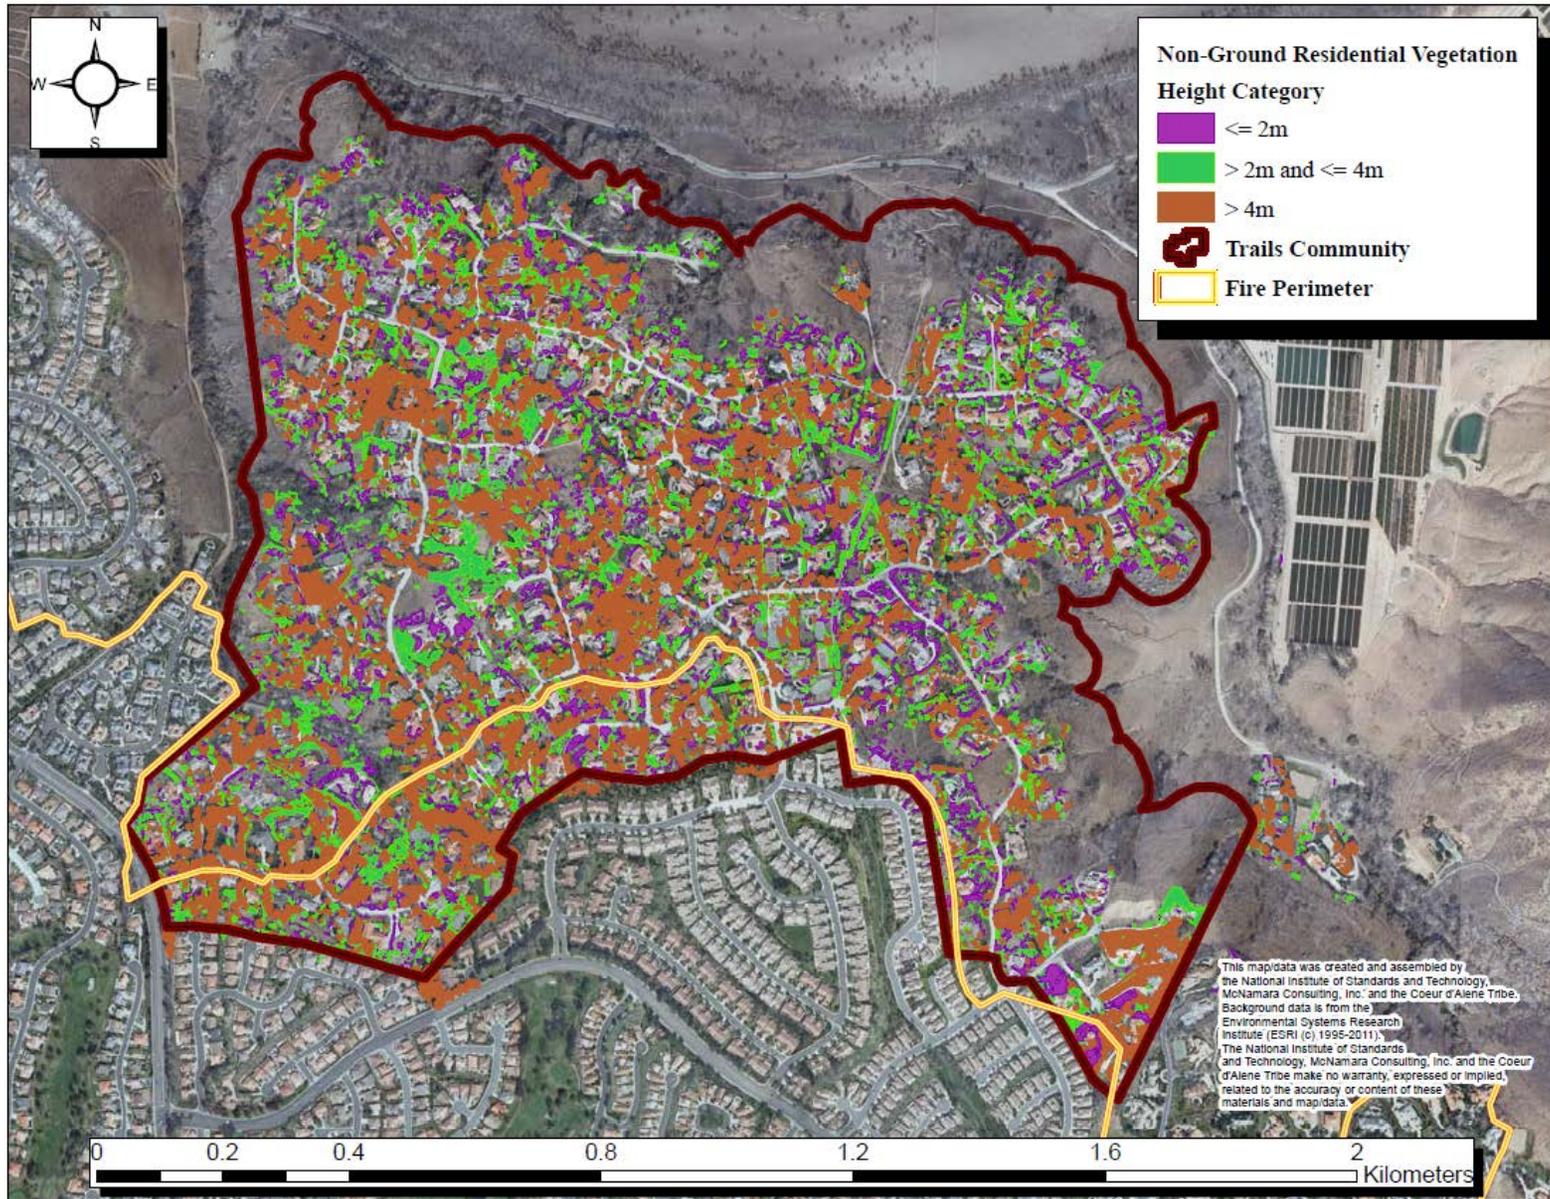
The height class vegetation polygons for non-ground vegetation mapped in the Trails community are displayed in Figure 10. Wildland vegetation community type polygons mapped in and around the Trails are displayed in Figure 11. Vegetation polygons displayed in Figure 10 were not mapped to community types but vegetation polygons

Figure 10 Above ground residential vegetation in the Trails overlaid with the Fire perimeter. Back ground imagery is 1 ft (0.3 m) horizontal resolution color imagery flown shortly after the fires.

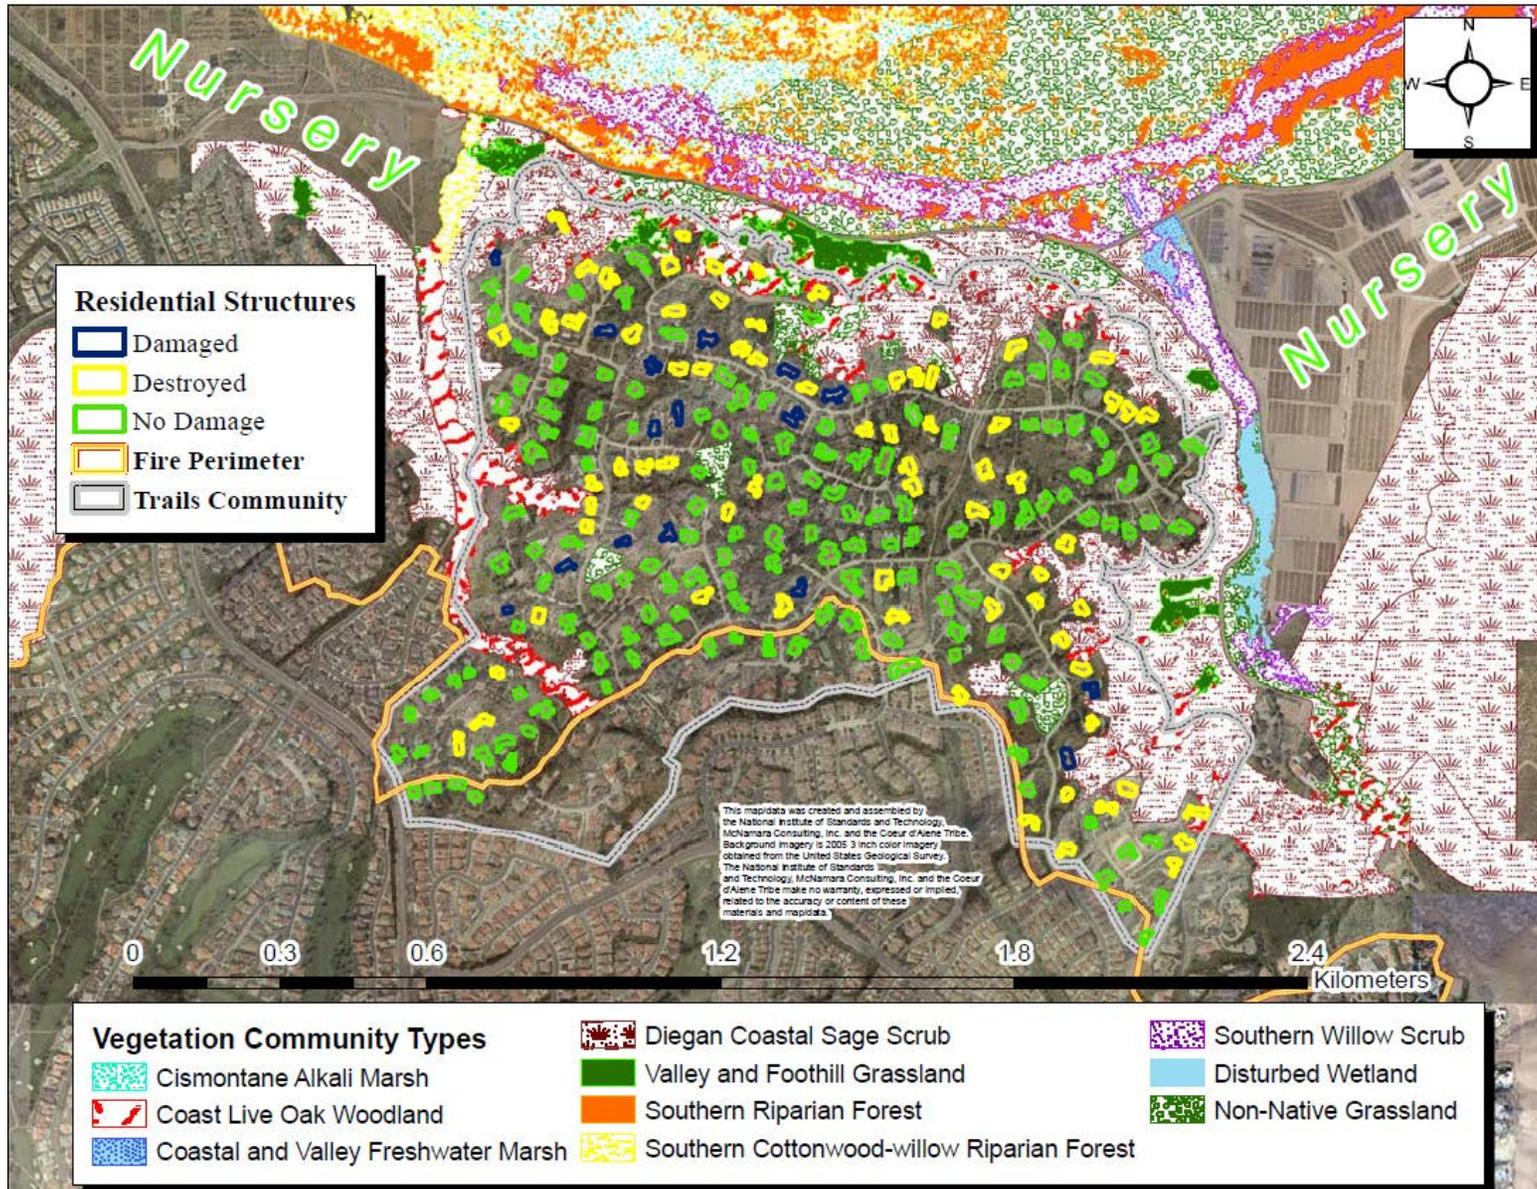
Figure 11 Wildland vegetation community types in and around the Trails overlaid with primary structures displayed by damaged status. Back ground imagery is 3 inch (8 cm) horizontal resolution color imagery from 2005.

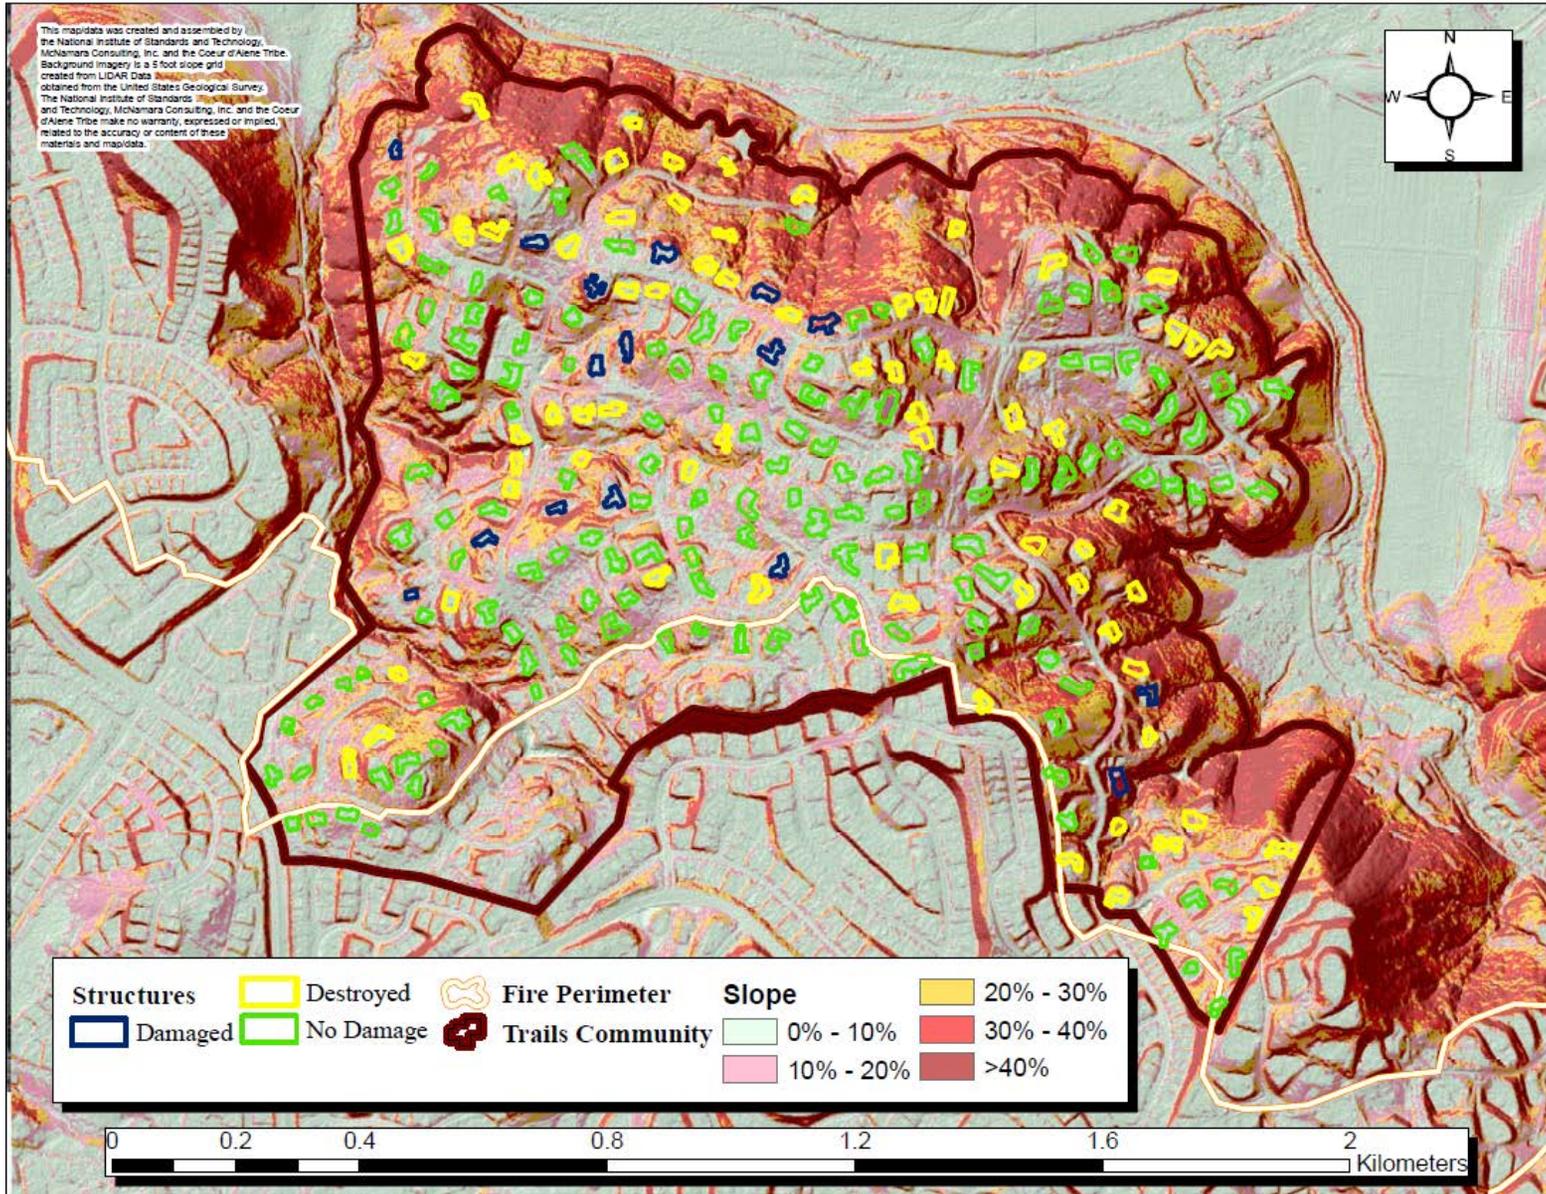
Other derivative products of the LIDAR point cloud included a digital elevation model (DEM) at a 1.5 meter (five foot) horizontal resolution derived from the LIDAR classified ground points using LP360. Ground points were converted to a triangulated irregular network (TIN) and the TIN was converted to a raster DEM using LP360. Again, using ArcGIS, percent slope and aspect grids were derived from the DEM and are shown in Figure 12 and Figure 13, respectively.

Figure 12 Trails percent slope raster data set derived from LIDAR 5 foot DEM overlaid with residential structure damage and destruction.

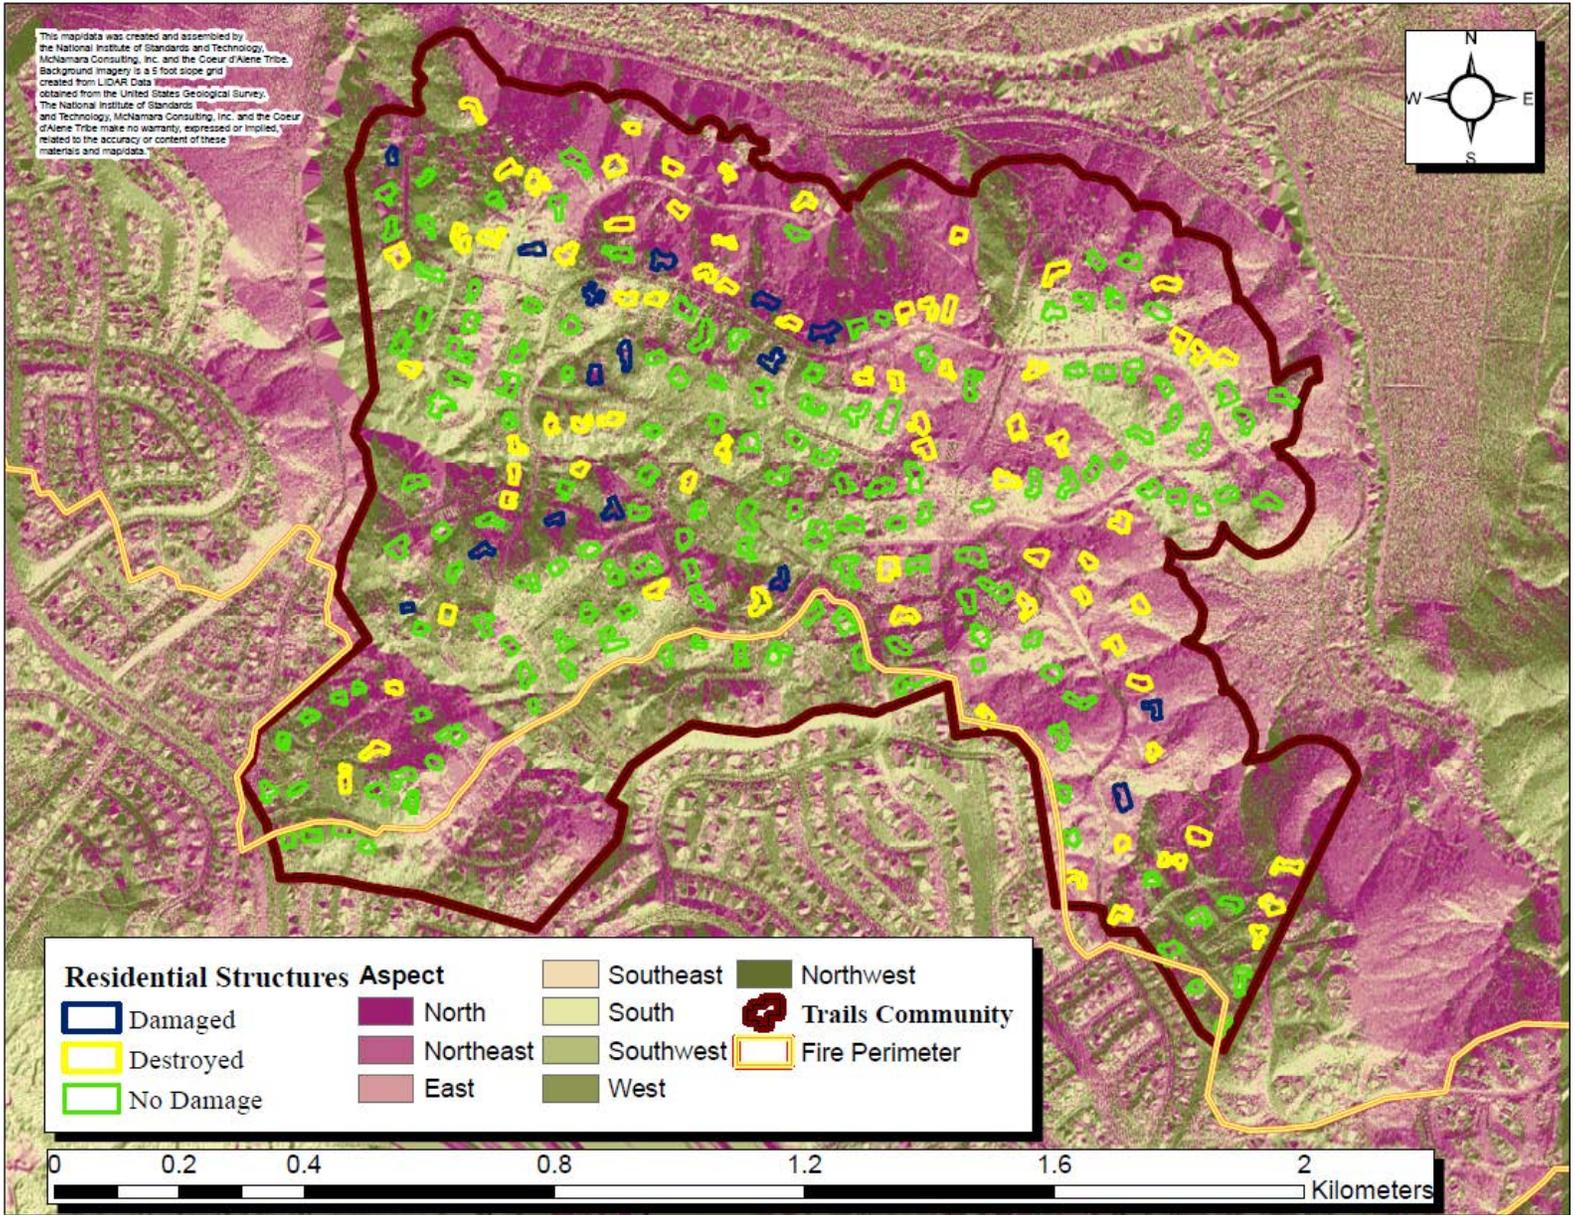
Figure 13 Trails aspect raster data set derived from LIDAR 5 ft (1.5 m) DEM and reclassified to eight directions and overlaid with primary structures displayed by damaged status.

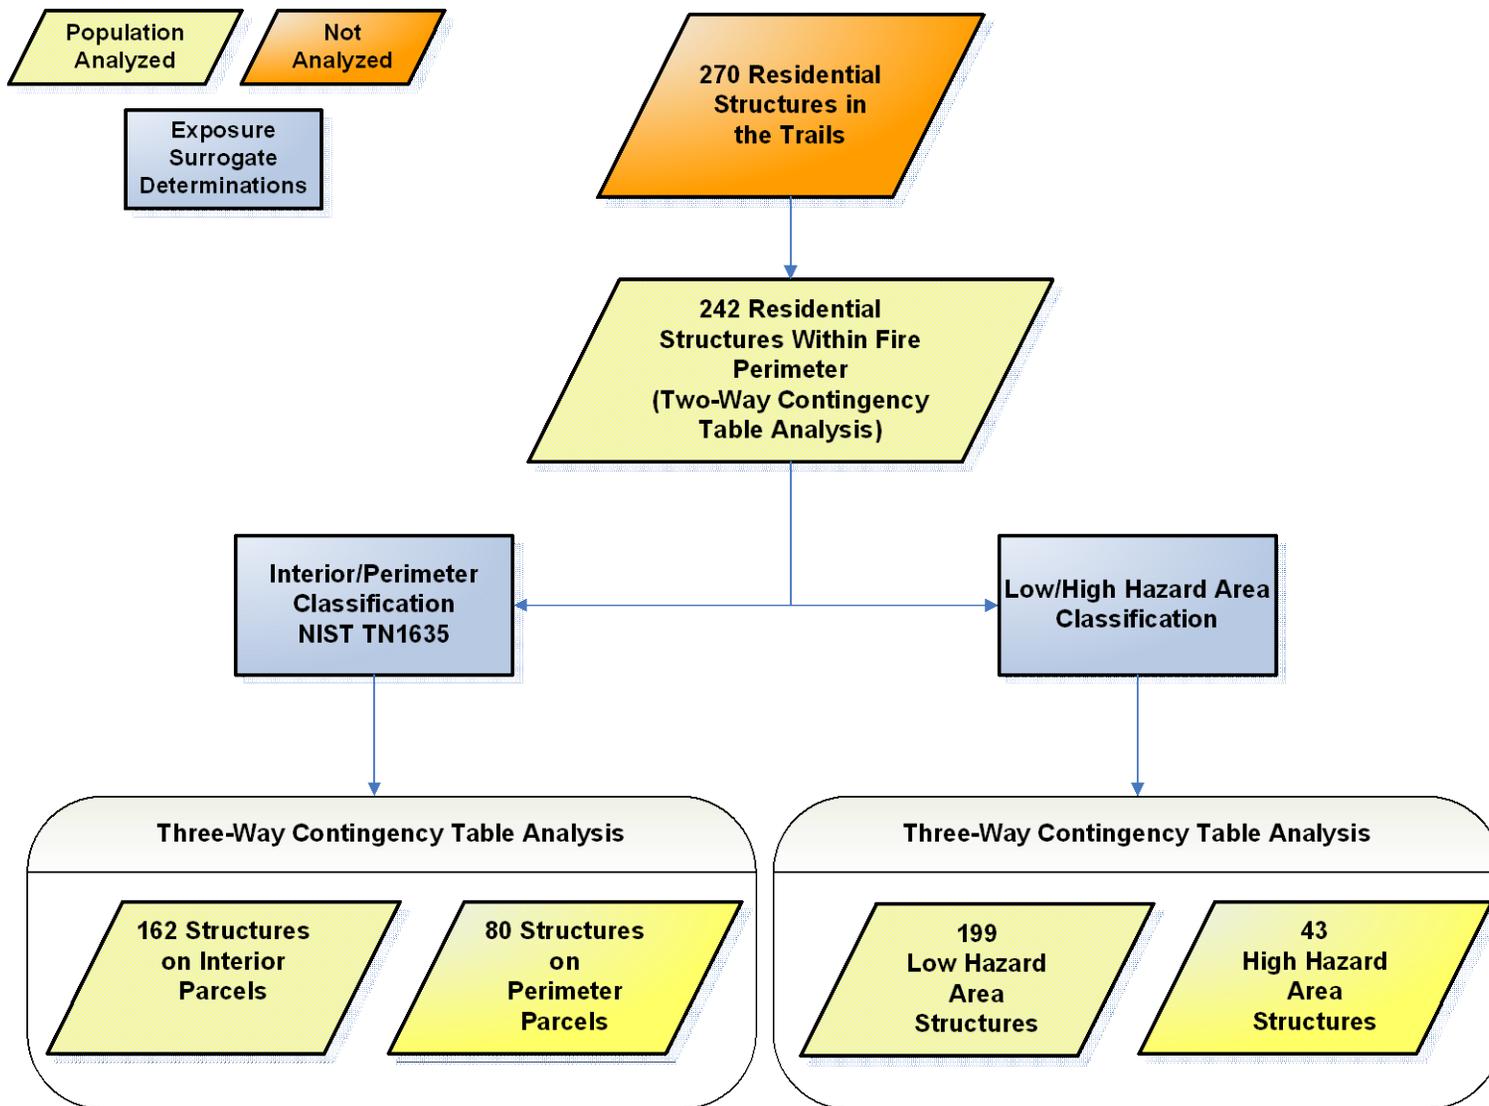
Certain methods presented in this section do assess the presence of Firewise treatments collectively but this is not intended to be an analysis of the combined effectiveness of Firewise treatments. The precise integration and accurate analysis of the data collected and produced in this report to determine the factor or, more likely, the set of factors under various scenarios that result in a structure's increased risk of ignition from wildland fire or embers is a complex process. A future report will attempt to address the feasibility of conducting such a task given the available data using various models (e.g. GIS, Logistic Regression, Fire Behavior Models) for demonstration. Nonetheless, an examination of the treatments presented below has been invaluable in the development of the NIST WUI Assessment System deployed at the Tanglewood Complex Fire (Amarillo, Texas 2011) and can be used to provide insight into the data in terms of data collection methodology for future post-fire assessments. More importantly, the NIST data collection methodology utilized in this report does facilitate the analysis of the Firewise treatments evaluated for this study, even if at a specific type of treatment level. The overall analysis framework for the assessment of the effectiveness of Firewise treatments is presented in Figure 15.

Figure 15 Overview of data analysis steps

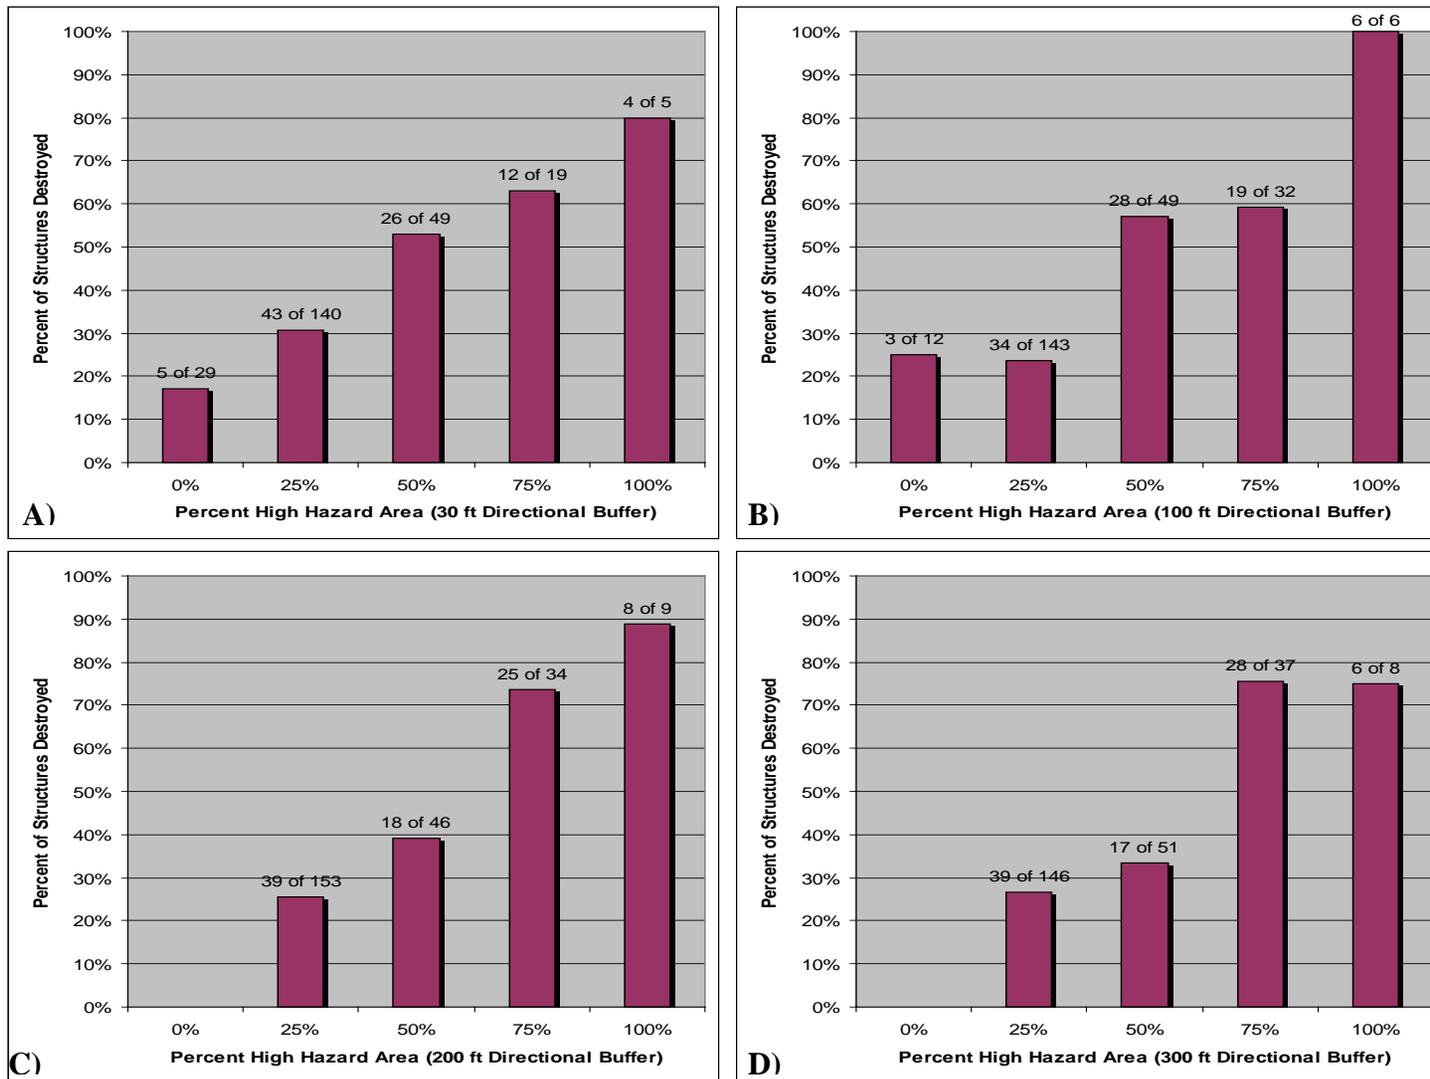
Evaluation for the high/low hazard area method is portrayed in Figure 25 displaying bar graphs showing percent of residential structures damaged or destroyed grouped by bins of percent of high hazard area present between 0 and 200 feet from the structure in the upwind direction. Figure 25 displays the above described bar graph for the following sector distances: 0 to 30 feet (0 m to 9 m), 0 ft to 100 ft (0 m to 30 m), 0 ft to 200 ft (0 m to 61 m) and 0 ft to 300 ft (0 m to 91 m). Another portrayal of the data shown in Figure 25 is presented in Table 18, displaying frequency counts of structure response with percent destruction by bins of percent high hazard area for four directional sectors from the structure. These losses, as described in Table 18, were for all structures independent of construction or landscaping hazard mitigation solutions. Aggregating the data further it can be seen that at the 30 foot sector and greater than 50% high hazard area in the down fire direction that 69% (20 of 29) of the structures were damaged or destroyed; 66% (25 of 38) at the 30 m (100 ft) sector; 75% (33 of 44) at the 61 m (200 ft) sector; and 76% (34 of 45) at the 91 m (300 ft) sector. As mentioned previously, the high/low method does not account for vegetation treatment and it is possible the lower average percent destruction in the 9 m to 30 m (30 ft and 100 ft) sector is due to this fact.

Figure 25 Bar graphs portraying percent primary structures destroyed by bins of percent of wildland vegetation present in the respective sector distance. A) Shows results for 0 ft to 30 ft (0 m to 9 m) sector. B) Shows results for 0 ft to 100 ft (0 m to 30 m) sector. C) Shows results for 0 ft to 200 ft (0 m to 61 m) sector. D) Shows results for 0 ft to 300 ft (0 m to 91 m) sector.
