NIST Technical Note 2055

Compartment Fire Experiments on Long-Span Composite-Beams with Simple Shear Connections Part 2: Test Results

November 2019

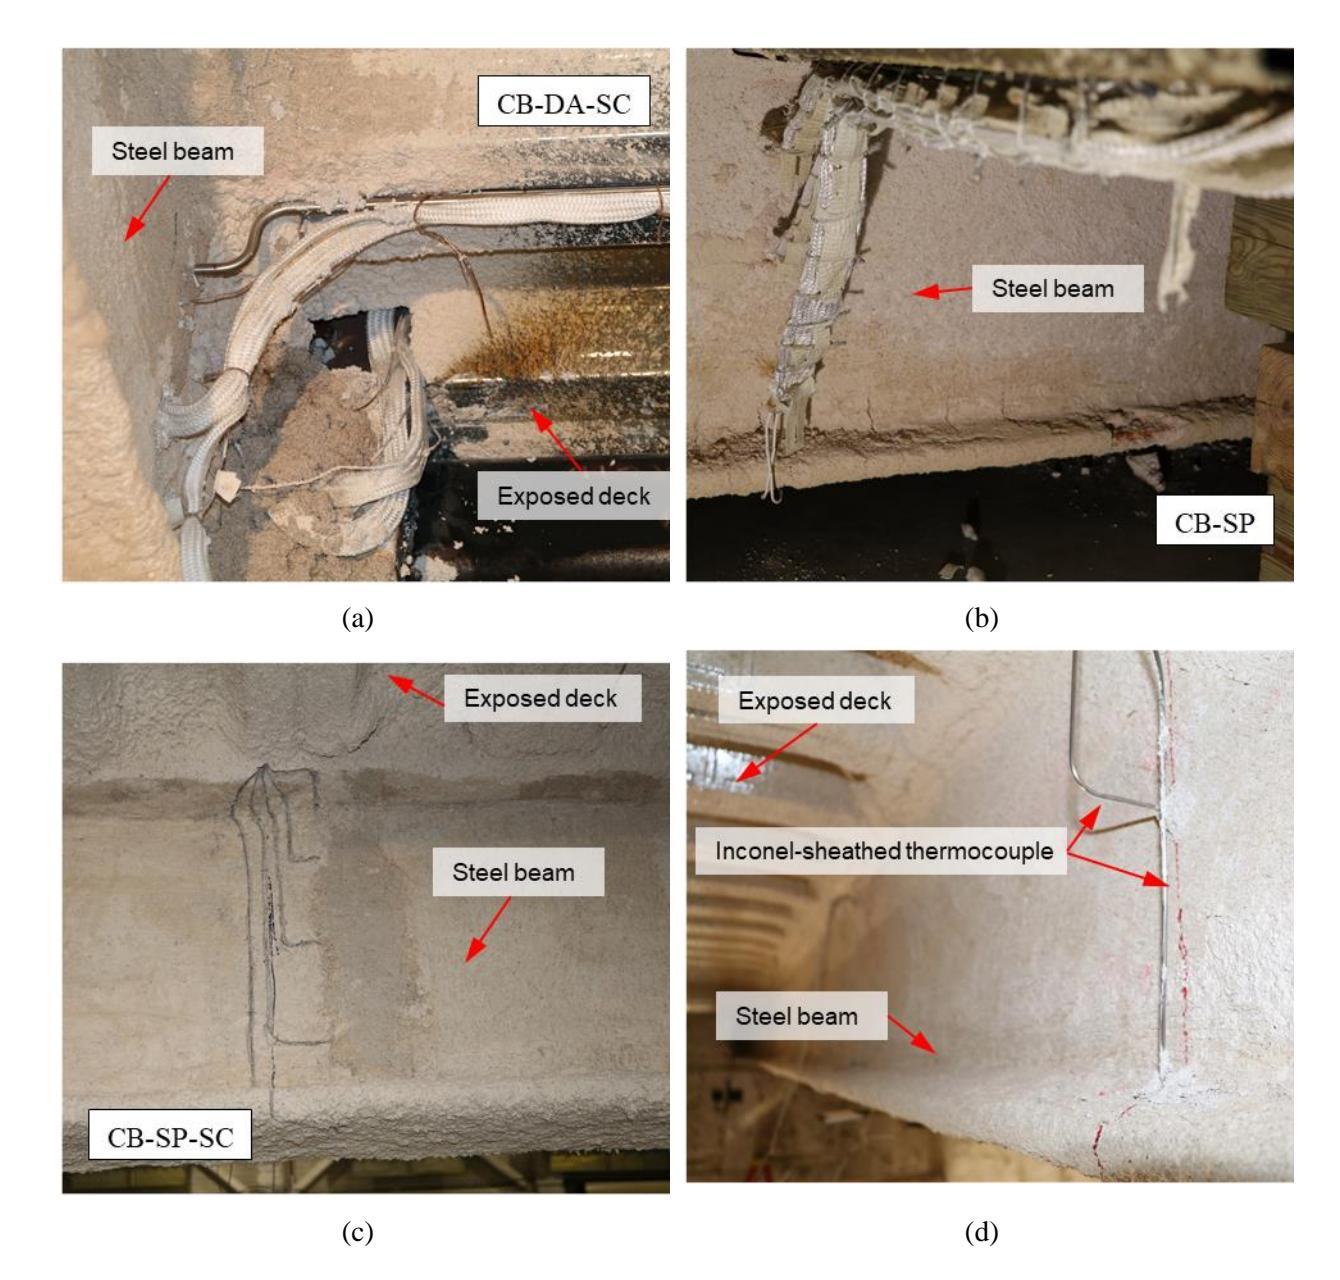
Bare-bead thermocouples were mounted to the W18×35 steel beams using a peening method (Choe et al. 2018) prior to the installation of the SFRM. However, the experiments showed that inadequate insulation of thermocouple lead wires affected the temperature data. For the first specimen (CB-DA), the exposed glass fiber shielding of thermocouples mounted to the steel beam (Figure 7b and Figure 7c) burned off around 10 min after ignition. As the specimen deformed in the fire, thermocouple lead wires made secondary junctions elsewhere inside the compartment in addition to the bead installed at the steel beams. For the remaining specimens, various insulation schemes were applied to salvage mounted thermocouples as described below.

For CB-DA-SC, both ceramic-impregnated fabric sleeves and stainless-steel piping were used to protect the glass-shielded thermocouple wires (Figure 28a). Figure 29a shows the bottom flange temperature measured using glass-sheathed thermocouples (TC3-15, TC4-15, TC5-15, TC6-15) and Inconel-shielded thermocouples (STC2, STC3). The temperature readings from both the glass shielded and Inconel sheathed thermocouples were similar until the fire exposure time reached around 11 min. Despite the use of ceramic-impregnated fabric sleeves as a supplementary cover, the glass braid insulation of thermocouple wires burned off when the upper layer gas temperature exceeded 500 °C. This insulation failure caused an apparent sudden increase in the bottom flange temperature readings from these thermocouples may indicate the average values of the bottom flange temperature and hot gas temperatures inside the compartment.

For CB-SP, each conductor of existing glass-shielded type-K thermocouples (alumel and chromel) were separated by high-temperature fabric sleeves and ceramic beads (Figure 28b). Figure 29b shows the bottom flange temperatures measured using glass-sheathed thermocouples with modified insulation (TC2-15, TC4-15) and Inconel-sheathed thermocouples (STC2, STC3). Both insulated thermocouples indicated the temperature data comparable until 32 min (Figure 29b) and became unreliable afterwards. For CB-SP-SC, glass-shielded thermocouple wires were placed under the SFRM coating of the steel beam and running through the concrete slab and thin grooved regions were then filled with fresh SFRM (Figure 28c). No thermocouple wires were directly exposed to upper layer gas temperatures. The temperature data from these thermocouples were more reliable as presented in Subsection 3.3.2.

Figure 28 Photographs of thermocouples mounted to the steel beams with various insulation methods: (a) high-temperature ceramic fabric and stainless-steel tubing for CB-DA-SC, (b) ceramic beads and fabric used to separate chromel and alumel wires for CB-SP (photo taken after test), (c) grooved SFRM coating for CB-SP-SC, and (d) Inconel-sheathed thermocouples.

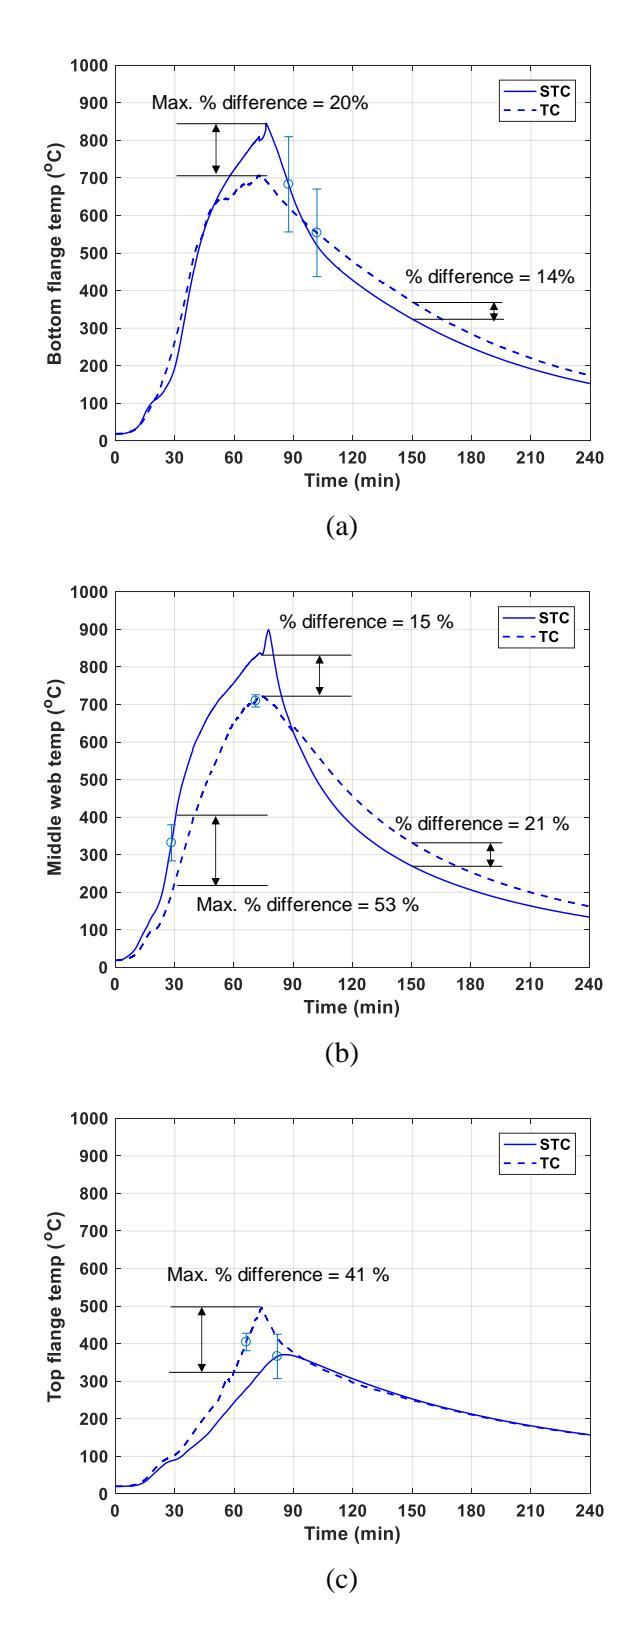
Figure 30 shows a comparison of the average temperature of the top flange, middle web, and bottom flange of the steel beam for CB-SP-SC using glass-sheathed thermocouples (protected under the SFRM layer) with that measured using Inconel-sheathed thermocouples. Glass-shielded thermocouples are indicated with TC; Inconel-sheathed thermocouples are labeled with STC. Table 10 shows a list of thermocouples used to calculate the average values and standard deviations plotted in Figure 30. Error bars indicate a maximum standard deviation. As shown in Figure 30a, for CB-SP-SC, both TC and STC thermocouples measured comparable bottom flange temperatures up to 50 min; however, the peak temperature differed by 20 % around 73 min. The SFRM coating on the lower flange cracked in tension as the steel beam deformed in fire, possibly introducing hot gas around the probes of STC thermocouples. For the middle web and the top flange (Figure 30b and Figure 30c), the temperature data from the two different methods deviated after less than 30 min of fire exposure. During the heating phase, the Inconel-sheathed thermocouples indicated the higher temperatures at the middle web but the lower temperatures at the top flange than the glass-sheathed thermocouples. The maximum discrepancy was 41 % at the middle web and 53 % at the top flange, suggesting that the STC probes were separated from the steel substrate. As the specimen bent during heating, the STC probe beads contacting the middle web might have been partially exposed to hot gases, resulting the higher temperatures than the TC probes. Conversely, the STC probe measuring the top flange was surrounded by SFRM filled between the bottom rib of the trapezoidal steel decking and the steel beam; hence, the displaced STC probe measured lower temperatures than the TC probes.

Figure 30 Comparison of temperatures of (a) bottom flange, (b) middle web, and (c) top flange measured using glass-sheathed (TC) and Inconel-sheathed (STC) thermocouples for CB-SP-SC. Error bars indicate the maximum standard deviation of temperatures measured at multiple locations along the beam length.

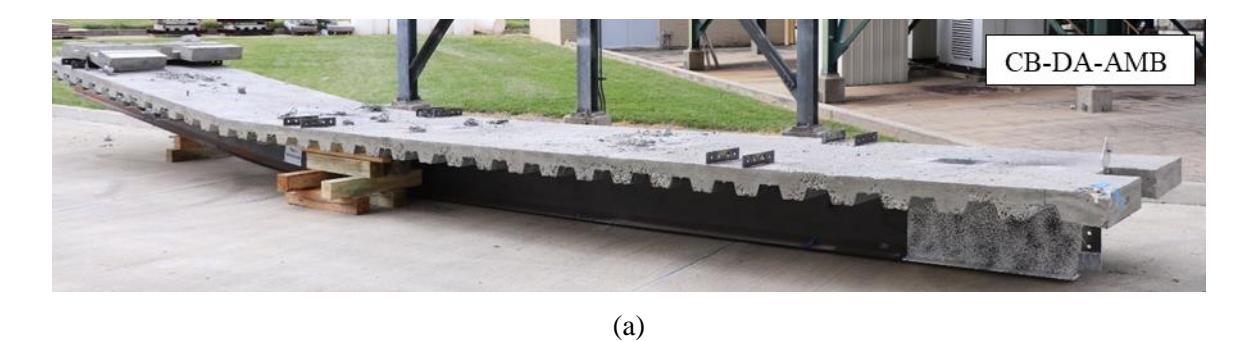
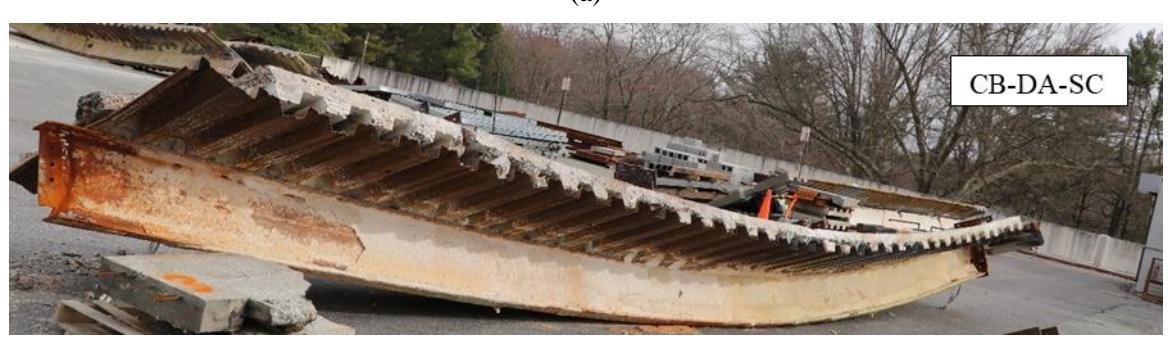
Figure 46 Photographs of deflected shape of (a) CB-DA-AMB and (b) CB-DA-SC.

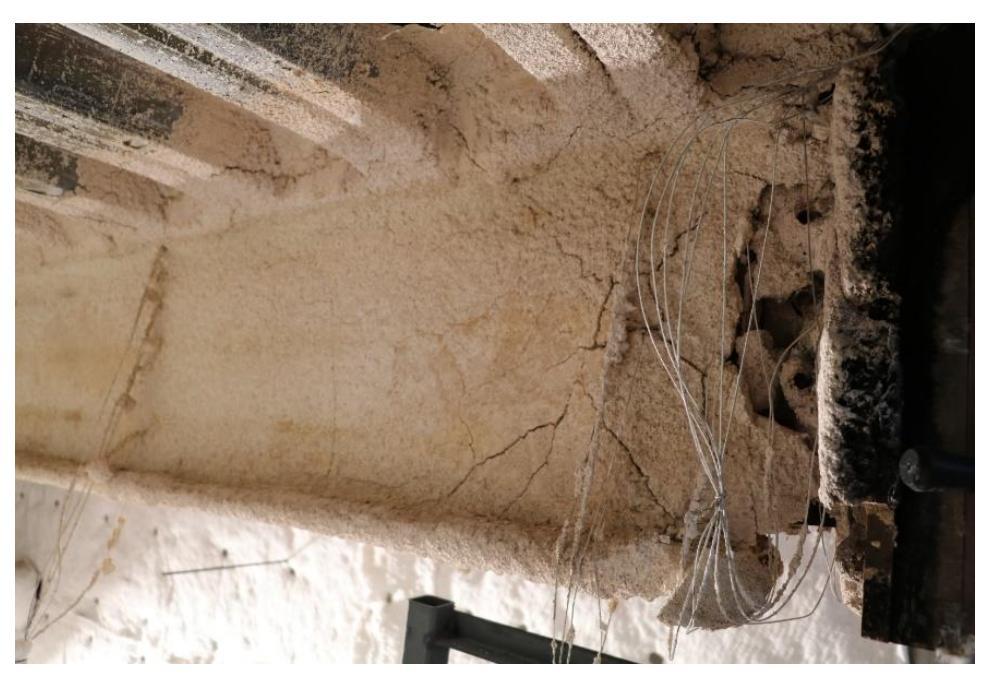
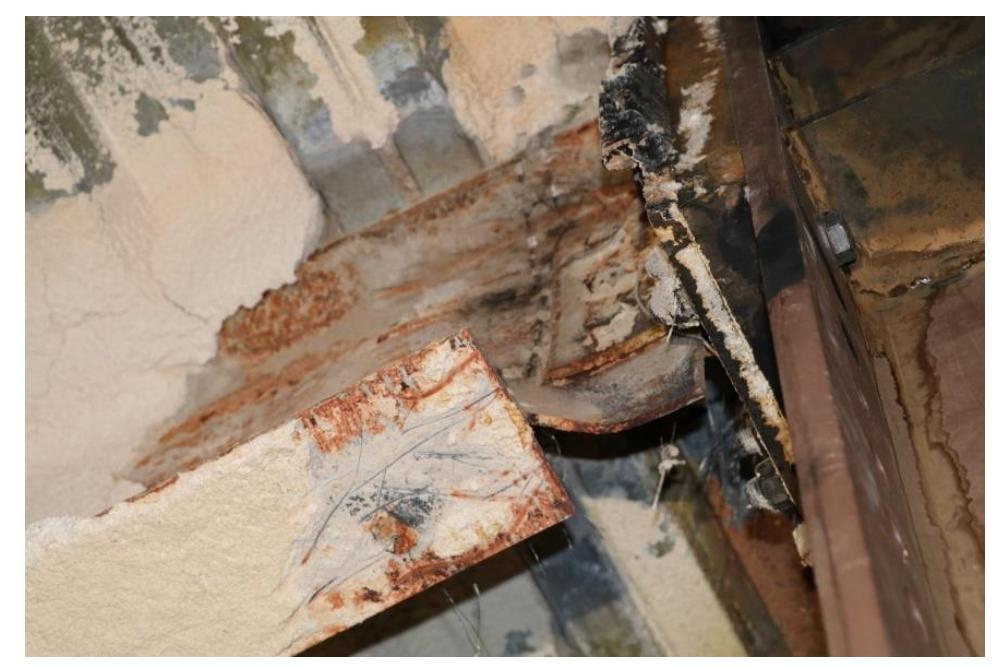
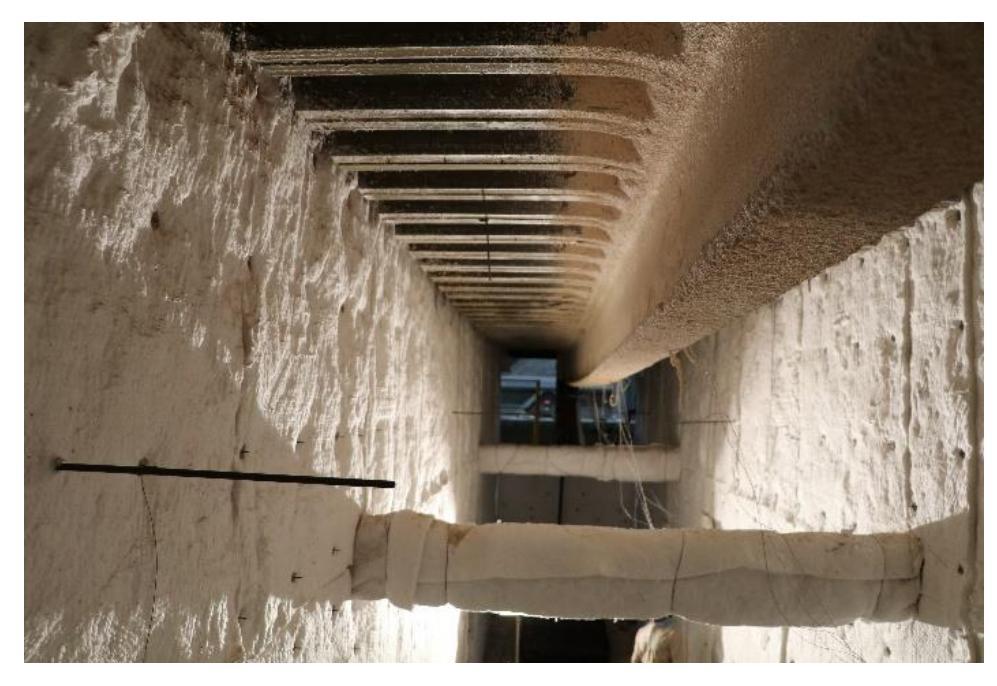
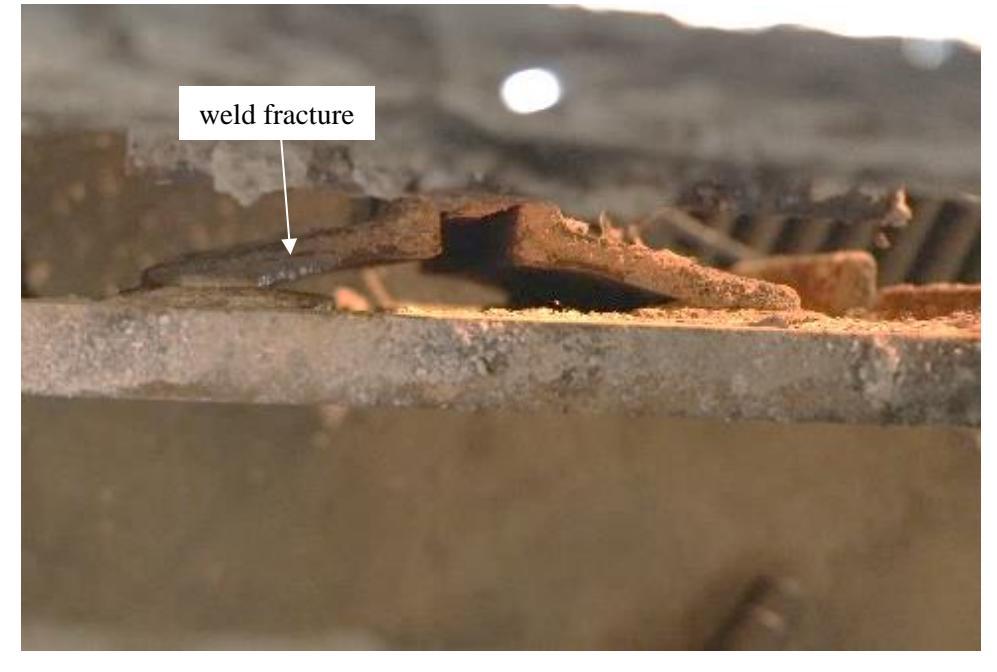
- Weld joint between the top of angle legs fractured (Figure 55d).
- No flexural cracks appeared on top of the concrete.

Figure 55 Post-test images of CB-DA: (a) cracked SFRM near east connection, (b) west angle connection after SFRM was removed, (c) steel beam covered with SFRM that remained intact after test, and (d) fracture of weld between top of angle legs and a sacrificial plate attached to the flange of east column.

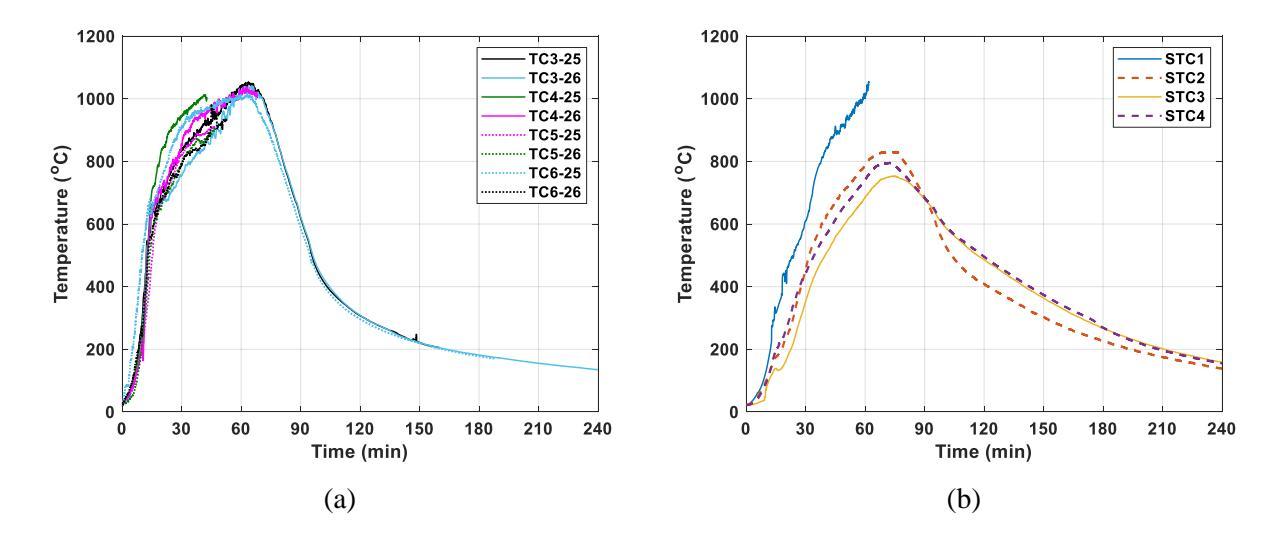
- Temperatures of exposed steel deck increased from 600 °C to over 1000 °C while the heat release rate was approximately 4000 kW from 13 min to 94 min (Figure 63a).

- The bottom flange temperature measured using Inconel sheathed thermocouples (STC2 through STC4) increased to nearly 700 °C on average at 60 min and to 800 °C at 94 min (Figure 63b) The higher temperature of STC1 was caused by dislodging of this thermocouple.

Figure 63 Temperatures of (a) exposed steel deck and (b) bottom flange temperature for CB-DA-SC. Discontinuity of data indicates dislodging of thermocouples.

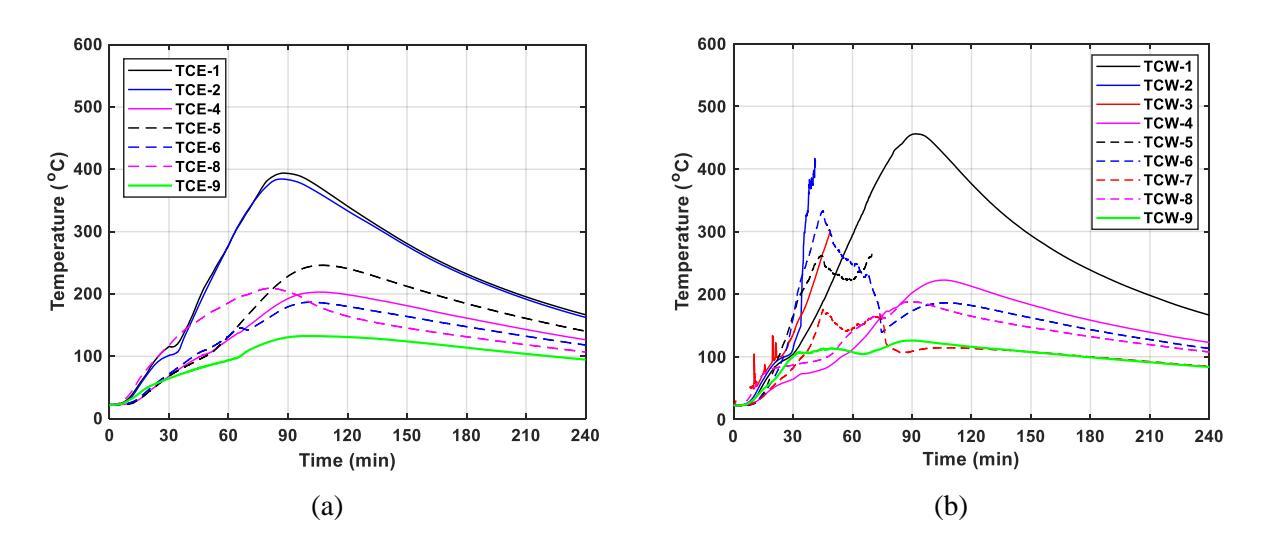
- For the east connection region, the beam web next to angle legs increased to 400 °C and the temperature of angles never exceeded 250 °C due to thicker coating of SFRM (Figure 64a). Some thermocouples in the west connection region were dislodged after 30 min (Figure 64b).

Figure 64 Temperatures of (a) east and (b) west connection region for CB-DA-SC. Discontinuity of data indicates dislodging of thermocouples.

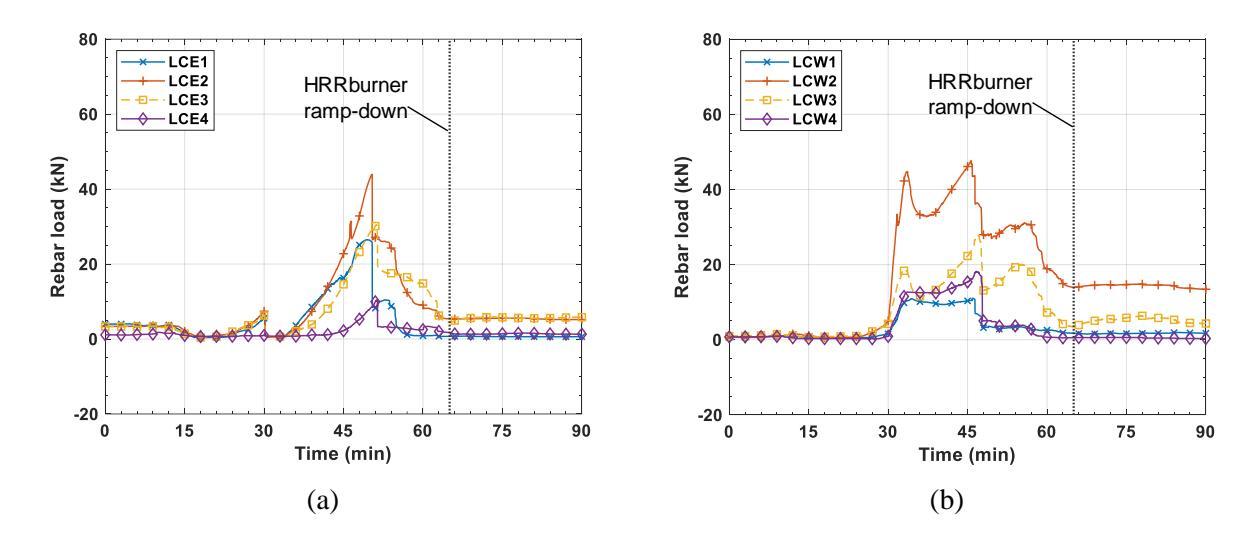
- Figure 65 shows the tensile loads on the No. 4 reinforcing bars anchored at the location of girders as a function of fire exposure time. In the east support, the load transferred through middle reinforcing bars (LCE2 and LCE3) sharply diminished around 50 min possibly due to concrete facture. In the west support, the slab continuity achieved by middle reinforcing bars (LCW2 and LCW3) appeared to be lost around 57 min.

Figure 65 Tensile loads on No. 4 reinforcing bars anchored at (a) east and (b) west end (CB-DA-SC).

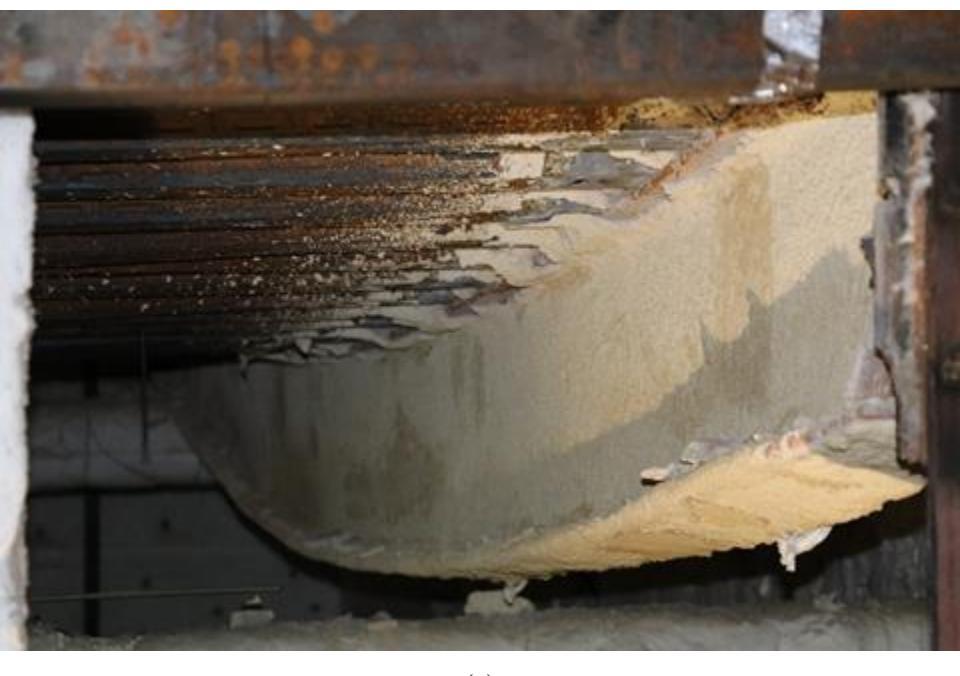
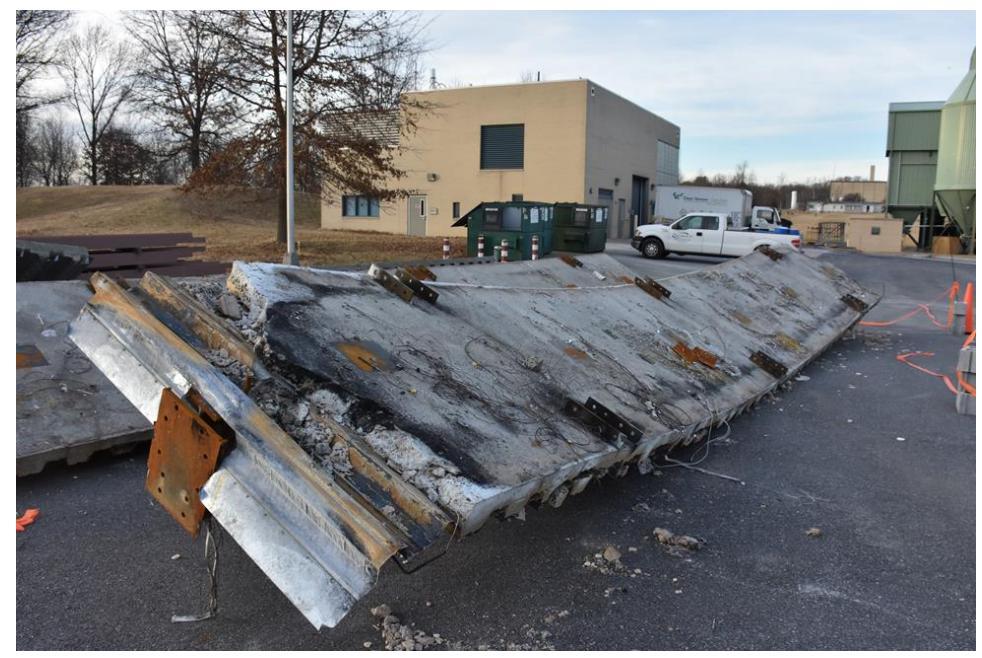
Figure 70 Photographs of (a) deflected shape of the steel beam covered with SFRM inside the test compartment, and (b) deformation of the concrete slab after cooling (CB-DA-SC)

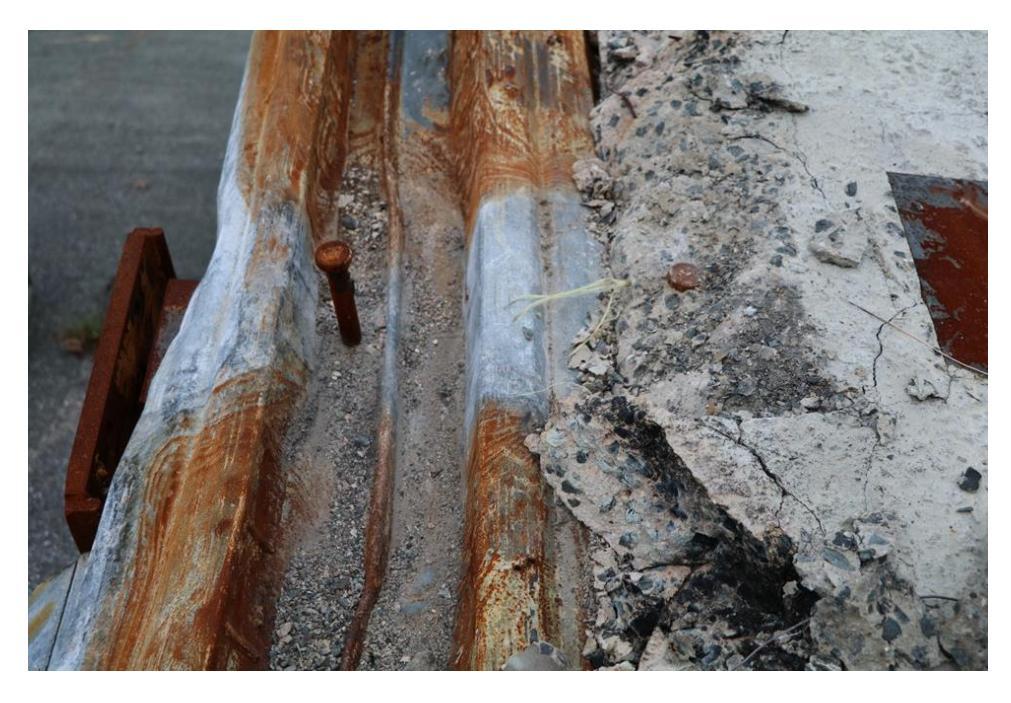
Figure 73 Photograph of shear studs at the west end after cooling (CB-DA-SC).

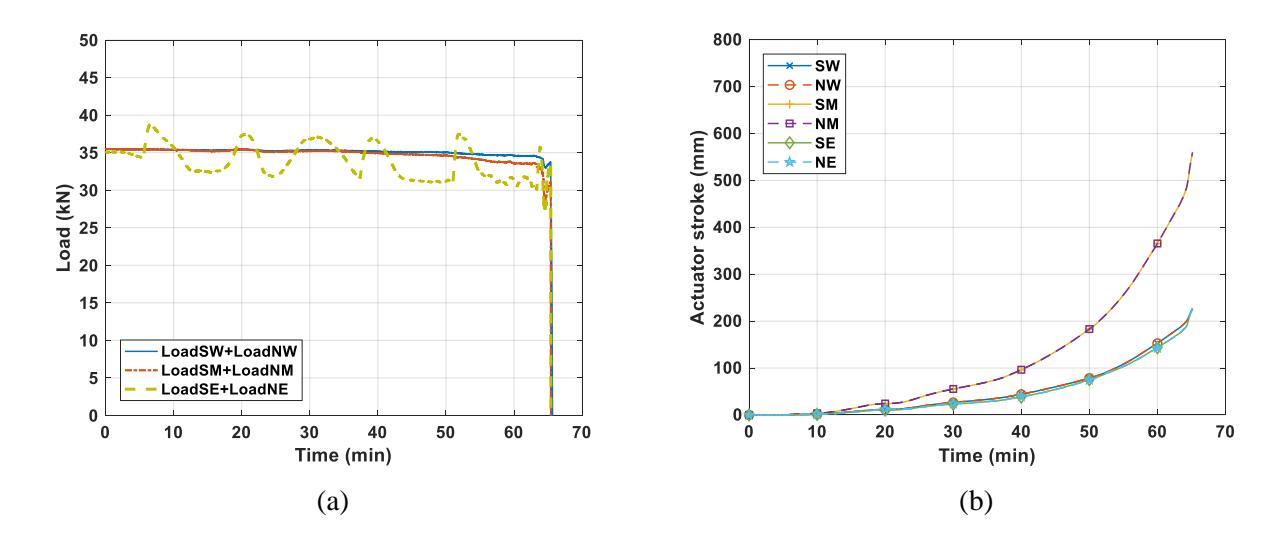
• As shown in Figure 74a, loads applied using SE and NE actuators fluctuated due to a servovalve problem similar to that observed in the testing of CB-DA. The standard deviation of the summed value (LoadNE+LoadSE) was almost 7 % over time. Loads applied using other coupled actuators appeared to be relatively steady during fire and the standard deviation was approximately 2 %.

- All coupled actuators maintained the same stroke length during fire loading (Figure 74a), implying negligible twisting of the test specimen.
- As shown in Figure 75, the rotation of east and west loading trusses (RotLT1 and RotLT3, respectively) diverged after 15 min, resulting in unequal loads at six points. The time-averaged value of six-point loads was 17.5 kN (estimated for a period of 72 min). The maximum standard variation was 3.5 kN before unloading.

Figure 74 Actuator data of CB-SP: (a) loads and (b) stroke lengths applied using six actuators (SW, NW, SM, NM, SE, and NE). Actuator stroke was not recorded after unloading.

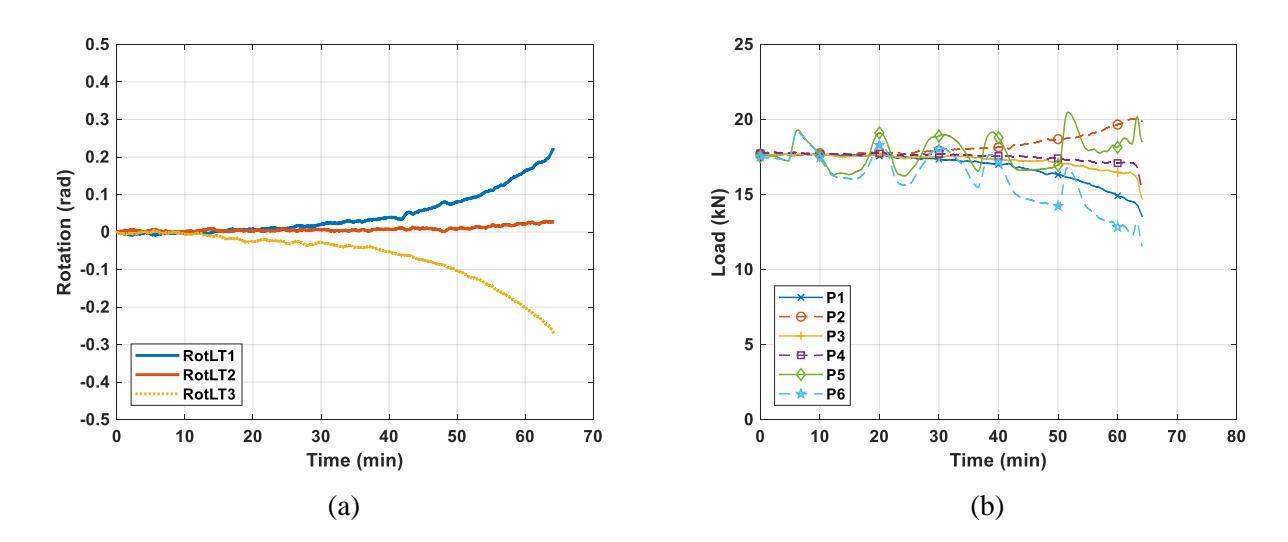
Figure 75 (a) Rotations of three loading trusses placed on top of the concrete and (b) six-point loads during fire loading, where P1 through P6 are the point loads from east to west ends (CB-SP).

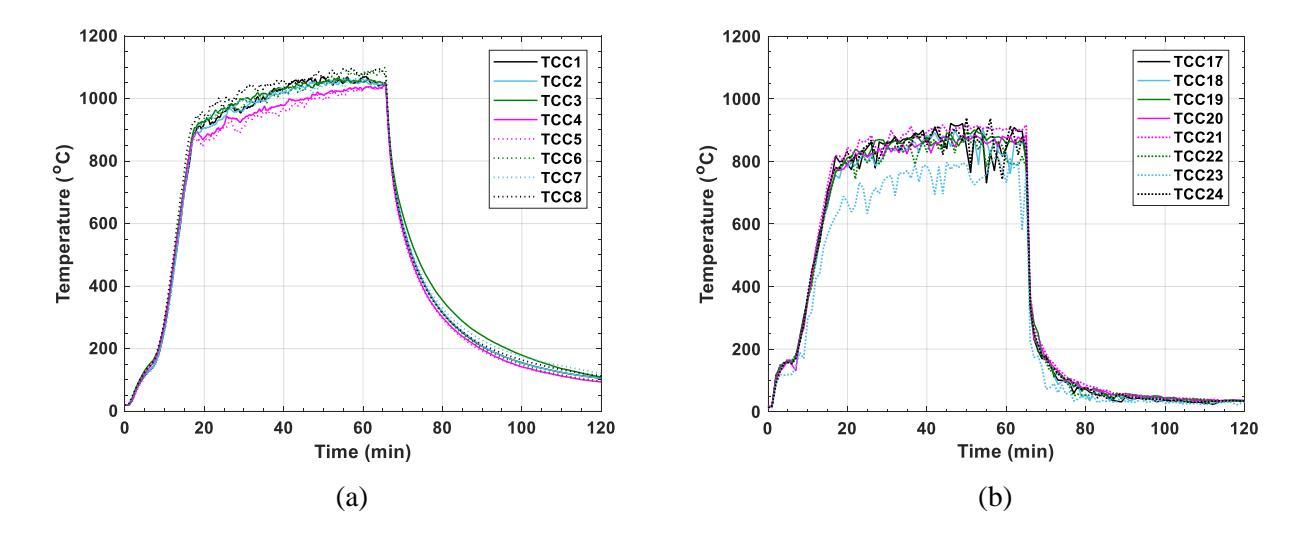
- The upper layer gas temperature within the compartment (Figure 76a), measured 81 cm below exposed steel decking, reached a maximum value of (1055 ± 20) °C before the fire was extinguished at 65 min. The value after ± symbol is the standard deviation of temperatures measured using TCC1 through TCC8.

- The temperature measured using thermocouples mounted outside of the test compartment above the vent openings was in the range of 800 °C to 900 °C while the HRRburner value was steady at 4000 kW from 15 min to 65 min (Figure 76b). TCC24 was about 100 °C lower.

Figure 76 Gas temperature data of CB-SP: (a) 81 cm below exposed steel decking and (b) above vent openings outside of the test compartment.

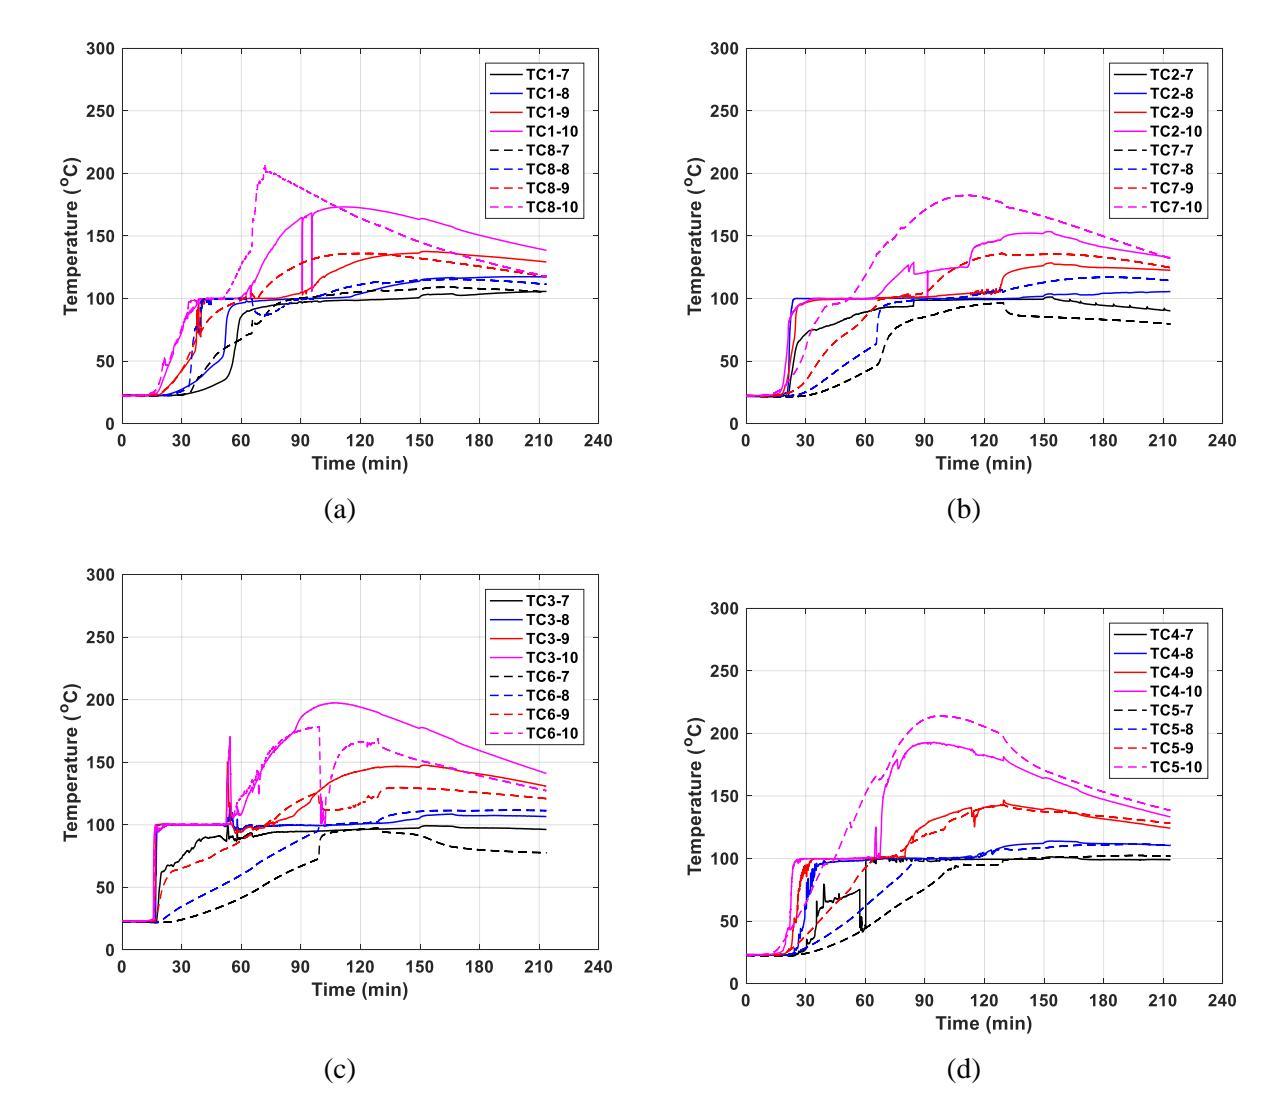
- Figure 77 shows the concrete temperatures in the slab directly above the W18×35 beam. The following sensors may have been faulty: TC2-all, TC3-all, TC4-all.

Figure 77 Concrete temperature along the longitudinal centerline of CB-SP: (a) sections TC1 and TC8, (b) sections TC2 and TC7, (c) sections TC3 and TC6, and (d) sections TC4 and TC5.

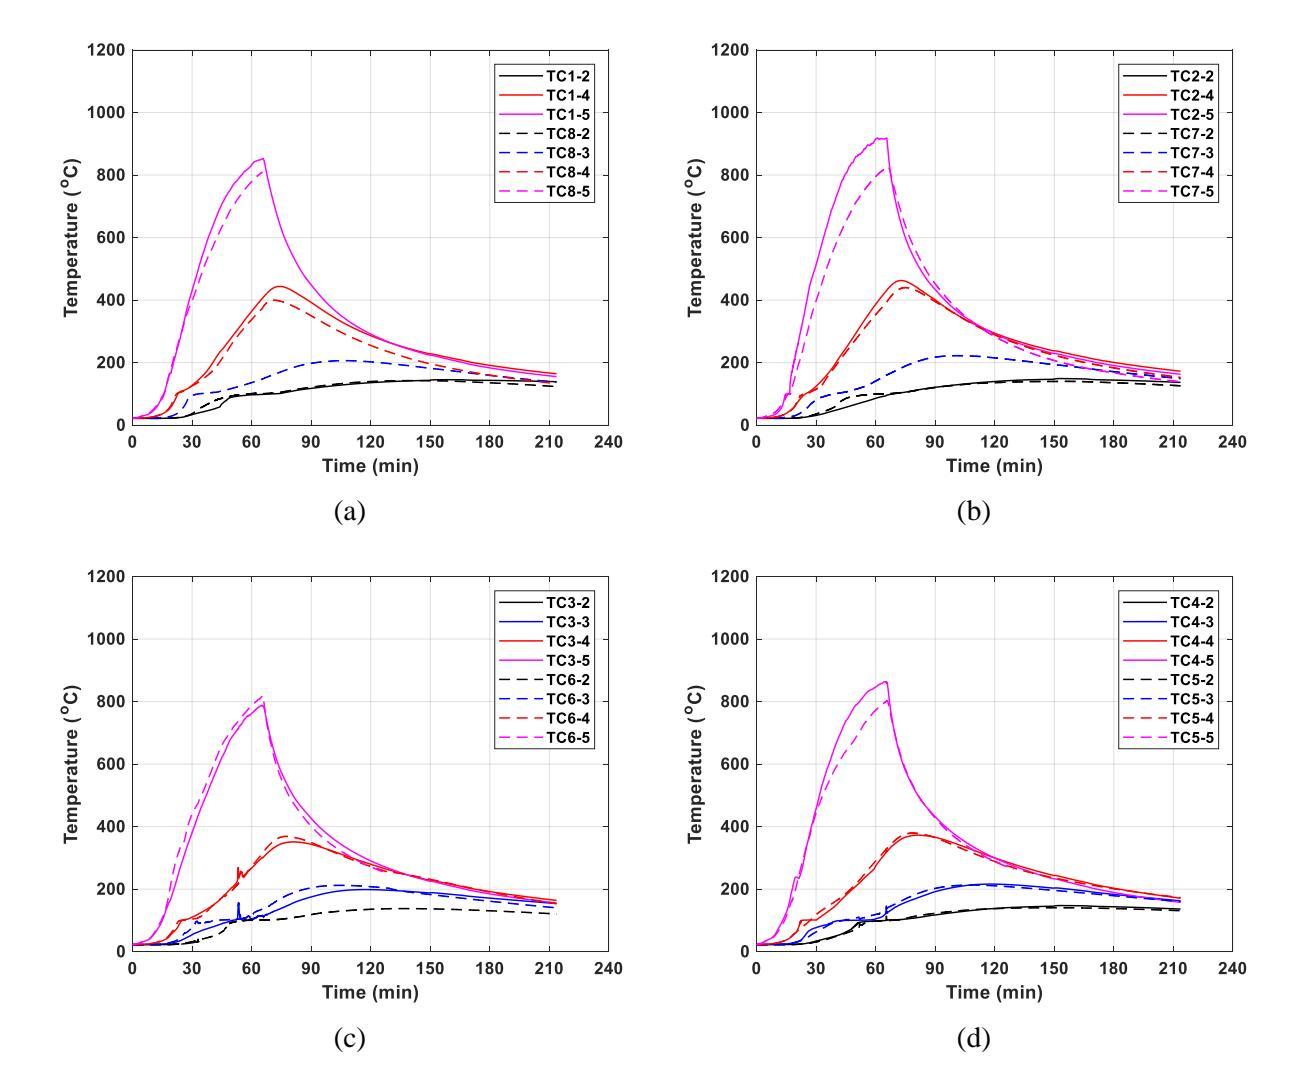
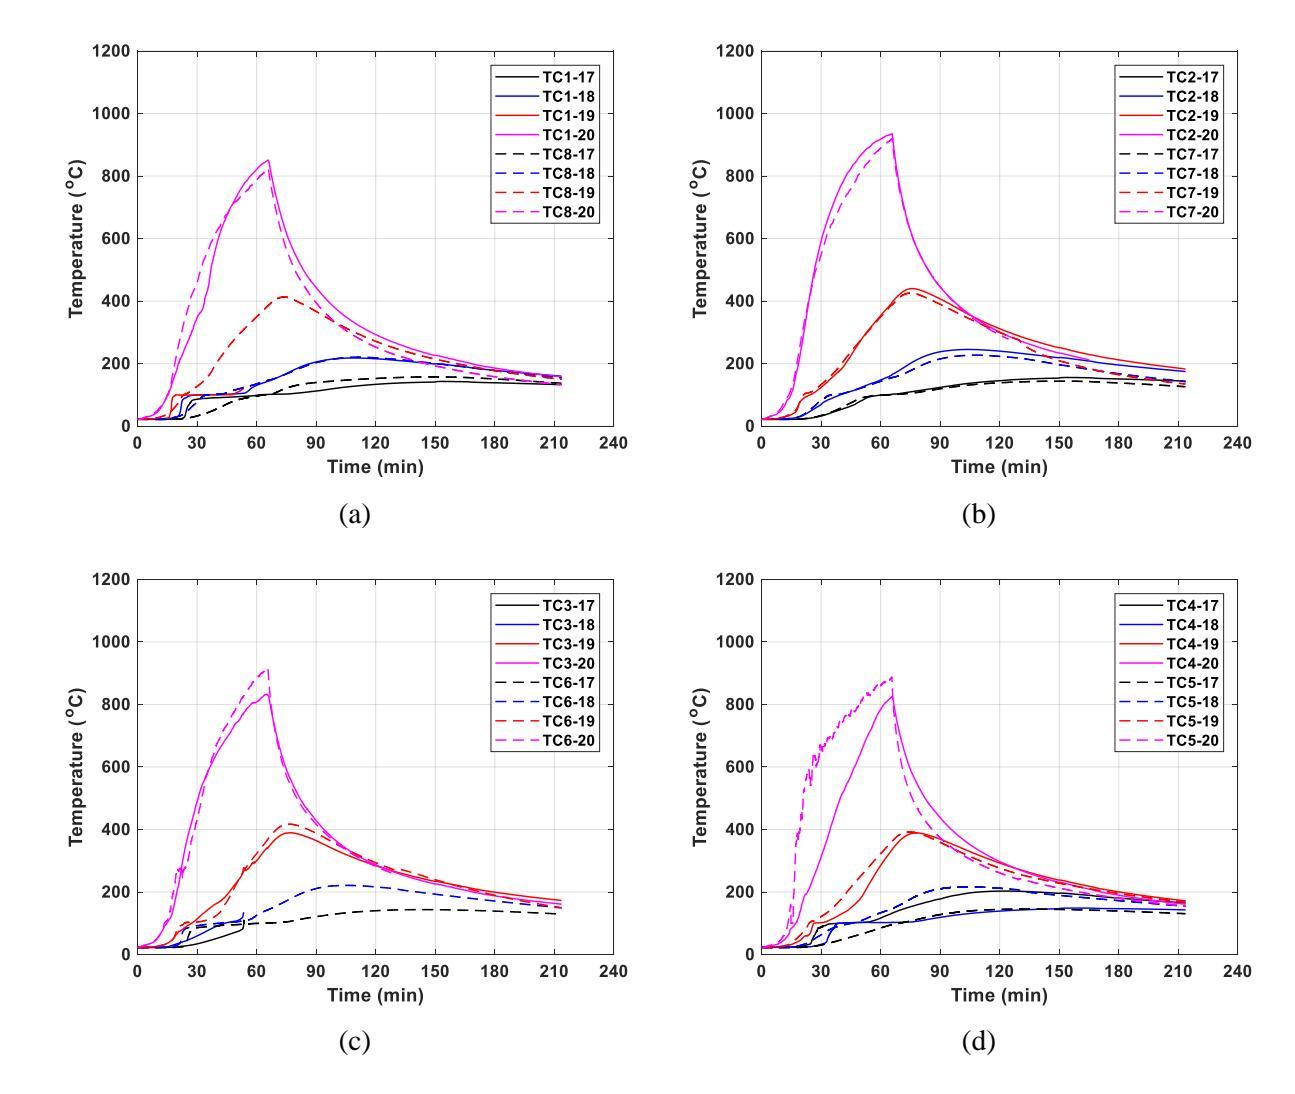
- Figure 78 and Figure 79 show that the north and south side of the slab (45.7 cm from the longitudinal centerline of the specimen) developed a consistent thermal gradient through the depth of the concrete. The bottom of the concrete slab (above exposed steel deck) reached a maximum value of 900 °C on average. The maximum temperature of the unexposed surface never exceeded 150 °C during heating and 200 °C during cooling.

Figure 78 Concrete temperature measured 45.7 cm from the north edge of CB-SP: (a) sections TC1 and TC8, (b) sections TC2 and TC7, (c) sections TC3 and TC6, and (d) sections TC4 and TC5.

Figure 79 Concrete temperature measured 45.7 cm from the south edge of CB-SP: (a) sections TC1 and TC8, (b) sections TC2 and TC7, (c) sections TC3 and TC6, and (d) sections TC4 and TC5.

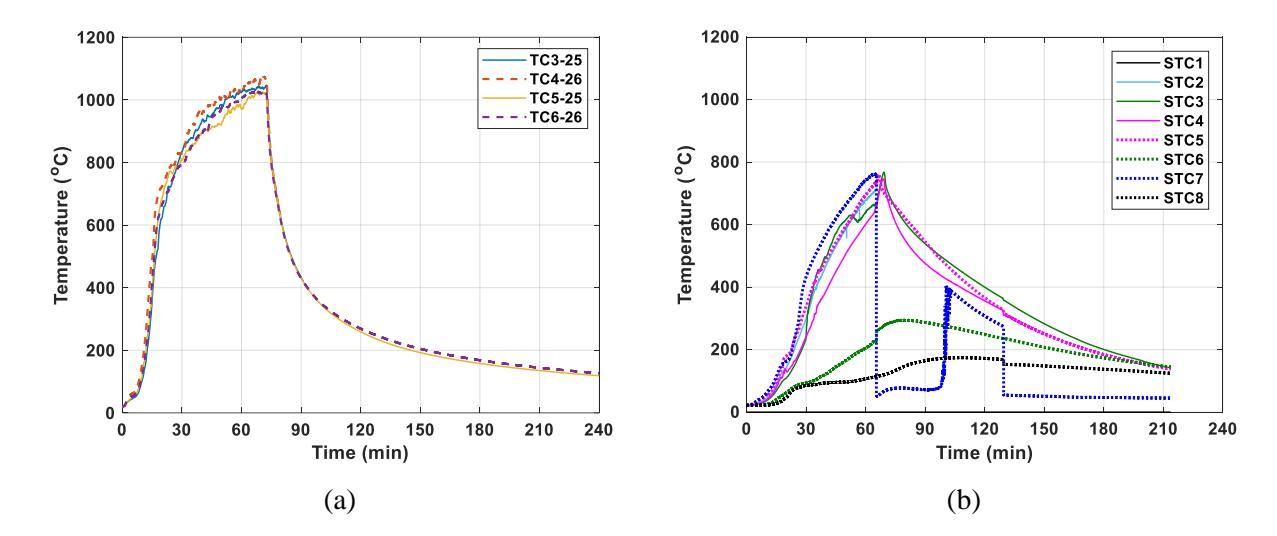
- Temperatures of exposed steel deck increased from 600 to over 1000 °C while the heat release rate was fixed at 4000 kW from 13 min to 65 min (Figure 80a).

- Figure 80b shows temperatures of the protected steel beam measure using Inconel sheathed thermocouples. Temperatures of the bottom flange (STC1 through STC4) and middle web (STC5 and STC7) reached nearly 750 °C on average at 65 min. Temperature of the protected top flange was very low and deemed unreliable because of possible dislocation of thermocouple beads into the concrete slab.

Figure 80 Temperatures of (a) exposed steel deck and (b) bottom flange temperature for CB-SP. Discontinuity of data indicates dislodging of thermocouples.

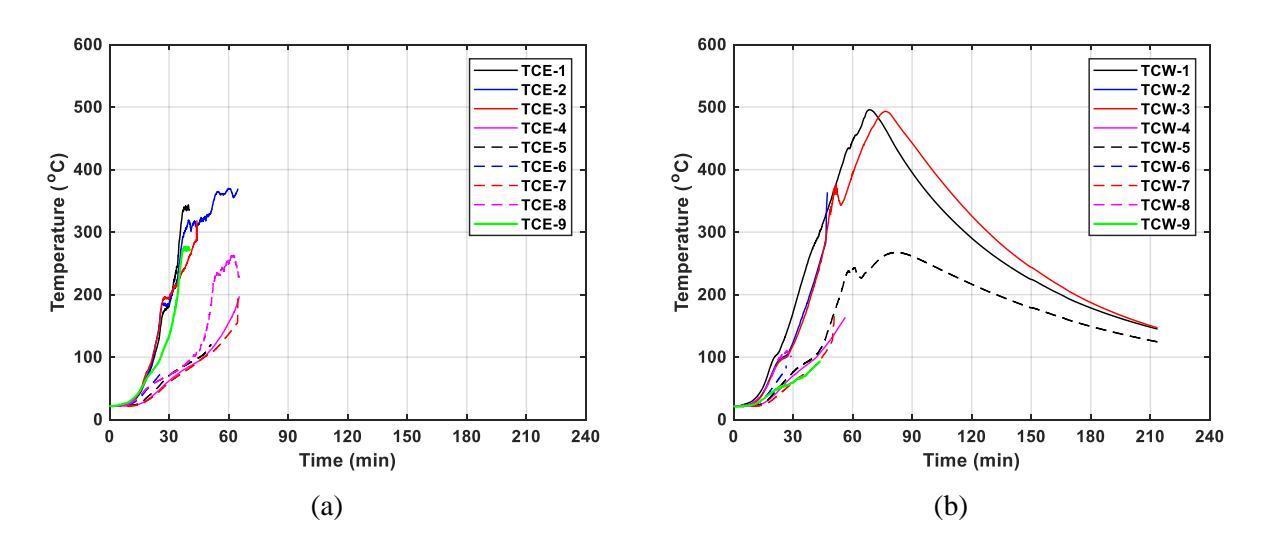
- As shown in Figure 81, thermocouples mounted in the west connection region were dislodged before 60 min. For the west connection region, temperatures of the web next to a shear tab increased to 500 °C and the temperature of the shear tab reached nearly 250 °C due to a thicker SFRM.

Figure 81 Temperatures of (a) east and (b) west connection region for CB-SP. Discontinuity of data indicates dislodging of thermocouples.

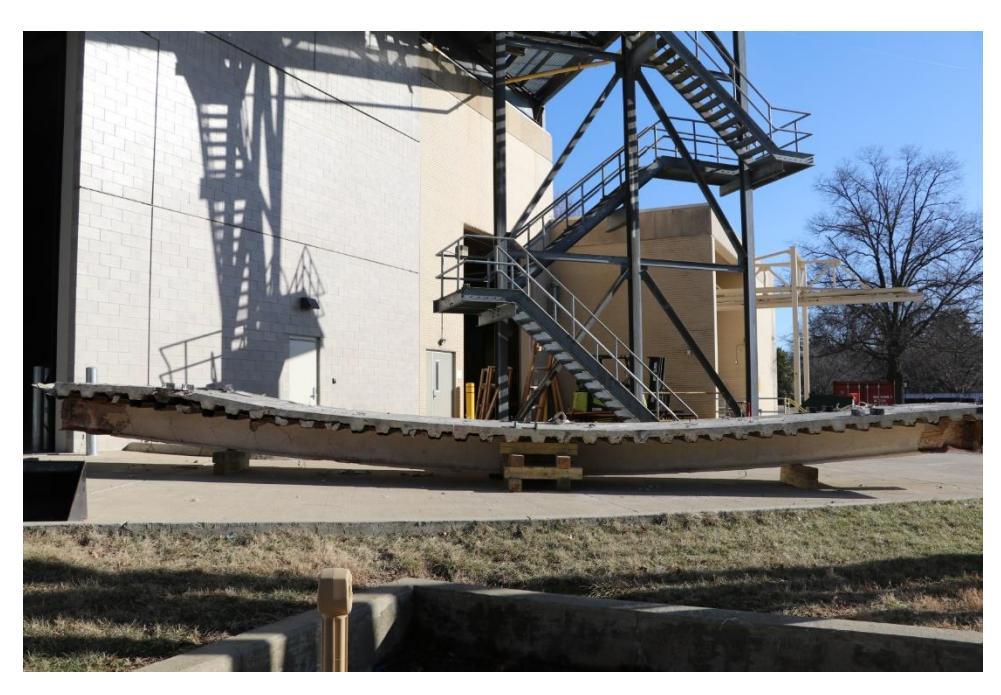
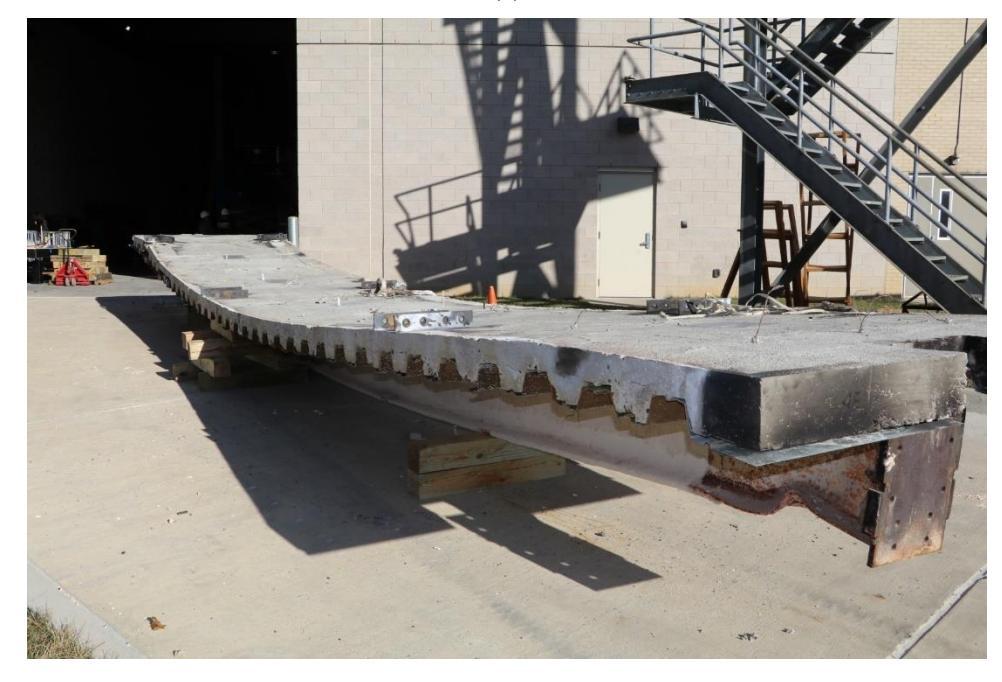
Figure 84 Photographs of the deflected shape of CB-SP: (a) front view and (b) perspective view.
