NIST Technical Note 2055

Compartment Fire Experiments on Long-Span Composite-Beams with Simple Shear Connections Part 2: Test Results

November 2019

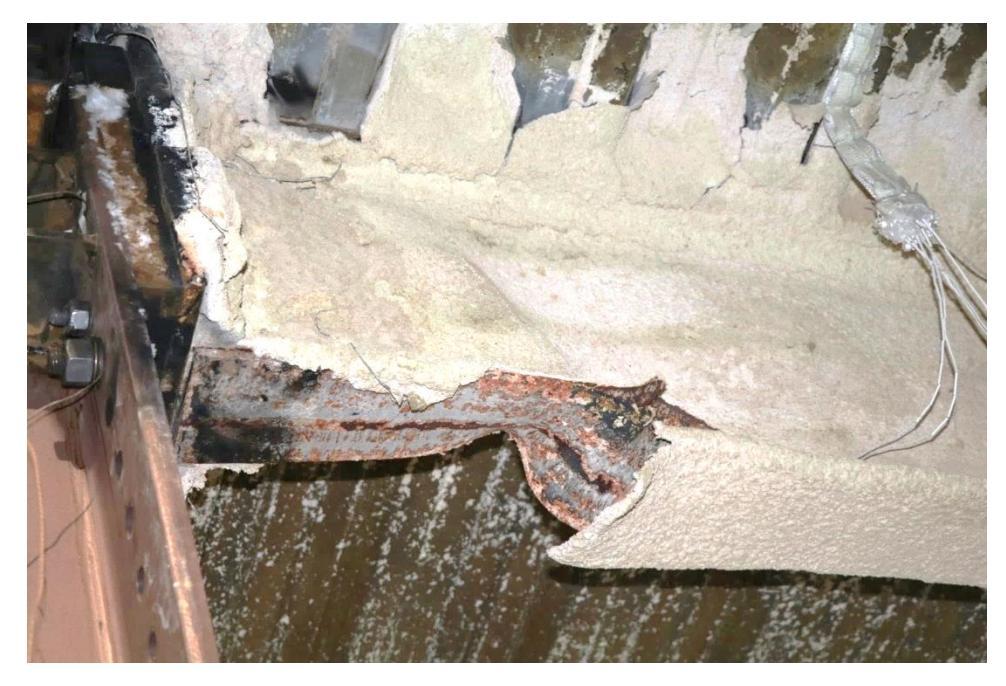
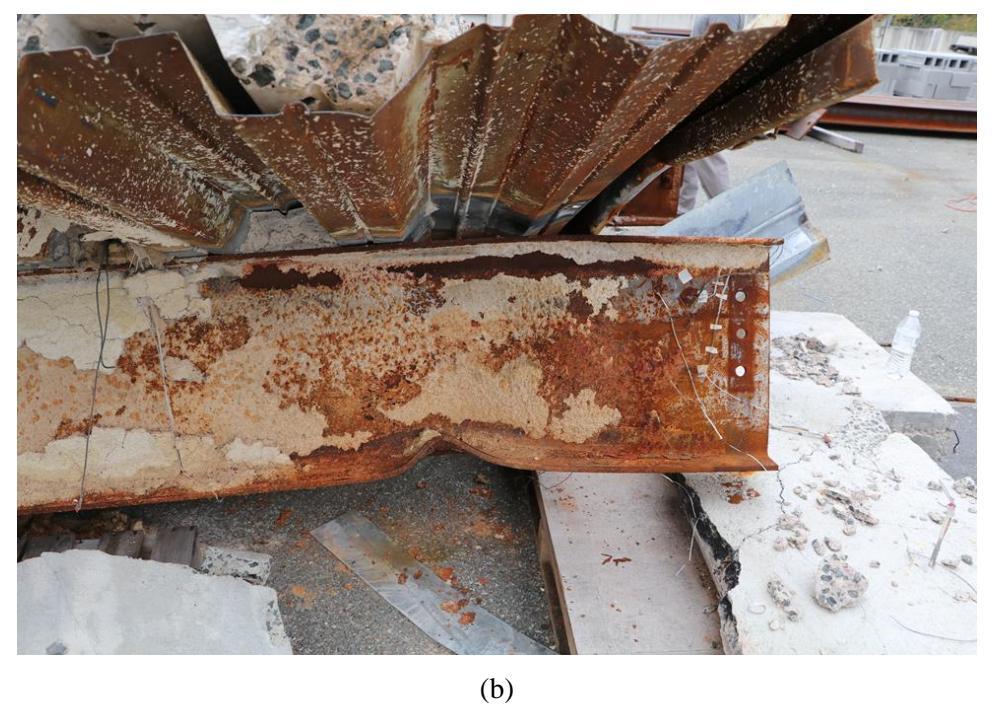
Figure 85 Photographs of CB-SP after cooling: (a) west connection region inside the test compartment and (b) east connection region after removal of the shear tab.

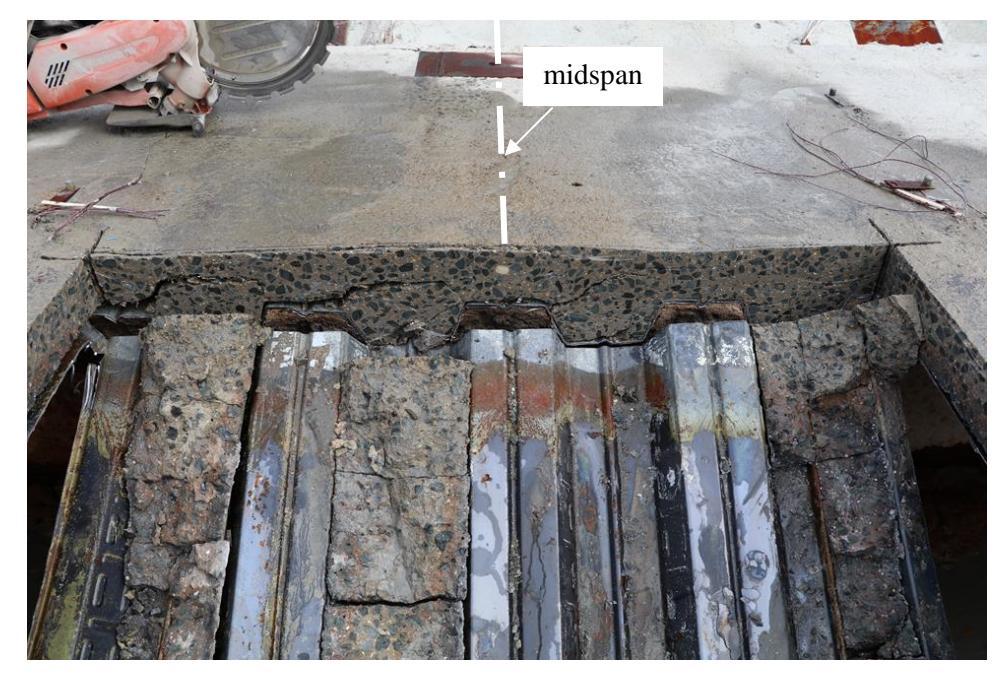
Figure 86 Photographs of CB-SP: (a) concrete slab at midspan after cut and (b) concrete slab and shear studs at west end.

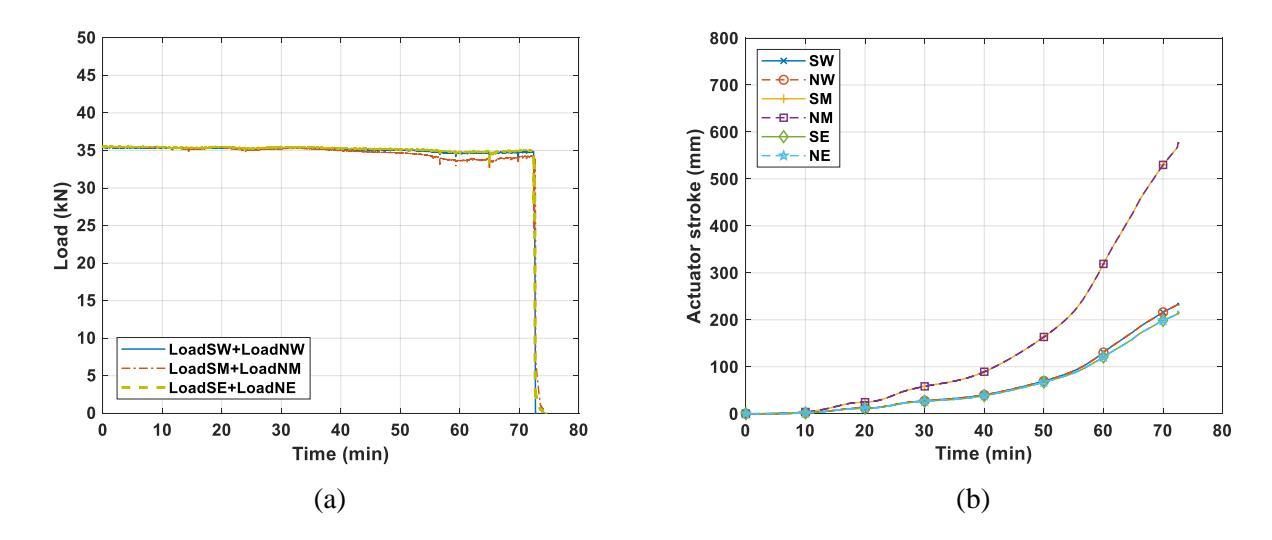
- A servo-valve of the NE actuator was replaced prior to the test. As shown in Figure 87, mechanical loads applied using coupled actuators were steady. The standard variation of loads from coupled actuators was less than 2 % during fire. The stoke lengths of coupled actuators remained almost identical prior to unloading, implying that no twisting of the concrete slab occurred.

Figure 87 Actuator data of CB-SP-SC: (a) loads and (b) stroke lengths applied using six actuators (SW, NW, SM, NM, SE, and NE). Actuator stroke was not recorded after unloading.

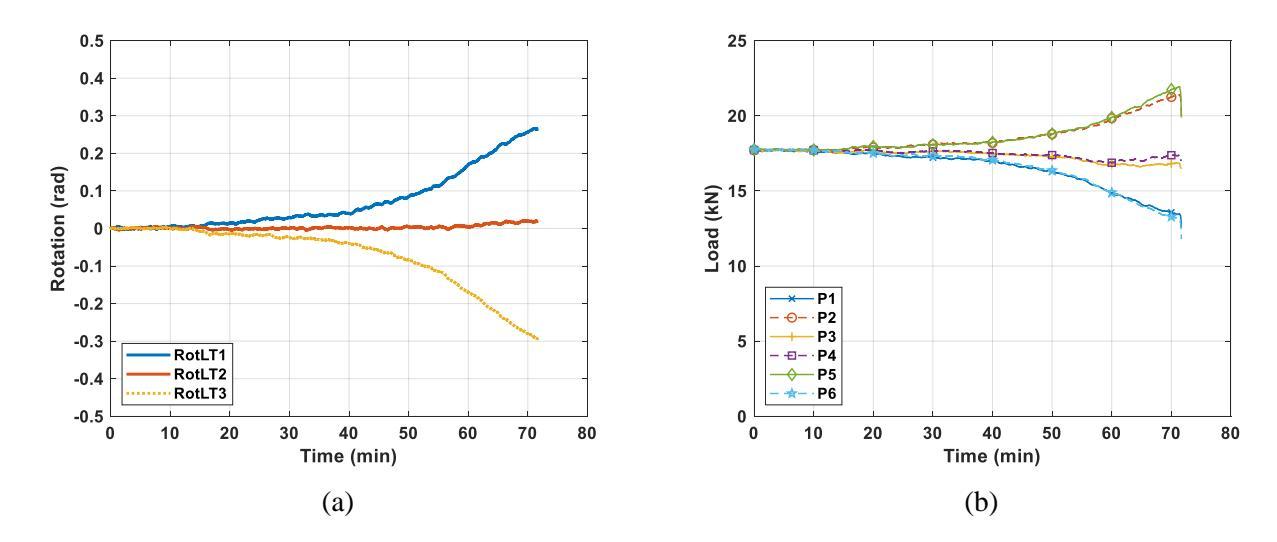
- Similar to previous tests, the rotation of east and west loading trusses (RotLT1 and RotLT3, respectively) diverged after 15 min (Figure 88), resulting in unequal loads at six points. The time-averaged value of six-point loads was 17.5 kN (estimated for a period of 72 min). The maximum standard variation was 3.8 kN before unloading.

Figure 88 (a) Rotations of three loading trusses placed on top of the concrete and (b) six-point loads during fire loading, where P1 through P6 are the point loads from east to west ends (CB-SP-SC).

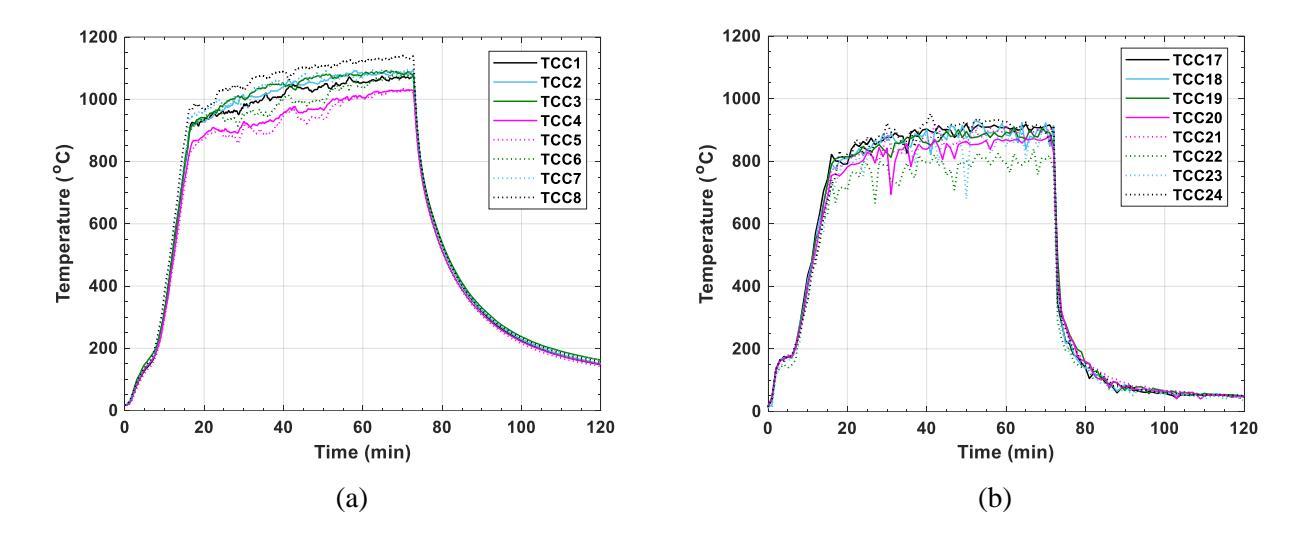
- Gas temperatures measured 81 cm below exposed steel decking inside the test compartment reached a maximum value of (1070 ± 30) °C before the extinguishment of a test fire at 73 min (Figure 89a). The value after ± symbol is the standard deviation of temperatures measured using TCC1 through TCC8. The temperature at the top of vent openings ranged from 800 °C to 900 °C at the HRRburner of 4000 kW from 16 min to 73 min (Figure 89b).

Figure 89 Gas temperature data of CB-SP-SC: (a) 81 cm below exposed steel decking and (b) above vent openings outside of the test compartment.

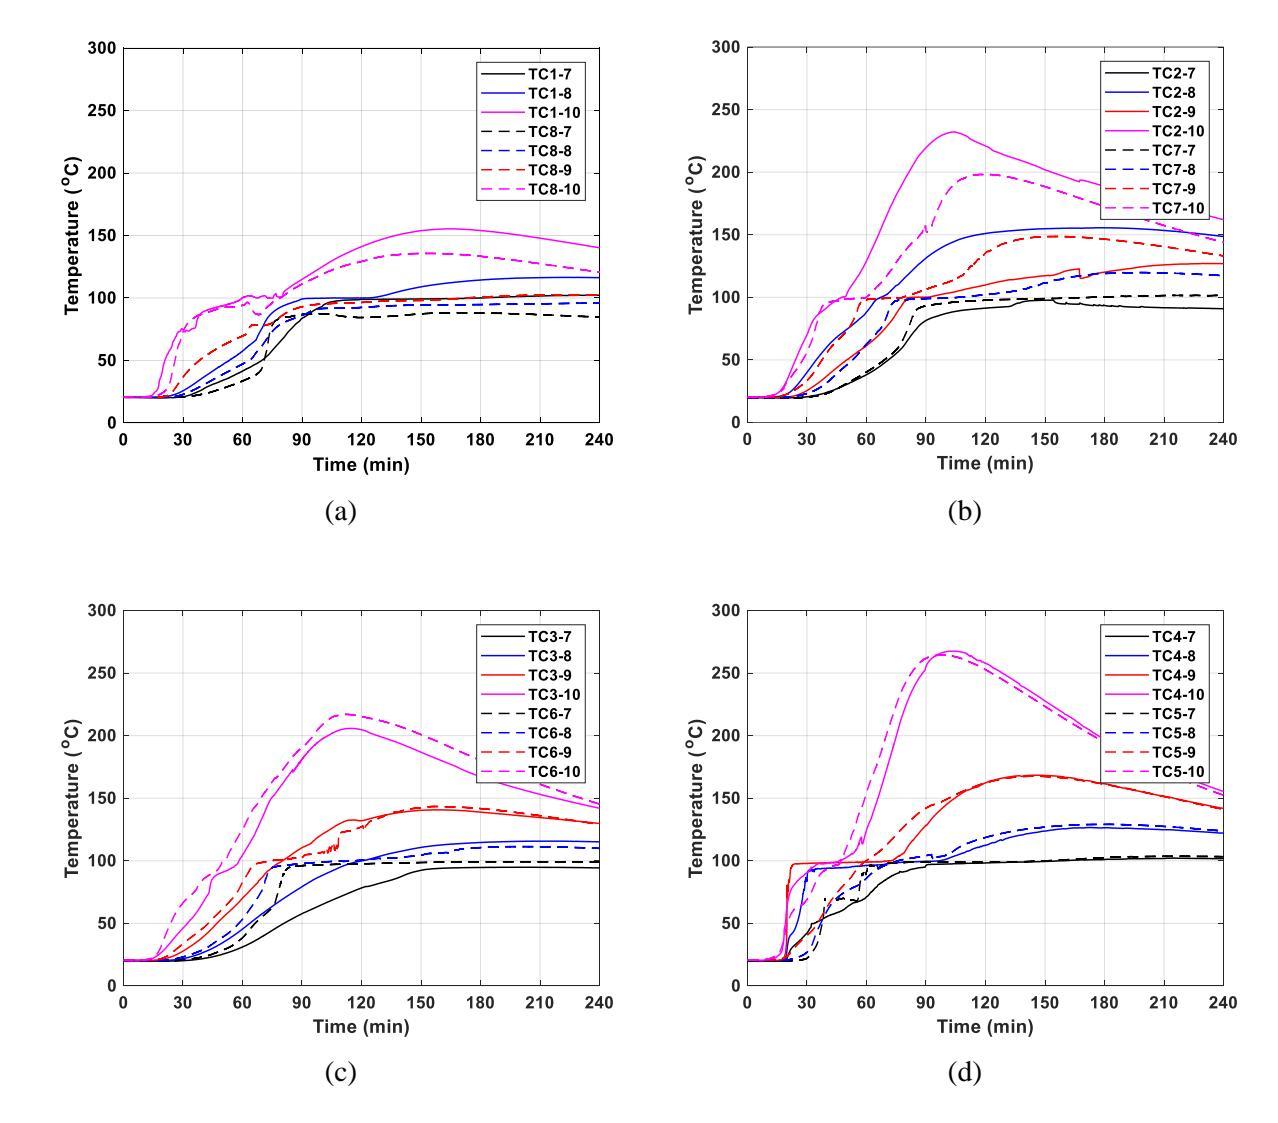
Figure 90 Concrete temperature along the longitudinal centerline of CB-SP-SC: (a) sections TC1 and TC8, (b) sections TC2 and TC7, (c) sections TC3 and TC6, and (d) sections TC4 and TC5.

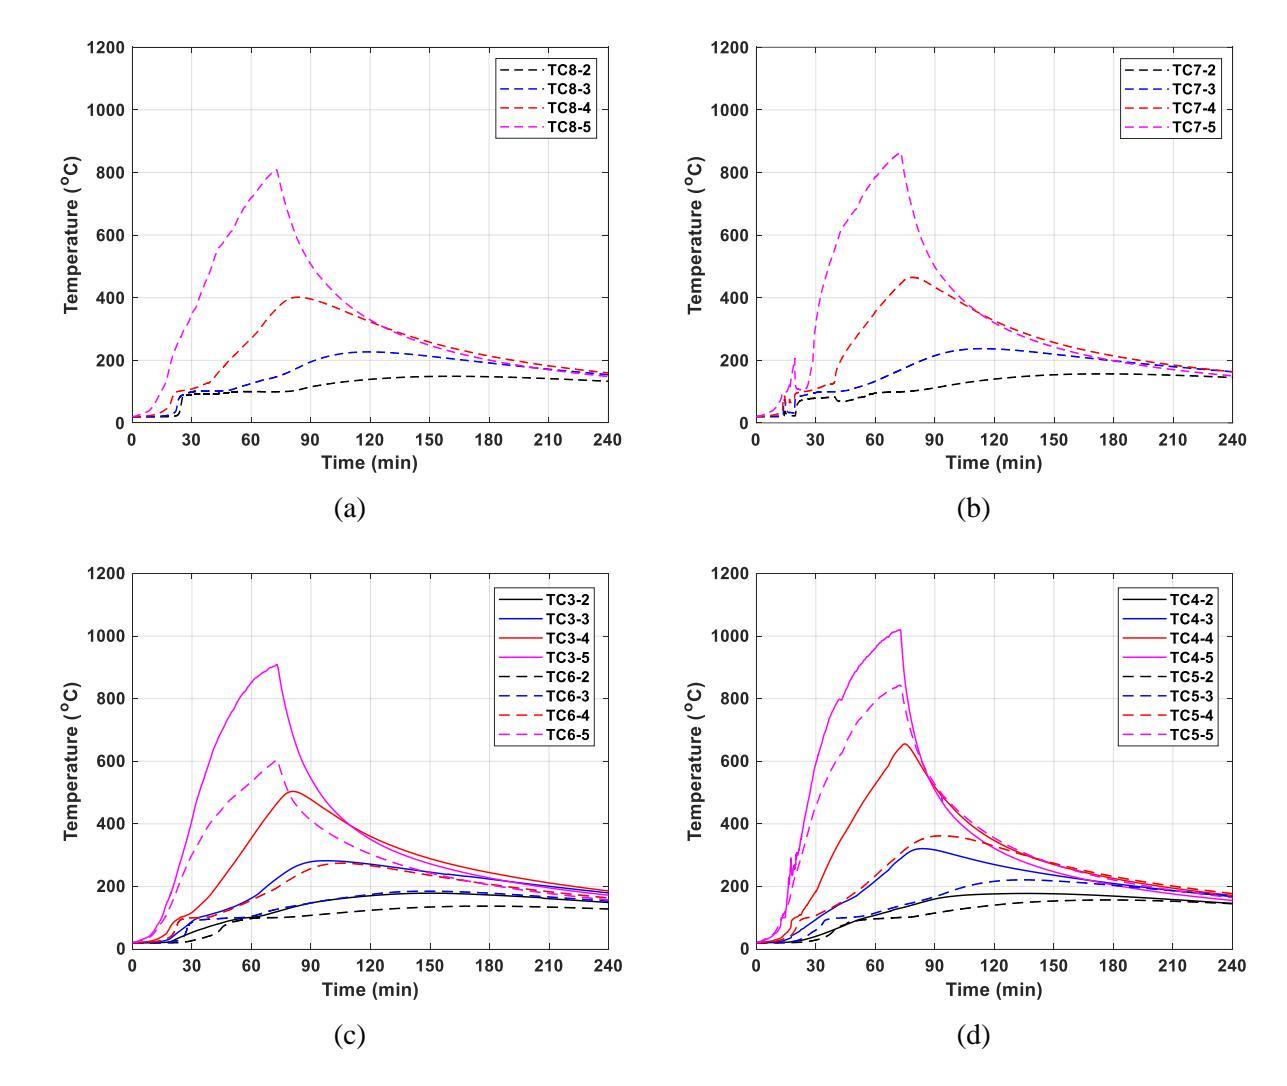
Figure 91 Concrete temperature measured 45.7 cm from the north edge of CB-SP-SC: (a) sections TC1 and TC8, (b) sections TC2 and TC7, (c) sections TC3 and TC6, and (d) sections TC4 and TC5.

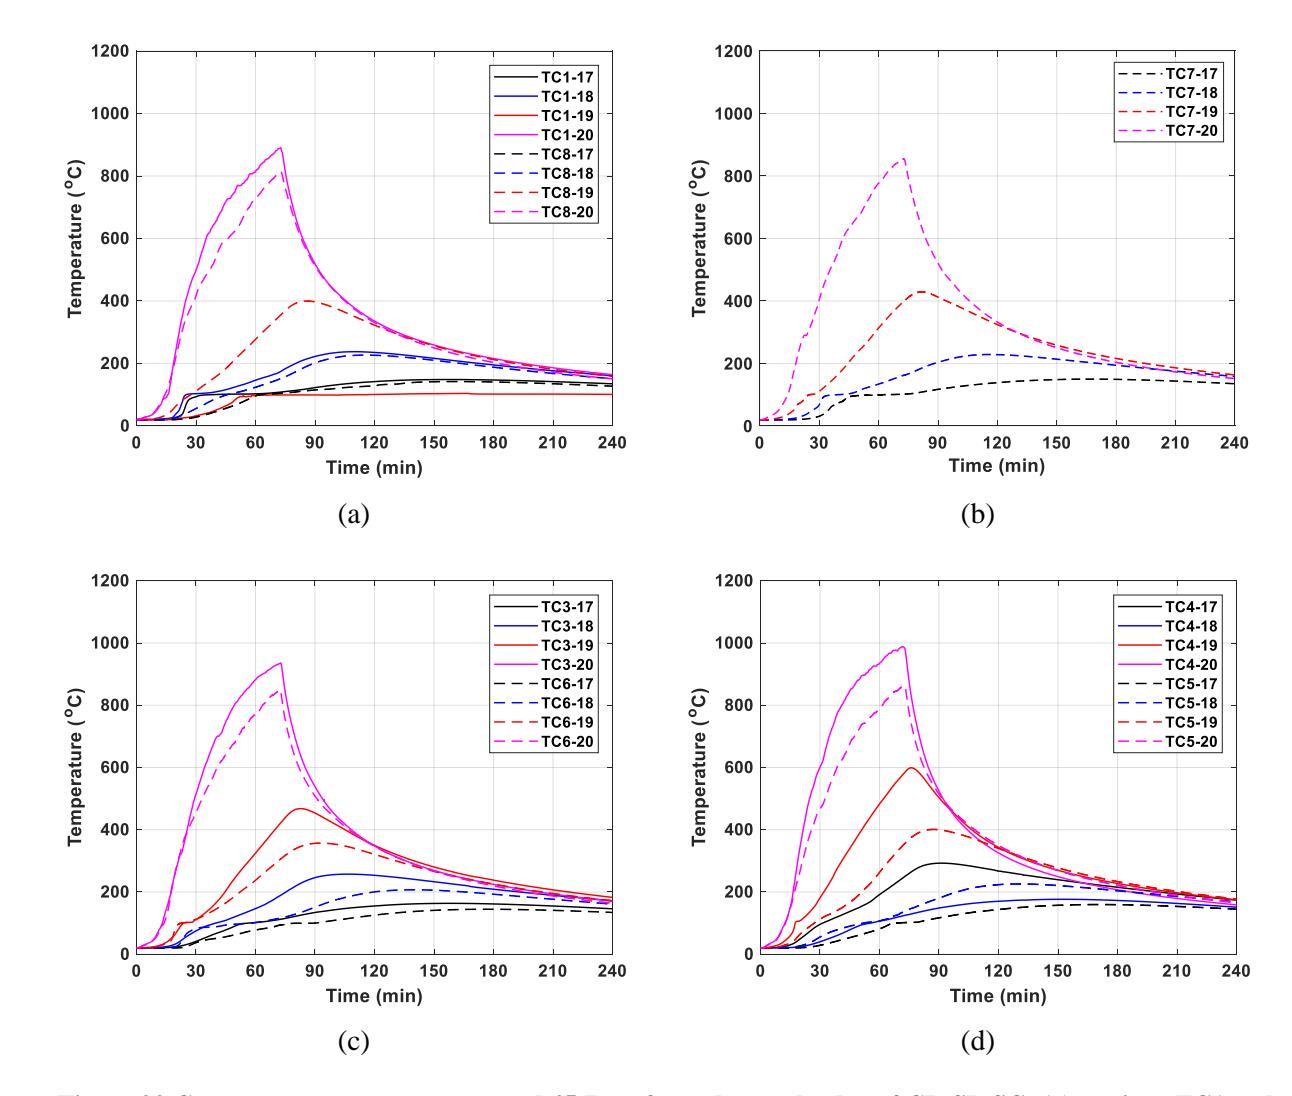
Figure 92 Concrete temperature measured 45.7 cm from the south edge of CB-SP-SC: (a) sections TC1 and TC8, (b) sections TC2 and TC7, (c) sections TC3 and TC6, and (d) sections TC4 and TC5.

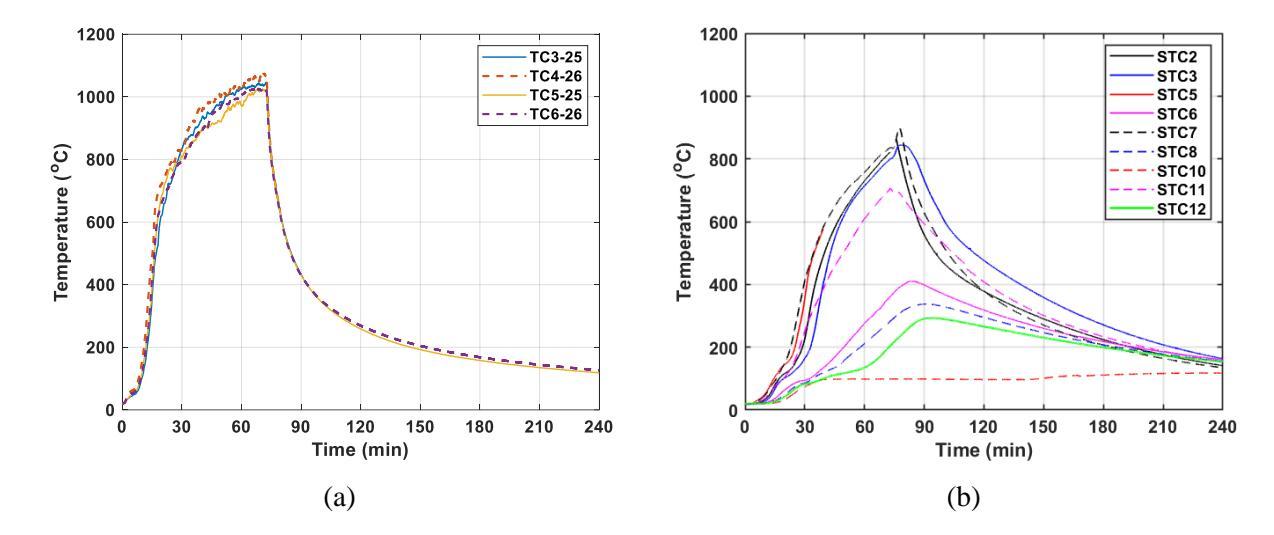
- Temperatures of exposed steel deck increased from 600 to over 1000 °C while the heat release rate was fixed at 4000 kW from 16 min to 73 min (Figure 93a).

- Temperatures of the protected steel beam measured using Inconel sheathed thermocouples reached about 800 °C at the bottom flange and middle web (Figure 93b). Temperatures measured using glass-sheathed thermocouples protected under SFRM reached a peak value of 750 °C (Figure 94).

Figure 93 Temperatures of (a) exposed steel deck and (b) steel beam measured using Inconel sheathed thermocopules for CB-SP-SC. Discontinuity of data indicates dislodging of thermocouples.

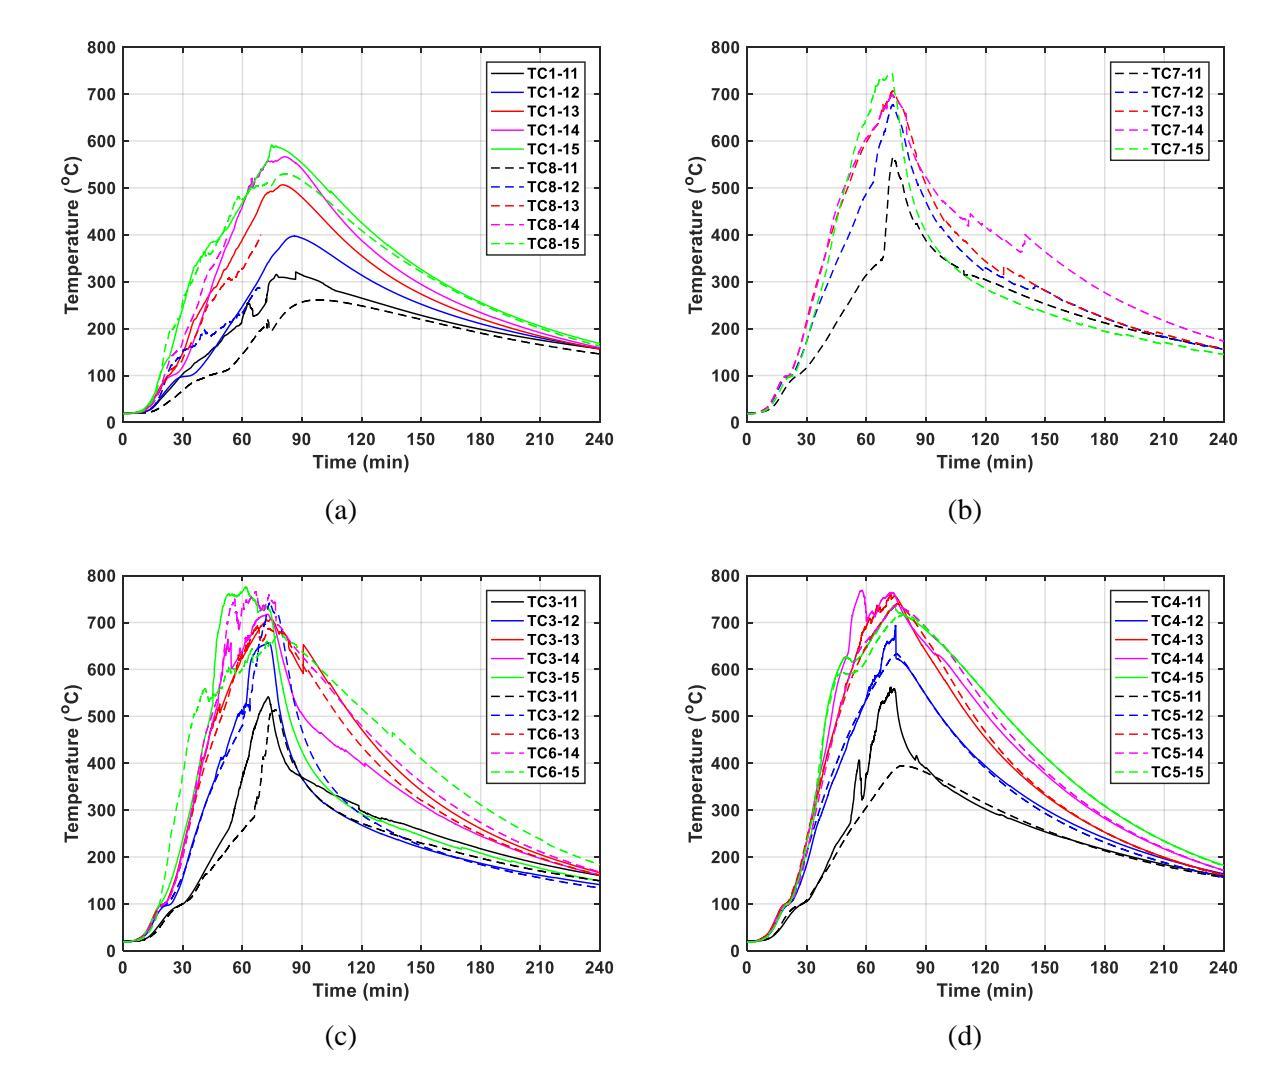
Figure 94 Temperatures of steel beam measured using glass-sheathed thermocouples for CB-SP-SC: (a) sections TC1 and TC8, (b) sections TC2 and TC7, (c) sections TC3 and TC6, and (d) sections TC4 and TC5. Discontinuity of data indicates dislodging of thermocouples.

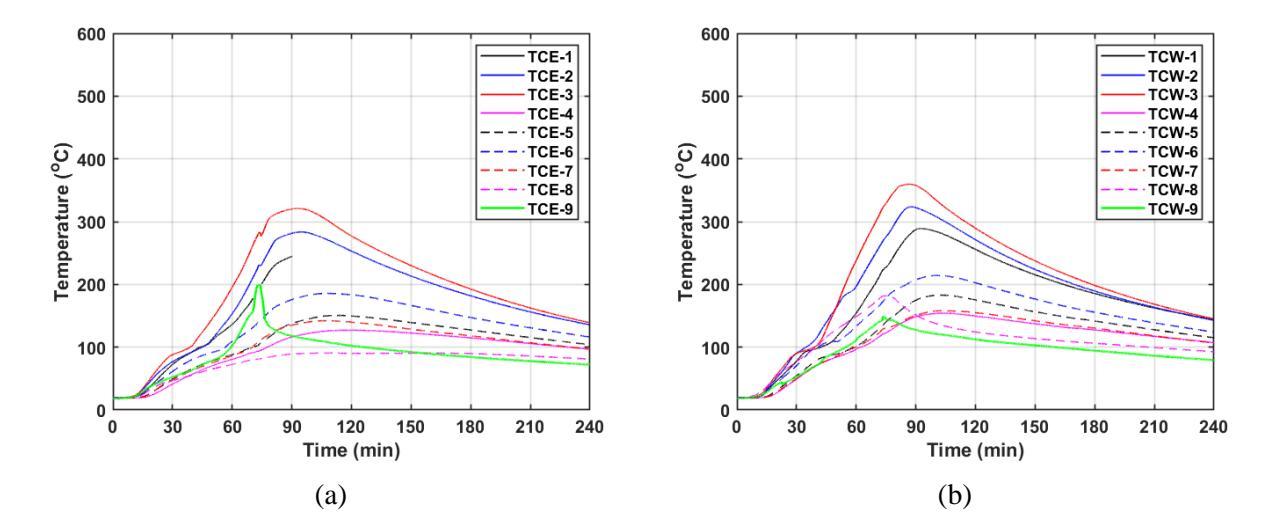
- Temperatures of the connection region increased to a peak value of 350 °C at the beam web and around 200 °C at the shear tab (Figure 95).
- Figure 96 shows the tensile loads on the No. 4 reinforcing bars anchored at the location of girders as a function of fire exposure time.

Figure 95 Temperatures of (a) east and (b) west connection region for CB-SP-SC. Discontinuity of data indicates dislodging of thermocouples.

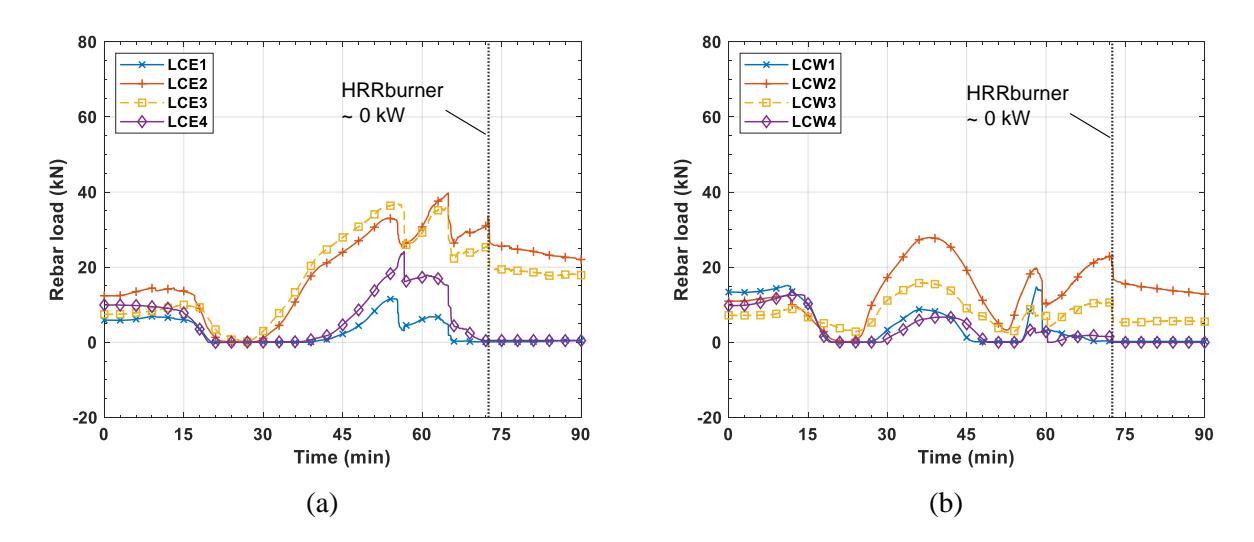
Figure 96 Tensile loads on No. 4 reinforcing bars anchored at (a) east and (b) west end (CB-SP-SC).

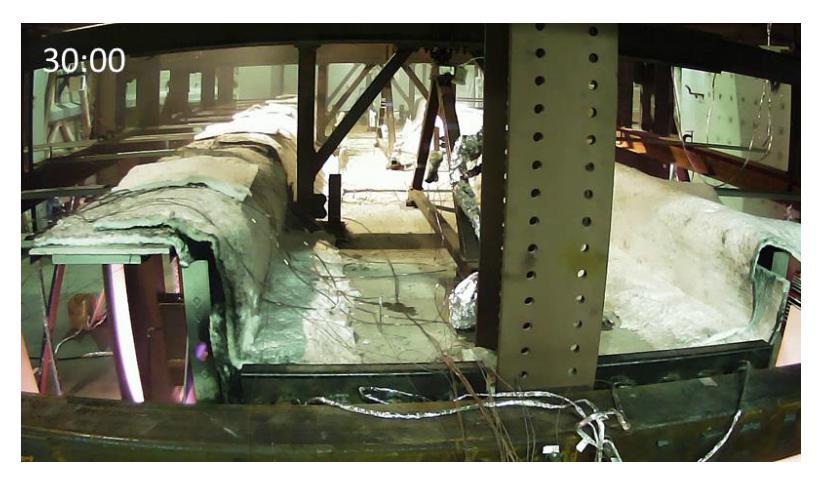
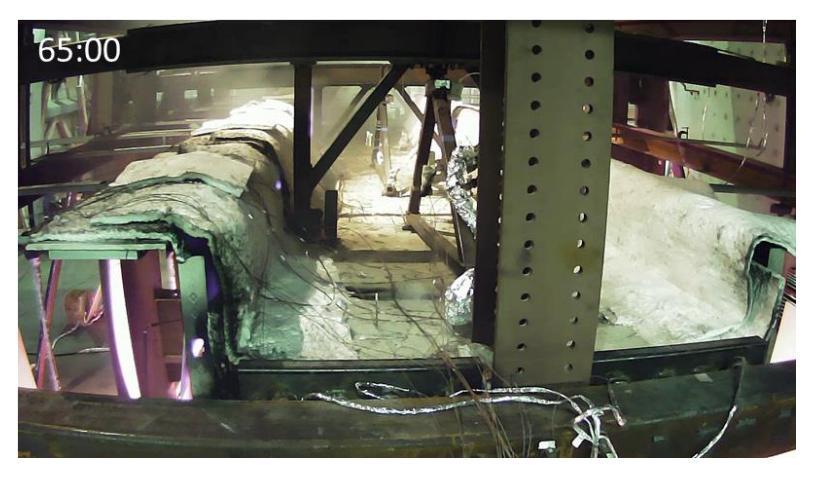
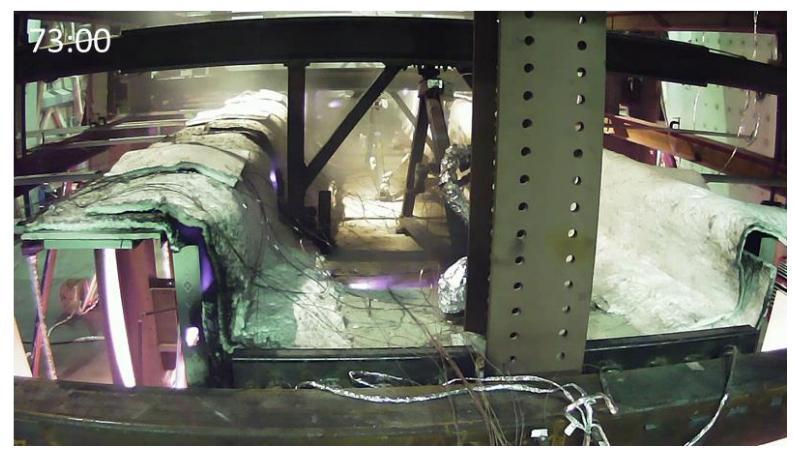
Figure 97 Still images of a video viewing top of the concrete near the east column for CB-SP-SC. Time (min: sec) is recorded after the fire was ignited.
D.4 Post-Test Conditions

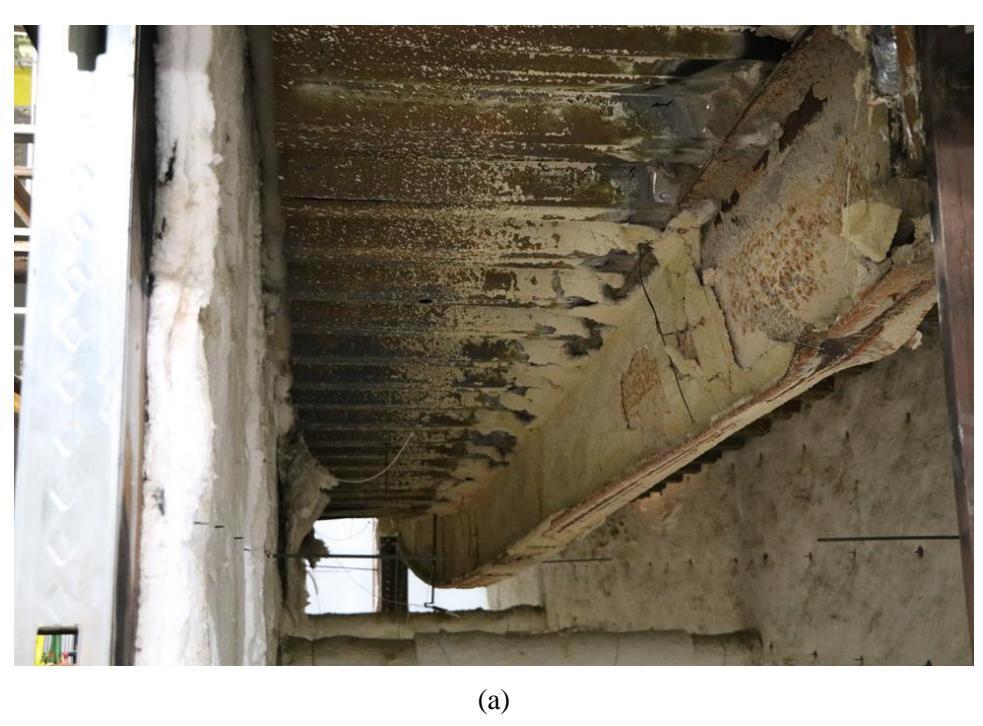
Figure 98 Photographs of CB-SP-SC after cooling: (a) deflected shape of the steel beam and (b) concrete slab after removal of loading frames.

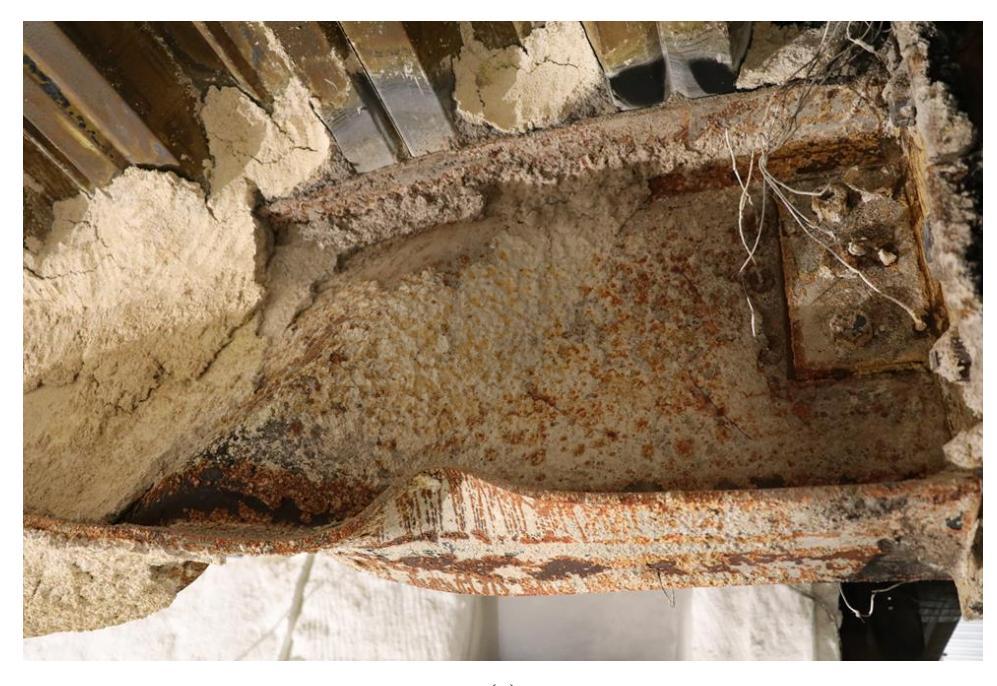
Figure 100 Photographs of CB-SP-SC after cooling: (a) concrete fracture at east end and (b) cut section of the concrete slab at midspan above the steel beam.
