NIST Technical Note 2135

A Case Study of the Camp Fire – Fire Progression Timeline

The Camp Fire ignited on November 8, 2018 in the foothills of the Sierra Nevada in Butte County, California. The first 24 hours were characterized by a fast-moving fire with initial spread driven by high winds up to 22 m/s (50 mi/h) and long-range spotting up to 6.3 km (3.9 mi) into the community. The fire quickly impacted the communities of Concow, Paradise, and Magalia. The Camp Fire became the most destructive and deadly fire in California history, with over 18 000 destroyed structures, 700 damaged structures, and 85 fatalities. After a preliminary reconnaissance, it was determined that abundant data was available to support an in-depth case study of this devastating wildland-urban interface (WUI) fire to increase our understanding of WUI fire spread, fire behavior, evacuation, and structure response. The methodology guiding the case study and a detailed timeline reconstruction of the fire progression and fire behavior are presented. Over 2200 observations about fire spread and behavior were collected during the case study. Subsequent reports will detail additional aspects of the incident includ

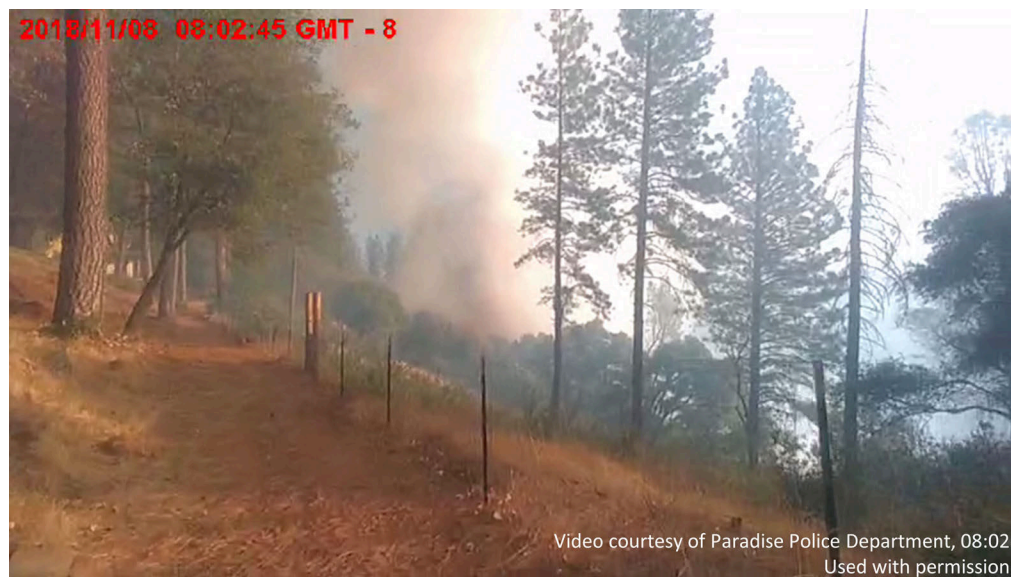
The first call reporting a spot fire in Paradise was placed at 07:49 off Lowry Lane. Paradise Police responded to the area, and body camera video recording captured the plume from the initial spot fire, seen in **Figure 27**.

Figure 27. Body camera recording shows the initial stages of the spot fire off Lowry Ln and Riverside Dr.

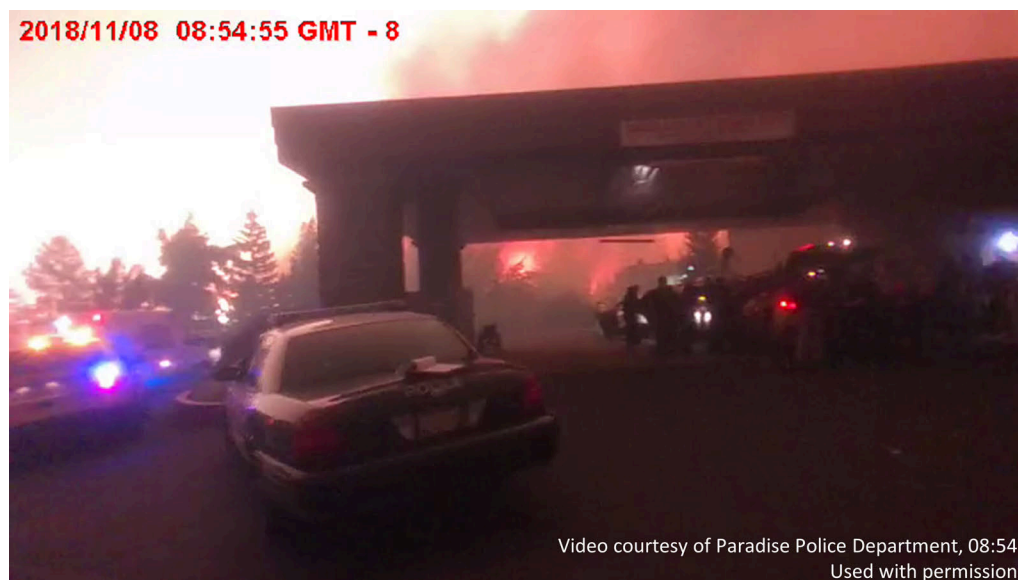
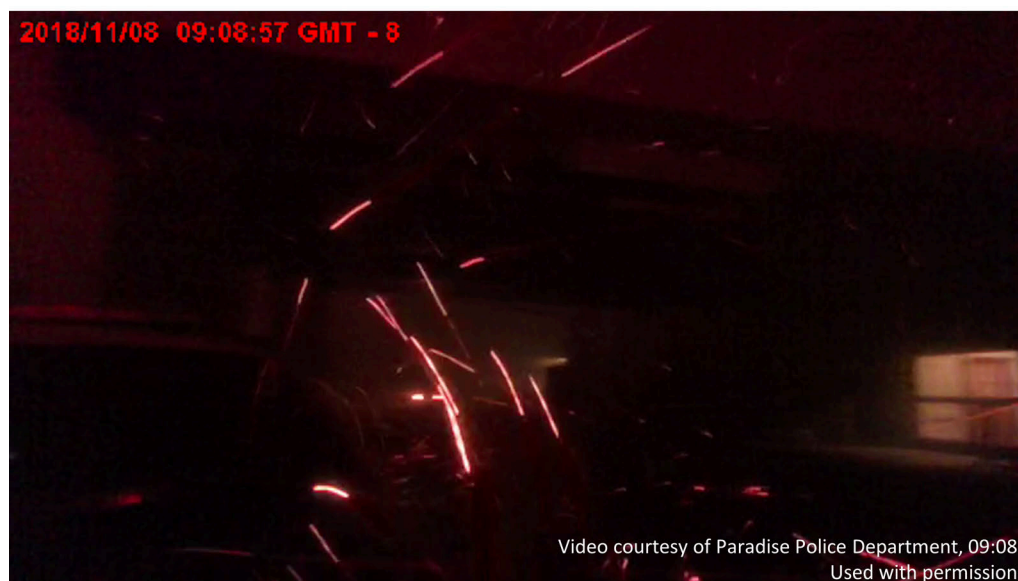
The first spot fire reported in the vicinity of the hospital was the Lowry Lane spot at 07:50, and fire subsequently approached the hospital campus. The first 911 calls reporting hospital buildings on fire were received at 08:30. **Figure 29** shows conditions on the FRH campus as evacuations were nearing completion at 08:54, with structures seen burning in the background. Within a short time period, blackout conditions prevailed as ember showers impacted the campus.

Figure 29. a) Fire burning on the Feather River Hospital campus before 08:54. b) Blackout conditions and heavy showers of large embers at 09:08. The video documents ember showers coming from the west as the fire front arrived from the east.

Given the local conditions and the lack of local weather data, it was not possible to determine whether the arrival of the fire front was driven primarily by an increase in local wind, by fire generating its own wind going upslope, or by some combination of the two. The conditions observed in videos taken during the fire indicate that within Paradise the wind never reached the high velocities observed on Rim Road. Wind observations in town ranged from calm to an estimated 9 m/s to 13 m/s (20 mi/h to 30 mi/h) [TD-021, TD-042, PPD Video]. These ambient winds enhanced fire spread in Paradise. As the fire became deep-seated, the increased fire intensity might have generated its own fire induced winds, as appeared to be the case with the approaching fire front. Given the lack of high-resolution spatiotemporal wind data, it was not possible to say if the predominant influence was regional and local winds or the fire-induced winds. An example of the influence of local wind conditions was observed at FRH at 09:08 when a video recording shows embers blowing from the west while the fire front arrived from the east, shown in **Figure 29**.

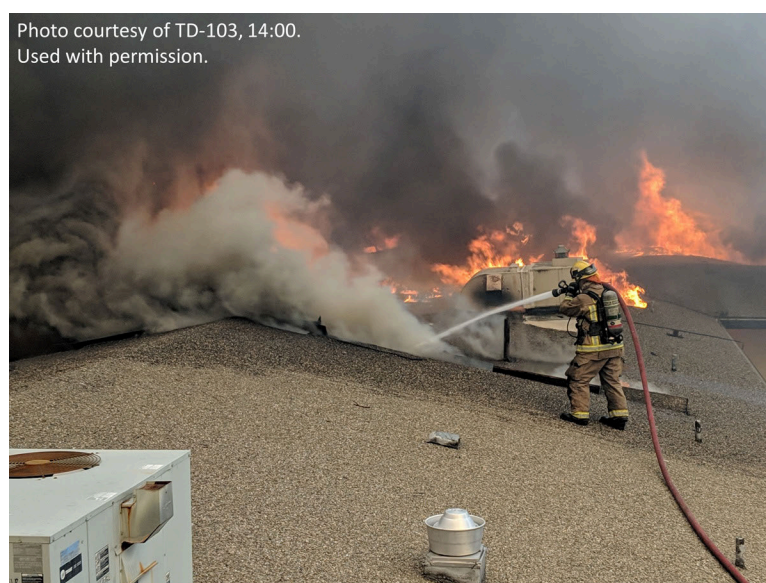
Figure 31. The cardiology section of FRH was destroyed. Extensive firefighting efforts prevented spread to other portions of the facility.

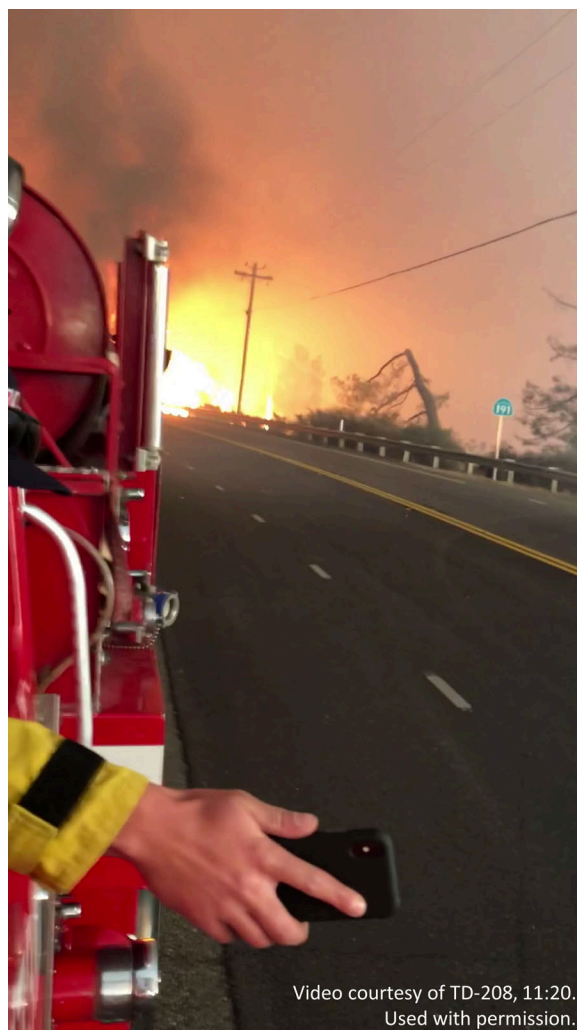
Figure 39. Heavy fire exposure from the canyon burns over Clark Rd just north of Airport Rd, delaying civilian evacuation and first responder access. View north at 11:20.

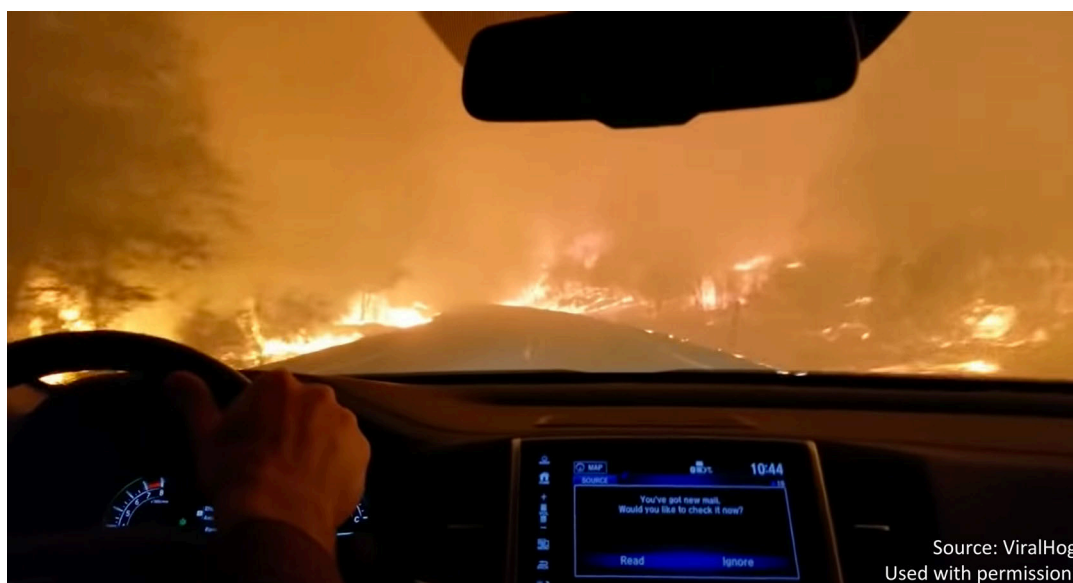
Figure 40. Skyway was burned over during the middle of evacuation efforts. Conditions are seen here at 10:44 just west of the lane divide at the town limits.

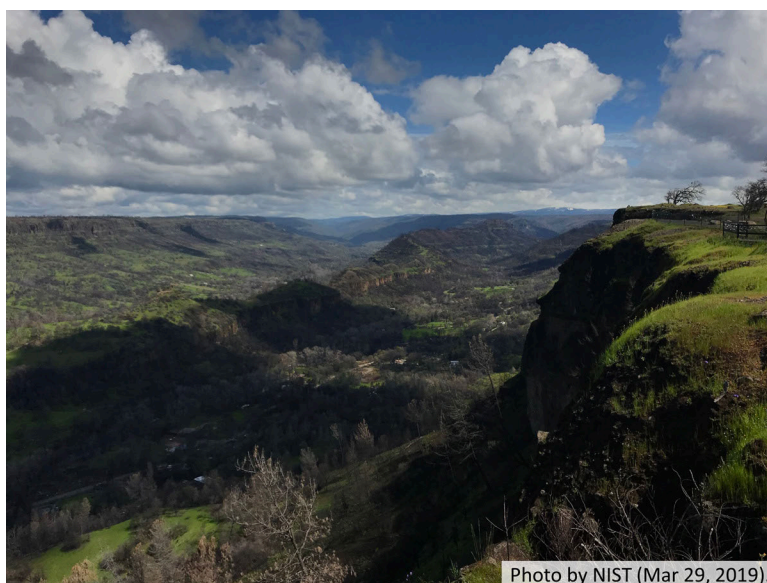
Figure 41. A view into Butte Creek Canyon from Lookout Point on Skyway shows the steep canyon walls. View north. Photo March 2019.

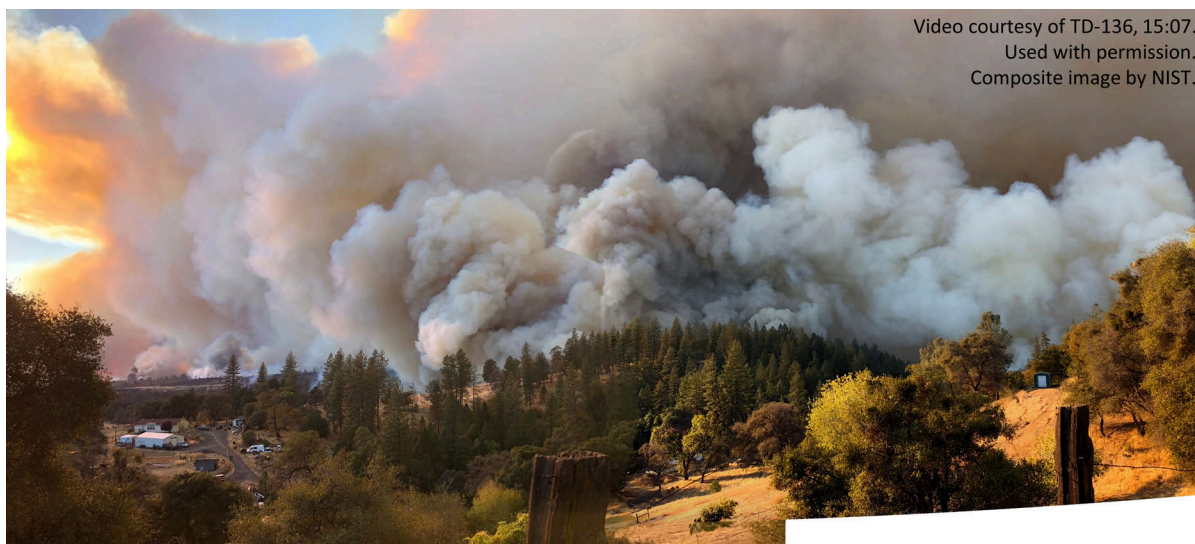
The fire continued to build in the drainages during the afternoon hours. **Figure 42** shows the view seen during the afternoon by first responders in the Nelson Bar Road area, with smoke coming from the Concow Creek drainage and West Branch canyons.

Figure 42. View west from Nelson Bar Rd where plumes of smoke are seen coming from beyond the ridge in the Concow Creek drainage, and beyond to Paradise (background, left).

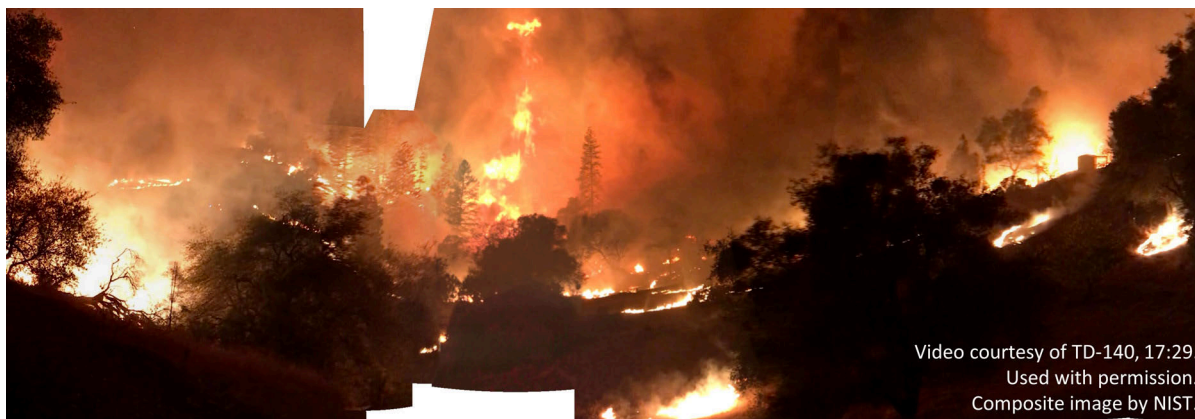
Figure 43. Fire activity increased in the drainage area, and the front rapidly spread south and east toward Nelson Bar Rd.

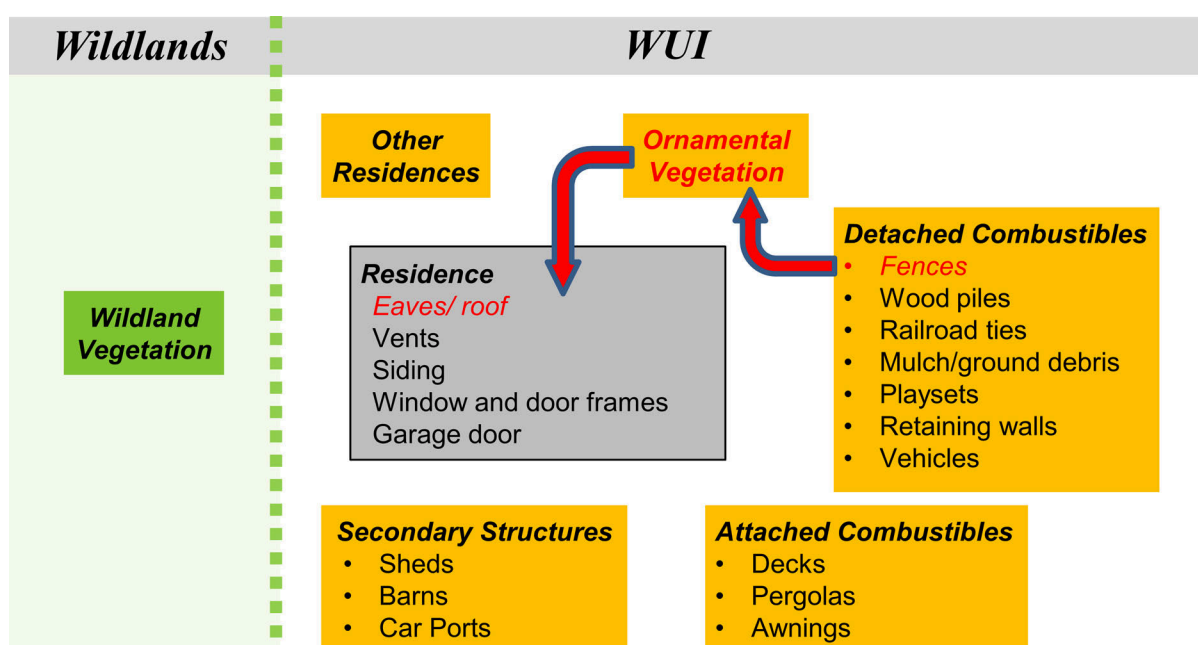
Direct observations of structure ignitions were identified in several TDs, videos, and photos, and highlighted several different ignition pathways. The data presented in **Table 35** illustrate the inter- and intra-parcel ignition pathways that were specifically identified through direct observations. **Figure 52** and **Figure 53** present photos from two structure ignition events with known pathways. **Figure 52a** shows a burning vehicle that was initially located approximately 2 m (6.5 ft) from the building and was moved by a dozer because it was igniting the side of the structure. **Figure 52b** shows a view of the damage as it appeared when surveyed by the NIST team during the field data collection effort. Evidence of ignition and defensive actions were confirmed by TD-091. **Figure 53** shows a structure ignition in Magalia as fire spread from vegetation and combustible fencing. **Figure 53a** and **b** were taken two minutes apart, and show the rapid fire spread to the eaves of the structure. **Figure 54** illustrates parcel-level fire vulnerabilities and hazards and highlights the structure ignition pathway for the case shown in **Figure 53**.

Figure 54. Numerous structure ignition pathways exist from the wildlands and inter- and intra-parcel exposure sources. The ignition pathway for the identified Dade Ct, Magalia structure ignition is highlighted.

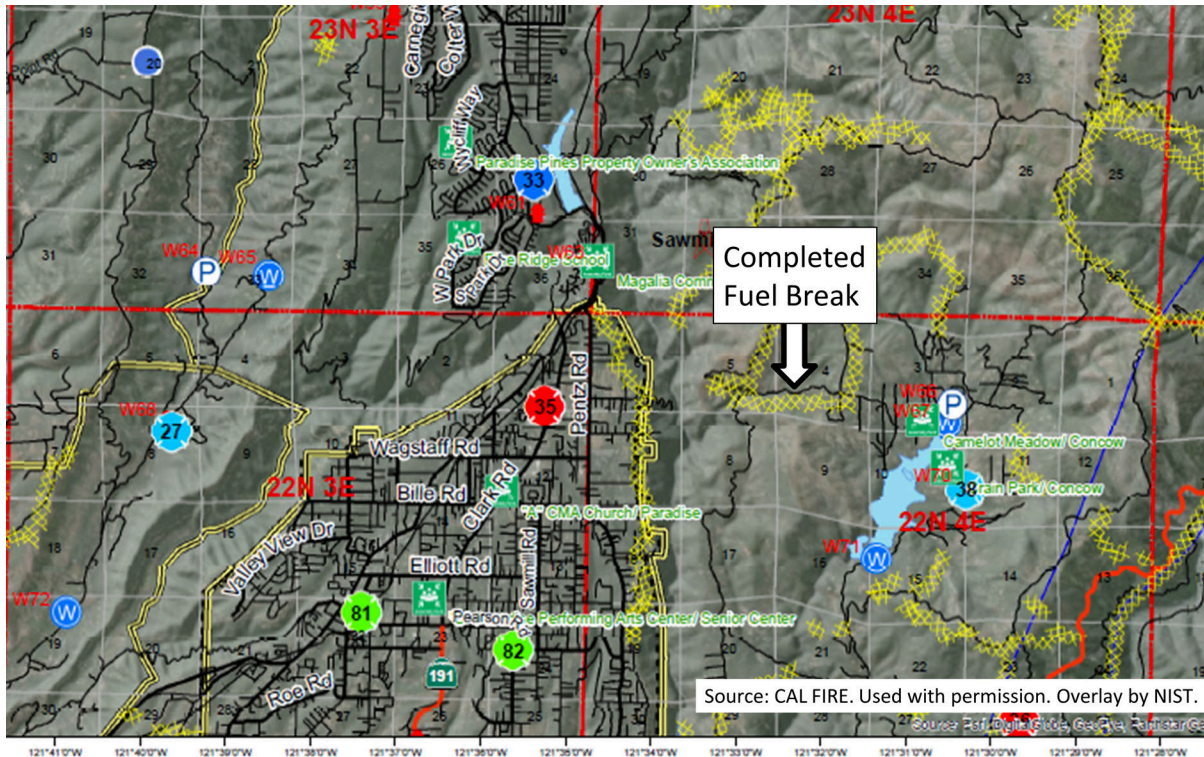
Fuel treatments have been used extensively to compartmentalize the landscape in the area around Paradise, Magalia, and in Concow [TD-008]. The goal of fuel treatments is to provide access for firefighting operations and reduce the total impact of wildfires by reducing the total acreage burned. **Figure 55** is an excerpt from the Butte County Wildland Fire Pre-Plan that illustrates fuel treatments around Paradise and Magalia. Fuel treatments have been used to influence wildland fire behavior and to protect critical infrastructure.

Figure 55. Wildland fire pre-plan for Butte County Fire Department Battalion 2.

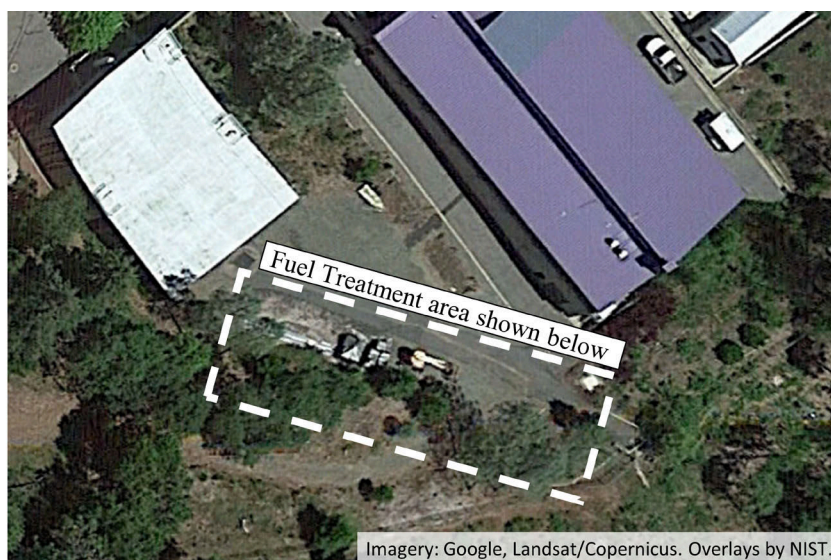
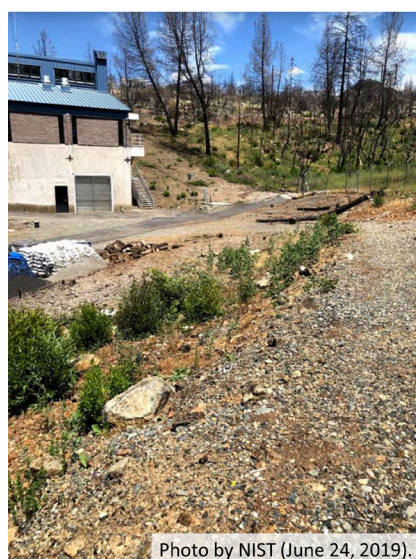
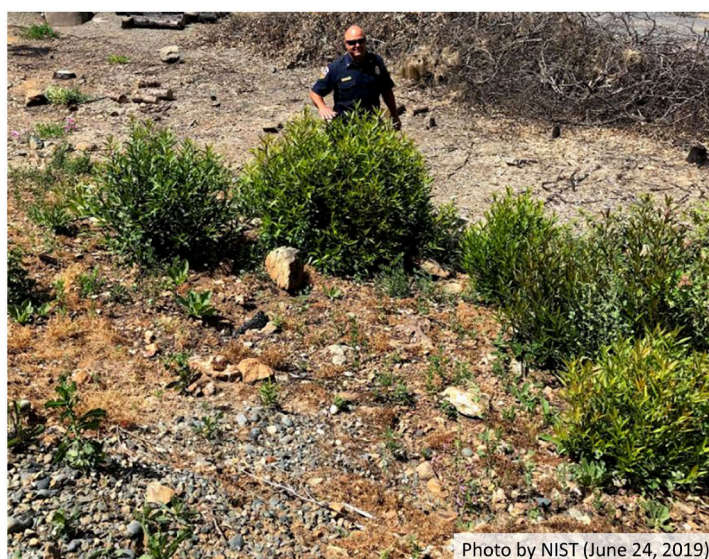
The fuel treatment around Paradise Irrigation District (PID) critical infrastructure, illustrated in **Figure 56**, was successful in protecting the facility when combined with defensive actions [TD-008]. This specific fuel treatment highlights pre-fire preparation and vegetative fuel reduction aimed at protecting critical infrastructure. The systematic analysis of the effectiveness of fuel treatments and their impact on fire behavior are beyond the scope of this report. There is a need for a detailed study to assess the impact of fuel treatments on wildland fire behavior and on their contributions to structure survivability, particularly when coupled with defensive actions.

Figure 56. Fuel treatment around Paradise Irrigation District critical infrastructure: a) prior to fuel treatment, May 2018, b) fuel treatment showing reduced fuel load, c) rapid post-fire vegetative growth in pre-fire fuel treatment areas.

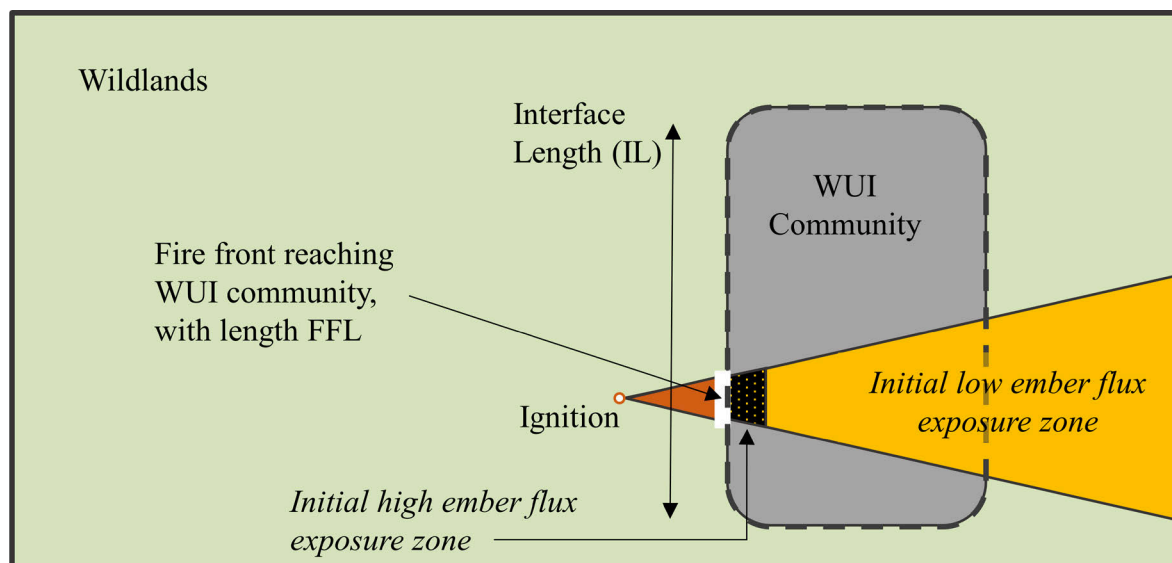
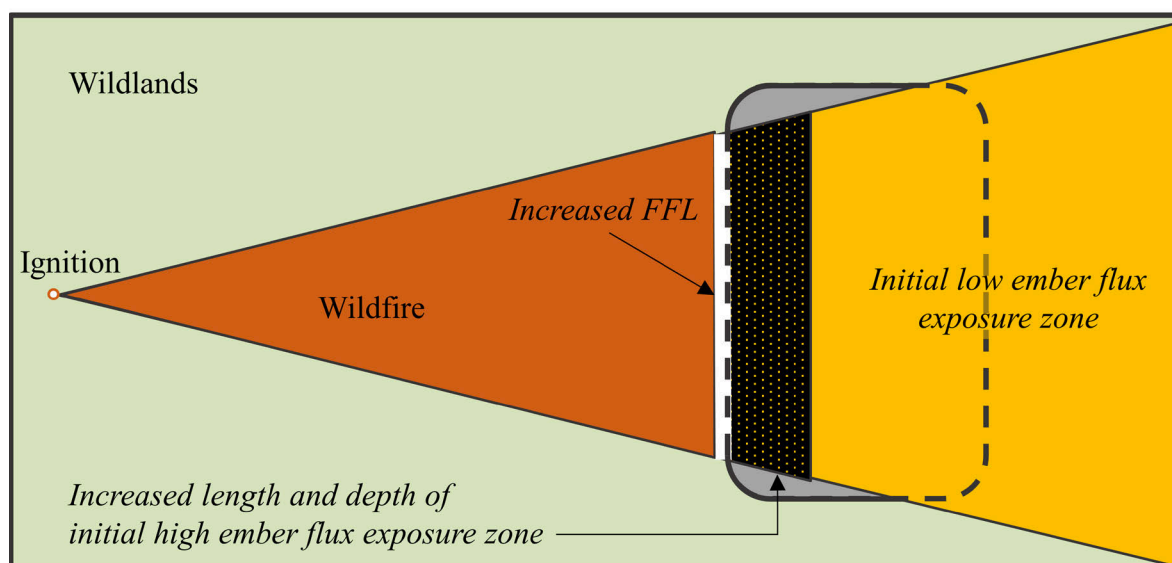
Figure 57 illustrates idealized fire spread scenarios with two different ignition locations away from the WUI community edge. In both cases the fire is not contained by the first responders before reaching the community. In the case where the ignition occurs near the community, the fire front length (FFL) represents only a small fraction of the community interface length (IL). The resulting initial impact on the community is relatively small, $FFL/IL \ll 1$, and therefore the high ember exposure zone downwind of the initial fire front also covers a small area of the WUI community.

The second (lower) scenario illustrated represents an idealized version of the Camp Fire. In this scenario, the wildland fire ignition occurs far from the community, and the fire has enough fuel and distance to develop a fire front that represents a large fraction of the interface length of the community. In this case, in addition to the extended direct fire front assault, the high ember exposure zone represents a large fraction of the community and is illustrated as having a longer and deeper reach into the community. This deeper reach is related to the higher overall intensity of the fire front. The increased area of initial high ember flux exposure has the potential to easily overwhelm fire-fighting resources and enables the fire to become well established throughout the community.

Figure 57. Idealized relationship between ignition location, a) near or b) far, from a WUI community and the fire front and ember exposures reaching the community. The wind is directed from left to right.

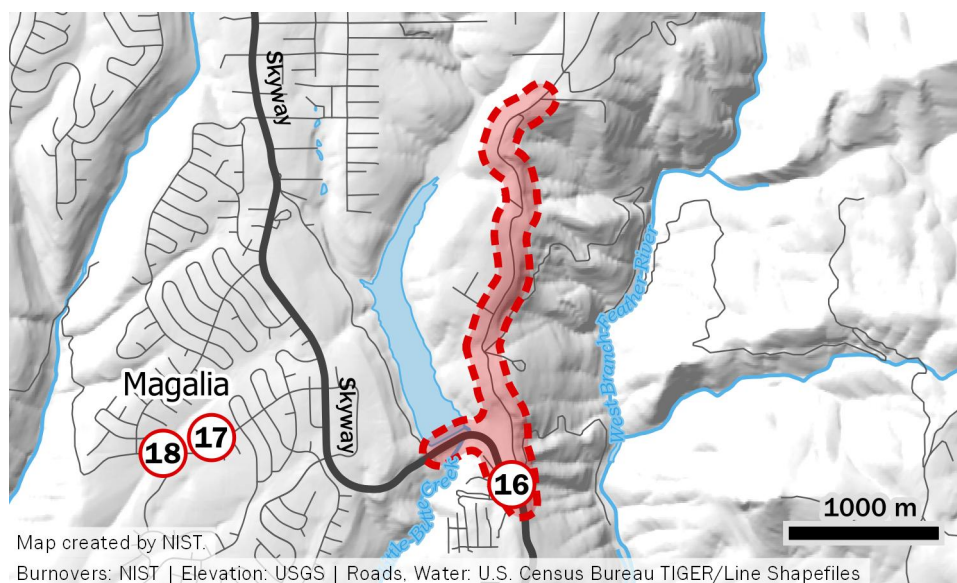
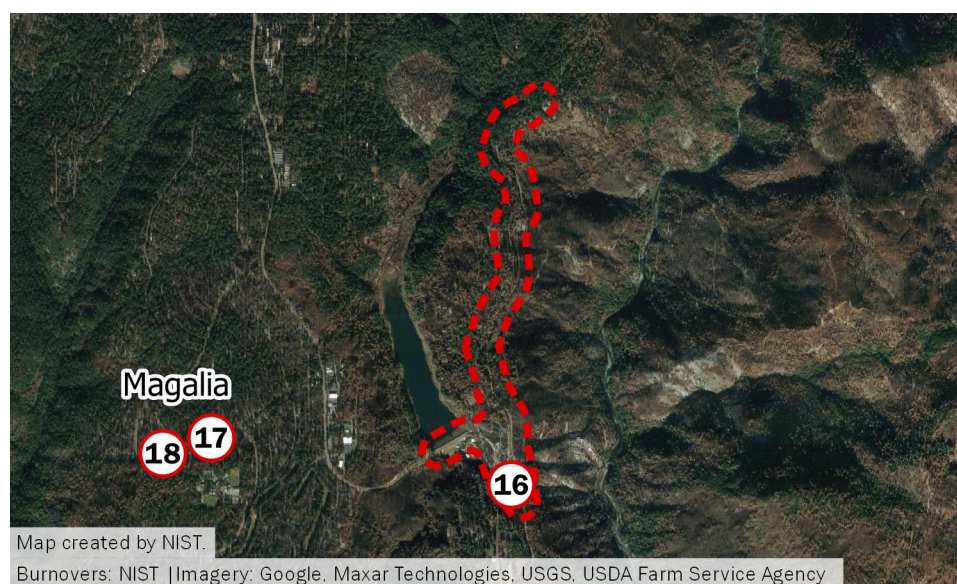
16. Coutolenc Road

Date/Time:	November 9, 00:00–02:00
Location:	Coutolenc Rd, Magalia, between Skyway and Ridgeway
Coordinates:	[39.812765, -121.578400]
Related TRA:	n/a
Summary:	At 23:30 a spot fire was identified in the West Branch Feather River Canyon. Shortly after midnight, into November 9, the wind increased to 15 m/s to 27 m/s (35 mi/h to 60 mi/h) and the spot fire grew rapidly, pushing uphill and west towards Coutolenc Road and Magalia. A strike team working on Coutolenc Road was split up as they escaped the oncoming fire; some engines had to drive north on Coutolenc Road and return through Magalia. The area surrounding the intersection of Coutolenc Road and Skyway remained impassable until at least 01:19, when first responders took refuge in the intersection of Skyway and Coutolenc Road, and on the dam of the Magalia Reservoir. Photos taken at 01:22 indicate continued crown fire activity along Coutolenc Road.

00:30–01:00	fire came over ridge, spotting	TD-043
00:37	fire has crossed Coutolenc Rd between Winchester Ln and Alphys Ln, burning with the wind toward Magalia Reservoir	TD-061

Topography:	along a ridge, canyon to either side
Roadway width:	7 m (22 ft)
Vegetation setbacks:	0 m to 2 m (0 to 6 ft)
Duration:	120 min
Extent of burnover (length of road affected):	3 km (2 mi)
Fire direction across road:	east to west
Wind intensity:	15 m/s to 27 m/s (35 mi/h to 60 mi/h)
Fuels:	brush/trees
Fire behavior:	wind-driven increase of fire pushed up slope through heavy vegetation, crowning fire through trees
Related TD:	TD-007, TD-040, TD-041, TD-043, TD-045, TD-061, TD-109, TD-115, TD-122, TD-123, TD-124, TD-125, TD-126, TD-127, TD-209
Related streets or keywords:	Skyway, Dogtown Rd

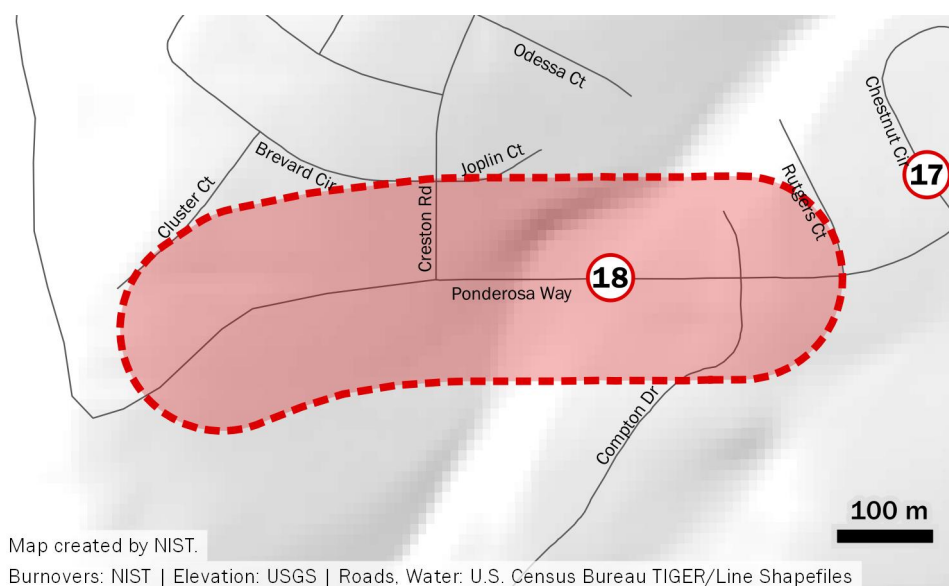
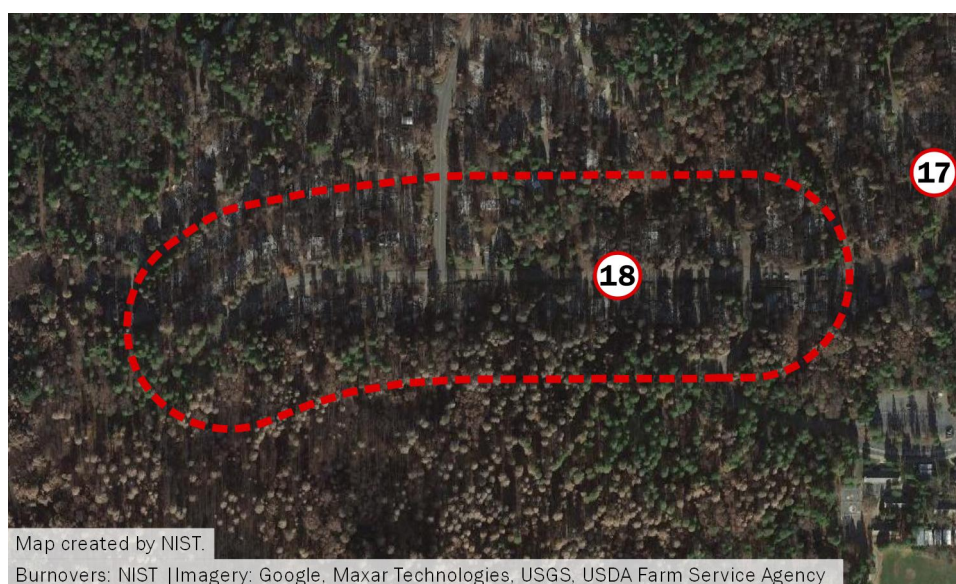
18. Ponderosa Way

Summary: At approximately 07:10 on November 9, firefighters were conducting door-to-door evacuations along Ponderosa Way as some civilians were still in the area. Within 10 minutes, by 07:20, fire approached Ponderosa Way from the south and west causing a rapid deterioration of local conditions resulting in fire blowing across Ponderosa Way. Firefighters with an elderly civilian in their engine drove through fire to get to safety. Additional fire engines retreated to a safety zone at Pine Ridge School on Compton Drive. There is insufficient data to determine the temporal extent of this turnover since firefighters left the area.

Topography:	Slight southwest aspect near top of canyon/ravine
Roadway width:	12 m (40 ft)
Vegetation setbacks:	0 m to 3 m (0 ft to 10 ft)
Duration:	n/d
Extent of burnover (length of road affected):	400 m (0.25 mi)
Fire direction across road:	southwest to northeast
Wind intensity:	“wind howling”, “high winds”
Fuels:	brush/trees
Fire behavior:	rapid increase in fire activity due to high winds, wind-driven fire
Related TD:	TD-061, TD-127, TD-128, TD-202, TD-203, TD-205, TD-207
Related streets or keywords:	Compton Dr, Creston Rd, Pine Ridge School
Street-level view:	Ponderosa Way at Compton Dr intersection near Pine Ridge School looking west.
Pre-fire imagery links:	Bing Maps Streetside
Post-fire imagery links:	No imagery available.

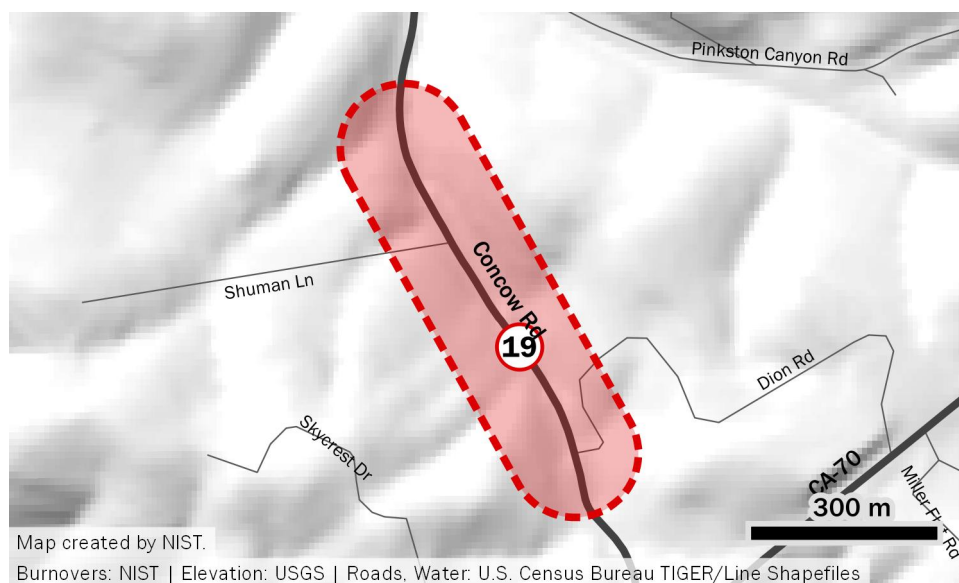
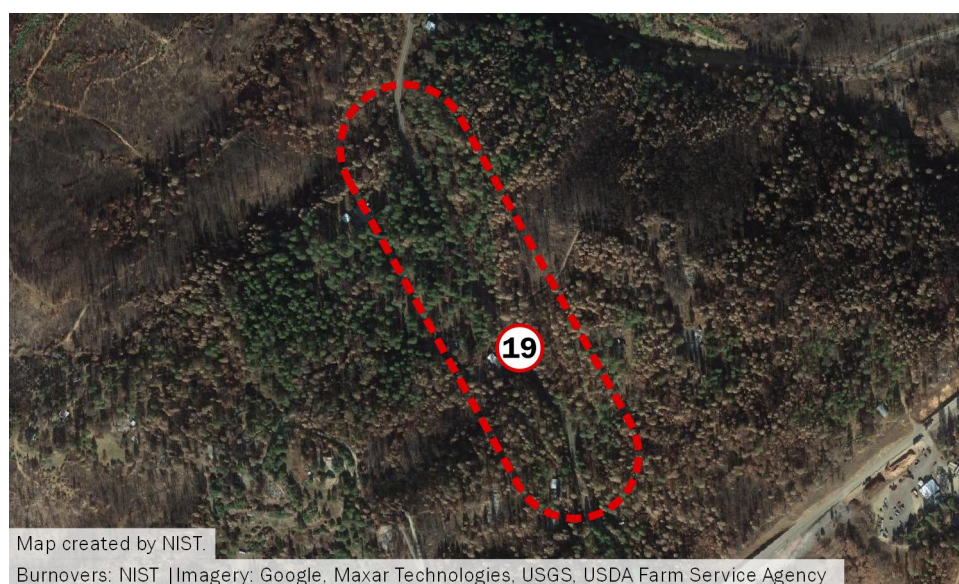
19. Concow Fire Station 37

Date/Time:	November 9, 07:15
Location:	Concow Rd, south of Concow, between Nelson Bar Rd and Hwy 70
Coordinates:	[39.721161, -121.523270]
Related TRA:	n/a
Summary:	At 06:40 on November 9, fire was blowing southwest across Pinkston Canyon Road towards Concow Road. Firefighters in the area of Fire Station 37 on Concow Road at Shuman Lane were concerned about getting pinched by the fire. Fire was burning on Shuman Lane at around 07:09 but the activity was not intense. However, over the next 10 minutes the wind increased dramatically to 9 m/s to 13 m/s (20 mi/h to 30 mi/h), fire activity quickly intensified, and Station 37 was surrounded by fire. Concow Road became impassable and only part of the strike team was able to drive through fire to Hwy 70. Other engines in the strike team had to turn around and wait for the fire activity to subside. Concow Road remained impassable until at least 07:50. There is insufficient data to determine the temporal extent of this burnover. This burnover is not known to have impacted any civilians.

07:20–07:27	wind shift; fire starts coming down from west side, then east side; both sides of Concow Rd are burning; firehouse is hit hard	TD-140
07:27–07:48	2 fire engines drive past head toward Hwy 70, but can't make it and come back to wait	TD-137

09:01	station is burned down	TD-137

Topography:	between ridges, up slope on both sides of roadway
Roadway width:	9 m (30 ft)
Vegetation setbacks:	0 m to 3 m (0 ft to 10 ft)
Duration:	n/d
Extent of burnover (length of road affected):	600 m (0.4 mi)
Fire direction across road:	n/d
Wind intensity:	9 m/s to 13 m/s (20 mi/h to 30 mi/h)
Fuels:	brush/trees
Fire behavior:	rapid increase in fire activity during sun rise and shifting winds.
Related TD:	TD-136, TD-137, TD-138, TD-139, TD-140
Related streets or keywords:	Concow Rd, Shuman Ln, Pinkston Canyon Rd, Concow pool
Street-level view:	Concow Rd looking north with fire station on the west side of Concow Rd.
Pre-fire imagery links:	Bing Maps Streetside
Post-fire imagery links:	Google Maps Street View

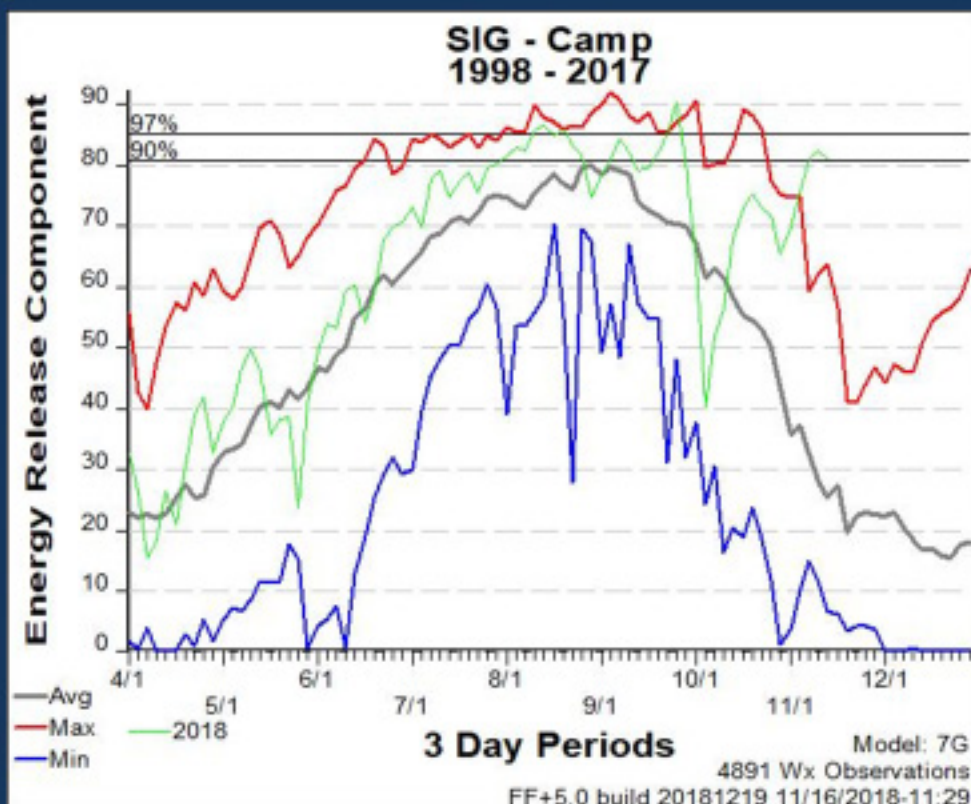
The Energy Release Component (ERC) of the National Fire Danger Rating System is a measure of *fuel dryness* and *flammability*.

The ERC was trending slightly above average all summer for the Northern Sierras, but in October it began trending well above average, and continued through to the day of the fire when it was above the historic record for the date and near the 90th percentile for all dates.
