**NIST Technical Note  
NIST TN 2267**

# **Fire Resilience of a Steel-Concrete Composite Floor System: Full-Scale Experimental Evaluation for Influence of Slab Reinforcement and Unprotected Secondary Beam (Test #3)**

October 2023

Test #3 was conducted to study the effect of enhanced slab reinforcement as well as unprotected secondary beams on the fire resilience of the composite floor systems. Similar to Test #2, the floor slab in the test bay was reinforced with 9.5 mm diameter deformed bars with a center-to-center spacing of 30 cm (230 mm<sup>2</sup>/m). Unlike in Test #1 and Test #2, the secondary beam and its end connections in the test bay were left unprotected in Test #3. The test floor was mechanically loaded to 2.7 kPa to mimic the code-prescribed gravity loads for fire conditions. The compartment test fire created upper-layer gas temperatures like those in standard fire resistance tests. A total of four natural gas burners distributed over the compartment floor created a peak gas temperature exceeding 1100 °C below the test floor. A wide transverse crack with flame leak above the floor developed at 132 min in the mid-panel region. The mid-panel vertical displacement rea

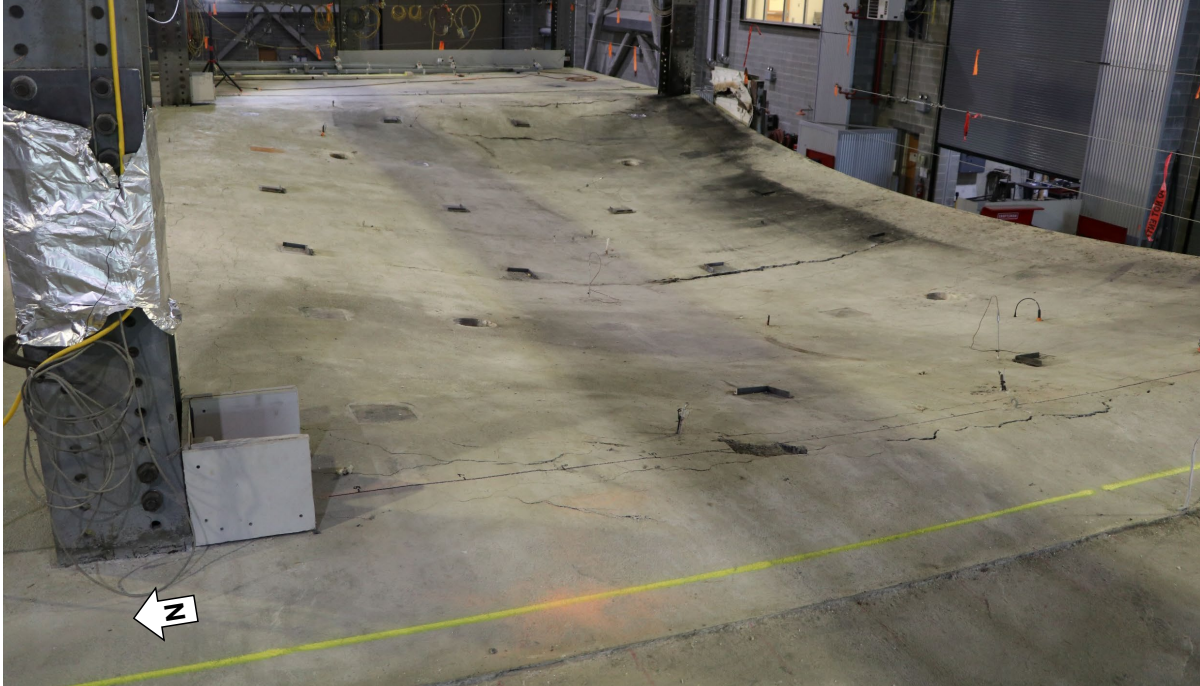
Fig. 33 and Fig. 34 show the deflected shape of the test floor after cool-down and concrete crack pattern on top of the floor specimen, respectively. As shown in Fig. 34, the concrete slab exhibited a large transverse crack opening, approximately 105 cm west of the transverse centerline of the test bay, with a maximum crack width after cooling of approximately 3.5 cm near the secondary beam. Most of the No. 3 reinforcing bars ruptured in this crack opening (Fig. 35) during the test. Flame leak above the slab through this transverse crack was observed after 132 min of fire exposure. The test floor exhibited cracks at other three locations (marked 2, 3, and 4 in Fig. 34) at 138 min of fire exposure, with flame leak above these cracks, although these cracks were smaller in size compared to the mid-panel transverse crack (marked 1). Concrete cracks at locations 2 and 3 also exhibited reinforcing bar fractures (Fig. 36). The test floor also exhibited cracks along the east, west, and north edges of the test-bay column grid (but within the footprint of the fire test compartment). The cracks along the west and east edges were larger toward the south columns but became smaller around the north columns. Along the west edge crack, the first five bars from the south end exhibited bar fracture (Fig. 37a and Fig. 37b) and the slab in that region lost continuity over the girders. The cracks along the east edge exhibited no bar fractures (Fig. 37c and Fig. 37d). Figure 38 shows the crack pattern in the north corners (locations 7 and 8) of the test floor and in the midspan of the north edge (location 9). The location of the north edge crack was about 64 cm from the north splice plate near the north-south centerline of the slab, indicating the development of that crack near the ends of the No. 4 reinforcing bars extended from the north splice plate. Those cracks did not exhibit any bar fractures. No cracks, bar slips, or bar fractures were observed in the regions of reinforcing bar splices, which were designed as ACI-318 [22] contact splices.

Fig. 33. Deflected shape of the test floor slab

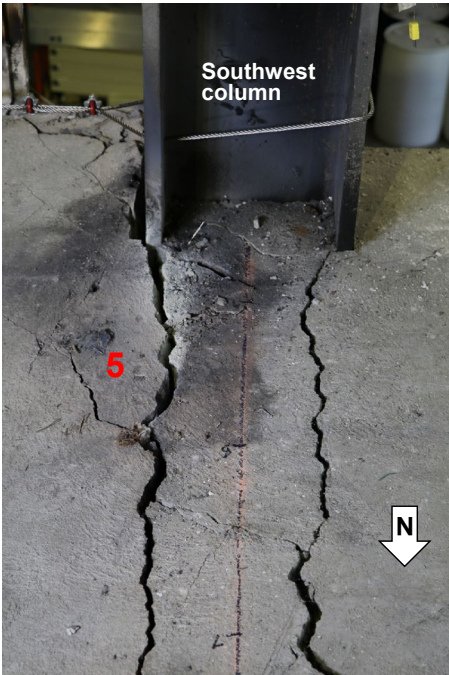
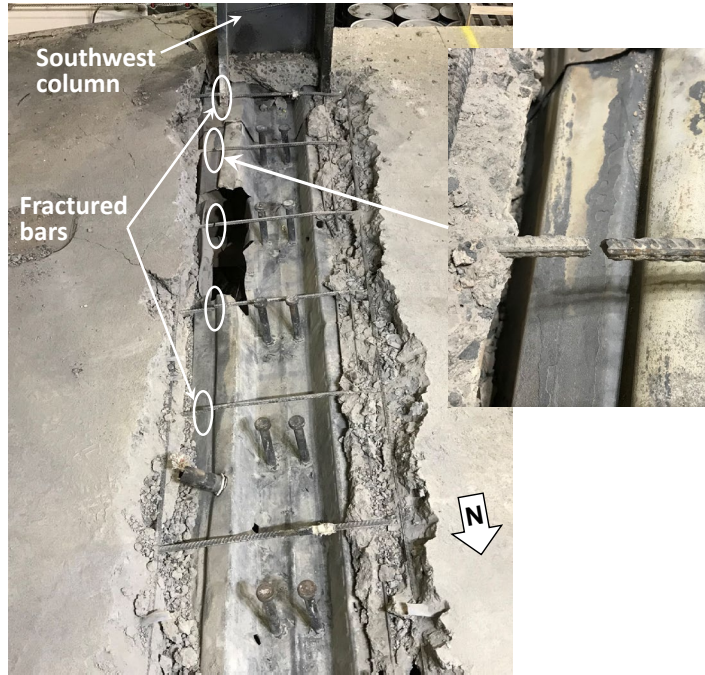
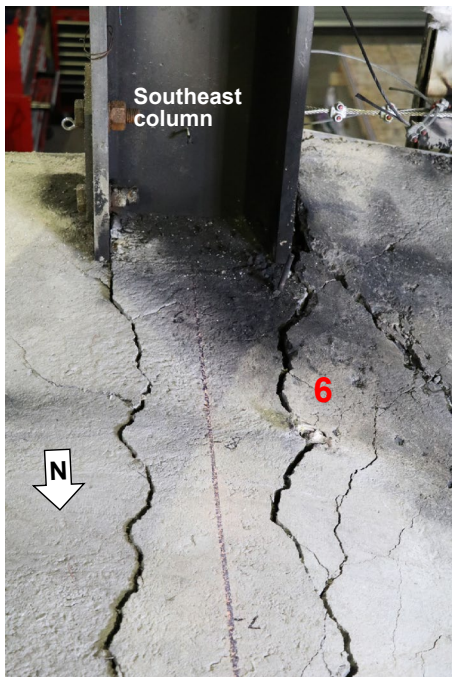
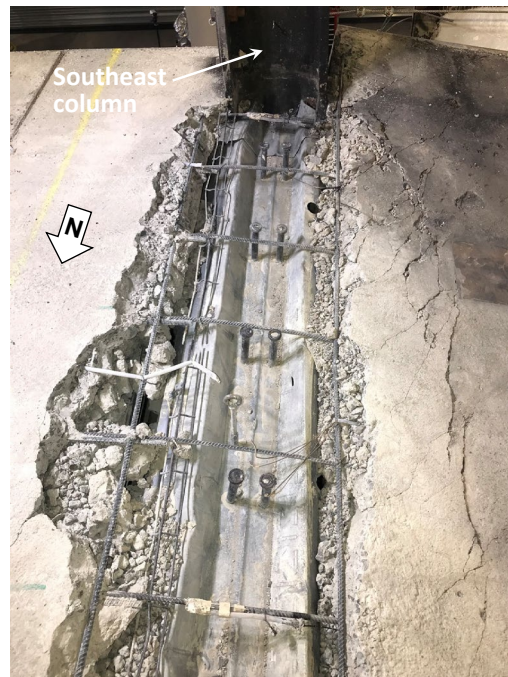
**Fig. 37.** (a) Concrete cracks along the west perimeter of the test bay; (b) reinforcing bar fractures along the west perimeter; (c) concrete cracks along the east perimeter of the test bay; (d) exposed reinforcing bars along the east perimeter (at Locations 5 and 6 in Fig. 20).

- 4) Compared to Test #1, the No. 3 bars placed in the test floor slab in Test #3 appeared to effectively control the formation of large concrete cracks along the perimeter of the test bay. Most of the concrete cracks along the perimeter, except near the south columns, were less than 10 mm wide after cooldown. The concrete crack along the west perimeter near the south

column exhibited rebar fractures. The floor specimen exhibited a wide transverse crack at 132 min with flame leak above the floor through this crack. The test floor exhibited cracks in the south east quarter of the test panel at 138 min with rebar fractures and flame leak through these cracks.

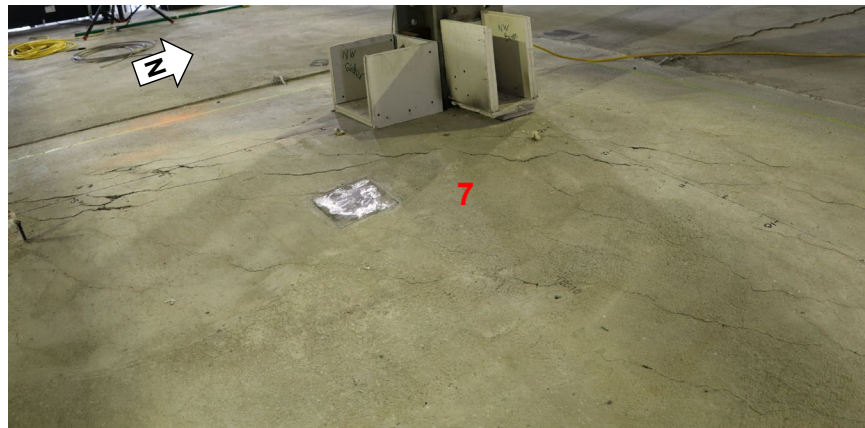
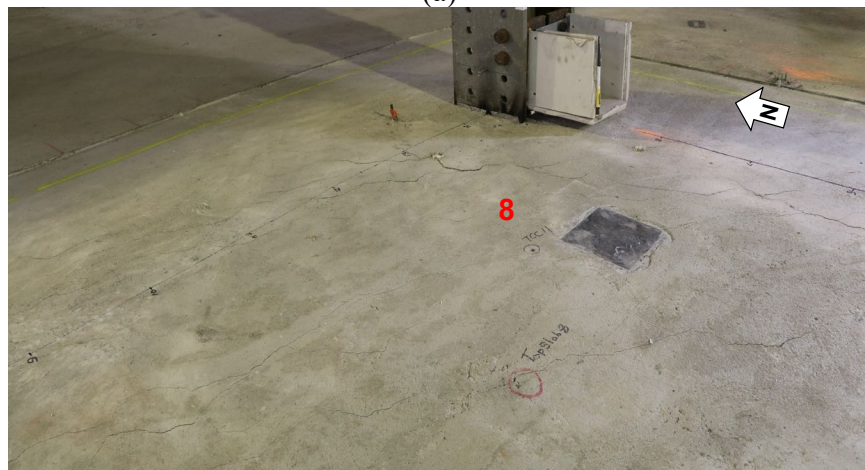
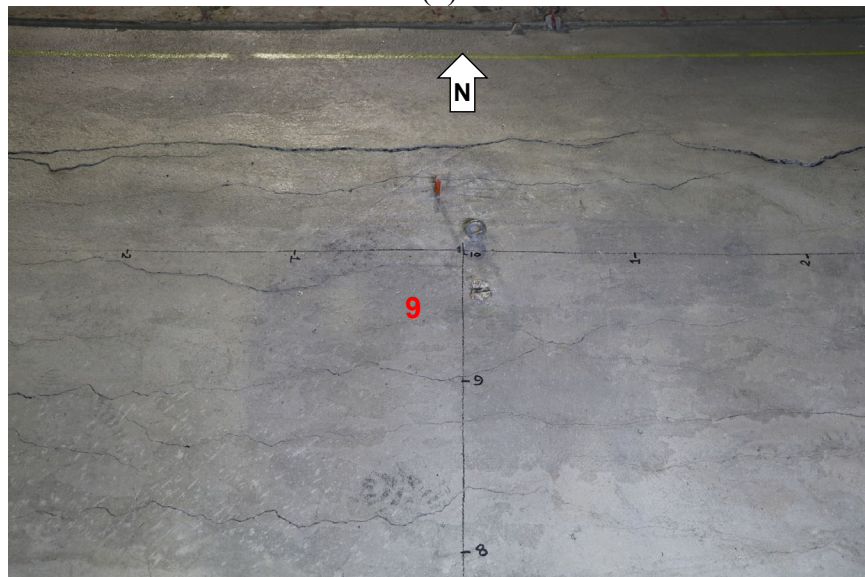
**Fig. 38.** Post-test photographs of the test floor slab at Locations 7, 8, and 9 in Fig. 20.

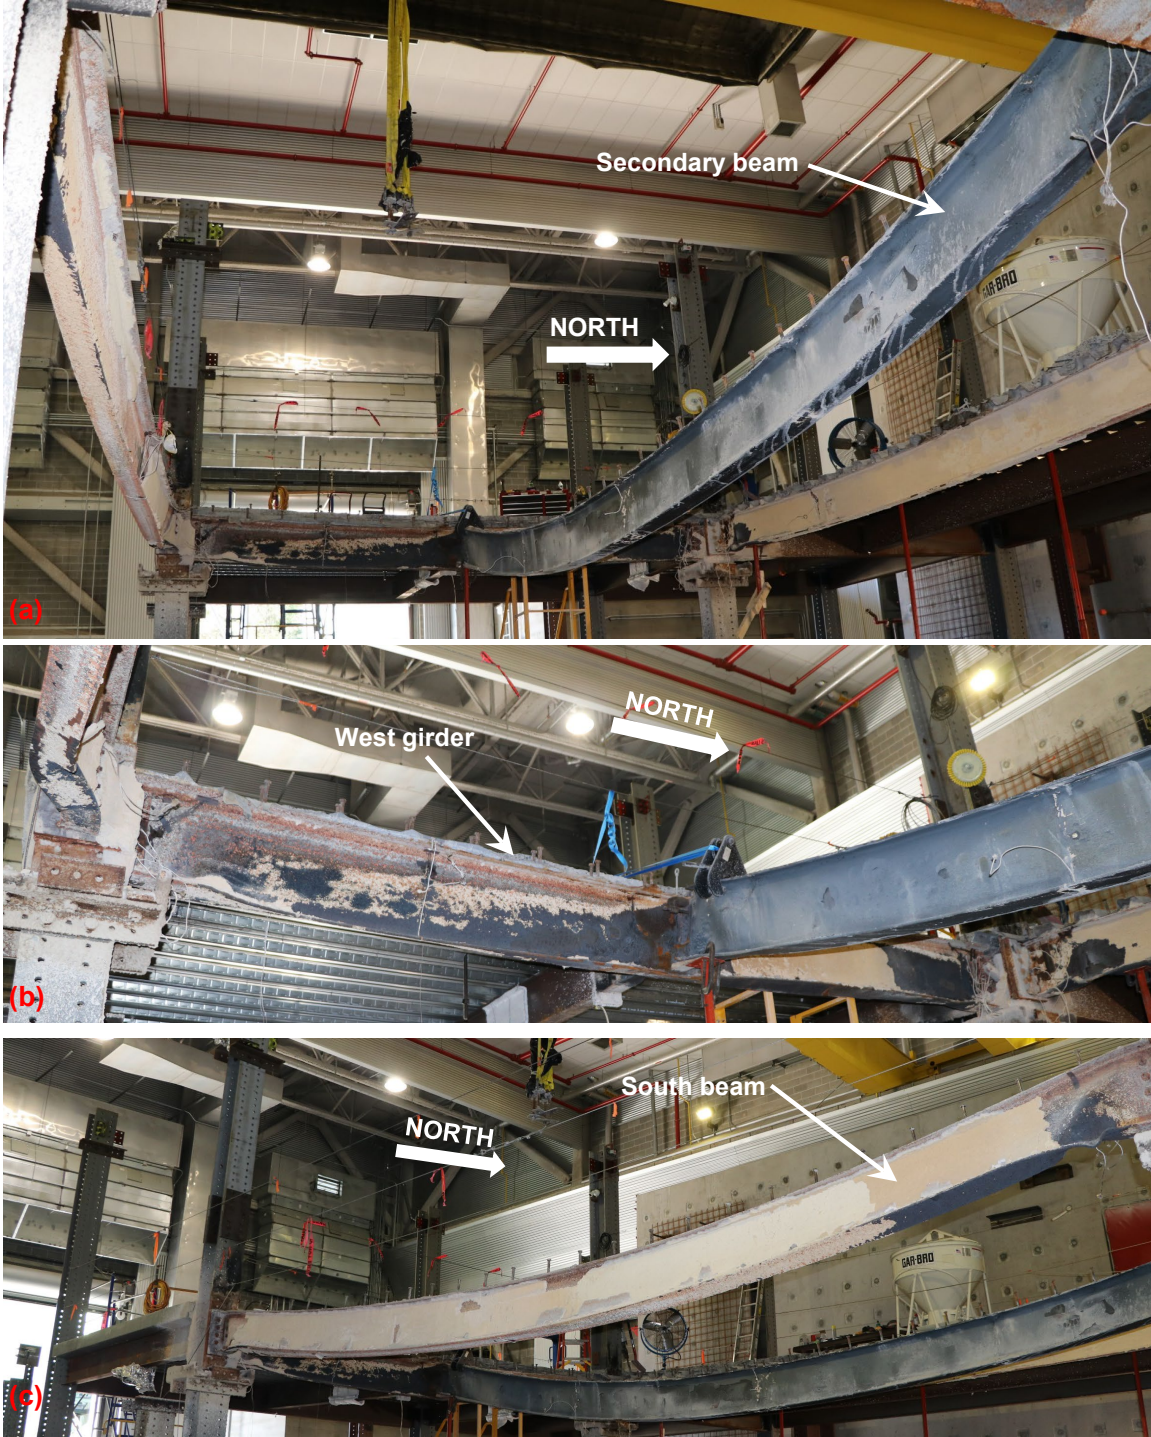
Figure 41 through Figure 43 show the post-test photographs of the fire damaged steel beams and connections. As shown, all floor beams, suffered from the test fire, exhibited permanent global deflection as well as both flange and web local buckling, although the severity of steel deformations varied among beams (Fig. 41). The north and south primary beams exhibited some degree of lateral deformation and twisting, whereas the secondary beam was mostly bent in its strong axis.

Fig. 41. Post-test photographs of the test bay beams after steel deck removal.

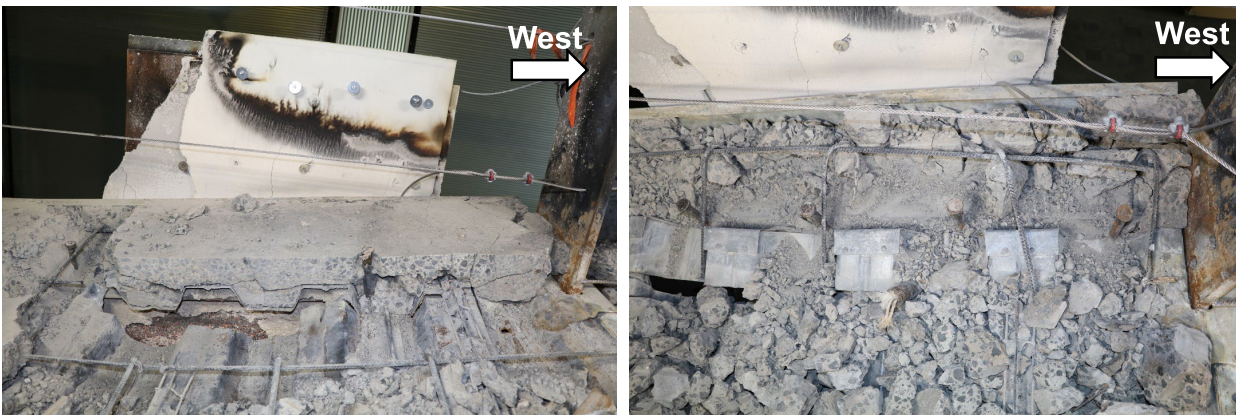
**Fig. 74.** Post-test photographs of headed studs (a) at the east end of north beam before concrete removal; (b) at the east end of north beam after concrete removal; (c) at the west end of north beam before concrete removal; (d) at the west end of north beam after concrete removal.
