NIST GCR 17-014

A Study on the Effect of Repeat Moderate Intensity Radiant Exposures on SCBA Facepiece Properties

July 2017

**A study on the effect of repeat moderate intensity
radiant exposures on SCBA facepiece properties**

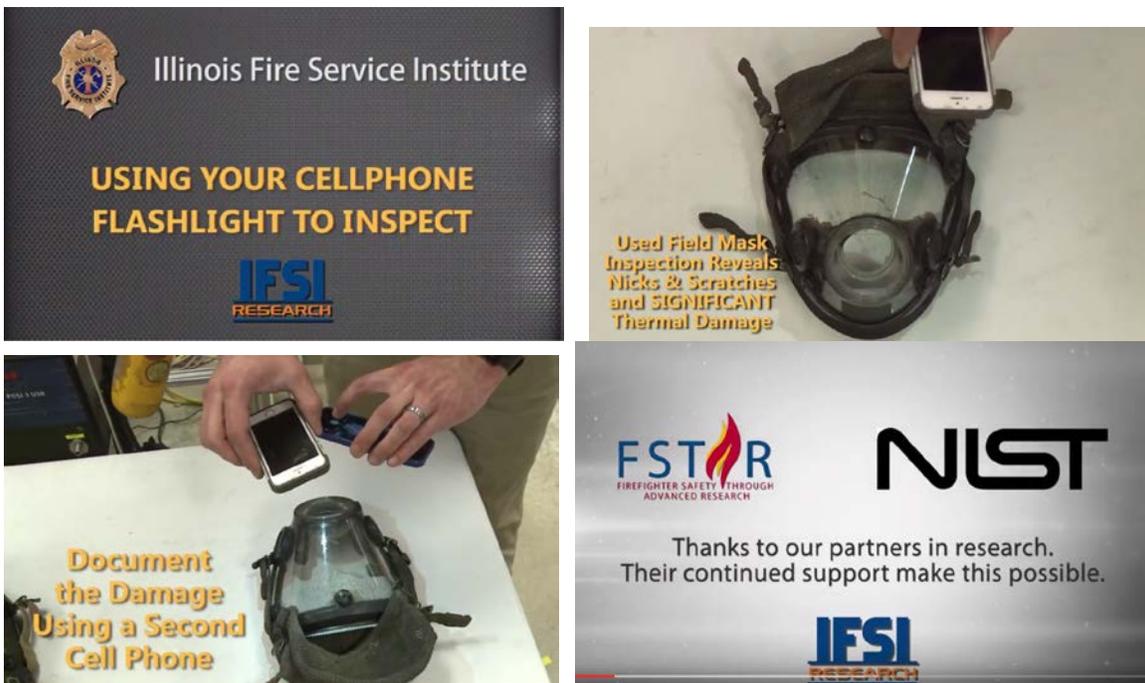
Figure 20. Screenshots from SCBA Inspection video produced and distributed to the Fire Service.

While developing a method to repeatably document and characterize the damage from these thermal exposures, a technique to create a shadow of the polycarbonate lens with a common cellular phone light was developed. This approach is an adaptation of a qualitative method that is sometimes used with sunlight, but provided a more repeatable means of imaging and possibly a standardizable approach. As Figure 19 shows, the damage from the 10 and 100 cycle exposures that is difficult to detect in Figure 18 becomes readily apparent with this approach. The utility of this technique was made apparent during multiple conversations with the Fire Service, so an on-line tutorial video was created and broadly distributed with the support of IAFC's FSTAR program (Figure 20). This video can be viewed on YouTube (<https://www.youtube.com/watch?v=eJVTfLfuFHc>).

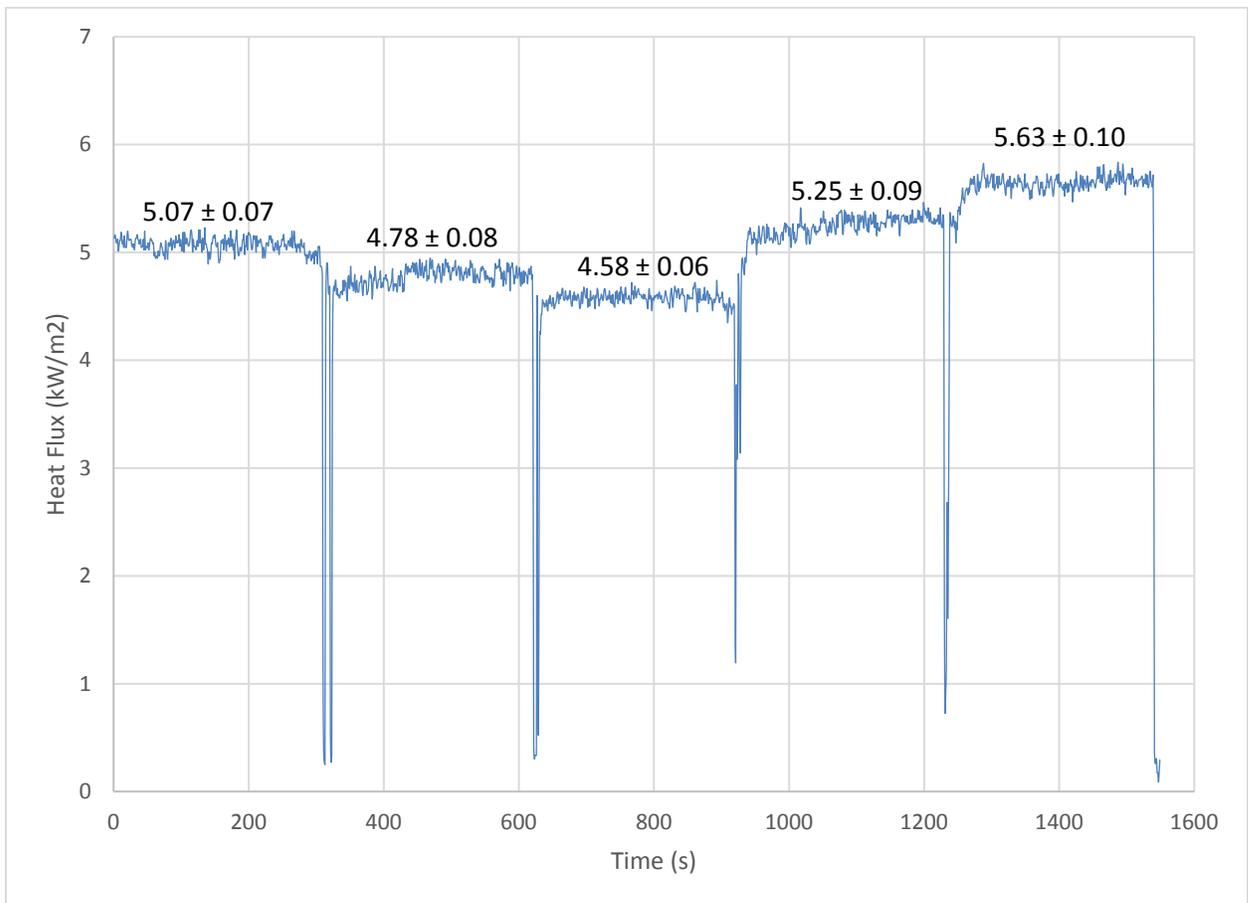
Figure 21: Relative impact of distance from the radiant panel on heat flux for approximate 5 kW/m² condition. Labels indicate mean ± standard deviation (kW/m²) for data collected at 1 Hz.

for 5 minutes. The gauge was then moved away from the radiant panel by 12.5 mm and 25 mm, and then moved towards the panel from the 5 kW/m² mark by 12.5 mm and 25 mm. Heat flux data was recorded at each location for five minutes (Figure 21). It can be seen that moving the cart 25 mm in either direction increases or decreases the heat flux by 0.5 kW/m². For a change in position of 12.5 mm, which is similar to the magnitude of the curvature effect, the impact on heat flux is approximately 0.25 kW/m². Thus, the outside samples (A, E) are being exposed to a ~5% lower heat flux than the center samples (B-D). While this variation is relatively small due to the curvature effect, the thermal damage developed in the lenses is significantly concentrated on the front section of the facepiece (Figure 19). This may suggest that exposures to the 5 kW/m² level provides a critical level for damage accumulation to occur.

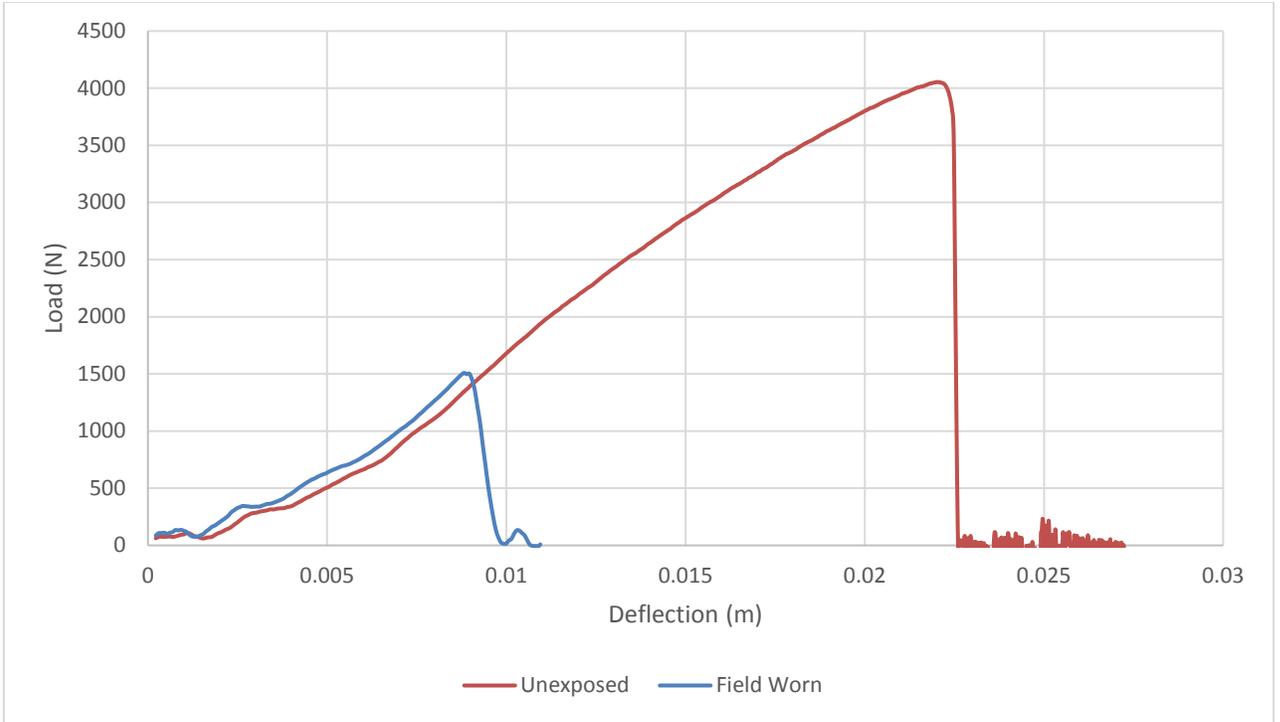
Figure 24: Typical load vs. deflection curves for impact tested samples.

load of $4.33 \text{ kN} \pm 0.28 \text{ kN}$ and a mean energy of $42.7 \text{ J} \pm 1.7 \text{ J}$. However, samples 1 and 2, failed with drastically reduced maximum load and energy absorption. Field worn sample 1 reached a maximum load of 0.80 kN and absorbed 11.2 J of energy prior to failure, while field worn sample 2 failed at a maximum load of 1.53 kN and absorbed only 6.3 J . The mechanism of failure for these two samples was consistent with brittle fracture rather than ductile failure. The load-deflection curves for field worn sample 2 and unexposed sample 4 are shown in Figure 24. These curves show that the field worn sample demonstrates not only a significantly reduced peak load, but also a decreased deflection to failure. Total energy absorption, which is directly related to the area under this load-time curve, is obviously reduced. Thus, the ability of the lenses that were exposed to the conditions in these field worn lenses would be significantly reduced.

The variation in impact properties among the field worn samples may not be surprising, since the history of thermal exposures to these lenses cannot be accurately quantified. Qualitatively, the lenses that performed similarly to the unexposed samples had less visible thermal damage than those exhibiting decreased properties. Field samples 3-5 had minor surface cracking and abrasions, whereas samples 1 and 2 had subsurface cracking and severe crazing. Figure 25 shows the difference in post-impact damage between samples, as well as typical fracture patterns.
