NIST GCR 18-018

Structures Ignited by Virginia WUI Fires 2/2015 – 2/2017

David D. Evans Lavern R. Scott William D. Walton Home Safety Foundation Chevy Chase, Maryland 20815-4206

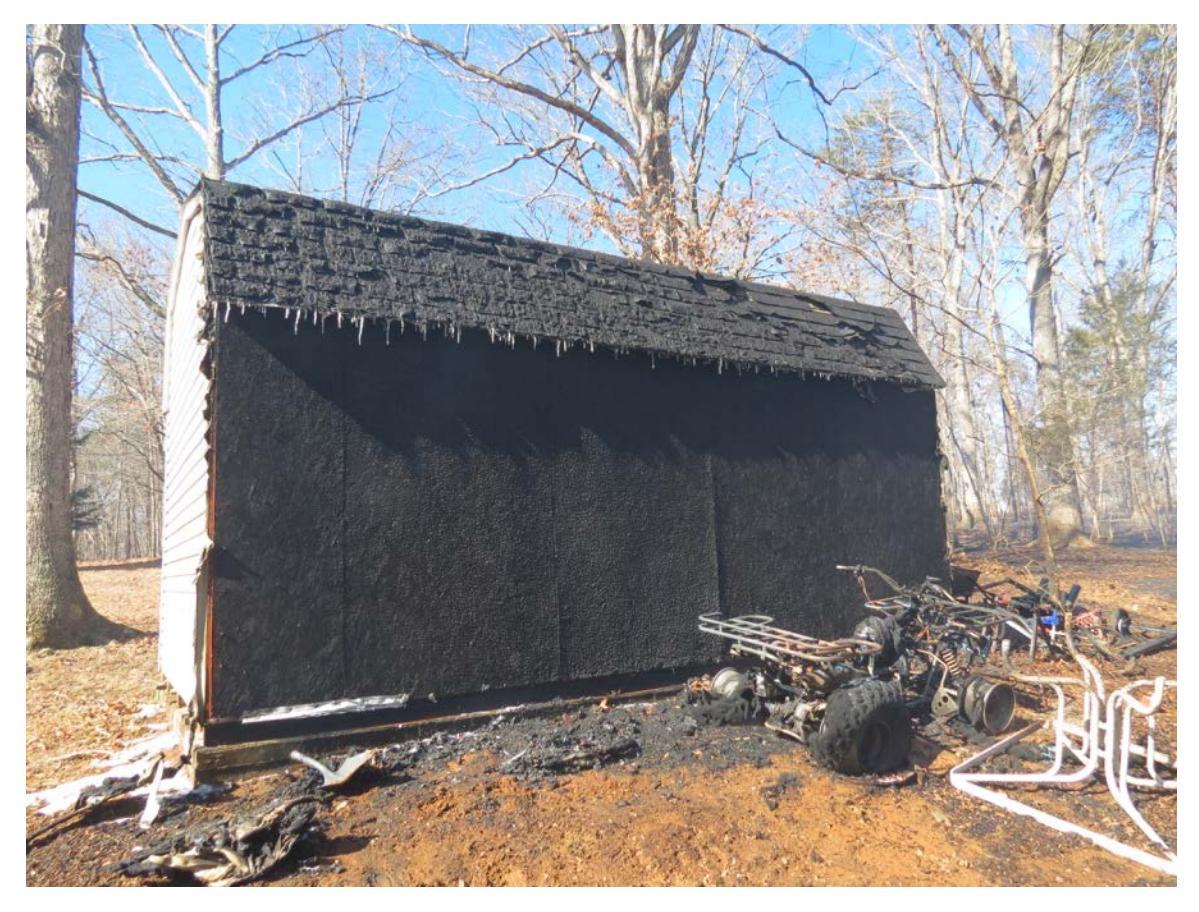
Fig. S1-3. Photo provided by the owner shows fire damage to the utility building on side C. Surface fire burning in leaves reached the structure, deforming the vinyl siding and igniting the OSB sheeting.

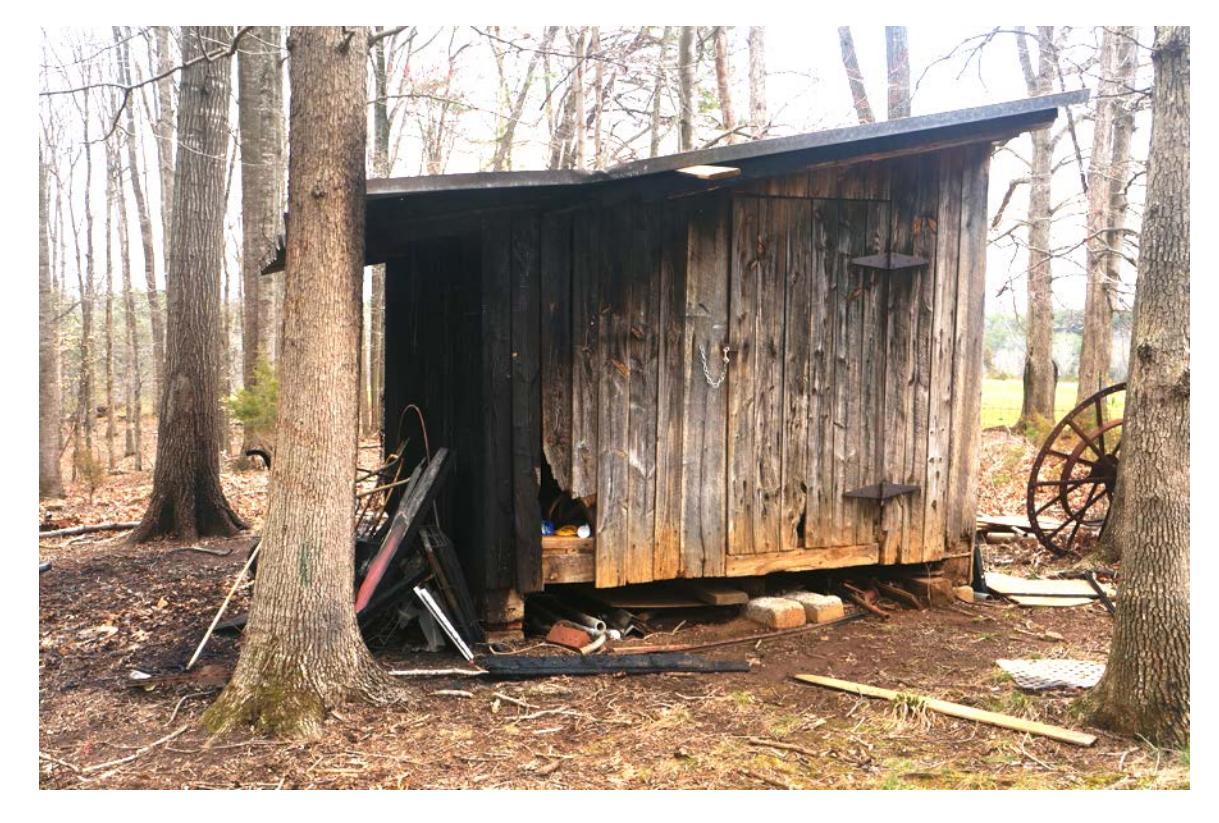
Fig. S2-1. Photo shows the damaged side A of the utility building. The blackened area on the left side of the photo is the damaged wall of side B.

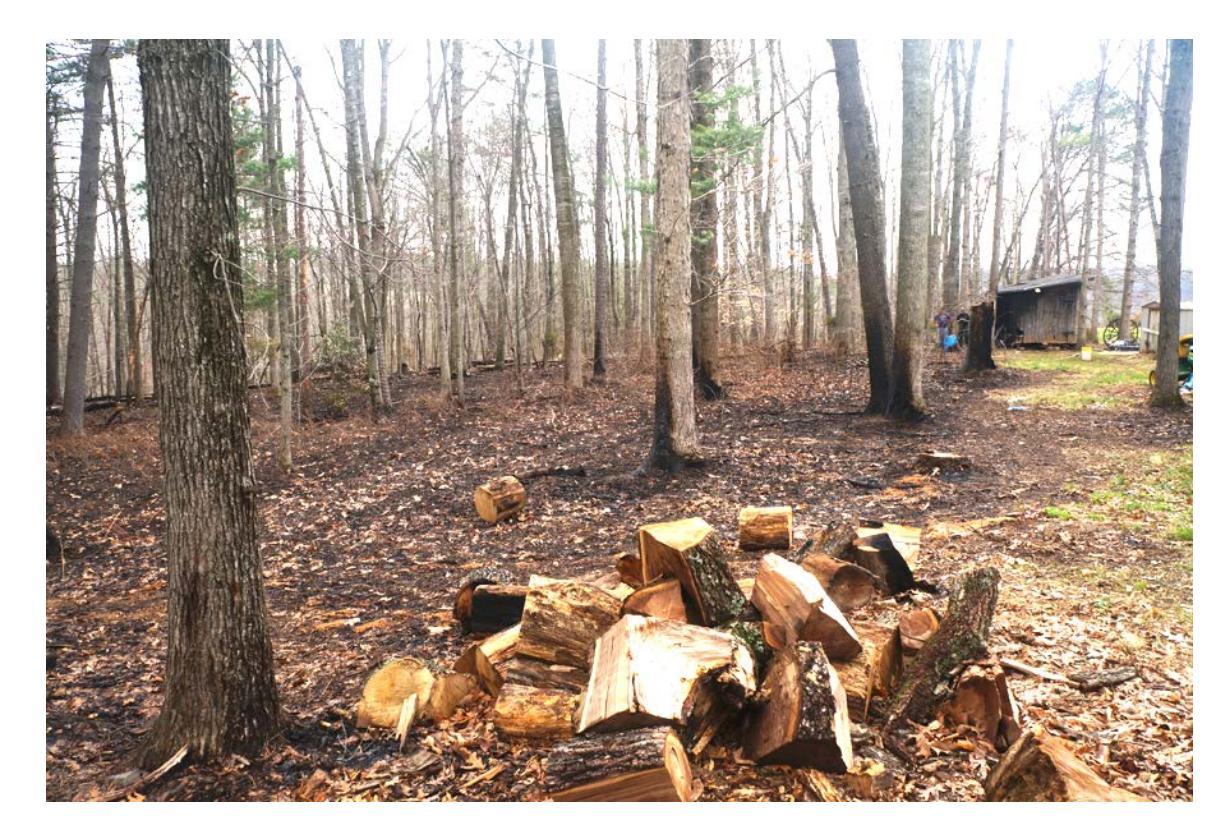
Fig. S2-2. Photo shows the surface fire's path of travel from near the boiler to the utility building. The wind speed was 9.8 m/s (22 mph) from the south, blowing from the right to the left in this photo.

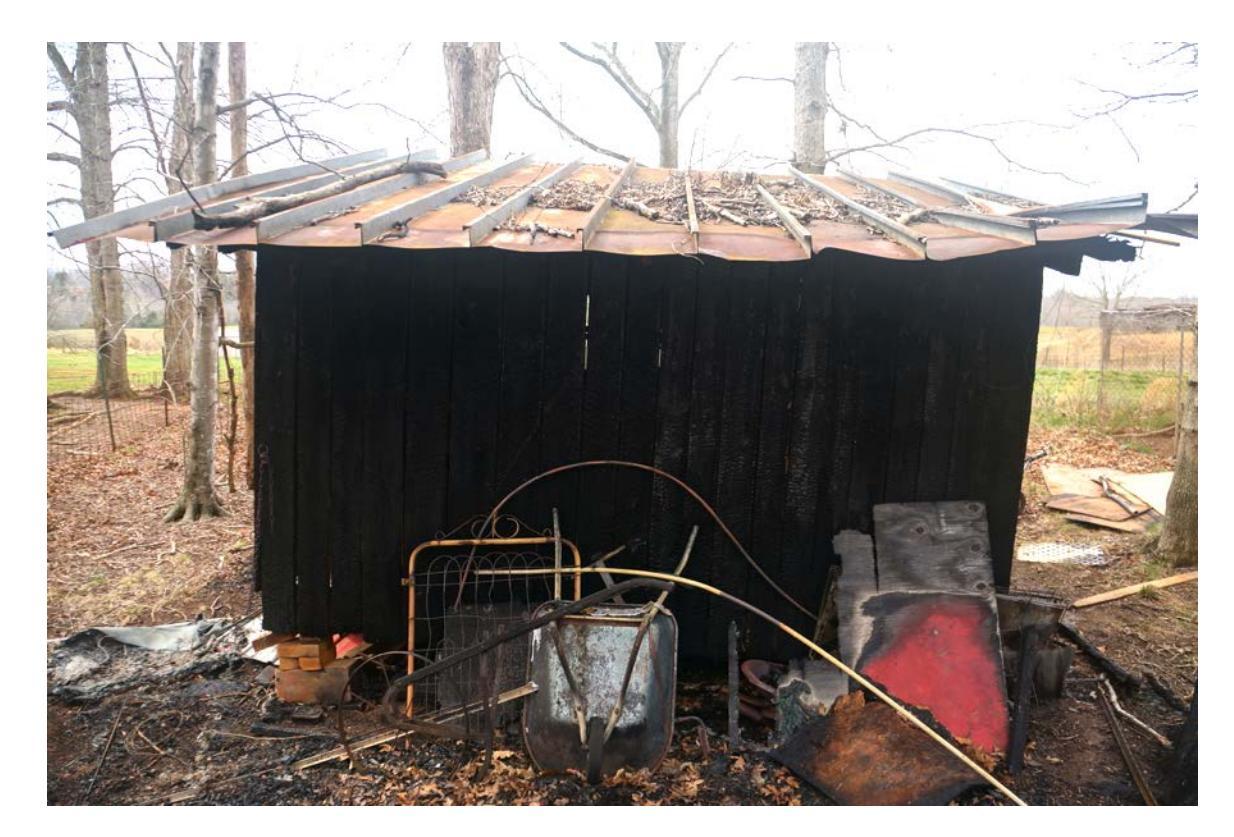
Fig. S2-3. Photo of damaged wood board siding on side B.

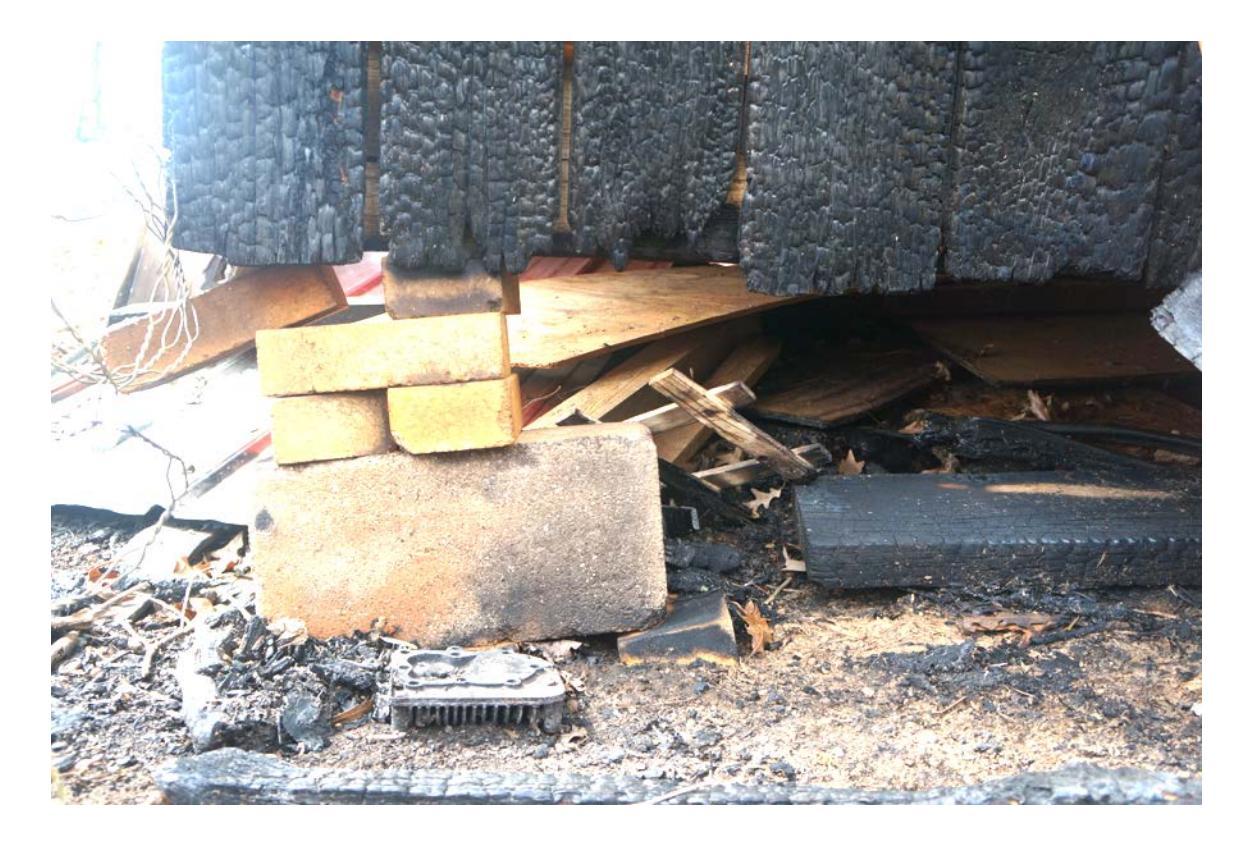
Fig. S2-4. Photo shows close-up view of damage to the bottom edge of wood board siding on side B. Deeper char damage was present along the weathered bottom edge of the wood board siding.

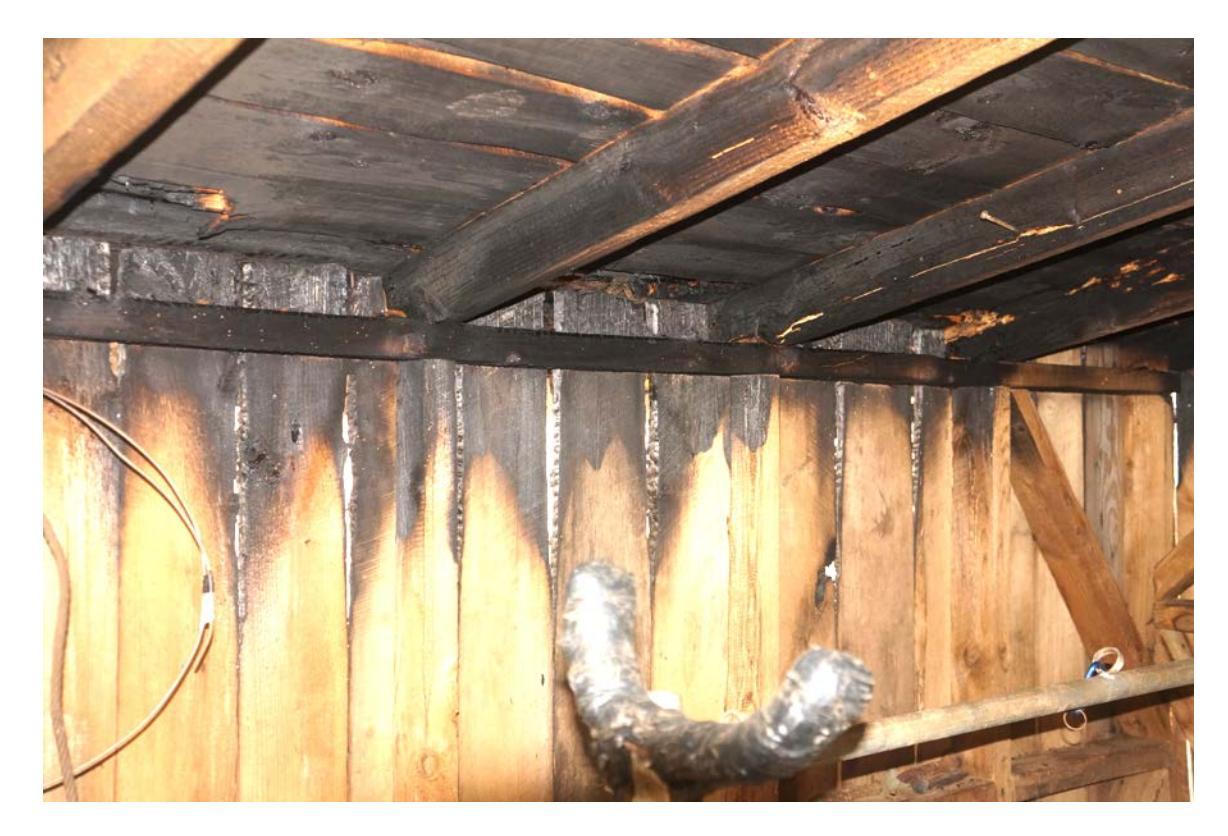
The fire spread up the entire exterior side B wall surface bottom to top. Fire damaged the exterior wall and corners of side B, the side B roof overhangs, soffits and ignited the rolled roofing material under the top layer of standing seam metal roofing. The fire made entry through the gaps in the wood board siding.

Fig. S2-5. Photo shows points of entry along the top wall plate of the side B wall. Fire entered through gaps in the wood board siding.

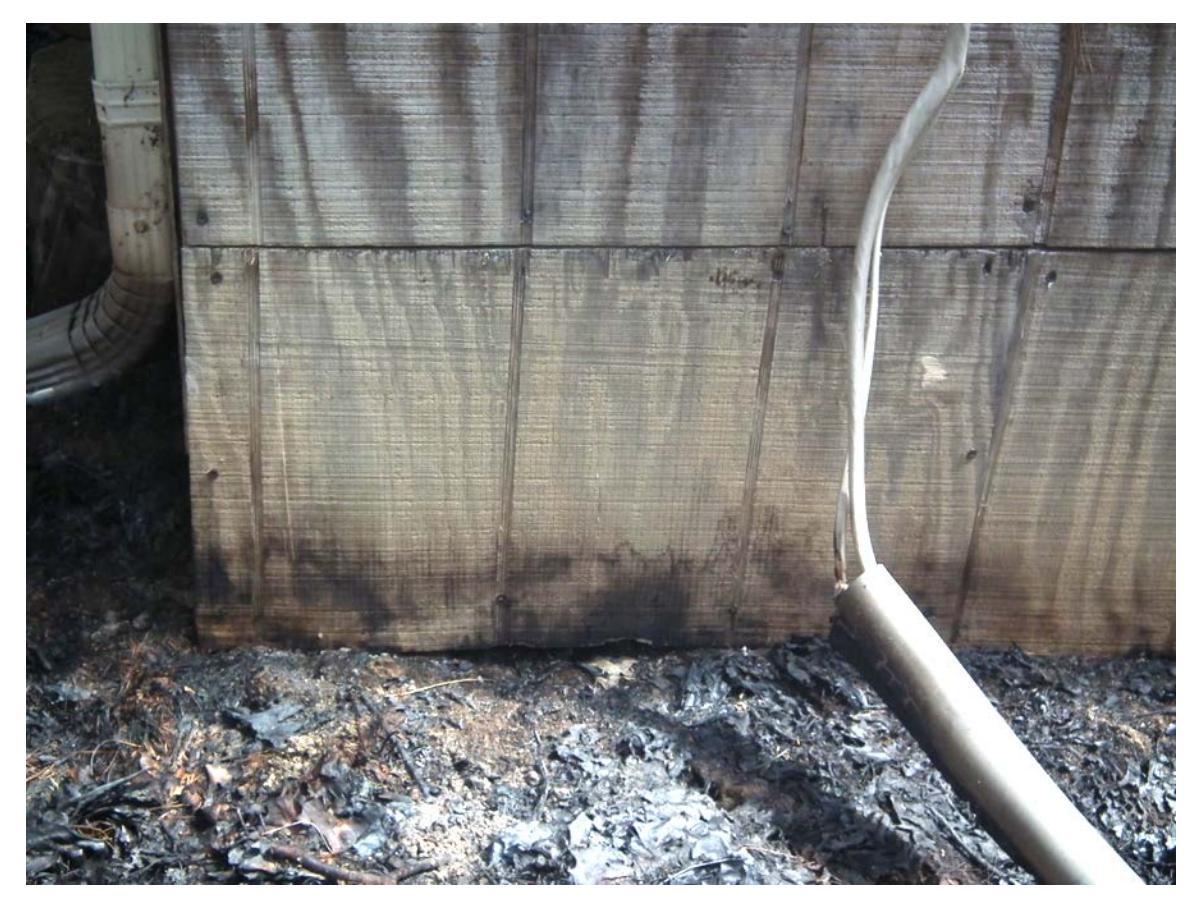
Fig. S3-3. Photo shows fire damage to T1-11 siding on side B near the corner with side C. A creeping surface fire burning in leaves reaching the base of the building ignited the bottom edge of the exterior siding.

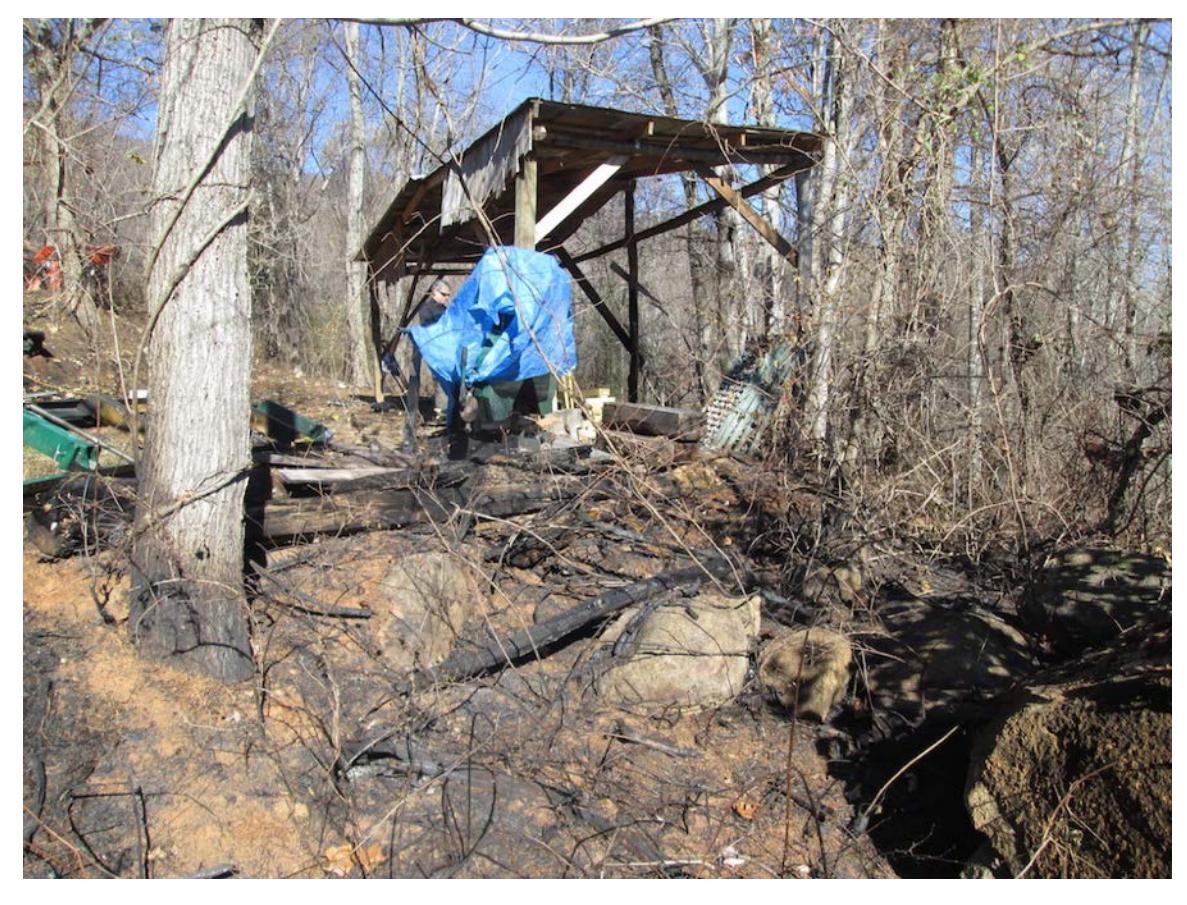
Fig. S4-2. Photo shows the burned area on side D where the surface fire entered the open pole structure near the corner with side C.

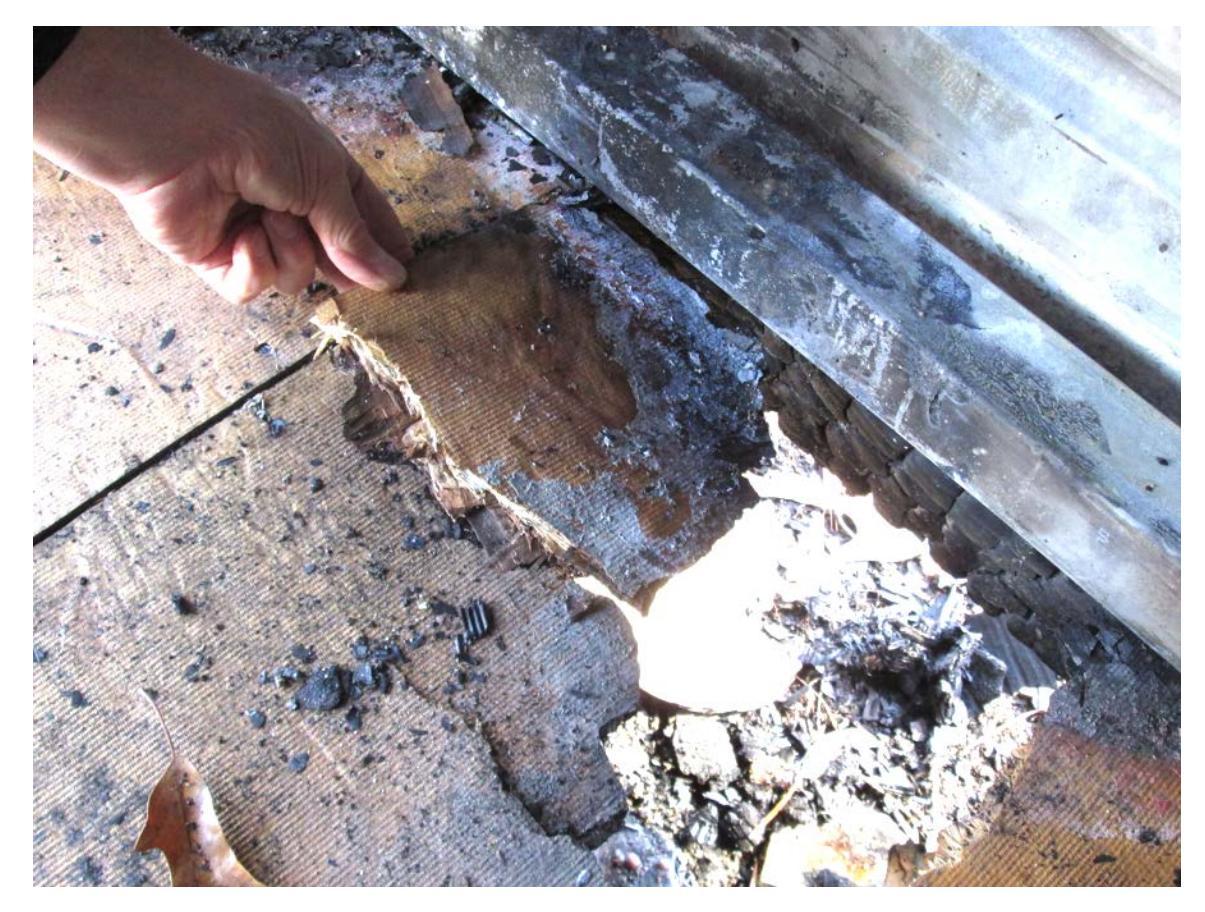
Fig. S5-5. Photo shows a close-up view of the location where the fire made entry into the building. A sample of the most damaged floor sheeting is shown at this location where the fire made entry. The sample was broken out by firefighters during extinguishment and overhaul operations.

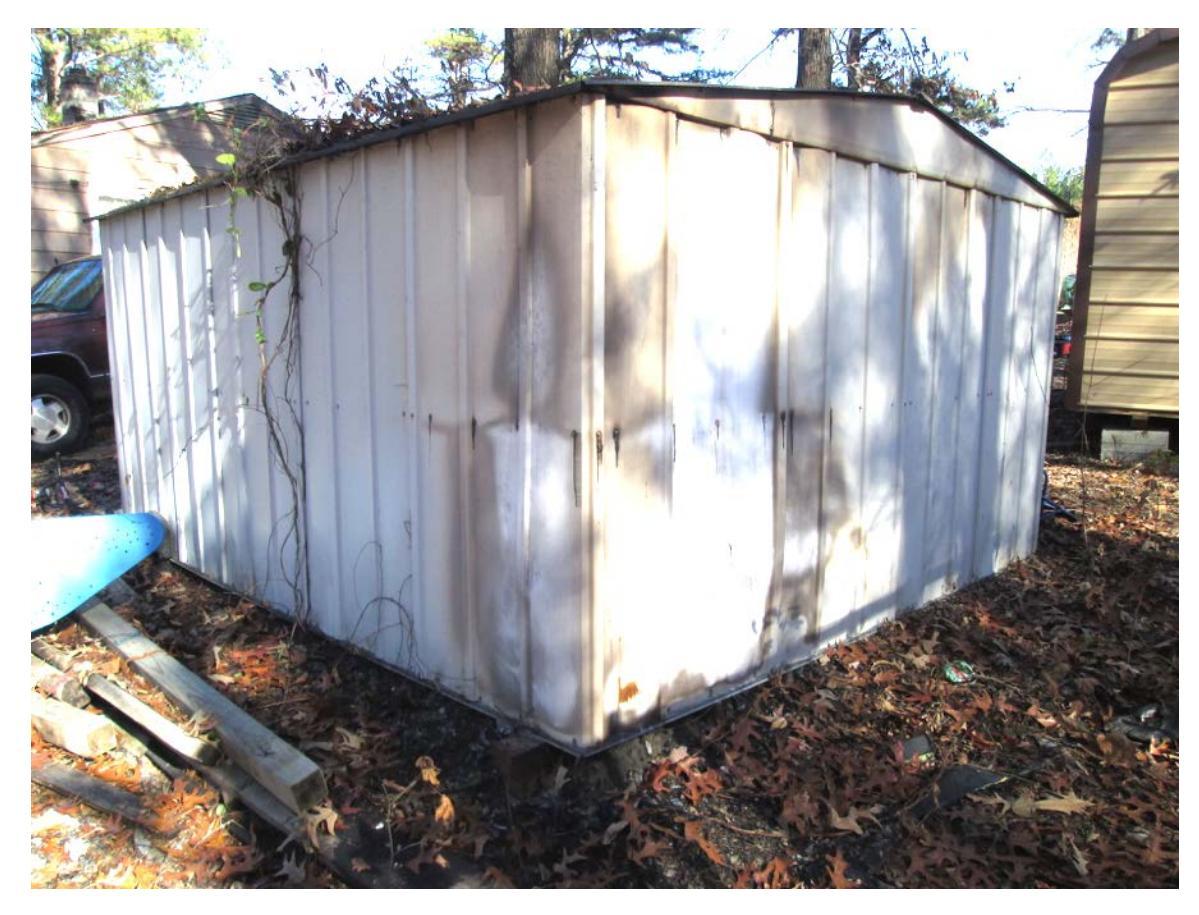
Fig. S6-2. Photo shows the heat damage to the C, D corner where the surface fire burned to the structure and made entry.

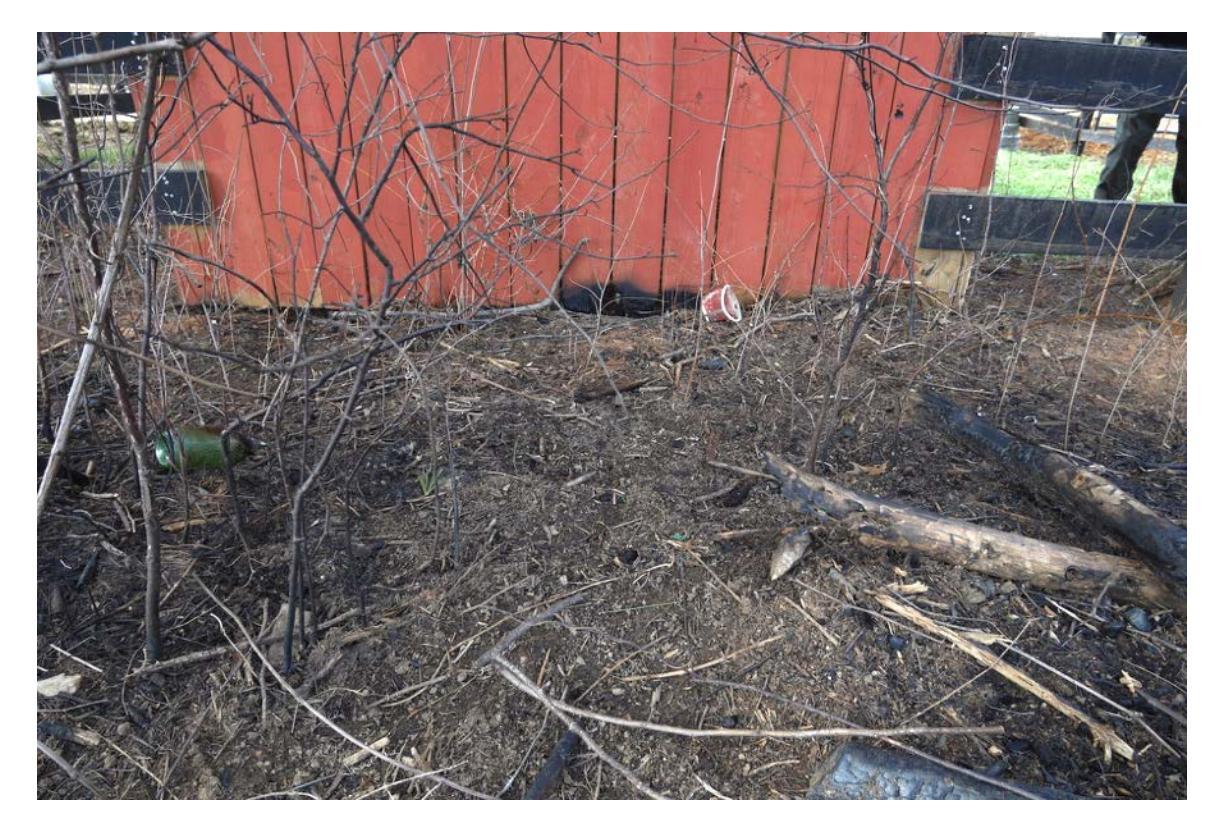
The surface fire burned in accumulations of pine needles and leaves to the base of the side B wall. The wood board siding had direct flame contact and ignited along the bottom edge. The fire made entry, burning between vertical spaces in the wood board siding along the bottom edge of the side B wall. The first item damaged was wood board siding through direct flame contact with a surface fire burning in pine needles and leaves.

Fig. S7-2. Photo shows burn pattern on the ground leading to the shed on side B with the fire damage at the bottom edge of the wood board siding.

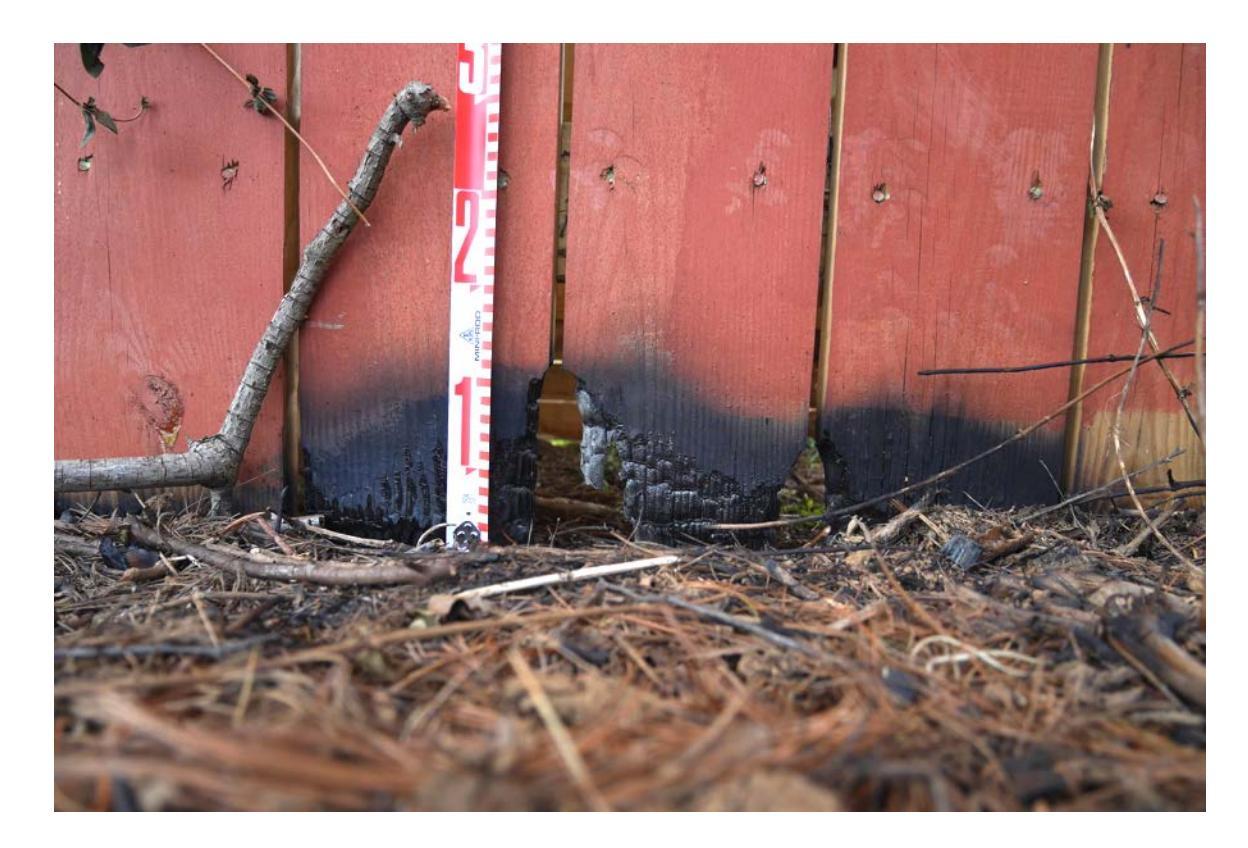
Fig. S7-3. Photo shows close-up view of exterior damage where the surface fire ignited the wood board siding and made entry.

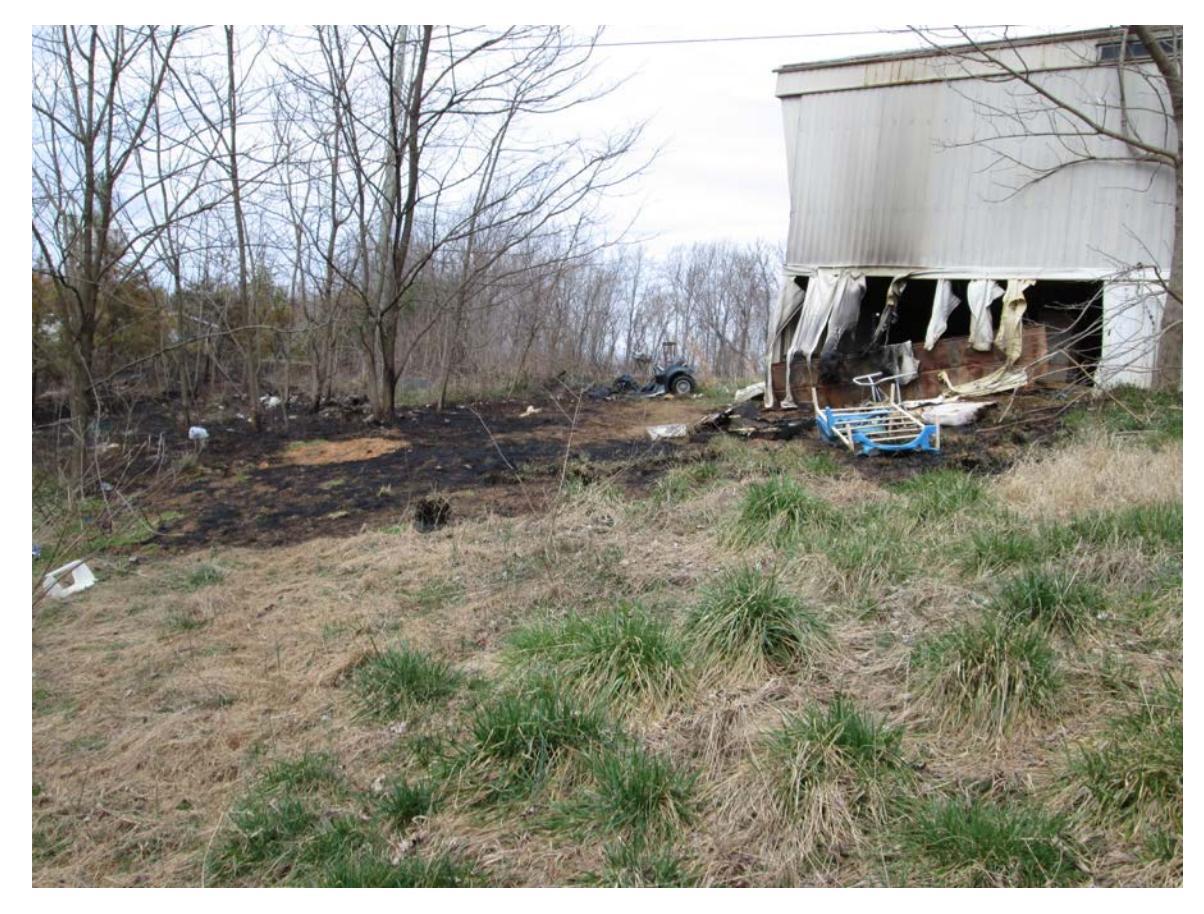
Fig. S9-2. Photo shows an overview of fire burn pattern in grassy area from side C of the mobile home. The trash burn spot where the surface fire started is located at the top of the hill in the center of the photo.

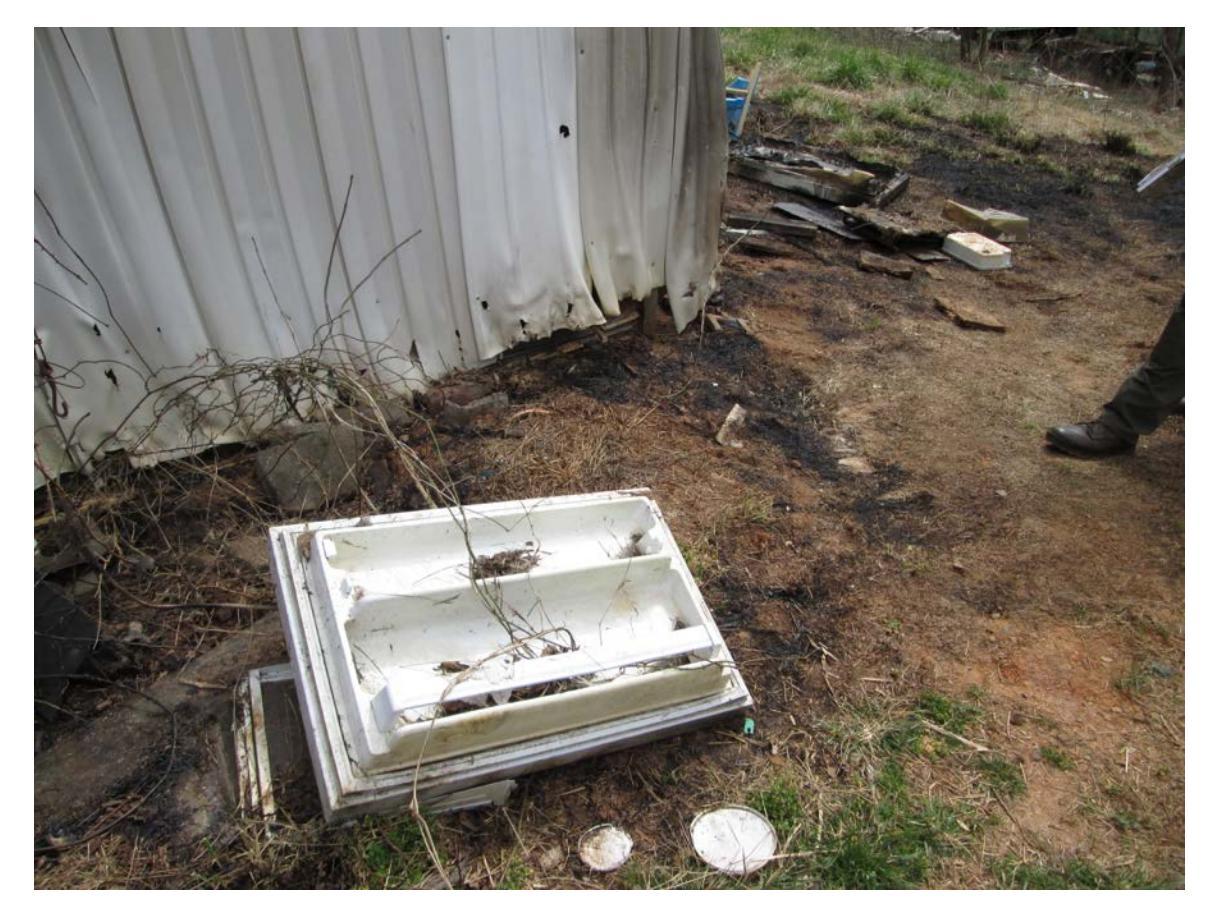
Fig. S9-5. Photo shows a close-up view of the burn pattern in grass to the mobile home side D at corner of side C and damaged vinyl siding.

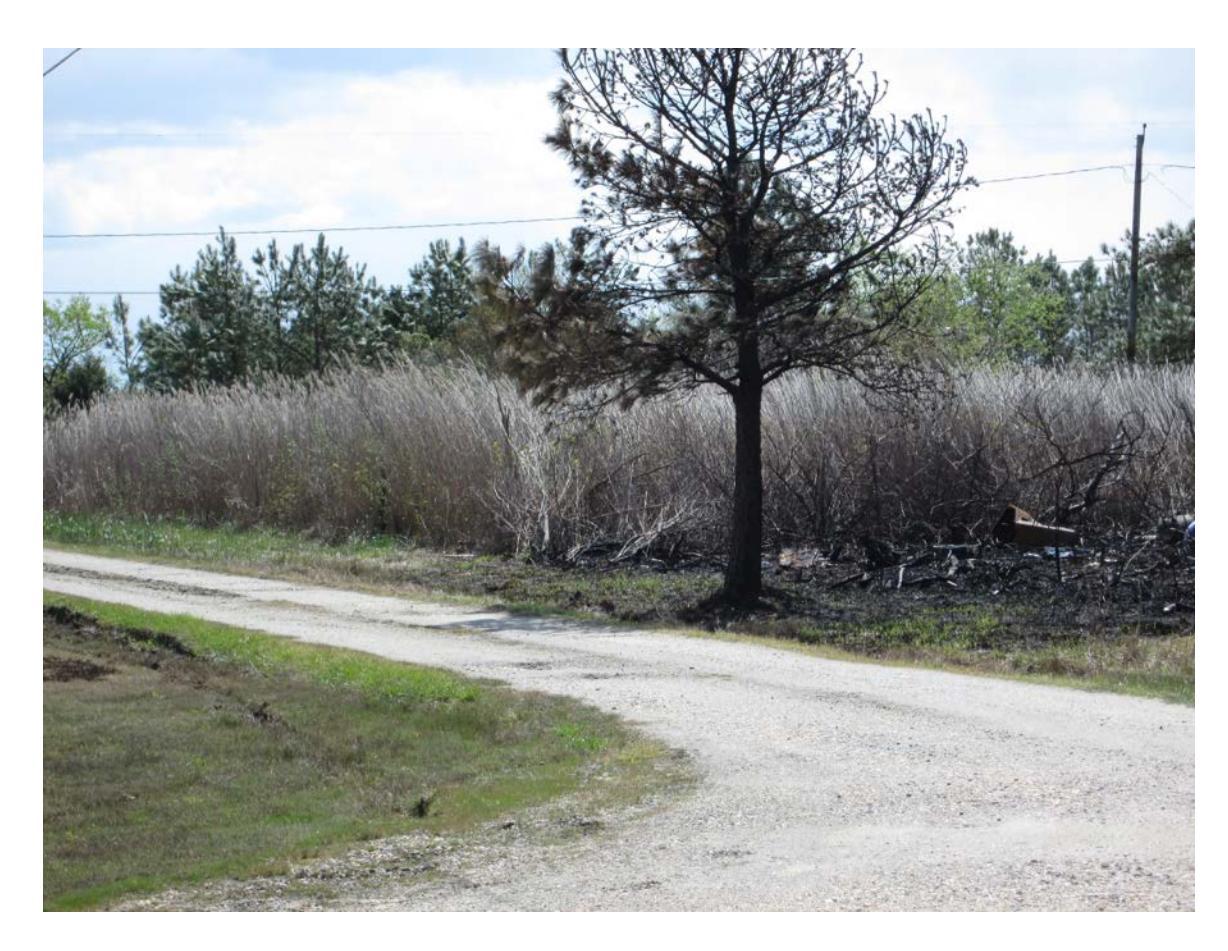
Fig. S10-4. Photo shows marshland fuels of invasive Phragmites reeds 1.8 m to 2.75 m (6 ft to 9 ft) tall. Fire spread was stopped by firefighters positioned in this driveway in front of side A.

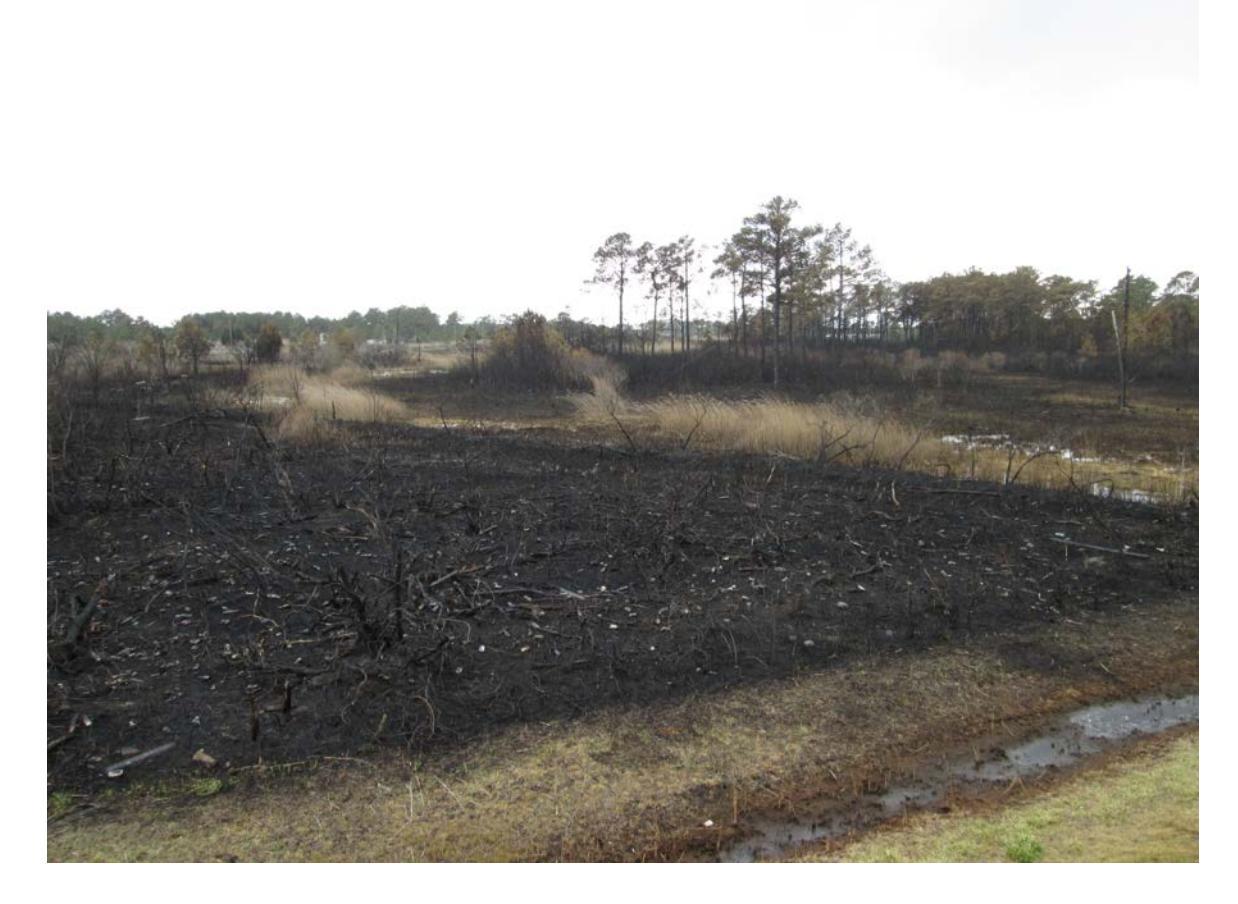
Fig. S10-5. Photo shows a view of burned area looking SW from the rear deck on side C of the residence. This was the direction the wildfire approached the residence.

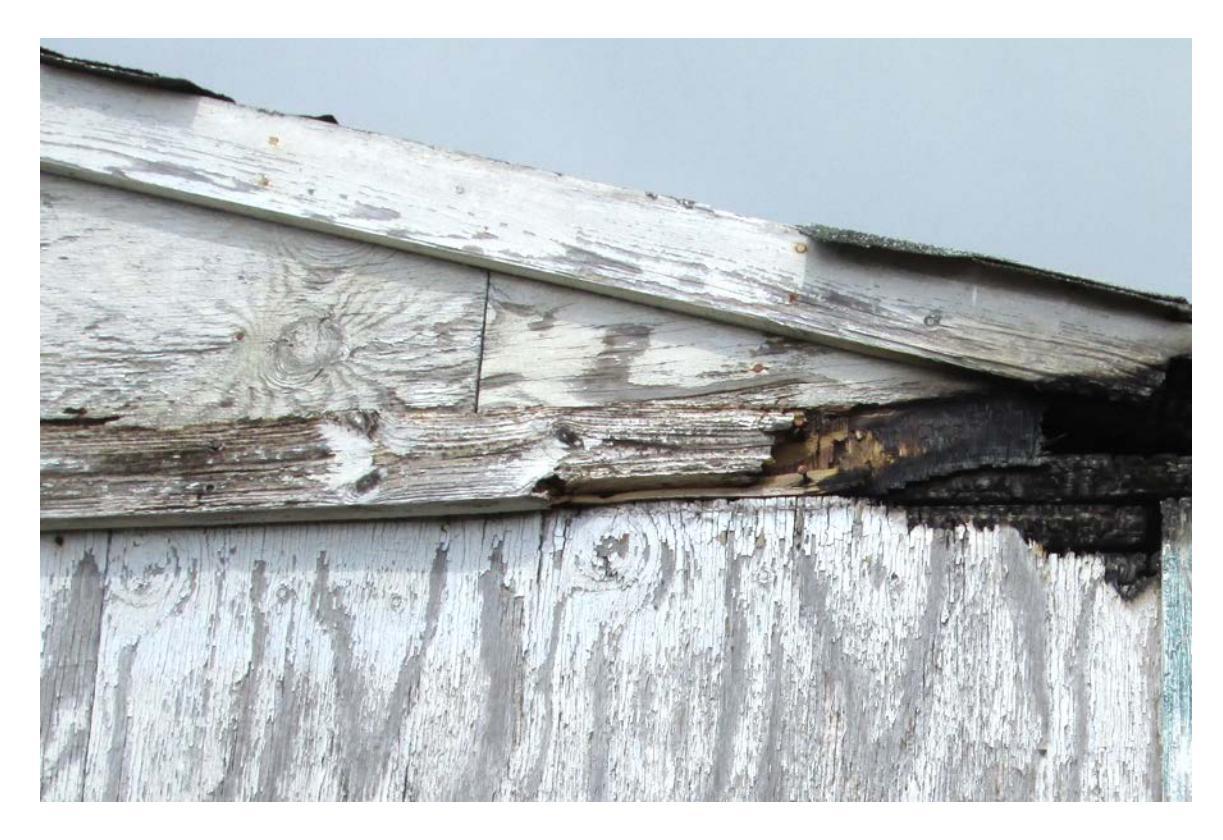
Fig. S11-4. The plywood siding and trim board of the utility building in place near the fire damage shows significant signs of weathering creating loose jagged edges receptive to catching flying firebrands.

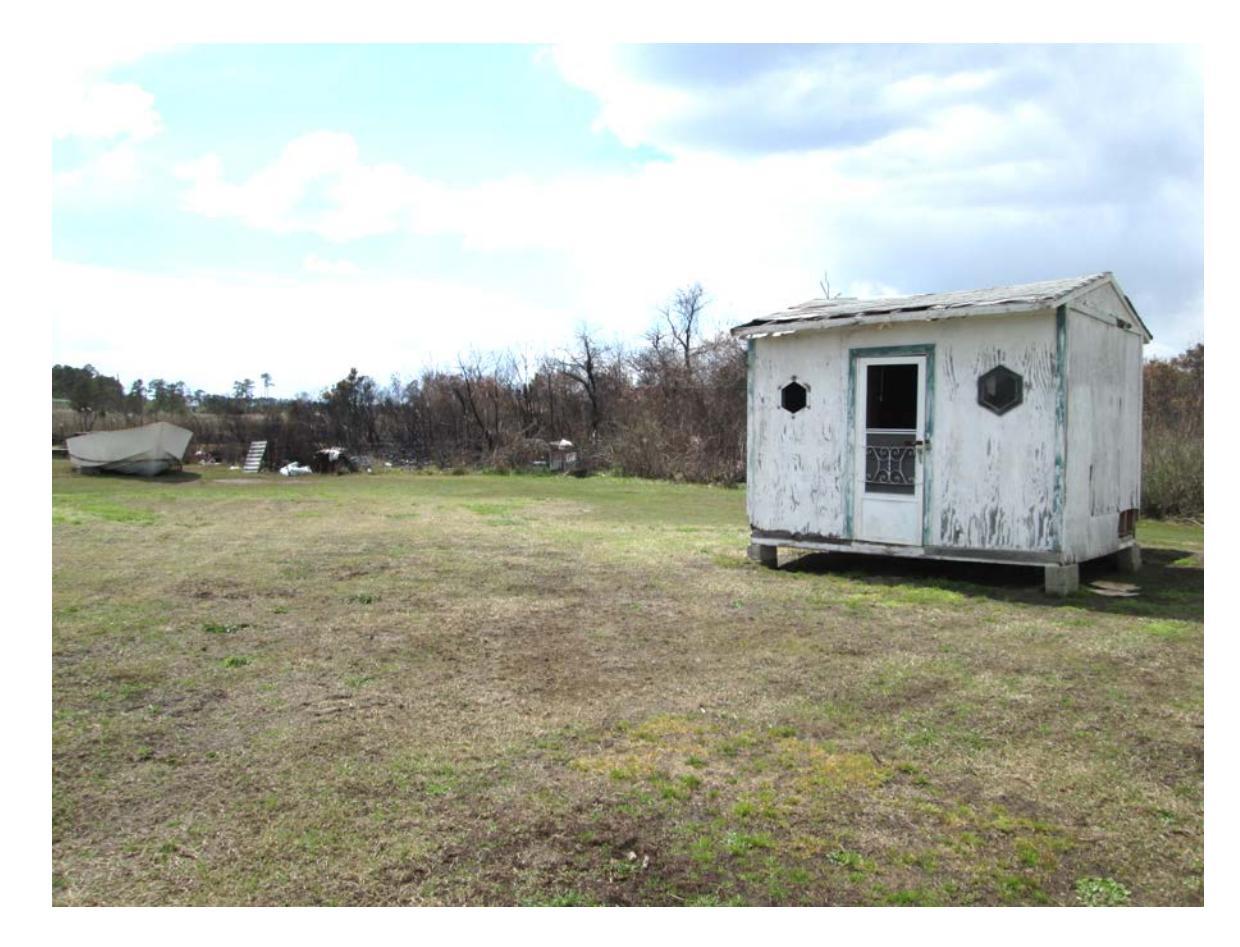
Fig. S11-5. Photo shows wildland fire area looking SW. This was the direction from which the fire approached the damaged utility building.

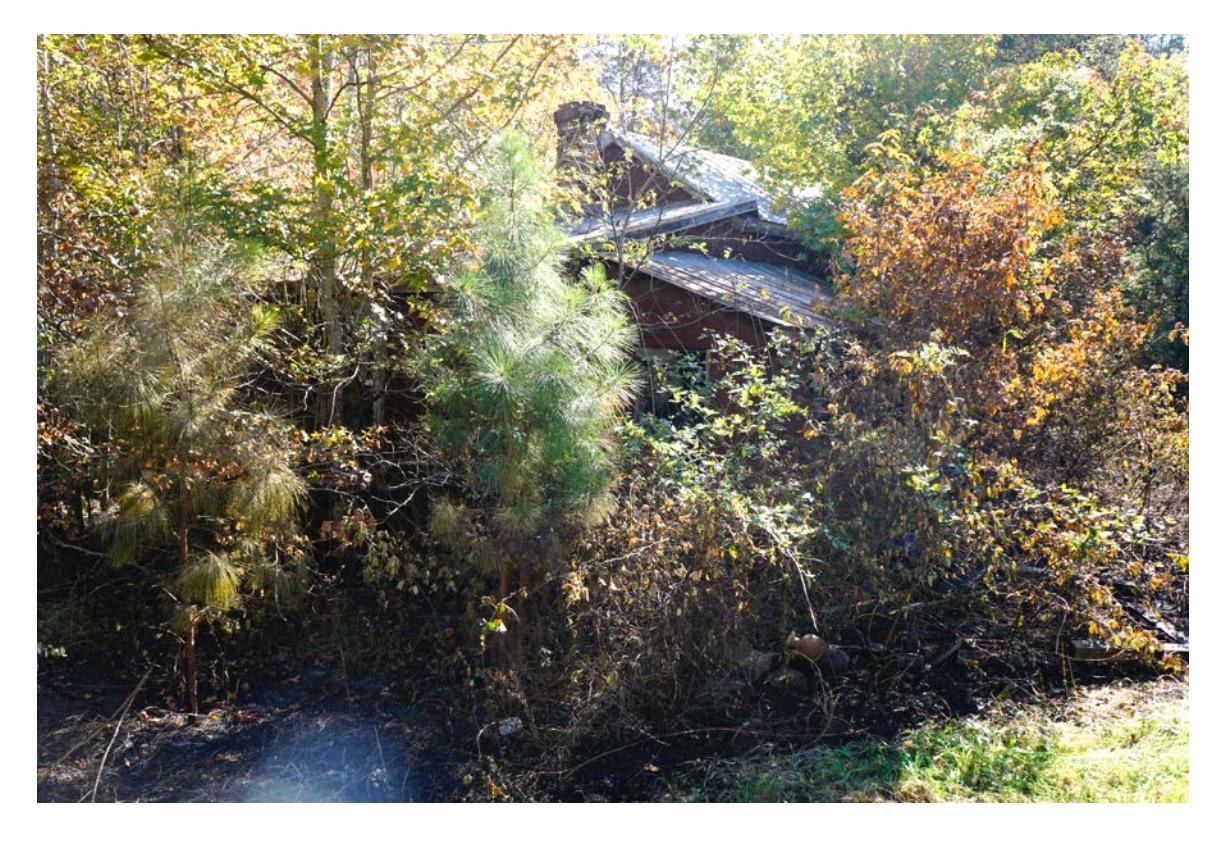
The first item damaged on the building was the side B entry door. The door was constructed with a wooden frame with upper and lower plywood panels. The lower plywood panel and frame sustained the fire damage. The creeping surface fire reached the side B doorway, igniting combustibles that lay in the doorway. The combination of leaves and other combustibles in the doorway ignited the wooden door.

Fig. S13-1. Photo shows the view of the abandoned home side B. The creeping surface fire burned in leaves under thick vegetation to the entrance door on side B.

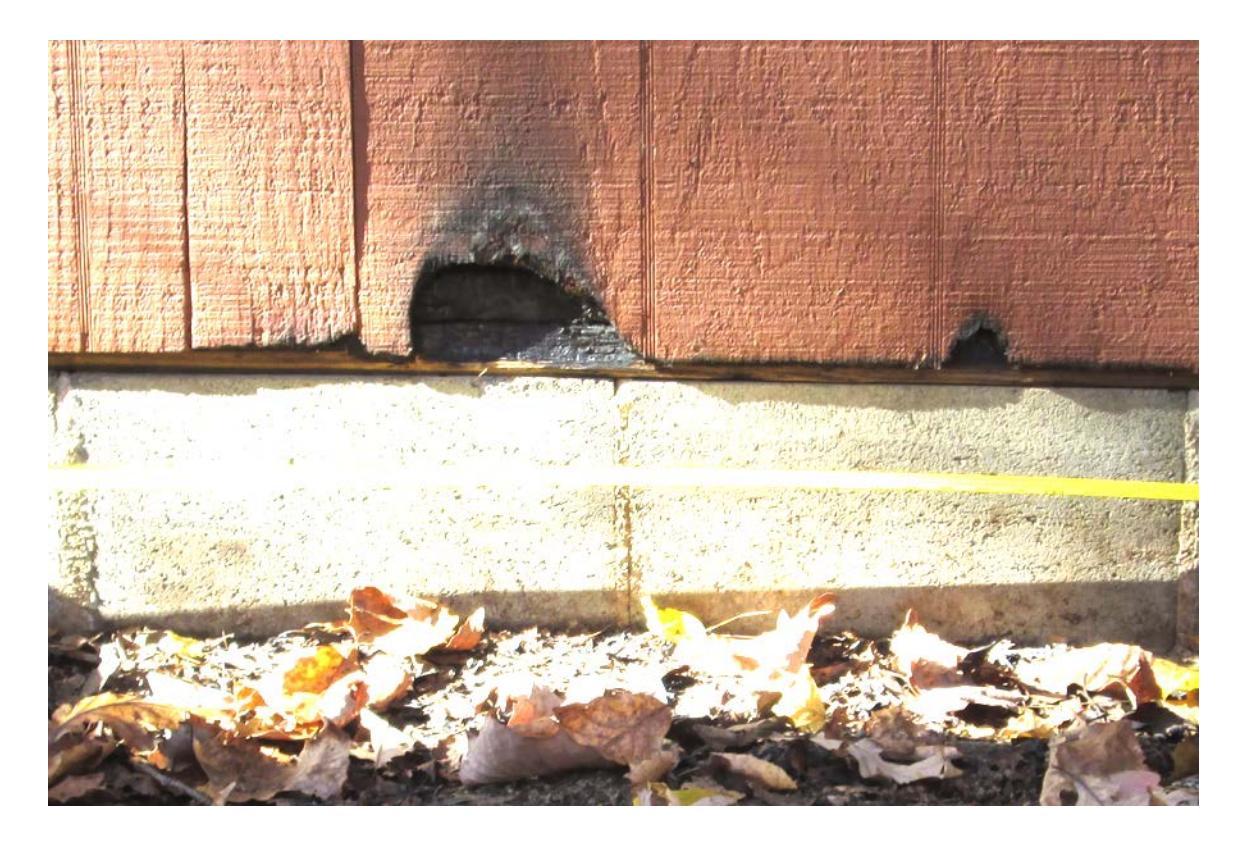
Fig. S14-2. Photo shows where two spots ignited on the side C exterior wall. The larger damaged spot on the left penetrated to the interior of the building. The smaller and lower spot burned through but encountered the wood sill plate and did not penetrate to the building interior.
