NIST GCR 18-018

Structures Ignited by Virginia WUI Fires 2/2015 – 2/2017

David D. Evans Lavern R. Scott William D. Walton Home Safety Foundation Chevy Chase, Maryland 20815-4206

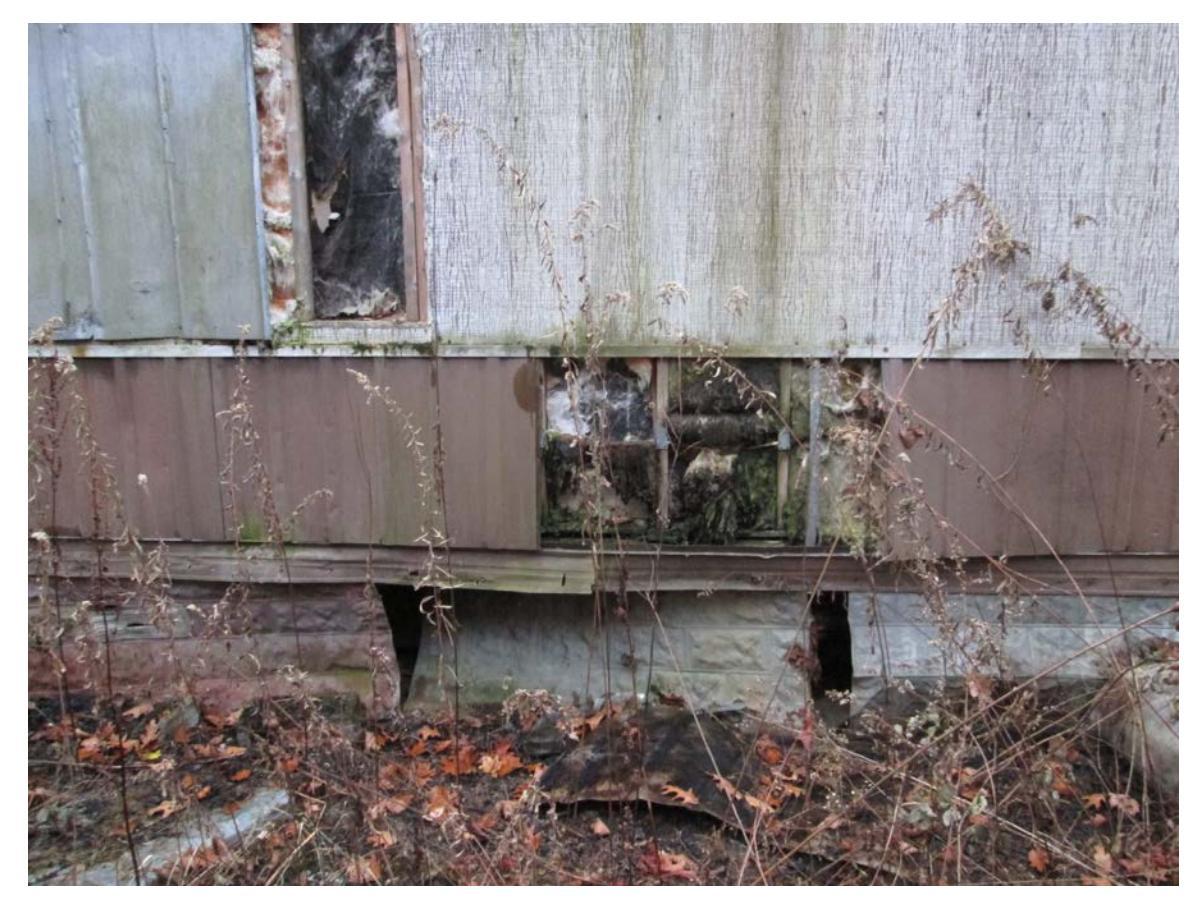
Fig. S16-2. Close-up of damaged area on side C. A section of metal siding was removed for what looked like overhaul by firefighters. The section of metal siding was on the ground with the blackened interior side facing up.

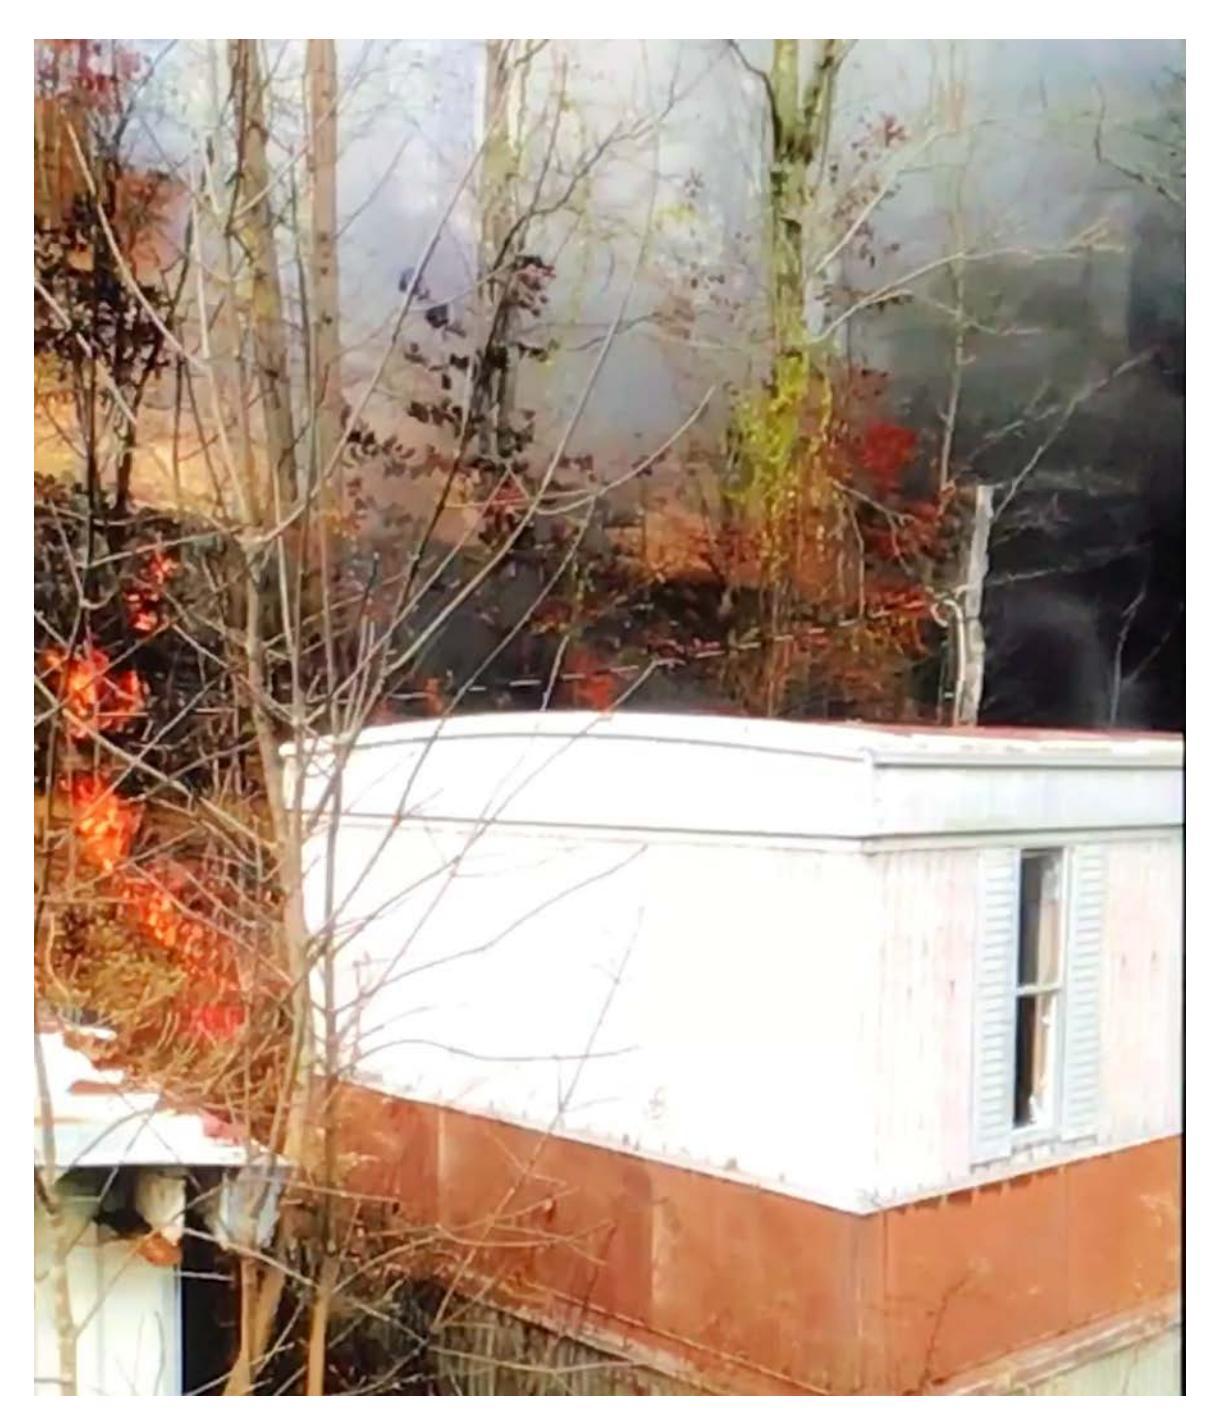
Fig. S16-5. Photo from cell phone video showing black smoke from the tire pile burning (right) and small surface fire burning (left) on the hillside opposite side C of the mobile home. The surface fire is moving away from the tire pile.

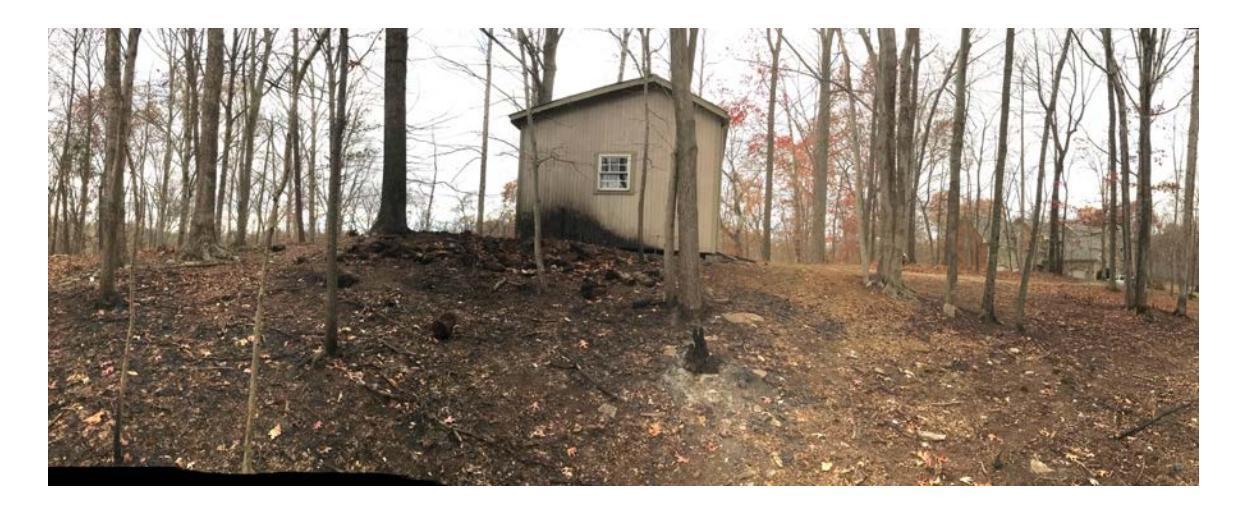
The first material damaged was wood T1-11 siding. The wood siding was ignited by a surface fire burning in a layer of leaves 5 cm to 13 cm (3 in to 5 in) deep. The surface fire was spreading uphill backing against the wind when it reached side B of the utility building. The fire made entry by burning through T1-11 siding in the area where the initial ignitions occurred.

Fig. S17-5. Photo shows the burn pattern leading to side B of the utility building. The surface fire burning leaves spread uphill, backing against a west wind reaching and igniting the utility building.

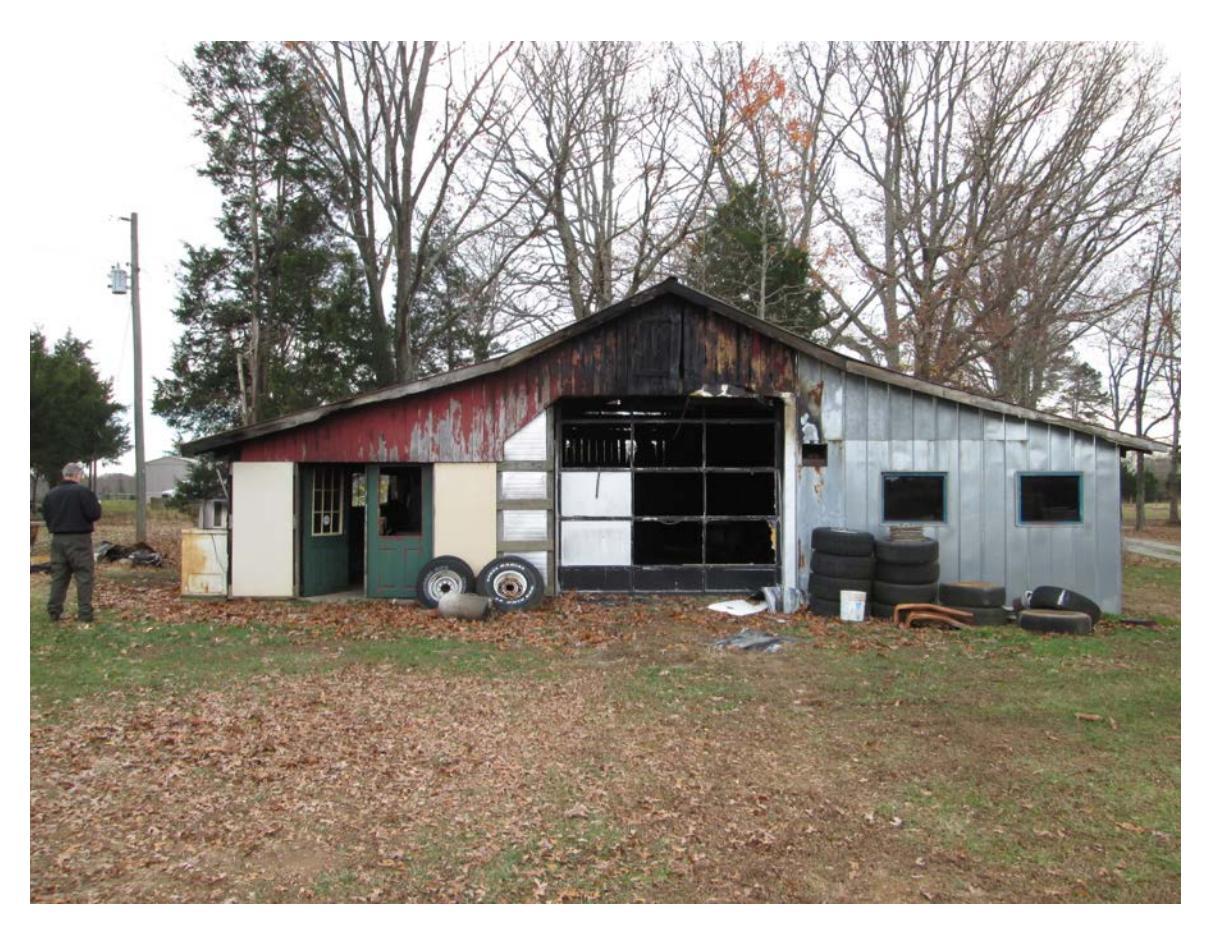
Fig. S18-1. Photo shows side A of the damaged shop building.

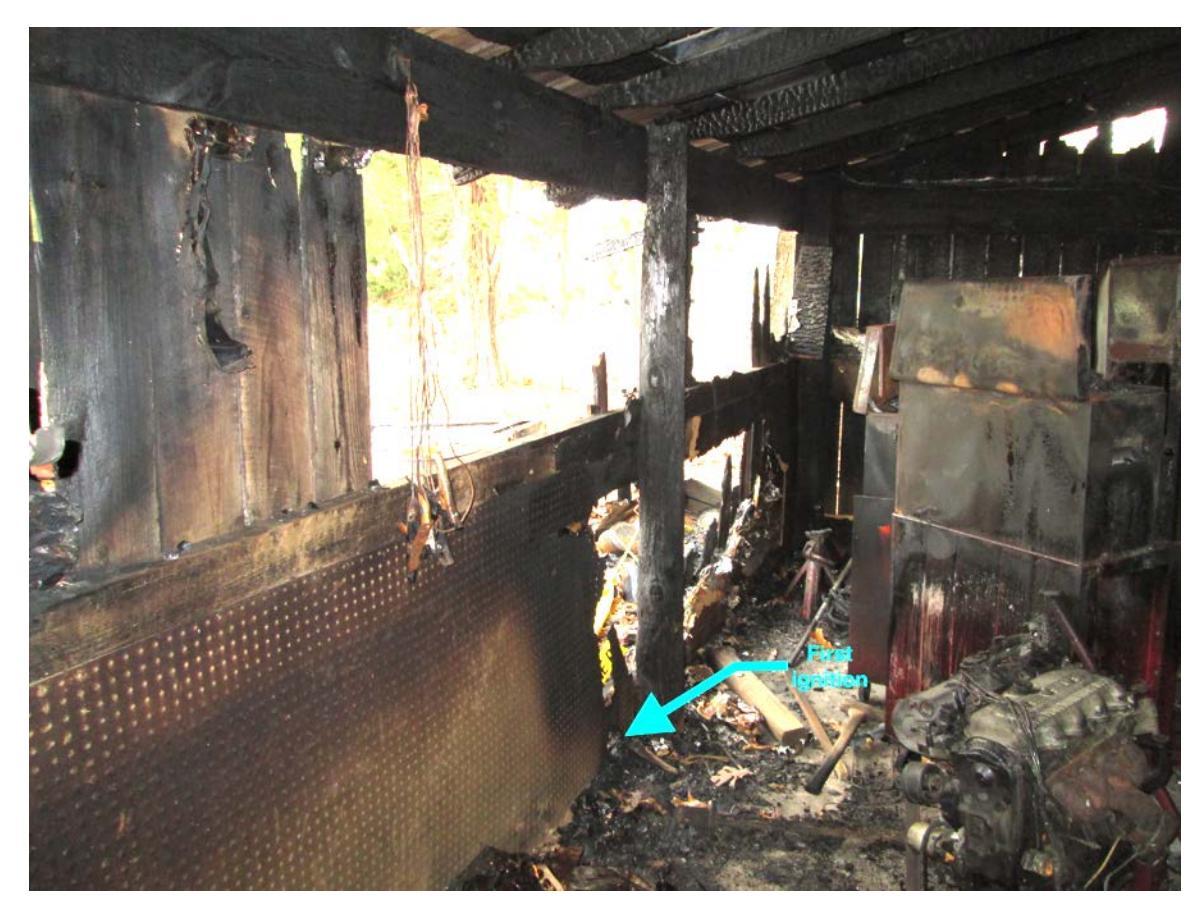
Fig. S18-4. Photo shows the interior fire damage to the side B wall opposite the exterior damage shown in figure S18-3. The lowest burned material is at the first ignition point indicated by the arrow.

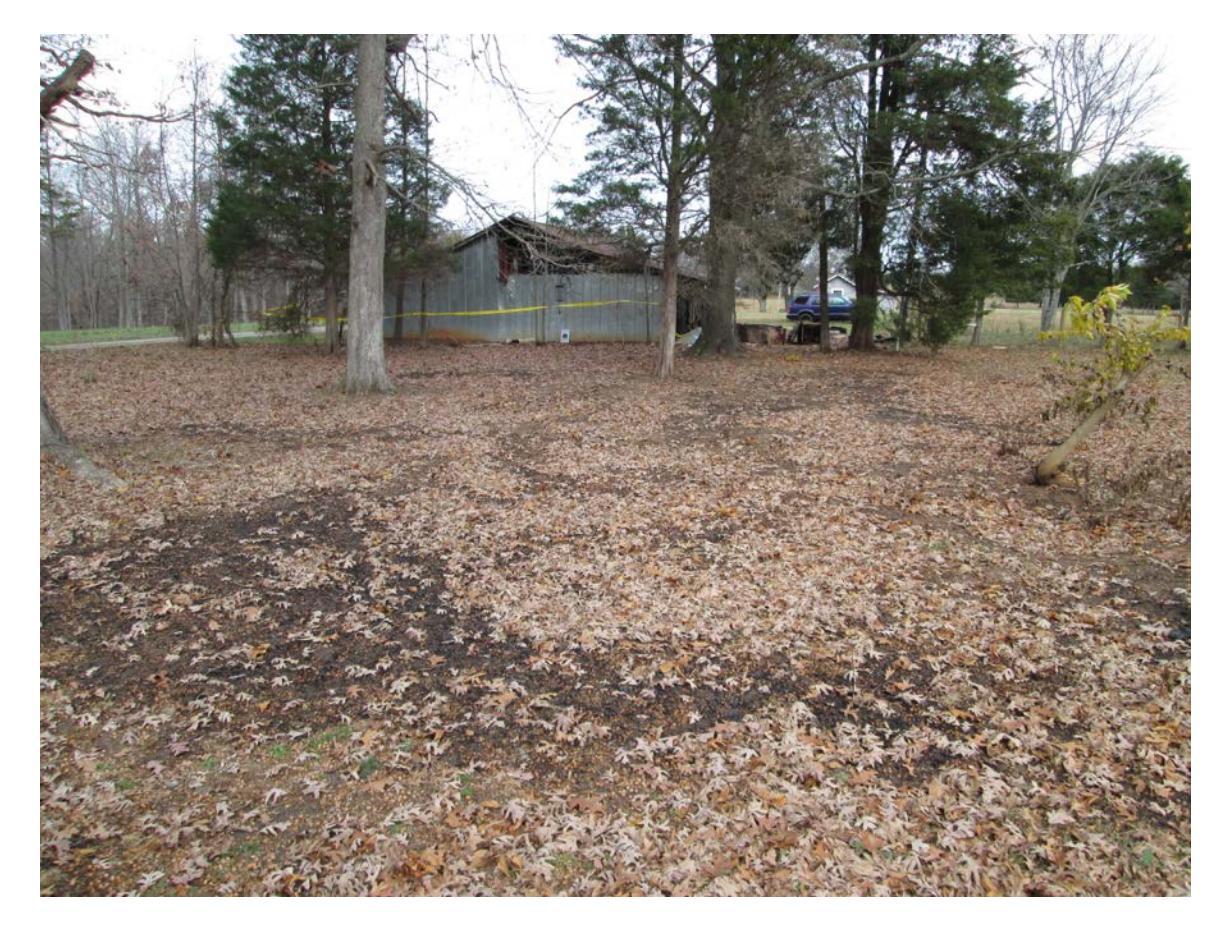
Fig. S18-5. Photo shows the area of the intentional burn and its proximity to the fire damaged shop building. The burn pattern is almost covered by new leaf fall.

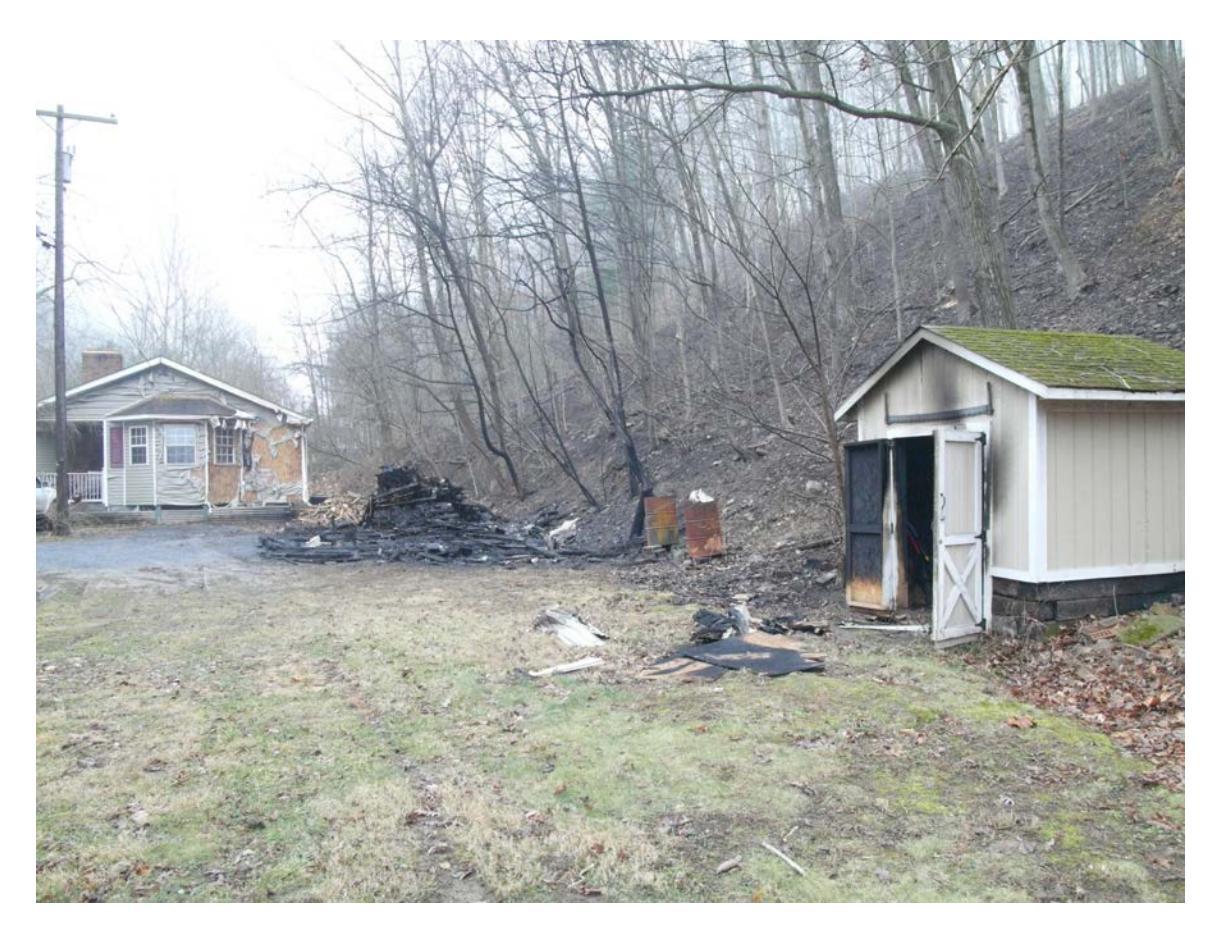
Fig. S19-5. Photo (looking south) shows fire area south of the trash barrel. This was the direction the wind was blowing toward. The trash barrel point of origin, surface fire burn pattern, remains of the large shed and damaged residence are shown.

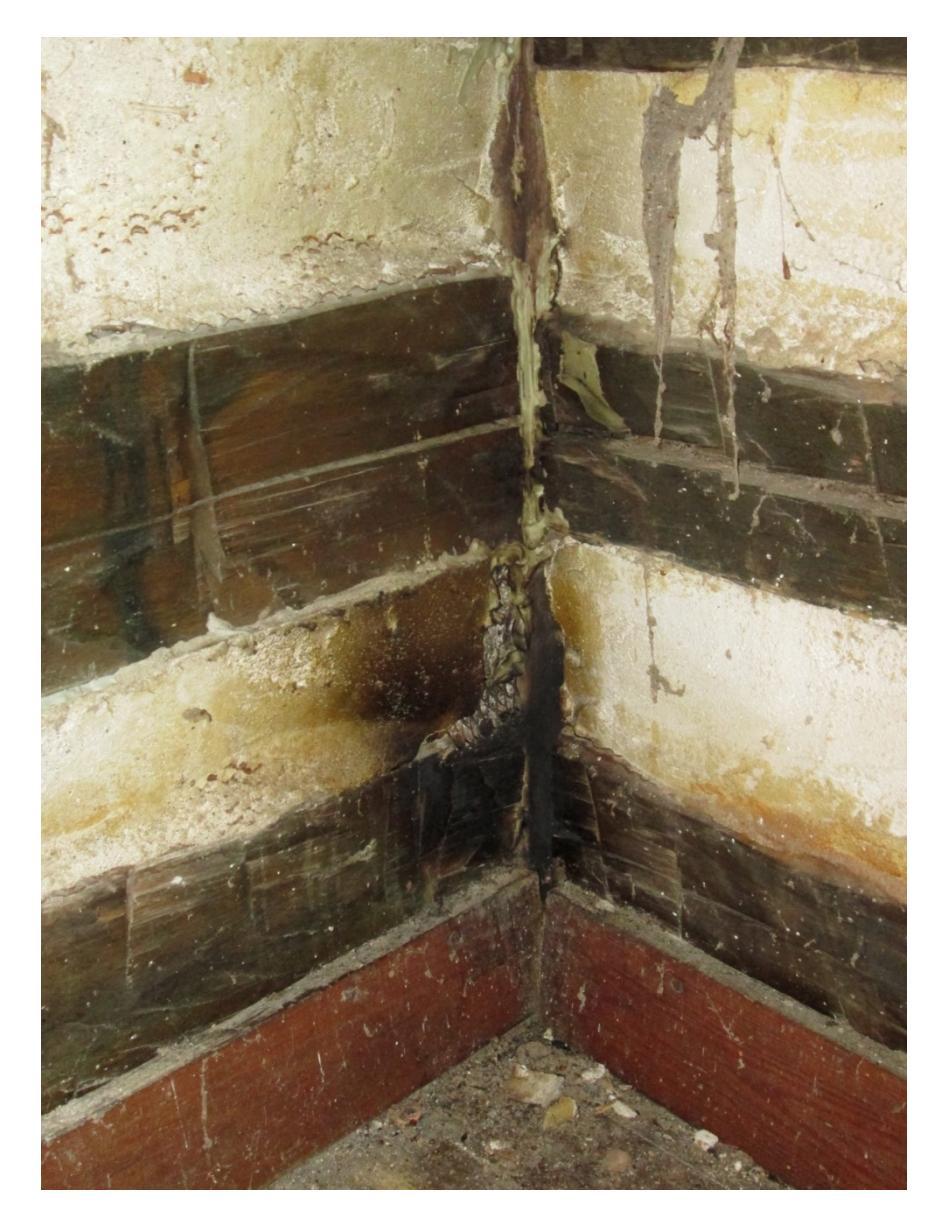
Fig. S21-6. Photo shows a close-up view inside Cabin #2 of the base of the corner of side A with side D where the fire penetrated the structure through gaps at the joints in the log wall construction.

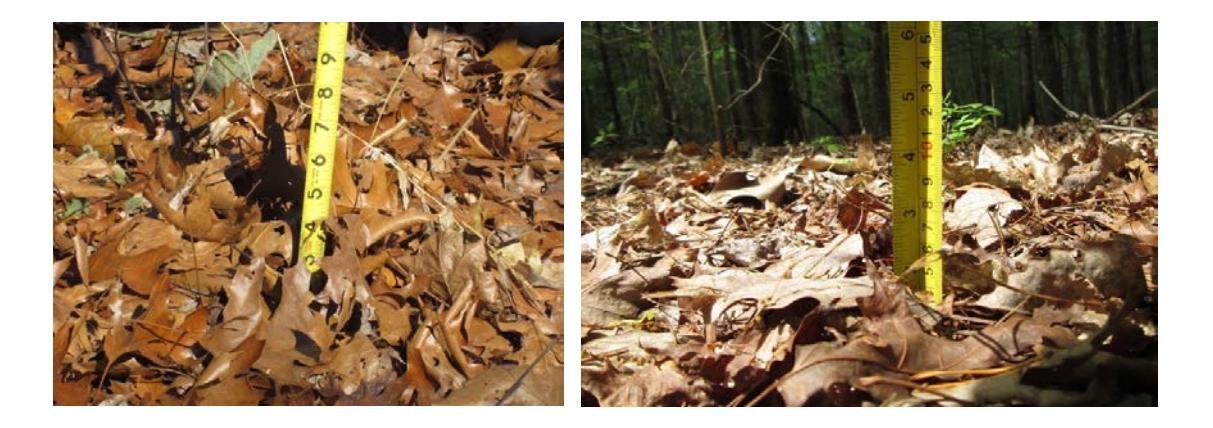
The layer depth of leaves measured at the fire site was the best available estimate of conditions that may have existed at the time of the fire. Measurements were consistently in the range of 5 cm to 13 cm (2 in to 5 in). The measurement itself has significant uncertainty as layers of leaves had an irregular surface and tend to fill in small irregular ground features, both of which may affect the measured depth.

Fig. 3. Depth of leaves in area indicated by owners as existed around the structures on the day of the fires, Structure #4 (left) 4 in (10 cm), Structure #13 (right) 2 in (5 cm).

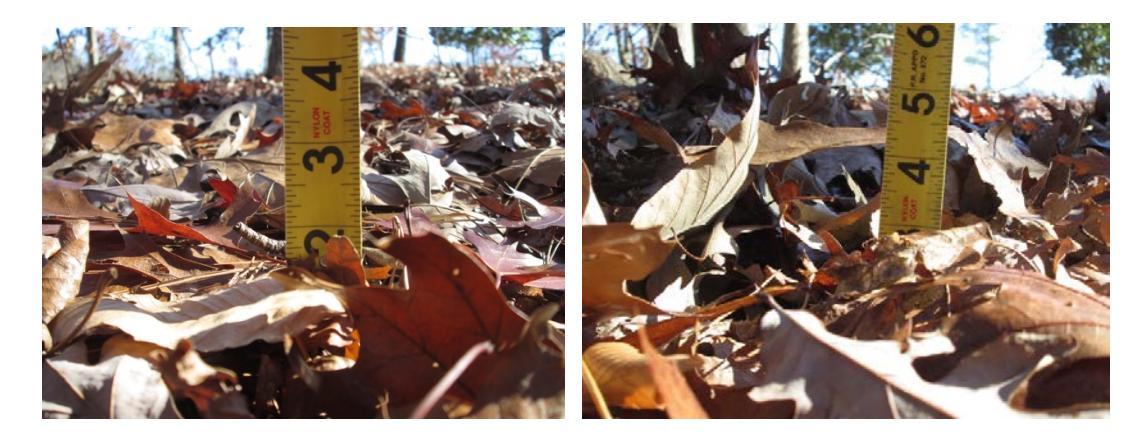
Fig. 4. Structure #5: Depth of leaves in area indicated by owner as existed around structure on the day of the fire, 2 in (5 cm) left and 3 in (8 cm) right.

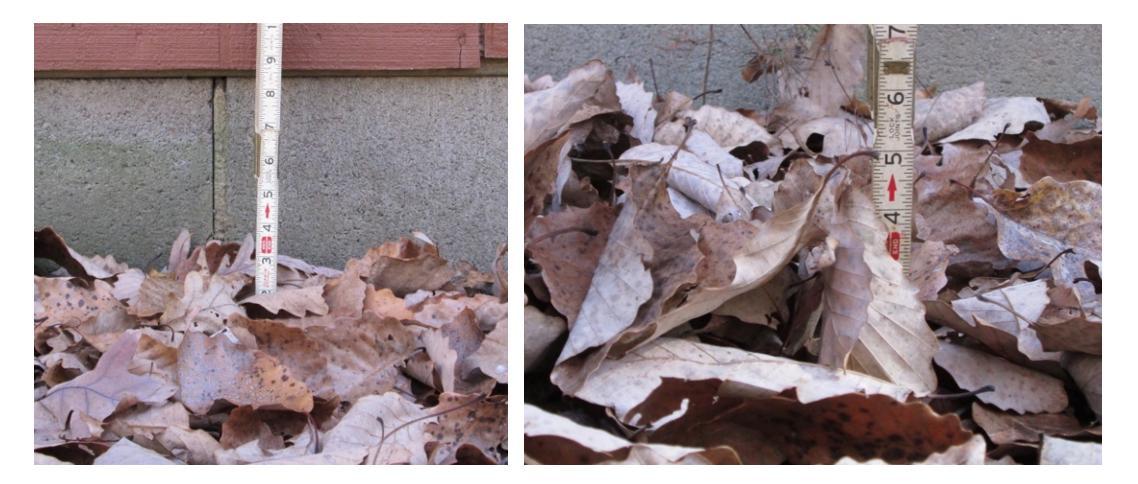
Fig. 5. Structure #14: Depth of leaves along undamaged side A indicated by owner as existed around the structure on the day of the fire, 2 in (5 cm) left and 4 in to 5 in (10 cm to 13 cm) right.

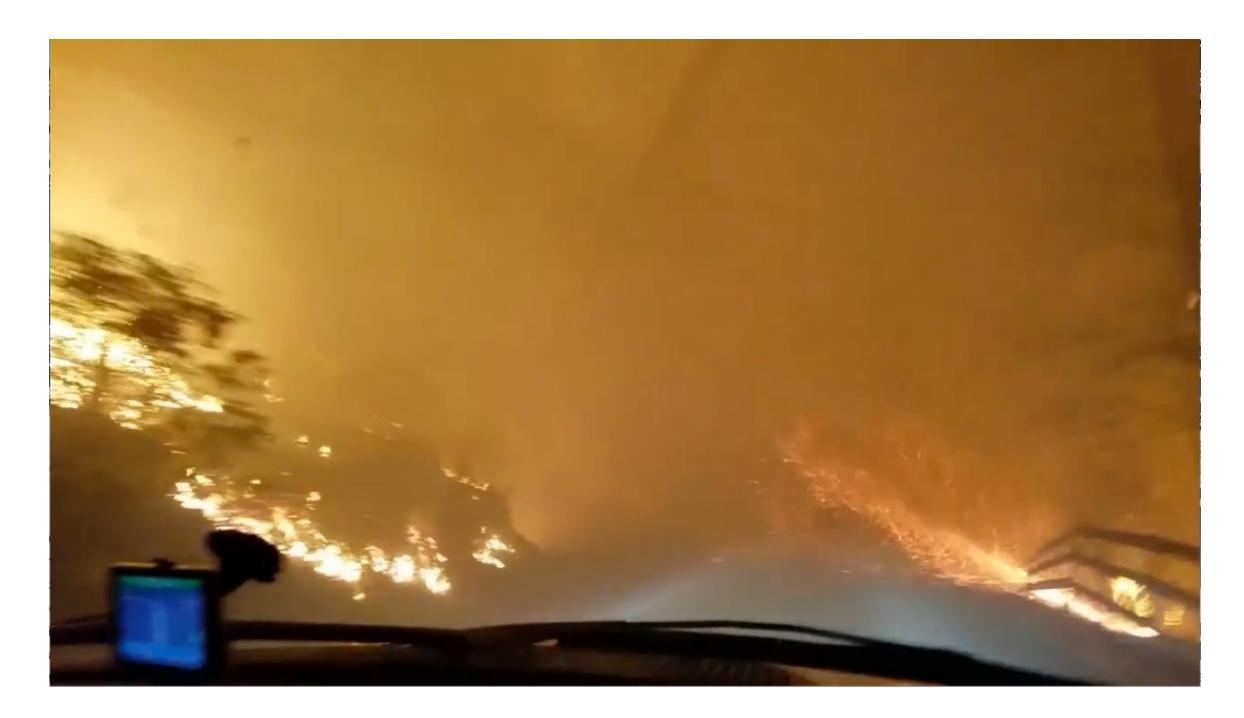
be a wind-driven upslope fire. Firebrands are being blown across the roadway from the right. Figure 7 shows the view from the right-side window as the vehicle passes by the fire shown on the right in Fig. 6. At the lower edge of the still image (Fig. 7), the leaf cover on the ground can be seen clearly.

Fig. 6. Vehicle drives towards hillside fire. Upslope wind drives burning leaves across roadway. Still frame from video [11].

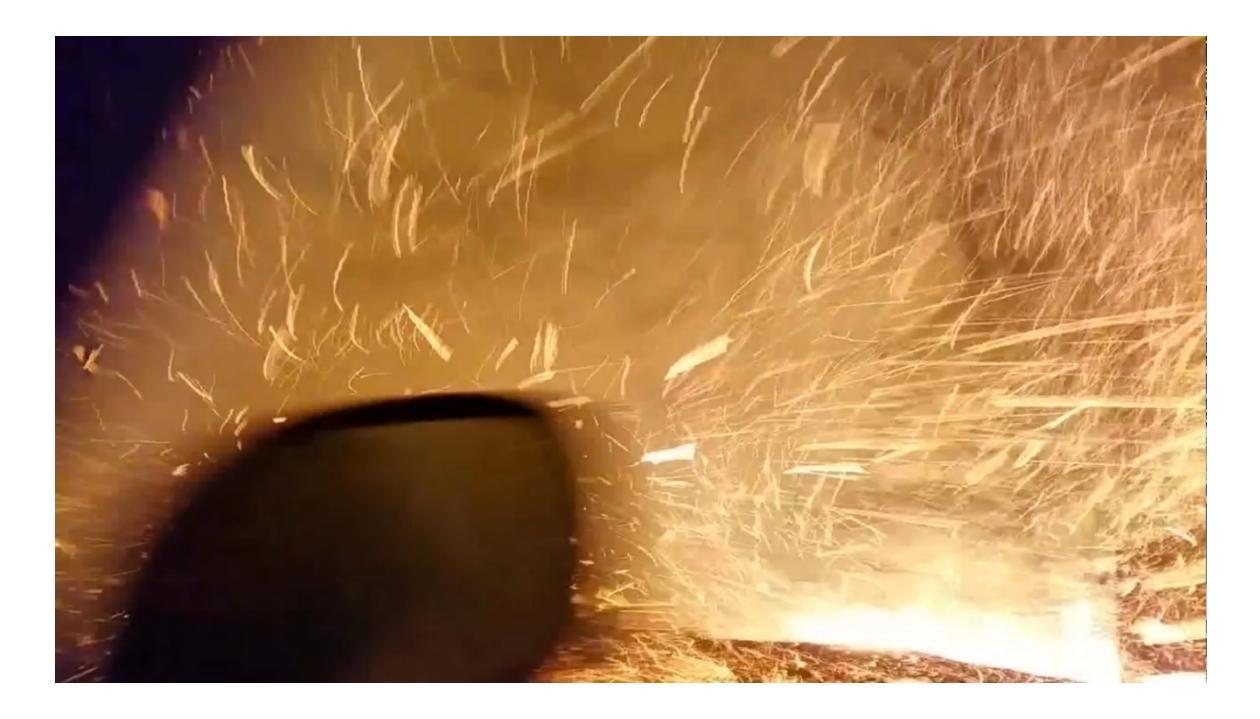
Fig. 7. Vehicle drives by the upslope ground fire on right in Figure 6. A ground cover of leaves is shown clearly in the lower right of this still frame from video [11].

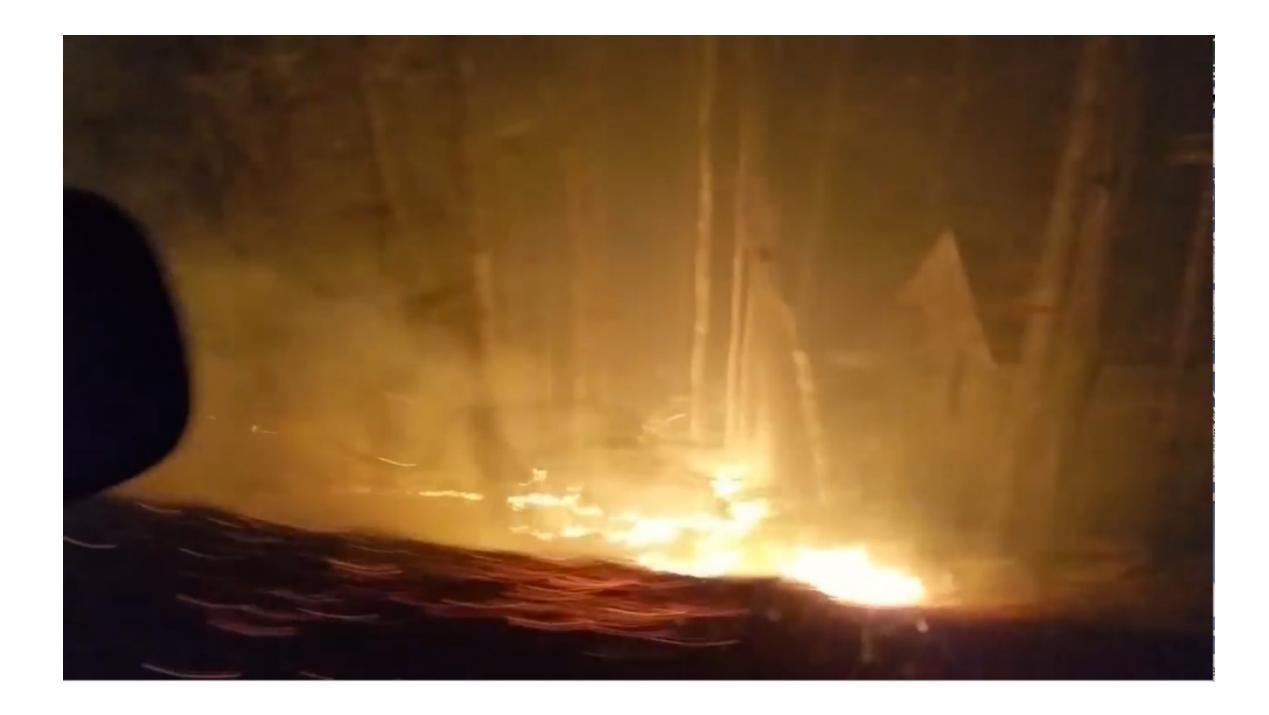
It was likely that the ground fire played an important role in the ignition of structures. Many of the Chalet Village resort cabins and chalets were built on properties that were heavily wooded with deciduous trees. Figure 8 is a still frame taken from the video [11] that shows a ground fire, in leaves and tree litter, threatening a structure on the right in the frame. Afterwards, this structure was found to be destroyed by fire [12].

Fig. 8. A ground fire, in leaves and tree litter, approaches structure as the vehicle passes. Still frame from video [11].
