Investigations of Near-Edge Ballistic Impacts on Law Enforcement Body Armor

Kirk D. Rice, Amanda L. Forster, Michael A. Riley,
and Nicholas G. Paulter, Jr.

September 2014

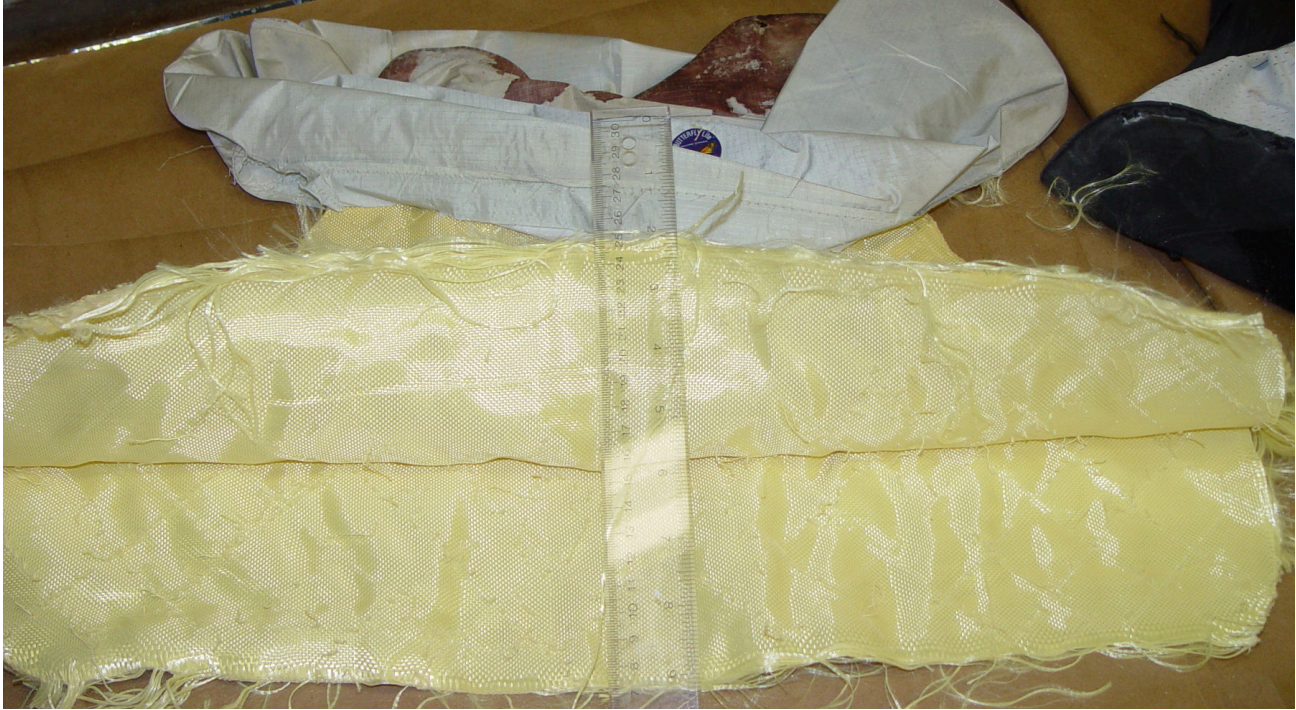
Figure 3.6: Panama City Beach Incident Panel with Stitching Removed.

The incident panel was deconstructed by removing the quilt stitching and through-stitching (the vertical stitching holding the two 11-layer packs together) from the lower 100 mm to 125 mm (4 in to 5 in) of the armor panel. The partially deconstructed panel is shown in the photograph in Figure 3.6. Full-length pieces of fabric, approximately 100 mm (4 in) wide, were cut from layers 1, 6, 11, 12, 17, and 22, where the strike face was designated layer 1 and the body-side layer was designated layer 22. The ballistic panel with sample material removed is shown in the photograph in Figure 3.7 and an example of one of the material samples being prepared for storage is shown in the photograph in Figure 3.8. Once the fabric samples were taken, individual yarns were extracted from the fabric samples. Material property tests performed on these yarns are described in Section 5.

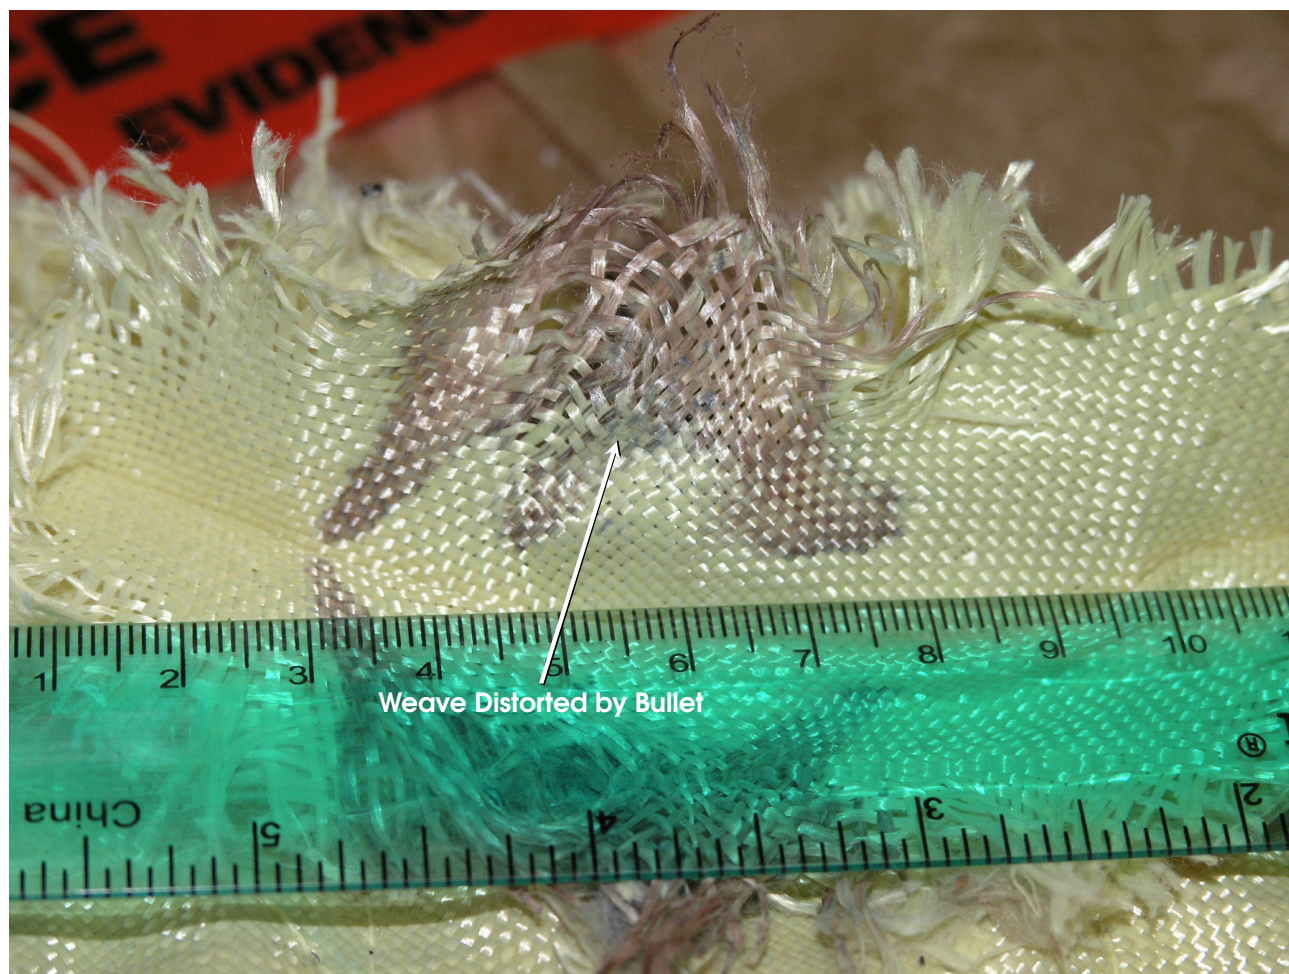
Figure 3.15: Incidence Location on Layer 3 of the Tampa Ballistic Material.

The next two photographs (Figures 3.15 and 3.16) show layers 3 and 4 of the incident armor, respectively. Layer 3 shows a small distortion in the weave where the bullet went through, but this is not visible in layer 4 (see arrows). The bullet appears to have slipped out of the edge of the armor around layer 2 or 3, wounding the officer.

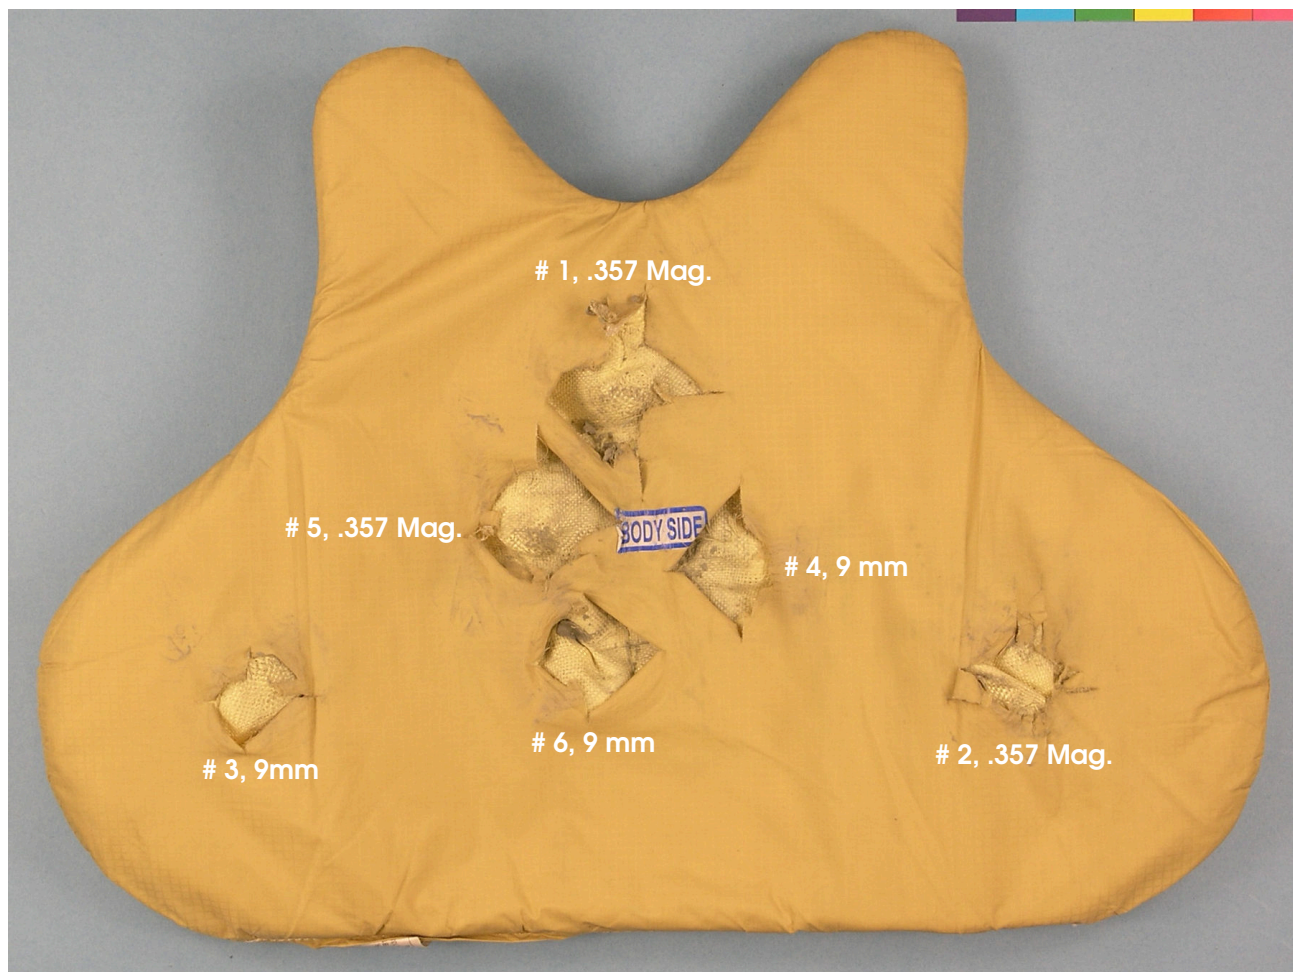
The panel was first tested with three shots of the NIJ Standard-0101.04 Type II .357 Magnum test cartridge – a Remington 10.2 g (158 gr) JSP bullet with a measured speed of $436 \text{ m/s} \pm 9.1 \text{ m/s}$ ($1430 \text{ ft/s} \pm 30 \text{ ft/s}$). These shots were fired at the #1, #2, and #5 locations, as described in NIJ Standard-0101.04 [18]. As in the standard test, the shots at the #1 and #2 locations were fired perpendicular (0° angle) to the armor, while the shot at the #5 location was fired at a 30° angle. As listed in Table 4.2, the armor successfully stopped all three shots; however, the measured BFS depths of the perpendicular shots were 53 mm and 45 mm, respectively. The results of these shots can be viewed in the photographs in Figures 4.8 and 4.9.

The panel was then tested with three shots of the NIJ Standard-0101.04 Type II 9 mm Luger test cartridge – a Remington 8.0 g (124 gr) FMJ bullet with a measured speed of $367 \text{ m/s} \pm 9.1 \text{ m/s}$ ($1205 \text{ ft/s} \pm 30 \text{ ft/s}$). These shots were fired at the #3, #4, and #6 locations. The shots at the #3 and #6 locations were fired perpendicular (0° angle) to the armor, while the shot at the #4 location was fired at a 30° angle. The armor successfully stopped all three bullets, and the BFS depths of the perpendicular shots were 40 mm and 35 mm, respectively. Again, the results of these shots can be viewed in the photographs in Figures 4.8 and 4.9.

Figure 4.8: Tampa Spare Panel, Strike Face, Post Testing.

Figure 4.9: Tampa Spare Panel, Body Side, Post Testing.

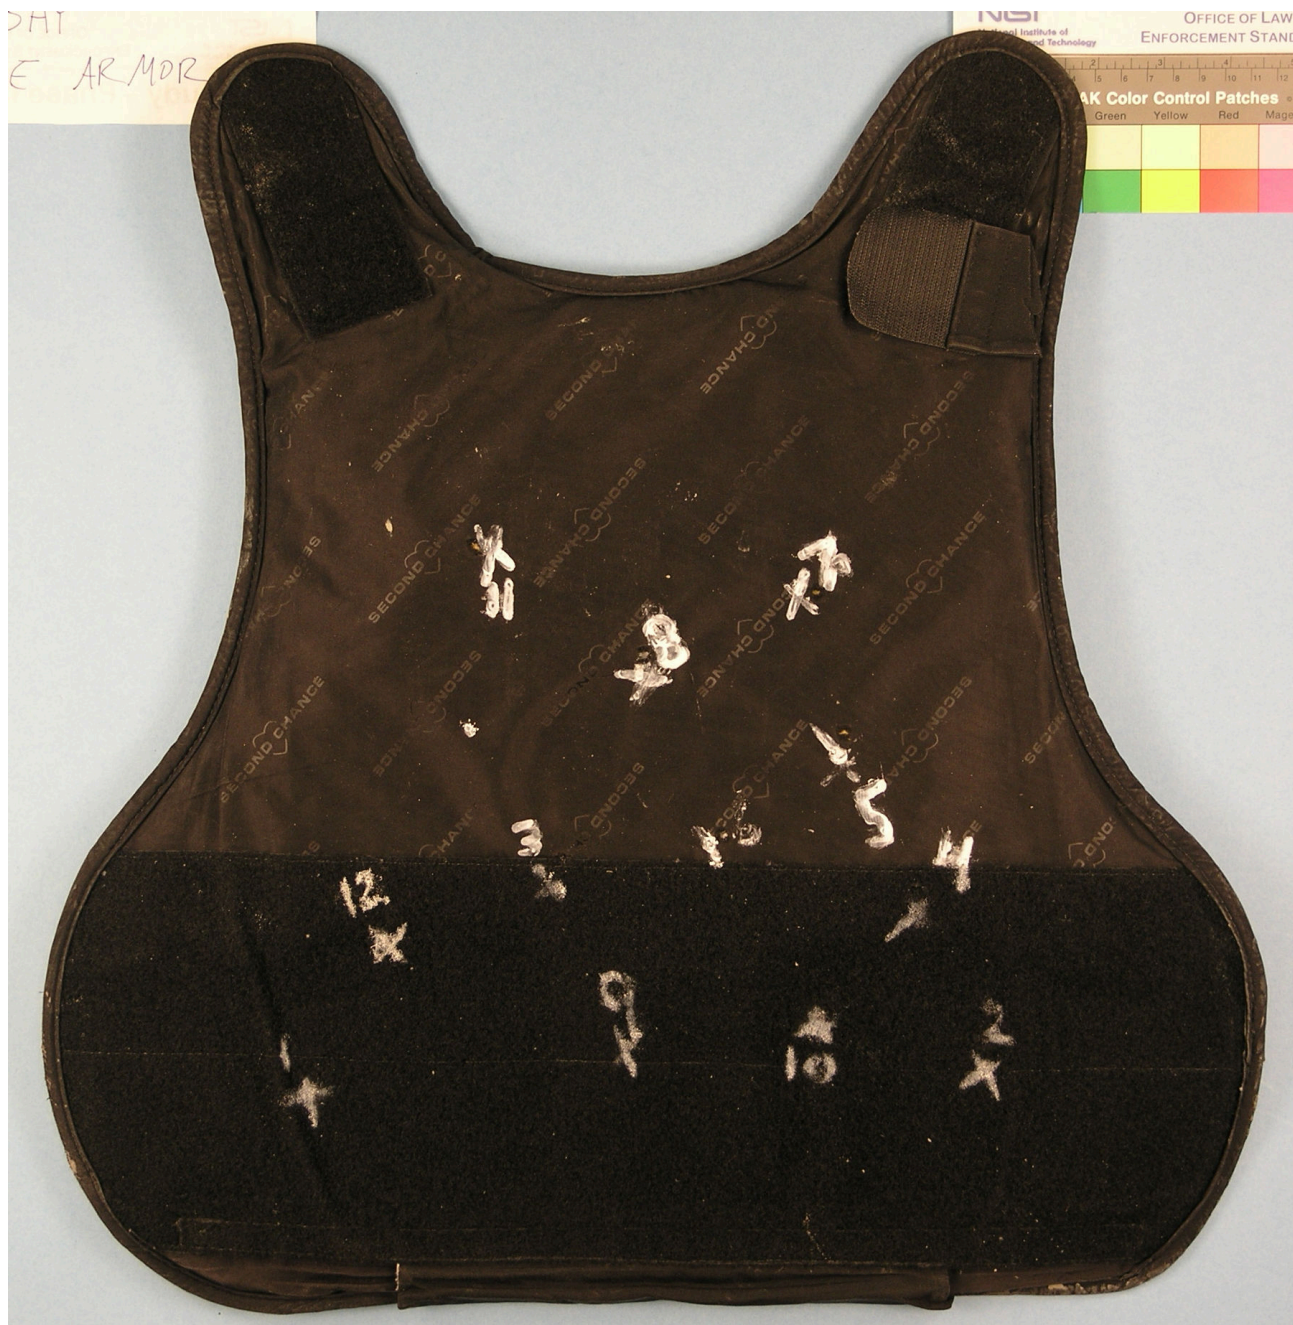
Figure 4.10: Incident Armor Back Panel used for Ballistic Limit Test.

The V_{50} ballistic limit test on the back panel of the incident armor, shown in the photograph in Figure 4.10, was conducted according to the methods and requirements of NIJ Standard-0101.04 [18]. All cartridges were hand loaded using new Remington .357 Magnum cartridge cases, Accurate Arms #2 propellant, and Remington 9 mm Luger, 8.0 g (124 gr) FMJ bullets. The cartridges were fired out of a special universal receiver barrel that has a .357 Magnum chamber and a 254 mm (10 in) barrel with SAAMI standard 9 mm Luger rifling [22]. This configuration with the .357 Magnum chamber and 9 mm barrel allows the 9 mm bullets to be fired at much higher speeds than can normally be achieved with a standard 9 mm Luger cartridge, while maintaining the other standard flight characteristics for the bullet.

which is slightly less than the estimated V_{50} of 507 m/s (1663 ft/s) for the incident armor back panel. This result provides evidence that the ballistic resistance of the incident armor had not degraded while in use.
