NIST Special Publication 901

The January 17, 1995 Hyogoken-Nanbu (Kobe) Earthquake

*Performance of Structures, Lifelines, and Fire
Protection Systems*

Riley Chung, Team Leader and Editor

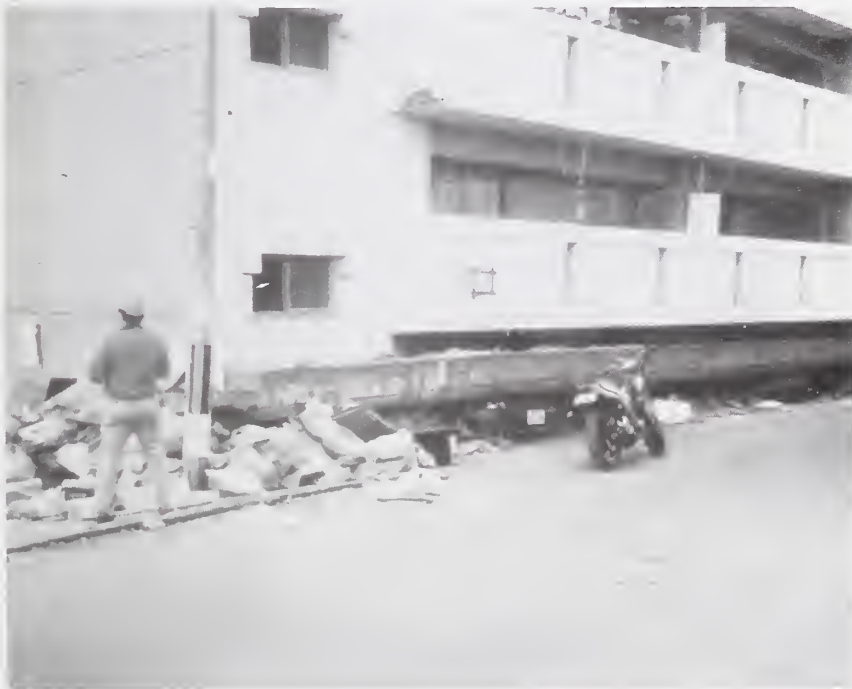
Figure 3.4.5 Failed ground floor shear wall - apartment building.

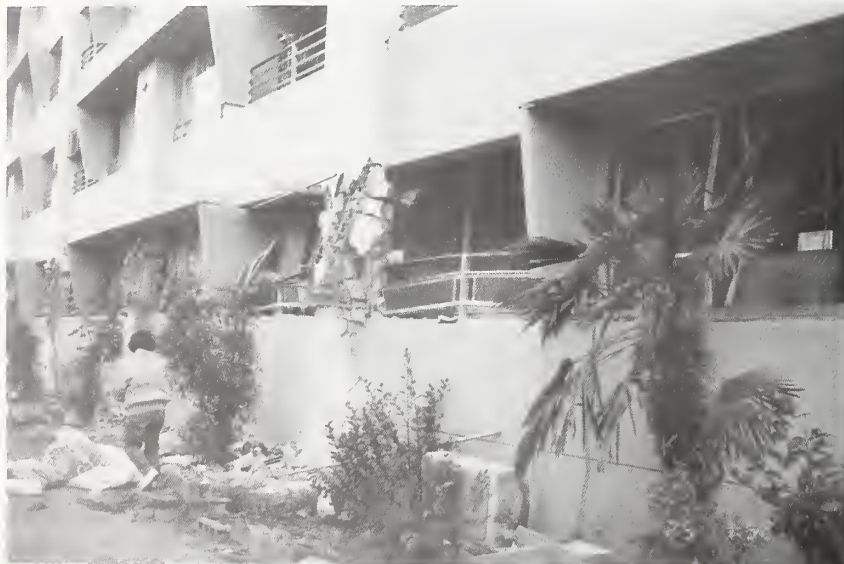
Figure 3.4.11 Short column effects - Fukae Mitsuku Housing Project.

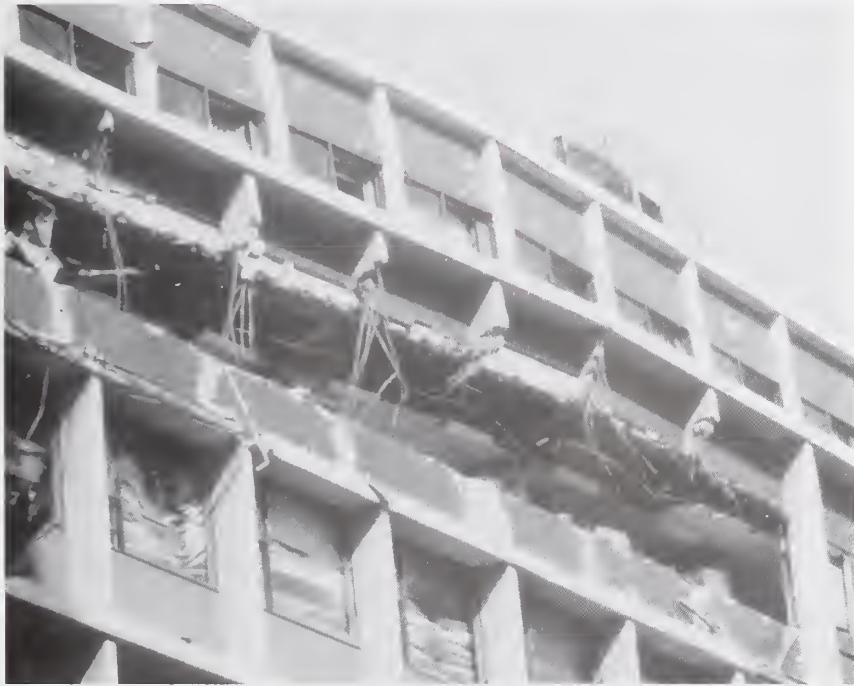
Figure 3.4.22 Upper story collapse - Downtown Kobe.

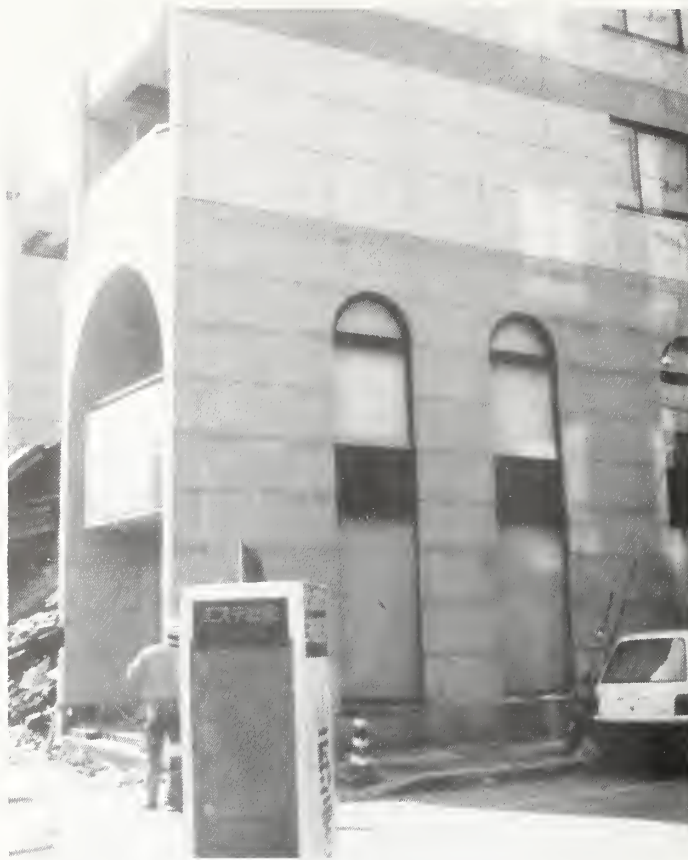
Figure 3.5.35 Seven-story steel frame SAGA Building - Flower Road in Kobe.

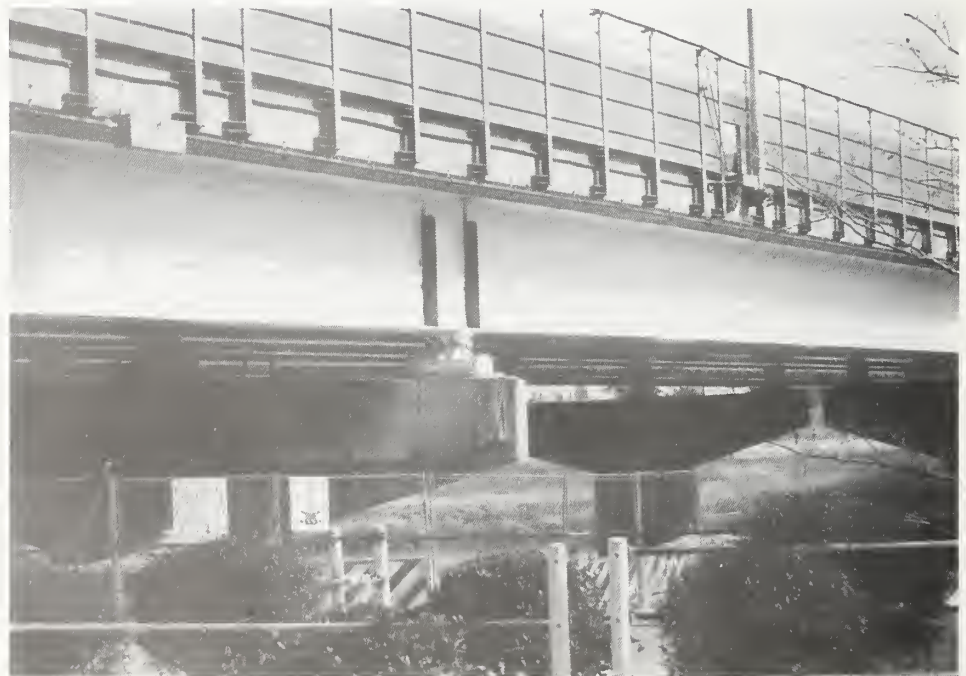
Figure 4.2.9 General view of Mukogawa Bridge, Meishin Expressway.

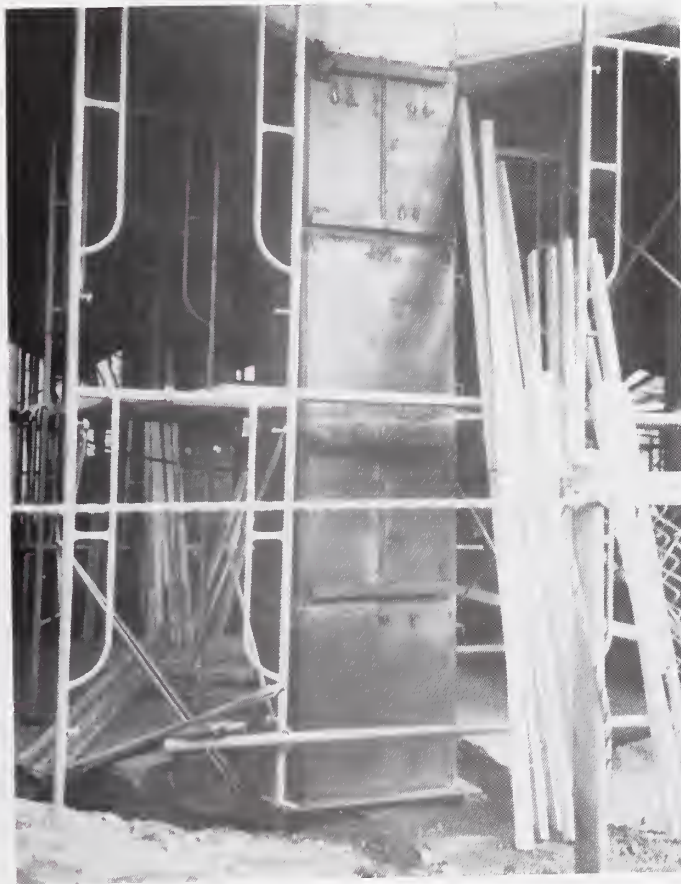
Figure 4.3.8 Jacketed column - JR Main Line.

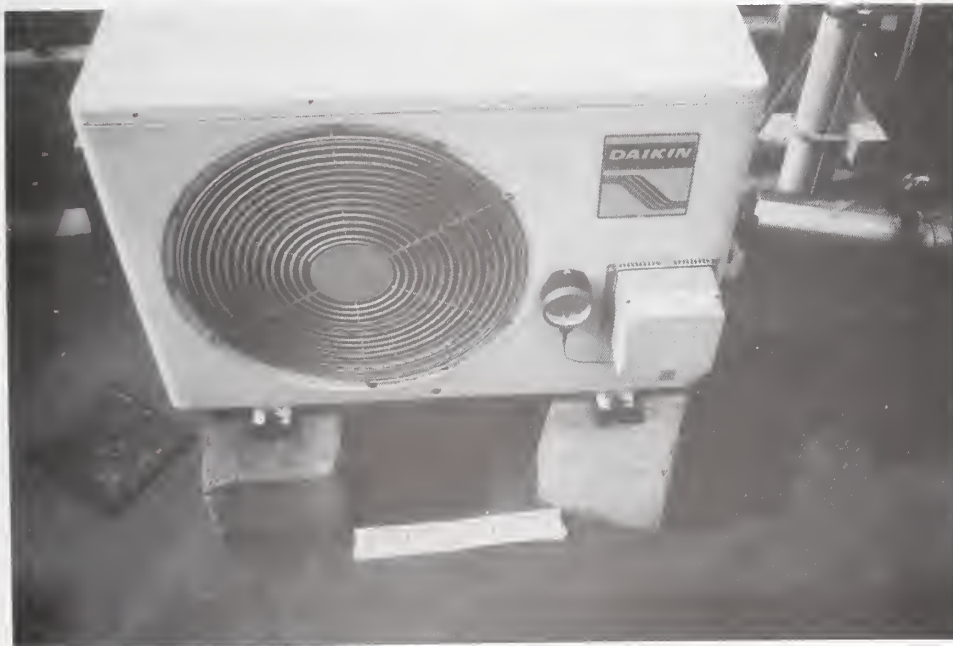
Figure 4.4.23 Heat exchanger on roof near control tower cab is rare example of poorly anchored equipment.

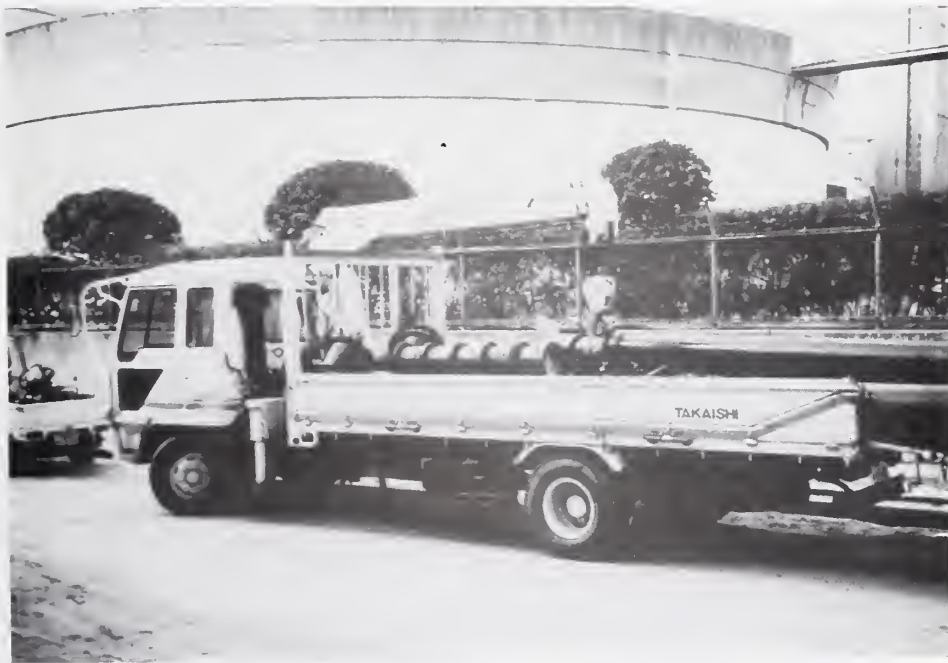
Photo 20 Kyoto Water Department truck and crew was making repair shown in Photo 19. The crew was directed to make the repair as quickly as possible, even though the repair might be temporary. The crew also indicated that the materials they used in Kyoto were completely different from those used by Kobe Water.

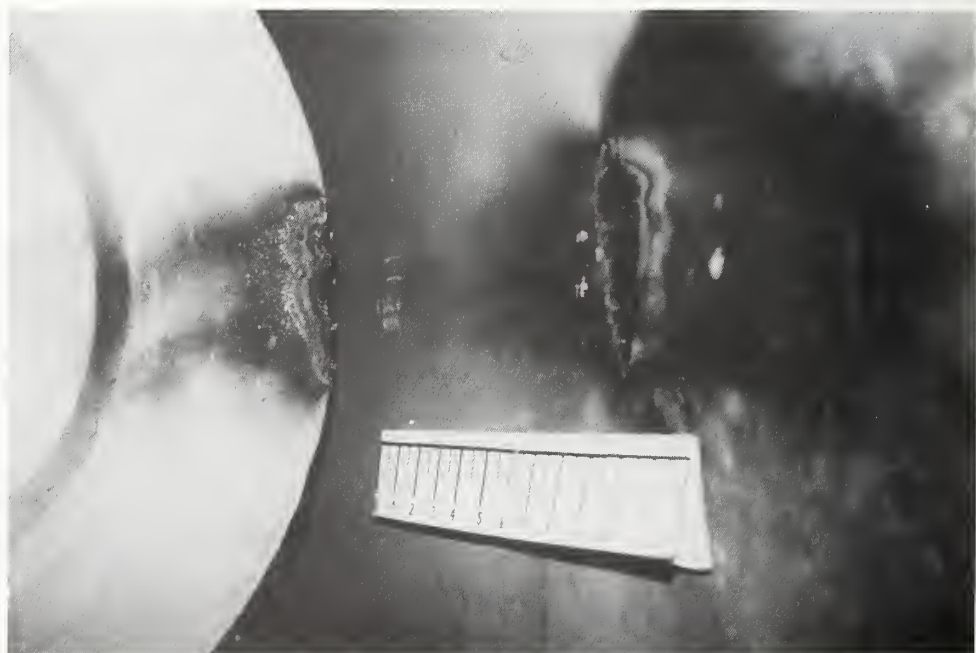
Figure 5.4.36 Movement of transformer damaged cabinet and shorted transformer case the tertiary output.

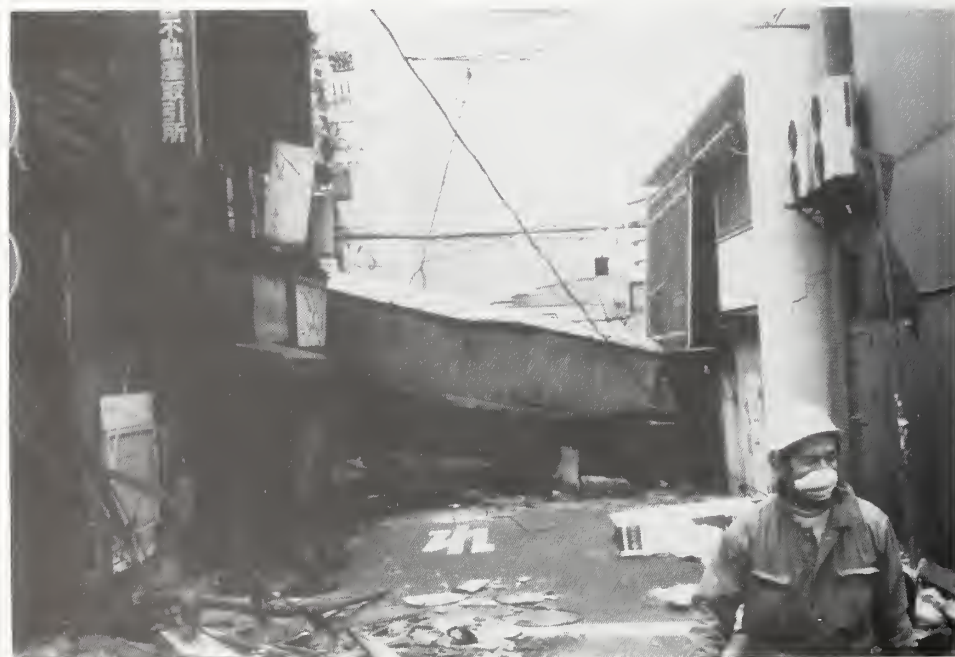
Figure 6.2.24 Road blocked by collapsed structure.

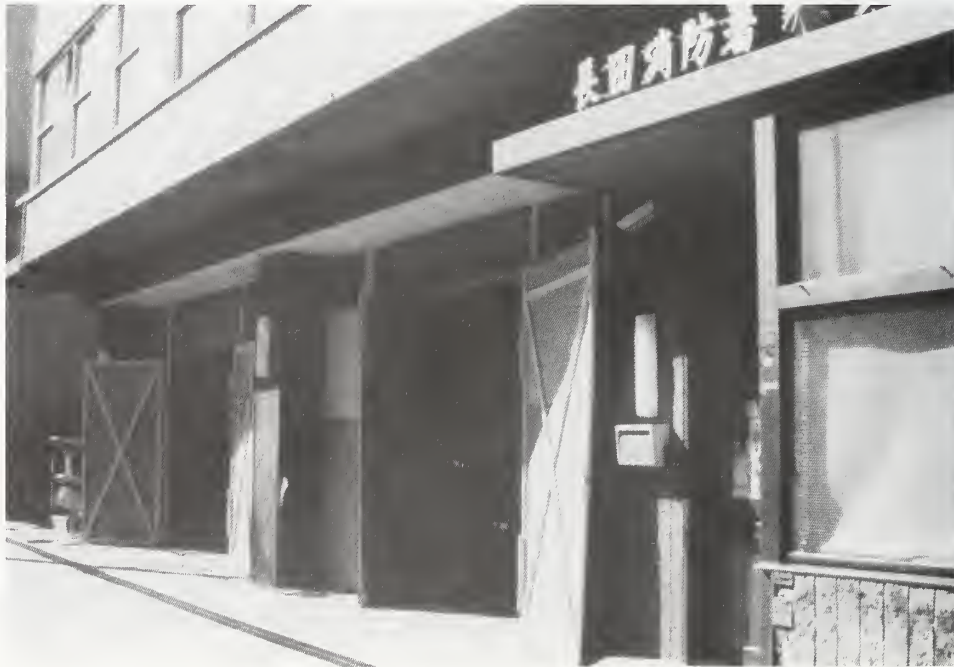
Figure 6.2.28 Fire station damaged by the earthquake.
