# TECHNOLOGIC PAPERS

No. 70

## DURABILITY OF STUCCO AND PLASTER CONSTRUCTION

(PROGRESS REPORT CONTAINING RESULTS  
OF INVESTIGATIONS UP TO APRIL, 1916)

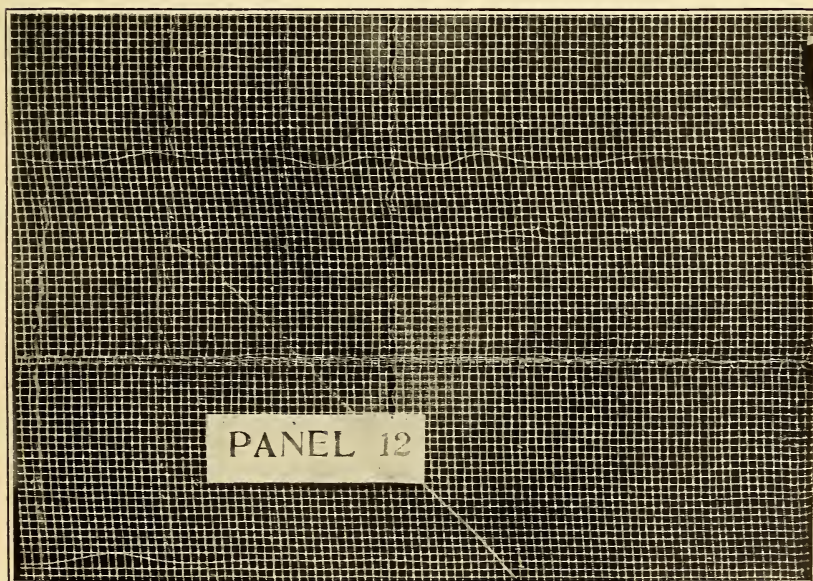
FIG. 10.—Galvanized woven wire lath on panel No. 12, showing furring 6 inches apart. Same construction on panel No. 9

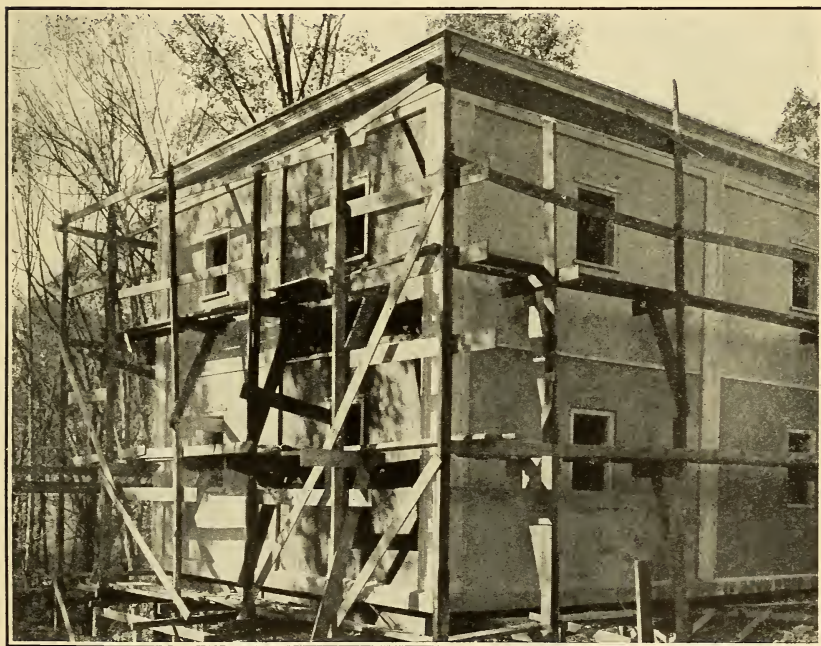
FIG. 18.—The four plaster board panels on the south end of the test structure, panels Nos. 26 and 27 on the second story, 28 and 29 on first story. The plaster board of panels Nos. 27 and 29 are shown coated with "Parlock" and ready for plastering. Panels Nos. 26 and 28 are already finished

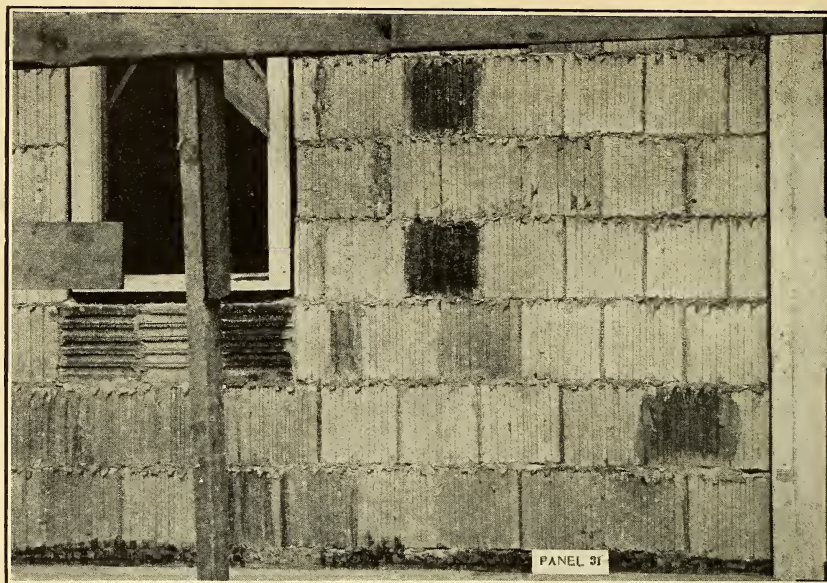
FIG. 21.—Hollow terra cotta tile of panel No. 31. Same construction in panels Nos. 32, 33, 34, and 53

Construction: Hollow terra-cotta tile, coated with cement gum, same as panel No. 31. (See Fig. 21.)

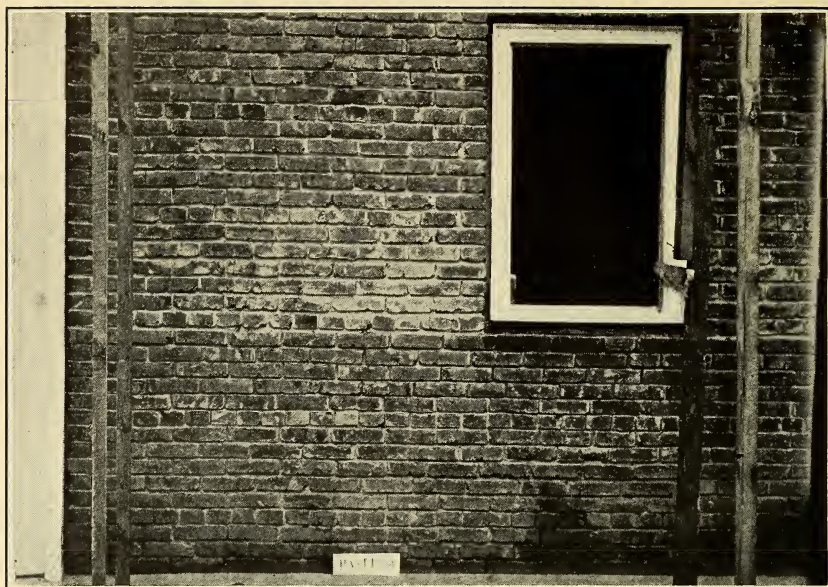
FIG. 25.—Brick of panel No. 39. Same construction in panel No. 40

Construction: Rough hard brick. (Shown in Fig. 25.)

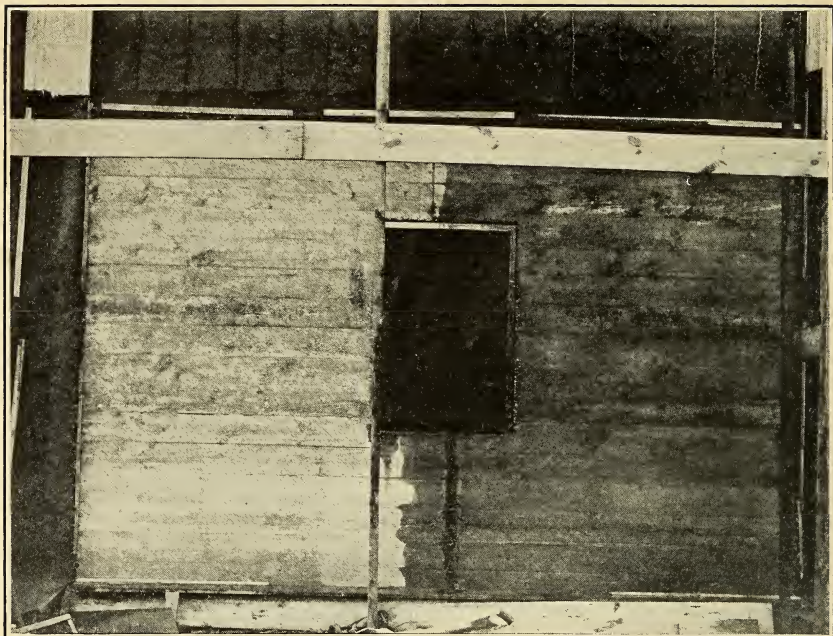
FIG. 28.—Concrete base of panel No. 45, showing right half saturated with water just before "Parlock" coating was applied

**Construction:** Monolithic concrete, poured September 14, coated with "parlock" October 26; right half of panel wetted at intervals for an hour or more previous to application of "parlock." (Shown in Fig. 28.) Figure 29 shows operator completing application of "parlock."

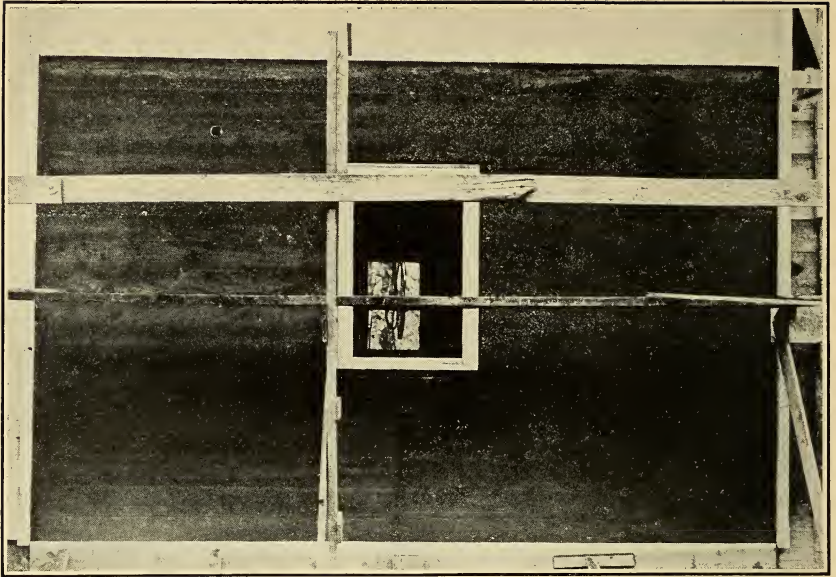
Construction: Monolithic concrete, poured November 16, forms removed and base treatment given prior to plastering November 18. Left half untreated (sec. a), right half wire brushed (sec. b). (Shown in Fig. 31. After this photograph was taken the smoother portions on right half were rebrushed.)

FIG. 31.—Concrete base of panel No. 49, left half untreated, right half wire brushed. (The smoother portions of the right half were rebrushed after the photograph was taken and just before plastering was begun)

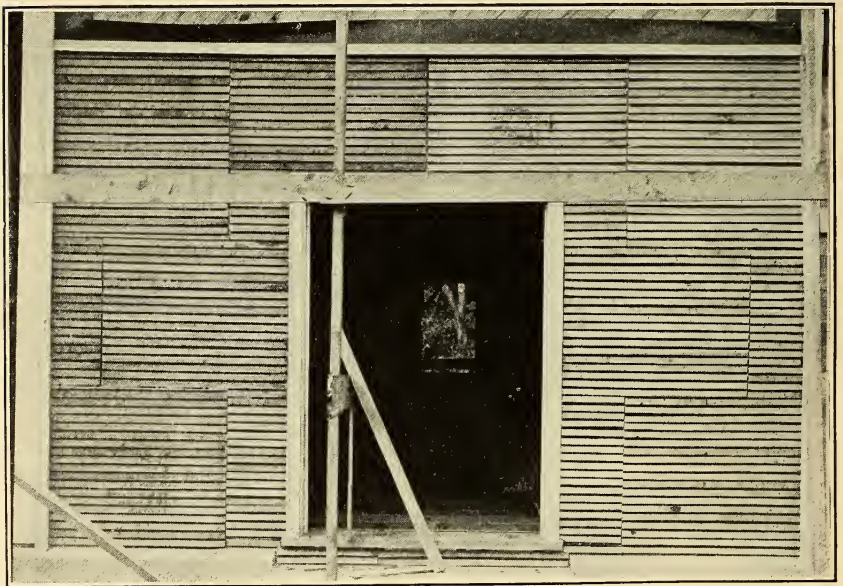
FIG. 32.—"Bishopric Board" on panel No. 51, left half creosoted lath, right half uncreosoted lath. Same construction on panel No. 52

Construction: Bishopric board, left half creosoted lath (sec. a), right half plain lath (sec. b). (Shown in Fig. 32.)

Remarks: Bishopric board is a proprietary stucco or plaster board, consisting of wood lath backed with paper which is first given a heavy coat of asphaltic compound on the lath side. This compound serves as a waterproof coat and as an adhesive between the lath and paper. The lath are dovetailed in order to insure a firm key for the plaster. The board is shipped in rolls containing 100 square feet and is applied in such manner as to break joints every 3 or 4 feet. (See Fig. 32.) Bishopric board may be applied over sheathing or directly to studs.
