STUDIES OF NOBLE-METAL THERMOCOUPLE STABILITY AT HIGH TEMPERATURES

P. D. Freeze and D. B. Thomas

NATIONAL AERONAUTICS AND SPACE ADMINISTRATION

Issued July, 1976

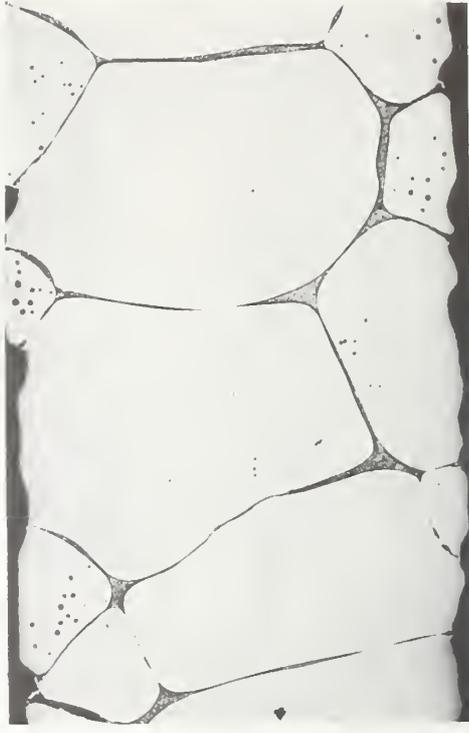
Figure 9 consists of four micrographs at a magnification of 80X of specimens
that experienced some structural deterioration. These specimens are longi-
tudinal sections, and the widths of the polished surfaces shown in the fig-
ures do not necessarily correspond to the product of the wire diameter
and the magnification. Following exposure to high temperature, some speci-
mens were found to be considerably deformed and enlarged, especially near
the tip. Figure 9a is a photograph of an iridium specimen taken from a
reference thermocouple aged for 88 hours at 1850°C in nitrogen; photograph
9b is of an iridium specimen taken from a test thermocouple aged for 88 hours
at 1850°C in air; photograph 9c is of an alloy specimen from the reference
thermocouple; and photograph 9d is of an alloy specimen from the test thermo-
couple. The wire diameter was 0.81 mm. Photograph 9a shows a very large
grain size, which indicates that grain growth had occurred. A slight sur-

face erosion of metal is evident near the tip of the sample, at the right.
These factors could have contributed to a structural weakening of the wire.
Photograph 9b shows larger grains at the tip than at the shank. Some sur-
face erosion is also in evidence. Photograph 9c shows erosion of metal at
the surface. This photograph also shows a grain-boundary second phase and
fine precipitate throughout the structure. It is probable that the grain-
boundary phase was a liquid contaminant or an oxygen-deficient oxide at the
test temperature, and that the precipitate in the grains was a sub-oxide
precipitated during cooling. This is suggested by the rounded appearance of
the grain-boundary corners. The lighter coloration of the oxide phase indi-
cates a lack of oxygen.

Photograph 9d shows considerable surface erosion, a second phase at the
grain boundaries, and fine precipitate throughout the structure. It seems
probable from the coloration of the oxide phase that the oxide liquid was
less oxygen-deficient than that for the specimen shown in 9c.

The possibility also exists that the observed structural deterioration of
specimens from the reference thermocouple resulted from contamination of
the nitrogen atmosphere with oxygen. During the final cooling phase of the
test, immediately prior to thermocouple failure, the test cells were sub-
jected to severe thermal shock, resulting in cracks in the reference cell
and permitting the entry of air. The precipitate areas found in the grain
structure of the specimens from the reference thermocouple probably resulted
from certain oxides that solidified during the rapid cooling which followed
failure of the test cell.

FIGURE 9: MICROGRAPHS OF SECTIONED COMPONENTS OF TEST (B, IRIDIUM AND D ALLOY) AND REFERENCE (A, IRIDIUM AND C, ALLOY) THERMOCOUPLES AGED AT 1850°C FOR 28 HOURS. THE MAGNIFICATION WAS 80X. FURTHER DESCRIPTION IS IN THE TEXT, 2.7.2. THERMOCOUPLE SYSTEM: IRIDIUM-40% RHODIUM VERSUS IRIDIUM.

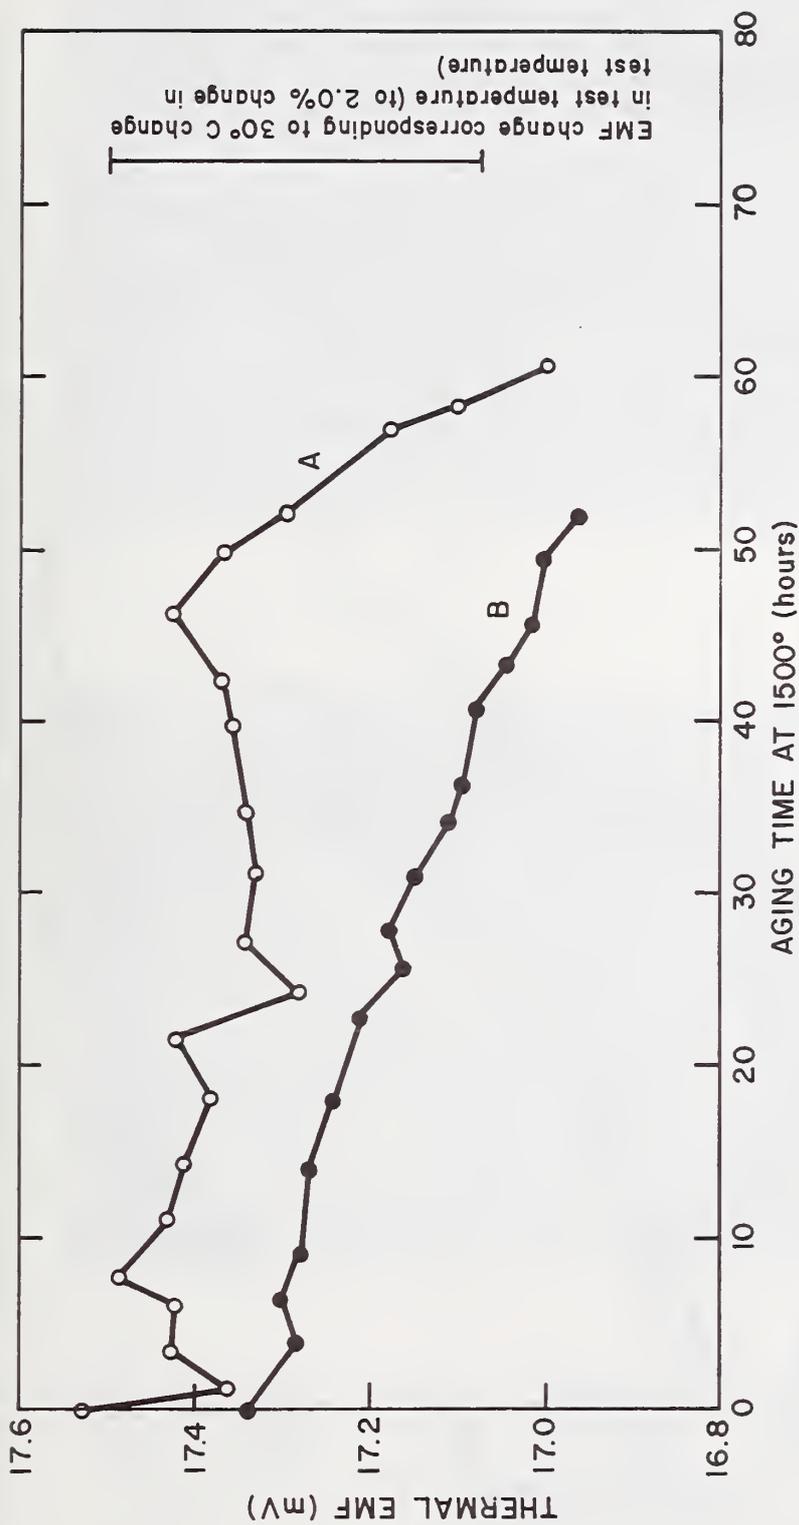
Figure 14 presents a comparison between the test performance of two platinum-13% rhodium versus platinum thermocouples, one stirrup, one wedge, alike in all respects other than junction configuration. The test conditions were a junction temperature of 1500°C and a gradient of 1475°C/cm; wire size was 0.51 mm. The plots are typical of the results in that the wedge thermo-couple experienced a continuous decrease in thermoelectric emf at an aver-age rate of 0.5°C per hour (corresponding to an equivalent 1.8% change in the junction temperature after 52 hours), while the emf of the stirrup thermocouple decreased about 0.2°C per hour for the first 50 hours, and then decreased rapidly at about 2.4°C per hour for the next 10 hours. At 60 hours, the emf had changed by the equivalent of 2.0% of the temperature.

FIGURE 14: COMPARISON OF THERMAL EMFS OF STIRRUP-CONFIGURATION THERMOCOUPLE (A) AND WEDGE-CONFIGURATION THERMOCOUPLE (B). THE TEST CONDITIONS WERE A JUNCTION TEMPERATURE OF 1500°C AND A GRADIENT OF 1475°C/CM; WIRE SIZE WAS 0.51 MM. THERMOCOUPLE SYSTEM: PLATINUM-13% RHODIUM VERSUS PLATINUM.

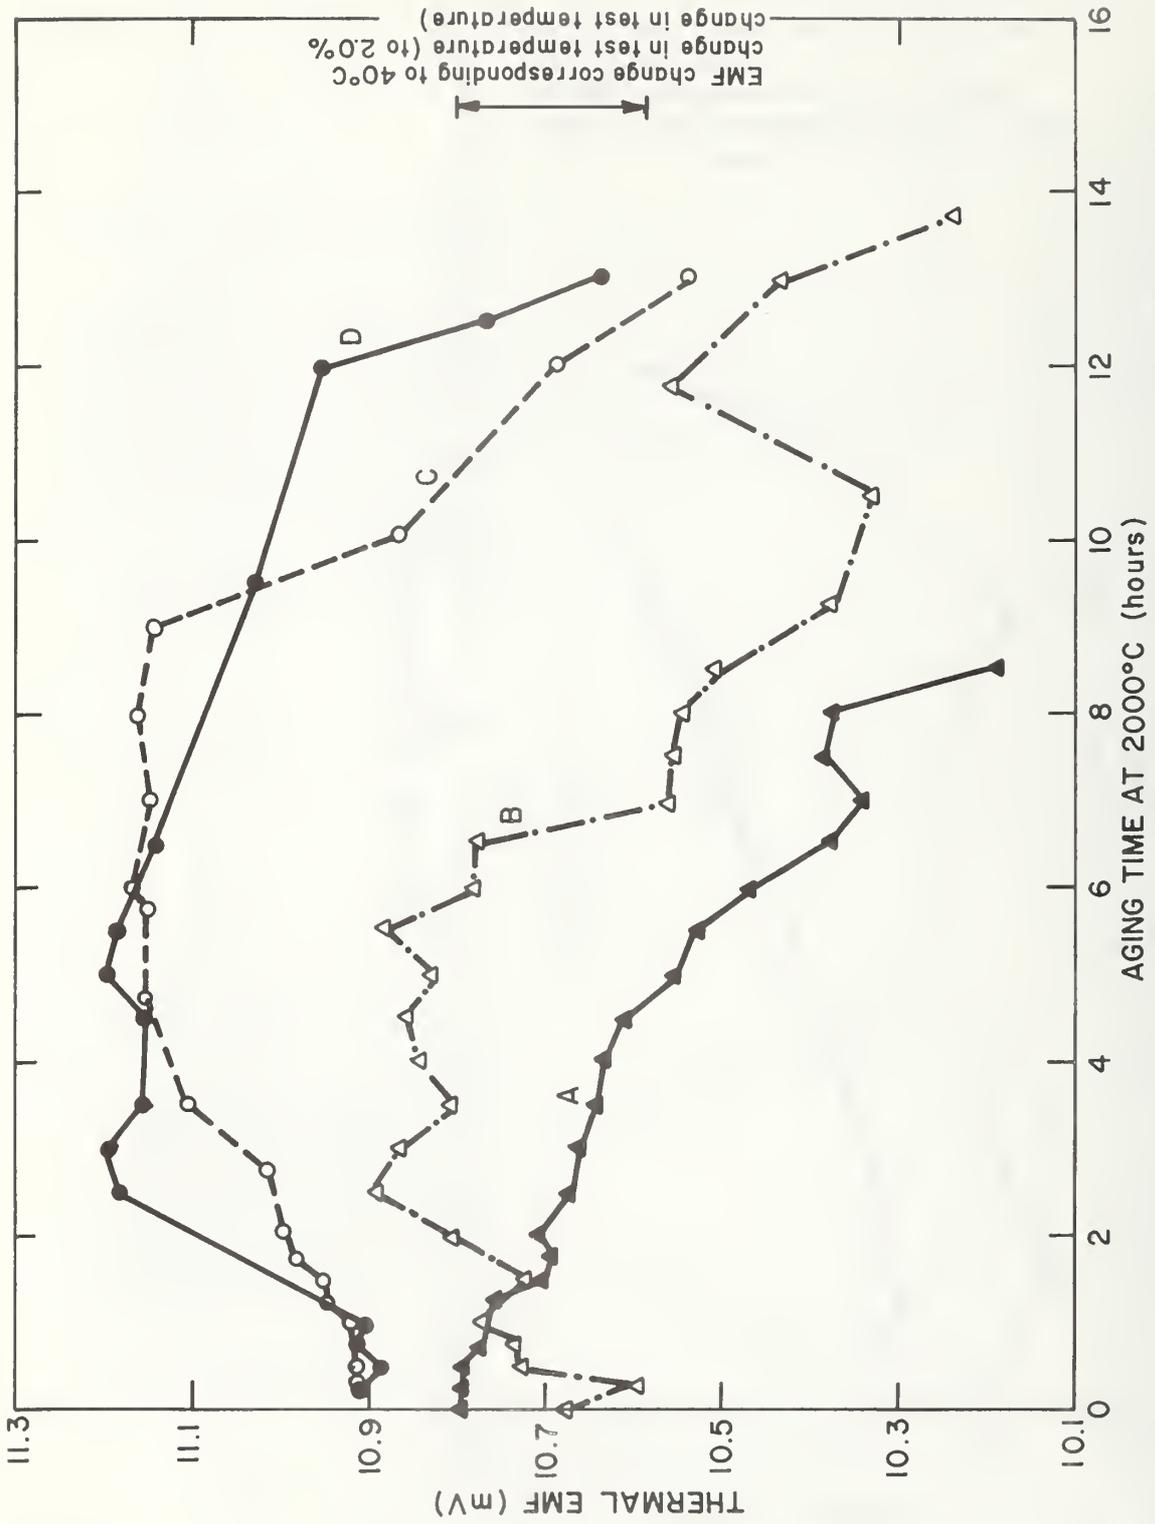
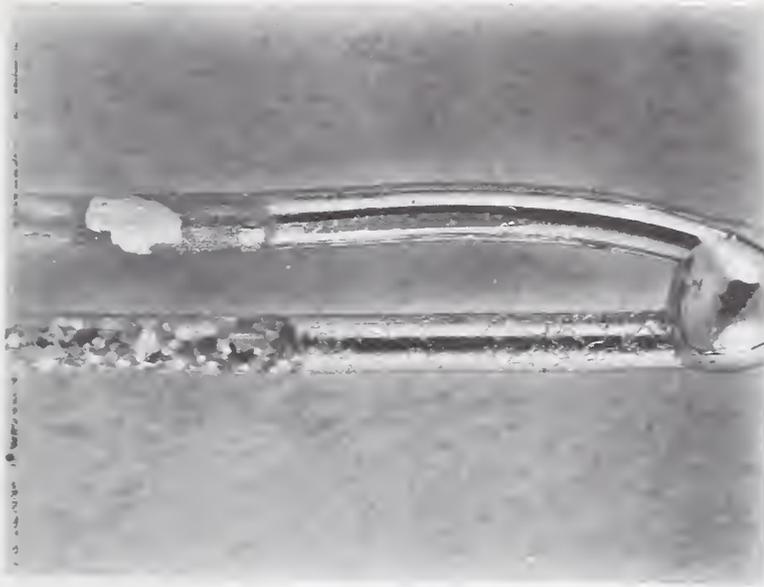
One of the thermocouples (A) exposed to the gradient of 700°C/cm behaved in
a peculiar manner not typical of others. This thermocouple experienced a
nearly steady decrease in thermoelectric output, with the thermoelectric
emf decreasing sharply before failure, which occurred at the junction center.
The other three thermocouples showed behavior similar to each other. During
the first few hours of the test, the emfs of these thermocouples increased
relative to the initial calibration. Then some fluctuation in output occurred
around a more-or-less stable value significantly above the initial calibration;
and finally the emfs decreased to below the initial calibration value until
failure occurred.

At times during the tests described in 3.7.1 and figure 15 with iridium-40% rhodium versus iridium thermocouples, a considerable amount of dark smoke was observed. Probably the smoke was evidence of significant iridium volatilization. If iridium were continuously lost from the alloy component, the thermocouple output might be expected to increase initially, stabilize for a short period, and then decrease to below its initial value, according to the preferential-oxidation hypothesis discussed in connection with the stability study. The thermoelectric emf changes shown in figure 15 for three thermocouples were, in general, consonant with the predicted behavior. Failure for these thermocouples occurred in the iridium component, close to the junction. Figure 19 presents four photographs at a magnification of 12X of the components of two of these thermocouples, one exposed to a gradient of 700°C/cm, the other, to a gradient of 1975°C/cm. The junction temperature was 2000°C. All photographs show that the wires had been severely eroded near the junction. The photographs also show that cooler portions of the wire were covered with a dark, spiny deposit. Analysis of this deposit showed that its major constituent was iridium, with traces of less than 1% of rhodium, copper, aluminum, and zinc.

FIGURE 15: PLOTS OF THERMAL EMFS OF FOUR THERMOCOUPLES FABRICATED FROM 0.51-MM-DIAMETER WIRE AND EXPOSED TO A JUNCTION TEMPERATURE OF 2000°C AND TO GRADIENTS OF 700°C/CM (A AND B), 1500°C/CM (C), AND 1375°C/CM (D). THESE PLOTS ARE DESCRIBED IN THE TEXT, 3.7.1. THERMOCOUPLE SYSTEM: IRIDIUM–40% RHODIUM VERSUS IRIDIUM.

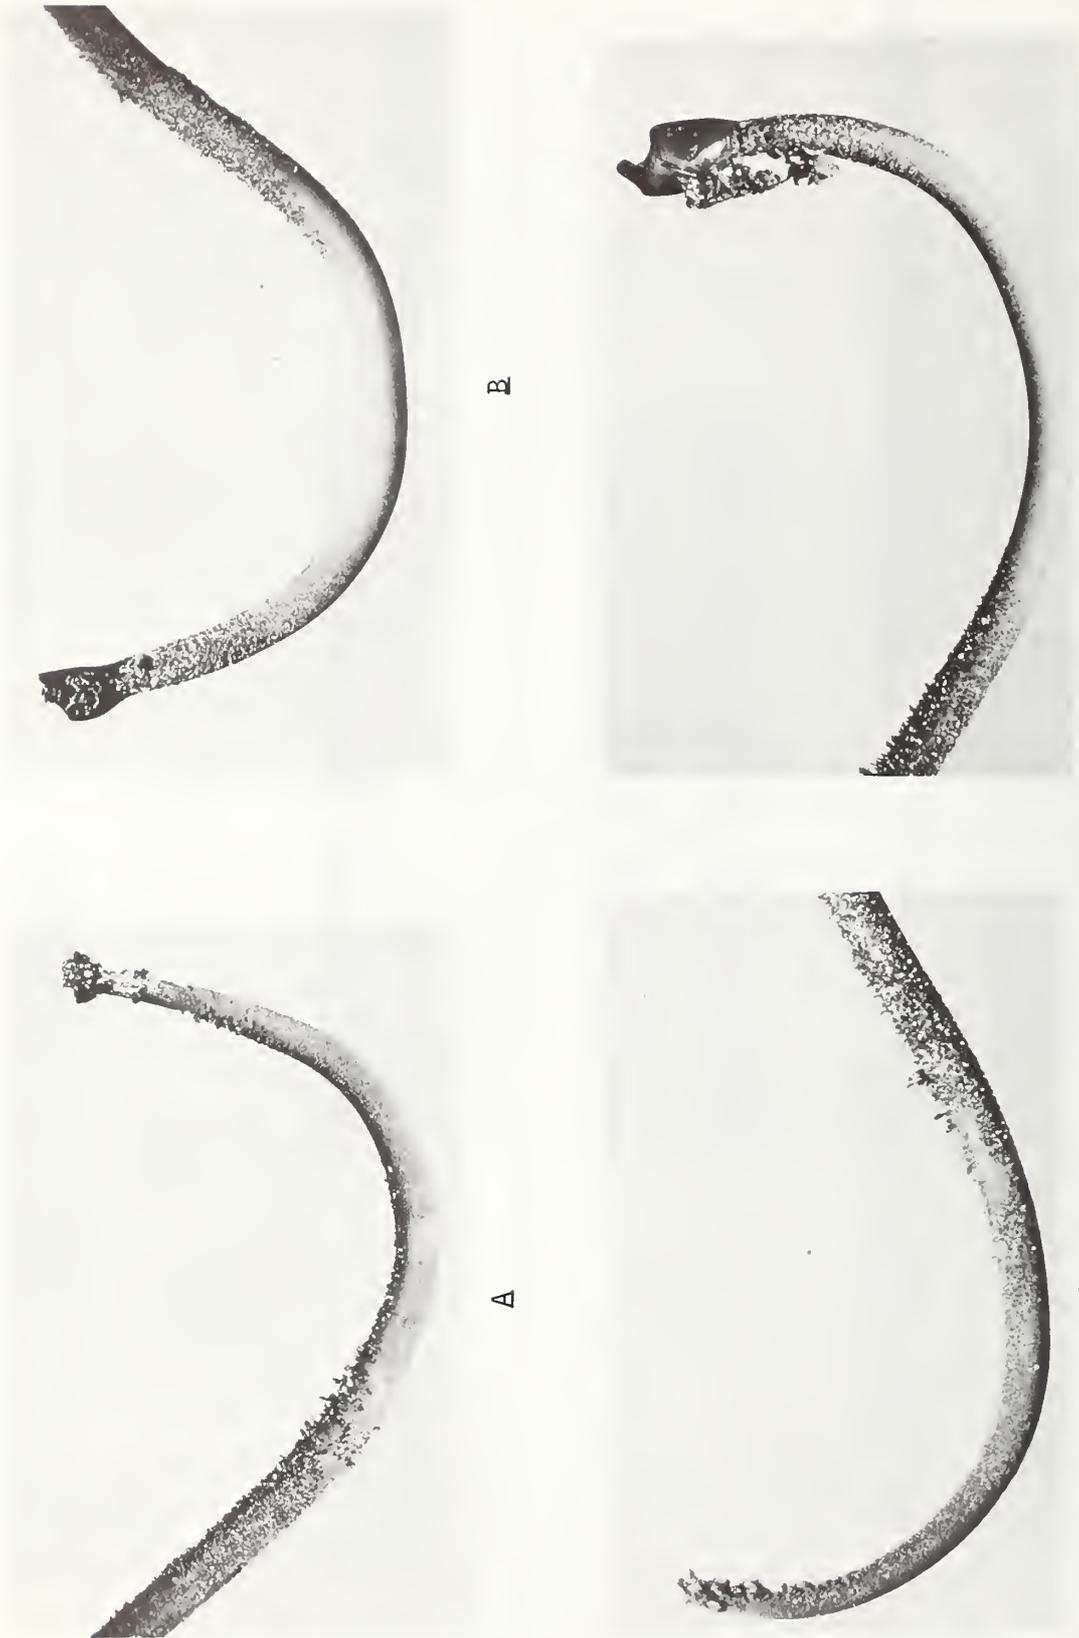
FIGURE 19: PHOTOGRAPHS AT A MAGNIFICATION OF 12X OF COMPONENTS OF TWO THERMOCOUPLES AGED AT 2000°C AND AT GRADIENTS OF 1975°C/CM (A AND B) AND 700°C/CM (C AND D). THE LENGTHS OF WIRE SHOWN ARE APPROXIMATELY 2.5 CM IN A AND B AND 3 CM IN C AND D. THE WIRE SIZE WAS 0.51 MM. FURTHER DESCRIPTION IS IN THE TEXT, 3.7.2. THERMOCOUPLE SYSTEM: IRIDIUM-40%- RHODIUM VERSUS IRIDIUM.
