NATIONAL BUREAU OF STANDARDS REPORT

THE HEATING PERFORMANCE OF AIR-TO-AIR HEAT PUMPS
IN MILITARY HOUSING

C. W. Phillips and P. R. Achenbach
Mechanical Systems Section
Building Research Division

Report to
Office of the Chief of Engineers
Bureau of Yards and Docks
Department of the Air Force

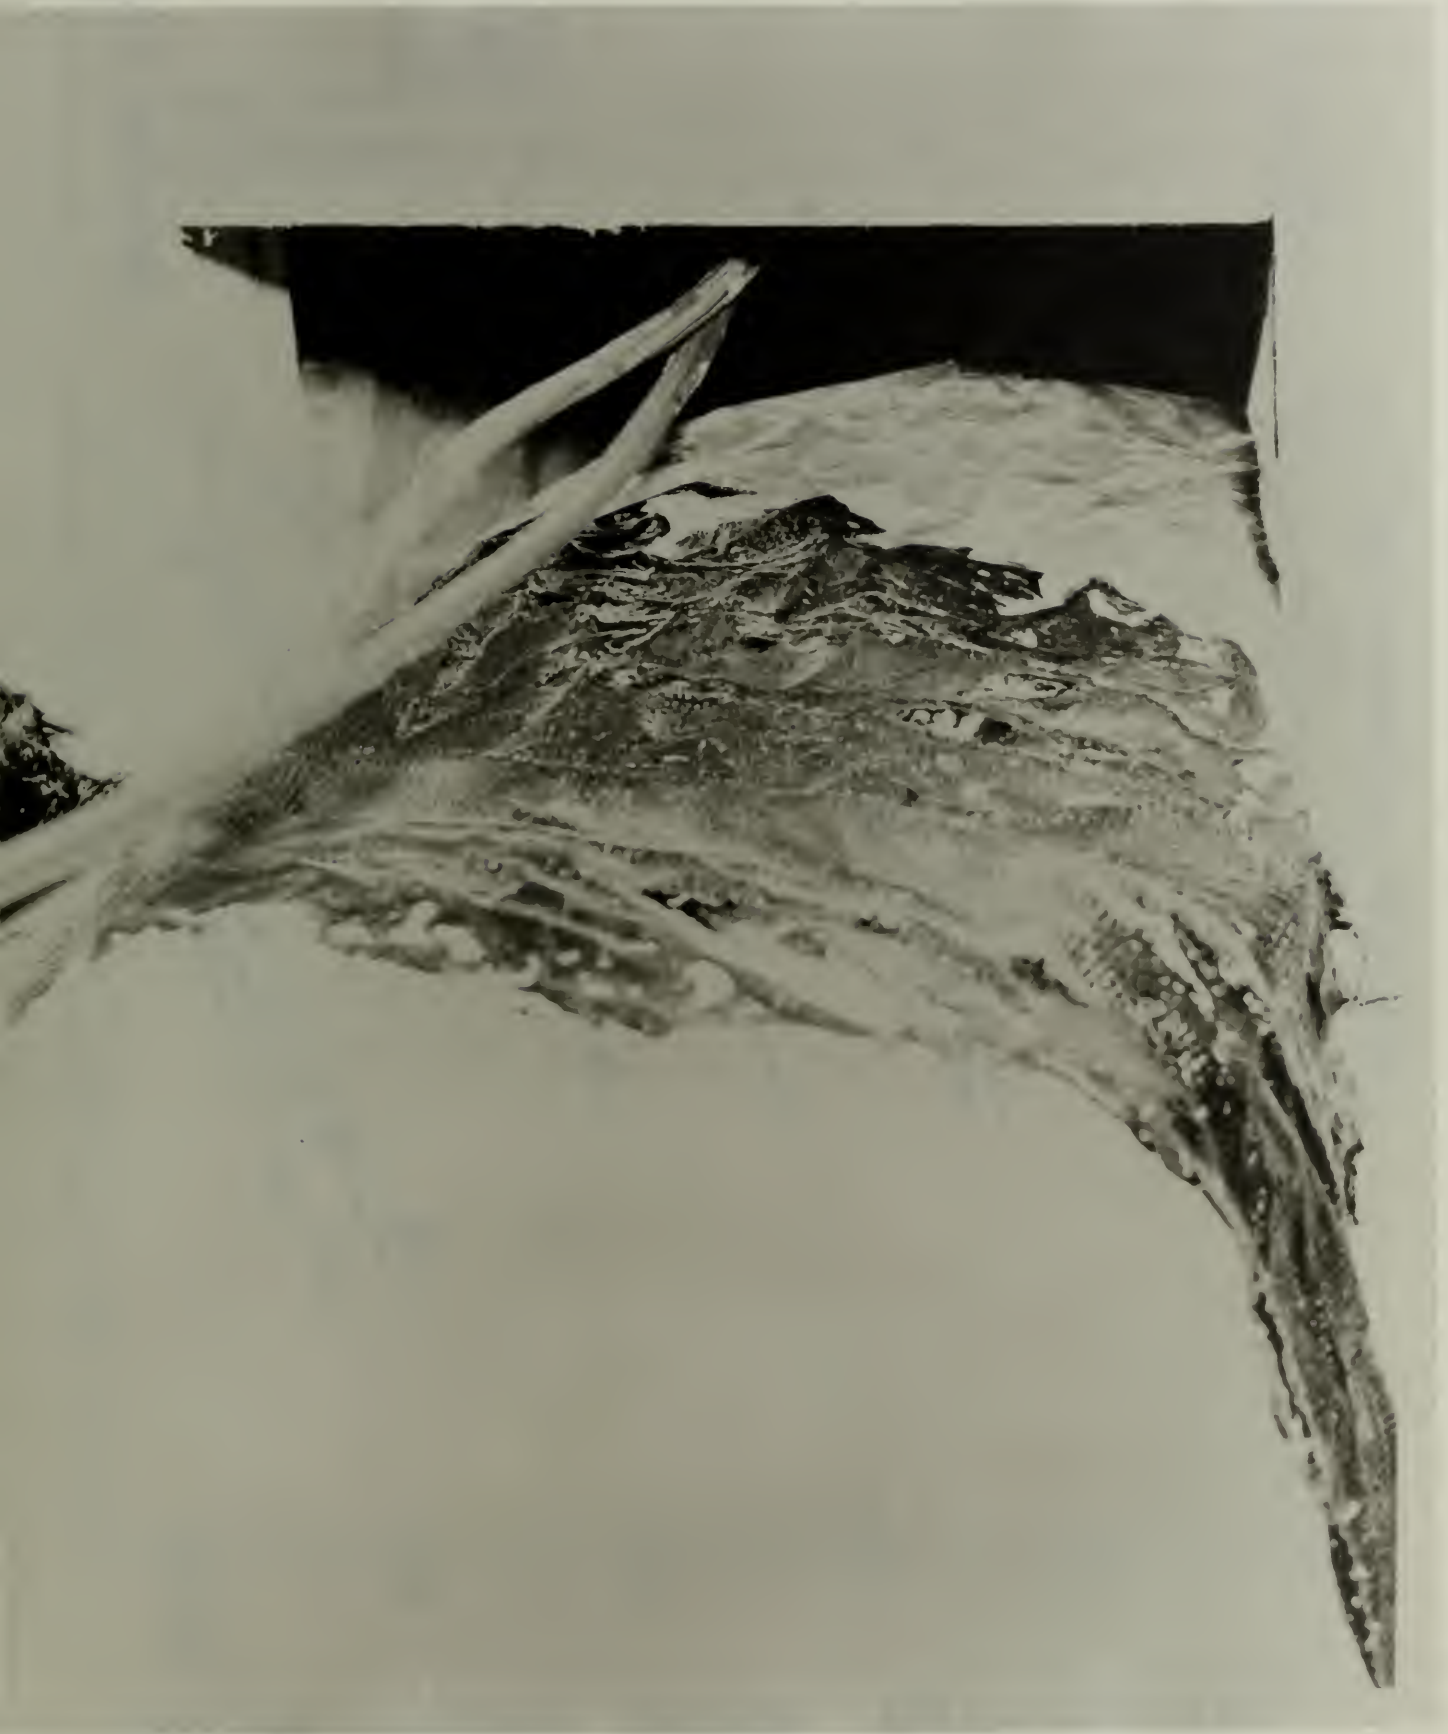
During the course of the tests at each air base, it became obvious that an appreciable amount of air was being drawn into the return air duct system from the attic. At Seymour Johnson AFB the leakage occurred principally where the return duct was fitted into the ceiling of the closet that was converted into a return-air passage as a modification of the original plans. At Columbus AFB the leakage occurred between the attic and the utility closet where the main supply duct passed through the utility closet wall into the space above a section of furred ceiling. The opening in the wall was larger than the duct, leaving a passage for air leakage as indicated by the darkest area at the right side of Figure 21. Therefore, near the end of the investigation at each site some measurements were made from which the order of magnitude of the air leakage could be determined. For this purpose, the return air grille and all of the supply grilles except one were covered to prevent any air flow through them. A 6-inch diameter duct was fitted to the one supply grille with an airtight connection. With the indoor fan running, all of the air that leaked into the return system from the attic was discharged through the 6-inch duct, assuming that no air leakage occurred in the discharge duct system. By measuring the air flow rate in the 6-inch duct, a minimum value of air leakage could be determined. Static pressures were measured downstream of the return air grille and in the supply plenum under the special conditions just described and also under normal operating conditions, so corrections to the measured air leakage could be made to account for difference in the pressure conditions at the points of leakage. The relation between the temperatures at the return air grille, at the inlet to the indoor coil, and in the attic during normal operating conditions were also used to compute the probable amount of air leakage from the attic.

Fig. 21. View showing path for air leakage (dark area at right) from attic into utility closet, Columbus AFB

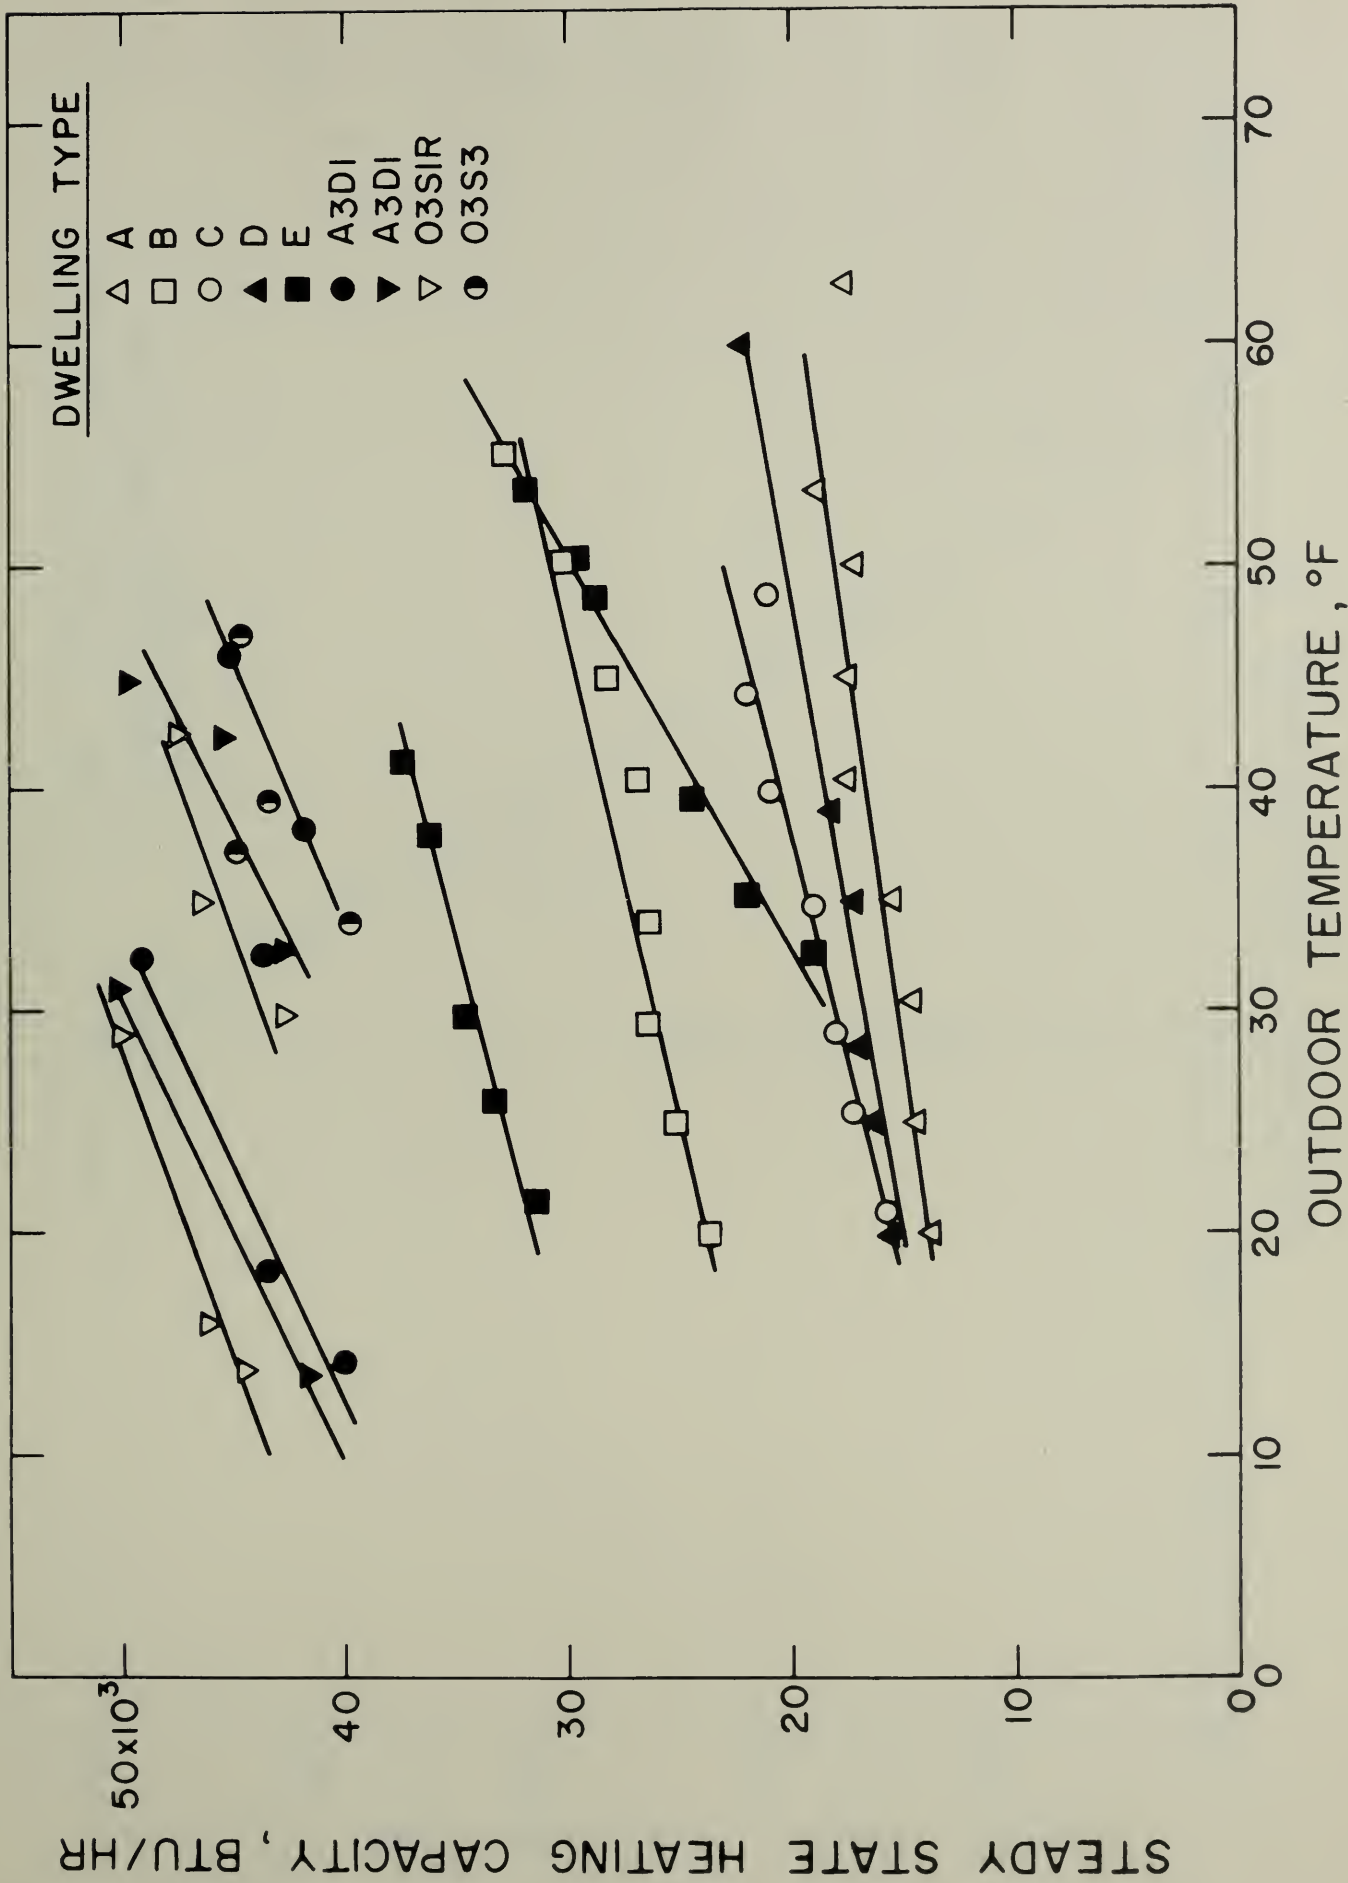
The lower group of six curves in Figure 22 applies to the heat pumps at Seymour Johnson AFB, whereas the upper group of three curves with a discontinuity at midlength represents the performance of four identical heat pumps used at Columbus AFB. It will be noted that the steady-state heating capacity of each of the heat pumps at Seymour Johnson AFB increased with rising outdoor temperature. The increase was approximately linear with outdoor temperature and ranged from 25 percent to 50 percent for the temperature range from 20°F to 50°F. The outdoor units of the heat pumps in dwelling types A, C, and D had similar compressor displacements and the indoor units in dwelling types C and D were identical. The heating capacities of these three systems did not differ greatly as shown in Figure 22. Dwelling types B and E had identical outdoor units

and similarly rated indoor units installed in them, but their measured capacities were different. Two capacity curves are shown in Figure 22 for dwelling E. The lower curve represents the capacities observed during the early part of the test period and the upper curve represents the capacities observed later after repair and maintenance operations were performed. After determining that the system did not appear to be developing its full capacity, the capillary tube on the indoor unit was replaced and the system was recharged with refrigerant. The improved performance is indicated by the comparison of the two capacity curves in Figure 22.

The observed values of steady state heating capacity for the heat pumps at Columbus AFB are somewhat scattered for any given dwelling. Some values obtained at Seymour Johnson AFB also deviate from the curves drawn through most of the plotted points. Such deviations could be caused by variations in air flow rate through the indoor coil resulting from dust accumulation on the air filter, by the effects of wind on the heat transfer in the outdoor coil, by variations in the indoor temperature level, and by other abnormalities in operating conditions.

Fig. 22. Steady State Heating Capacity of the Compression System in Nine Sample Houses for a Range of Outdoor Temperature
