RESEARCH PAPER RP771

EXPERIMENTS ON EXTERIOR WATERPROOFING MATERIALS FOR MASONRY

By Daniel W. Kessler

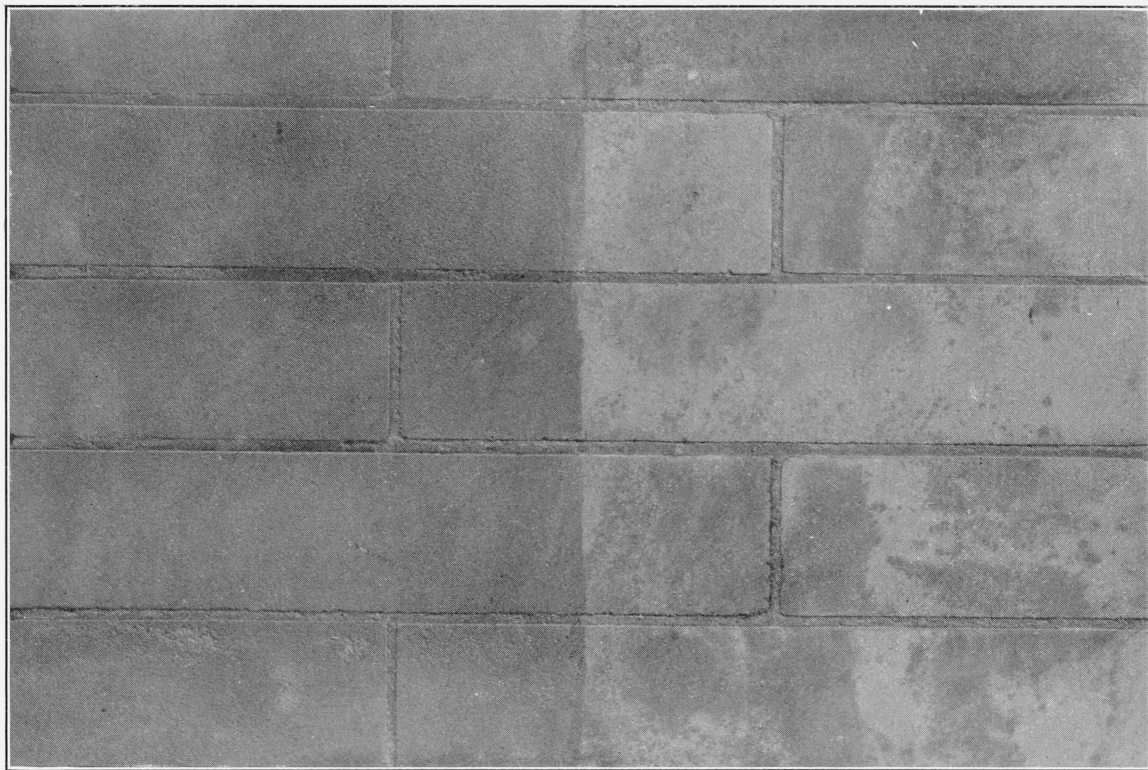
FIGURE 11.—*Leaching test on limestone panel 1.*
Right-hand half treated with a 10-percent paraffin solution.

The entire back face of the brick was coated with a bituminous waterproofing. A coping of the same stone covered the entire top of each panel. Four typical panels are shown in figures 11 to 14. The stone facing is on the south side. The photographs show the present appearance of the facing. The right-hand half of each panel was treated with a waterproofing and the left half was untreated. The mortars used for setting the stone and brick are shown in table 5.

The lower part of panel 1 was cleaned with an abrasive grit and water. The appearance is shown in figure 11. A moderate amount of scouring served to remove the deposit of dust. An attempt made to clean panel 2 with a wax solvent left a film of about the same appearance as the newly applied treatment.

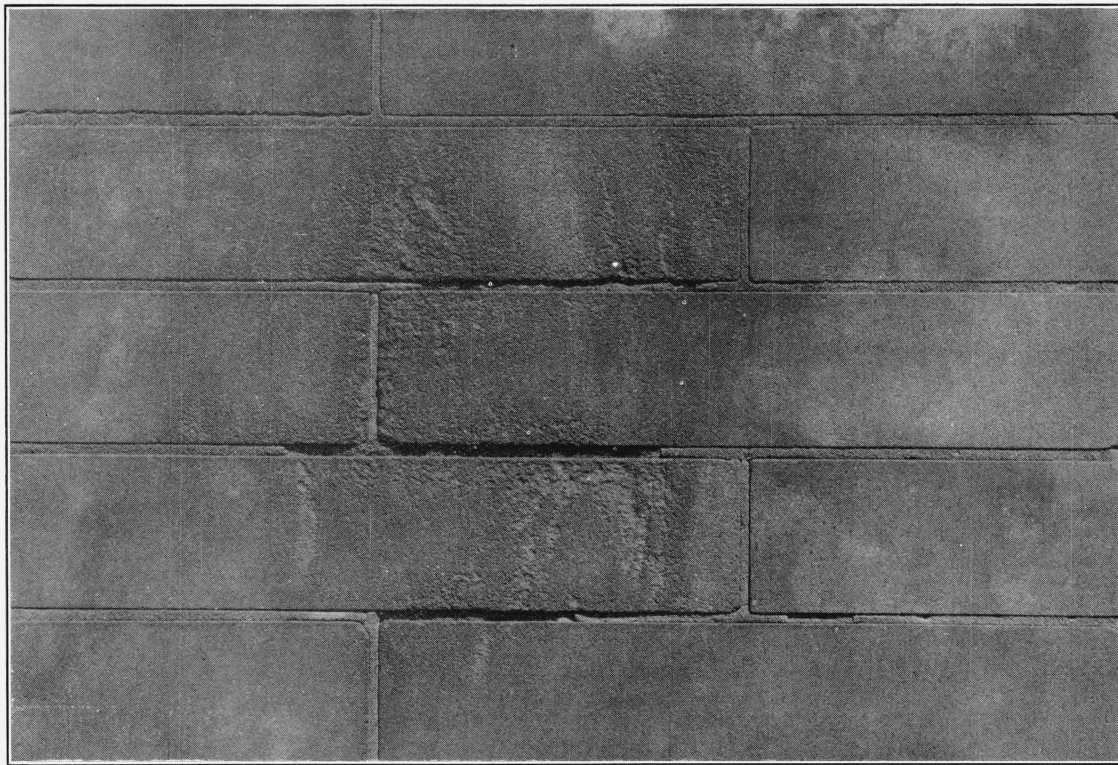
FIGURE 12.—*Leaching test on limestone panel 3.*
Right-hand half treated with a 4-percent solution of aluminum soap.

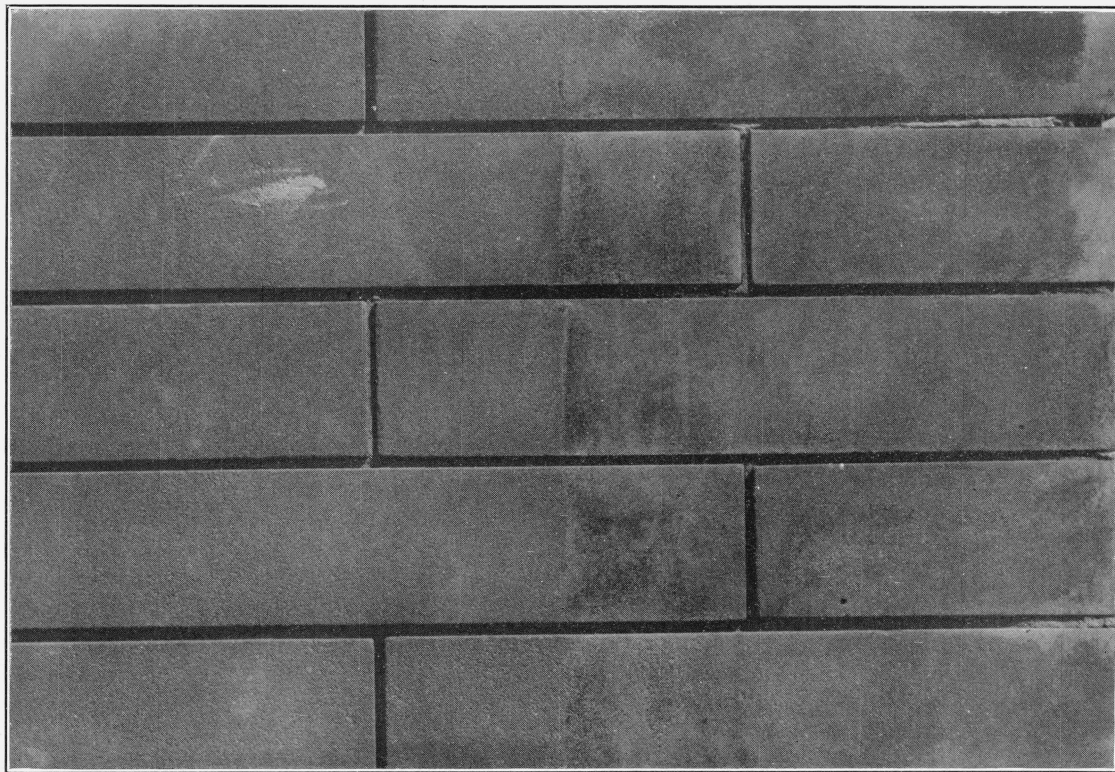
FIGURE 14.—*Leaching test on limestone panel 7.*
Right-hand half treated with a 15-percent paraffin solution.
