**BUILDING
MATERIALS
AND
STRUCTURES**

REPORT BMS104

Structural Properties of Prefabricated Plywood Lightweight Constructions for Walls, Partitions, Floors, and Roofs Sponsored by the Douglas Fir Plywood Association

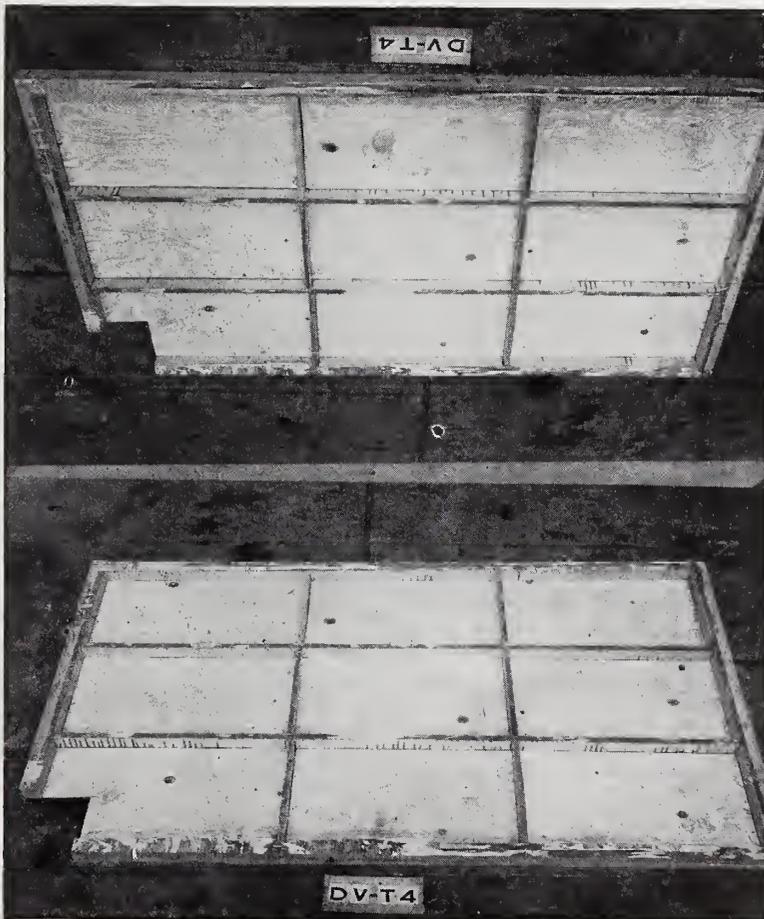
FIGURE 2. Wall DV.
Typical 4-foot specimen.

After each specimen was tested, one face was removed to expose the framing, and samples of framing and plywood were cut for moisture-content determination and for identification of the species. Figures 2 to 8, inclusive, are typical specimens.

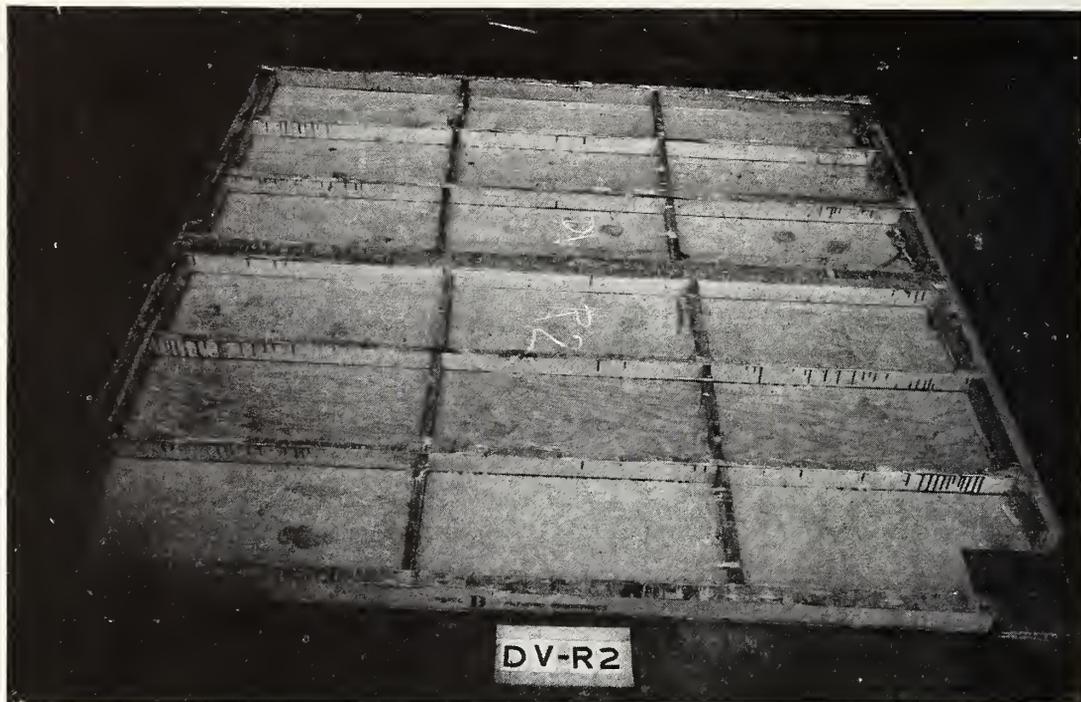
FIGURE 3.—Wall DV.
Typical 8-foot specimen.

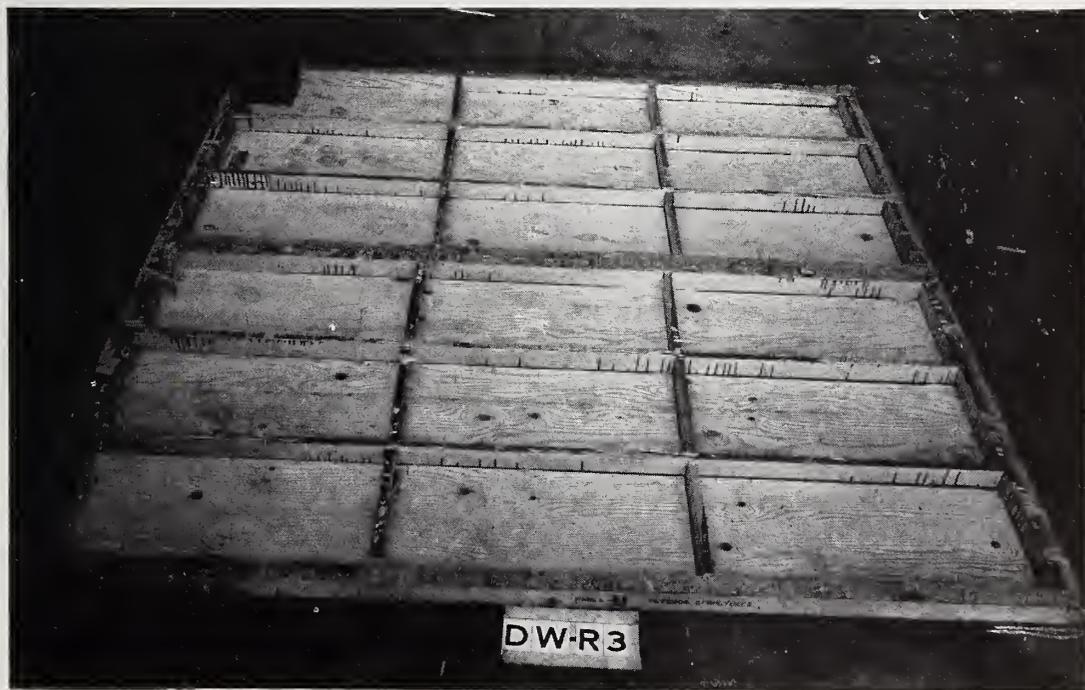
FIGURE 5.—Partition DW.
 Typical 8-foot specimen.

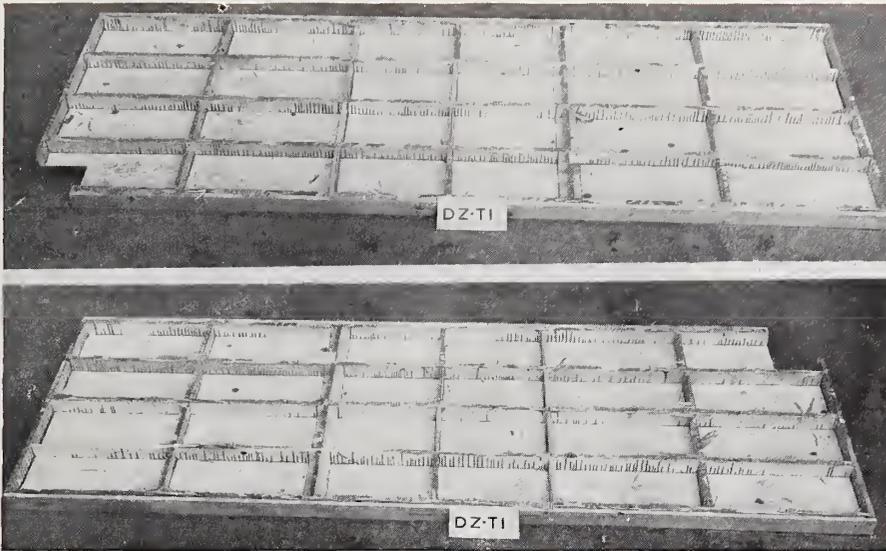
FIGURE 8.—Roof DZ.
Typical specimen.

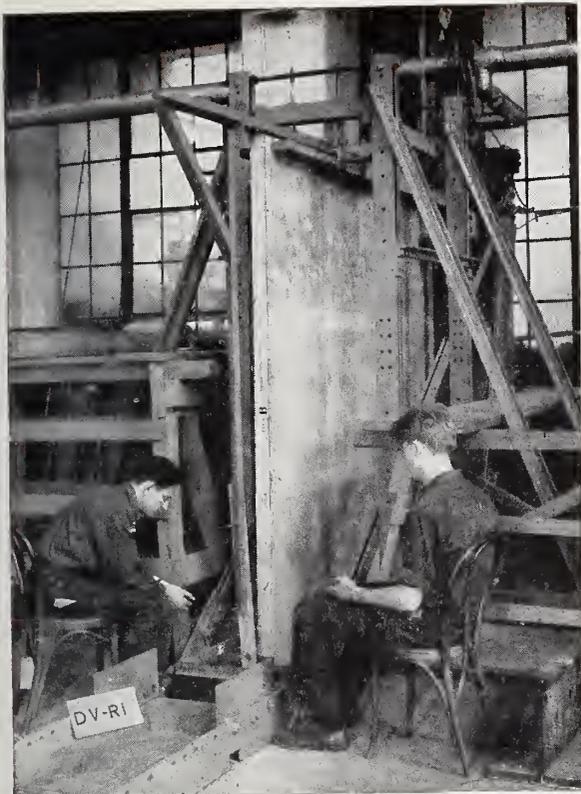
FIGURE 22.—Wall specimen *DV-R1* under racking load.

Wall specimen *DV-R1* under racking load is shown in figure 22. The results of the racking-load test for specimen *DV-R1, R2,* and *R3* are given in table 4 and figure 23.

The racking loads were applied to the top plate, and the stop was in contact with the bottom plate at the diagonally opposite corner of the specimen. Under a load of 1.50 kips/ft, the two 4- by 8-ft plywood sheets on each side of the specimen *R1* exhibited relative vertical displacement. Crushing occurred at the front lower plate, and the top plate failed in compression under the maximum load. A noise, apparently glue failure, was heard at 0.8 kip/ft in specimen *R2*. At 2.2 kips/ft crushing occurred at the bottom plate and at 2.3 kips/ft the top plate sheared from the plywood.

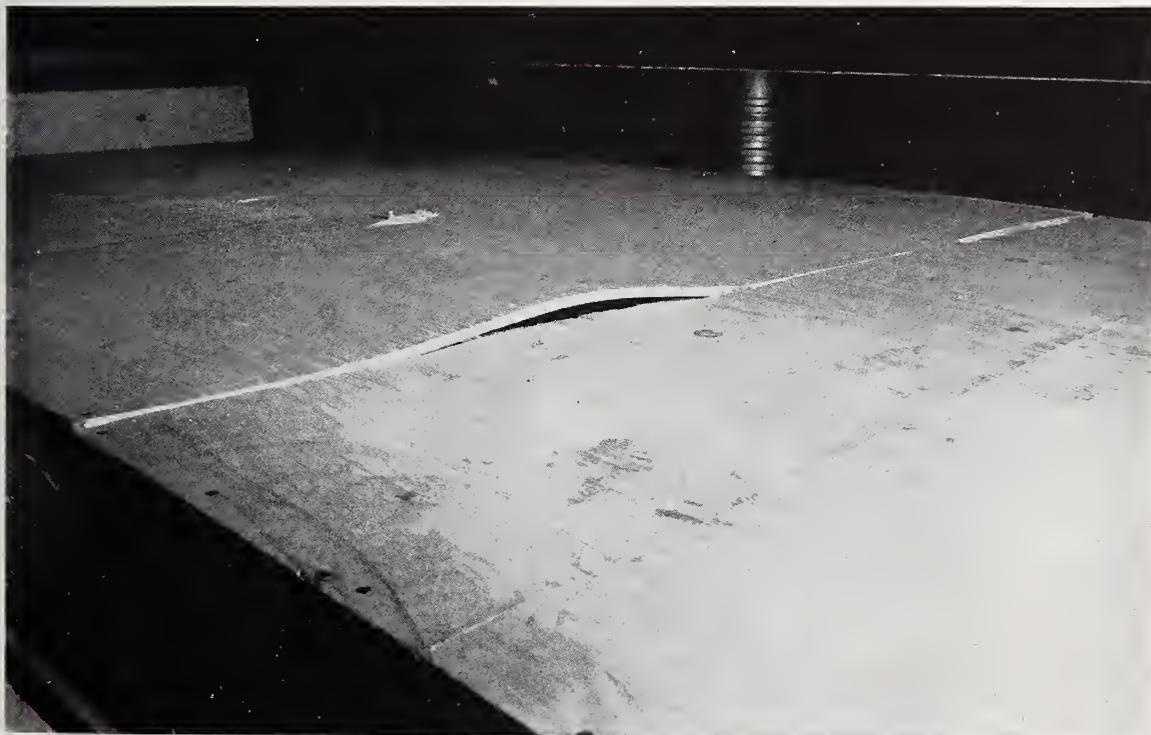
FIGURE 39.—Failure in butt joint of plywood ceiling of floor specimen *DY-T1*.

Under the maximum load, specimens *T1*, *T2*, and *T3* failed in tension at the transverse butt splice in the ceiling plywood as shown in figure 39. Examination after test disclosed a failure in one half spline, horizontal shear failure in four joists, and tensile failure in two joists of *T1*. Three joists failed by horizontal shear in *T2*. One half spline and one joist broke in tension, and three joists failed in horizontal shear in *T3*.

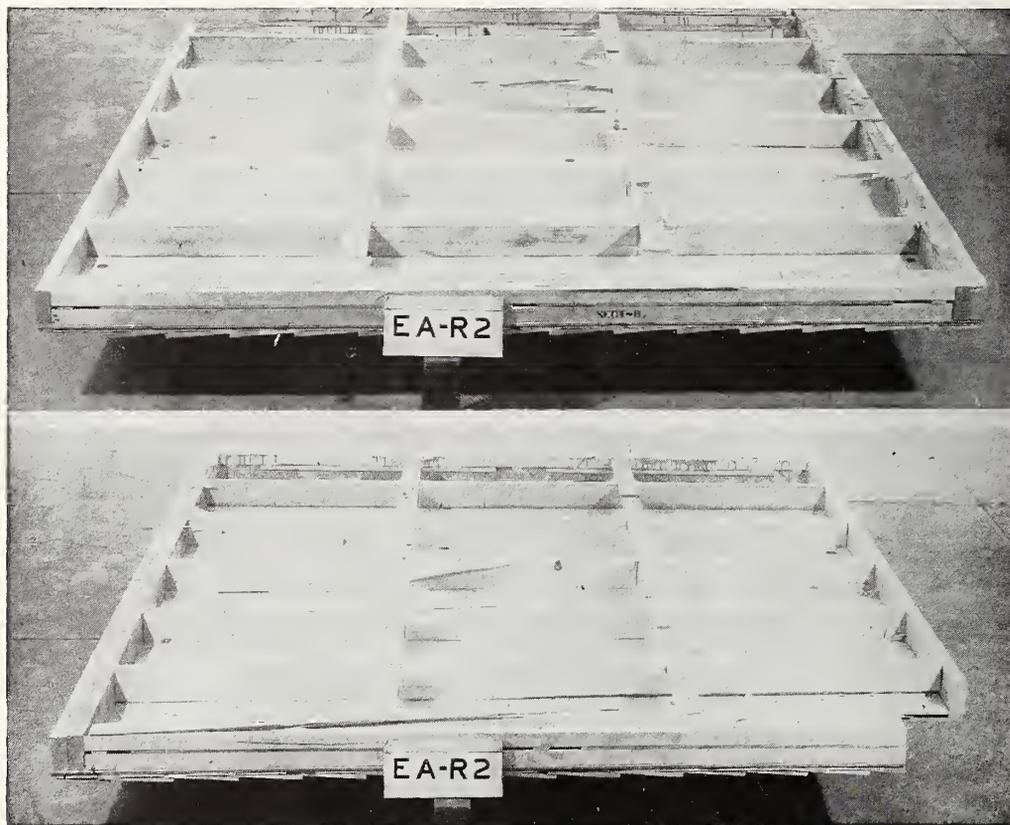
FIGURE 52.—Wall EA.
Typical 8-foot specimen.

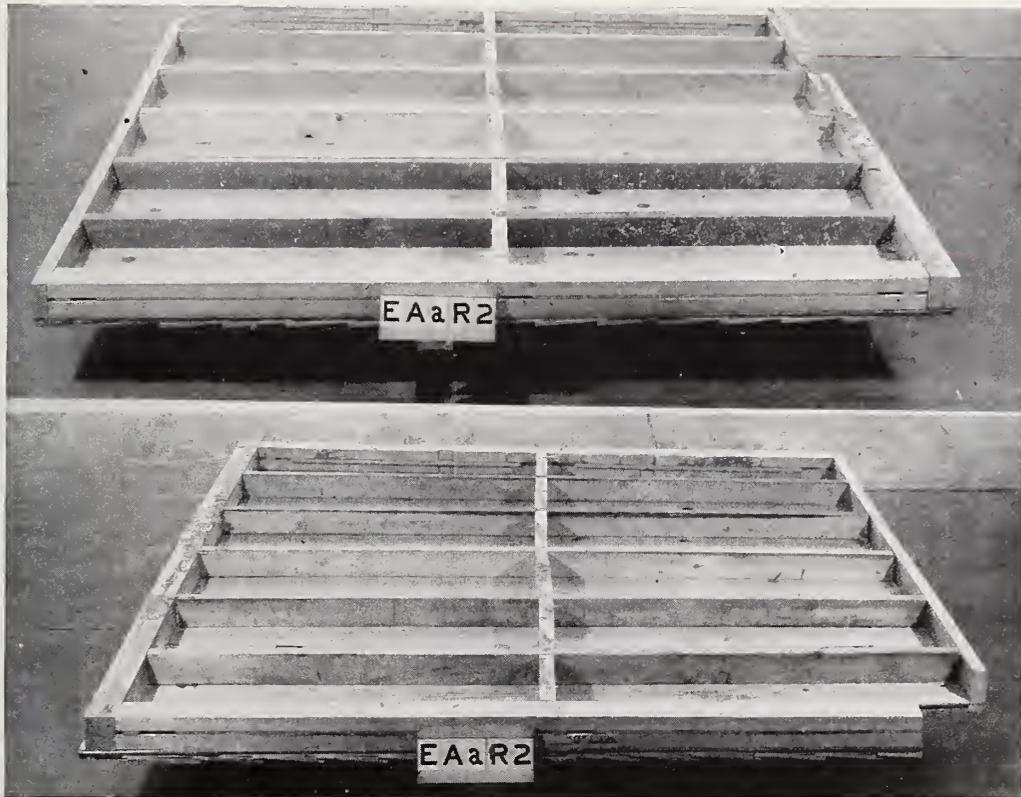
FIGURE 53.—Wall *EAa*.
Typical 8-foot specimen.

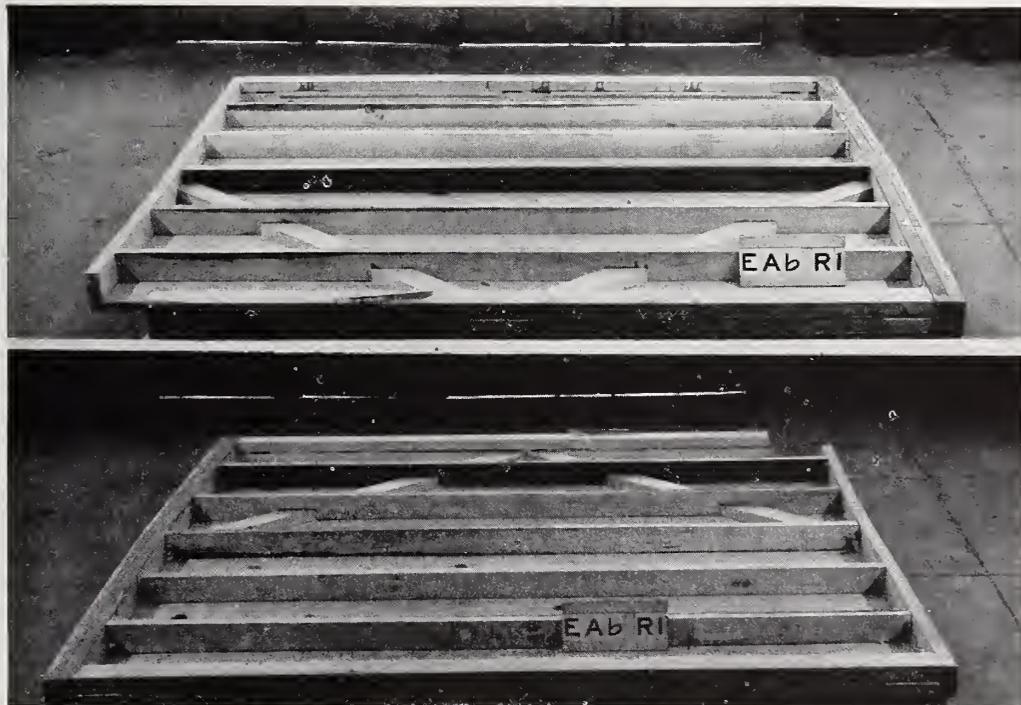
FIGURE 54.—Wall *EAb*.
Typical 8-foot specimen.
