Fire Resistance of Structural Clay Tile Partitions

Building Materials and Structures Report BMS113

United States Department of Commerce
National Bureau of Standards

by Harry D. Foster, Earl R. Pinkston,
and S. H. Ingberg

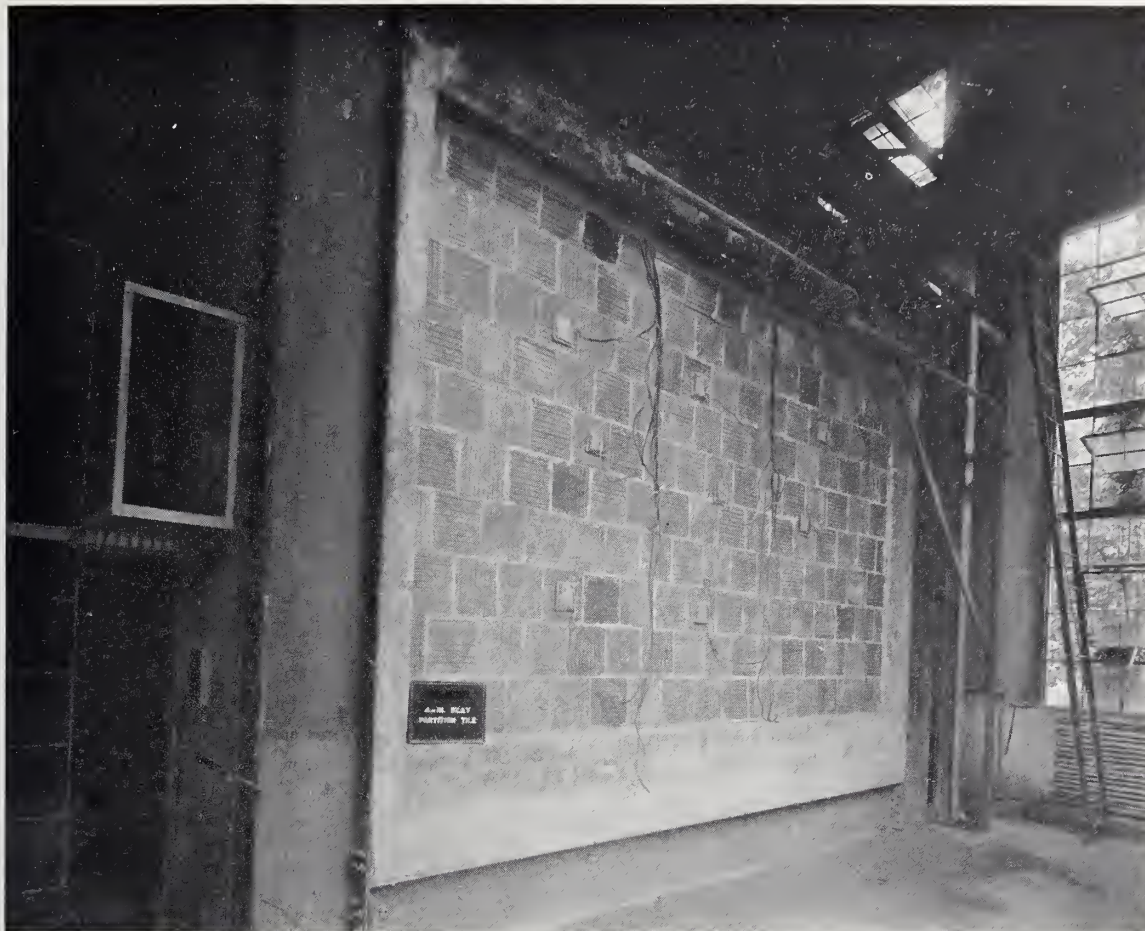
FIGURE 3. Partition 4 in furnace after a fire exposure of $12\frac{1}{2}$ min, on the opposite side.
The restraining frame, observation windows, and asbestos pads for protecting thermocouples are shown.

The temperature of the unexposed surface of the partitions were measured with Chromel-Alumel thermocouples insulated with asbestos sleeving and with the hot junctions under flexible, oven-dry, felted-asbestos pads 6 in. square and 0.4 in. thick held firmly against the partition. Extra thermocouples and a supply of dry cotton waste were on hand for use over cracks or other places on the surface of the partitions where high temperatures developed. The arrangement of the thermocouples on the surface of a partition is shown in figure 3.

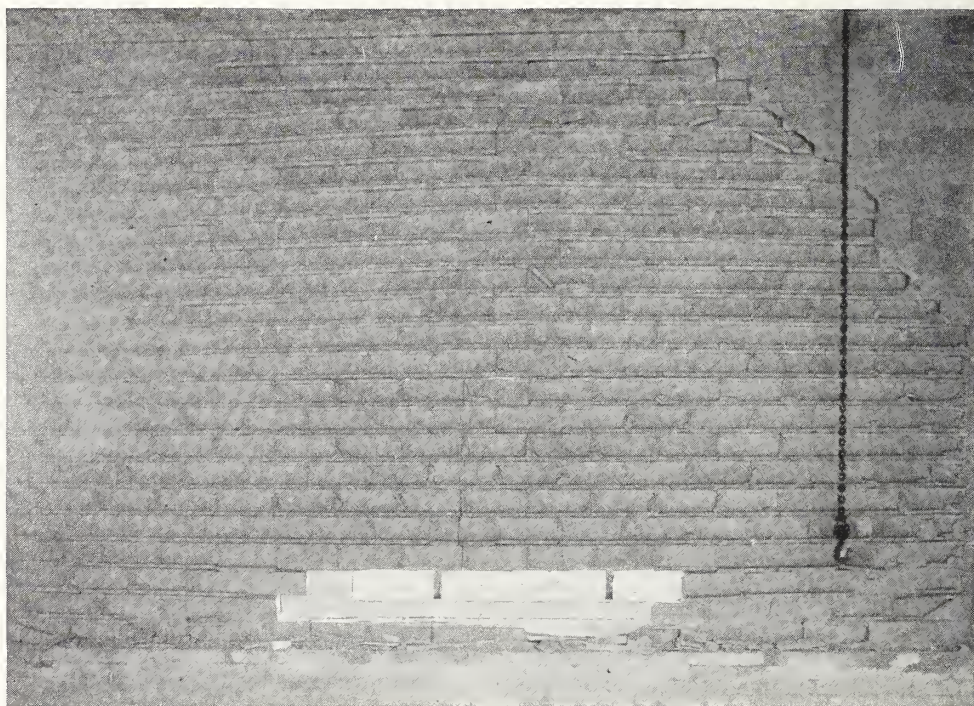
FIGURE 5. Exposed side of partition 9 showing the hole that limited the fire resistance of the partition.

Test 9.—Four-inch partition plastered on the unexposed side, one cell in thickness, Ohio fire clay unglazed double-shell face tile, and side construction. At 2½ min, popping noises were heard and a thin horizontal crack formed across the full width of the partition at midheight. At 3½ min, the popping sounds increased in frequency and intensity. At 6 min, the cracking sounds diminished and the horizontal crack noted at 2½ min was closed. At 8 min, diagonal cracks appeared across the lower corners. At 14½ min, rapidly recurring sounds indicated that the cross webs in many of the tiles were fractured. At 16¾ min, exposed shells fell from the lower courses. At 19¼ min and at 22¼ min, additional exposed shells fell. At 24 to 25 min, horizontal cracks appeared on the unexposed surface 10 and 18 in. from the top, near the center. At 31½ min, a hole formed in the lower part of the partition, figure 5. At 32 min, the gas was turned off.

The fire resistance was limited by the formation of a hole in the lower part of the partition at 31½ min. Deflection and temperature curves, figures 11 and 15.

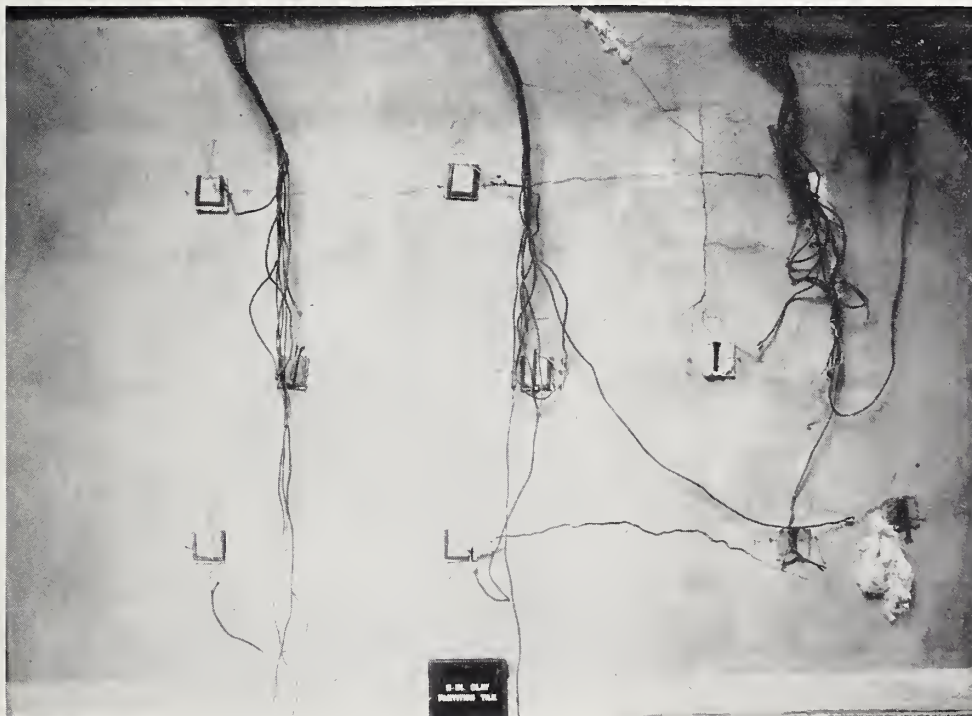
FIGURE 9. *Unexposed side of partition 19 showing cotton waste which ignited at 1 hr 50 min.*

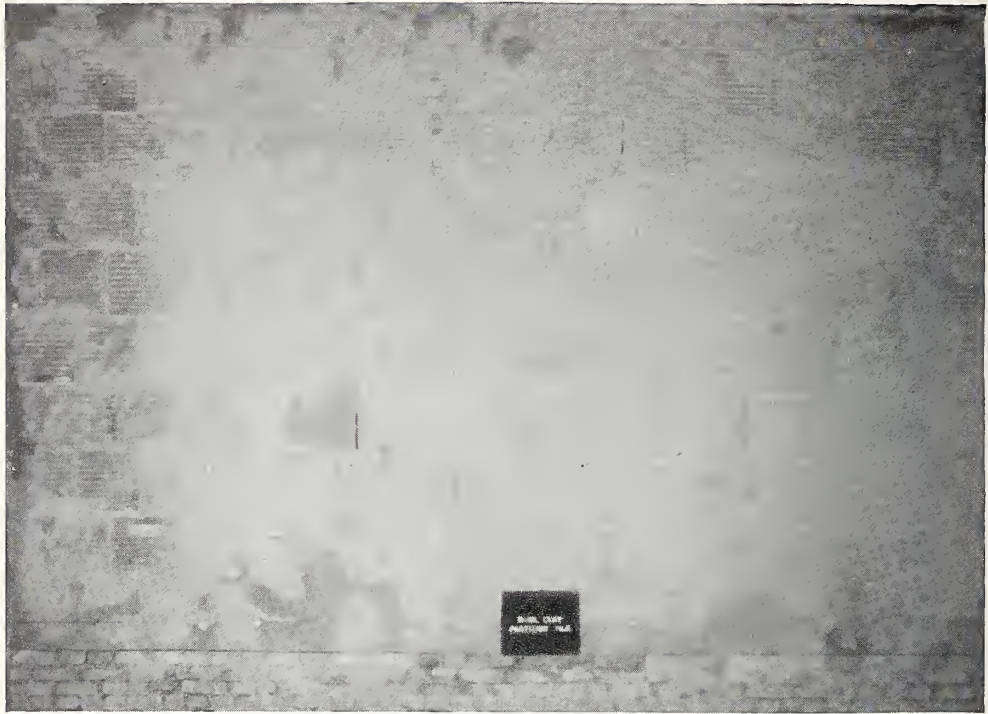
FIGURE 10. Exposed side of partition 20 showing that the plaster was washed off by the hose-stream.
