REPORT BMS30

Structural Properties of a
Wood-Frame Wall Construction
Sponsored by the
Douglas Fir Plywood Association

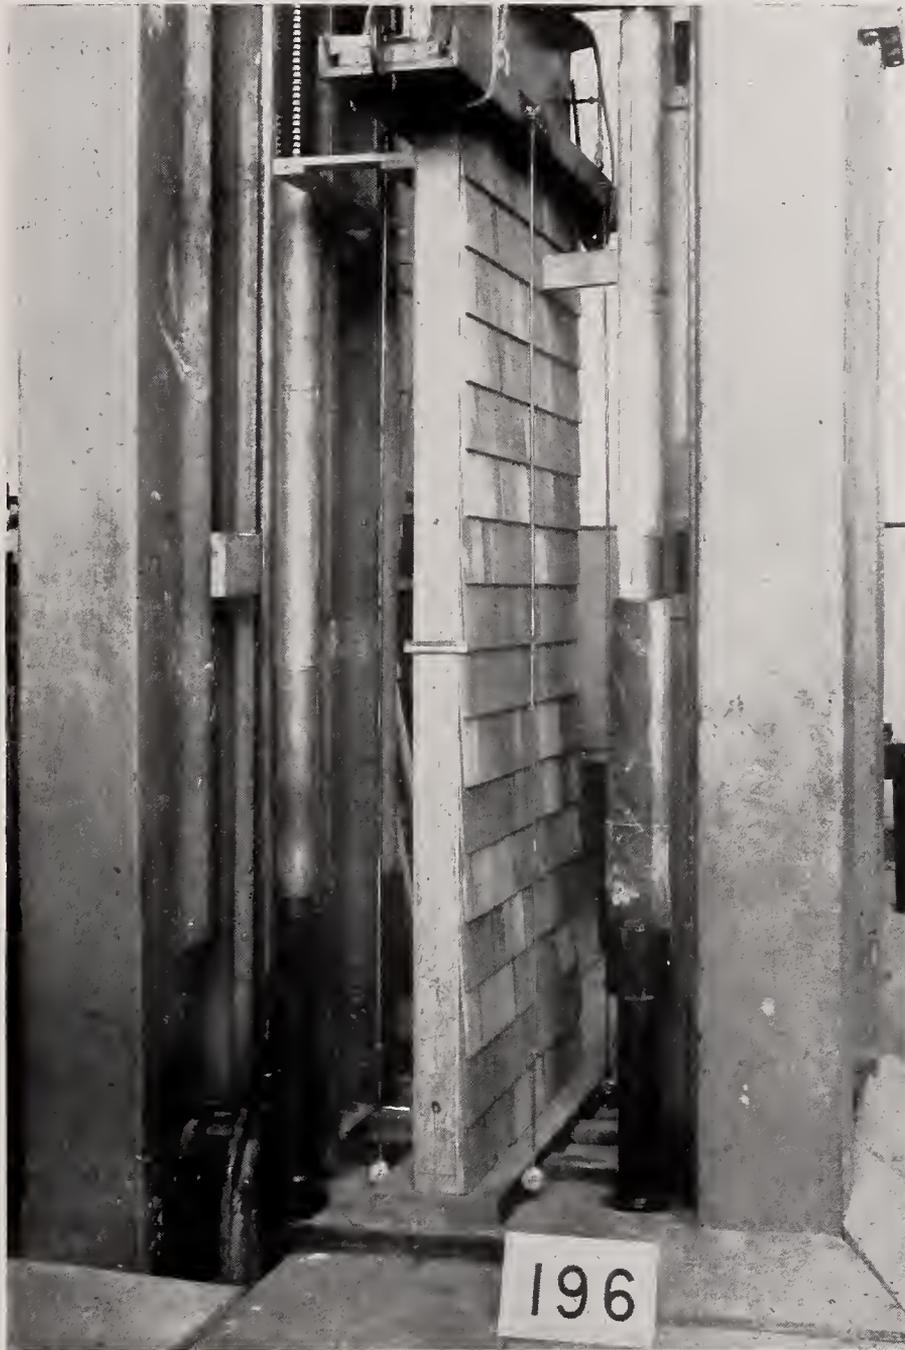
FIGURE 4.—Wall specimen *BU-C1* under compressive load.

Wall specimen *BU-C1* under compressive load is shown in fig. 4. The results for wall specimens *BU-C1*, *C2*, and *C3* are shown in table 4 and in figs. 5 and 6.
