REPORT BMS42

Structural Properties
of Wood-Frame Wall and
Partition Constructions With
"Celotex" Insulating Boards

Sponsored by
The Celotex Corporation

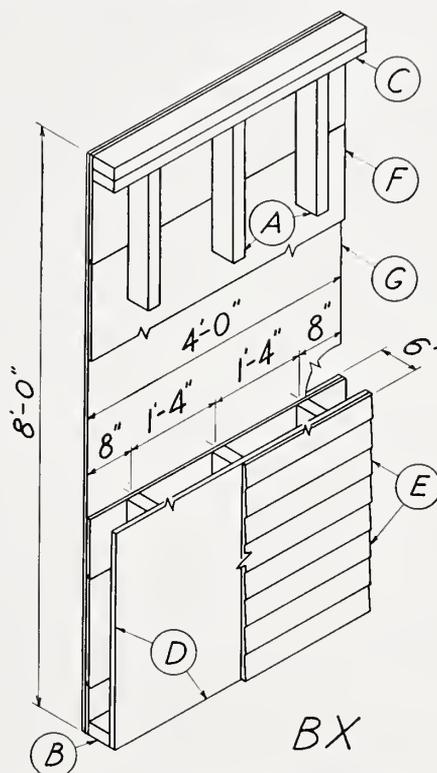
FIGURE 4.—Four-foot wall specimen BX.

A, stud; B, floor plate; C, top plate; D, insulating-board sheathing; E, bevel siding; F, insulating-board lath; and G, plaster.

The 4-ft. wall specimens, shown in figure 4, were 8 ft. 0 in. high, 4 ft. 0 in. wide, and 6 in.

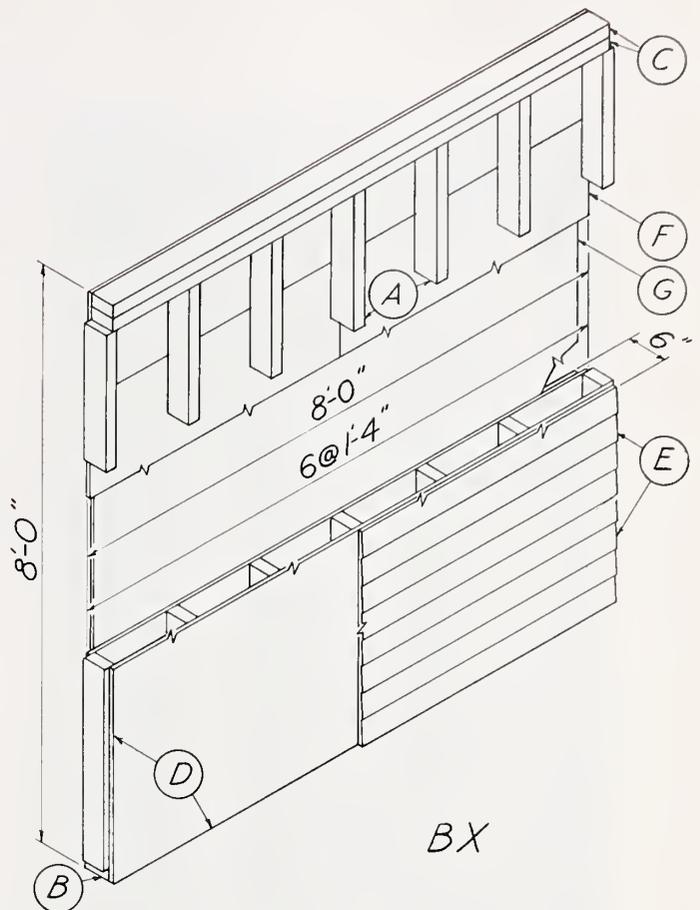
FIGURE 7.—*Eight-foot wall specimen BX.*

A, stud; B, floor plate; C, top plate; D, insulating-board sheathing; E, bevel siding; F, insulating board lath; and G, plaster.

The 8-ft. wall specimens, shown in figure 7, were 8 ft. 0 in. high, 8 ft. 0 in. face width, and 6 in. thick. The specimens were similar to the 4-ft. specimens, except that there were seven studs, spaced 1 ft. 4 in. on centers. A stud at each edge extended one-half its thickness beyond the faces. The over-all width was 8 ft. 1½ in.

The 8-ft wall specimens were 8 ft 0 in. high, 8 ft 0 in. face width, and 5½ in. thick, and were similar to the 8-ft specimens of wall *BX*, shown in figure 7, except that the inside face was building board, not lath and plaster.

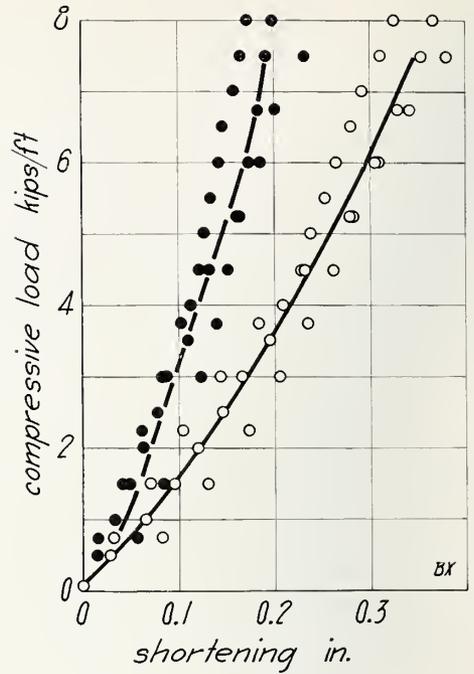
FIGURE 9.—Compressive load on wall BX. Load-shortening (open circles) and load-set (solid circles) results for specimens BX-C1, C2, and C3. Load was applied 1.21 in. (one-third the thickness of the frame) from the inside surface of the studs. The loads are in kips per foot of actual width of specimen.

Wall specimen *BX-C1* under compressive load is shown in figure 8. The results for wall specimens *BX-C1*, *C2*, and *C3* are shown in table 8 and in figures 9 and 10.

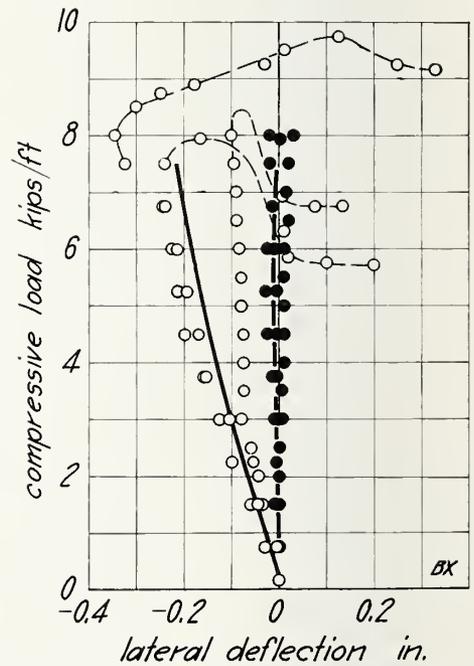
FIGURE 10.—Compressive load on wall BX. Load-lateral deflection (open circles) and load-lateral set (solid circles) results for specimens BX-C1, C2, and C3. Load applied 1.21 in. (one-third the thickness of the frame) from the inside surface of the studs. The loads are in kips per foot of actual width of specimen. The deflections are for a gage length of 7 ft 10 in., the gage length of the deflectometers.

The lateral deflections shown in figure 10 were plotted to the right of the vertical axis for deflections of the specimen at midheight toward the outside face (positive deflection) and to the left for deflections toward the inside (plastered) face (negative deflection).

Although the load was eccentric toward the inside face, each of the specimens deflected initially toward the inside face, probably because the stiffness of the plaster counteracted the effect of the eccentric load. The deflections of the specimens were similar to the deflections under similar eccentric loads of other wood-frame constructions, as described in report BMS25, Structural Properties of Conventional Wood-Frame Constructions for Walls, Partitions, Floors, and Roofs, and report BMS31, Structural Properties of "Insulite"

was toward the outside face. The dotted lines in figure 10 show the relation between lateral deflection and load for each of the specimens after the maximum load. The change in the direction of the deflection curve probably indicates progressive local failure of the plaster.

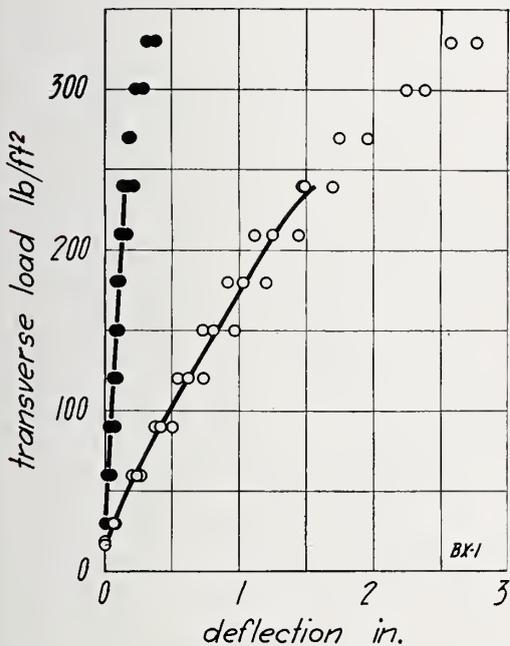
FIGURE 11.—Transverse load on wall *BX*, load applied to inside face.
Load-deflection (open circles) and load-set (solid circles) results for specimens *BX-T1*, *T2*, and *T3* on the span 7 ft 6 in.

The results of the transverse-load test are shown in table 8 and in figure 11 for wall specimens *BX-T1*, *T2*, and *T3*, loaded on the inside (plastered) face, and in figure 12 for wall specimens *BX-T4*, *T5*, and *T6*, loaded on the outside face.

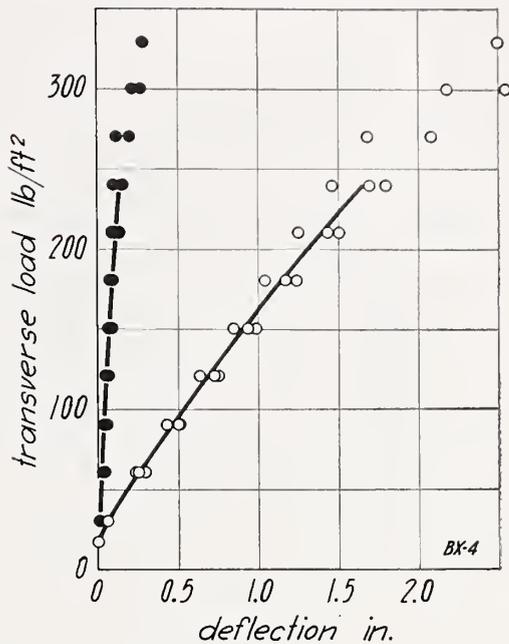
FIGURE 12.—Transverse load on wall *BX*, load applied to outside face.

Load-deflection (open circles) and load-set (solid circles) results for specimens *BX-T4*, *T5*, and *T6* on the span 7 ft 6 in.

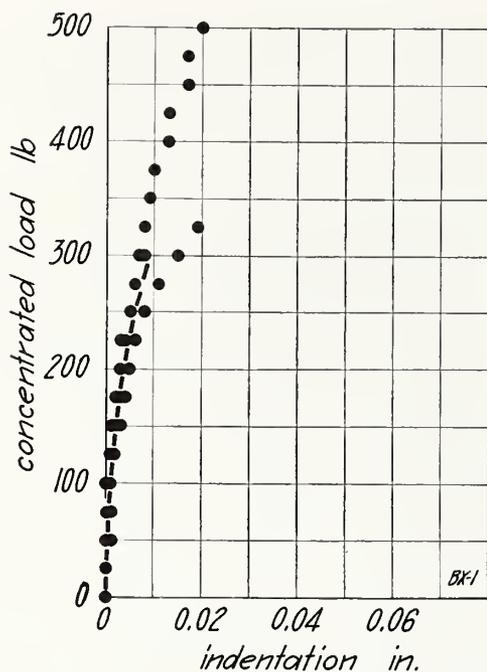
FIGURE 13.—Concentrated load on wall BX, load applied to inside face.

Load-indentation results for specimens BX-P1, P2, and P3.

The results of the concentrated-load test are shown in table 8 and in figure 13 for wall specimens BX-P1, P2, and P3, loaded on the inside

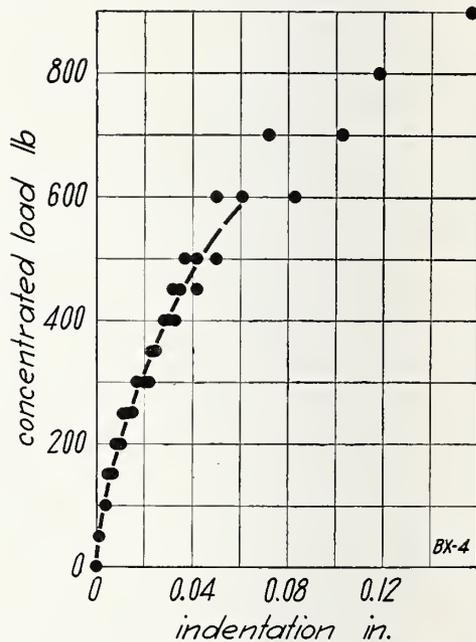
FIGURE 14.—Concentrated load on wall BX, load applied to outside face.

Load-indentation results for specimens BX-P4, P5, and P6.

(plastered) face, and in figure 14 for wall specimens BX-P4, P5, and P6, loaded on the outside face.

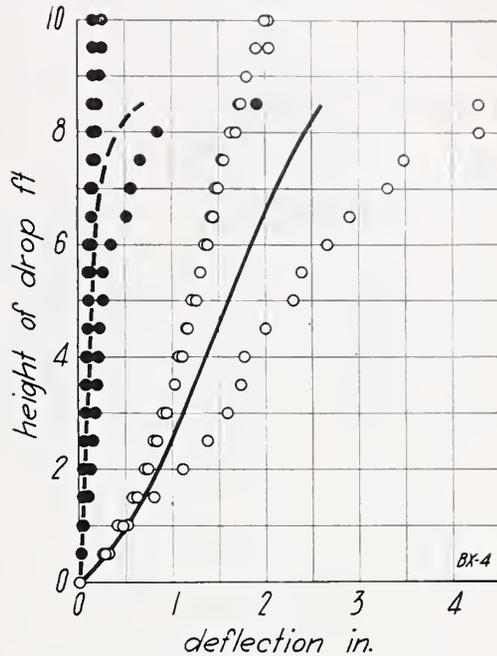
FIGURE 16.—Impact load on wall BX, load applied to outside face.

Height of drop-deflection (open circles) and height of drop-set (solid circles) results for specimens *BX-14*, *I5*, and *I6* on the span 7 ft 6 in.

inside (plastered) face, and in figure 16 for wall specimens *BX-14*, *I5*, and *I6*, loaded on the outside face.

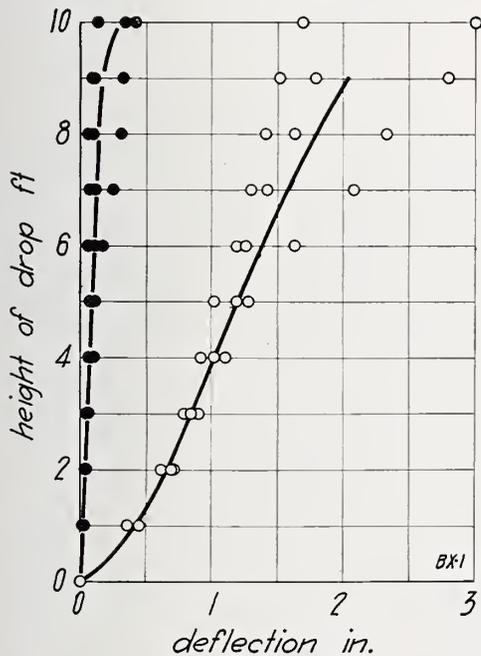
FIGURE 15.—Impact load on wall BX, load applied to inside face.

Height of drop-deflection (open circles) and height of drop-set (solid circles) results for specimens *BX-11*, *I2*, and *I3* on the span 7 ft 6 in.

The results of the impact test are shown in tables 8, 9, and 10 and in figure 15 for wall specimens *BX-11*, *I2*, and *I3*, loaded on the

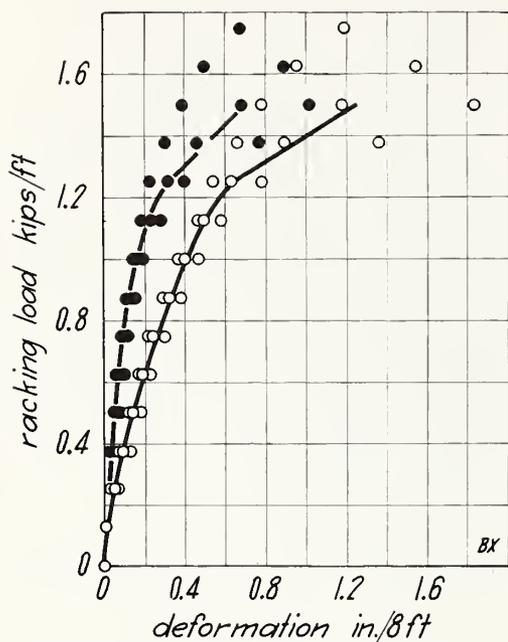
FIGURE 17.—Racking load on wall *BX*.

Load-deformation (open circles) and load-set (solid circles) results for specimens *BX-R1*, *R2*, and *R3*. The loads are in kips per foot of the face width of specimen.

The racking-load test results for wall specimens *BX-R1*, *R2*, and *R3* are shown in table 8 and in figure 17.

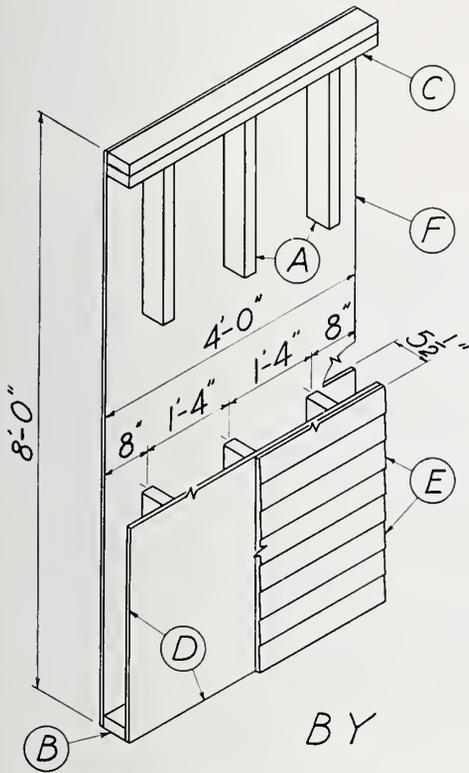
FIGURE 18.—Four-foot wall specimen *BY*

A, stud; *B*, floor plate; *C*, top plate; *D*, insulating-board sheathing; *E*, wood bevel siding; *F*, building board.

The 4 ft wall specimens, shown in figure 18, were 8 ft 0 in. high, 4 ft 0 in. wide, and 5½ in. thick, each a wood frame to which the faces were fastened. The frame consisted of three studs, *A*, fastened to a floor plate, *B*, and to a top plate, *C*, by nails. The outside face was insulating-board sheathing, *D*, and wood bevel siding, *E*. The inside face was building board, *F*. The specimens were not painted.

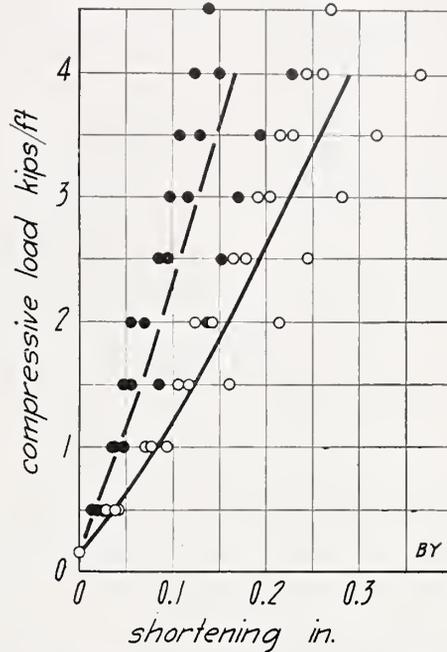
FIGURE 19.—Compressive load on wall *BY*.

Load-shortening (open circles) and load-set (solid circles) results for specimens *BY-C1*, *C2*, and *C3*. Load applied 1.21 in. (one-third the thickness of the frame) from the inside surface of the studs. The loads are in kips per foot of actual width of specimen.

The results for wall specimens BY-C1, C2, and C3 under compressive load are shown in table 8 and in figures 19 and 20.

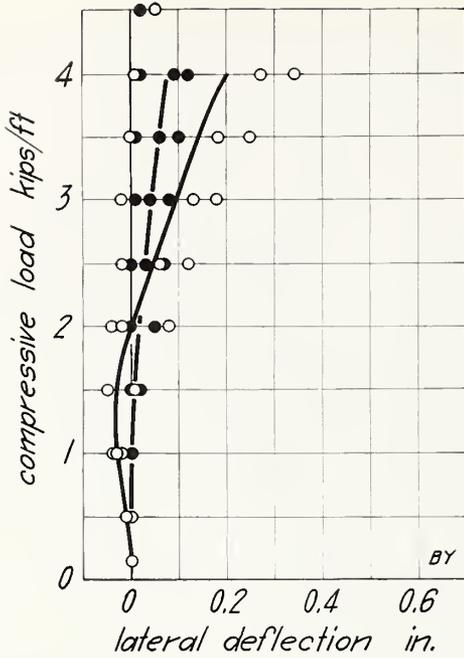
FIGURE 20.—Compressive load on wall BY.

Load-lateral deflection (open circles) and load-lateral set (solid circles) results for specimens BY-C1, C2, and C3. Load applied 1.21 in. (one-third the thickness of the frame) from the inside surface of the studs. The loads are in kips per foot of actual width of specimen. The lateral deflections are for a gage length of 7 ft 10 in., the gage length of the deflectometers.

In figure 20 the lateral deflections were plotted to the right of the vertical axis for deflections of the specimens at midheight toward the outside face (positive deflection) and to the left for deflections toward the inside face (negative deflection). The deflection of the specimens toward the inside (building board) face under loads less than 3.5 kips/ft is similar to the deflections under eccentric compressive loads found for other wood-frame constructions, as described in reports BMS25 and BMS31.

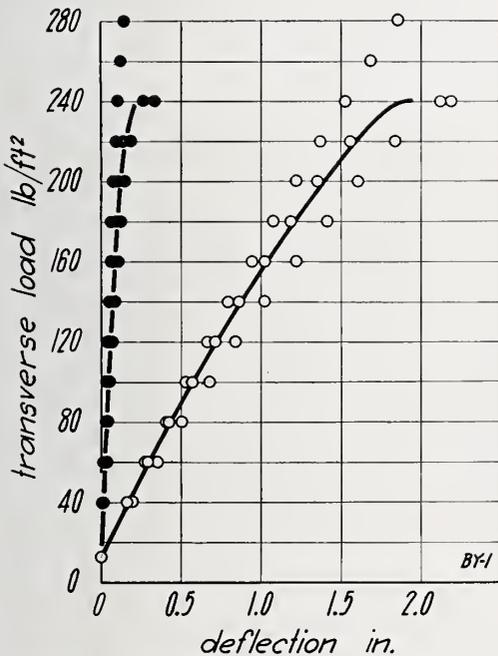
FIGURE 22.—Transverse load on wall *BY*, loaded on the inside face.

Load-deflection (open circles) and load-set (solid circles) results for specimens *BY-T1*, *T2*, and *T3* on the span 7 ft 6 in.

Wall specimen *BY-T1* under transverse load is shown in figure 21. The results are given in table 8 and in figure 22 for wall specimens *BY-T1*, *T2*, and *T3*, loaded on the inside face, and in figure 23 for wall specimens *BY-T4*, *T5*, and *T6*, loaded on the outside face.

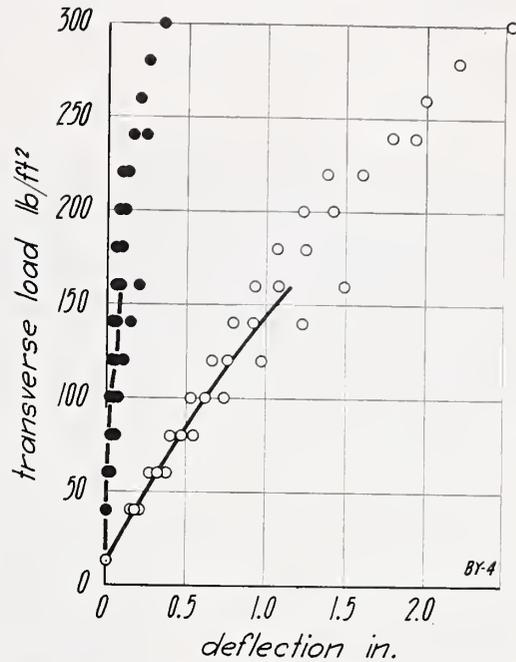
FIGURE 23.—Transverse load on wall *BY*, loaded on the outside face.

Load-deflection (open circles) and load-set (solid circles) results for specimens *BY-T4*, *T5*, and *T6* on the span 7 ft 6 in.

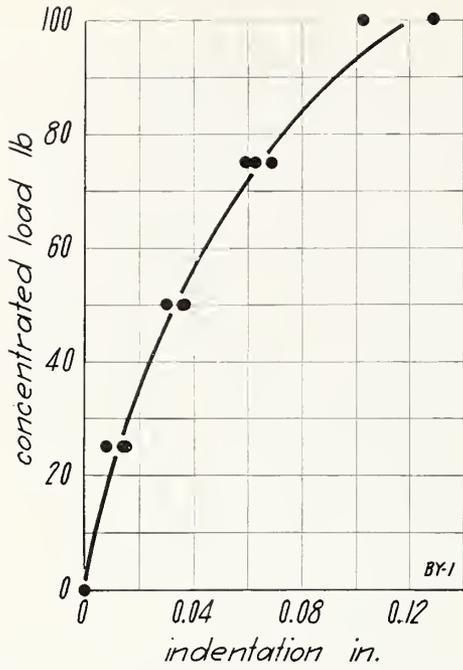
FIGURE 24.—Concentrated load on wall BY, load applied to inside face.

Load-indentation results for specimens BY-P1, P2, and P3.

Results of the concentrated-load test are shown in table 8 and in figure 24 for wall speci-

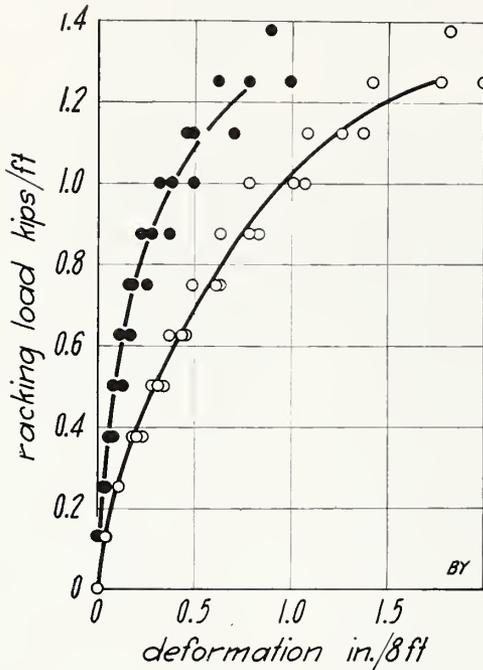
FIGURE 29.—Racking load on wall *BY*.

Load-deformation (open circles) and load-set (solid circles) results for specimens *BY-R1*, *R2*, and *R3*. The loads are in kips per foot of the face width of specimen.

specimens *BY-R1*, *R2*, and *R3* are given in table 8 and in figure 29.

The racking loads were applied only to the top plate and the stop was in contact only with the floor plate. At loads of 1.125, 1.125, and 0.875 kips/ft on specimens *R1*, *R2*, and *R3*, respectively, there was noticeable vertical displacement of the building board at the

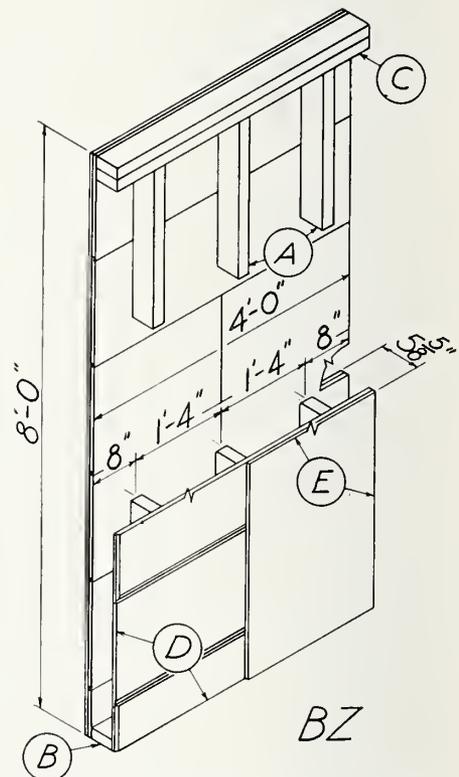
FIGURE 30.—Partition specimen *BZ*.

A, studs; *B*, floor plate; *C*, top plate; *D*, insulating-board lath; *E*, plaster.

The partition specimens, shown in figure 30, were 8 ft 0 in. high, 4 ft 0 in. wide, and 5½ in. thick; and they consisted of a frame of three studs, *A*, fastened to a floor plate, *B*, and a top plate, *C*, by nails, with insulating-board lath, *D*, and plaster, *E*, as both faces. The specimens were not painted.

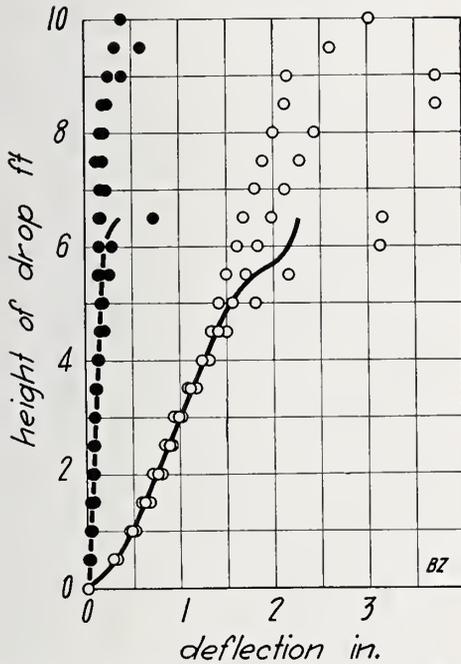
FIGURE 33.—Impact load on partition *BZ*.

Height of drop-deflection (open circles) and height of drop-set (solid circles) for specimens *BZ-11*, *12*, and *13* on the span 7 ft 6 in.

Partition specimen *BZ-I1* during the impact test is shown in figure 32. The results for specimens *BZ-I1*, *I2*, and *I3* under impact load are given in tables 12 and 13 and in figure 33.

After the 10-ft drop on specimens *I1* and *I3* the sets were 0.39 and 4.00 in., respectively. The lath on the face not loaded was separated from the studs at midspan.

After the 10-ft drop on specimen *12* the set was 0.77 in., and no further effects were observed.

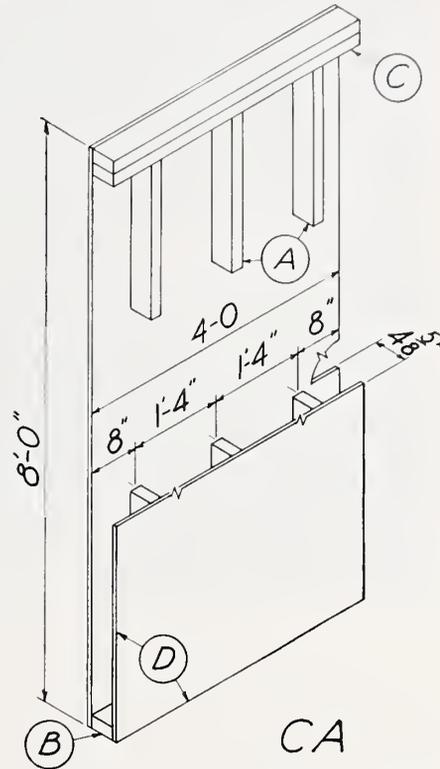
FIGURE 34.—Partition specimen *CA*.

A, stud; *B*, floor plate; *C*, top plate; *D*, building board.

The partition specimens in figure 34 were 8 ft 0 in. high, 4 ft 0 in. wide, and 4½ in. thick; and consisted of a frame of three studs, *A*, fastened to a floor plate, *B*, and a top plate, *C*, by nails, with building board, *D*, as both faces. The specimens were not painted.

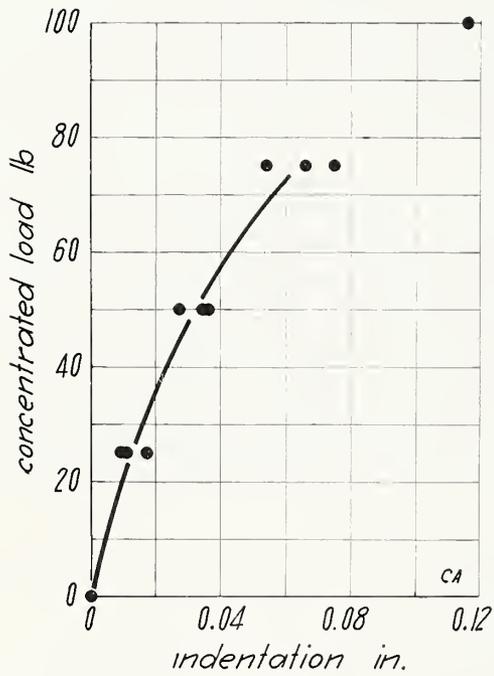
FIGURE 36.—Concentrated load on partition CA. Load-indentation results for specimens CA-P1, P2, and P3.

Partition specimen *CA-P3* under concentrated load is shown in figure 35. The results for specimens *CA-P1*, *P2*, and *P3* are given in table 12 and in figure 36.

The concentrated loads were applied on the building board midway between two studs, approximately 2 feet from one end. At the maximum load failure occurred by punching of the disk through the building board.

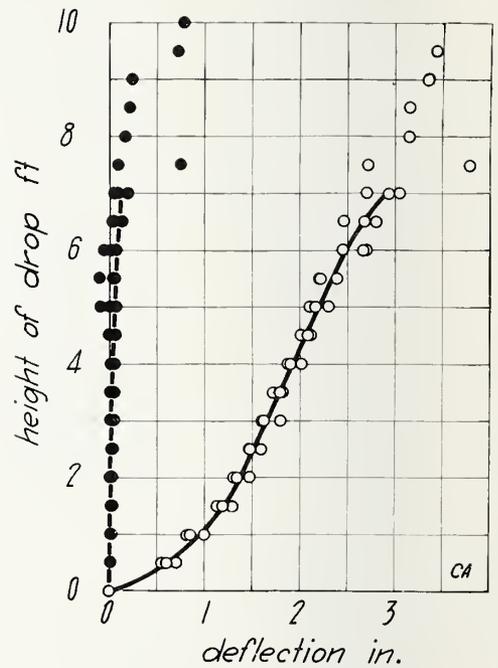
FIGURE 37.—Impact load on partition CA. Height of drop-deflection (open circles) and height of drop-set (solid circles) for specimens CA-I1, I2, and I3 on the span 7 ft 6 in.

The results for partition specimens *CA-11*, *12*, and *13* under impact load are shown in tables 12 and 14 and in figure 37.
