Exterior masonry walls of houses or other buildings may occasionally be penetrated by wind-driven rains, with subsequent damage to the interior finish of such structures. An extensive investigation in the water-permeability of small masonry wall specimens has resulted in the publication of reports on the permeability of masonry walls when first constructed, after being exposed outdoors, and after being subjected in the laboratory to alternate wetting and drying and in the dry condition to extremes of temperature. This is a report on the water permeability of walls built of masonry units.

$<sup>^{1}</sup>$  Building Materials and Structures Report BMS7, Water Permeability of Masonry Walls.

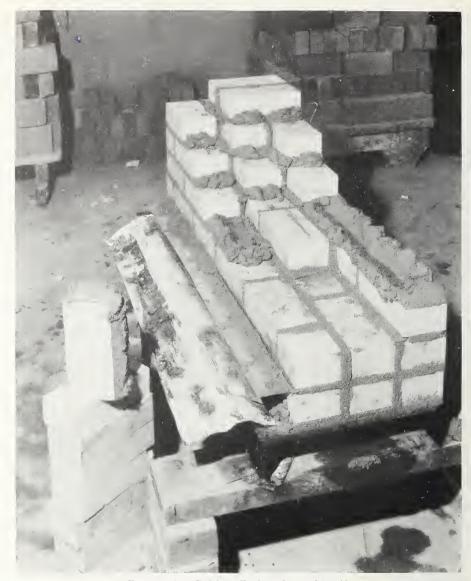
FIGURE 8.—Brick wall of workmanship A'.

The bed joints are furrowed and vertical joints are completely filled. Note the mortar on the stretcher brick, which is ready to be placed in one of the backing wythes after the bed joint is placed.

Type A'.—Illustrated in figure 8 is workmanship A'. This was used in 10 walls and was the same as type A, except that the bed joints, under the brick, were furrowed, not leveled. The joints in the wall face were tooled.

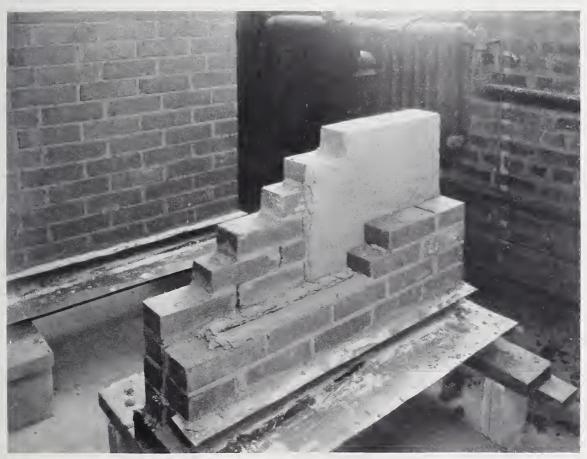
FIGURE 9.—Brick wall of workmanship F.

Except for the parging, this wall is typical of type B workmanship. Bed joints are furrowed and head joints are huttered at the wall faces. The parging is applied to the rear of the facing wythe before laying the backing wythe. This wall contains no header brick hut is honded by metal hrick ties (not shown).

Type F.—Workmanship F, illustrated in figure 9, was similar to that used in brick walls of workmanship B, except that the collar joints contained mortar pargings. The bed joints were furrowed, and the head joints were buttered at the wall faces. The stretcher courses in the facing were laid to the elevation of the header course or to that of the course containing brick ties. A mortar parging % to ½ in, thick was carefully applied to the back of the wythe and keyed into the open head joints. The units in the backing wythe were then brought to the elevation of the bonding course. If the wall contained three wythes, as in 12-im, all-brick walls, a mortar parging was similarly applied to

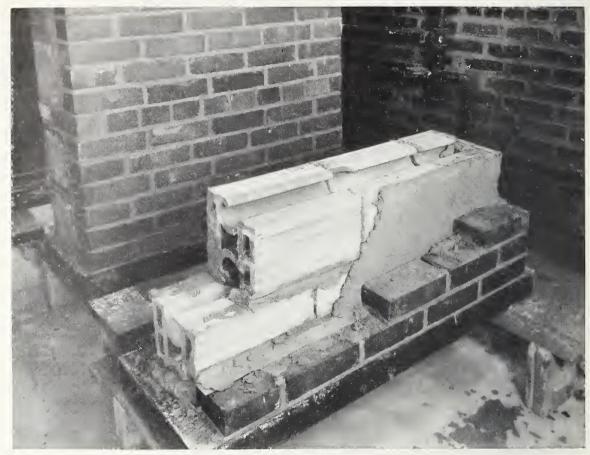
FIGURE 10.—Brick-faced wall of workmanship G and G'.

Parging applied to face of the backing. Head joints in both the hollow units and the brick are buttered only at the wall faces.

Type G.—Workmanship G was used in three brick-faced walls backed with hollow units and is illustrated in figure 10. It was similar to that of type F, except that the parging in the collar joint was applied to the backing. The hollow units were laid to the elevation of the brick header courses, using workmanship B. Bed joints were placed under the outer shells of the hollow units, and the head joints were buttered only at the back of the wall. A mortar parging % to 1/2 in. thick was then applied to the backing, and the brick facing was laid as in workmanship B to the top of the header course. A narrow open space was left between the back of the bricks and the face of the parging. The head joints in header courses were buttered, not completely filled. The joints in the wall face were tooled.

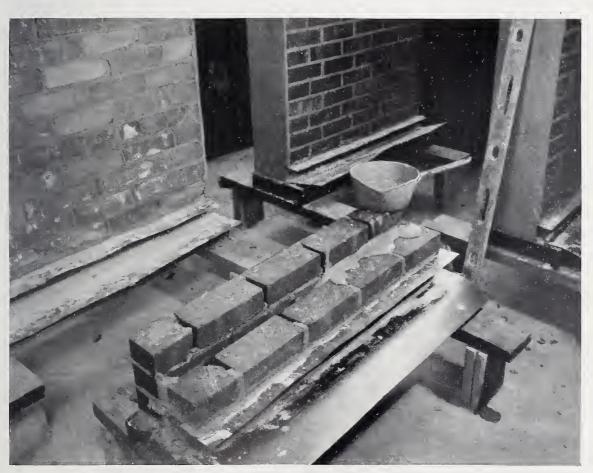
Figure 11.—Brick wall of workmanship H, grouted.

Wall B52–BB9H2 under construction. Note the mortar plugs at the ends of the collar joints and the buttered head joints. All the vertical joints were filled with grout as the backing was laid, one course at a time.

Type H.—The letter H designates a work-manship used in building eight grouted brick walls. The method usually followed, and illustrated in figure 11, was to lay the brick as in type B workmanship, plugging the ends of the collar joints with mortar, after which a grout was poured as the brick were laid, one course at a time. The brick in the facing were sometimes laid several courses above the backing or to the height of the bonding course. When furrows in the bed joints were made close to

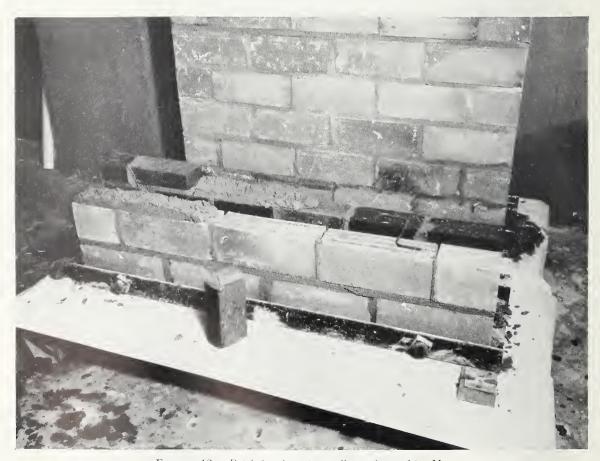
Figure 12.—Brick-faced cavity wall, workmanship M.

Note the brick ties and the cut joints inside the cavity. The head joints in the tile are buttered on back face only. This wall was constructed for structural tests but is typical, except for lower flashing, of cavity walls built for water-permeability tests.

placed to divert possible leakage to the backs of the walls, as is shown in figure 1, and not to divert leakage to the exposed faces, as is usually recommended in specifications for eavity walls. Joints of the brick facings were tooled. A typical cavity-wall construction (similar to that described in BMS24) is shown in figure 12.

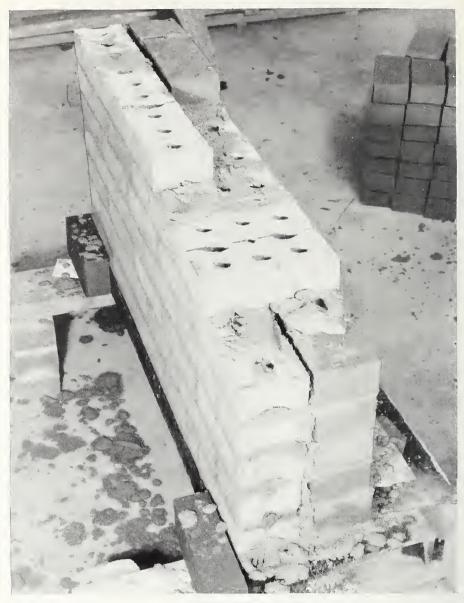
Figure 13.—Brick wall of workmanship N.

Sponsored construction wall B302 under construction. Note the recessed ends of the stretcher bricks and the sides of the header bricks, which are filled with mortar after the bricks are laid in the wall, without buttering the head joints; the collar joint was left open. The joints in the facing were subsequently tooled.

Workmanship N, illustrated in figure 13, was used in constructing three walls of "Tight-Wall" brick (bricks  $R_1$ ,  $R_2$ , and  $R_3$ ) laid in common American bond, with mortar 2. The bricks were recessed at the ends of stretcher units and at the sides of headers. The bed joints were furrowed, and the stretchers in the facing wythe were laid end to end on the bed joint without applying mortar to the ends of the units. Stretcher bricks  $R_1$  and  $R_3$  were about 3/8 in. longer at one face than at the other; and the long faces were laid in contact with each other at the back of the facing wythe, so that a %-in. open joint was left at the head joints in the wall face. Stretcher brick  $R_2$  were of equal lengths front and back and these brick were laid end to end, about % in. apart. The maximum width of aperture between stretcher units, measured parallel to the face of the walls, was about 1% in. for brick  $R_1$  (wall B300) and about 1% in, for bricks  $R_2$  and  $R_3$  (walls B301 and B302, respectively). Mortar was slushed into the openings between the ends of the bricks, filling the space between the units. Header bricks were laid similarly, and both the front and rear cavities between the header bricks were filled with mortar.

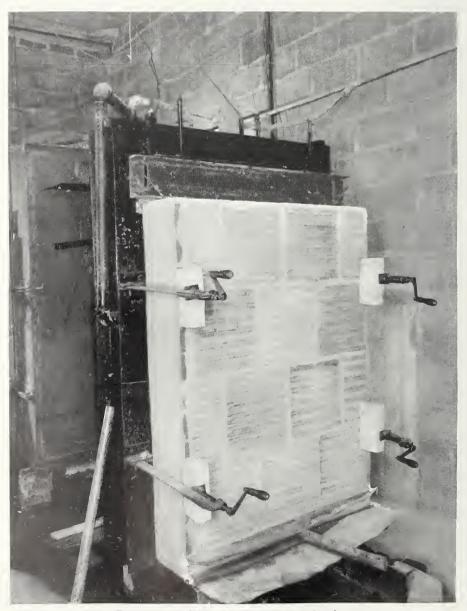
$\label{eq:Figure 15.} Figure \ 15. -Water-permeability \ test \ chamber.$  Wall similar to B127-j8A2 in position for test. Back of wall not whitewashed (preliminary test).

The apparatus is shown in figures 14 and 15. The walls were supported on metal skids during the permeability tests, and they were clamped into position against the sponge-rubber gaskets of the testing apparatus so that the exposed face formed one side of a pressure chamber. An air pressure was maintained within the chamber, and water from a perforated tube was applied to the upper portion of the exposed face (inside the chamber) at the rate of 40 gal (152) liters) per hour. Since the exposed length of the wall was 35 in., the amount of water applied per linear foot of wall per hour was 13.7 gal (52 liters), an amount sufficient to cover the wall face with a thin sheet of running water. The applied air pressure was equal to that produced by a head of 2 in. of water, about the maximum difference in pressure on two faces of a wall which may be caused by a wind having a velocity of 50 mph.
