BUILDING  
MATERIALS  
AND  
STRUCTURES

REPORT BMS95

Tests of Cement-Water Paints  
and Other Waterproofings for  
Unit-Masonry Walls

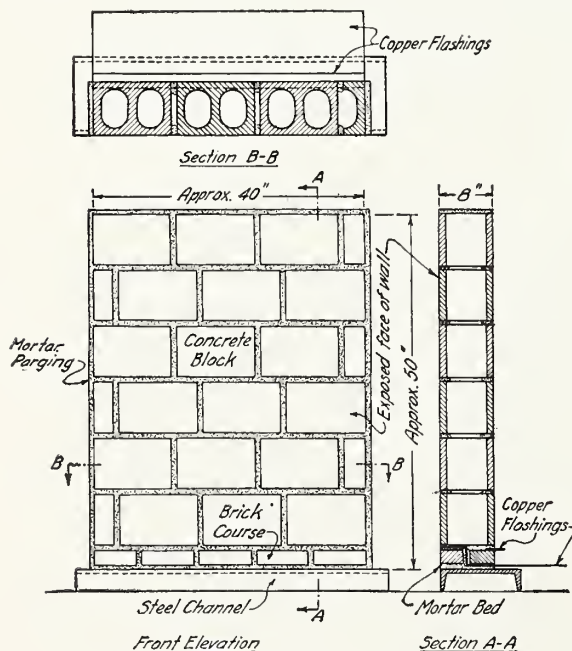
FIGURE 1.—Typical concrete-block wall.

the bottom. A typical concrete-block wall is shown in figure 1, and a typical brick masonry wall is shown in figure 1 of BMS82. Of the 131 specimens tested, 44 were built of block *m*, 39 of block *n*, and 32 of brick *c*. Experienced masons were employed for the construction of the walls, and all but one specimen was built at the Bureau.

Waterproofings applied to the backs (unexposed faces) of the walls covered the edges of the end and top parings, but they were not applied to those portions of the walls between the upper and lower flashings (fig. 1).

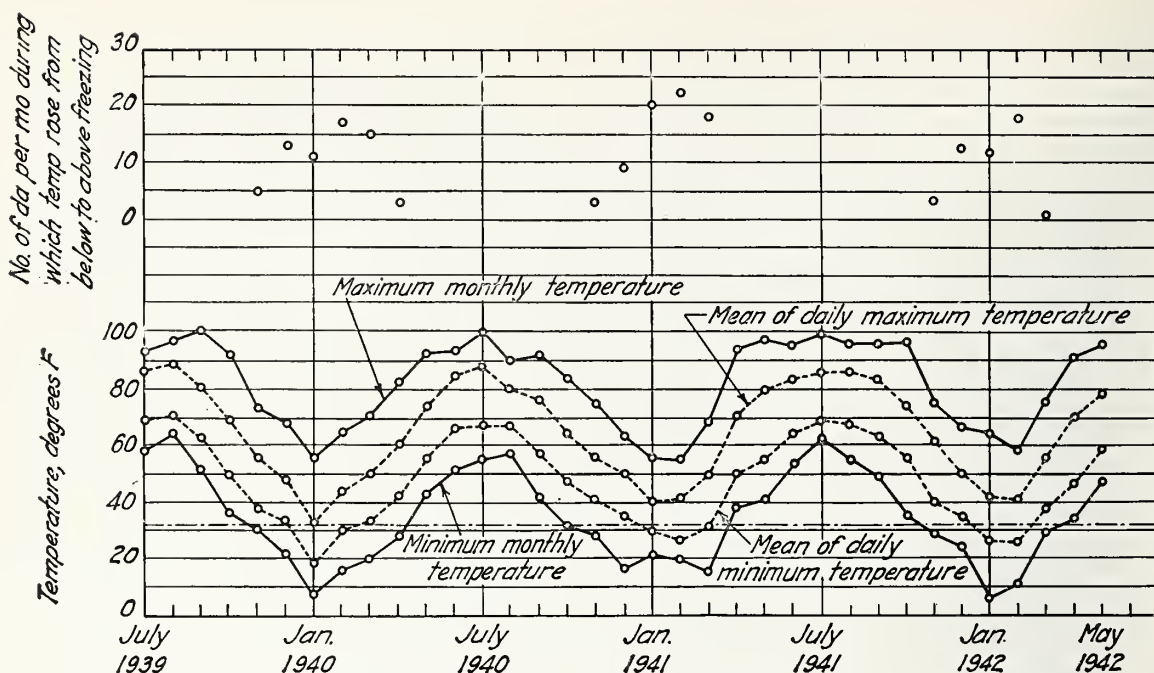
FIGURE 2.—Temperature record.

The monthly maximum and minimum air temperature and the monthly mean of daily maximum and daily minimum air temperatures are shown in figure 2, which also shows the number of thawing cycles per month. The air temperature fell below and then rose above freezing about 60 times each winter, and the data (obtained from the Weather Bureau) indicate that the air temperature did not rise above freezing more than once in any one day. The monthly precipitation for the period January 1939 to May 1942 is given in table 4.

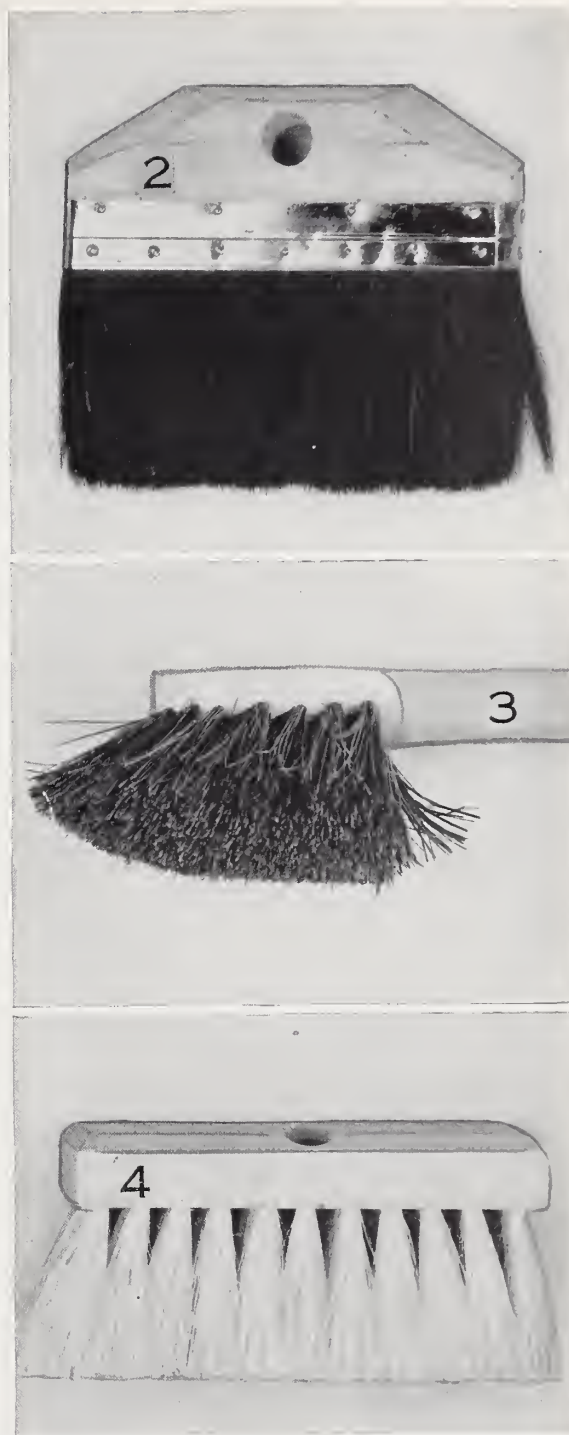
FIGURE 3.—Brushes used to apply the cement-water paints and some other waterproofings.

Brush 2 was a whitewash brush, brush 3 a fender-cleaning brush, and brush 4 a roofing brush.

The three kinds of brushes, numbered 2, 3, and 4, shown in figure 3 were used to apply the

The material was applied to the back of the wall with a whitewash brush (brush 2, fig. 3), and the amount applied was 16.5 lb/100 ft<sup>2</sup>. The wall was tested for permeability 6 weeks after it was waterproofed.

on successive days, using a roofing brush (brush 4, fig. 3). A considerable portion of the larger sand particles dropped from the walls, especially during application of the first coats, and the proportion of cement in the grout remaining on the wall was probably larger than is indicated. The first coats were wetted lightly before the second ones were applied. The grout was frequently stirred during its application, and the amounts applied were approximately equal for each coat. The amounts of cement used for both coats were 23.5 and 24.4 lb/100 ft<sup>2</sup> of wall area for walls B98 and B108, respectively. The amount of cement used was slightly greater in weight than the average weight of the dry powder required for the coatings of cement-water paints applied to similar walls. The walls were wetted twice daily for 3 days and were tested for permeability about 3 months after treatment.

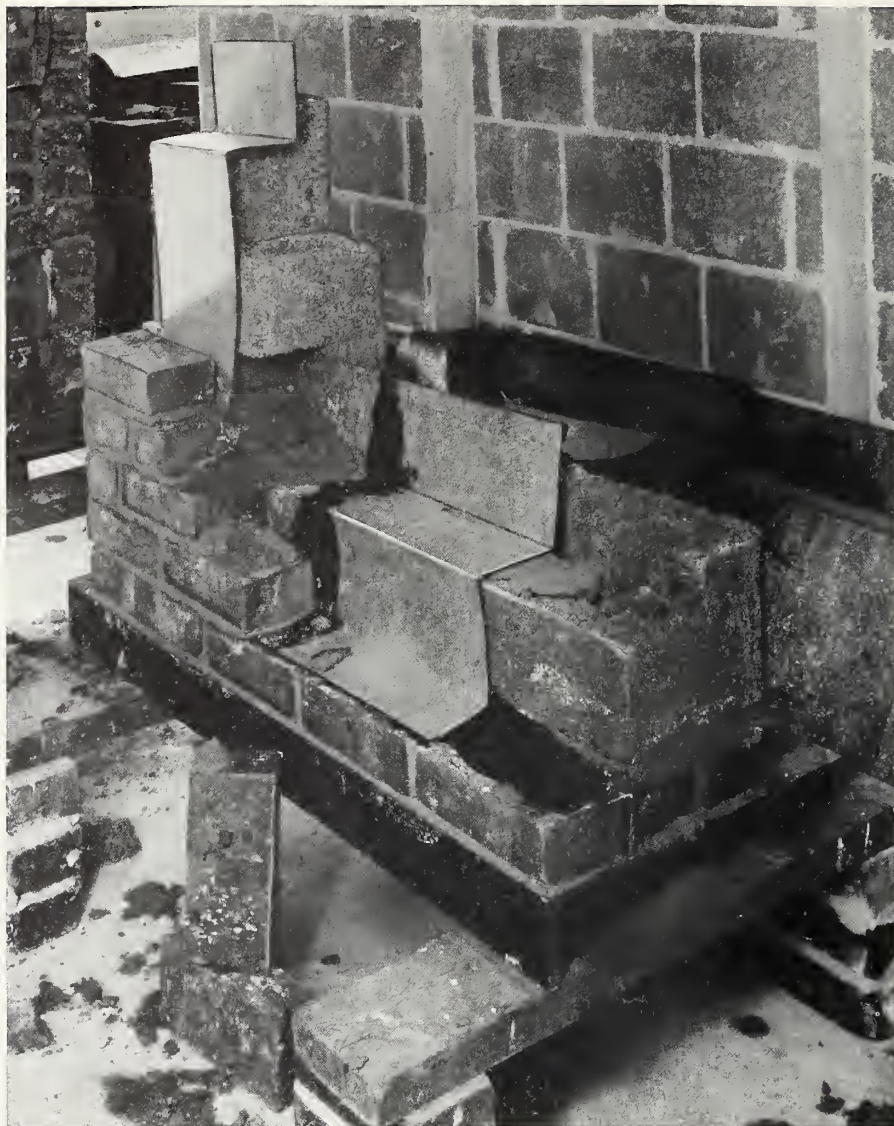
FIGURE 4.—Wall B236 during construction.

The lower membrane is bonded to the copper flashing.

The waterproofing units were made of heavy asphalt-impregnated felt or paper dusted with mica. They were preformed to fit the brick and course dimensions, and were lapped and sealed at the ends to form a series of waterproof membranes, as shown in figures 4, 5, 6, and 7. The vertical joints between the units were lapped 4 in. and sealed with an asphalt plastic cement of troweling consistency, which contained cut-back asphalt and asbestos fiber. The walls were laid in common American bond, starting with three stretcher courses. They were constructed in two groups, differing from each other in the extent and method of filling the interior of the vertical joints with mortar. The membrane waterproofings, placed in some of the walls of each group, were similar.

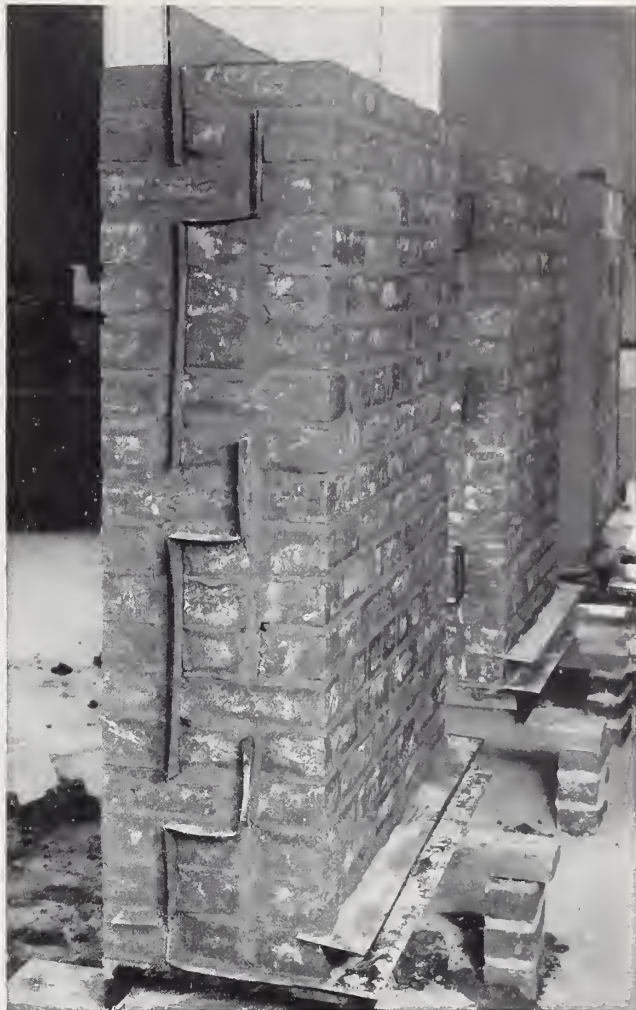
FIGURE 5.—*Brick wall containing membrane waterproofing.*

Brick Waterproofing Co., series 1.

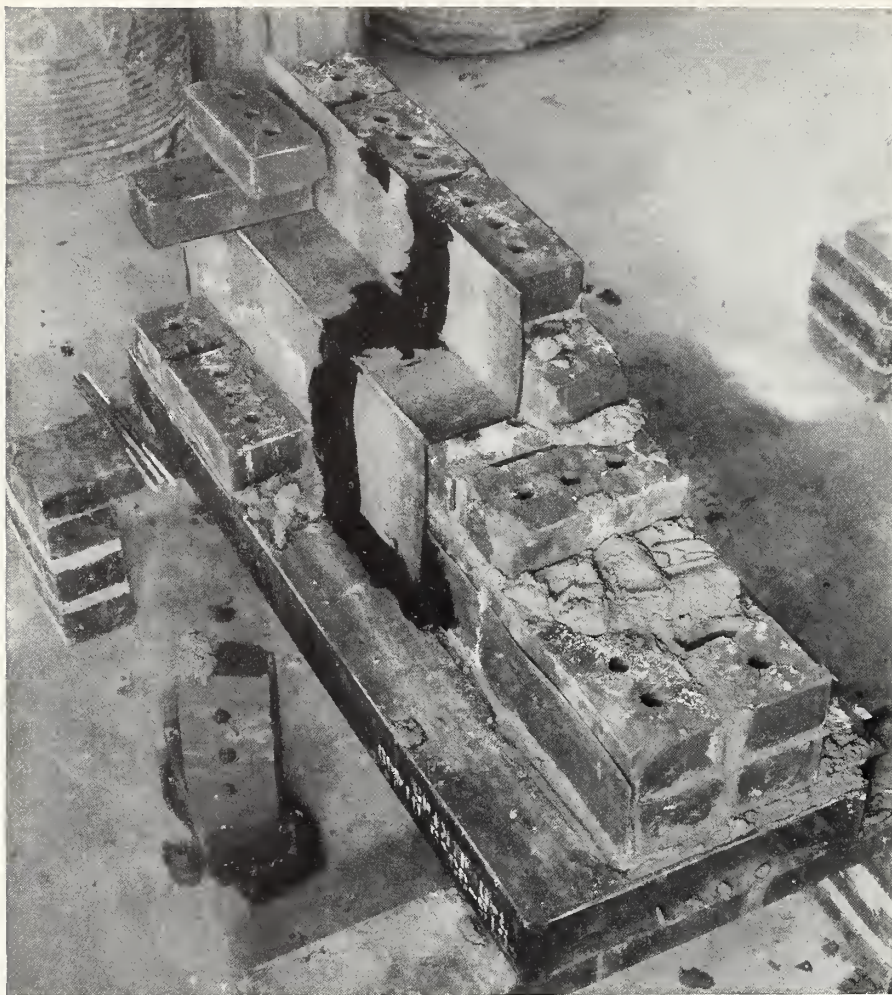
FIGURE 6.—Brick wall during construction, series 2.

The bed joints in the walls of the second group were furrowed. The head joints in the facing tier were filled solidly with mortar; those in the center and backing tiers were buttered. The face of the backing tier was parged. The collar joint between the facing and center tiers was filled with mortar by heavily buttering the sides of the brick and by slushing from above. No mortar was placed between the membrane, if used, and the vertical face of the center tier. The suction of the brick was nearly 40 g (table 1). The face joints were cut flush, and weep holes were made in the lower portions of the bed joints in the second stretcher course of the facing. The holes did not extend past the first collar joint and did not penetrate the membrane.

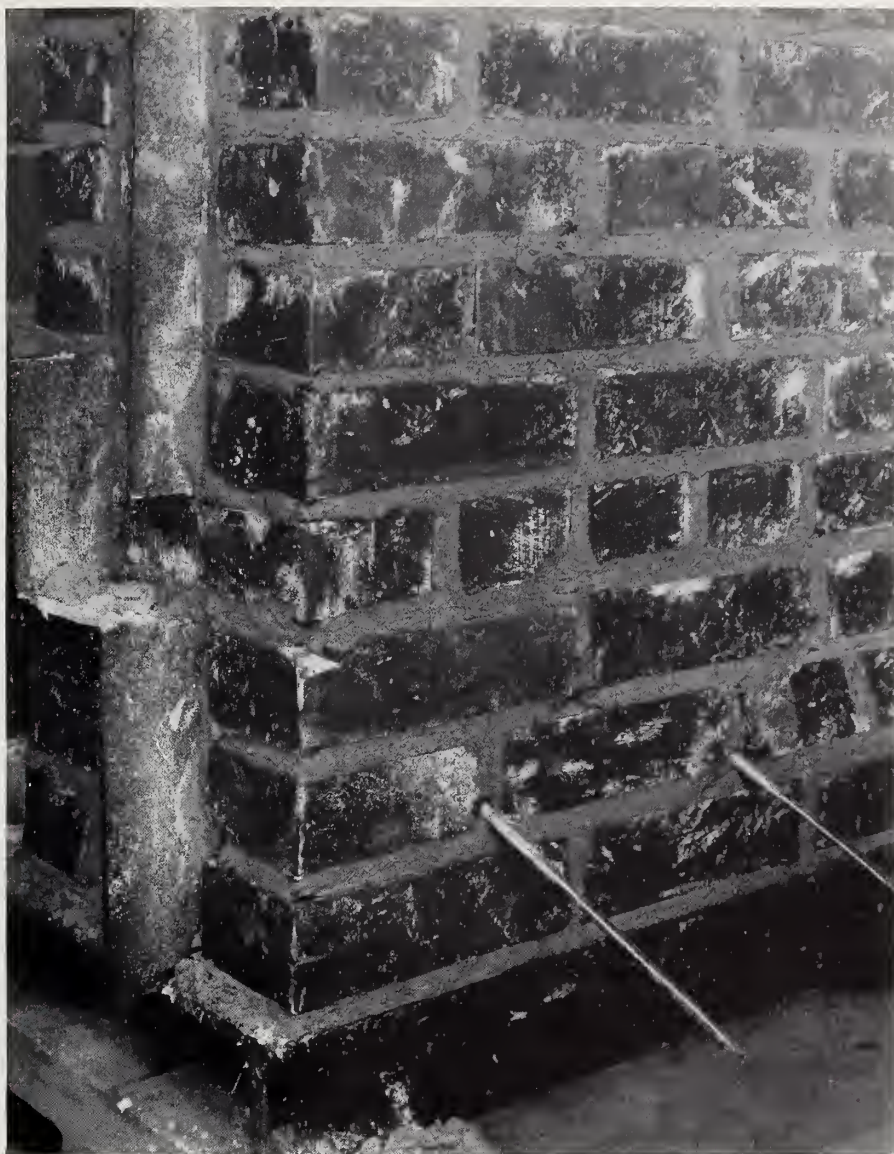
FIGURE 7.—*Brick wall, series 2.*

Note weep holes in facing.

The walls of the second series were of a less permeable construction than those of the first, and the plain specimens, built without the membranes, were rated *P*. All the walls contained weep holes at the bottom of the facing tiers. Waterproofed walls B263 and B265 were rated *E*. When again tested, after plugging the weep holes, wall B263 was rated *G*, and wall B265 was again rated *E*.

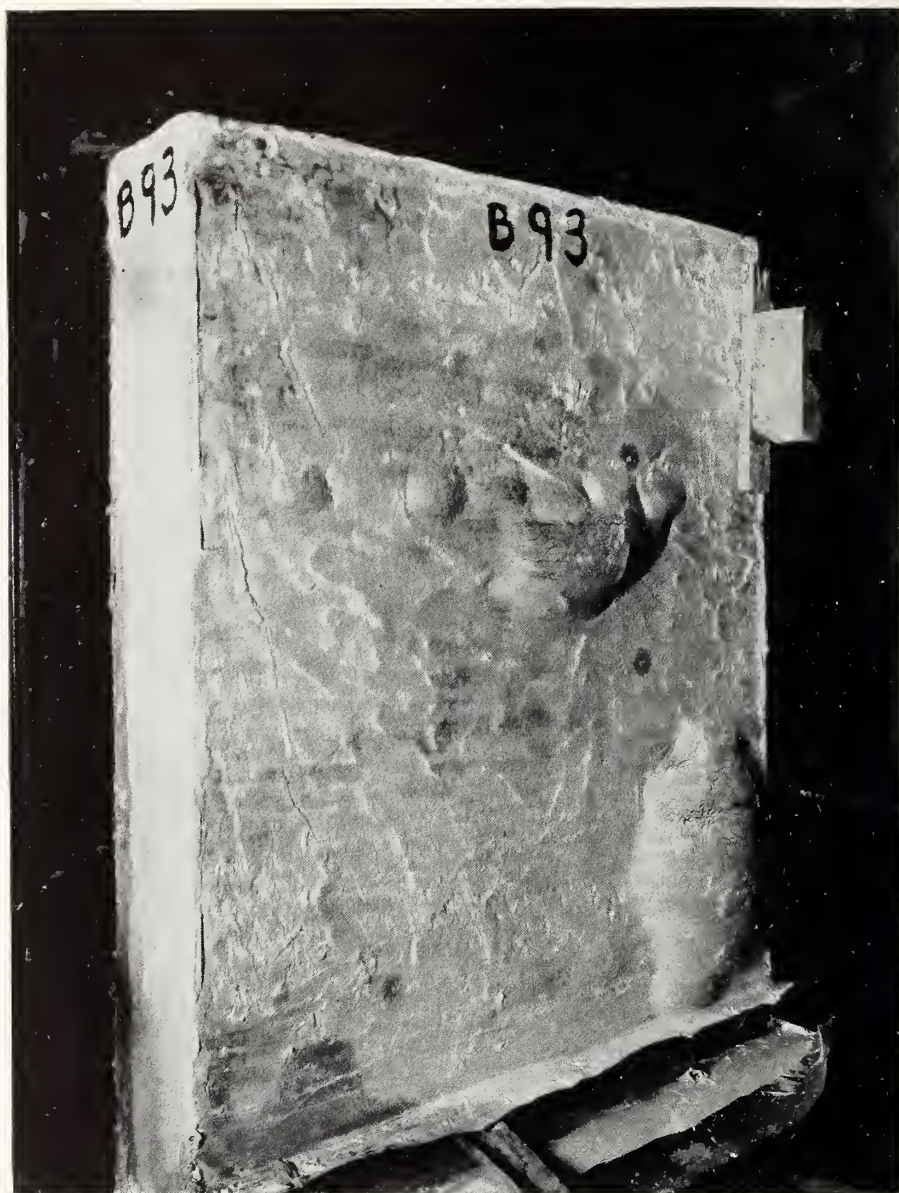
FIGURE 8.—Back of wall B93, about 5 hours after start of test.

The wall was treated on the back with bituminous plastic cement.

One coat of a bituminous plastic cement of troweling consistency (waterproofing 45, table 18) was applied to the back of wall B93-cc45. The material, known as Ruberoid Plastic Cement, was made by the Ruberoid Co., Baltimore, Md., and it met the requirements of Federal Specification SS-C-153, type I, asphaltic base.

Large blisters formed at and below the second header course from the bottom of the wall and at the lower-right portion of the wall in about 4 or 5 hr, as shown in figure 8. The large
