BUILDING SCIENCE SERIES

11

Fire Resistance Of Steel Deck Floor Assemblies

U.S. DEPARTMENT OF COMMERCE
National Bureau of Standards

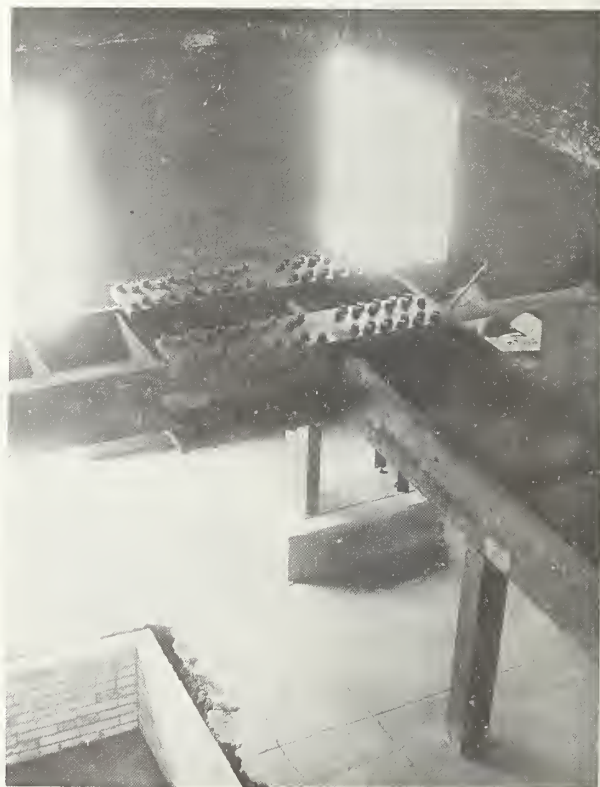
FIGURE 2.—Floor test furnace during construction; corner fastening and column supports visible.

Figure 2 shows a portion of the furnace restraining frame during construction and before erection of the furnace walls. The system of corner fastening and column support can be seen. The burnout room with a bare steel deck floor in place is shown in figure 3. In figure 4, the furnace space can be seen, with a steel deck-and-beam floor in place, prior to installation of the protective ceiling assembly beneath the floor.

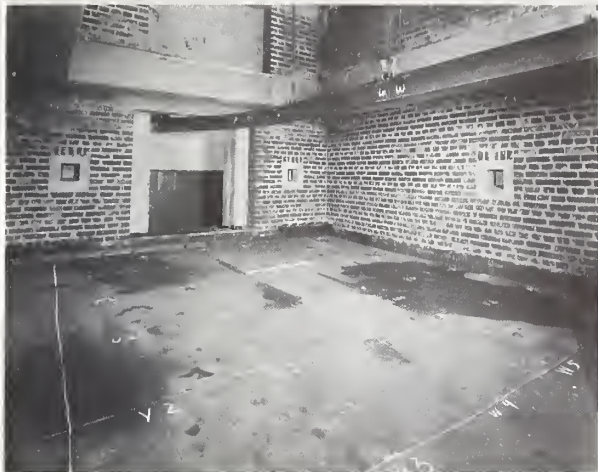
FIGURE 3.—Upper furnace space; bare steel-deck floor.

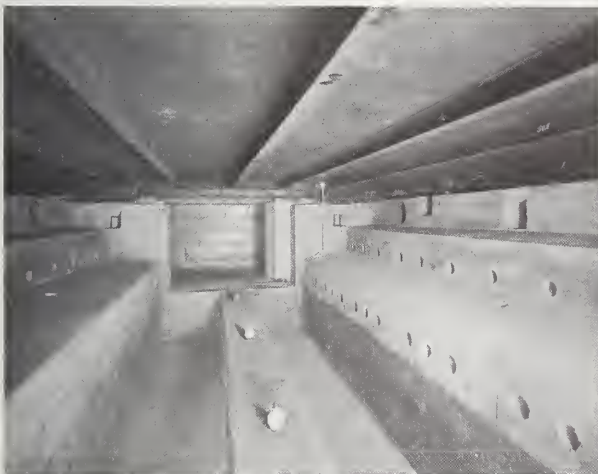
FIGURE 4.—Lower furnace, steel deck-and-beam floor in place, prior to installation of protective ceiling.

The furnace was gas fired, with 48 venturi-type burners, arranged in two rows on each side. The burners on each side of the furnace were housed in a plenum chamber supplied with low pressure air. An auxiliary air supply was provided in the combustion chamber of the furnace through six air inlets in line with each bottom row of burners. Three 9-in diam flues on each side served to carry off the combustion gases. Some of the burner, air, and flue openings are visible in figure 4.

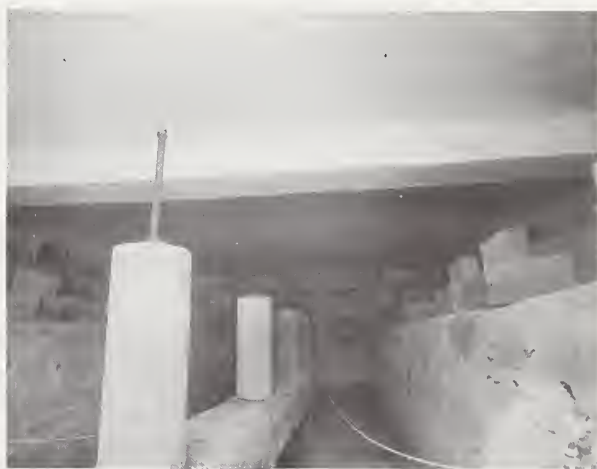
FIGURE 5.—Lower furnace showing iron pipes for protection of furnace temperature-measuring thermocouples.

Iron pipes protecting thermocouples in the furnace may be seen in figure 5, and in the burnout space above the floor in figure 6. Figure 7 shows the weighted asbestos pads covering the bare thermocouple junctions in contact with the unexposed surface of a floor.

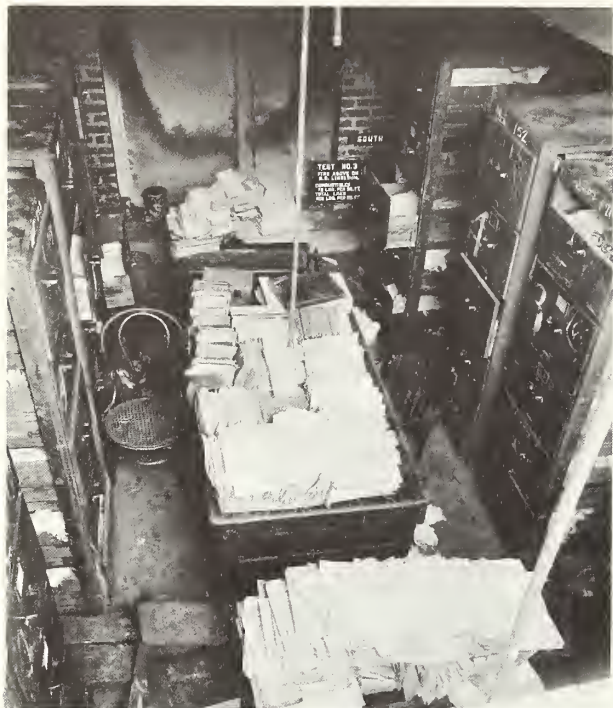
FIGURE 6.—Burnout space above the floor; thermocouples contained in suspended iron pipes; showing arrangement of combustible materials.

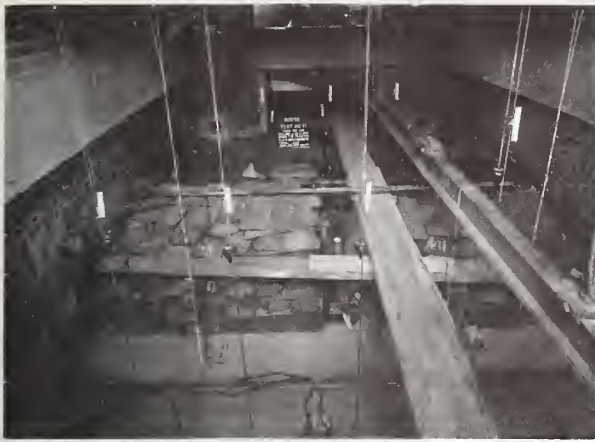
FIGURE 7.—Top of floor for standard fire test, showing asbestos pads covering surface thermocouples, deflection measuring tapes, and method of loading with pig iron.

The deflections of the floors were measured by means of graduated invar tapes attached to the floor components. Readings on the tapes were made by use of a transit mounted on a stable support external to the floor. For floors subjected to top fire exposure, the tapes were fastened to pins welded to the beams or under sides of the floor plates, and brought down through the ceiling plaster. In those tests having bottom fire exposure, the tapes were attached to pins screwed into the top of the steel plates and extended up to wires running over pulleys (see fig. 7). In all cases, the tapes were held vertical by weights.

In the tests with the fire exposure below the floor, the applied loads consisted entirely of pig iron placed in rows on the floor surface, except in Test 15, where the weights were uniformly distributed over the entire floor. The weights used in all of the tests, except that of Test 15, were raised from the floor surface by means of iron pipes placed directly on the floor. This established definite points of loading at the beginning of the test and permitted air circulation under the weights. In the later tests, upright sections of pipe were installed to form a small gap at the center of each row, thus preventing arch action of the stacked weights due to deflection of the floor. The arrangement is illustrated in figure 7.

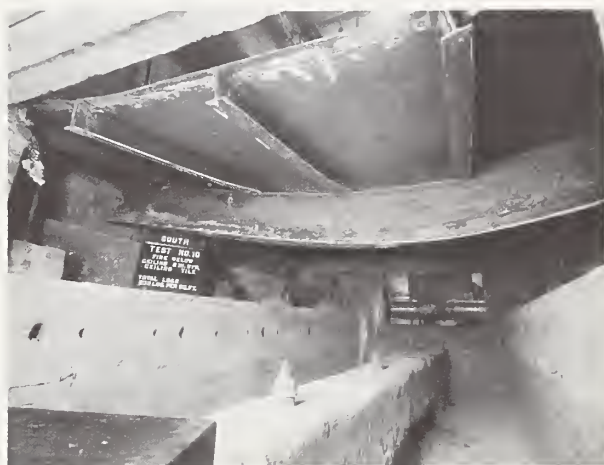
FIGURE 14.—Deformation of girder and cantilever beams after 5-hr fire exposure (ceiling and girder covering removed).

The deflections of the end of the cantilevered beams were affected by the type of floor structure as well as by the heat of the fire. In Test 10, where the beams were continuous over the girder, the cantilevered ends showed considerable upward movement as the center of the long span moved downward. At the end of the test, however, the cantilevered beams were down approximately 14 in, following the large deflection of the girder. In Tests 11 and 13, in which the deflections at the center of the main span beams were small, there was only a small upward movement of the cantilevered ends, about 1 in maximum. The ends of the cantilevered beams in Test 14 also moved upward in the early phases of the fire exposure, but shortly after the completion of the test, exhibited a

downward deflection of approximately 11 in, about the same as the maximum deflection of the girder. In these tests, it appeared that the displacement of the cantilevered beams was more a function of the movement of the supporting girder than the effect of heat on their unsupported ends. The comparative deformation, after test, of a girder and cantilever beams supported on it can be observed in figure 14.
