## Fire Endurance of Gypsum Board Walls and Chases Containing Plastic and Metallic Drain, Waste and Vent Plumbing Systems

# Fire Endurance of Gypsum Board Walls and Chases Containing Plastic and Metallic Drain, Waste and Vent Plumbing Systems

*NBS Building Science Series, no. 72*

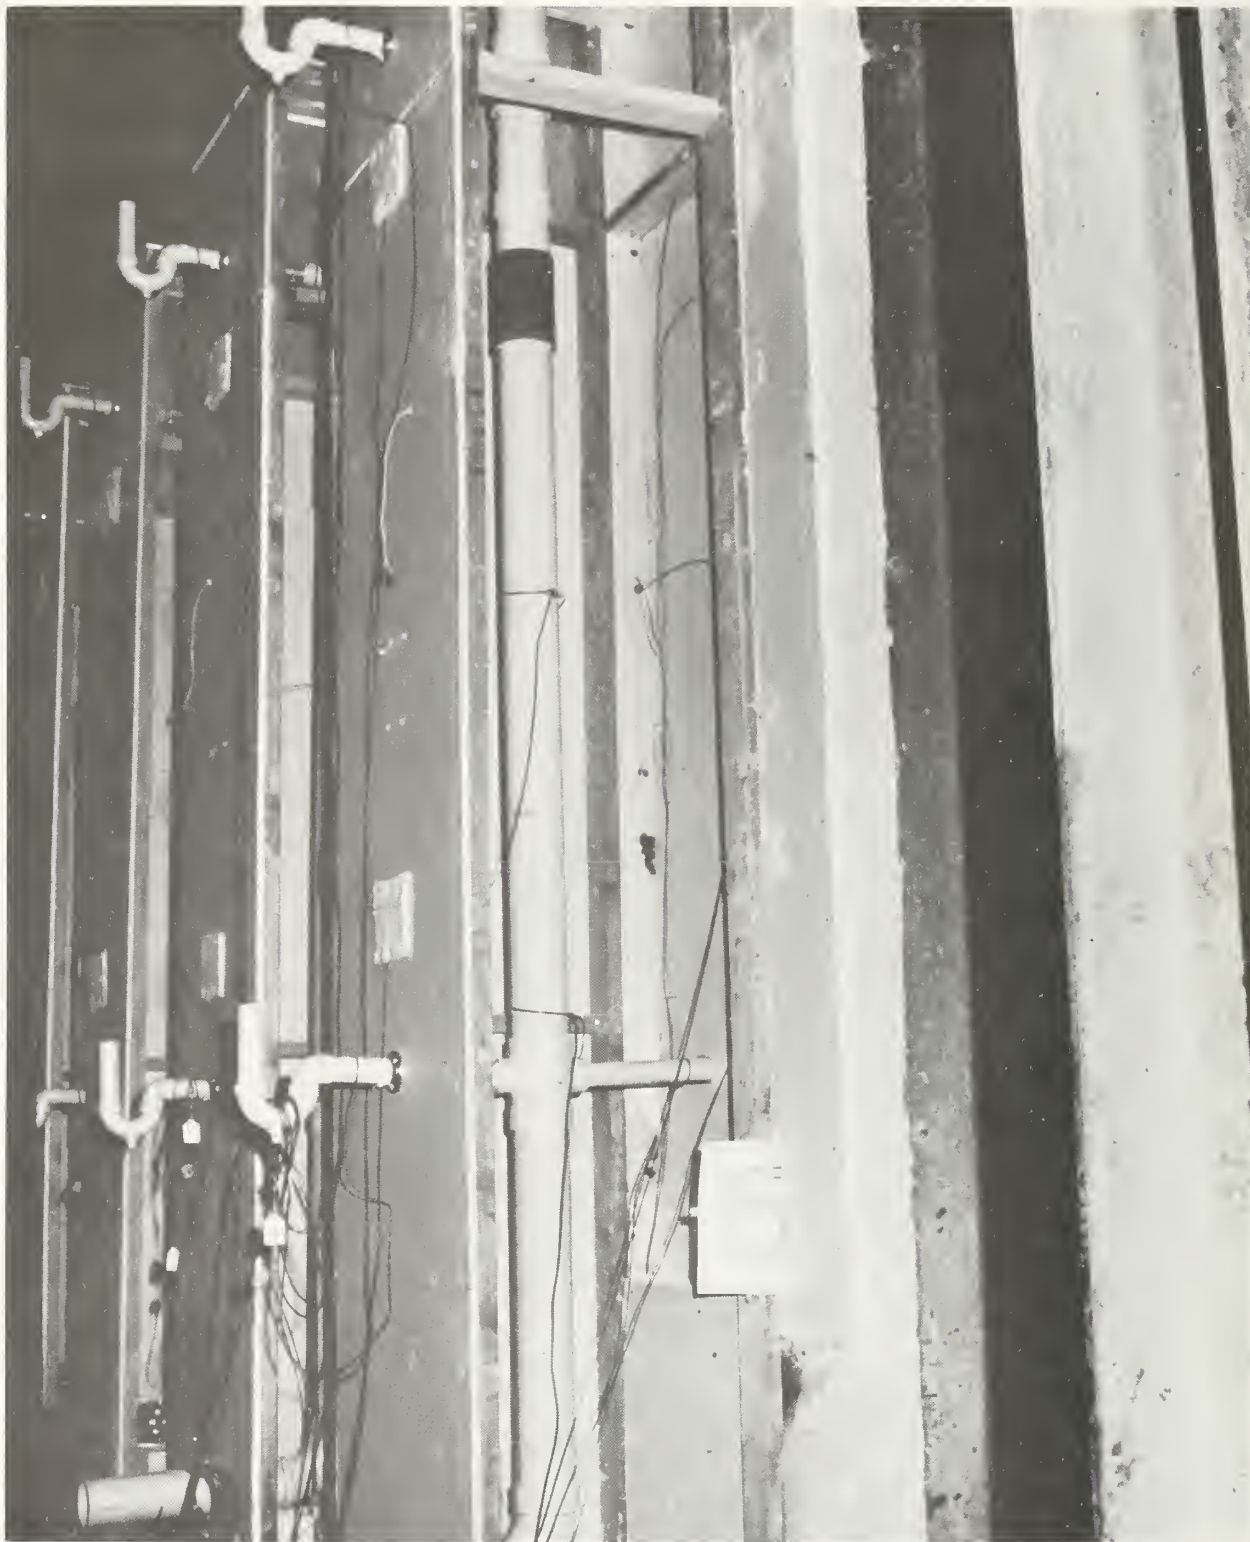
Figure 8. Photograph of chase 5  
with side removed.

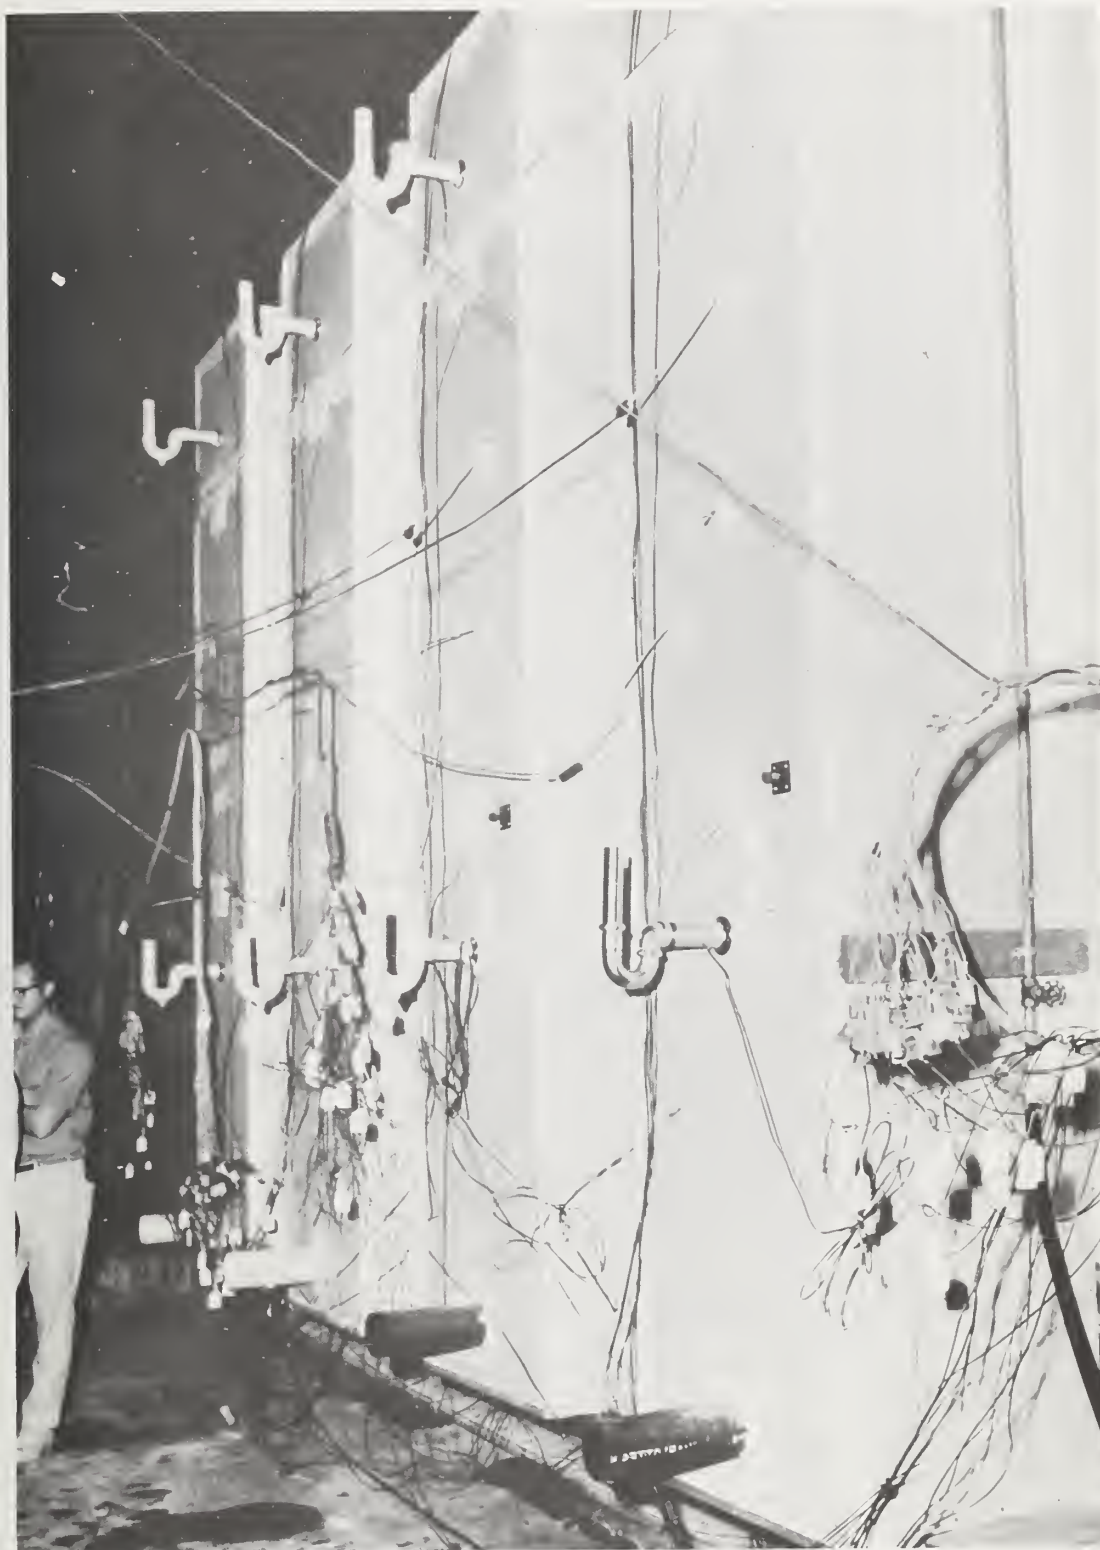
Figure 11. Photograph of chases  
in test 2.

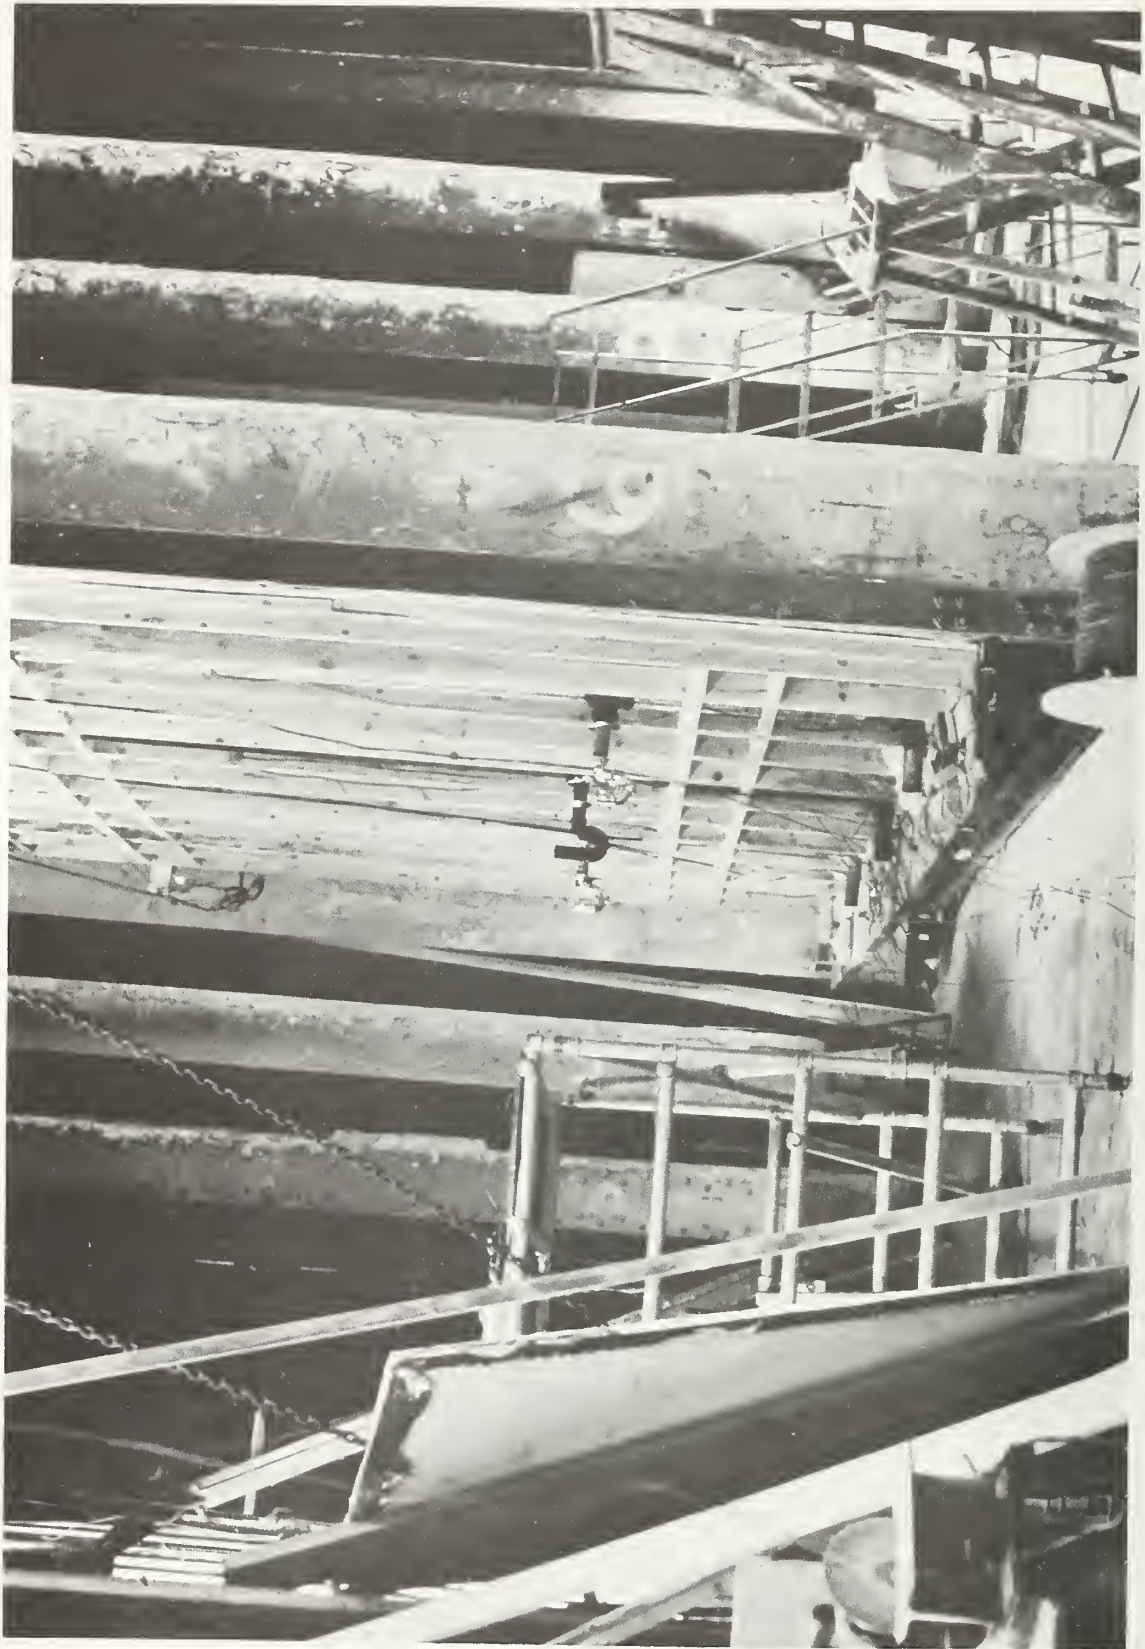
Figure 14. Photograph of wall construction in test 3.

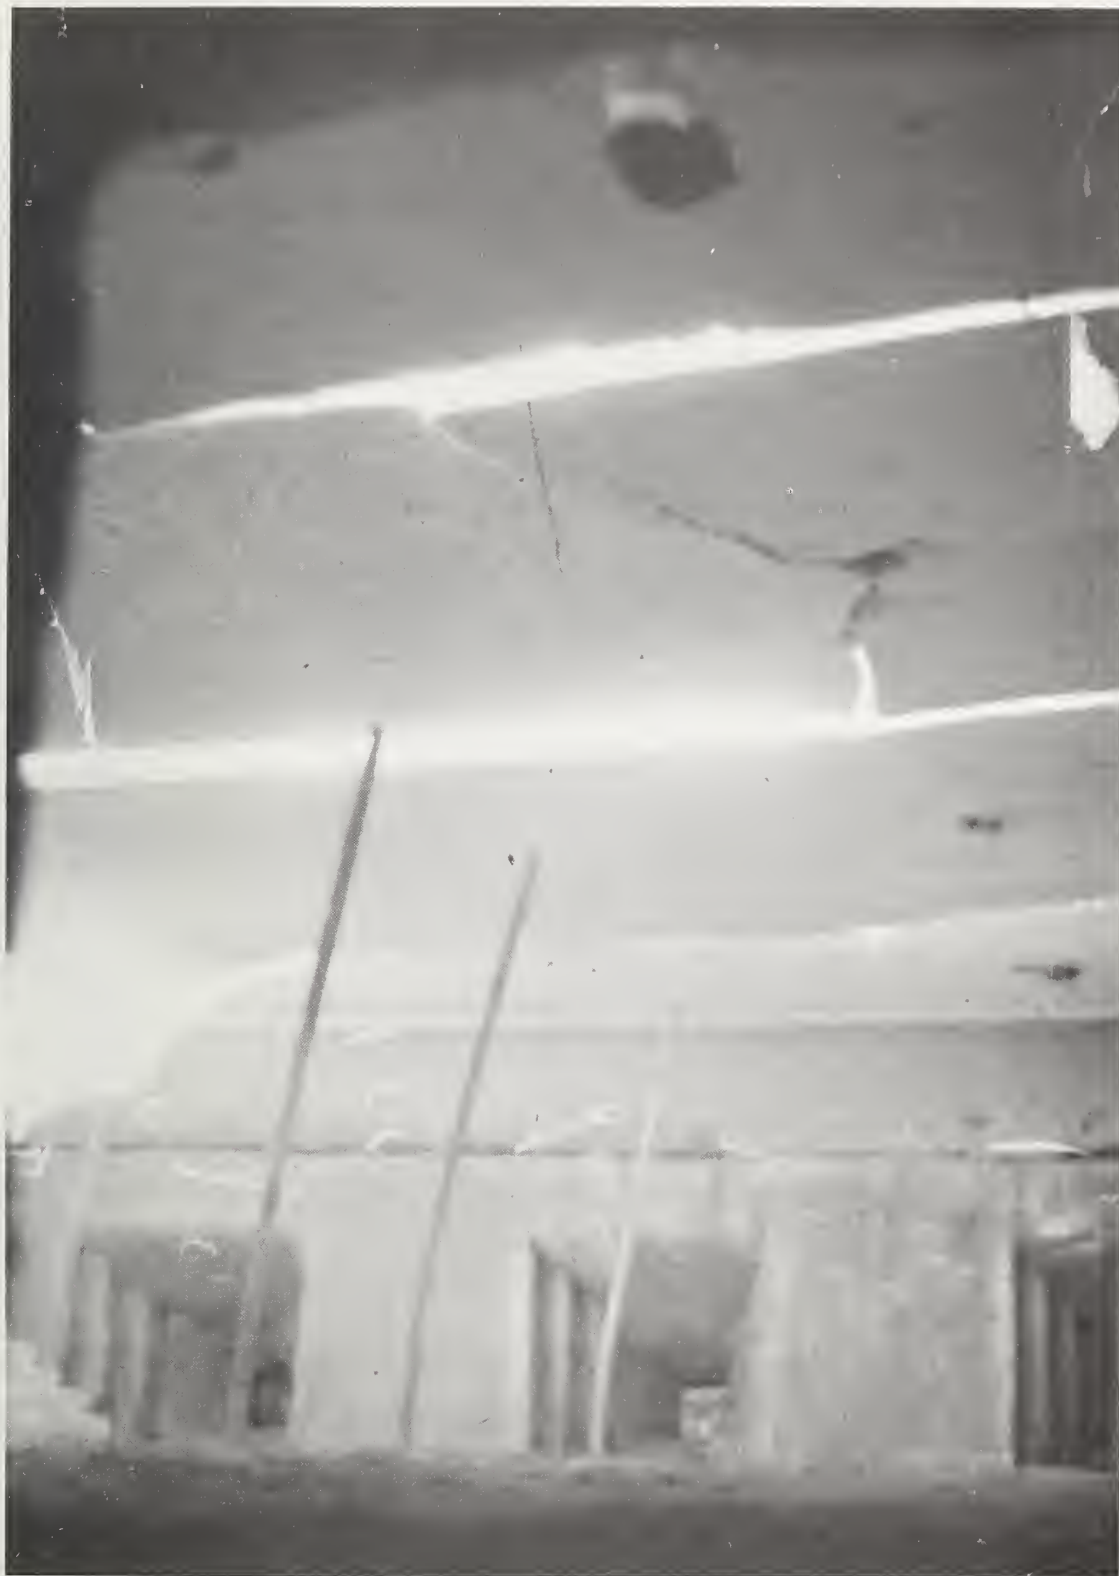
Figure 64. Smoke transmission in test 1.

The transmission of light through the smoke in the upper section of the four chases in Test 1 is compared in figure 64. Smoke meters were not used in any of the subsequent tests.
