NBSIR 76-1021

Fire Spread Along A Mobile Home Corridor

Interim Report

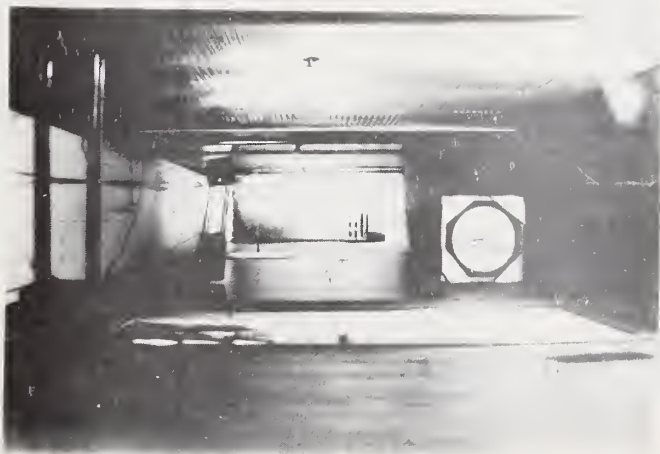
Figure 3. Typical corridor test setup, illustrating the location of the ignition source.

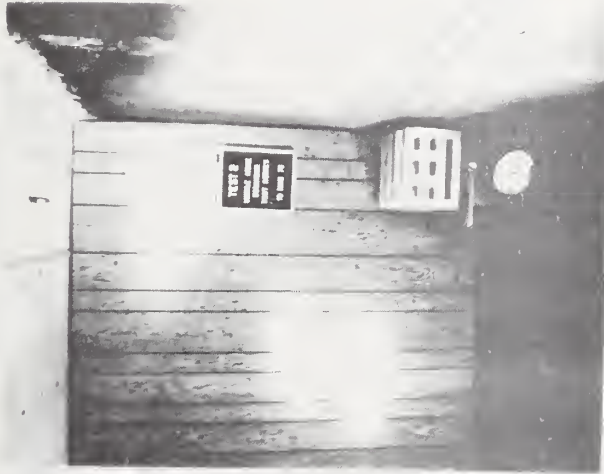
Figure 4. Typical corridor test setup illustrating the positioning of the ignition source in a corner configuration.

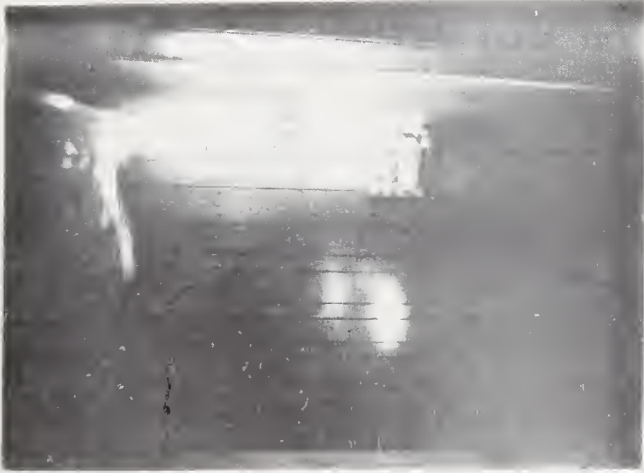
Figure 5. Illustration of the initial fire growth resulting from ignition of a 6.4-kg wood crib.

Figure 5 illustrates the initial fire growth resulting from the exposure of a wall partition to ignition by a 6.4-kg (14-lb) wood crib. The burning of the wood crib was characterized by a maximum flame height of 1.5 m to 1.8 m (5 to 6 ft). This peak flame height normally occurred within the first 1-3/4 minutes of the test. Due to the positioning and size of the wood crib, the duration of direct impingement on the wall by this crib fire was approximately 2 to 2-1/2 minutes. Without significant contribution from the wall material, the test fire did not propagate beyond the crib.

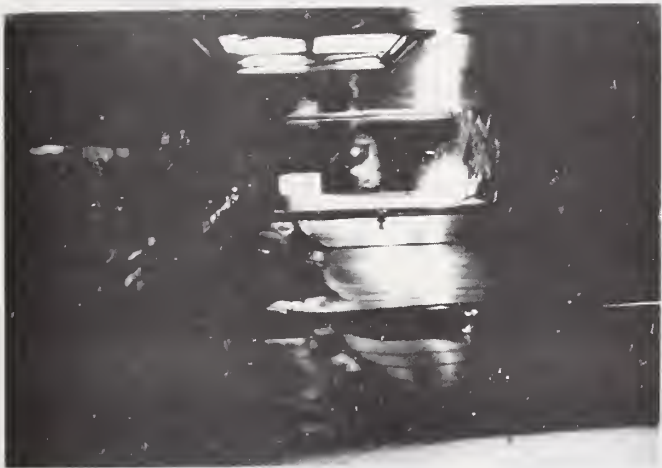
Figure 10a. Illustration of damage along interior and exterior corridor walls in Test No. 5.

The next group includes Test No. 1 (W-4/C-1), Test No. 4 (W-4 on W-1/C-3) and Test No. 9 (W-2/C-1). While post-test observations indicated a reduction in severity, extensive damage was still found in the corridor and the adjacent rooms. Figures 10a, 10b, 11a and 11b, illustrate the damage resulting from Test No. 5 and Test No. 9. The temperature exceeded the 100 °C (212 °F) criterion level approximately 50 seconds later than for the tests in the first group (see figure 12). In all three tests, the 100 °C (212 °F) temperature criterion was exceeded at one or both of the points where temperature was monitored (TC 37,41) before six minutes had elapsed.

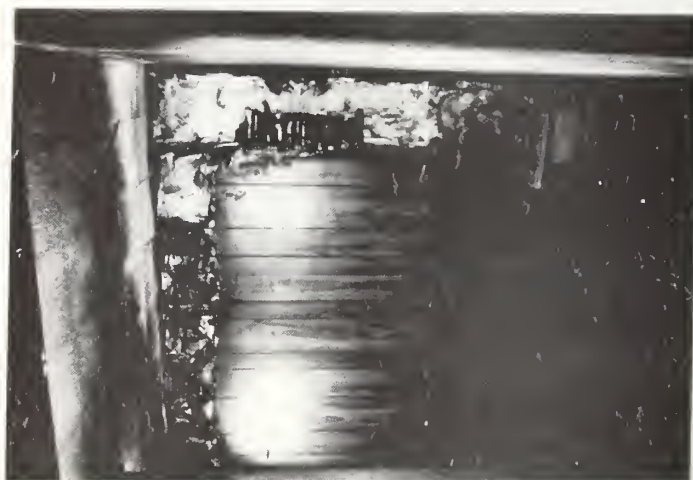
Figure 11b. Illustration of damage in the immediate area of the ignition source in Test No. 9.

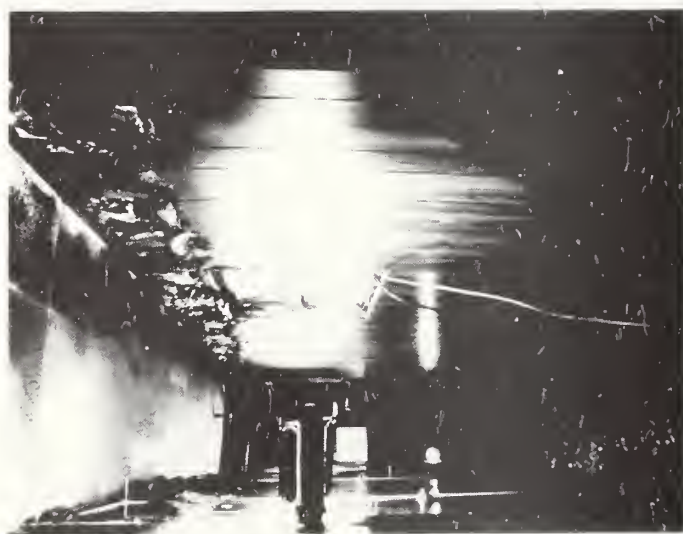
Figure 11a. Illustration of damage along interior and exterior corridor walls in Test No. 9.
