NBSIR 80-2045 (DoE)

ANALYSIS OF EROSION-RELATED FAILURE
INFORMATION FROM COAL GASIFICATION SYSTEMS

Metallurgy Division
Center for Materials Science
National Measurements Laboratory
National Bureau of Standards
Washington, DC 20234

March 10, 1980
Final Report

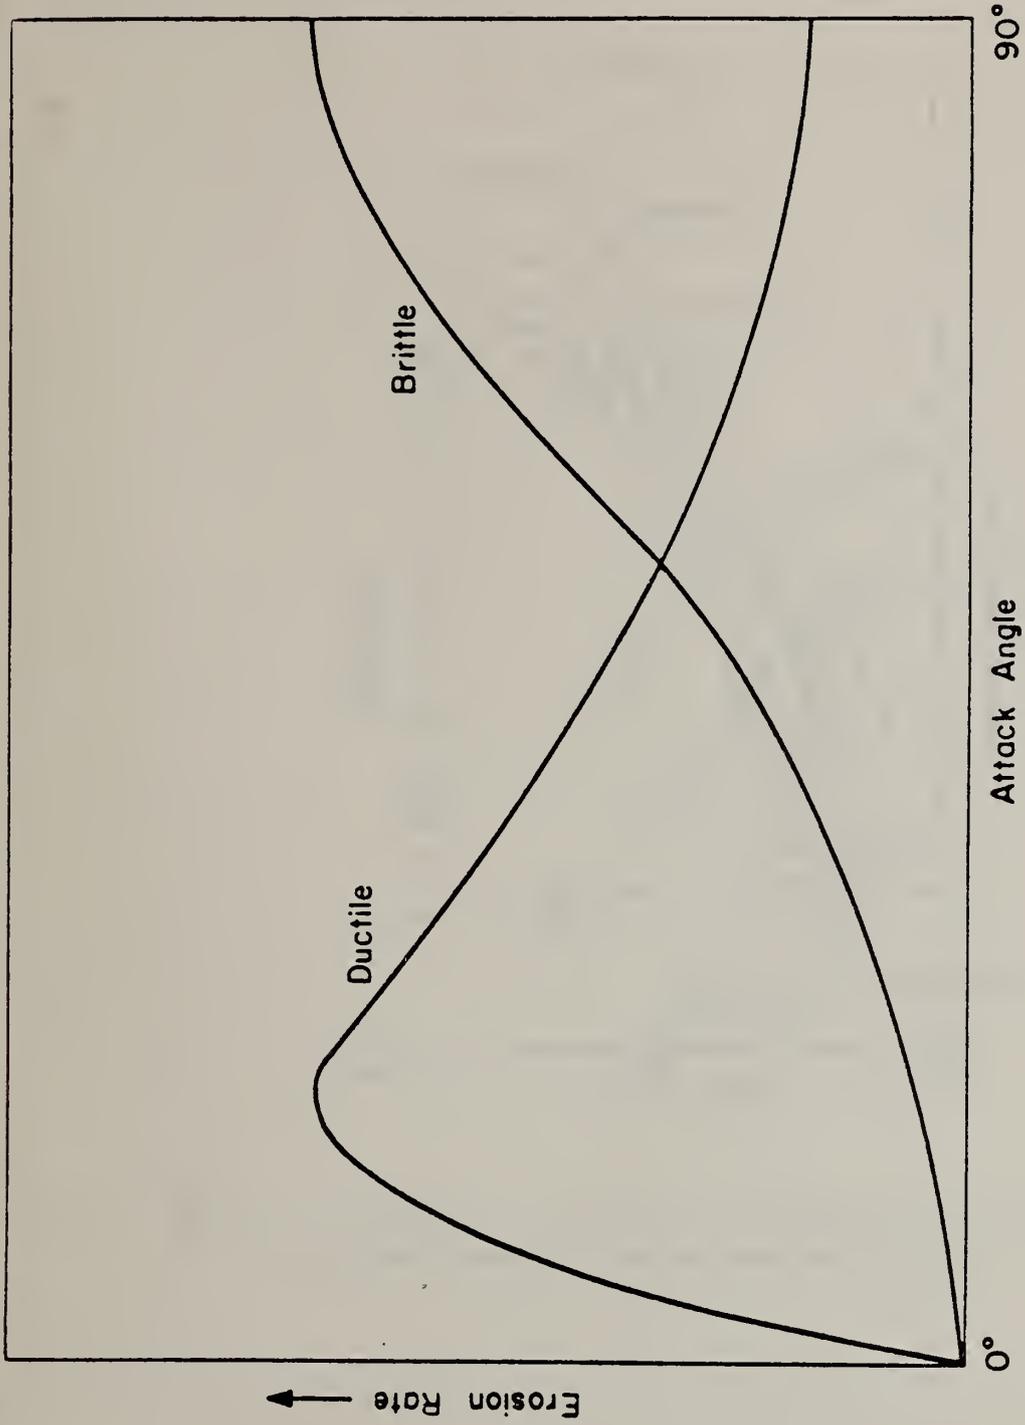
Fig. 1. Schematic representation of erosion rate vs attack angle.

The variation of erosion, usually measured in mass or volume loss from the specimen per unit mass of impacting abrasive, as a function of angle of attack of the particles is shown schematically in Fig. 1 for brittle and for ductile materials. For ductile materials the peak erosion loss occurs at around 20° . For brittle materials the peak erosion loss occurs at around 90° (normal incidence). Thus, designers should avoid these erosion angles for the materials involved. The dependence of erosion rate on particle velocity has been measured for many materials over typically two or three orders of magnitude in velocity. The erosion rate is found to increase as v^2 to v^3 in most cases.^{6,14} The velocity exponent has been reported not to depend on the type of material (Fig. 2); however, detailed studies have shown some dependence of the velocity exponent on the temperature of erosion (Fig. 3). A reduction in particle or flow velocity can drastically reduce erosion rate and may be the most effective design approach.

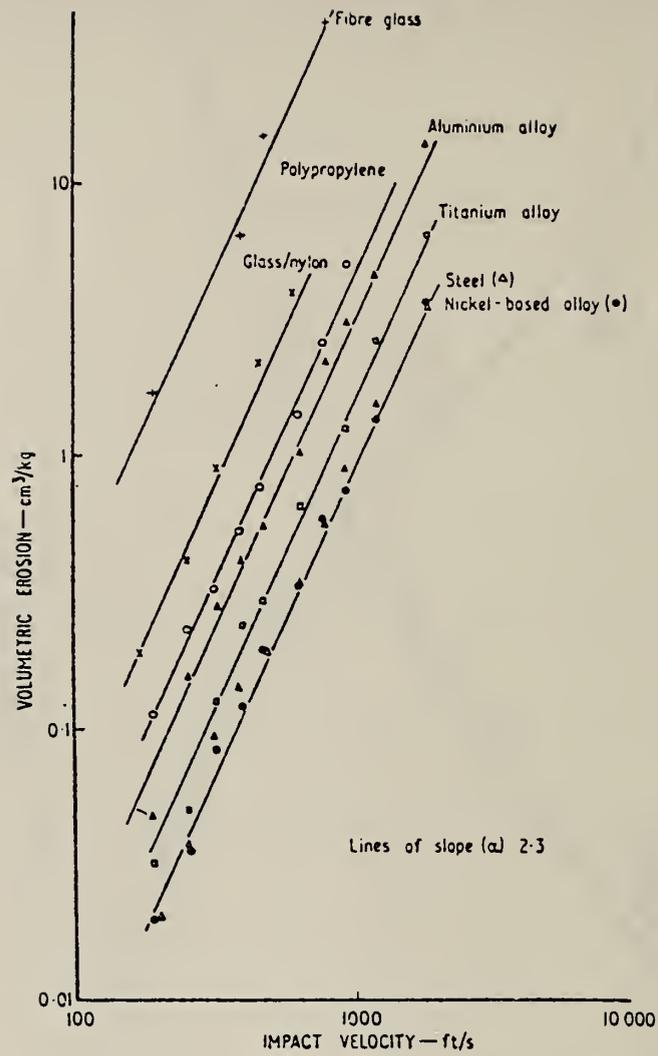
Fig. 2. Influence of velocity on erosion for different materials.¹⁵

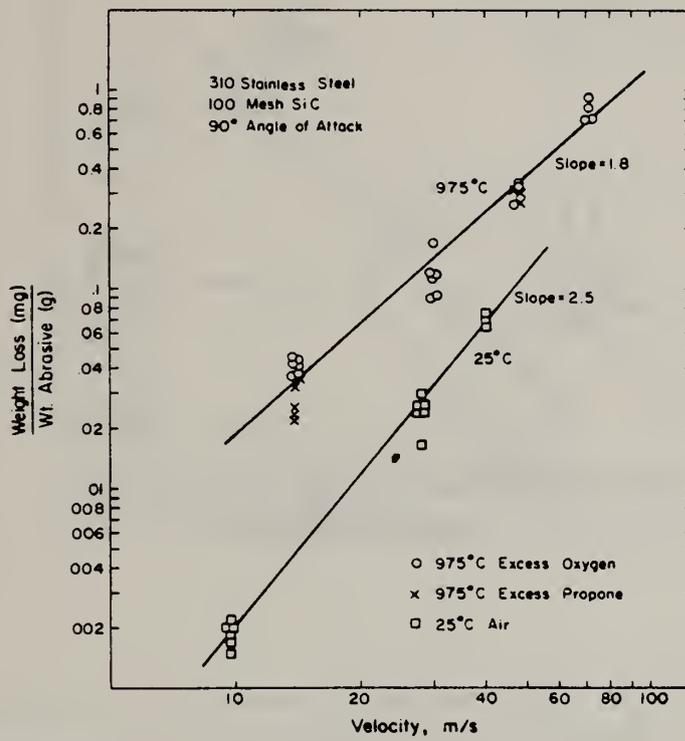
Fig. 3. Velocity dependence of erosion of stainless steel at 975°C and 25°C.¹¹

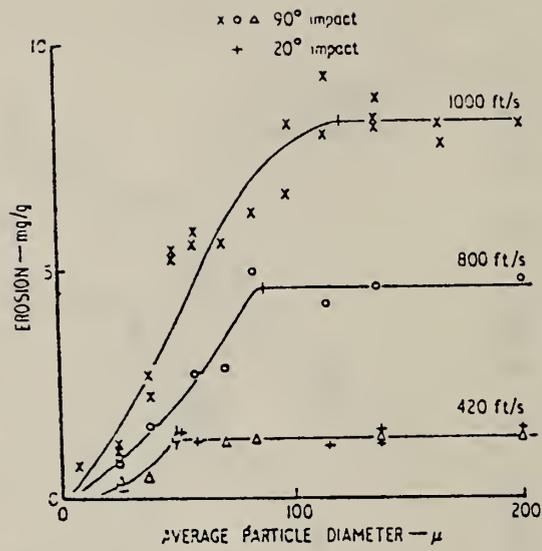
Fig. 4. Influence of particle size on erosion of an 11 percent chromium steel.¹⁵

The dependence of erosion on particle size has also been studied by several workers. Goodwin et al.¹⁵ have examined the erosion of steel by quartz particles over a large size range. As shown in Fig. 4, an increase in erosion with increasing particle size was found up to a limiting size, above which the erosion remained constant and then increased for particle sizes greater than about 500 μm . A theory explaining this result has been proposed.¹⁶ Much interest has been centered on the erosion effects of very small particles e.g., less than 5 μm in diameter. There have been conflicting reports in the literature for such small particles. Recent studies, however, have shown significant erosion of metals by particles as small as 2 μm .¹⁷ The effect of particle size as measured using flat test specimens may not be applicable in all geometries as shown by the recent work of Mills and Mason.¹⁸ In studying erosion in 90° tube bends due to the conveying of abrasive sands, they reported that depth of penetration for 70 μm particles was much greater than for 230 μm particles. Further a different surface morphology resulted and a different angle of maximum penetration was found.

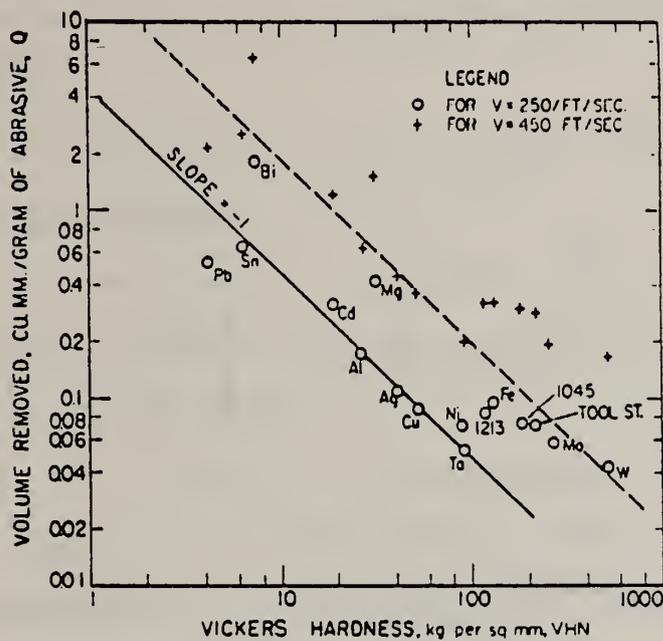
Fig. 5. Volume removal as a function of hardness (VHN) for metals eroded at $\alpha=20$ deg and velocities of 250 and 450 ft/sec. (No data were taken for nickel at 450 ft/sec.) All metals except cadmium were in annealed condition.⁶

One material parameter that has been of particular interest in connection with the understanding of ductile material erosion is indentation hardness. Numerous correlation studies have been attempted to determine the relation of hardness to erosion rate. In Fig. 5 some results⁶ are shown. There the erosion rate of different metals decreases with increasing value of material hardness. However, the effect of hardness variation for one alloy (varied through thermal treatments of a tool steel) was found to produce little effect on erosion rate. The influence of other erosion parameters such as particle concentration in the erosive stream, particle hardness, and particle strength, have only been examined in a few instances. In the case of particle concentration, divergent findings have been reported.²⁰ It would seem that relative erosion (specimen mass loss divided by impacting erosive mass) should be independent of particle concentration so long as each particle event is equally effective. At higher concentrations, where particle interference (shielding) effects occur at the specimen surface, the relative erosion should be expected to decrease and this has been reported.^{10,20} At elevated temperatures, the hot hardness and high temperature toughness of both the specimen and the eroding materials would be important parameters to consider.

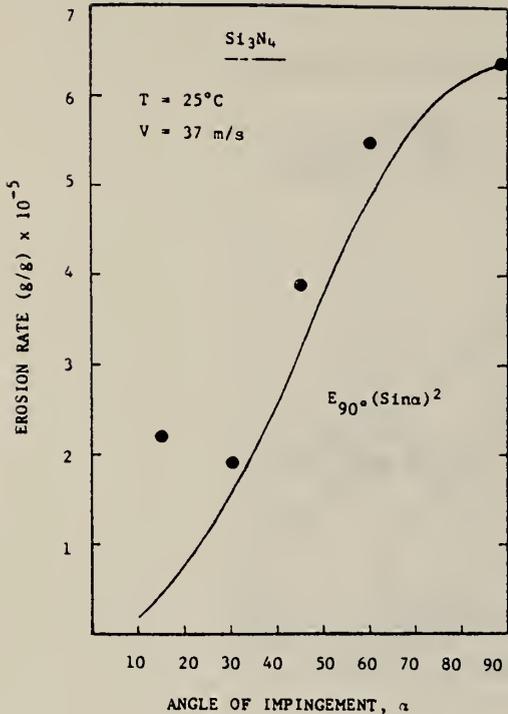
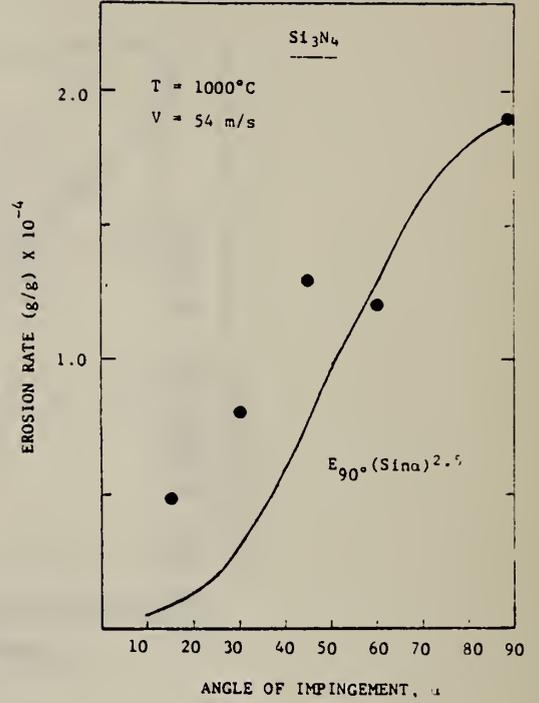
Fig. 6. Erosive wear of hot-pressed silicon nitride as a function of impingement angle. Curves represent erosion dependence for purely brittle behavior.²¹

Brittle ceramic materials exhibit a maximum in erosion rate at an angle of 90° (Fig. 6). This type of behavior has been used to classify materials as either brittle or ductile with regard to erosion. Actually, most ceramic materials exhibit behavior that is neither completely ductile nor completely brittle.
