Fire Performance of Selected Residential Floor Constructions Under Room Burnout Conditions

J. B. Fang

Center for Fire Research
National Engineering Laboratory
National Bureau of Standards
U.S. Department of Commerce
Washington, DC 20234

Interim Report

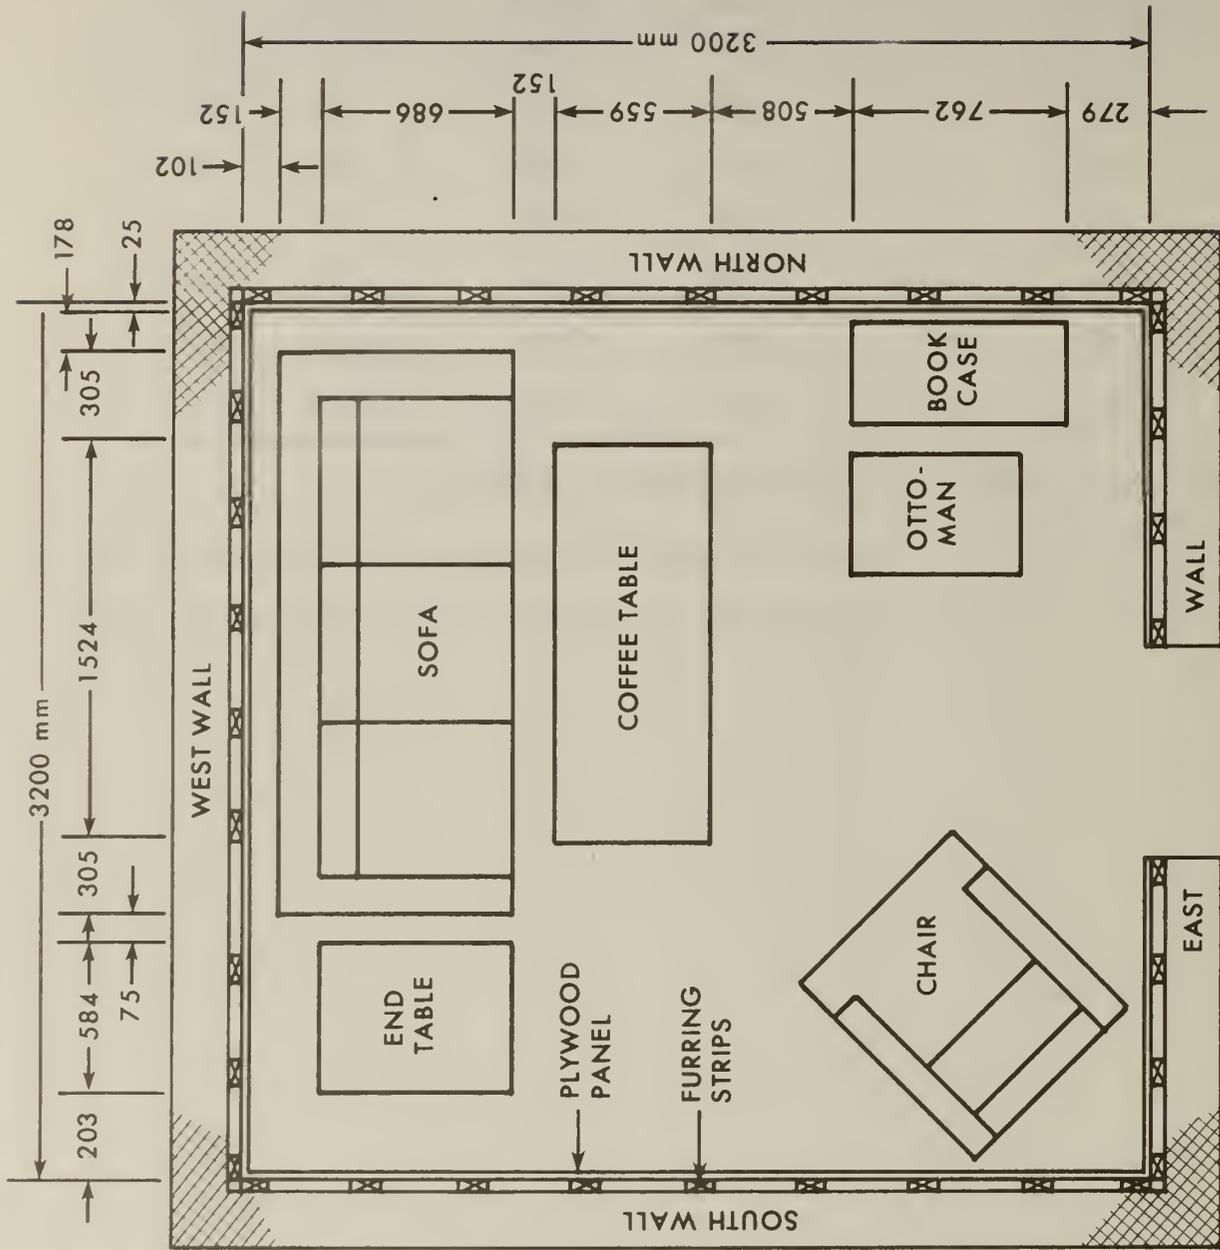
Figure 1. Plan View of the Test Room Showing Locations of Furniture and Wall Linings

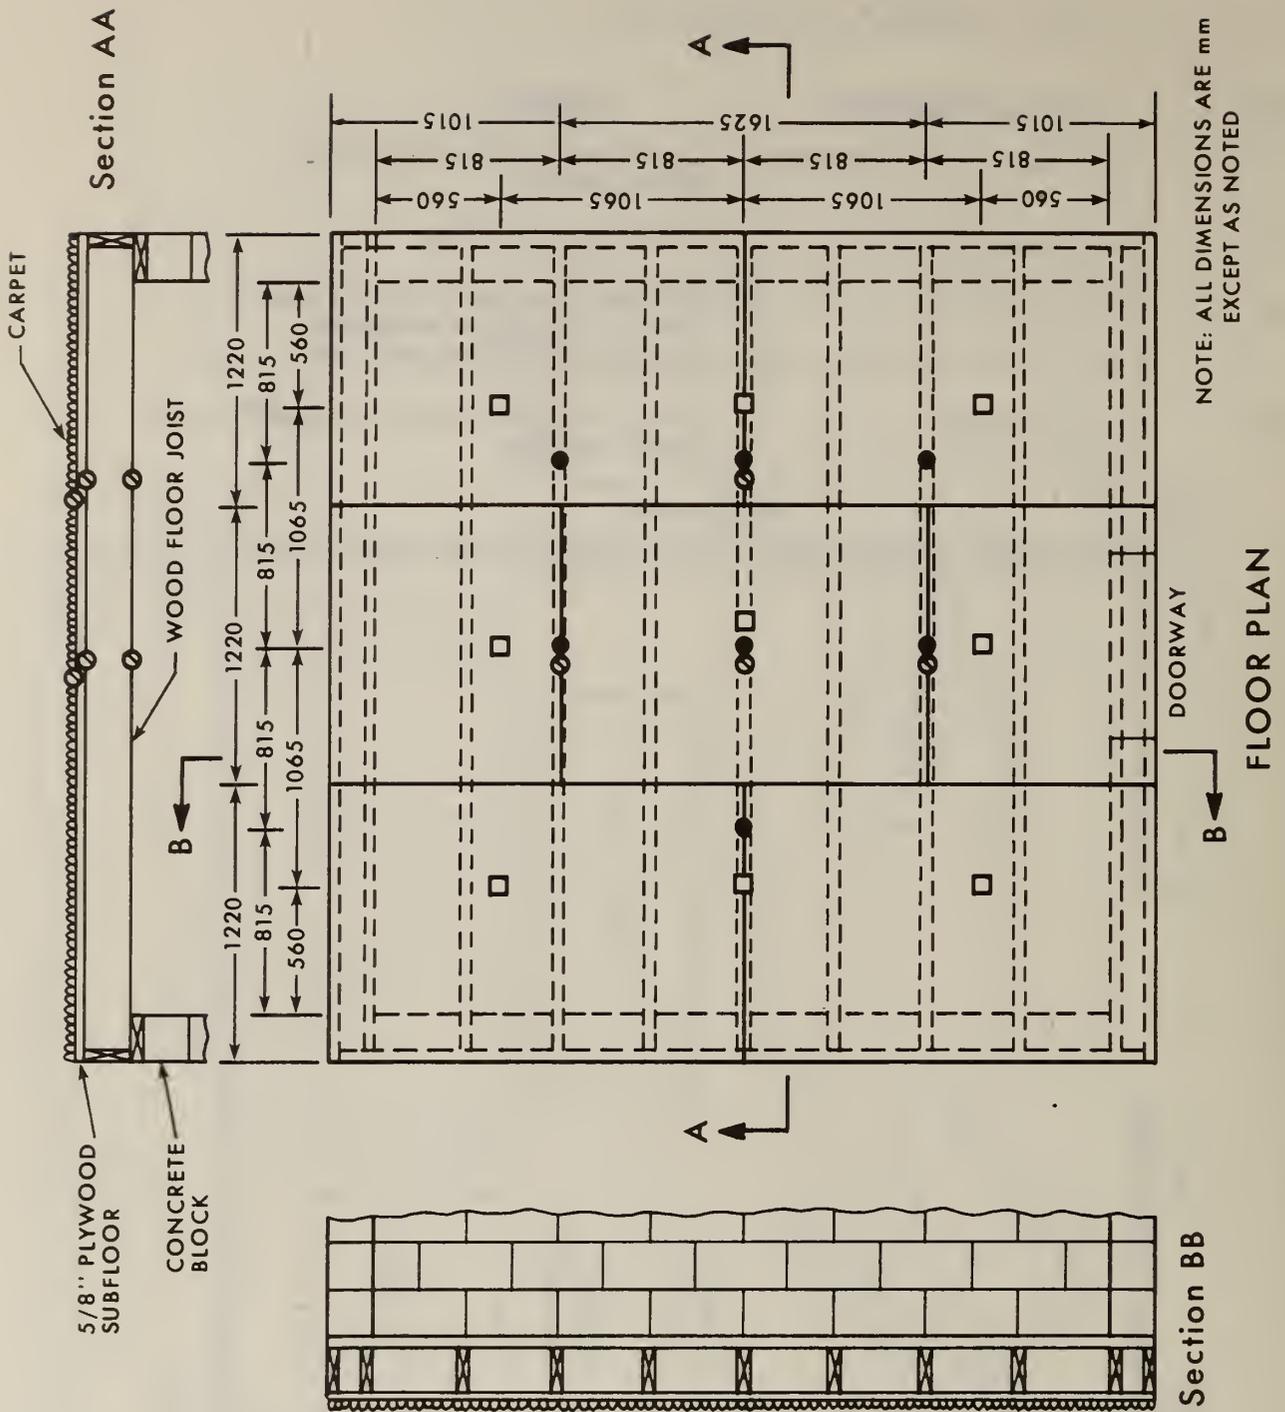
<u>Symbol</u>	<u>Type of Transducers</u>	<u>Locations</u>
○	Displacement Potentiometer	Center and quarter-points of floor joists
□	1 Thermocouple	On the top of carpet
⊙	3 Thermocouples	At the bottom and top of floor joist, and on the unexposed surface of plywood subfloor
⊗	1 Thermocouple (tests 5 to 7)	On the exposed surface of gypsum board ceiling.

Figure 2. Floor-Ceiling Assembly Construction and Instrumentation Layout for Test 1.

linear displacement potentiometers mounted on one wall of the test building. A total of 6 check points for each test structure were employed to provide the relative movement of the floor surface as shown in figures 2 to 6, 9, and 10.

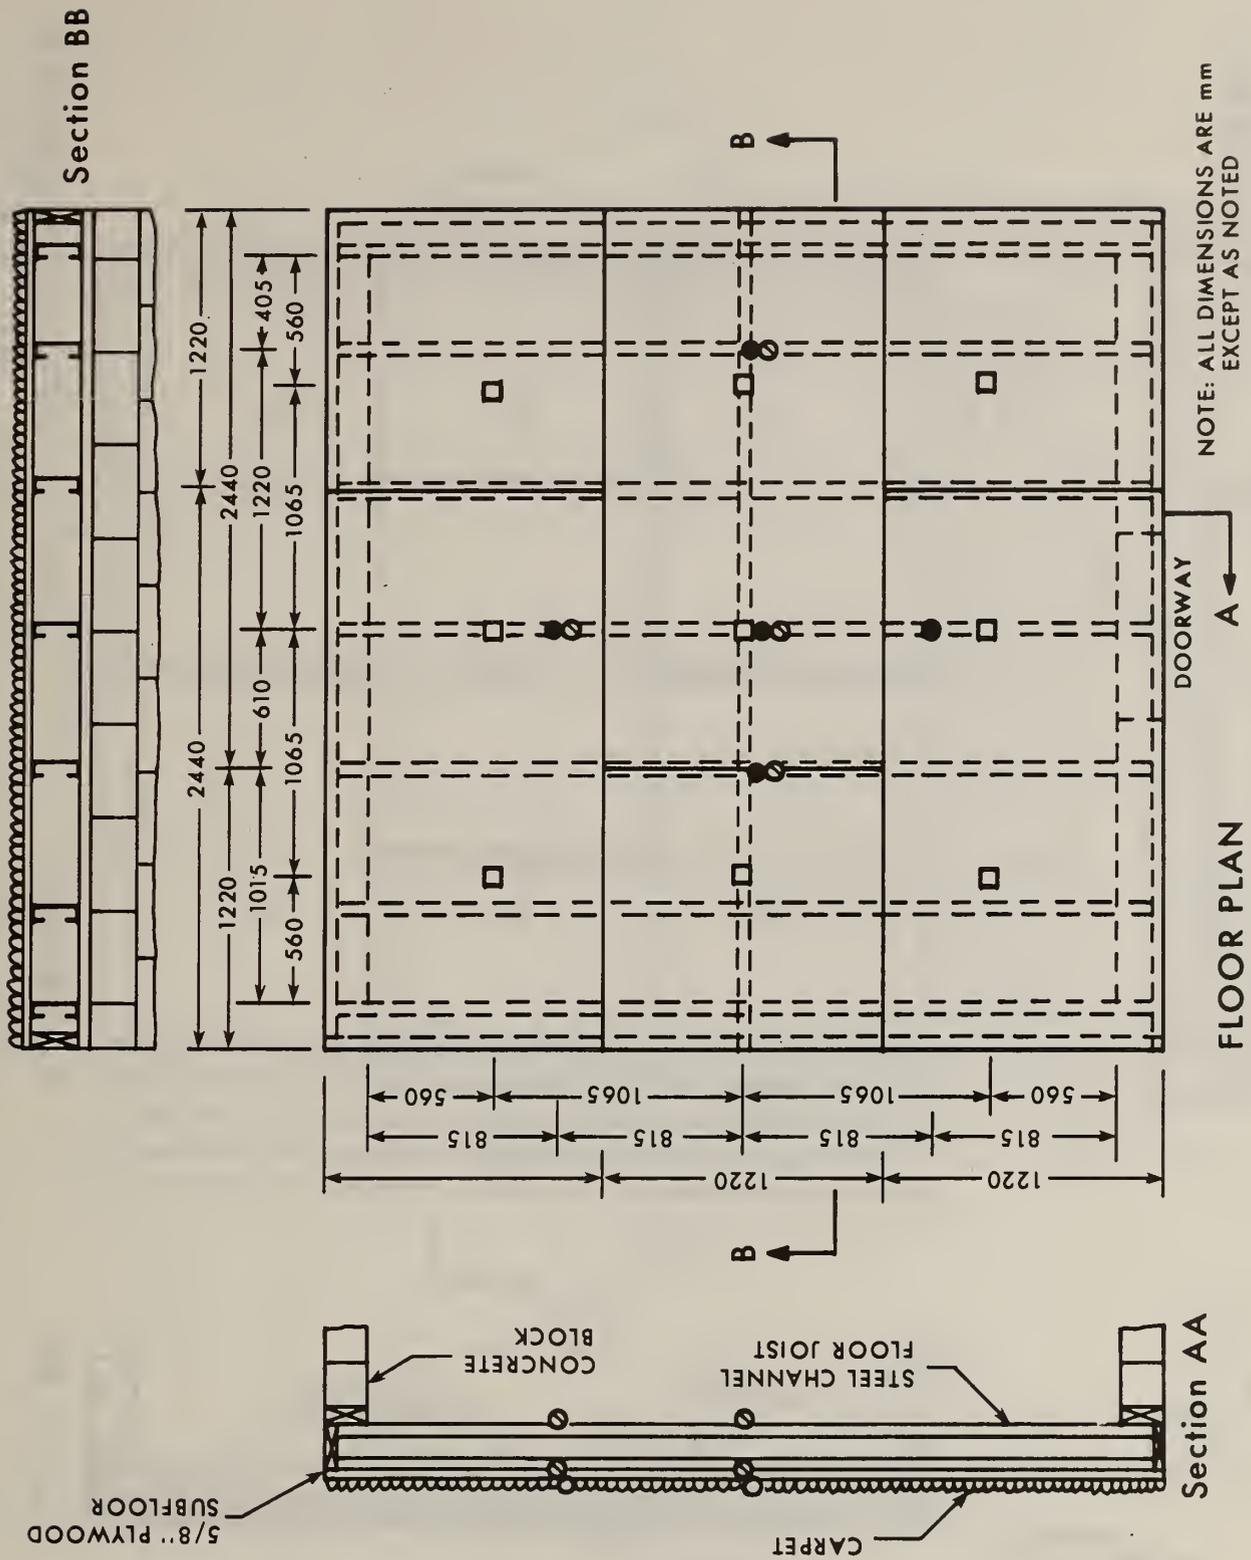
Figure 3. Floor-Ceiling Assembly Construction and Instrumentation Layout for Test 2.

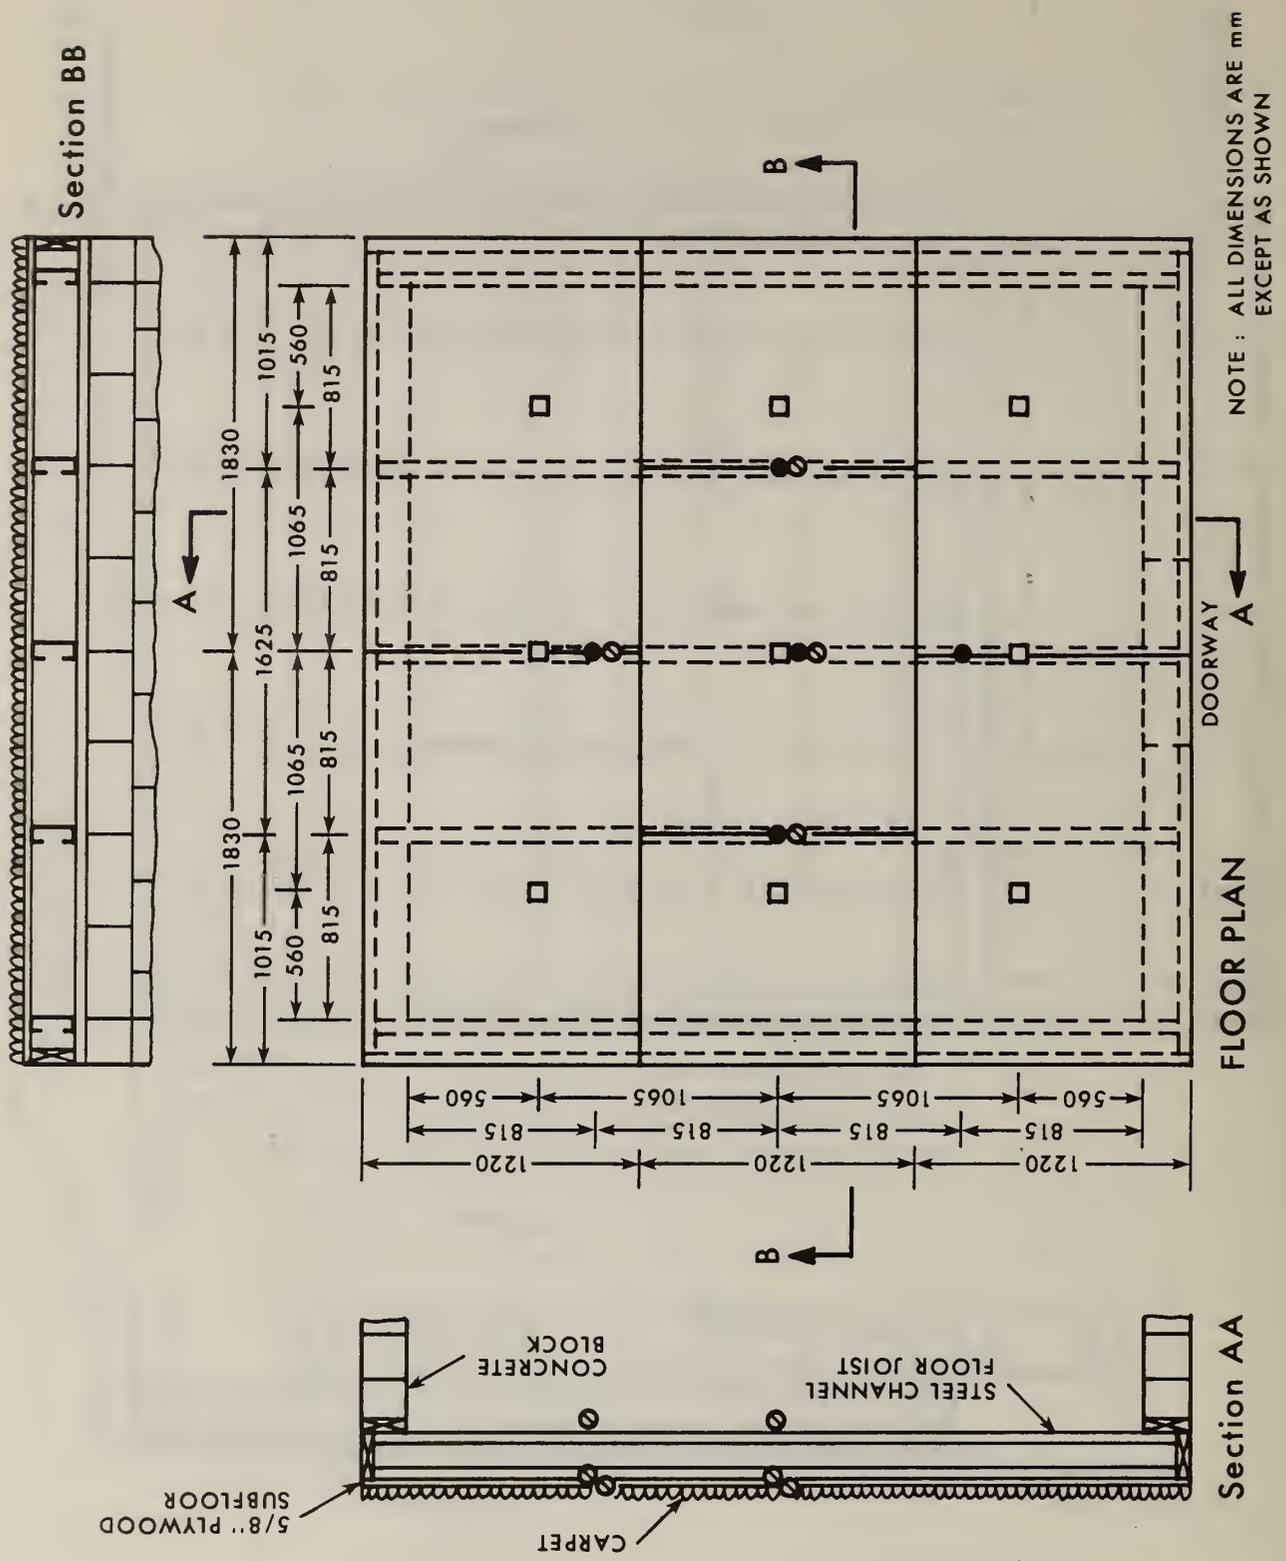
Figure 4. Floor-Ceiling Assembly Construction and Instrumentation Layout for Test 3.

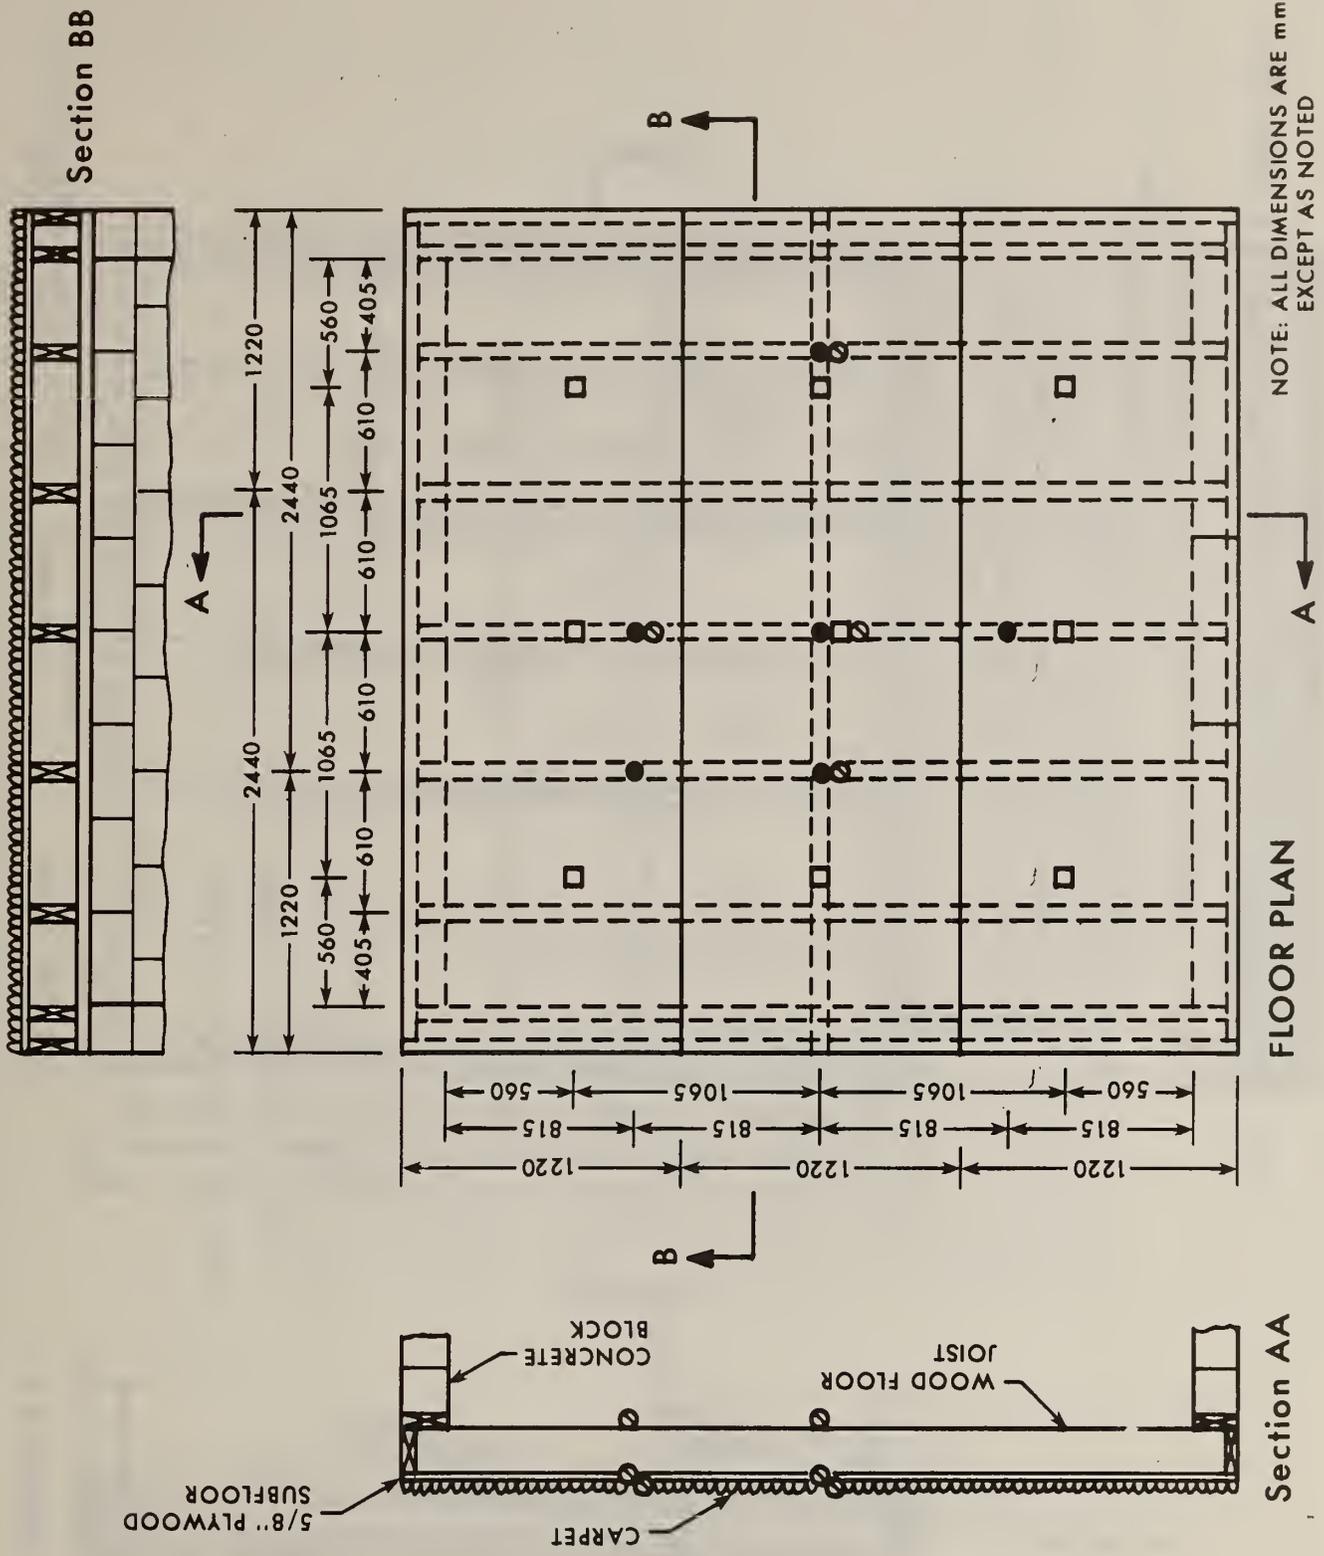
Figure 5. Floor-Ceiling Assembly Construction and Instrumentation Layout for Test 4.

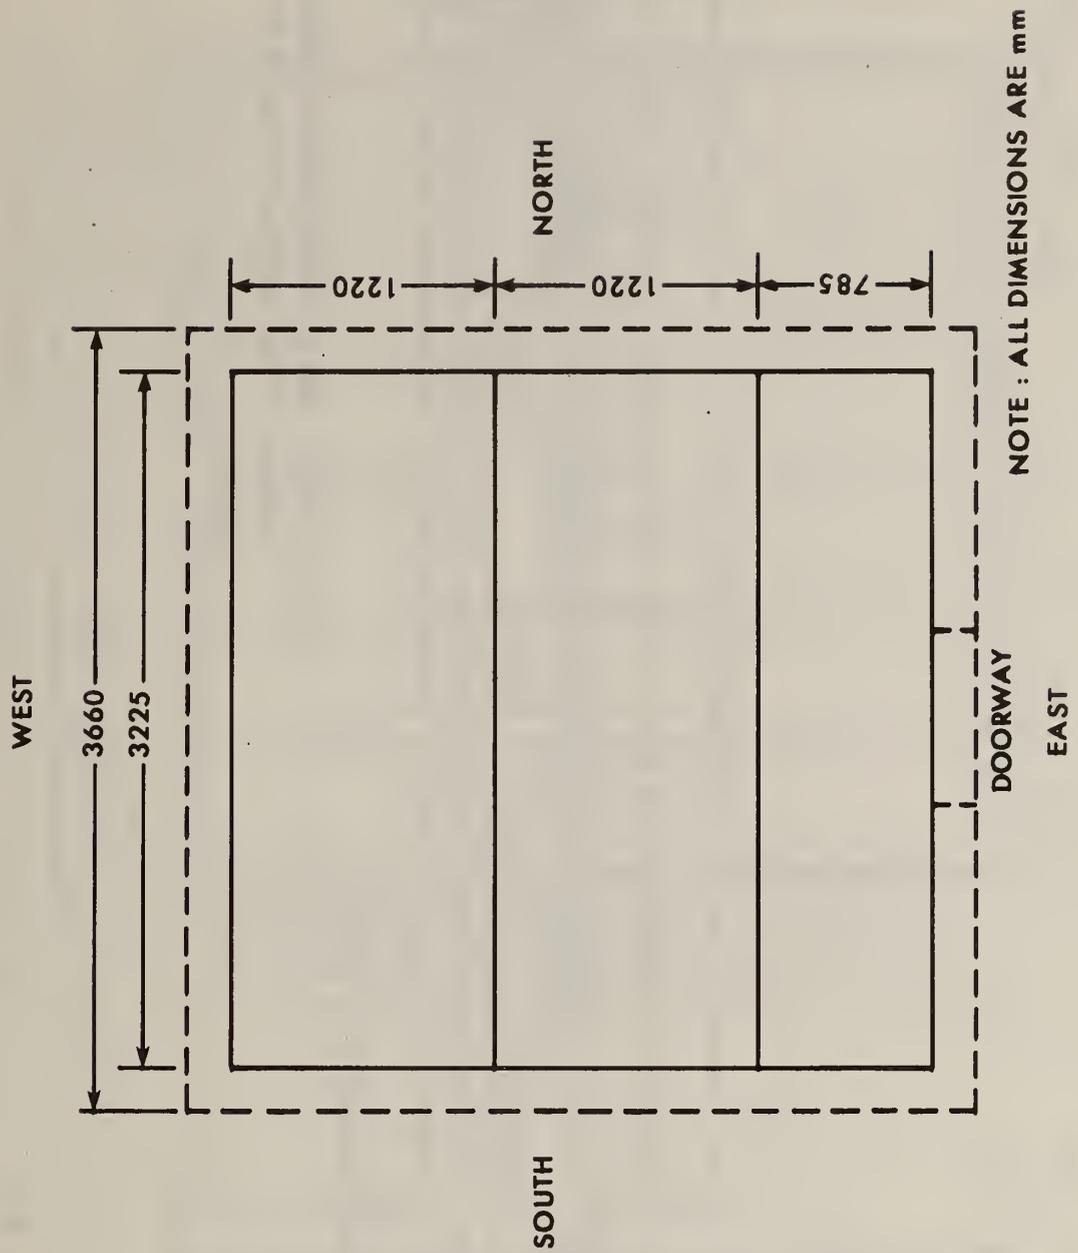
Figure 7. Floor Plan Showing Layout of Gypsum Board Ceiling for Tests 5 to 7.

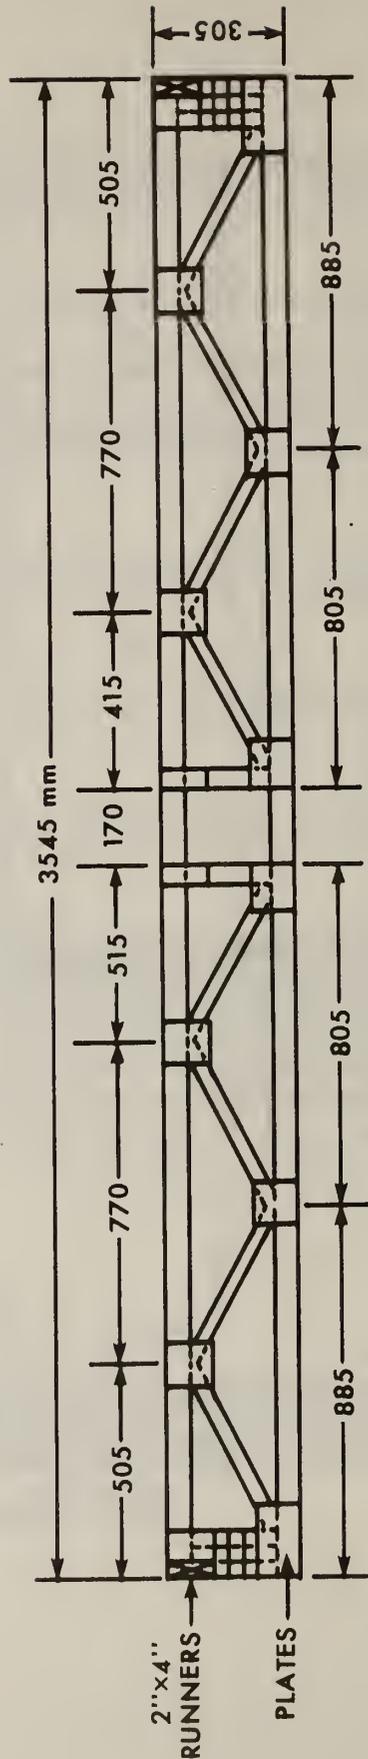
NOTE: PLATES - RONEL SERIES 5000 (20 GAUGE)
 LUMBER - TC, BC SOUTHERN PINE #2 2"x4" K.D.
 WEBS #3

Figure 8. Details of Wood Truss Construction for Test 6.

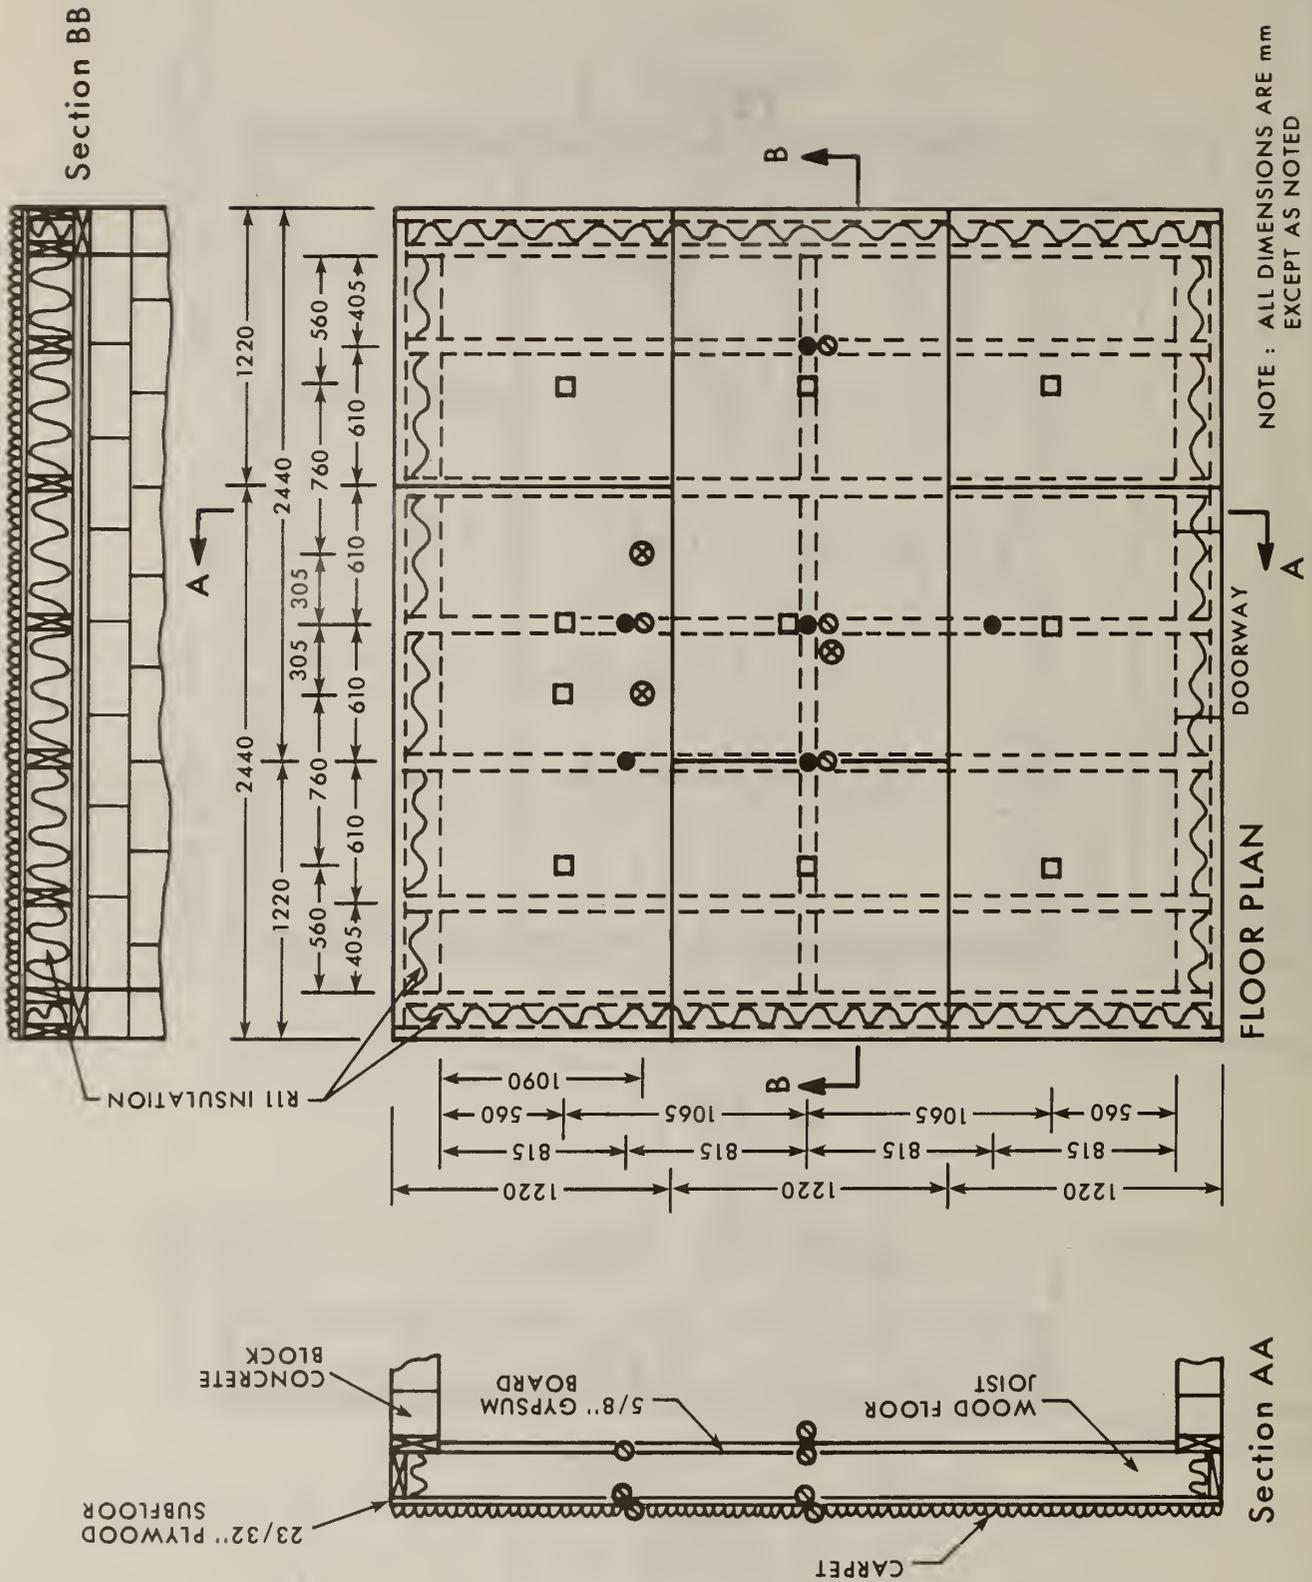
Figure 10. Floor-Ceiling Assembly Construction and Instrumentation Layout for Test 7.

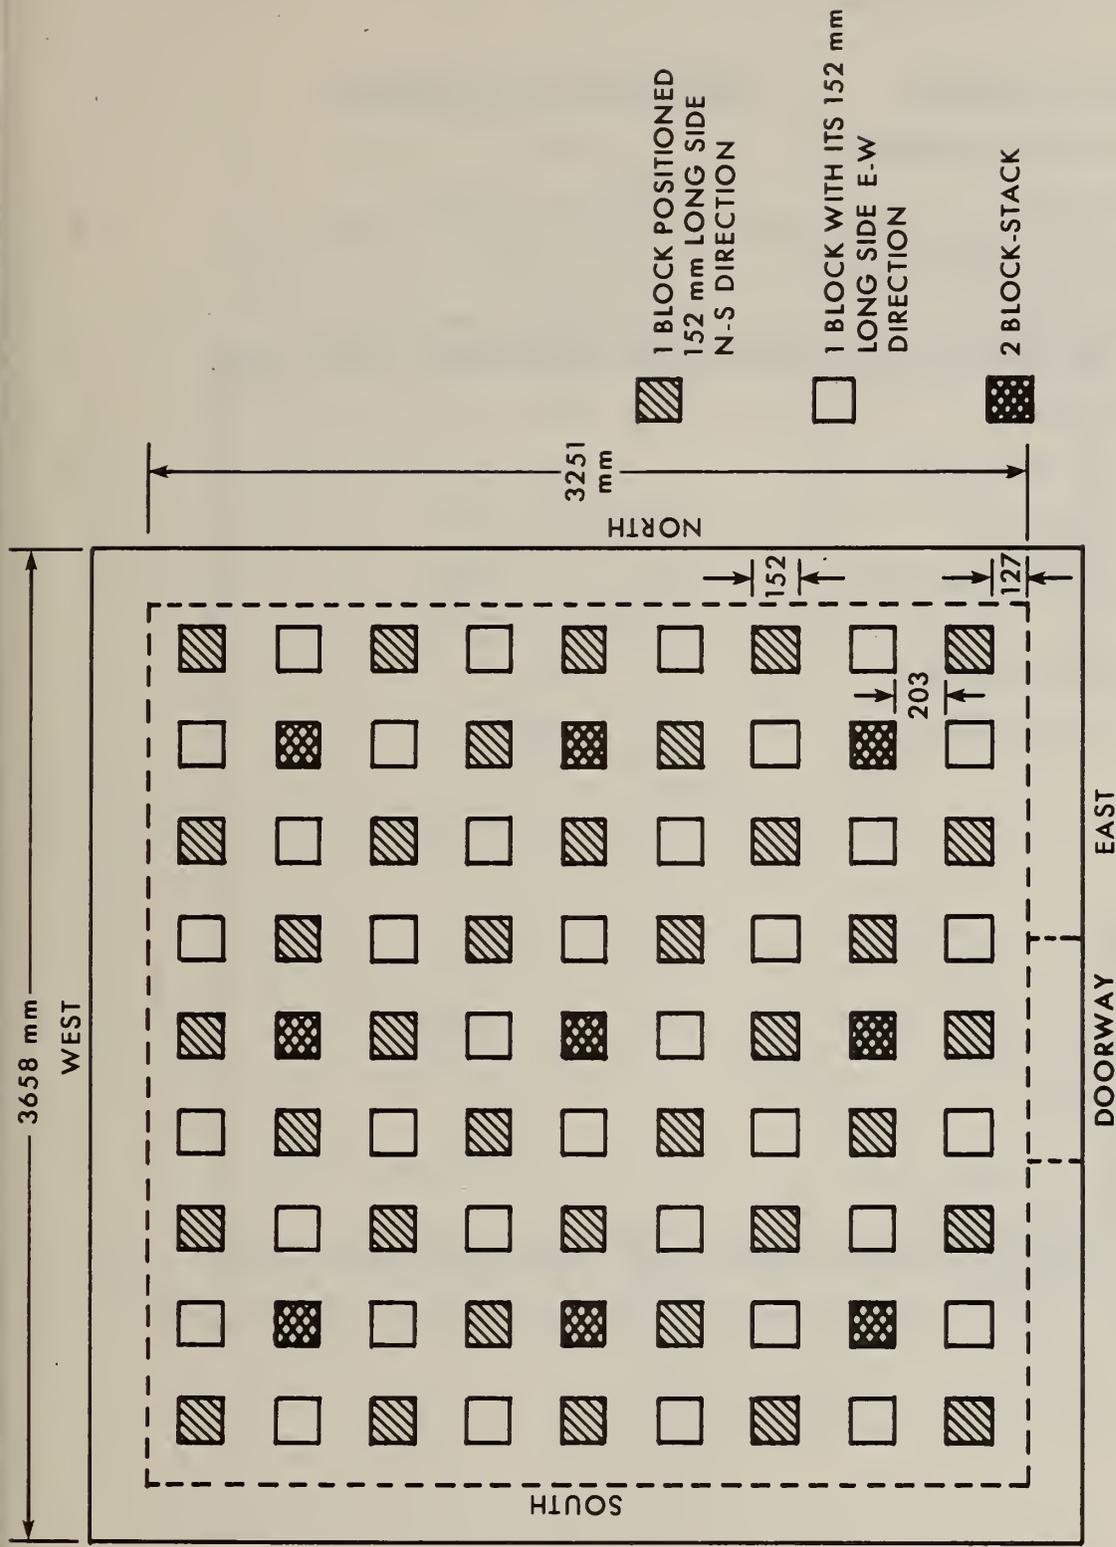
Figure 11. Layout of Steel Blocks Distributed Uniformly Over the Top of Floor Assembly for Test 7.

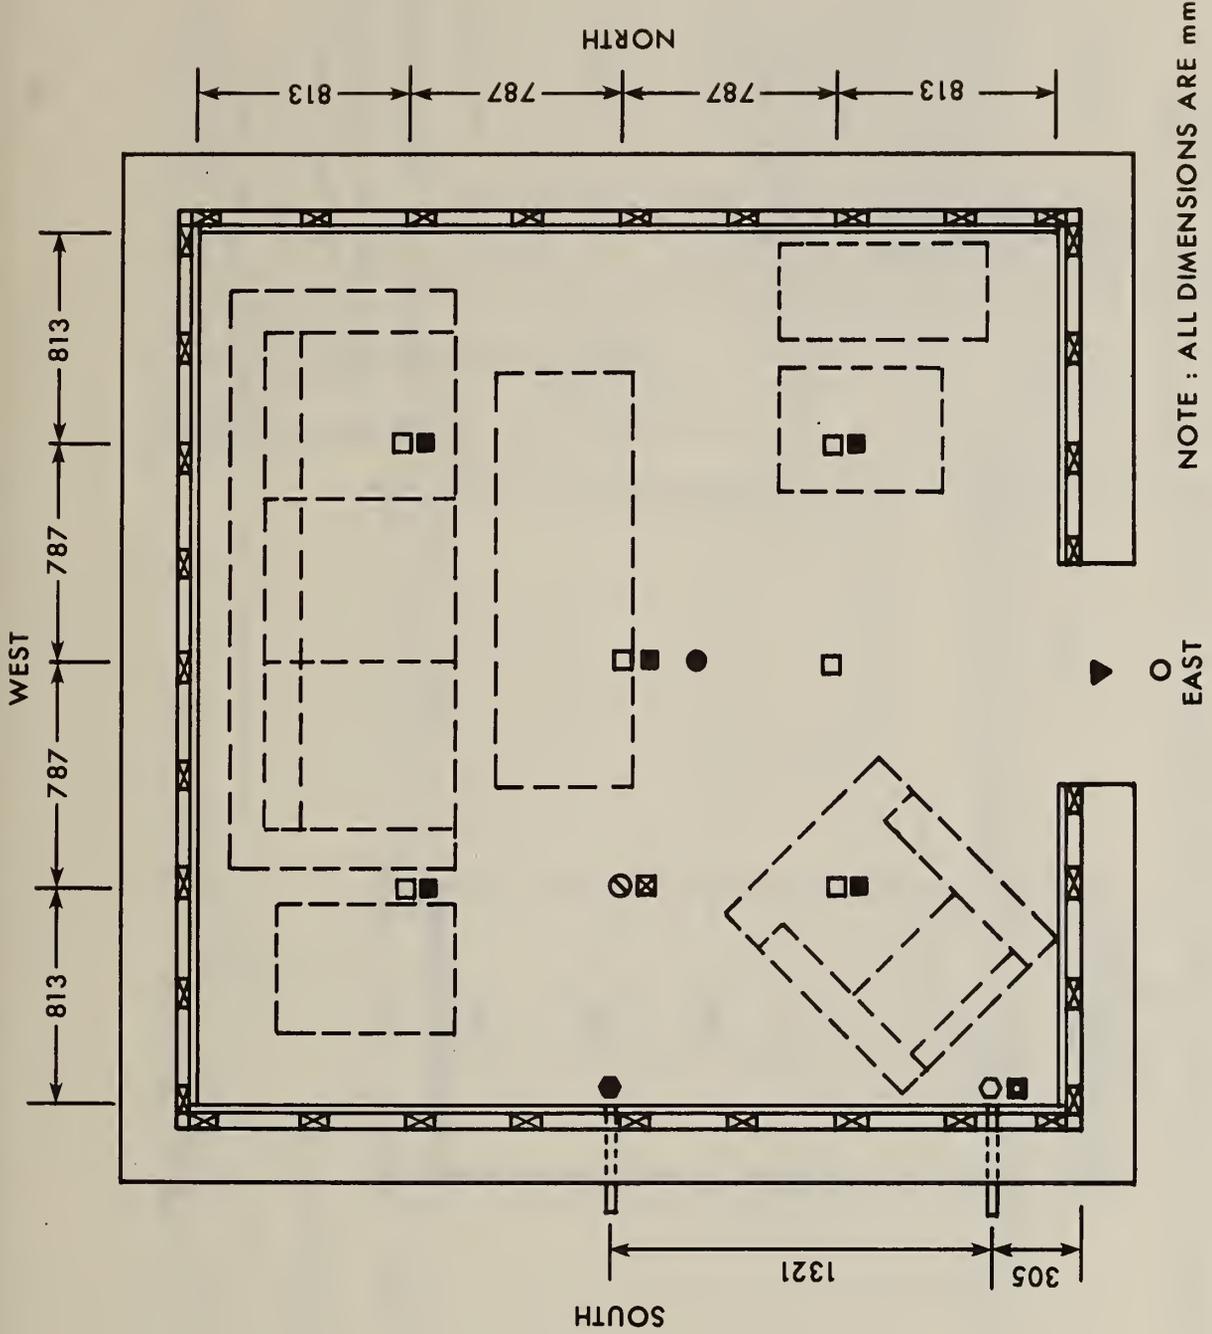
<u>Symbol</u>	<u>Type of Transducers</u>	<u>Distance Below the Ceiling (m)</u>
□	1 Fast Response Thermocouple	0.61
■	3 Thermocouples	0.30, 0.61, 1.22
⊙	2 Fast Response Thermocouples	0.61, 1.22
⊗	7 Thermocouples	0.025, 0.15, 0.30, 0.61, 1.22, 1.70, 2.21
◻	1 Thermocouple	0.61
●	1 Total Heat Flux Gauge	2.30
▼	3 Gas Sample Ports	0.36, 0.66, 1.04
○	6 Static Pressure Probes	0.10, 0.30, 0.61, 1.22, 1.70, 2.13
●	1 Static Pressure Probe	0.10
○	1 Total Heat Flux Gauge	1.30

Figure 12. Plan View of the Test Room Showing Instrumentation Layout

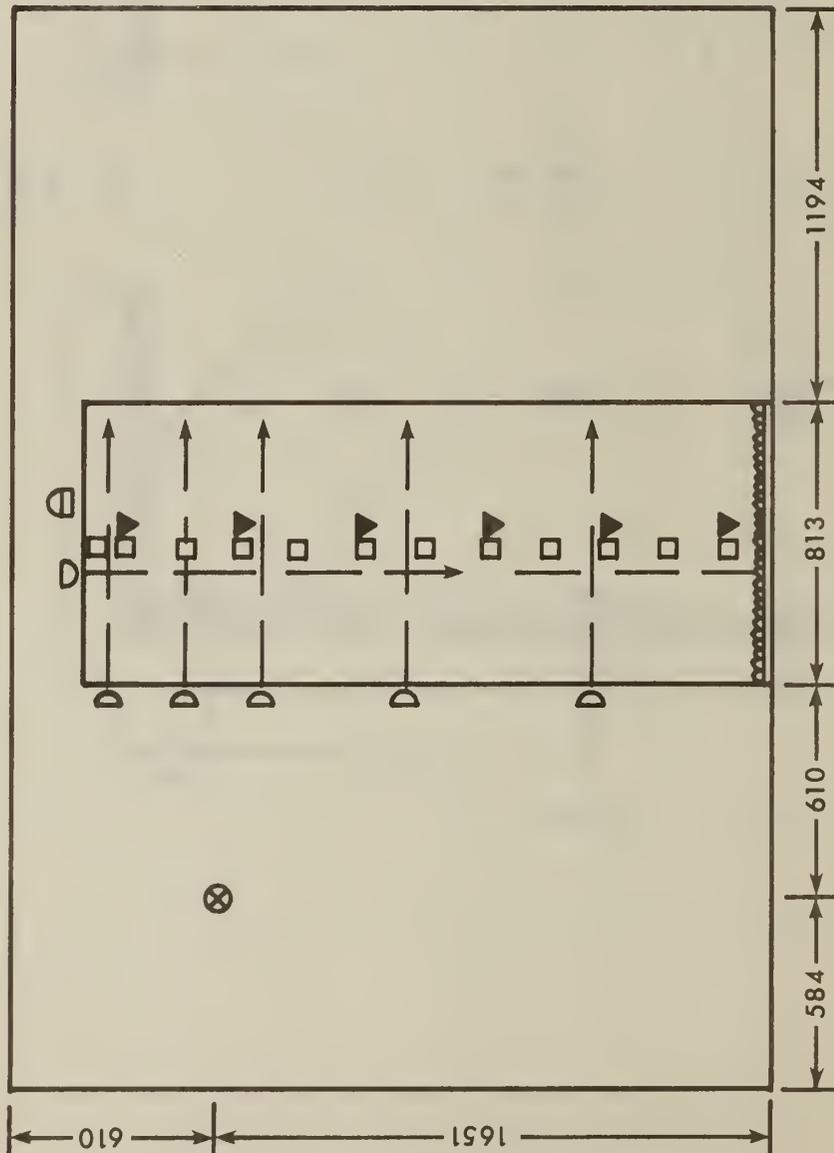
- DOUBLE-WIRE THERMOCOUPLE IN DOORWAY
- ▽ BI-DIRECTIONAL VELOCITY PROBE
- D HORIZONTAL SMOKE METER
- VERTICAL SMOKE METER
- ⊖ INCLINED SMOKE METER
- ⊗ DOUBLE-WIRE THERMOCOUPLE ON EAST PLYWOOD WALL

Figure 13. Instrumentation Layout at the Doorway Opening

The horizontal velocities of the air entering and leaving the fire room through the doorway opening were monitored with 6 bi-directional flow probes in conjunction with variable reluctance differential pressure transducers and carrier demodulators. These probes were installed normal to the plane of the opening along its vertical centerline and located at 0.13, 0.48, 0.84, 1.19, 1.55, and 1.91 m from the top of the doorway, as illustrated in figure 13.

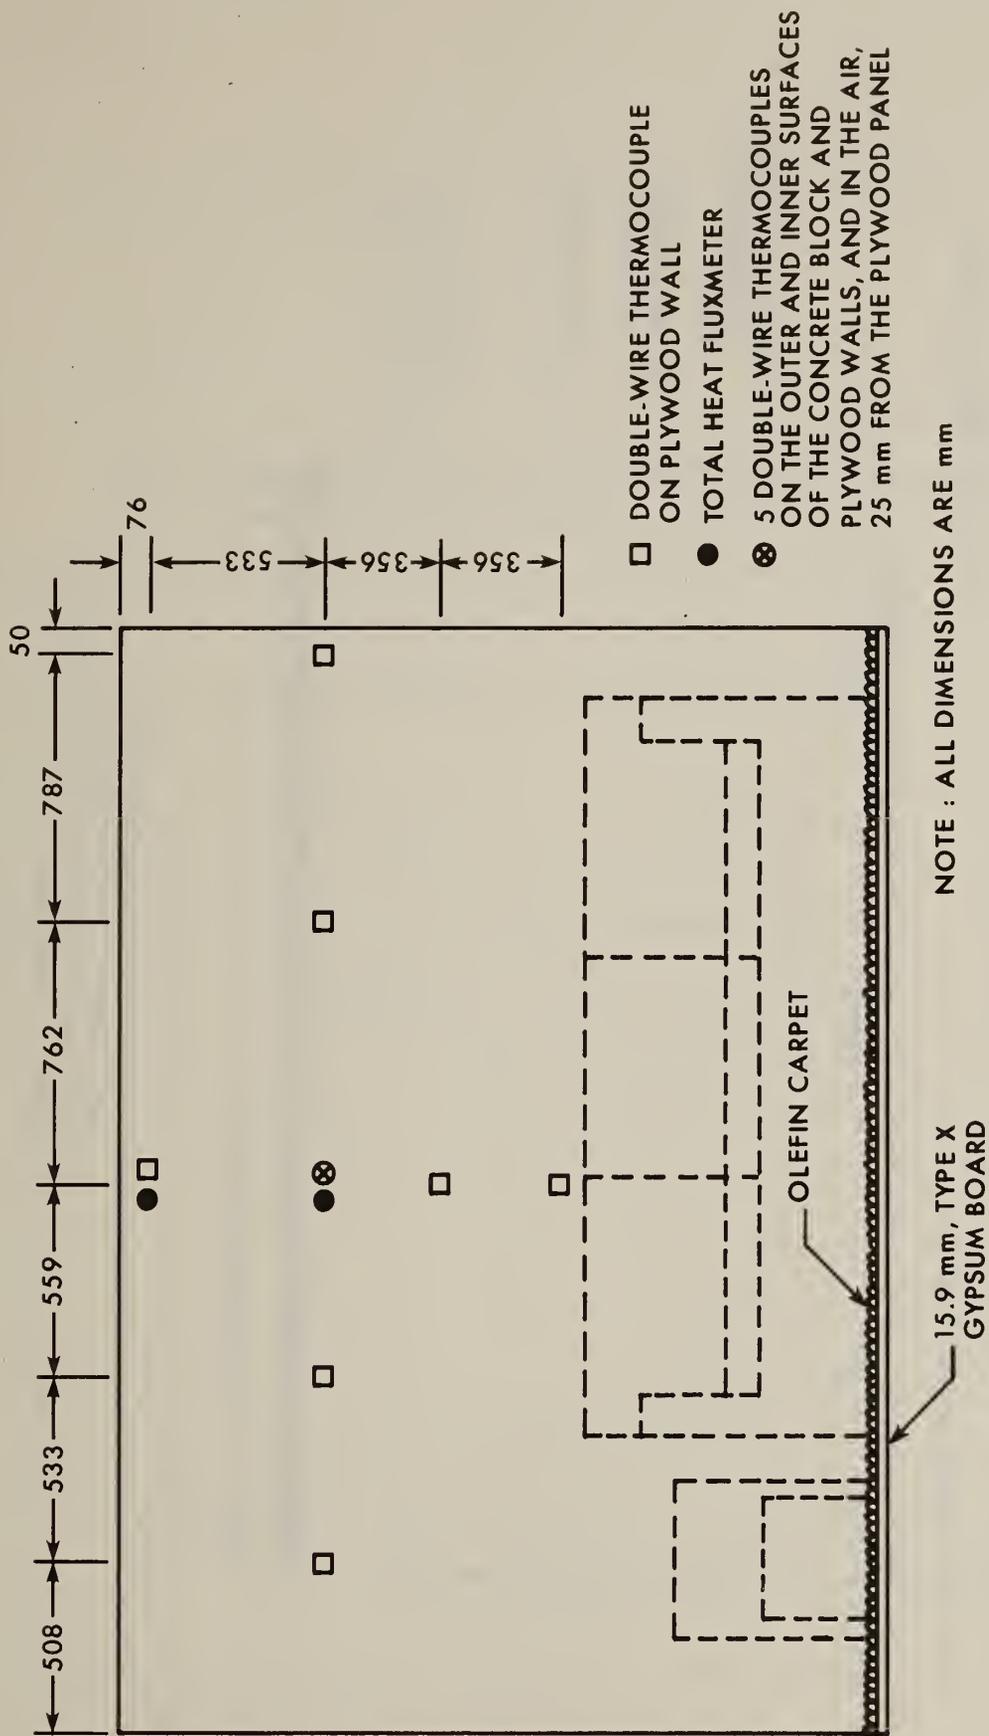
Figure 14. Instrumentation Layout-View of West (Back) Wall Showing Wall Thermocouples and Heat Flux Meters

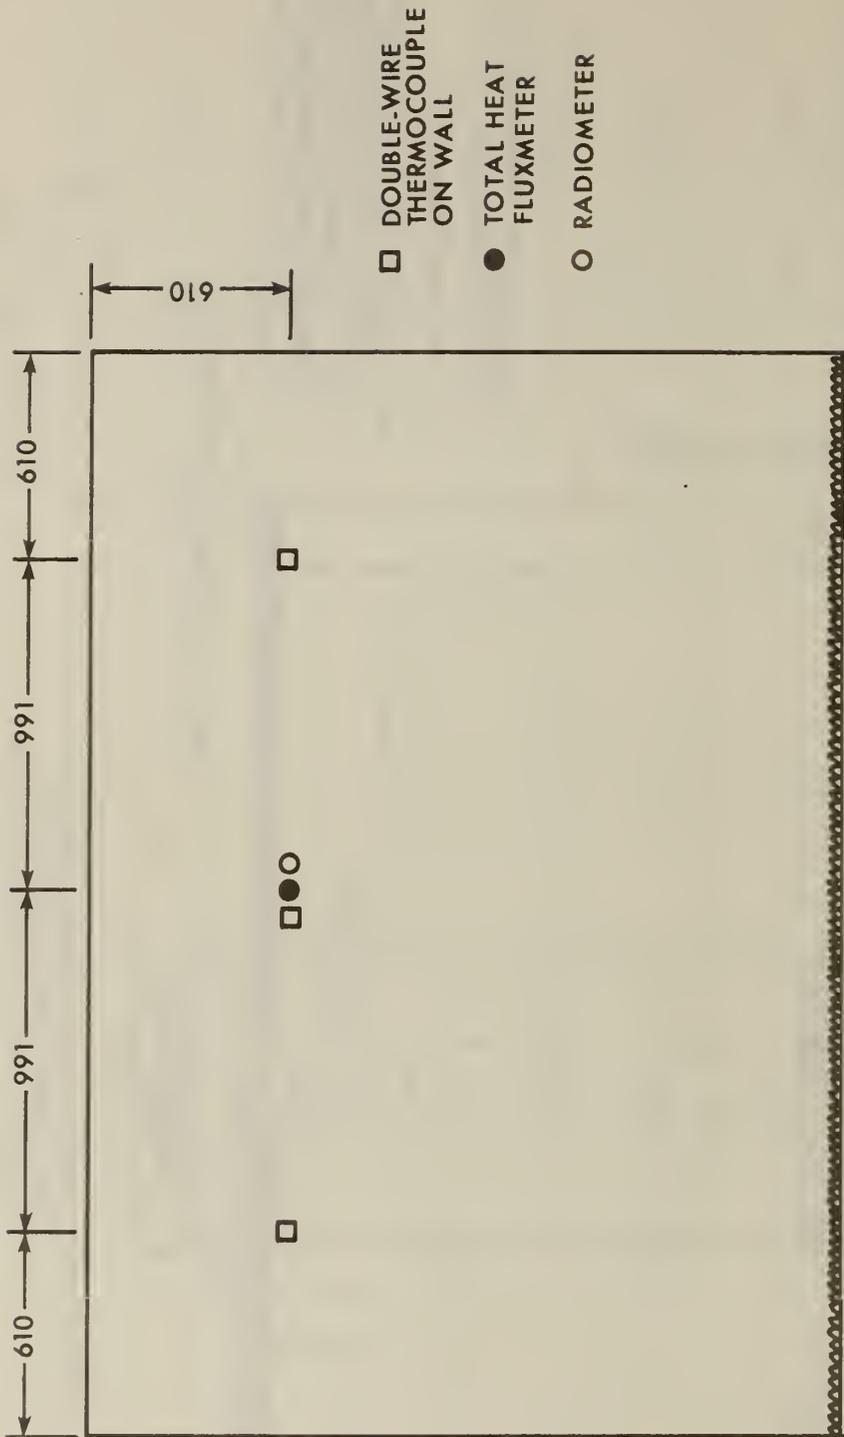
- DOUBLE-WIRE THERMOCOUPLE ON WALL
- TOTAL HEAT FLUXMETER
- RADIOMETER

Figure 15. Instrumentation Layout-View of South Plywood Wall Showing Wall Thermocouples, Total Heat Flux Meter and Radiometer

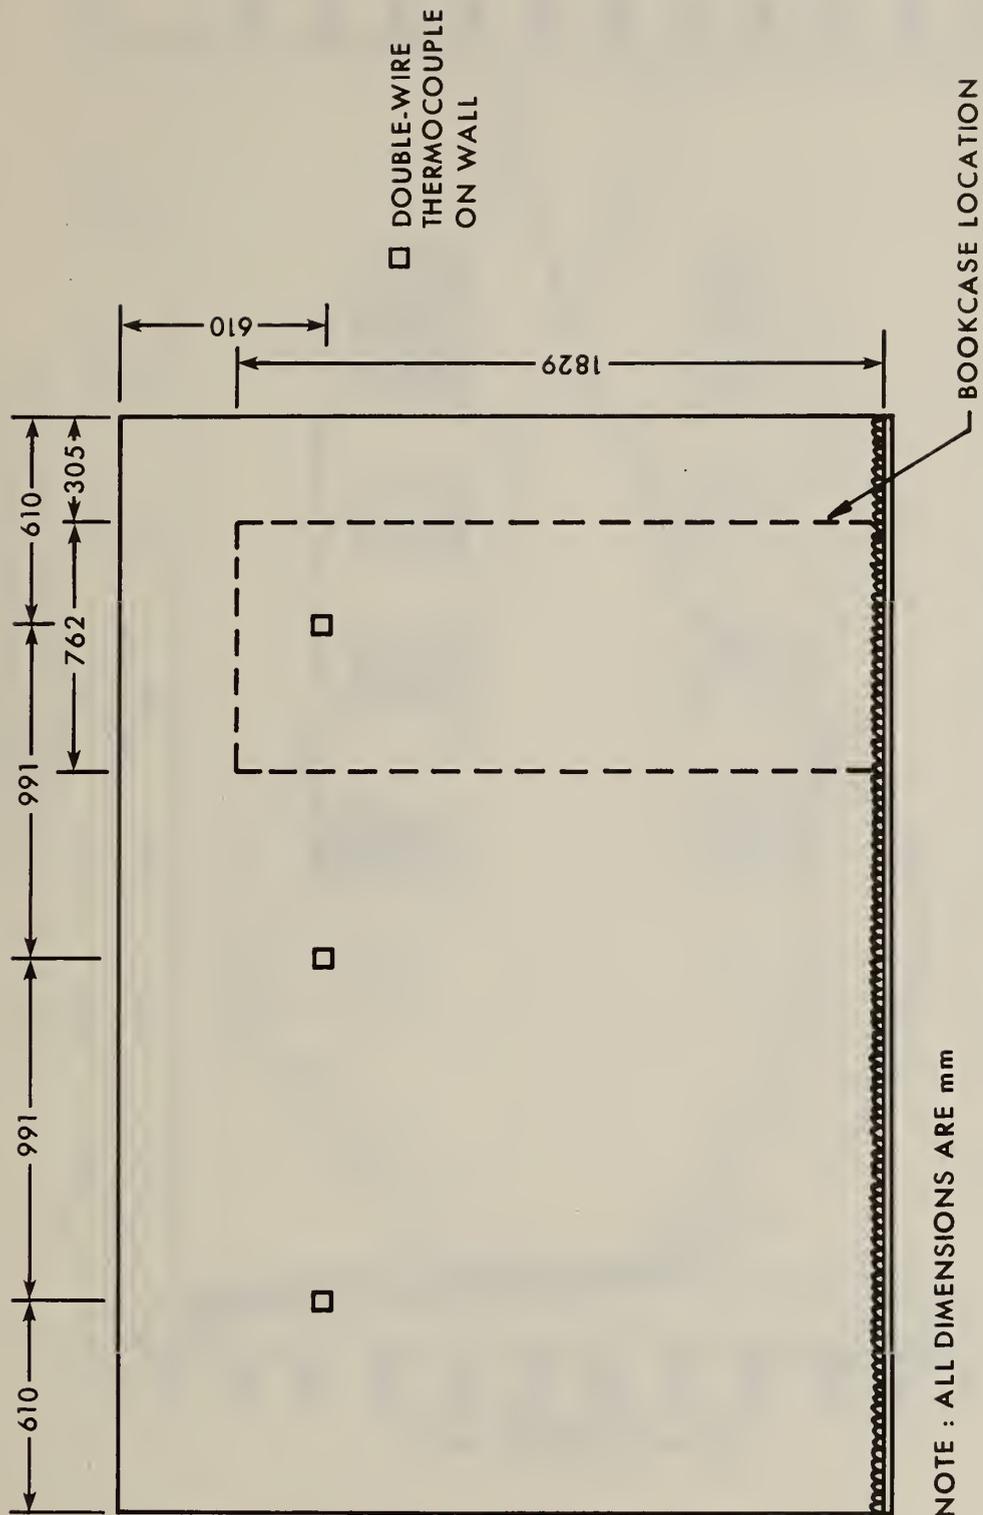
Figure 16. Instrumentation Layout-View of North Plywood Wall Showing Wall Thermocouples
