Fire Performance of Selected Residential Floor Constructions Under Room Burnout Conditions

J. B. Fang

Center for Fire Research
National Engineering Laboratory
National Bureau of Standards
U.S. Department of Commerce
Washington, DC 20234

Interim Report

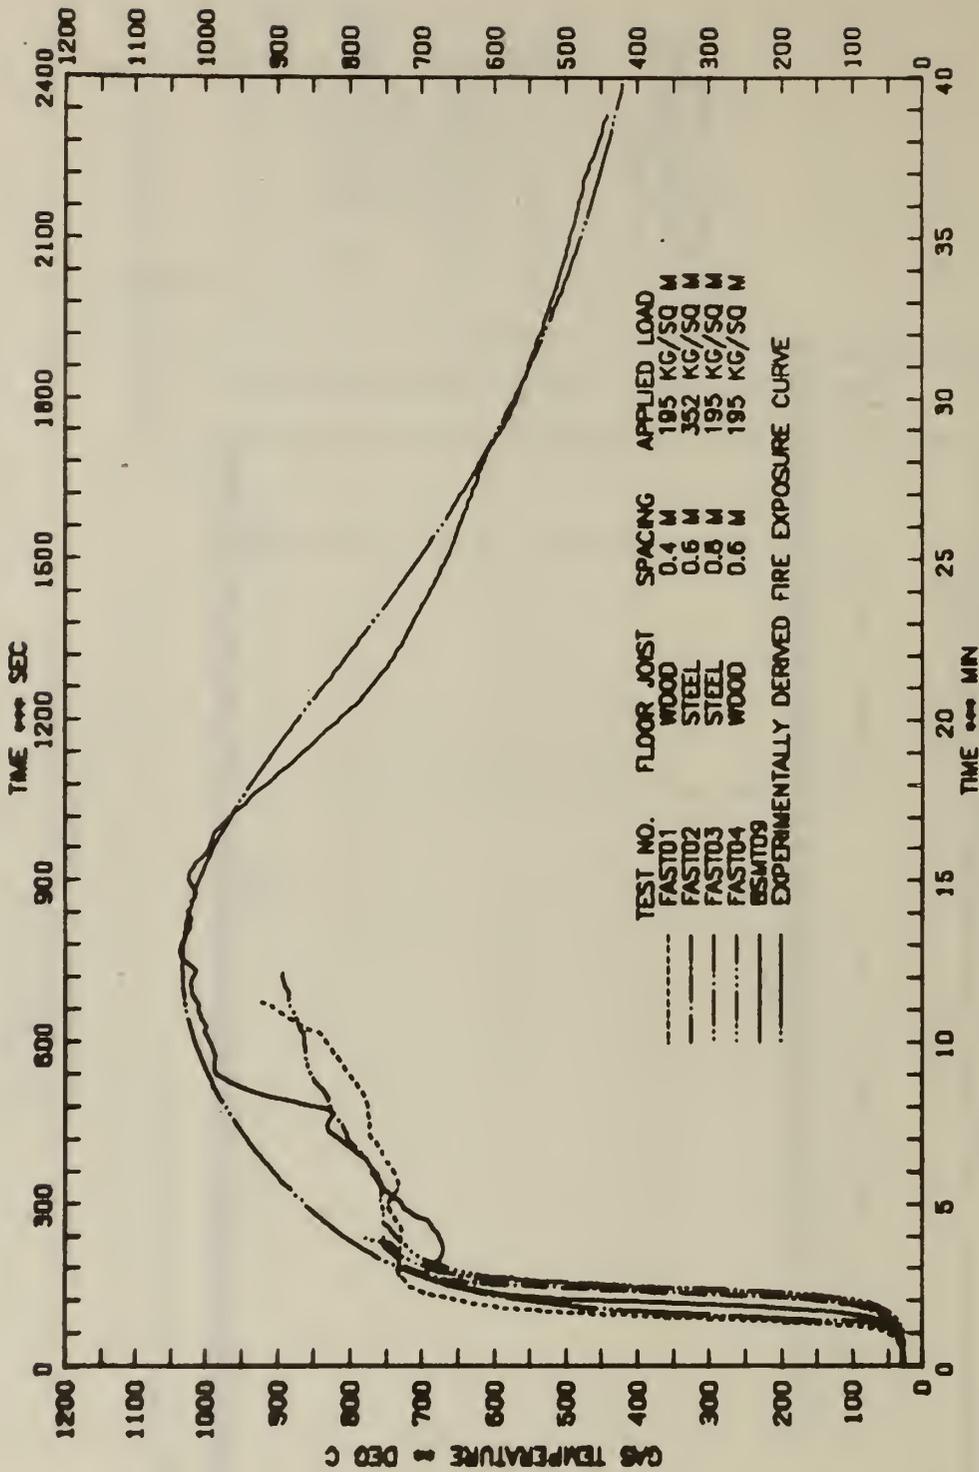
Figure 17. Comparison of Average Upper Room Gas Temperature for Tests 1 to 4 and Experimentally Derived Fire Exposure Curve

Time variations of the average gas temperature in the upper part of the fire room for all the tests conducted are shown in figures 17 and 18 along with the newly developed fire exposure curve. The derived fire exposure curve was obtained by approximating the experimental temperature versus time curve obtained in test 9 from a series of basement room fire tests [2] with a smooth curve. In this particular test, the 3.2 x 3.2 m burn room was finished with plywood paneling walls and gypsum board ceiling, and furnished with a typical loading of 23 kg/m² of domestic furniture. The newly developed

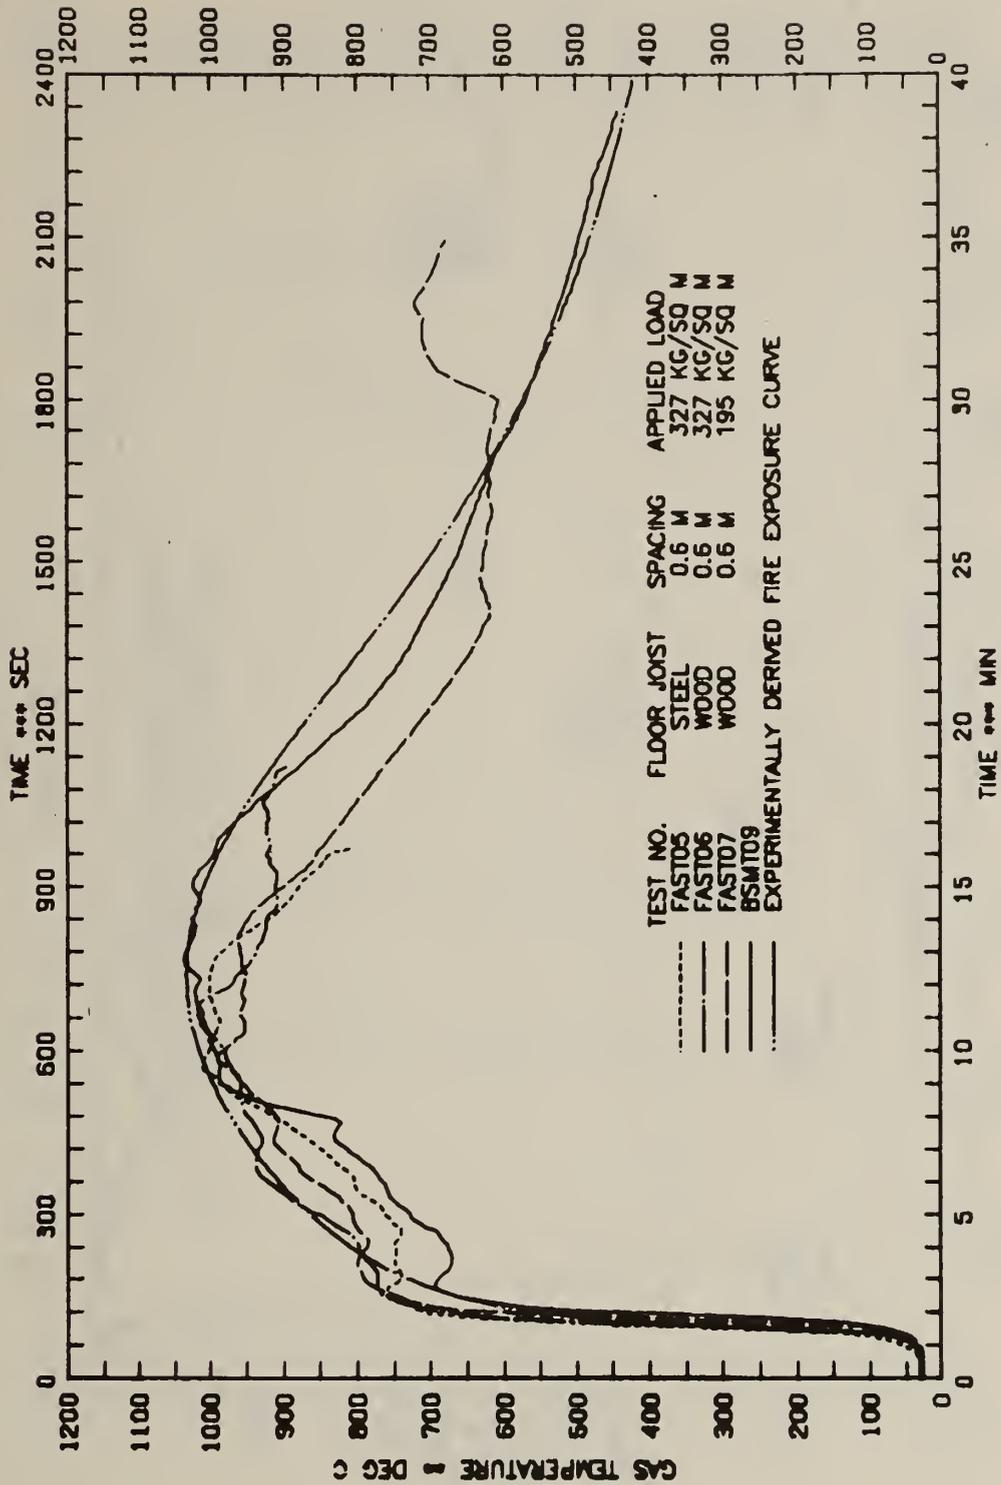
Figure 18. Comparison of Average Upper Room Gas Temperature for Tests 5 to 7 and Experimentally Derived Fire Exposure Curve

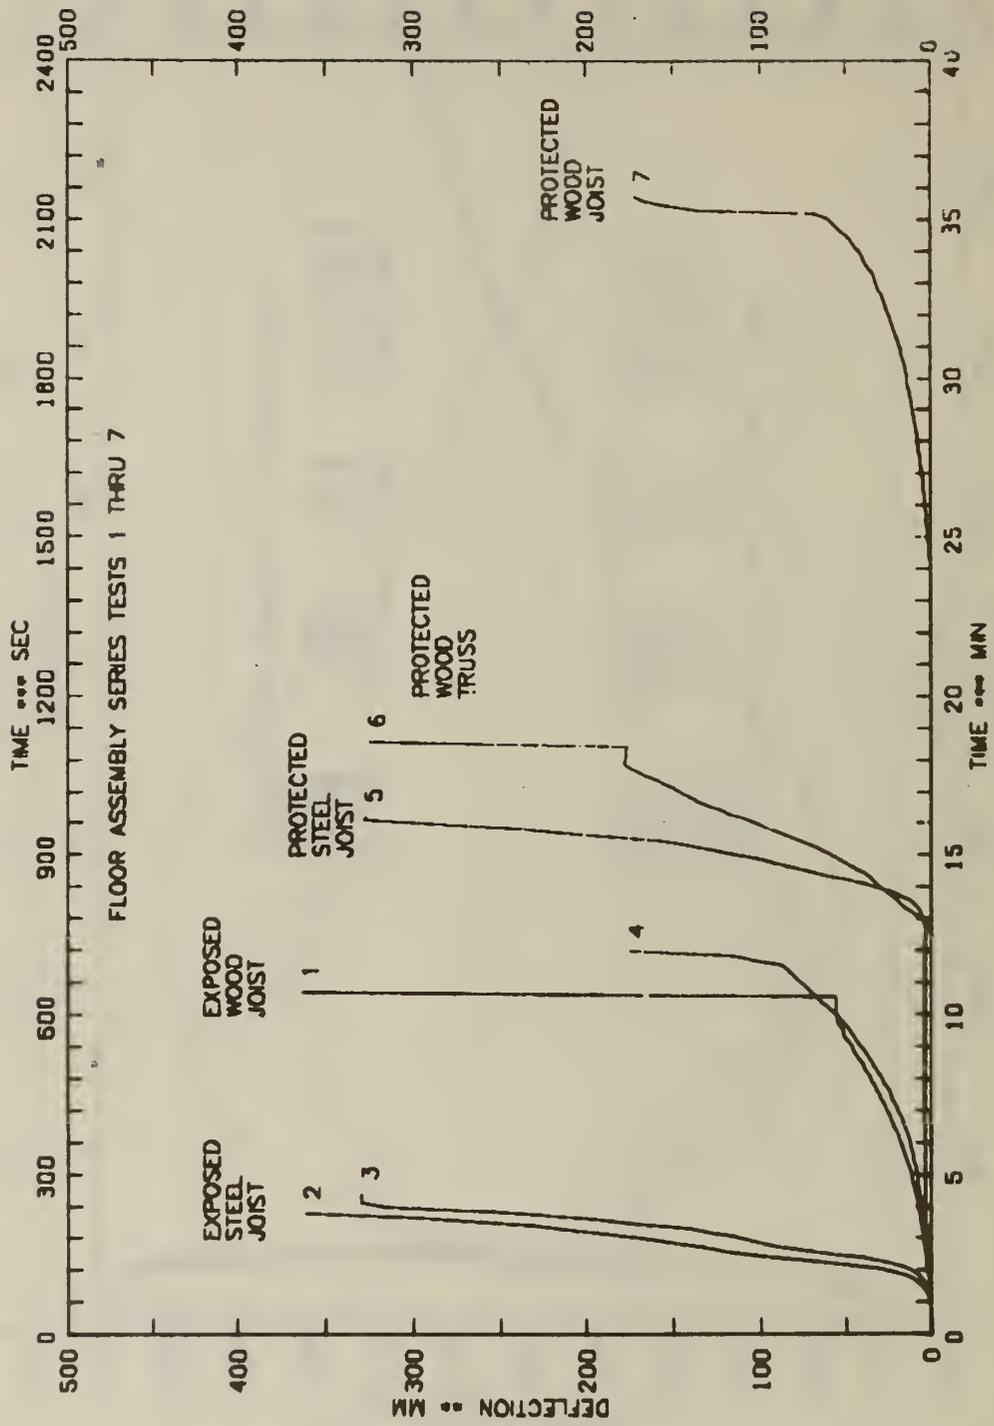
Figure 19. Floor Deflection Measured at the Center of the Test Assembly

The time variations of the floor deflections measured at the center of the test assembly for individual tests are shown in figure 19. As shown, the steel framed floors (tests 2, 3, and 5) had similar deflection curves where the deflection became significant only near the time of structural

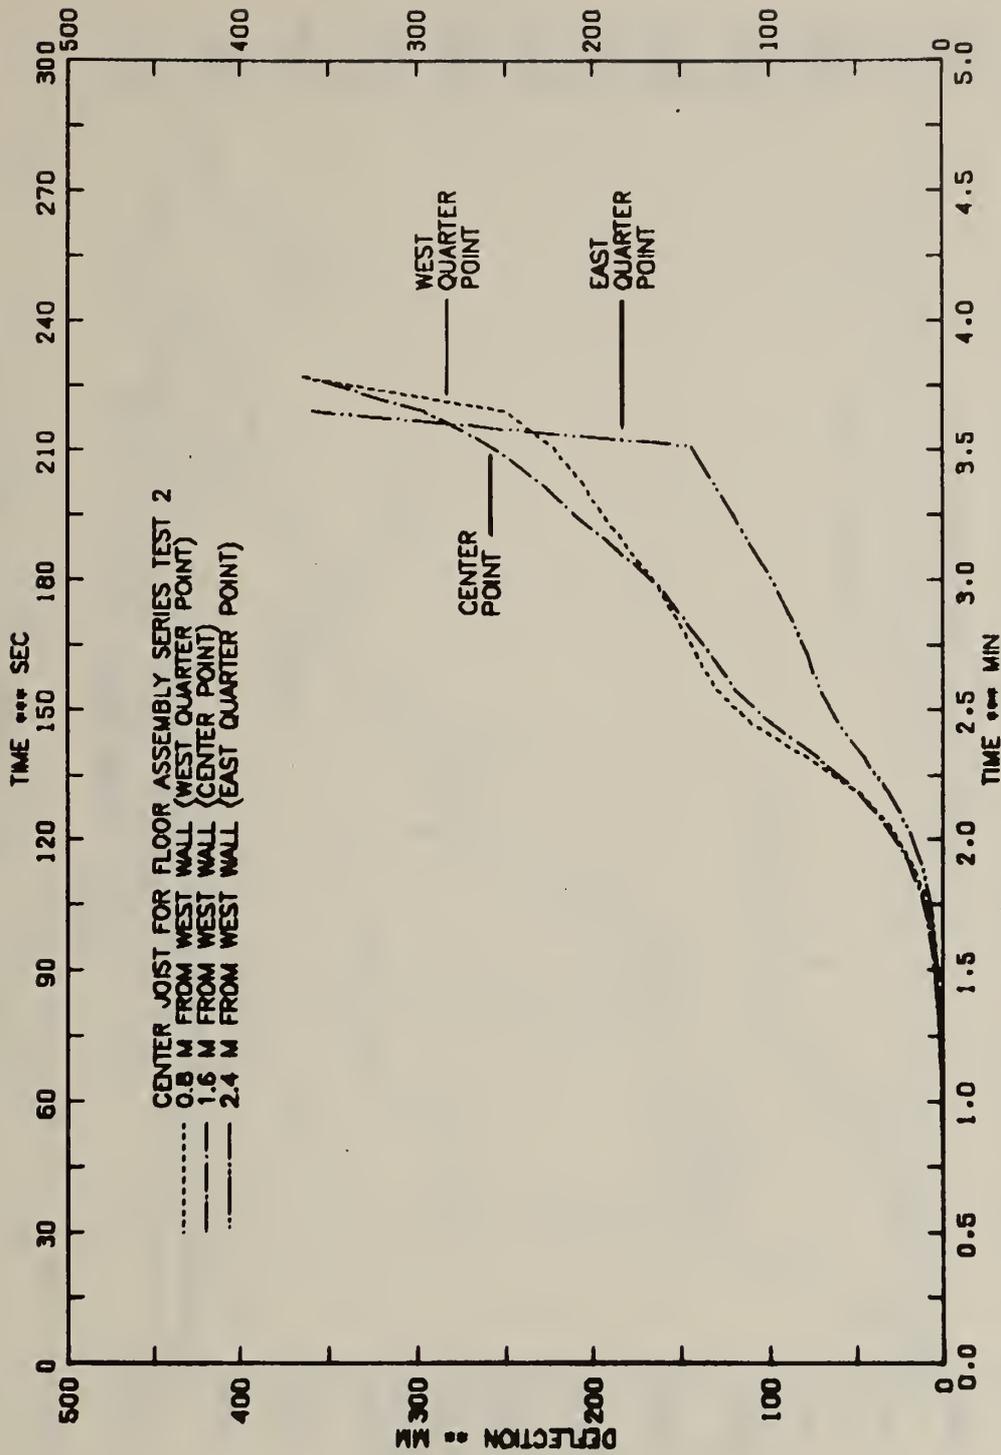
Figure 20. Floor Deflections at Center and Quarter Points Along the Center Joist at Various Times for Test 2

Figure 20 illustrates the floor deflections at the center and the quarter points along the centrally located joist at various times for test 2. It can be seen from the figure that the rates of deflections at the center and the west quarter point increased more rapidly than that at the east quarter point, although the temperature differences in the room at these locations were less than 60°C. The temperatures developed in the steel joist at the sections of both quarter points were found to be approximately the same, but the deflection was substantially different, especially at times of imminent collapse of the joist. The reason for this wide variation in deflection during the course of the fire is not known. (Note that the west quarter point was over the sofa where the exposure might be greater for the first 4 minutes.)

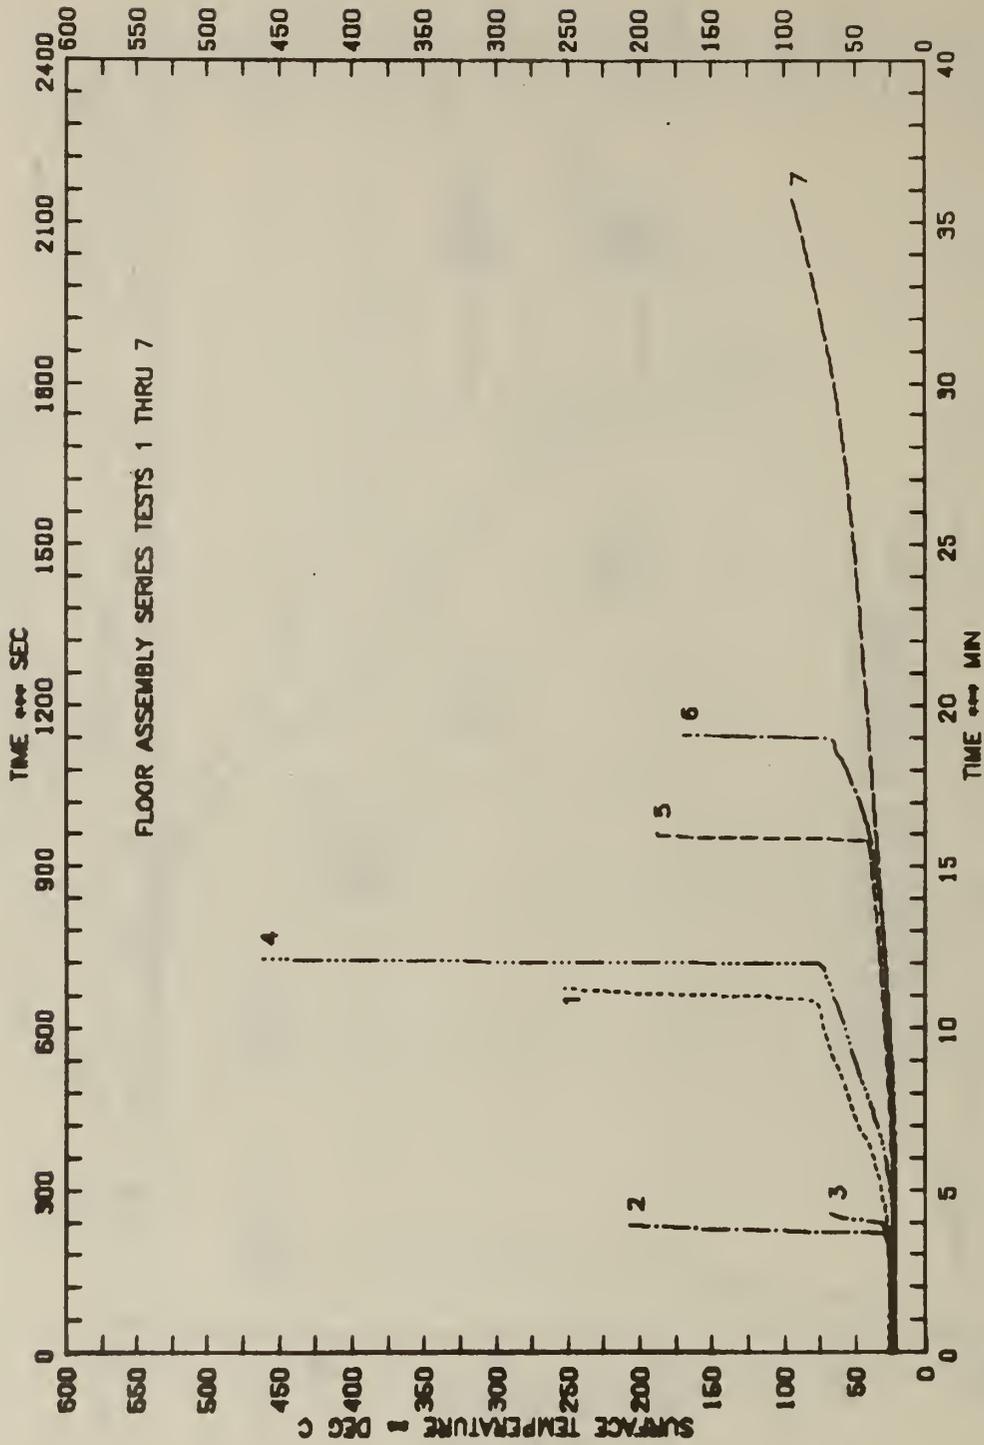
Figure 21. Time Variations of Average Surface Temperatures on the Unexposed Side of Test Assembly for all Tests Performed

The average surface temperatures on the unexposed side of the floor-ceiling assembly as a function of time for all the tests performed are shown in figure 21. These average temperatures were derived from averaging the readings of 10 thermocouples attached on the carpet surface, including 9 equally spaced thermocouples and one located 1.52 m from the south edge and 0.76 m from the west end of the assembly. As would be expected, the unprotected assemblies (tests 1 to 4) had a faster rise in surface temperature than the floor systems with a fire protective ceiling (tests 5 to 7). In the tests conducted, the average temperature increases of greater than 139°C above the initial temperature on the unexposed surface were not observed before failure by passage of flames through the assembly. As shown, the protective ceiling delayed the time of temperature failure by approximately 12 minutes for 13 mm gypsum board and more than 23 minutes for 16 mm type X gypsum wallboard.

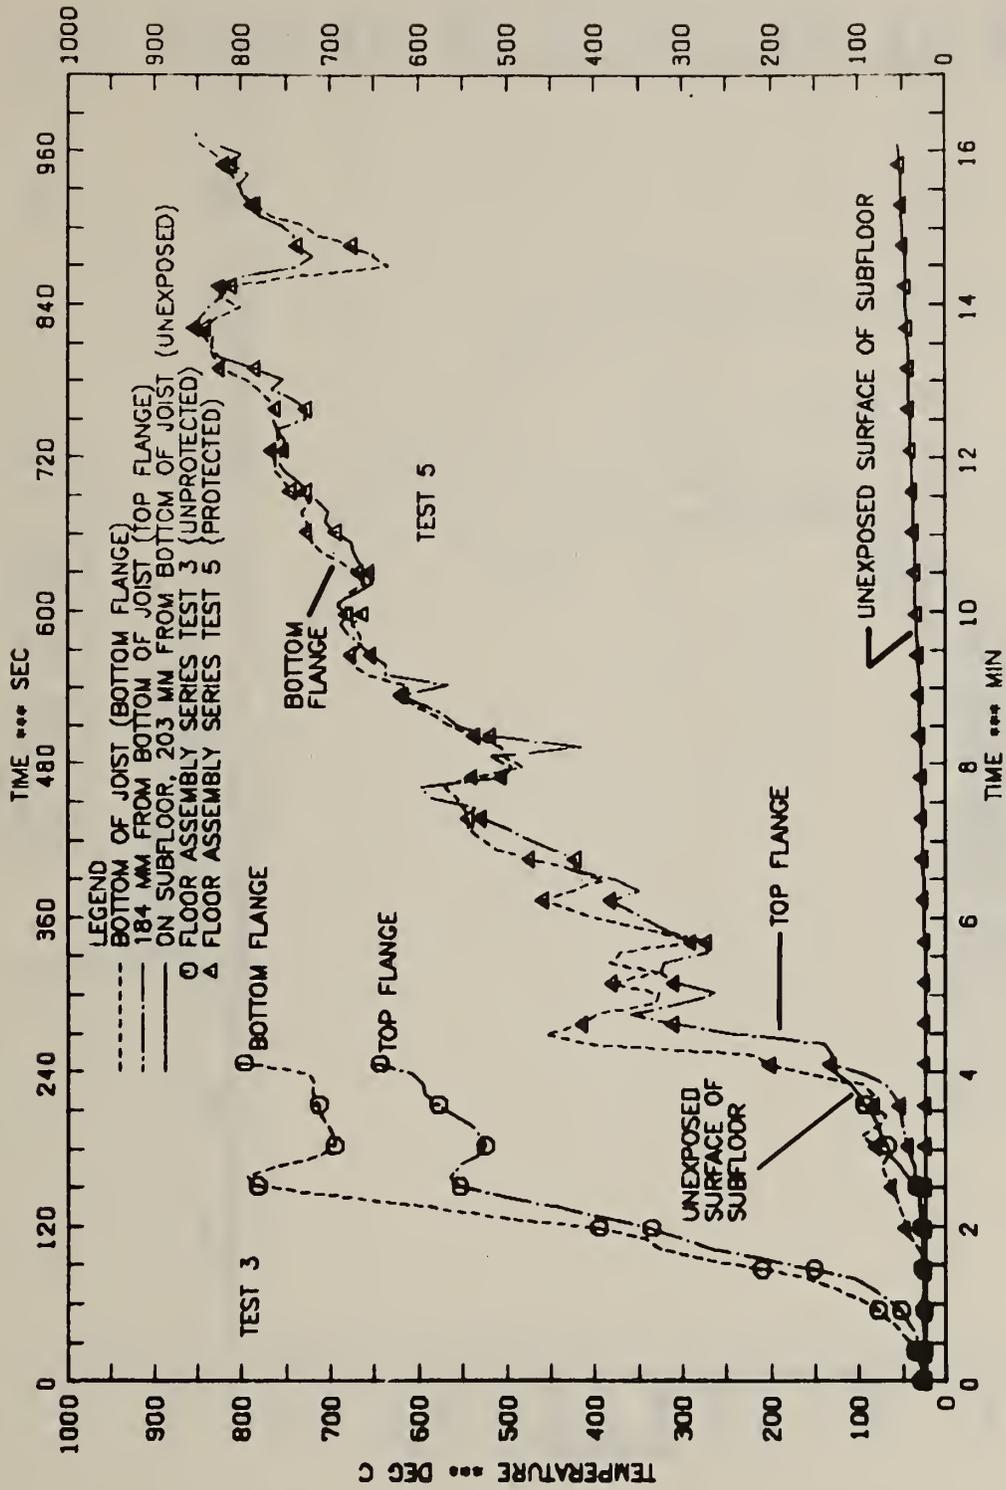
Figure 22. Comparison of Surface Temperature of Steel Joist and Plywood Subfloor for Assemblies With and Without a Protective Ceiling

A comparison of the surface temperatures attained at the top and bottom of the steel joist and that at the top of the plywood subfloor located above the center of the room for the tests with and without a protective ceiling (tests 5 and 3) is shown in figure 22. As shown, the temperature in the top flange of the floor joist was consistently lower than that in its bottom surface. This was due to the fact that there was continuous conduction of heat away from the top surface to the cooler plywood subfloor, and for the

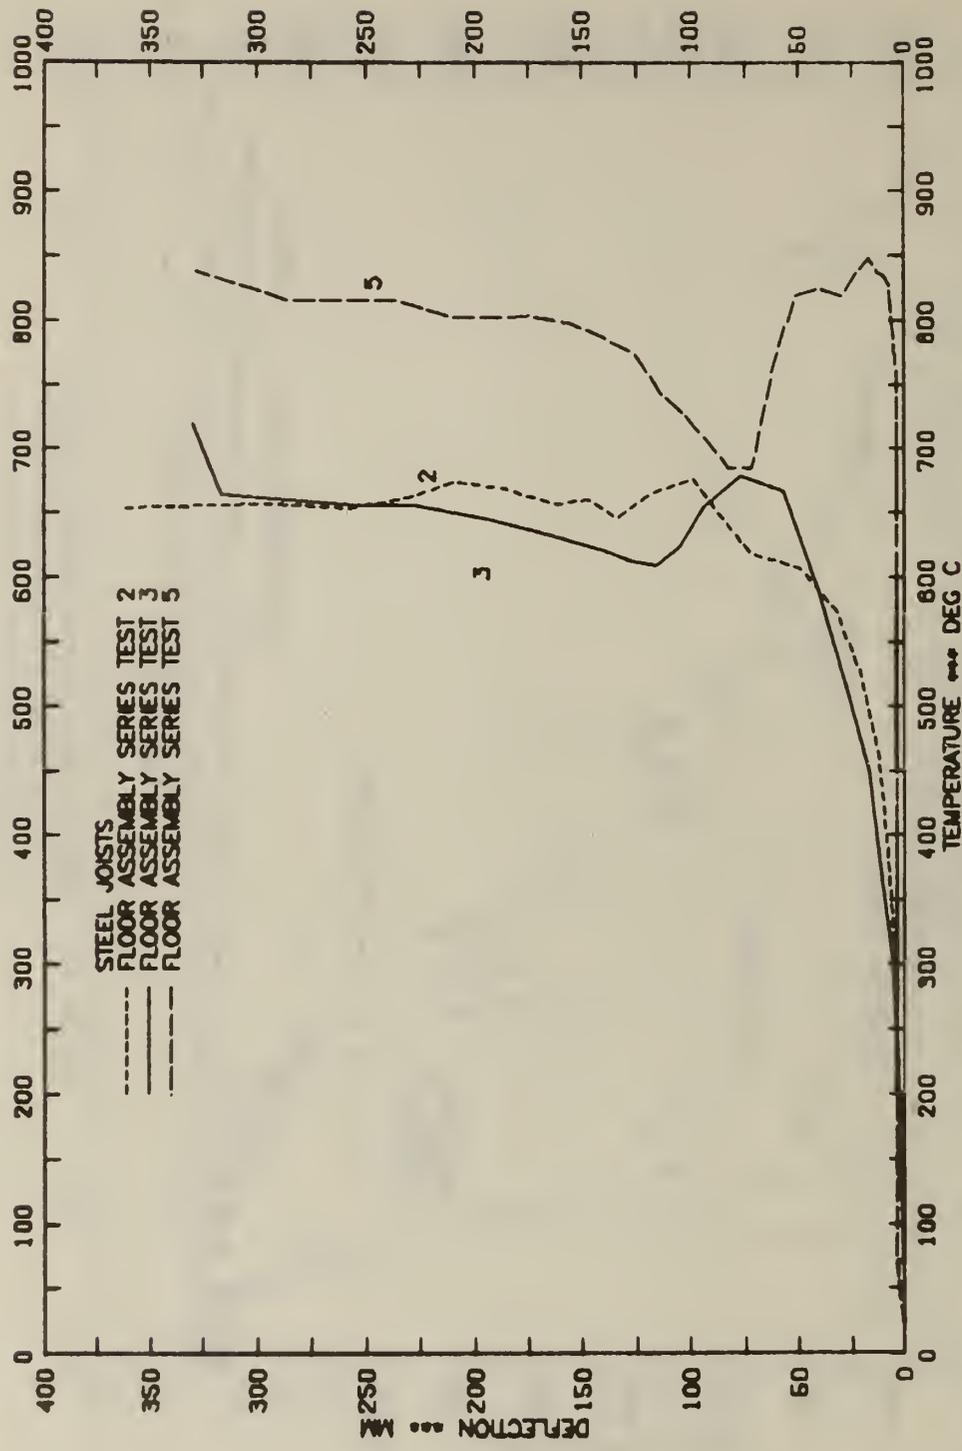
Figure 23. Relationship Between Floor Deflection and Steel Joist Temperature at Center of Test Assembly

Figure 23 shows a plot illustrating the relationship between the measured floor deflection at the center of the test assembly and the corresponding average temperature of the centrally located steel joist at the same instance for tests 2, 3, and 5. The steel temperature was obtained by averaging the readings of the two thermocouples attached to the top and bottom of one cross section along the longitudinal centerline of the test assembly. As shown in the figure, the deformation of the steel joist became greater as the average temperature of the structural element increased with fire development. Rapid deflection of the assembly occurred and the floor joist failed to support the applied load when the joist reached a temperature level of approximately 650°C for the unprotected floor assembly and 820°C for the floor with a fire protective ceiling. These steel temperatures were higher than the permissible temperature of 593°C for steel structural elements [1]. There was a considerable fall in the steel temperature when the floor deflection was approximately 80 mm in test 5. This was probably due to the decrease in local air temperatures resulting from the dilution of the heated air surrounding the joist by the gaseous pyrolysis products from the decomposing plywood subfloor. A similar plot of floor deflection versus the average of the surface temperatures measured at the top and bottom of the cross-section located at the middle of the center joist involving wood framed floors for tests 1, 4, and 7 is given in figure 24. As shown, significant deflection was not perceived until the average exterior temperatures of wood joists attained a temperature level ranging between 650 and 750°C. The failure of wooden structural elements was as a result of the reduction in cross sectional area due to charring and burning during the fires. The charred and burned areas were estimated to vary from approximately 53 to 75 percent original cross sectional area for these tests. With the decrease in cross sectional area, the shear and bending stresses increased and the joist failed when these stresses exceeded its yield point.

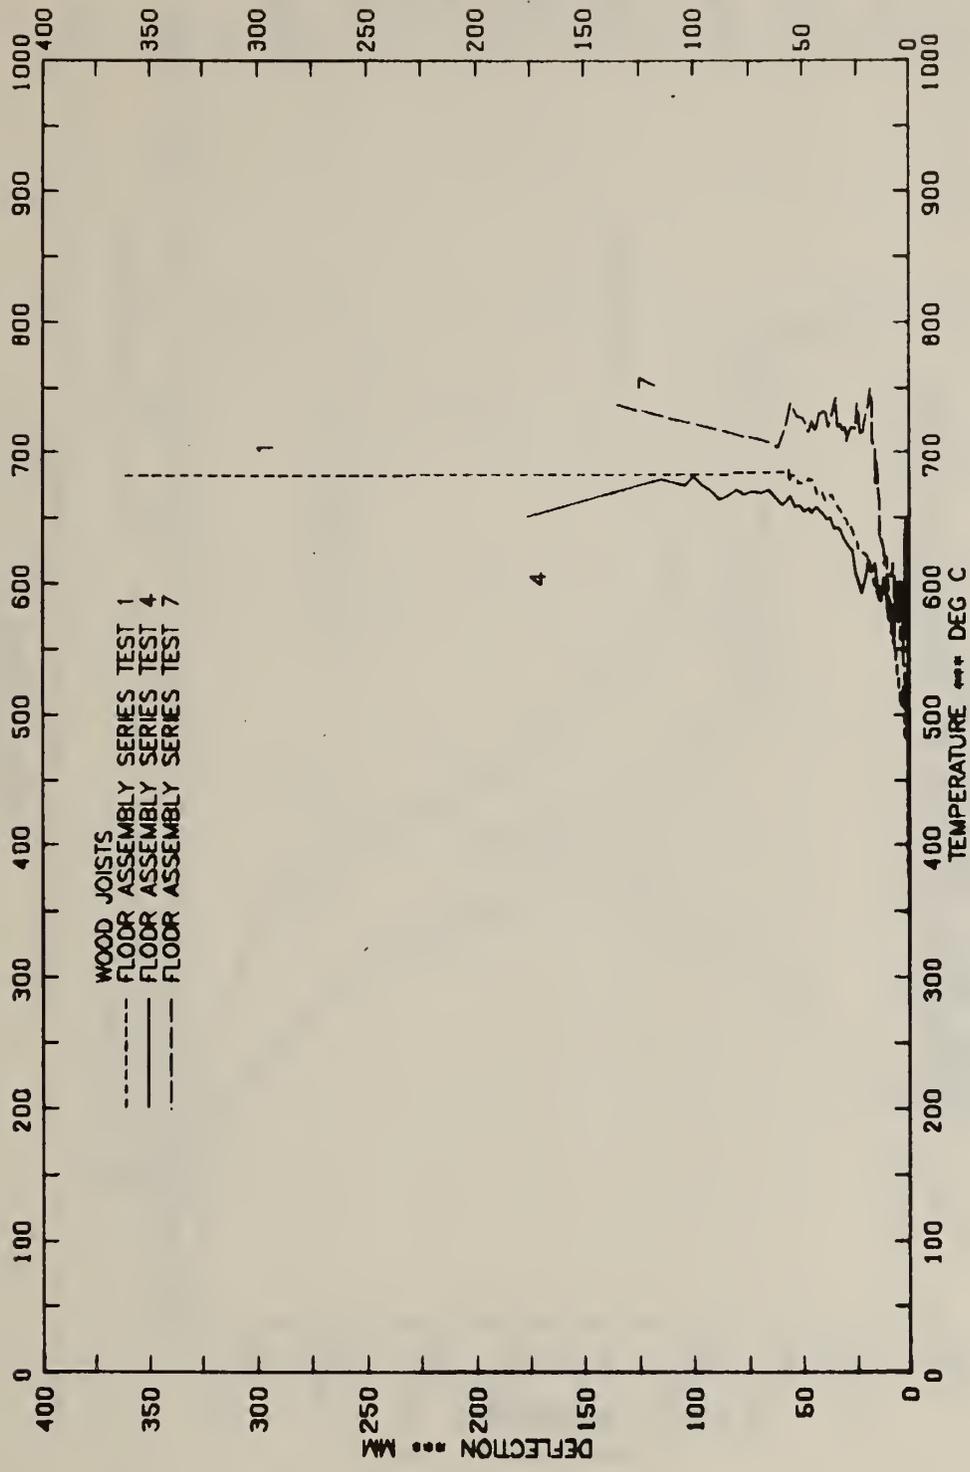
Figure 24. Relationship Between Floor Deflection and Wood Joist Temperature at Center of Test Assembly

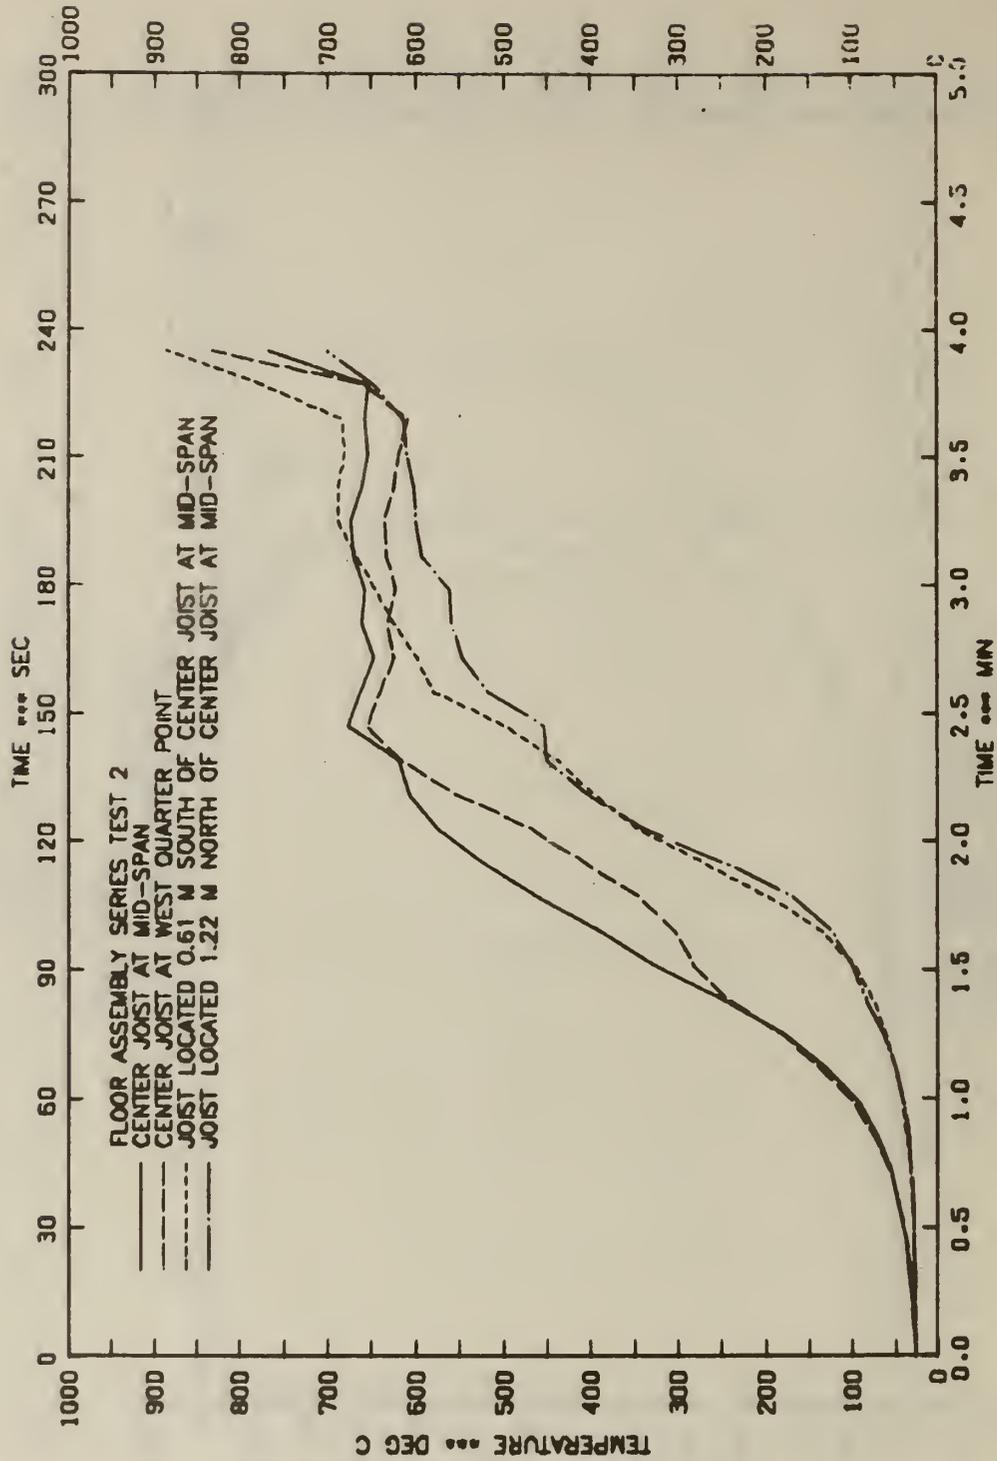
Figure 25. Time Variation of Average Temperature of Steel Joists at Various Locations

The time variations of the steel temperatures derived from averaging the values of surface temperatures measured at the top and bottom of the cross sections situated at various locations are shown in figure 25. It can be noted that the temperatures developed at two locations in the center joist increased more rapidly prior to room flashover than those in the other two neighboring joists due to earlier and direct exposure to the developing fire. However, this temperature difference attributed to relative locations of floor joists involved with the fire reduced with time after flashover.

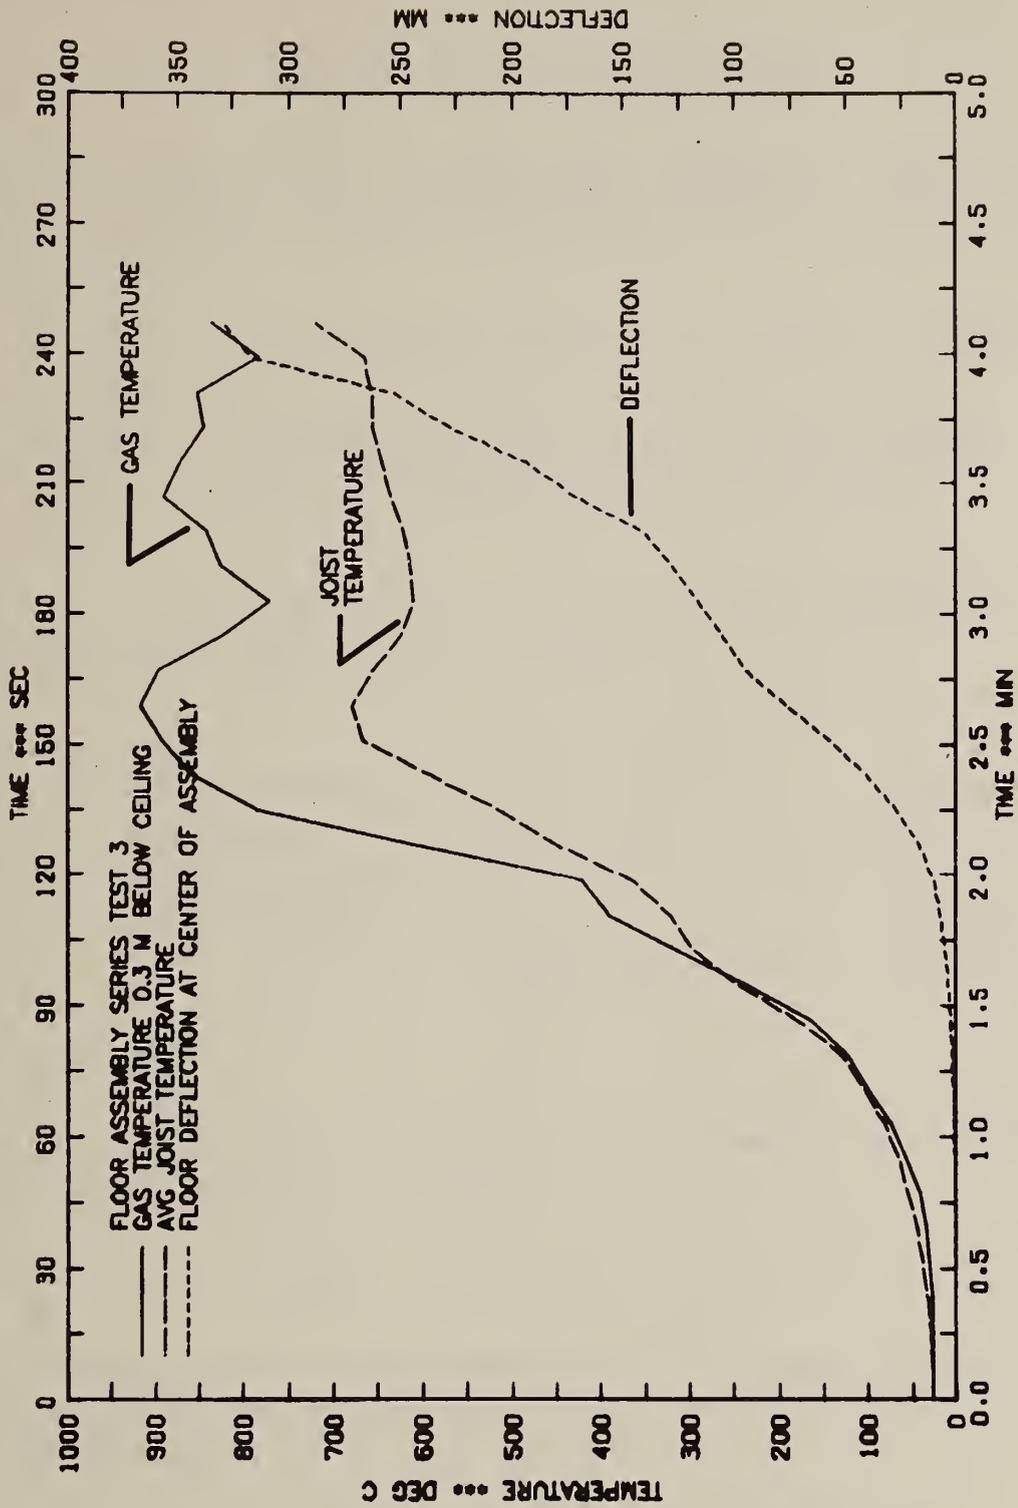
Figure 26. Relationship Between Floor Deflection and Temperature of Surrounding Gas and Steel Joist Temperature

The variations in time of the central deflection of the test assembly and the temperatures of the steel joist and room gas located along the vertical centerline of the test room for test 3 are shown in figure 26. As shown, the temperatures attained in steel member closely followed the temperature levels of surrounding gas, which depended upon the fire process. This was attributed to small thermal inertia because of the relatively high thermal conductivity and small thickness of steel joists used in the assembly. Also shown in the figure, the floor deflection increased with an increase in the joist temperatures.
