Burning Behavior of Selected Automotive Parts from a Minivan

Thomas J. Ohlemiller
John R. Shields

August, 1998
Building and Fire Research Laboratory
National Institute of Standards and Technology
Gaithersburg, MD 20899

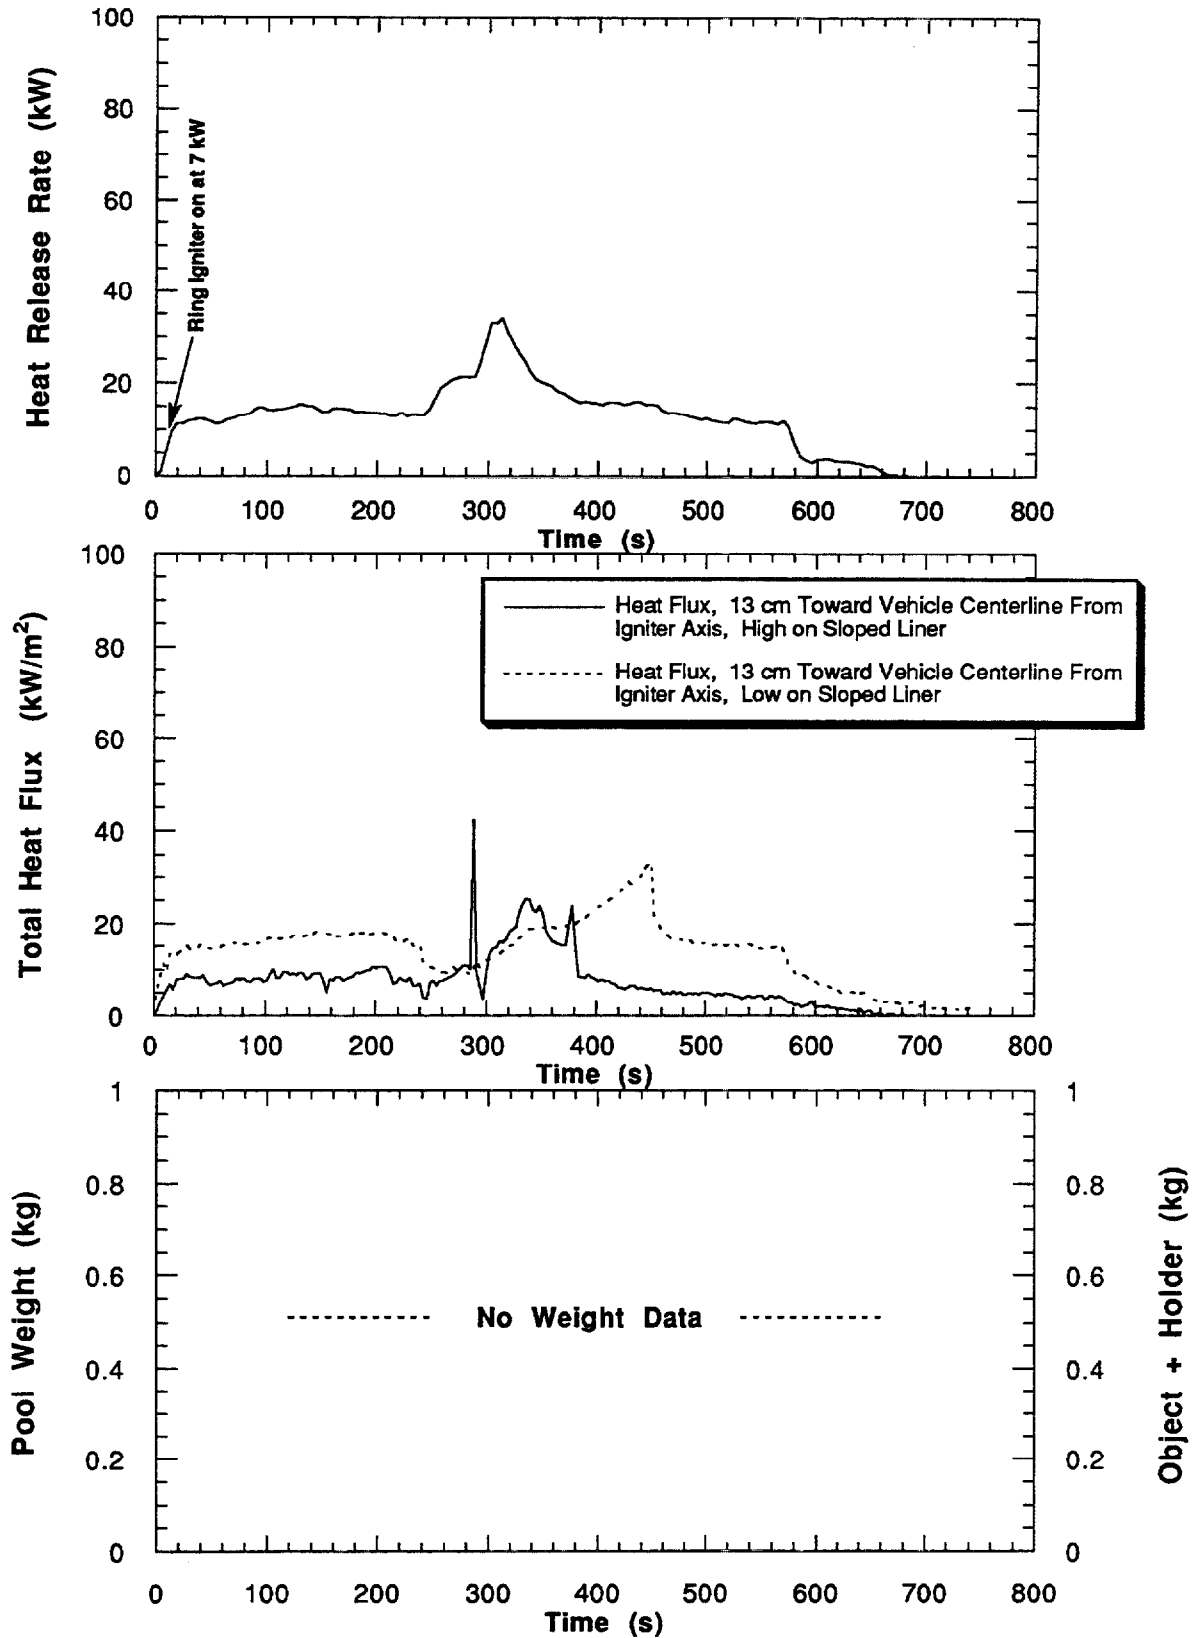
Driver's Side Half of Hood Liner

Figure 23b. Burn test results, driver's side half of minivan hood liner.

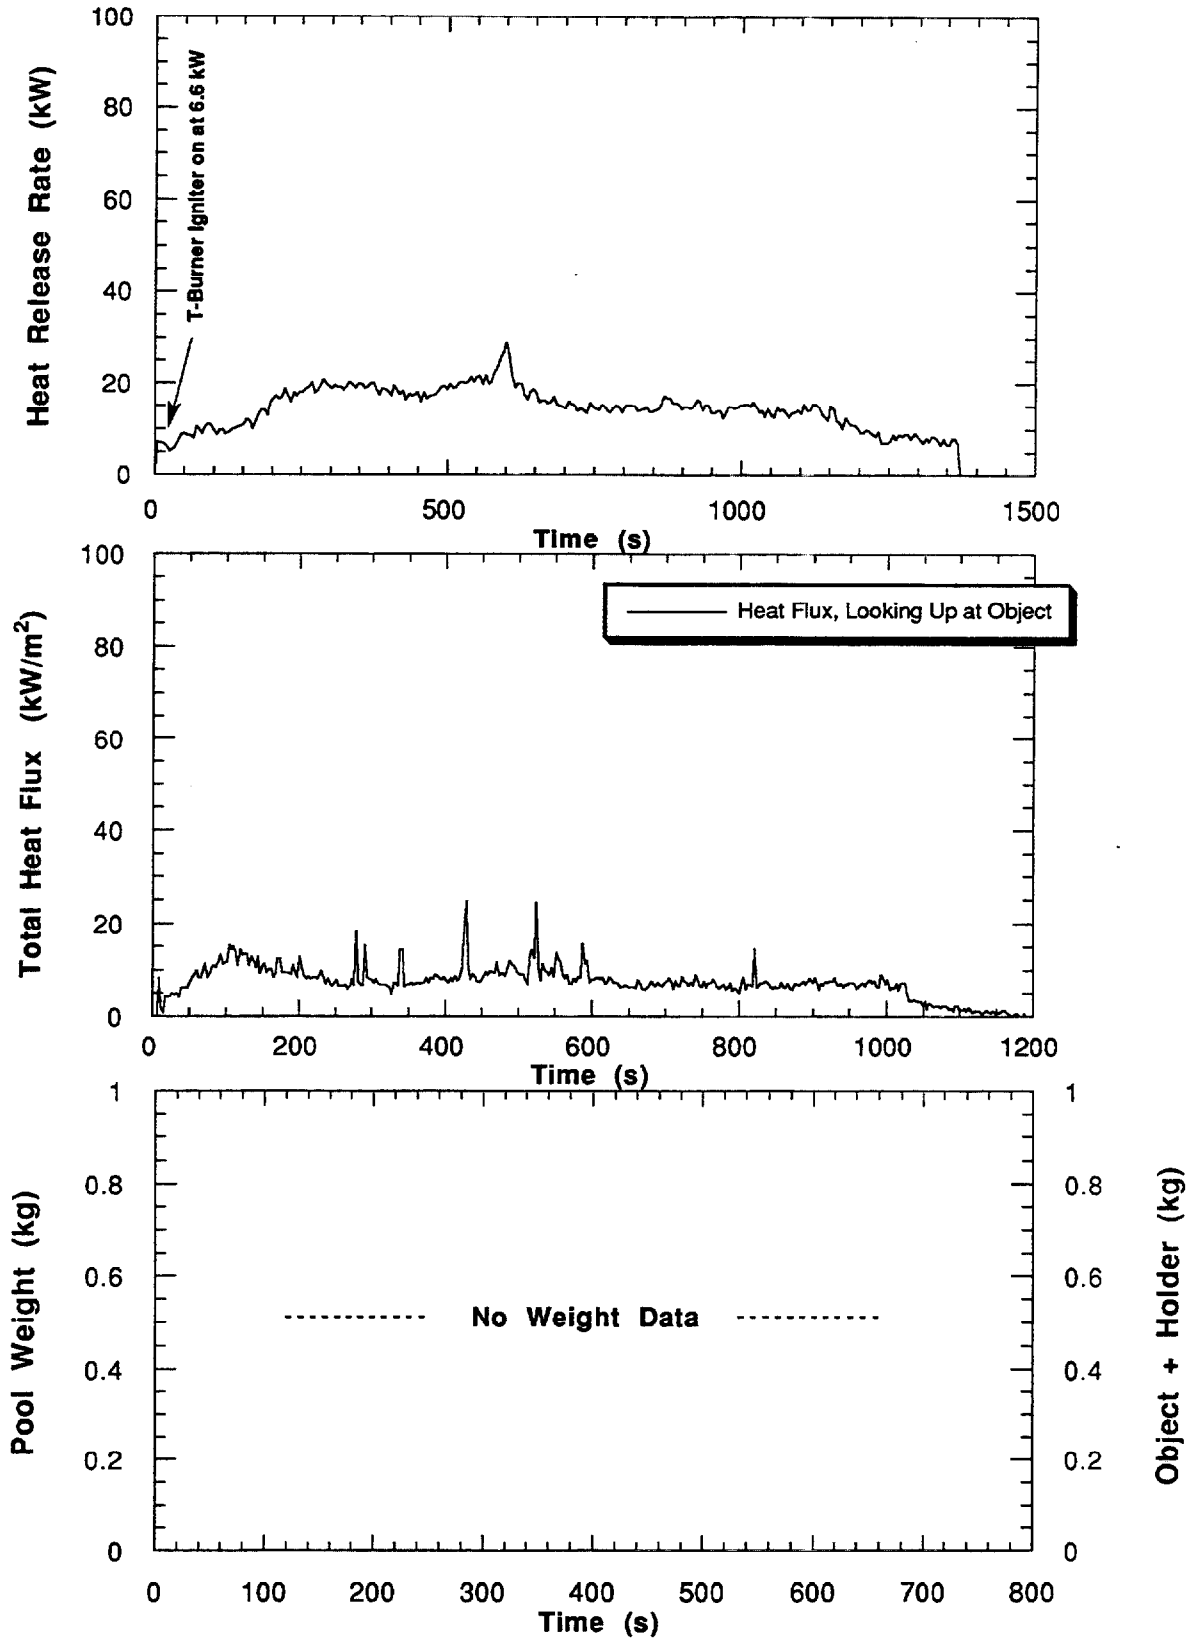
Head Liner (Front Half)

Figure 28b. Burn test results for front half of minivan passenger compartment head liner.

Fig. 28b shows the results of the second test (forward half of the liner). Here, for unclear reasons, there was some oscillatory coupling between the igniter and the liner, causing the igniter flame to pulsate every few seconds. It did not appear to have any serious consequences on the overall behavior. Nevertheless, that behavior did differ somewhat from that seen in the first test. The initial spreading discoloration front did not reach as far before stopping (10 cm to 15 cm less far). At about 2 min after ignition the flexible foam layer began again to break loose in an area laterally outside that monitored by the thermocouples but, this time, it did not ignite and thus the process halted temporarily. If it occurred on the opposite side it was obscured by smoke. At about 4 min flames began to spread away from one end of the igniter, laterally along the bottom edge of the liner. By 6 min this small flame had reached the corner of the liner on that side and began to grow, reaching further in (and higher) on the liner surface, evidently burning off the flexible foam layer. It ignited the drooped down portion of the flexible foam layer and started a general surge in fire growth throughout roughly 1/4 (or less) of the liner over the next minute; this is the source of the spike in heat release rate seen in Fig. 28b. The later portions of this appeared to involve some flaming of the rigid foam layer. Beyond this time, little else of note happened.

The heat flux data in Fig 28b are not affected by drooping of the headliner. However, it is likely that the source of the heat flux is the area of the liner heated by the igniter. One of the thermocouples around this gage location read 400 °C to 600 °C for much of the test time. Others were in the 200 °C to 300 °C range. These were gas temperatures; if the charred liner surface was heated by these gases to 300 °C to 400 °C over the area viewed by the gage, it would account for the flux level seen. (Recall that a similar effect was seen with the hood liner.) Unfortunately, the gage did not view any flame spread processes.
