**EXPERIMENTAL TESTING OF ROOF TO WALL
CONNECTIONS IN WOOD FRAME HOUSES**

Michael A. Riley and Fahim Sadek

April 2003

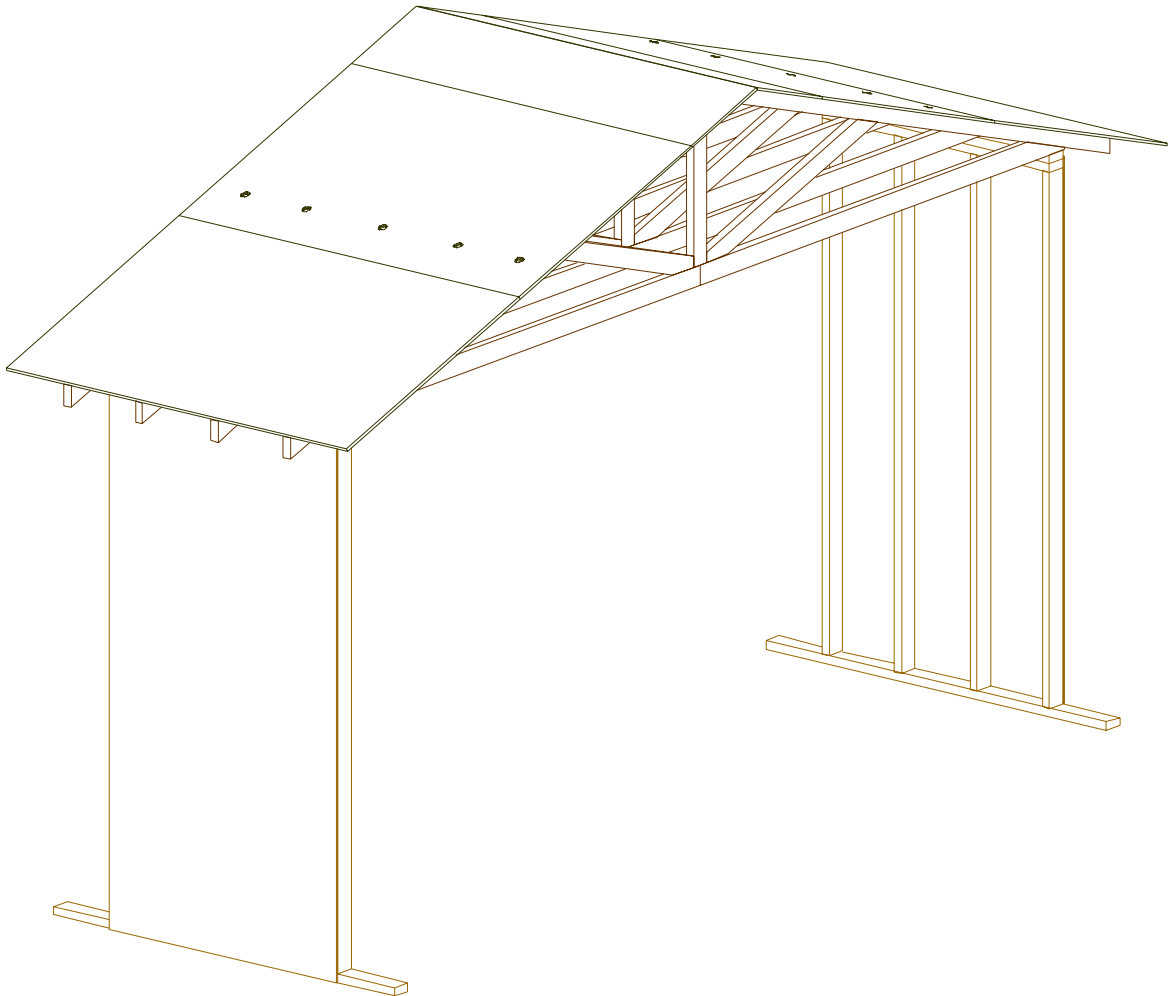
Figure 2.1. Sketch of a typical test specimen.

The specimens represent a center cut through a simple wood-frame house. Each specimen consisted of two 1.22 m (4 ft) long by 2.47 m (8 ft 1.25 in) high shear walls that supported four roof trusses with spans of 4.88 m (16 ft). A sketch of a test specimen is shown in Figure 2.1, and a photo of one specimen is shown in Figure 2.2

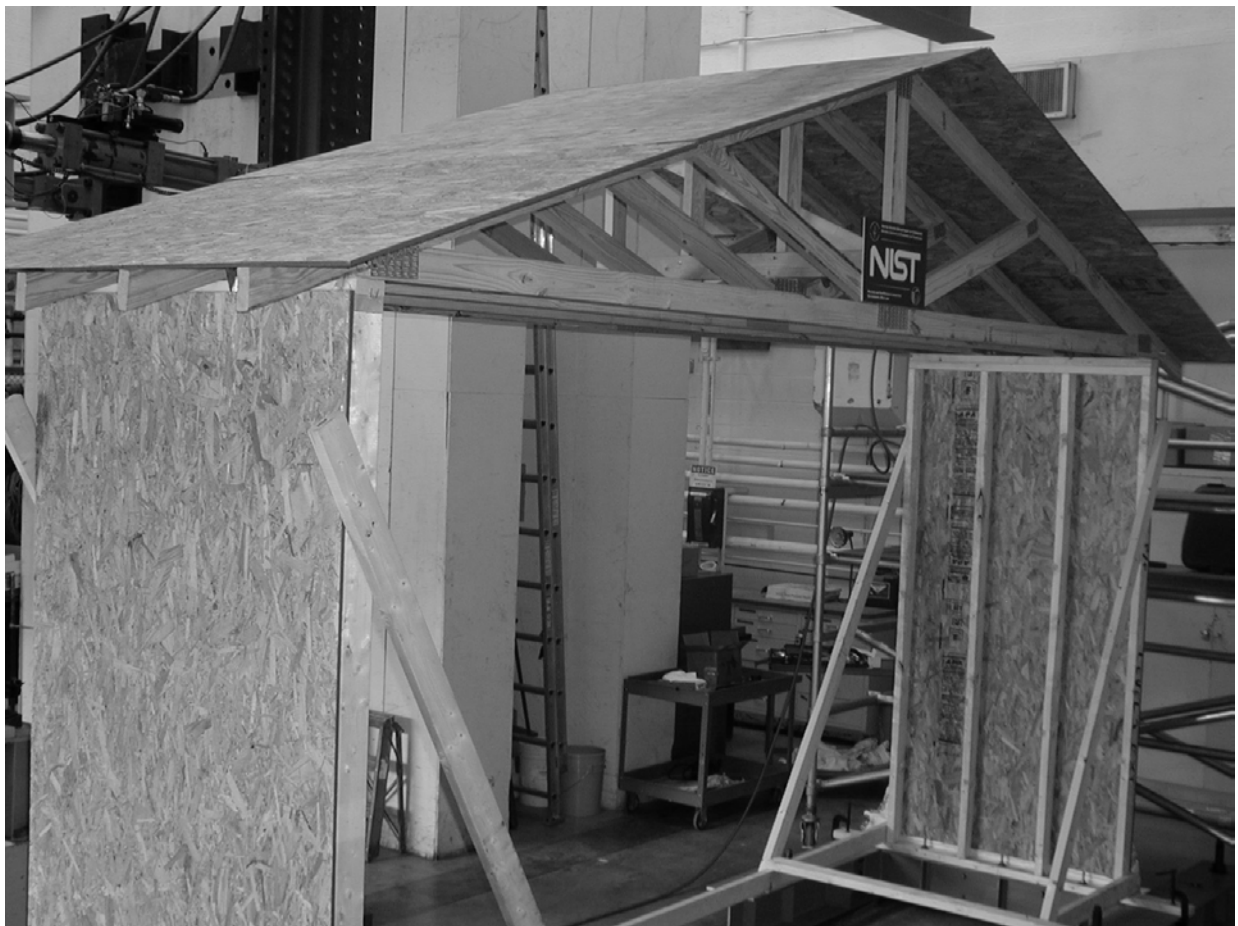
Figure 2.2. Typical test specimen before instrumentation.

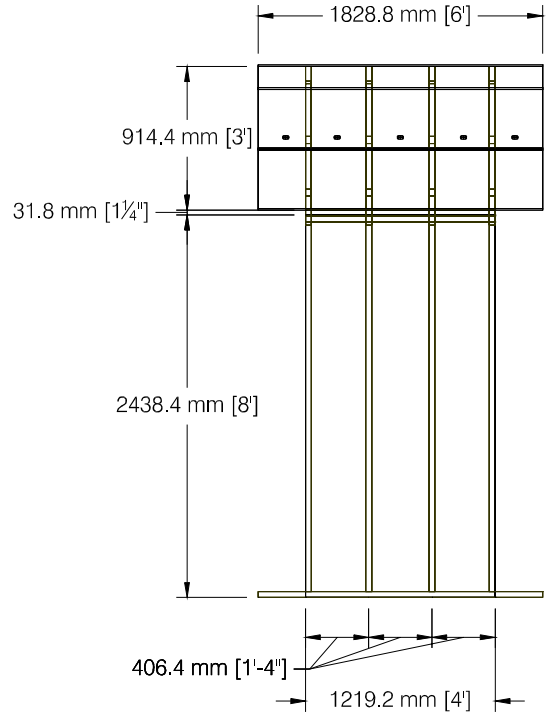
Figure 2.3. Side view of specimen.

As can be seen in Figures 2.3 and 2.4, the framing for each shear wall consisted of double top plates, a single bottom plate, and

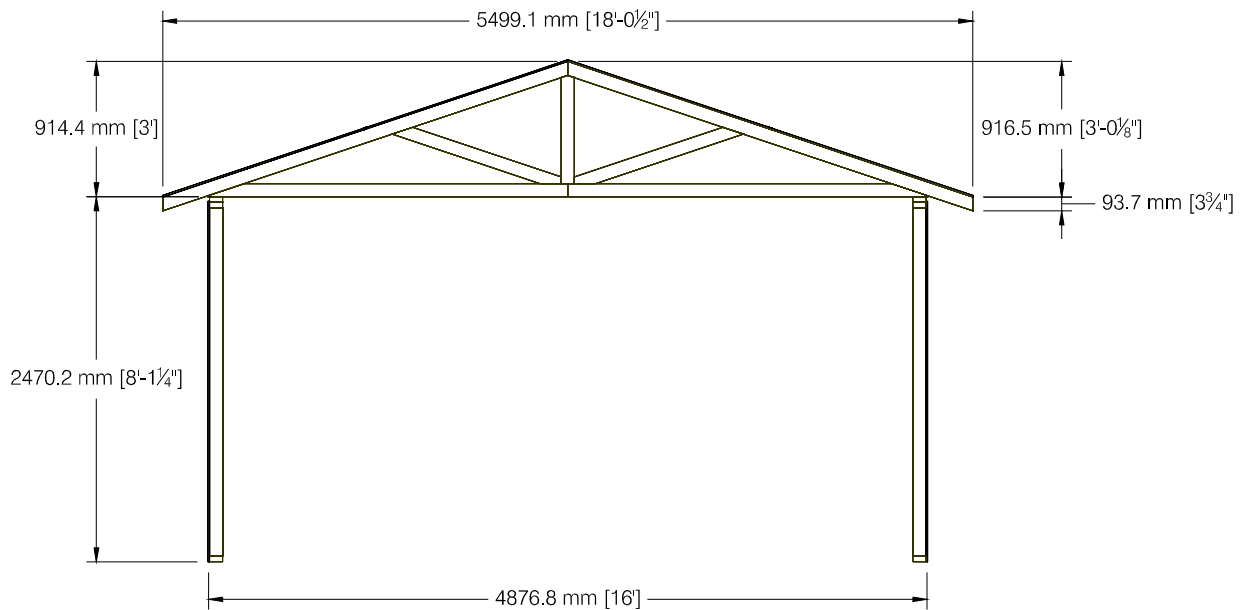
Figure 2.4. Front view of specimen.

The pre-fabricated roof trusses, which are shown in Figure 2.4, had a top chord slope of 4:12, and were spaced 0.41 m (16 in) apart. All truss elements were 38 mm x 89 mm (2 by 4 nominal) members. The roof sheathing consisted of 11 mm (7/16 in) thick OSB panels attached to the trusses us-

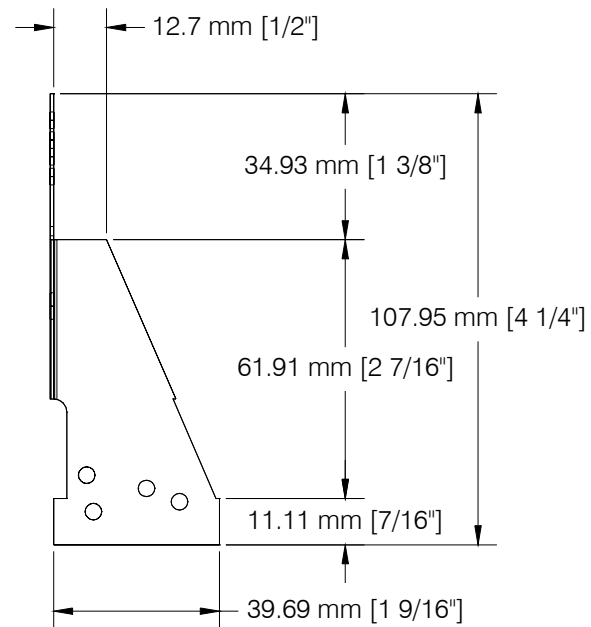
Figure 2.6. Dimensions of hurricane clips.

were toe-nailed through the truss and into the top plate of the wall for erection purposes. Then a simple, sheet metal hurricane clip of the type shown in Figure 2.5 was added to provide the primary load path between the truss and the walls. The standard dimensions of the clips used are shown in Figure 2.6. These clips were attached to the trusses and the top plate of the wall using four 8d common nails.

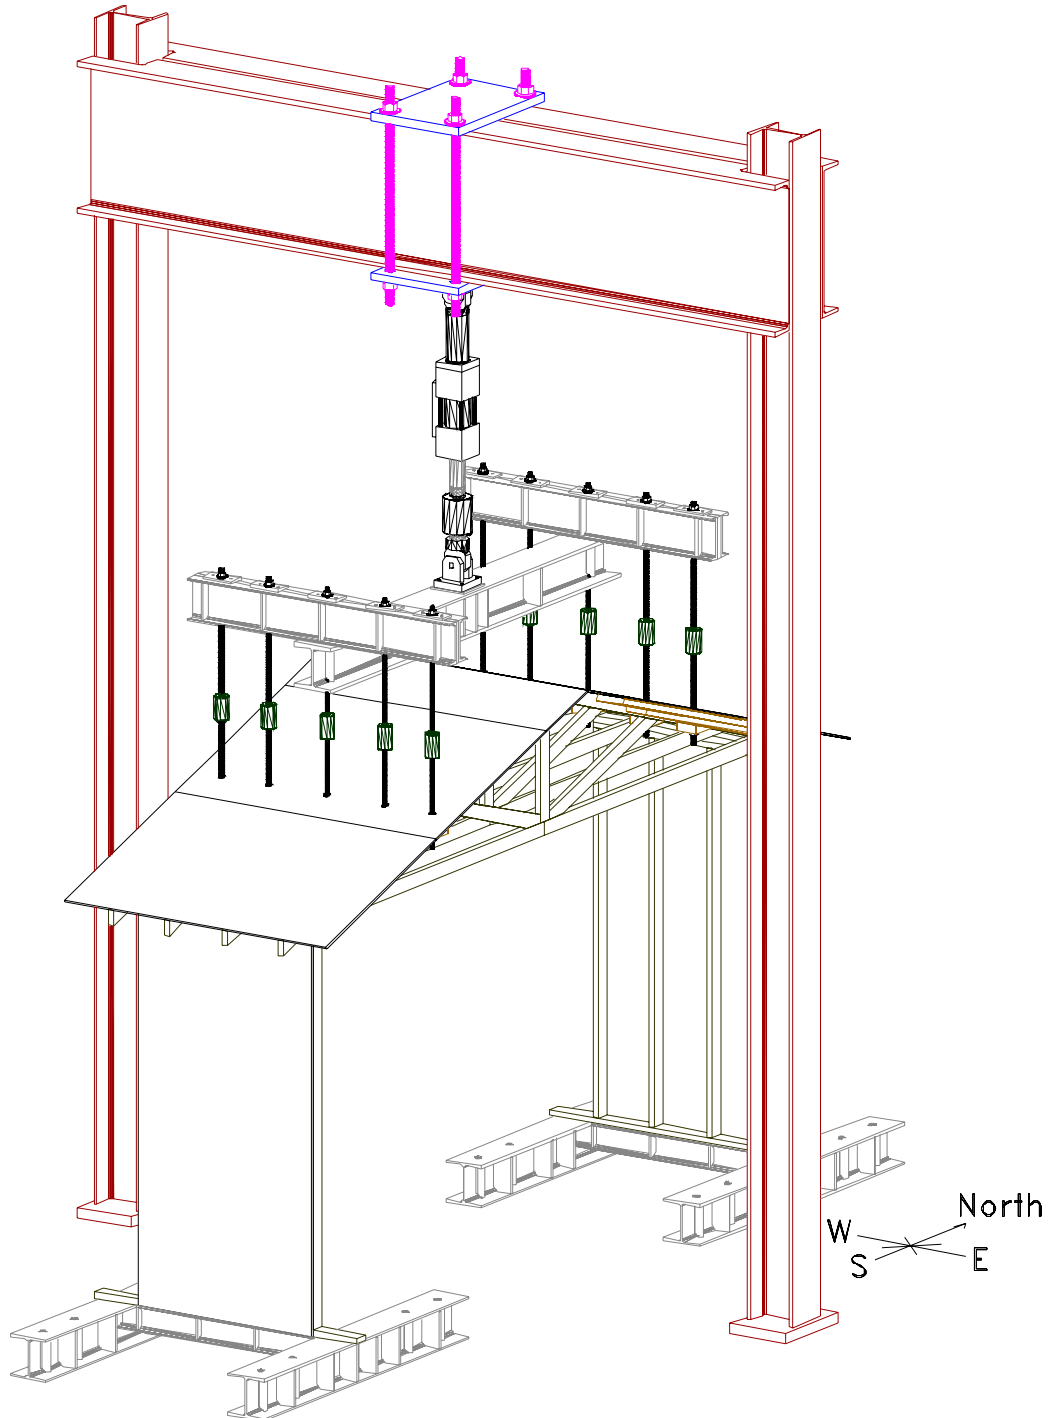
Figure 2.7. Sketch of specimen for uplift load test

The uplift loads were applied using a vertical actuator with a steel load tree that distributed the load to ten points on the roof sheathing, as shown in Figure 2.7. The uplift point loads were further distributed using 38 mm x 184 mm (2 by 8 nominal) lumber members that were connected to the roof sheathing, but not the trusses. These boards spread the load over a larger area, and prevented local failure of the sheathing.

Both the vertical and horizontal actuators push against a steel reaction frame, which can be seen in Figures 2.7 through 2.9. For the uplift loads an actuator with a 152 mm

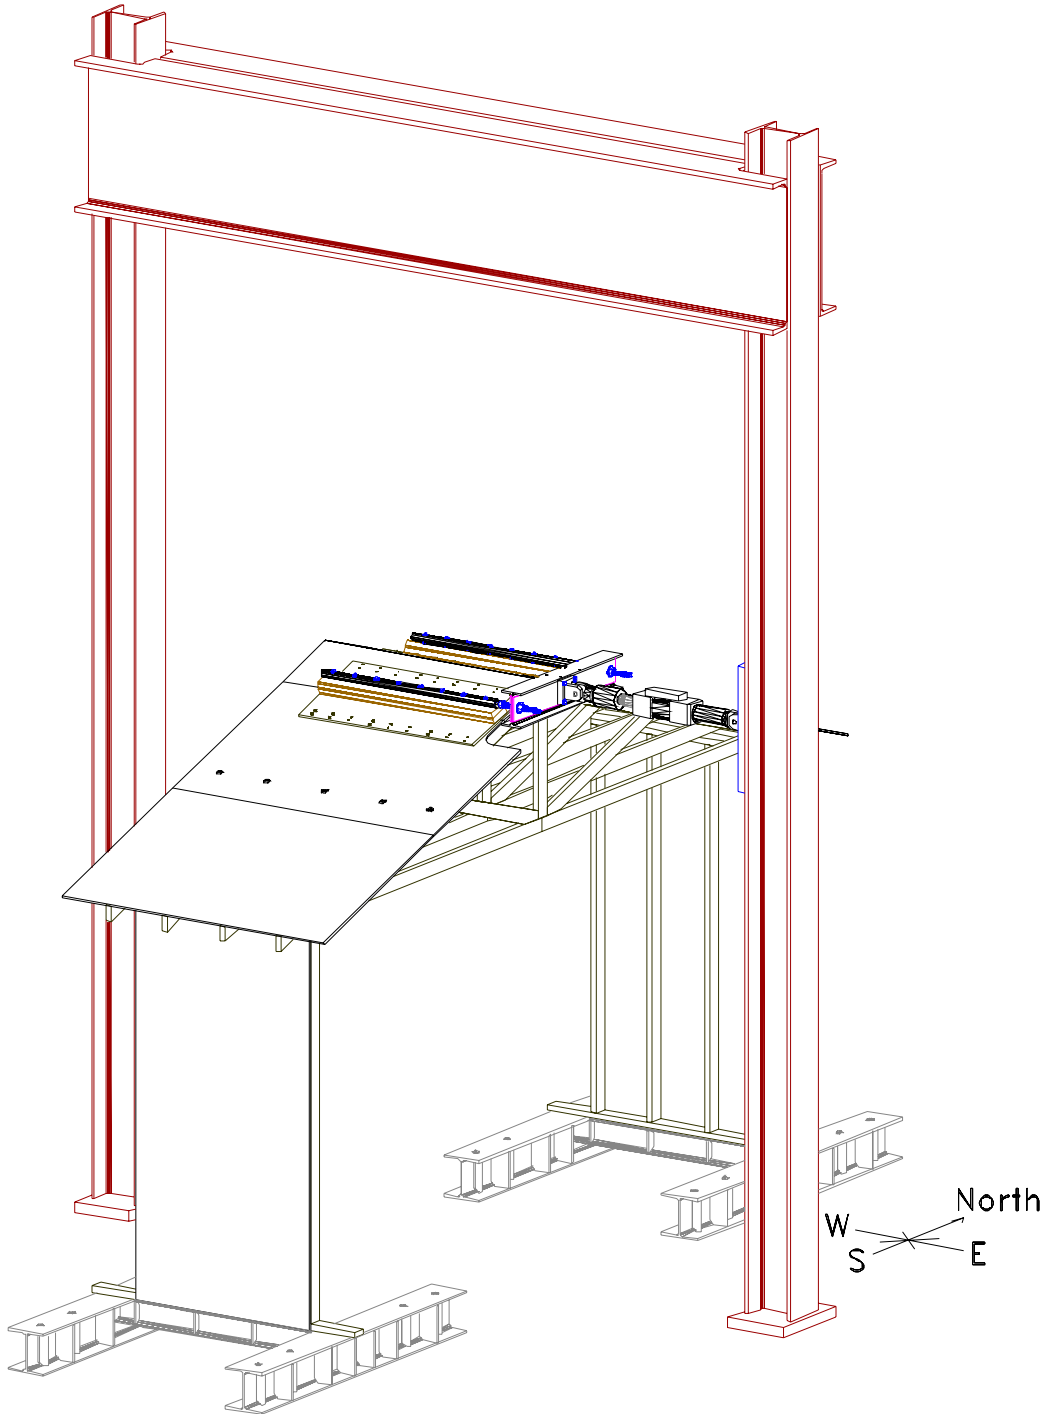
Figure 2.8. Sketch of specimen for lateral load test

38 mm x 184 mm (2 by 8 nominal) lumber members that were screwed to the roof sheathing on either side of the ridge. This configuration, shown in Figure 2.8, allowed the load to be applied through the roof's center of mass, without applying any un-

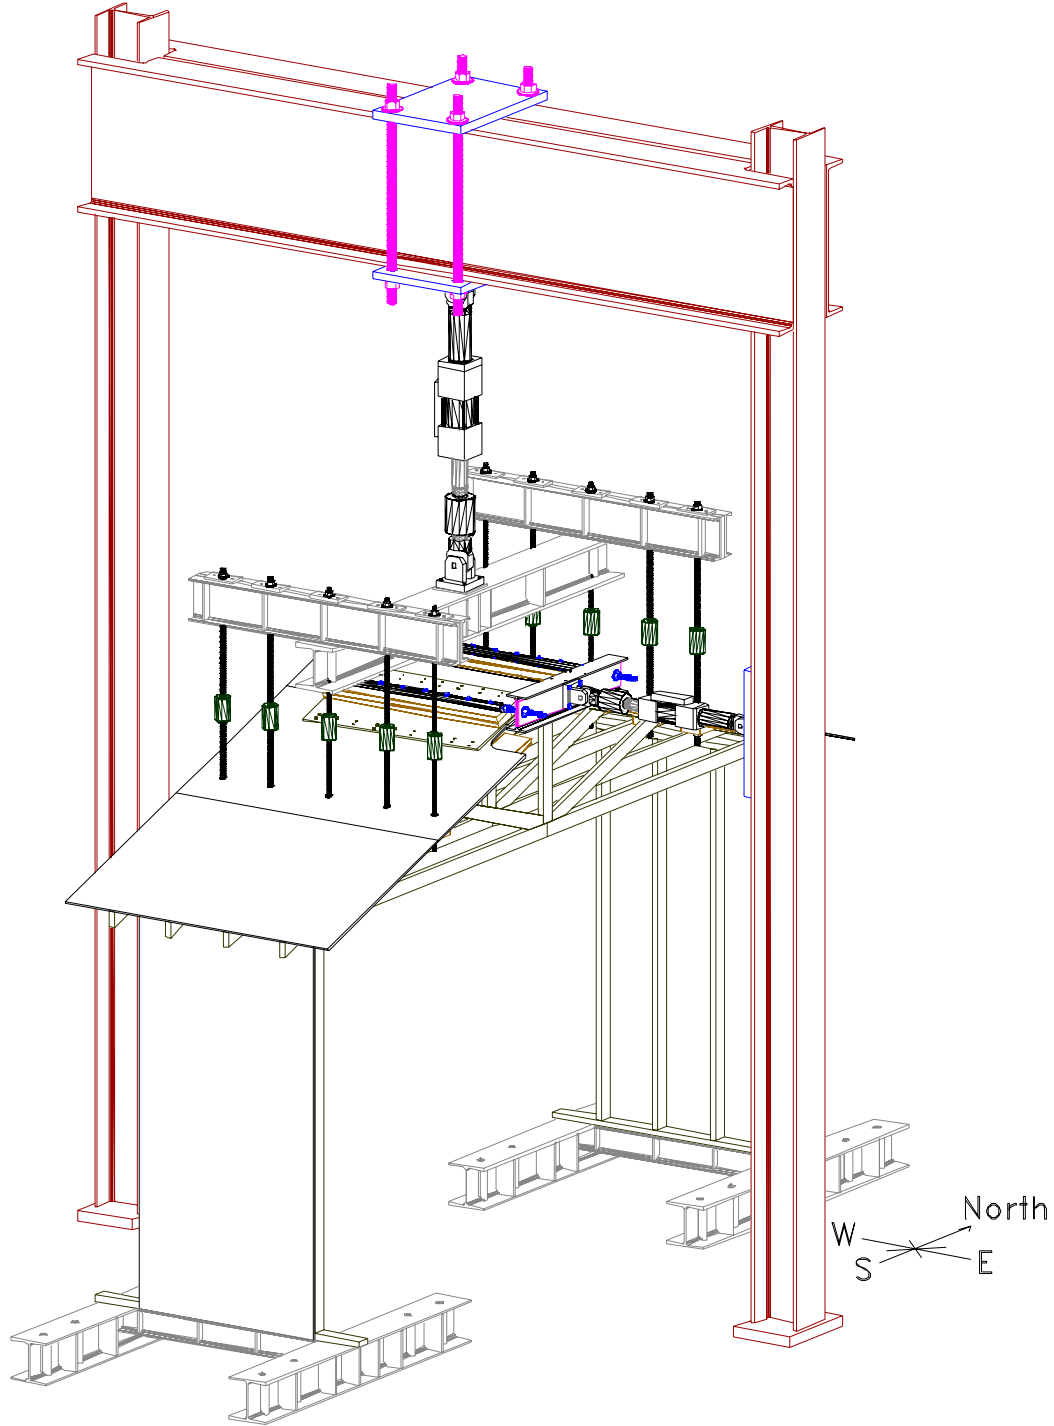
Figure 2.9. Sketch of specimen for combined vertical and lateral load test.

combined, as shown in Figure 2.9.

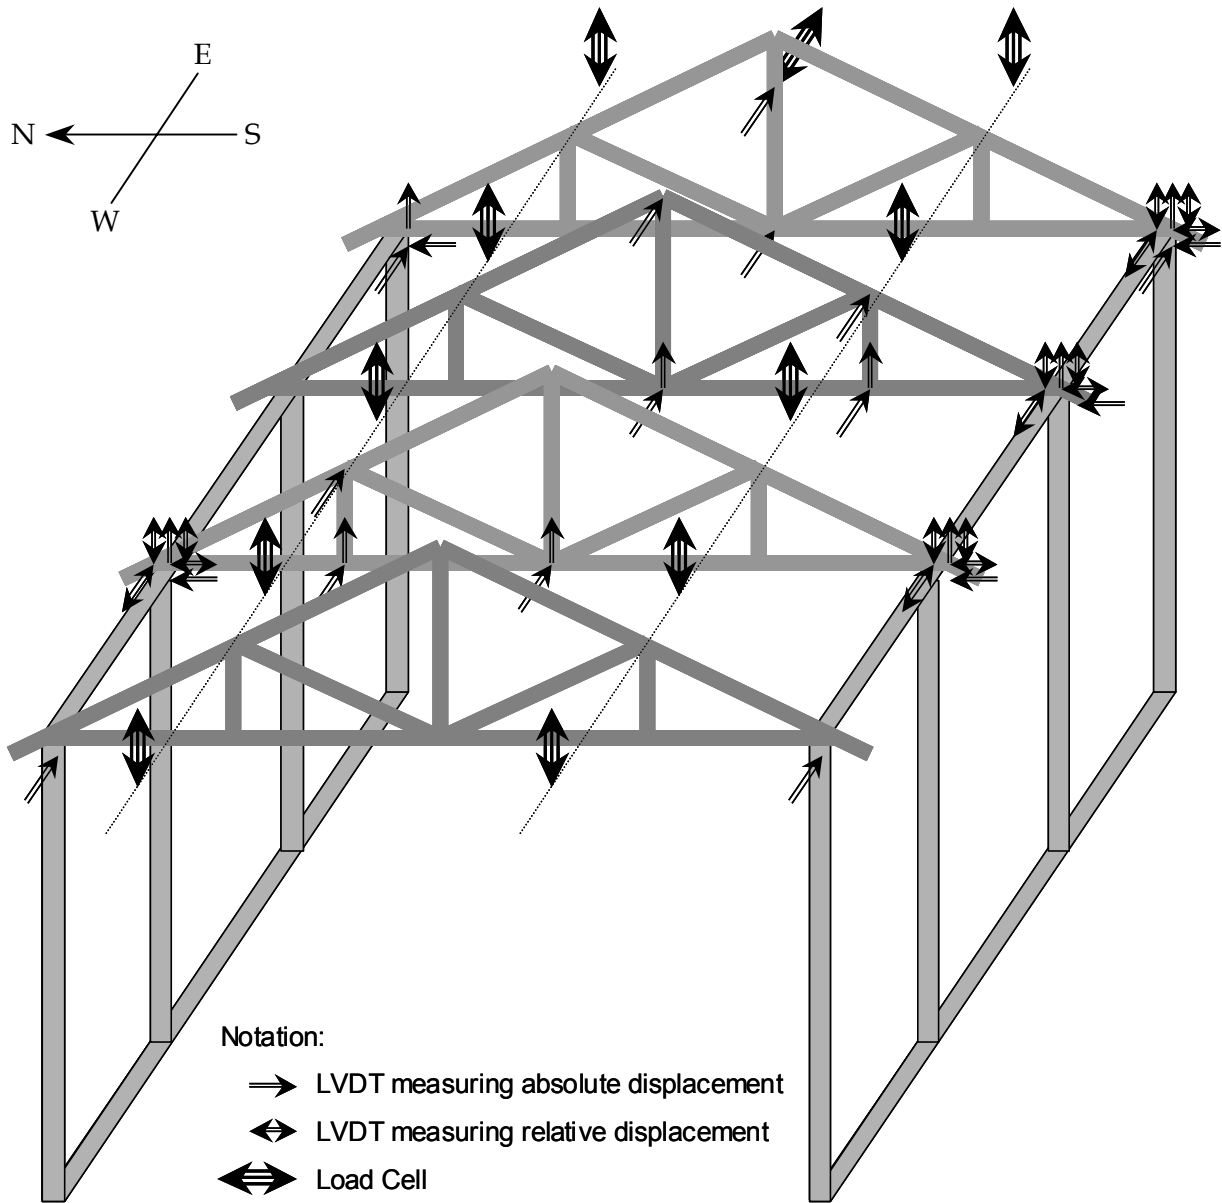
Figure 2.10. Locations of displacement sensors and load cells on the specimens.

north-south direction. The positions of these sensors are shown in Figure 2.10.

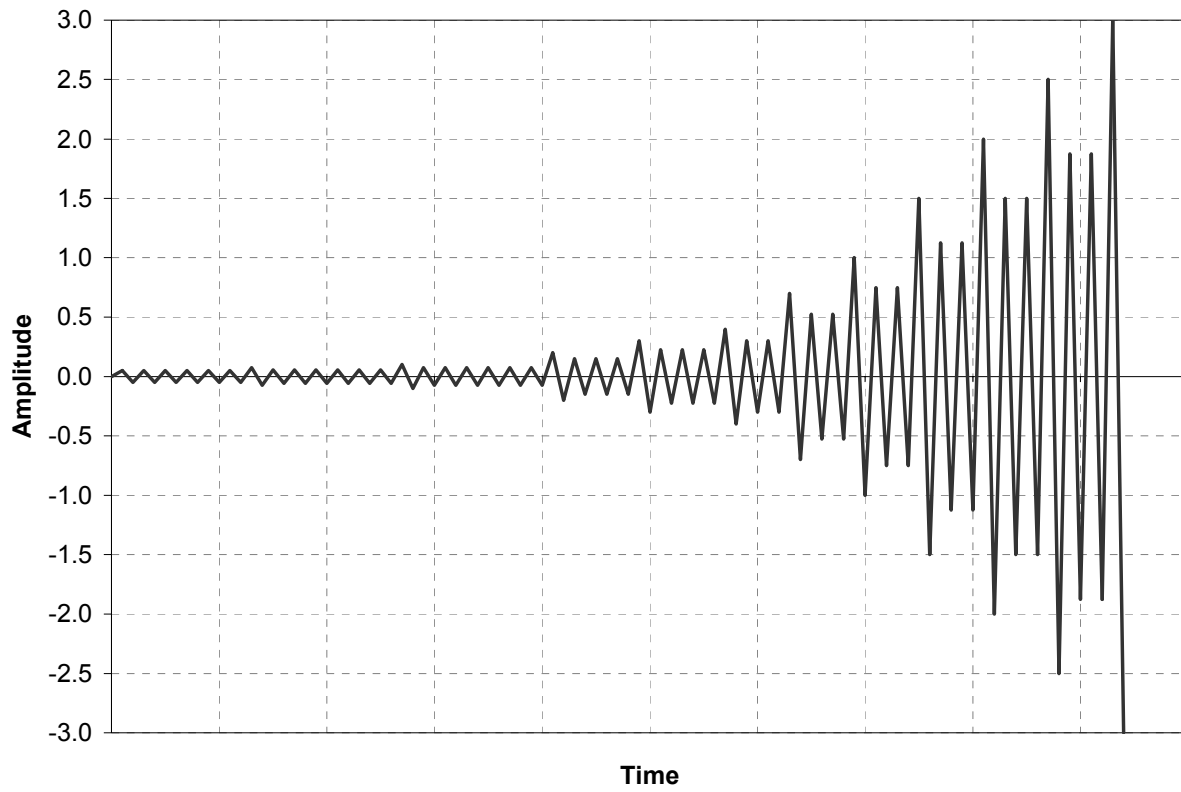
Figure 2.11. Generic (dimensionless) lateral displacement curve for cyclic lateral load tests.

The fourth test series was the cyclic lateral loading, which was intended to simulate the effects of earthquake motion on the connections. The applied motion was a constant velocity (CV) deformation waveform with increasing amplitudes over time. The generic version of this waveform is shown in Figure 2.11. This waveform is based on the work of Krawinkler et al. (2001). For application in a test, the waveform is scaled such that the unit amplitude of the generic waveform is equal to 60% of the deformation in a specimen subjected to monotonic lateral loading at the point in the test after the peak capacity has been exceeded and the response force has dropped to 80% of the peak value.

For the current tests, the period of the waveform was 30 s. The unit amplitude was scaled to 37.24 mm (1.466 in) for the specimen with toe-nailed connections and to 50.19 mm (1.976 in) for the specimen with hurricane clips. In both cases, the absolute peak amplitude was limited to 73.7 mm (2.90 in), due to the actuator stroke limits.

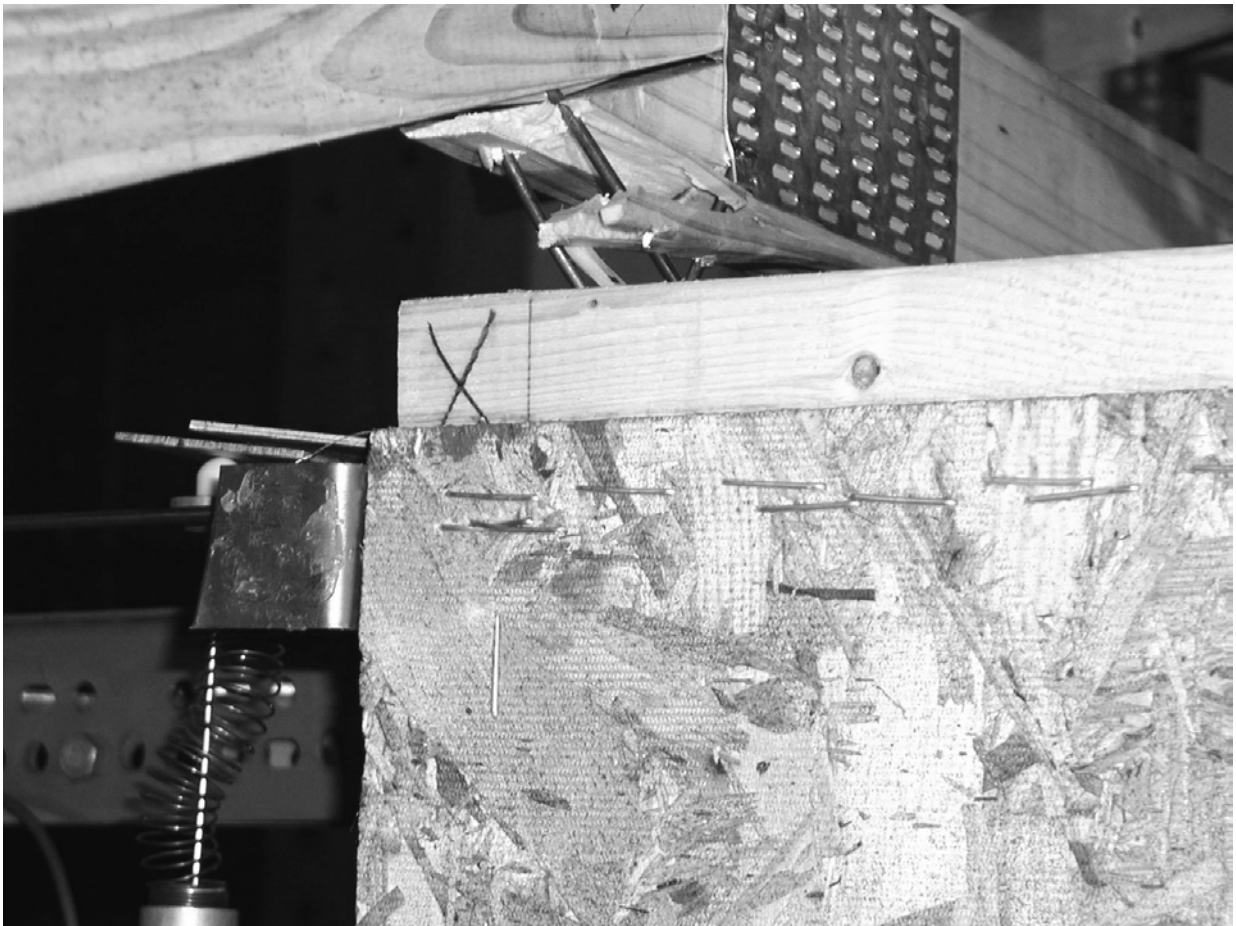
Figure 3.1. Failure of toe-nailed truss to wall connection.

the roof of the toe-nailed connection specimen at a rate of 6.35 mm/min (0.25 in/min) for a period of approximately 360 s. This deformation is shown in Figure 3.2 and the resulting loads are shown in Figure 3.3. The specimen failed on one side at the connection between the trusses and the top plate of the wall after about 125 s. The failure mode was characterized as the nails withdrawing from the top plate, which resulted in separation in the bottom wood fibers of the bottom chord as can be seen in Figure 3.1. The specimen continued to exhibit some resistance, although the strength was relatively small after 200 s, and continued to decrease as all of the connections on one side of the

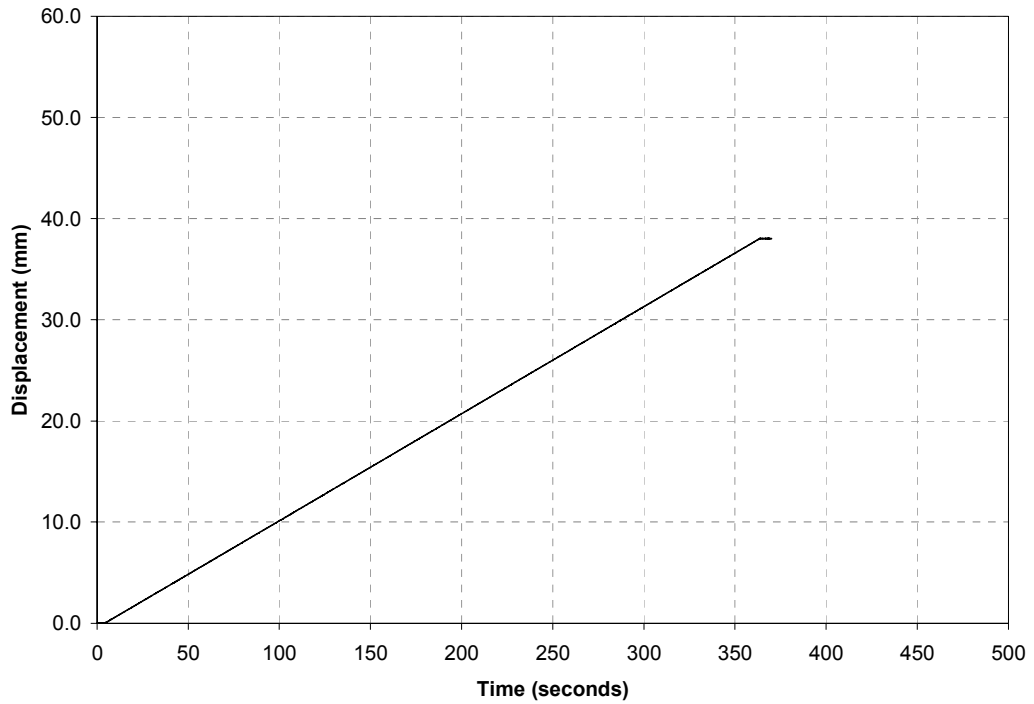
Figure 3.2. Vertical displacement applied to specimen with toe-nailed connections.

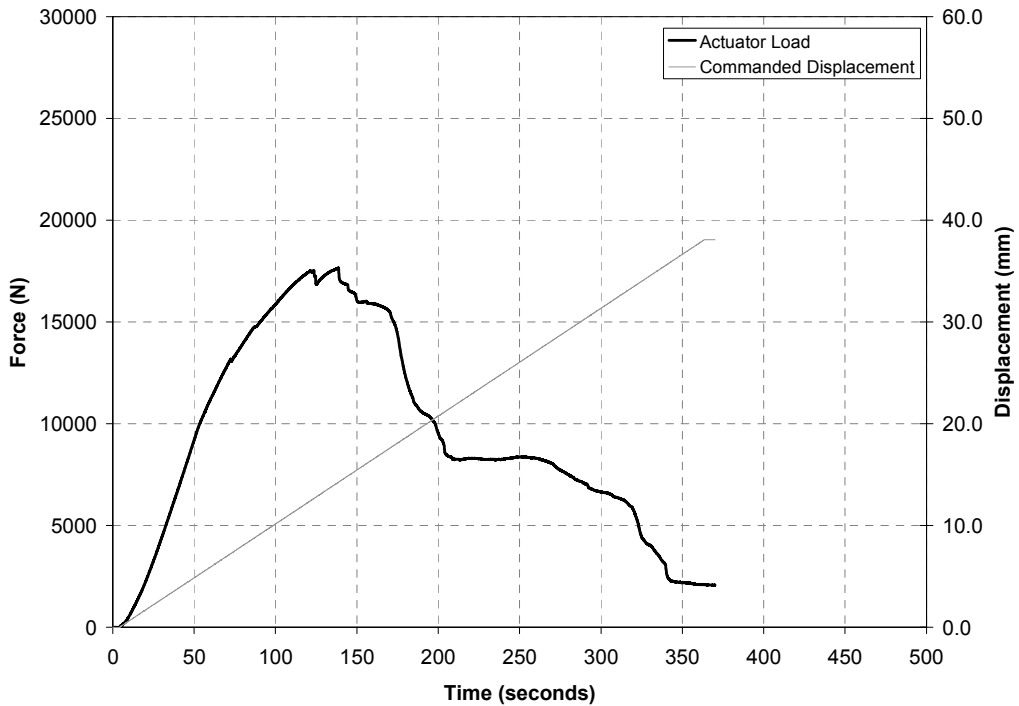
Figure 3.3. Vertical load applied to specimen with toe-nailed connections.

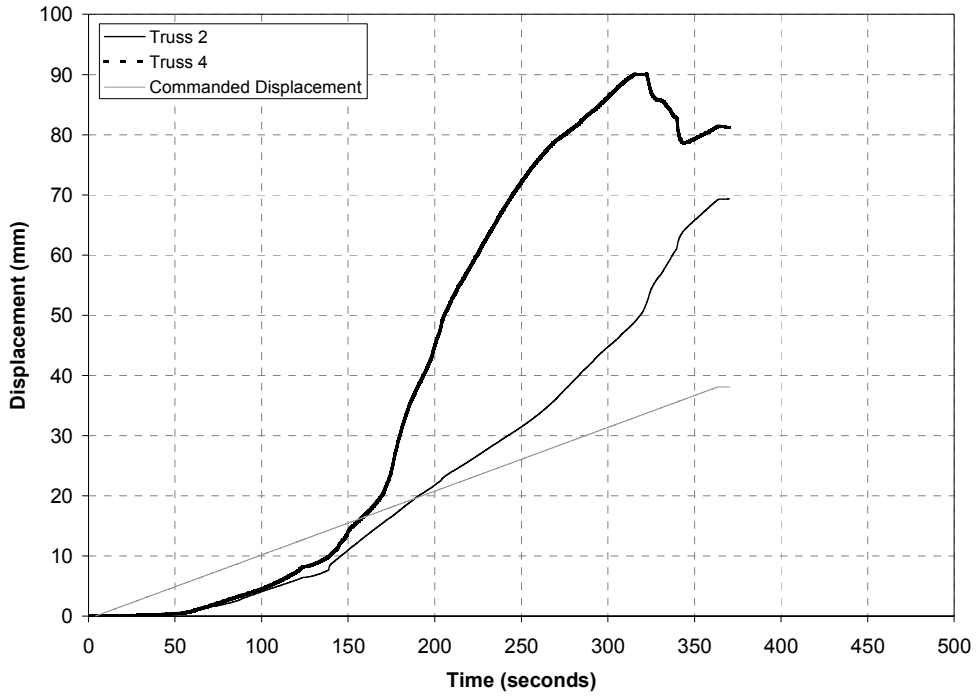
Figure 3.4. Connection deformation response of specimen with toe-nailed connections.

Figure 3.4 shows the deformation that occurred at two connections during the test. The outer connection, truss 4, failed first. The drop in the deformation for this truss occurred near the end of the test, when the opposite outer connection finally failed. Truss 2 is an inner truss, and was the third of the four connections to separate completely. The load-deformation curves for these two connections are shown in Figure 3.5.

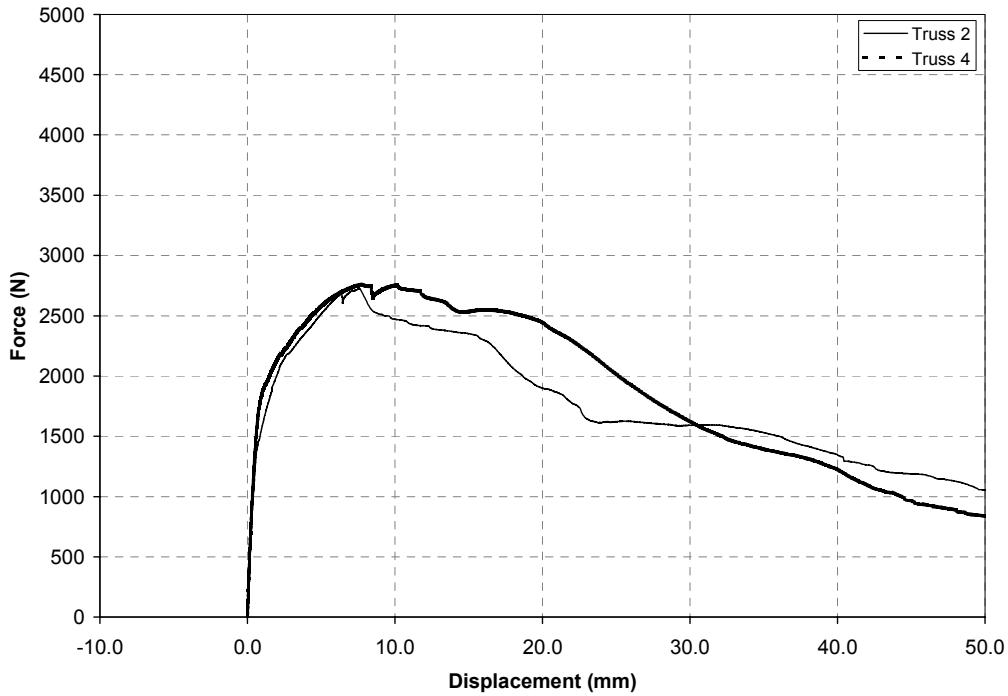
Figure 3.5. Load-deformation response of specimen with toe-nailed connections.

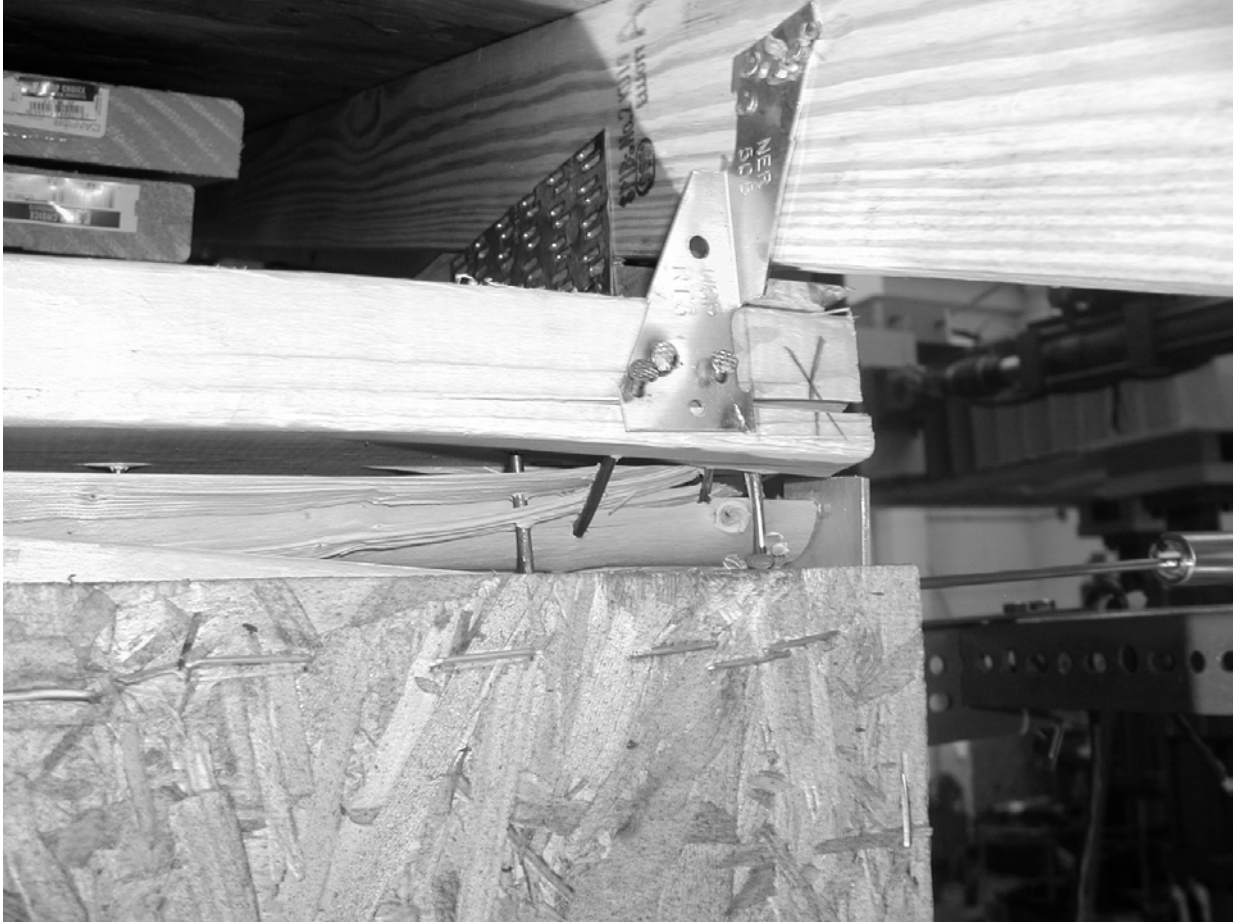
Figure 3.6. Failure of hurricane clip connection.

The specimen with the stronger hurricane clip connections was tested twice. The first failure occurred on the lightly instrumented side of the specimen, and consisted of the entire top plate pulling loose from the wall studs and cladding. The specimen was repaired and retested. During the second test, failure was observed on the other side in the walls' top plate, as can be seen in Figure 3.6. The hurricane clip remained attached to the upper member of the top plate and the truss, while the upper member of the top plate and a portion of the lower member separated from the rest of the wall. This failure mode clearly illustrated the improved strength of the hurricane clip connection.

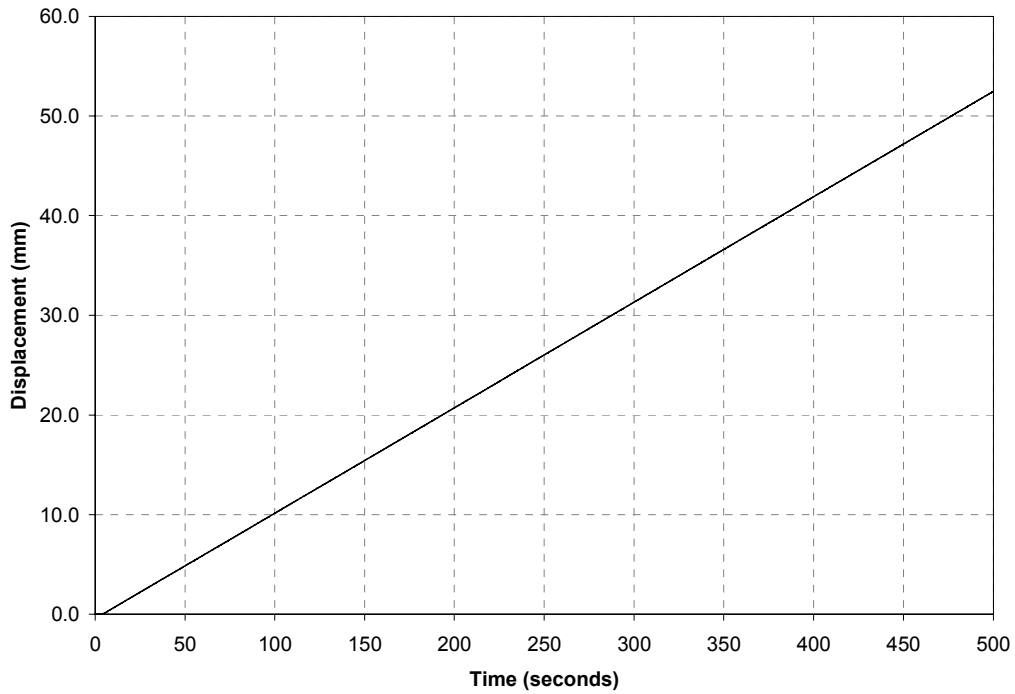
Figure 3.7. Vertical displacement applied to specimen with hurricane clips.

During both tests, this specimen was loaded in the same way as the toe-nailed connection specimen, except that the loading period was increased and, as can be seen in Figure 3.7, the applied deformation increased proportionally. During the first test, the connections began to lose stiffness after about 150 s, but they did not fail until approximately 225 s. Due to the nature of the failure, the resistance of the specimen dropped by about half when the first failure occurred. This response can be observed in Figure 3.8.

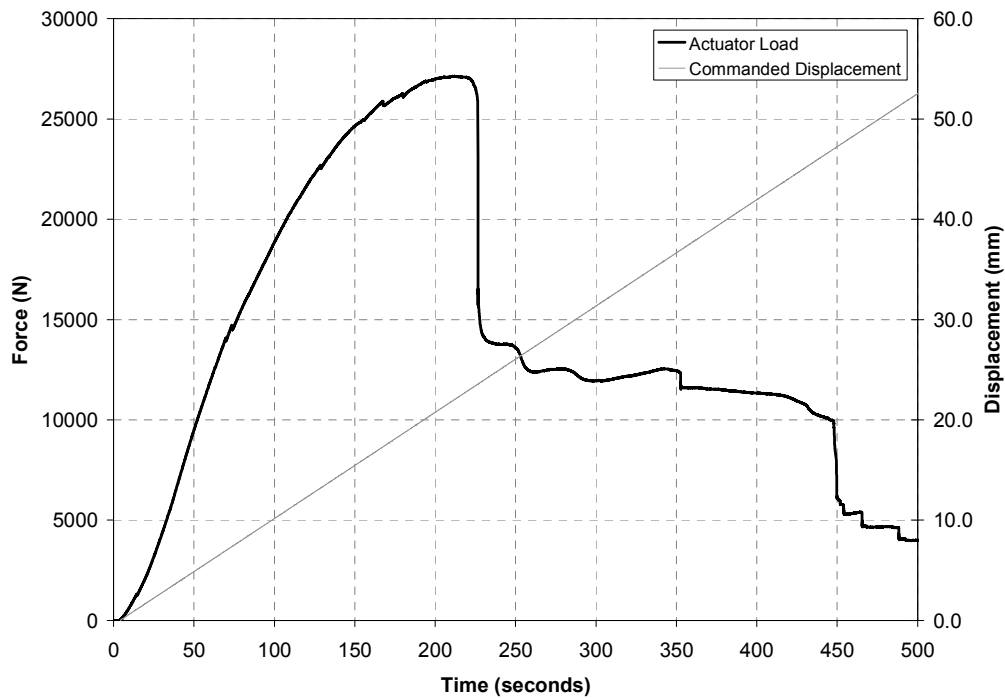
Figure 3.8. Vertical load applied to specimen with hurricane clips.

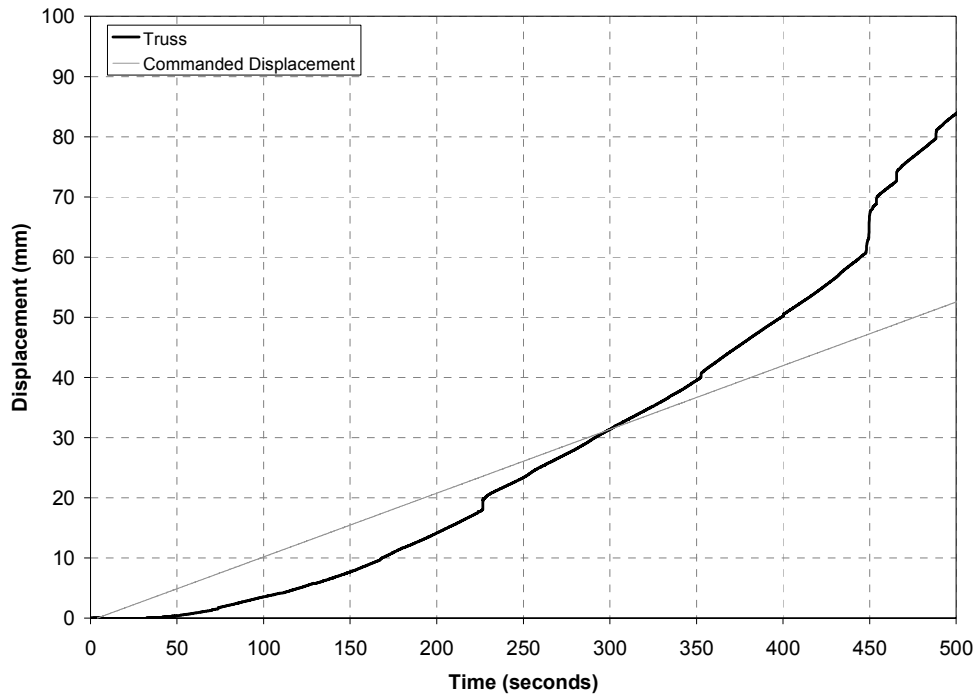
Figure 3.9. Connection deformation response of first test with hurricane clips.

The deformation that occurred at one of the inner truss connections during the first test is shown in Figure 3.9, while the deformation at three connections during the second test is shown in Figure 3.11. The corresponding load-deformation curves are shown in Figure 3.10 (first test) and Figure 3.12 (second test). As can be seen in these two figures, the hurricane clip connections showed good ductility, continuing to carry significant, but reduced, load at relatively large levels of deformation.

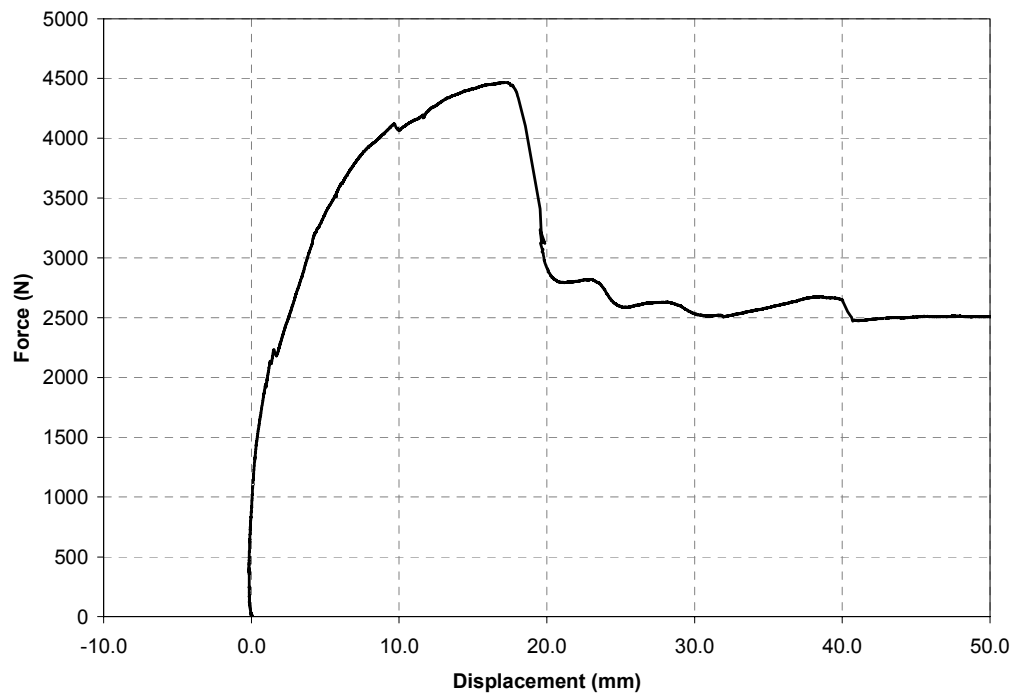
Figure 3.10. Load-deformation response of first test with hurricane clips.

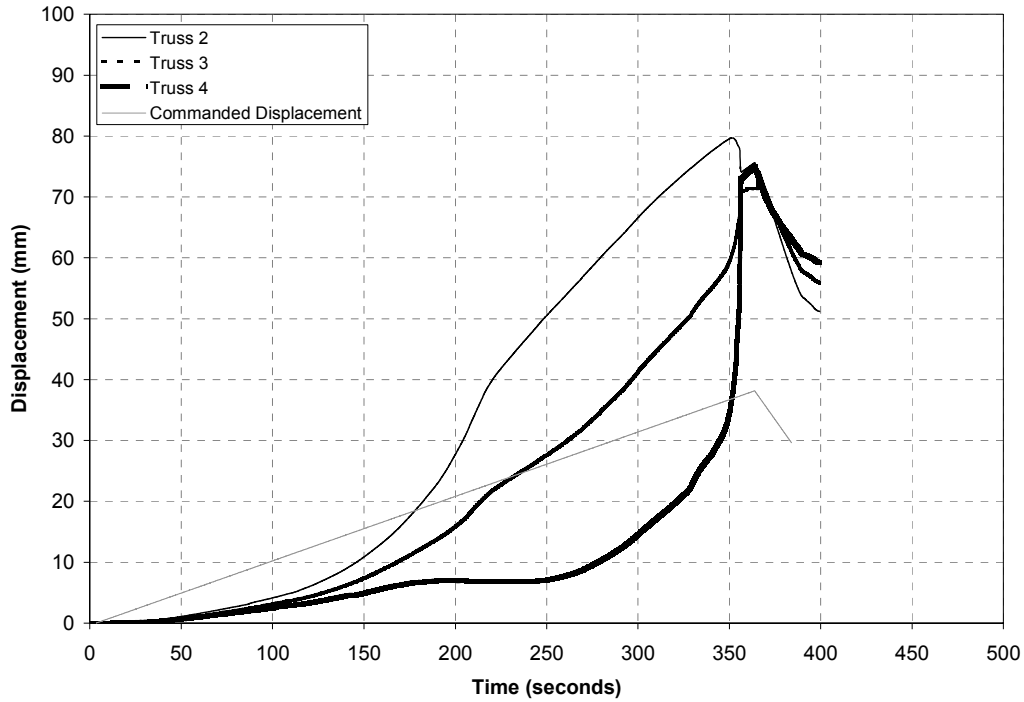
Figure 3.11. Connection deformation response of second test with hurricane clips.

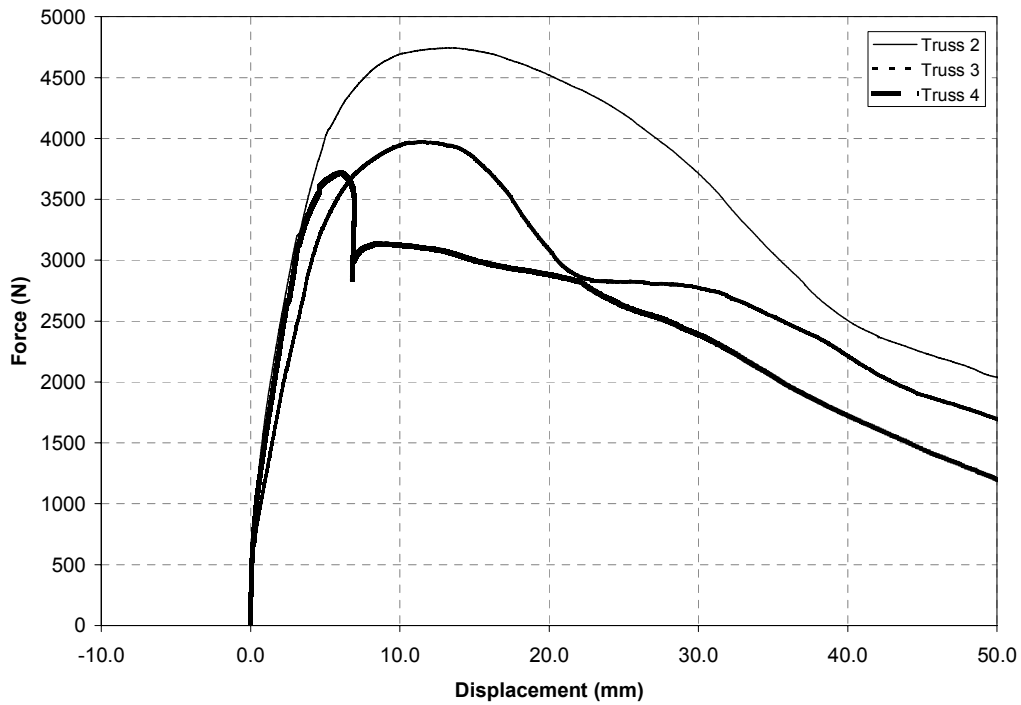
Figure 3.12. Load-deformation response of second test with hurricane clips.

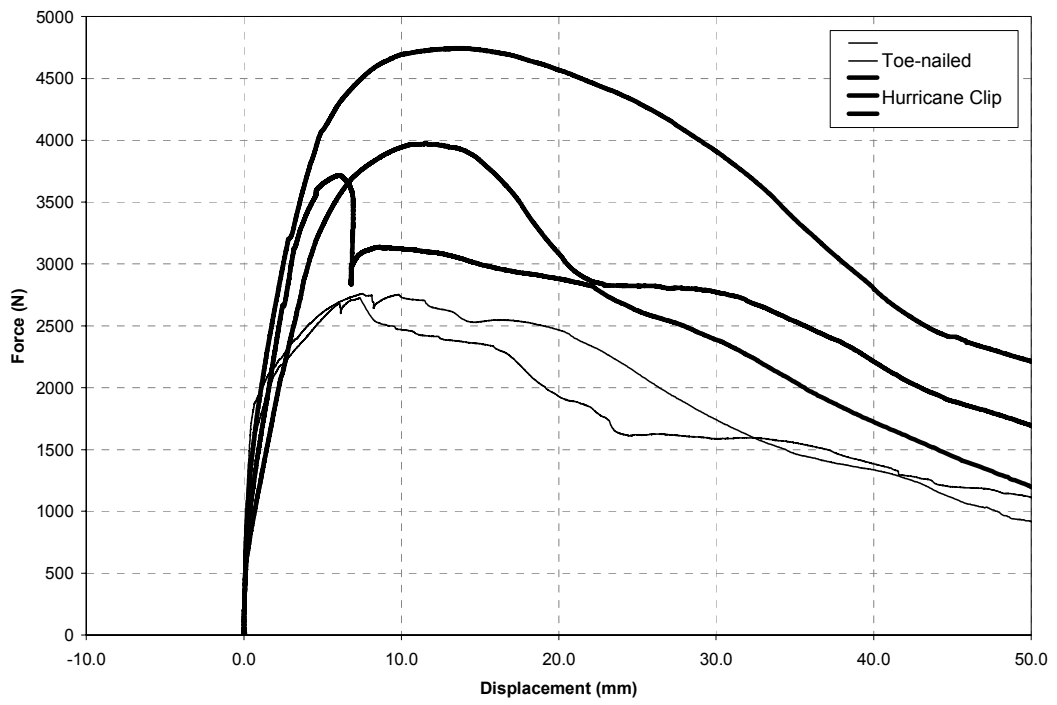
Figure 3.13. Comparison of responses with toe-nailed connections and hurricane clips.

A direct comparison of the responses with the two types of connections is shown in Figure 3.13. The behavior of both of these types of connections is highly nonlinear, and once either of these connections reaches their ultimate load they lose a significant portion of their resistance. However, Figure 3.13 clearly shows that the hurricane clip connection has a significantly higher uplift capacity, and in most cases a larger failure deformation than the toe-nailed connections. In addition, the residual strength of the hurricane clip connection tended to be greater than the capacity of the toe-nailed connection.
