**EXPERIMENTAL TESTING OF ROOF TO WALL
CONNECTIONS IN WOOD FRAME HOUSES**

Michael A. Riley and Fahim Sadek

April 2003

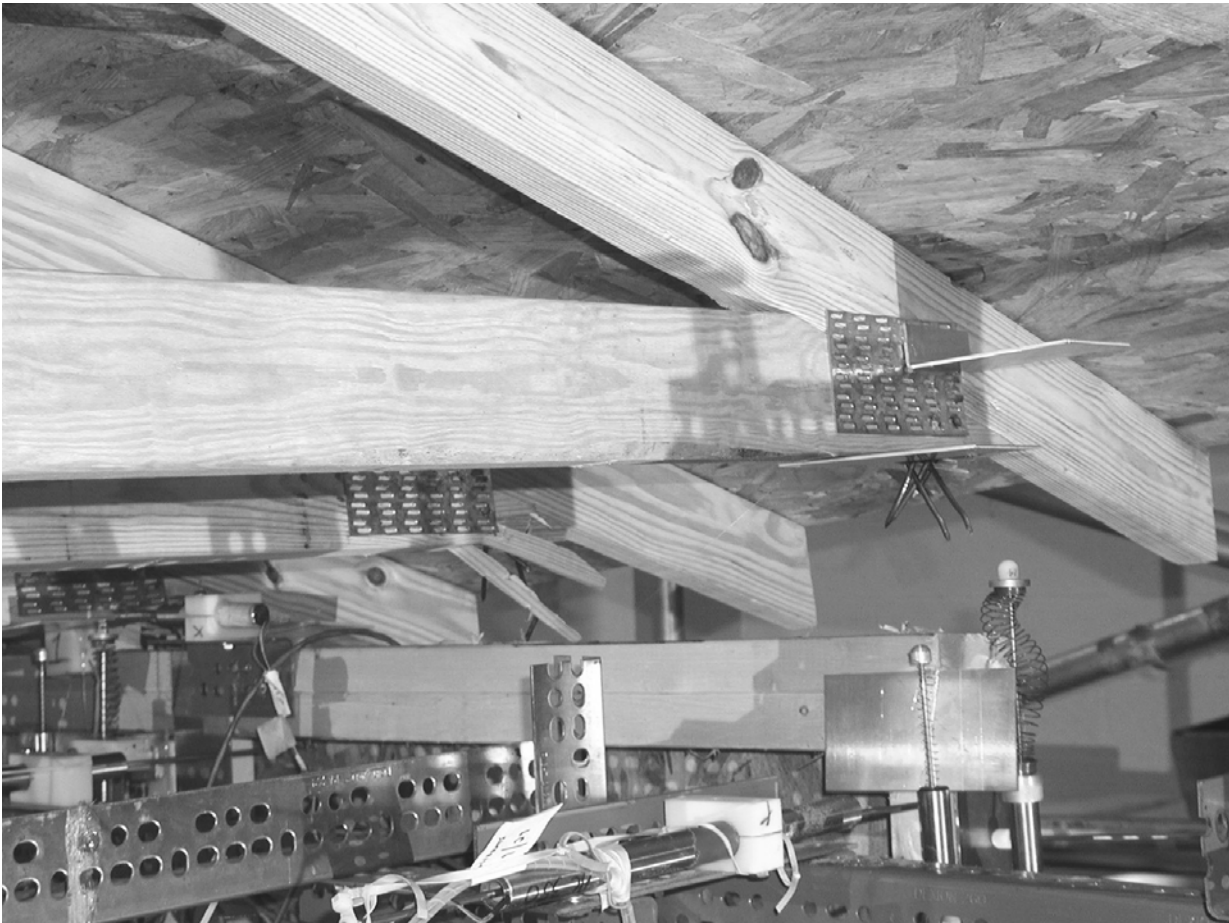
Figure 4.1. Failure of toe-nailed connection with lateral load.

For the specimen with toe-nailed connections, the lateral deformation was applied at a constant rate of 12.7 mm/min (0.50 in/min) for a period of about 330 s, as can be observed in Figure 4.2. The resulting load is shown in Figure 4.3. The specimen resisted the applied load with constantly decreasing stiffness, until about 270 s into the test. At this point, the tension, due to the overturning moments, in the connections at one end caused the outer truss to pull free of the top plate. This failure can be seen in Figure 4.1. As in the case of the uplift loading, the failure mode can be characterized as nail withdrawal from the top plate. This failure resulted in the wood splitting in the bottom chord of one inner truss, but little damage to the wood of the outer truss.

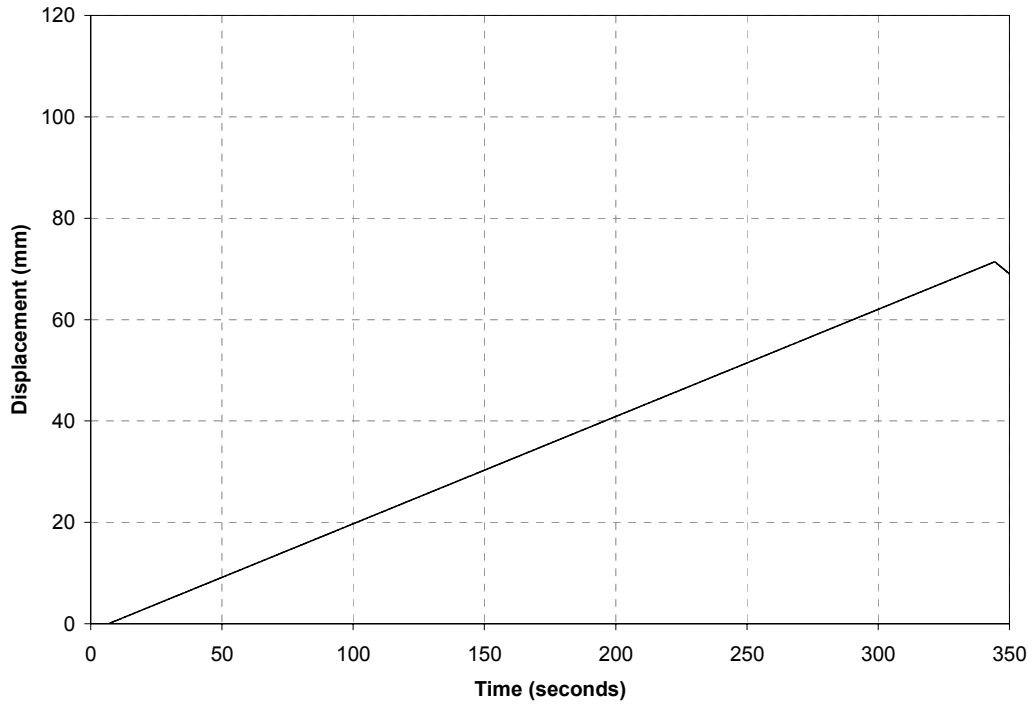
Figure 4.2. Lateral displacement applied to specimen with toe-nailed connections.

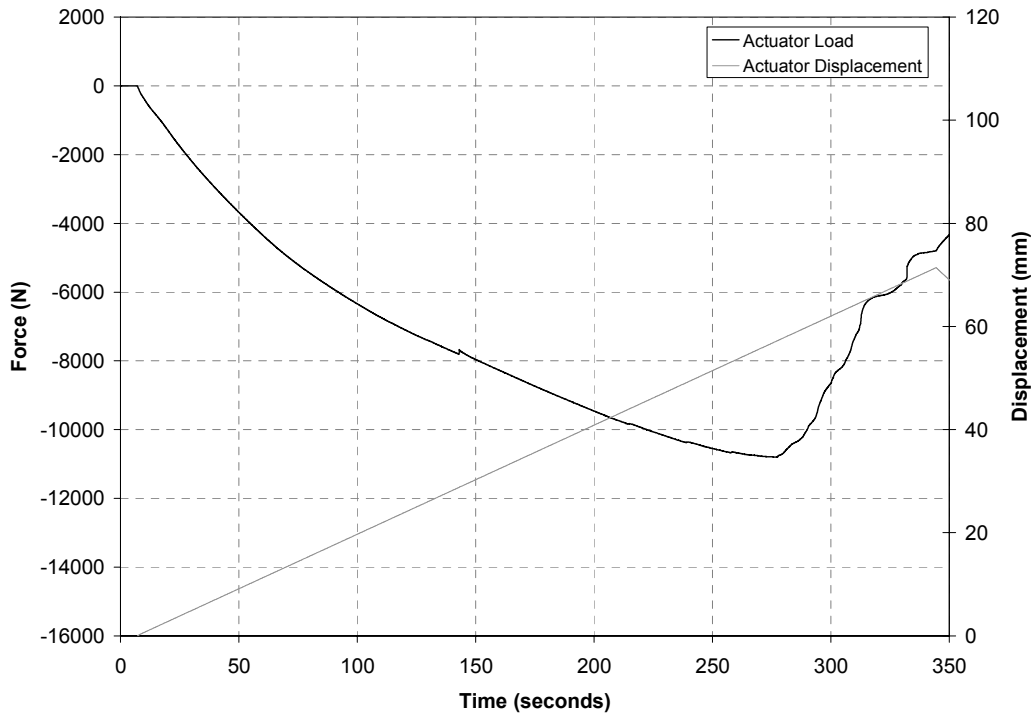
Figure 4.3. Lateral load applied to specimen with toe-nailed connections.

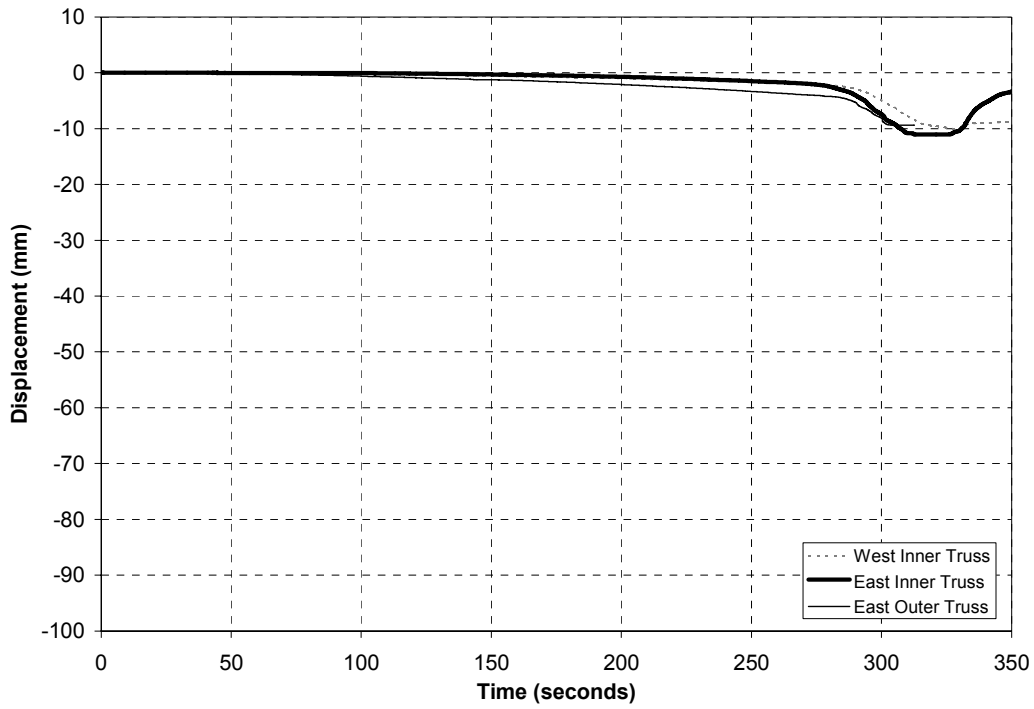
Figure 4.4. Lateral displacement responses for trusses with toe-nailed connections.

The lateral deformations in the toe-nailed connections of three of the trusses are shown in Figure 4.4, while the uplift deformations in the same connections are shown in Figure 4.5. From these results it is clear that the connections were quite stiff in shear, but more flexible in tension. The corresponding force displacement responses are shown in Figures 4.6 and 4.7. The responses of all three connections were quite similar in shear, but the outer connection, which failed first, was clearly carrying

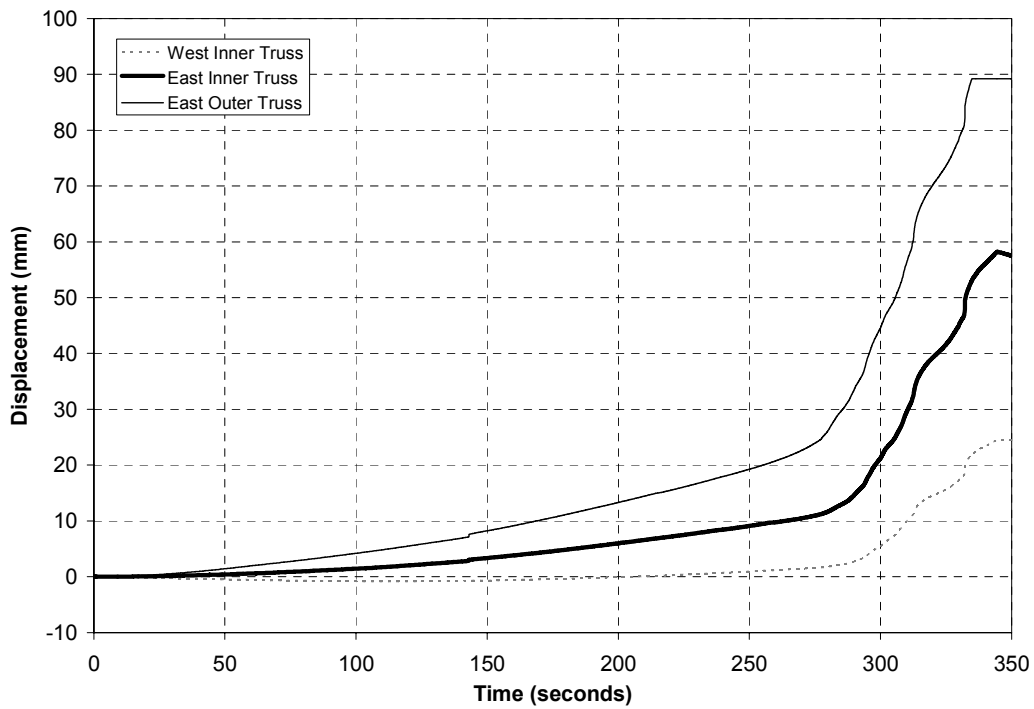
Figure 4.5. Uplift displacement responses for trusses with toe-nailed connections.

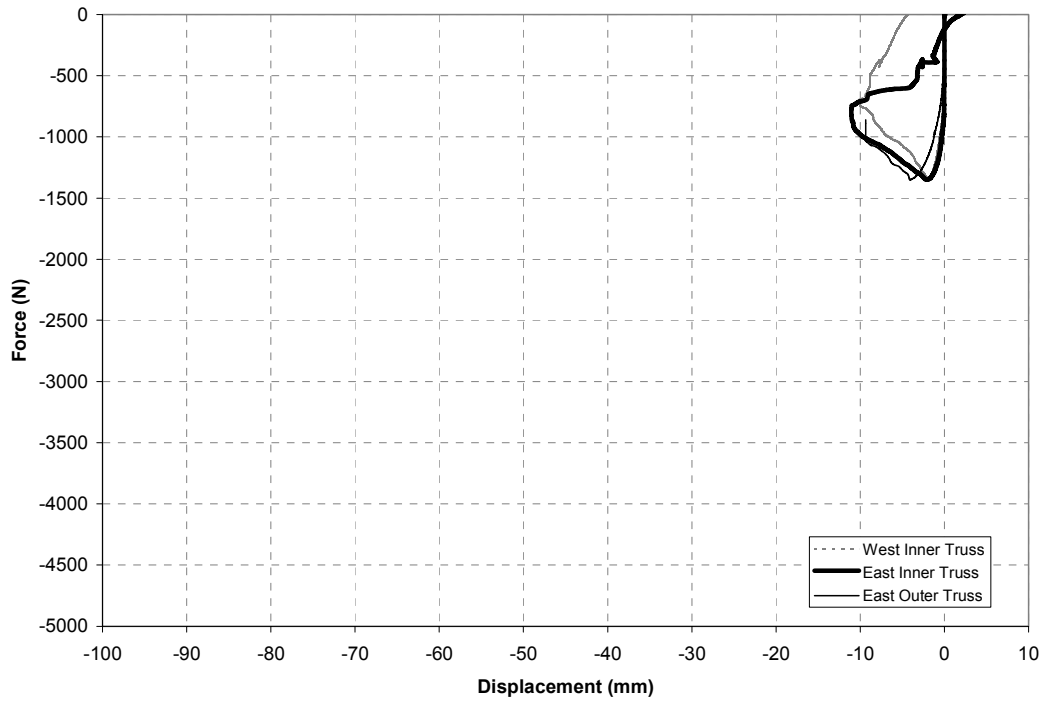
Figure 4.6. Lateral force-displacement responses for trusses with toe-nailed connections.

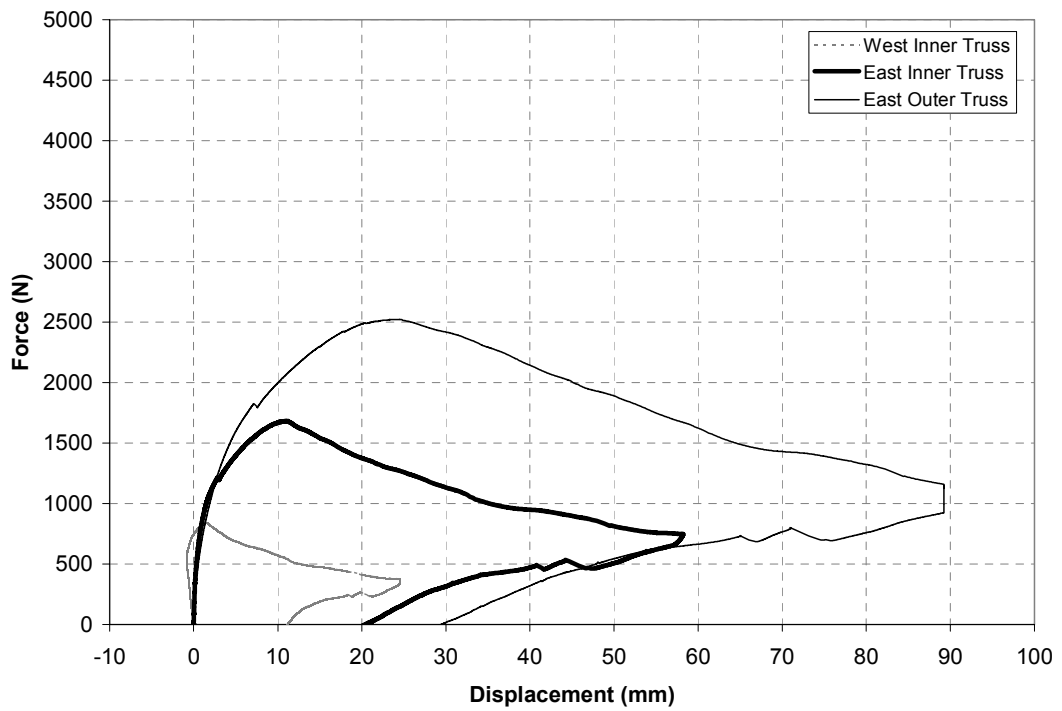
Figure 4.7. Uplift force-displacement responses for trusses with toe-nailed connections.

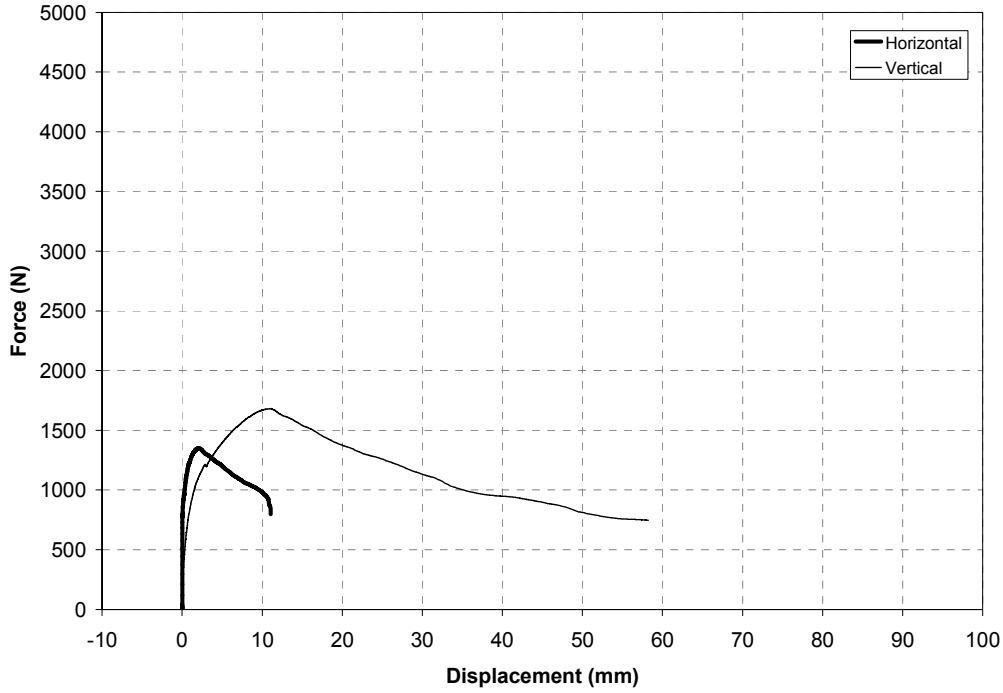
Figure 4.8. Comparison of lateral and vertical responses for inner truss with toe-nailed connections.

The lateral and vertical components of the response of the east inner truss are shown in Figure 4.8. These curves clearly show a difference in the lateral and vertical stiffness of the connection, and how much more deformation occurred in the vertical direction than the lateral. Figure 4.9 shows the same response for the east outer truss. In this case the difference in the stiffnesses before failure is not as great, but again the vertical deformation is much greater than the lateral deformation. It is notable that the peak vertical load carried by this connection is nearly as large as the load carried by the toe-nailed connections tested with uplift loading.

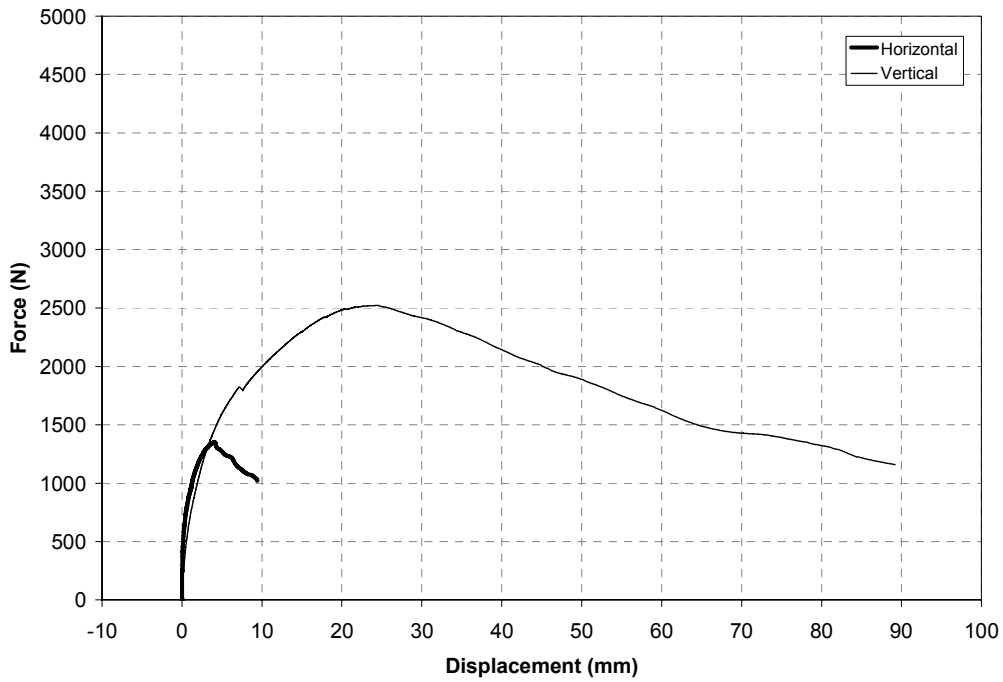
Figure 4.9. Comparison of lateral and vertical responses for outer truss with toe-nailed connections.

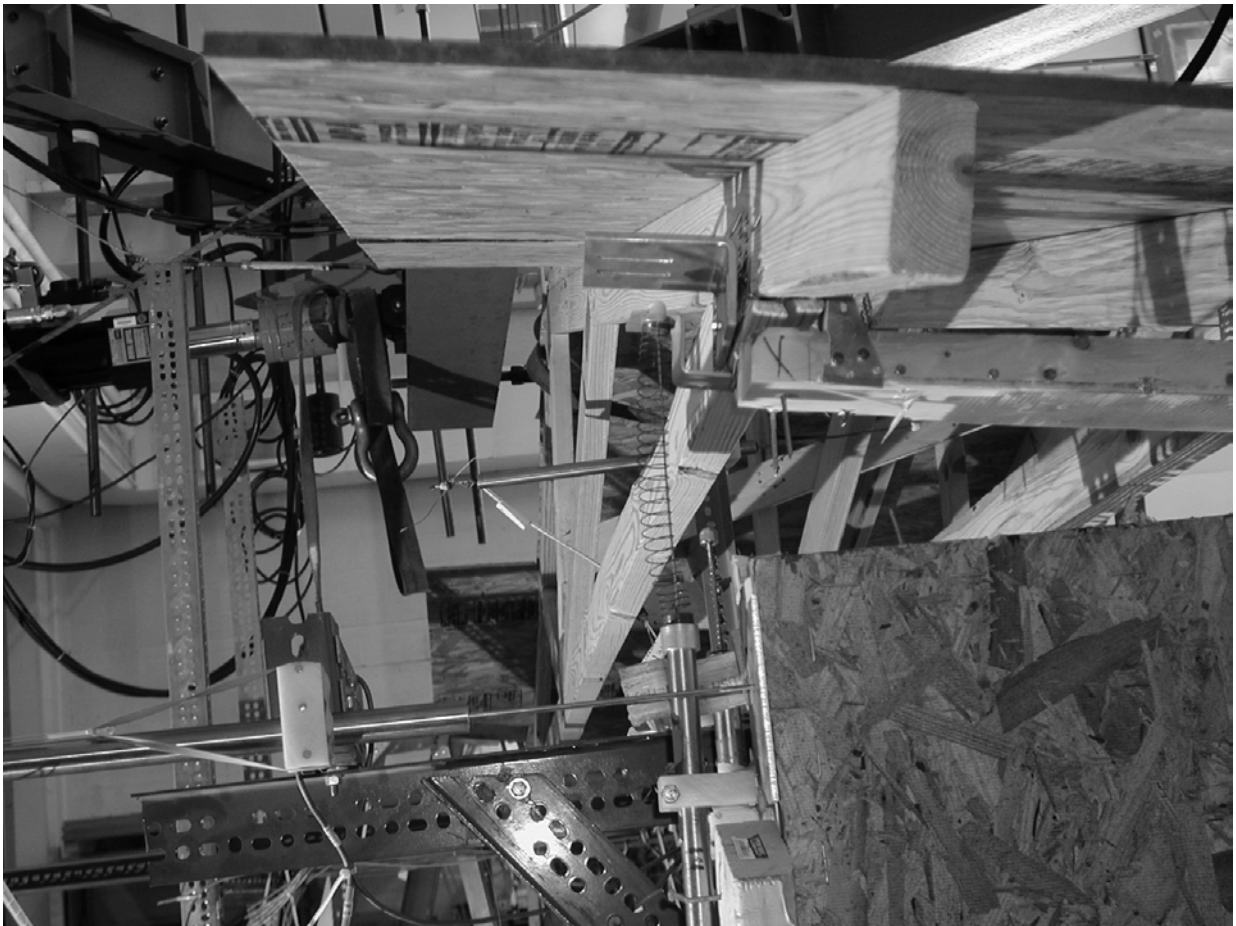
Figure 4.10. Failure of hurricane clip connection with lateral load.

For the specimen with hurricane clips, the lateral deformation was applied at a constant rate of 25.4 mm/min (1.0 in/min) for a period of about 250 s, as can be observed in Figure 4.11. The load that resulted is shown in Figure 4.12. The specimen resisted the applied load with a near constant stiffness, until about 170 s into the test. At this point, the outer truss pulled free of the top plate. As in the case of the toe-nailed connections, the tension due to the overturning moments appeared to play a major role in the failure, which can be seen in Figure 4.10. Also as in the prior test, the failure mode can be characterized as nail withdrawal from the top plate.

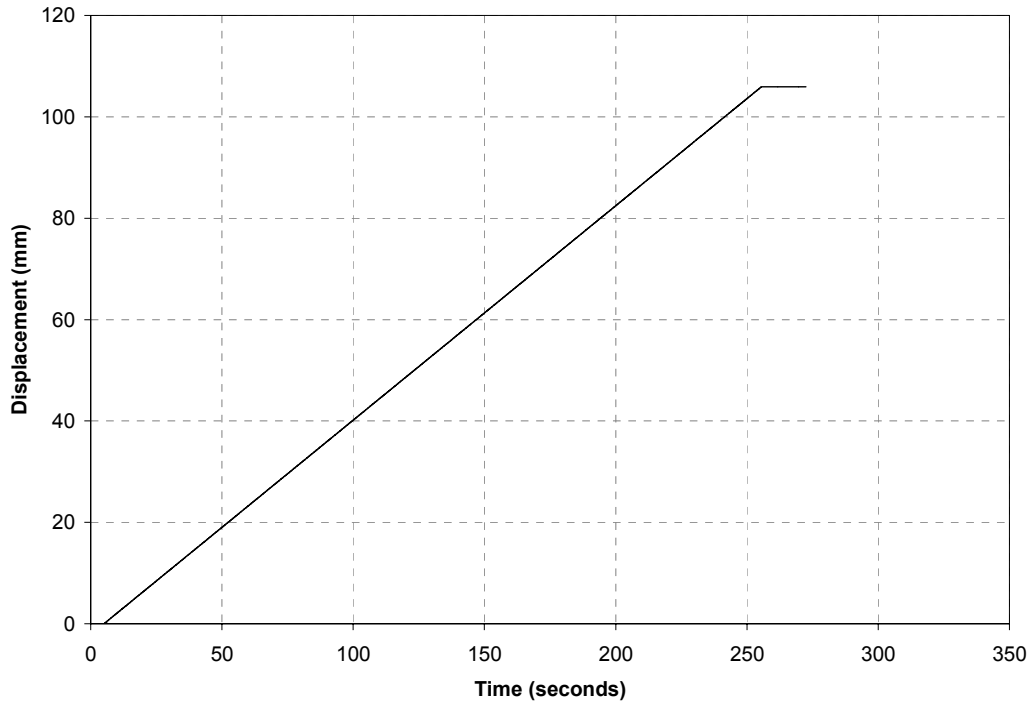
Figure 4.11. Lateral displacement applied to specimen with hurricane clips

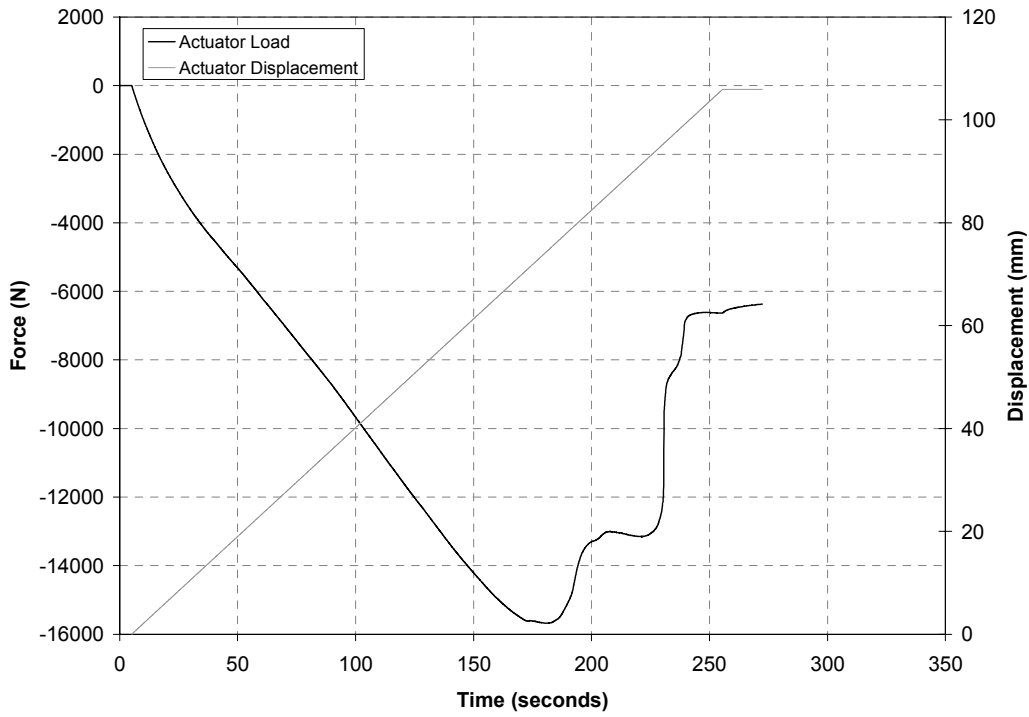
Figure 4.12. Lateral load applied to specimen with hurricane clips

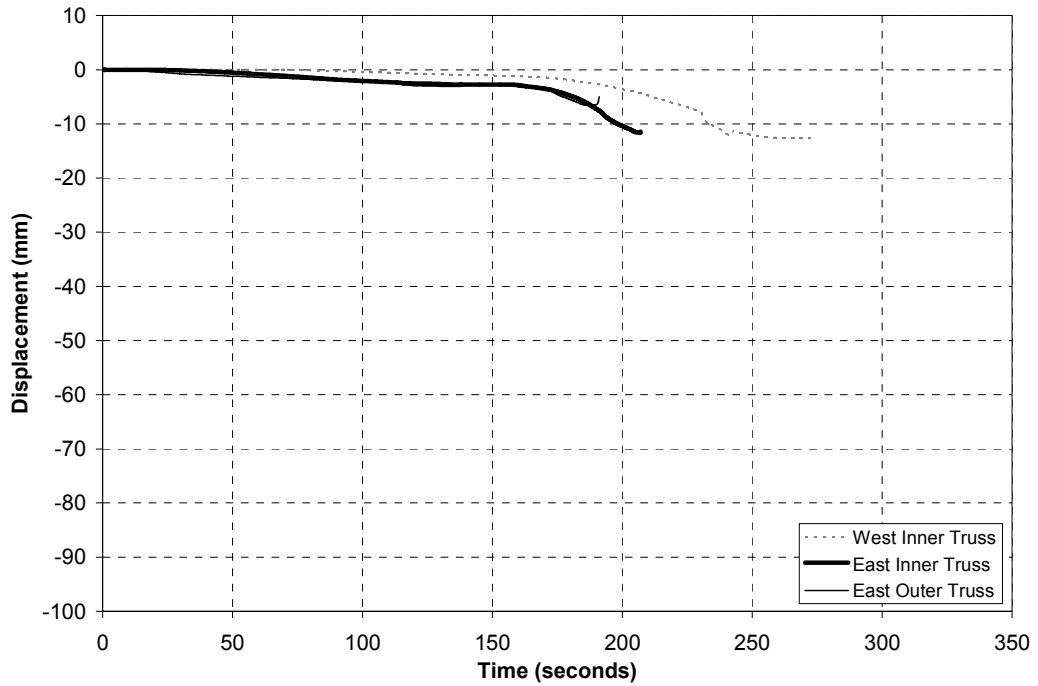
Figure 4.13. Lateral displacement responses for trusses with hurricane clips.

The lateral deformations in the connections of three of the trusses are shown in Figure 4.13, and the uplift deformations in these connections are shown in Figure 4.14. From these results it is clear that like the toe-nailed connections, the hurricane clip con-

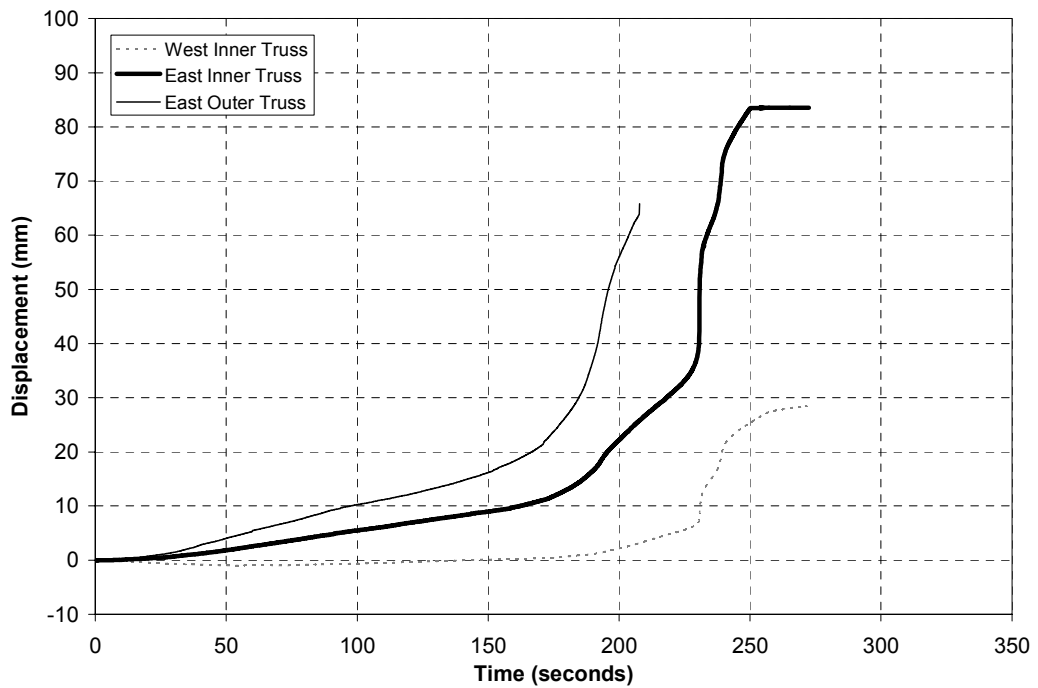
Figure 4.14. Uplift displacement responses for trusses with hurricane clips.

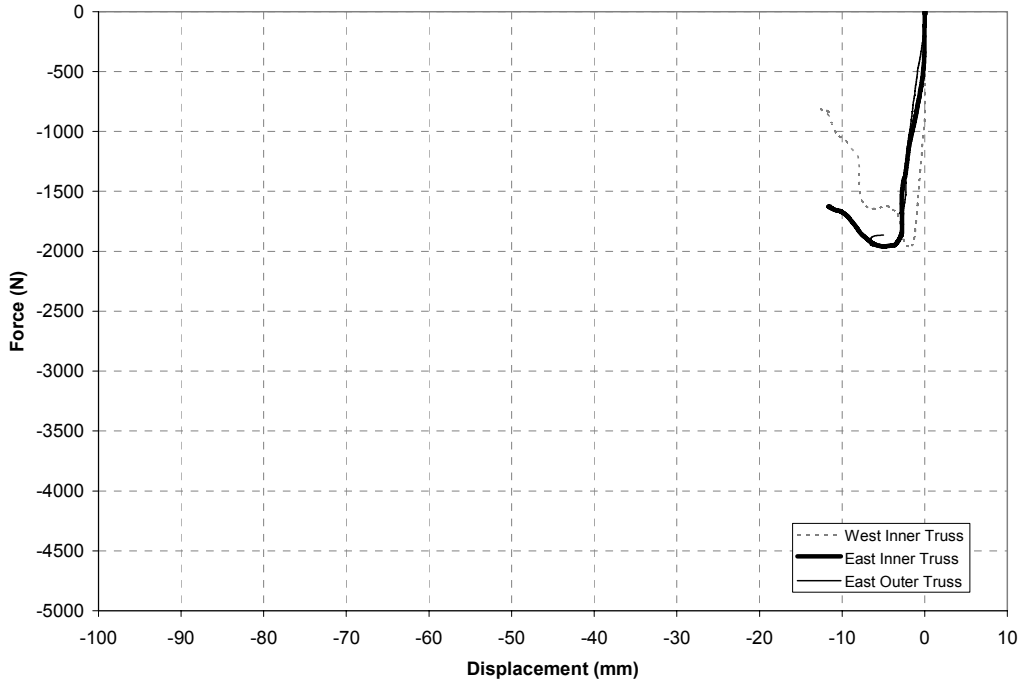
Figure 4.15. Lateral force-displacement responses for trusses with hurricane clips.

nections were quite stiff in shear, but relatively flexible in tension. The corresponding force displacement responses are shown in Figures 4.15 and 4.16. Again, the responses of all three connections were quite similar in shear, but the outer connection, which failed first, was clearly carrying greater tension due to the overturning moments, and the westernmost connection never reached its failure capacity.

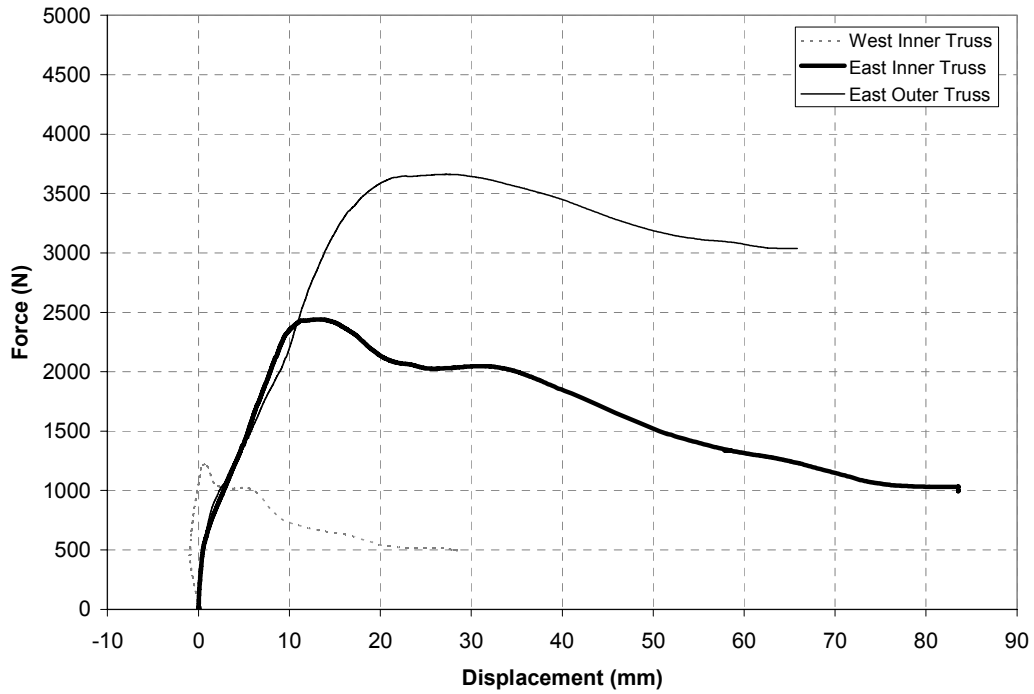
Figure 4.16. Uplift force-displacement responses for trusses with hurricane clips.

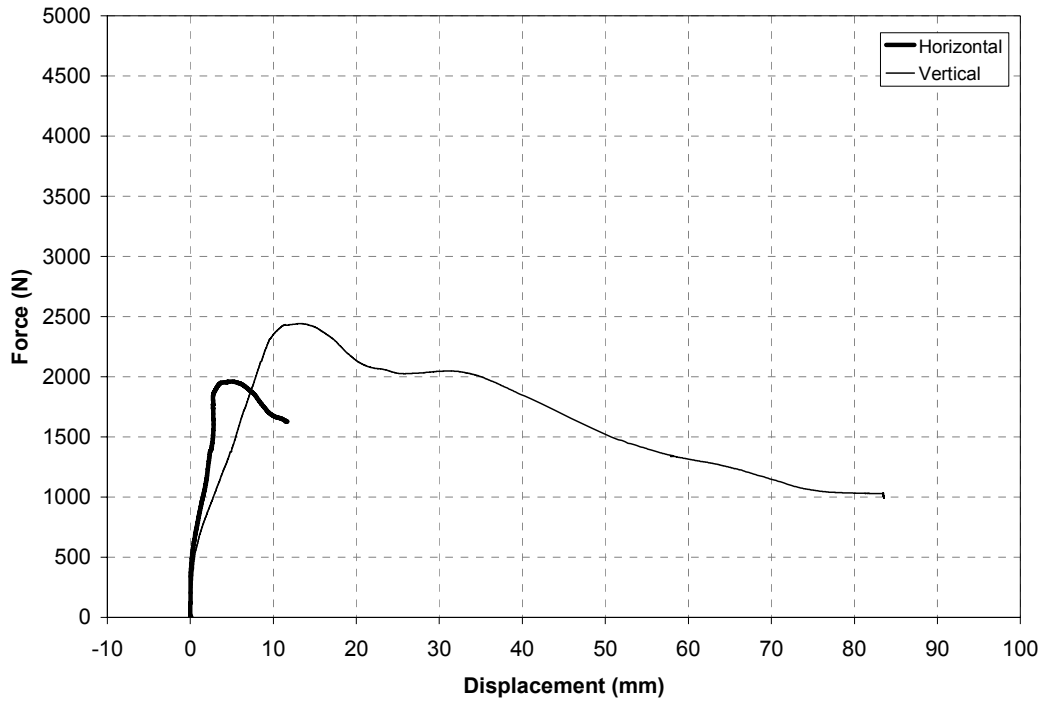
Figure 4.17. Lateral and vertical responses for inner truss with hurricane clips.

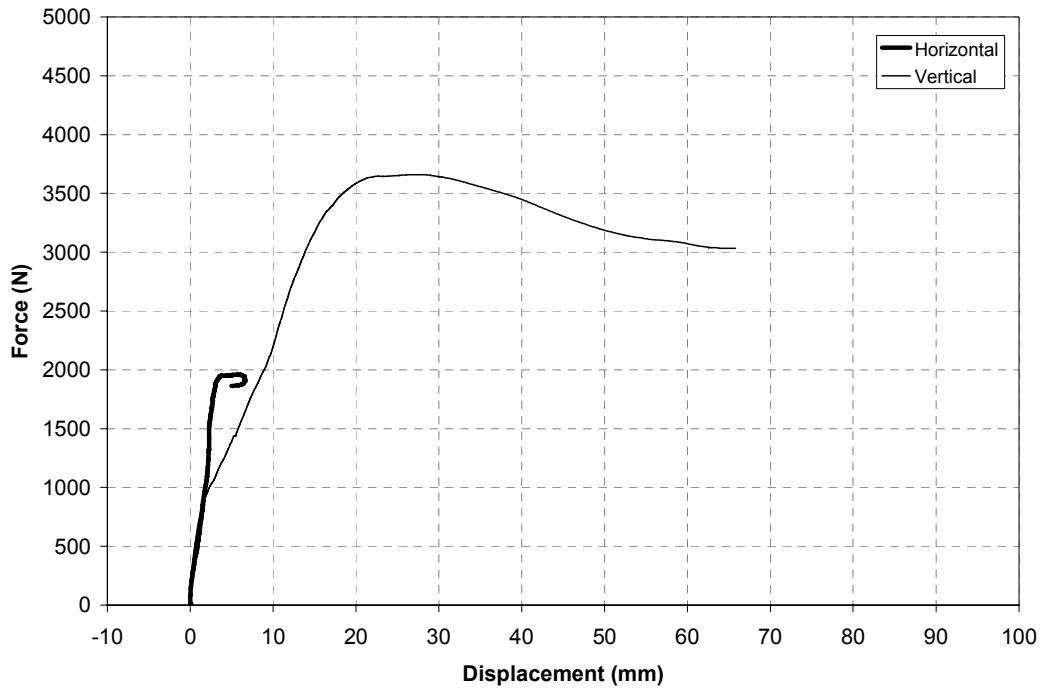
Figure 4.18. Lateral and vertical responses for outer truss with hurricane clips.

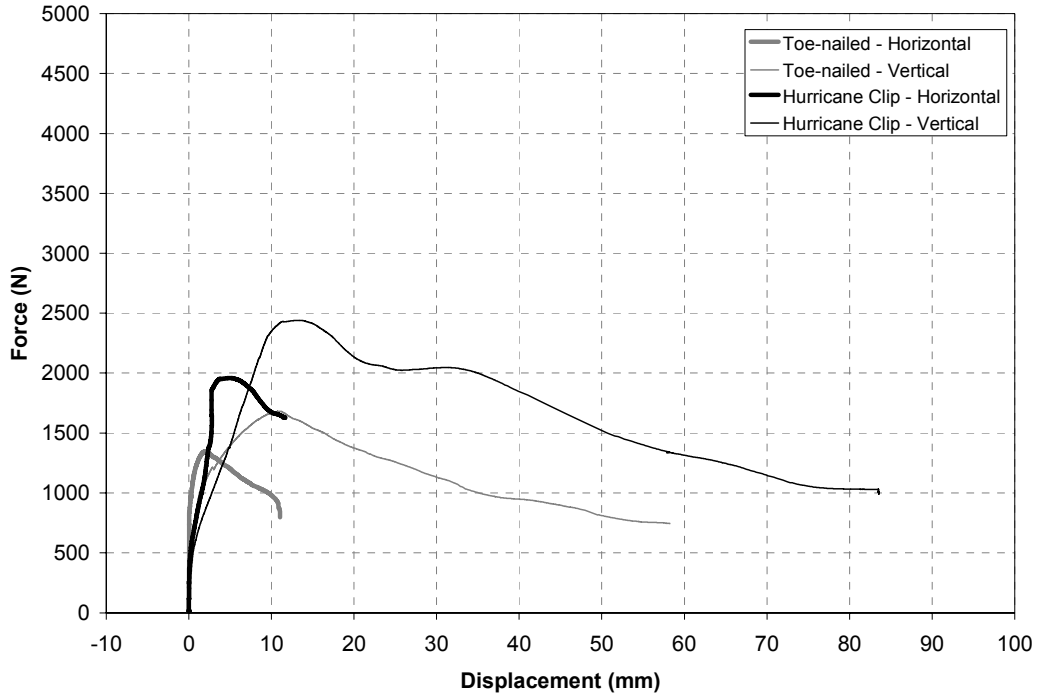
Figure 4.19. Comparison of responses of inner trusses.

A direct comparison of the responses at the inner trusses with the two types of connections is shown in Figure 4.19, while the responses at the outer trusses are shown in Figure 4.20. The behavior of both of these types of connections is highly nonlinear, with most of the deformation occurring in the vertical direction. These figures clearly show that the hurricane clip connections

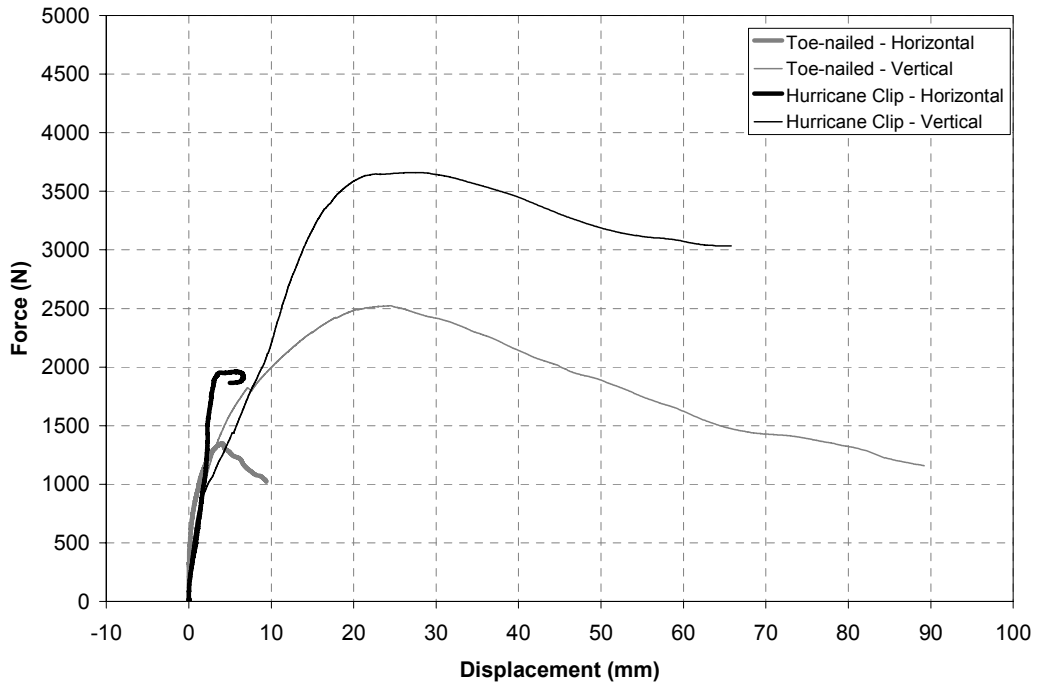
Figure 4.20. Comparison of responses of outer trusses.

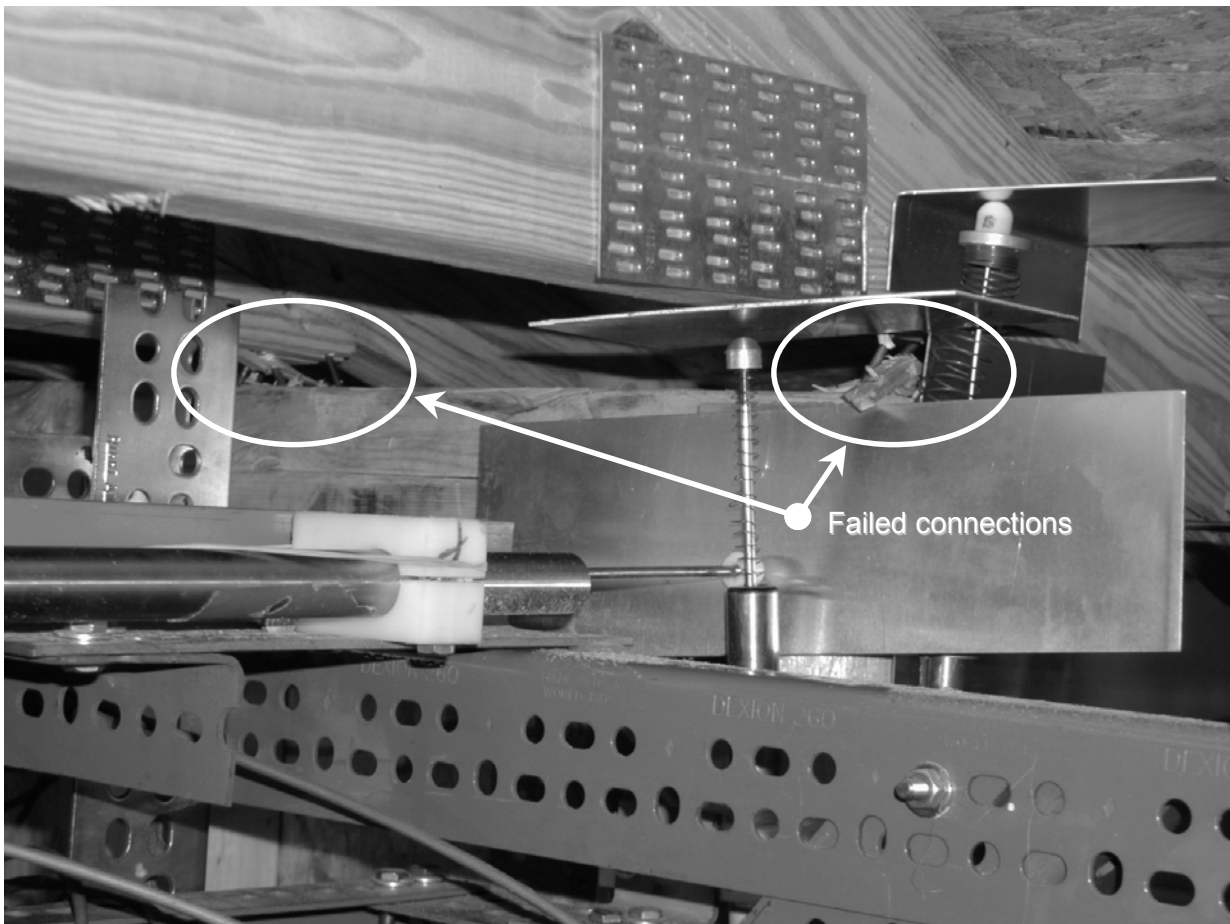
Figure 5.1. Failure of toe-nailed connection with cyclic load.

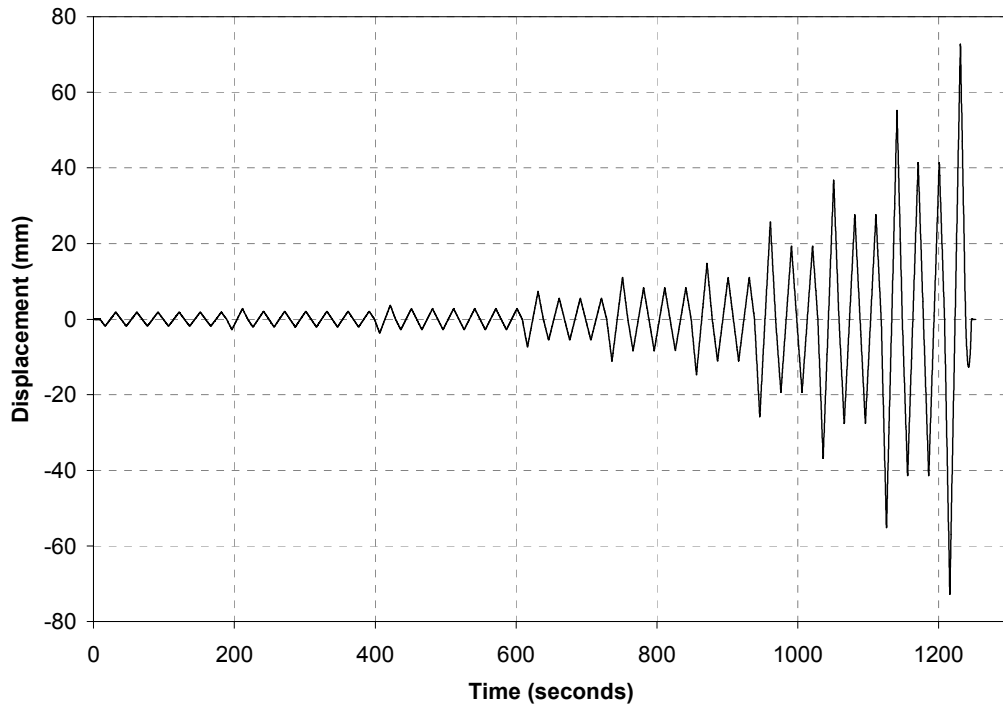
Figure 5.2. Lateral displacement applied to specimen with toe-nailed connections.

For the specimen with toe-nailed connections, the waveform described in section 2.4, was applied with a cycle period of 30 s and the unit amplitude of the generic waveform scaled to 32.24 mm (1.466 in). The resulting displacement curve is shown in Figure 5.2, and the resulting load is shown in Figure 5.3. Although the specimen's stiffness decreased during the test, the specimen resistance continued to increase until the final large cycle of motion, about 1220 s into the test. At this point, the connections at tension end of the specimen pulled free of the top plate. This failure can be seen in Figure 5.1. As in the case of the previous tests with the toe-nailed connections, the failure was due to the nails withdrawing from the top plate. This failure resulted in some wood splitting in the top plate of the wall, but little damage to the wood of the trusses.

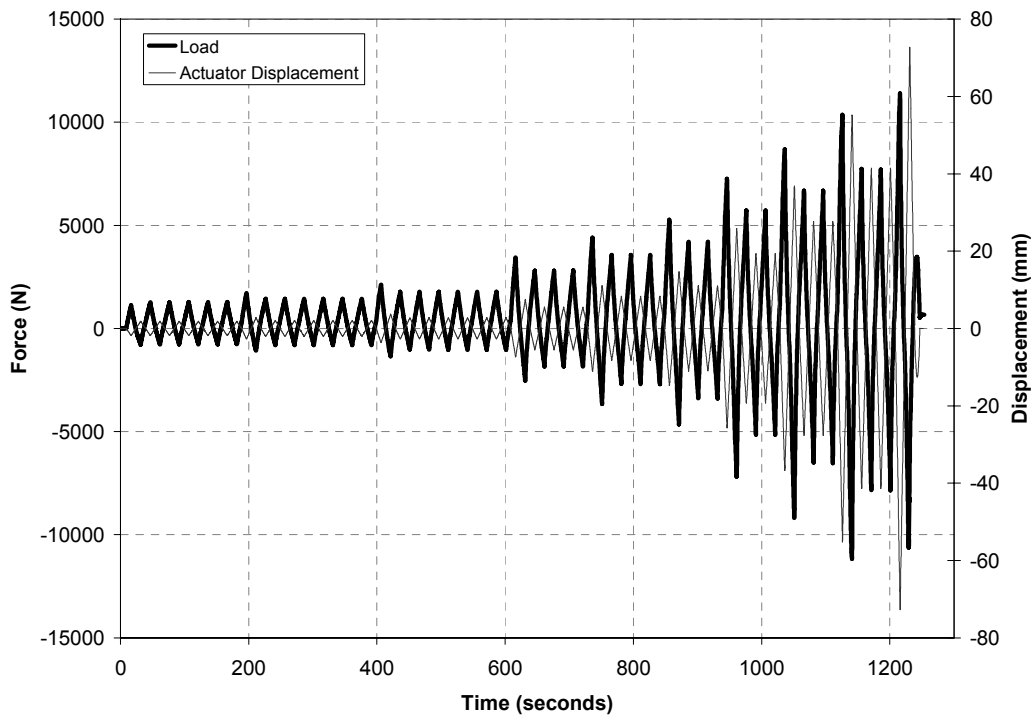
Figure 5.3. Lateral load applied to specimen with toe-nailed connections.

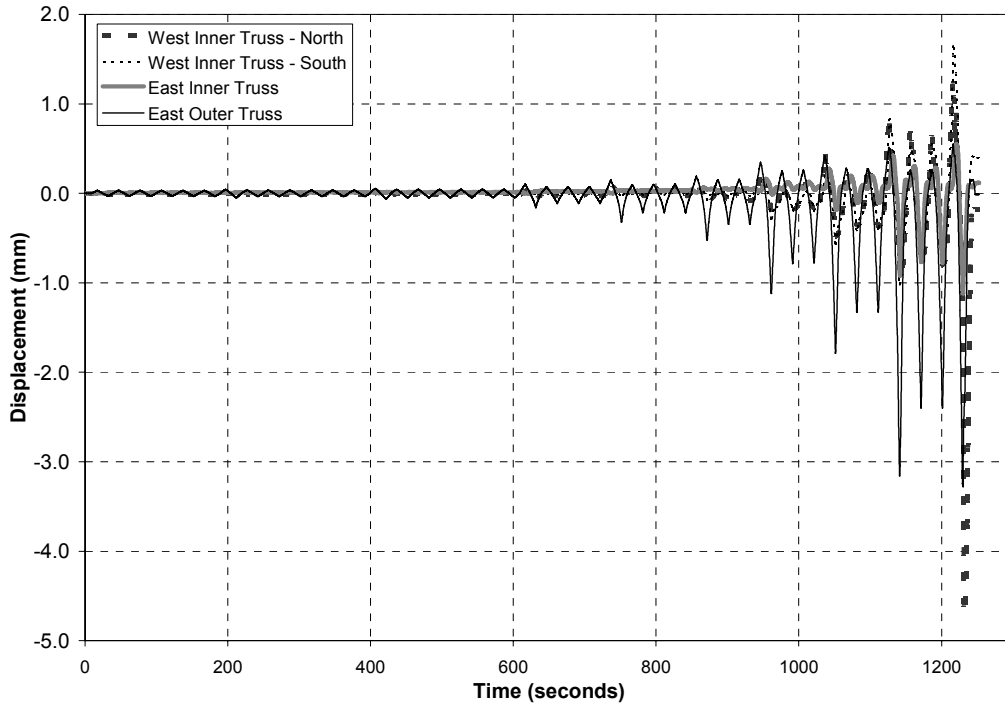
Figure 5.4. Lateral displacement responses for trusses with toe-nailed connections.

The lateral deformations in the toe-nailed connections of four connections for three of the trusses are shown in Figure 5.4. Note that the failure occurred on the north side of the specimen, so three of the four curves represent the non-failing response. From this figure it can be noted that the outer truss connection on the south side, which did not completely fail, began to deform significantly after about 600 s. The inner truss connection on the north side had relatively moderate shear deformations until the last cycle before it failed.

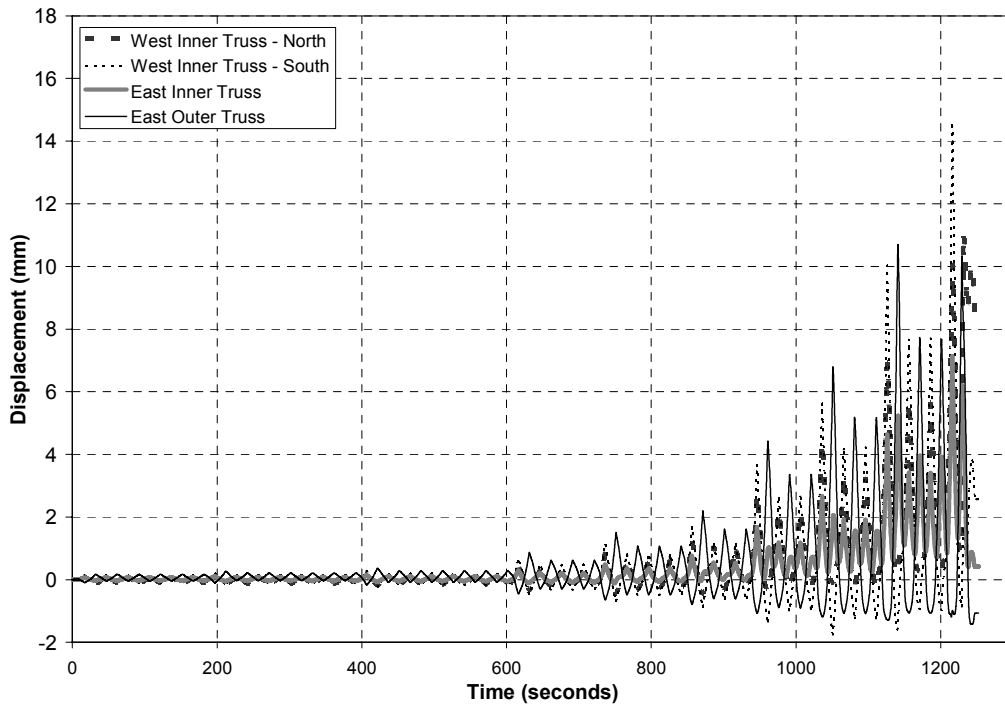
Figure 5.5. Uplift displacement responses for trusses with toe-nailed connections.

The corresponding uplift deformations in the connections are shown in Figure 5.5. From these results it is clear that the connections were more flexible in tension, and that both the outer truss connection on the south side and the inner truss connection on the north side began to deform more than the other connections after about 600 s.

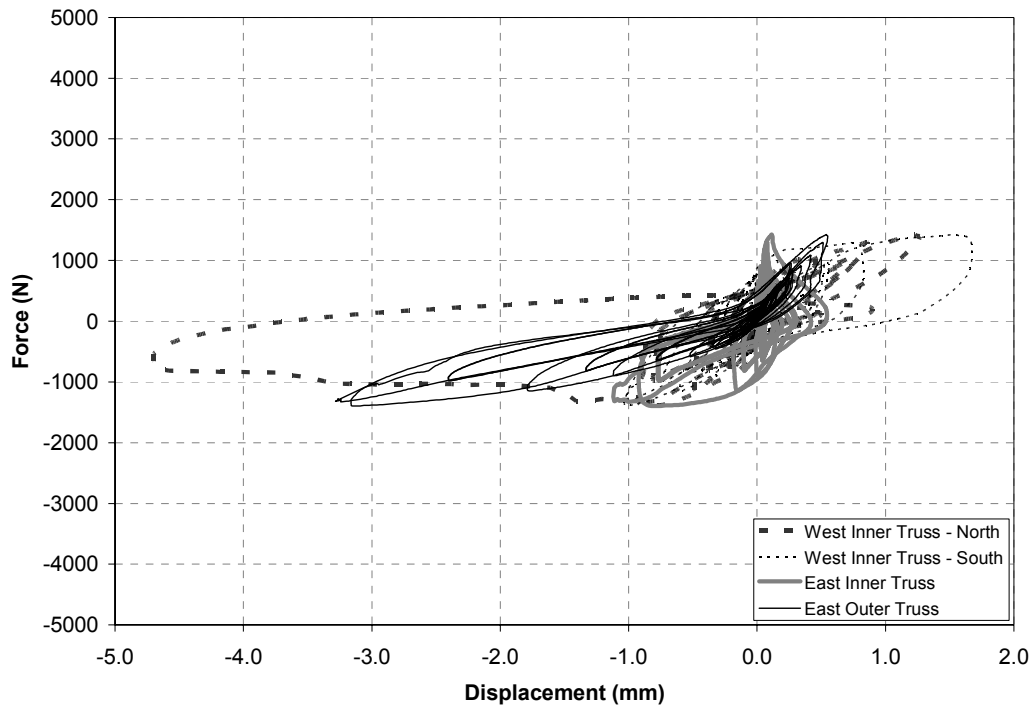
Figure 5.6. Lateral force-displacement responses for trusses with toe-nailed connections.

The corresponding force-displacement responses are shown in Figures 5.6 and 5.7. The responses of all four connections exhibit significant hysteresis, indicating that these connections would dissipate a significant amount of seismic energy before failure. For all connections except the east outer truss connection, the envelopes of the lateral and uplift responses during this test were similar to the responses observed during the monotonic lateral load test. However, the east connection on the outer truss exhibited more lateral deformation and less lateral stiffness than the other connections, while carrying more vertical load than was typical in prior tests.
