**EXPERIMENTAL TESTING OF ROOF TO WALL
CONNECTIONS IN WOOD FRAME HOUSES**

Michael A. Riley and Fahim Sadek

April 2003

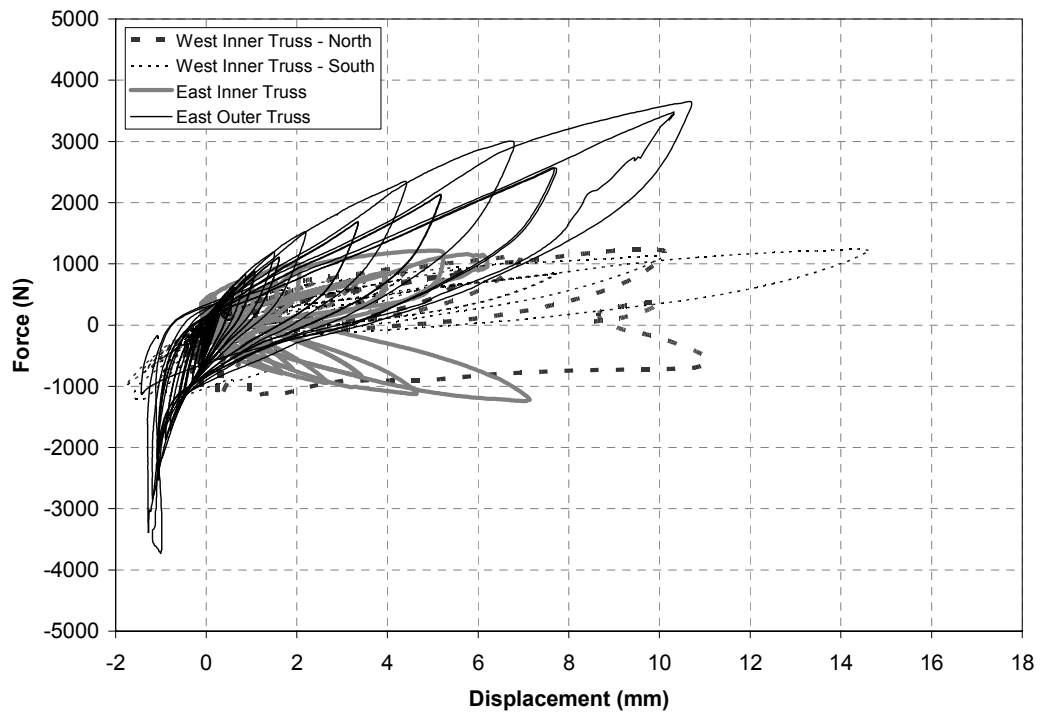
Figure 5.7. Uplift force-displacement responses for trusses with toe-nailed connections.

The corresponding force-displacement responses are shown in Figures 5.6 and 5.7. The responses of all four connections exhibit significant hysteresis, indicating that these connections would dissipate a significant amount of seismic energy before failure. For all connections except the east outer truss connection, the envelopes of the lateral and uplift responses during this test were similar to the responses observed during the monotonic lateral load test. However, the east connection on the outer truss exhibited more lateral deformation and less lateral stiffness than the other connections, while carrying more vertical load than was typical in prior tests.

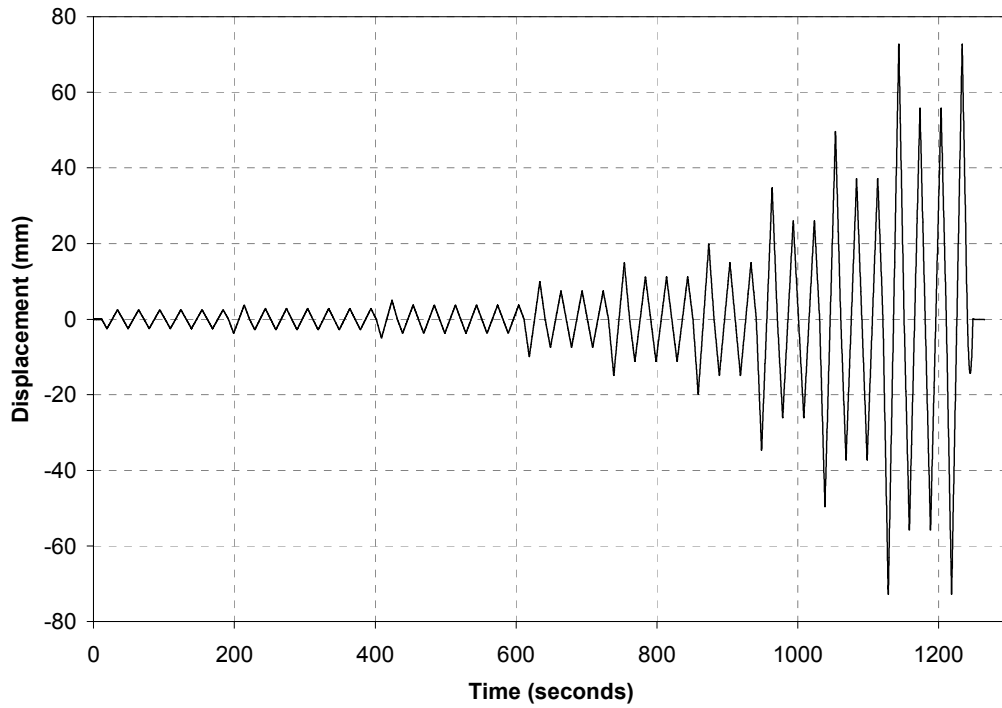
Figure 5.8. Lateral displacement applied to specimen with hurricane clips.

For the specimen with hurricane clips, the waveform described in section 2.4, was applied with a cycle period of 30 s and the unit amplitude of the generic waveform scaled to 50.19 mm (1.976 in), as can be observed in Figure 5.8. The load that resulted is shown in Figure 5.9. The specimen resisted the applied load with some degradation in stiffness, but increasing resistance, until the last large deformation cycle, which occurred approximately 1220 s into the test. At this point the specimen's north wall began to fail at the sill plate, with the studs and cladding pulling free of the sill. The hurricane clip connections had not yet failed when the test was stopped.

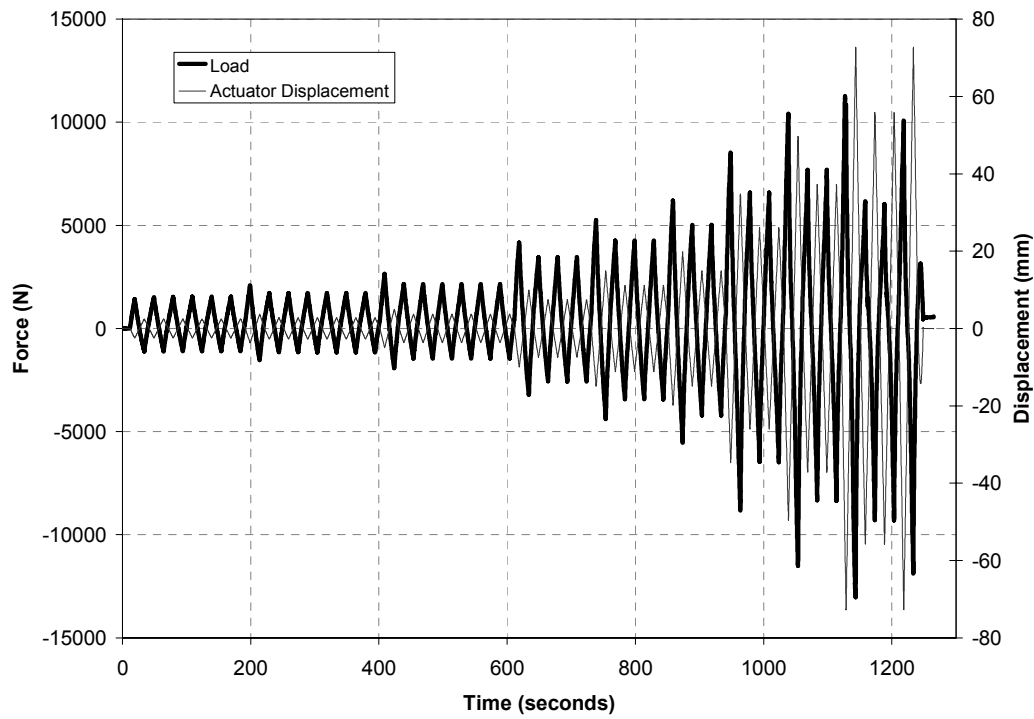
Figure 5.9. Lateral load applied to specimen with hurricane clips.

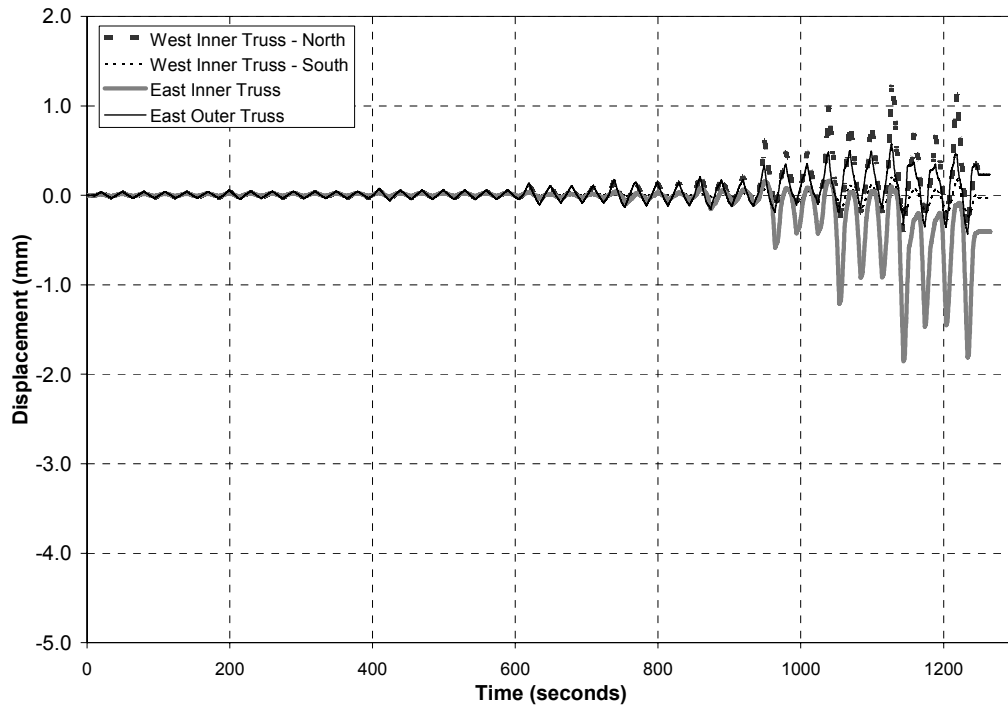
Figure 5.10. Lateral displacement responses for trusses with hurricane clips.

The lateral deformations in the connections of three of the trusses are shown in Figure 5.10, and the uplift deformations in these connections are shown in Figure 5.11. While none of the connections failed, the responses shown in Figure 5.10 clearly indicate that the connection in the east inner truss may have begun to fail at about 950 s into the test. Based on the responses shown in both figures, it is clear that, as in the monotonic lateral load test, the hurricane clip connections were quite stiff in shear, but relatively flexible in tension.

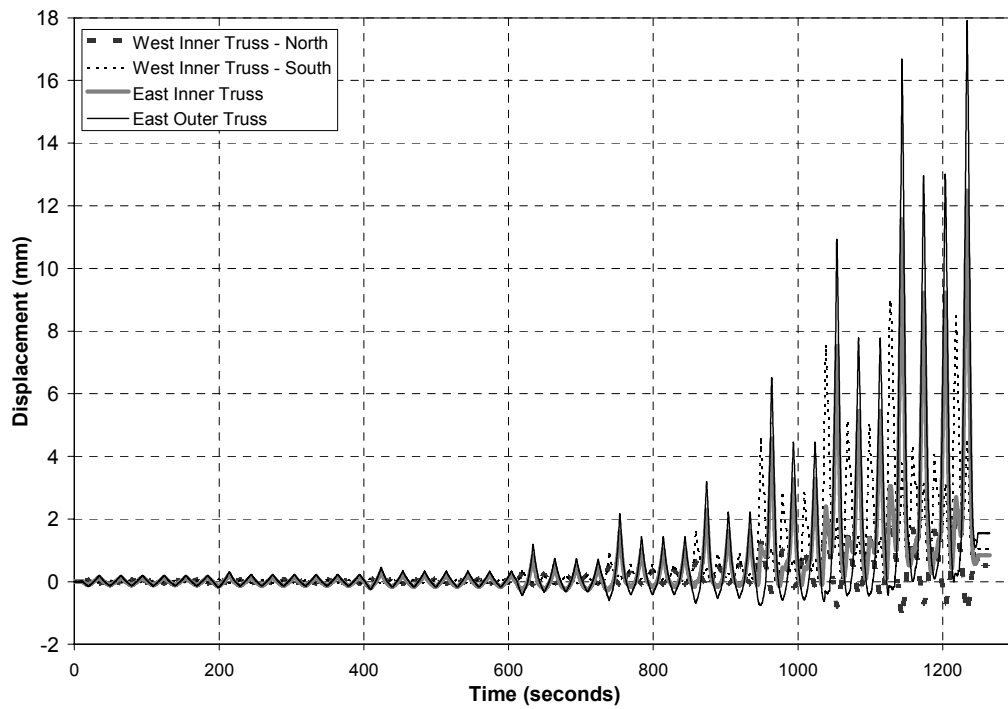
Figure 5.11. Uplift displacement responses for trusses with hurricane clips.

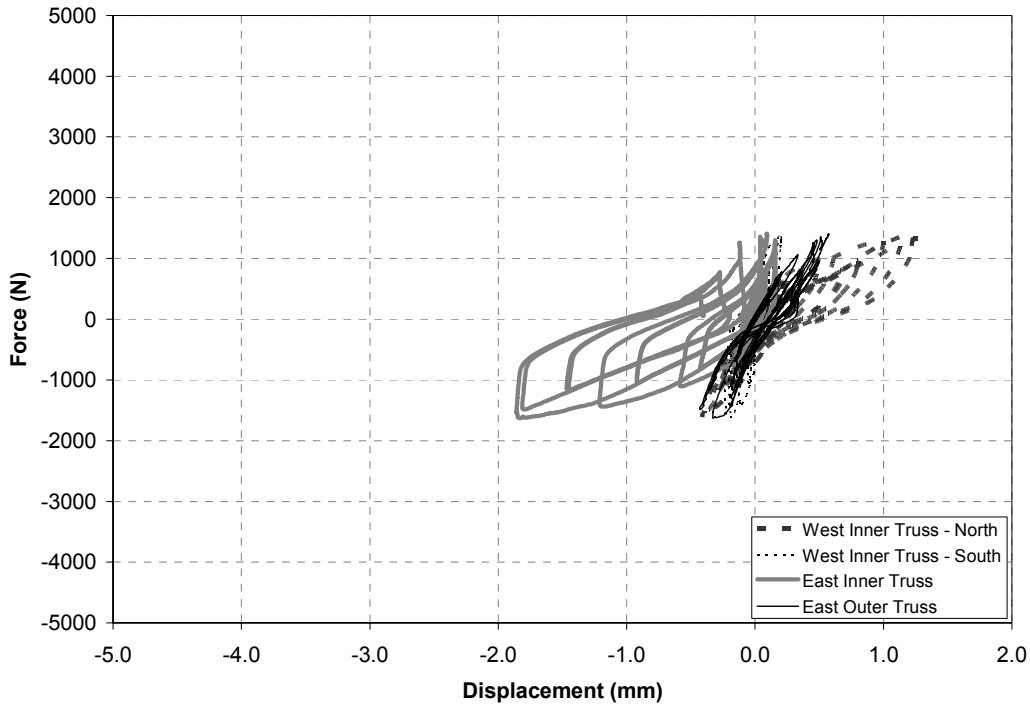
Figure 5.12. Lateral force-displacement responses for trusses with hurricane clips.

The corresponding force displacement responses are shown in Figures 5.12 and 5.13. As in the case of the toe-nailed connections, the responses of all four connections shown in these figures exhibit significant hystere-

sis. The east inner truss connection, which may have begun to fail early in the test, had the largest hysteresis. All of the connections responses had envelopes that were similar to the responses observed during the monotonic lateral load test. Since none of the connections failed entirely, the ultimate load capacity for the connections with this type of loading was not determined. However, it is clear for this load case the hurricane clips were stronger than the wall itself.

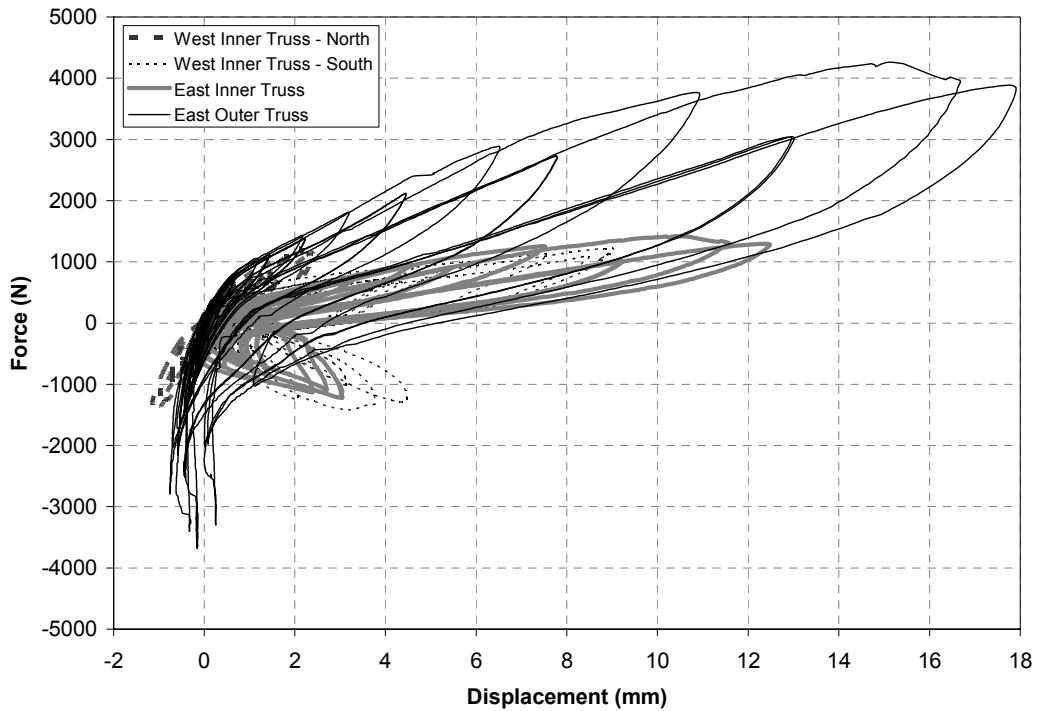
Figure 5.13. Uplift force-displacement responses for trusses with hurricane clips.

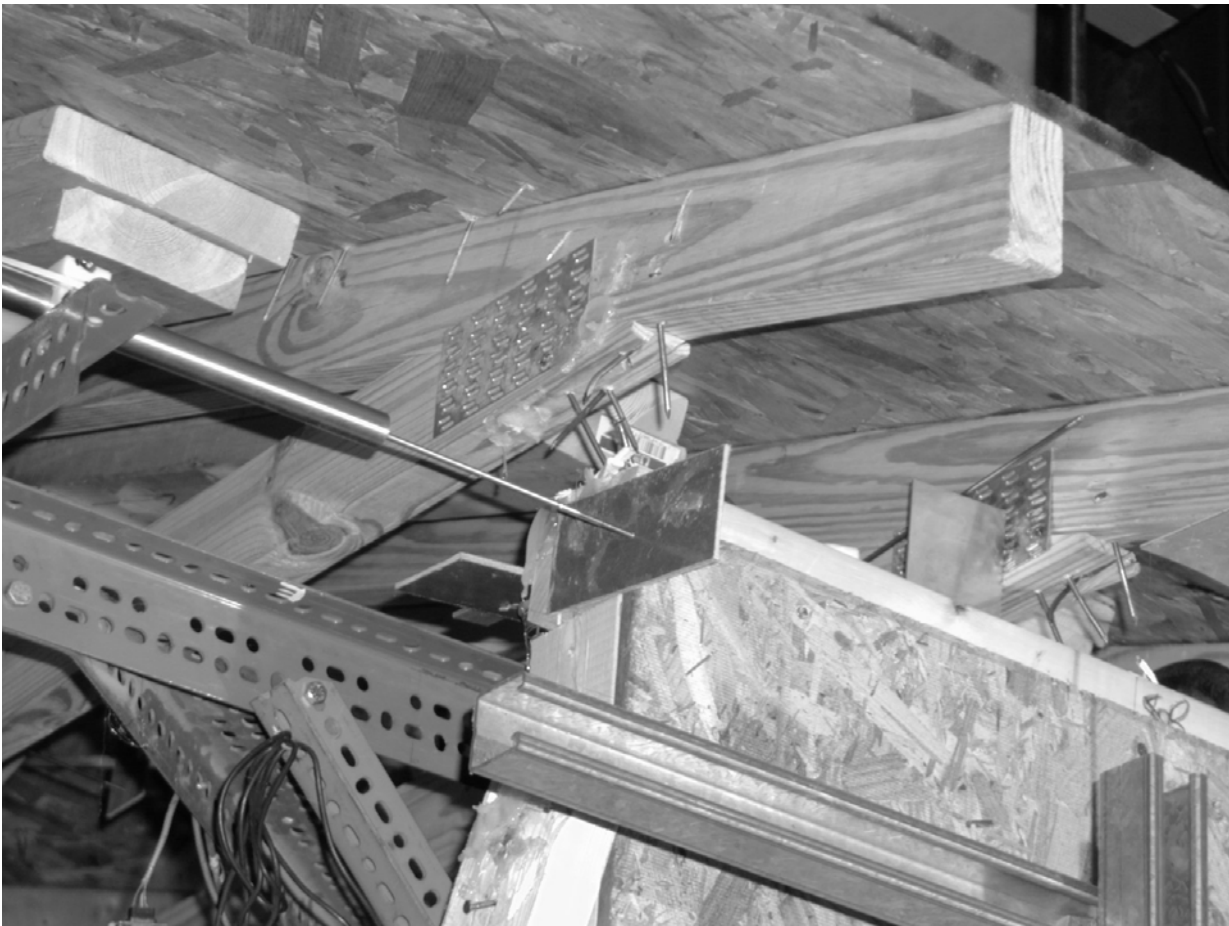
Figure 6.1. Failure of toe-nailed connection with combined load.

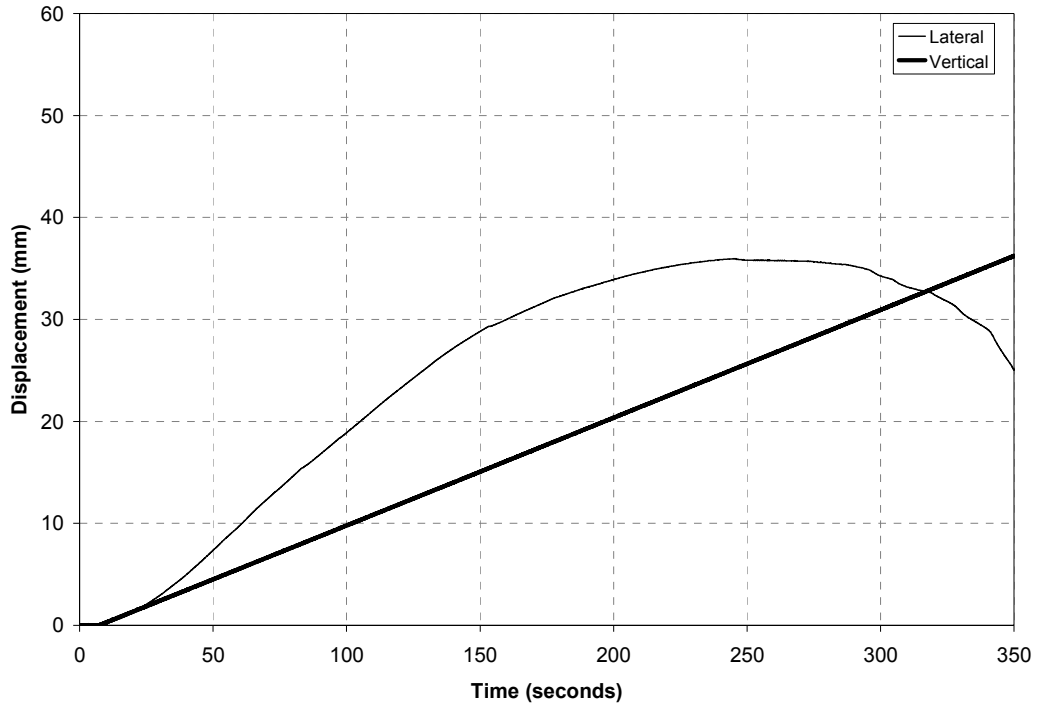
Figure 6.2. Displacements applied to specimen with toe-nailed connections.

The two deformations applied to the specimen with toe-nailed connections are shown in Figure 6.2. The resulting loads are shown in Figure 6.3. As in the previous tests, the specimen's stiffness decreased throughout the test, but the resistance continued to increase until connections began to fail about 250 s into the test. At this point the nails in the connection that was being placed in tension by the overturning moment from the lateral portion of the load pulled free from the top plate of the wall, as shown in Figure 6.1. This failure resulted in some wood splitting in the top plate of the wall, but little other damage to the material.

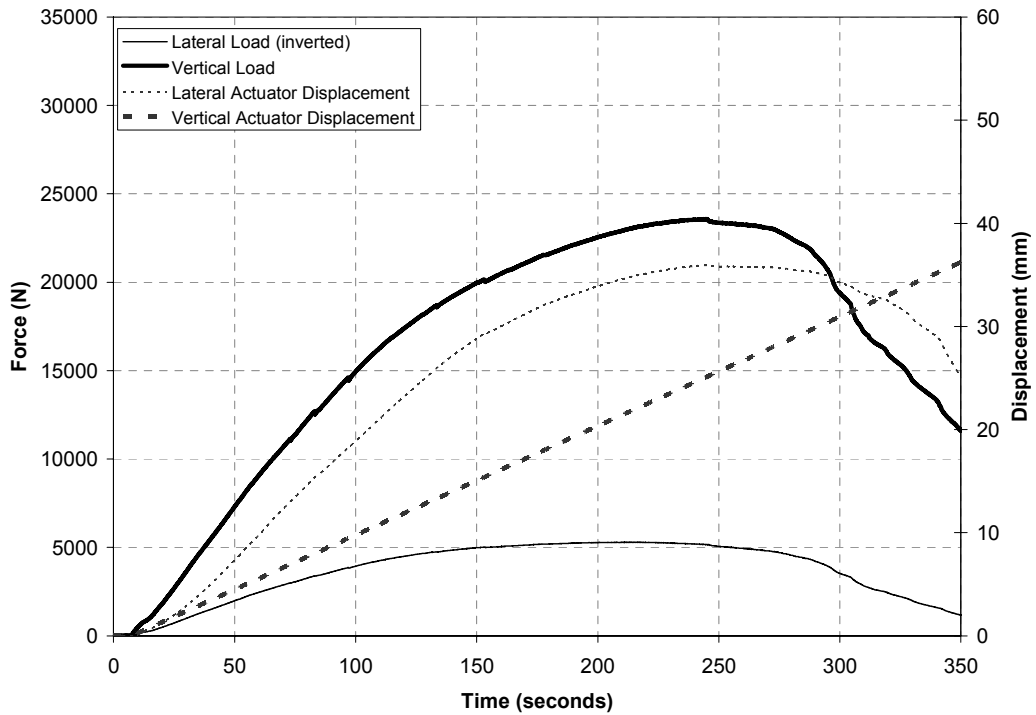
Figure 6.3. Loads applied to specimen with toe-nailed connections.

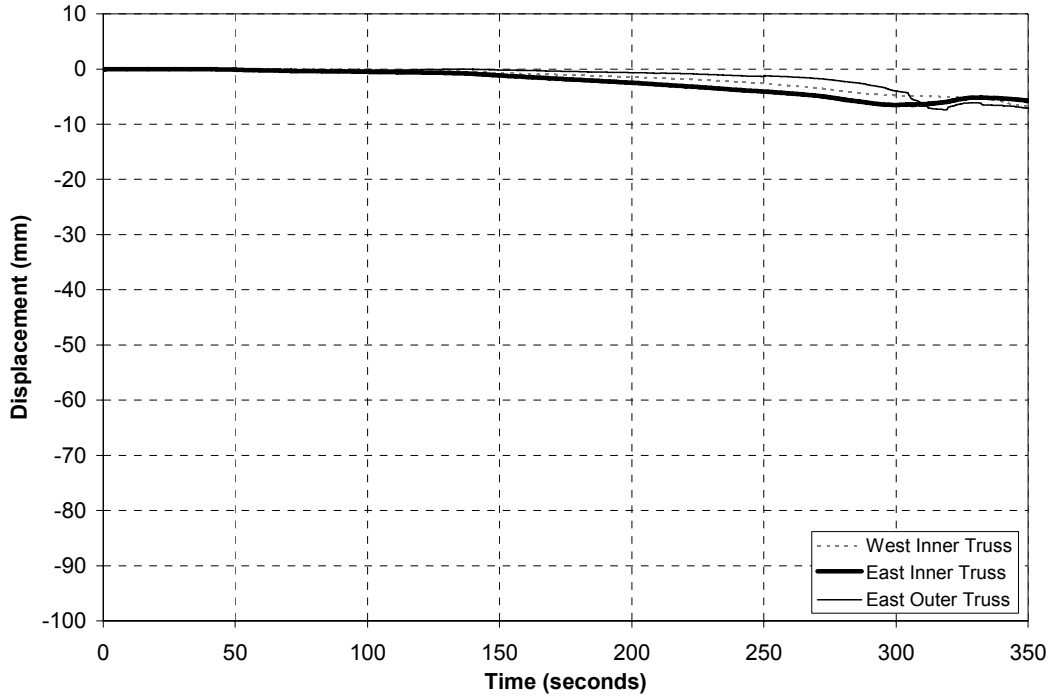
Figure 6.4. Lateral displacement responses for trusses with toe-nailed connections.

The lateral deformations in the toe-nailed connections of three of the trusses are shown in Figure 6.4 and the uplift deformations in the same connections are shown in Figure 6.5. The corresponding force displacement responses are shown in Figures

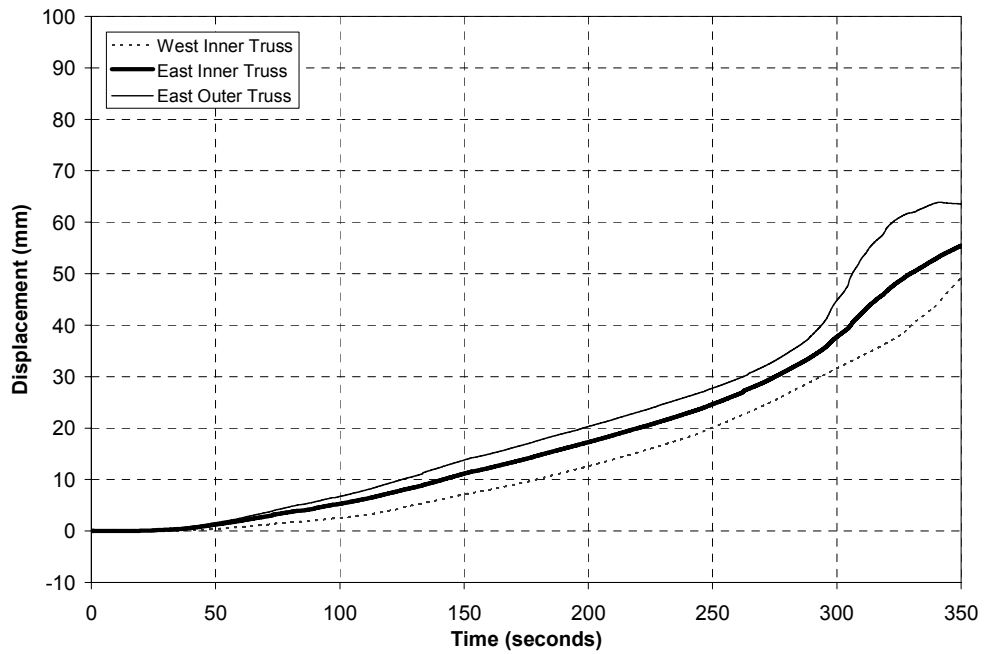
Figure 6.5. Uplift displacement responses for trusses with toe-nailed connections.

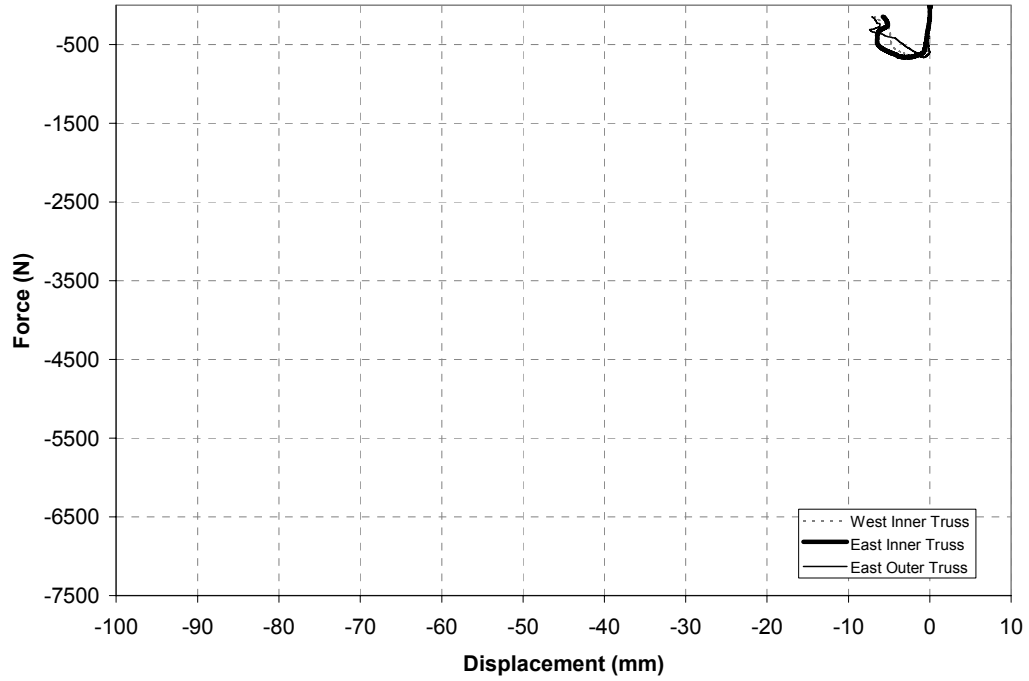
Figure 6.6. Lateral force-displacement responses for trusses with toe-nailed connections.

6.6 and 6.7. The responses of all three connections were quite similar in both shear and tension, although the outer connection, which failed first, was carrying slightly more tension, due to the overturning moments caused by the lateral load.

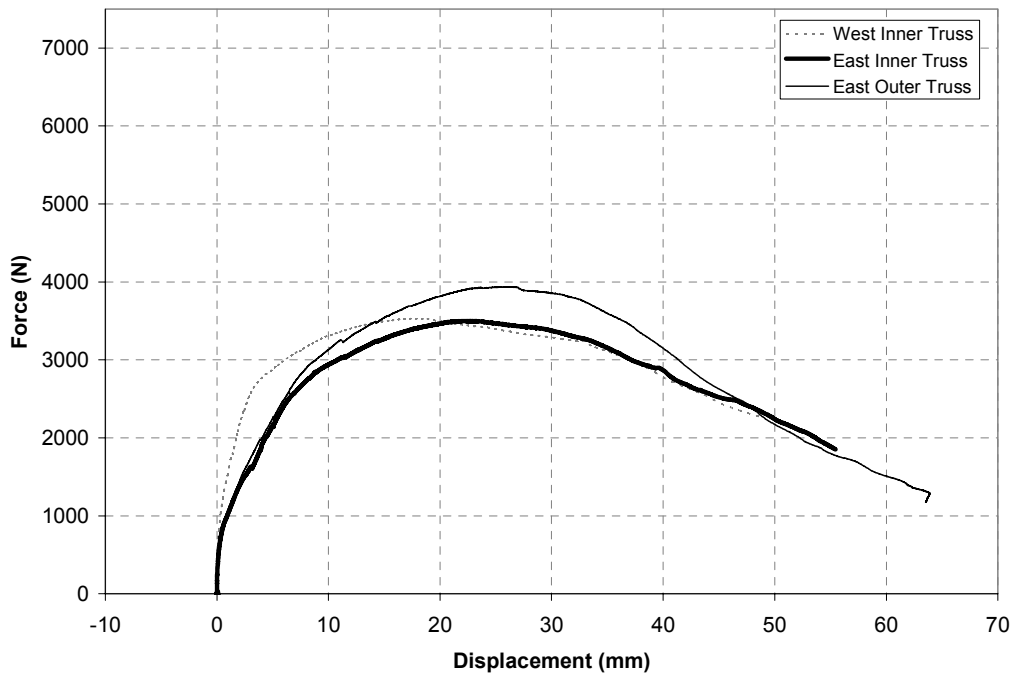
Figure 6.7. Uplift force-displacement responses for trusses with toe-nailed connections.

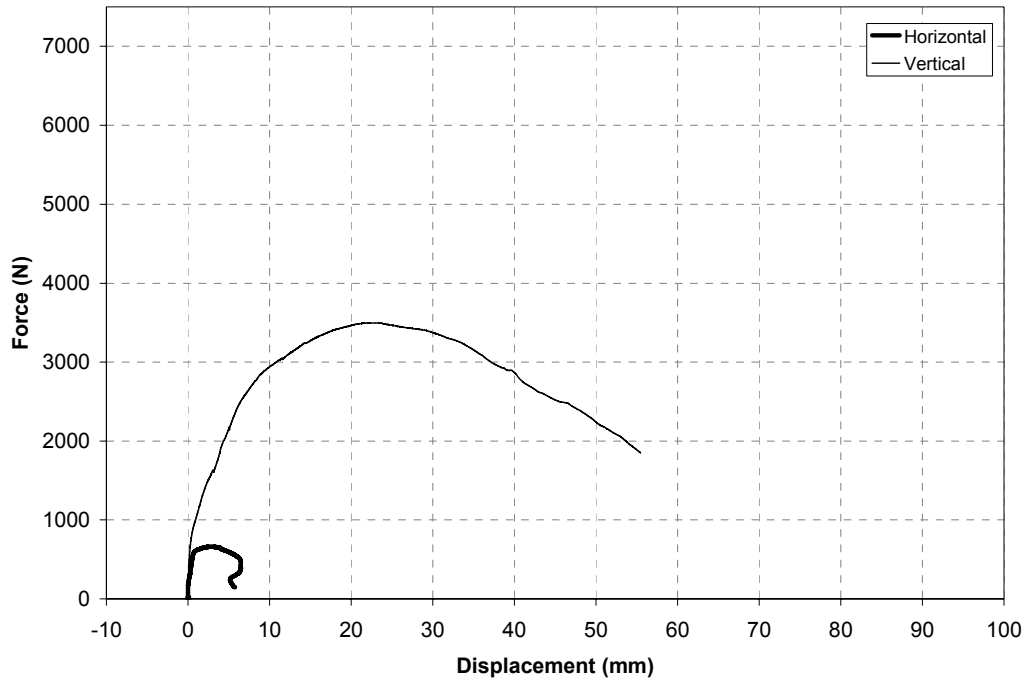
Figure 6.8. Lateral and vertical responses for inner truss with toe-nailed connections.

The lateral and vertical components of the response of the east inner truss are shown in Figure 6.8, while Figure 6.9 shows the same response for the east outer truss. These curves clearly show that during this test there was little difference in the initial lateral and vertical stiffnesses of the connection. The curves also illustrate how much more deformation occurred in the vertical direction than the lateral. The peak vertical loads carried by these connections were greater than the loads carried by similar connections subjected to uplift loading alone.

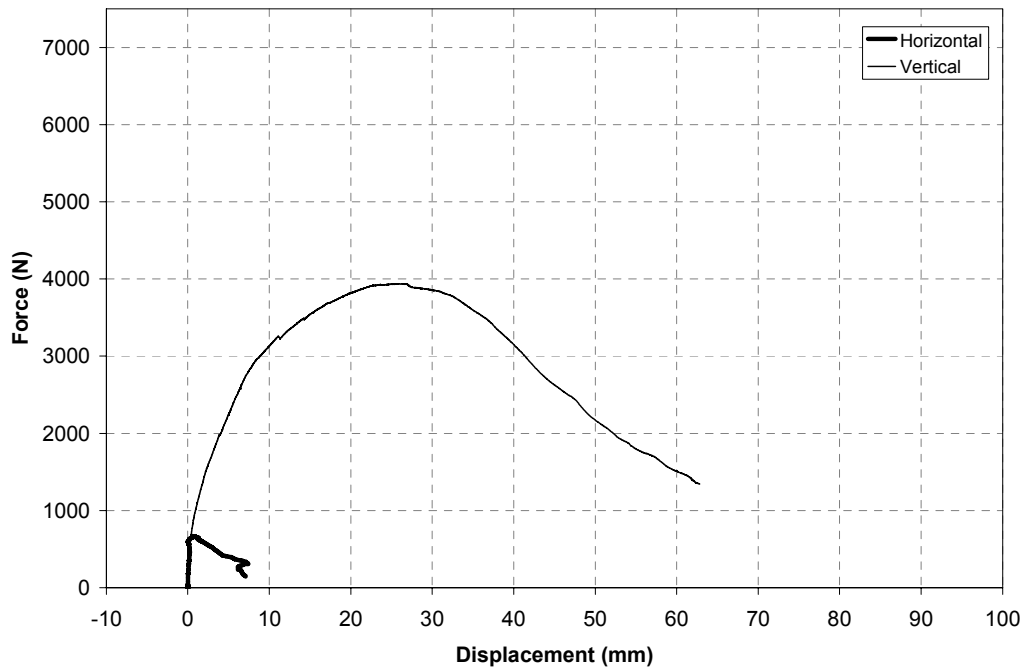
Figure 6.9. Lateral and vertical responses for outer truss with toe-nailed connections.

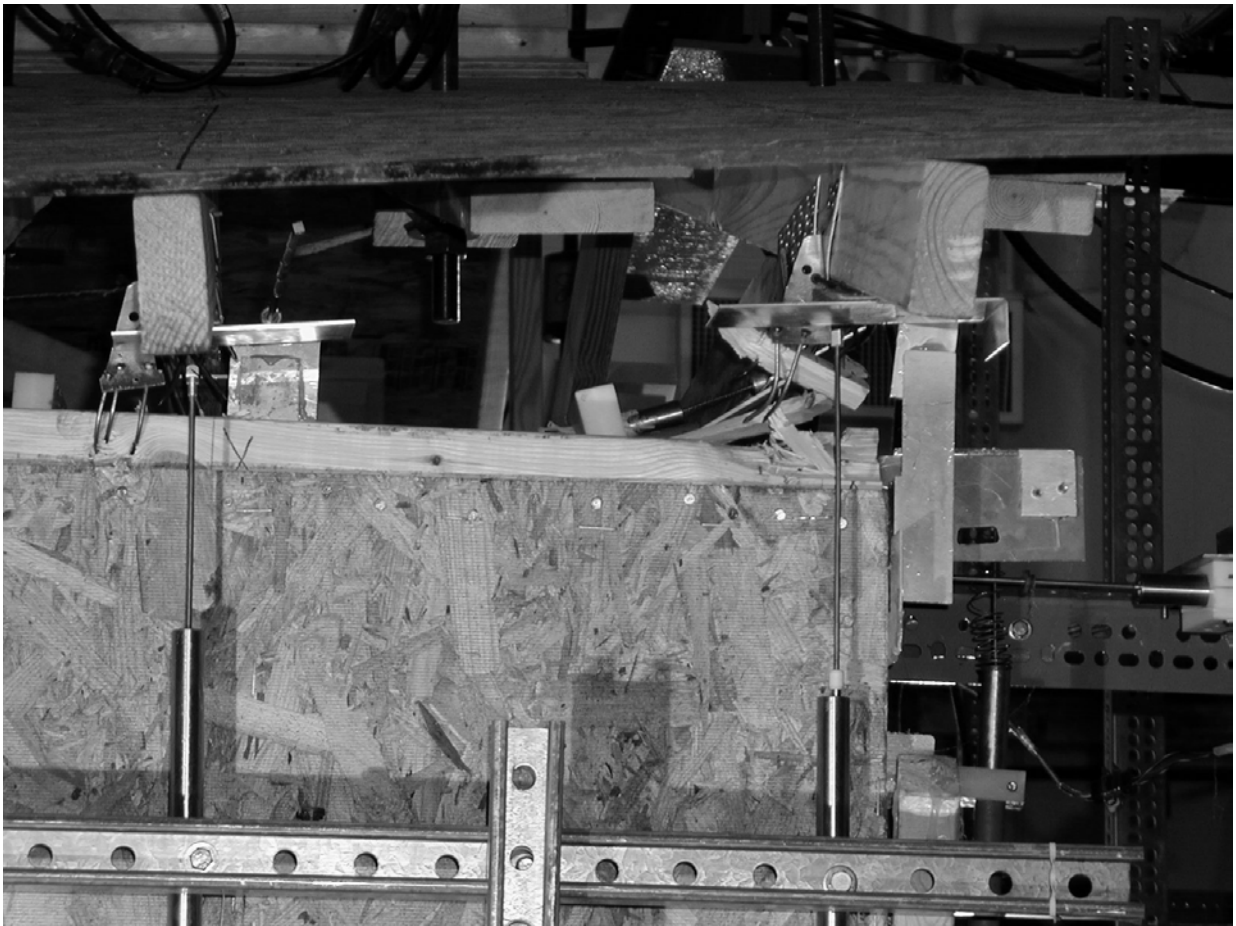
Figure 6.10. Failure of hurricane clip connection with combined load.

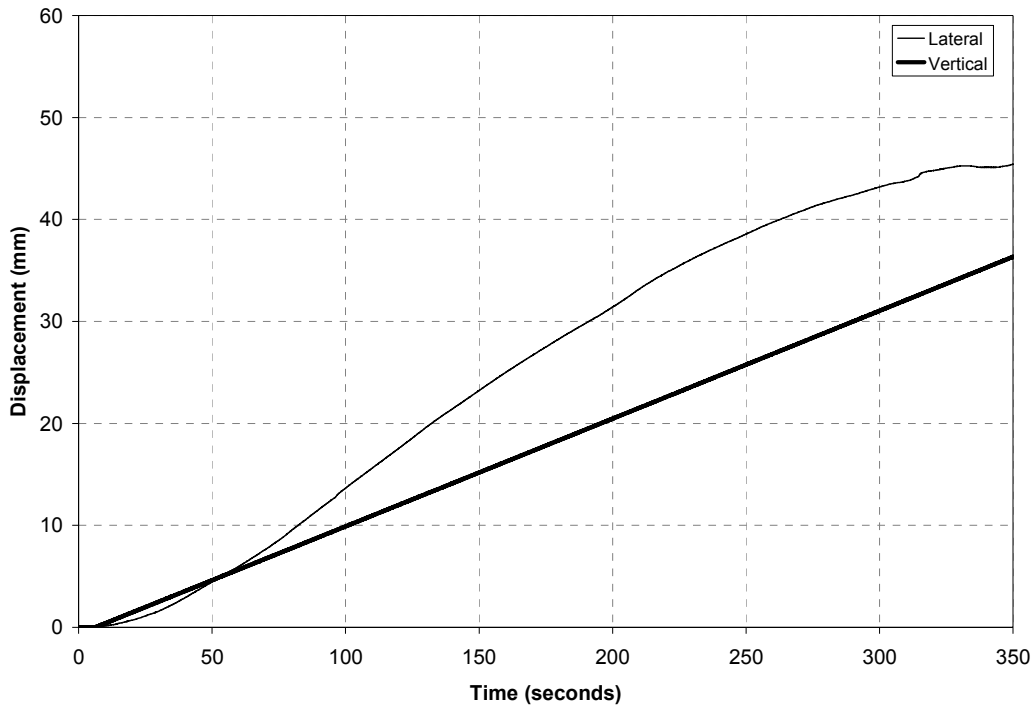
Figure 6.11. Displacements applied to specimen with hurricane clips.

The two deformations applied to the specimen with hurricane clips are shown in Figure 6.11, and the applied loads are shown in Figure 6.12. As was the case in the monotonic lateral load test, the specimen resisted the applied load with a near constant stiffness, until the first connection began to fail at about 180 s into the test. The failure occurred at the connection on the outer truss that was in tension from both the uplift and the overturning moment due to the lateral load. The failure consisted of the top plate of the wall splitting, which allowed the hurricane clip to pull free, as can be seen in Figure 6.10. The connection of the inner truss next to the one that failed first, failed by the nails withdrawing from the intact top plate.

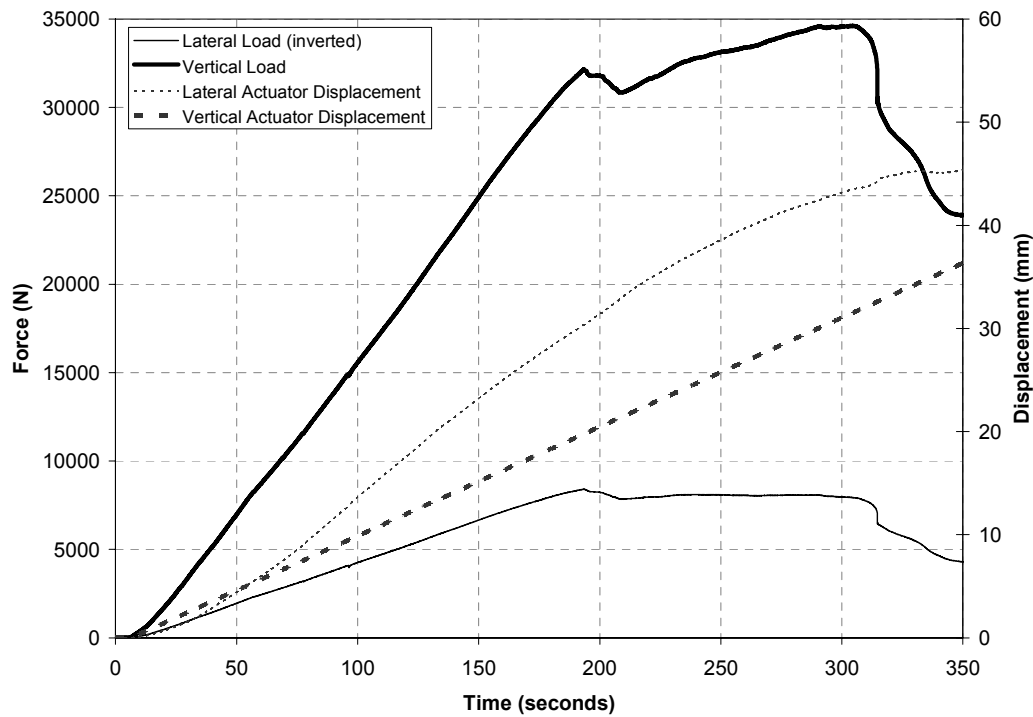
Figure 6.12. Loads applied to specimen with hurricane clips.

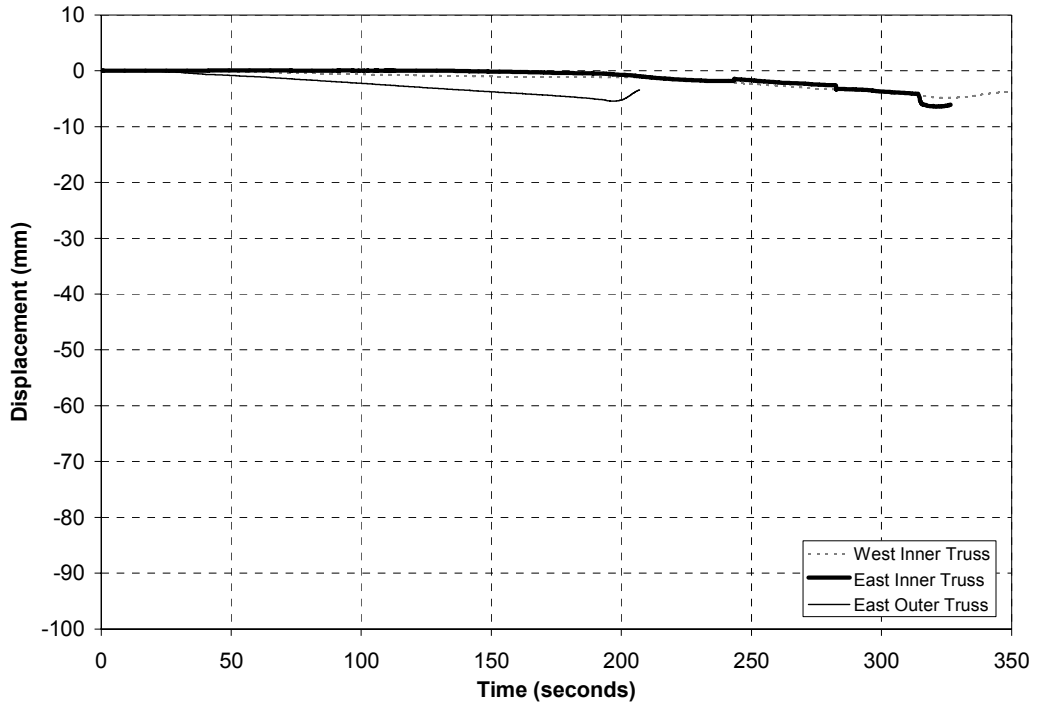
Figure 6.13. Lateral displacement responses for trusses with hurricane clips.

6.13, and the uplift deformations in these connections are shown in Figure 6.14. The corresponding force displacement responses are shown in Figures 6.15 and 6.16. Again, the responses of the two inner connections were quite similar, but the outer connection, which failed first, exhibited much less stiffness in both shear and uplift, and failed at a relatively low load. In fact, the capacity of this connection was only slightly greater than the toe-nailed connections and much less than other hurricane clip connections. The reduced capacity may have been due to an inherent weakness in the wood of the top plate, or a split in the wood caused by a poorly driven nail.

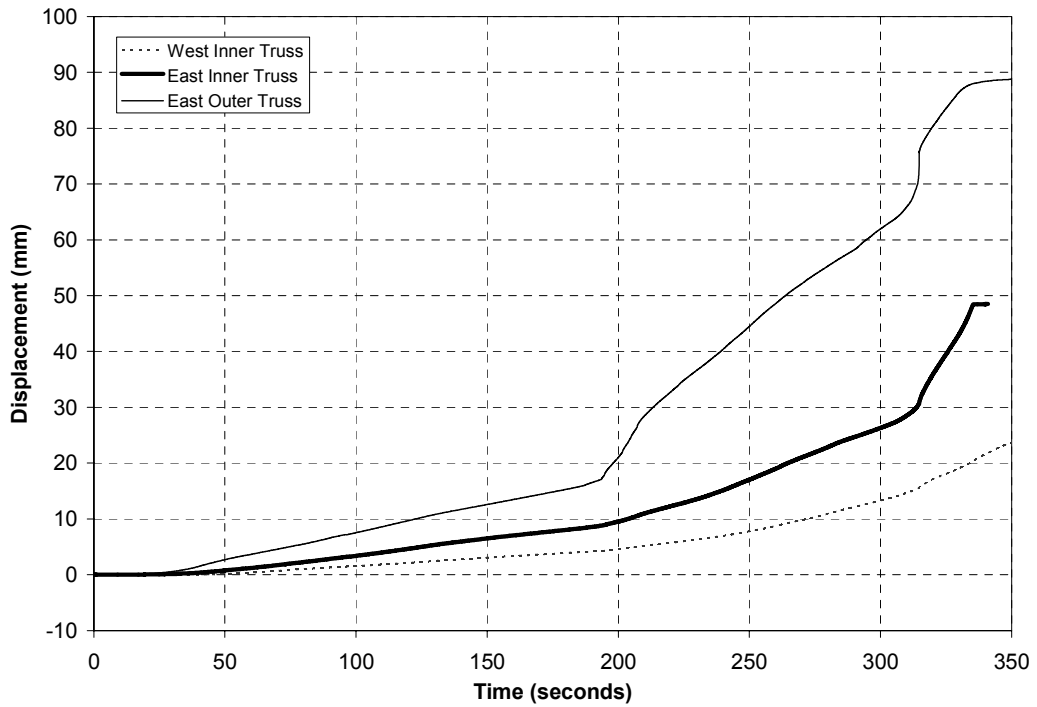
Figure 6.14. Uplift displacement responses for trusses with hurricane clips.

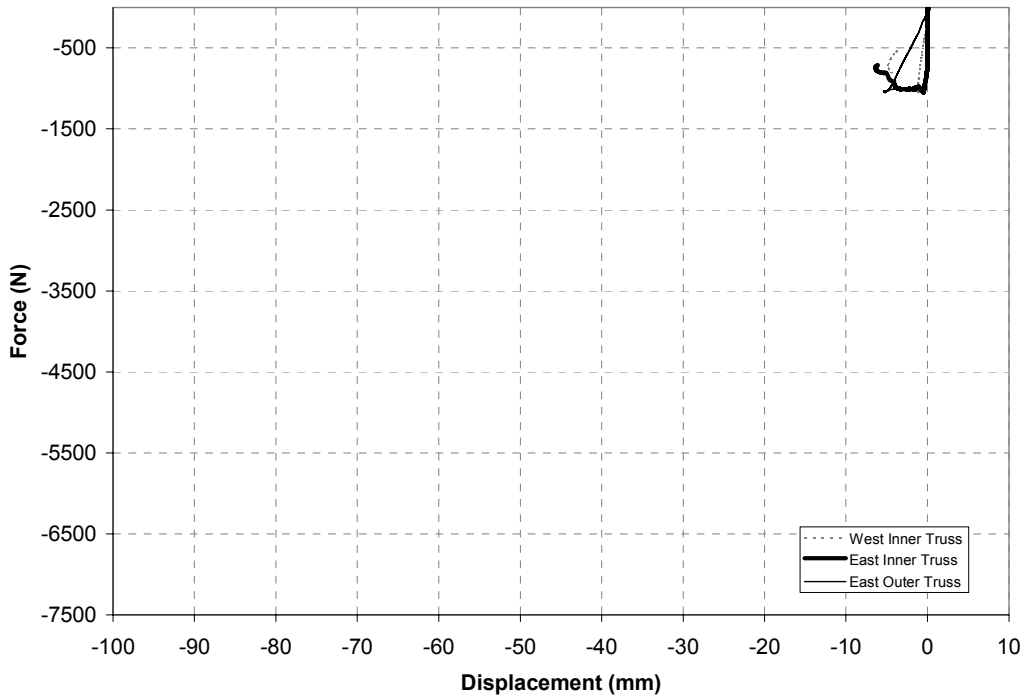
Figure 6.15. Lateral force-displacement responses for trusses with hurricane clips.

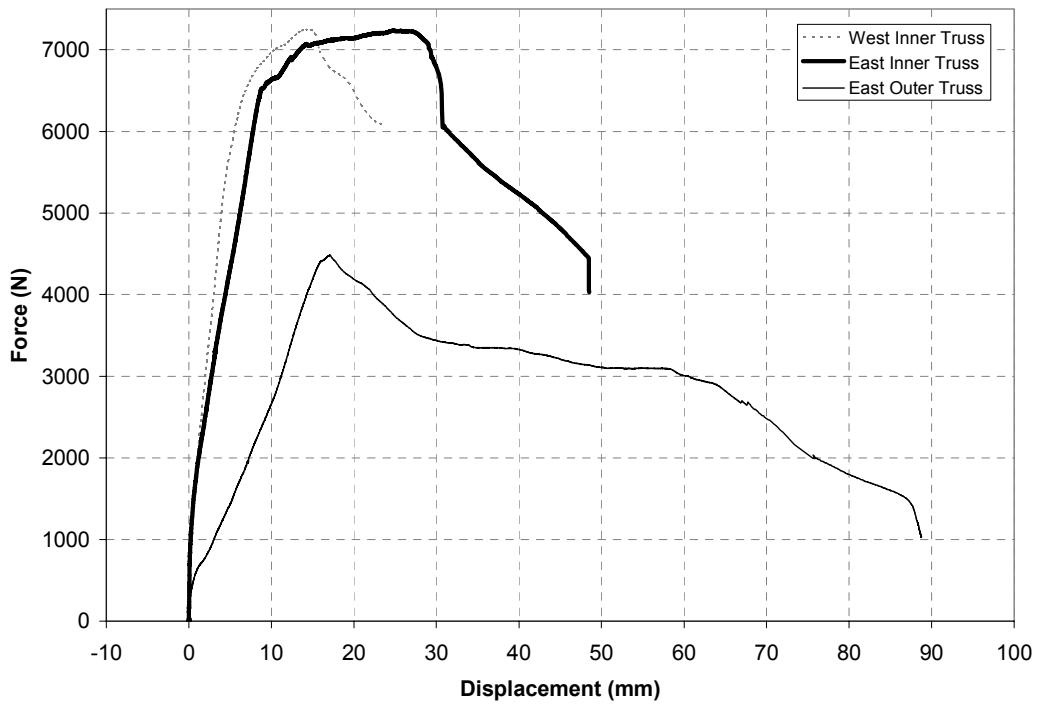
Figure 6.16. Uplift force-displacement responses for trusses with hurricane clips.

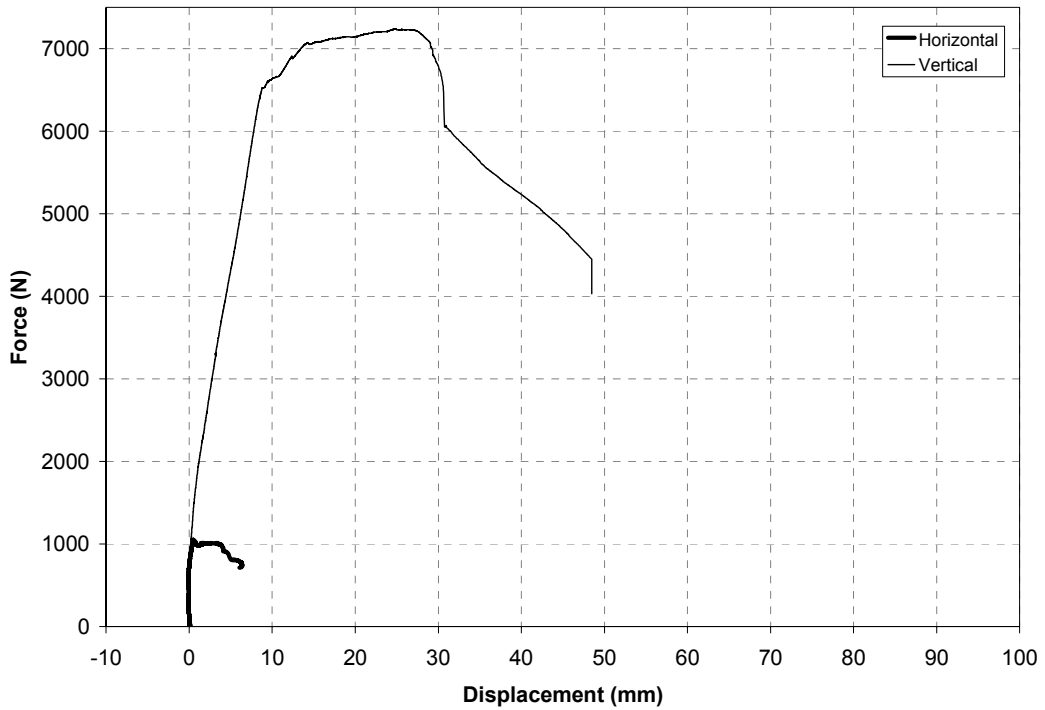
Figure 6.17. Lateral and vertical responses for inner truss with hurricane clips.

Figure 6.17 shows the lateral and vertical components of the response of the east inner truss. These curves clearly show that the initial lateral and vertical stiffnesses of the connection were nearly equal, and how much more deformation occurred in the vertical direction than the lateral. Figure 6.18 shows the same response for the east outer truss. In this case, both of the connection stiffnesses are much less than those of the inner truss. As mentioned above, the outer truss connection failed at a relatively small load, and the deformations at failure were much greater than for the other connections.

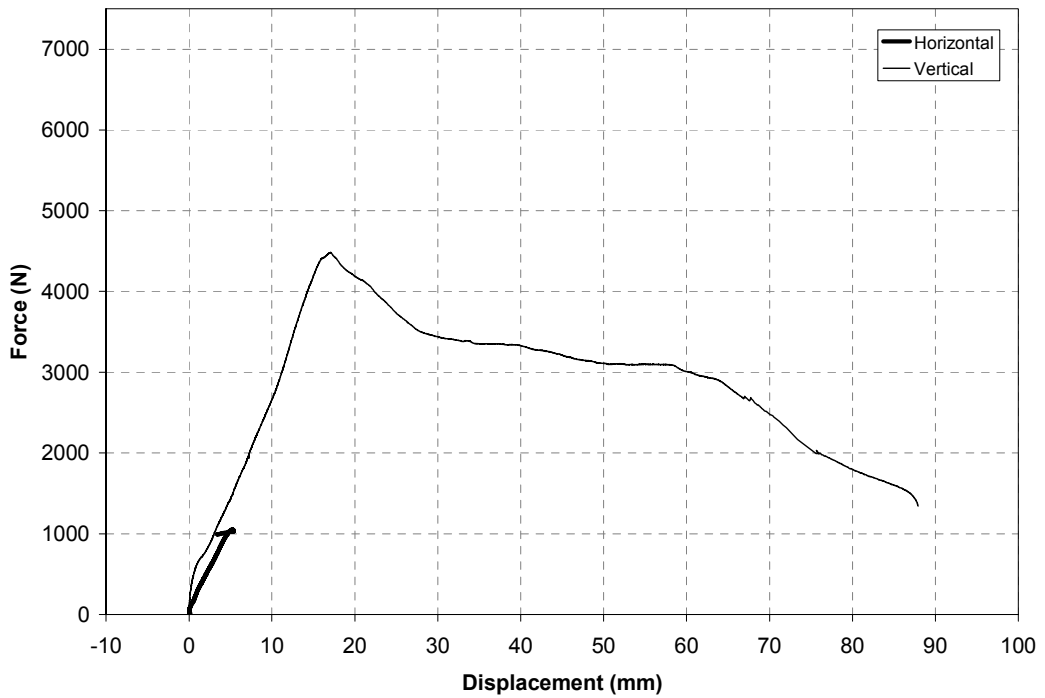
Figure 6.18. Lateral and vertical responses for outer truss with hurricane clips.

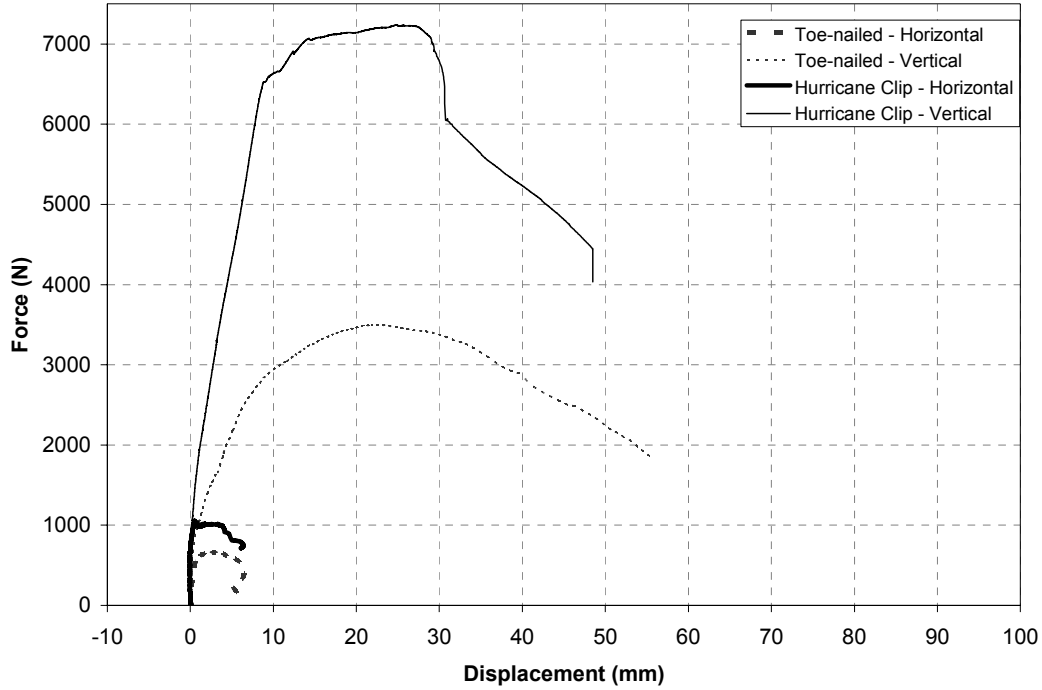
Figure 6.19. Comparison of responses of inner trusses.

A direct comparison of the responses at the east inner trusses with the two types of connections is shown in Figure 6.19, while the responses for the outer trusses are shown in Figure 6.20. The behavior of the inner trusses matches the behavior seen in other loading cases, with the hurricane clips providing a much greater capacity than the toe-nailed connections. However, as discussed above, and clearly visible in Figure 6.20, the outer truss hurricane clip connection that failed when the top plate of the wall split provided only a slightly greater capacity than the toe-nailed connection. These curves highlight the great variability that can occur in the response of wood frame construction, due to both the variabil-
