**EXPERIMENTAL TESTING OF ROOF TO WALL
CONNECTIONS IN WOOD FRAME HOUSES**

Michael A. Riley and Fahim Sadek

April 2003

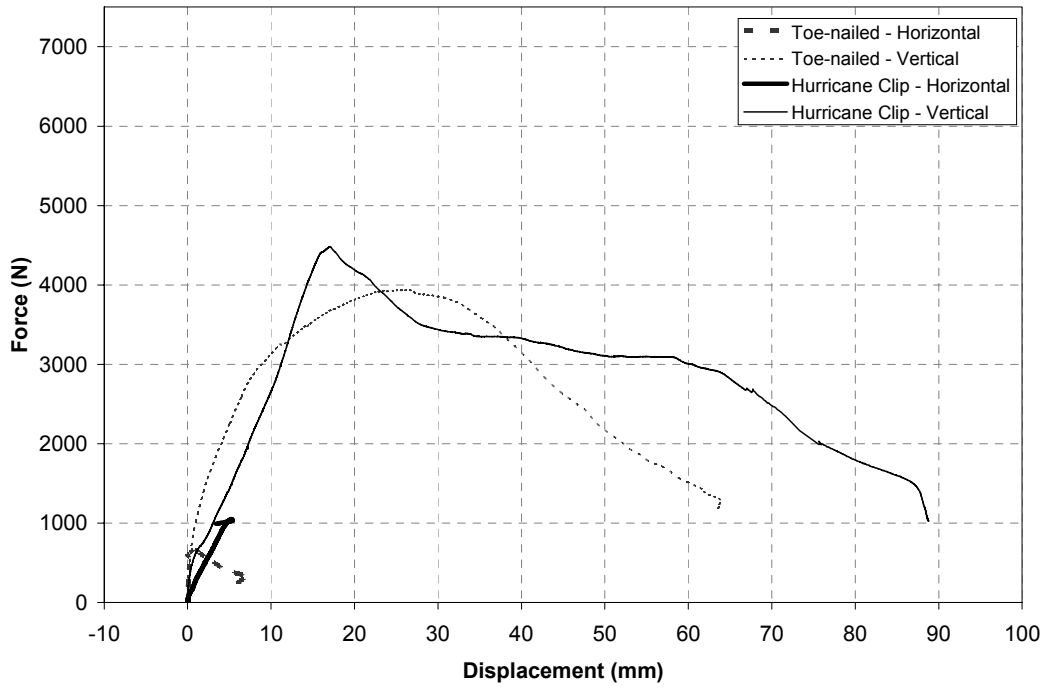
Figure 6.20. Comparison of responses of outer trusses.

A direct comparison of the responses at the east inner trusses with the two types of connections is shown in Figure 6.19, while the responses for the outer trusses are shown in Figure 6.20. The behavior of the inner trusses matches the behavior seen in other loading cases, with the hurricane clips providing a much greater capacity than the toe-nailed connections. However, as discussed above, and clearly visible in Figure 6.20, the outer truss hurricane clip connection that failed when the top plate of the wall split provided only a slightly greater capacity than the toe-nailed connection. These curves highlight the great variability that can occur in the response of wood frame construction, due to both the variabil-

ity in the materials and in the quality of workmanship. Note, however, that the overall strength of the specimen was not greatly compromised by the weak outer connection. The combined strength of the other three hurricane clips on that wall of the specimen allowed the specimen to resist almost 45% more load than the specimen with toe-nailed connections.
