# NATIONAL BUREAU OF STANDARDS REPORT

REPORT  
OF  
EXPERIMENTS TO DETERMINE THE FIRE RESISTANCES  
OF  
TWO PREFABRICATED WOOD WALLS

J. V. Ryan  
Fire Protection Section  
Building Technology Division

U. S. DEPARTMENT OF THE AIR FORCE  
Headquarters U. S. Air Force  
Washington 25, D. C.

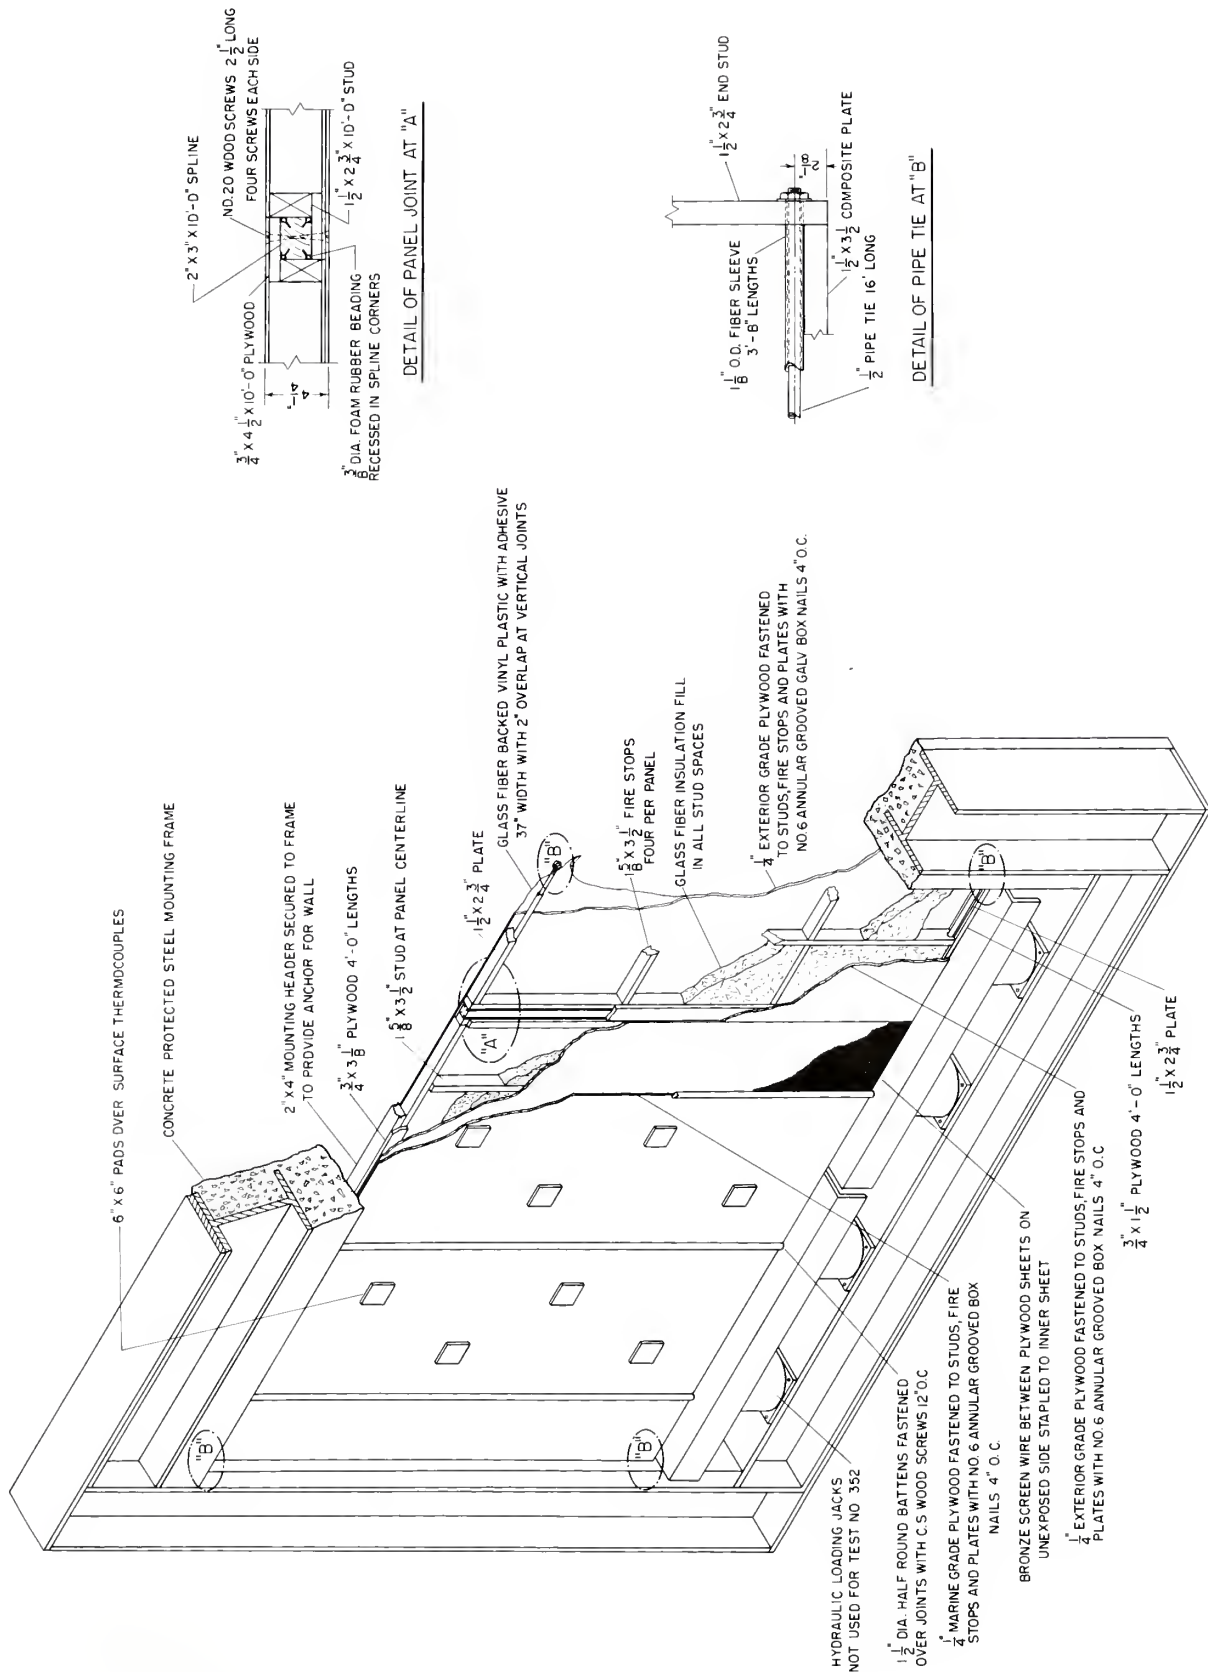
Figure 1. Construction and mounting details of prefabricated wooden exterior wall.

FIG 1 CONSTRUCTION AND MOUNTING DETAILS OF PREFABRICATED WOODEN EXTERIOR WALL

a) Splines: 10 ft lengths of 2 by 3 in. wood members. The four long edges were recessed and slotted, and fitted with 3/8-in. diameter foam rubber bending, as shown in Figure 1, detail A. There were 2 1/8-in. diameter holes through the splines centered 2 1/2 in. from each end, parallel to the 3 in. dimension. The wood surfaces were coated with the same paint as the panels.

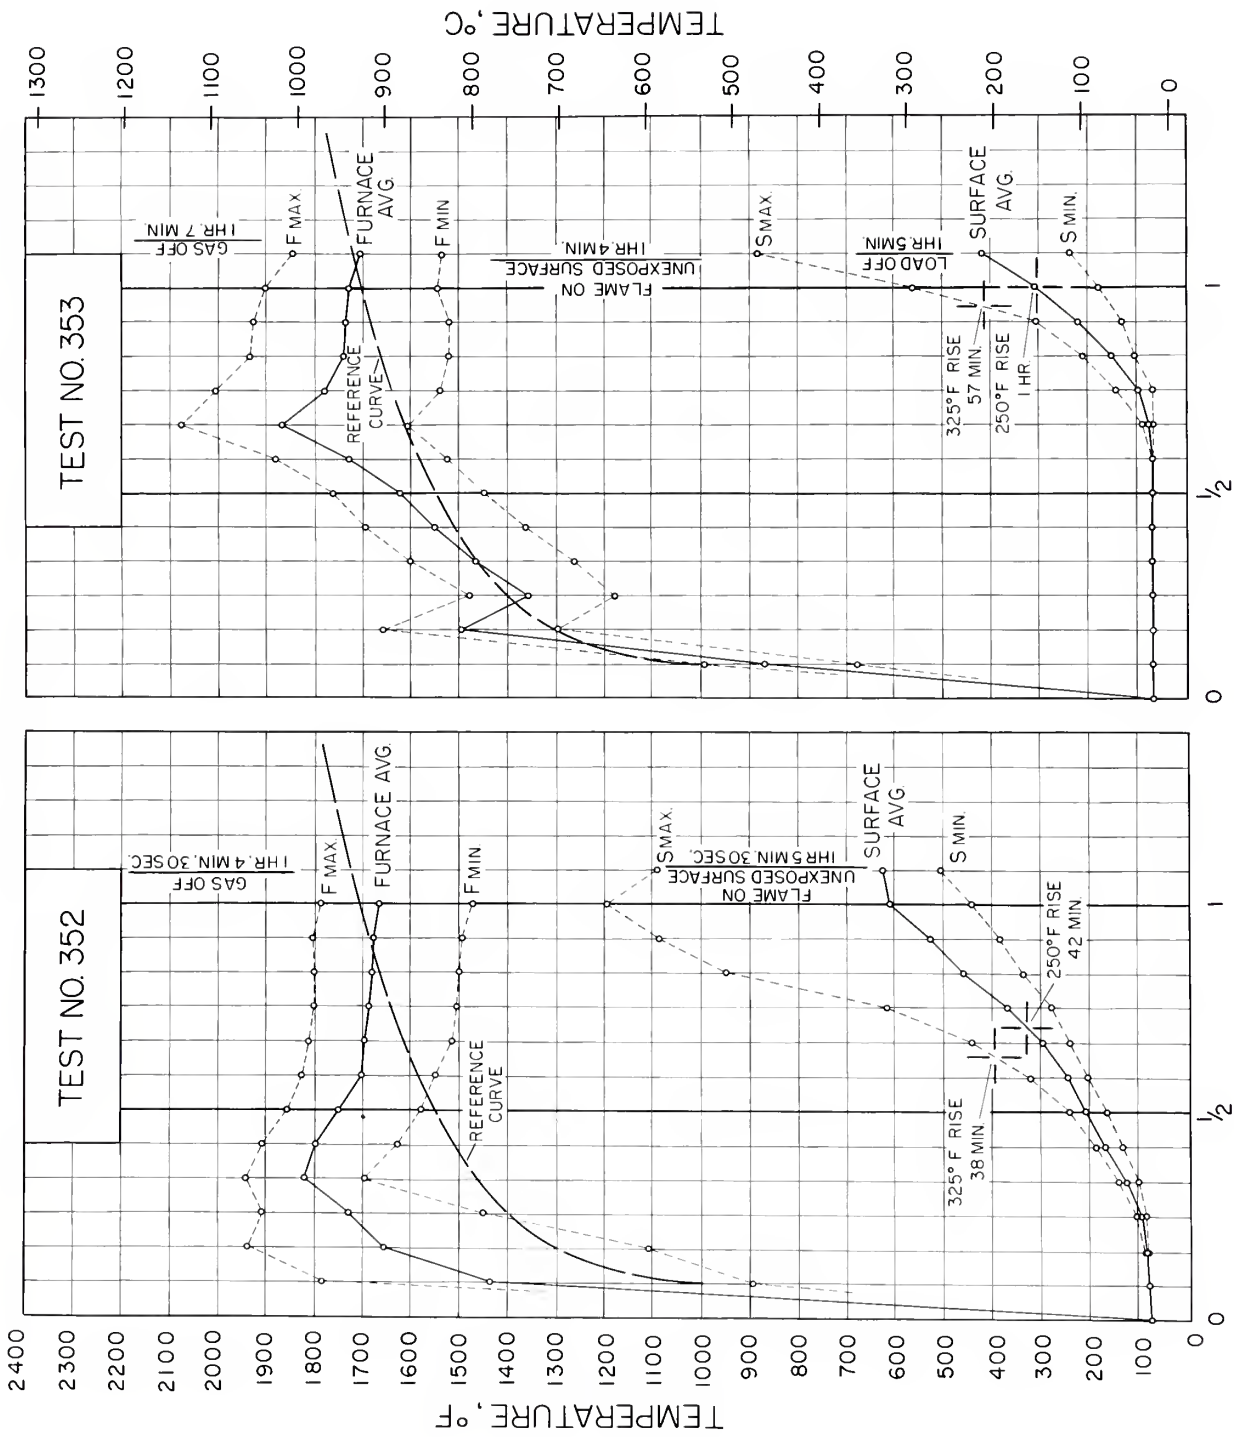
FIG 2 TEMPERATURES OBSERVED DURING FIRE-ENDURANCE TESTS

The temperatures observed during the experimental test are represented in figure 2. The temperature at one thermocouple on the unexposed surface had risen 325 degree F above the initial temperature at 30 min and the average on the unexposed surface had risen 250 degree F above the initial temperature at 42 min. The average furnace temperatures were higher than those of the standard time-temperature curve during most of the test. The fire exposure severity, defined as the ratio of the area under the curve of average furnace temperature to the area under the standard time-temperature curve, was 121 percent. Therefore, a correction of 40 min was applicable to the 30 min limiting time, making the corrected fire endurance of the experimental specimen 44 min.

The temperatures observed during the experimental test are represented in figure 2. The temperature at one thermocouple on the unexposed surface had risen 325 degree F above the initial temperature at 57 min and the average at all the thermocouples on the unexposed surface had risen 250 degree F above the initial average at 1 hr. The average furnace temperatures were somewhat higher than those of the standard time-temperature curve during part of the test. The fire exposure severity was 105 percent. A correction of +2 min was applicable to the 57 min limit, making the corrected fire endurance of the experimental specimen 59 min.

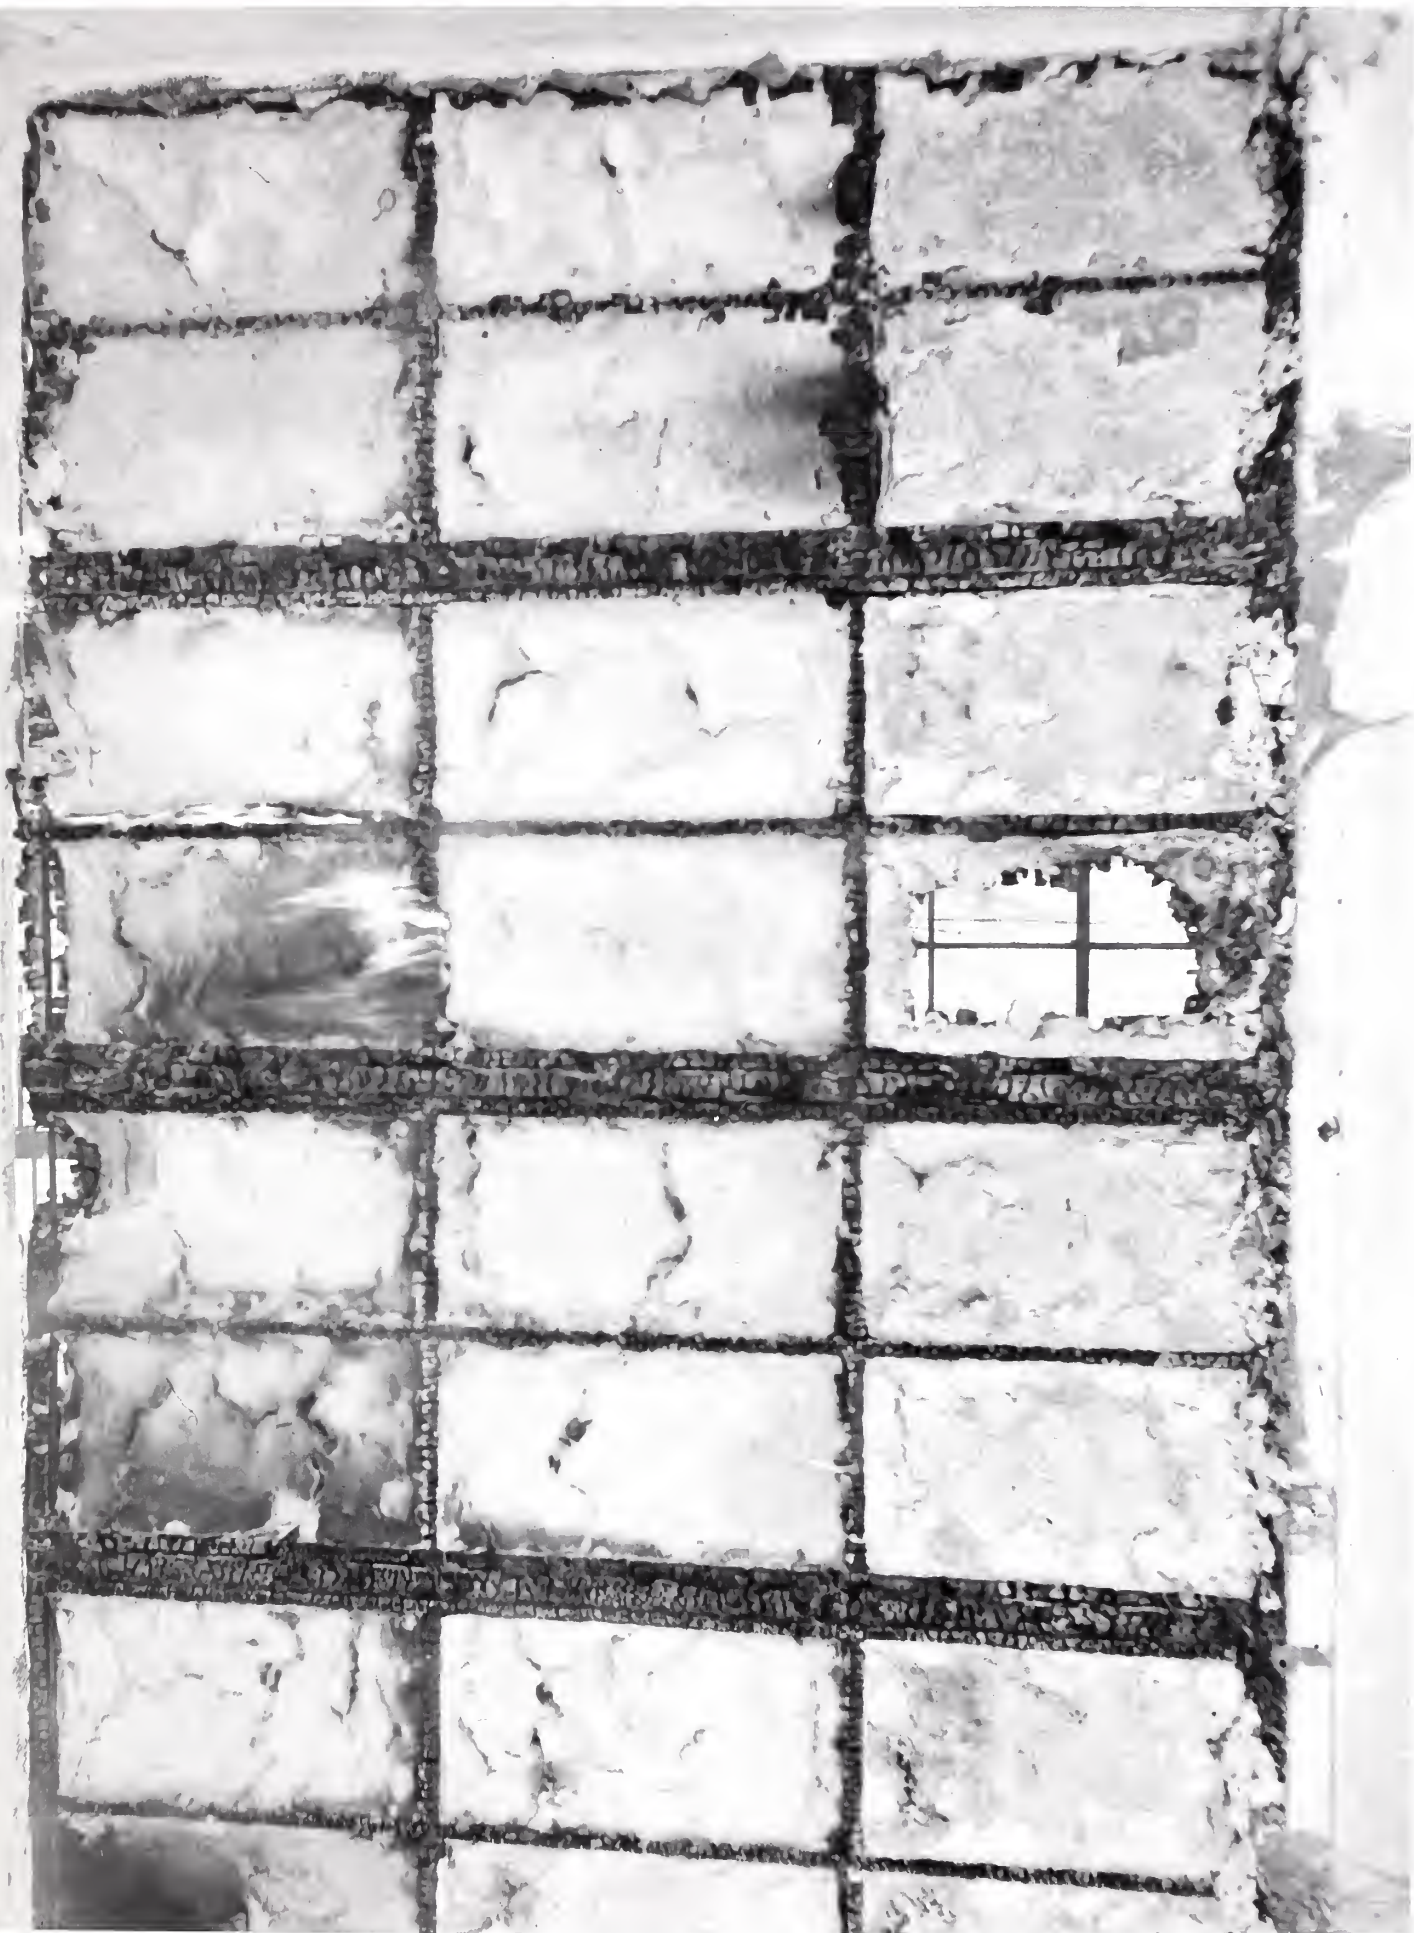
Figure 3. Exposed surface of exterior wall after  
fire endurance test 3/4.
