NATIONAL BUREAU OF STANDARDS REPORT

9871

HAIL RESISTANCE OF ROOFING PRODUCTS

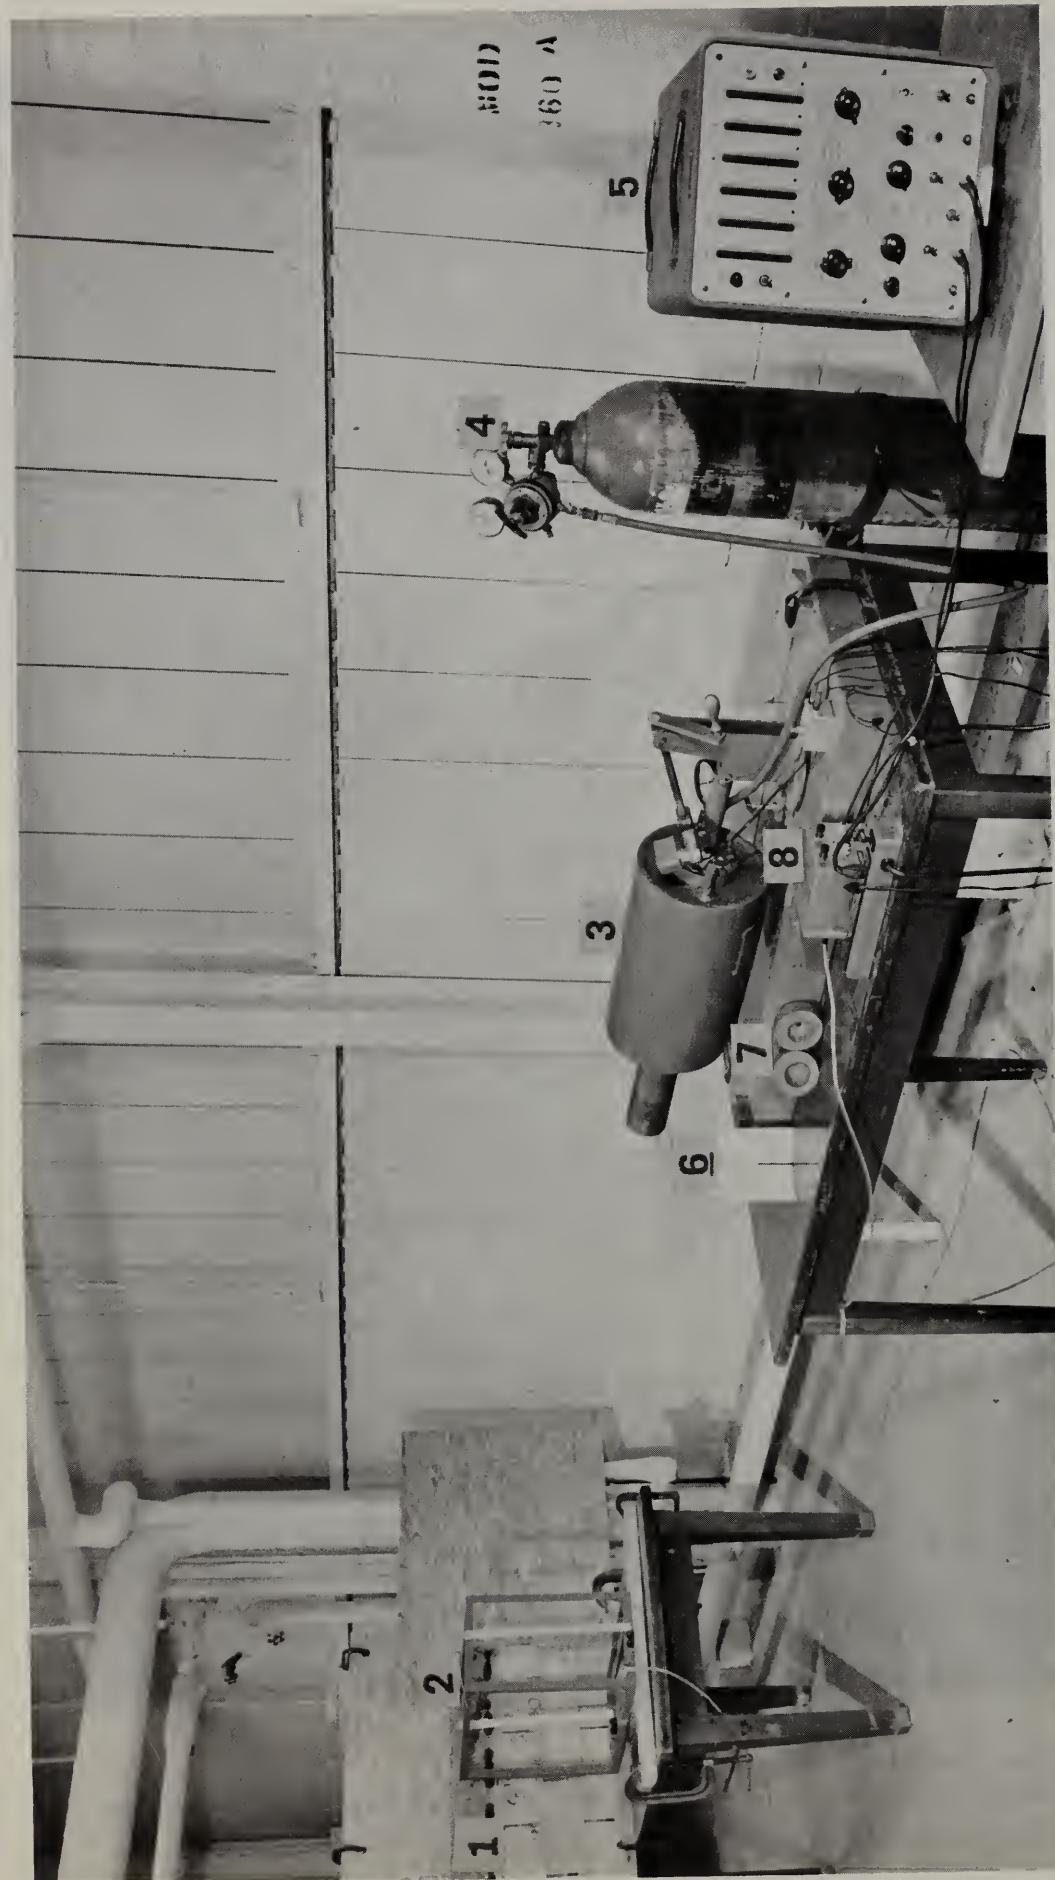
Figure 2 - Hail-Resistance Apparatus

The apparatus consisted of a compressed air gun, for launching the hailstones, a timer, for determining their velocity, and a target area, for positioning the specimen to be tested. The physical layout of the apparatus is shown in Figure 2.

Reading from left to right, the apparatus consisted of a specimen (target) area (1), a timing range (2), the gas gun (3), the gas cylinder (4), the timer (5), hailstone carrier (6), the hailstone molds (7) and the triggering mechanism (8). The roofing specimen to be tested is mounted on a roof deck, just as in service, and clamped in place against the backstop in position (1). The timing range consists of a metal frame of 3/4-inch angle iron on which are mounted two microswitches 2.0 feet apart. The actuating levers on the microswitches contain metal hooks, which are used to hold one end of one-inch computer tapes, the other ends of which are fastened to the top members of the frames with masking tape, also 2.0 feet apart. The tapes are kept under tension such that any impact on them will close the microswitches and actuate the triggering mechanism to start and stop the counter (5).

The compressed air gun (4) is a commercially available device manufactured by Diamond King, Inc. (El Segundo, California). It is their Mark 14 model, with a 3-1/4 inch inside diameter barrel and a maximum muzzle velocity of 300 ft/sec. The counter is a Hewlett-Packard Model No. 523B microsecond counter, with both starting and stopping gates and a direct readout.

The specimen on its deck was held against the backstop in Figure 2 with large C clamps. The 1-inch computer tapes were hooked to the
5 microswitches and fastened under tension, just insufficient to close the switches, with masking tape to the top of the timing frame. A hailstone of the desired size was taken from the freezer, cleaned of any burrs or projecting pieces of ice (from the gate in the mold), weighed, and placed in its carrier, which was slid into the barrel of the gun as far
10 as possible. Air, or nitrogen, was permitted to enter the gun until the desired pressure was reached. The valves between the gun and the tank were closed (to protect the pressure regulator), the pressure gage was removed from the gun, and the gun was fired by opening the solenoid valve.
