NIST Technical Note 1894

Effects of Wind Speed and Angle on Fire Spread along Privacy Fences

Erik L. Johnsson
Alexander Maranghides

July 2016

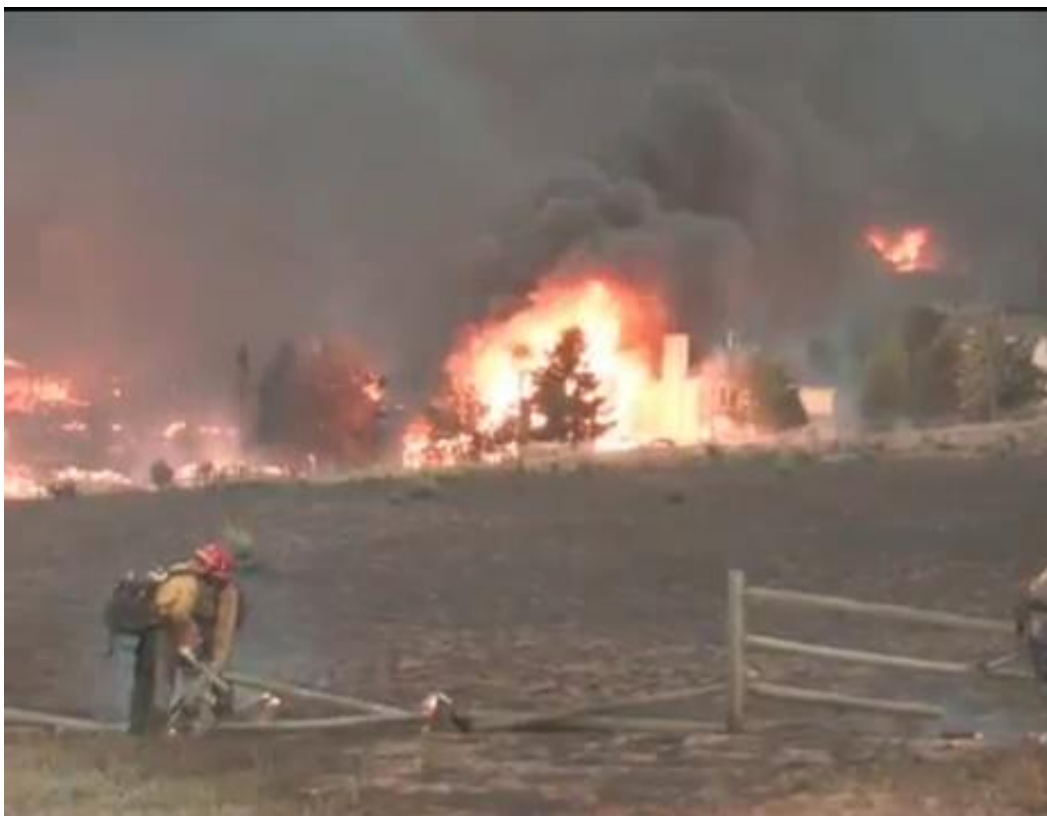
Figure 1 Picture of an ignited wood fencing assembly in Colorado, 2012; Courtesy of Colorado Springs Fire Department.

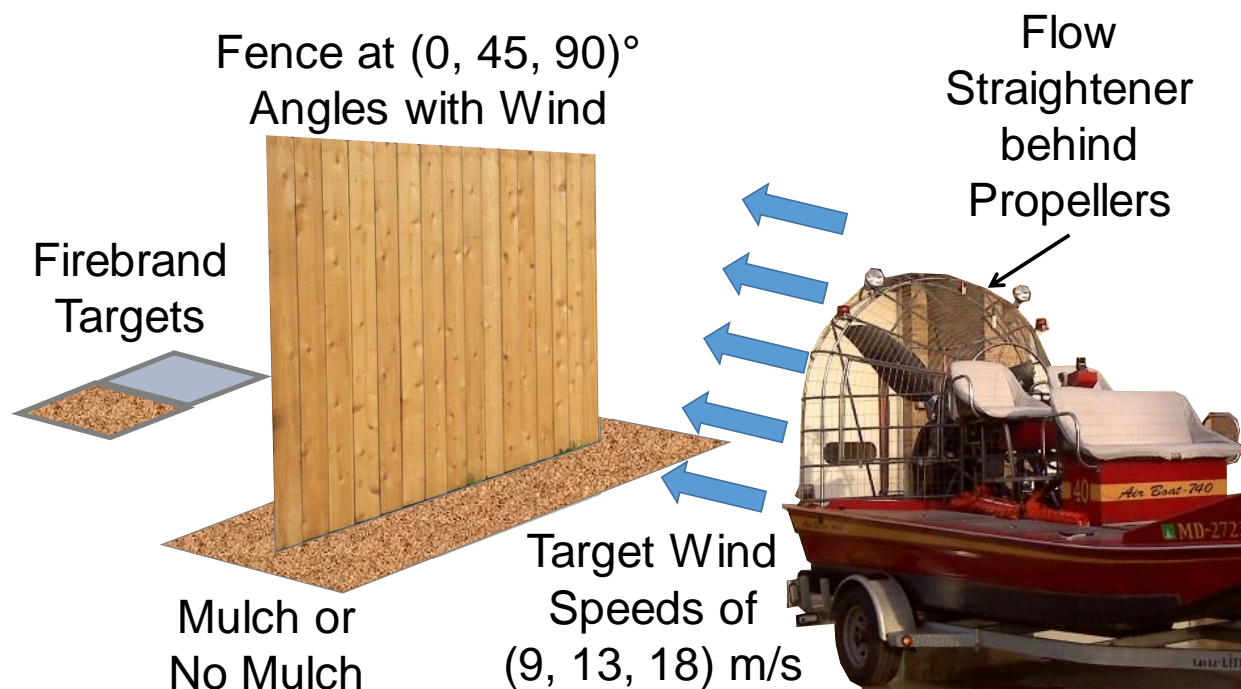
Figure 2 Cartoon of the major components of the wind-driven fence fire spread experiments.

The basic experimental set-up consisted of an airboat, flow straightener, walls, fence, mulch pan, burner, firebrand targets, and measurement equipment. Figure 2 is a cartoon of the major components of the experiment. The experiments were located at the MCFRTA which is used for a variety of indoor and outdoor fire training so the set-up had to be confined to a relatively small area away from other facilities and combustibles. Testing was also, in some cases, curtailed due to cold, likely chances of rain, and ambient winds over 7 m/s (≈ 15 mph).

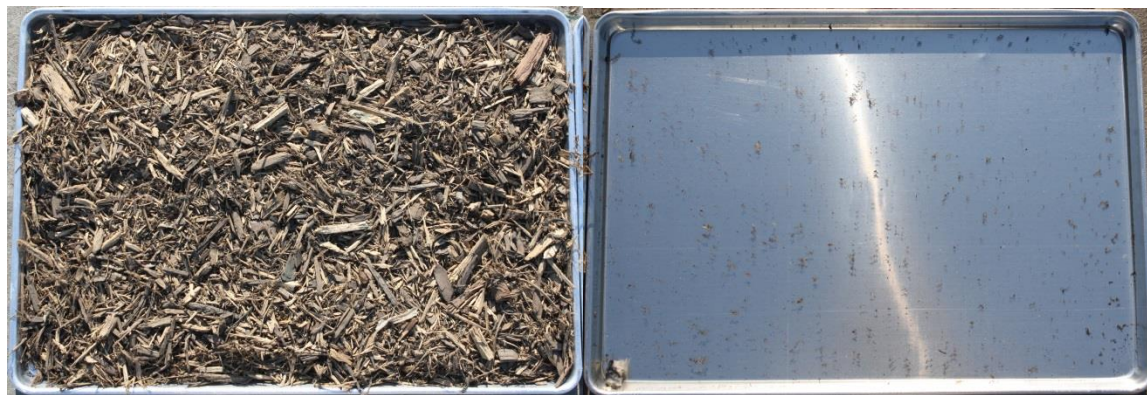
Figure 4 Photographs of a pair of firebrand targets after Test 7 (cedar at 45°, 13.5 m/s). One pan is filled with about 2 cm of mulch (left) and the other contains about 4 mm of water (right). These were placed in 3.05 m intervals downwind of the trailing edge of the fence.

Four sets of 46 cm x 66 cm aluminum pans were used as firebrand targets to observe whether and how blown firebrands from the burning fence and mulch bed caused spotting of nearby combustibles. A photograph of a pair of targets is shown in Figure 4. One pan of each target pair was filled with about 2 cm (0.8 in) depth of mulch to see if firebrands could ignite it, and the other pan was filled with about 4 mm of water to capture the firebrands reaching that position for examination of their size and other characteristics. Four sets of targets were placed at 3.05 m (10 ft) intervals downwind from the trailing edge of the fence along the centerline of the wind corridor. The trailing edge position relative to other fixed aspects of the test set-up varied with the orientation angle of the fence with the wind. For moderate or high wind speeds, the pans were weighted to prevent them from moving.

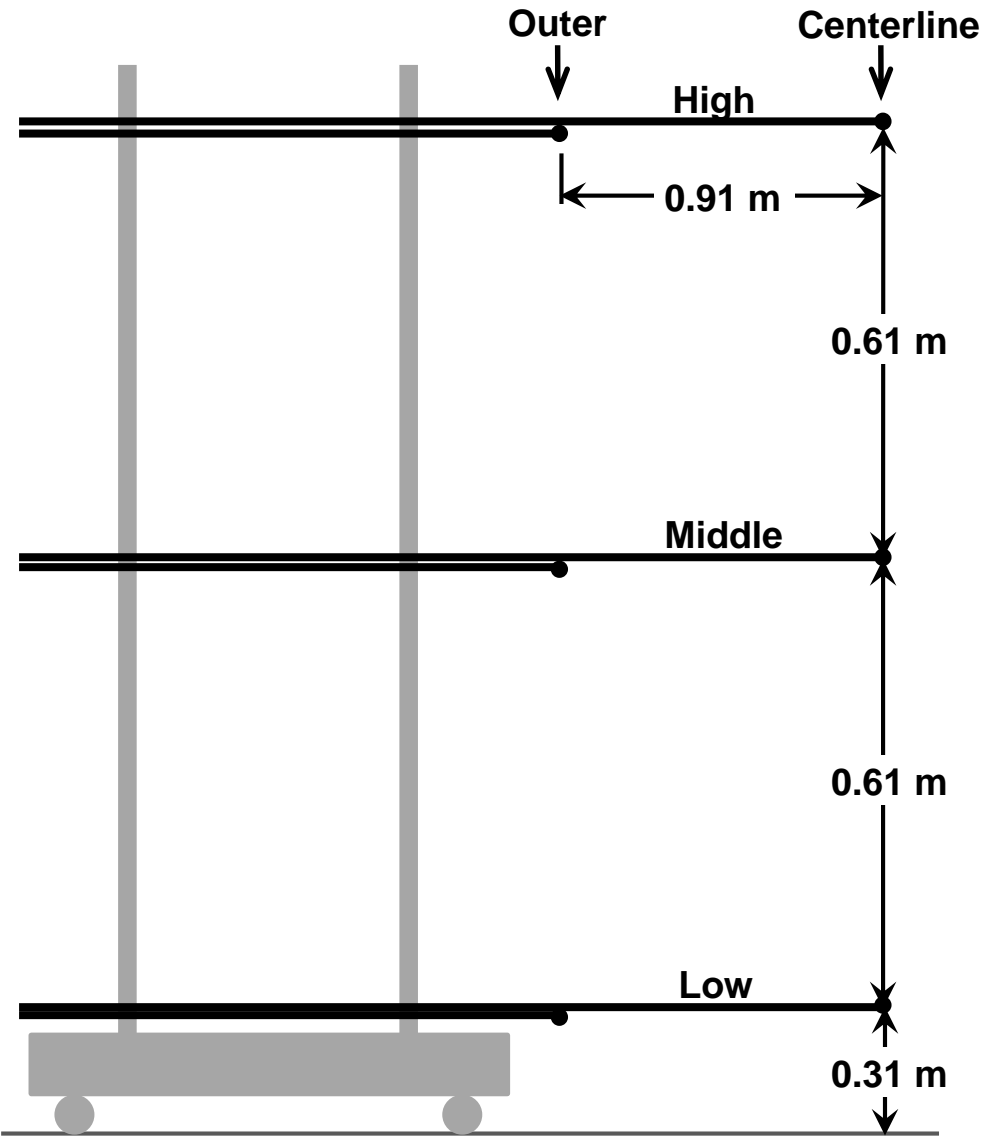
Figure 5 A diagram of the bi-directional probe array used to measure the velocity field.

In order to measure the wind velocity field, a grid of six bi-directional pressure probes was used with three arranged vertically at 30.5 cm, 91.4 cm, and 152.4 cm heights (measured from the ground) on the centerline of the set-up and another three at the same heights but 91 cm off of the centerline. Figure 5 is a diagram showing the probe array arrangement. The probes were located in the same plane as the ends of the walls. Temperatures were measured with k-type thermocouple beads made from 24 AWG wire (0.51 mm diameter) which had response times of approximately 1 s for the highest wind speeds. Ambient temperature was measured with thermocouples located near the pressure probes. Wind speed was calculated from the pressure and temperature measurements. The 18 m/s wind speed profiles could only be partially measured because some pressure sensors over ranged, however that wind speed had been measured previously with a vane anemometer at the high centerline position.

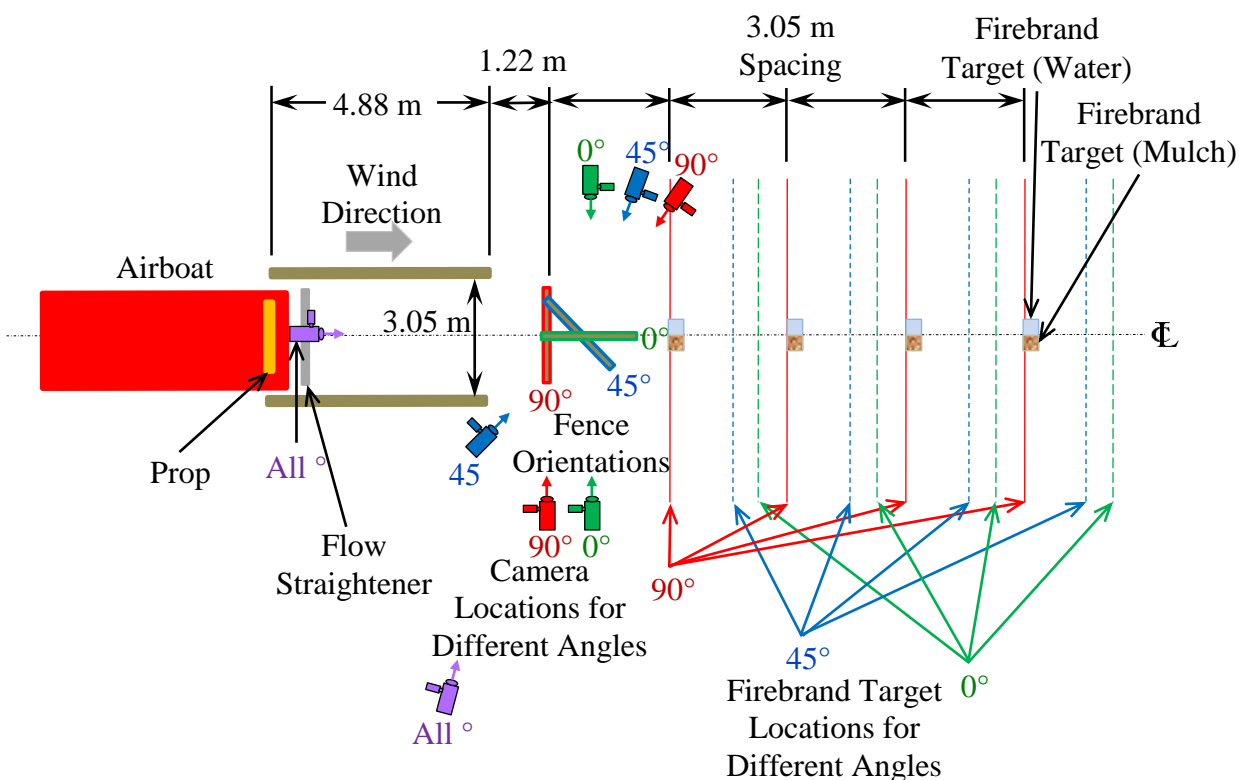
Figure 6 A top view schematic of the experimental setup showing the relative positions of the fence, firebrand targets, and video cameras for the three fence orientation angles.

upwind of the test area near the airboat, and up on a neighboring building looking down at the whole setup from one side. Figure 6 is a top view schematic of the experimental setup showing the relative positions of the video cameras for the three fence orientations. Digital still photographs were taken throughout the testing period and afterward.

Table 2 lists all of the tests and their conditions. The Test 6 configuration differed from the other 45° tests in that the burner ignited the fence on the structure side (the side with the horizontal stringers), and the fence was turned so the structure side faced the wind. Test 18 was conducted under only ambient conditions and no imposed wind. The top view schematic of Figure 6 shows the experimental setup including the relative positions of the fence, targets, and cameras for the three fence orientations.

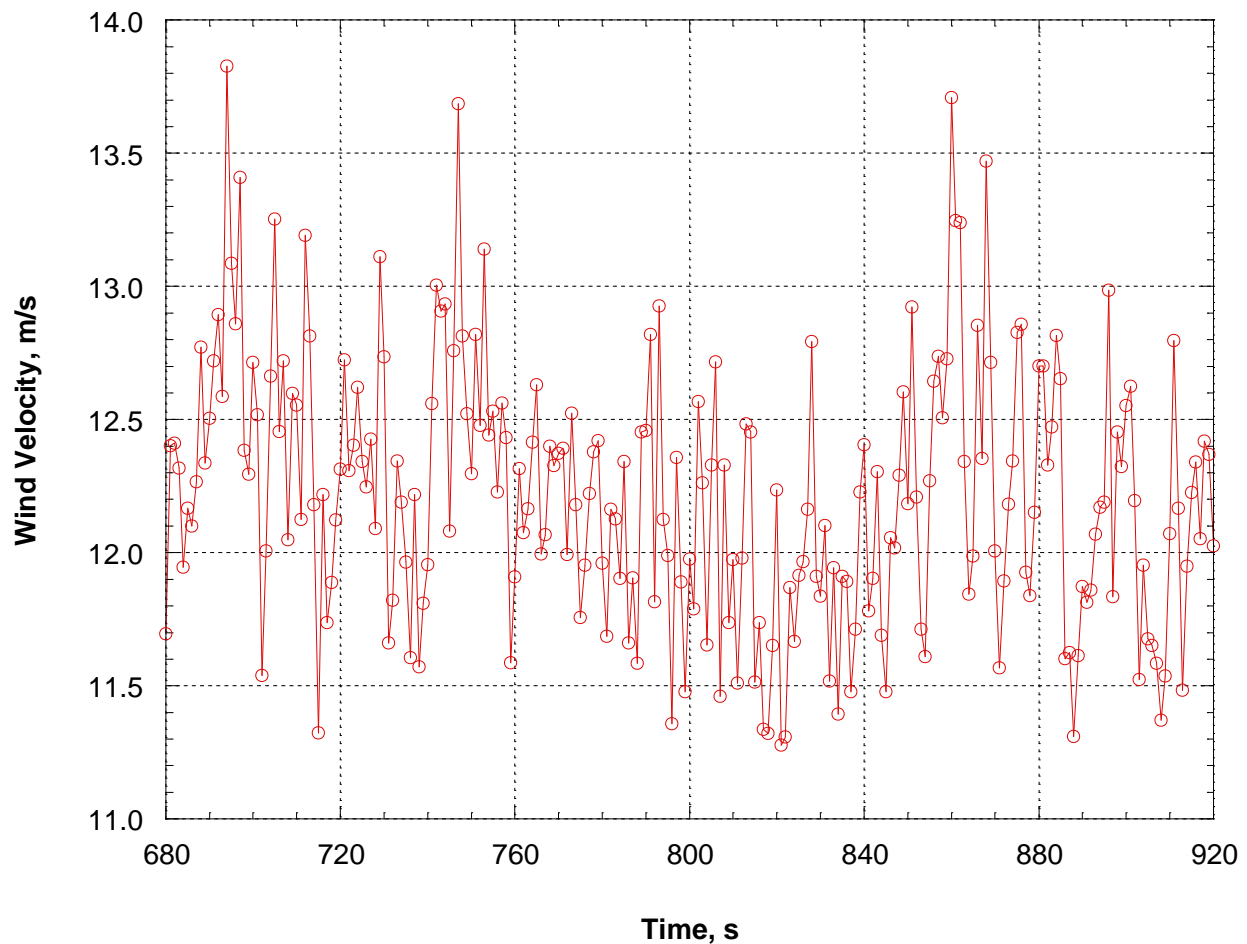
Figure 7 A plot of 4 min of velocity versus time data from the middle height (0.91 m from ground) bi-directional probe on the centerline for Test 9 (cedar, 0°, 13.5 m/s) showing the level of velocity fluctuations measured.

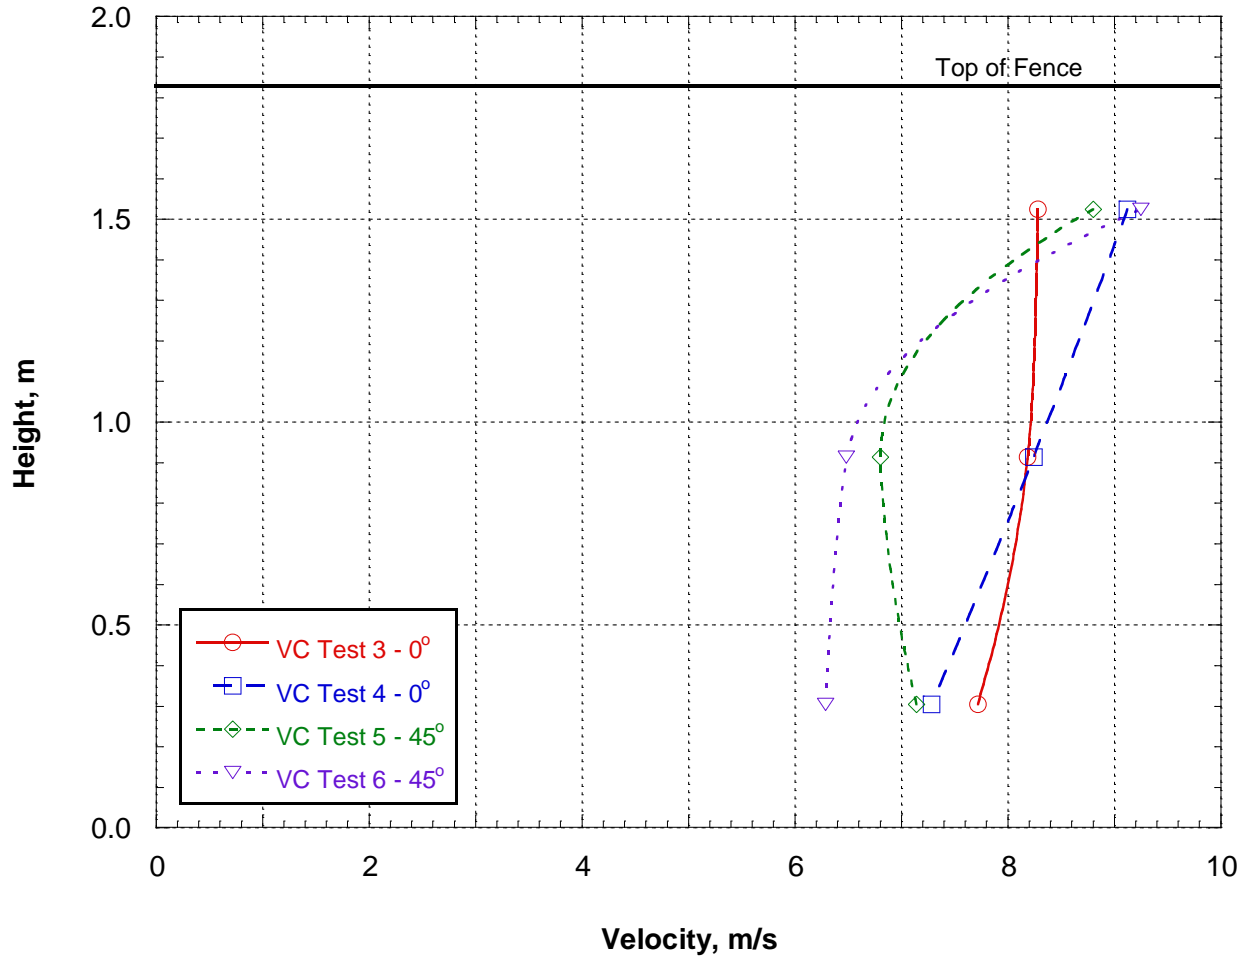
Figure 8 A plot of height versus velocity for the tests with complete vertical velocity data for the nominal wind speed of 9 m/s. The points represent the mean velocities during the steady wind period. Standard errors for the average velocities ranged from 0.02 m/s to 0.06 m/s. Smooth curves were fit through the points to facilitate visualization of the profile.

Figure 8 is a plot of the measured average velocity vertical profiles at the centerline for the experiments with a nominal 9 m/s wind field. Measurements were taken at 30.5 cm, 91.4 cm, and 152.4 cm from the ground at a distance of 1.22 m in front of the fence. Standard errors for

the average velocities due to fluctuations ranged from 0.02 m/s to 0.06 m/s. According to this data, the actual average velocities in the nominal 9 m/s cases were between 7 m/s and 8.5 m/s. The plot shows that the lowest height velocities were 1 m/s to 2 m/s less than those at the highest position. The middle height velocities were about halfway between those above and below except for the 45° cases. The 45° configuration produced markedly different profile shapes than the 0° configuration. This difference could be due to the fence causing some angle-dependent upstream flow effects.

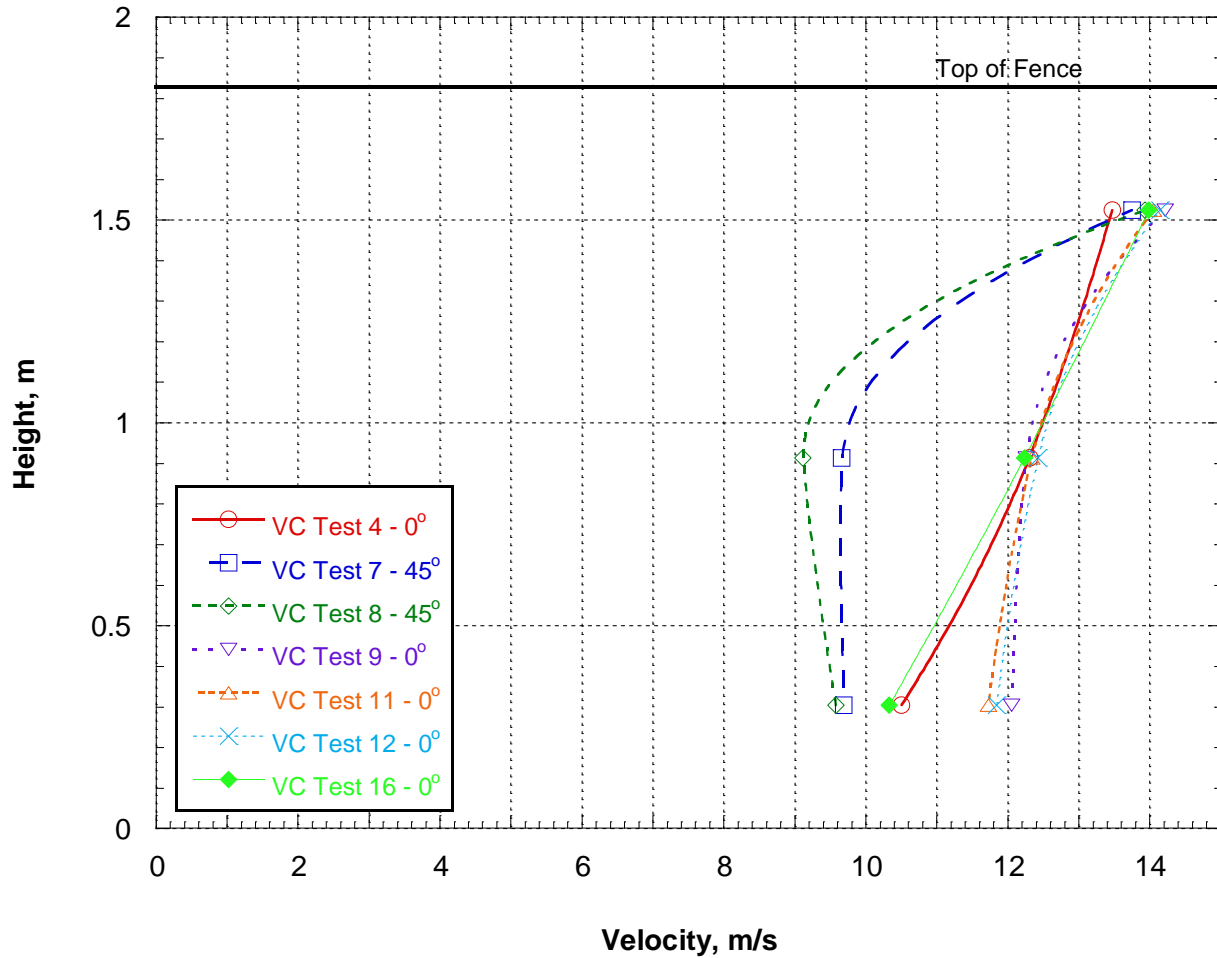
Figure 9 A plot of height versus velocity for the tests with complete vertical profile velocity data for the nominal wind speed of 13.5 m/s. The points represent the mean velocities during the steady wind period. Standard errors for the average velocities ranged from 0.01 m/s to 0.17 m/s. Smooth curves were fit through the points to facilitate visualization of the profile.

The plot in Figure 9 is similar to the plot in Figure 8 but is for the nominal 13.5 m/s cases. Because the pressure transducers had a maximum range of around 14.3 m/s, some data were truncated to that value and underestimated the true velocity and lowered the standard error. The maximum standard error for the average velocities due to fluctuations was 0.17 m/s, but typical standard errors were on the order of 0.04 m/s. The actual average velocities in the nominal 13.5 m/s cases were between 10 m/s and 12.5 m/s (probably 13.5 m/s considering the truncation of some of the data). The plot shows that the lowest height velocities were 2 m/s to 4 m/s less

than those at the highest position. For the 0° cases, the profiles were nearly linear with the middle height velocities about halfway between those above and below. For the 45° cases, the profiles were markedly different than for 0° and were not linear but showed large velocity changes between the middle and highest positions.

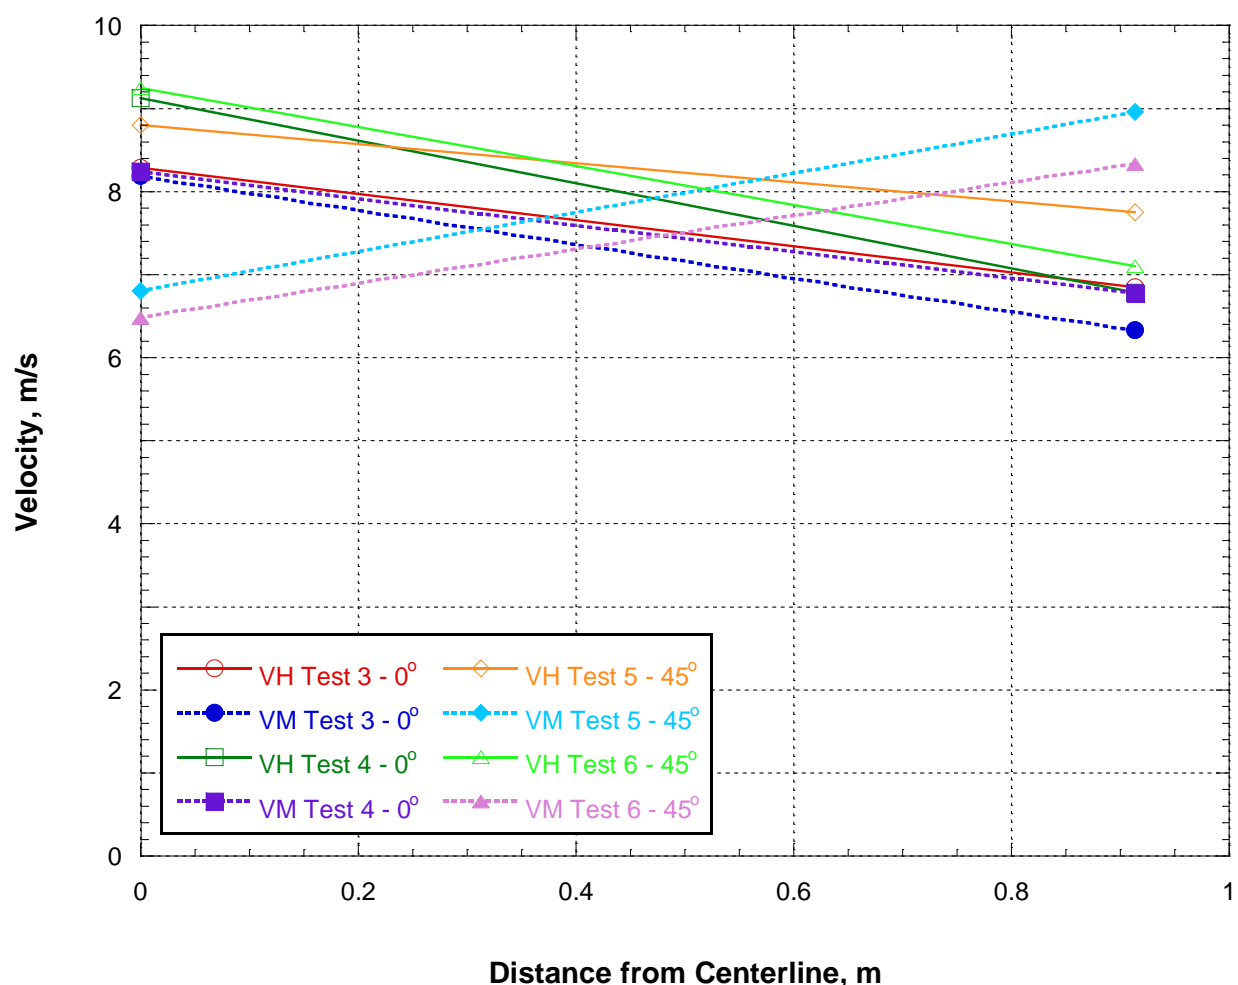
Figure 10 A plot of velocity versus distance from the centerline for the tests with complete horizontal profile velocity data for the nominal wind speed of 9 m/s. The points represent the mean velocities during the steady wind period. Standard errors for the average velocities ranged from 0.02 m/s to 0.06 m/s. Lines were fit through the points to facilitate visualization of the profile.

Figure 10 is a plot of the measured average velocity horizontal profiles between the centerline and 91.4 cm from the centerline at the highest and middle heights for the experiments with a nominal 9 m/s wind field. In the plot, the x-axis represents the ground, and the y-axis represents the center of the fence (but 1.22 m upstream). Open symbols represent the highest position (152.4 cm), and filled symbols represent the middle position (91.4 cm). Standard errors for the average velocities due to fluctuations ranged from 0.02 m/s to 0.06 m/s. The plot shows that for most cases, the outer (away from the centerline) velocities are lower than those on the centerline, typically by 1 m/s to 2 m/s. The middle height position for the 45° configuration (Tests 5 and 6) had an inverted situation where the outer velocities were about 2 m/s higher than those on the centerline. This again shows the possibility of some upstream effect of the fence which would have only impacted the centerline velocities. It also seems to only have affected the middle height and not the probes 1.5 m off of the ground.

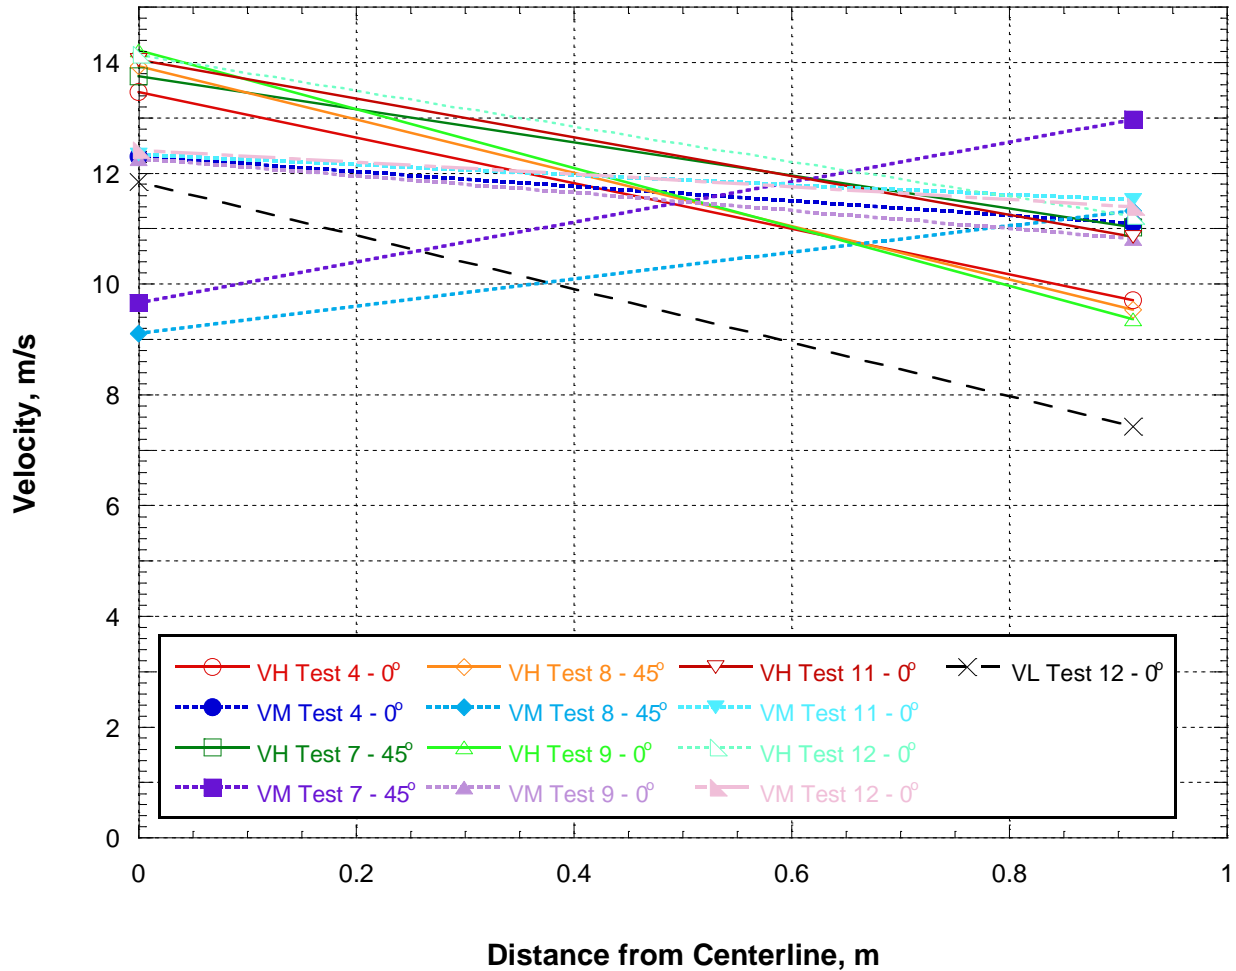
Figure 11 A plot of velocity versus distance from the centerline for the tests with complete horizontal profile velocity data for the nominal wind speed of 13.5 m/s. The points represent the mean velocities during the steady wind period. Standard errors for the average velocities ranged from less than 0.01 m/s to 0.21 m/s. Lines were fit through the points to facilitate visualization of the profile.

The plot in Figure 11 is similar to the plot in Figure 10 but is for the nominal 13.5 m/s cases. The maximum standard error for the average velocities due to fluctuations was 0.21 m/s, but typical standard errors were on the order of 0.05 m/s. The plot shows that for most cases, the outer (away from the centerline) velocities are lower than those on the centerline, typically by 2 m/s to 3 m/s, but as much as 4.4 m/s for the lowest position (Test 12 data). For Tests 4, 9, 11, and 12, the centerline velocity for the middle position was only 1 m/s higher than the outer velocity at the same position. The middle height position for the 45° configuration (Tests 7 and 8) had an inverted situation where the outer velocities were higher by 2 m/s to 3 m/s than those on the centerline. Again, this possible upstream effect of the fence only impacted the centerline velocities at the middle height position.

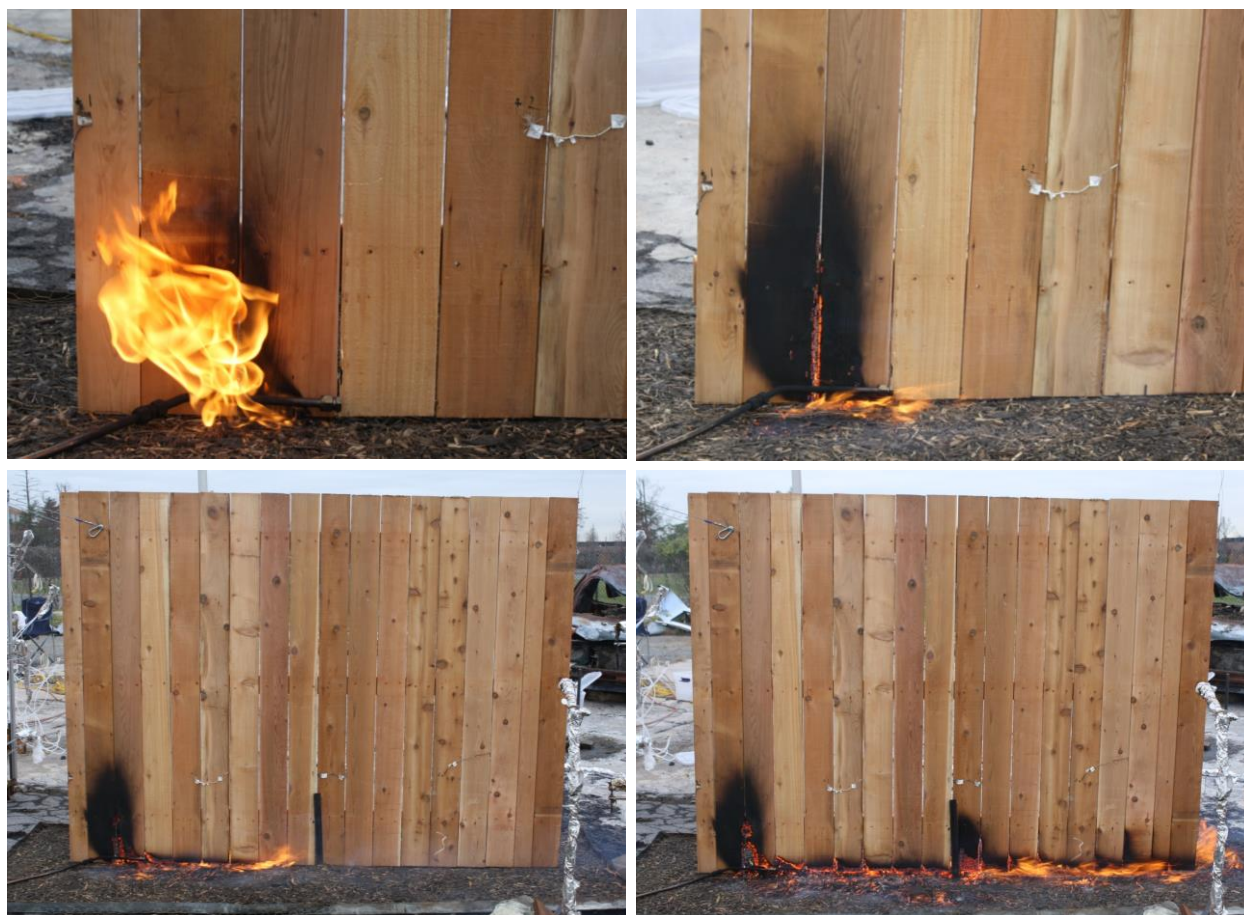
Figure 12 Photographs of Test 15 (cedar at 0°, 13.5 m/s) showing progression of the fire: ignition (UL), initial wind-blown fire (UR), spread to half of the fence (BL), and spread to the full fence (BR). Wind direction was left to right.

The straight sections of fence need to stay upright and rigid to simulate real fence sections installed in the ground. To do this required the steel "feet" attached to the horizontal stringers as well as some cabling. The feet were made of 2 cm angle for strength, but this also created a slight obstacle for the wind, and small stagnation and recirculation zones formed when the fire passed by them. It does not seem that the feet impeded the downwind fire spread but they did enhance some localized upward burning as can be seen in Figure 12 (bottom right photograph).

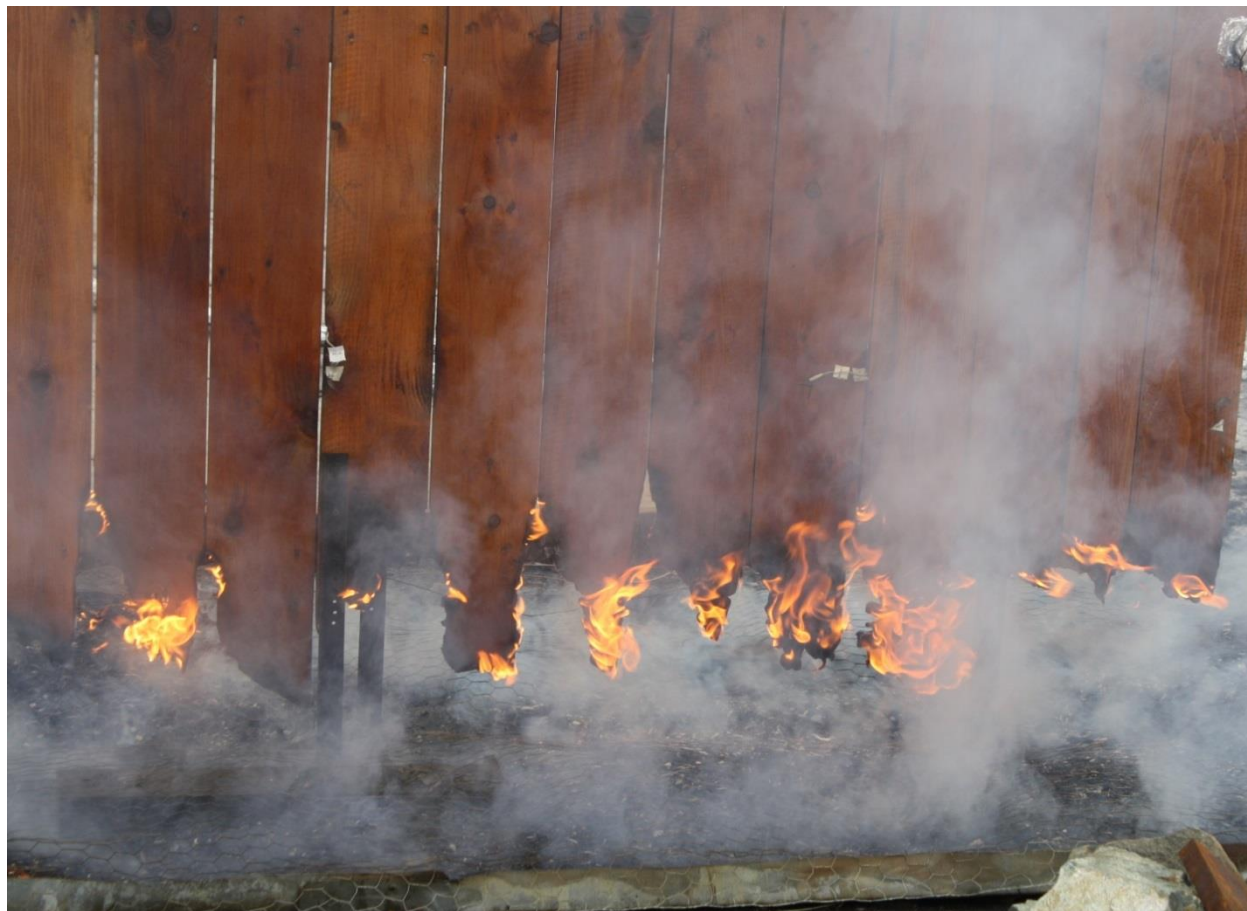
Figure 13 Photograph from Test 13 (preservative-coated cedar at 0° , 13.5 m/s) showing flames attached to several fence boards and a significant amount of material burned away from the board ends. Wind direction was left to right.

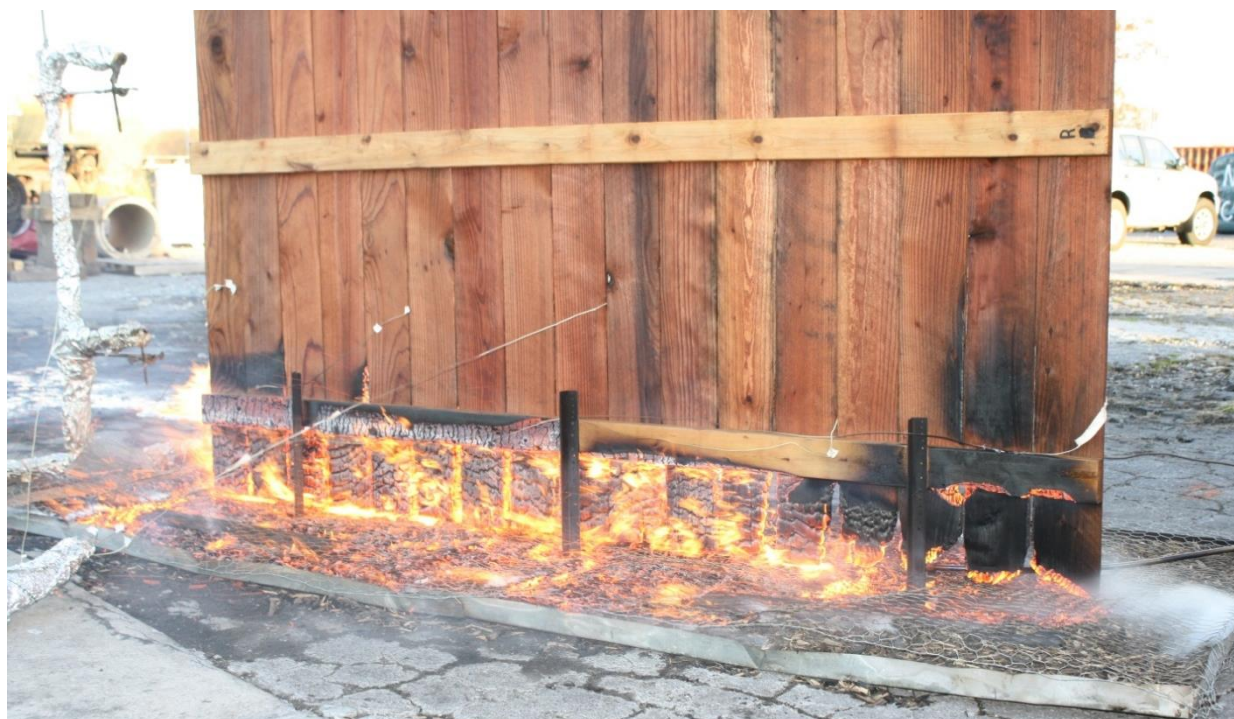
Figure 14 Photograph from Test 12 (preservative-coated redwood at 0°, 13.5 m/s) showing substantial burning of the lower 2/3 of the structure side of the fence after the fire progressed (from right to left) to the end.

Since only one test of each type was performed, the results aren't statistically significant, but it can be said that the spread rates were among the fastest tested and were similar despite the preservative. There were some qualitative differences when preservative was used compared to the cases when it wasn't. After the wind was stopped, the non-preserved wood generally stopped burning within about 2 min, but for the cedar with preservative, the flames continued on the fence for about 4 min, and for redwood with preservative they lasted about 5 min. Also, for preserved redwood, the post-wind flames burned upward past the middle horizontal 2x4 to about 1.04 m which was further than for any other experiment. A close-up photograph of the preserved-cedar experiment in Figure 13 shows the attached flames along the bottom of the fence boards. The Figure 14 photograph taken during the preserved-redwood experiment shows the whole structure side of the fence with substantial burning taking place.

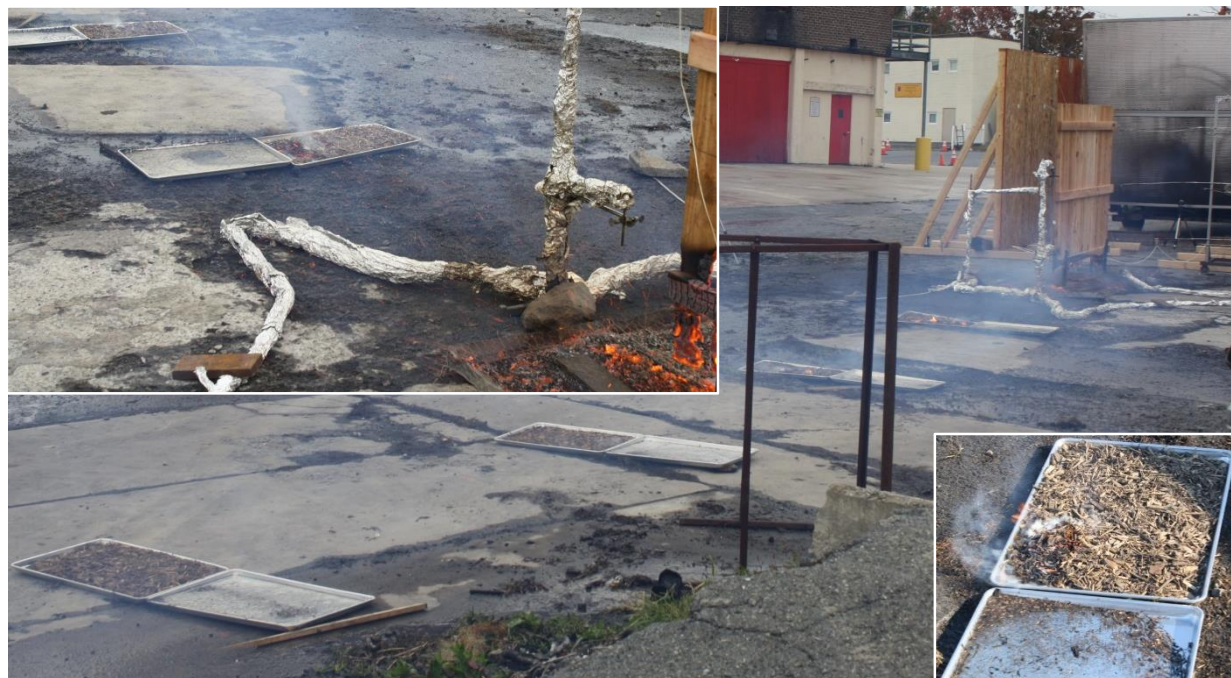
Figure 15 Photographs from Test 9 (cedar at 0°, 13.5 m/s) showing three perspectives on the first (3.05 m) target pan with burning mulch and airborne firebrands.

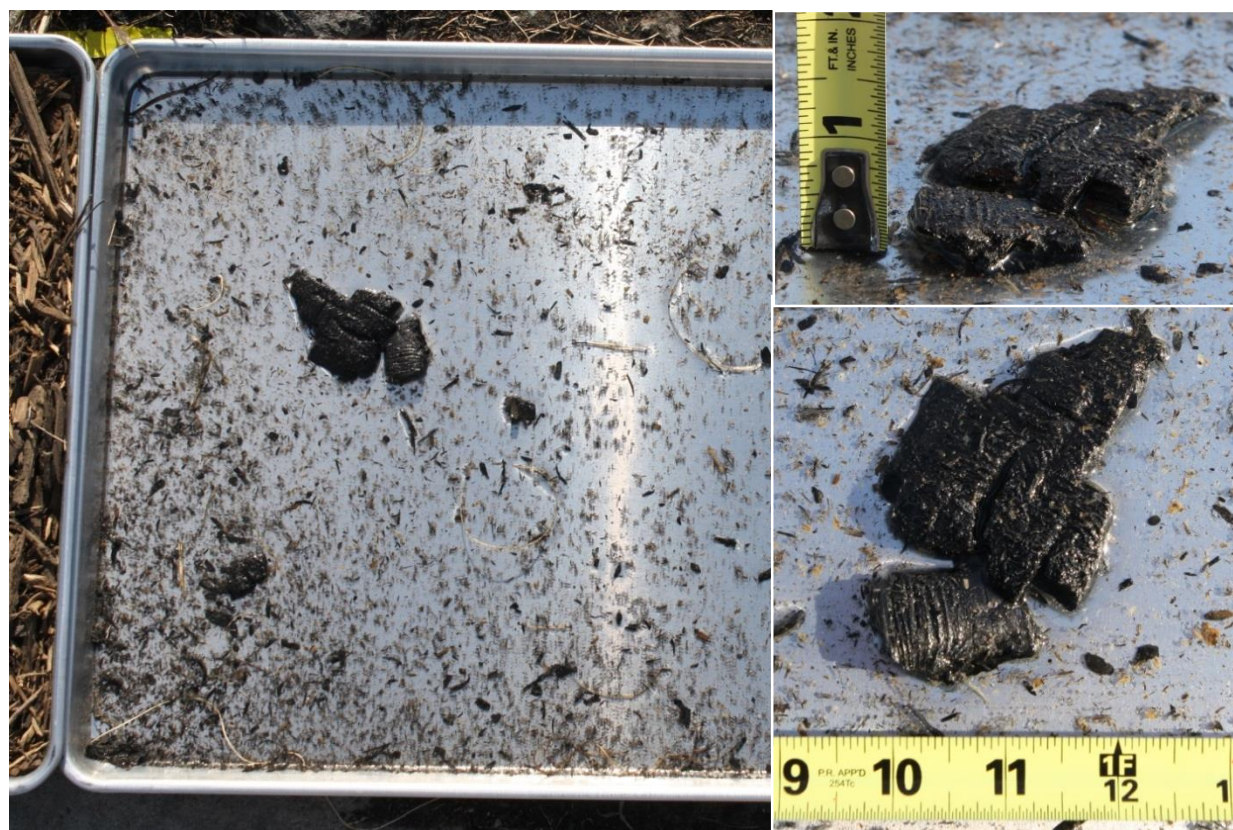
Figure 16 A photograph of a fence-generated firebrand in the first (3.05 m from fence) water pan surrounded by smaller mulch-generated firebrands produced during Test 12 (preservative-coated redwood at 0°, 13.5 m/s). Additional photographs provide size reference for the firebrand.

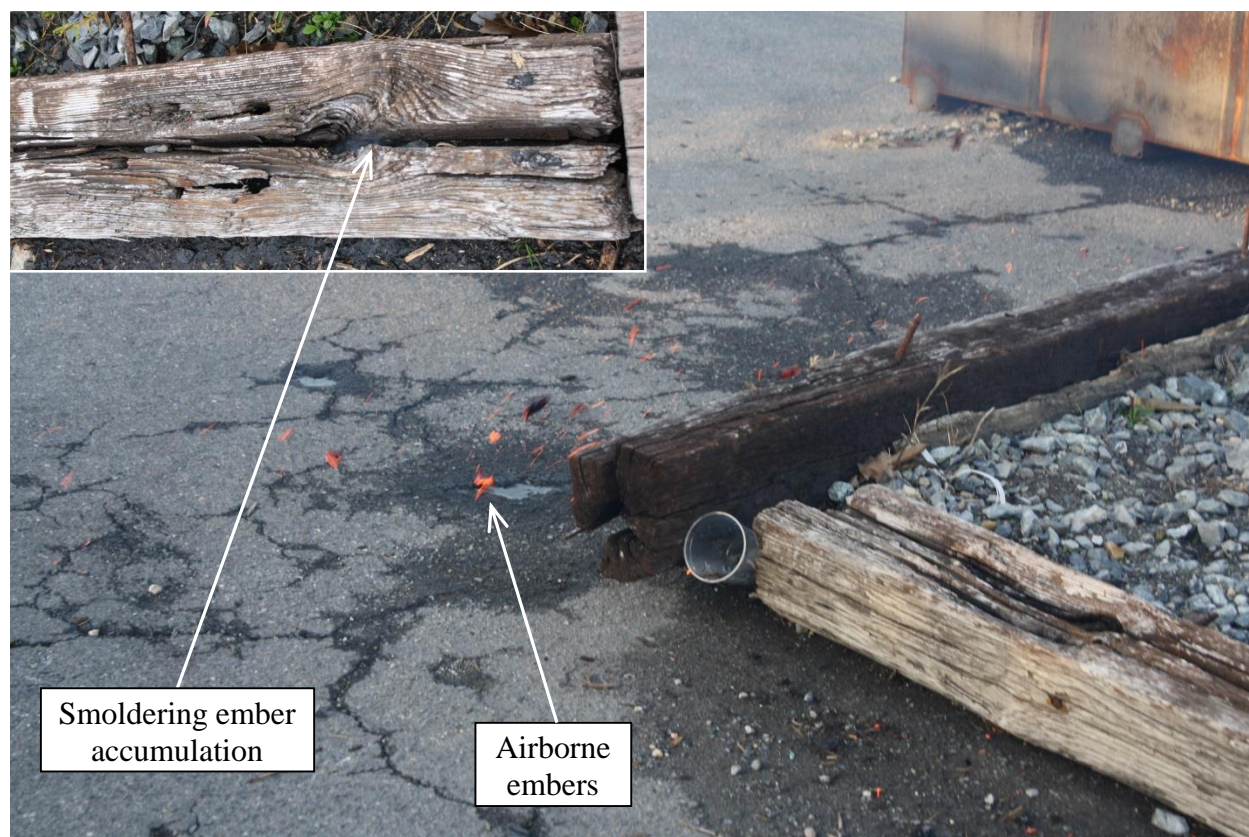
Figure 17 A photograph of a weathered and cracked railroad tie type of timber located over 18 m from the fence (upper left). During Test 10 (cedar at 0°, 18 m/s), the timber was ignited in at least two locations where firebrands accumulated in cracks. The other photograph (bottom right) shows firebrands flying near the other end of the timber.

In some experiments, fence and mulch firebrands were blown substantially further than the furthest target, and some downwind ignitions of combustibles were seen. As an example, Figure 17 shows photographs of a weathered and cracked railroad tie type of timber located over 18 m from the fence. The timber (upper left photograph) was ignited in at least two locations where firebrands accumulated in cracks. The lower left photograph shows the firebrand shower near the timber.
