**NIST Technical Note 2215**

# **Characteristics of Nuclear Power Plant Fires Involving Electrical Enclosures**

Isaac T. Leventon  
Kevin B. McGrattan  
Rick D. Davis  
Kenneth Hamburger  
Nicholas Melly

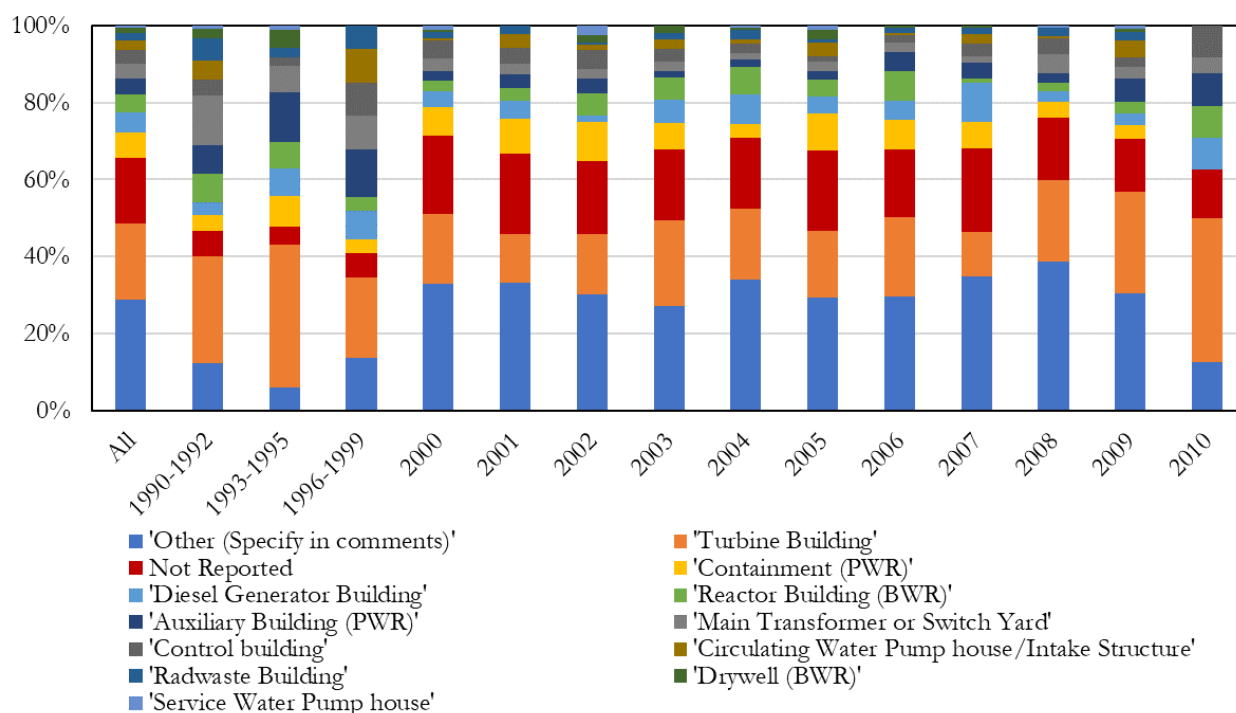
**Figure 2.** Starting location ("Building Start") frequency of reported fire events in the FEDB by year

Figure 2 plots time-resolved frequencies for fire locations of reported events in the FEDB (i.e., fractions of events with a specific “Building Start” option out of all fire events recorded during that time period). Here, fire event frequencies are generally reported in one-year intervals except between 1990-1999; a longer time interval is used during these years to ensure that each interval contains at least 80 unique fire events (see Fig. 1), which allows for calculation of more meaningful distributions of event frequencies. Presented in this form, these results indicate no significant trend in fire location with time. That is, between 1990 and 2011, no single “Building Start” location shows a consistent increase or decrease in reported fire event frequency. Beginning in the year 2000, fire event location was three times more likely to be reported as ‘Other’ or ‘Not Reported’ as compared to from events in the FEDB reported prior to the year 2000. Tabulated values for the information plotted in Fig. 2 are available in Table A1 of Appendix A.

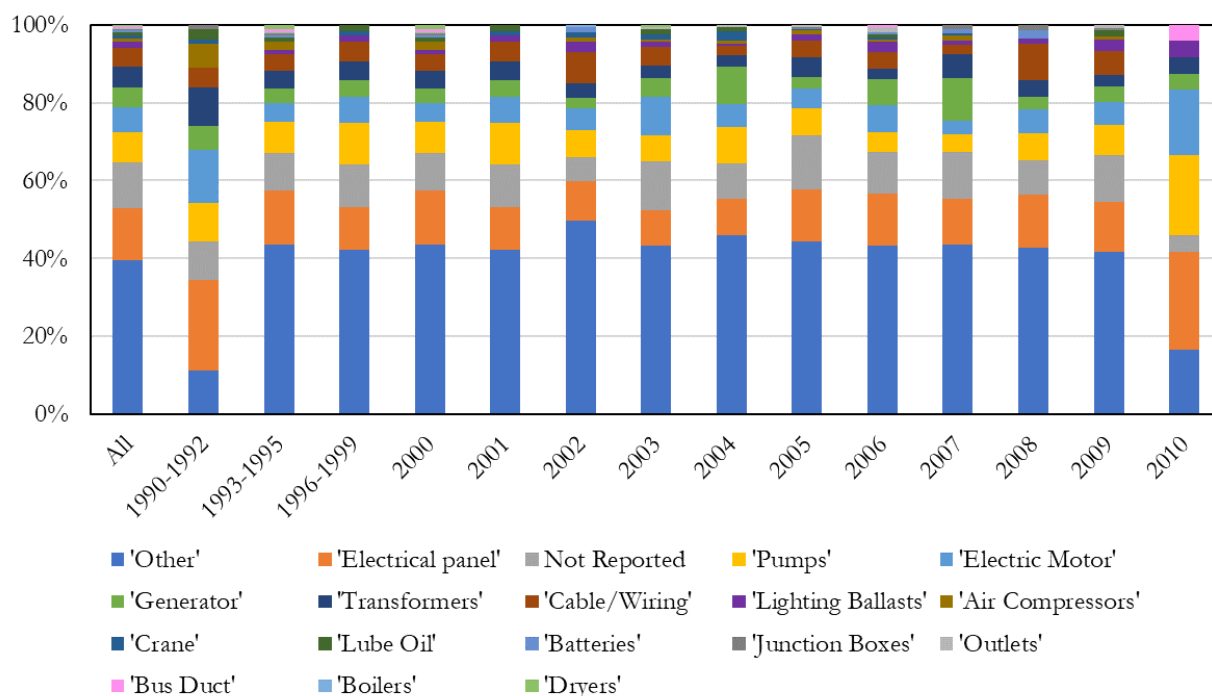
**Figure 4.** First item ignited (“Component Start Group”) in all fire events reported in the FEDB by year

Figure 4 plots time-resolved frequencies of the first item ignited for all reported events in the FEDB. This figure reveals that there are no significant year-to-year variations in reported first item ignited; that is, between 1990 and 2011, no single “Component Start Group” option shows a consistent increase or decrease in reported fire event frequency. In years in which the first item ignited is significantly less often reported as ‘Other’ (e.g., 1990-1992, 2010) electrical panels, motors, pumps, and transformers are reported as the first item ignited for a larger fraction of fire events. Tabulated values for the information plotted in Fig. 4 are available in Table A3 of the Appendix.

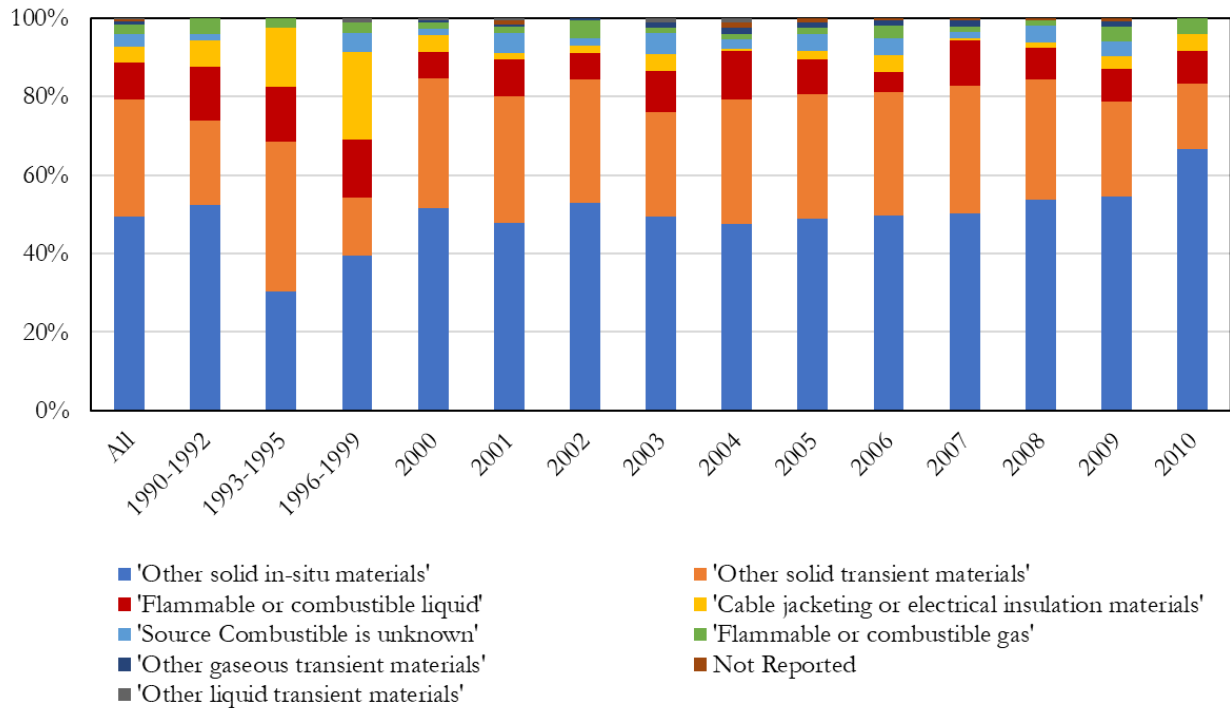
**Figure 5.** Combustible initiating group of all fire events in the FEDB by year

Table 6 reports the combustible initiating group of each fire event reported in the FEDB. In 79.2% of all fire events, the initiating combustible is a solid material: either in-situ/permanent (e.g., structural or electrical components, interior finish materials, or cable jacketing) or transient (e.g., temporary thermal insulation materials, electrical wiring/equipment, cellulose, and trash). However, for approximately 10 % of all reported incidents, a flammable or combustible liquid (e.g., grease or lube, fuel, or transformer oil) was involved (i.e., reported as the initiating combustible). Comparing fire events reported after 2000 versus those reported between 1990 to 1999 (Fig. 5), there was a decrease in the fraction of events that were initiated by flammable or combustible liquids (from 14.2 % to 8.8%) and by ‘Cable jacketing or electrical insulation materials’ (from 13.5% to 2.4%). Primarily, a larger percentage of these more recent events were instead reported with ‘Other’ or ‘Unknown’. Specifically, from 2004 to 2010, the fraction of fires reported to be initiated by ‘Other solid in-situ materials’ monotonically increased from 47.6 % to 66.7 % of events. Tabulated values for the information plotted in Fig. 5 are available in Table A4 of the Appendix.

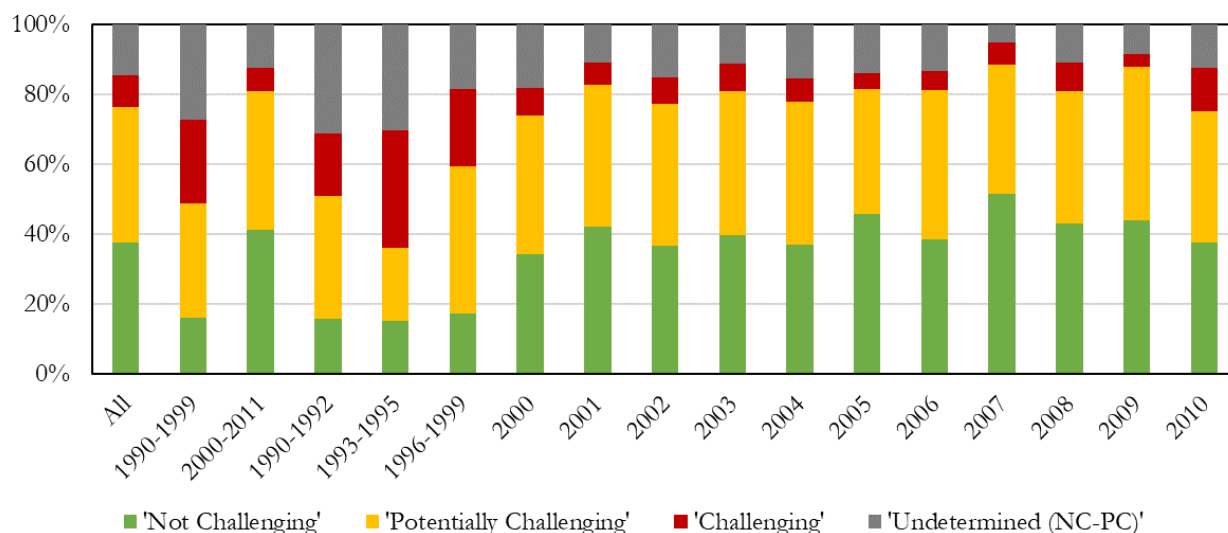
**Figure 7.** “Challenging Determination” of all fire events in the FEDB by year

Table 8 shows the reported challenging determination of all fire events in the FEDB. Most events (76.4%) in the FEDB are reported as ‘Not Challenging’ (NC) or ‘Potentially Challenging’ (PC); just under 10% of events in the FEDB are reported as ‘Challenging’ (CH). Section 2.1 of this report provides an overview of how this classification is determined. As seen in Fig. 1, there was a sudden increase (6 to 8 fold) in the number of fire events reported each year in the 2000s versus in the previous decade. Following the trend seen in fire event duration (reported in Section 2.2.5), it appears that this increase was primarily due to the increased reporting frequency of less challenging events, as seen in Fig. 7. Comparing fire events reported after 2000 versus those reported between 1990 to 1999, the fraction reported as not challenging increased from an average of 15.9% to 41.1% and the fraction reported as challenging decreased from an average of 23.9% to 6.6%. After 2000, the number of PC fire events increased, on average, from approximately 32.9% to 40.0% of all reported events each year. Between 2000-2010, there was no significant or systematic increase or decrease in the relative fractions of fire events reported each year as NC, PC, CH, or NC-PC. Tabulated values for the information plotted in Fig. 7 are available in Table A6 of the Appendix.

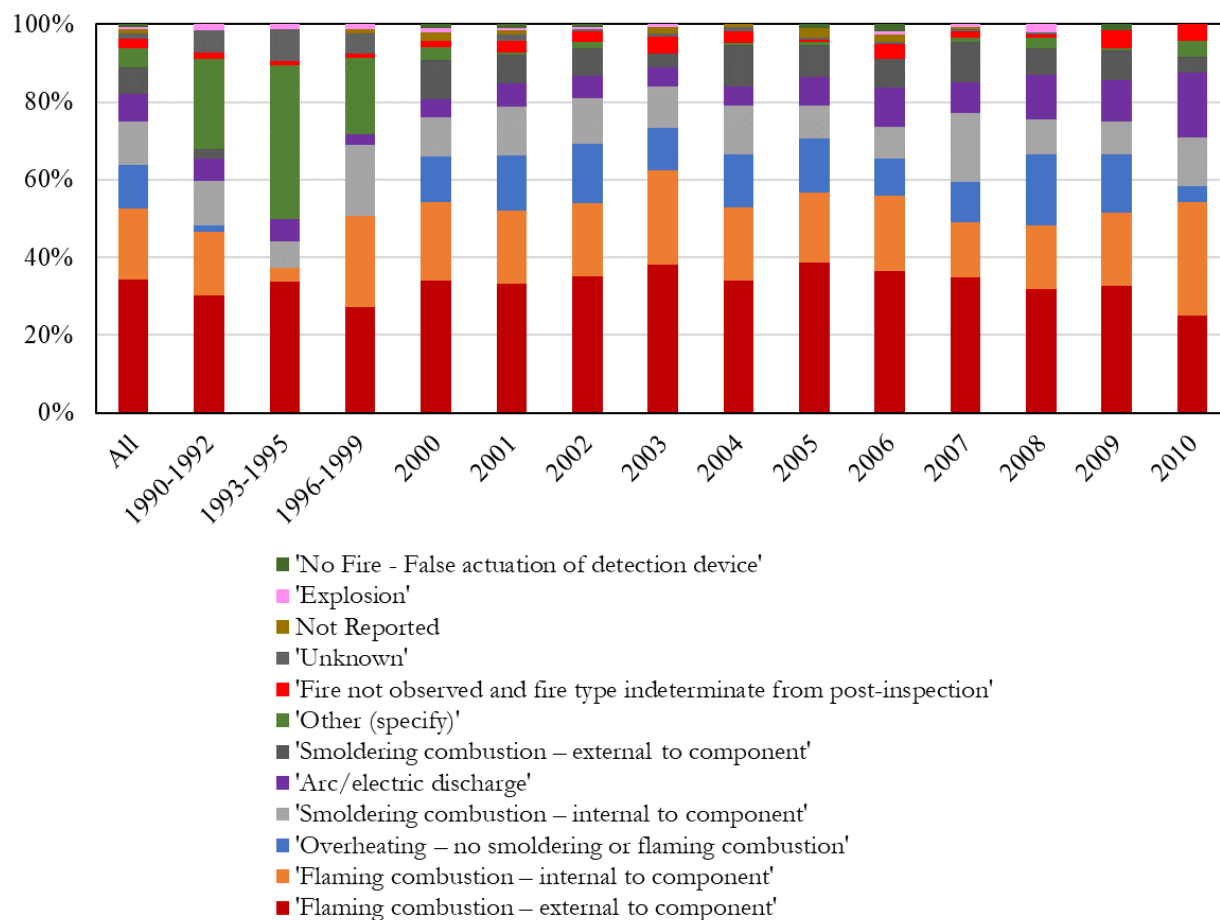
**Figure 8.** Fire Characterization Type of all events in the FEDB by year

For this subset of fire events (1850 out of 1998 total events), comparing events that occurred in the 2000s to the 1990s, fewer events reported ‘flaming combustion - external to component’ (35.9% vs. 45.8%) -and ‘smoldering combustion - internal to component’ (11.4 % vs. 18.2%) but more events reported ‘smoldering combustion - external to component’ (8.2% vs. 1.6%) and ‘overheating, with no smoldering or flaming’ (13.5% vs. 1.0 %). For most fire types, no significant change in reporting frequency was observed within a given decade; however, as seen in Fig. 8, the fraction of fires characterized by arc/electric discharge steadily increased throughout the 2000s from 5.1% to 17.1% of all ‘known’ cases. Tabulated values of the number of events reported yearly (between 1990 and 2010) with each “Fire Characterization Type” are available in Table A7 of the Appendix.

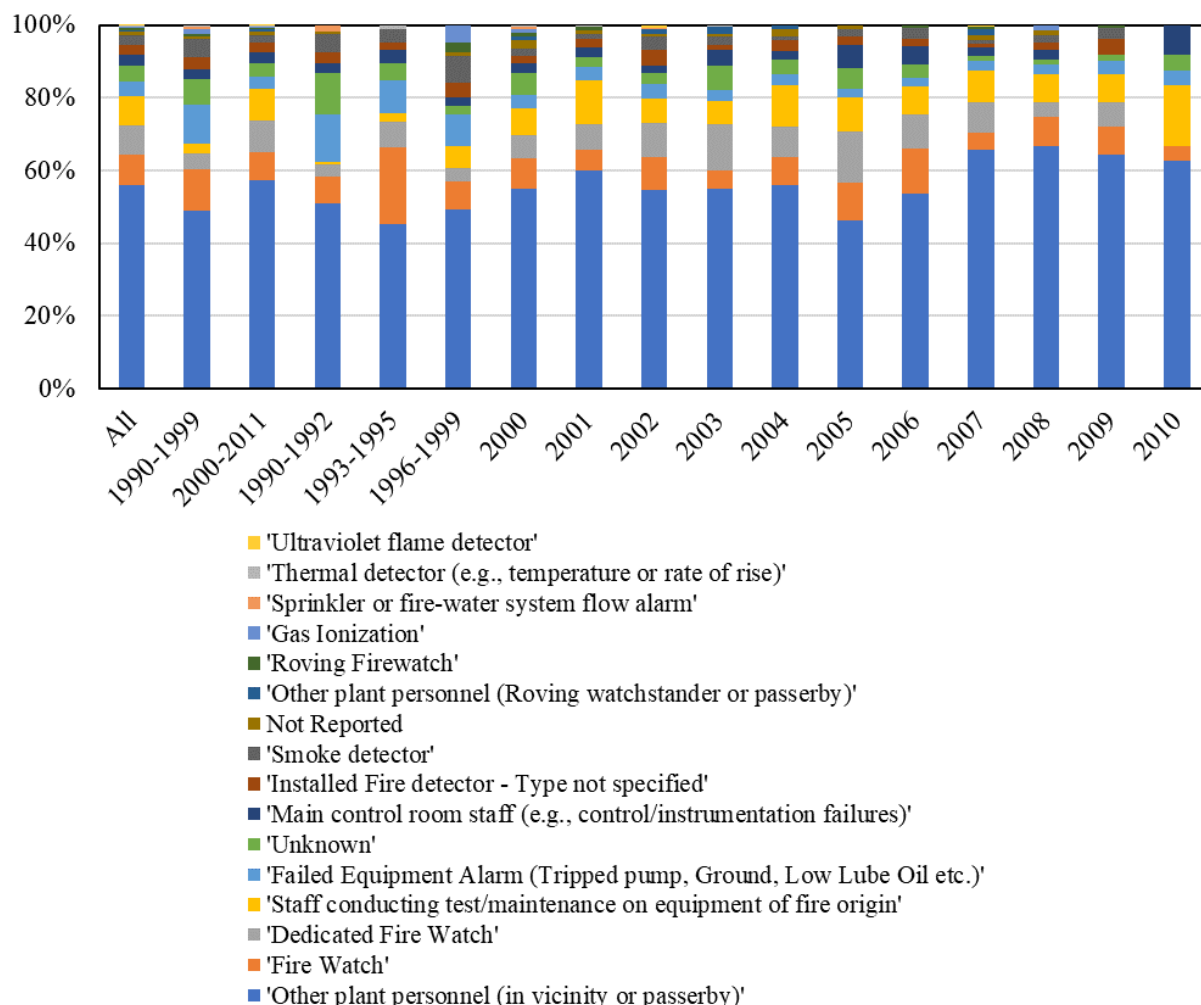
**Figure 9.** Fire Detection Method of all Fire Events in the FEDB by year

As seen in Figs. 9 and 10, Between 1990 and 2011, there are few significant, systematic trends/variations in reported fire detection or fire extinguishing methods. For detection, prior to 2000, there was, however, a continuous year to year decrease in the fraction of fire events detected by a failed equipment alarm; this value decreased from 13.1% of events reported between 1990-1992 to an average of 3.2% of events reported between 2000-2011. Additionally, during this same time period, there was an increase in the fraction of fires detected by staff conducting tests or maintenance on the equipment of fire origin from 2.8% of events reported between 1990-1999 to 8.7% of events reported between 2000-2011. For suppression, prior to 2000, 41.2% of all reported fires were put out by a team response from the plant fire brigade or response from the plant fire brigade with outside support; however, after 2000, only 11.7% of reported fires required a fire suppression effort of team fire brigade or greater. This trend may support previous observations (reported in Sections 2.2.5 and 2.2.6) that the increase in the number events reported each year in the 2000s (as compared to the

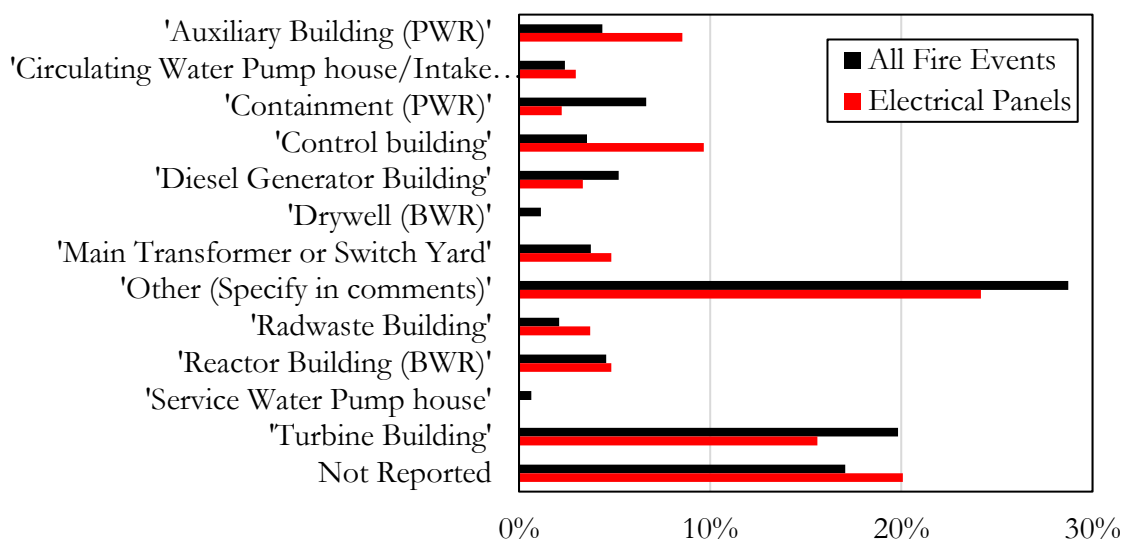
**Figure 11.** Starting location (“Building Start”) frequency of fire events in the FEDB: comparison between all reported events and those starting in electrical panels.

Figure 11 plots the relative frequencies of different starting locations (“Building Start”) of fire events reported in the FEDB. Here, location frequencies are plotted both for all events reported in the FEDB and just those identified as occurring in electrical enclosures. In this work, electrical enclosure fires reported in the FEDB were identified as those reported with the component start group ‘Electrical Panel’, as this was the most accurate available option to describe such fire events. Consequently, in Fig. 11 (and throughout section 2.3), when discussing fires that occurred in electrical enclosures, these events are identified in figure legends with the title, ‘Electrical Panels’.

For approximately 44% of fire events reported to occur in electrical enclosures (i.e., fire events in the FEDB with the Component Start classification: ‘Electrical Panel’) fire location is defined as ‘Other (Specify in Comments)’ or simply ‘Not Reported’. This limited starting location reporting frequency for enclosure fires is consistent with the trend for all fire events in the FEDB. When “Building Start” information is available (i.e., when considering only the fire events in electrical enclosures for which a “Building Start” location is explicitly defined), the largest number of reported fires in electrical enclosures start in ‘Turbine’ (28.0%), ‘Control’ (17.3%), ‘Auxiliary (PWR)’ (15.3%), ‘Main Transformer or Switch Yard’ (8.7%), and ‘Reactor’ (8.7%) buildings. As seen in Fig. 11, as compared to total reported fire events in NPPs, fires in electrical enclosures are nearly twice as likely (1.9x) to occur in auxiliary (PWR) and 2.6x as likely to occur in control buildings. However, fires in electrical enclosures are approximately three times (3x) *less* likely to occur in Containment (PWR) buildings, as compared to all fire events reported in the FEDB.

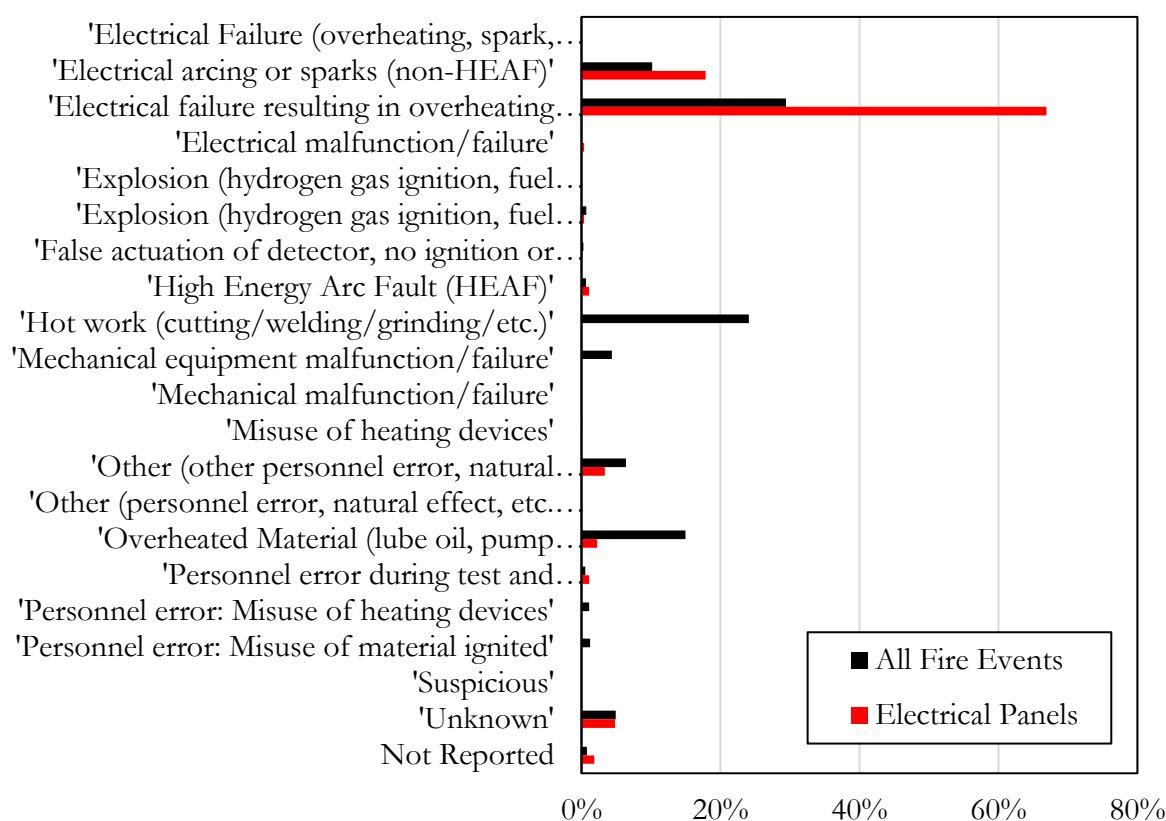
**Figure 12.** “Fire Cause Start” for events reported in the FEDB: comparison between all reported events and those starting in electrical panels.

Table 12 reports the total number (and relative frequency) of the initial cause (i.e., “Fire Cause Start”) of each electrical enclosure fire event reported in the FEDB. As seen here, 86.2% of these fires were initiated by some kind of electrical failure: arcing, sparks, or overheating (both HEAF and non-HEAF). As seen in Fig. 12, compared to all fire events, electrical enclosure fires are significantly more likely to start due to an electrical failure leading to overheating or electrical arcing or sparks; additionally, although the sample size is small, electrical enclosure fires are also 50% more likely to occur due to a HEAF (as compared to all fires in NPPs). Electrical enclosure fires have not been reported to start due to hot work or failure or malfunction of mechanical equipment (two leading causes of total fires in the FEDB).

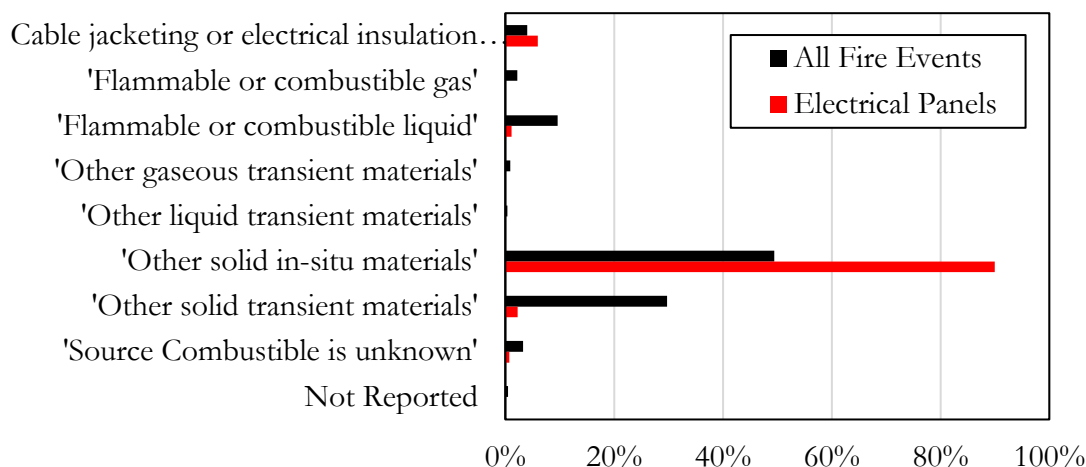
**Figure 13.** “Combustible initiating group” of events reported in the FEDB: comparison between all reported events and those starting in electrical panels.

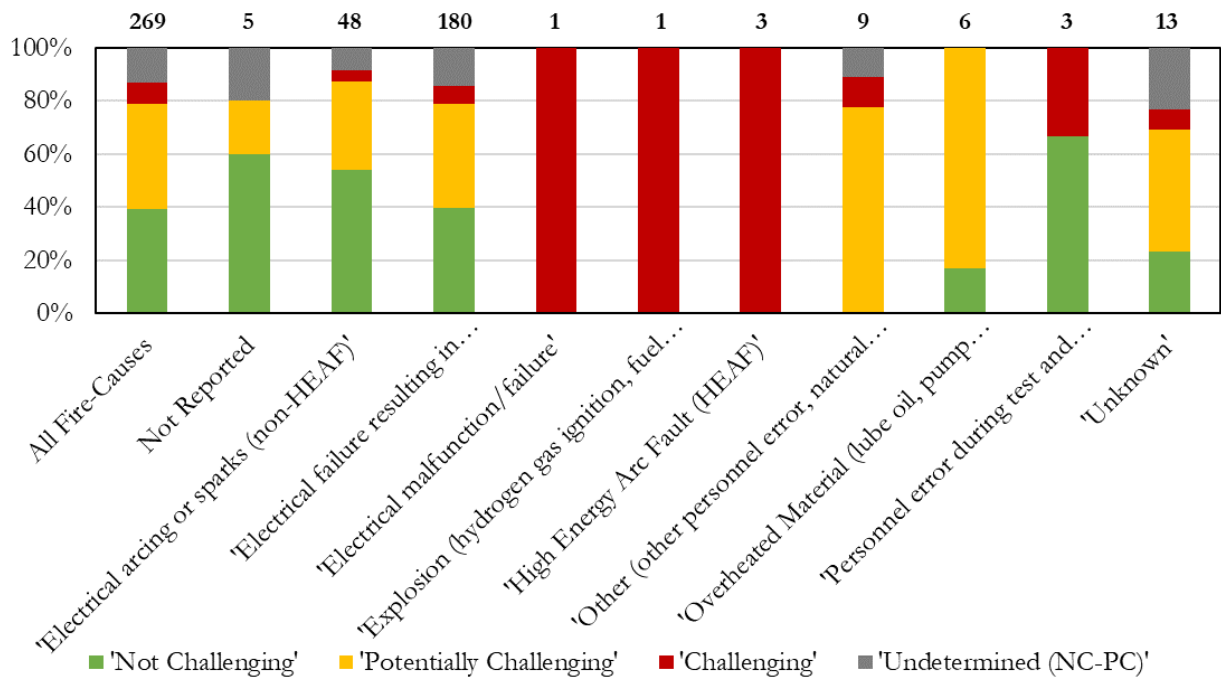
**Figure 16.** “Challenging Determination” of electrical enclosure fires in the FEDB given a specific fire cause.

To better understand how fire severity varies given different fire causes, the fraction of fire events with each “Challenging Determination” given a specific fire cause (e.g., overheating, HEAF, personnel error) is plotted in Figure 16. Here, the numbers in bold across the top of the figure indicate the number of fire events with a specific fire cause. As seen here, high energy arc faults (HEAFs) and explosions are particularly dangerous. By definition (see Table 4-2 of the updated FEDB [5]), these fires are reported as challenging and thus having “an observable and substantive effect on the environment outside the initiating source (e.g., damage or ignition of neighboring components).” Because there is significant overlap in the “fire cause start” categories related to electrical failure (i.e., more than 85% of all electrical panel fires are reported to be caused by the related categories ‘electrical arcing or sparking’ or ‘electrical failure resulting in overheating’) it is challenging to define relationships between the challenging determination of these events and their reported causes. In section 2.3.6 of this report, the impact of “Fire Cause Start” on the specific type of reported fire behavior or damage is analyzed in further detail.

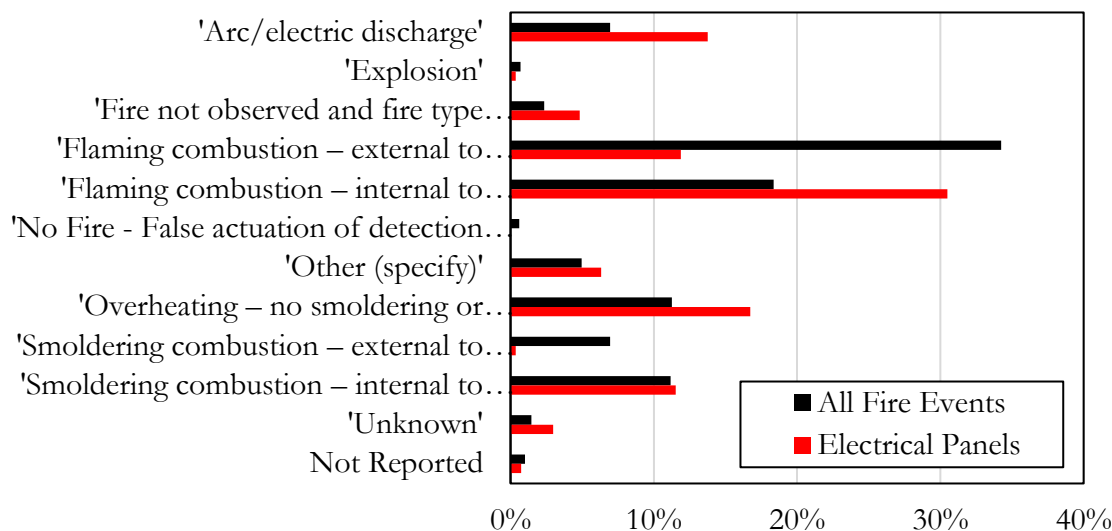
**Figure 17.** Fire Characterization of events reported in the FEDB: Comparison between all reported events and those starting in electrical panels.

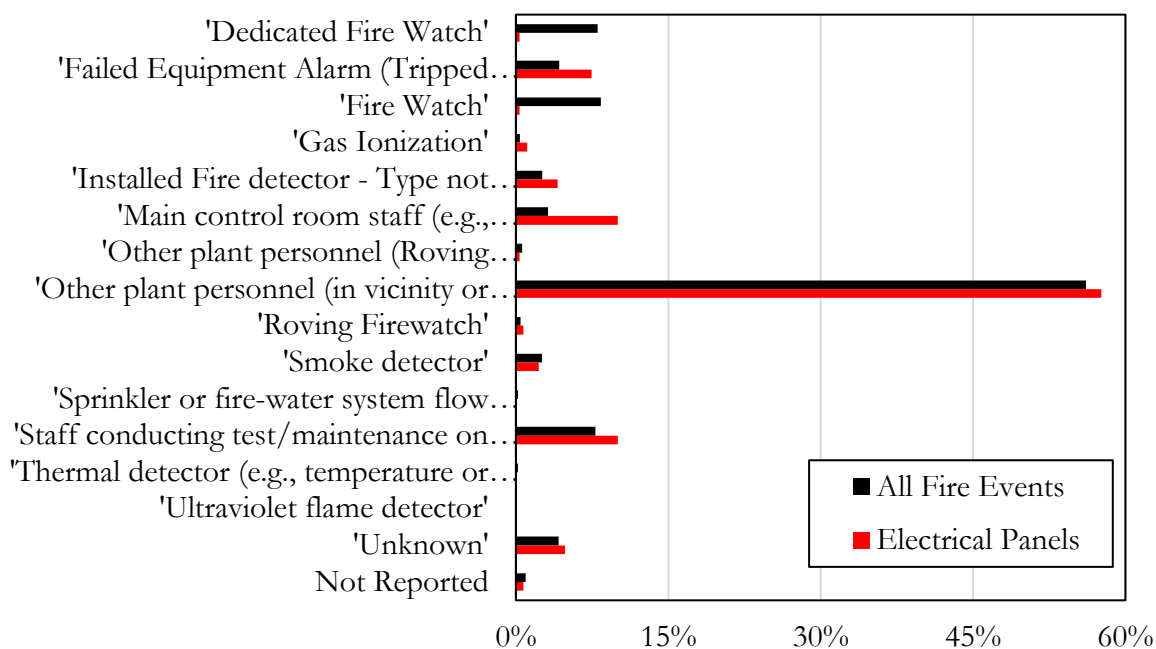
**Figure 19.** Fire Detection Method of events reported in the FEDB: comparison between all reported events and those starting in electrical panels.

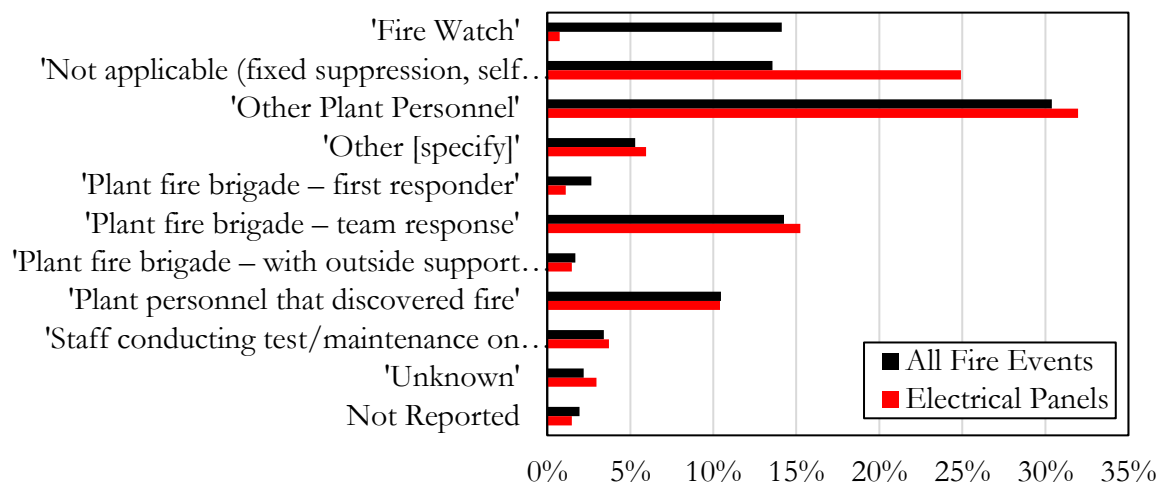
**Figure 20.** Fire Extinguishment method of fires reported in the FEDB: comparison between all reported events and those starting in electrical panels.
