# REPORT BMS38

Structural Properties of Two "Dunstone" Wall Constructions Sponsored by the W. E. Dunn Manufacturing Co.

by HERBERT L. WHITTEMORE, AMBROSE H. STANG, and DOUGLAS E. PARSONS

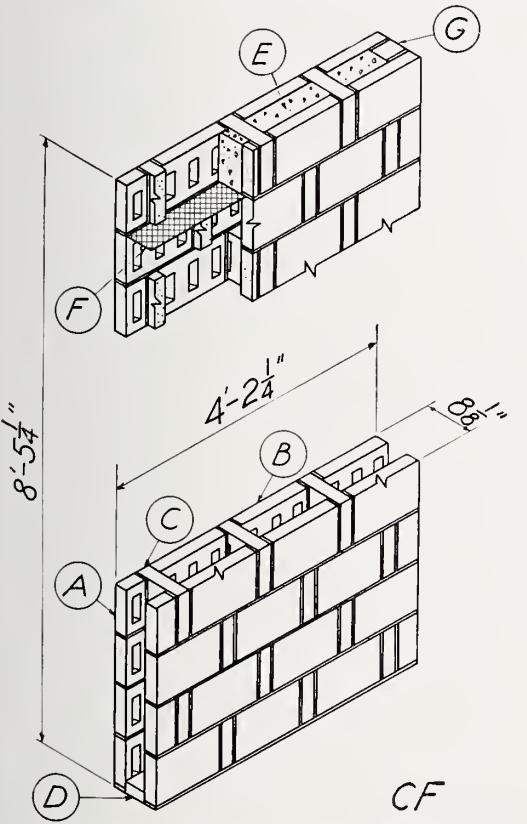
FIGURE 1.—Four-foot wall specimen CF. A, 1-core block as stretcher; B, 3-core block as stretcher; C, 2-core block as bonding header; D, mortar 2 in. thick; E, concrete fill; F, expanded metal; G, 1-core block for end of concrete form.

The 4-ft wall specimens with vertical headers were 8 ft 5¼ in. high, 4 ft 2¼ in. wide, and 8½ in. thick, and had 12 courses of blocks. The blocks formed an all-rolok in Flemish bond wall, as shown in figure 1. Each course con-

sisted of 1-core blocks, A, and 3-core blocks, B, as stretchers with 2-core blocks, C, as bonding headers. The details of the blocks are shown in figures 2 and 3. The bed joints and head joints were completely filled with mortar and were cut flush with the surface of the wall.

The space between the blocks of the first course was filled with mortar, D, to a height of about 2 in. above the bottom of the wall to support the first course during construction. The top course was filled with concrete, E. The bottom form for the concrete was made by placing a length of expanded-metal corner bead, hammered flat, F, in the bed joint and filling the openings in the expanded metal with mortar. Two 1-core blocks, G, laid in the space between the blocks of the top course served as the end forms for the concrete. The concrete was poured on the day following the completion of the specimen.

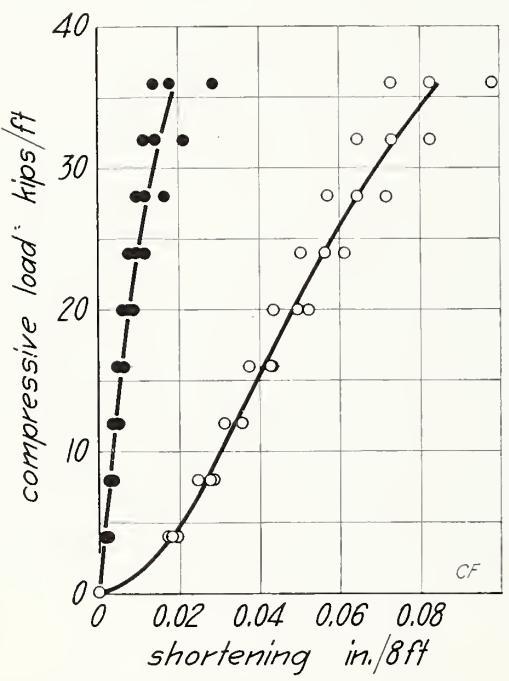
FIGURE 5.—Compressive load on wall CF.

Load-shortening (open circles) and load-set (solid circles) results for specimens CF-CI, C2, and C3. The load was applied one-third the thickness (2.71 in.) from one face. The loads are in kips per foot of actual width of specimen.

At loads of 32.0 and 39.6 kips/ft stretchers, at one edge on the face nearer the load line and near the top, cracked vertically in specimens C1 and C2, respectively. Specimen C1 collapsed at the maximum load, failing by cracking of the stretchers on the inside face near the top. Specimen C2 failed by breaking of all the headers midway between the two faces. Specimen • A kip is 1,000 lb. <sup>d</sup> Test discontinued. Specimen did not fail.

*C3* failed by breaking of the headers at one edge near the top.

Wall specimen CF-C1 under compressive load is shown in figure 4. The results for wall specimens CF-C1, C2, and C3 are shown in table 6 and in figures 5 and 6.

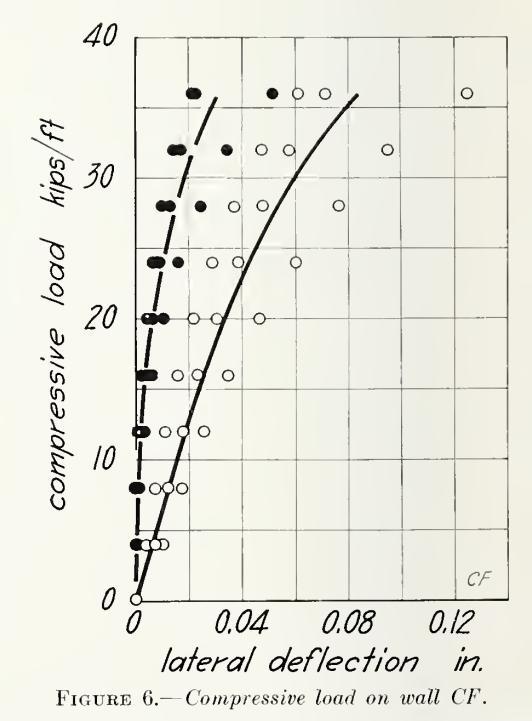
Load-lateral deflection (open circles) and load-lateral set (solid eircles) results for specimens CF-C1, C2, and C3. The load was applied one-third the thickness (2.71 in.) from one face. The loads are in kips per foot of actual width of specimen. The deflections and sets are for a gage length of 7 ft 6 in., the gage length of the deflectometers.

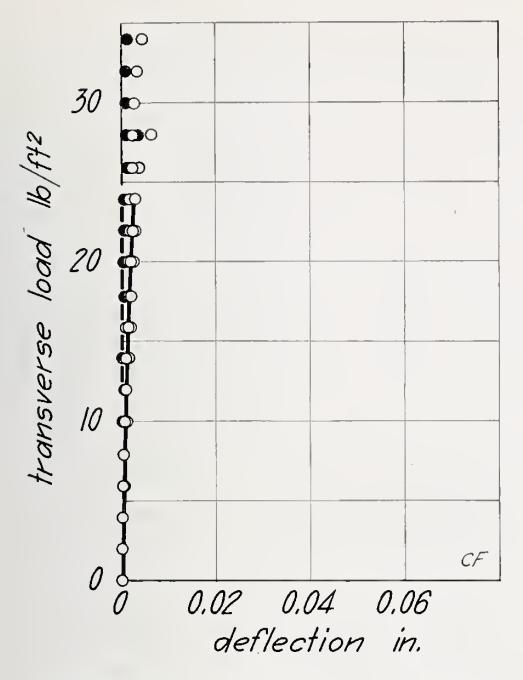
FIGURE 7.—Transverse load on wall CF.

Load-deflection (open circles) and load-set (solid circles) results for specimens CP-TI, T2, and T3 on the span 7 ft 6 in. The deflections and sets are for a gage length of 7 ft 6 in., the gage length of the deflectometers.

Each of the specimens T1, T2, and T3 failed by rupture of the bond between the mortar and the concrete blocks at a bed joint between loading rollers.

The results of the transverse load are shown in table 6 and in figure 7 for wall specimens CF-T1, T2, and T3.

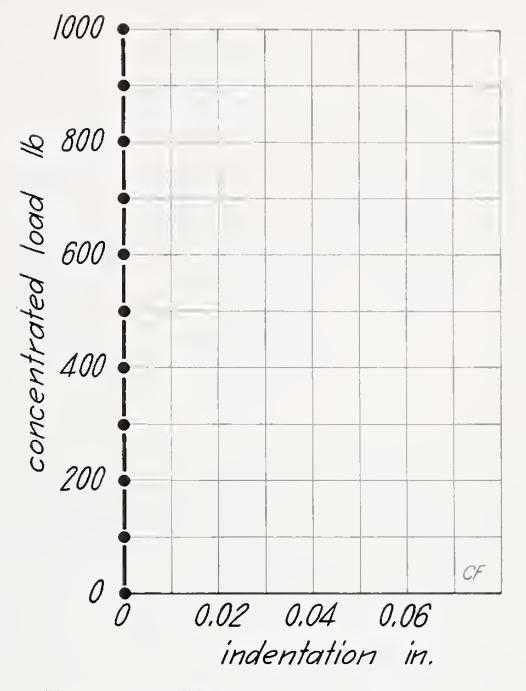
FIGURE S.—Concentrated load on wall CF. Load-indentation results for specimens CF-P1, P2, and P3.

Wall specimens CF-P1, P2, and P3, loaded on a stretcher block near the center of the wall, showed no measurable indentation after a load of 1,000 lb had been applied and released.

The results of the concentrated load on wall specimens CF-P1, P2, and P3 are shown in table 6 and in figure 8.

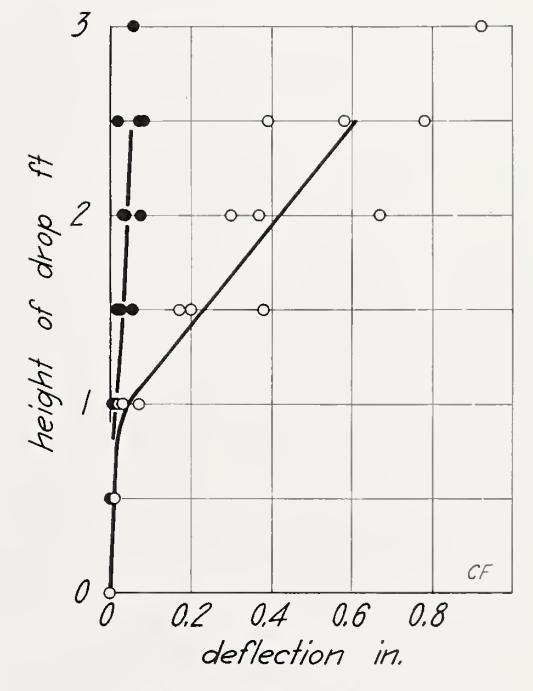
FIGURE 9.—Impact load on wall CF.

In each of the specimens I1, I2, and I3 a bond crack appeared in a bed joint near midspan on the face not struck at a height of drop of 1.5 ft. In each case failure occurred at this bond crack, which extended to the face struck.

Height of drop-deflection (open circles) and height of drop-set (solid circles) results for specimens CF-I1, 12, and 13 on the span 7 ft 6 in.

The results of the impact load on wall specimens CF-I1, I2, and I3 are shown in table 6 and in figure 9.

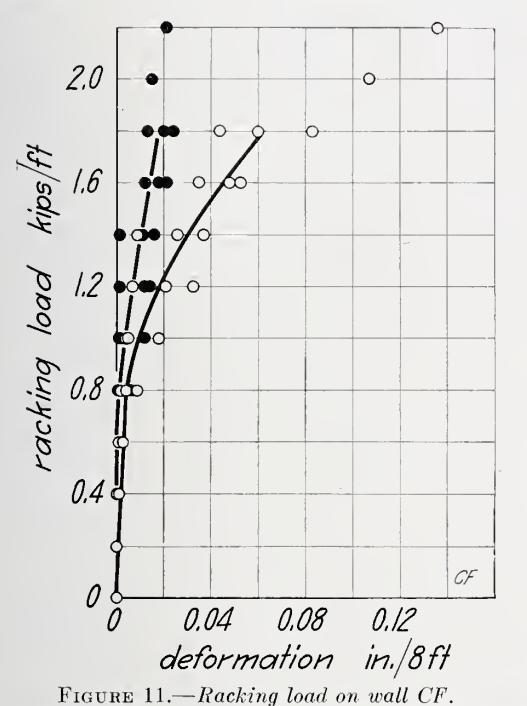
The deformations and sets shown in figure 11 were computed from the deformeter readings. The gage length of the deformeters was 7 ft 2 in.

Stepwise cracks through the bed and head joints appeared in specimens R1 and R2 at a load of 1.5 kips/ft and in R3 at a load of 1.2 kips/ft. Each of the specimens failed by rupture of the cracked bed and head joints approximately along a diagonal between the point of application of the load and the stop.

Load-deformation (open circles) and load-set (solid circles) results for specimens *CF-R1*, *R2*, and *R3*. The loads are in kips per foot of actual width of specimen.

The results of the racking load on wall specimens CF-R1, R2, and R3 are shown in table 6 and in figure 11.

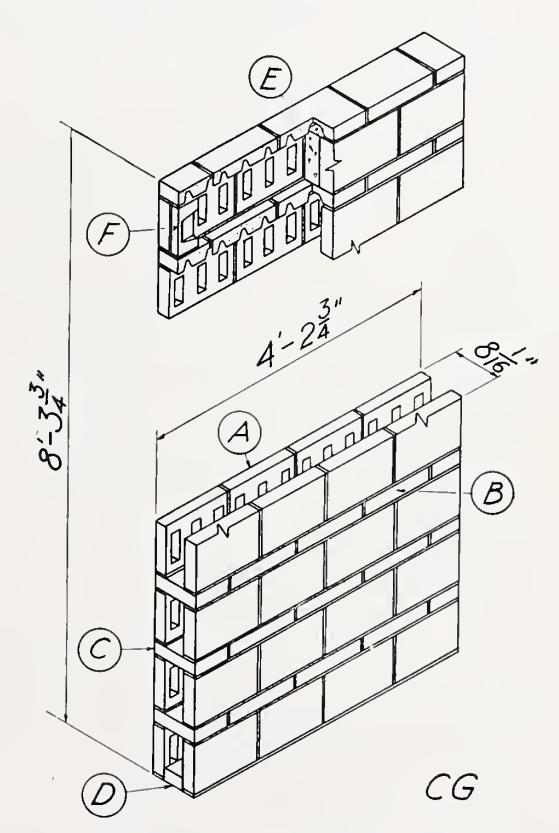
FIGURE 12.—Four-foot wall specimen CG.

The 4-ft wall specimens with horizontal headers were 8 ft  $3\frac{3}{4}$  in. high, 4 ft  $2\frac{3}{4}$  in. wide, and  $8\frac{5}{16}$  in. thick, and had 18 courses of blocks. The blocks formed an all-rolok wall, every other course being a header course with the

blocks laid flat, as shown in figure 12. Threecore blocks (shown in fig. 3) laid on edge, A, were used in the stretcher courses and the same size blocks laid flat, B, were used in the header courses. Blocks, C,  $1\frac{1}{2}$ -core, were used to stagger the head joints. The bed joints and the

head joints were completely filled with mortar and were cut flush with the surface of the wall. After the first course was laid, about 2 in. of mortar, D, was spread in the cavity to support the blocks laterally. The uppermost stretcher course was filled with concrete, E. A 1-core block, F (shown in fig. 2), laid inside this course, served as the end form for the concrete. The top header course was placed after the concrete was poured.

A, 3-core block as stretcher; B, 3-core block as header; C, 1½-core block; D, mortar 2in. thick; E, concrete fill; F, 1-core block for and of concrete form.

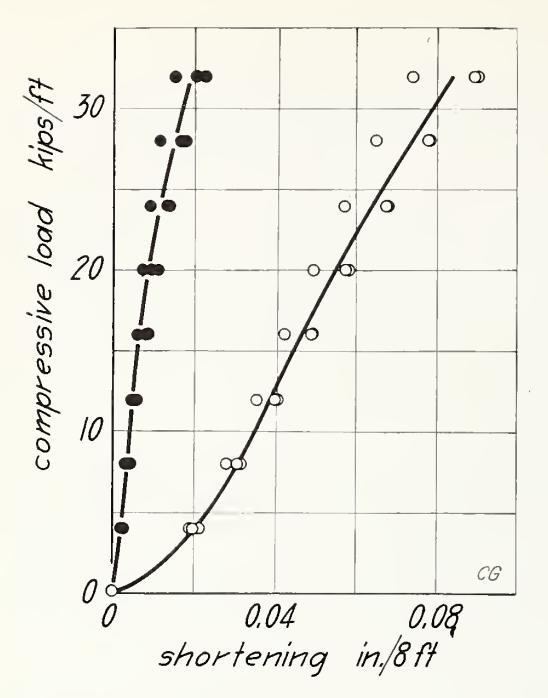
FIGURE 13.- Compressive load on wall CG.

Load-shortening (open circles) and load-set (solid circles) results for specimens CG-CI, C2, and C3. The loads were applied one-third the thickness (2.69 in.) from one face. The loads are in kips per foot of actual width of specimen.

In specimen C1, a block on the face nearer the load line at one end near midheight crushed at a load of 34.5 kips/ft. Failure occurred by the crushing of blocks and mortar in the two adjacent courses on the face nearer the load line and near midheight. Specimens C2 and C3 failed by breaking of the headers at the inner surfaces of both faces, each header breaking in two places. Specimen C2, at the maximum load, collapsed suddenly without warning.

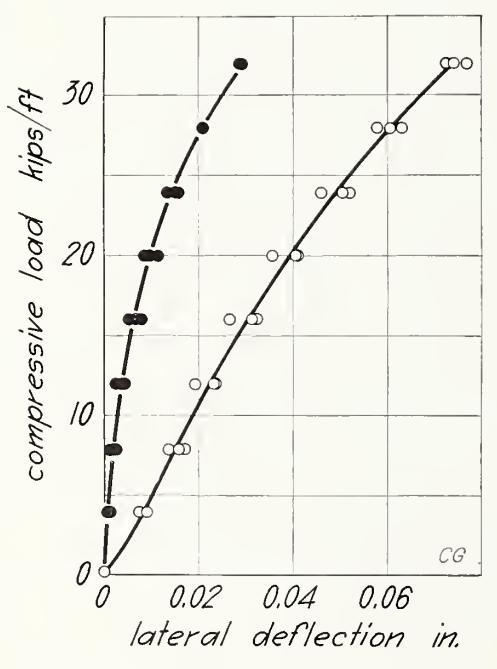
FIGURE 14.—Compressive load on wall CG.

Load-lateral deflection (open circles) and load-lateral set (solid eireles) results for specimens CG-C1, C2, and C3. The load was applied one-third the thickness (2.69 in.) from one face. The loads are in kips per foot of actual width of specimen. The deflections and sets are for a gage length of 7 ft 6 in., the gage length of the deflectometers.

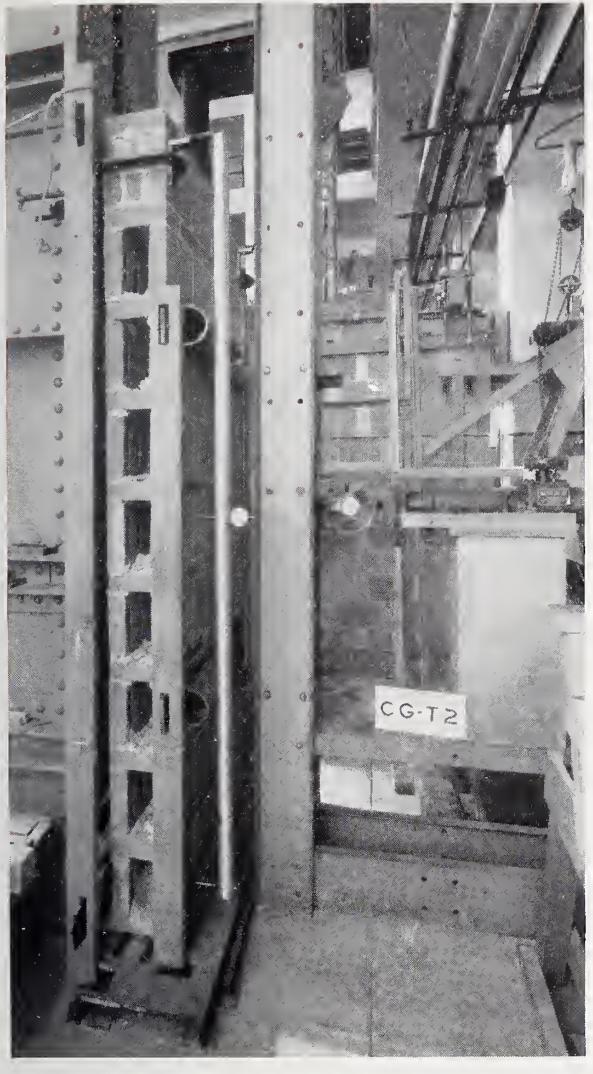
FIGURE 15.— Wall specimen CG-T2 under transverse load.

After specimen T2 had been set in place for the transverse test, but before a load had been applied, it was noticed that a bond crack in the bed joint below the fourteenth course existed in both faces. This crack was probably caused by moving the specimen into position for testing. The maximum load on specimen T2was 10.3 lb/ft<sup>2</sup>, at which load the initial crack widened.

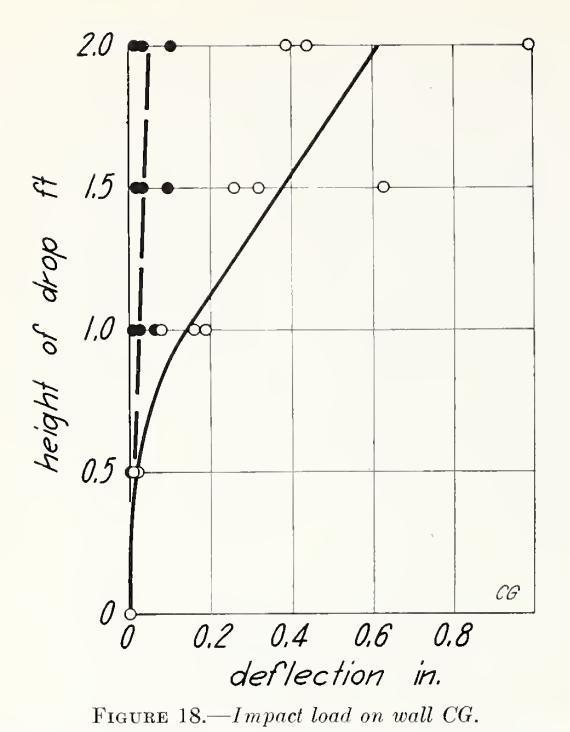
Height of drop-deflection (open circles) and height of drop-set (solid circles) results for specimens CG-I1, I2, and I3 on the span 7 ft 6 in.

A bond crack appeared in a bed joint near midspan on the face not struck in specimens CG-I1, I2, and I3 at a height of drop of 1.0, 1.5, and 1.0 ft, respectively. In each case, at failure, this bond crack extended to the face struck.

The results of the impact load on wall specimens CG-I1, I2, and I3 are shown in table 6 and in figure 18.

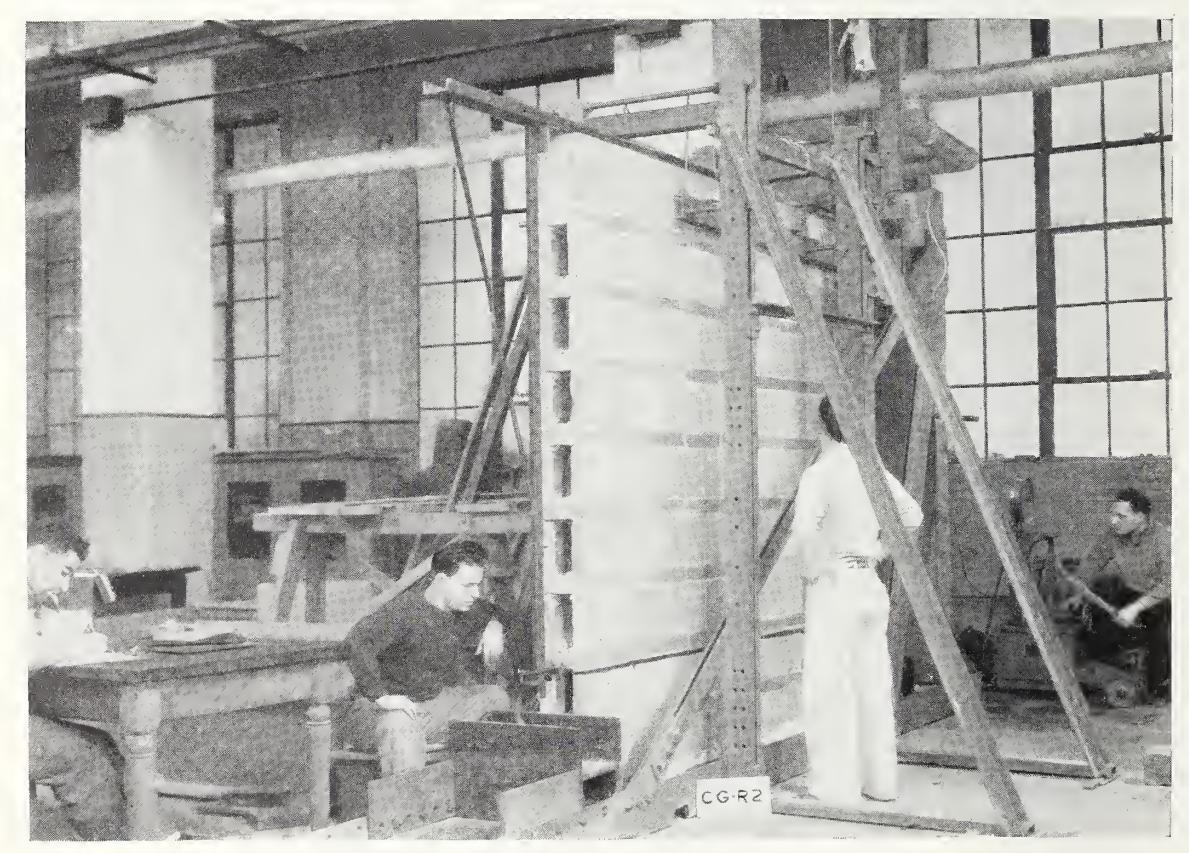
FIGURE 19.—Wall specimen CG-R2 under racking load.
[ 12 ]

Each of the specimens failed by rupture of the bed and head joints in stepwise cracks approximately along a diagonal between the point of application of load and the stop. In addition, in each case the concrete blocks at the toe cracked diagonally at the maximum load.

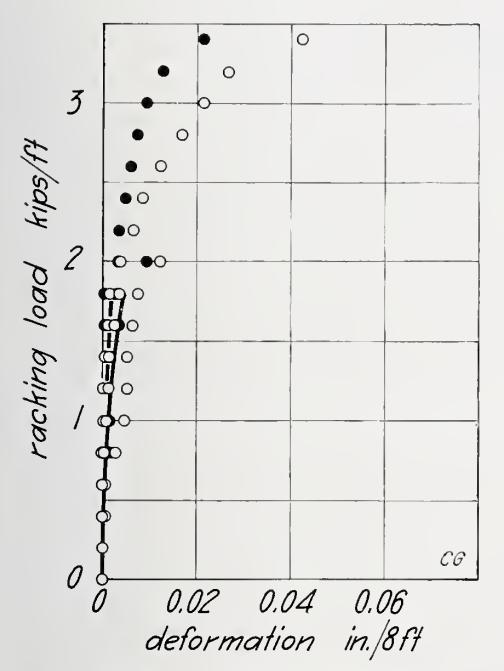
FIGURE 20.—Racking load on wall CG.

The deformations and sets shown in figure 20 were computed from the deformeter readings. The gage length of the deformeters was 6 ft 7 in.

Load-deformation (open circles) and load-set (solid circles) results for specimens CG-RI,  $R^2$ , and  $R^3$ . The loads are in kips per foot of actual width of specimen.
