FINAL REPORT ON EVALUATION OF THE WEATHERING CHARACTERISTICS OF THE TYPE 2 ALUMINIZED STEELS

**NBS PROJECT** 421.04 - 4212401

# FINAL REPORT ON EVALUATION OF THE WEATHERING CHARACTERISTICS OF THE TYPE 2 ALUMINIZED STEELS

by Joseph W. Pitts

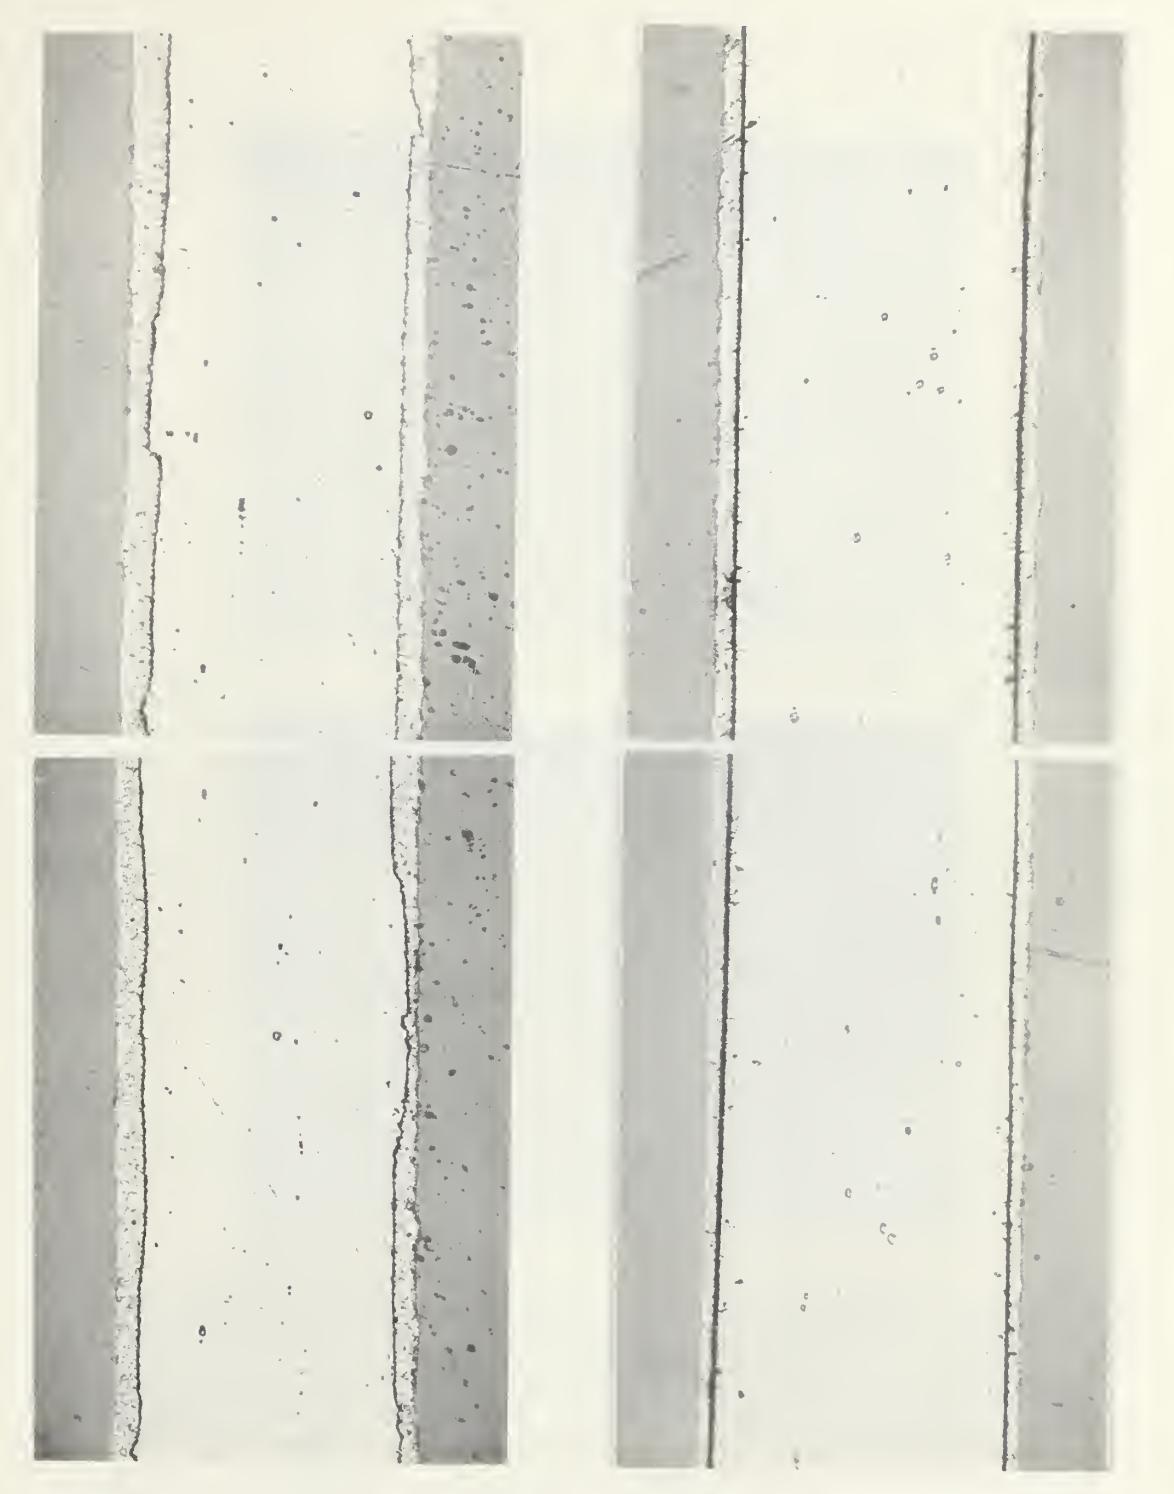
Figure 1. Photographs of flat surfaces of the Al-Si-coated steel (left) and the Al-coated steel (right). The splotches on the latter are actually smooth, uniform areas that appear dark in the photograph because of specular reflection of the oblique illumination. Magnification: 1X

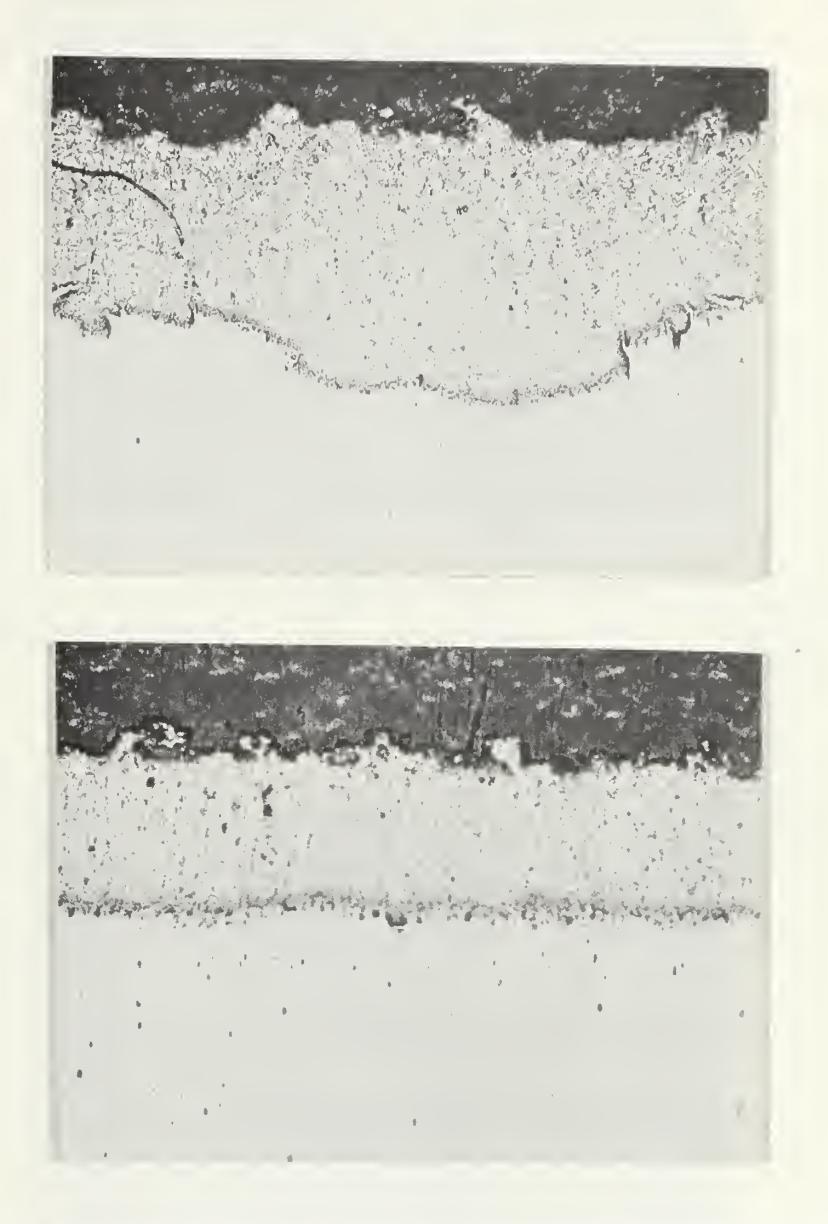
Figure 3. Photomicrographs of polished metallographic taper sections of the Al-Si-coated steel (upper) and the Al-coated steel (lower). The specimens were mounted at an angle of 7° from the horizontal which has the effect of extending the coating thickness about 8 times.

Magnification: 35X

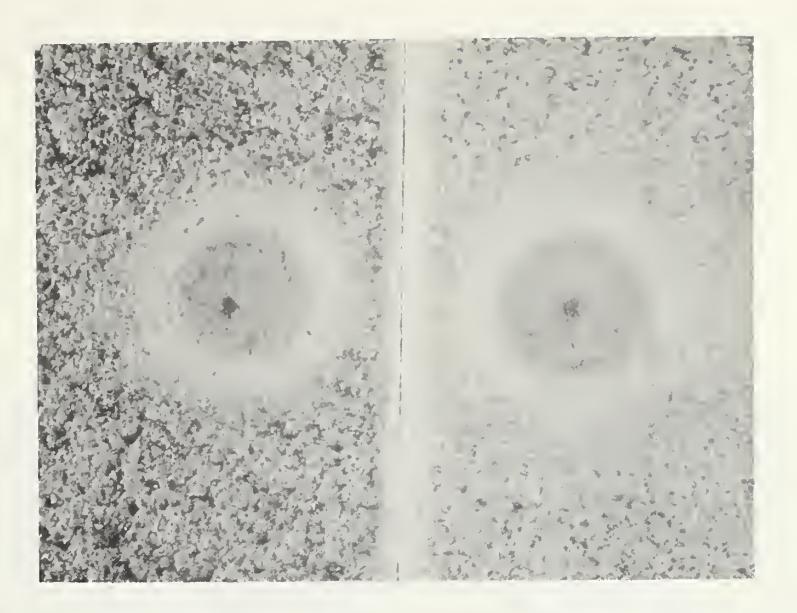
Figure 4. Photograph showing an abraded spot on a specimen of the Al-Si-coated steel (left) and an abraded spot on a specimen of the Al-coated steel (right). Magnification: 8X

The end-point break-through to the substrate normally occurs in the center of the abraded area, because the abrasive jet is most intense at the center and tapers off toward the perifery, but the end-point spot for the Al-Si-alloy coating frequently appeared off-center, rather than at the center of the abraded area as would be expected for a uniform coating on a smooth base. Figure 4 (left) shows the substrate spot slightly off-center; in other cases the eccentricity was more pronounced.

On an uneven substrate it is statistically probable that some point on the substrate below the abraded area, other than the center point, would be closest to the surface and thus would become exposed first when the coating was abraded away. The fact that the aluminum-silicon coating was non-uniformly thick on a rough substrate undoubtedly accounts for the eccentricity of the end-point. Whether or not this condition also accounts for the lower abrasion resistance values is another question. It probably has an effect, but one must also consider that the two coatings have different compositions and that the alloy layers have different thicknesses and are much harder than the basic coating materials.

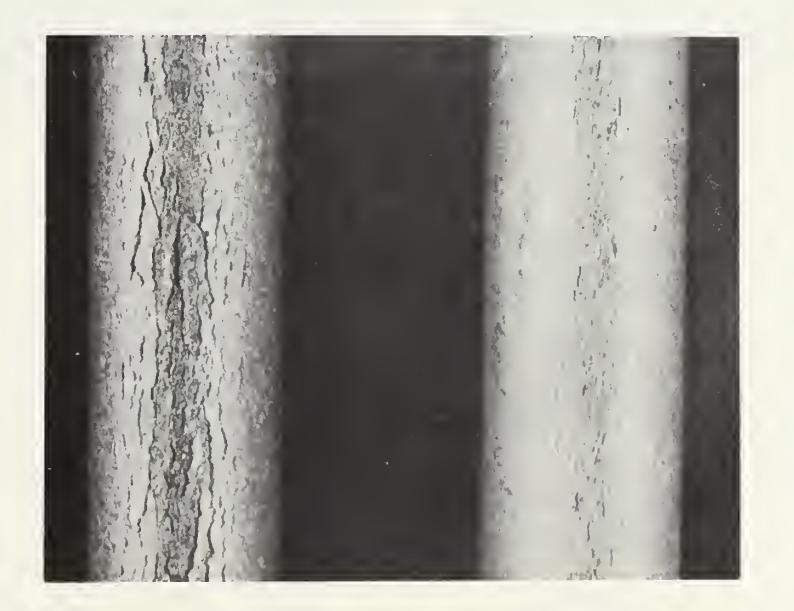
Figure 5. Photograph showing specimens of the Al-Sicoated steel (left) and the Al-coated steel (right), each bent 180° on two thicknesses of itself. The longitudinal center line of each specimen is the line of maximum tensile stress. The darker bands along the center lines are caused by the oblique lighting coming from both sides. Magnification: 7X

Both coatings sustained some damage along the bent edges where the coating was placed in tension, but suprisingly the aluminum coating appeared to withstand the bending better than the aluminum-silicon coating. The former developed very few actual cracks, but showed a general rippled pattern characteristic of non-uniform plastic flow. On the other hand the aluminumsilicon coating had developed numerous rather wide cracks, indicating brittle fracture of the coating. Figure 5 shows photographs of the bent edges of the specimens. No flaking or peeling of either coating was observed, therefore, it is assumed that they both meet the bending requirements of MIL-S-4174A.

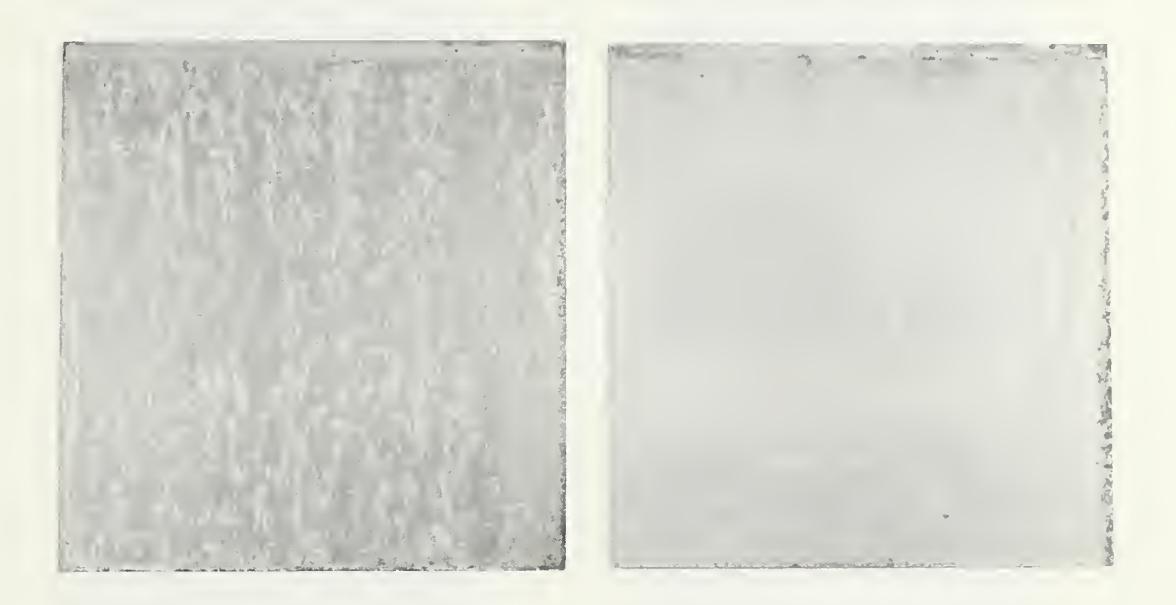
Figure 6. Photographs of 1 ft<sup>2</sup> specimens of the Al-Sicoated steel (left) and the Al-coated steel (right), after 26 days in the salt spray test. The top edges of both specimens were covered with plastic tape during the test. The 90° bends are on the left hand edges while the right-hand and bottom edges are sheared, unprotected edges. The concave and convex deformations are barely discernable in the lower quarter of each specimen. Reduction: about  $\frac{1}{4}$  size

Photographs of the aluminized steel panels are shown in Figure 6. The 90° bend that was made near one edge of each specimen is on the left side in the photographs and was in the verticle position during the test. The sheared edge seen at the top of the photographs was also at the top during the test and was covered with adhesive plastic tape. The right hand and bottom sheared edges were unprotected and, as can be seen, the right hand edge (which was in the verticle position during the test) corroded considerably more than the bottom edge.

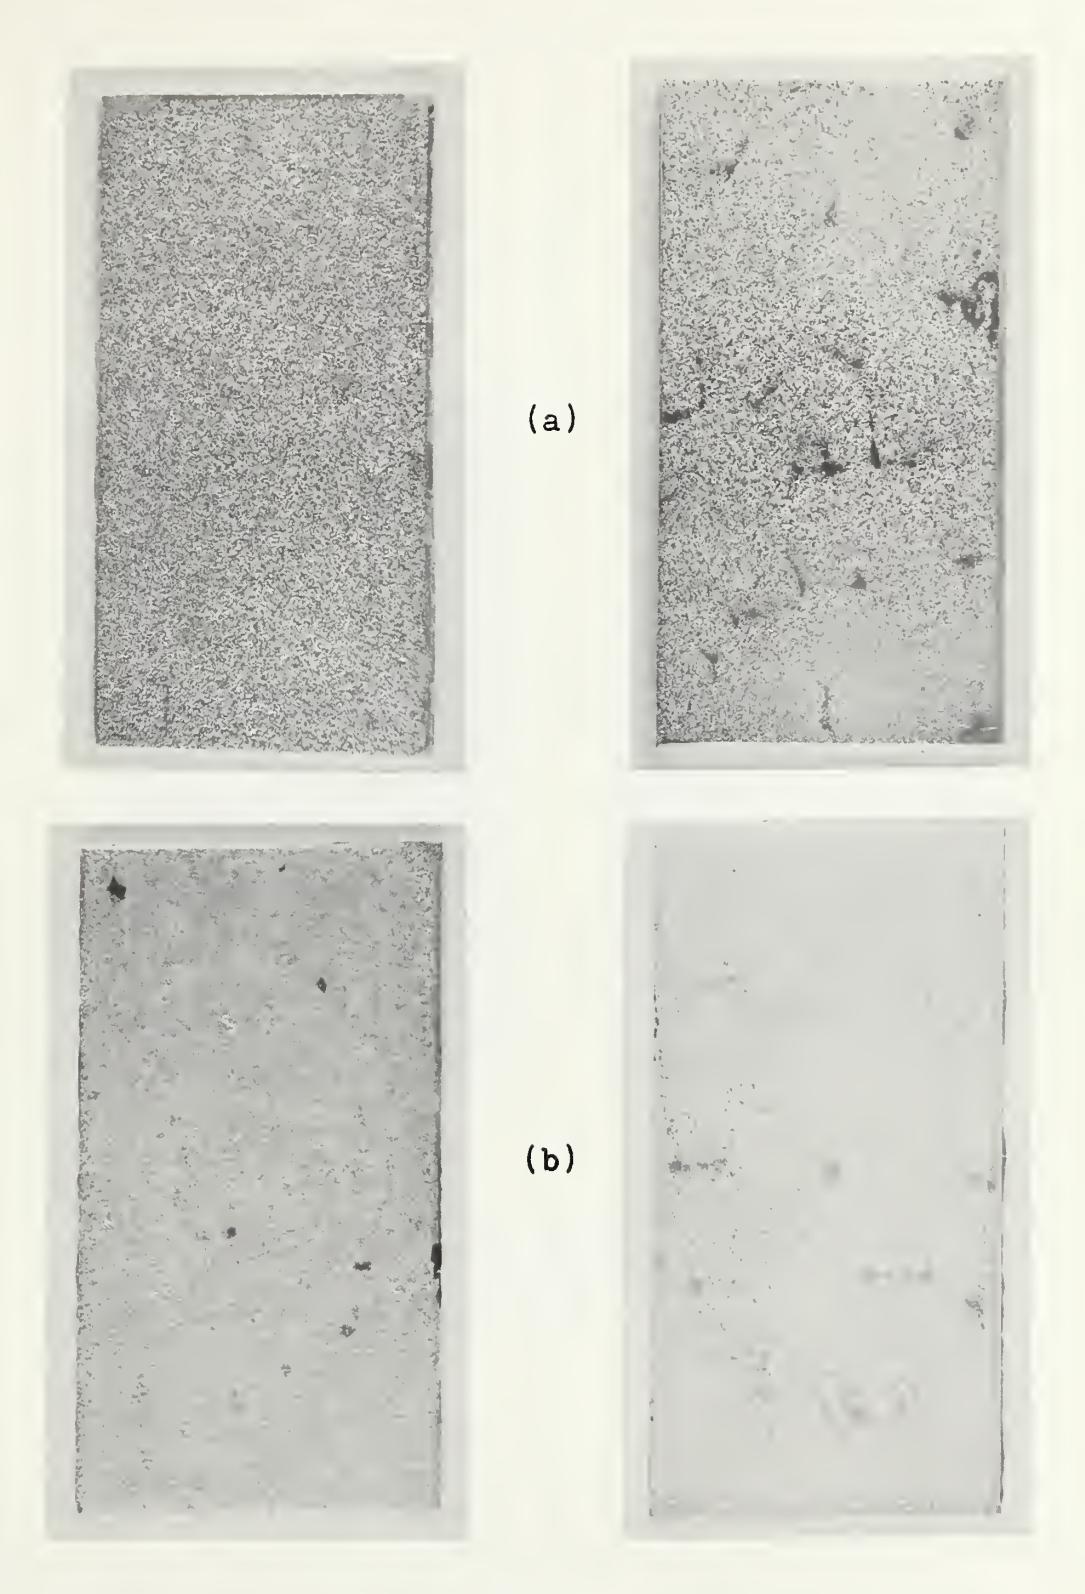
Figure 7. Photographs of specimens of Al-Si-coated steel (left) and Al-coated steel (right), before (a) and after (b) 24 hours of alternate wetting and drying in air containing about 400 ppm SO<sub>2</sub>.

Magnification: 2.4X

- a. With 1 ppm SO<sub>2</sub> in the atmosphere, no change could be detected on either material after 24 hours' exposure.
- b. When the SO<sub>2</sub> concentration was increased to about 400 ppm and after 24 hours' exposure, the Al-Si-coated specimen had developed about 12 pinhole, reddish-brown rust spots over the 1-1/2 in. x 3/4 in. exposed surface. The Al-coated specimen showed no signs of iron rust, but the surface had a slightly whitish appearance indicating oxidation of the aluminum.

- e. Typical results of conditions b. c. and d. above are shown in Figures 7, 8, and 9 respectively.

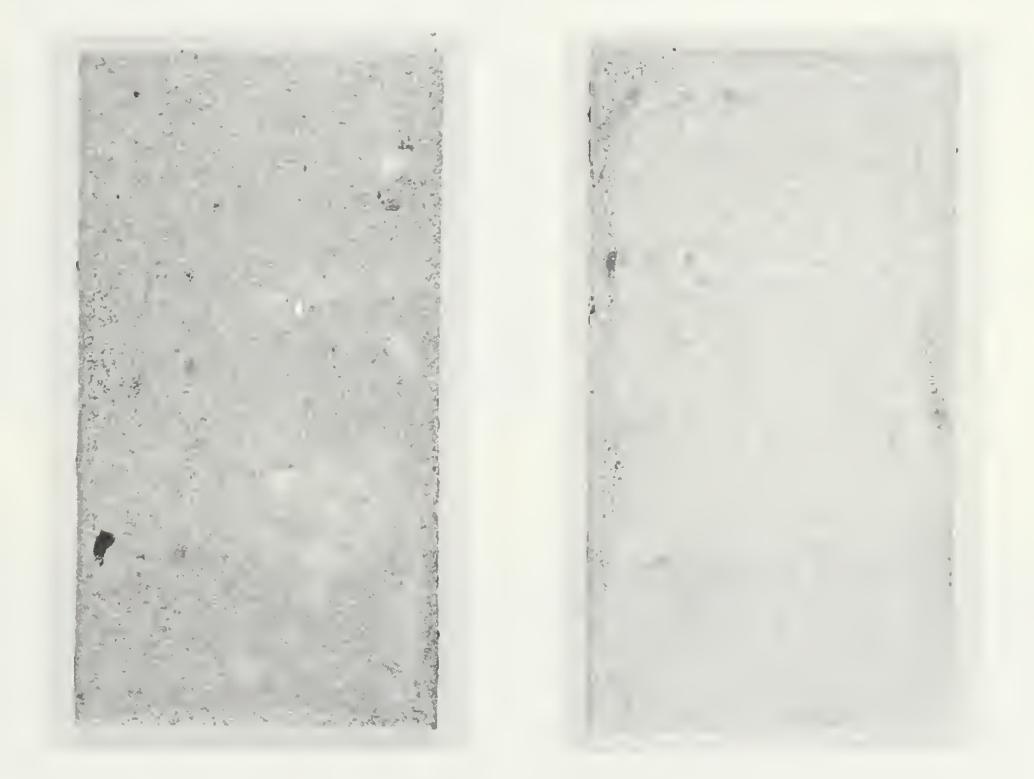
Figure 8. Photographs of specimens of Al-Si-coated steel (left) and Al-coated steel (right) after 72 hours of alternate wetting and drying in air containing about 100 ppm SO<sub>2</sub>.

Magnification: 2.4X

- c. With 100 ppm SO<sub>2</sub> and an exposure time of 3 days, rust spots again appeared on the A1-Si coating and also some white areas developed, indicating aluminum oxide. The A1 coating again showed no signs of iron rust, but the appearance of the white aluminum oxide was more pronounced than in the previous test and was more extensive than occurred on the A1-Si coating.

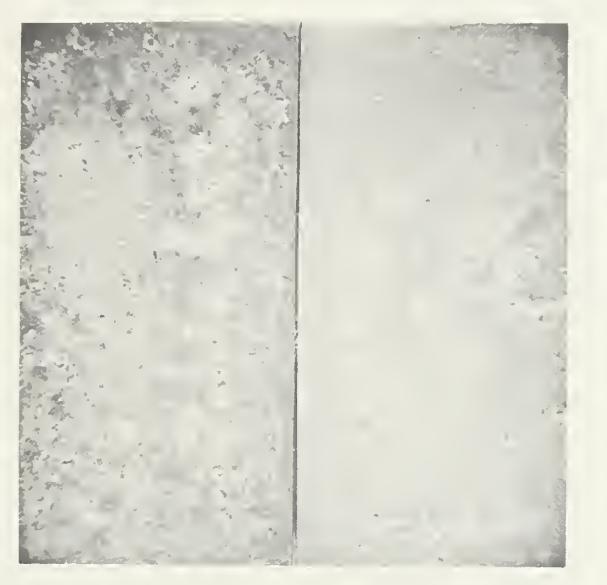
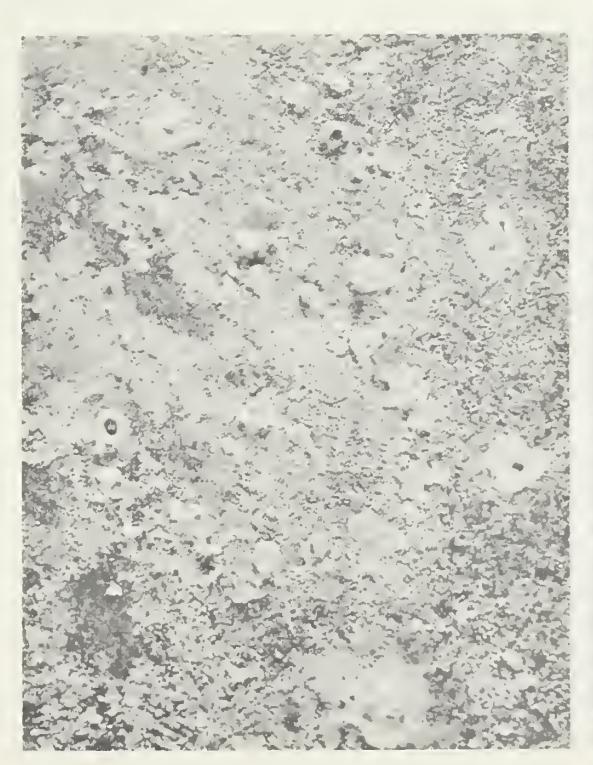
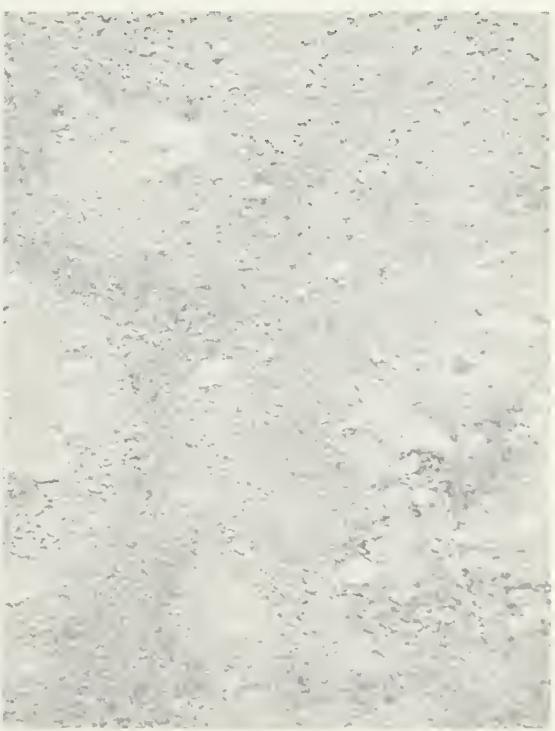
Figure 9. Photographs of specimens of Al-Si-coated steel (left) and Al-coated steel (right) after 7 days of alternate wetting and drying in air containing about 150 ppm SO<sub>2</sub>. Magnification: 2X

Below: Same specimens. Magnification: 7.6X

- d. The last test was for 7 days in 150 ppm SO<sub>2</sub>. Massive coating corrosion occurred on both materials. There was some evidence of iron rust on the A1-Si coating, but it was either less than previously observed or was partially masked by the voluminous amount of white corrosion product.
