NBS Special Publication 480-18

Report on an Investigation of the High Speed Hazards of Steel Belted Radial Tires on Police Patrol Cars

Jared J. Collard Law Enforcement Standards Laboratory Center for Consumer Product Technology National Bureau of Standards Washington, D. C. 20234

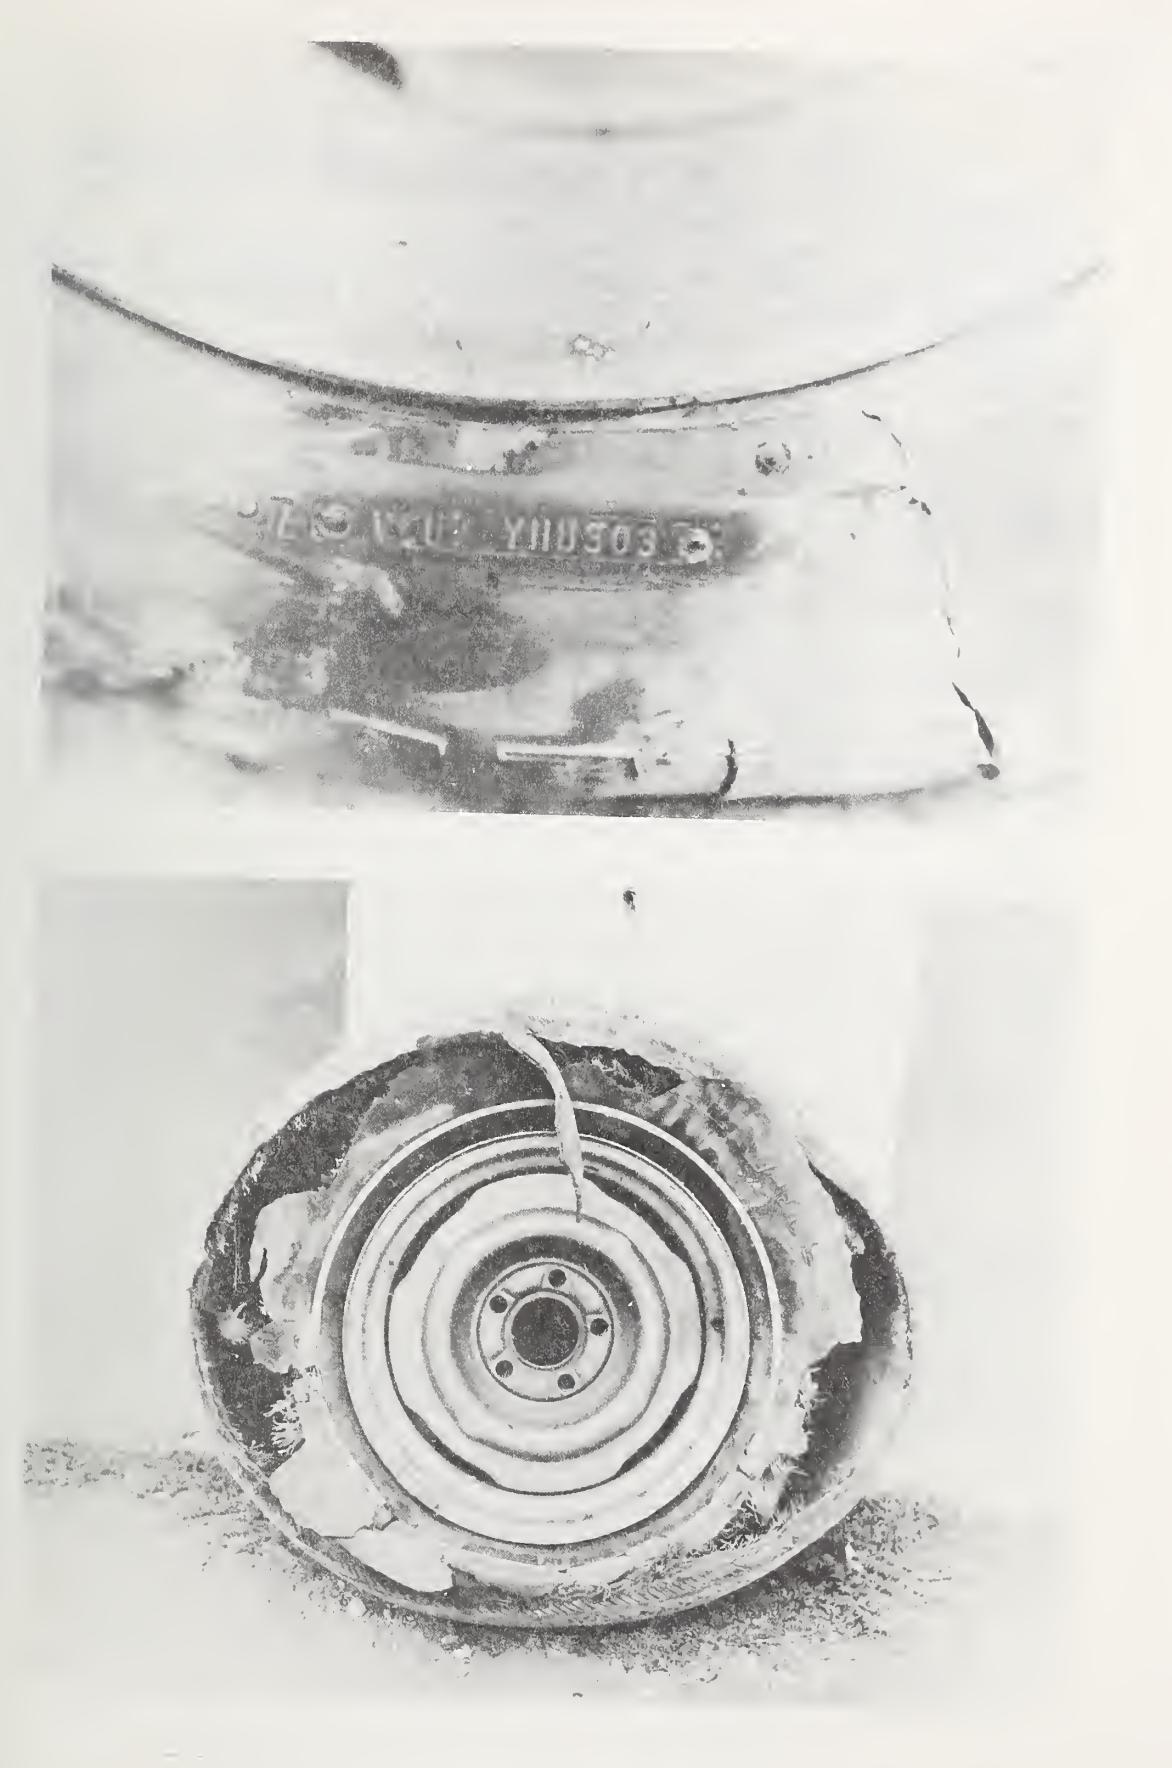
2.30 miles South to Eve:	rgreen			
		North		
	I- 65			
	Pa	aved Shoulder		
	Ó.₽	Right rear tire blew out he	P C	
	Pa	aved Shoulder		
	Gı	rass Median		
	Pa	aved Shoulder		
1	Pa	aved Shoulder		
Diagram Scale 1 inch = (20 feet) (10 feet)	Location Ir	aterstate # 65 .30 miles South to Evergreen in	. 10	A.M. (P.M.)
Signature of Reporting Officer(s)	Badge No.	Reporting Police Agency	DATE	
Sgt. J. T. Smelley	904	Alabama State Troopers 06	27	74
