# NBS SPECIAL PUBLICATION 640

# Innovation for Maintenance Technology Improvements

Proceedings of the 33rd Meeting of the Mechanical Failures Prevention Group, held at the National Bureau of Standards, Gaithersburg, MD, April 21-23, 1981

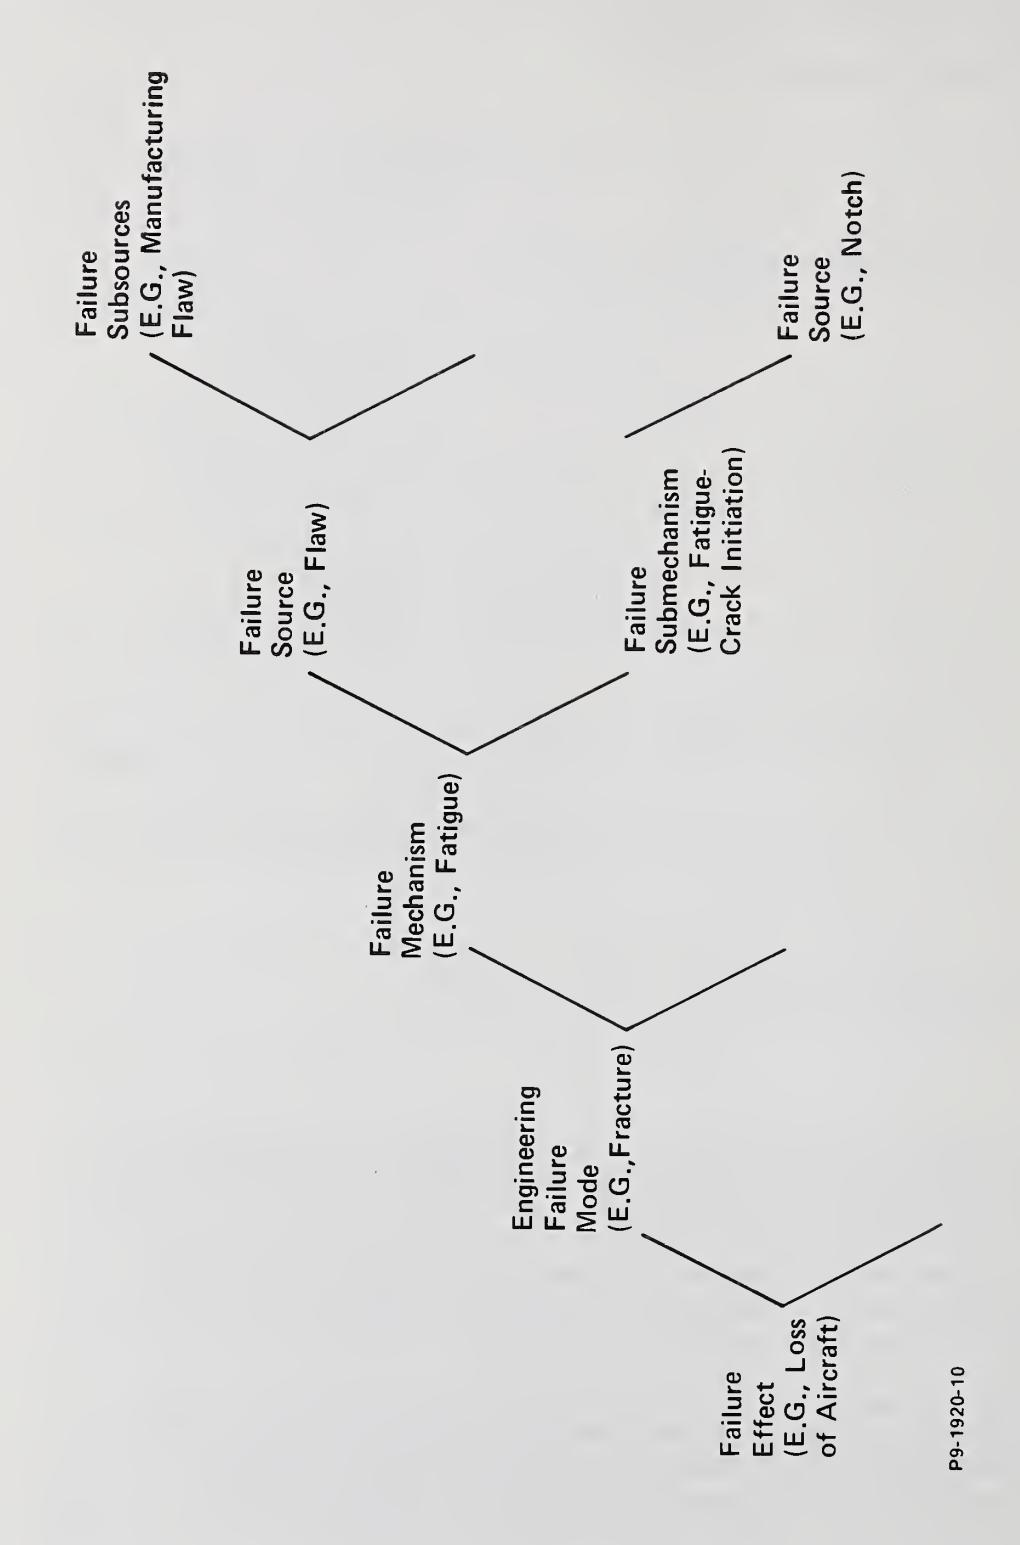
FIGURE 4: FMCA FAILURE TREE SCHEMATIC.

In the performance of the above failure analysis scheme, the construction of a failure tree may be of use. Such a construction also may be of use in presenting in a graphical format the results of a potential failure analysis. The failure tree itself is a graphical construction, similar to a decision tree<sup>2,5</sup> that illustrates failure mechanisms, sub-mechanisms, sources, sub-sources, and their relationship to one another. Driving forces may be shown below failure mechanisms and sub-mechanisms and other notations may be contained on the tree. Although the discussion of the analysis methods contained herein begins or ends with an identified engineering failure mode not a failure effect, the logical completion of a potential failure analysis will often require consideration of failure effects. Nevertheless, in this regard, it often may be preferable to consider the functional failure mode which corresponds to an engineering failure mode and perform a

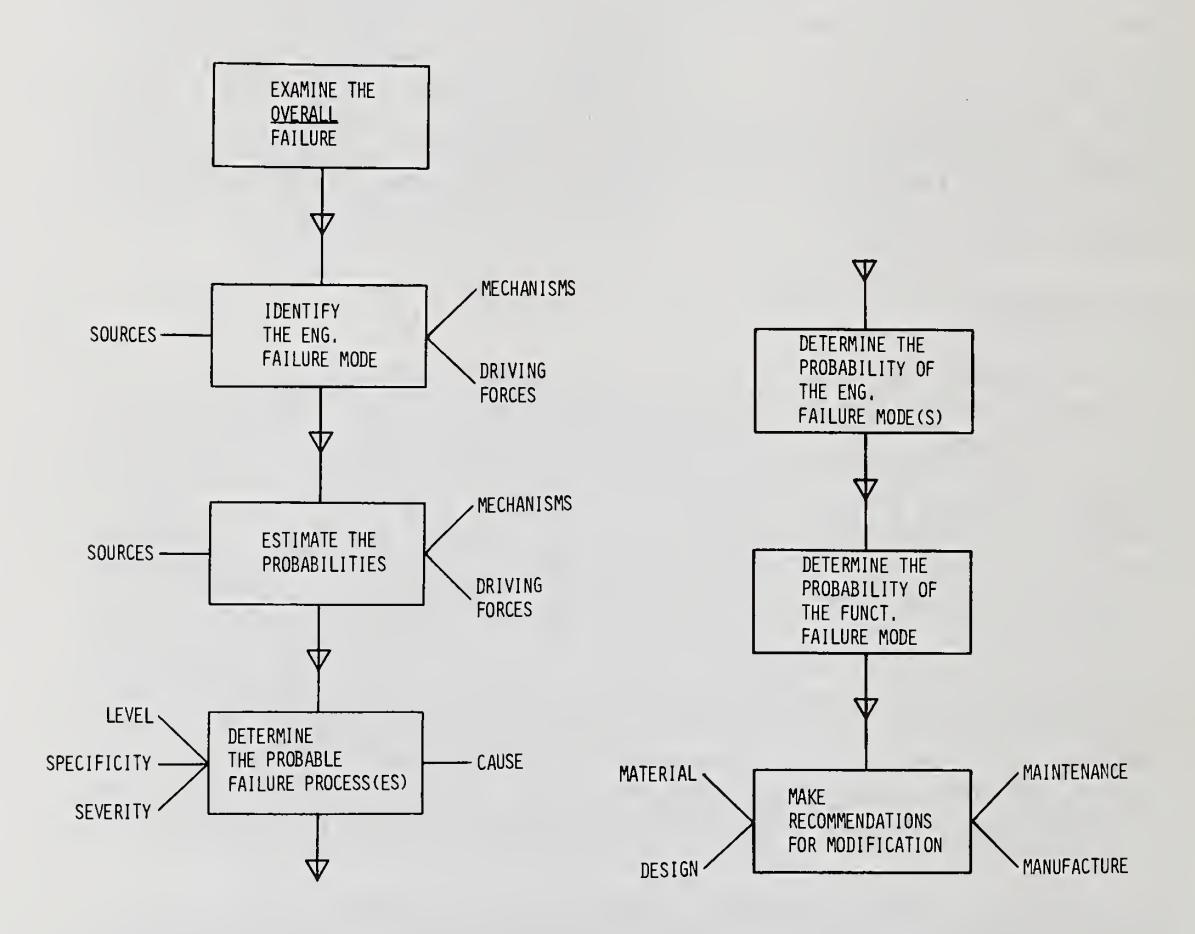
FIGURE 5: FMCA FAILURE ANALYSIS OUTLINE.

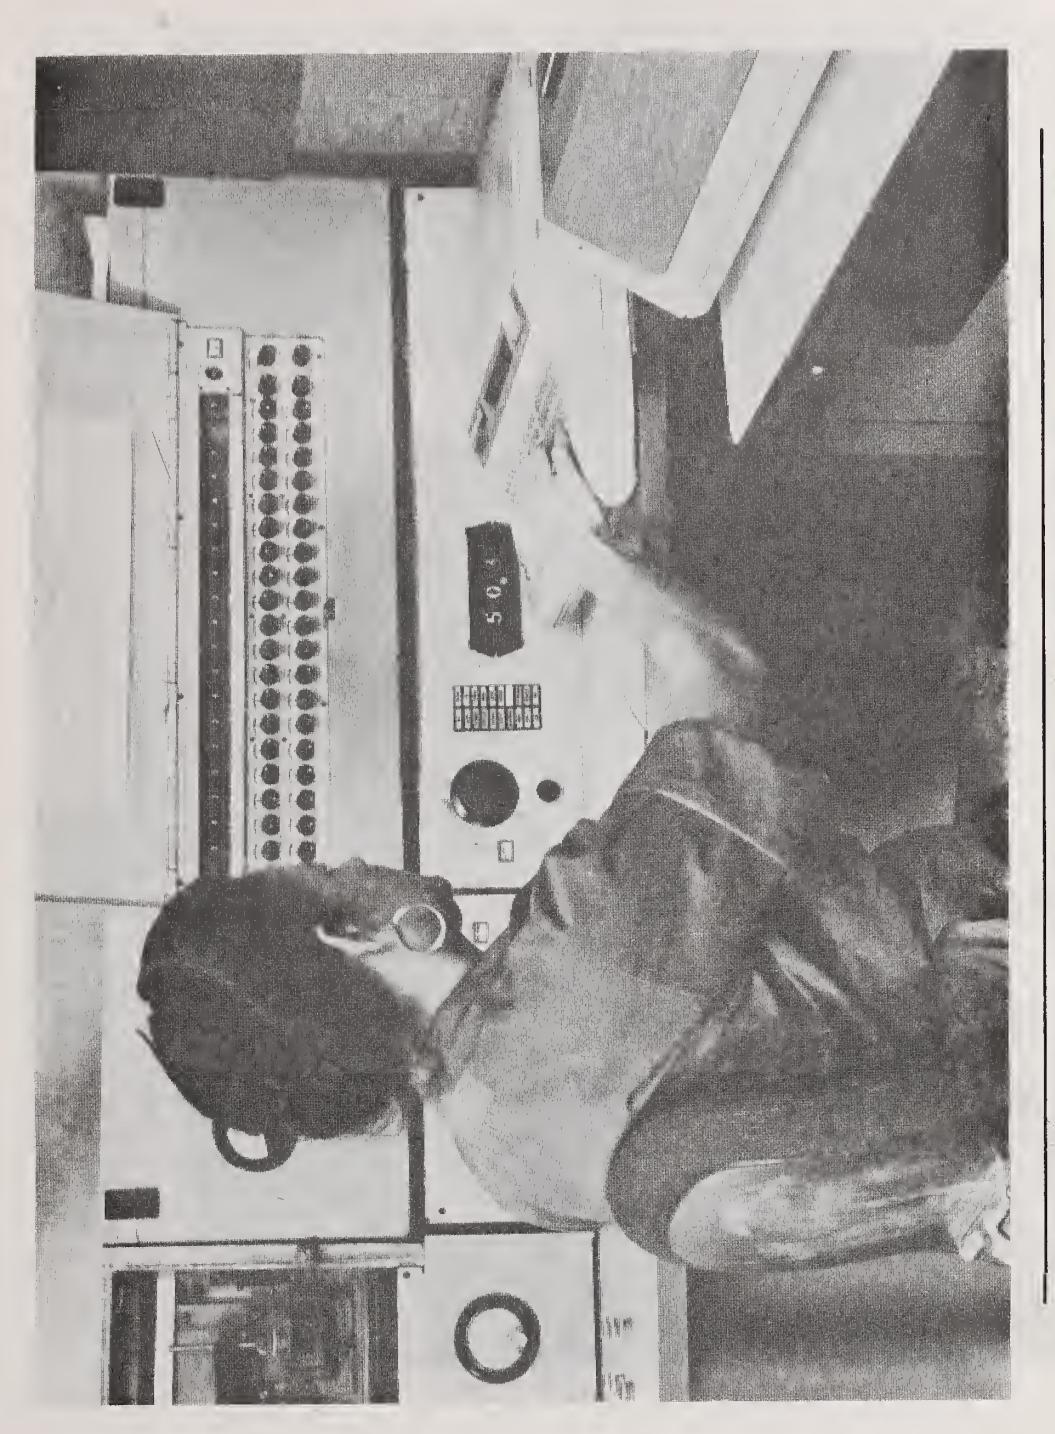
A Baird Corporation model FAS II atomic emission spectrometer interfaced to a Hewlett-Packard 9825 minicomputer. The H-P 9825 is used here as a data logger, recording analytical results on tape cartridges. These are in turn played through a central processing unit which updates the appropriate equipment files on a client's floppy disc.

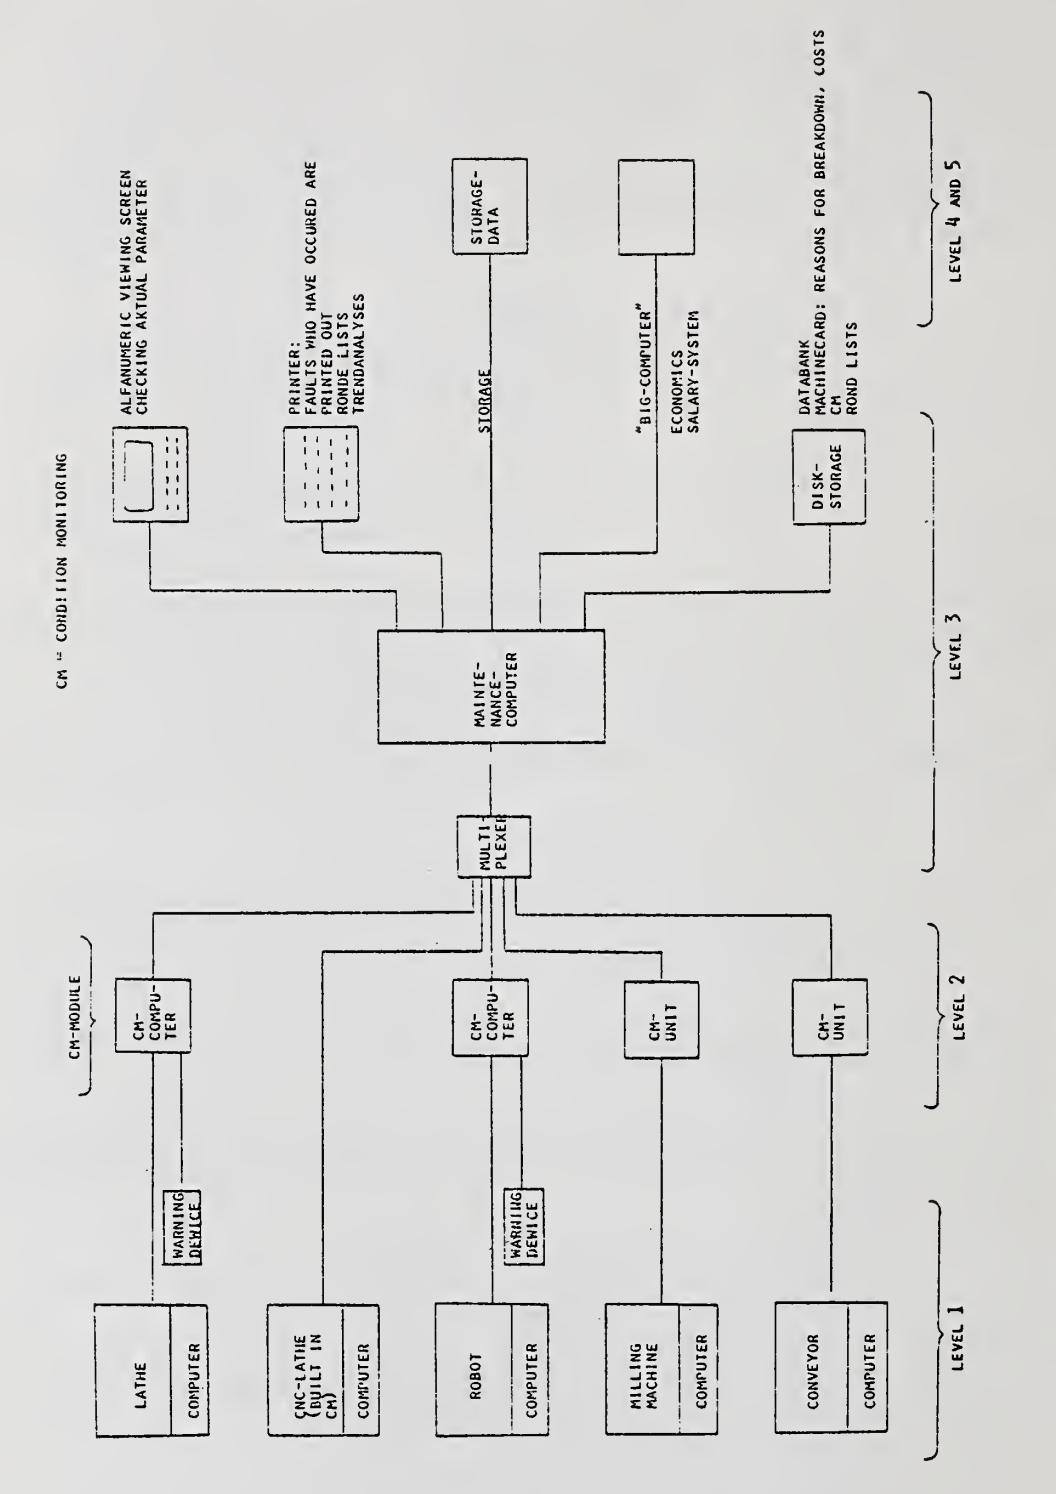
Fig. 2. Condition monitoring system for mechanical industry

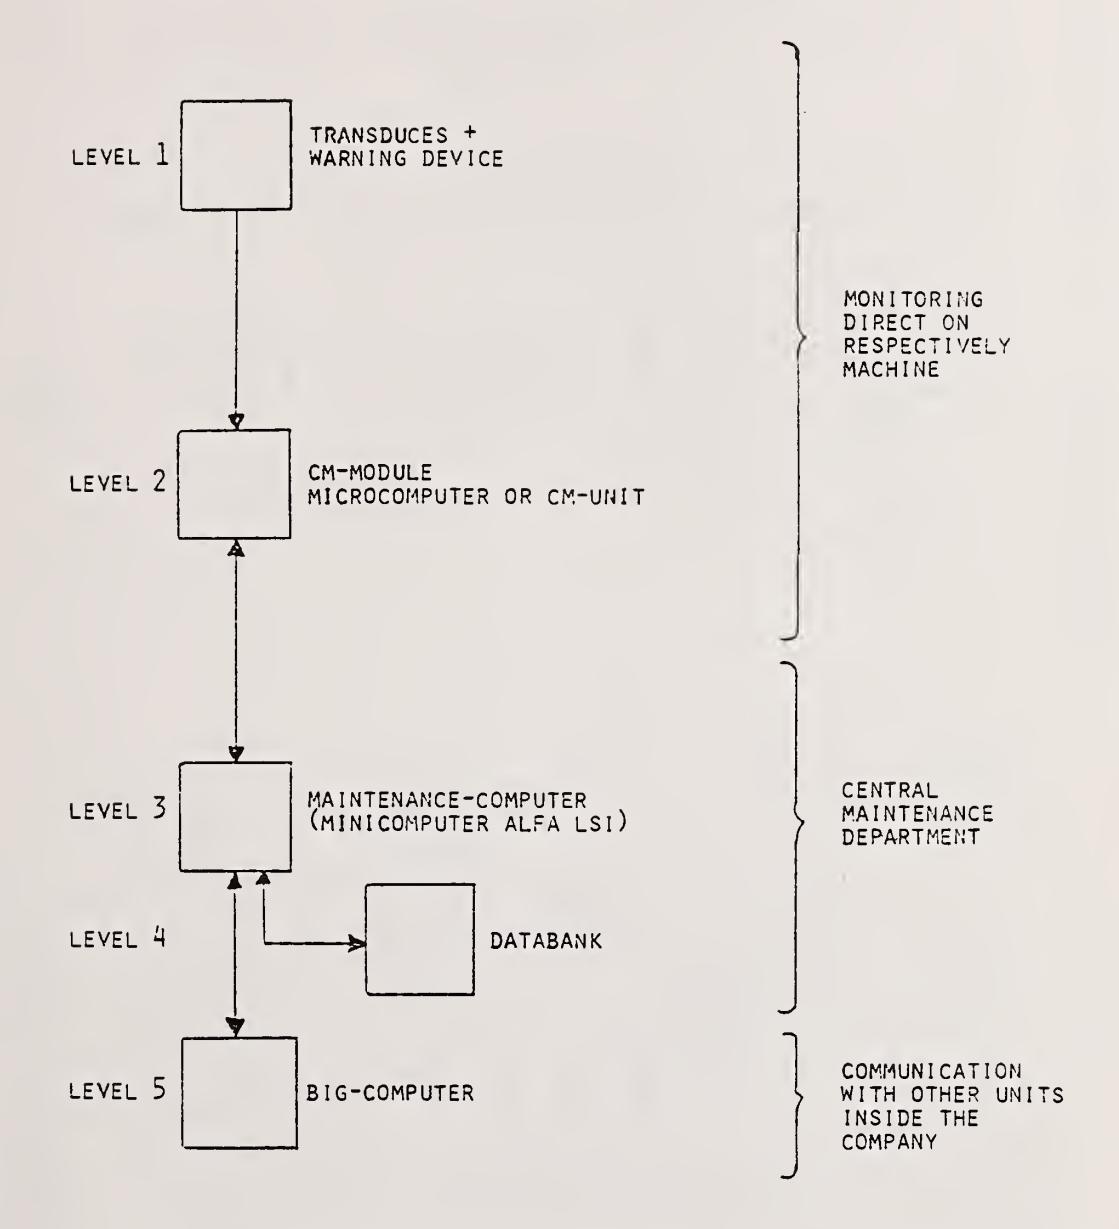
Fig. 3 Different levels in the maintenance system

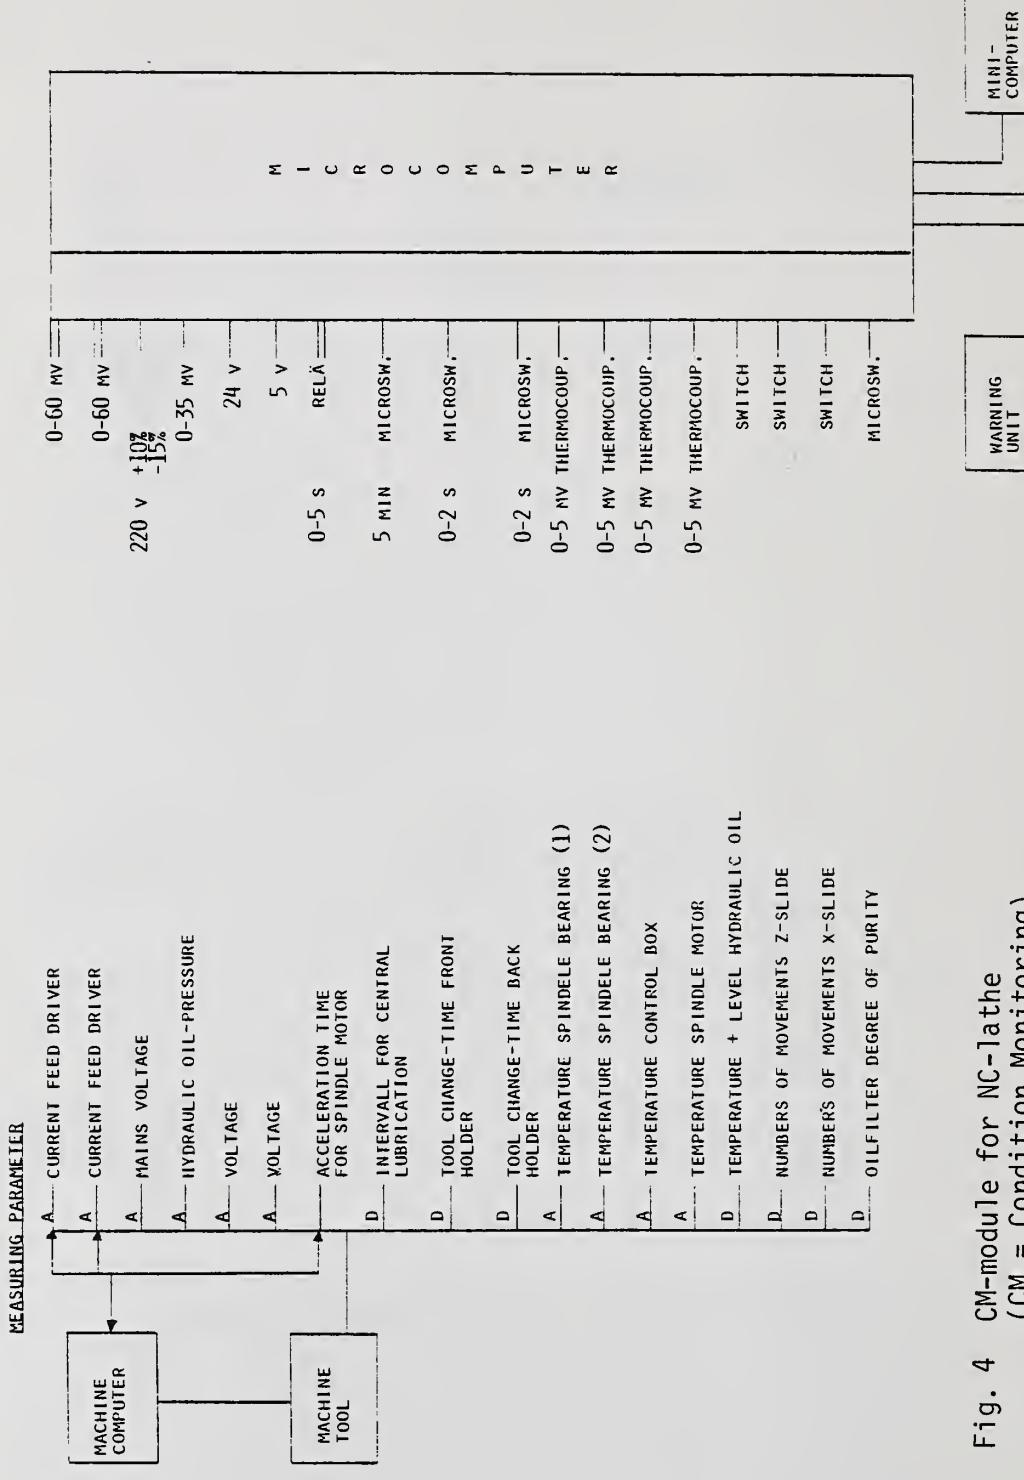
(CM = Condition Monitoring) CM-module for NC-lathe

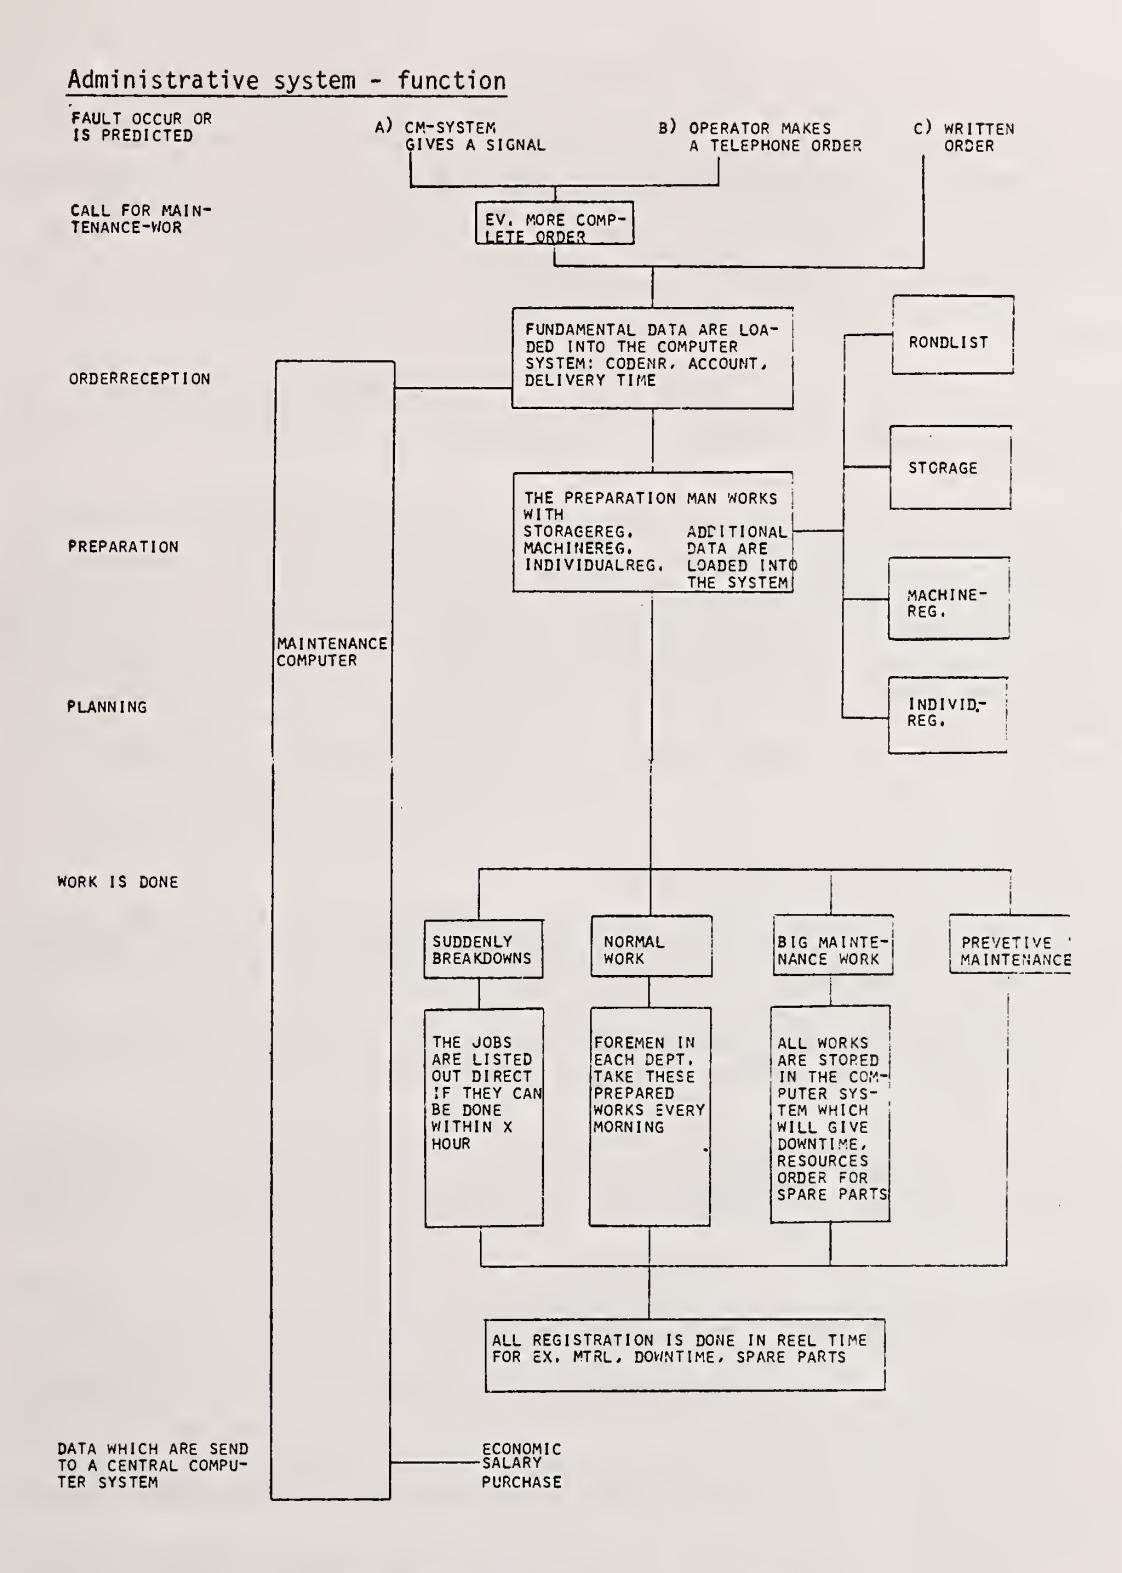
Fig. 5. Administrative maintenance system

The integration between an ACMS and an administrative system for maintenance can be seen in figure 5.

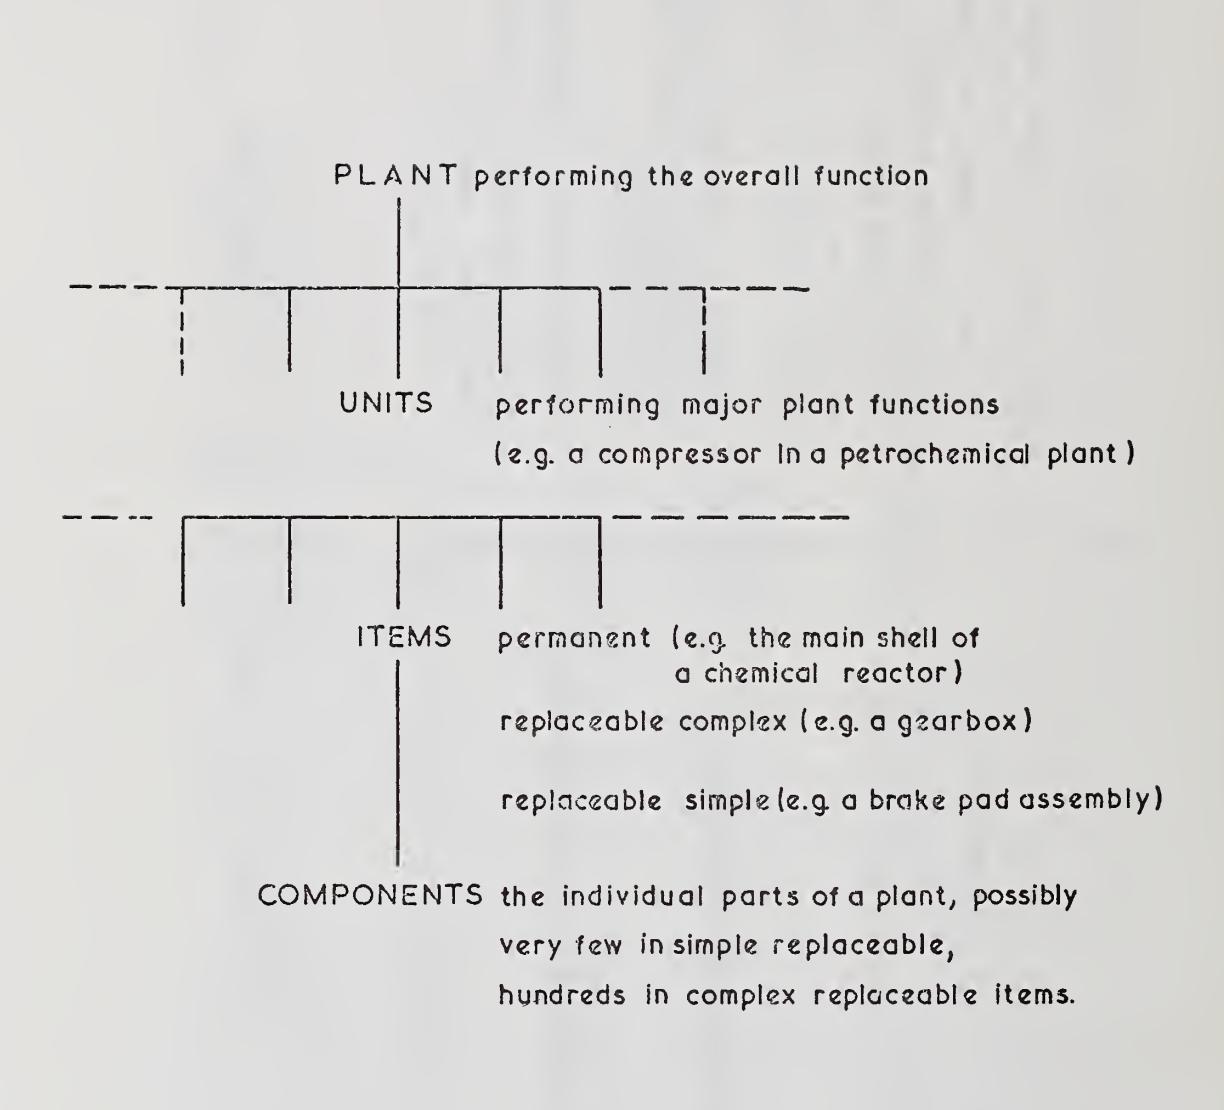
FIGURE 2. PLANT HIERARCHY.

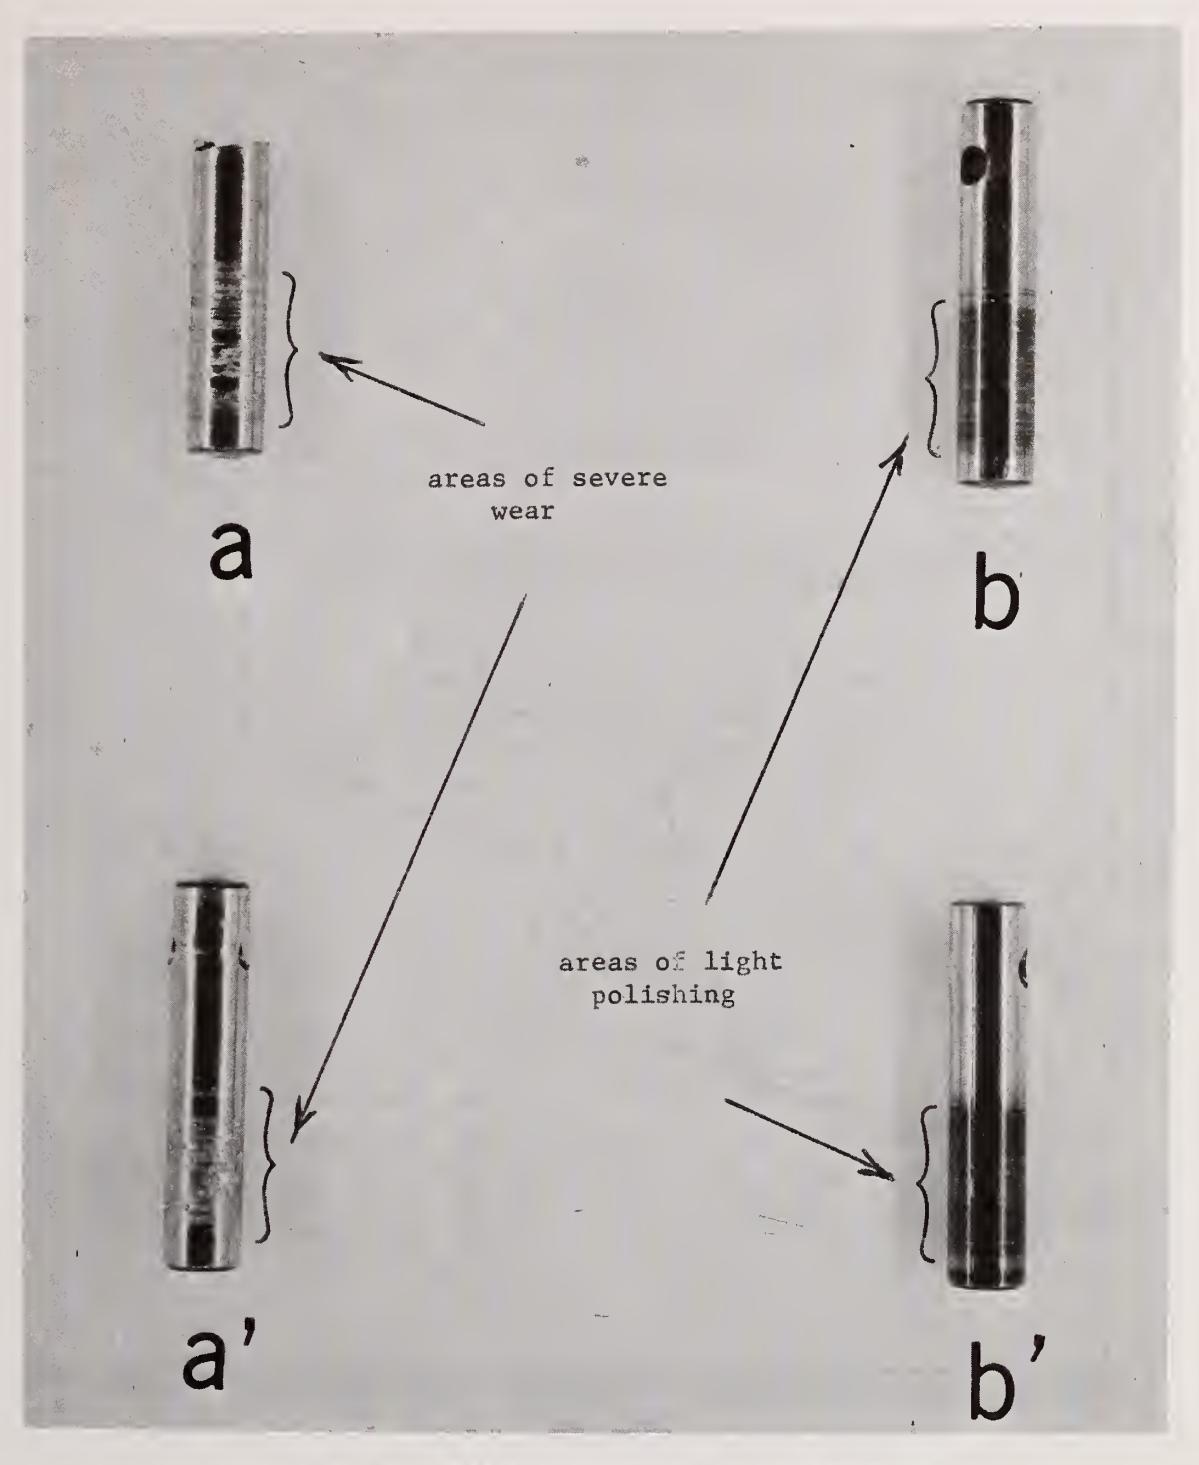
Figure 1. Effect of SbSbS4 on Abrasive Wear

а	=	grease	MIL-G-24139	with	5%	grit			
b	=		IT	11		н	and	5%	SbSbS4
a'	=	11	MIL-G-10924	11		11			-
Ъ'	=	н	н	н		11	and	5%	SbSbS4

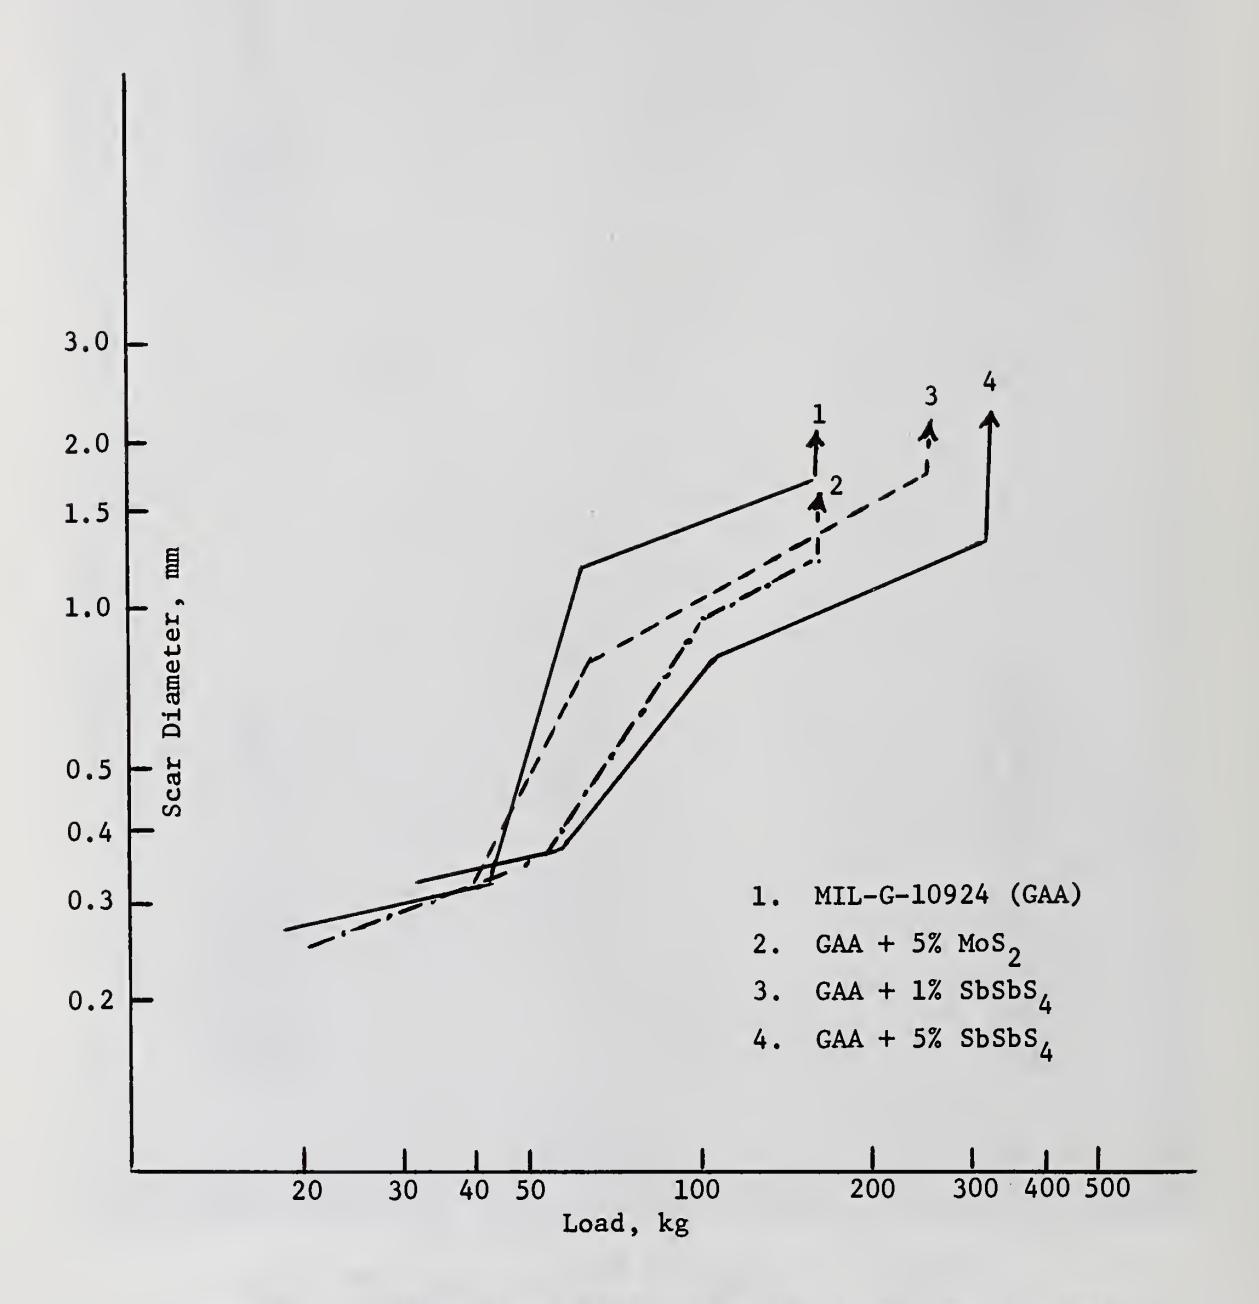
Figure 2. Wear Scar Diameter vs. Load; AISI-C-52100 Steel Balls; 25°C, 1800 rpm, 10s

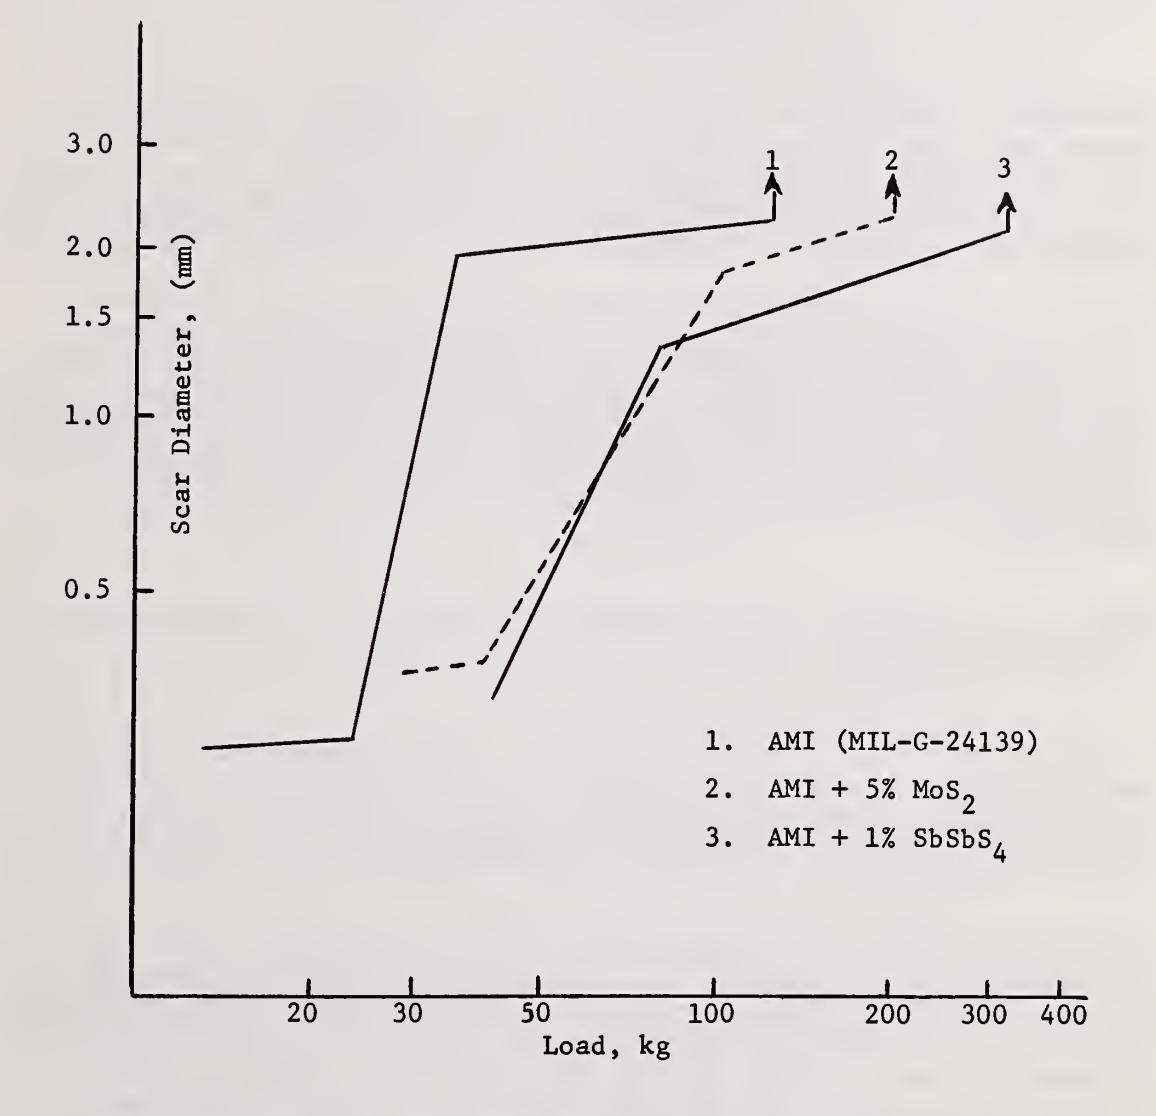
Figure 3. Wear Scar Diameter vs. Load; AISI-C-52100 Steel Balls; 25°C, 1800 rpm, 10s

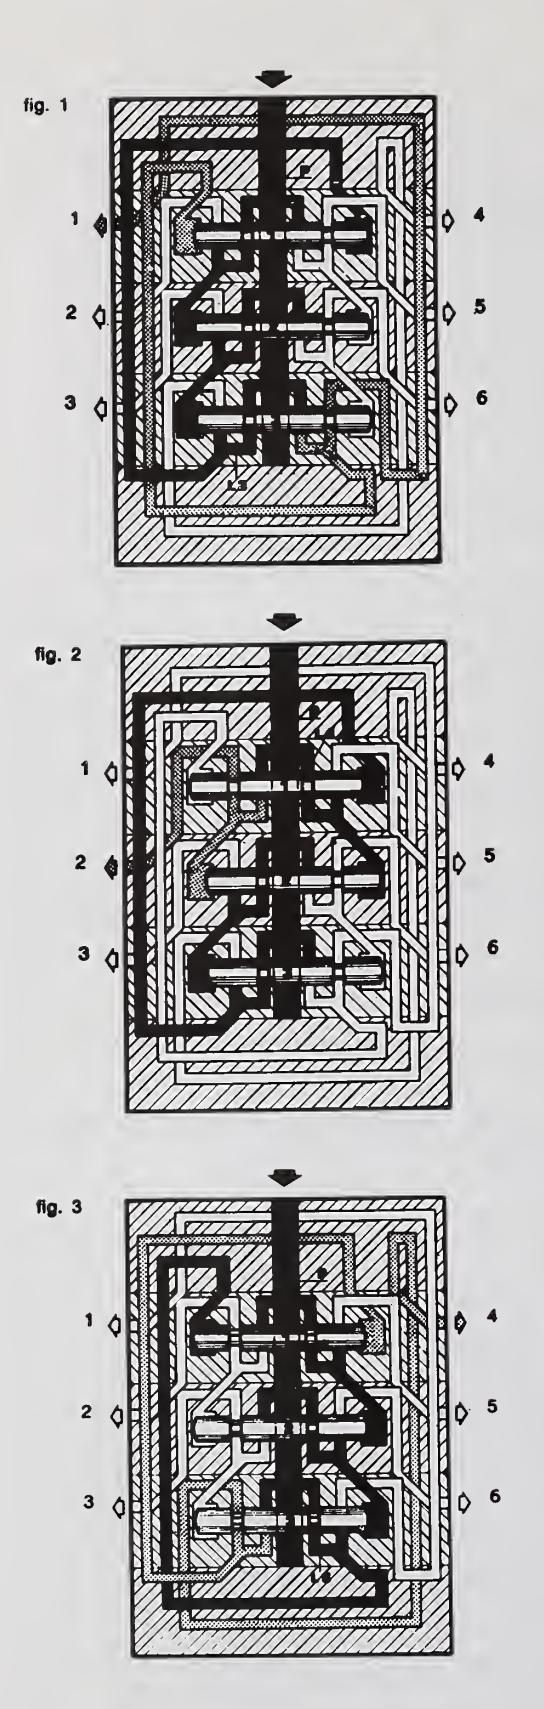
Fig. 1 shows the pressure path, i.e. dark shaded areas, as the first spool begins to move across.

The operation of the spool-valves is best observed in diagramatic form (see overleaf):-

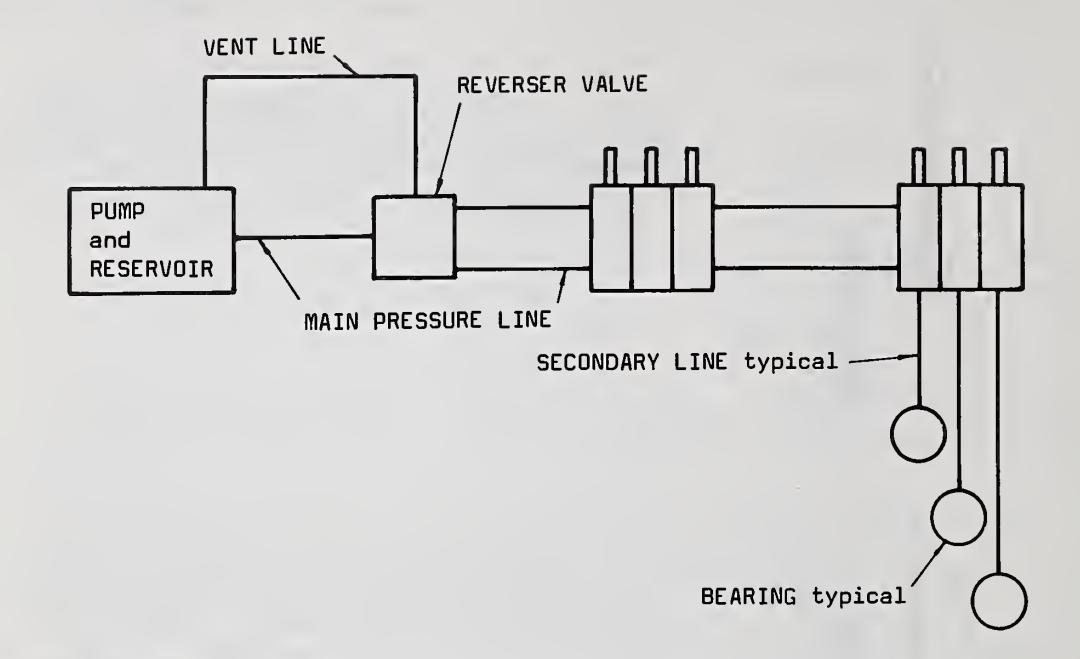
A typical system layout is shown overleaf:-

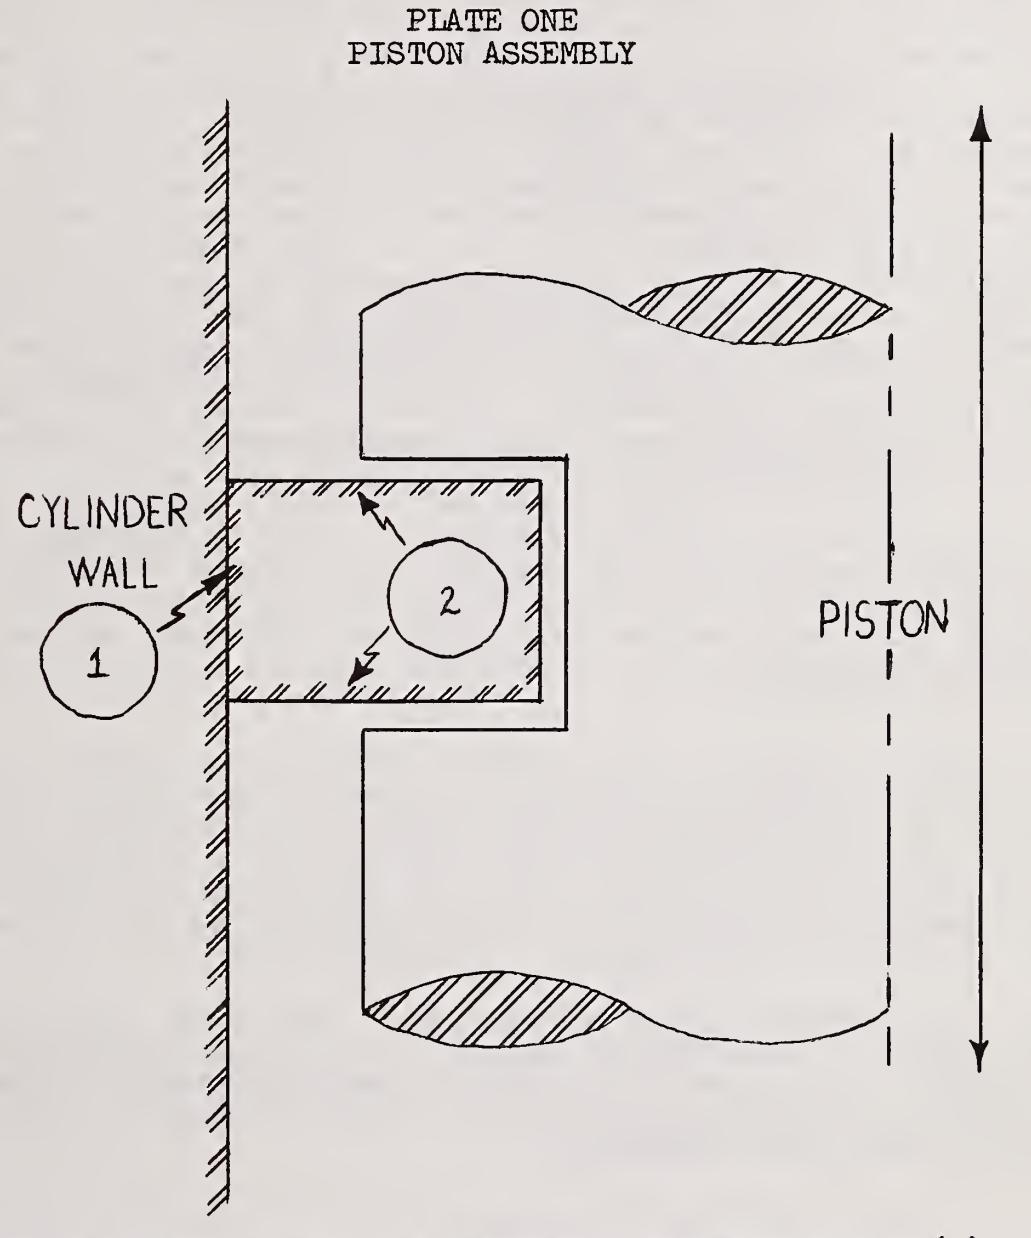
When the implanted  $MoS_2$  is exhausted on surface one (1) it will be replaced by implanted  $MoS_2$  on surfaces two (2) nearest the cylinder wall.

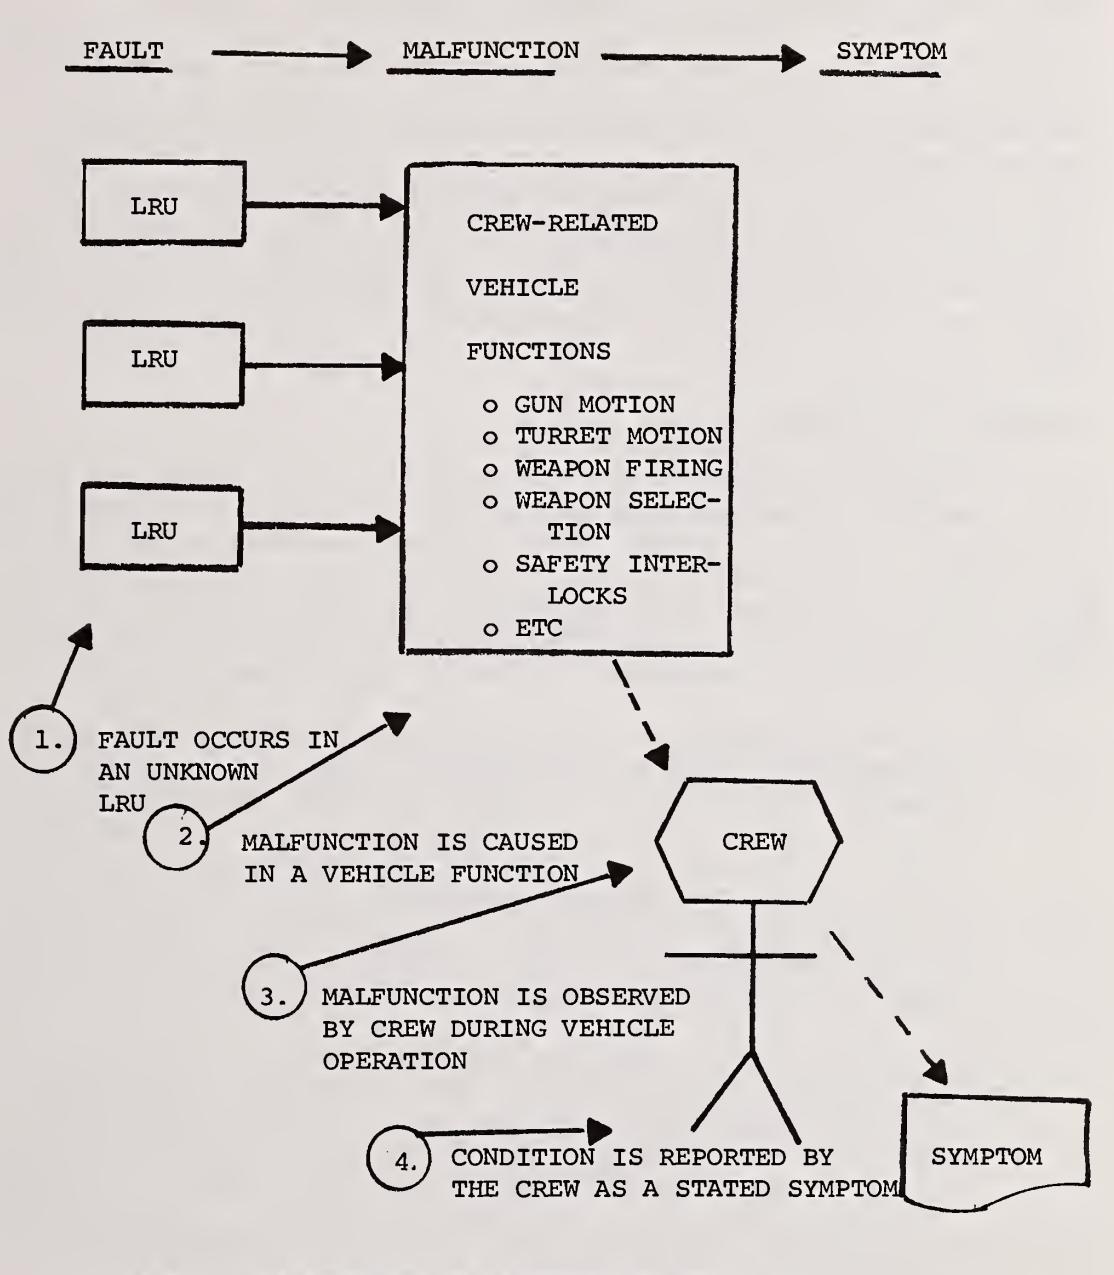
FIGURE 2. PERCEPTION OF MALFUNCTION LEADS TO STATEMENT OF A SYMPTOM

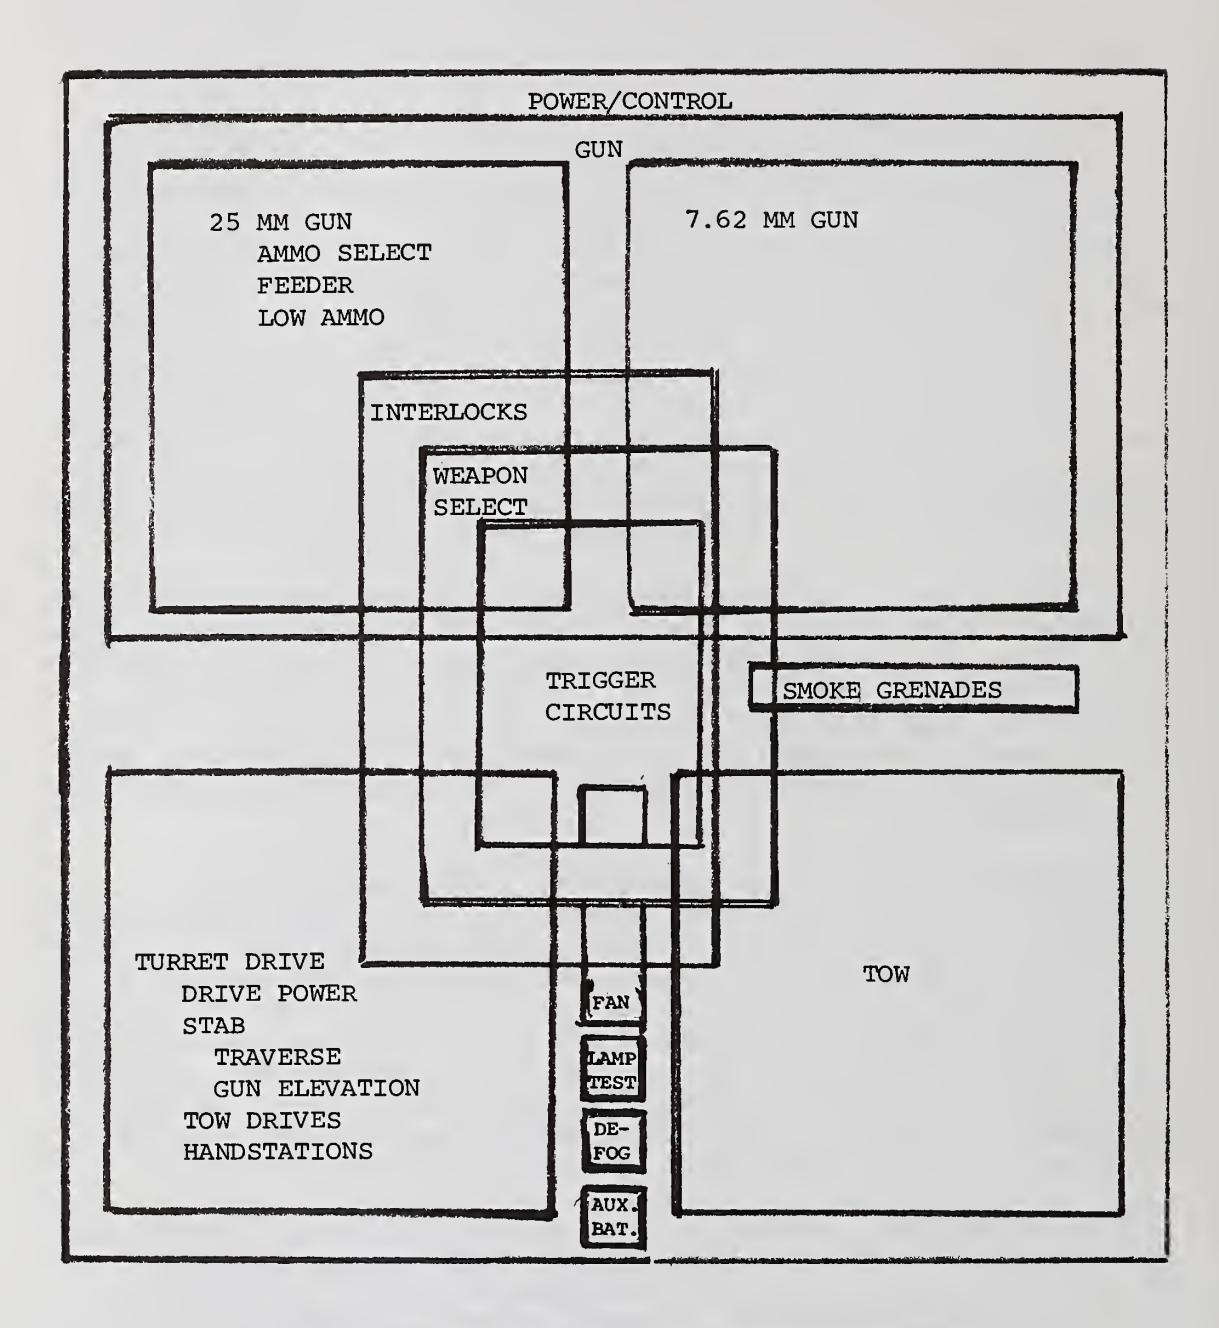
FIGURE 3. FUNCTIONAL ZONES OF INTER-DEPENDENCE FVS TURRET SUBSYSTEMS
