# NBS SPECIAL PUBLICATION 640

# Innovation for Maintenance Technology Improvements

Proceedings of the 33rd Meeting of the Mechanical Failures Prevention Group, held at the National Bureau of Standards, Gaithersburg, MD, April 21-23, 1981

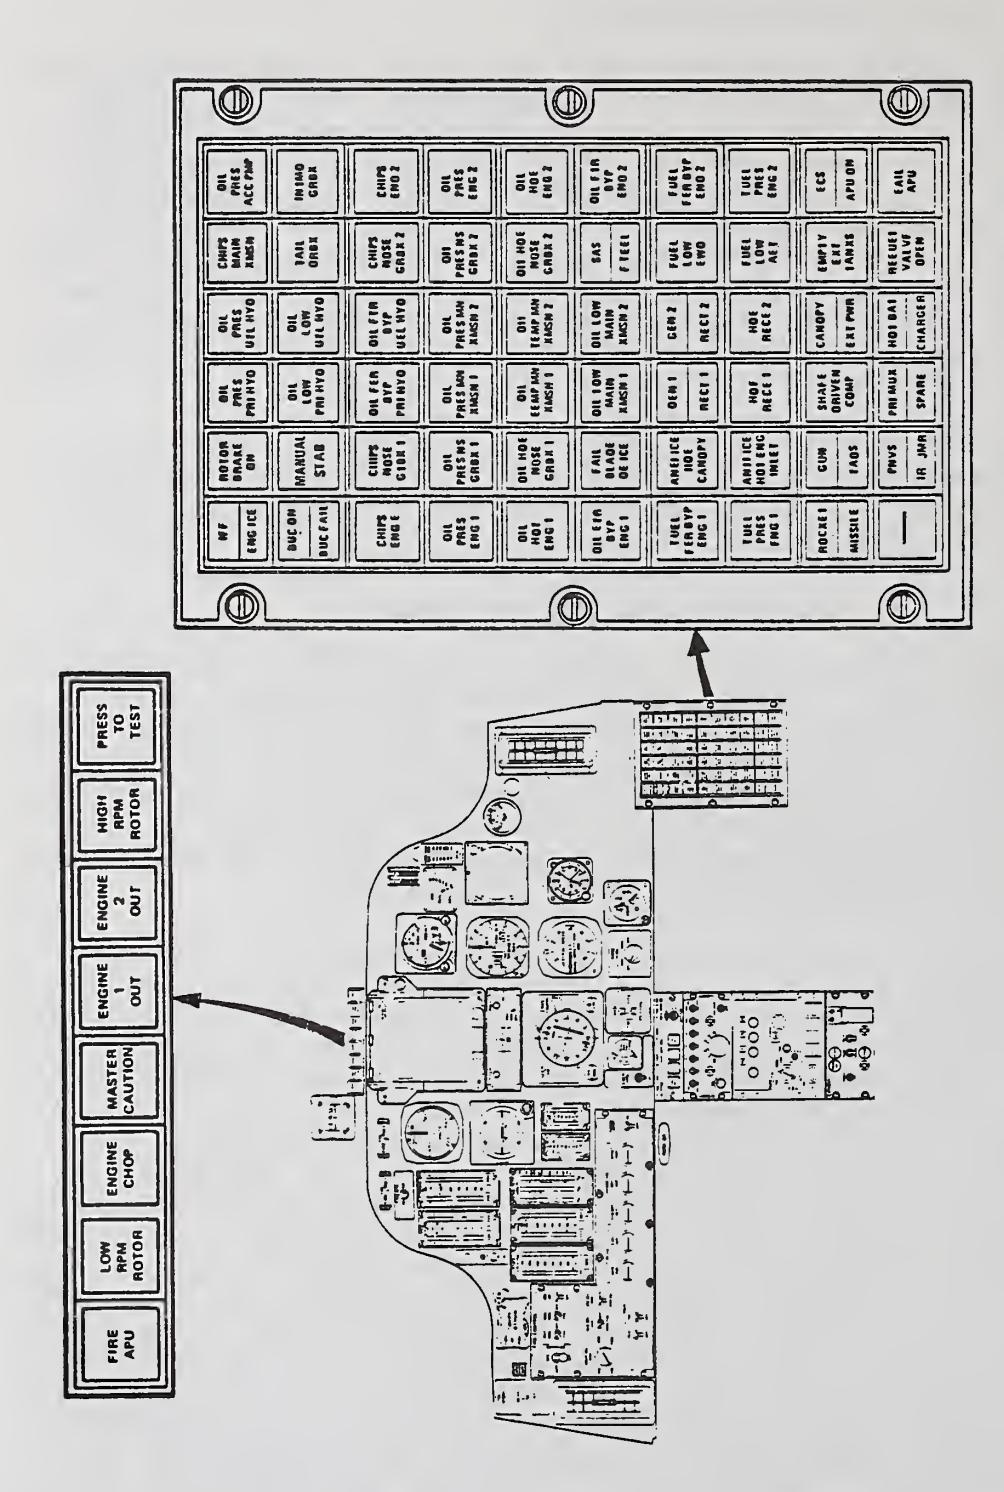
Pilot's Master Caution and Warning/Caution, Warning and Advisory Panels Figure 4:

Master Caution and Warning Panels and Caution, Warning and Advisory Panels (Figures 4 and 5) are installed in both the pilot and copilot/ gunner stations. The two Master Caution and Warning Panels, one located on the top center of the pilot's instrument panel and the other on the top right side of the copilot/gunner's instrument panel, provide the initial indications of impending failure, actual failures, or dangerous conditions. The MASTER CAUTION display on these Master Caution and Warning Panels is pushbutton operated. Initially, the MASTER CAUTION will flash (5 ±1 hertz rate) when a Caution, Warning and Advisory Panel segment simultaneously starts flashing  $(2 \pm 1 \text{ hertz rate})$ . Pressing the MASTER CAUTION display will cause it to extinguish and will convert the flashing fault segment to steady on. It will remain on until the fault or condition is corrected. When the PRESS TO TEST button on the Master Caution and Warning Panel is pressed, all Caution, Warning and Advisory lights in the crewstation are illuminated. When any of the remaining warning lights on the Master Caution and Warning Panel are lit, immediate attention is required by the crew members in accordance with operating instructions. An aural tone (700 to 1000 hertz continuous sweep) is incorporated with the LOW RPM ROTOR, ENG 1 OUT and ENG 2 OUT segments

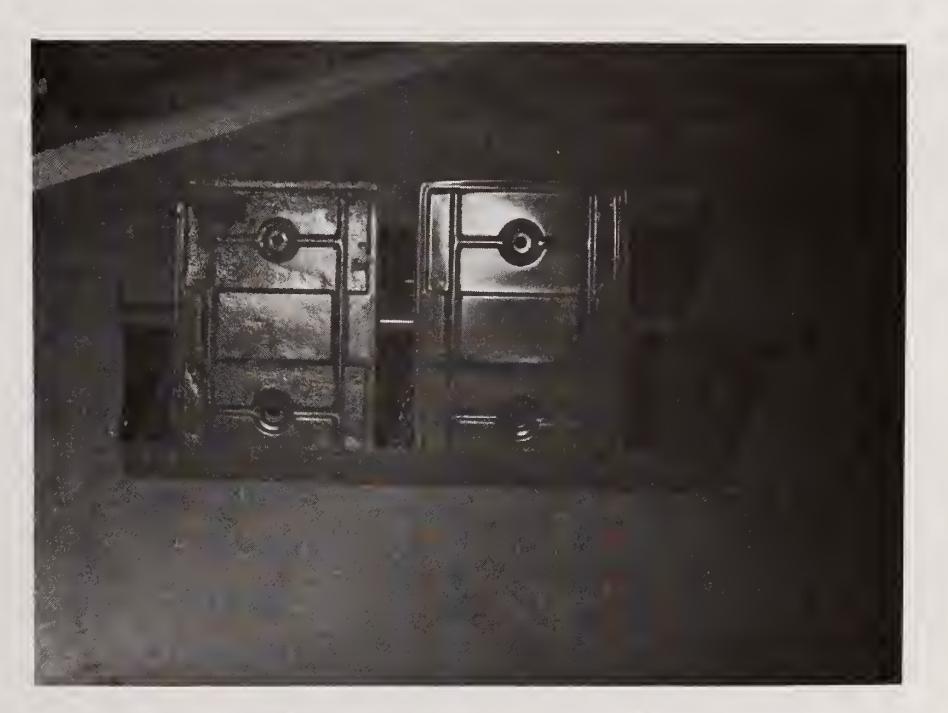
Figure 5. A corroded and a new battery tray.

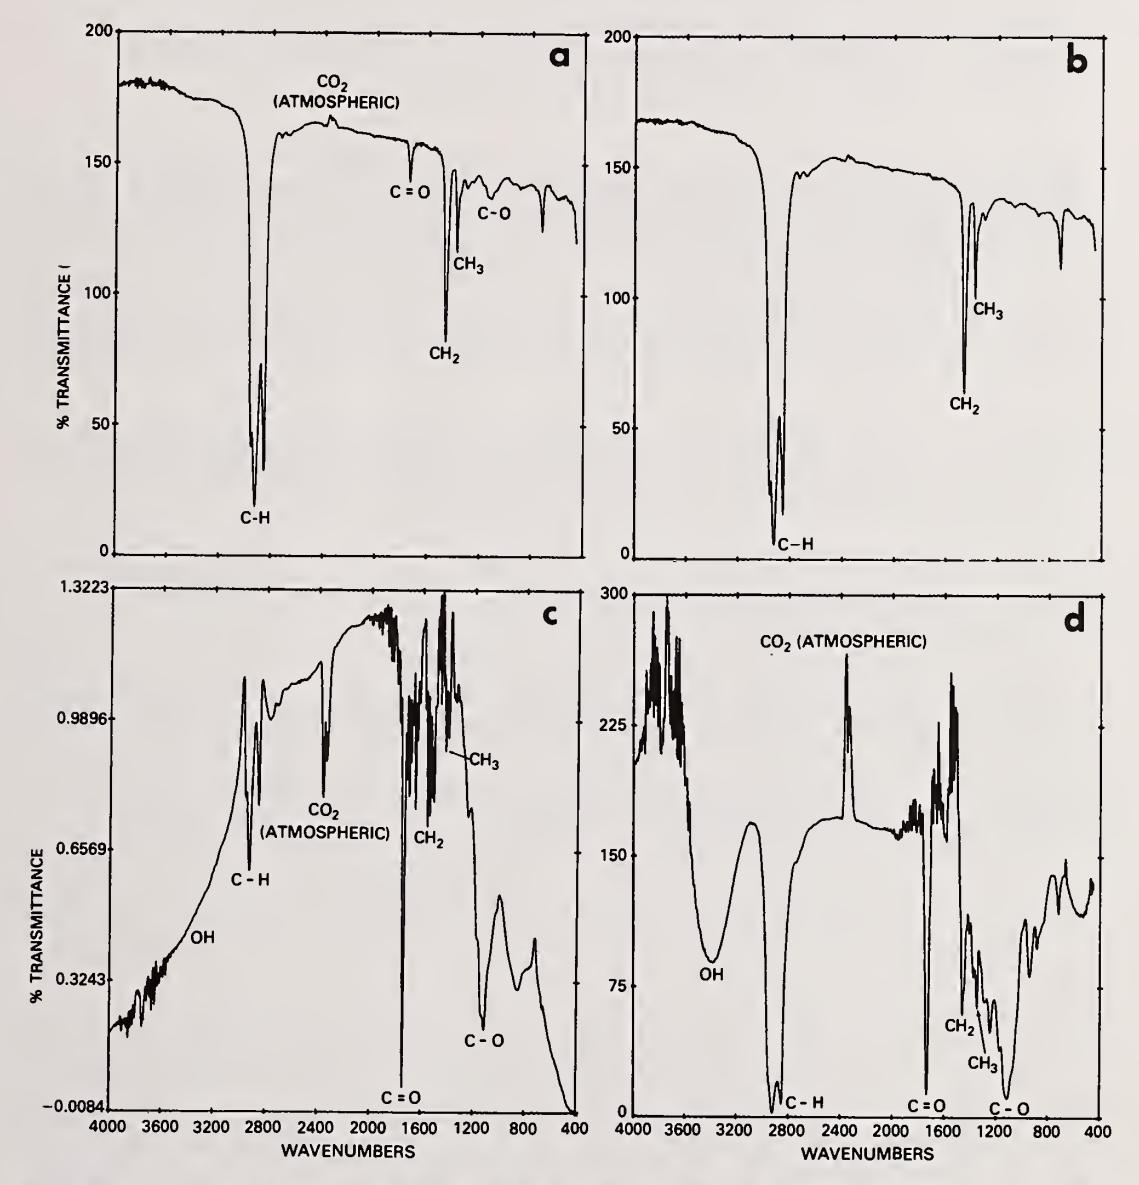
Figure 1: Antistatic Agent Transfer from Antistat-Containing Polymer Film to Lubricant After 5 Months Contact as Monitored by FTIR Spectra. a) Liquid Remaining on Substrate After Contact of SHC-B with PE + PEG; b) Pure SHC-B; c) Component Remaining After Subtraction of Fig.lb from Fig.la; d) Pure PEG

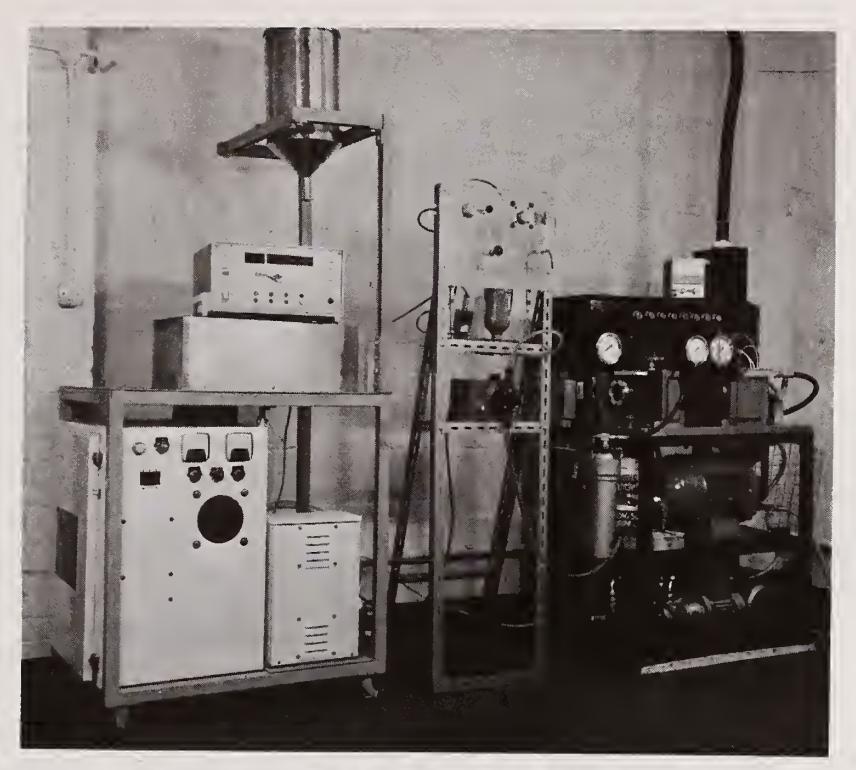
FIG. 1 Layout of Equipment.

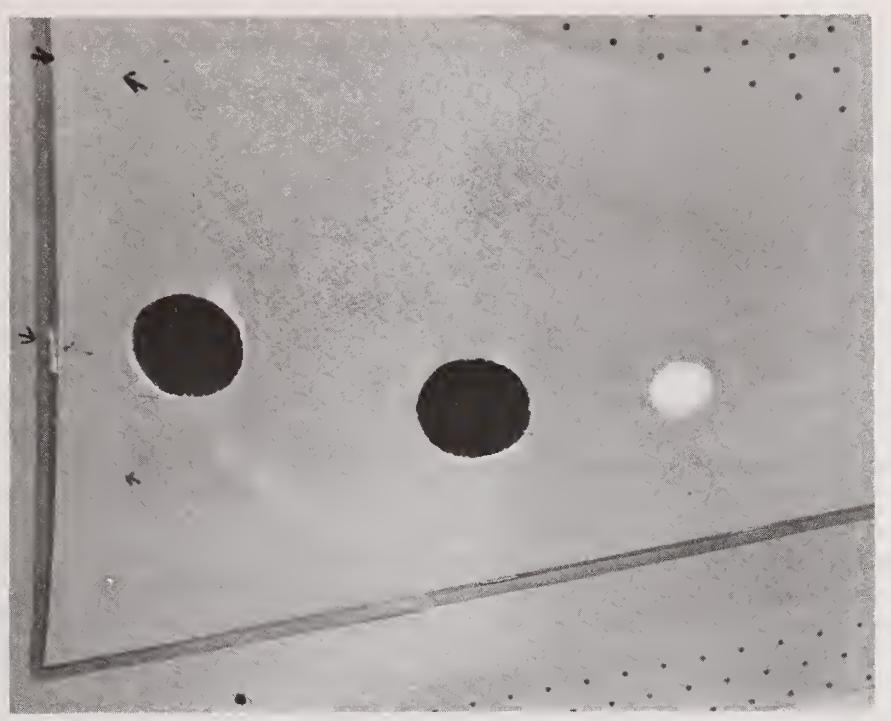
Figure 7. 757 Wing Panel Repairs in Progress

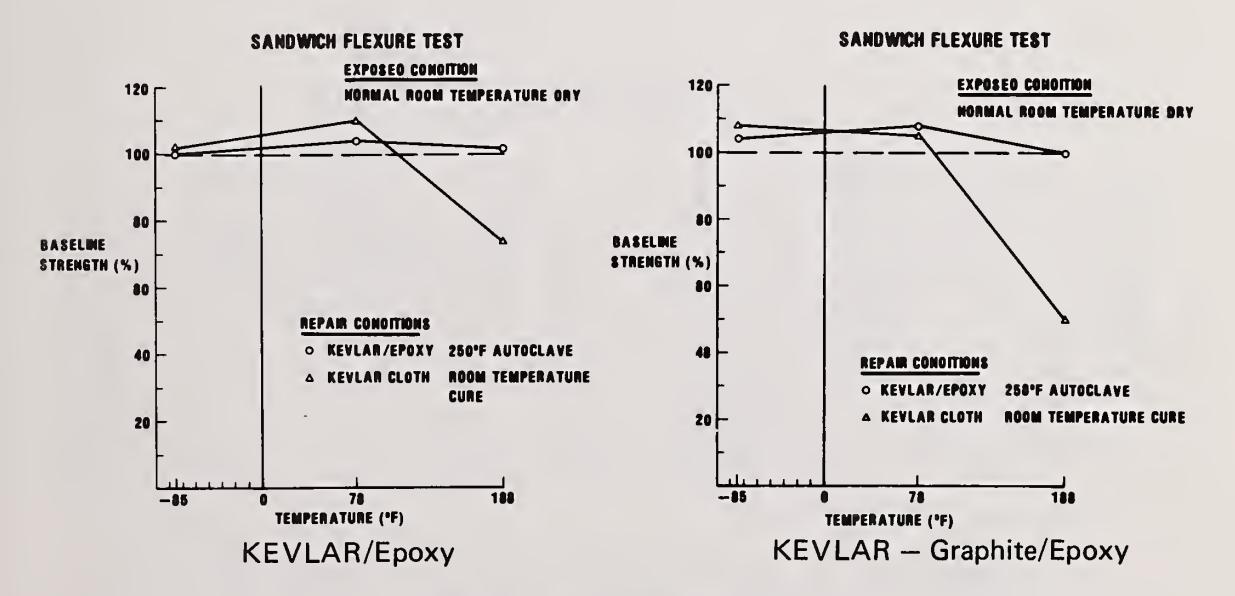
Figure 9. 250°F Cure Specimens

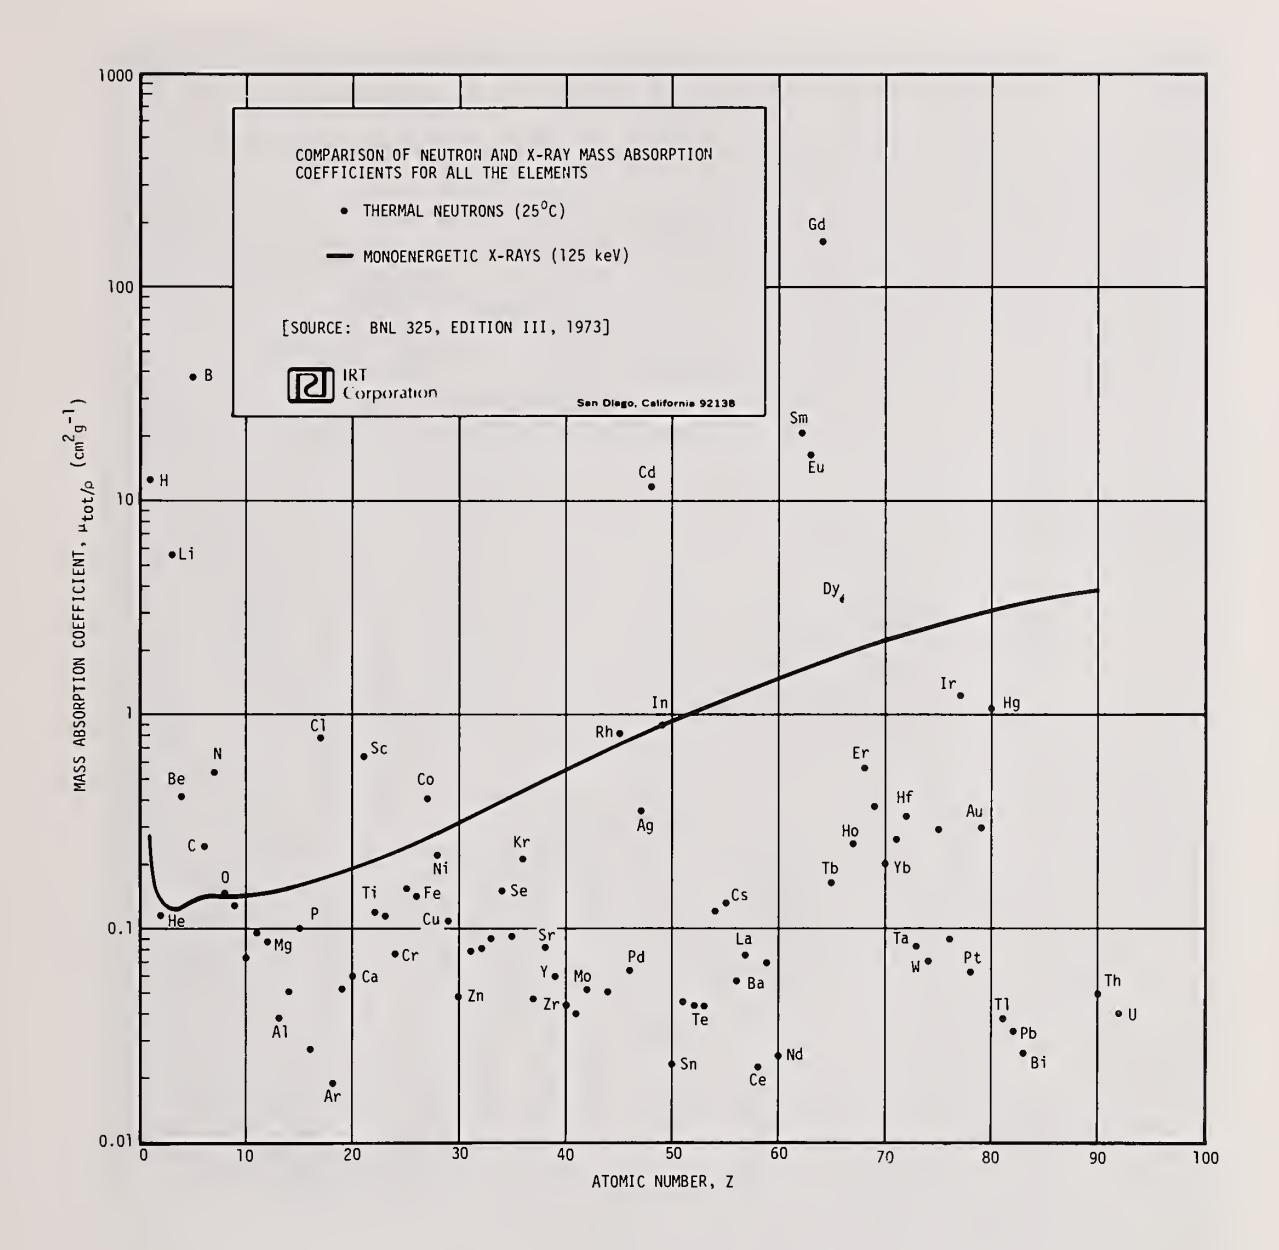
Figure 1. Comparison of x-ray and n-ray mass absorption coefficients

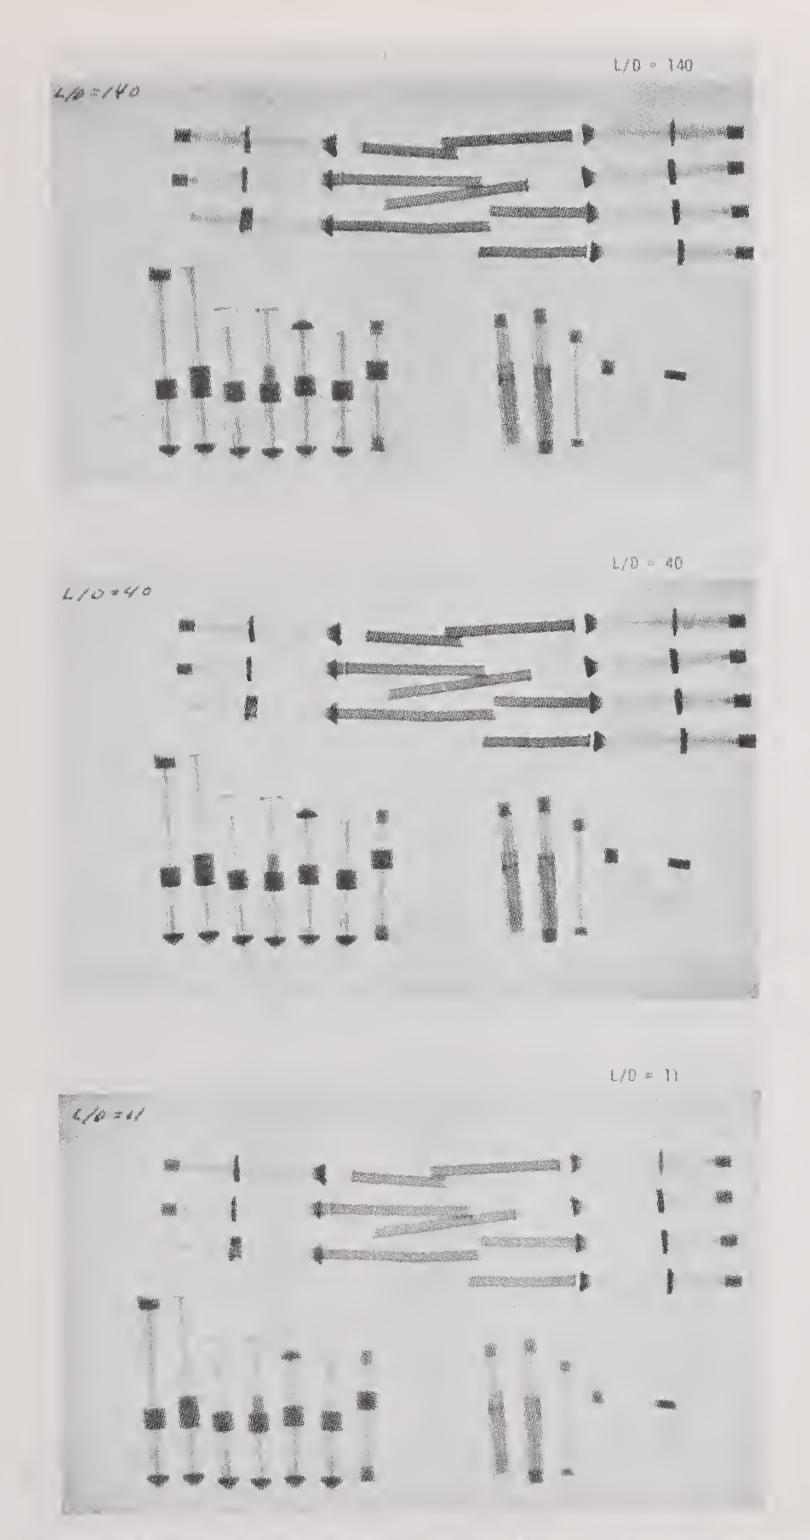
Figure 3. Prints of neutron radiographs of explosive train devices having known defects (such as missing end tips) taken with L/D ratio (resolution) of 140, typical of reactor-based radiography, and L/D ratios of 40 and 11, more typical of Cf-252-based neutron radiography.

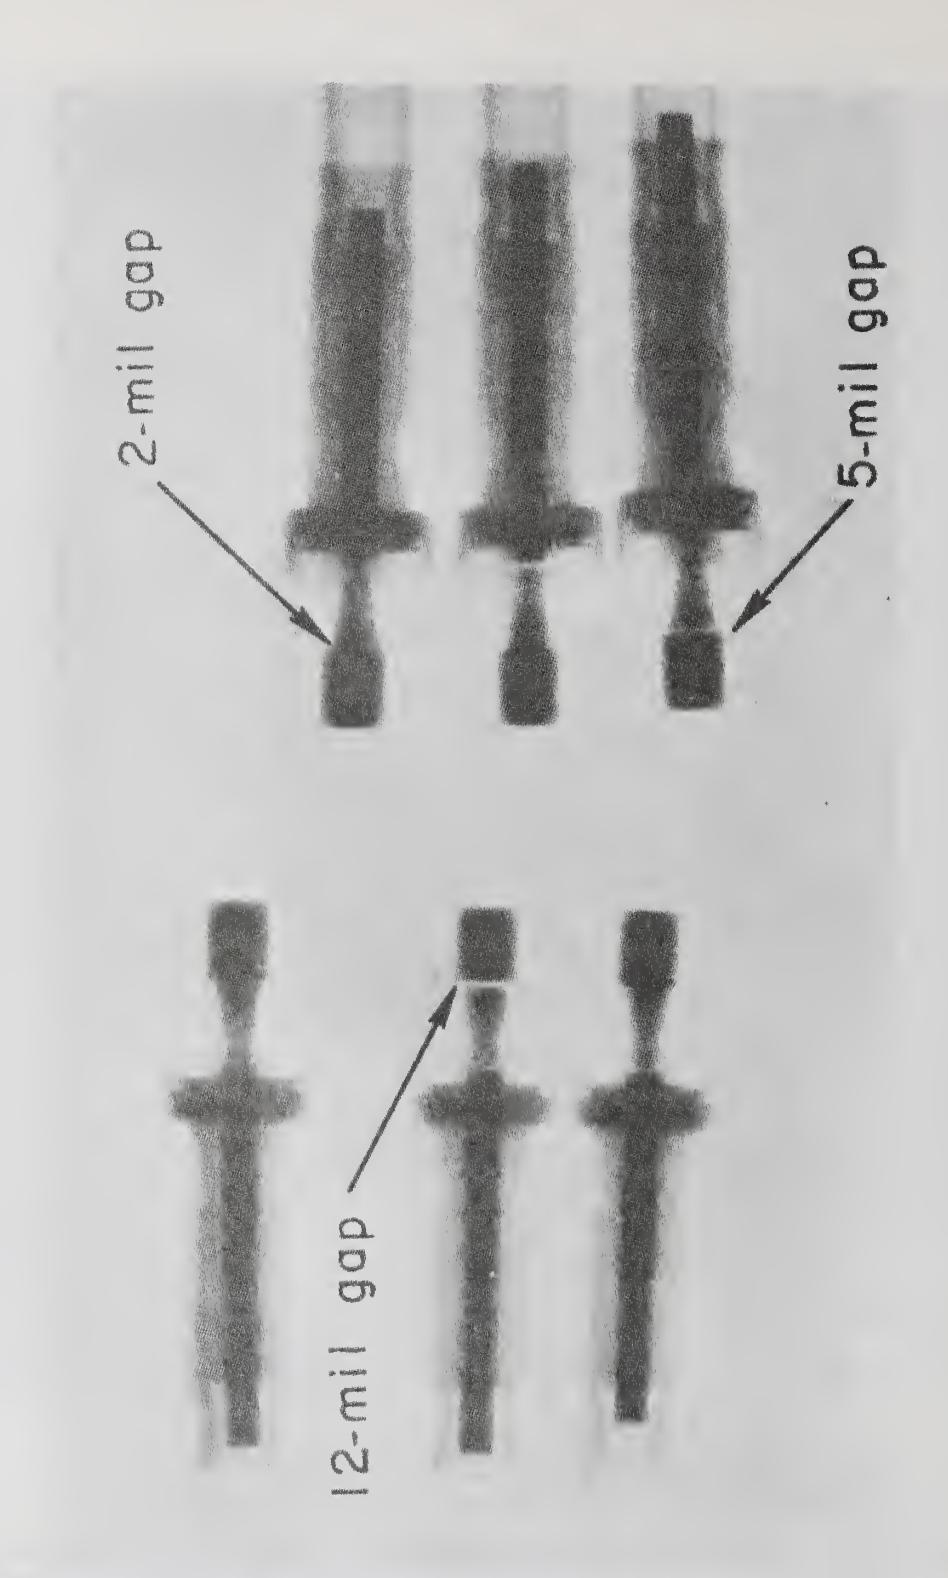
Figure 4. Enlarged print of neutron radiograph of shielded mild detonating cords with known defects (gaps of 12, 6, and 2 mils) identified by the arrows.

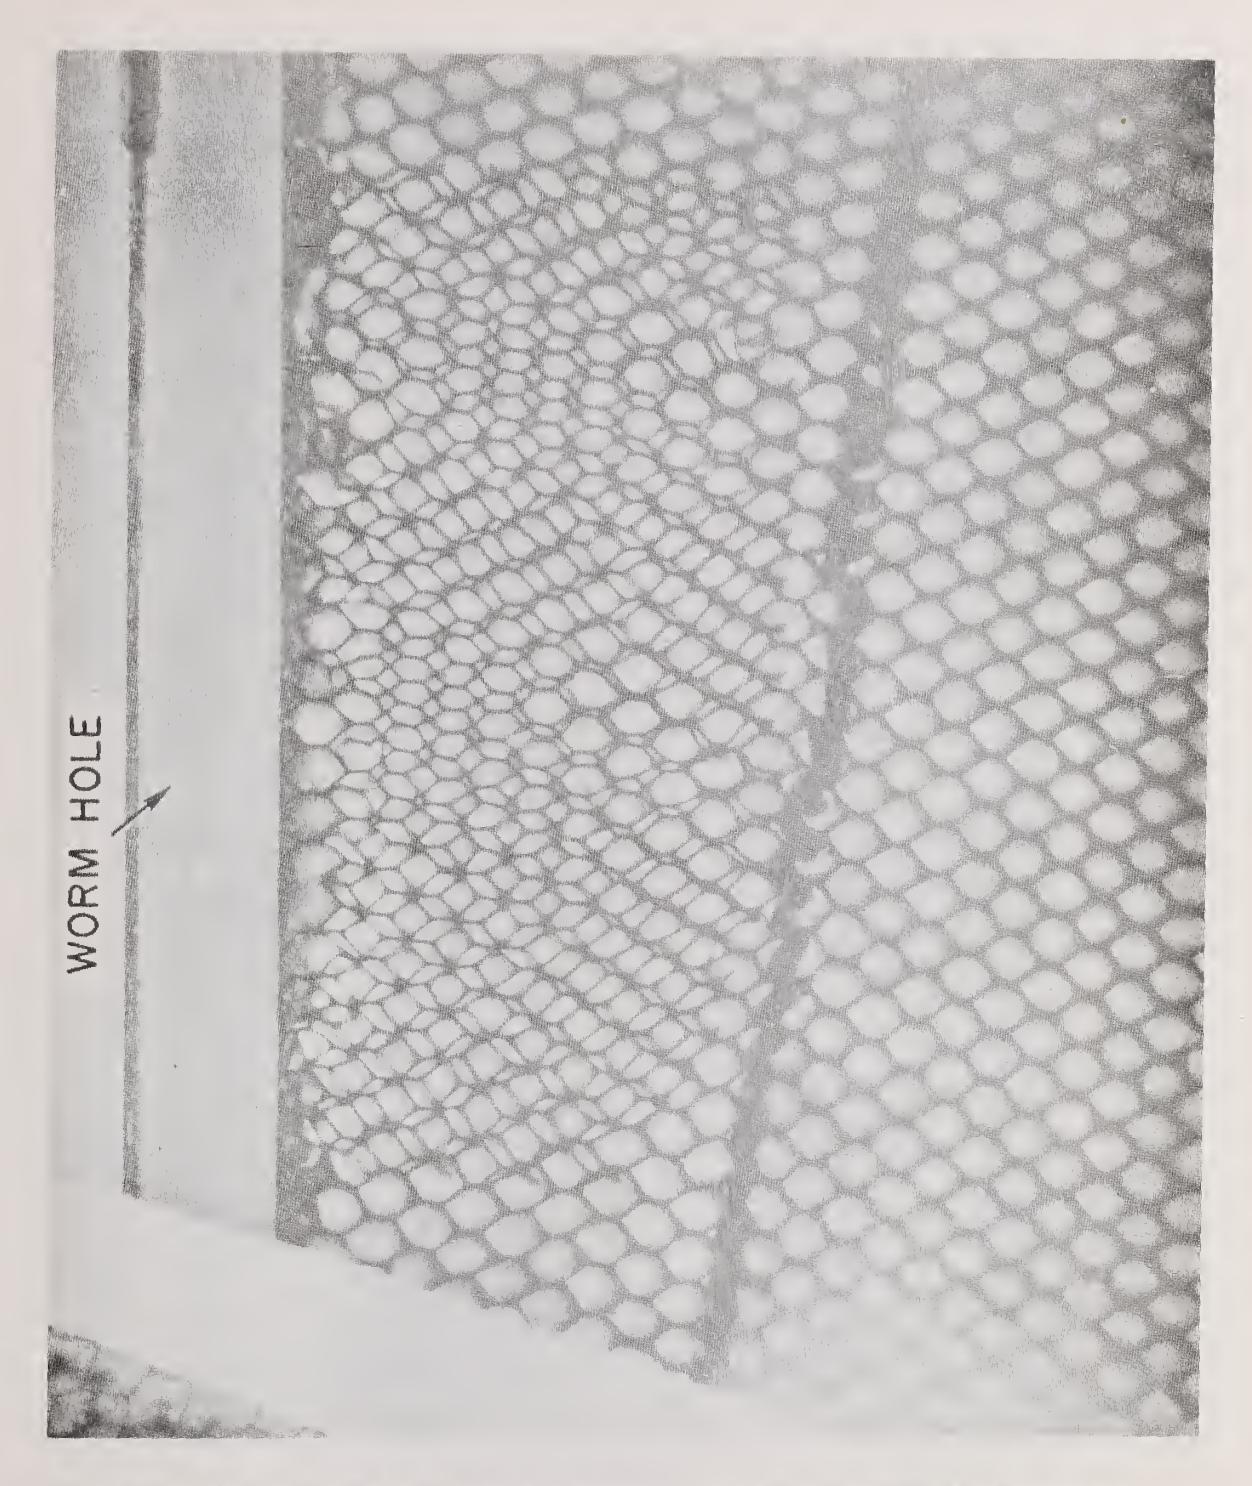
Figure 9. Neutron radiograph of a portion of the leading edge of the vertical stabilizer of an F-111 aircraft. The adhesive bond line between the aluminum arrowhead and the aluminum skin shows adhesive deficiencies providing possible leakage paths between the honeycomb cells and the outside environment. One such "worm hole" is labeled.

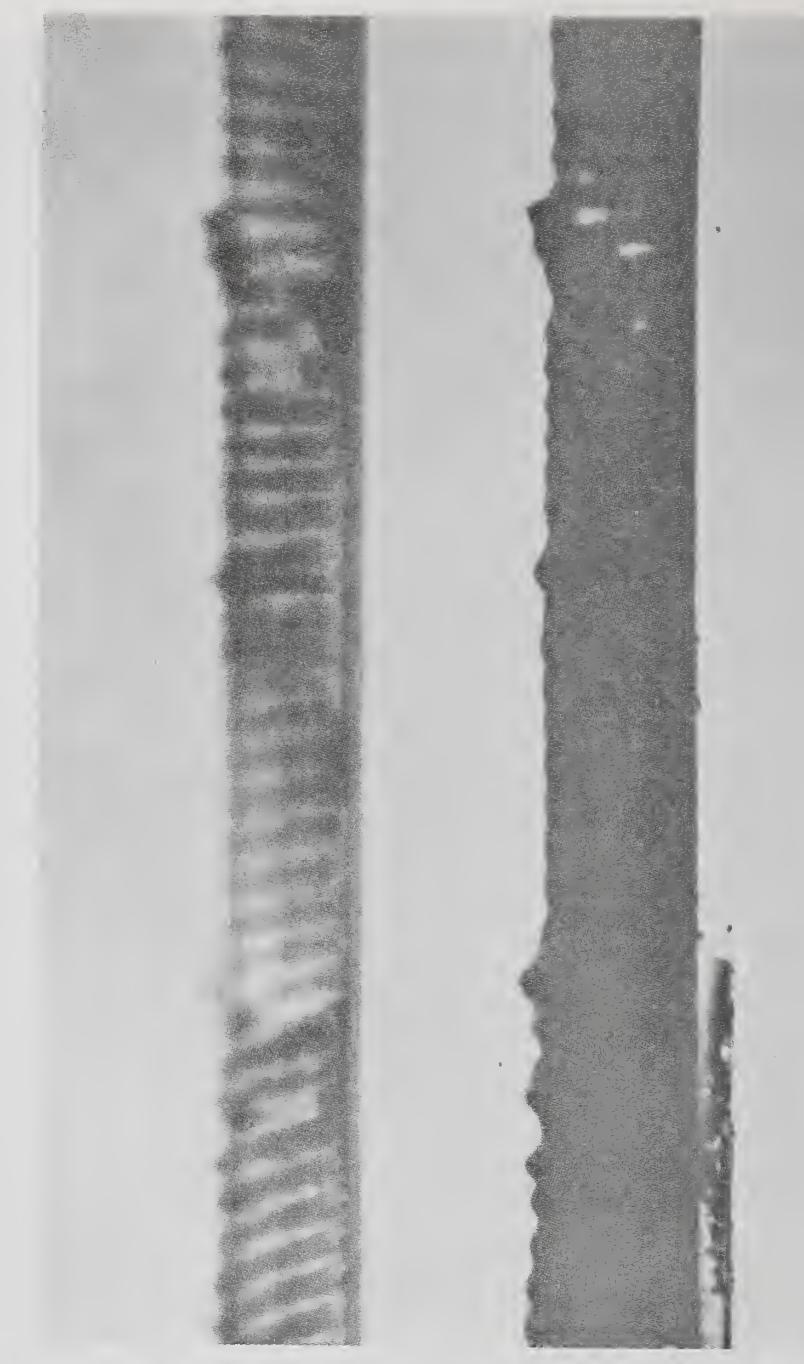
Figure 10. A composite of two neutron radiographs of a portion of a 540 helicopter blade system. The one at the left is a standard neutron radiograph showing the bond line between the C-spar and the spar closure clip, as well as the honeycomb. The one at the right shows the result after treatment with an enhancing agent. The penetration of the enhancing agent into the disbonded area helps clearly identify the extent of the disbond.

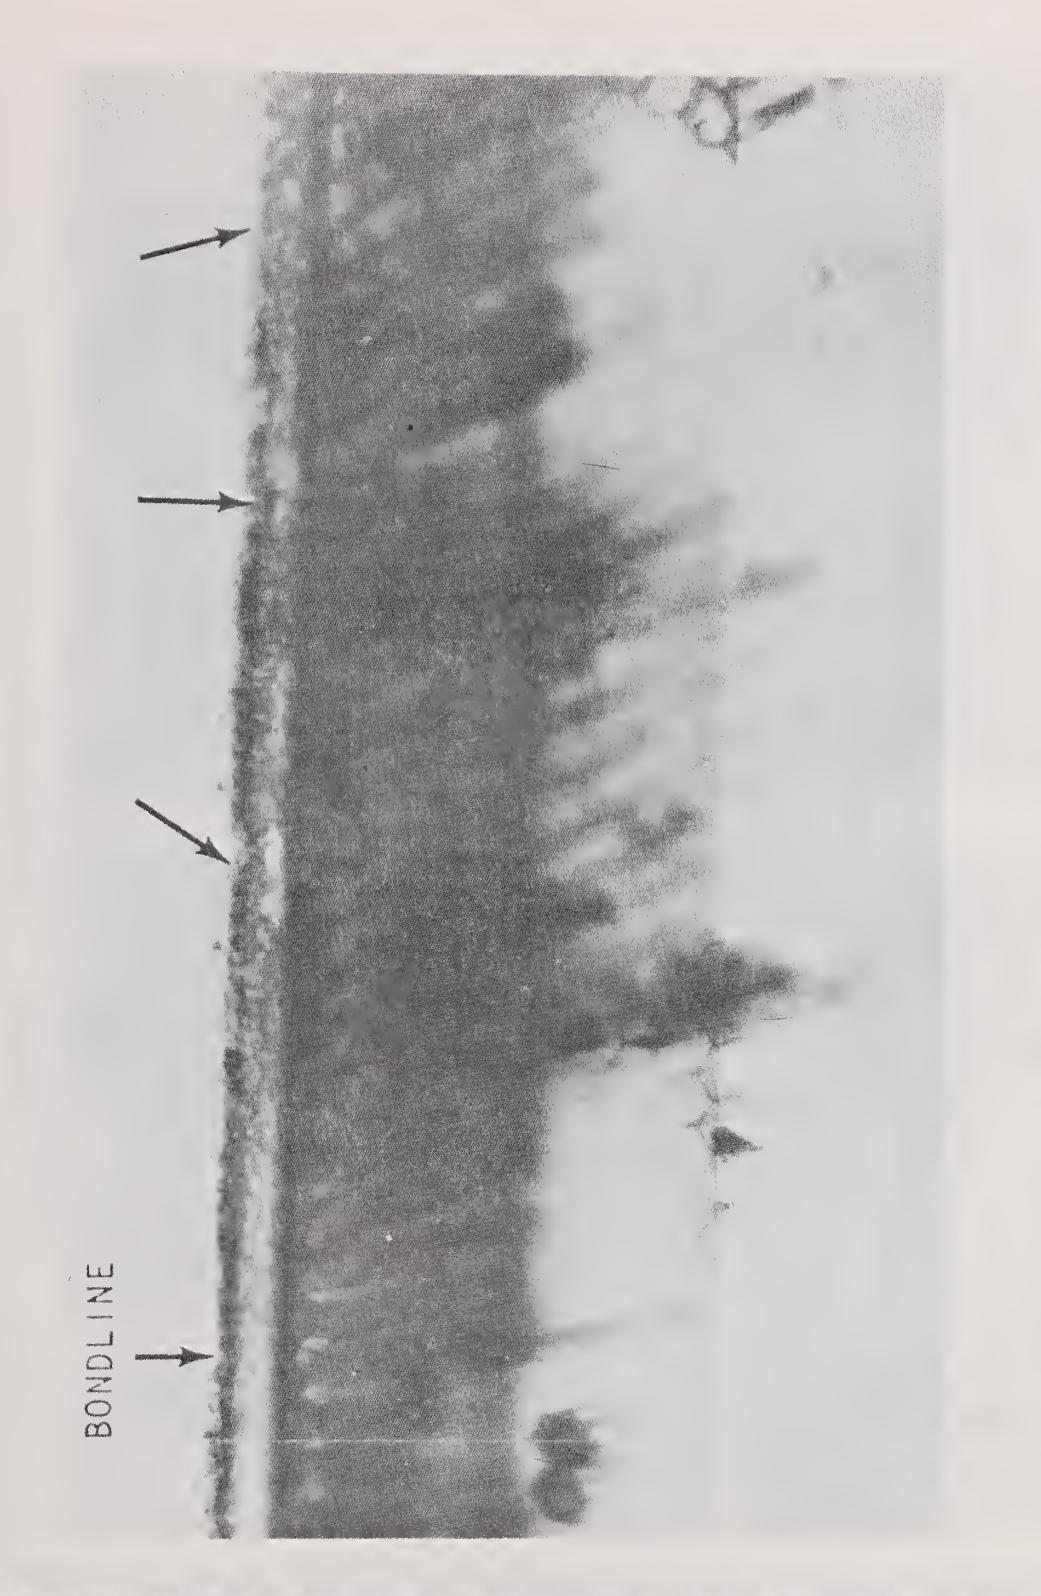
Figure 11. Neutron radiograph of a helicopter blade with fretting corrosion. The uneven nature of the bond line results from metal-to-metal contact due to inadequate quantities of adhesive.

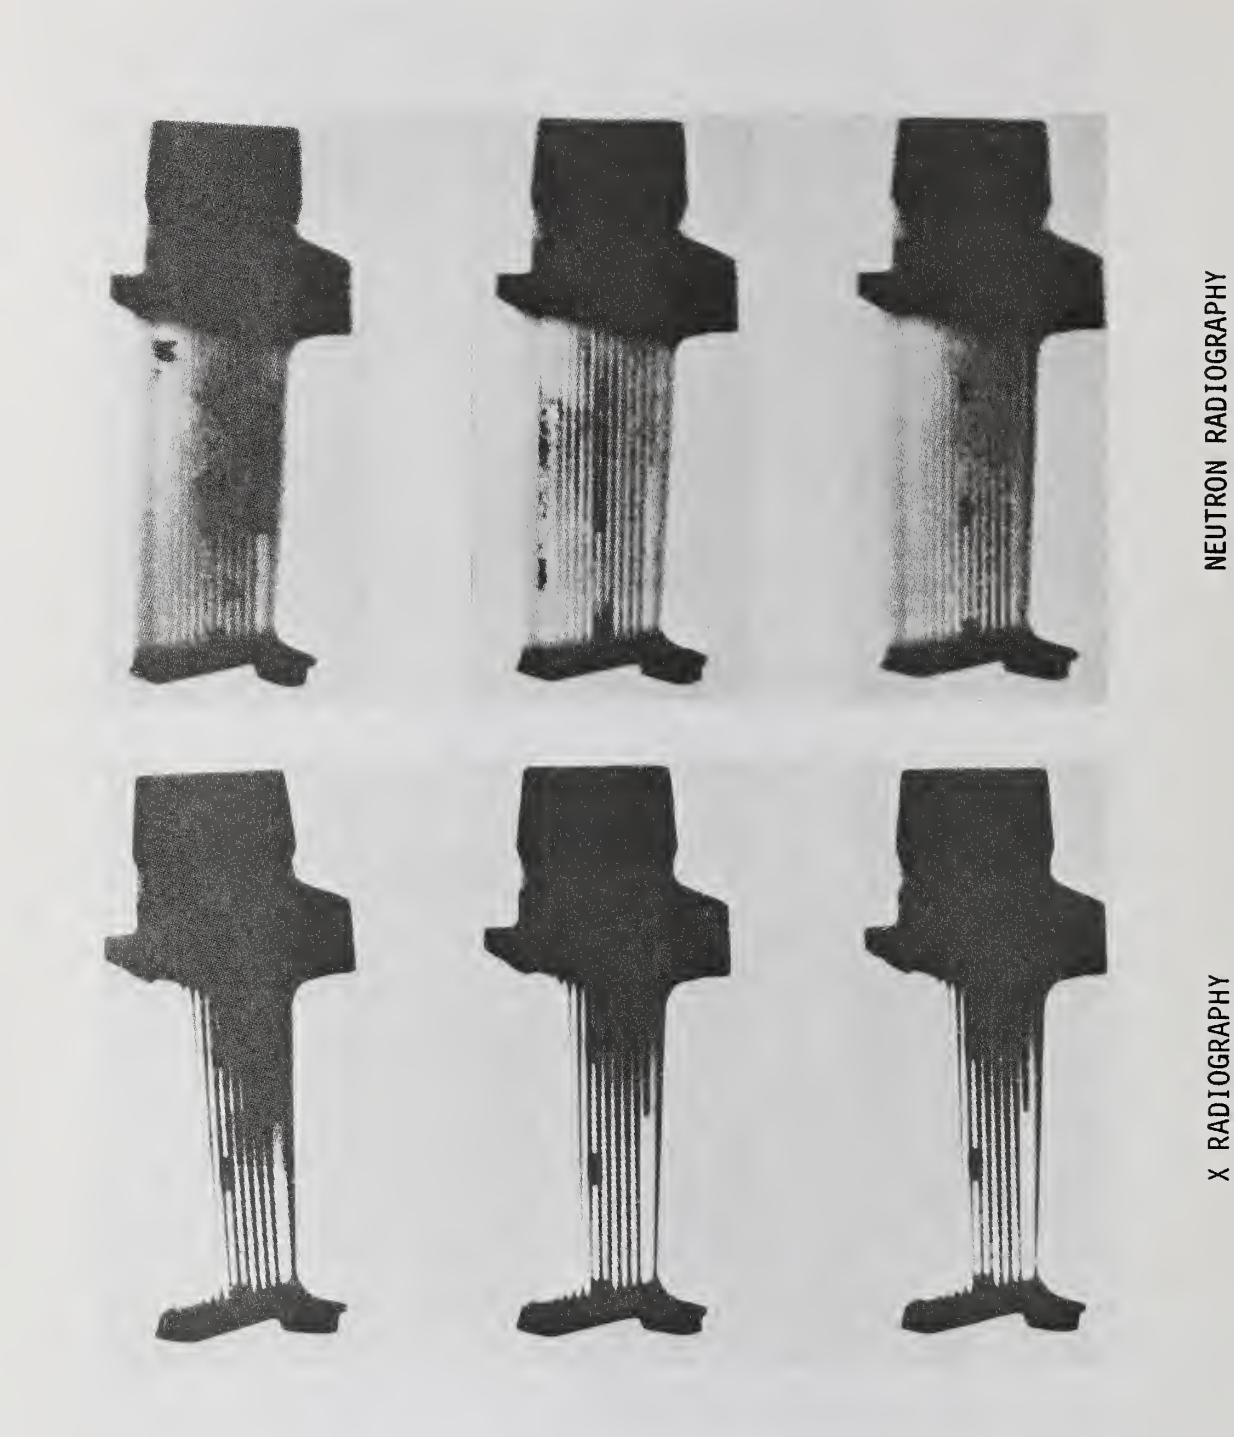
Figure 12. Comparison of x-radiograph and neutron radiograph for inspecting turbine blades for residual ceramic core. The set at the bottom is x-rays, and the one at the top was obtained with neutrons.

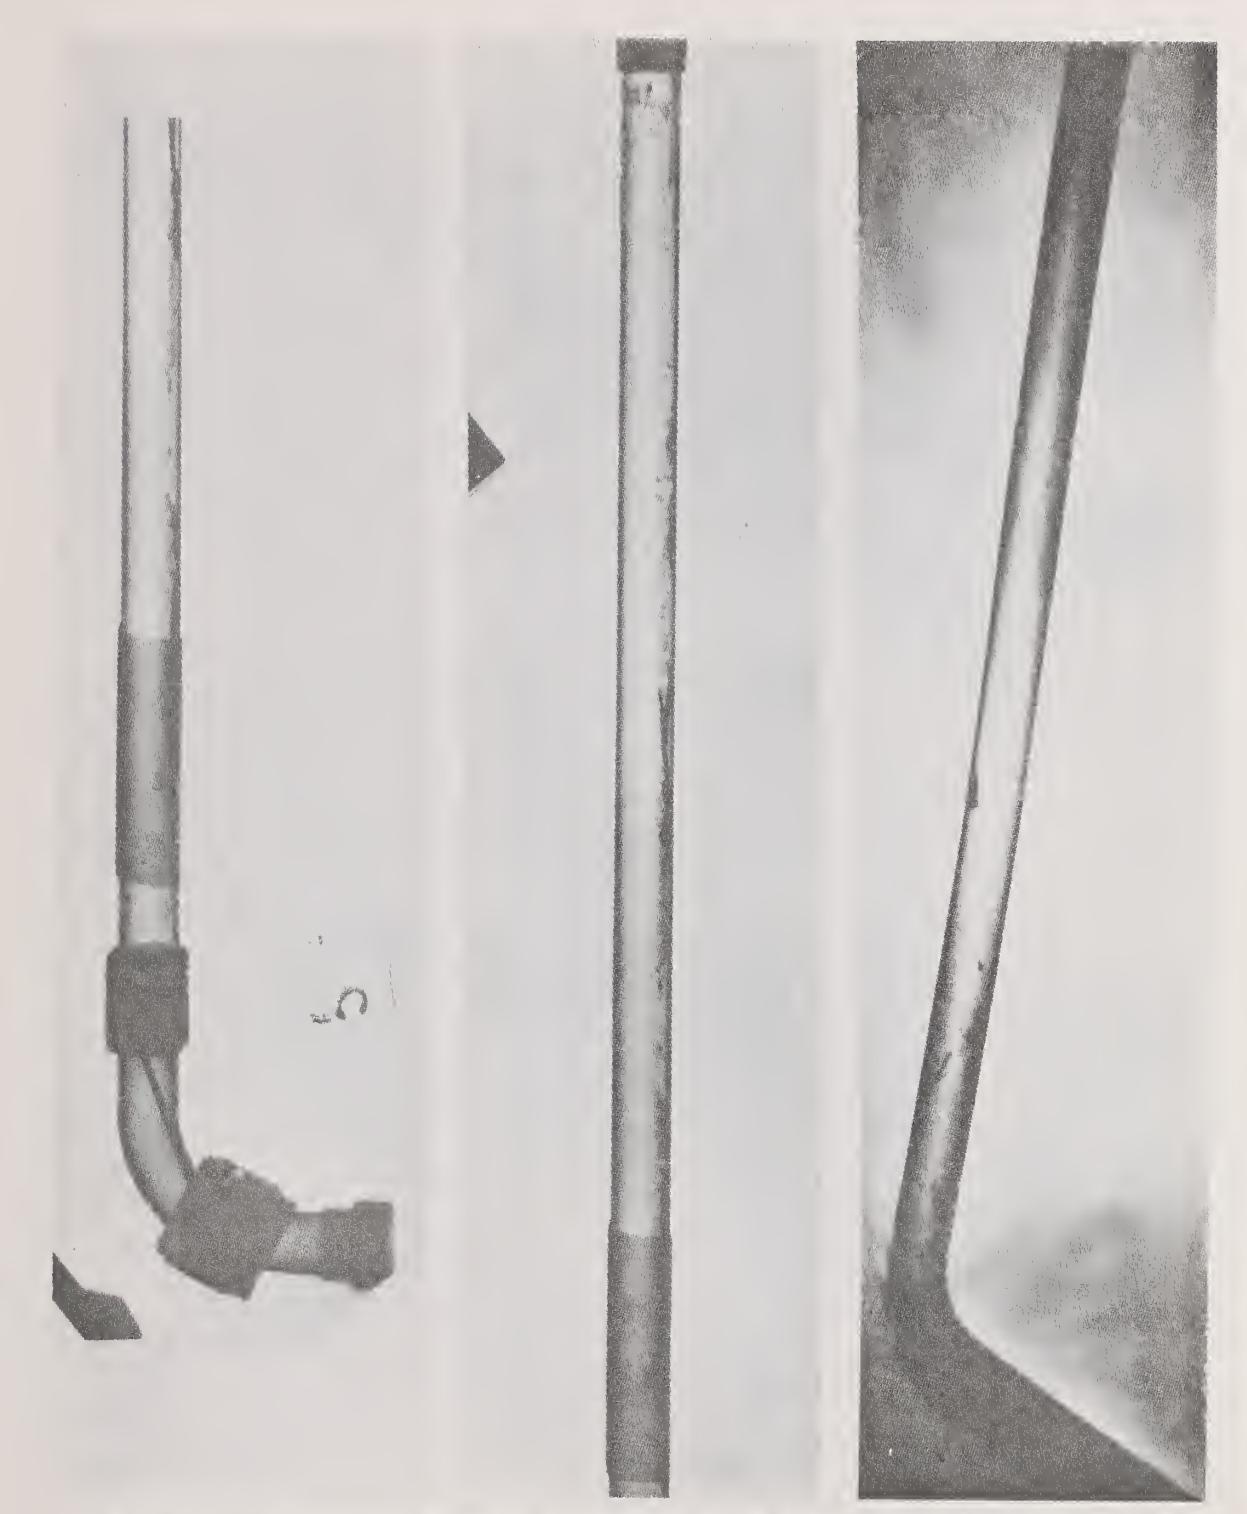
Figure 13. Neutron radiograph of portions of oil lines in aircraft engine showing coke deposits on the inner walls. A large piece of coke dislodged from the tube wall, is seen resting near the shoulder of the J-shaped tube.

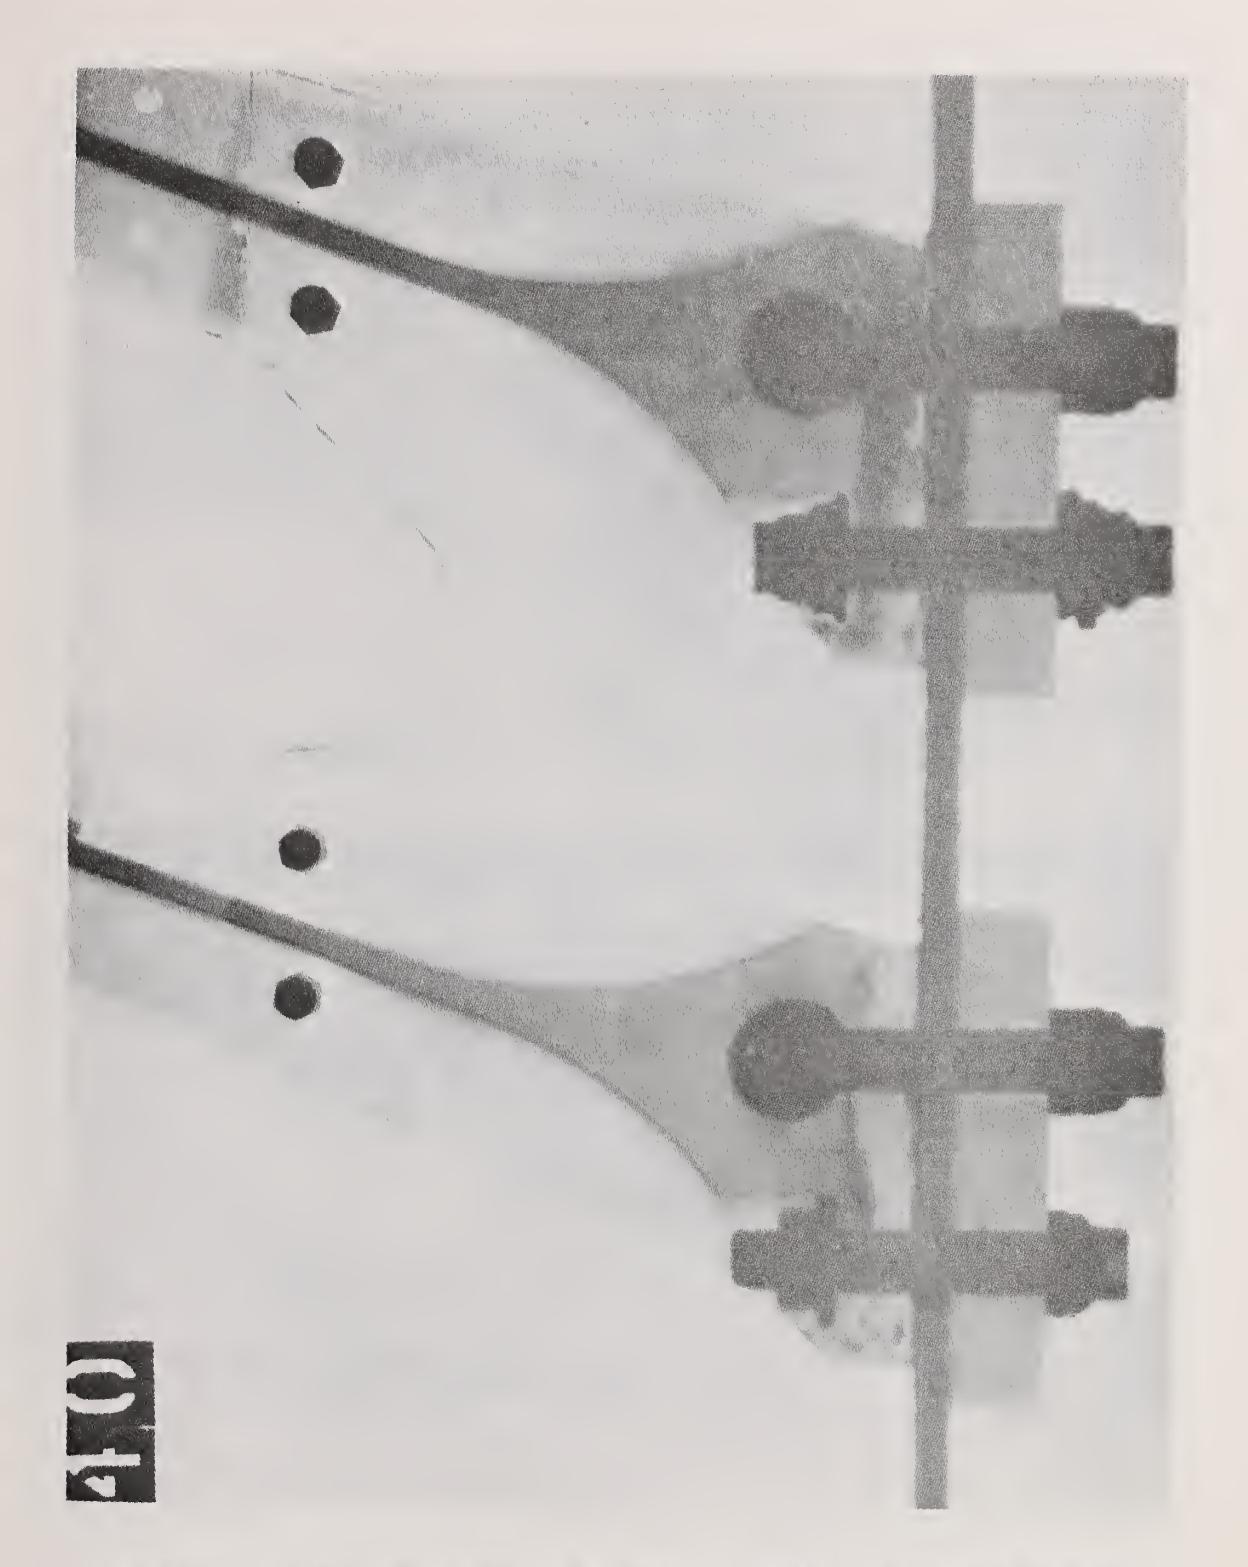
Figure 15. Neutron radiograph of a portion of the DC-9 wing tank showing the outline of the stringer, tee cap, and a set of bolts. The corroded area is visible through the stringer approximately two inches thick.

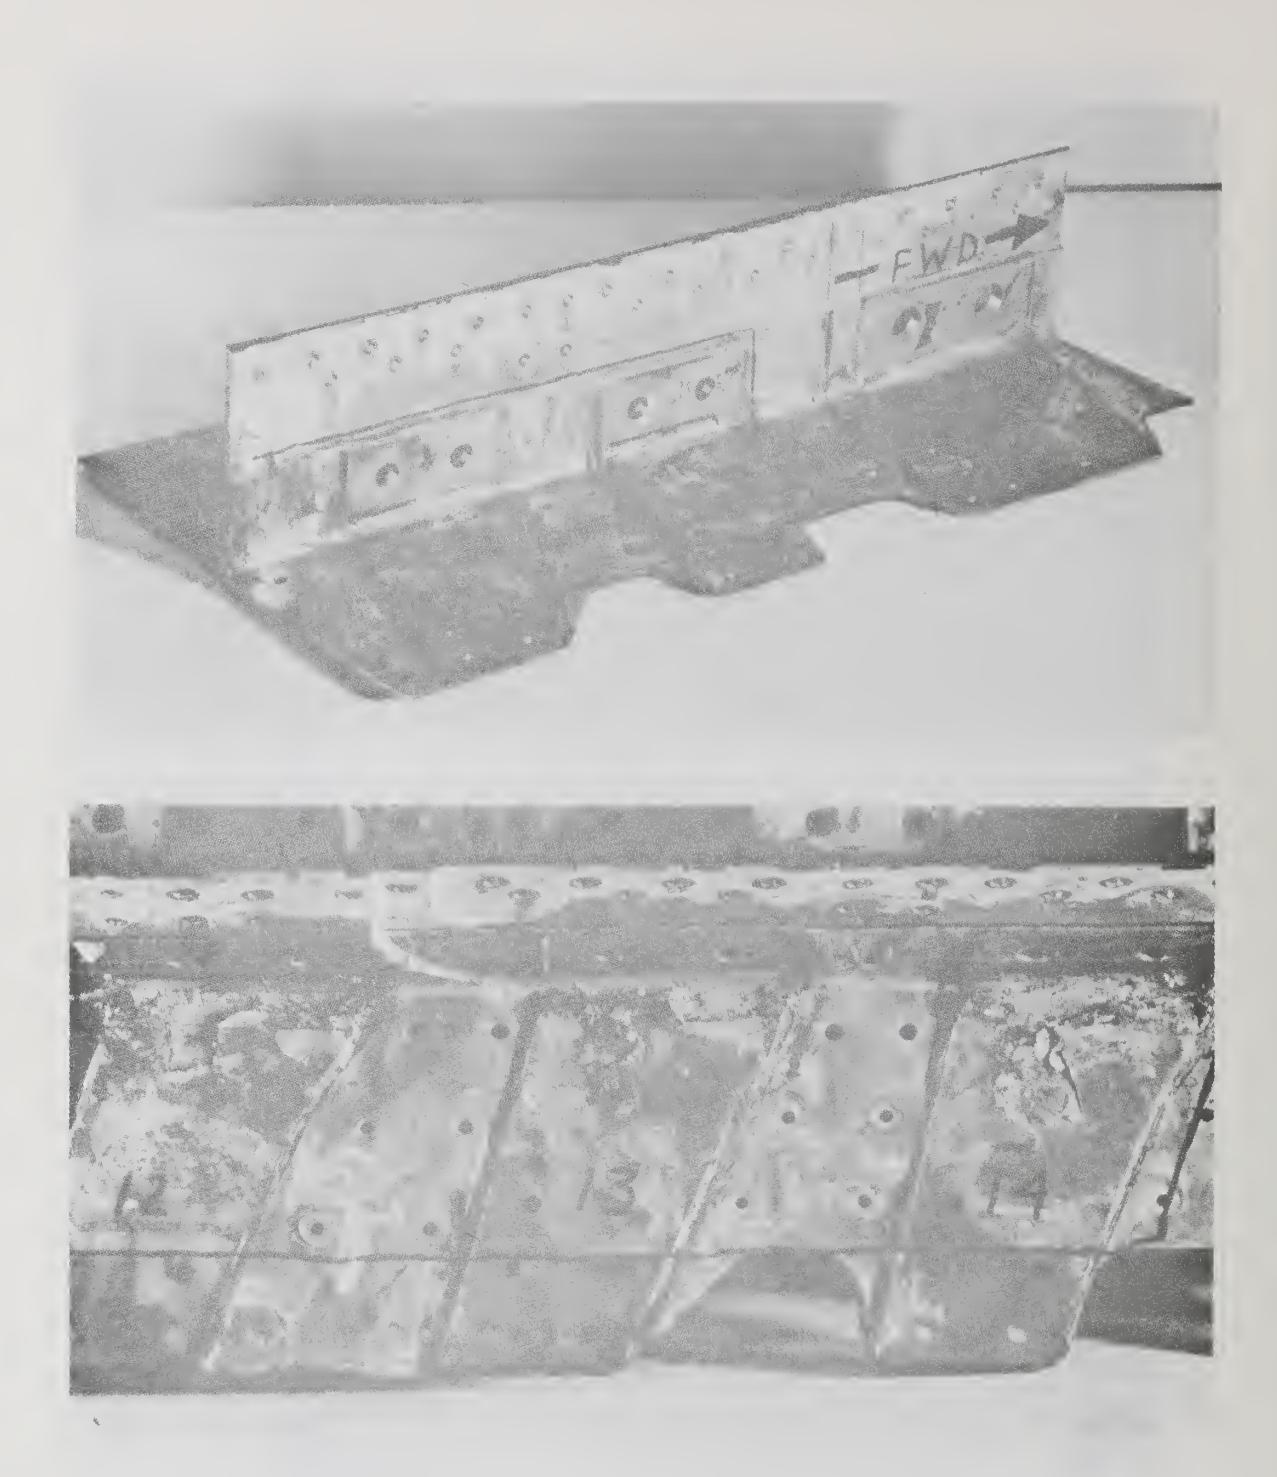
Figure 16. Photograph showing two views of the tee-cap surface from the DC-9 wing tank. Tee caps identified as 13 and 14 correspond to radiographs displayed in Figure 15.
