# NBS SPECIAL PUBLICATION 640

# Innovation for Maintenance Technology Improvements

Proceedings of the 33rd Meeting of the Mechanical Failures Prevention Group, held at the National Bureau of Standards, Gaithersburg, MD, April 21-23, 1981

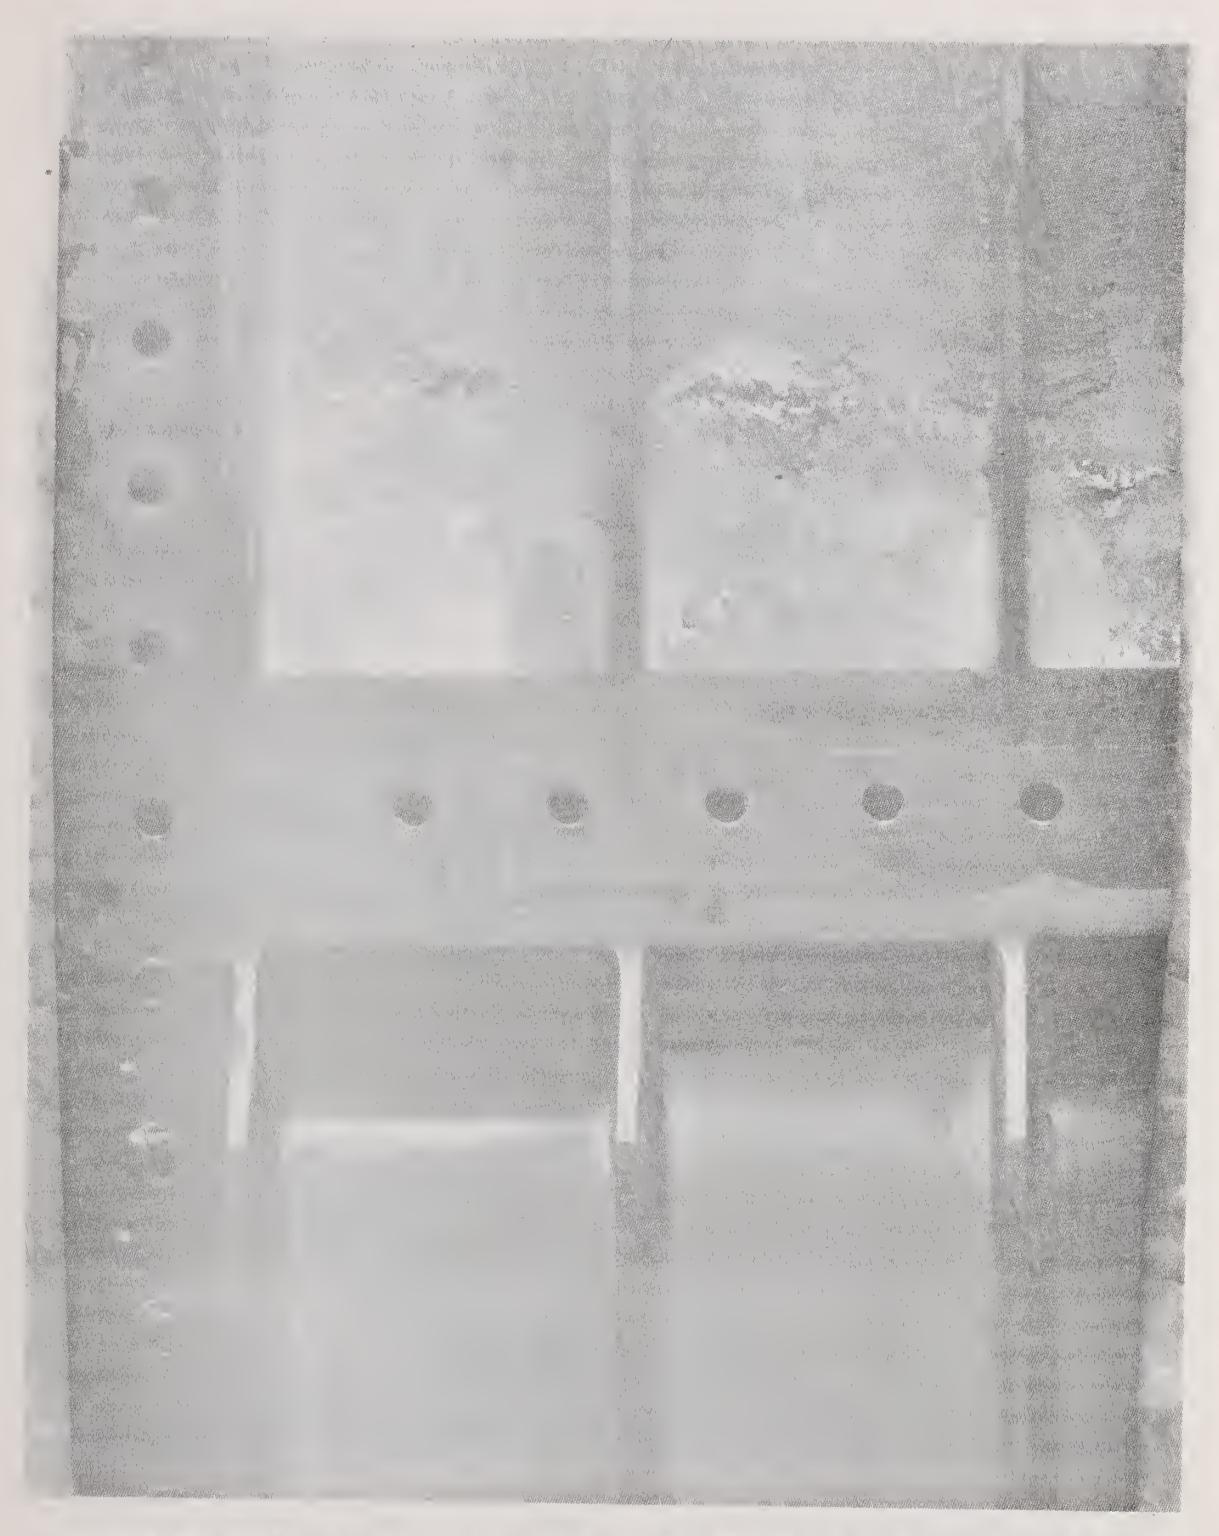
Figure 17. Photograph of a portion of the lower wing skin structure of a C-130 aircraft, showing the origin of the corrosion attack. The extent of corrosion is not clear from such visual inspection.

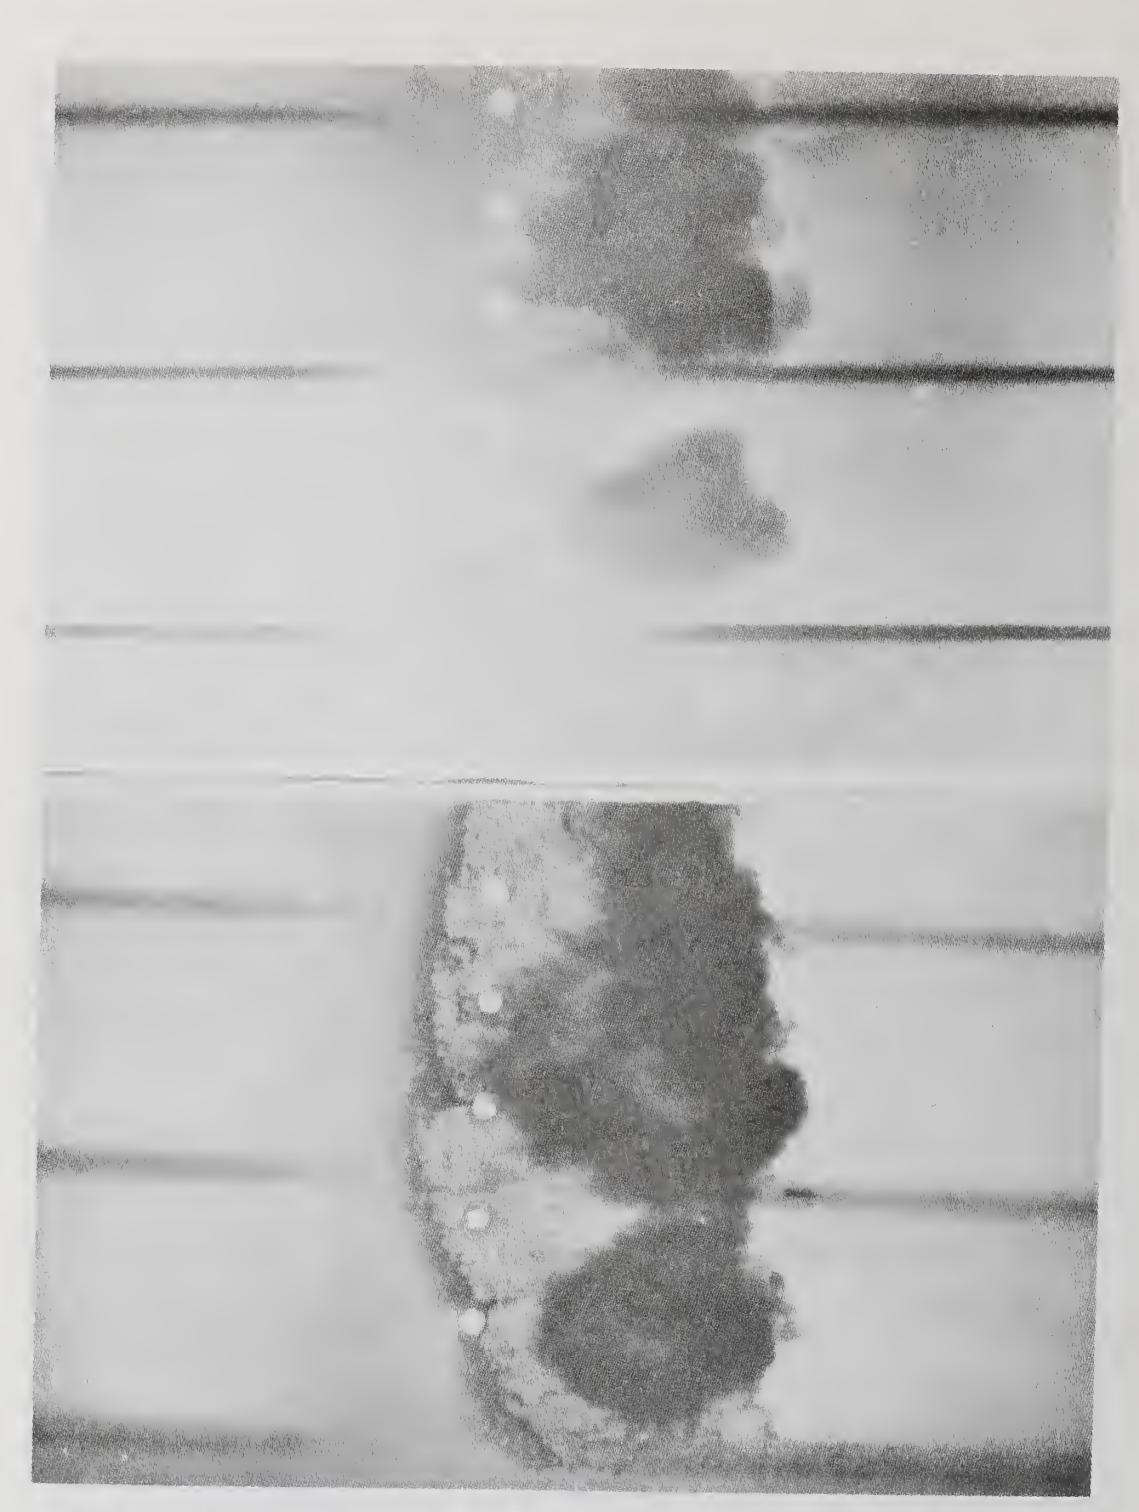
Figure 18. Neutron radiograph of C-130 wing structure. The neutron radiograph at the top is obtained in the usual way, and the one at the bottom with the use of a penetrant. The intergranular corrosion is seen to extend beyond the rivet holes, clearly explaining the cause of fuel leak from these holes.

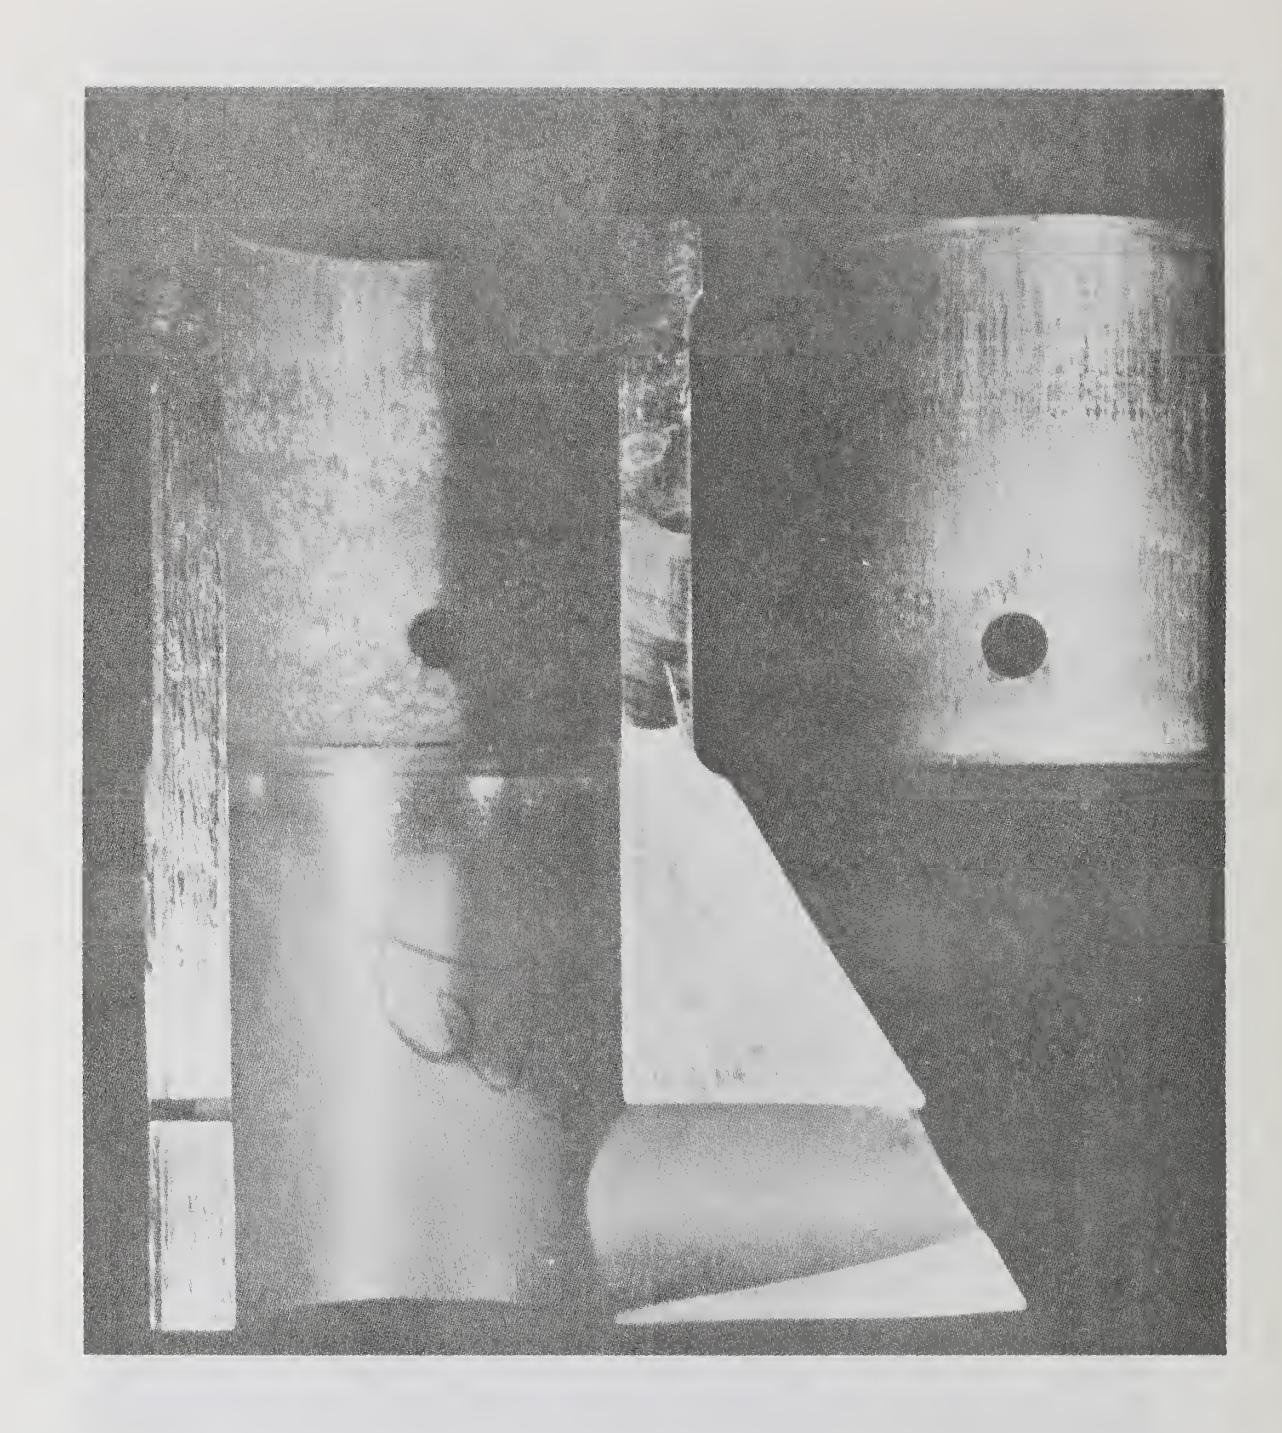
Figure 20. Photograph of the sectioned trunnion area showing the extent and shape of stress-corrosion crack

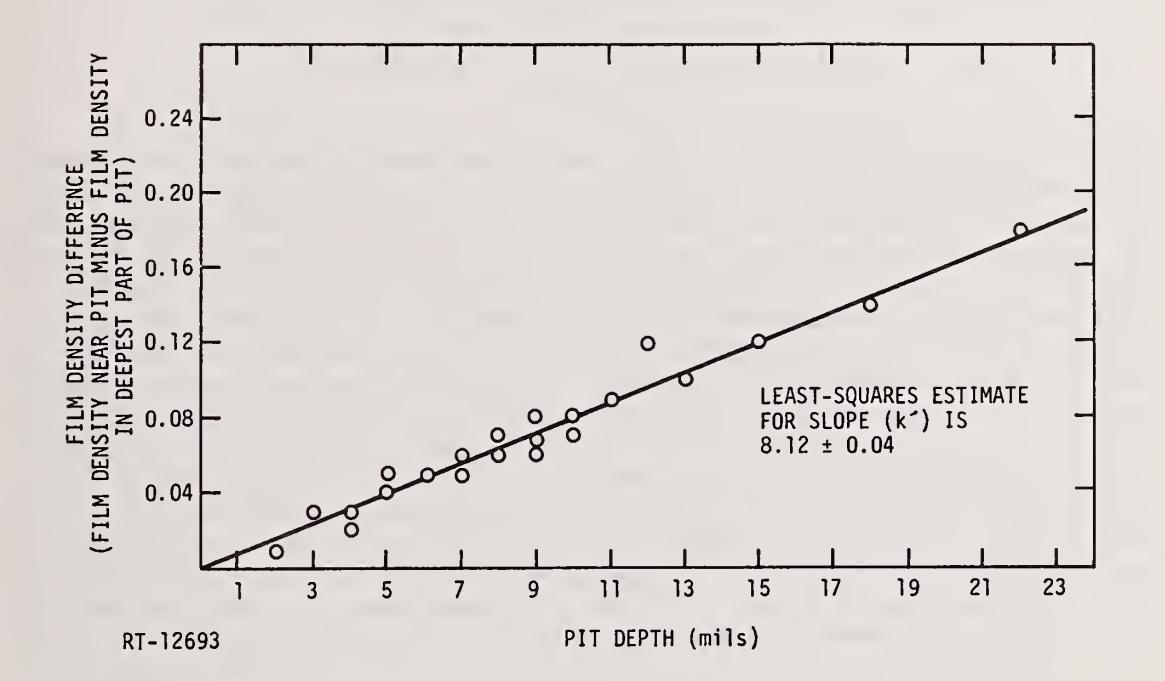
Figure 21. Graph of film density difference versus pit depth for corroded pits located on F-4 torque box panels (with AA film)

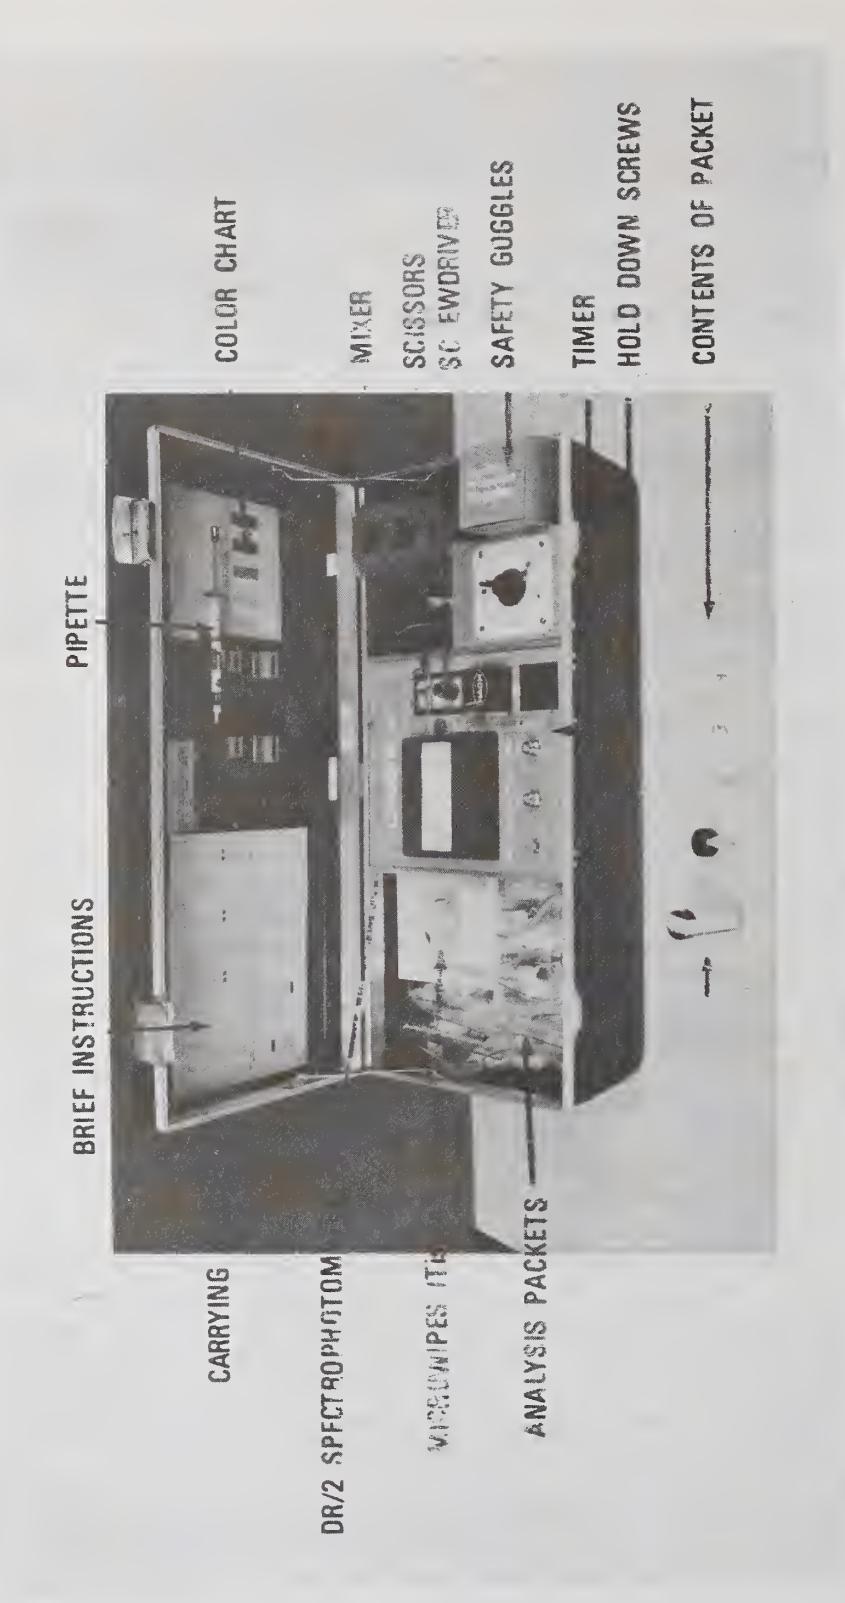
Figure 2. Colorimetric oil analysis field test kit.

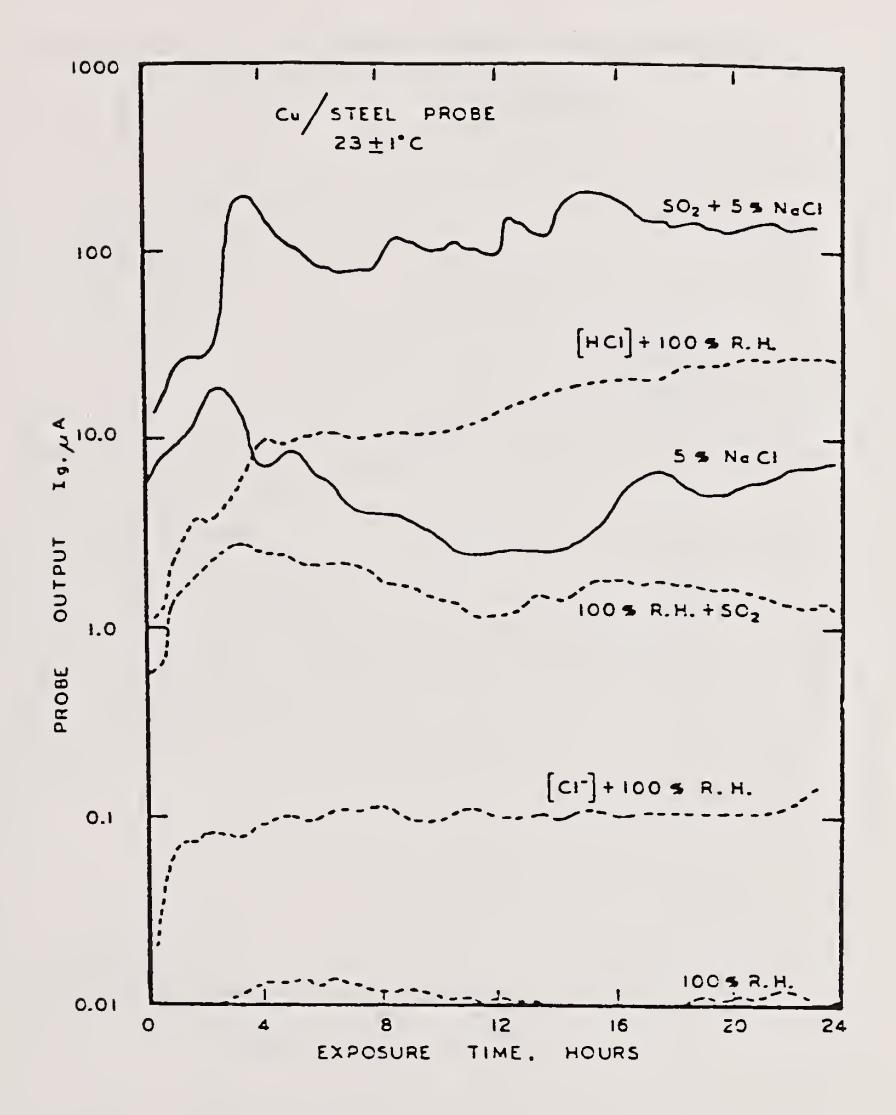
FIGURE 2. GALVANIC CURRENT TRANSIENTS OF COPPER/STEEL PROBE EXPOSED TO VARIOUS LABORATORY SIMULATED ENVIRONMENTS.

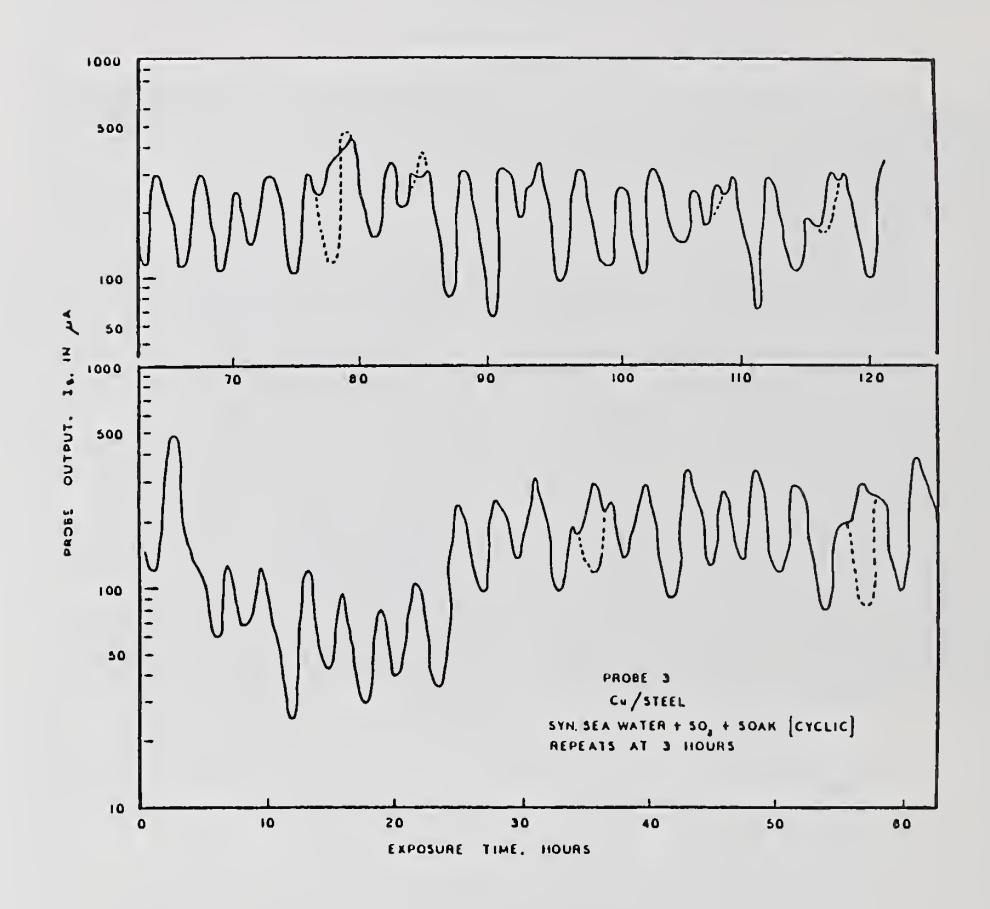
FIGURE 7. PERFORMANCE OF COPPER/STEEL PROBE IN AN ALTERNATING CORROSIVE ENVIRONMENT (SOAK CYCLE) OVER A LONG PERIOD OF EXPOSURE SHOWING THE CYCLIC NATURE OF THE ENVIRONMENTAL CORROSIVITY TEST.
#### IMPROVING MAINTENANCE. MANPOWER UTILIZATION
