U. S. DEPARTMENT OF COMMERCE  
NATIONAL BUREAU OF STANDARDS

UNDERGROUND CORROSION

CIRCULAR C450

[Issued November 27, 1945]

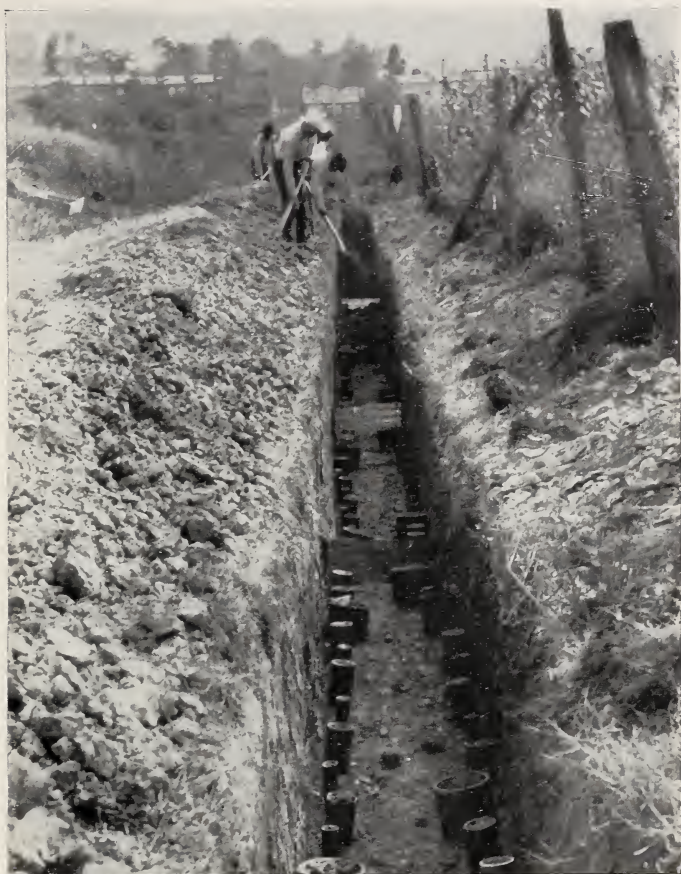
FIGURE 4.—Burial of soil corrosion specimens near Alexandria, Va., in 1922.

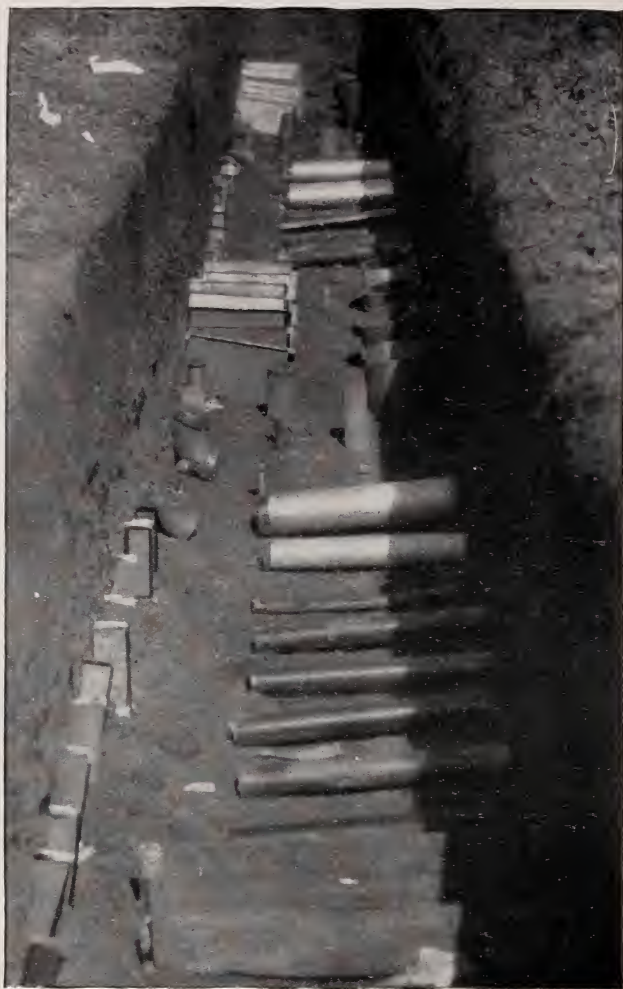
FIGURE 5.—*Arrangement of specimens buried in 1924*

Note two soil horizons.

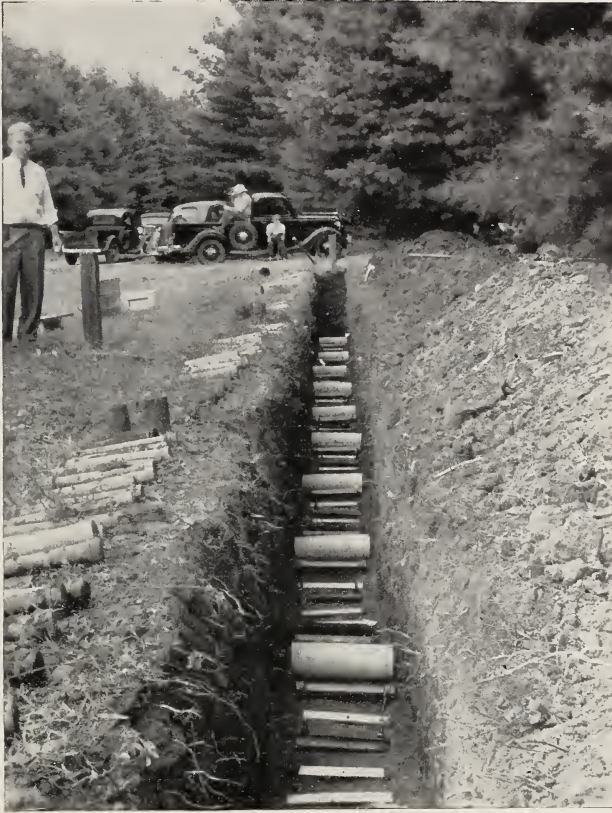
FIGURE 6.—Arrangement of specimens buried near Baltimore, Md., in 1932.

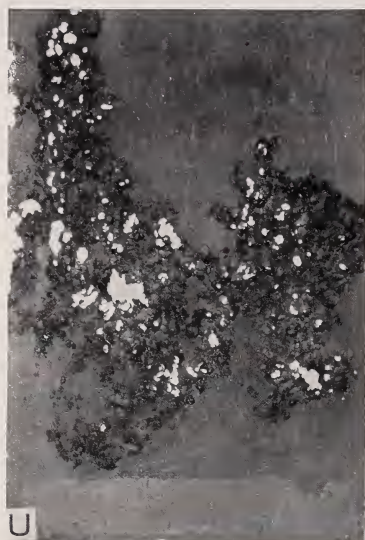
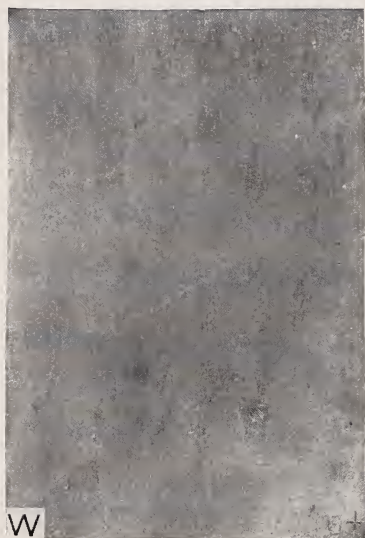
FIGURE 14.—Specimens of high-alloy sheet buried 9 years in Docas clay at Cholame, Calif. (soil 64).

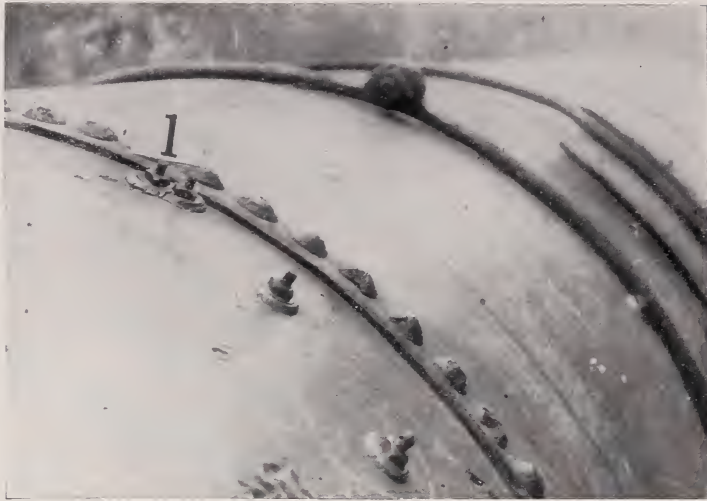
FIGURE 19.—*Three types of repairs on a water line.*

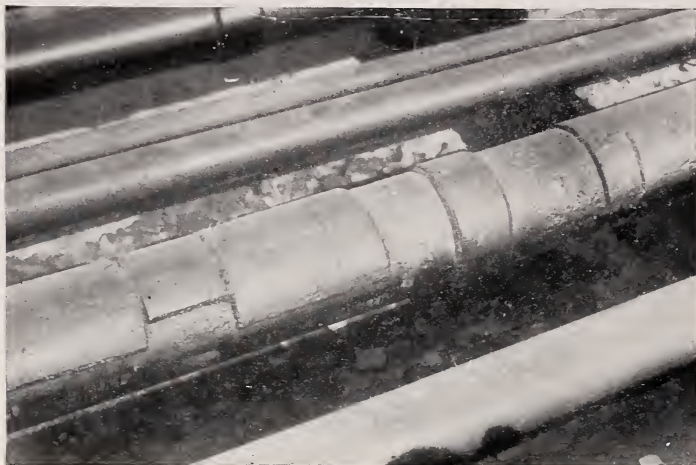
FIGURE 21.—“Half-sole” (welded patch) method of pipe repair.

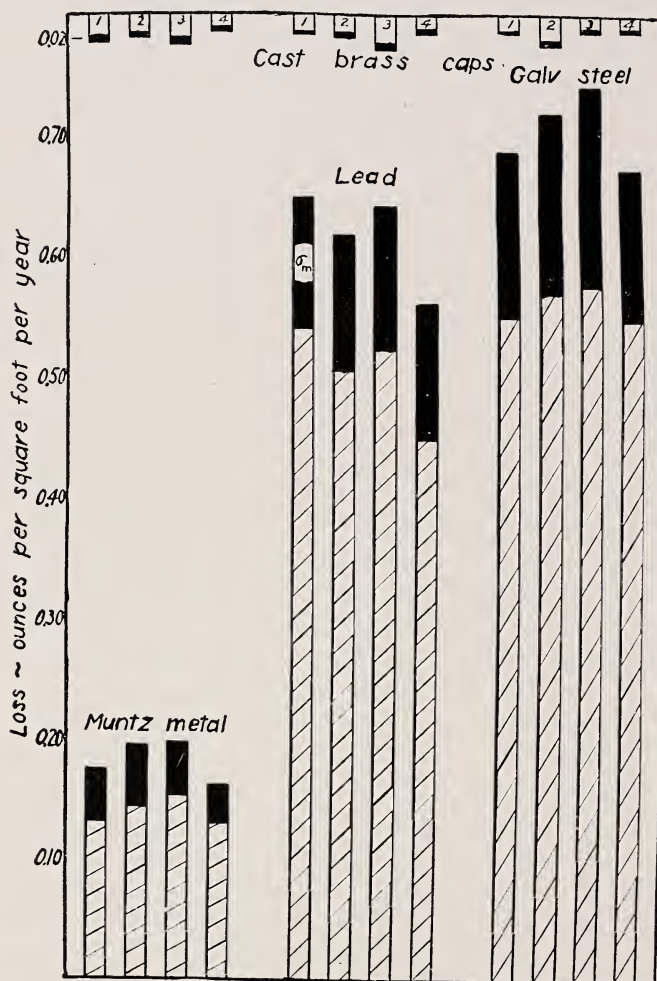
FIGURE 22.—Average rates of corrosion of cast-brass fittings and attached nipples in 15 soils.

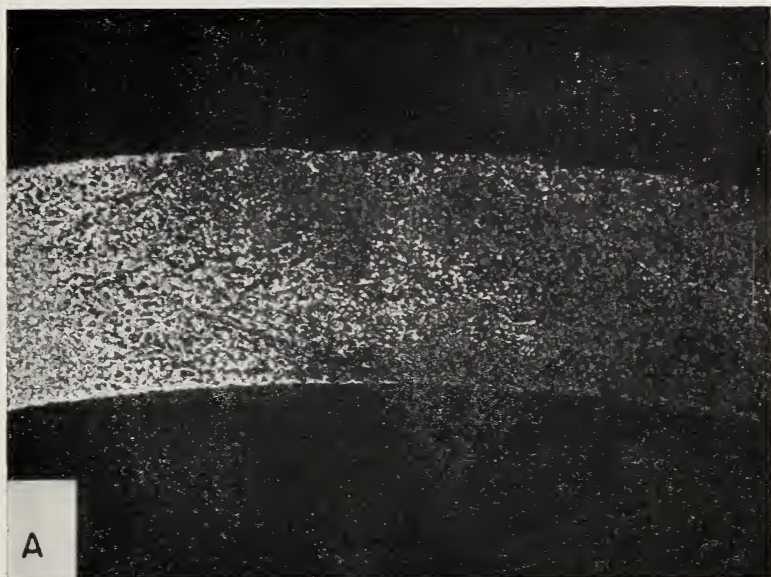
FIGURE 25.—Two-and-one leaded brass (leaded silicon brass) exposed 9.53 years to Sharkey Clay

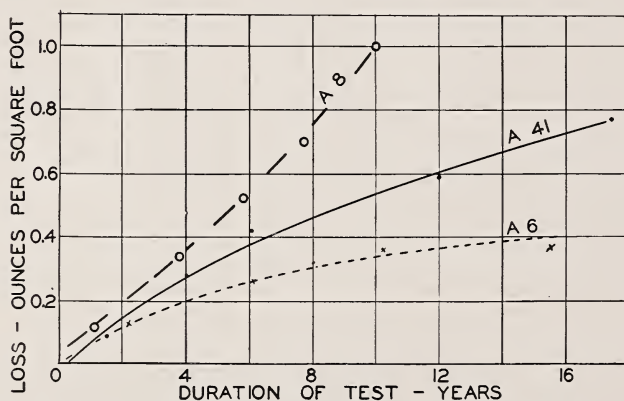
FIGURE 29.—Loss-of-weight-time curves for lead sheath in different soils.

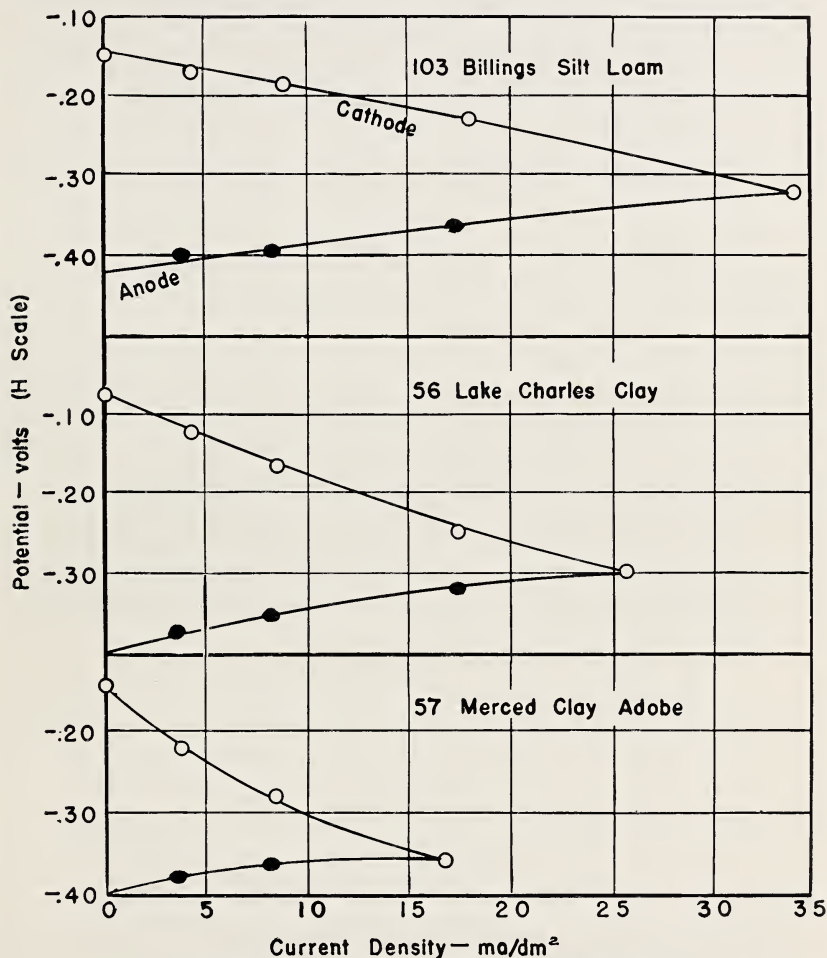
FIGURE 42.—Current-density-potential curves.

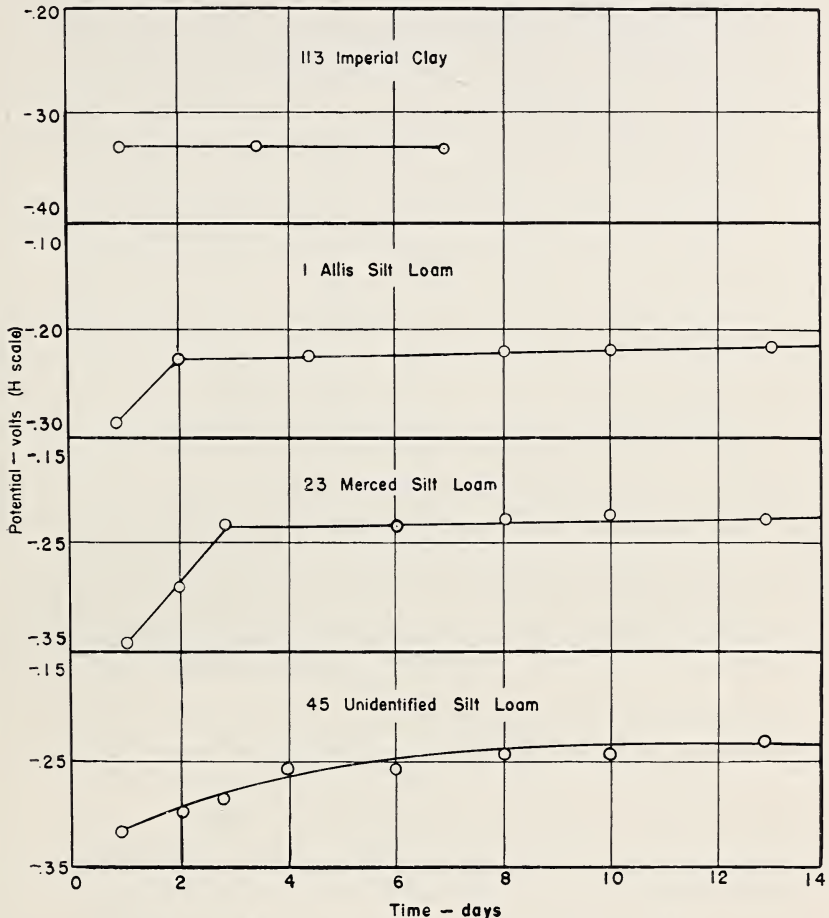
FIGURE 43.—Relation between corrosion potential and time.

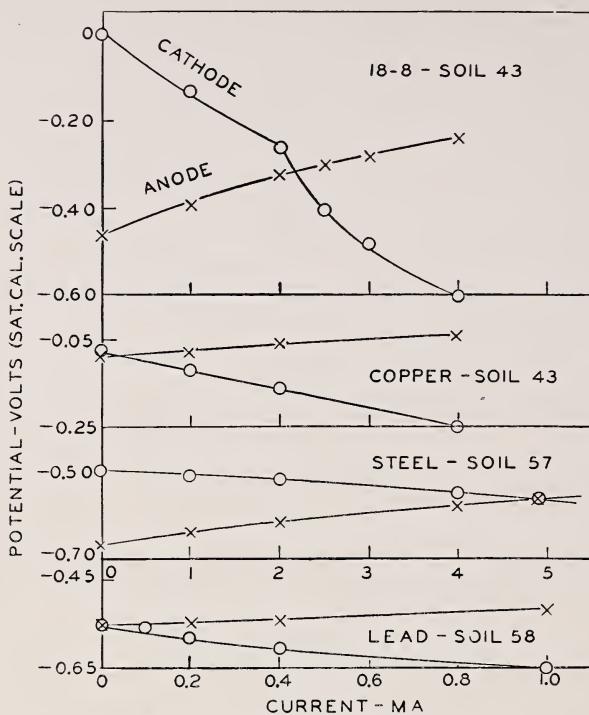
FIGURE 46.—Corrosion under cathodic control.

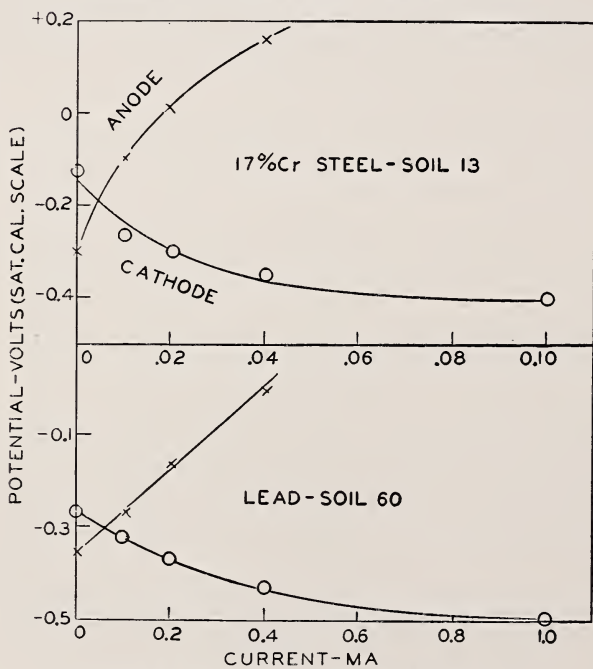
FIGURE 47.—Corrosion under anodic control.

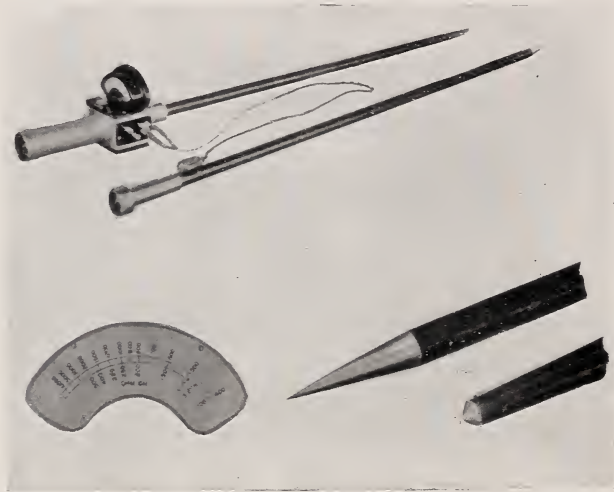
FIGURE 49.—Shepard soil resistivity meter.

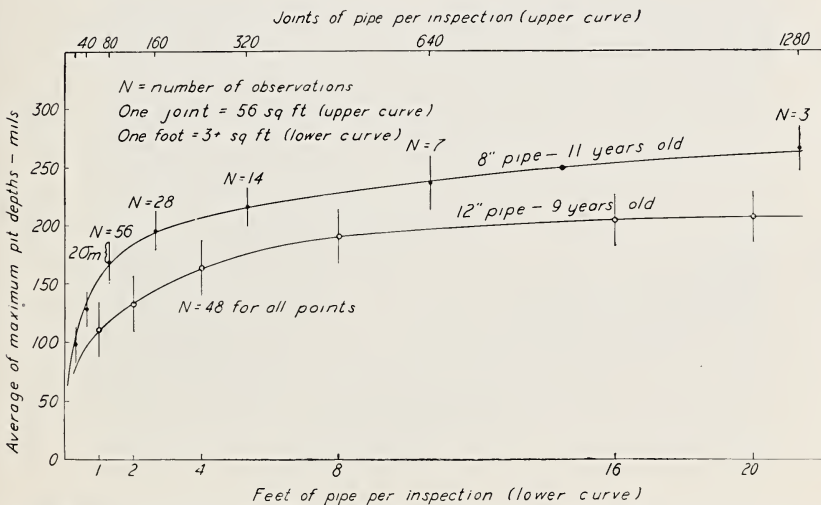
FIGURE 70.—Relation of area of pipe inspected to the maximum pit depths on each area.

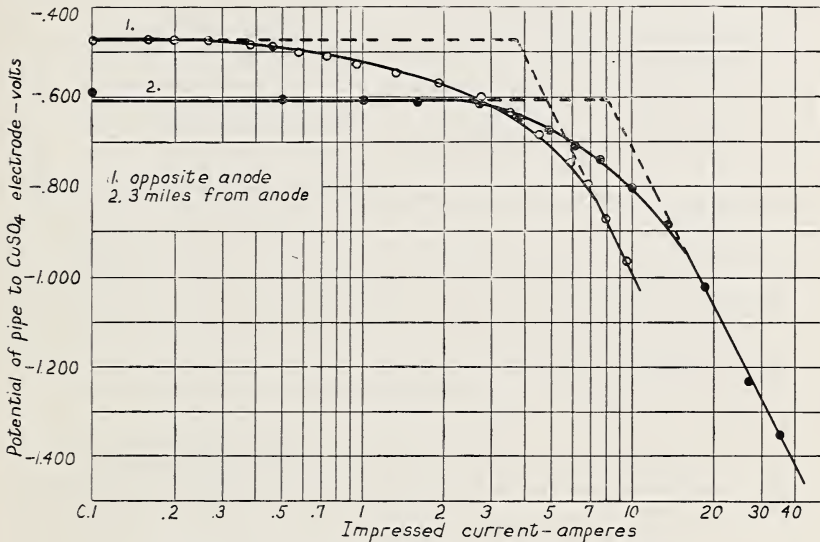
FIGURE 77.—Current-potential curves for 6-inch pipe.
