# NIST Technical Note 1648

## HEATING MODE PERFORMANCE MEASUREMENTS FOR A RESIDENTIAL HEAT PUMP WITH SINGLE-FAULTS IMPOSED

W. Vance Payne  
Seok Ho Yoon  
Piotr A. Domanski

September 2009

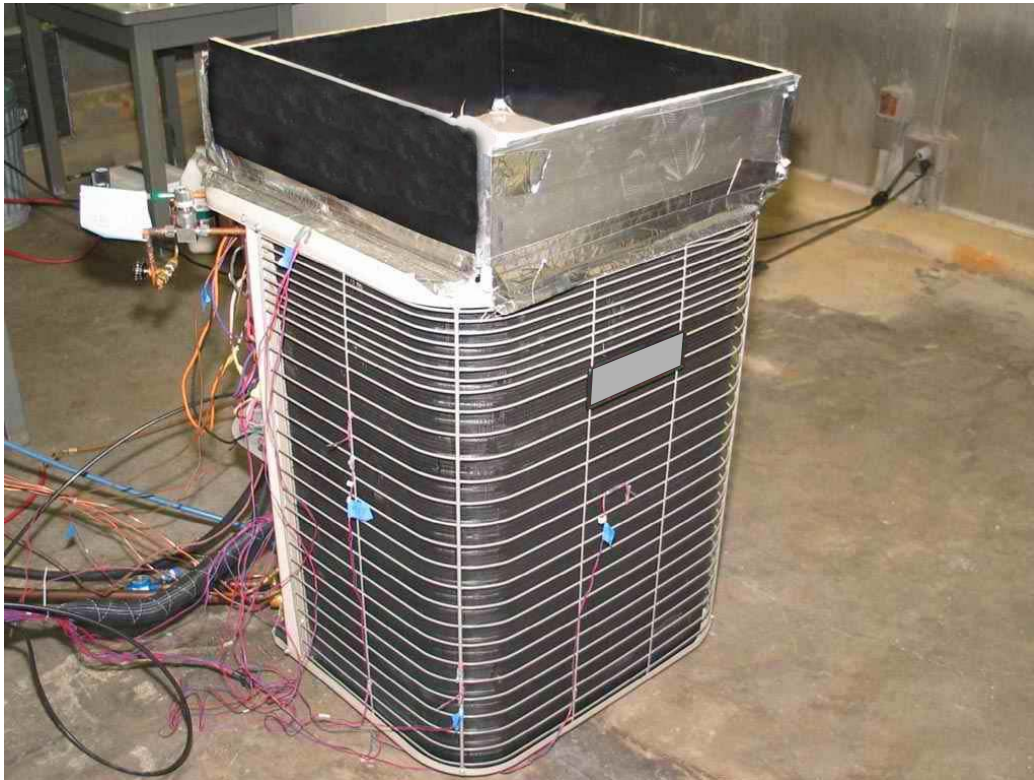
Figure 3.1. Side view of the outdoor section with the flow guide

Figure 3.1 shows the outdoor section. A flow guide was attached to the top of the unit to aid in the traverse of a hot wire anemometer. The coil had 81 cm x 175 cm of finned area, with 7 fins cm<sup>-1</sup> of a wavy-lanced type fins. Figure 3.2 shows a schematic of the outdoor heat exchanger refrigerant circuitry.

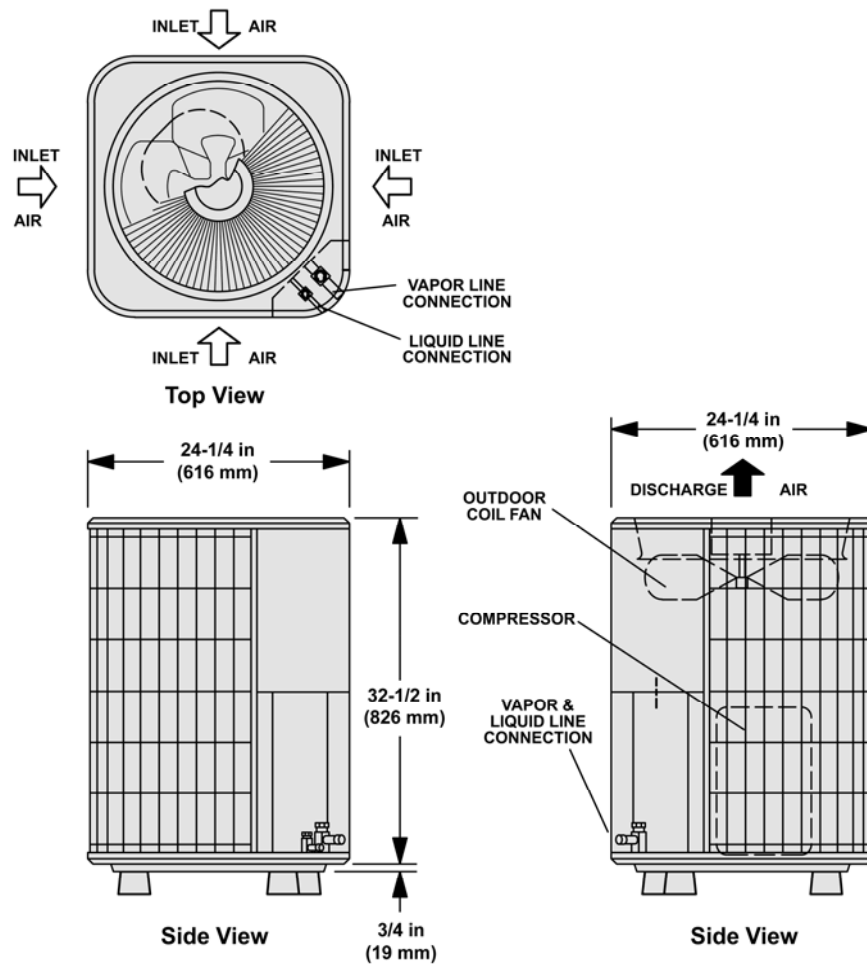
Figure 3.3. Outdoor section dimensions

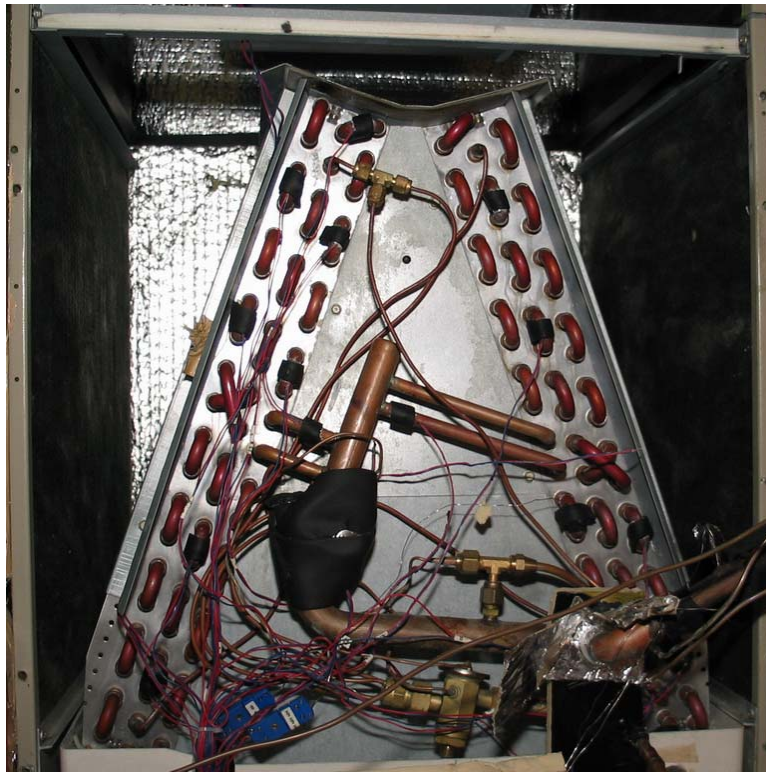
Figure 3.4. Side view of the indoor coil in an upflow configuration

Figure 3.4 shows the side view of the indoor coil assembly. It comprised two identical slabs and was designed for airflow from the bottom to the top. The two slabs were configured in an A-shape at an angle of  $60^\circ$ . Each slab of the coil had  $48.5 \text{ cm} \times 43 \text{ cm}$  of finned area with  $5 \text{ fins cm}^{-1}$  of the wavy-lanced type. Figure 3.5 shows the refrigerant circuitry for both slabs. Each slab had two inlets from the TXV and two outlets connected to the suction manifold. Figure 3.6 shows the configuration and outside dimensions of the indoor fan-coil unit. The airflow rate through the coil was approximately  $1700 \text{ m}^3 \text{ h}^{-1}$  during standard cooling tests. With the same fan speed, heating airflow rate varied from  $1650 \text{ m}^3 \text{ h}^{-1}$  to  $1675 \text{ m}^3 \text{ h}^{-1}$ . Fin thickness for both the indoor and outdoor coils was  $0.12 \text{ mm}$ . The indoor blower and system functions were controlled through normal thermostat low voltage wiring, powered by the airhandlers low voltage transformer, connected to single-pole single-throw (SPST) manually activated switches.

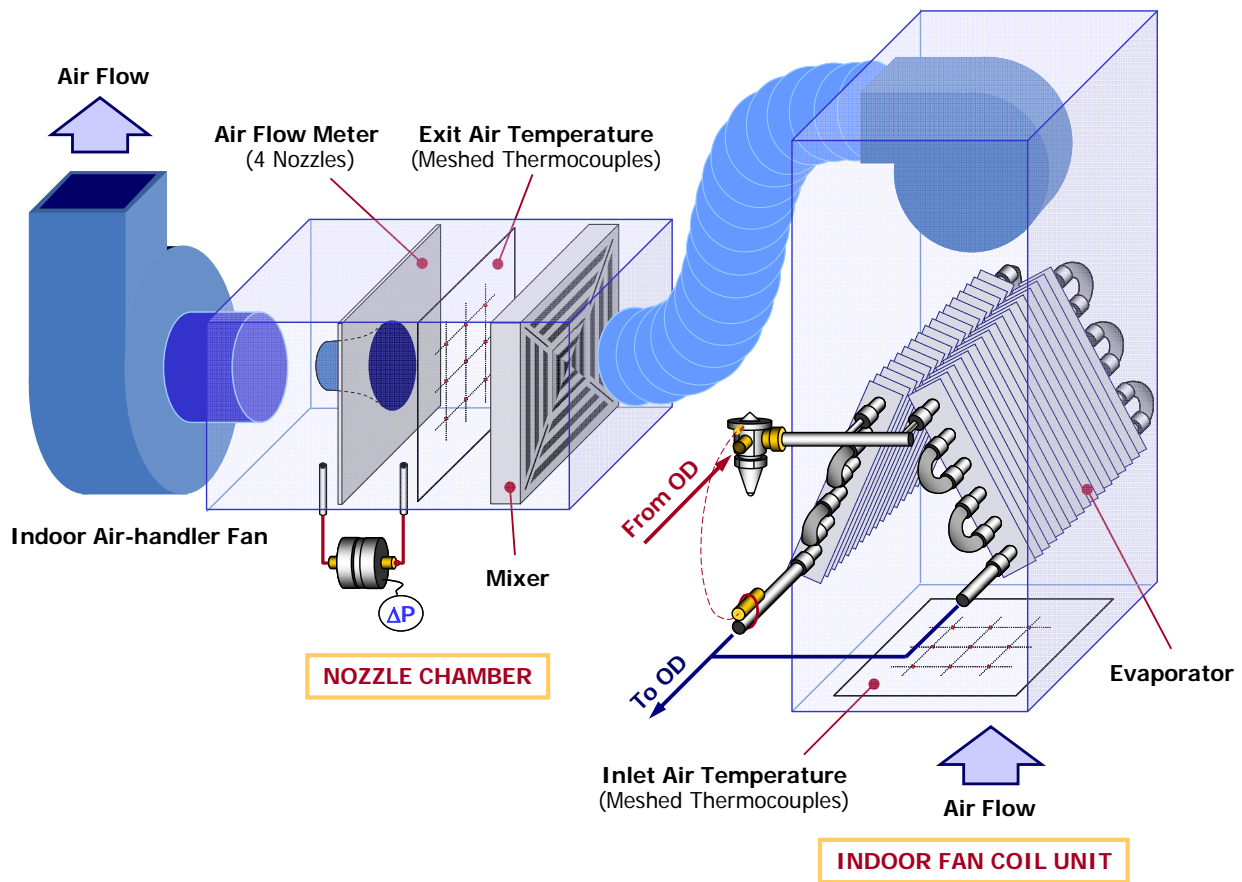
Figure 3.7. Air duct arrangement in the indoor environmental chamber

Figure 3.7 shows the air duct arrangement in the indoor environmental chamber. The ductwork was constructed according to the applicable standards (ANSI/ASHRAE Standard 51, ANSI/ASHRAE Standard 37). The air was pulled through the test apparatus by a centrifugal fan located at the outlet of the nozzle chamber ductwork. Figure 3.8 shows the schematic diagram of the heat pump installation. On the air side, the setup involved measurements of dry-bulb and dew-point temperatures, barometric pressure and pressure drop. Dew-point temperature was measured at the inlet of the evaporator ductwork and downstream of the evaporator and air mixers. Twenty-five node, T-type thermocouple grids and thermopiles measured air temperatures and temperature change, respectively.

For this study the no-fault, reference air mass flow rate was set to  $1699 \text{ m}^3 \text{ h}^{-1}$ . For faulty tests, we reduced the speed of the nozzle chamber fan at the end of ductwork (see Figure 3.7). The fault level was the percent change in air mass flow rate with respect to the reference mass flow rate measured at no-fault conditions.

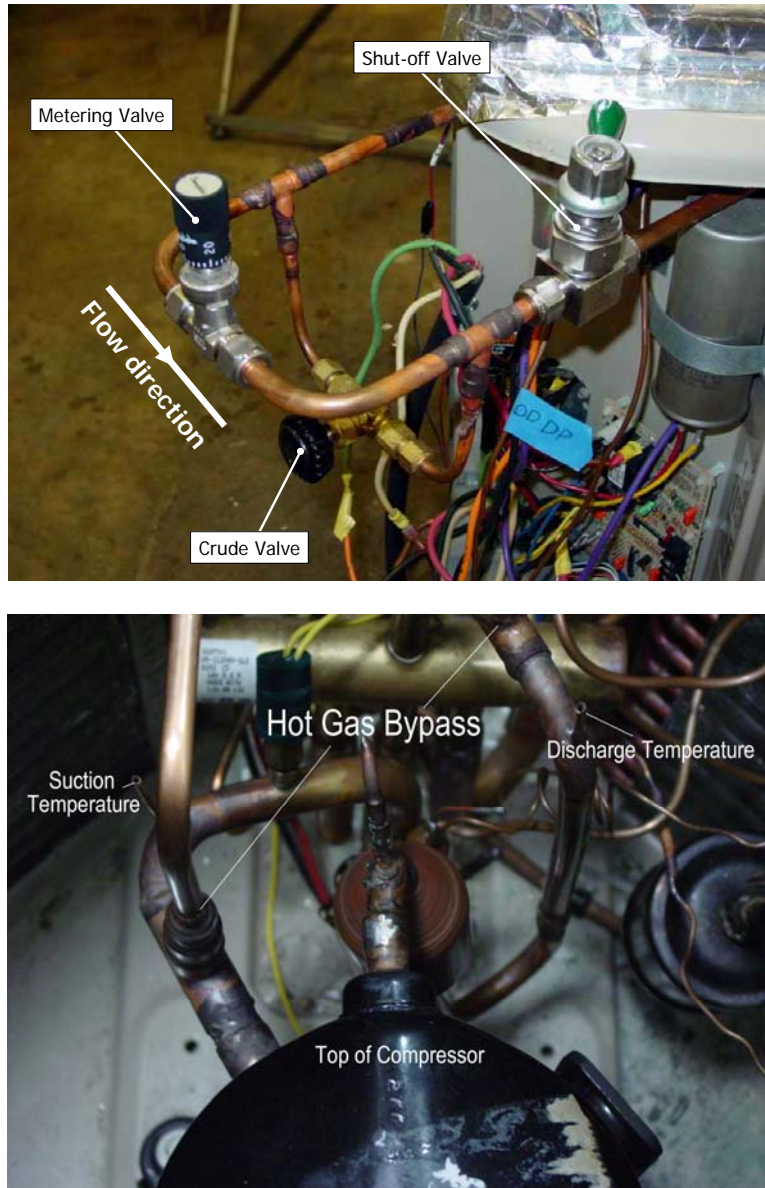
Figure 3.9. Hot gas bypass used for compressor/reversing valve leakage fault

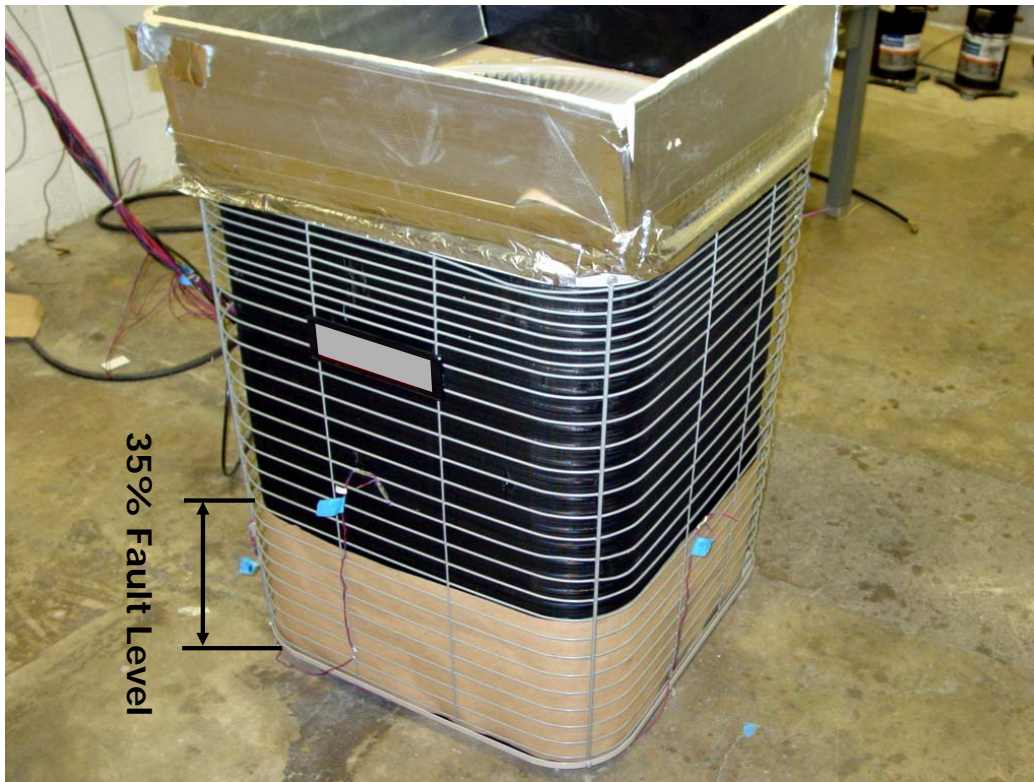
Figure 3.10. Outdoor unit with lower finned area blocked (35 % of the entire finned area blocked)

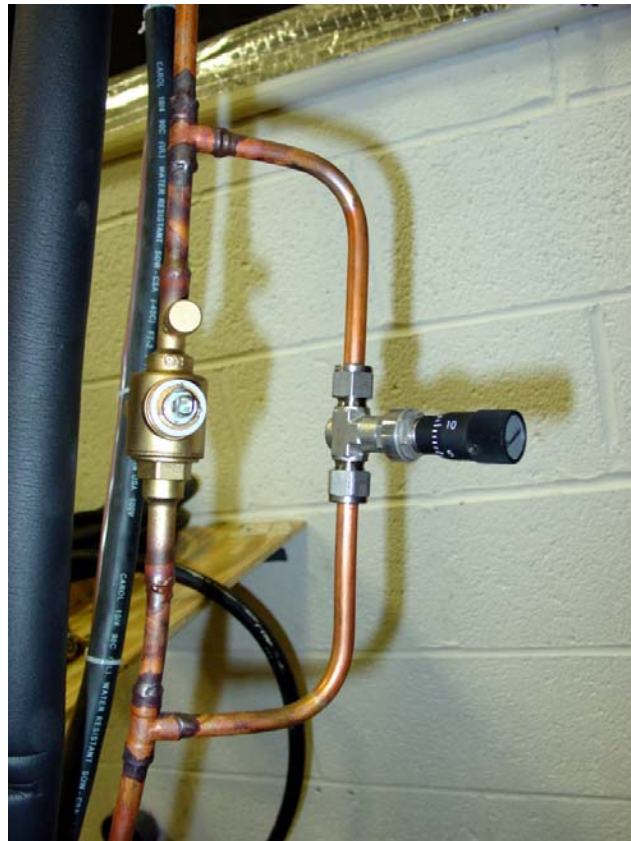
Figure 3.11. Artificial setup to implement a liquid line restriction fault using a shut-off valve and a metering valve

To simulate an increased liquid line flow restriction, we installed a shut-off valve and metering valve in the liquid refrigerant line in a parallel configuration as shown in Figure 3.11 approximately 182 cm from the outdoor unit and within the outdoor chamber. By modulating the two valves, we controlled the liquid line restriction. The level of the liquid line restriction fault was the percent change in the liquid line pressure drop with respect to the pressure differential between the condenser exit and the evaporator inlet at the no-fault condition.

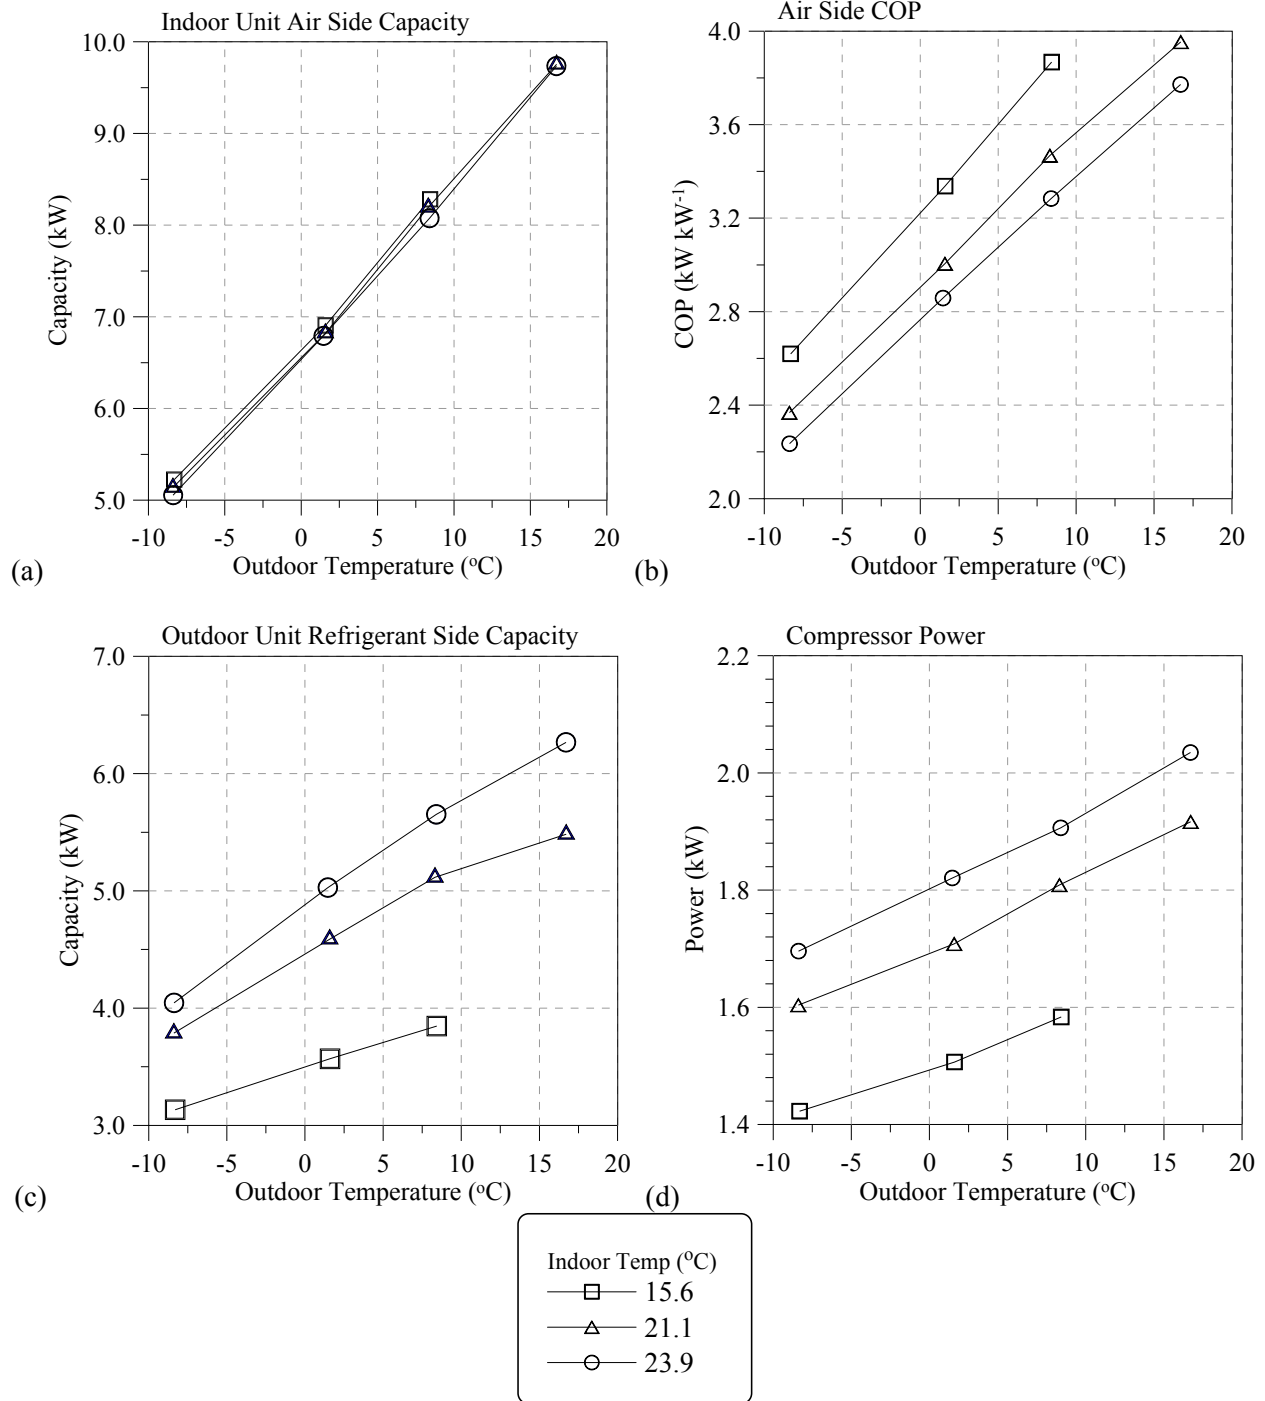
Figure 4.2.1.1. Capacity, COP, and compressor power for steady-state no-fault tests

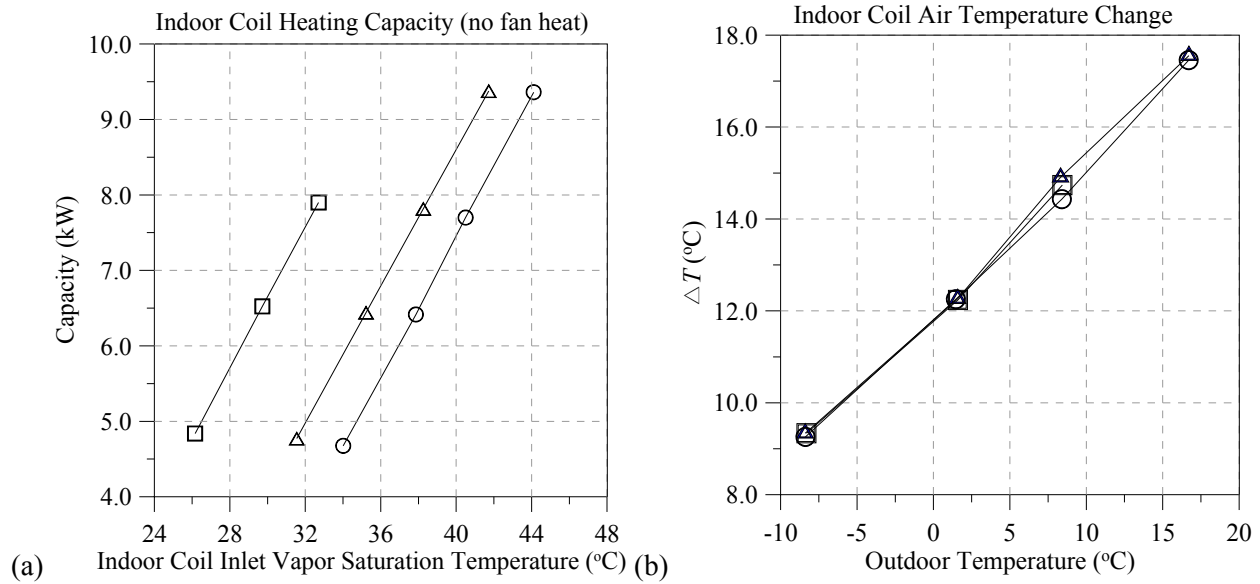
Figure 4.2.2.1. Indoor coil heating capacity and air temperature change for steady-state no-fault tests (for symbols see Figure 4.2.1.1)

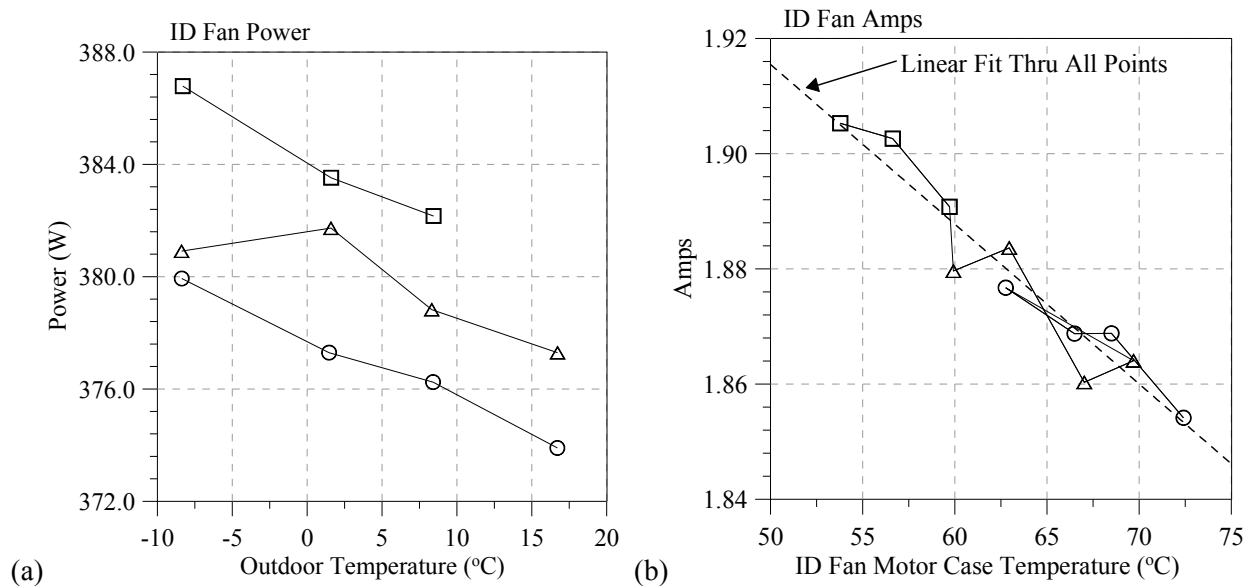
Figure 4.2.2.2. Indoor unit fan power and amps during heating mode steady-state no-fault tests (see Figure 4.2.1.1 for symbols)

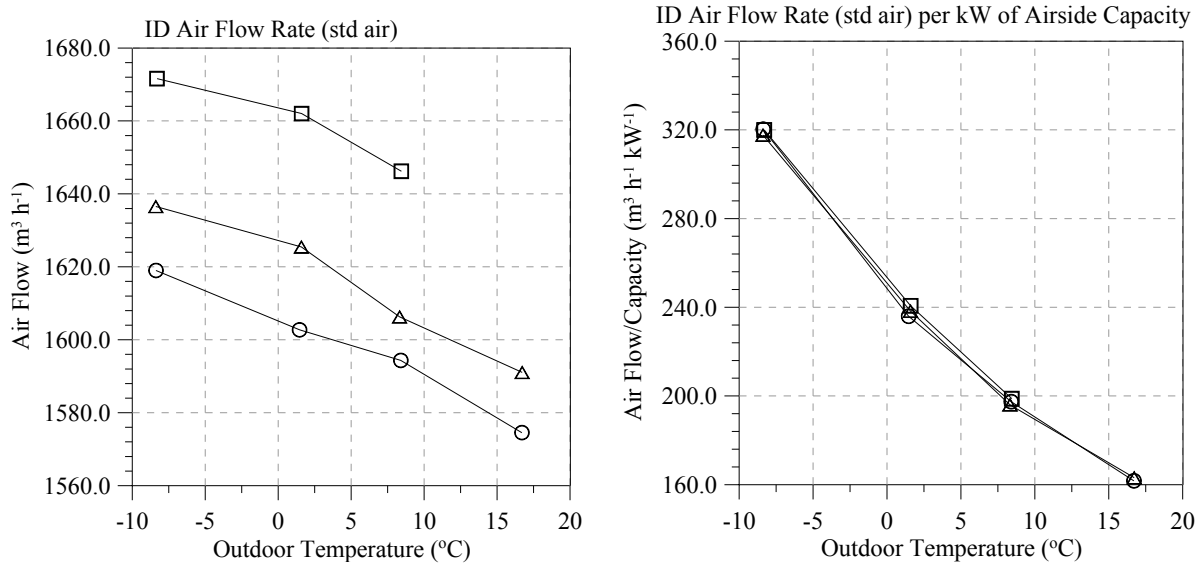
Figure 4.2.2.3. Indoor unit air flow rate and capacity-normalized air flow for steady-state no-fault tests (see Figure 4.2.1.1 for symbols)

Figure 4.2.2.3 shows the indoor unit standard air flow rate and the air flow rate per unit heating capacity. The indoor fan operates at constant speed thus more mass flow is produced at lower indoor temperatures.

At a given indoor temperature the indoor air flow decreases with increasing outdoor temperature due to higher temperature changes (more capacity and less dense air) at higher outdoor temperatures. Air flow rate per unit of heating capacity is not a function of indoor temperature.

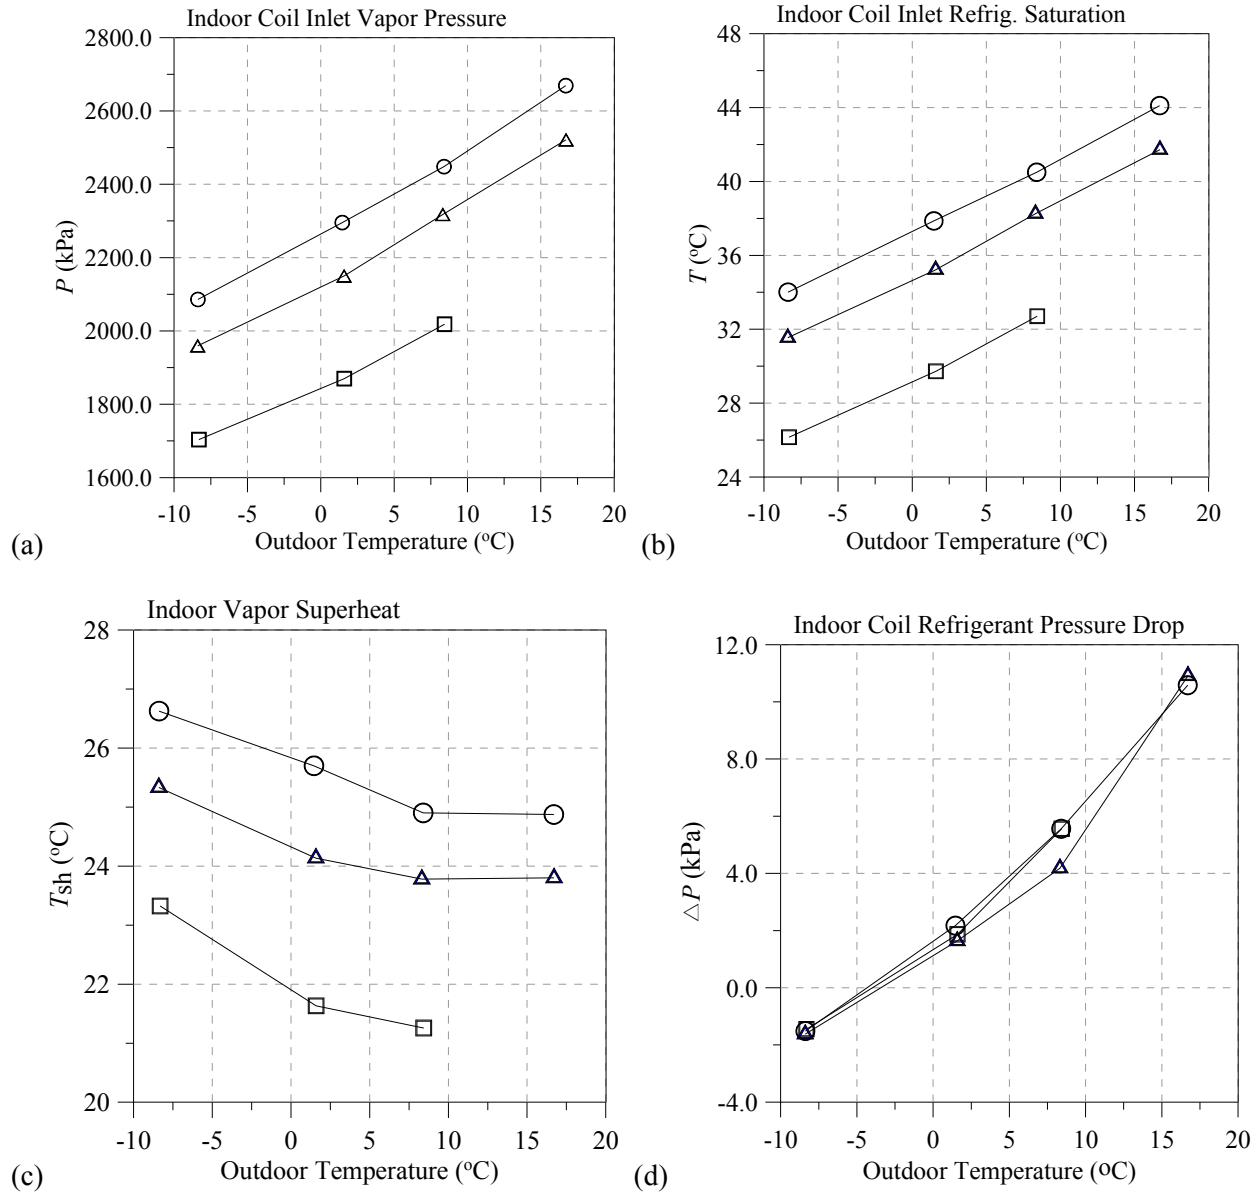
Figure 4.2.2.4. Condenser or indoor coil refrigerant measurements for steady-state no-fault tests (see Figure 4.2.1.1 for symbols)

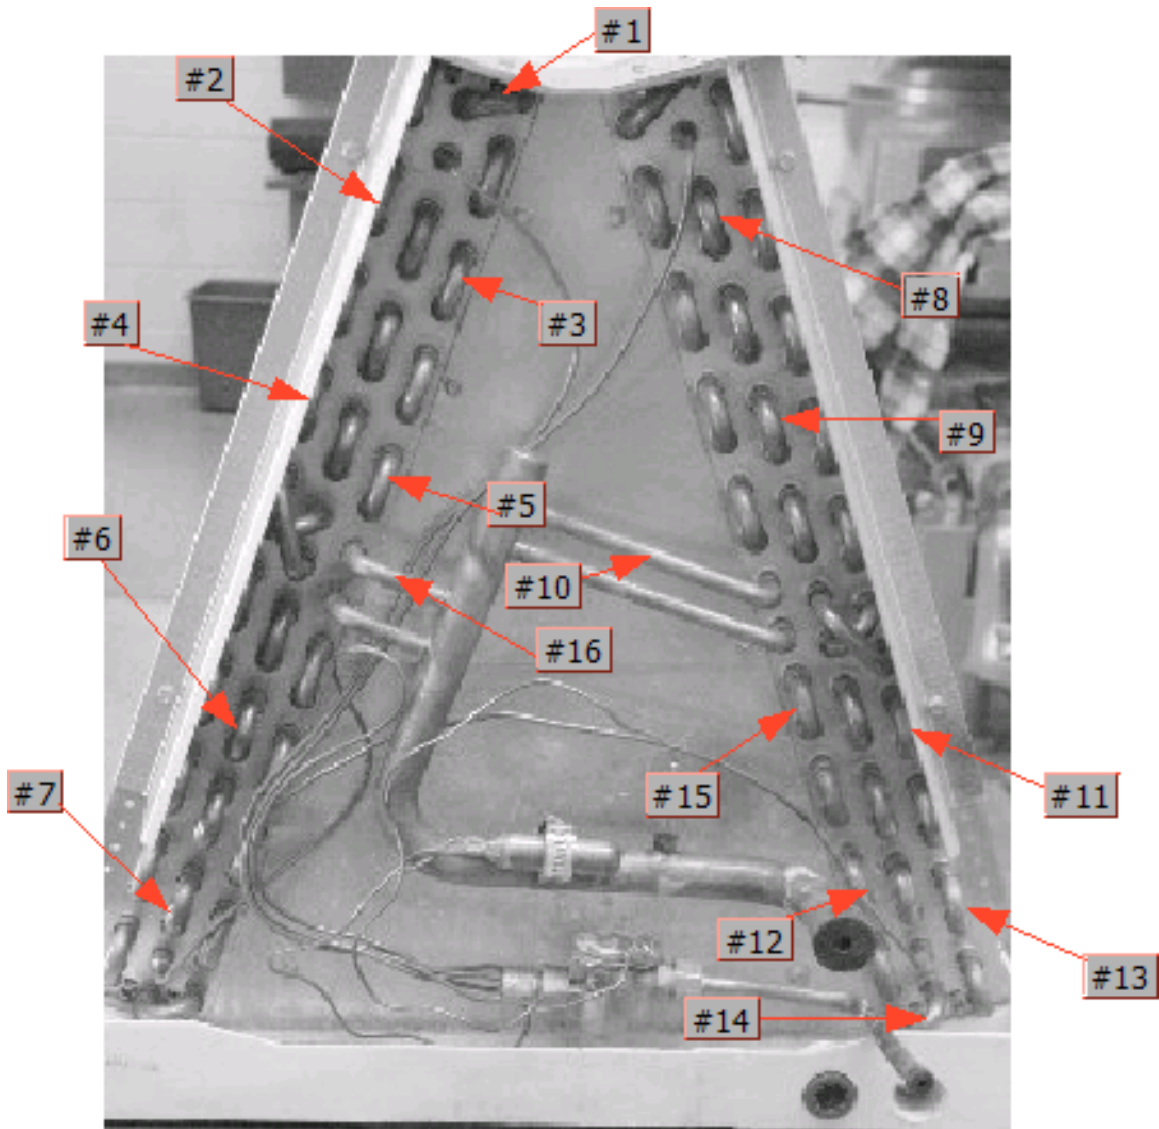
Figure 4.2.2.5. Thermocouple locations on the indoor heat exchanger

Figure 4.2.2.5 shows the location of various thermocouples attached to the indoor heat exchanger. Figure 4.2.2.6 compares temperature measured at locations #3, #5, #12, and #15 with the refrigerant saturation temperature corresponding to the pressure at the condenser inlet. As figures (a) and (b) indicate, tube bend temperatures after the first pass are indicative of the saturation temperature at the condenser inlet pressure.

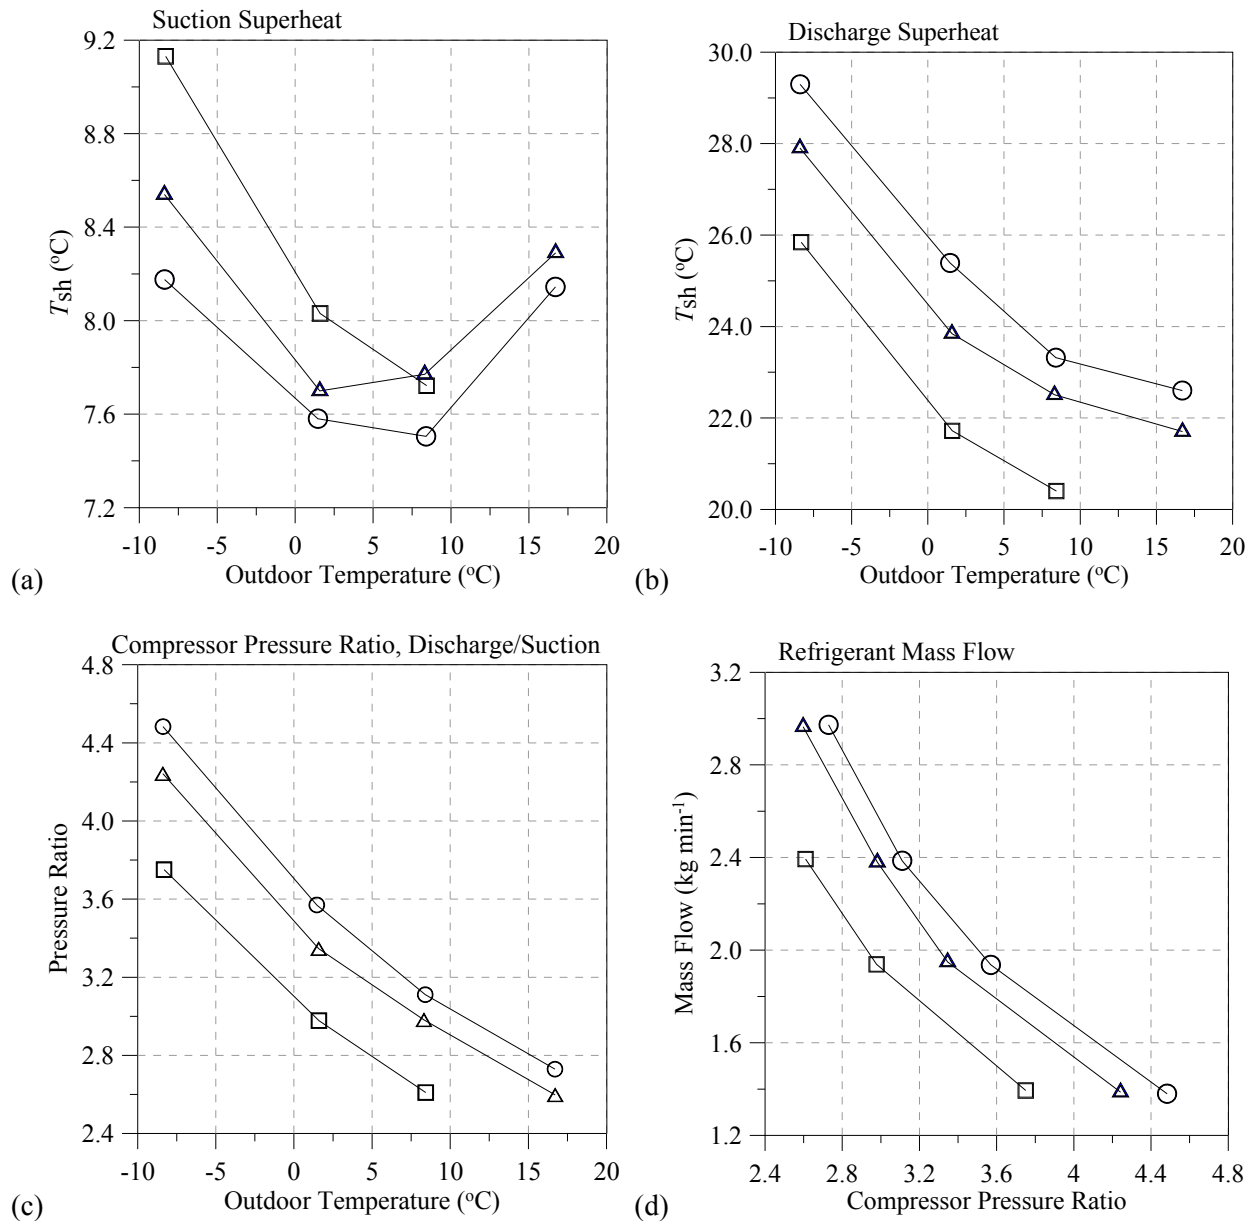
Figure 4.2.3.1. Compressor refrigerant characteristics for steady-state no-fault tests (see Figure 4.2.1.1 for symbols)

Figure 4.2.3.1 through 4.2.3.5 shows different compressor characteristics during No-Fault Steady-State, NFSS, tests at three indoor temperatures.

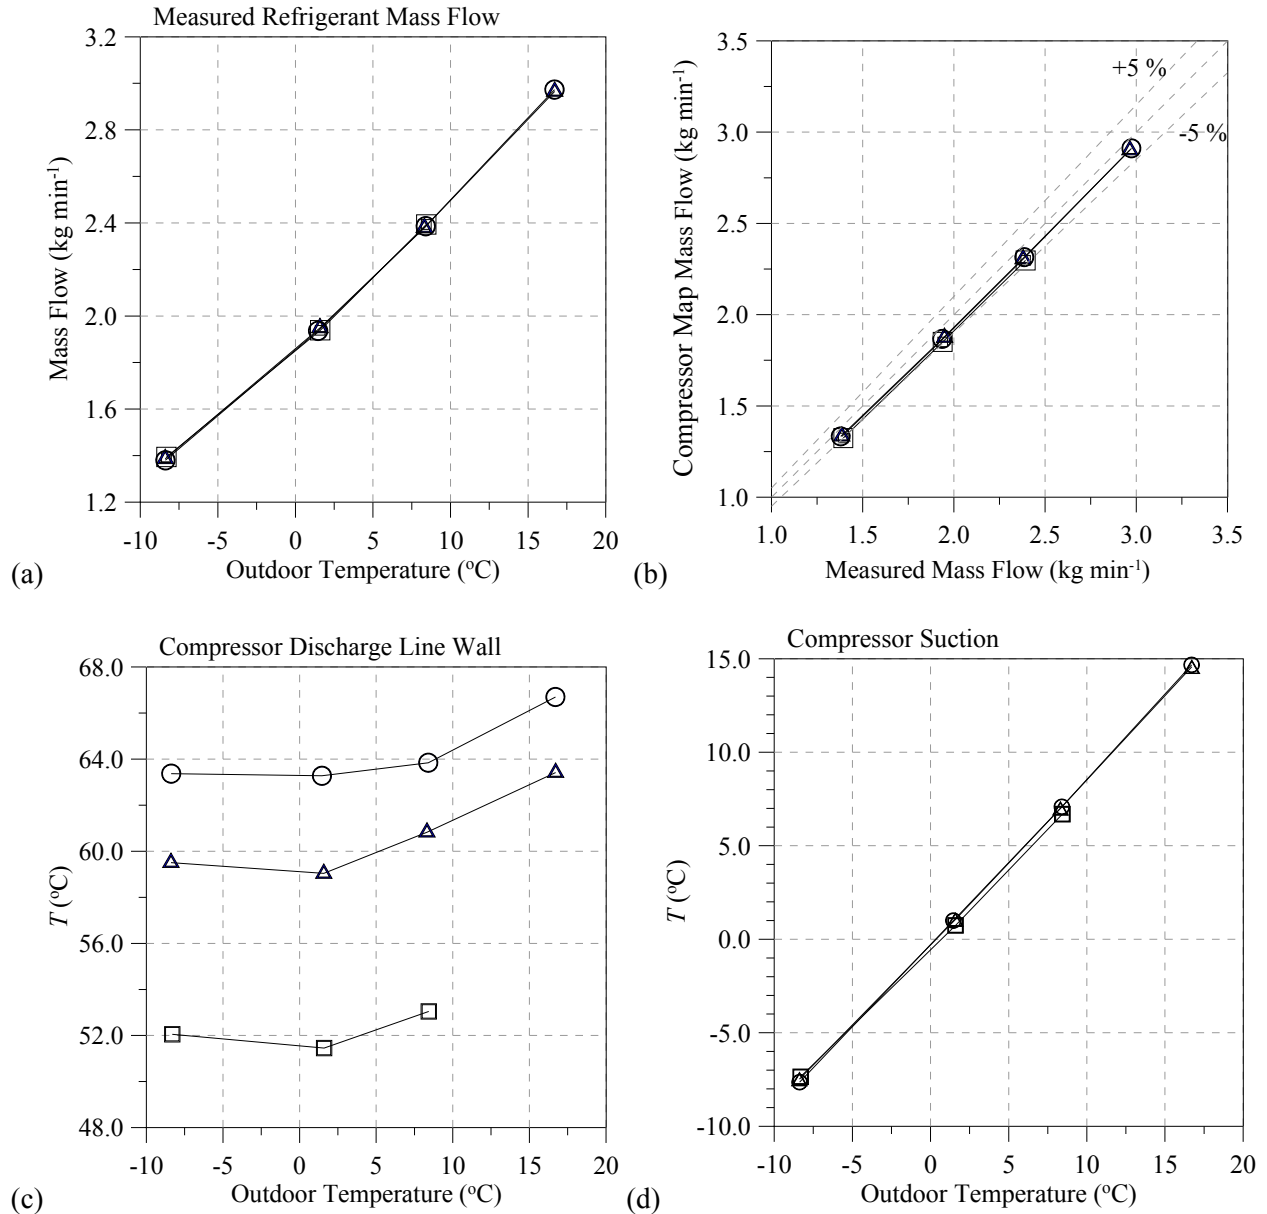
Figure 4.2.3.2. Refrigerant mass flow rate and temperatures for steady-state no-fault tests (see Figure 4.2.1.1 for symbols)

Figure 4.2.3.2 shows that the compressor map mass flow rate was within -5 % of the measured mass flow. This is very good agreement and not typical of all compressors. Discharge and suction temperatures as a function of outdoor temperature are also shown.

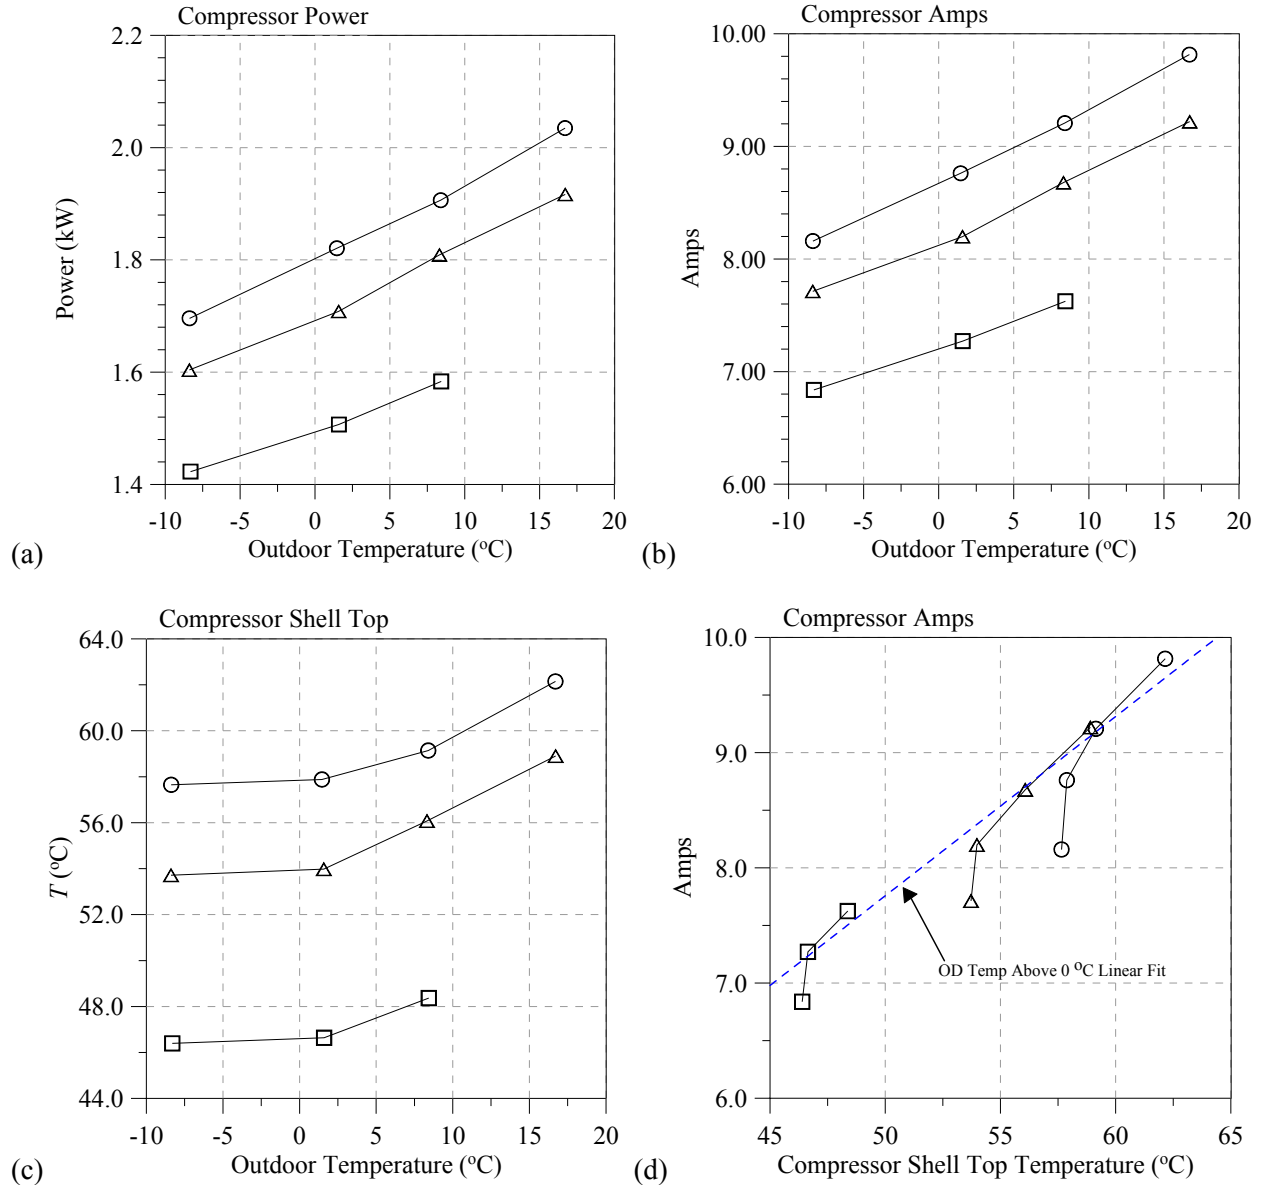
Figure 4.2.3.3. Compressor power, amps, and shell temperature for steady-state no-fault tests (see Figure 4.2.1.1 for symbols)

Compressor power and casing temperature characteristics are shown in Figure 4.2.3.3. Power and current demand are very linear with outdoor temperature for a given indoor temperature. The compressor current appears to correlate with compressor shell top temperature, especially at temperatures above 0 °C; above 0 °C the amps closely approach a linear function of shell top temperature. Figure 4.2.3.4 shows, as expected, that compressor amps correlate to pressure ratio and suction/discharge temperature difference across the compressor.

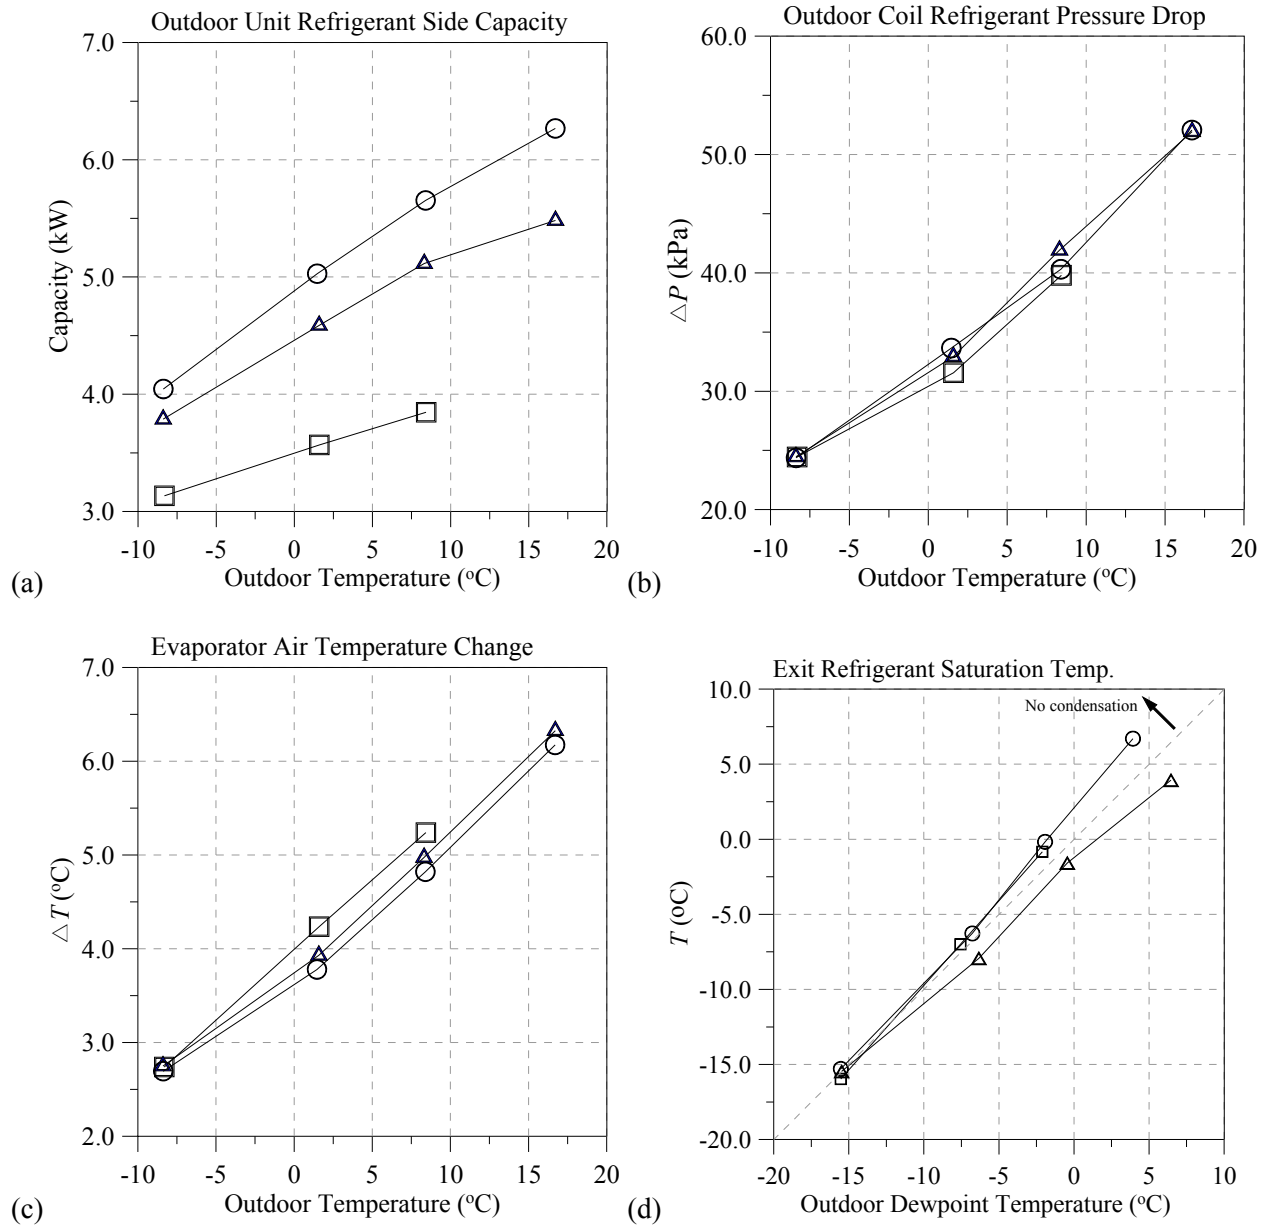
Figure 4.2.3.5. Evaporator refrigerant side capacity, pressure drop, and evaporator temperatures for steady-state no-fault tests (see Figure 4.2.1.1 for symbols)

Figure 4.2.3.5 shows refrigerant side capacity and general characteristics of the outdoor heat exchanger. Figure (d) shows that the evaporator exit refrigerant saturation temperature was below the outdoor dew-point for the 21.1 °C indoor temperature tests; condensation could form upon the coil for some of these tests.

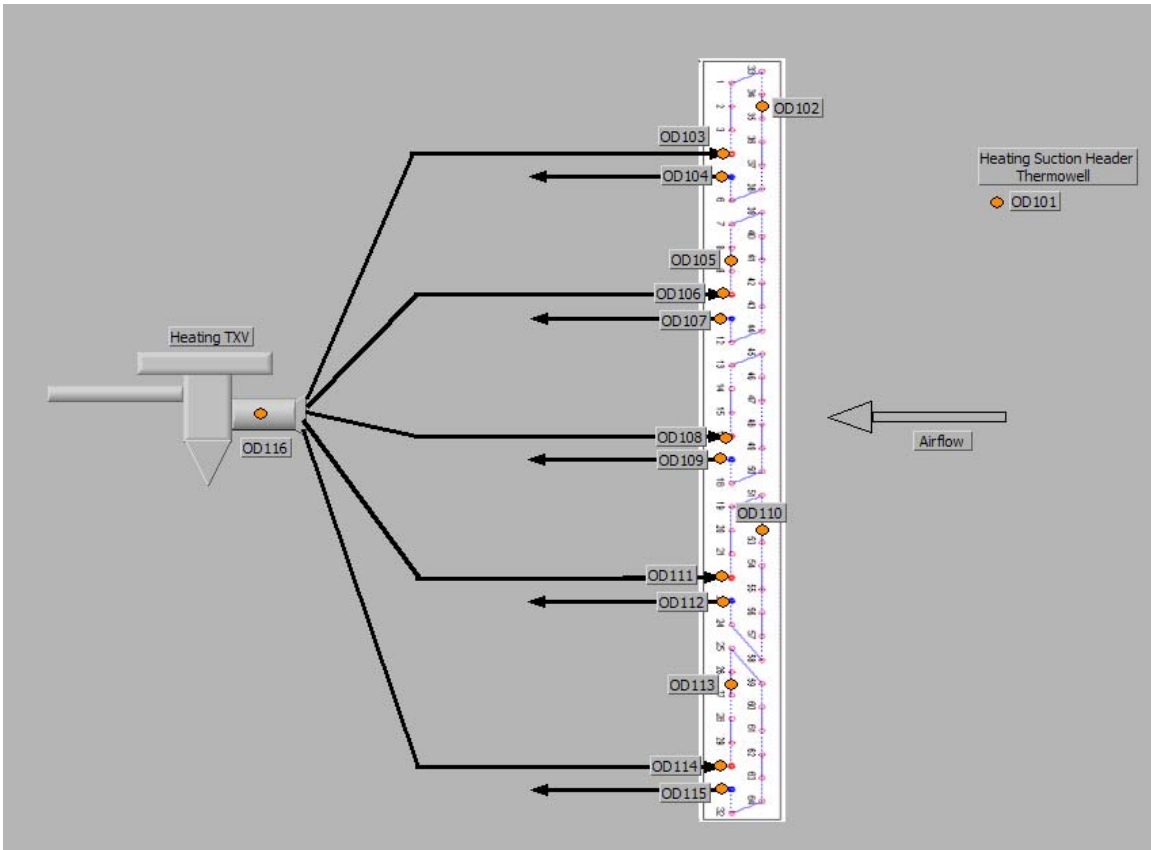
Figure 4.2.3.6. Outdoor heat exchanger thermocouple placements

Figure 4.2.3.6 shows the placement of thermocouples for the outdoor heat exchanger (evaporator). Figure 4.2.3.7 compares evaporator bend temperatures to the exit refrigerant saturation temperature calculated from a measured pressure. The measurements taken close to the evaporator inlets all appear to represent the two-phase refrigerant temperature equally and differ from the evaporator exit saturation temperature by an average offset of  $+2.1 \pm 0.3$  °C. Any of these temperatures could be used to represent the evaporator exit saturation temperature using a constant offset.

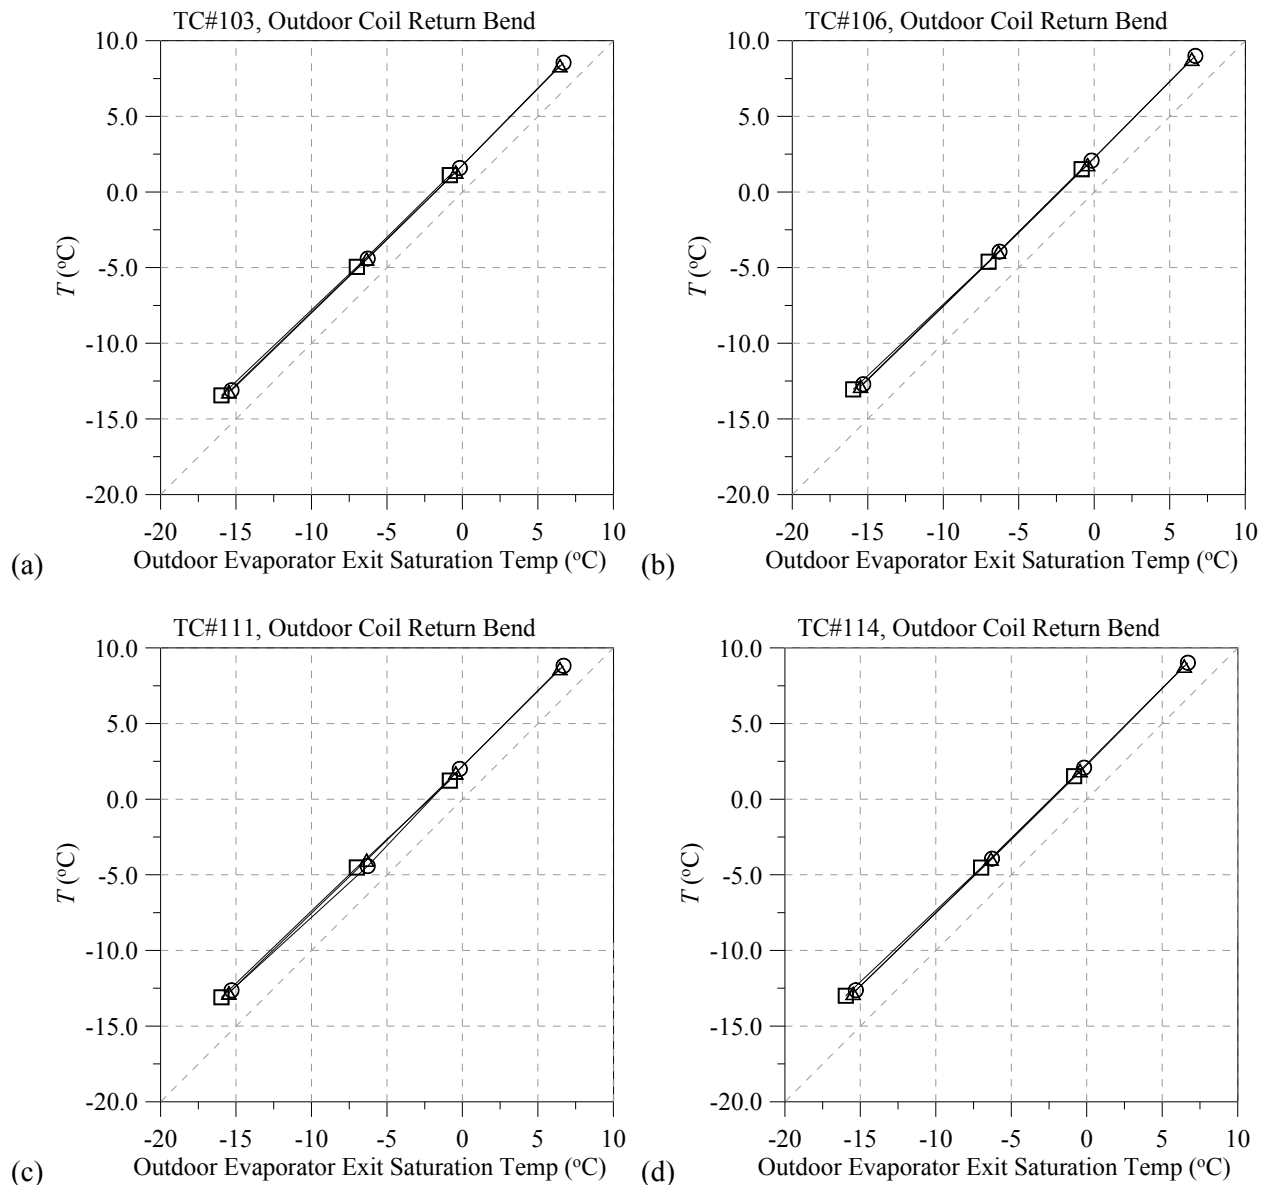
Figure 4.2.3.7. Evaporator bend temperatures as a function of outdoor evaporator exit refrigerant saturation temperature (see Figure 4.2.1.1 for symbols)
