# NIST Technical Note 1648

## HEATING MODE PERFORMANCE MEASUREMENTS FOR A RESIDENTIAL HEAT PUMP WITH SINGLE-FAULTS IMPOSED

W. Vance Payne  
Seok Ho Yoon  
Piotr A. Domanski

September 2009

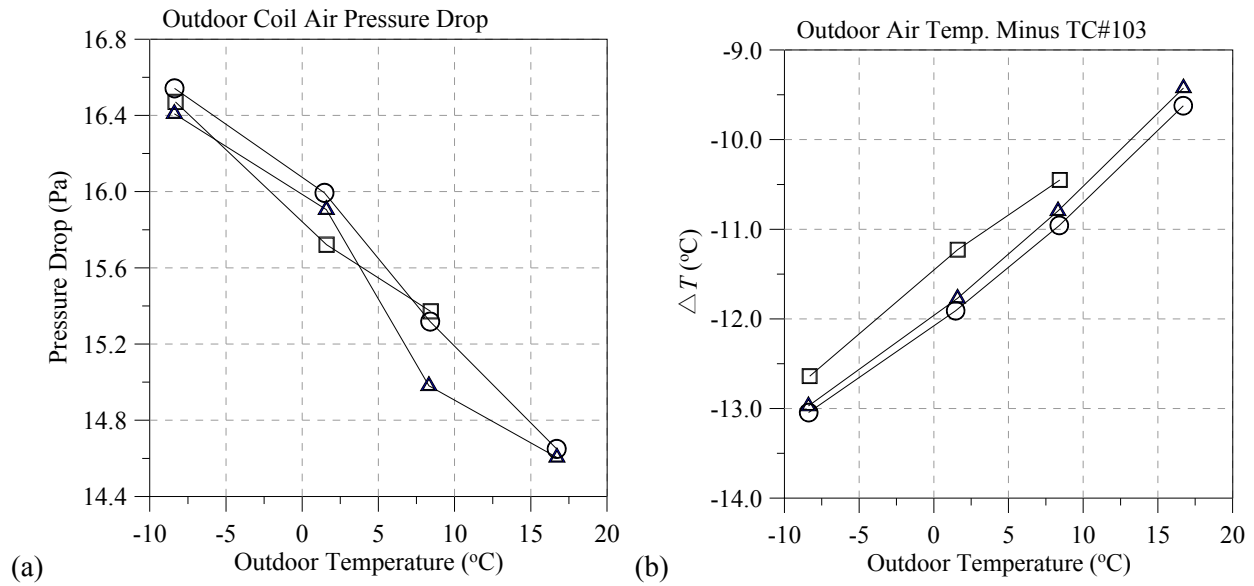
Figure 4.2.3.8. Evaporator air pressure drop and air temperature minus TC#103 for steady-state no-fault tests (see Figure 4.2.1.1 for symbols)

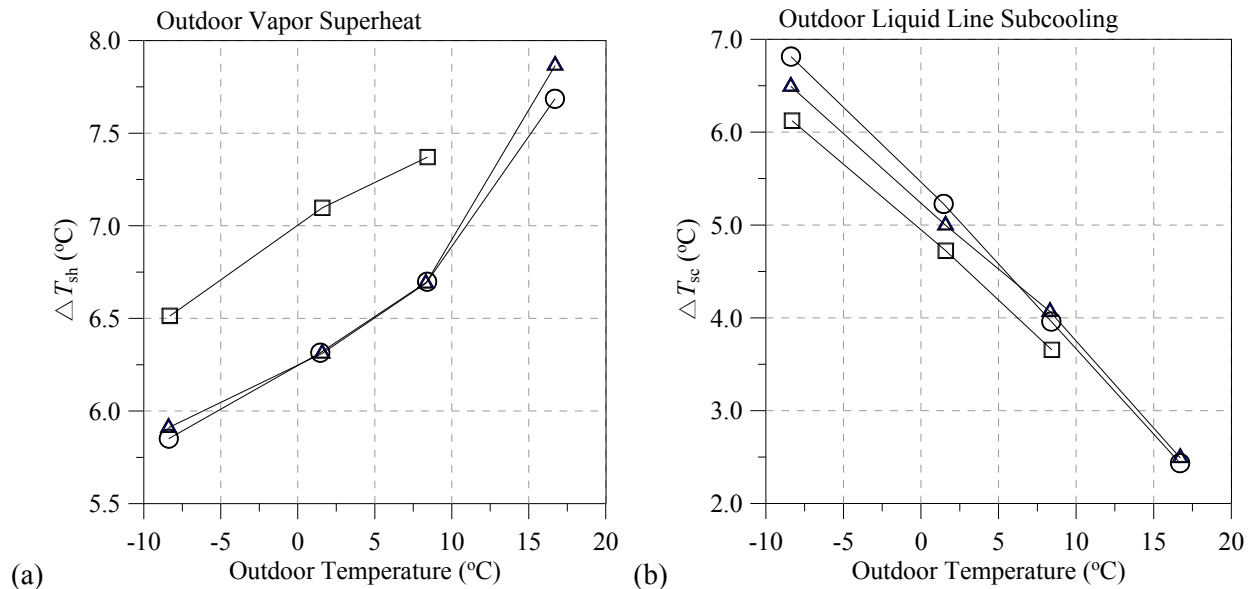
Figure 4.2.3.9. Refrigerant superheat and subcooling at the outdoor service valves for steady-state no-fault tests (see Figure 4.2.1.1 for symbols)

Figure 4.2.3.9 shows more refrigerant side characteristics of the evaporator. The exit refrigerant superheat remains within the range from 5.8 °C to 7.8 °C as outdoor temperature increases. Superheat does not follow a linear trend at the two highest indoor temperatures. Figure (b) shows that refrigerant liquid subcooling at the service valve decreases linearly as outdoor temperature increases; higher heating capacity correlates with lower subcooling.

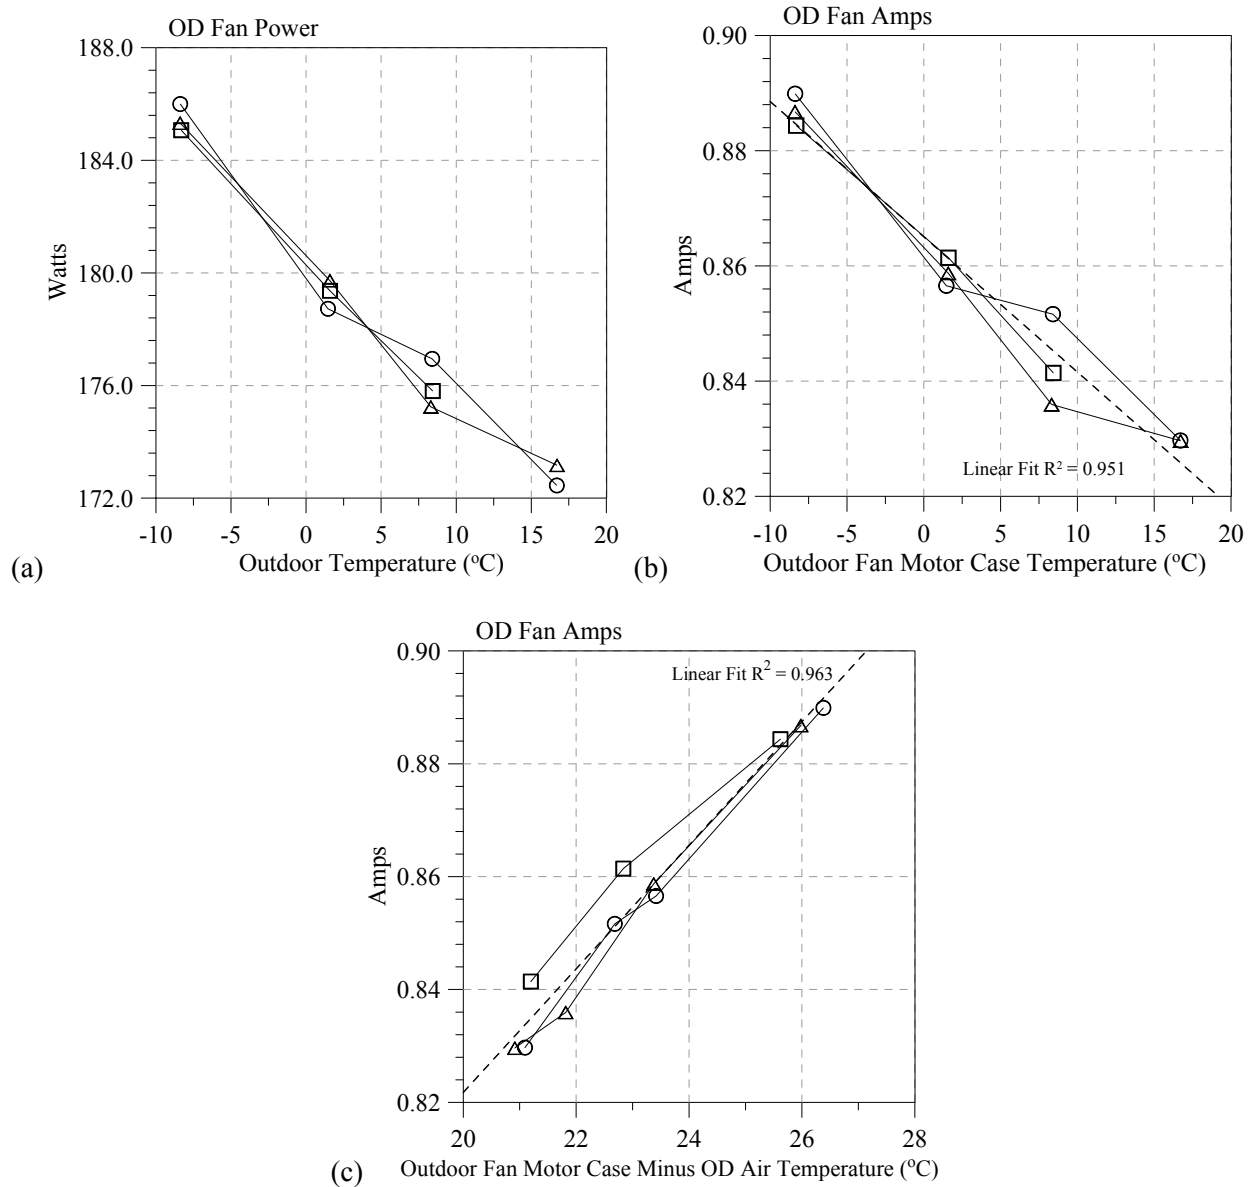
Figure 4.2.3.10. Outdoor fan power characteristics for steady-state no-fault tests (see Figure 4.2.1.1 for symbols)

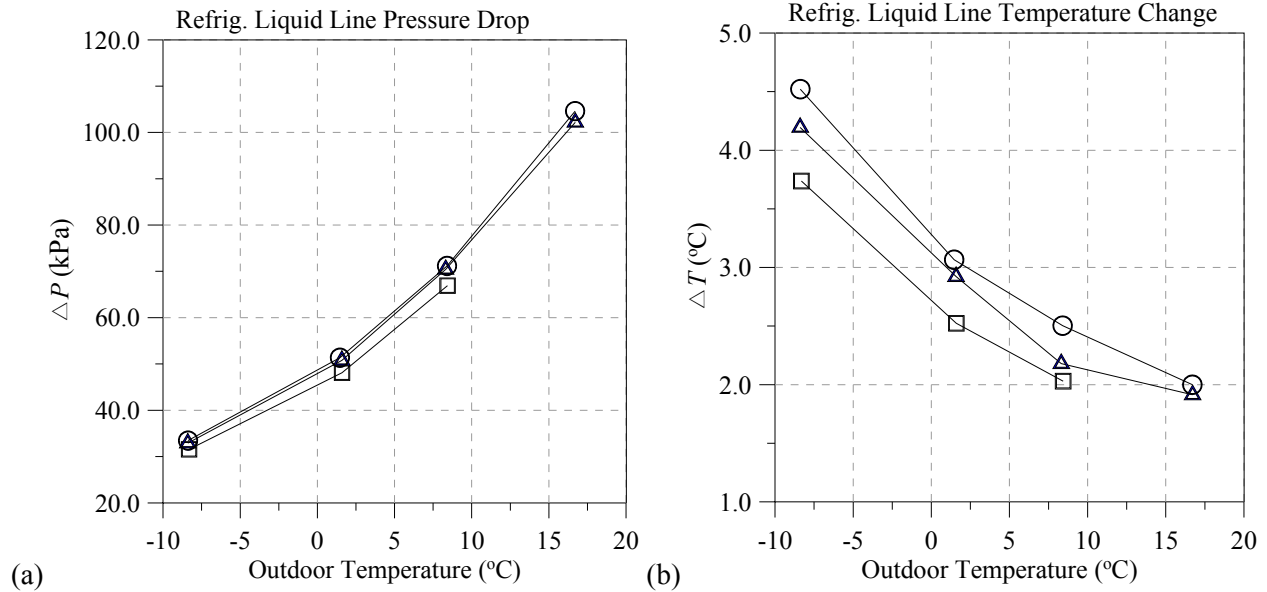
Figure 4.2.3.11. Refrigerant liquid line pressure drop and temperature change for steady-state no-fault tests(see Figure 4.2.1.1 for symbols)

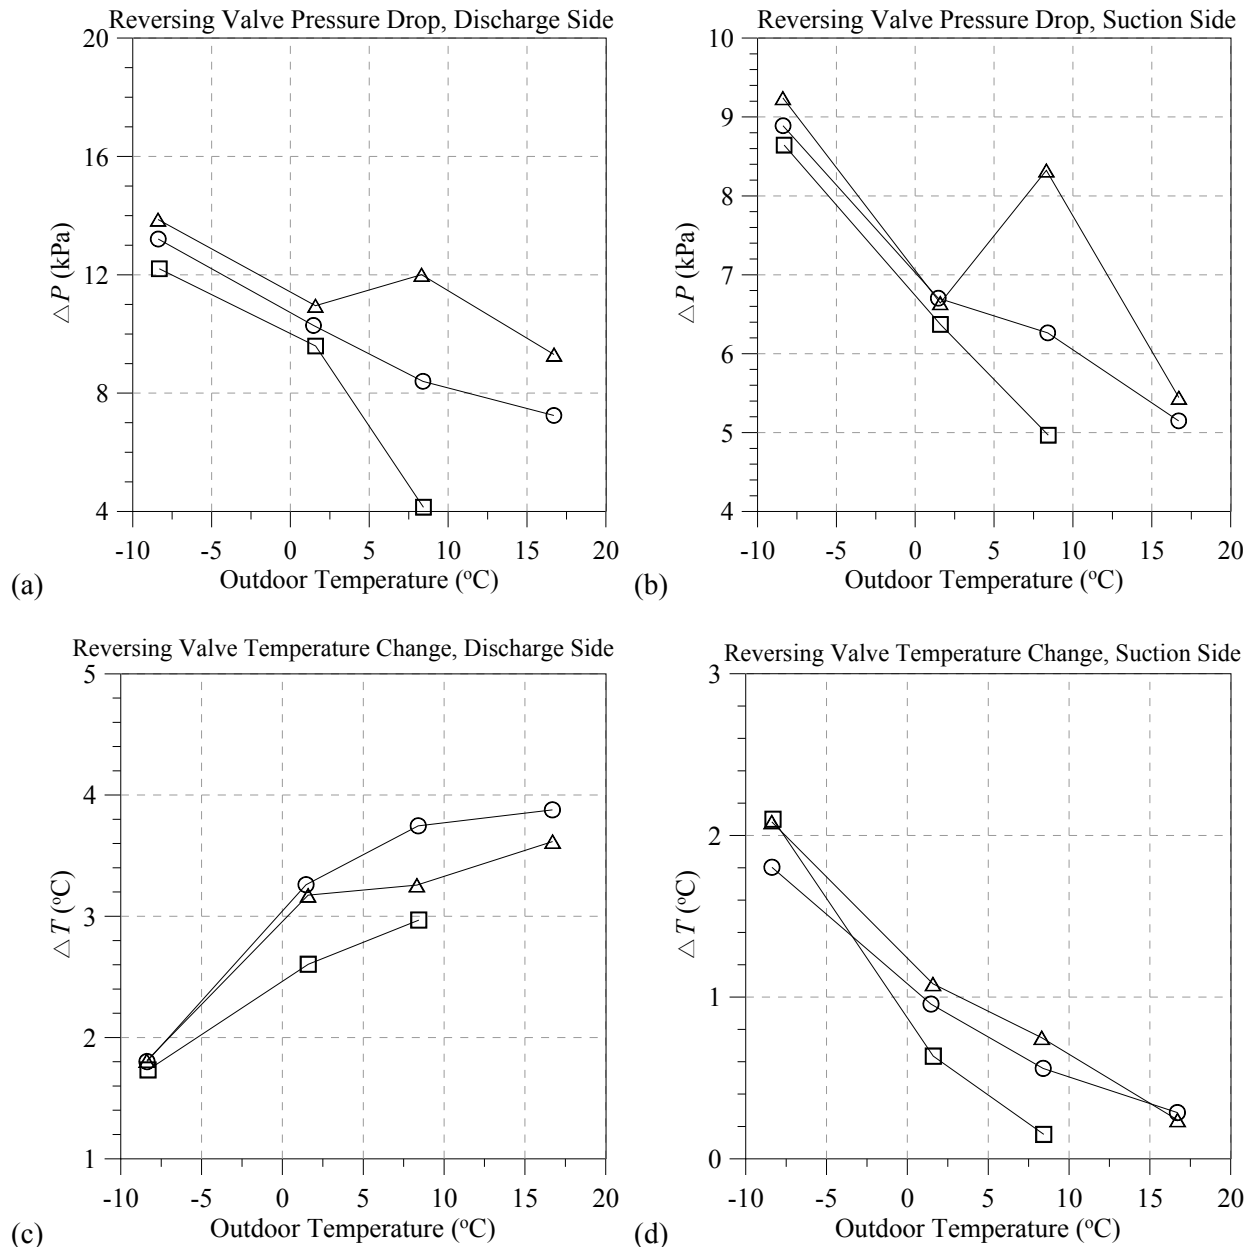
Figure 4.2.3.12. Reversing valve pressure drops and changes in superheat for steady-state no-fault tests (see Figure 4.2.1.1 for symbols)

Figure 4.2.3.12 shows reversing valve pressure drops and superheat changes for steady-state no-fault tests. Pressure drops have the greatest variability at an outdoor temperature of  $8.3^{\circ}\text{C}$ , being the highest at an indoor temperature of  $21.1^{\circ}\text{C}$  and lowest at an indoor temperature of  $15.6^{\circ}\text{C}$ . For all these tests at an outdoor temperature of  $8.3^{\circ}\text{C}$ , the refrigerant mass flow rate was fairly constant,  $2.4 \pm 0.05 \text{ kg min}^{-1}$ . Tests at indoor temperatures other than  $21.1^{\circ}\text{C}$  have a much more linear pressure drop with outdoor temperature. The reason for the higher pressure drop at  $21.1^{\circ}\text{C}$  indoor/ $8.3^{\circ}\text{C}$  outdoor does not appear obvious at this time, but divergence from a smooth temperature change (seen in Figures (c)) is also present. This may suggest a bad valve seating at this condition, but the mass flow data did not suggest this was the case.

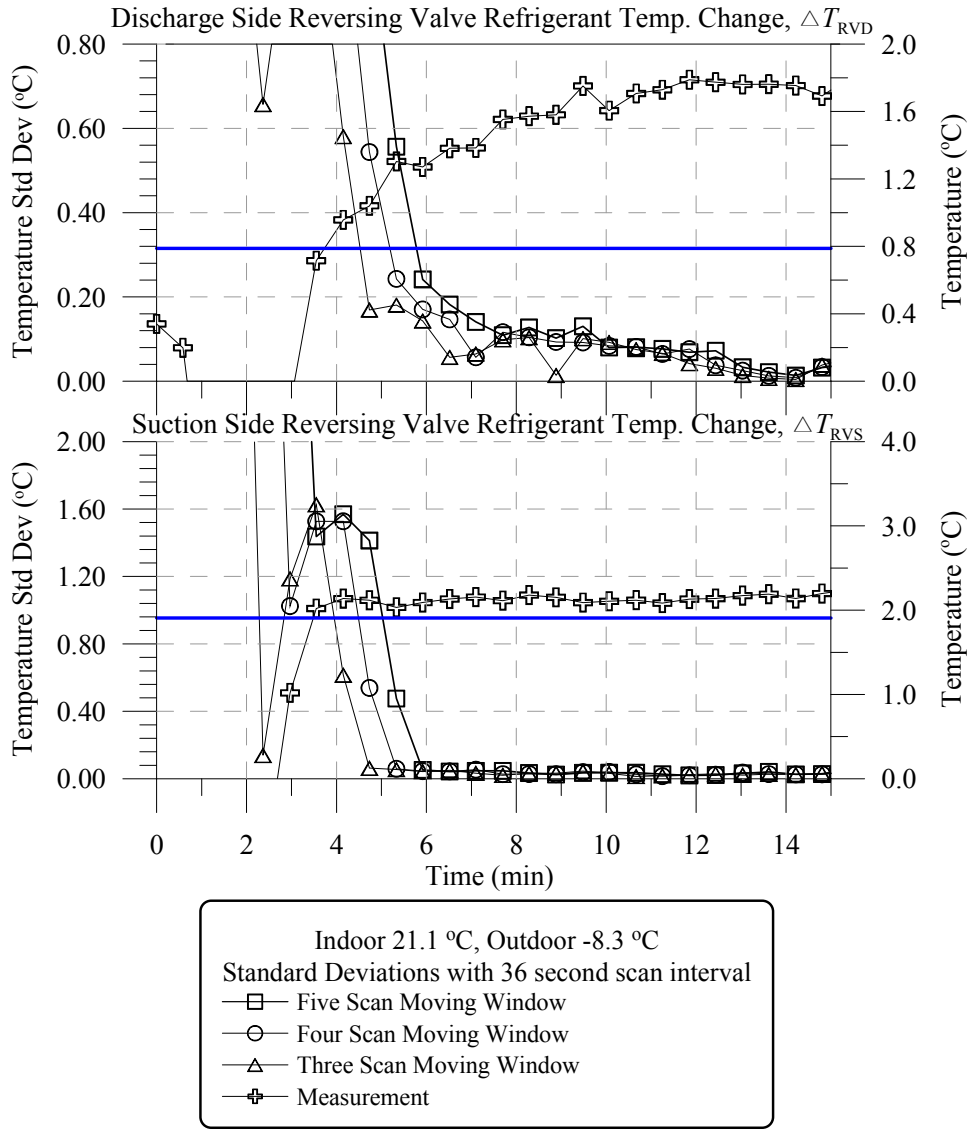
Figure 4.3.2.7. Transient variation of  $\Delta T_{RVD}$  and  $\Delta T_{RVS}$  for a no-fault test at an outdoor dry-bulb temperature of -8.3 °C

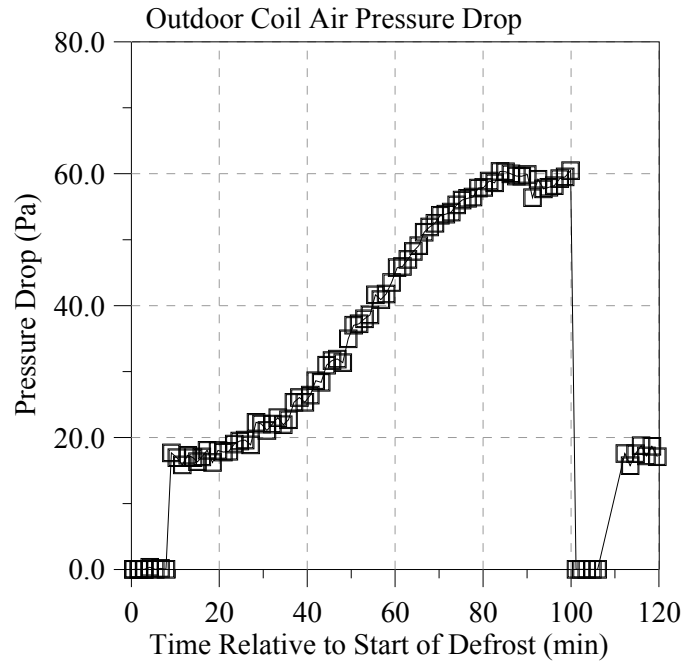
Figure 4.4.1. Outdoor coil air pressure drop during frosting at an outdoor dry-bulb/dew-point temperature of  $(2.2 \pm 0.6) \text{ }^\circ\text{C}/(-2.7 \pm 0.8) \text{ }^\circ\text{C}$  and indoor dry-bulb temperature of  $(21.1 \pm 0.2) \text{ }^\circ\text{C}$

During the frosting tests, the average outdoor dry-bulb and dew-point temperatures plus or minus one standard deviation were  $(2.2 \pm 0.6) \text{ }^\circ\text{C}$  and  $(-2.7 \pm 0.8) \text{ }^\circ\text{C}$  (68 % RH), respectively, and the indoor dry-bulb temperature was  $(21.1 \pm 0.2) \text{ }^\circ\text{C}$ . The presence of frost manifested itself in an increased air pressure drop, as shown in Figure 4.4.1.

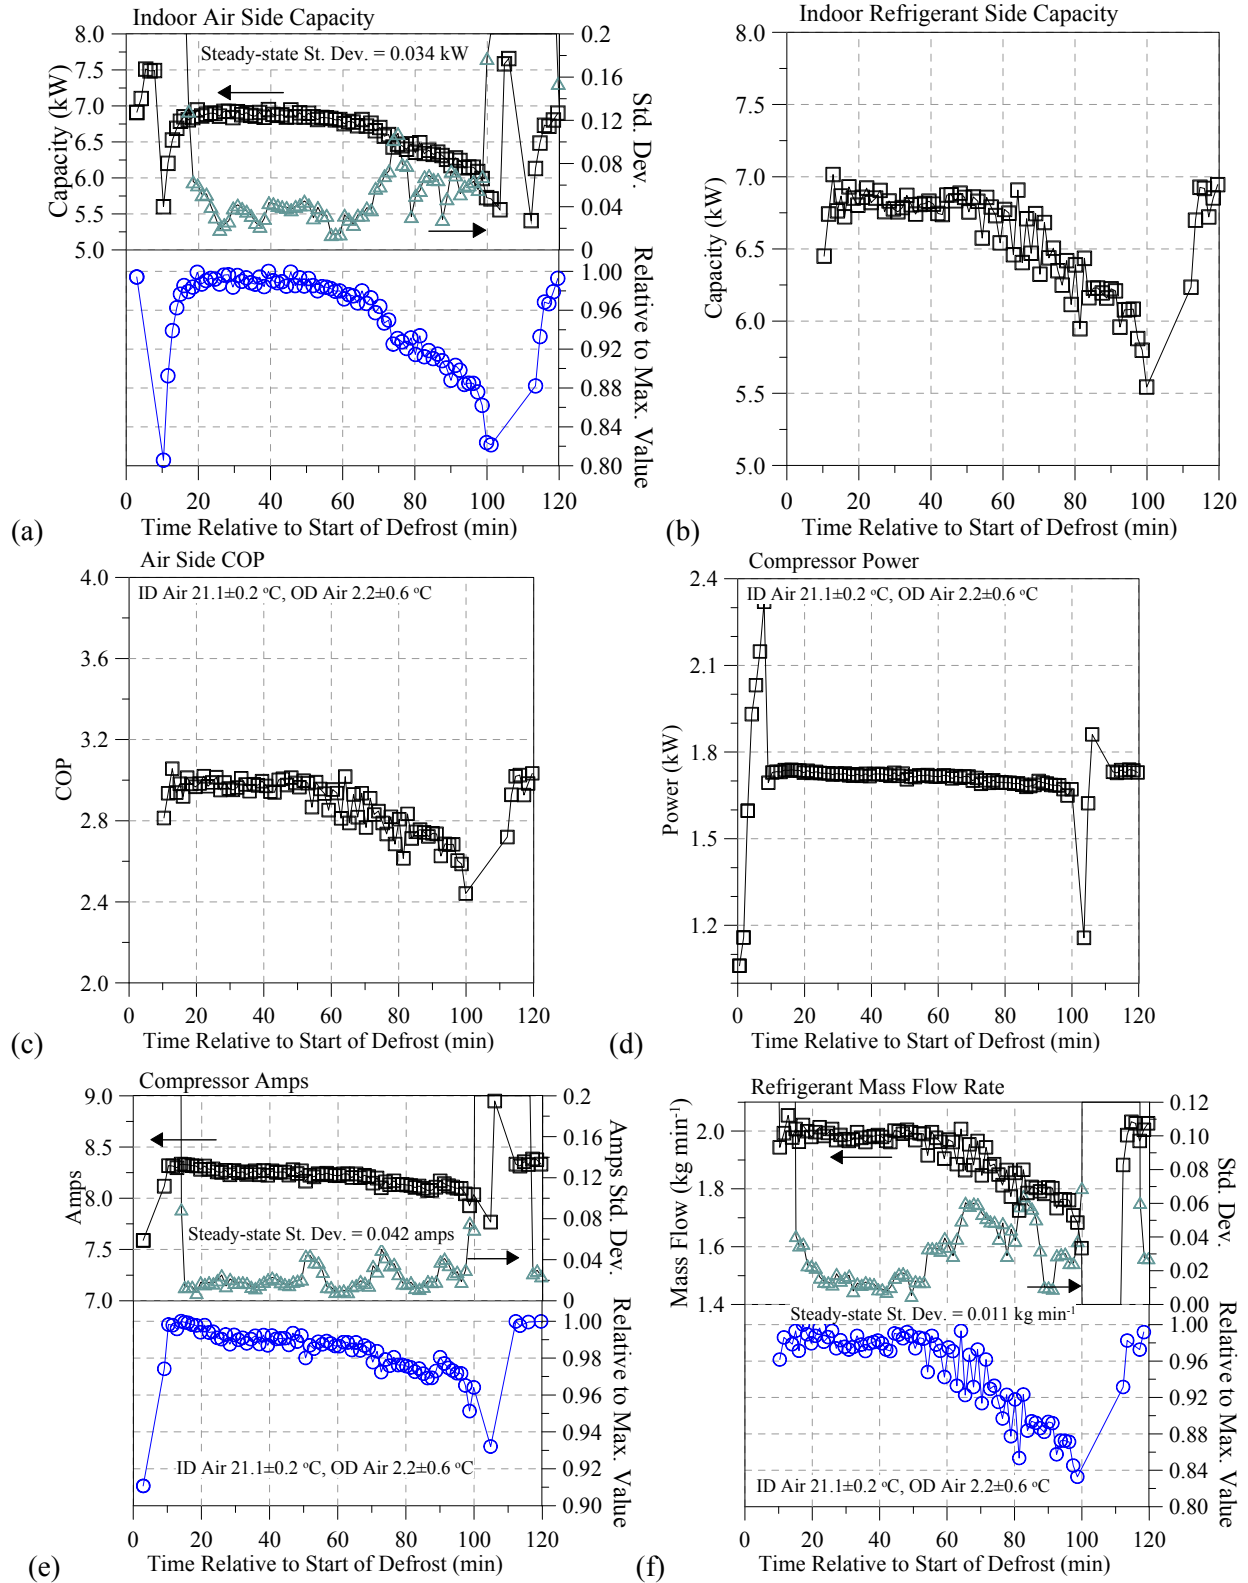
Figure 4.4.1.1. (a) Air side heating capacity, (b) refrigerant side heating capacity, (c) COP, (d) compressor power, (e) compressor amps, and (f) refrigerant mass flow rate for a frosting no-fault test

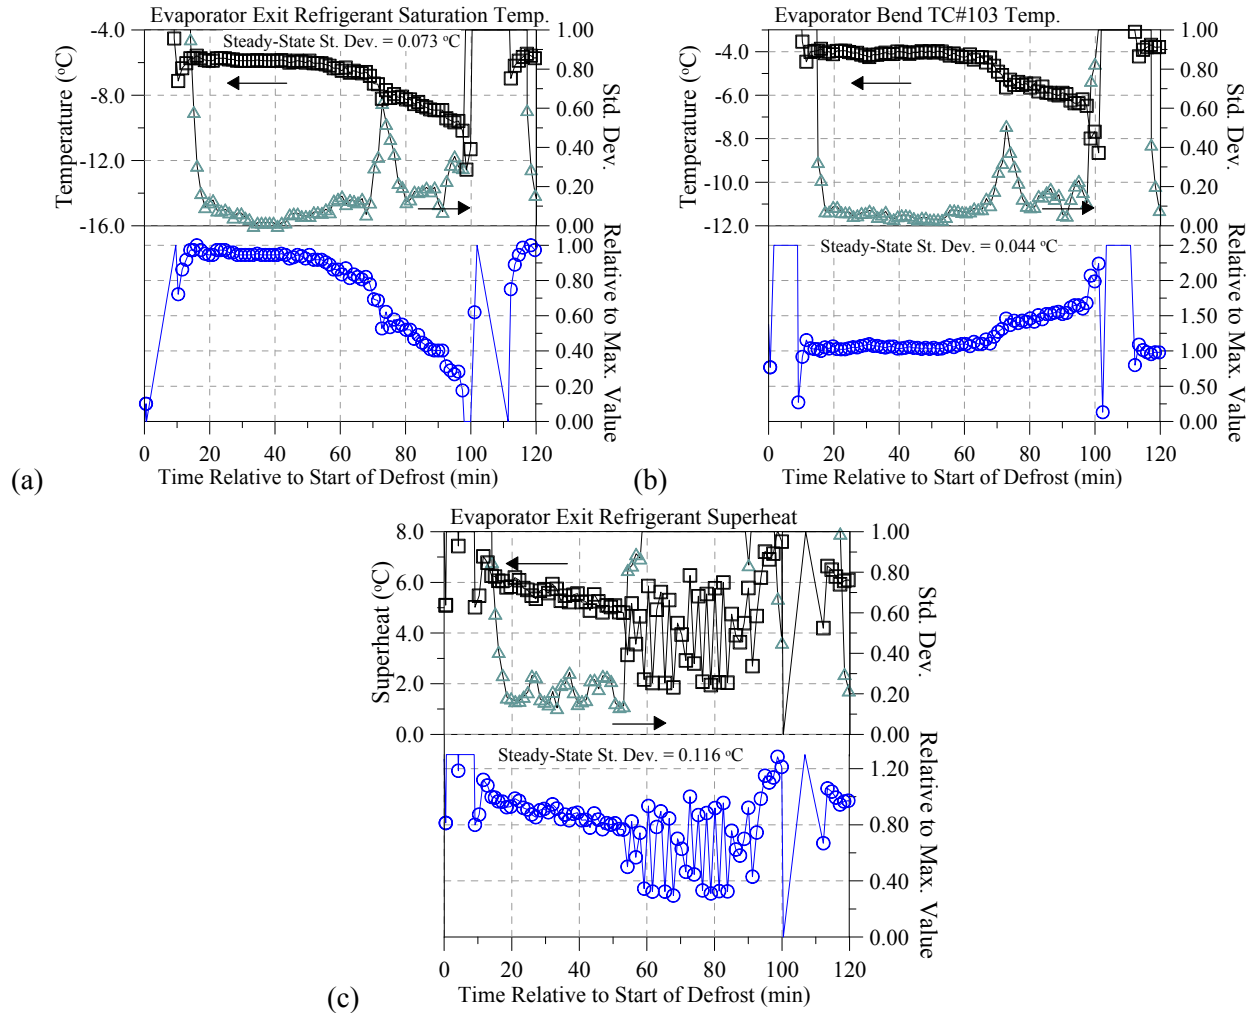
Figure 4.4.2.1. (a) Evaporator exit saturation temperature, (b) evaporator bend thermocouple #103, and (c) evaporator exit superheat for a frosting no-fault test

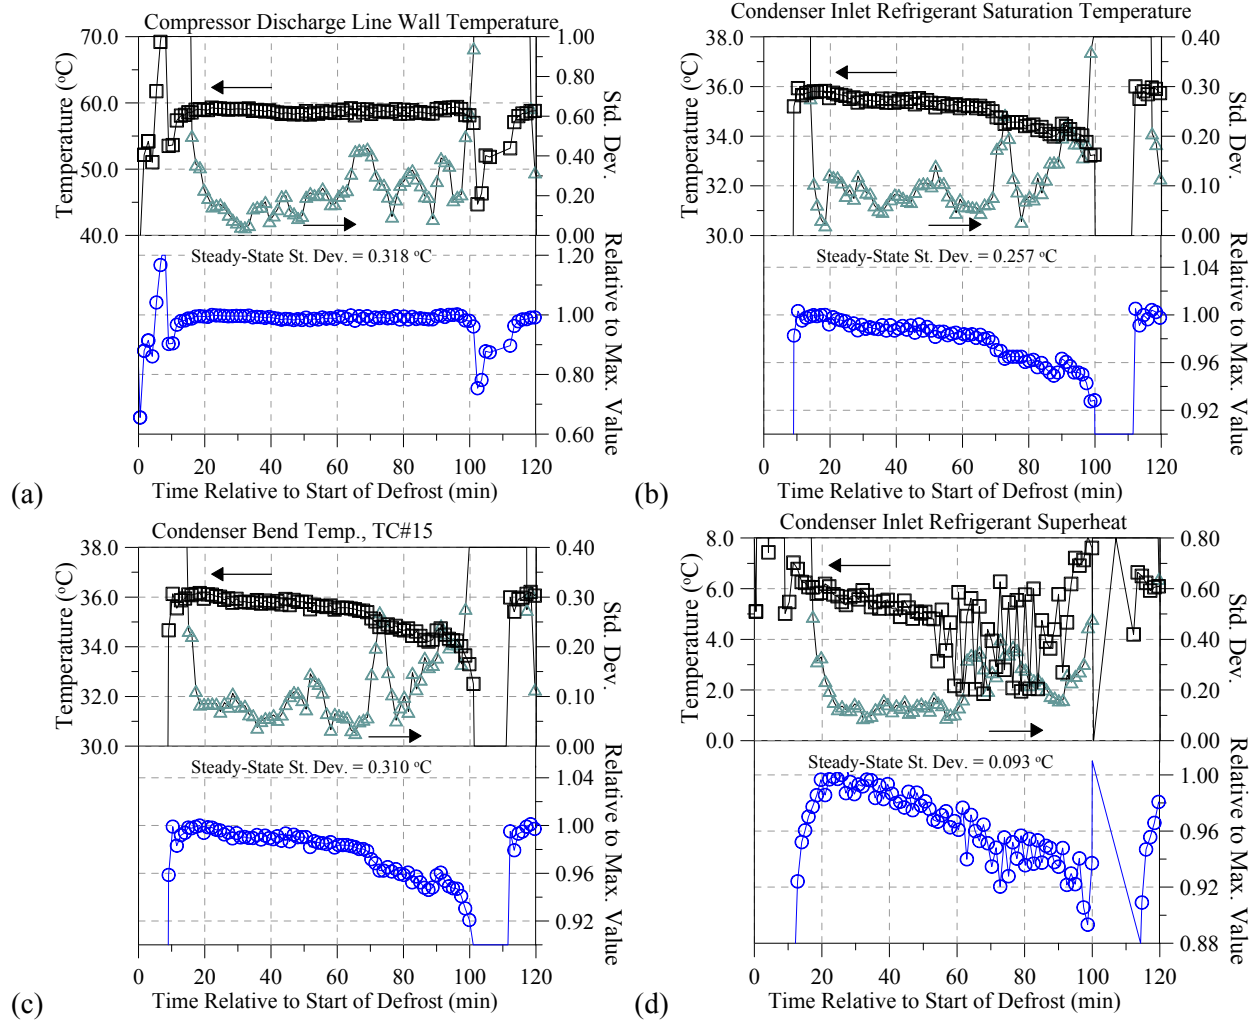
Figure 4.4.2.2. (a) Compressor discharge line wall temperature, (b) condenser inlet refrigerant vapor saturation temperature, (c) condenser bend thermocouple,  $T_{C15}$ , and (d) condenser inlet refrigerant superheat for frosting no-fault tests

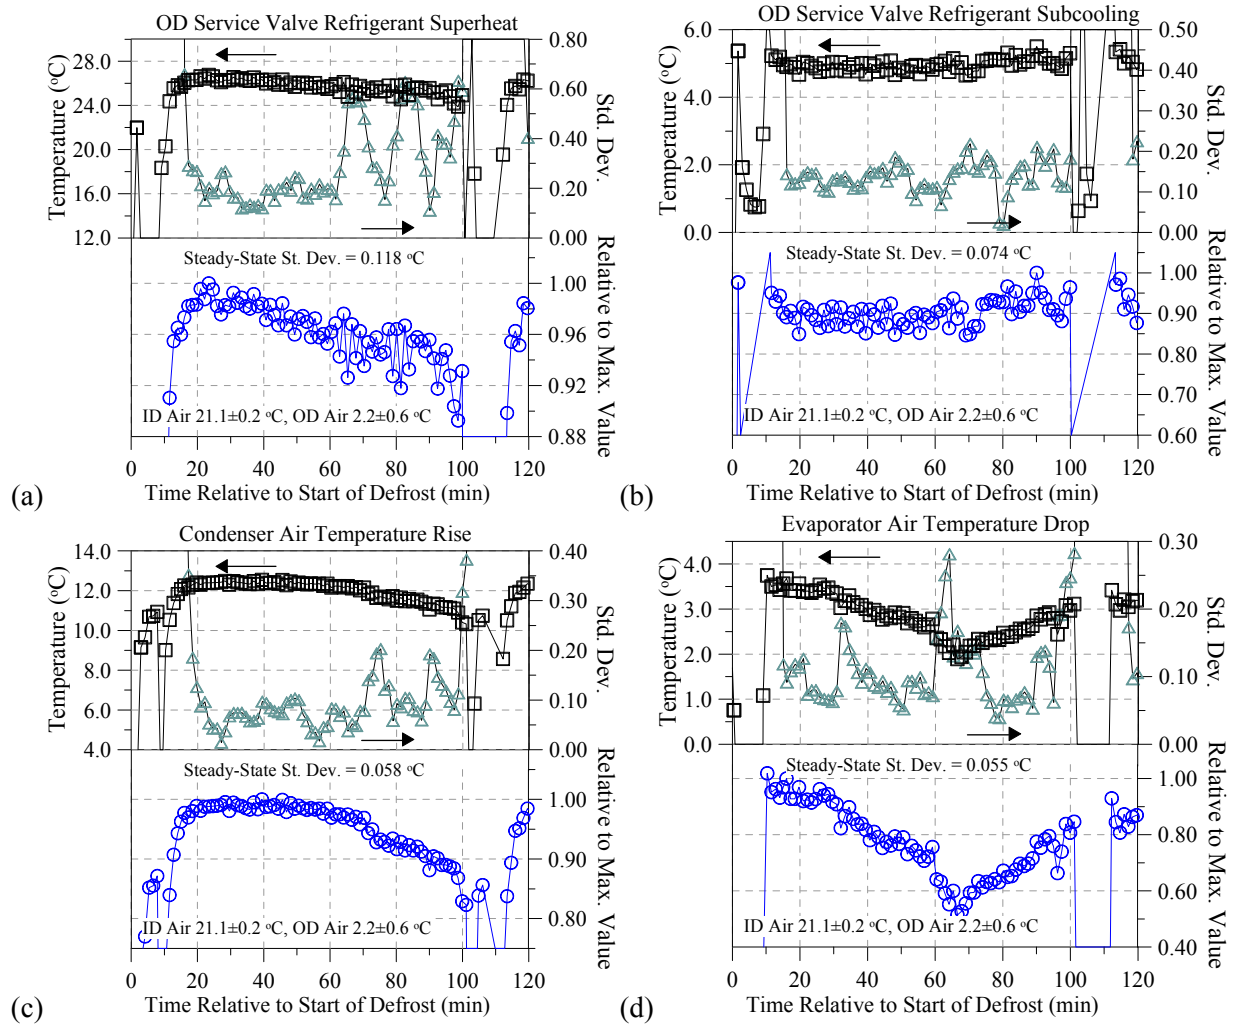
Figure 4.4.2.3. (a) Refrigerant vapor superheat at the outdoor service valve, (b) refrigerant liquid subcooling at the outdoor service valve, (c) condenser air temperature rise, and (d) evaporator air temperature drop for frosting no-fault test

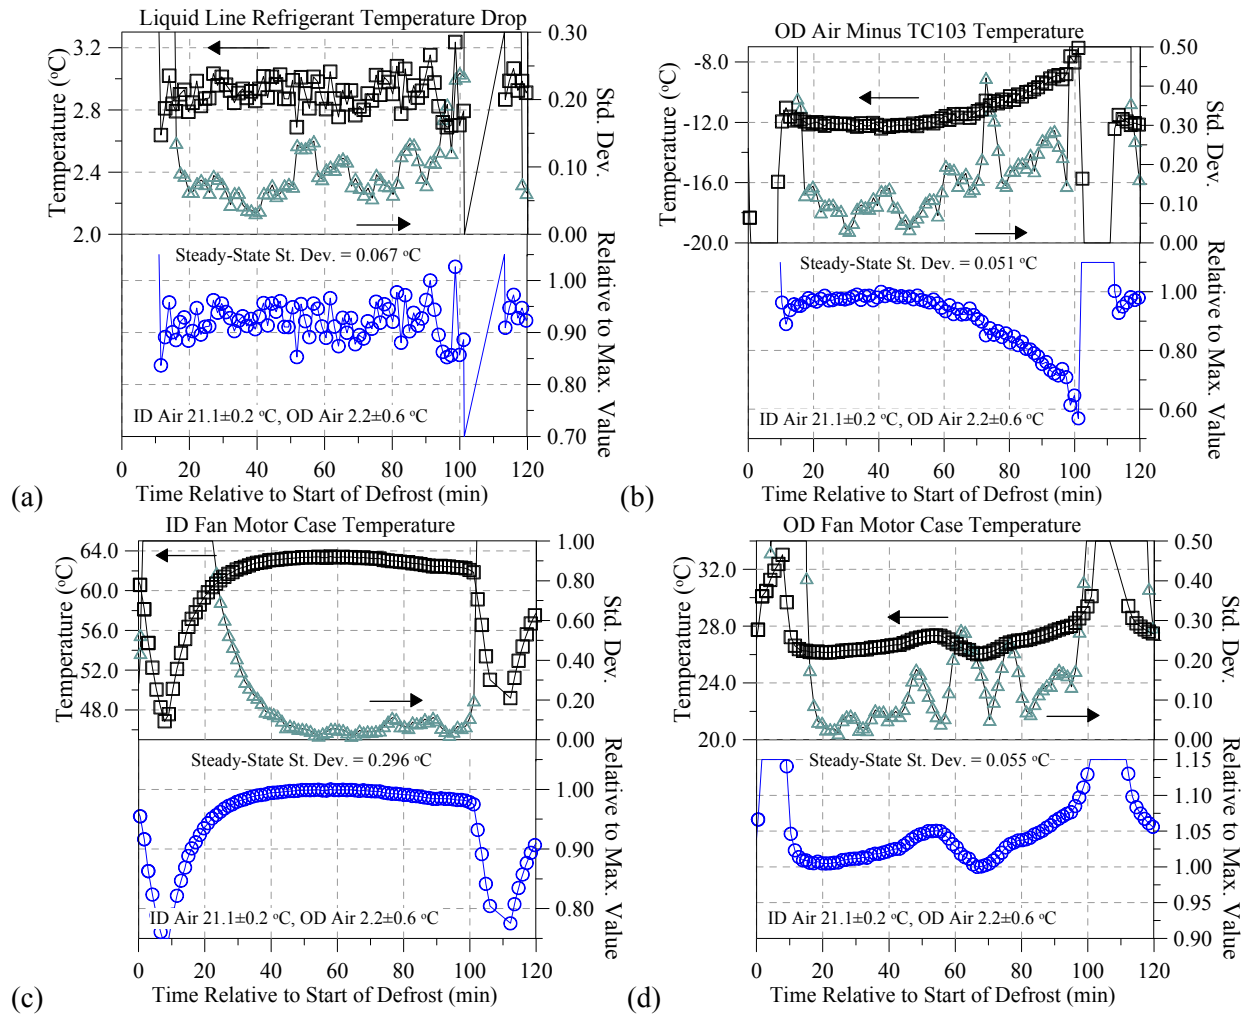
Figure 4.4.2.4. (a) Liquid line refrigerant temperature drop, (b) outdoor air temperature minus TC#103, (c) indoor fan motor case temperature, and (d) outdoor fan motor case temperature for frosting no-fault test

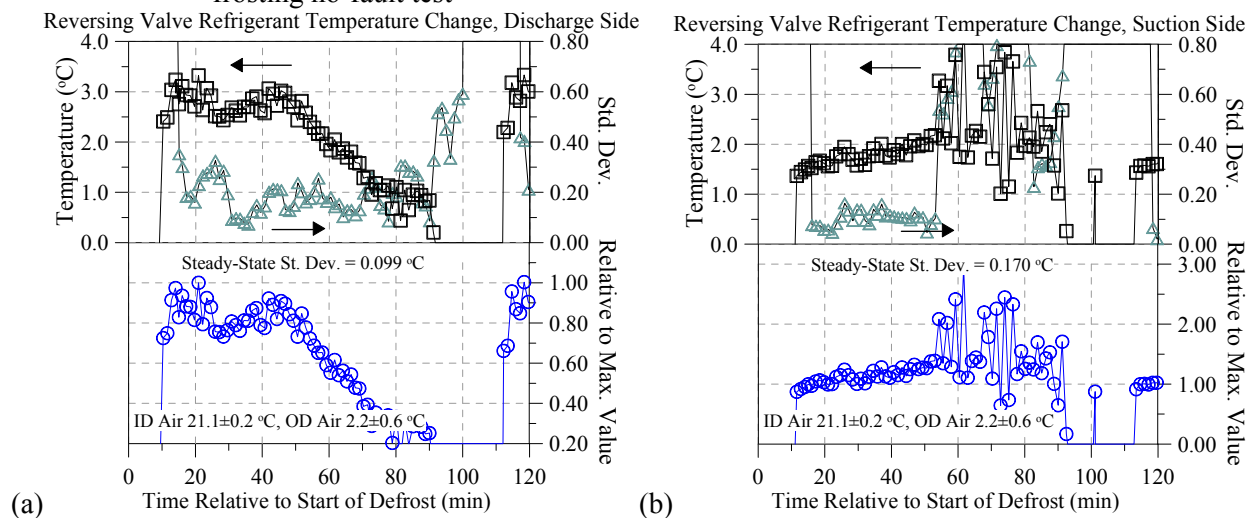
Figure 4.4.2.5. (a) Reversing valve refrigerant temperature change on the discharge side and (b) reversing valve refrigerant temperature change on the suction side for frosting no-fault test

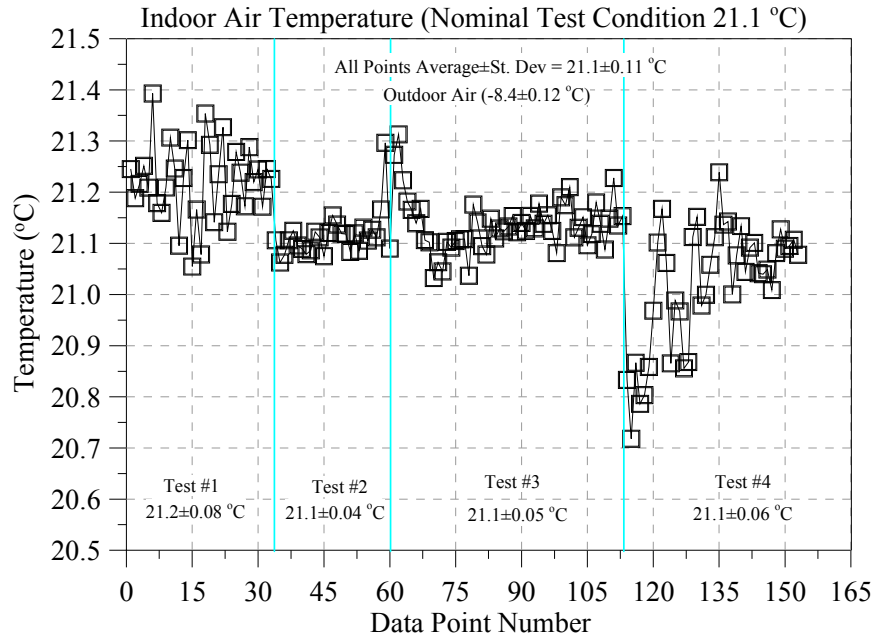
Figure 4.5.1. Variation of indoor air dry-bulb temperature for several test cases with nominal conditions of 21.1 °C indoor and -8.3 °C outdoor dry-bulb temperatures

Table 4.5.1 compares selected reference features and the average of the four repeat tests (Tests #1, #2, #3, and #4) for a given nominal test condition of 21.1 °C indoor and -8.3 °C outdoor dry-bulb temperatures. The highest percent difference between the reference and the repeat feature values occurred for  $\Delta T_{RVS}$  and  $\Delta T_{scv}$ . This is just one example of the variation in system features when trying to exactly replicate test conditions from one test in another test. Figures 4.5.1 and 4.5.2 graphically show the test temperature conditions listed as an average value plus or minus one standard deviation in these figures.

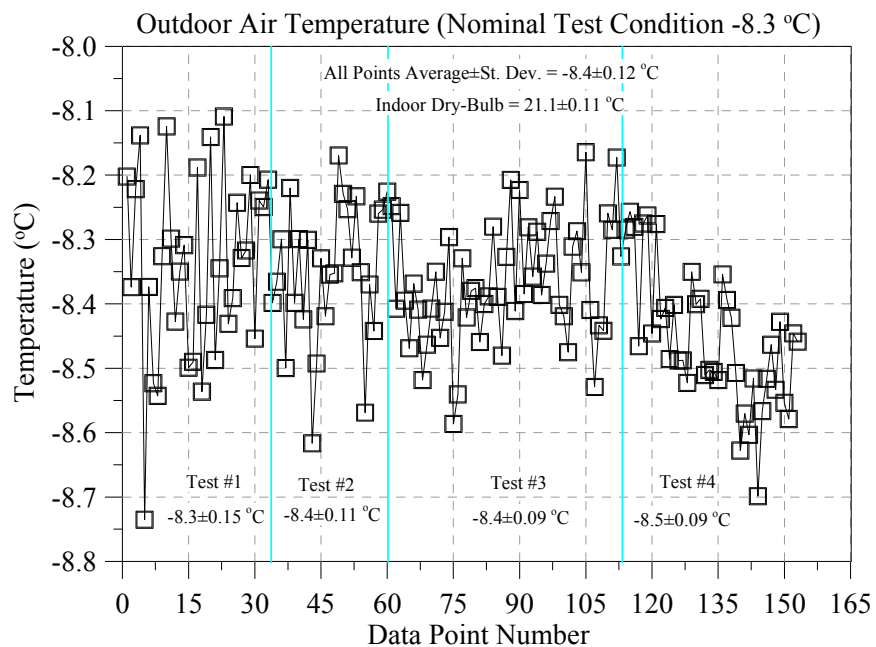
Figure 4.5.2. Variation of outdoor air dry-bulb temperature for several test cases with nominal conditions of 21.1 °C indoor and -8.3 °C outdoor dry-bulb temperatures

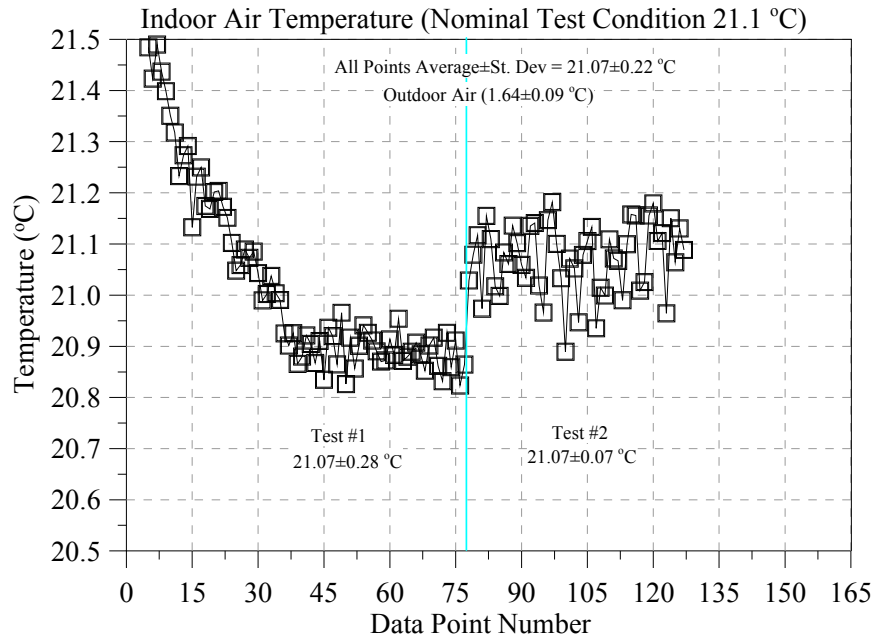
Figure 4.5.3. Variation of indoor air dry-bulb temperature for several test cases with nominal conditions of 21.1 °C indoor and 1.67 °C outdoor dry-bulb temperatures

Table 4.5.2 compares selected features of the reference and a repeat tests (Tests #1 and #2) for a given nominal test condition of 21.1 °C indoor and 1.7 °C outdoor dry-bulb temperatures. The highest percent difference between the reference and the repeat feature values occurred for  $\Delta T_{RVD}$  and  $\Delta T_{shE}$ . Figures 4.5.3 and 4.5.4 graphically show the test temperature conditions listed as an average value plus or minus one standard deviation in these figures. As Figure 4.5.3 shows, test conditions with the same average

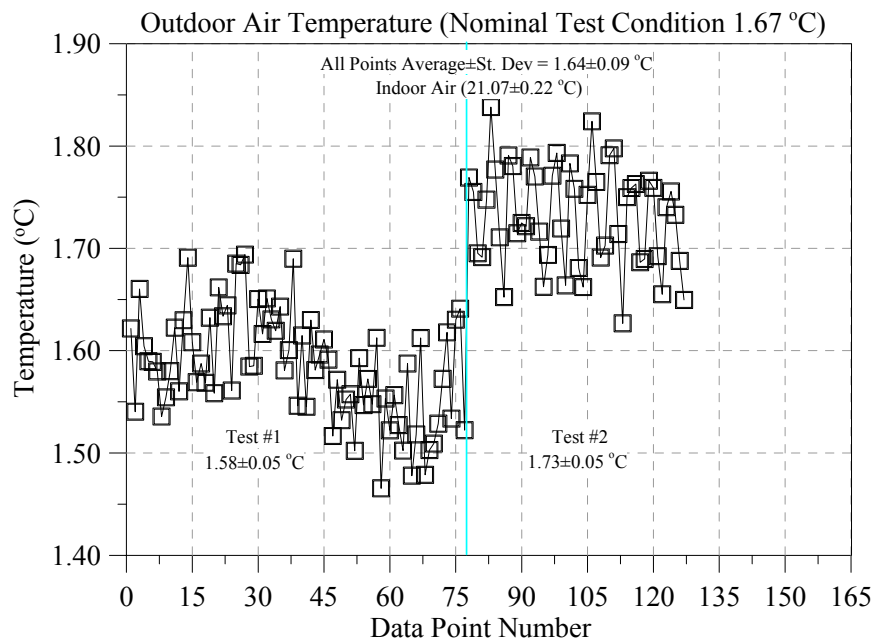
Figure 4.5.4. Variation of outdoor air dry-bulb temperature for several test cases with nominal conditions of 21.1 °C indoor and 1.67 °C outdoor dry-bulb temperatures

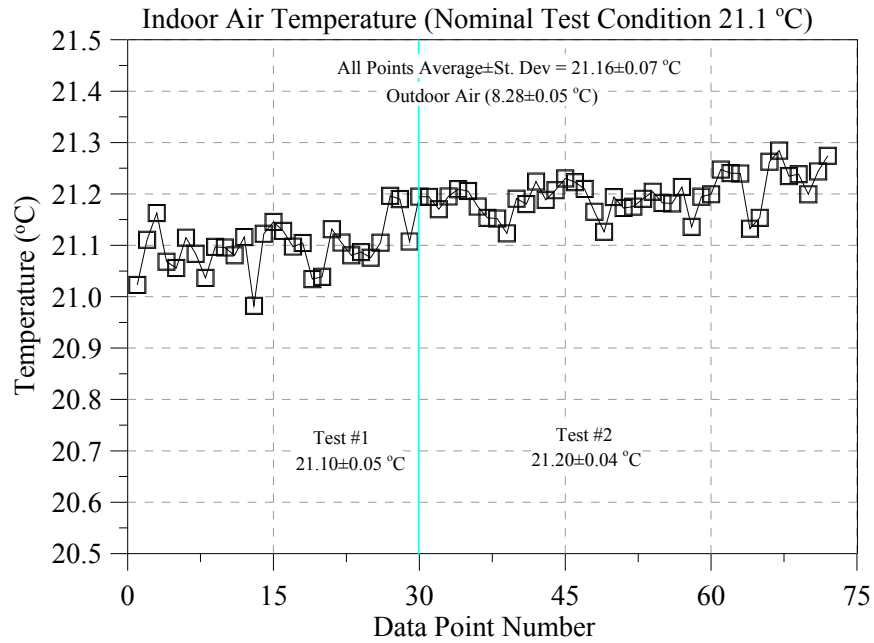
Figure 4.5.5. Variation of indoor air dry-bulb temperature for several test cases with nominal conditions of 21.1 °C indoor and 8.3 °C outdoor dry-bulb temperatures

Table 4.5.3 compares selected features of the reference and repeat tests (Tests #1 and #2) for a given nominal test condition of 21.1 °C indoor and 8.3 °C outdoor dry-bulb temperatures. The highest percent difference between the reference and the repeat feature values occurred for  $T_{ER}$  and  $\Delta T_{shE}$ . Figures 4.5.5 and 4.5.6 graphically show the test temperature conditions; both indoor and outdoor conditions are matched within 0.1 °C, but evaporator exit superheat and saturation temperature still had substantial variations from one test to the next.

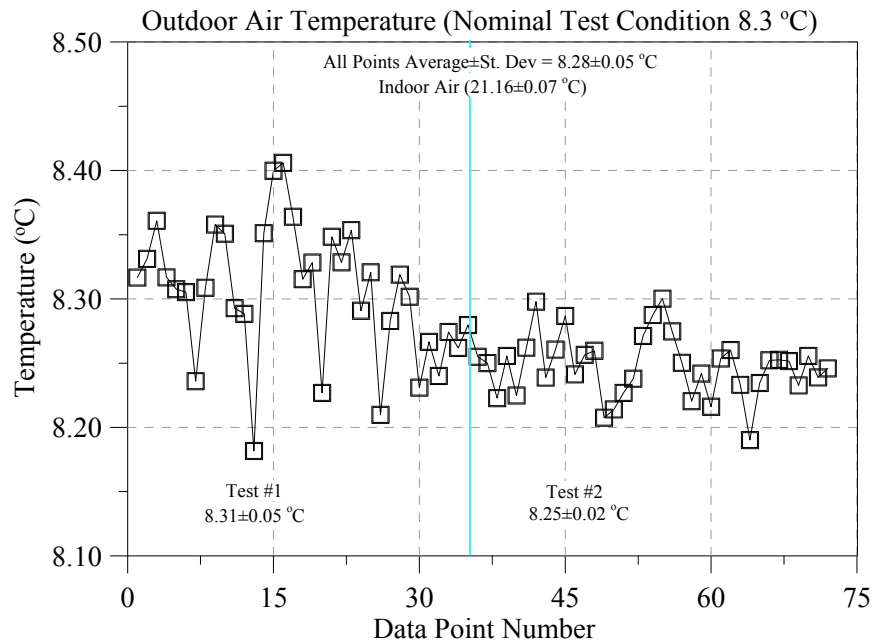
Figure 4.5.6. Variation of outdoor air dry-bulb temperature for several test cases with nominal conditions of 21.1 °C indoor and 8.3 °C outdoor dry-bulb temperatures

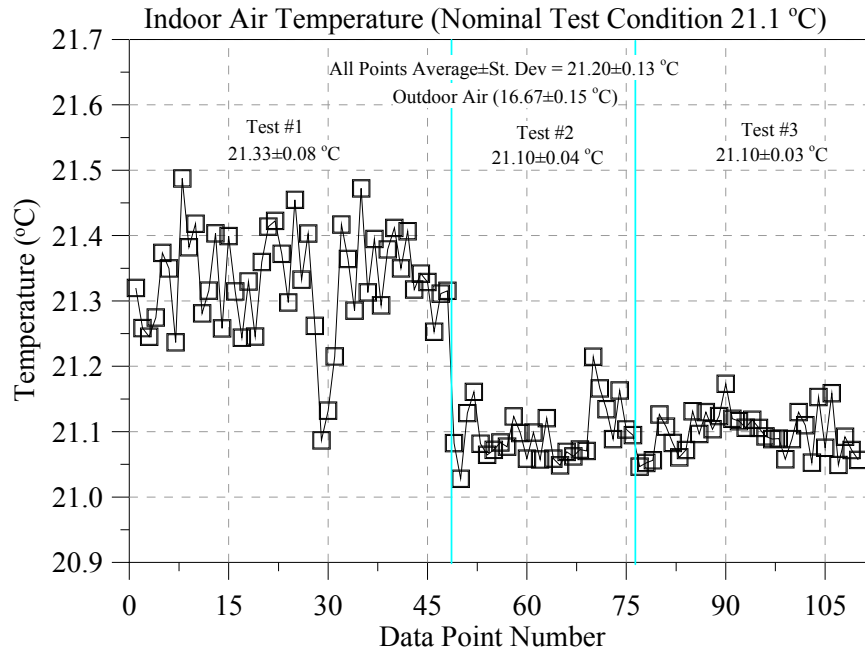
Figure 4.5.7. Variation of indoor air dry-bulb temperature for several test cases with nominal conditions of 21.1 °C indoor and 16.7 °C outdoor dry-bulb temperatures

Table 4.5.4 compares selected features and repeat tests (Tests #1, #2 and #3) for a given nominal test condition of 21.1 °C indoor and 17.6 °C outdoor dry-bulb temperatures. The highest percent difference between the reference test and the repeat feature values occurred for  $\Delta T_{RVS}$ ,  $\Delta T_{LL}$ ,  $\Delta T_{scV}$ ,  $T_{ER}$ , and  $\Delta T_{shE}$ . Figures 4.5.7 and 4.5.8 graphically show the test temperature conditions.

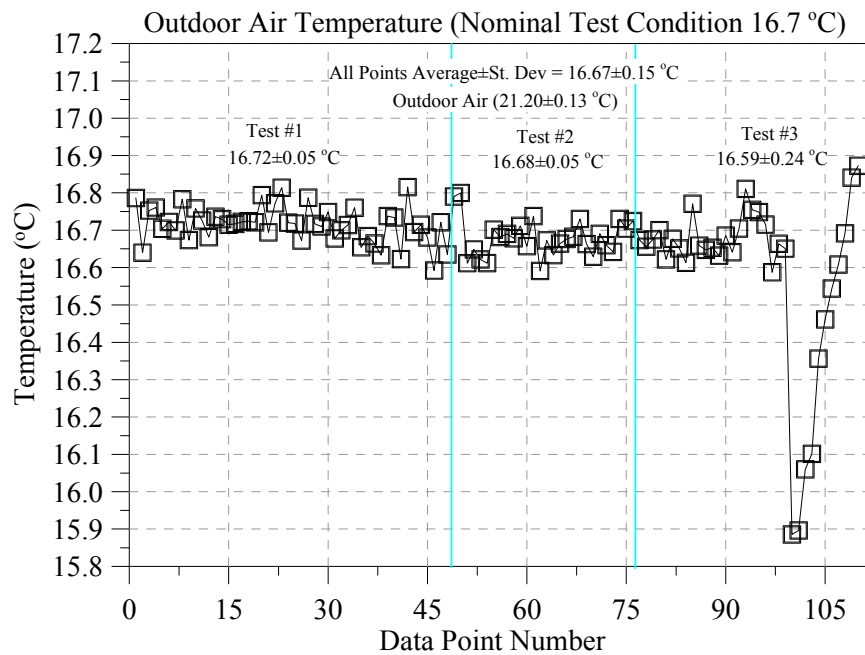
Figure 4.5.8. Variation of outdoor air dry-bulb temperature for several test cases with nominal conditions of 21.1 °C indoor and 16.7 °C outdoor dry-bulb temperatures

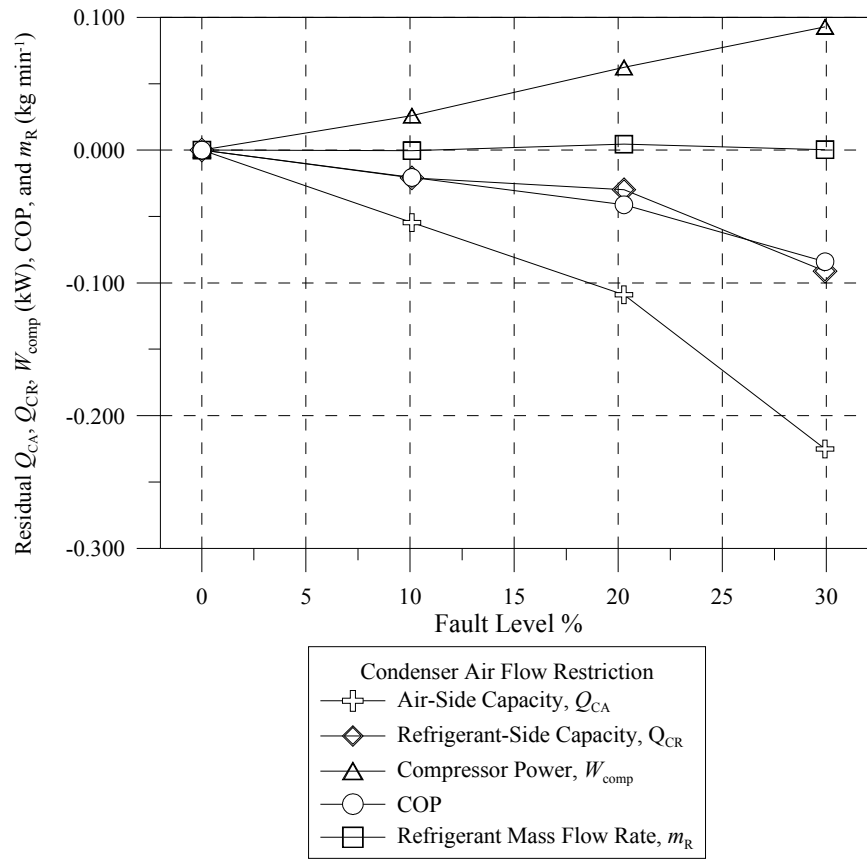
Figure 5.1.1. Residual of selected features with a condenser fouling fault at an indoor dry-bulb temperature of 21.1 °C and outdoor conditions of -8.3 °C/Dry:  $R[Q_{CA}]$ ,  $R[Q_{CR}]$ ,  $R[W_{comp}]$ ,  $R[COP]$ , and  $R[m_R]$

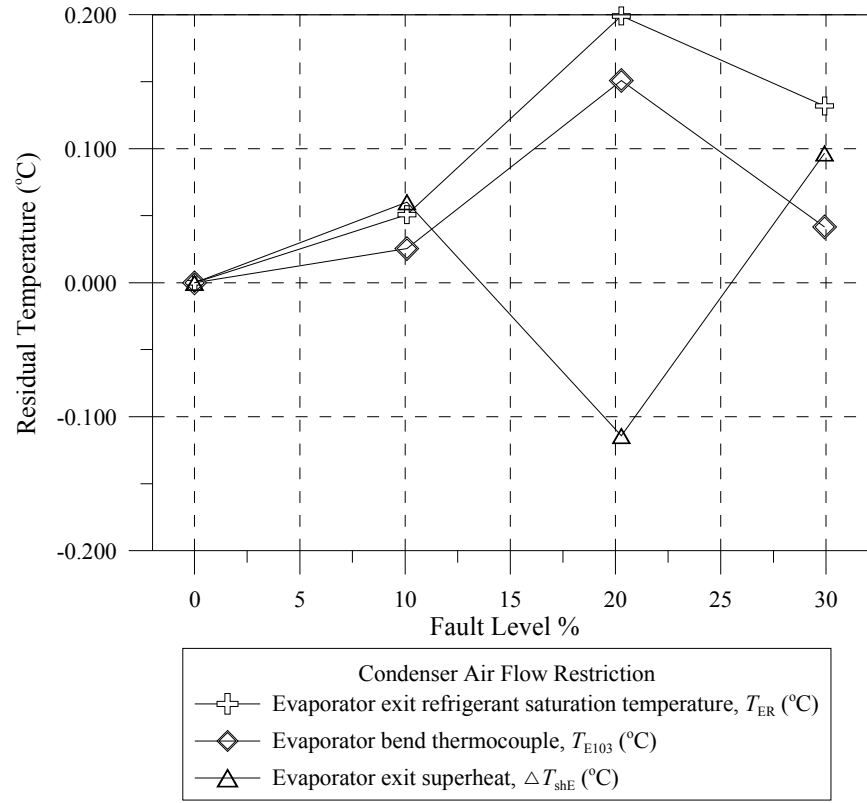
Figure 5.1.2. Residual of selected features with a condenser fouling fault at an indoor dry-bulb temperature of 21.1 °C and outdoor conditions of -8.3 °C/Dry:  $R[T_{ER}]$ ,  $R[T_{E103}]$ , and  $R[\Delta T_{shE}]$
