# NIST Technical Note 1648

## HEATING MODE PERFORMANCE MEASUREMENTS FOR A RESIDENTIAL HEAT PUMP WITH SINGLE-FAULTS IMPOSED

W. Vance Payne  
Seok Ho Yoon  
Piotr A. Domanski

September 2009

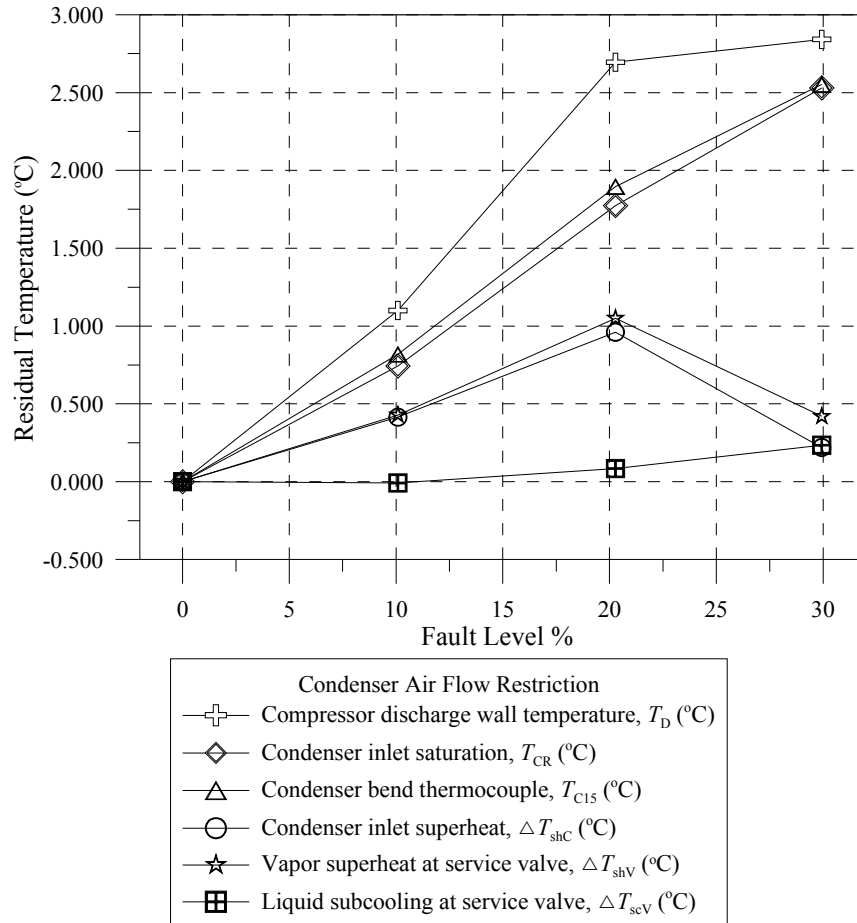
Figure 5.1.3. Residual of selected features with a condenser fouling fault at an indoor dry-bulb temperature of 21.1 °C and outdoor conditions of -8.3 °C/Dry:  $R[T_D]$ ,  $R[T_{CR}]$ ,  $R[T_{C15}]$ ,  $R[\Delta T_{shC}]$ ,  $R[\Delta T_{shV}]$ , and  $R[\Delta T_{scV}]$

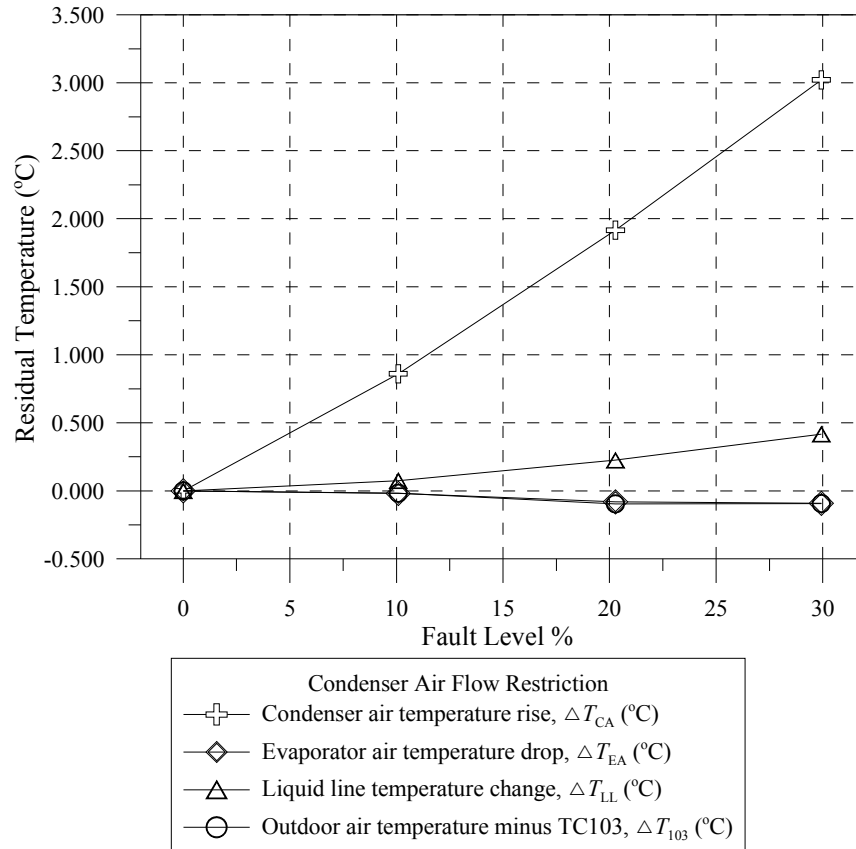
Figure 5.1.4. Residual of selected features with a condenser fouling fault at an indoor dry-bulb temperature of 21.1 °C and outdoor conditions of -8.3 °C/Dry:  $R[\Delta T_{CA}]$ ,  $R[\Delta T_{EA}]$ ,  $R[\Delta T_{LL}]$ , and  $R[\Delta T_{103}]$

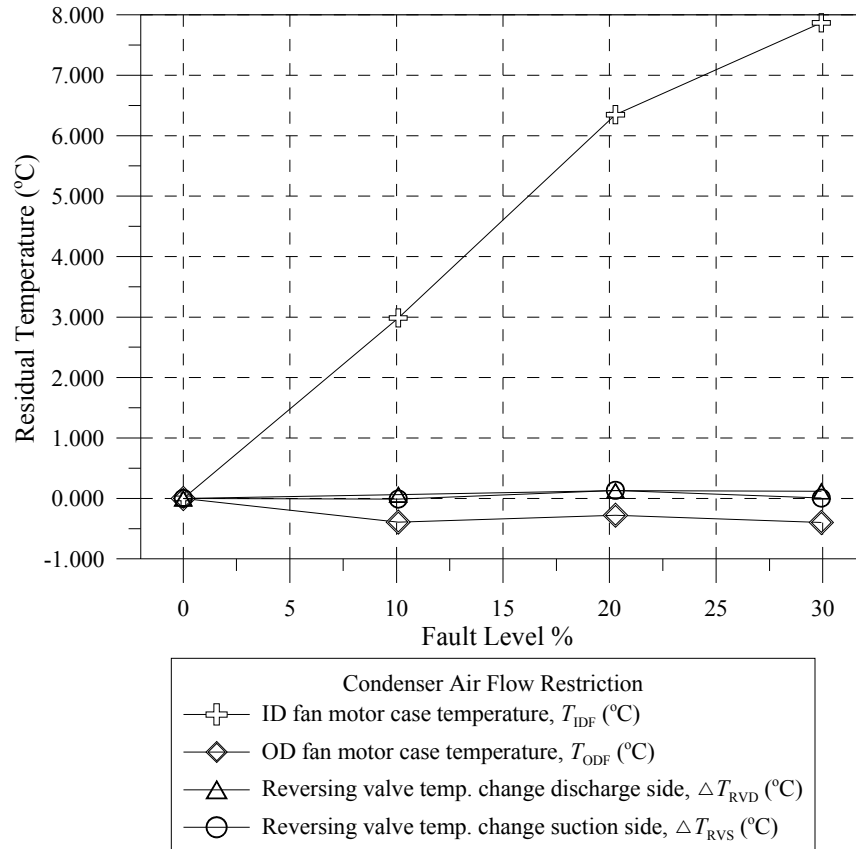
Figure 5.1.5. Residual of selected features with a condenser fouling fault at an indoor dry-bulb temperature of 21.1 °C and outdoor conditions of -8.3 °C/Dry:  $R[T_{IDF}]$ ,  $R[T_{ODF}]$ ,  $R[\Delta T_{RVD}]$ , and  $R[\Delta T_{RVS}]$

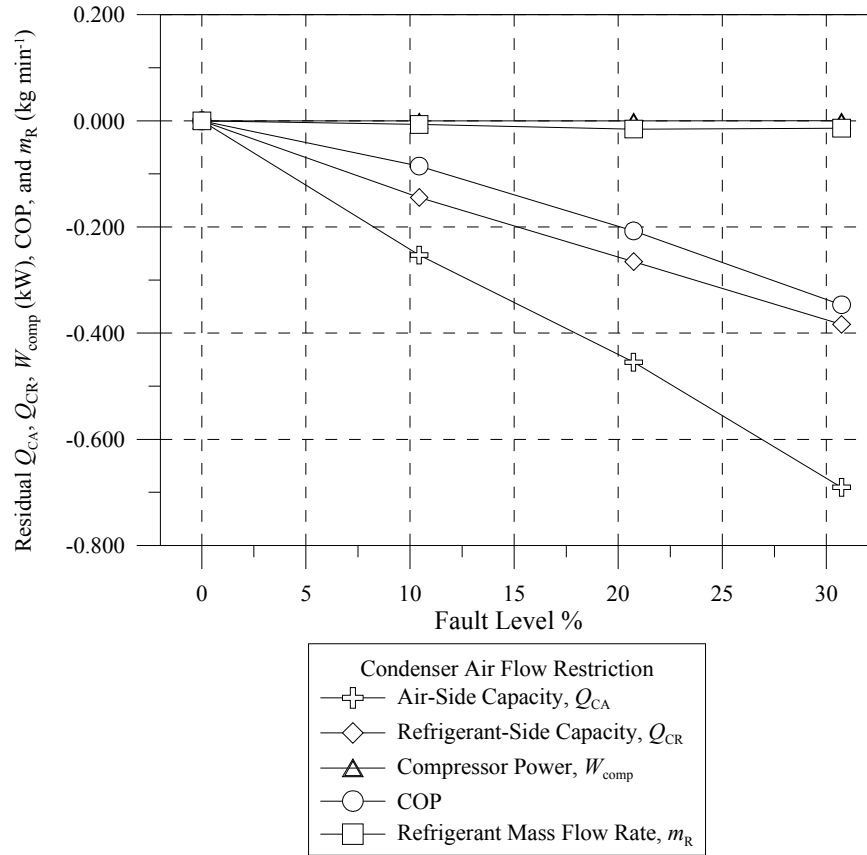
Figure 5.1.6. Residual of selected features with a condenser fouling fault at an indoor dry-bulb temperature of 21.1 °C and outdoor conditions of 8.3 °C/72.5 % RH:  $R[Q_{CA}]$ ,  $R[Q_{CR}]$ ,  $R[W_{comp}]$ ,  $R[COP]$ , and  $R[m_R]$

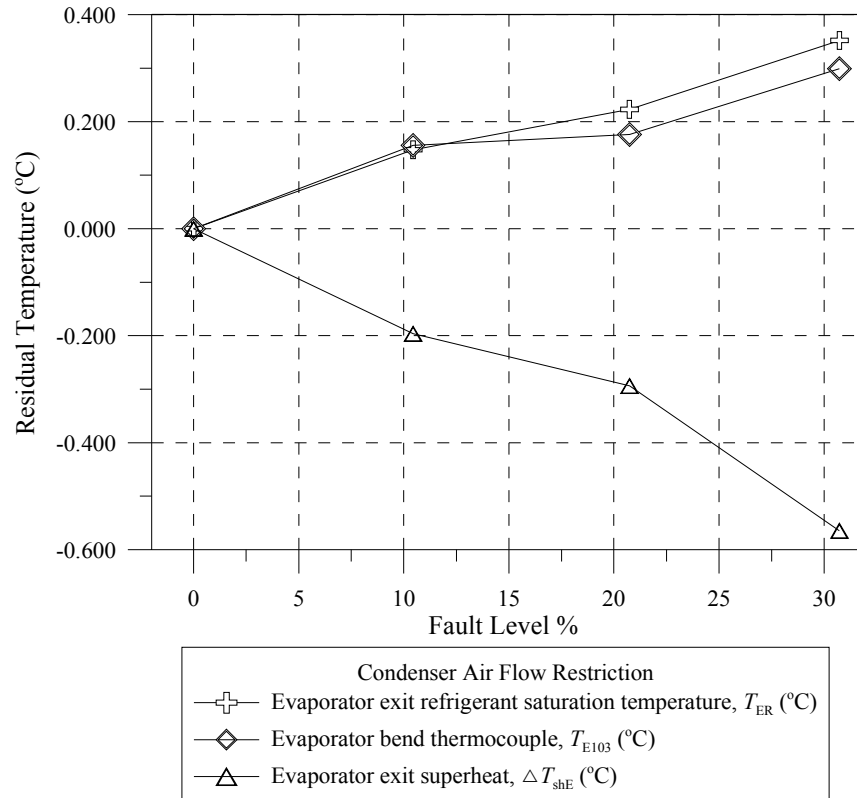
Figure 5.1.7. Residual of selected features with a condenser fouling fault at an indoor dry-bulb temperature of 21.1 °C and outdoor conditions of 8.3 °C/72.5 % RH:  $R[T_{ER}]$ ,  $R[T_{E103}]$ , and  $R[\Delta T_{shE}]$

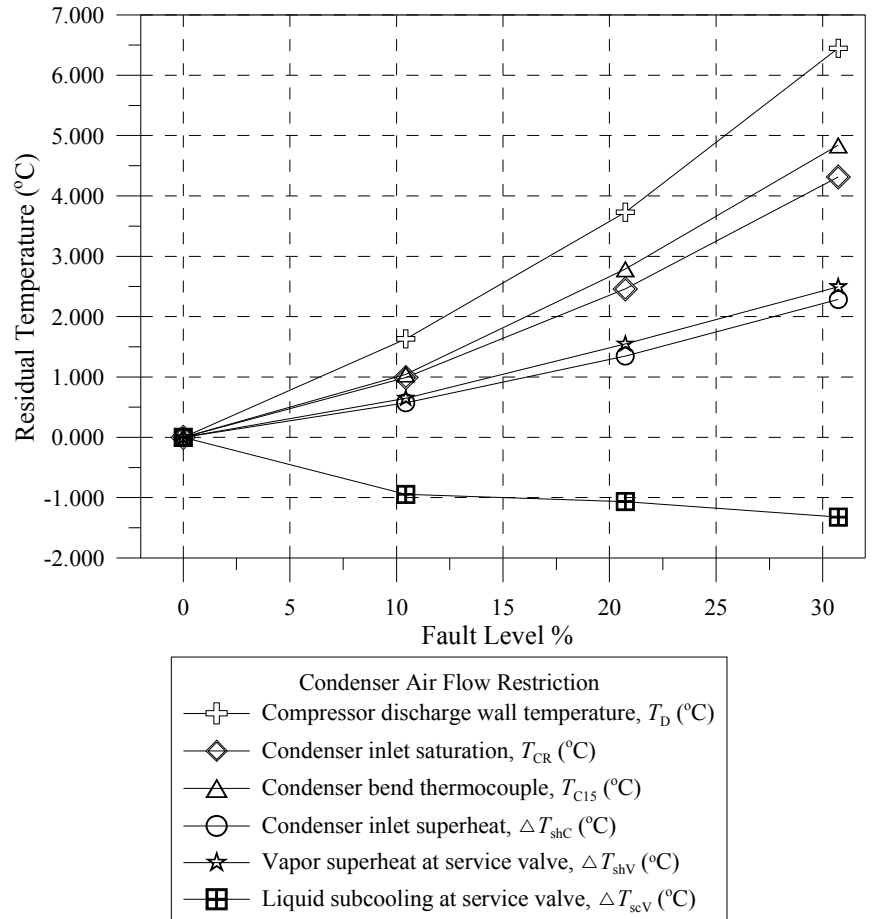
Figure 5.1.8. Residual of selected features with a condenser fouling fault at an indoor dry-bulb temperature of 21.1 °C and outdoor conditions of 8.3 °C/72.5 % RH:  $R[T_D]$ ,  $R[T_{CR}]$ ,  $R[T_{C15}]$ ,  $R[\Delta T_{shC}]$ ,  $R[\Delta T_{shV}]$ , and  $R[\Delta T_{scV}]$

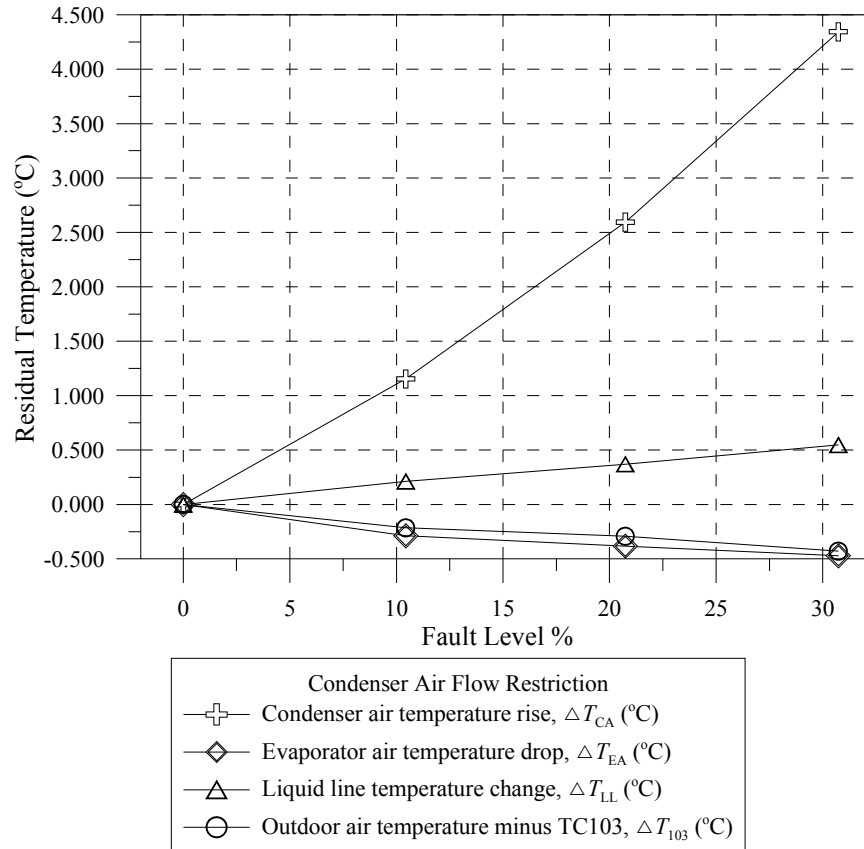
Figure 5.1.9. Residual of selected features with a condenser fouling fault at an indoor dry-bulb temperature of 21.1 °C and outdoor conditions of 8.3 °C/72.5 % RH:  $R[\Delta T_{CA}]$ ,  $R[\Delta T_{EA}]$ ,  $R[\Delta T_{LL}]$ , and  $R[\Delta T_{103}]$

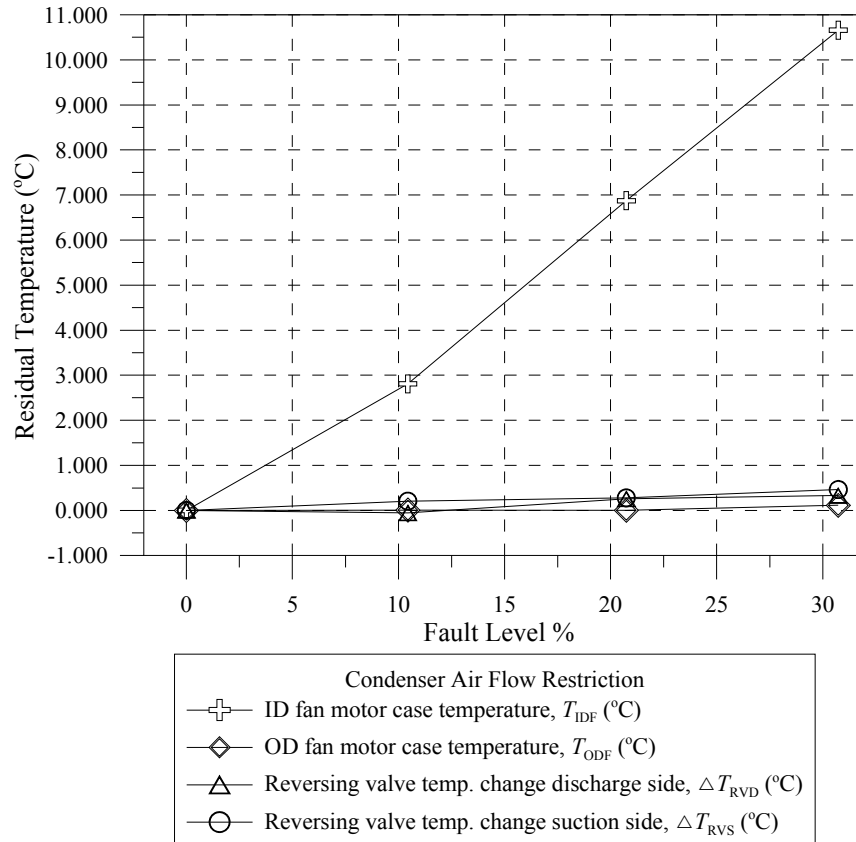
Figure 5.1.10. Residual of selected features with a condenser fouling fault:  $R[T_{IDF}]$ ,  $R[T_{ODF}]$ ,  $R[\Delta T_{RVD}]$ , and  $R[\Delta T_{RVS}]$  at an indoor dry-bulb temperature of 21.1 °C and outdoor conditions of 8.3 °C/72.5 % RH

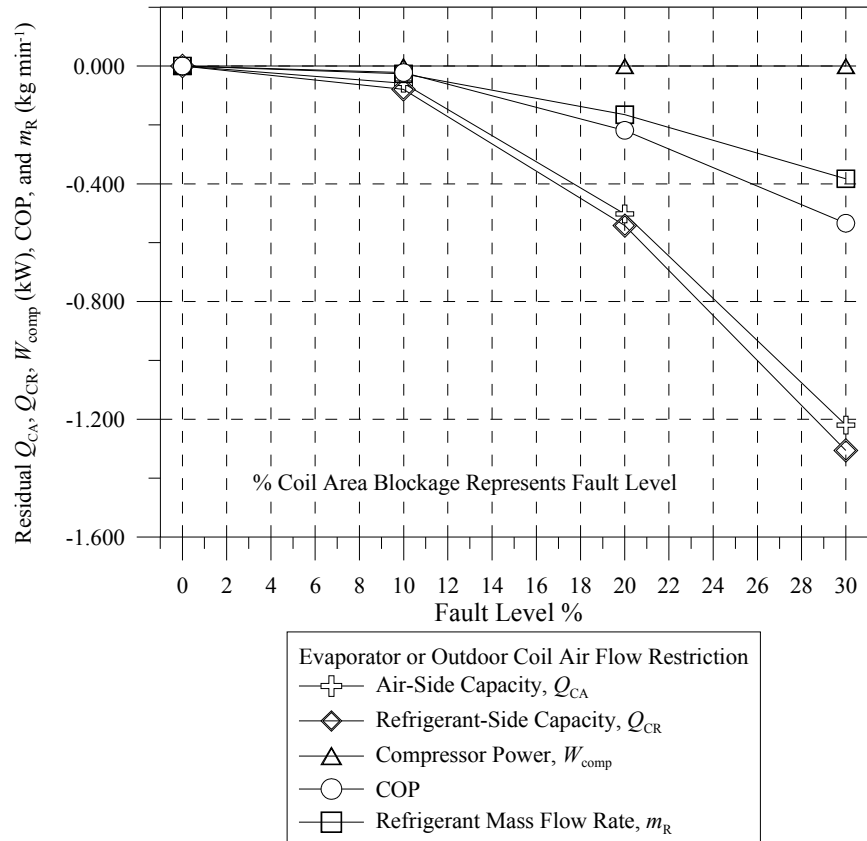
Figure 5.2.1. Residual of selected features with evaporator air flow faults at an indoor dry-bulb temperature of 21.1 °C and outdoor conditions of -8.3 °C/Dry:  $R[Q_{CA}]$ ,  $R[Q_{CR}]$ ,  $R[W_{comp}]$ ,  $R[COP]$ , and  $R[m_R]$

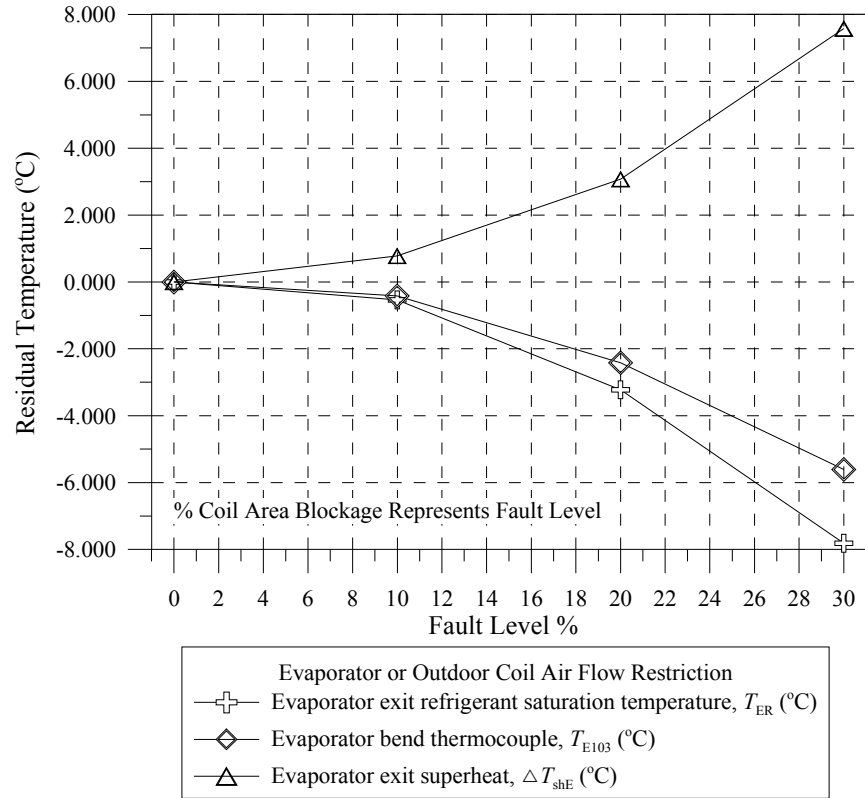
Figure 5.2.2. Residual of selected features with an evaporator fouling fault at an indoor dry-bulb temperature of 21.1 °C and outdoor conditions of -8.3 °C/Dry:  $R[T_{ER}]$ ,  $R[T_{E103}]$ , and  $R[\Delta T_{shE}]$

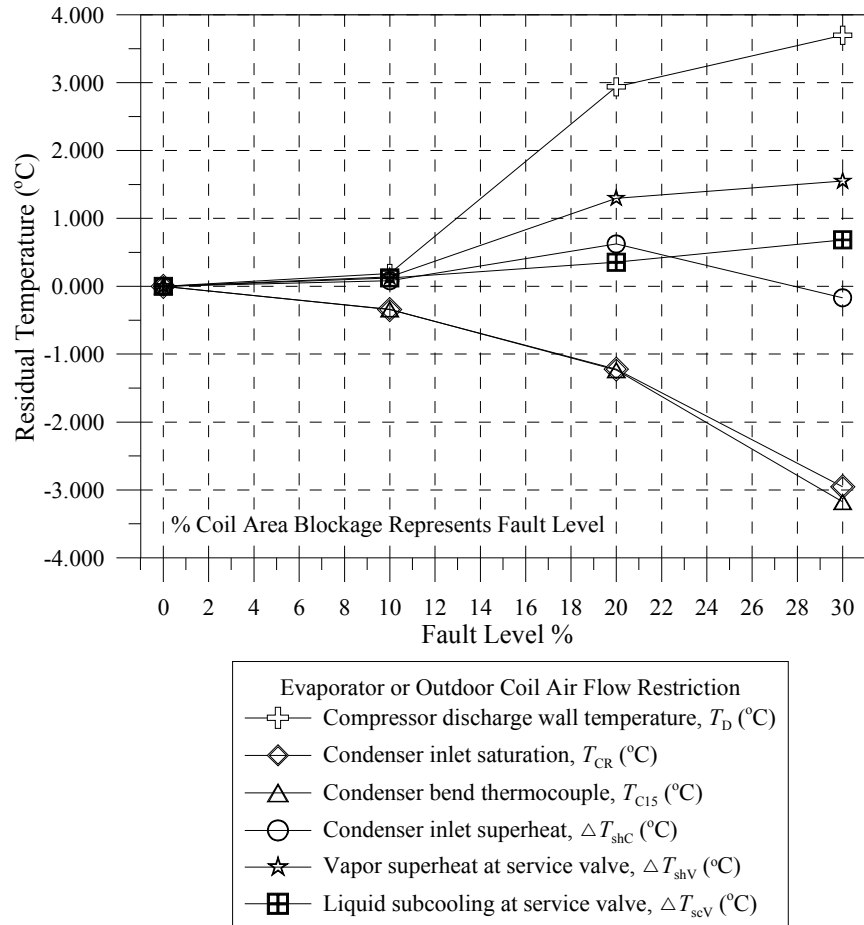
Figure 5.2.3. Residual of selected features with an evaporator fouling fault at an indoor dry-bulb temperature of 21.1 °C and outdoor conditions of -8.3 °C/Dry:  $R[T_D]$ ,  $R[T_{CR}]$ ,  $R[T_{C15}]$ ,  $R[\Delta T_{shC}]$ ,  $R[\Delta T_{shV}]$ , and  $R[\Delta T_{scV}]$

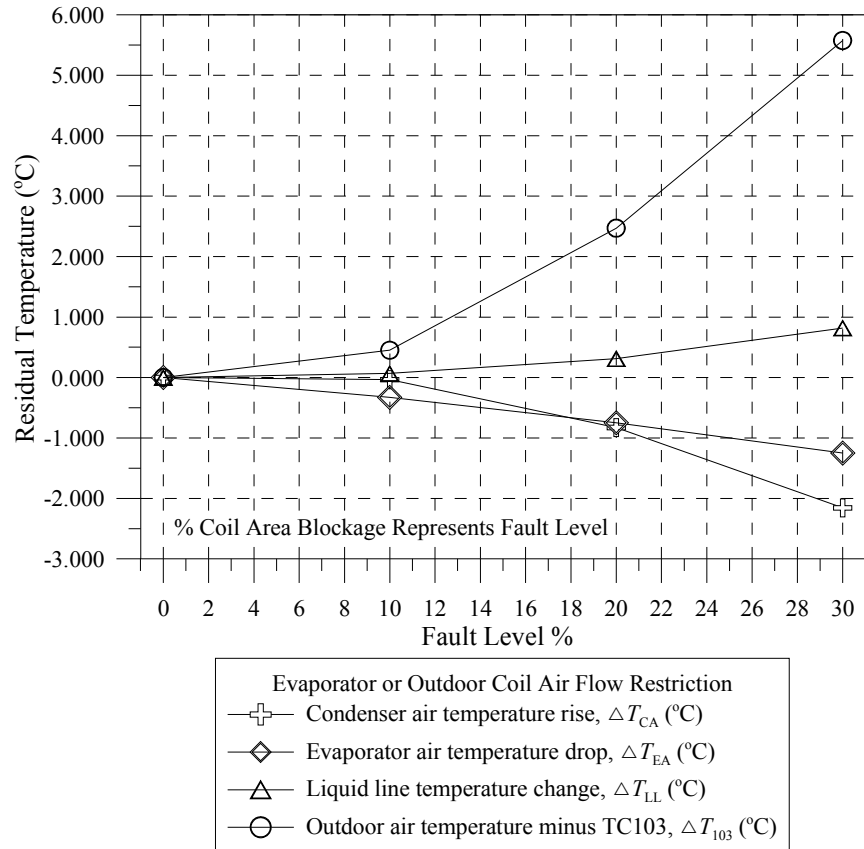
Figure 5.2.4. Residual of selected features with an evaporator fouling fault at an indoor dry-bulb temperature of 21.1 °C and outdoor conditions of -8.3 °C/Dry:  $R[\Delta T_{CA}]$ ,  $R[\Delta T_{EA}]$ ,  $R[\Delta T_{LL}]$ , and  $R[\Delta T_{103}]$

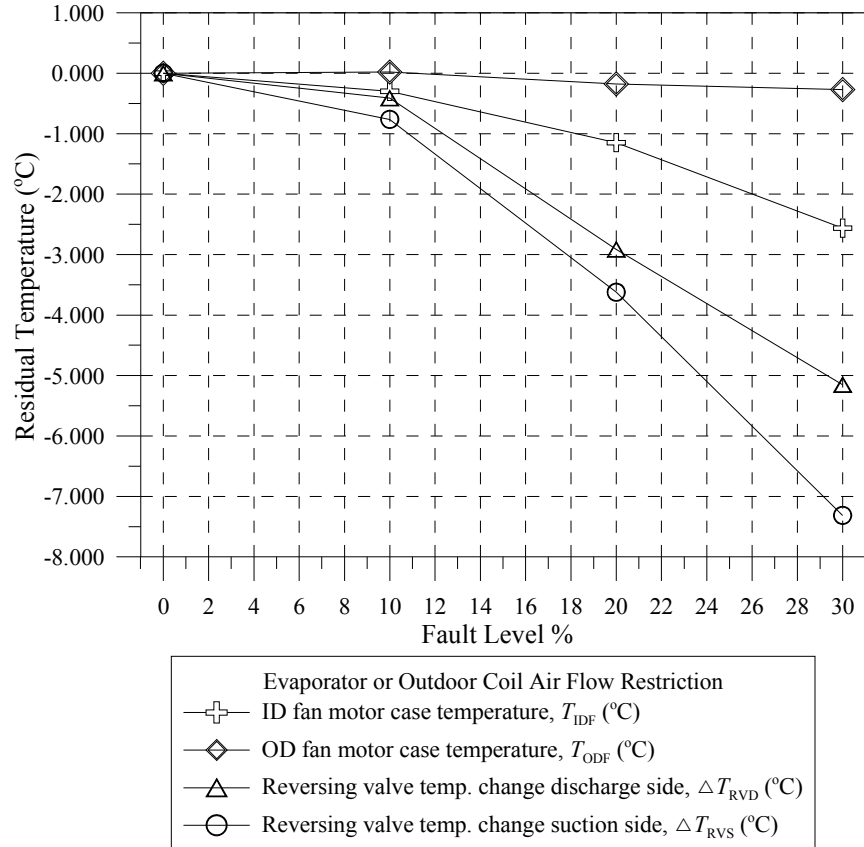
Figure 5.2.5. Residual of selected features with an evaporator fouling fault at an indoor dry-bulb temperature of 21.1 °C and outdoor conditions of -8.3 °C/Dry:  $R[T_{IDF}]$ ,  $R[T_{ODF}]$ ,  $R[\Delta T_{RVD}]$ , and  $R[\Delta T_{RVS}]$

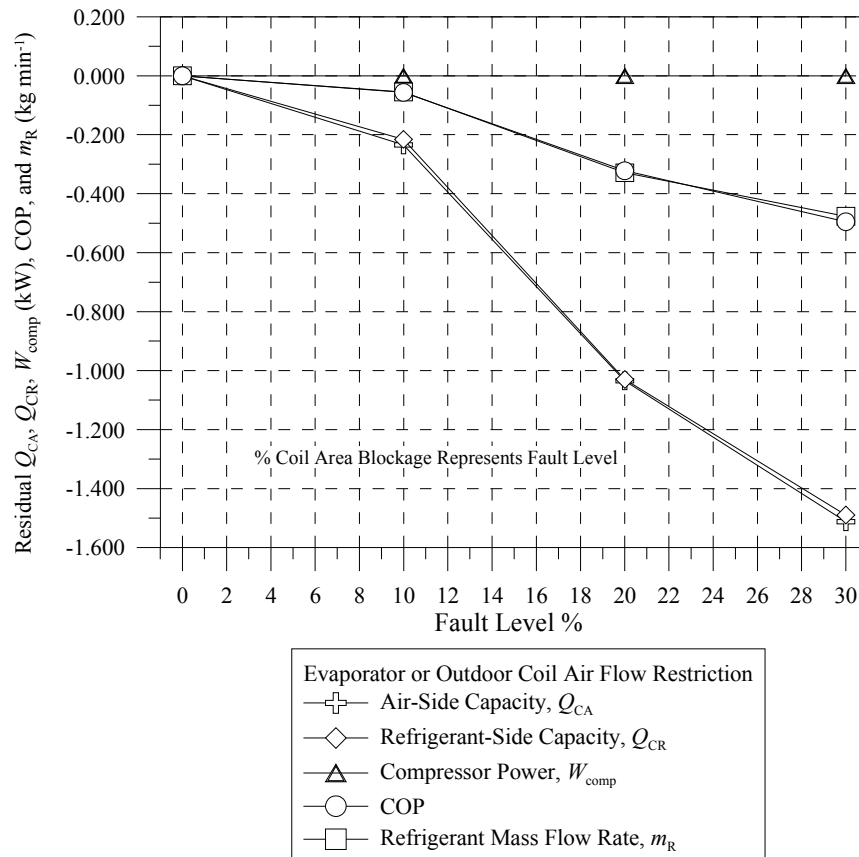
Figure 5.2.6. Residual of selected features with evaporator air flow faults imposed at an indoor dry-bulb temperature of 21.1 °C and outdoor conditions of 8.3 °C/72.5 % RH:  $R[Q_{CA}]$ ,  $R[Q_{CR}]$ ,  $R[W_{comp}]$ ,  $R[COP]$ , and  $R[m_R]$

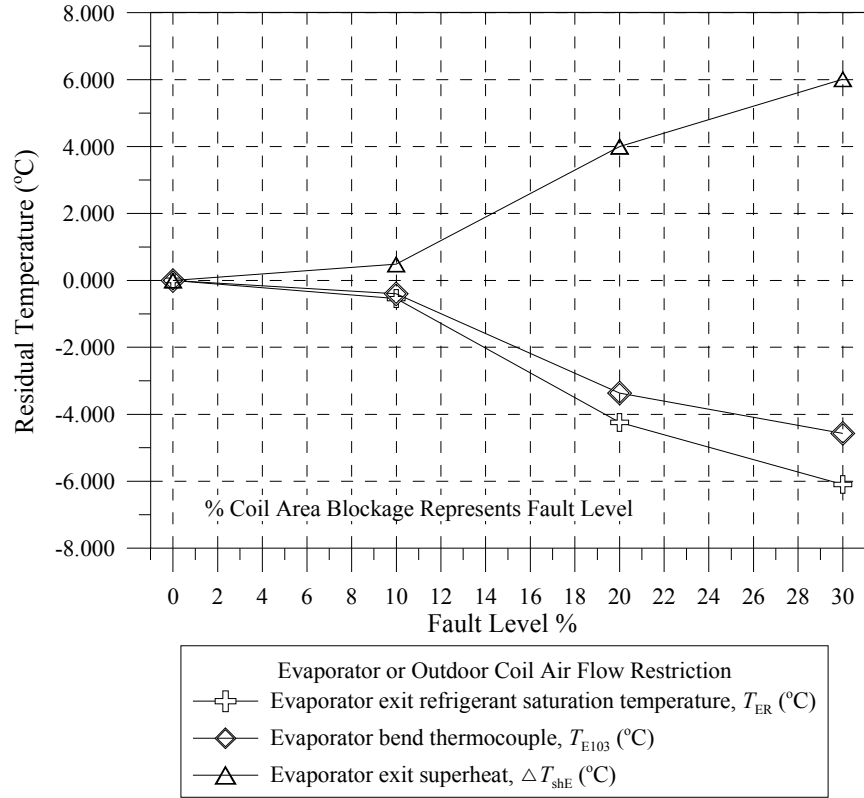
Figure 5.2.7. Residual of selected features with an evaporator fouling fault at an indoor dry-bulb temperature of 21.1 °C and outdoor conditions of 8.3 °C/72.5 % RH:  $R[T_{ER}]$ ,  $R[T_{E103}]$ , and  $R[\Delta T_{shE}]$

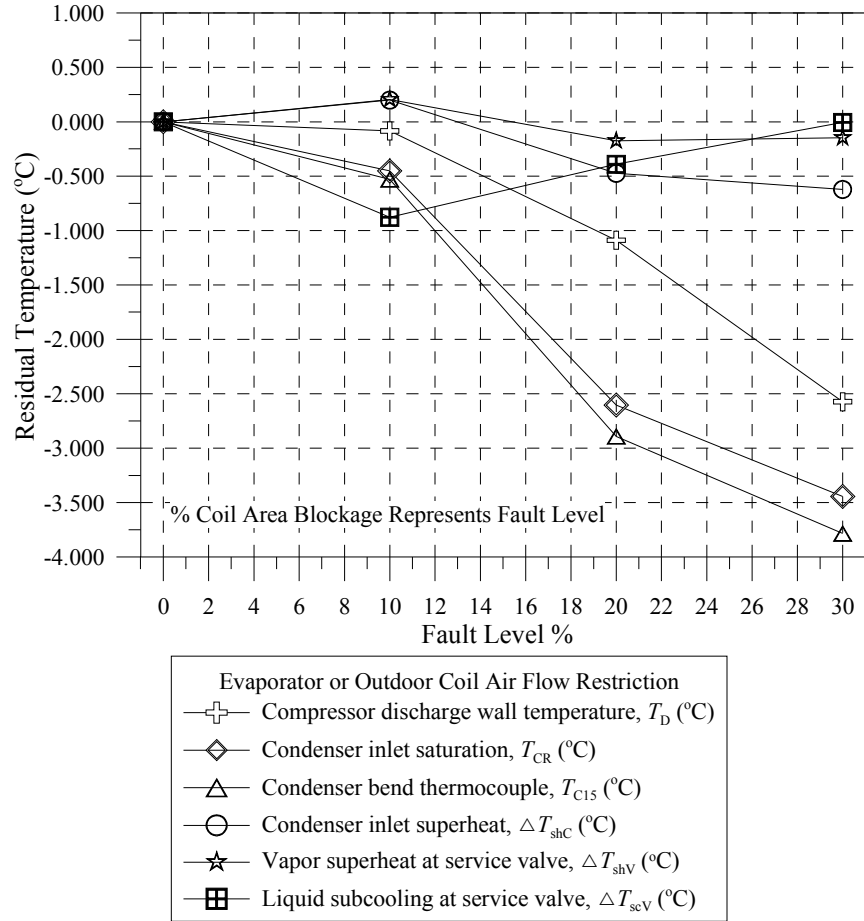
Figure 5.2.8. Residual of selected features with an evaporator fouling fault at an indoor dry-bulb temperature of 21.1 °C and outdoor conditions of 8.3 °C/72.5 % RH:  $R[T_D]$ ,  $R[T_{CR}]$ ,  $R[T_{C15}]$ ,  $R[\Delta T_{shC}]$ ,  $R[\Delta T_{shV}]$ , and  $R[\Delta T_{scV}]$

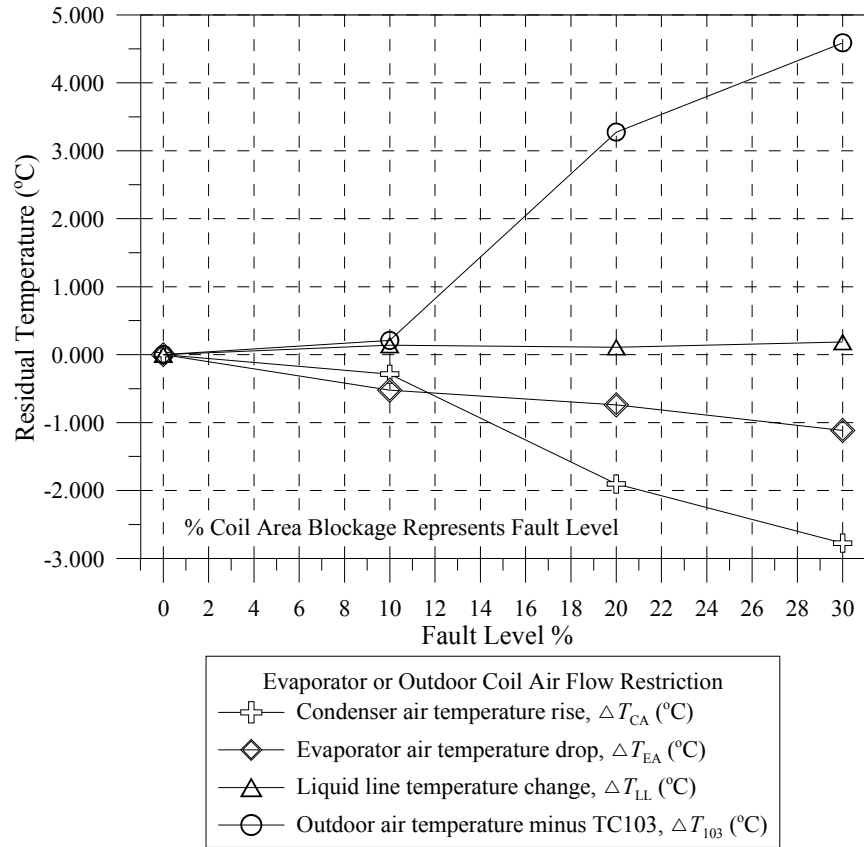
Figure 5.2.9. Residual of selected features with an evaporator fouling fault at an indoor dry-bulb temperature of 21.1 °C and outdoor conditions of 8.3 °C/72.5 % RH:  $R[\Delta T_{CA}]$ ,  $R[\Delta T_{EA}]$ ,  $R[\Delta T_{LL}]$ , and  $R[\Delta T_{103}]$

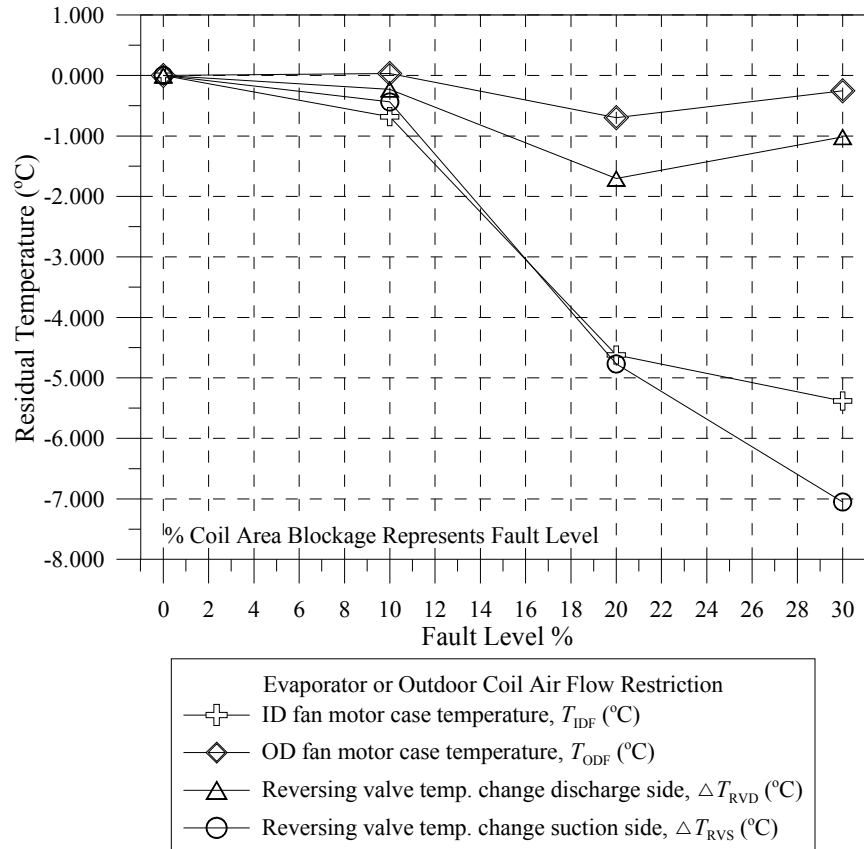
Figure 5.2.10. Residual of selected features with an evaporator fouling fault at an indoor dry-bulb temperature of 21.1 °C and outdoor conditions of 8.3 °C/72.5 % RH:  $R[T_{IDF}]$ ,  $R[T_{ODF}]$ ,  $R[\Delta T_{RVD}]$ , and  $R[\Delta T_{RVS}]$

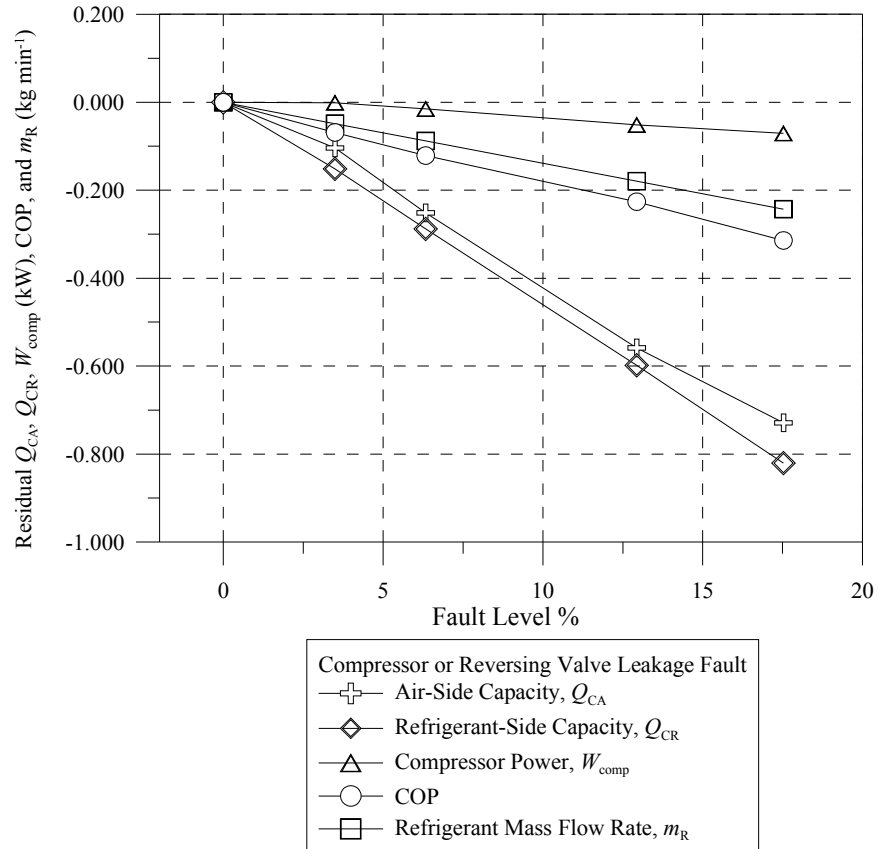
Figure 5.3.1. Residual of selected features with compressor or four-way valve refrigerant leakage faults imposed at an indoor dry-bulb temperature of 21.1 °C and outdoor conditions of -8.3 °C/Dry:  $R[Q_{CA}]$ ,  $R[Q_{CR}]$ ,  $R[W_{comp}]$ ,  $R[COP]$ , and  $R[m_R]$

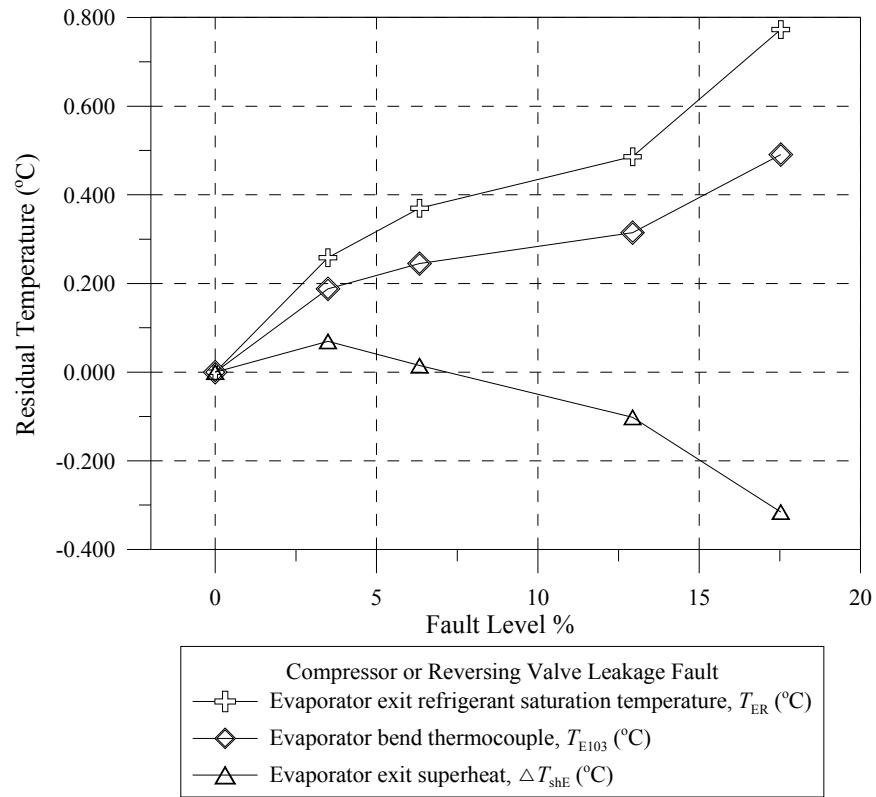
Figure 5.3.2. Residual of selected features with compressor or four-way valve refrigerant leakage fault at an indoor dry-bulb temperature of 21.1 °C and outdoor conditions of -8.3 °C/Dry:  $R[T_{ER}]$ ,  $R[T_{E103}]$ , and  $R[\Delta T_{shE}]$

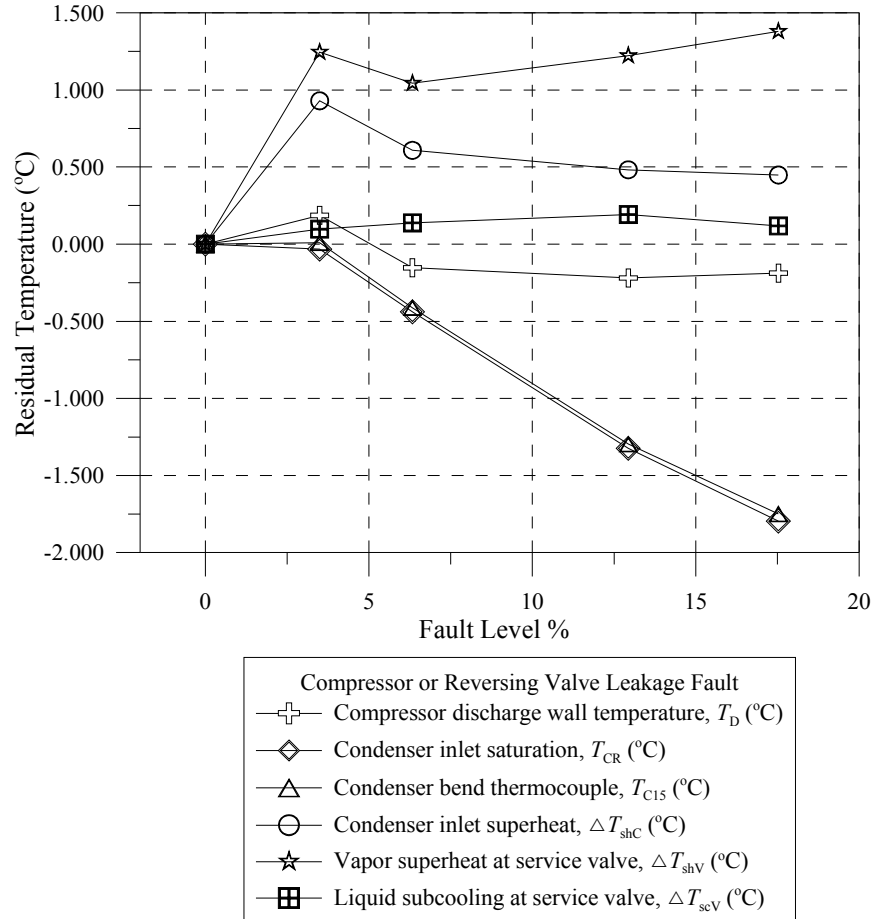
Figure 5.3.3. Residual of selected features with compressor or four-way valve refrigerant leakage fault at an indoor dry-bulb temperature of 21.1 °C and outdoor conditions of -8.3 °C/Dry:  $R[T_D]$ ,  $R[T_{CR}]$ ,  $R[T_{C15}]$ ,  $R[\Delta T_{shc}]$ ,  $R[\Delta T_{shv}]$ , and  $R[\Delta T_{scv}]$

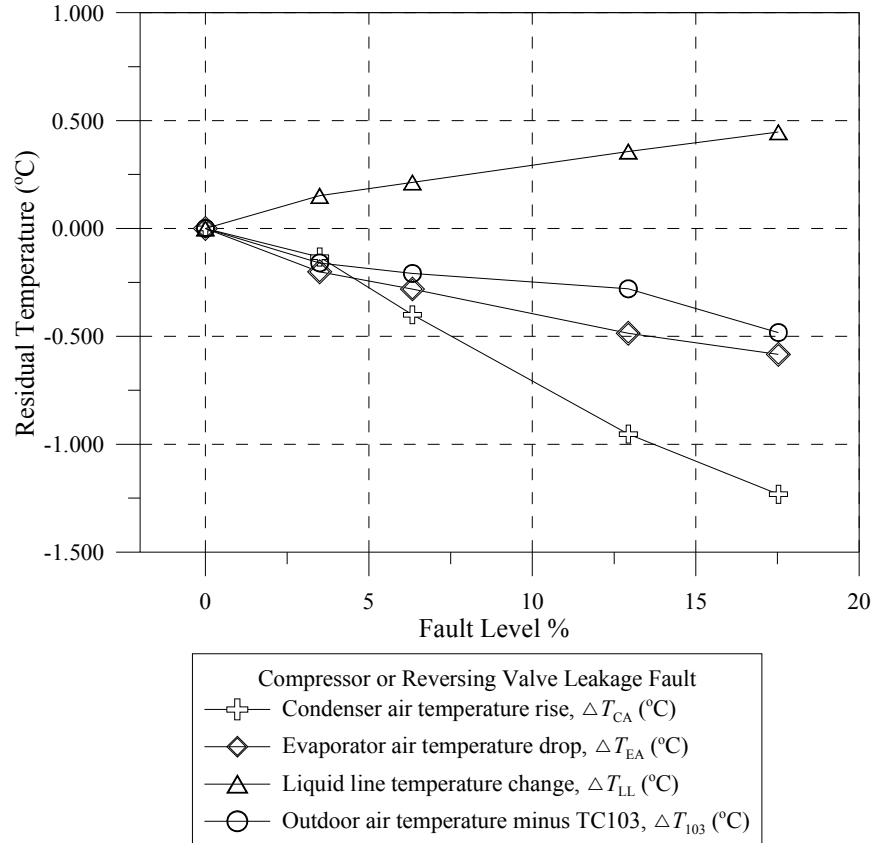
Figure 5.3.4. Residual of selected features with compressor or four-way valve refrigerant leakage fault at an indoor dry-bulb temperature of 21.1 °C and outdoor conditions of -8.3 °C/Dry:  $R[\Delta T_{CA}]$ ,  $R[\Delta T_{EA}]$ ,  $R[\Delta T_{LL}]$ , and  $R[\Delta T_{103}]$

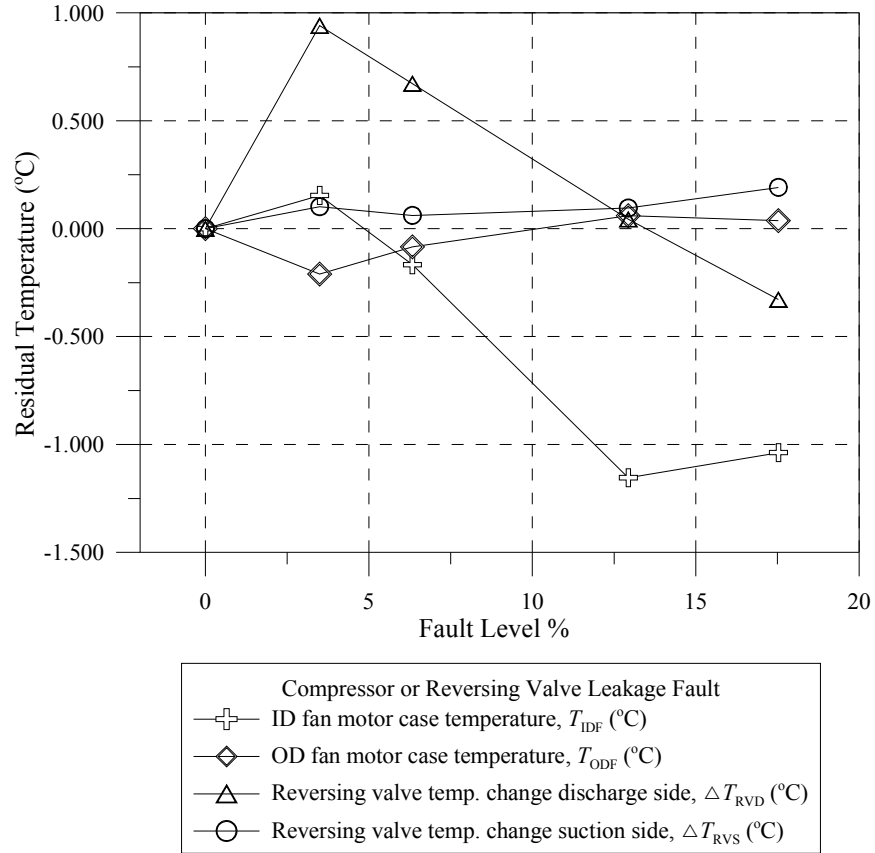
Figure 5.3.5. Residual of selected features with compressor or four-way valve refrigerant leakage fault at an indoor dry-bulb temperature of 21.1 °C and outdoor conditions of -8.3 °C/Dry:  $R[T_{IDF}]$ ,  $R[T_{ODF}]$ ,  $R[\Delta T_{RVD}]$ , and  $R[\Delta T_{RVS}]$

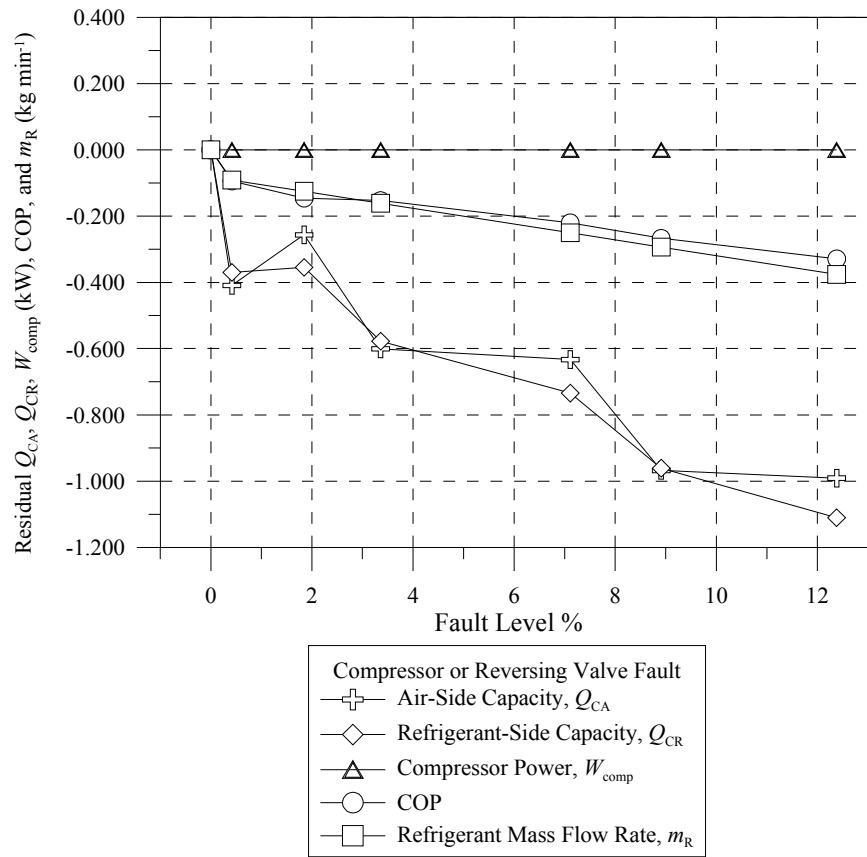
Figure 5.3.6. Residual of selected features with compressor or four-way valve refrigerant leakage faults imposed at an indoor dry-bulb temperature of 21.1 °C and outdoor conditions of 8.3 °C/72.5 % RH:  $R[Q_{CA}]$ ,  $R[Q_{CR}]$ ,  $R[W_{comp}]$ ,  $R[COP]$ , and  $R[m_R]$

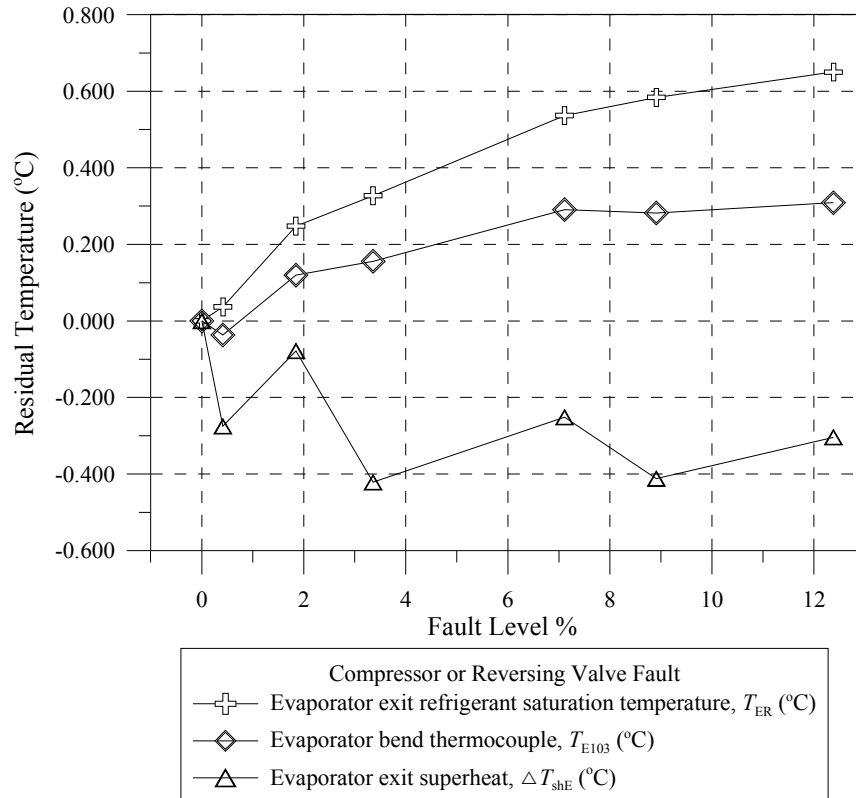
Figure 5.3.7. Residual of selected features with compressor or four-way valve refrigerant leakage fault at an indoor dry-bulb temperature of 21.1 °C and outdoor conditions of 8.3 °C/72.5 % RH:  $R[T_{ER}]$ ,  $R[T_{E103}]$ , and  $R[\Delta T_{shE}]$

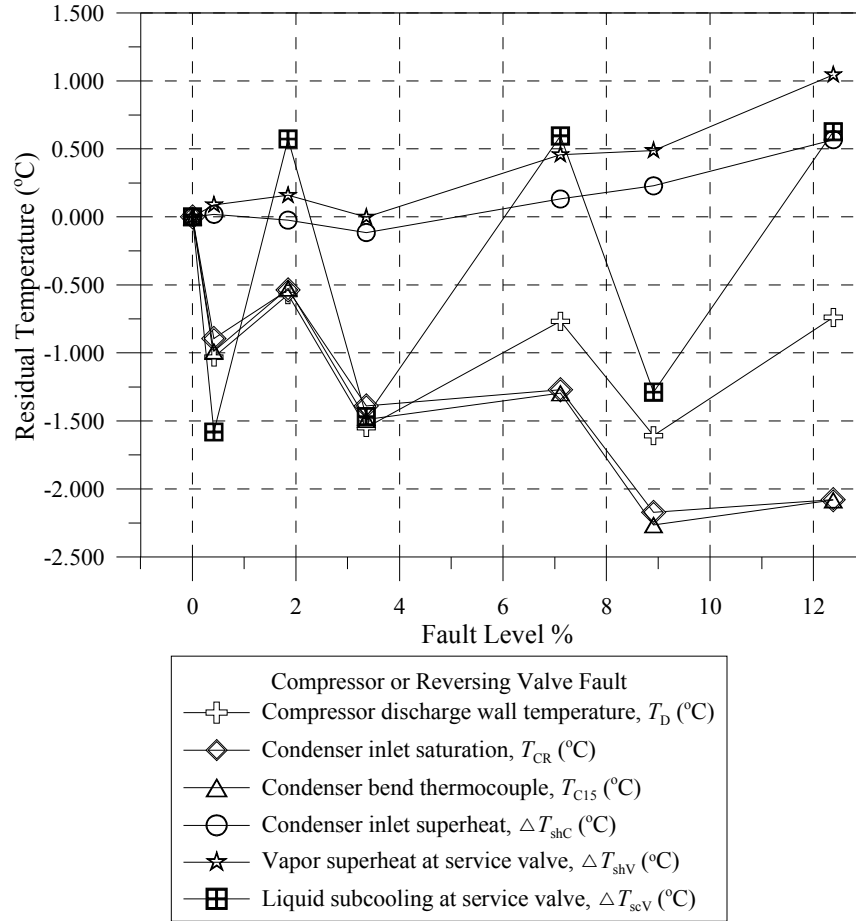
Figure 5.3.8. Residual of selected features with compressor or four-way valve refrigerant leakage fault:  $R[T_D]$ ,  $R[T_{CR}]$ ,  $R[T_{C15}]$ ,  $R[\Delta T_{shC}]$ ,  $R[\Delta T_{shV}]$ , and  $R[\Delta T_{scV}]$  at an indoor dry-bulb temperature of 21.1 °C and outdoor conditions of 8.3 °C/72.5 % RH

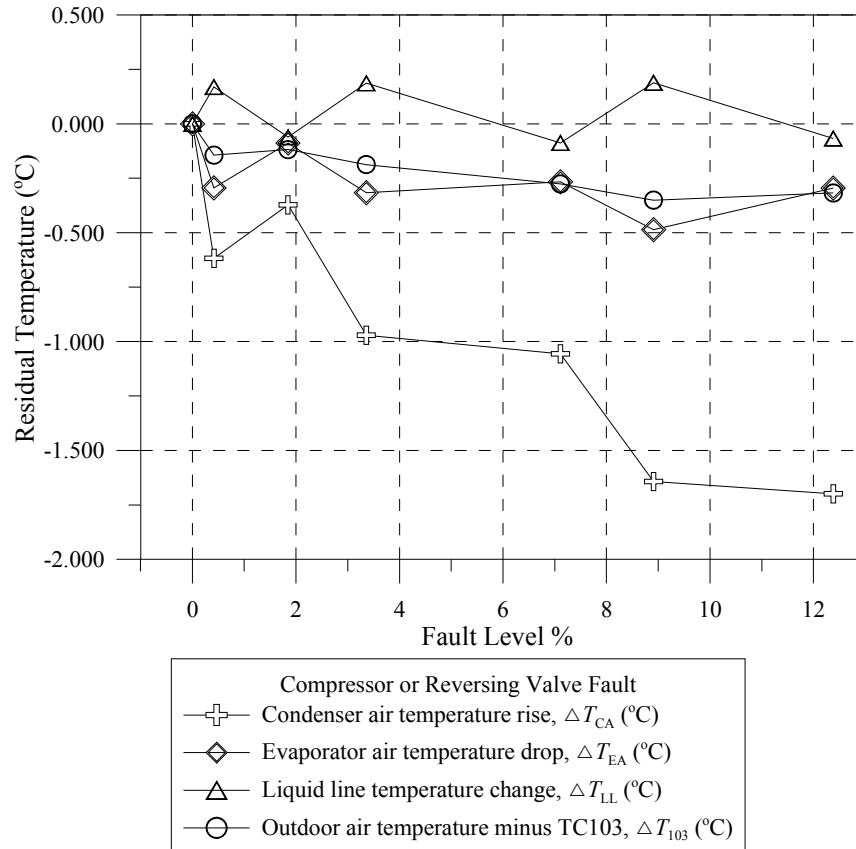
Figure 5.3.9. Residual of selected features with compressor or four-way valve refrigerant leakage fault at an indoor dry-bulb temperature of 21.1 °C and outdoor conditions of 8.3 °C/72.5 % RH:  $R[\Delta T_{CA}]$ ,  $R[\Delta T_{EA}]$ ,  $R[\Delta T_{LL}]$ , and  $R[\Delta T_{103}]$

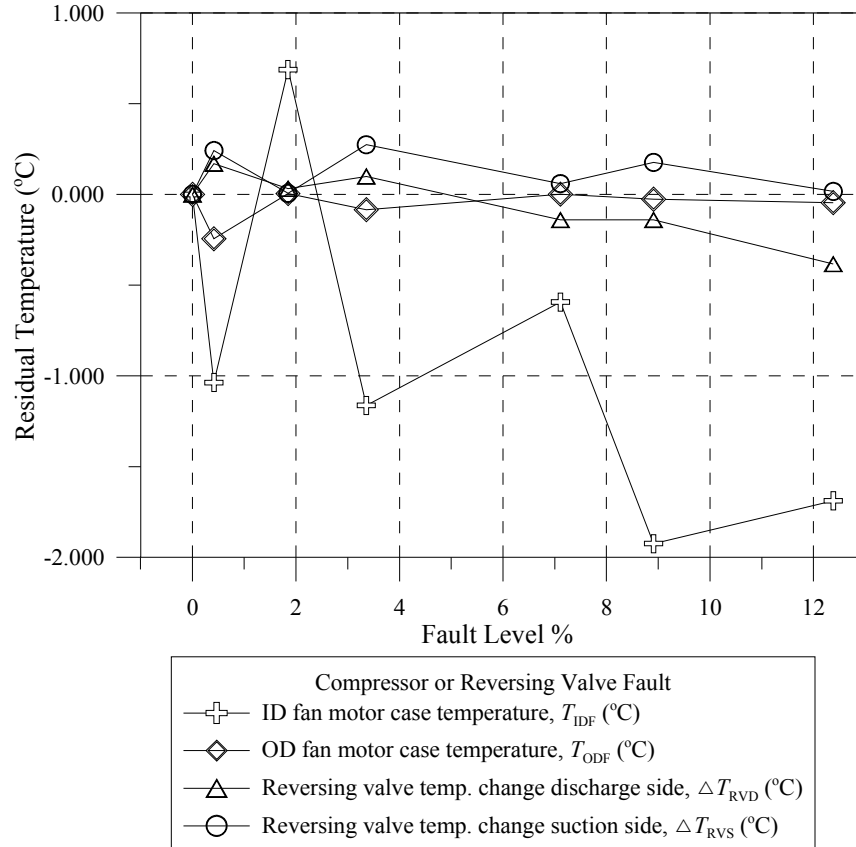
Figure 5.3.10. Residual of selected features with compressor or four-way valve refrigerant leakage fault at an indoor dry-bulb temperature of 21.1 °C and outdoor conditions of 8.3 °C/72.5 % RH:  $R[T_{IDF}]$ ,  $R[T_{ODF}]$ ,  $R[\Delta T_{RVD}]$ , and  $R[\Delta T_{RVS}]$
