# NIST Technical Note 1648

## HEATING MODE PERFORMANCE MEASUREMENTS FOR A RESIDENTIAL HEAT PUMP WITH SINGLE-FAULTS IMPOSED

W. Vance Payne  
Seok Ho Yoon  
Piotr A. Domanski

September 2009

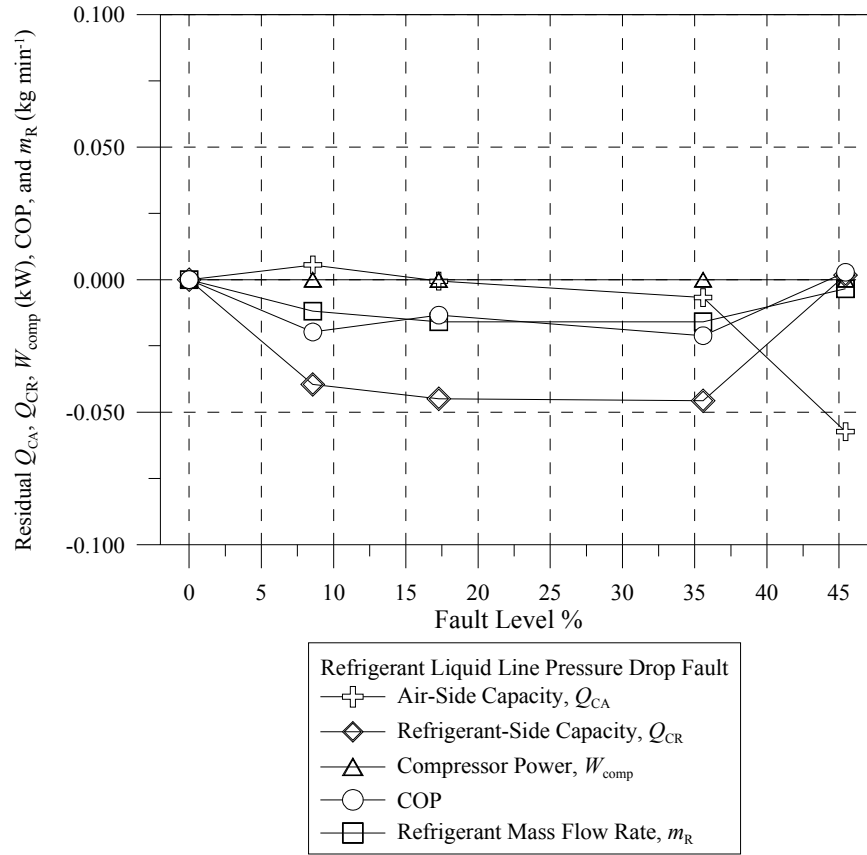
Figure 5.4.1. Residual air-side capacity, refrigerant-side capacity, compressor power, COP, and refrigerant mass flowrate with liquid line restriction faults imposed at an indoor dry-bulb temperature of 21.1 °C and outdoor conditions of -8.3 °C/Dry

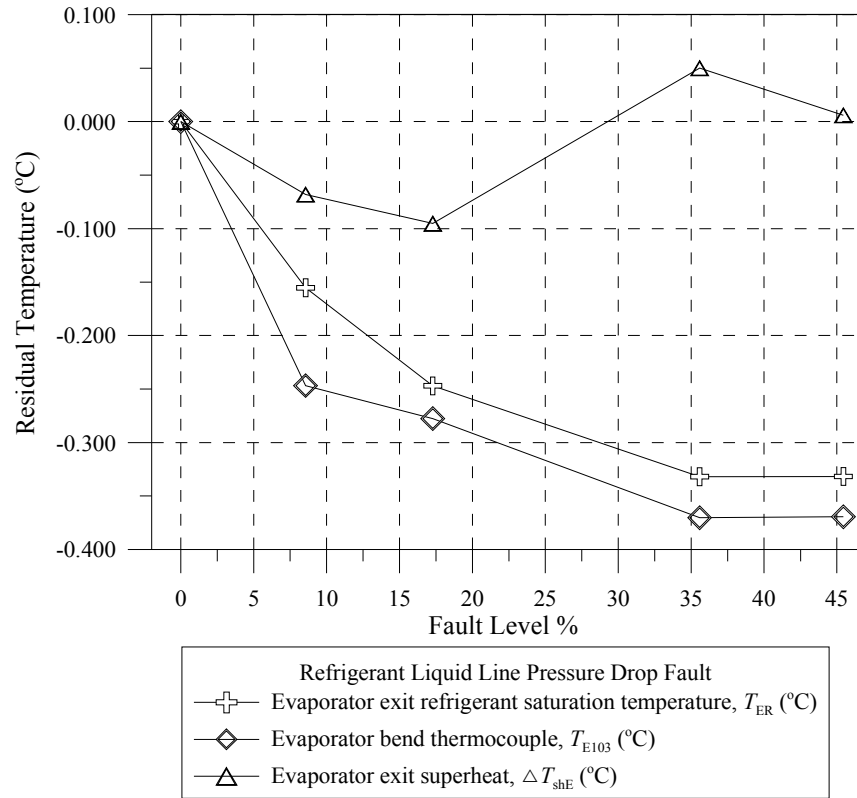
Figure 5.4.2. Residual of selected features with liquid line restriction faults at an indoor dry-bulb temperature of 21.1 °C and outdoor conditions of -8.3 °C/Dry:  $R[T_{ER}]$ ,  $R[T_{E103}]$ , and  $R[\Delta T_{shE}]$

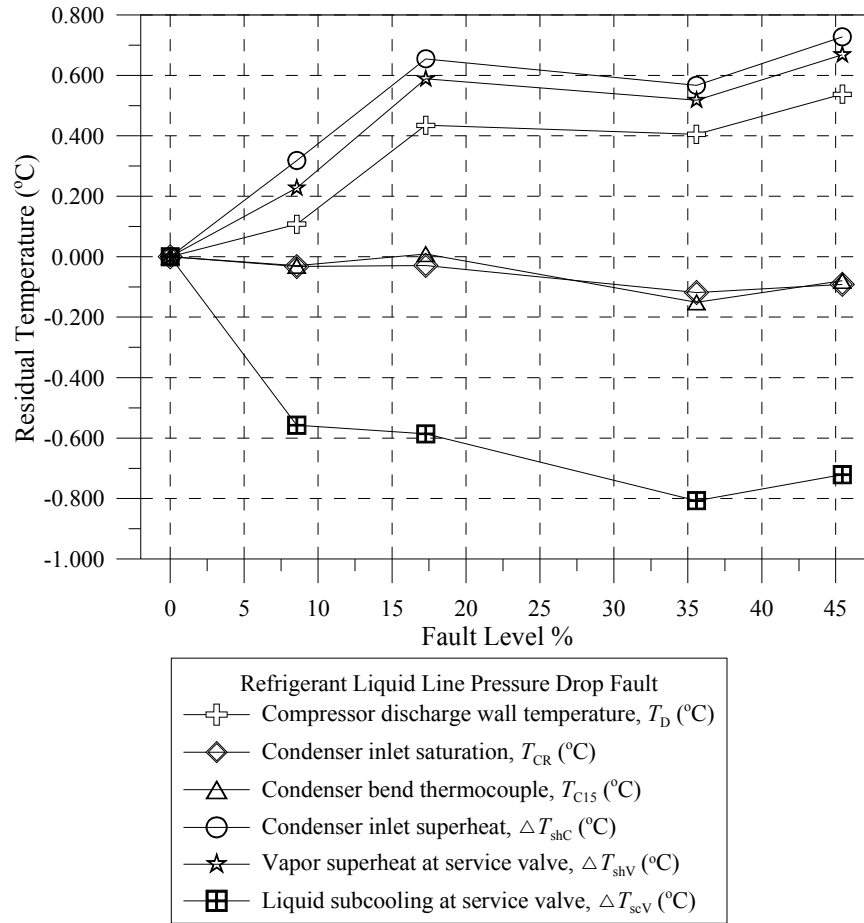
Figure 5.4.3. Residual of selected features with liquid line restriction faults at an indoor dry-bulb temperature of 21.1 °C and outdoor conditions of -8.3 °C/Dry:  $R[T_D]$ ,  $R[T_{CR}]$ ,  $R[T_{C15}]$ ,  $R[\Delta T_{shC}]$ ,  $R[\Delta T_{shV}]$ , and  $R[\Delta T_{scV}]$

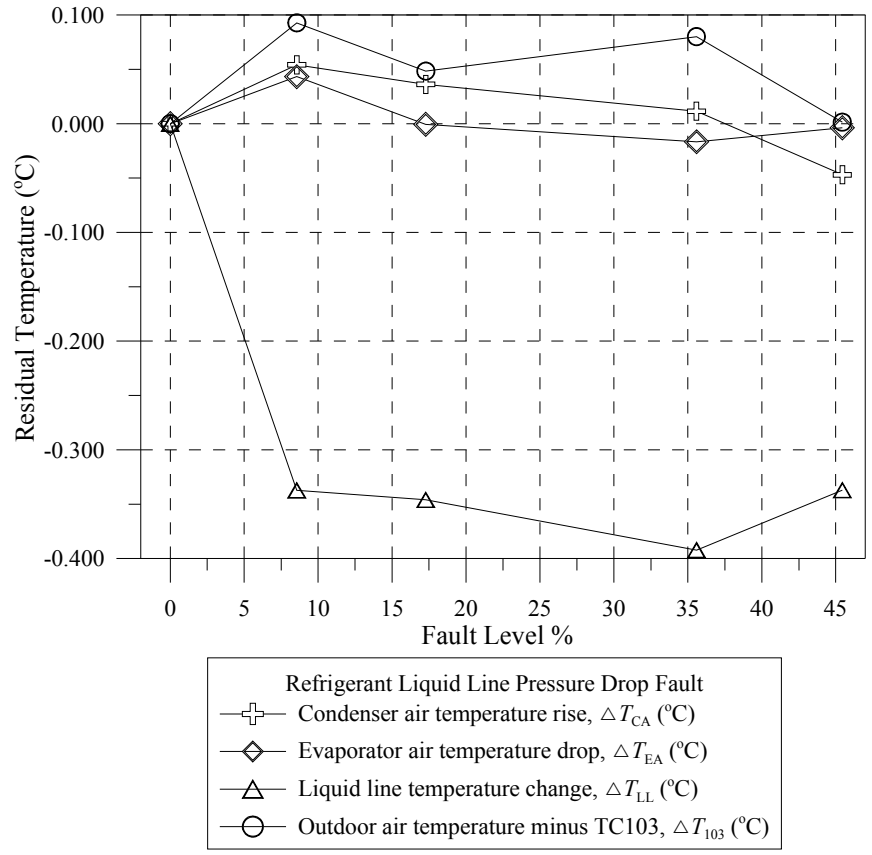
Figure 5.4.4. Residual of selected features with liquid line restriction faults at an indoor dry-bulb temperature of 21.1 °C and outdoor conditions of -8.3 °C/Dry:  $R[\Delta T_{CA}]$ ,  $R[\Delta T_{EA}]$ ,  $R[\Delta T_{LL}]$ , and  $R[\Delta T_{103}]$

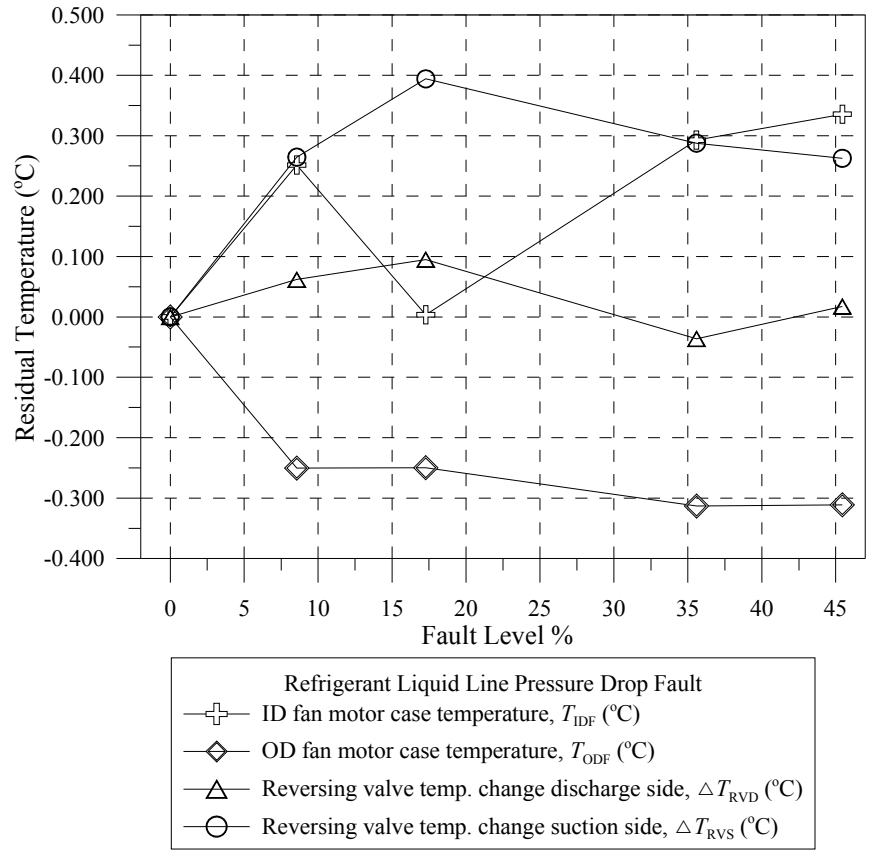
Figure 5.4.5. Residual of selected features with liquid line restriction faults at an indoor dry-bulb temperature of 21.1 °C and outdoor conditions of -8.3 °C/Dry:  $R[T_{IDF}]$ ,  $R[T_{ODF}]$ ,  $R[\Delta T_{RVD}]$ , and  $R[\Delta T_{RVS}]$

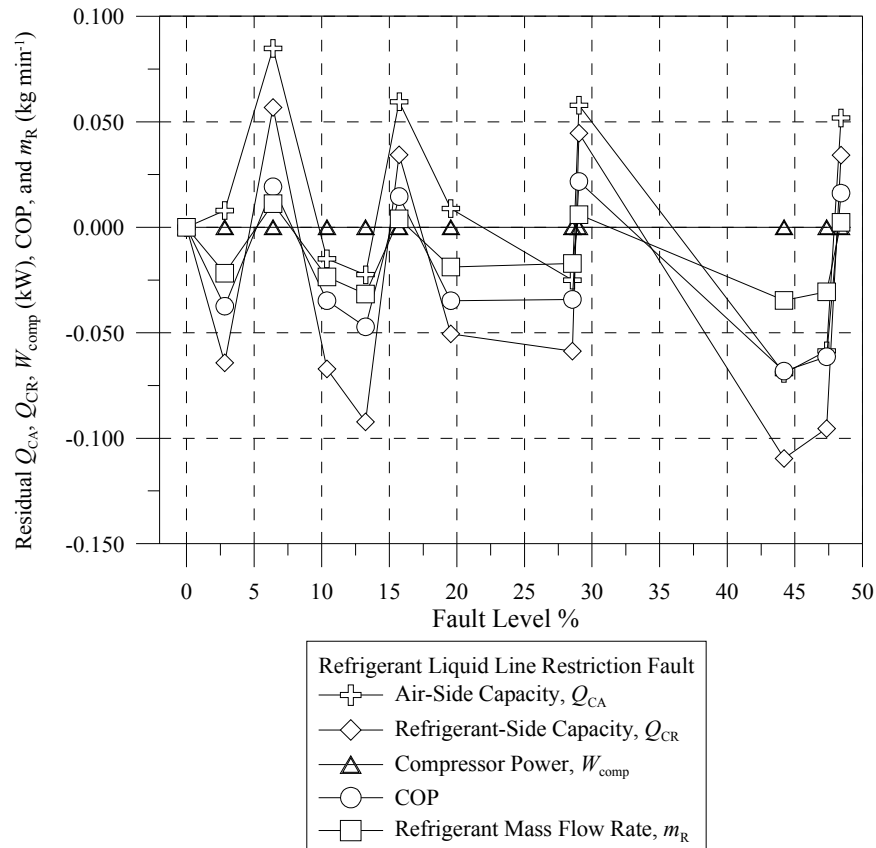
Figure 5.4.6. Residual of selected features with refrigerant liquid line restriction faults imposed at an indoor dry-bulb temperature of  $21.1\text{ }^{\circ}\text{C}$  and outdoor conditions of  $8.3\text{ }^{\circ}\text{C}/72.5\text{ \% RH}$ :  $R[Q_{CA}]$ ,  $R[Q_{CR}]$ ,  $R[W_{comp}]$ ,  $R[COP]$ , and  $R[m_R]$

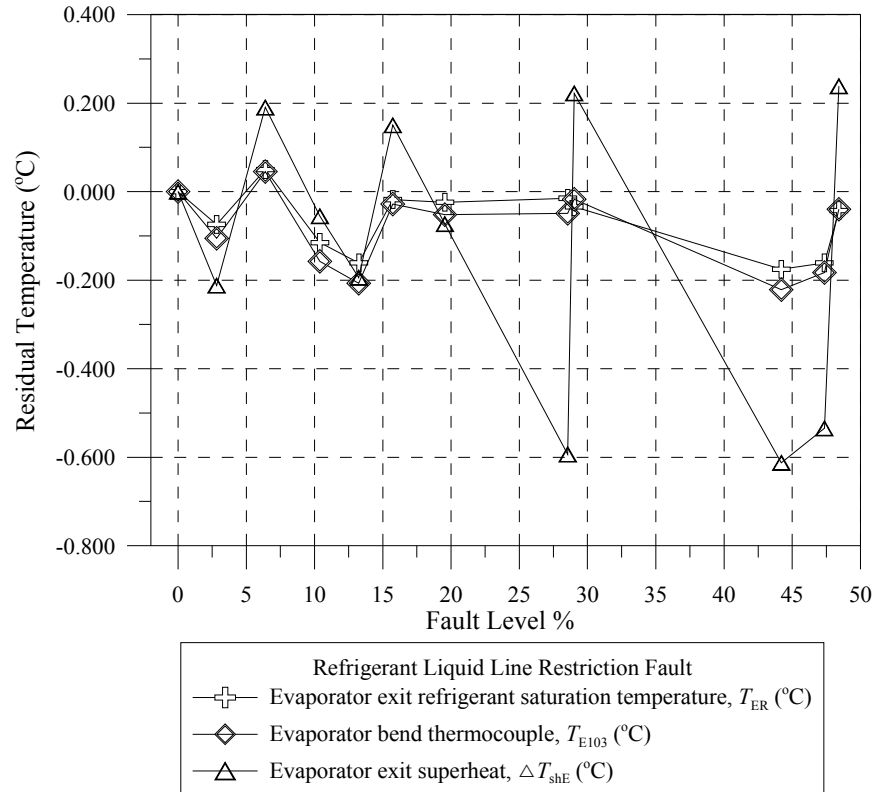
Figure 5.4.7. Residual of selected features with a refrigerant liquid line restriction fault at indoor dry-bulb temperature of 21.1 °C and outdoor conditions of 8.3 °C/72.5 % RH:  $R[T_{ER}]$ ,  $R[T_{E103}]$ , and  $R[\Delta T_{shE}]$

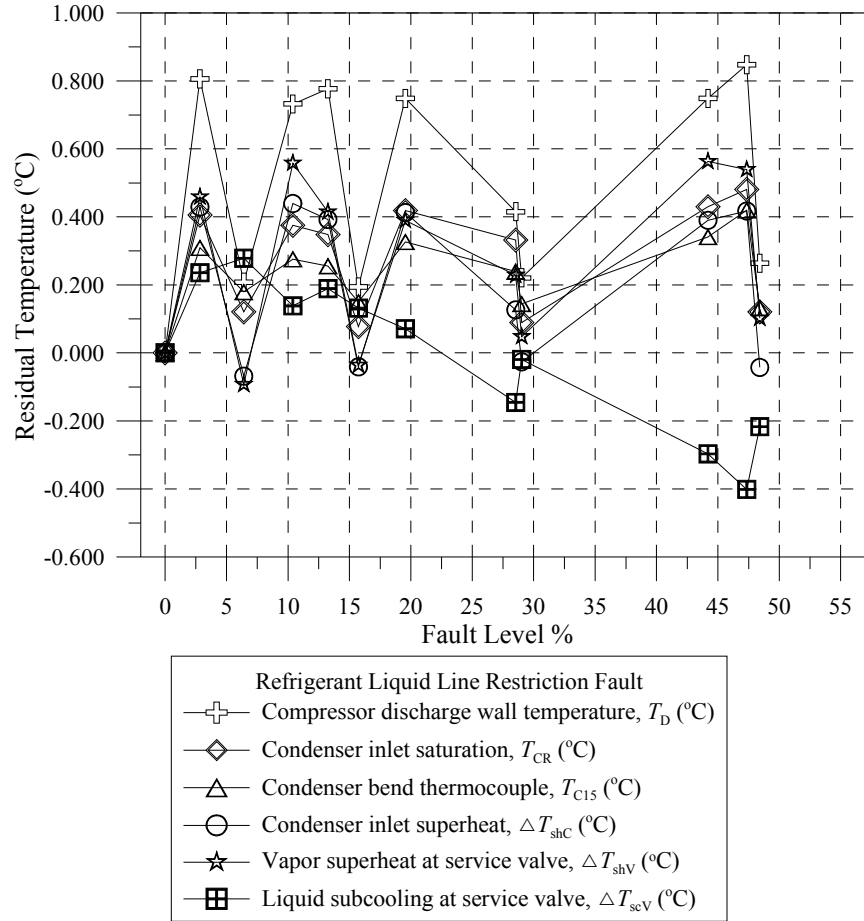
Figure 5.4.8. Residual of selected features with a refrigerant liquid line restriction fault at indoor dry-bulb temperature of 21.1  $^{\circ}\text{C}$  and outdoor conditions of 8.3  $^{\circ}\text{C}/72.5\%$  RH:  $R[T_D]$ ,  $R[T_{CR}]$ ,  $R[T_{C15}]$ ,  $R[\Delta T_{shC}]$ ,  $R[\Delta T_{shV}]$ , and  $R[\Delta T_{scV}]$

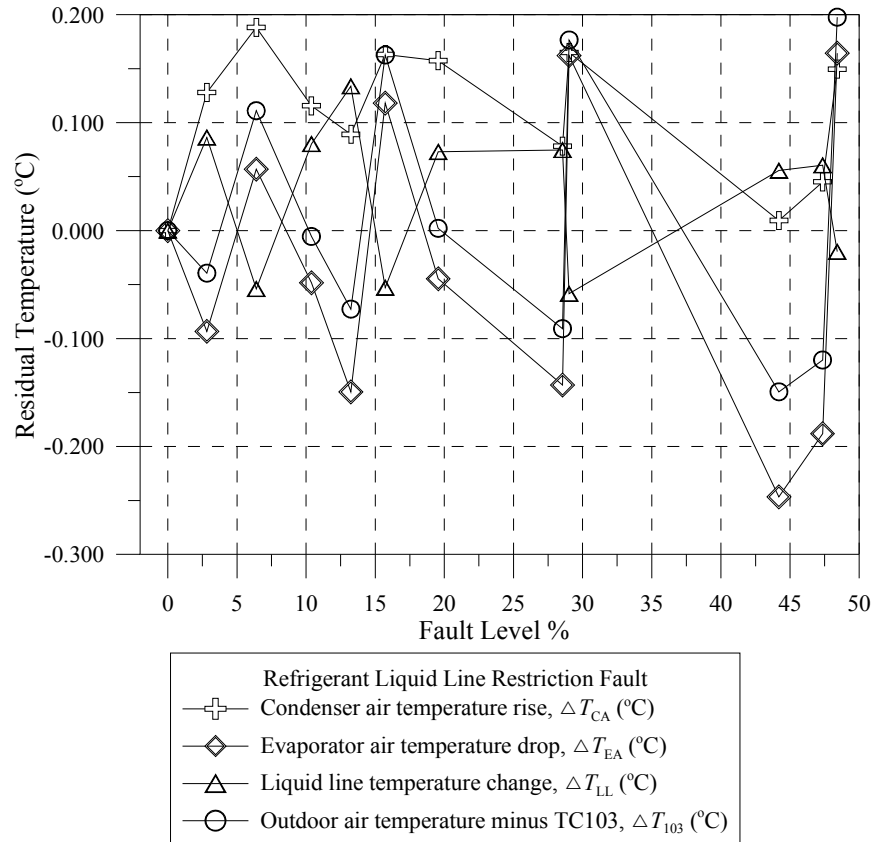
Figure 5.4.9. Residual of selected features with a refrigerant liquid line restriction fault at indoor dry-bulb temperature of 21.1 °C and outdoor conditions of 8.3 °C/72.5 % RH:  $R[\Delta T_{CA}]$ ,  $R[\Delta T_{EA}]$ ,  $R[\Delta T_{LL}]$ , and  $R[\Delta T_{103}]$

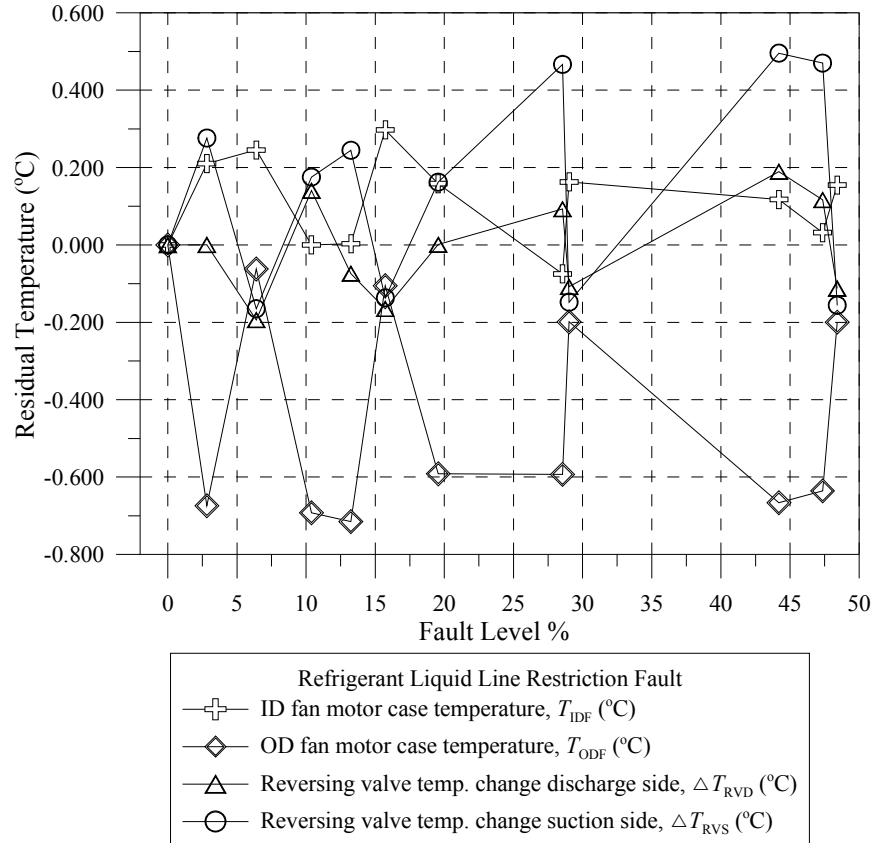
Figure 5.4.10. Residual of selected features with a refrigerant liquid line restriction fault at indoor dry-bulb temperature of 21.1 °C and outdoor conditions of 8.3 °C/72.5 % RH:  $R[T_{IDF}]$ ,  $R[T_{ODF}]$ ,  $R[\Delta T_{RVD}]$ , and  $R[\Delta T_{RVS}]$

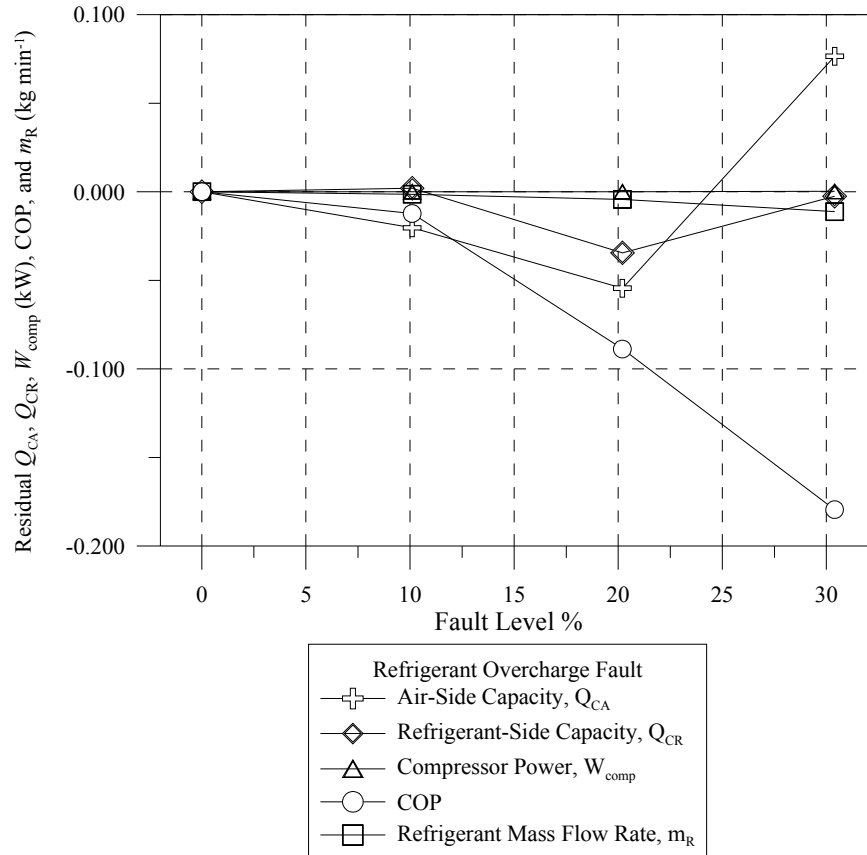
Figure 5.5.1. Residual of selected features with overcharged refrigerant faults imposed at an indoor dry-bulb temperature of 21.1 °C and outdoor conditions of -8.3 °C/Dry:  $R[Q_{CA}]$ ,  $R[Q_{CR}]$ ,  $R[W_{comp}]$ ,  $R[COP]$ , and  $R[m_R]$

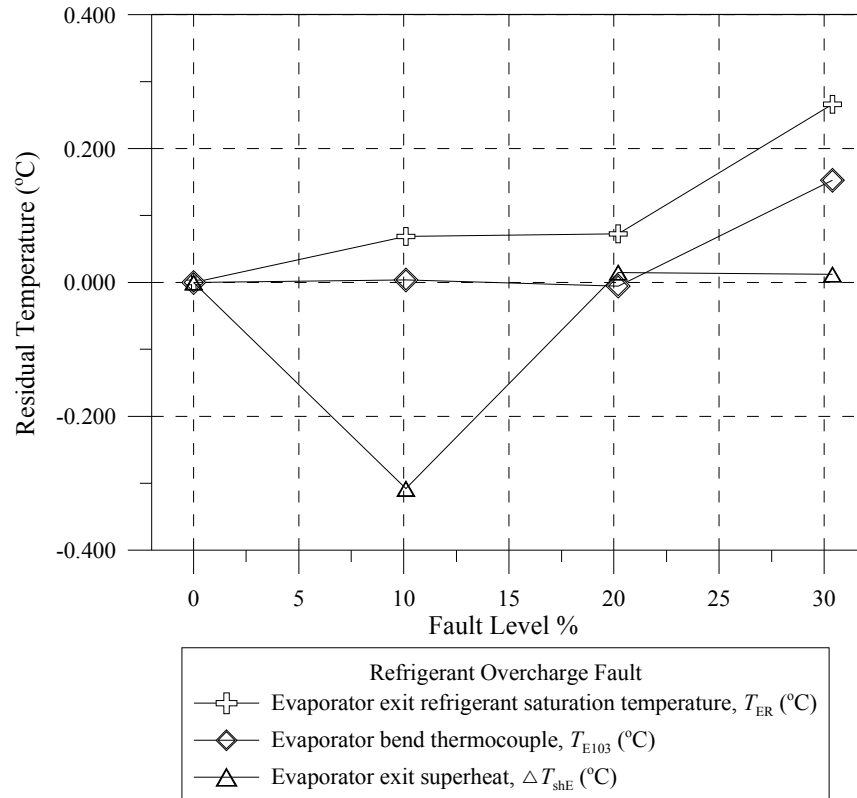
Figure 5.5.2. Residual of selected features with overcharged refrigerant faults at an indoor dry-bulb temperature of 21.1 °C and outdoor conditions of -8.3 °C/Dry:  $R[T_{ER}]$ ,  $R[T_{E103}]$ , and  $R[\Delta T_{shE}]$

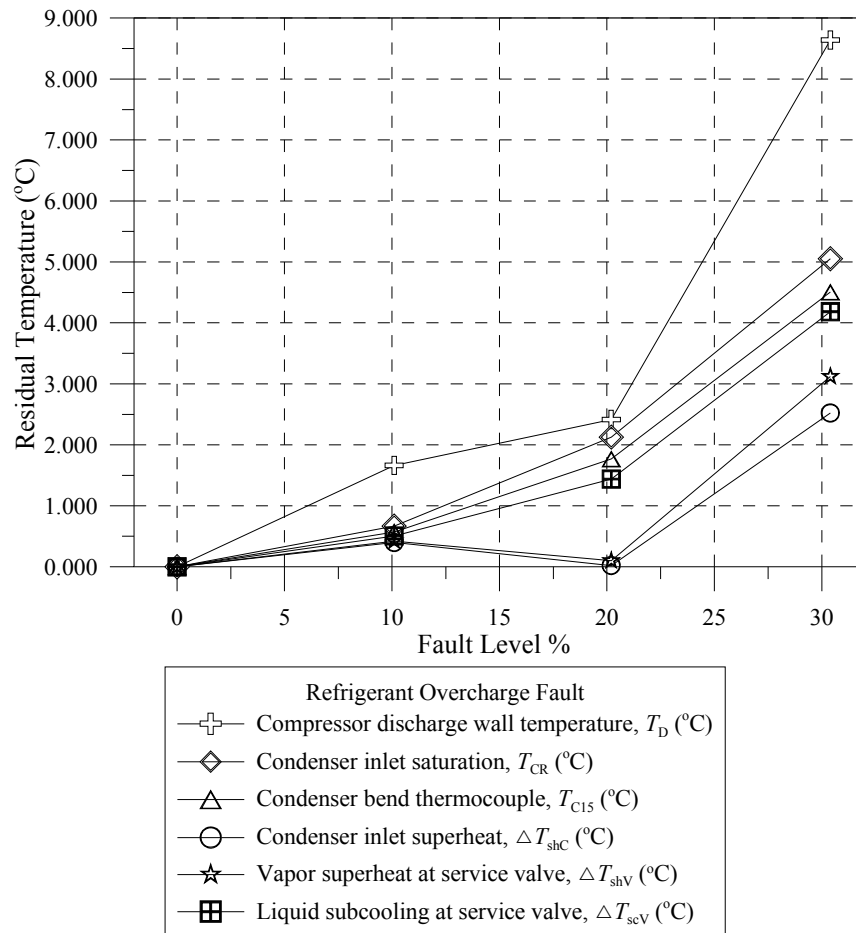
Figure 5.5.3. Residual of selected features with overcharged refrigerant faults at an indoor dry-bulb temperature of 21.1 °C and outdoor conditions of -8.3 °C/Dry:  $R[T_D]$ ,  $R[T_{CR}]$ ,  $R[T_{C15}]$ ,  $R[\Delta T_{shC}]$ ,  $R[\Delta T_{shV}]$ , and  $R[\Delta T_{scV}]$

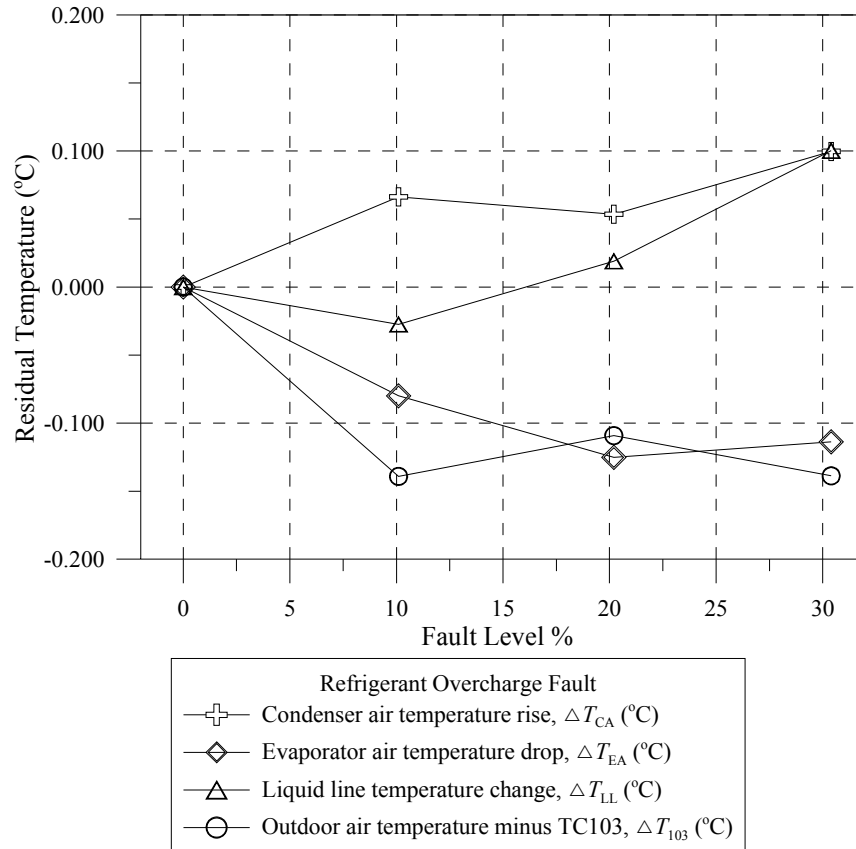
Figure 5.5.4. Residual of selected features with overcharged refrigerant faults at an indoor dry-bulb temperature of 21.1 °C and outdoor conditions of -8.3 °C/Dry:  $R[\Delta T_{CA}]$ ,  $R[\Delta T_{EA}]$ ,  $R[\Delta T_{LL}]$ , and  $R[\Delta T_{103}]$

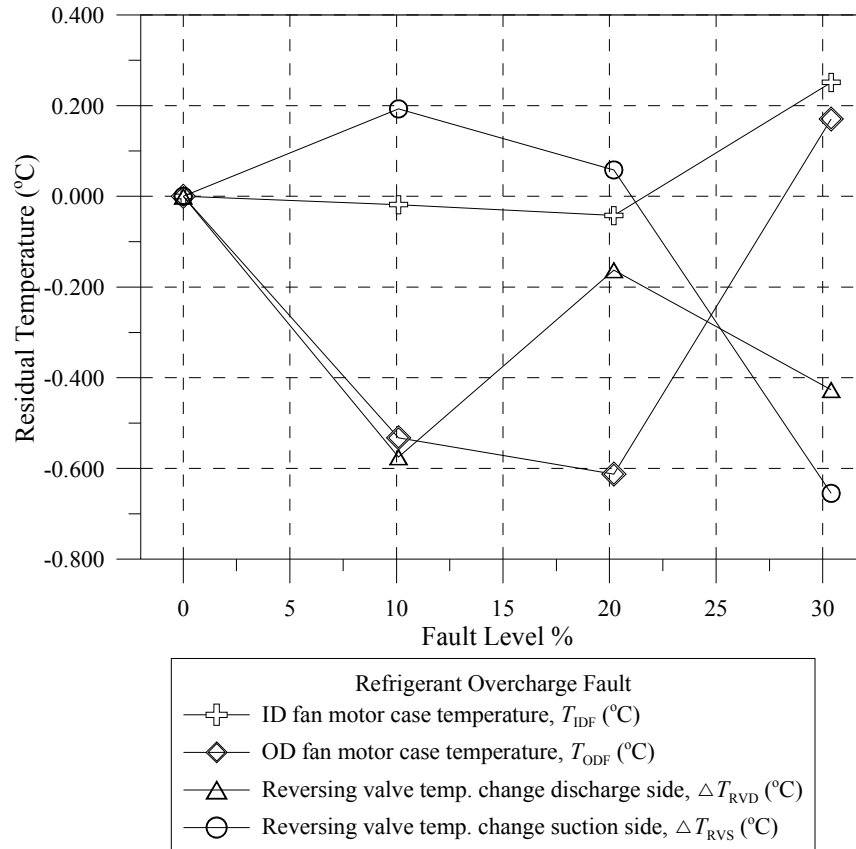
Figure 5.5.5. Residual of selected features with overcharged refrigerant faults at an indoor dry-bulb temperature of 21.1 °C and outdoor conditions of -8.3 °C/Dry:  $R[T_{IDF}]$ ,  $R[T_{ODF}]$ ,  $R[\Delta T_{RVD}]$ , and  $R[\Delta T_{RVS}]$

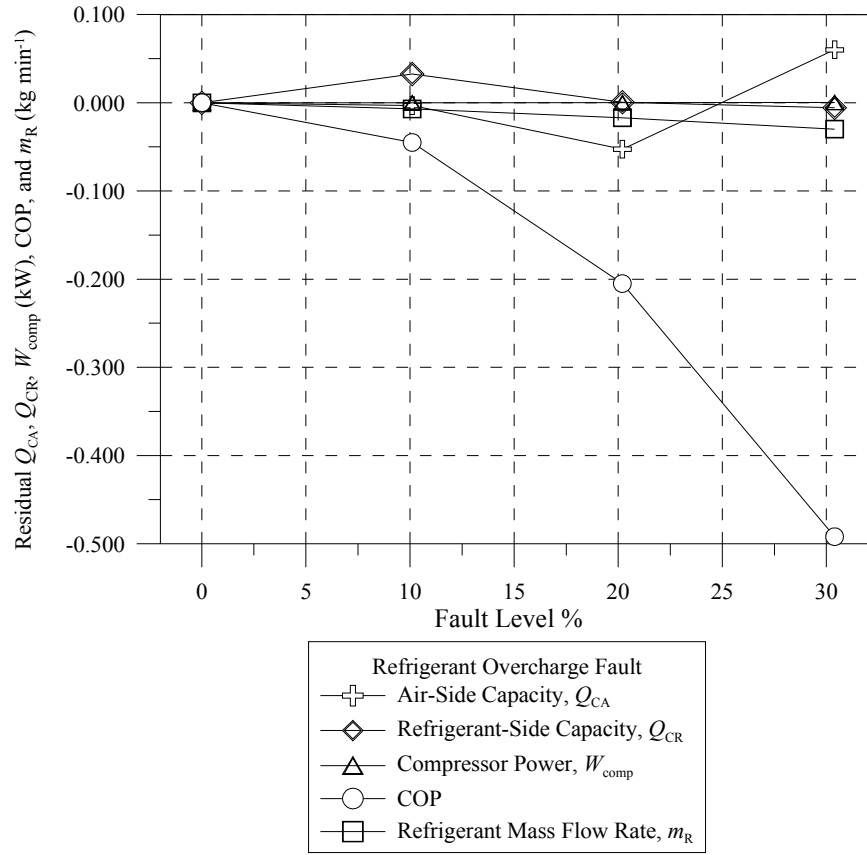
Figure 5.5.6. Residual of selected features with overcharged refrigerant faults imposed at an indoor dry-bulb temperature of 21.1 °C and outdoor conditions of 8.3 °C/Dry:  $R[Q_{CA}]$ ,  $R[Q_{CR}]$ ,  $R[W_{comp}]$ ,  $R[COP]$ , and  $R[m_R]$

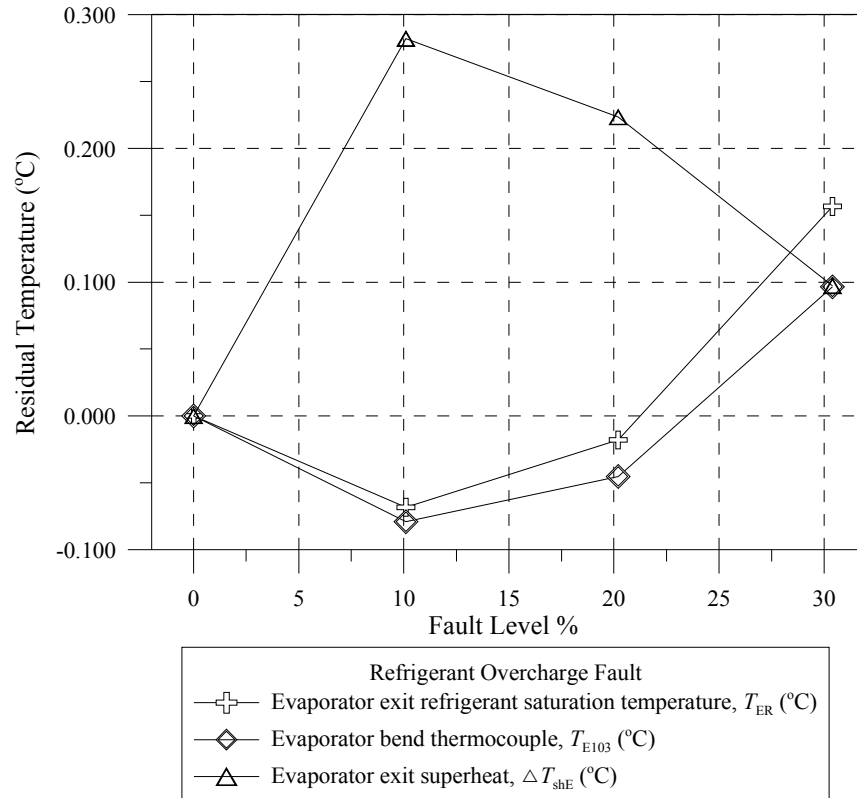
Figure 5.5.7. Residual of selected features with overcharged refrigerant faults at indoor dry-bulb temperature of 21.1 °C and outdoor conditions of 8.3 °C/Dry:  $R[T_{ER}]$ ,  $R[T_{E103}]$ , and  $R[\Delta T_{shE}]$

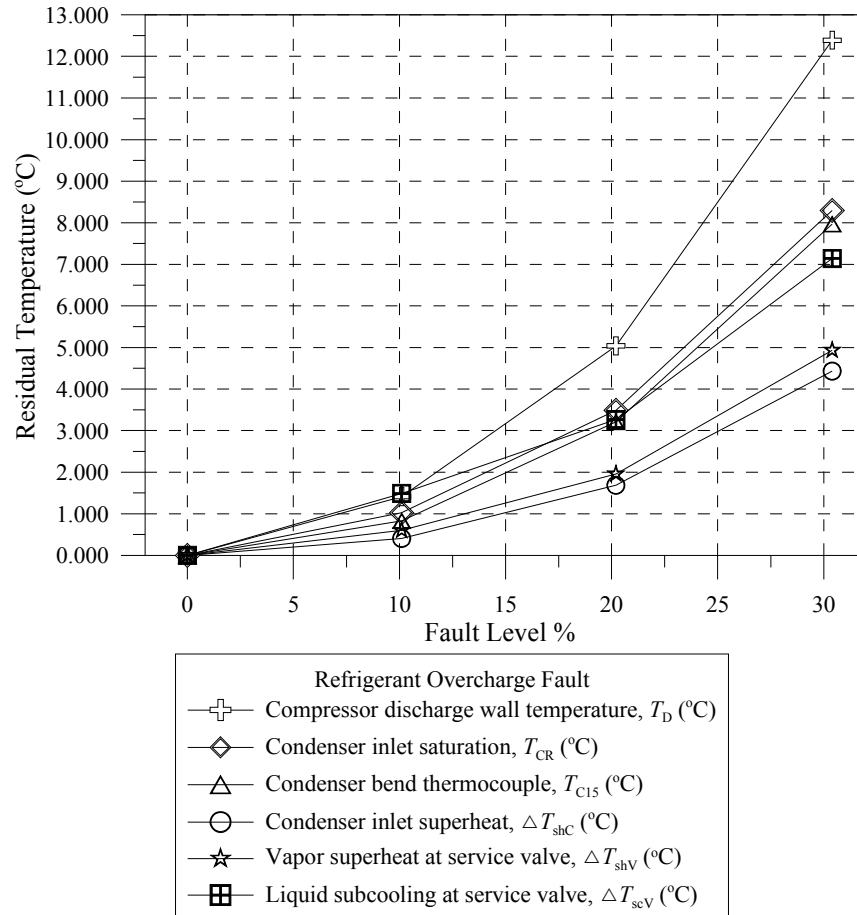
Figure 5.5.8. Residual of selected features with overcharged refrigerant faults at indoor dry-bulb temperature of 21.1 °C and outdoor conditions of 8.3 °C/Dry:  $R[T_D]$ ,  $R[T_{CR}]$ ,  $R[T_{C15}]$ ,  $R[\Delta T_{shC}]$ ,  $R[\Delta T_{shV}]$ , and  $R[\Delta T_{scV}]$

Table 5.5.2 shows the residual's linear slopes and the percent changes in the system characteristics and temperatures for the overcharged refrigerant fault. Compressor discharge temperature and condenser inlet refrigerant saturation temperature were the features that changed the most;  $T_D$  and  $T_{CR}$  residual slopes were  $0.403 \text{ C } \%^{-1}$  and  $0.270 \text{ C } \%^{-1}$ , respectively. Subcooling and superheat at the service valve along with superheat at the condenser inlet showed substantial change with their residual slopes being  $0.229 \text{ C } \%^{-1}$ ,  $0.160 \text{ C } \%^{-1}$ , and  $0.144 \text{ C } \%^{-1}$ , respectively.

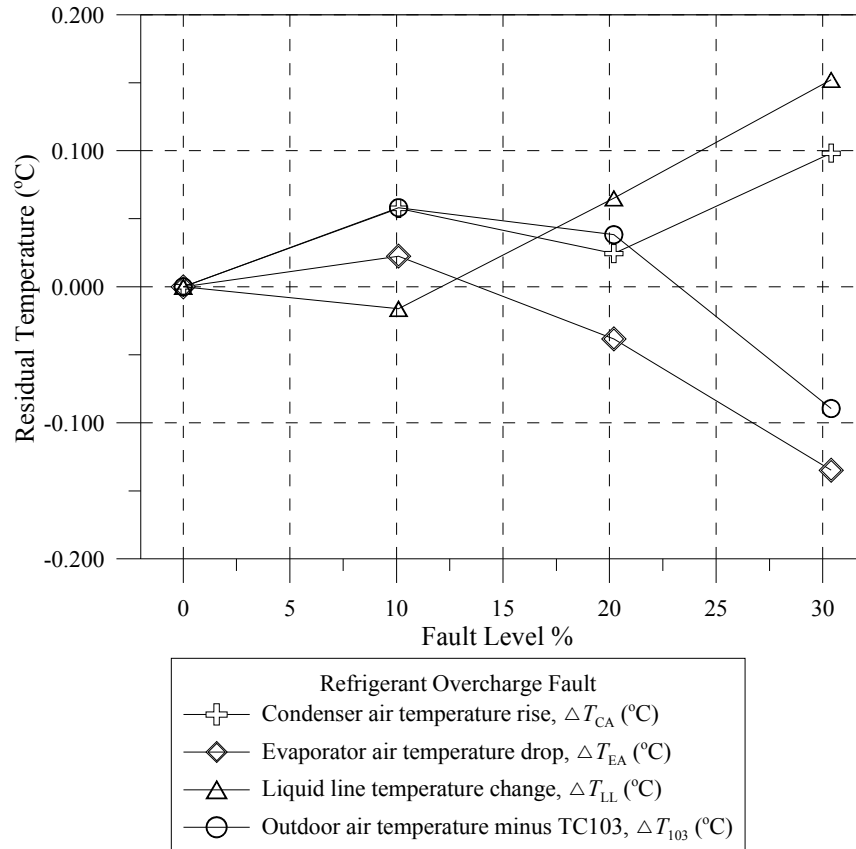
Figure 5.5.9. Residual of selected features with overcharged refrigerant faults at indoor dry-bulb temperature of 21.1 °C and outdoor conditions of 8.3 °C/Dry:  $R[\Delta T_{CA}]$ ,  $R[\Delta T_{EA}]$ ,  $R[\Delta T_{LL}]$ , and  $R[\Delta T_{103}]$

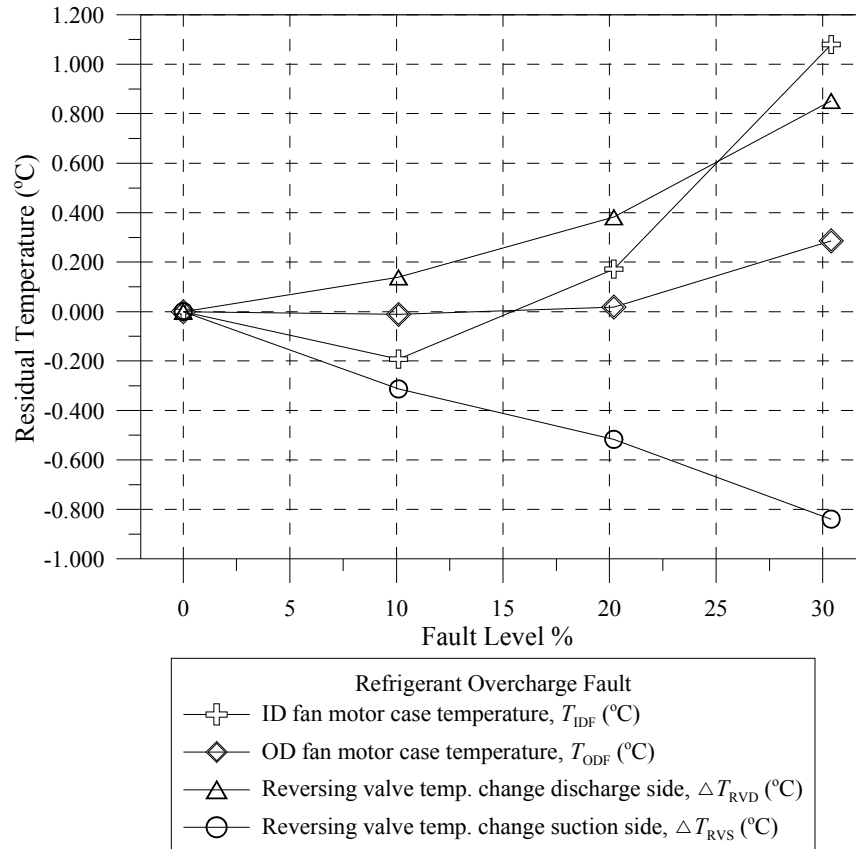
Figure 5.5.10. Residual of selected features with overcharged refrigerant faults at indoor dry-bulb temperature of 21.1 °C and outdoor conditions of 8.3 °C/Dry:  $R[T_{IDF}]$ ,  $R[T_{ODF}]$ ,  $R[\Delta T_{RVD}]$ , and  $R[\Delta T_{RVS}]$

Figure 5.5.10 shows the residuals of  $T_{IDF}$ ,  $T_{ODF}$ ,  $\Delta T_{RVD}$ , and  $\Delta T_{RVS}$ . Compared to the NFSS value, the temperature change across the cold side of the four-way valve decreased with increasing fault level. The mirroring of the suction side by the discharge side reversing valve temperature change held at all fault levels. Overall, the residuals are small, within  $1^\circ\text{C}$  of the minimum level of fault.

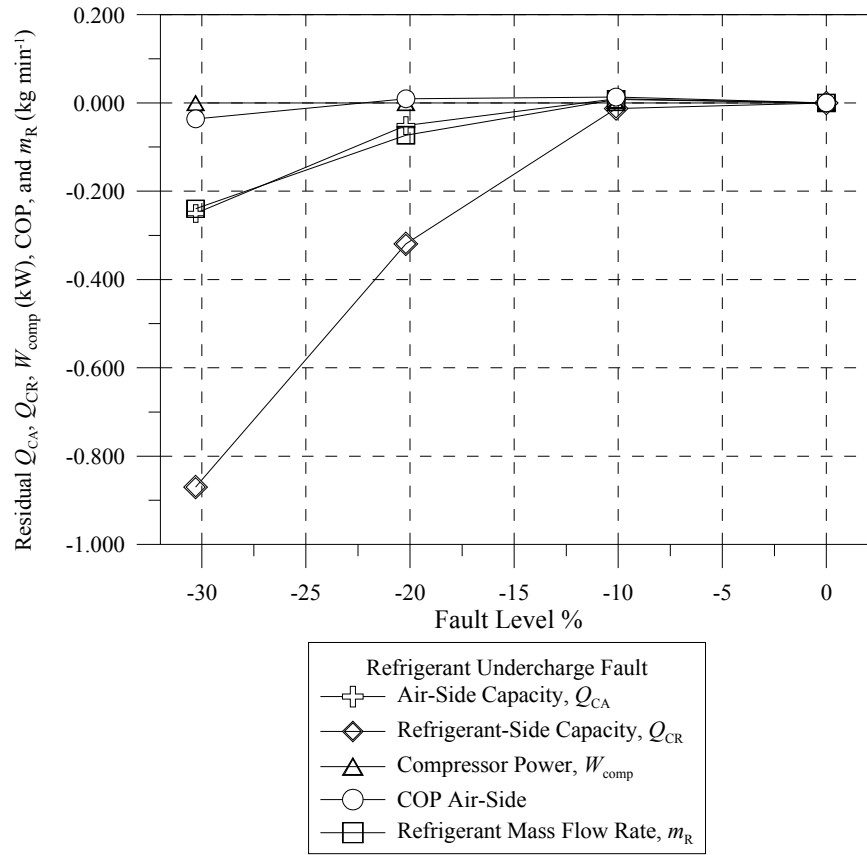
Figure 5.6.1. Residual of selected features with undercharged refrigerant faults imposed at an indoor dry-bulb temperature of 21.1 °C and outdoor conditions of -8.3 °C/Dry:  $R[Q_{CA}]$ ,  $R[Q_{CR}]$ ,  $R[W_{comp}]$ ,  $R[COP]$ , and  $R[m_R]$

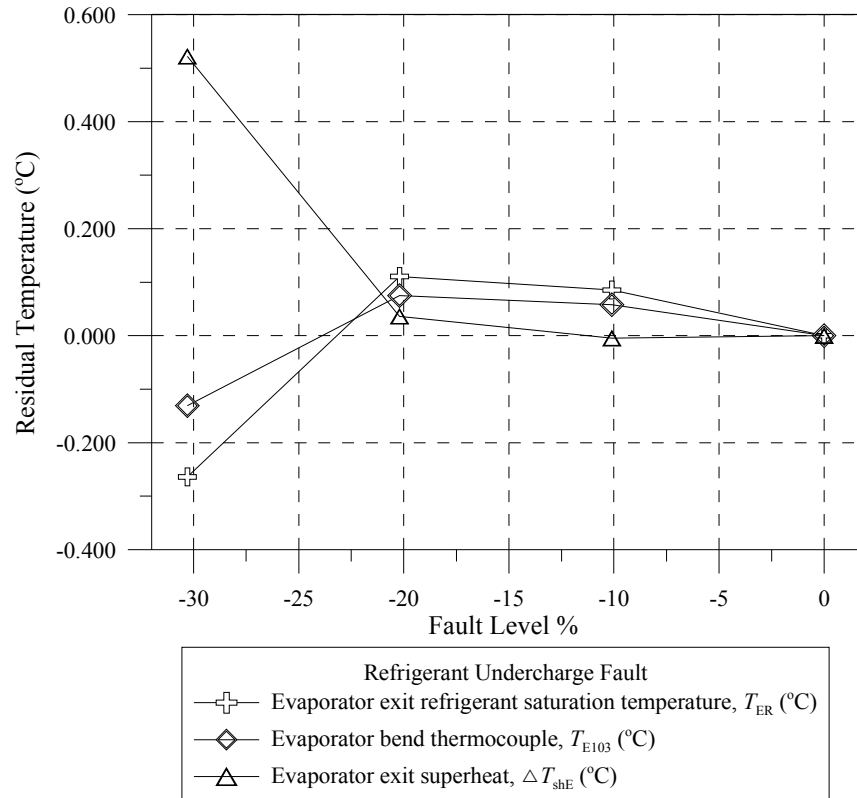
Figure 5.6.2. Residual of selected features with undercharged refrigerant faults at indoor dry-bulb temperature of 21.1 °C and outdoor conditions of -8.3 °C/Dry:  $R[T_{ER}]$ ,  $R[T_{E103}]$ , and  $R[\Delta T_{shE}]$

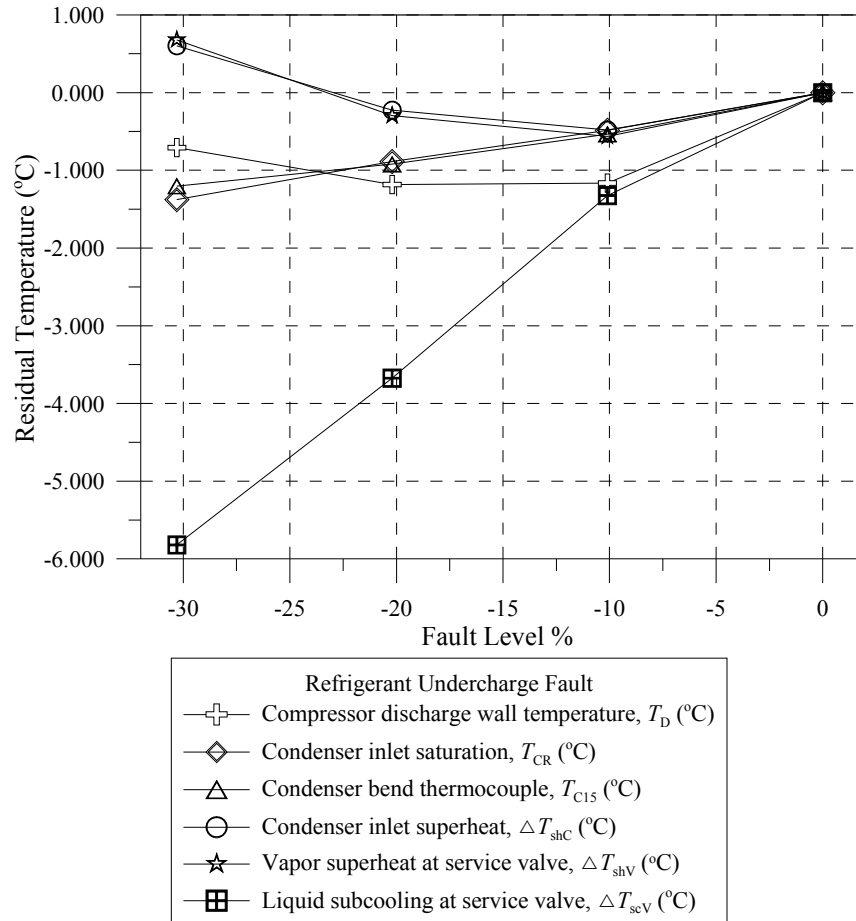
Figure 5.6.3. Residual of selected features with undercharged refrigerant faults at indoor dry-bulb temperature of 21.1 °C and outdoor conditions of -8.3 °C/Dry:  $R[T_D]$ ,  $R[T_{CR}]$ ,  $R[T_{C15}]$ ,  $R[\Delta T_{shC}]$ ,  $R[\Delta T_{shV}]$ , and  $R[\Delta T_{scV}]$

Table 5.6.1 shows the residual's linear slopes and the percent changes in the system characteristics and temperatures for the undercharged refrigerant fault. The prominent features for the undercharge fault are liquid line subcooling, liquid line temperature drop from the outdoor service valve to the indoor TXV inlet, condenser inlet saturation temperature, and vapor line superheat at the service valve. Interestingly, the indoor fan case temperature residual was comparable to the service valve superheat residual for indicating an undercharge fault.

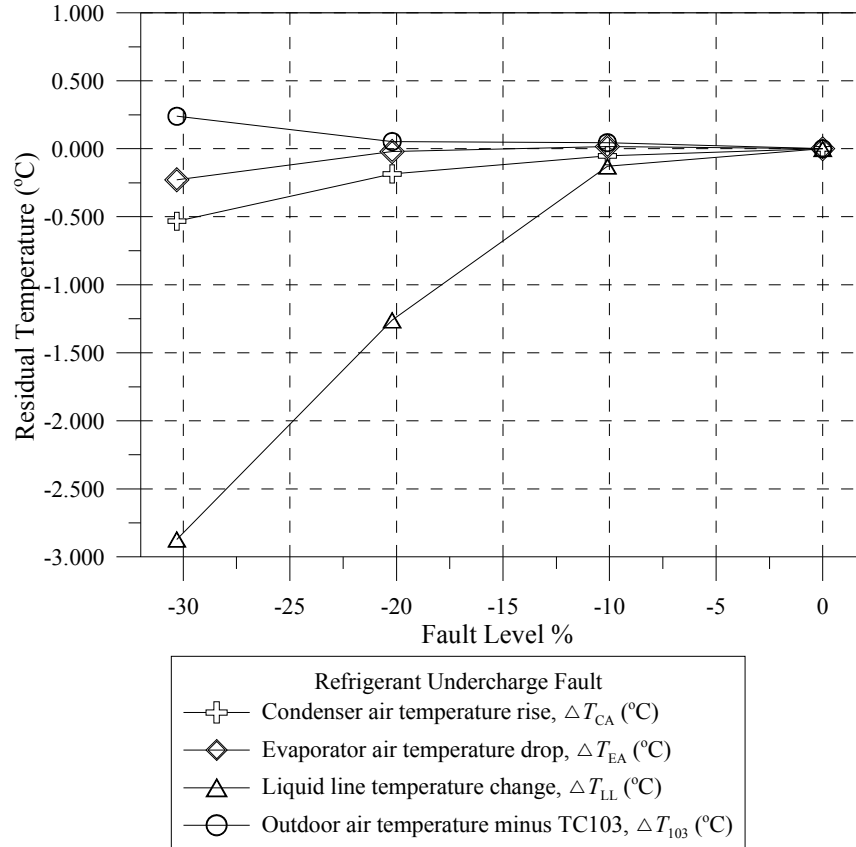
Figure 5.6.4. Residual of selected features with undercharged refrigerant faults at indoor dry-bulb temperature of 21.1 °C and outdoor conditions of -8.3 °C/Dry:  $R[\Delta T_{CA}]$ ,  $R[\Delta T_{EA}]$ ,  $R[\Delta T_{LL}]$ , and  $R[\Delta T_{103}]$

Figure 5.6.4 shows residuals for  $\Delta T_{CA}$ ,  $\Delta T_{EA}$ ,  $\Delta T_{LL}$ , and  $\Delta T_{103}$ . The figure shows that the liquid line temperature change is a good indicator for loss of refrigerant charge. This was the second largest slope seen for all features. It is interesting to note that very little variation in any feature occurs at up to a 10 % undercharge. The TXV is able to correct mass flow rate until, somewhere between 10 % and 20 % undercharge, the presence of two-phase refrigerant at the TXV inlet causes it to open fully and begin performing like a fixed area expansion device.

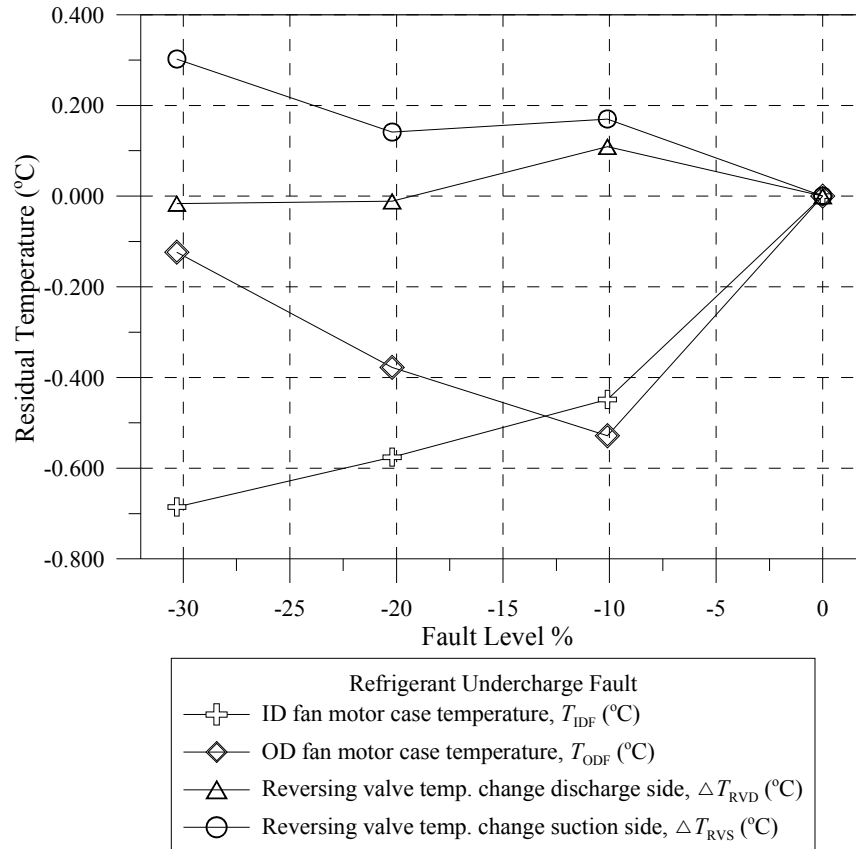
Figure 5.6.5. Residual of selected features with undercharged refrigerant faults at indoor dry-bulb temperature of 21.1 °C and outdoor conditions of -8.3 °C/Dry:  $R[T_{IDF}]$ ,  $R[T_{ODF}]$ ,  $R[\Delta T_{RVD}]$ , and  $R[\Delta T_{RVS}]$

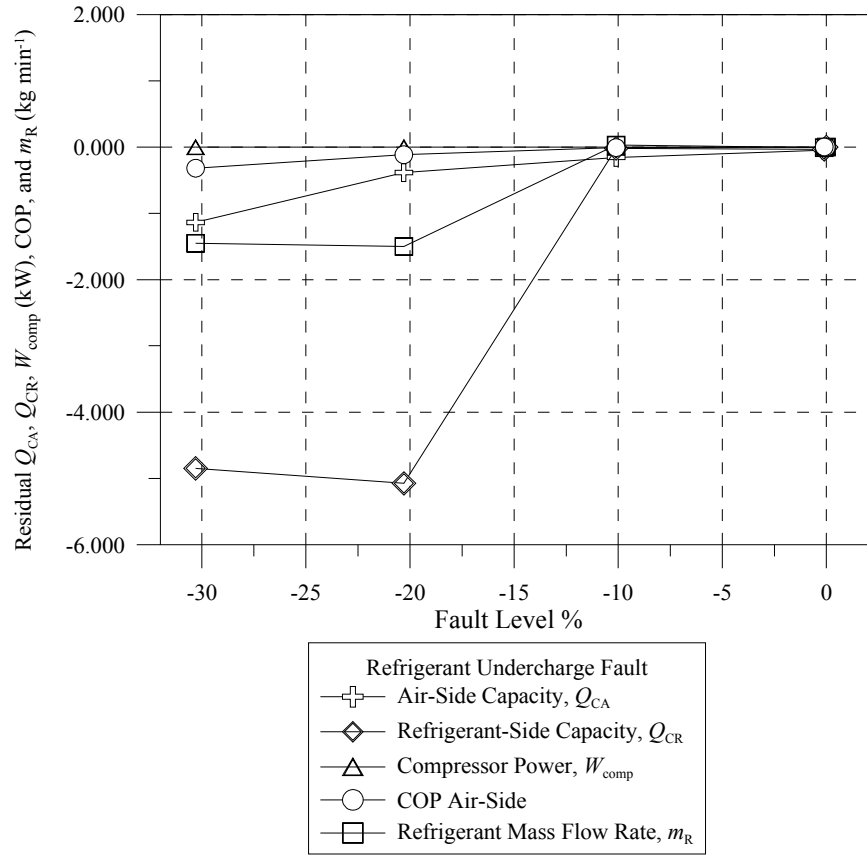
Figure 5.6.6. Residual of selected features with undercharged refrigerant faults imposed at an indoor dry-bulb temperature of 21.1 °C and outdoor conditions of 8.3 °C/Dry:  $R[Q_{CA}]$ ,  $R[Q_{CR}]$ ,  $R[W_{comp}]$ ,  $R[COP]$ , and  $R[m_R]$

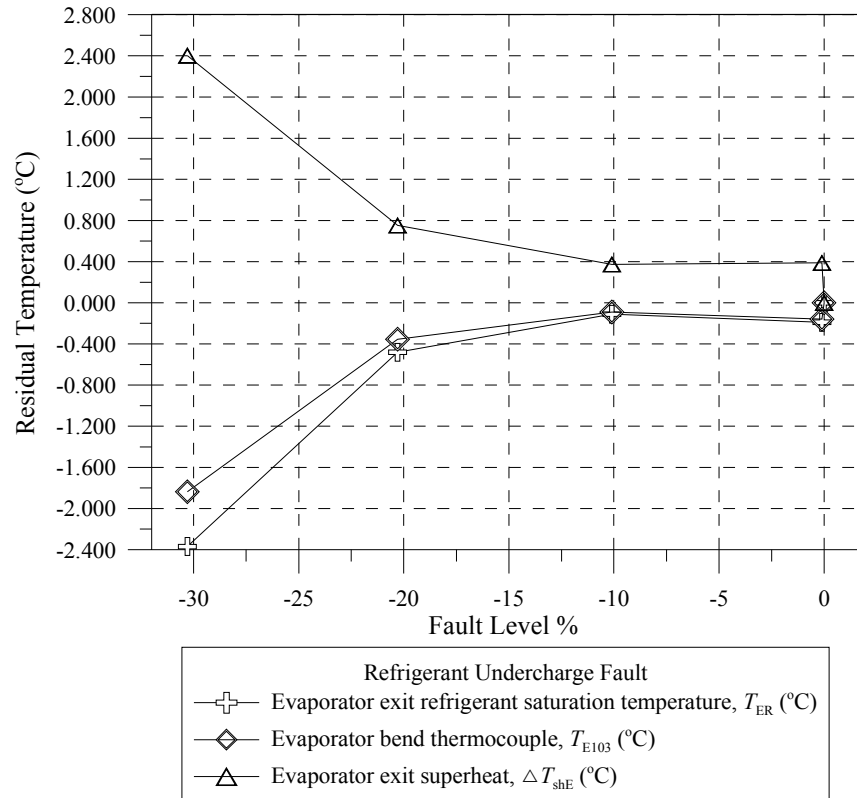
Figure 5.6.7. Residual of selected features with undercharged refrigerant faults at indoor dry-bulb temperature of 21.1 °C and outdoor conditions of 8.3 °C/Dry:  $R[T_{ER}]$ ,  $R[T_{E103}]$ , and  $R[\Delta T_{shE}]$
