# NIST Technical Note 1648

## HEATING MODE PERFORMANCE MEASUREMENTS FOR A RESIDENTIAL HEAT PUMP WITH SINGLE-FAULTS IMPOSED

W. Vance Payne  
Seok Ho Yoon  
Piotr A. Domanski

September 2009

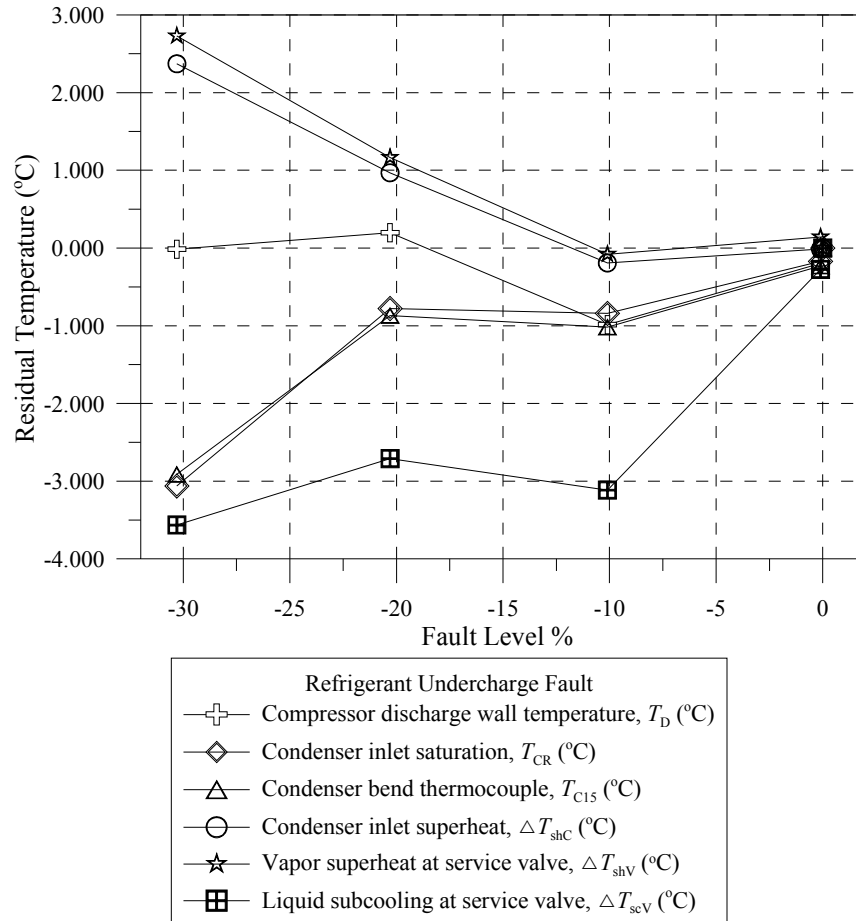
Figure 5.6.8. Residual of selected features with undercharged refrigerant faults at indoor dry-bulb temperature of 21.1 °C and outdoor conditions of 8.3 °C/Dry:  $R[T_D]$ ,  $R[T_{CR}]$ ,  $R[T_{C15}]$ ,  $R[\Delta T_{shC}]$ ,  $R[\Delta T_{shV}]$ , and  $R[\Delta T_{scV}]$

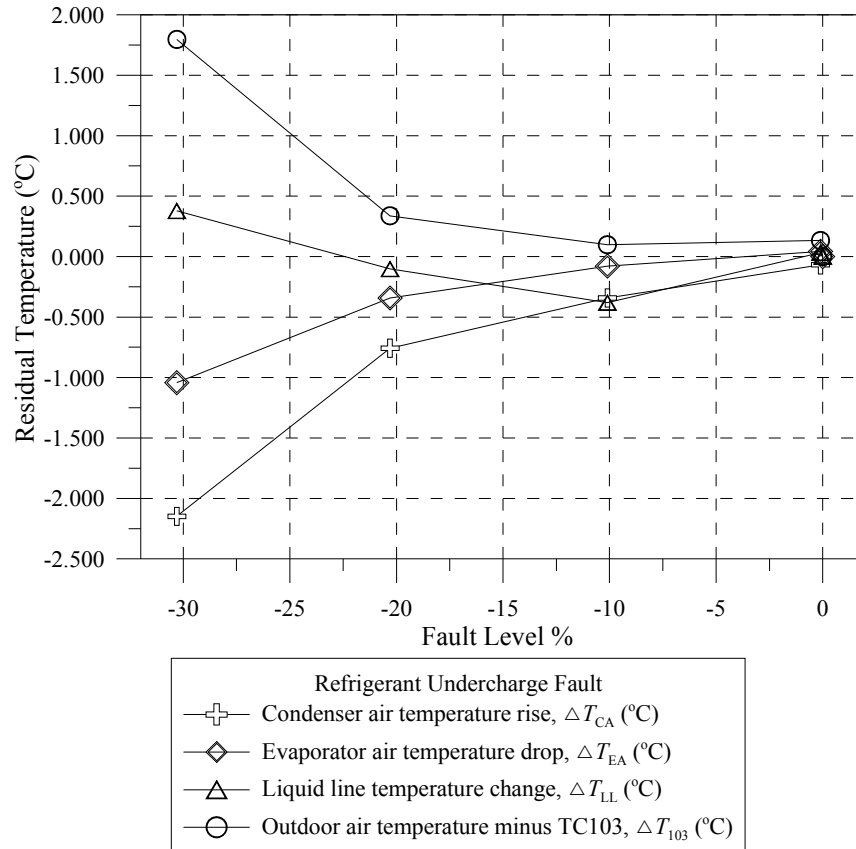
Figure 5.6.9. Residual of selected features with undercharged refrigerant faults at indoor dry-bulb temperature of 21.1 °C and outdoor conditions of 8.3 °C/Dry:  $R[\Delta T_{CA}]$ ,  $R[\Delta T_{EA}]$ ,  $R[\Delta T_{LL}]$ , and  $R[\Delta T_{103}]$

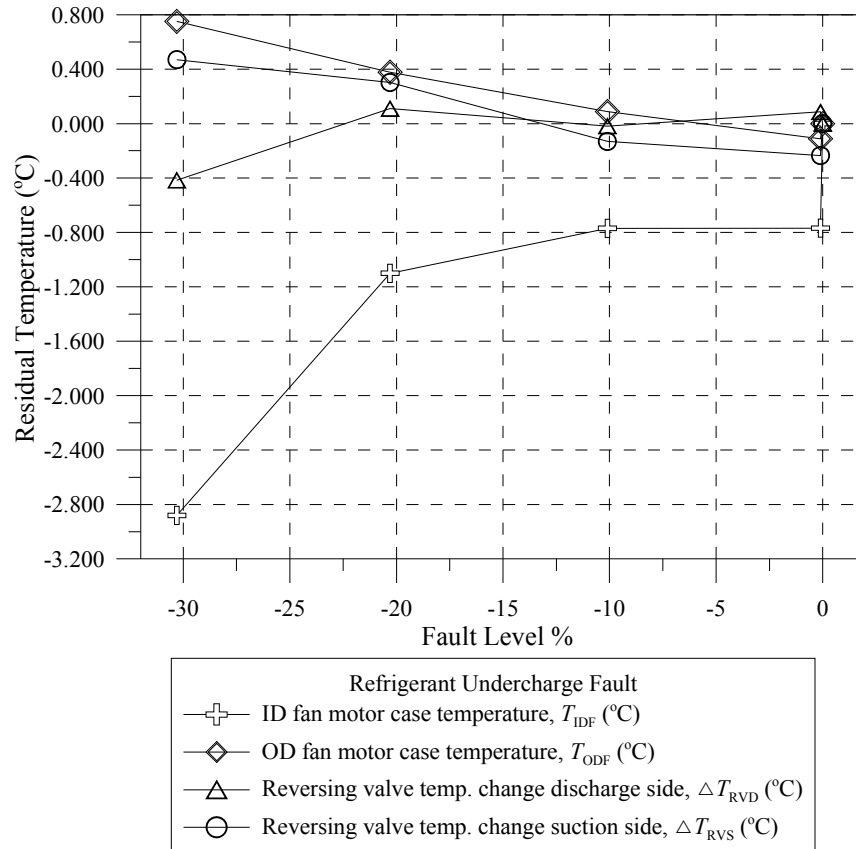
Figure 5.6.10. Residual of selected features with undercharged refrigerant faults at indoor dry-bulb temperature of 21.1 °C and outdoor conditions of 8.3 °C/Dry:  $R[T_{IDF}]$ ,  $R[T_{ODF}]$ ,  $R[\Delta T_{RVD}]$ , and  $R[\Delta T_{RVS}]$

Figure 5.6.10 shows the residuals of  $T_{IDF}$ ,  $T_{ODF}$ ,  $\Delta T_{RVD}$ , and  $\Delta T_{RVS}$ . The indoor fan case temperature residual showed the strongest correlation to refrigerant undercharge. The second largest residual slope occurred for the outdoor fan motor case temperature.

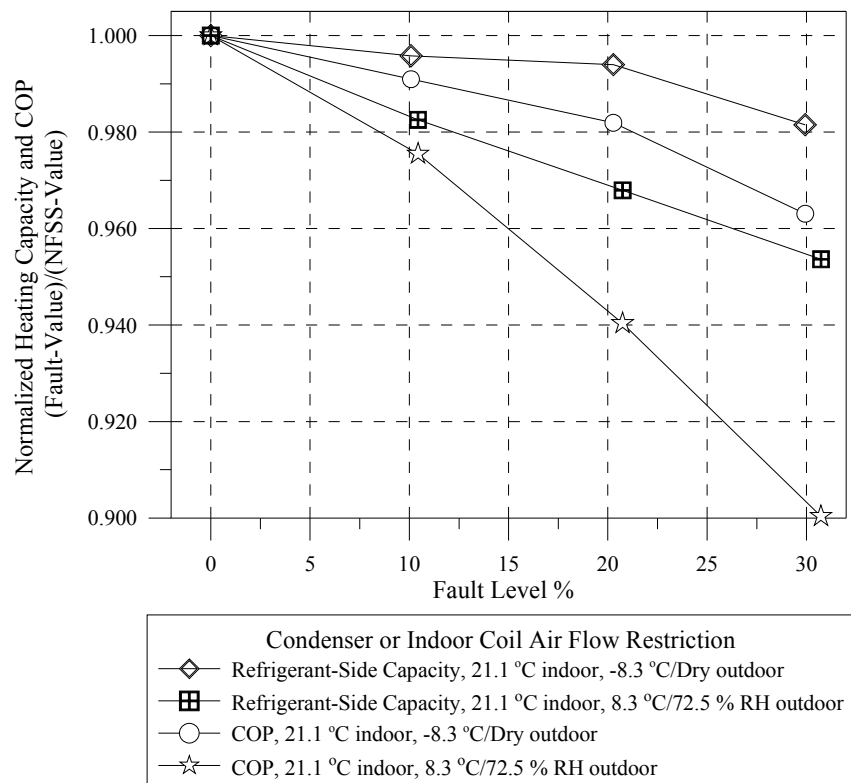
Figure 5.7.1. Normalized heating capacity and COP for condenser or indoor coil air flow restriction

Figure 5.7.1 shows the effects of condenser or indoor coil air flow restriction faults on the heating capacity and COP. It is interesting to note the linear nature of the normalized values with increasing air flow restriction across the indoor heat exchanger. Higher fault levels indicate more reduction in the air flow rate across the indoor coil (condenser). At higher outdoor temperature the fault had a greater effect upon capacity and COP. There was a 10 % reduction in COP with a 30 % reduction in indoor coil air flow rate at outdoor ambient conditions of 8.3 °C/72.5 % RH.

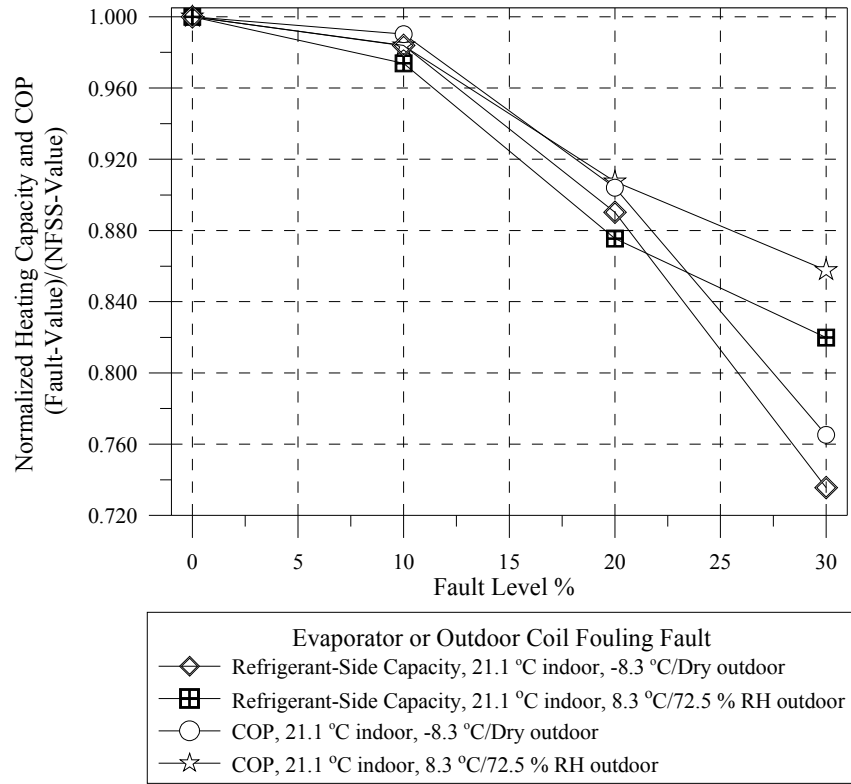
Figure 5.7.2. Normalized heating capacity and COP for evaporator or outdoor coil fouling faults

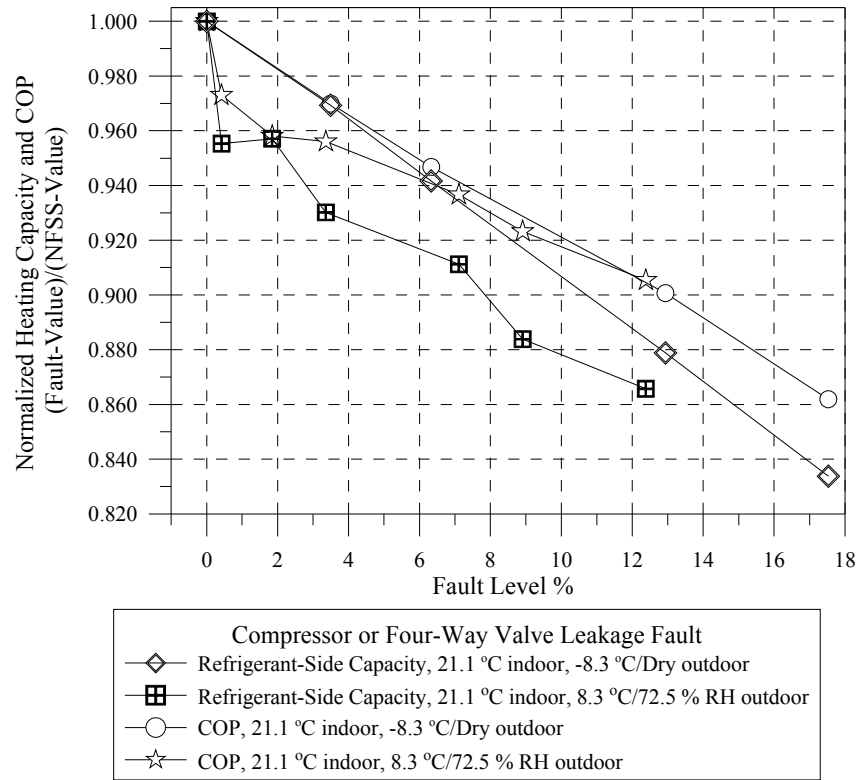
Figure 5.7.3. Normalized heating capacity and COP for compressor or four-way valve leakage faults

Figure 5.7.3 shows how a compressor valve or a four-way reversing valve leakage fault affects heating capacity and COP. Heating capacity at the higher temperature outdoor conditions was more affected by this fault; heating capacity decreased by almost 14 % as refrigerant mass flow rate decreased more than 12 %. COP degradation was comparable at the higher and lower outdoor ambient conditions.

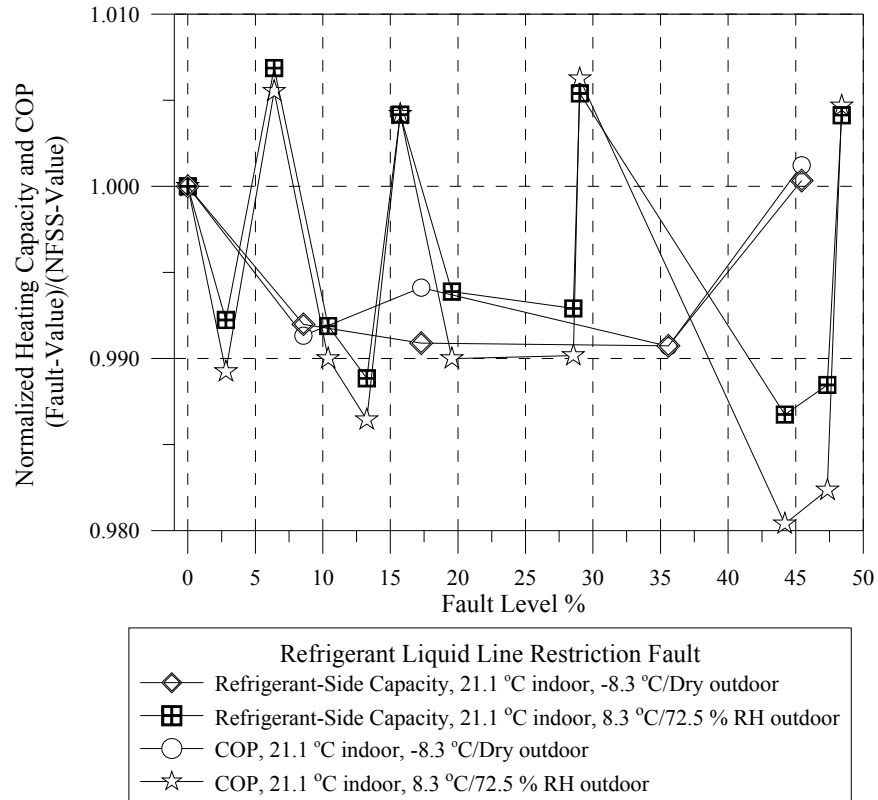
Figure 5.7.4. Normalized heating capacity and COP for refrigerant liquid line flow restriction faults

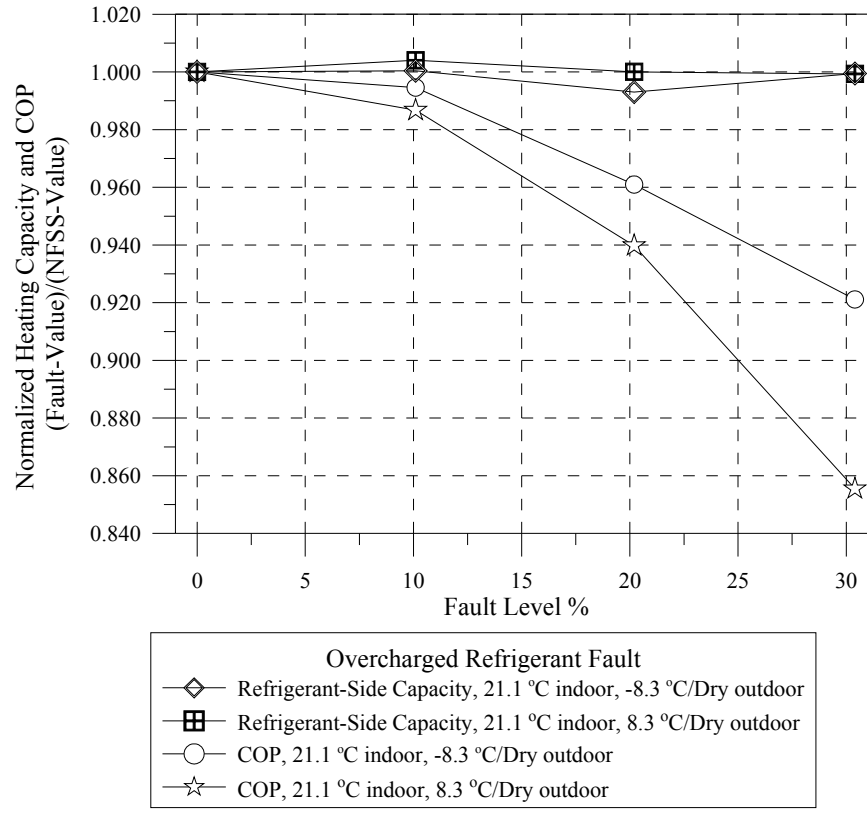
Figure 5.7.5. Normalized heating capacity and COP for refrigerant overcharge faults

Figure 5.7.5 shows that refrigerant overcharge has negligible effects on heating capacity, but more of an effect upon COP. At the higher temperature outdoor ambient conditions, the COP dropped by more than 14 % as the refrigerant was overcharged 30 %.

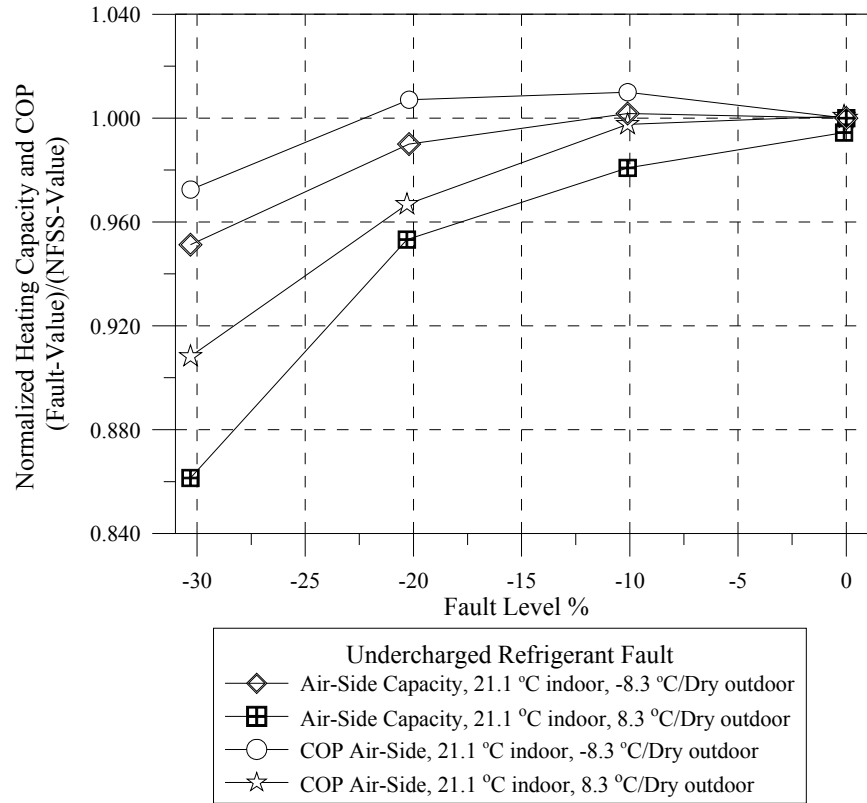
Figure 5.7.6. Normalized heating capacity and COP for refrigerant undercharge faults

Figure 5.7.6 shows that undercharge faults have more effect upon heating capacity than the overcharge faults, especially at higher temperature outdoor ambient conditions. For a slightly more than 30 % undercharge fault, heating capacity decreased by almost 14 % while COP dropped by almost 9 %.
