Fire Effects and Fire Control in Nitrocellulose Photographic-Film Storage

United States Department of Commerce
National Bureau of Standards
Building Materials and Structures Report 145

J. V. Ryan, J. W. Cummings, and A. C. Hutton

Building Materials and Structures Report 145

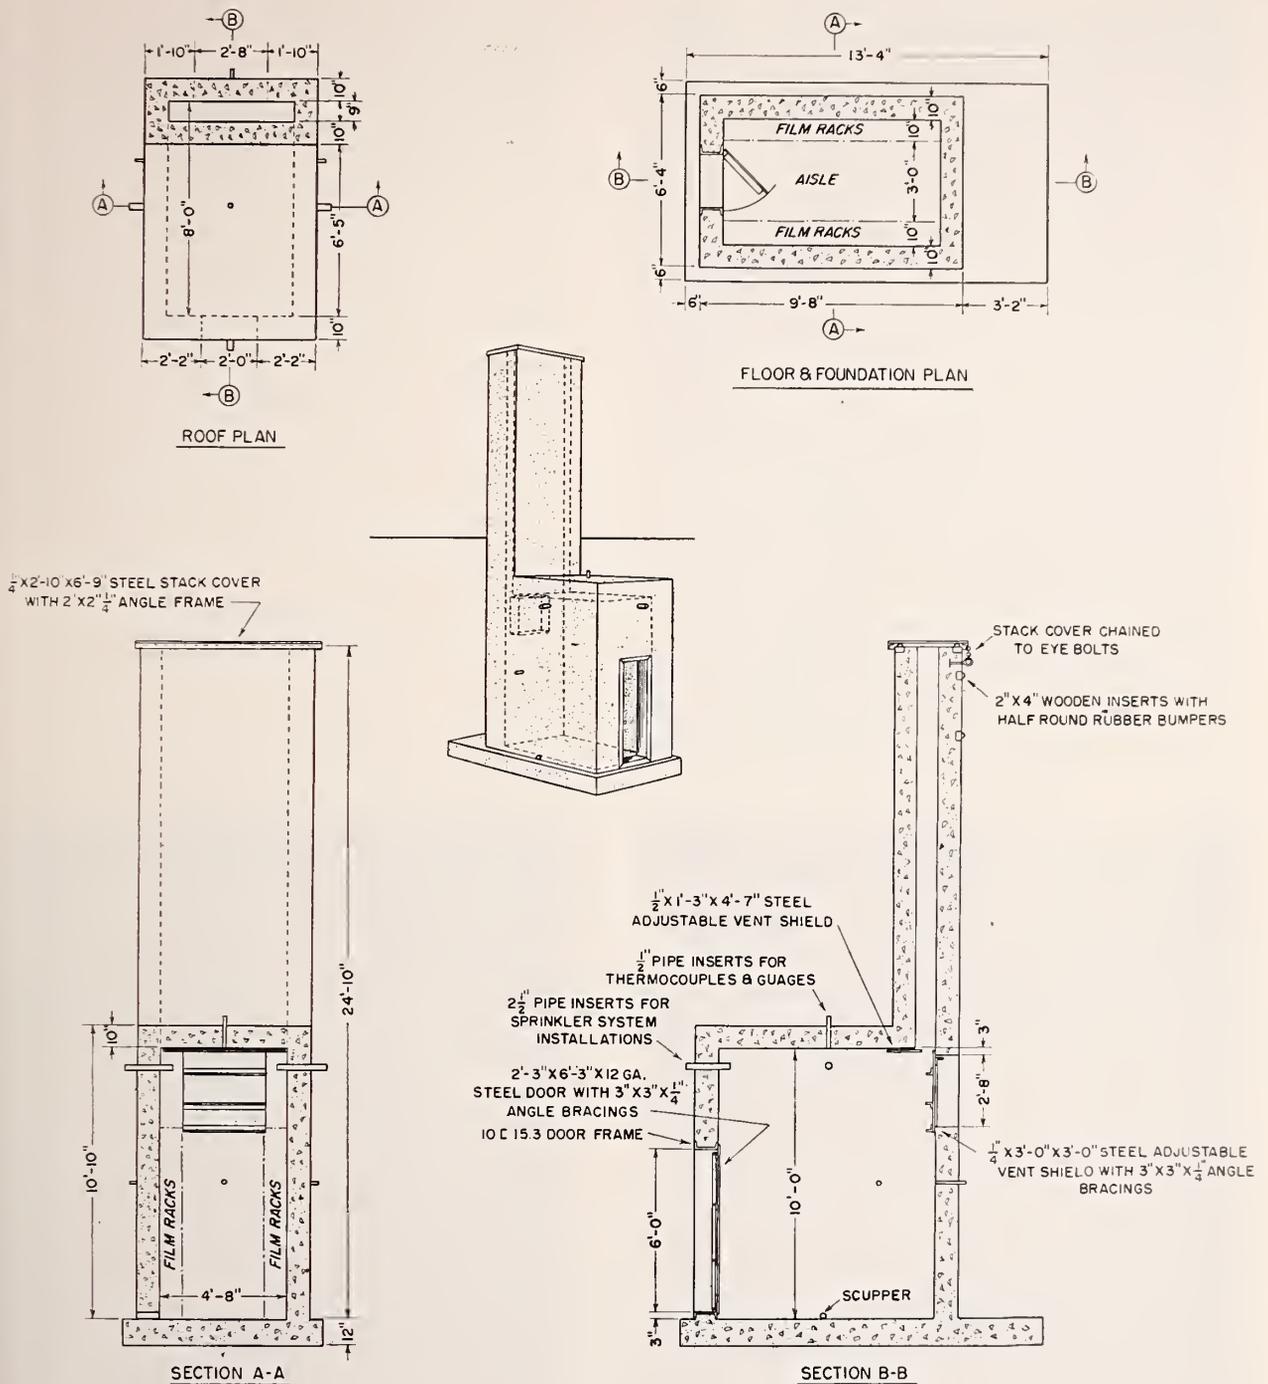
FIGURE 1. Construction details of 373-ft³ reinforced-concrete experimental film vault near Beltsville, Md.

The reinforced-concrete vault, figure 1, in which two experimental programs were conducted under the direction of the Inter-Agency Committee was in the form of a cubicle with a door at one end, an opening in the opposite wall, and an opening in the ceiling at the same end as the wall opening. The ceiling opening led to a vertical vent stack, which simulated the vent of the lower vault of a two-level building. The inner dimensions of the vault were 4 ft 8 in. wide by 8 ft deep by 10 ft high. The vertical stack was an additional 14 ft 10 in. high. The walls, floor, ceiling, and stack were of 10-in.-thick reinforced concrete. The door and coverings for each vent were of steel.

Both the vertical and horizontal vents were equipped with steel plates that could be adjusted to change the area of vent opening. An experimental cover of steel, weighing 256 lb, was laid over the 504-in.² opening at the top of the vertical stack. It was held in place only by its weight. The vault door was hung to open inward and bear on the jamb on both sides, top, and bottom when closed. The vault was provided with pipes through the walls to permit the installation or connection of temperature- and pressure-measuring equipment, sprinkler systems, and fire and smoke detectors.

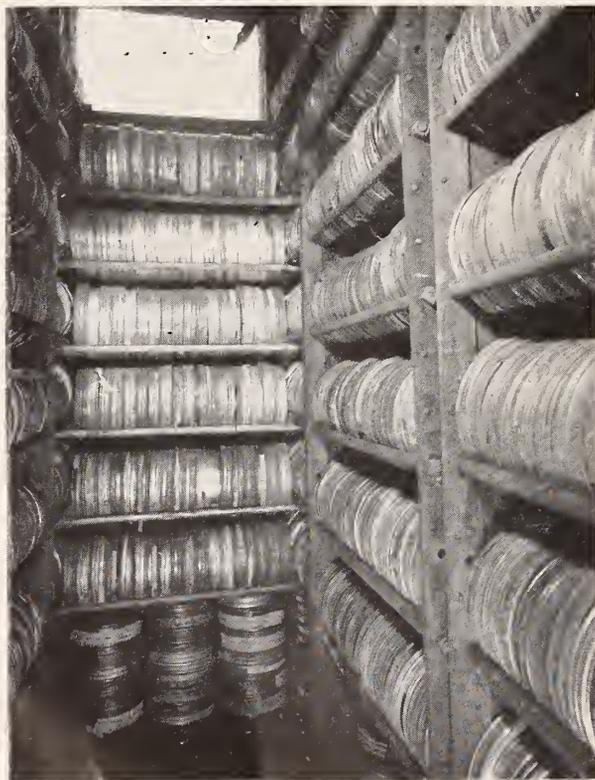
FIGURE 2. Fully loaded vertical-storage skeleton film racks in vault.

The horizontal vent opening is at the top.

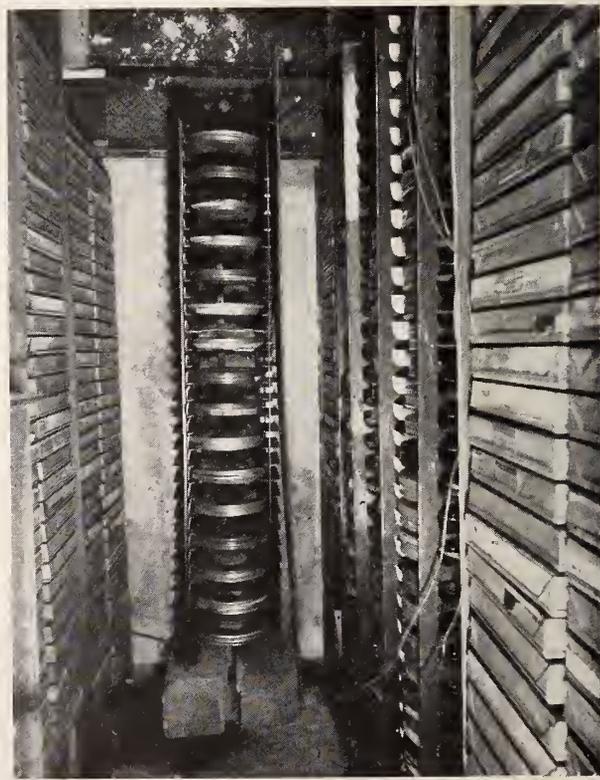
FIGURE 3. Loaded horizontal-storage skeleton film racks in vault, experiment 1.

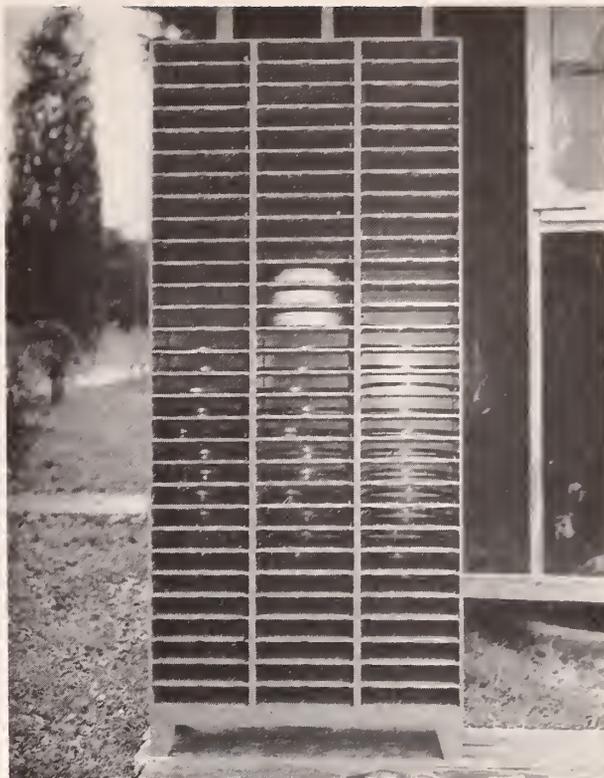
FIGURE 5. Open-front compartmented film rack, showing film extractors.

Each open-front compartmented rack consisted of three vertical rows of compartments, 30 in a row, and stood 6 in. off the floor on sheet-metal legs. The over-all dimensions were 2 ft 11 $\frac{5}{8}$ in. wide by 6 ft 11 $\frac{1}{6}$ in. high by 11 $\frac{3}{8}$ in. deep. They were constructed of light-gage sheet steel and insulated with $\frac{1}{4}$ -in. gypsum board applied to the underside of each shelf and the sides and rear of each compartment. The clear space of each compartment of the open-front rack was 11 in. wide by 11 in. deep by 2 $\frac{1}{2}$ in. high. Each compartment was equipped with a film extractor, which consisted of a flexible steel strip attached to the left front corner, from where it curved around the rear of the compartment to the right front and passed through a guide. Pulling the loose end caused the ejection of the film can. The rack is shown in figure 5.

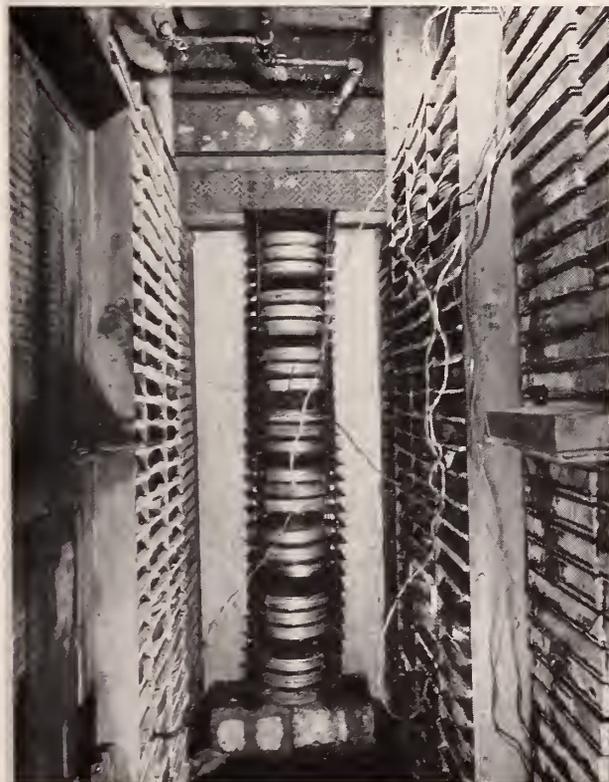
FIGURE 4. Compartmentation of horizontal-storage skeleton racks by means of insulation boards.

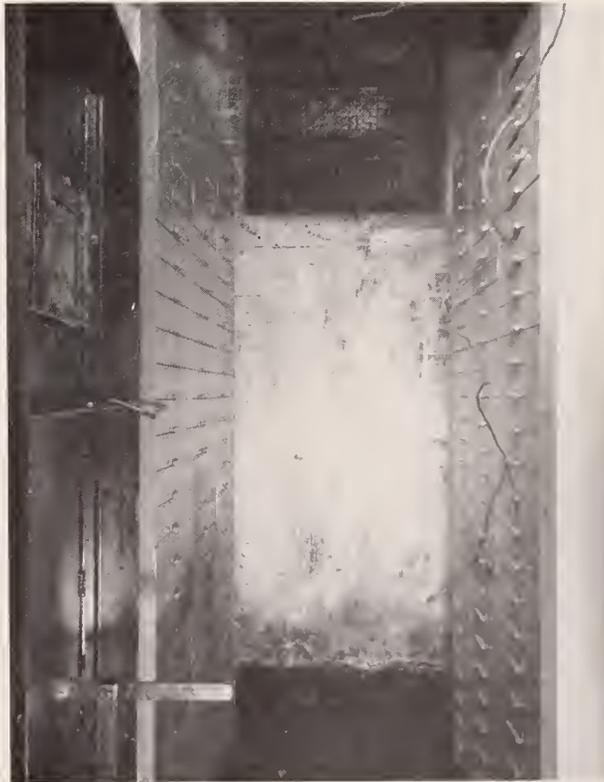
FIGURE 6. Closed-front compartmented film racks in vault.

each compartment. The door was hung at the top from a piano-type hinge. The clear space of each compartment was $11\frac{1}{2}$ in. wide by $11\frac{1}{4}$ in. deep by $2\frac{1}{2}$ in. high. Each compartment was equipped with the same type of extractor as in the open-front rack. The rack is shown in figure 6.

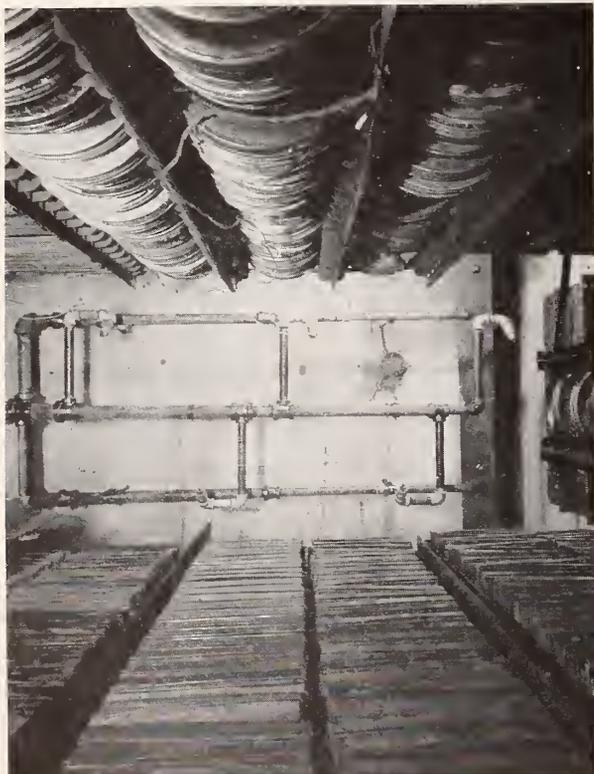
FIGURE 7. Pipes for overhead sprinkler systems, with open spray heads installed, experiment 3.

The open spray heads were used with the directed-spray system under "deluge" conditions in which discharge of all heads was actuated by a "deluge" valve located outside the vault in the supply line. Each head consisted of a hollow

bullet-shaped nozzle, inside of which was a fixed piece having a central venturi tube and three curved blades. The water entering the head was separated into two streams by the inner piece; a small central stream through the $\frac{1}{8}$ -in. venturi where its speed was increased, and a larger annular stream through the fixed blades, which gave it a rotary motion. The central and annular streams reunited as they entered the $\frac{3}{16}$ -in. orifice, producing the spray emitted from the head. Each head was designed to discharge 10 gpm at a pressure of 15 lb/in.² or 15 gpm at 32 lb/in.² pressure.

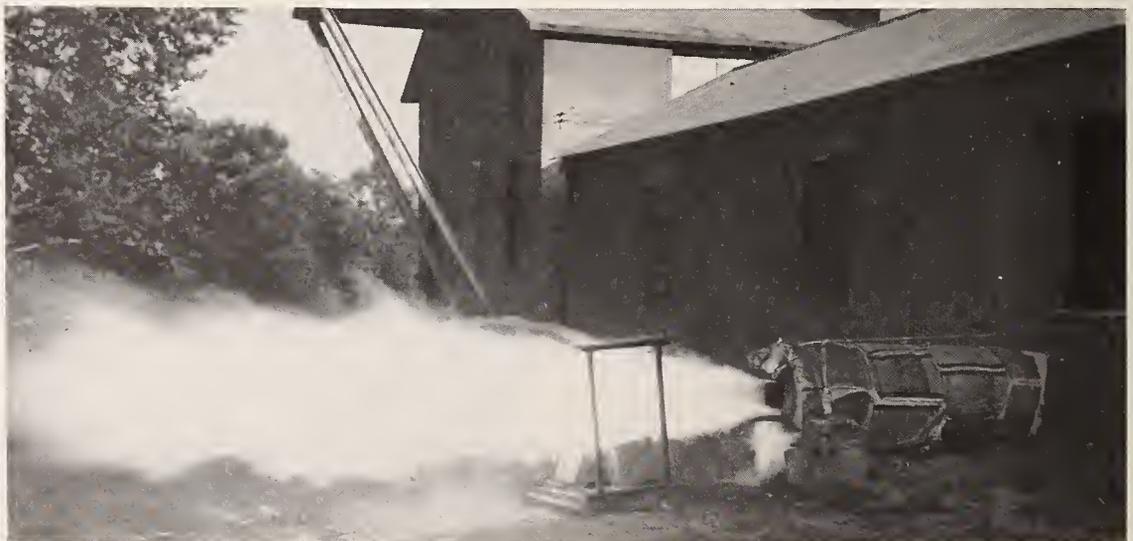
FIGURE 8. Discharge of gas and flames from 22-ft³ steel chamber during experiment 8 at National Bureau of Standards.

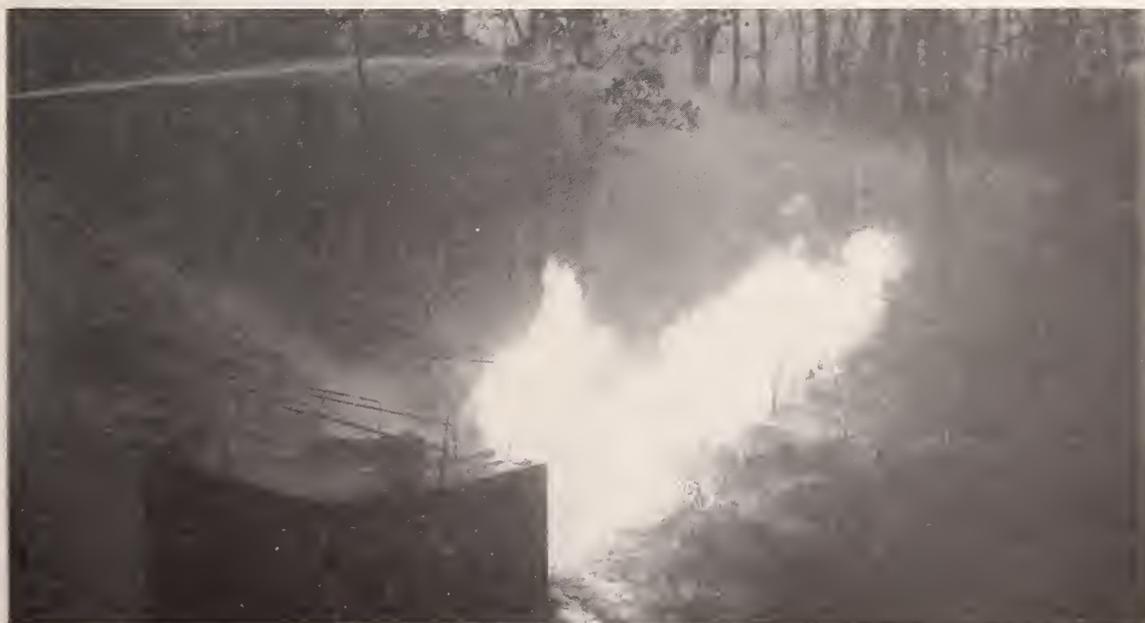
FIGURE 9. Discharge of gas and flames from 128-ft³ concrete chamber during experiment 14 at National Bureau of Standards.

Actual water flow 25.2 gpm per head, five heads operated. Apparent duration of combustion 7 min, maximum recorded pressure 0.15 lb/in.². Only about half as many cans of film burned out in rack containing the igniter can as in opposite rack. The discharge of fumes, shown in figure 9, was very dense.

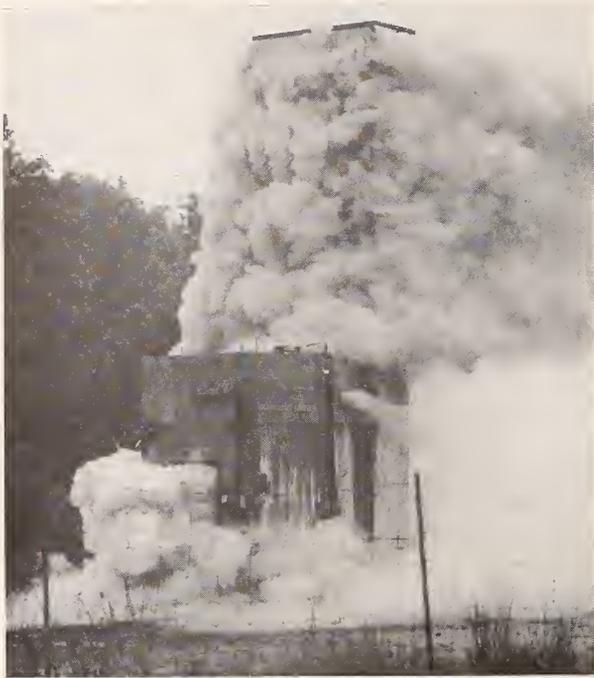
FIGURE 10. *Discharge of dense fumes from Beltsville vault during experiment 2, vent cover in place on vertical vent.*

The features observed, as well as the temperature and pressure data, varied appreciably from experiment to experiment. Following ignition of the igniter roll, fumes were produced and escaped from within the vault in clouds that ranged from light to very heavy. In 5 (9 through 13) of the 13 experiments, only 1 (No. 9) of which included sprinkler protection, the fumes became ignited outside the vault. In 1 of these 5 (No. 12) the flame lengths reached 100 ft and film was thrown over 350 ft, both distances horizontally. Flames and ejected film from the vertical vent reached estimated heights of 70 and 500 ft, respectively, in yet another (No. 11). The differences from experiment to experiment were brought about largely by the use of different types of sprinklers and regulation of the water-flow rate. No sprinklers were used in 4 of the experiments (10 through 13). Table 3 contains much of the data from the individual experiments, arranged in groups according to the type of sprinkler used. The data from this program are given in groups I through IV. The recorded temperature maxima may have been less than the true maxima due to the limited number of thermocouples and their locations in the vault as well as the possibility of wetting of thermocouple junctions in sprinkler discharges. However, the tabulated temperatures give an indication of the order of magnitude that might be expected. Discharges of dense fumes and flames from the vertical and horizontal vents are shown in figures 10 through 14.

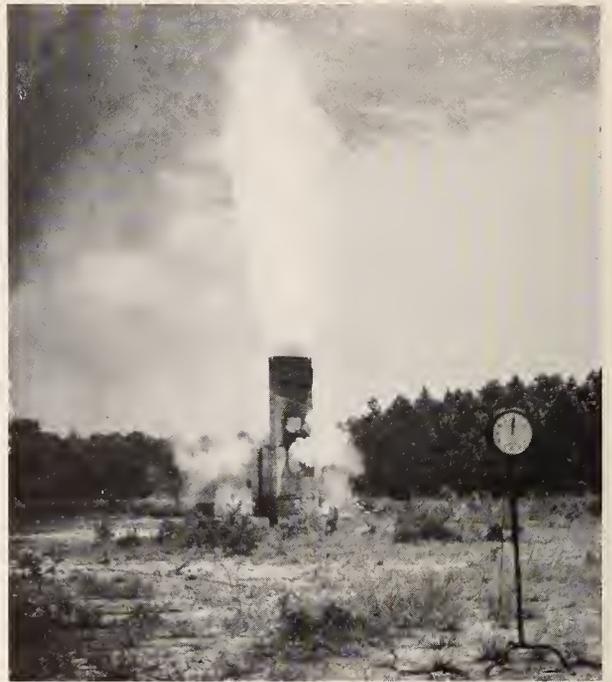
FIGURE 11. *Discharge of flames about 60 ft above vertical vent after vent cover blown off, experiment 11 in Beltsville vault.*

Actual water flow 14.8 gpm per head, until increased to 24.3 gpm per head at 16 min 30 sec, six heads operated. All but about 7 percent of the film was burned out. Nearly all of the unburned film was in the bottom racks on the side opposite the igniter can. The fire could not be controlled by the initial water flow and only after several minutes, if at all, by the maximum flow obtainable. However, the duration of combustion indicated that the sprinklers retarded the rate of combustion. The maximum recorded temperature and pressure were 1,562° F (850° C) and 0.22 lb/in.², respectively. Figure 11 shows the cloud of fumes just as their ignition started at the vent.

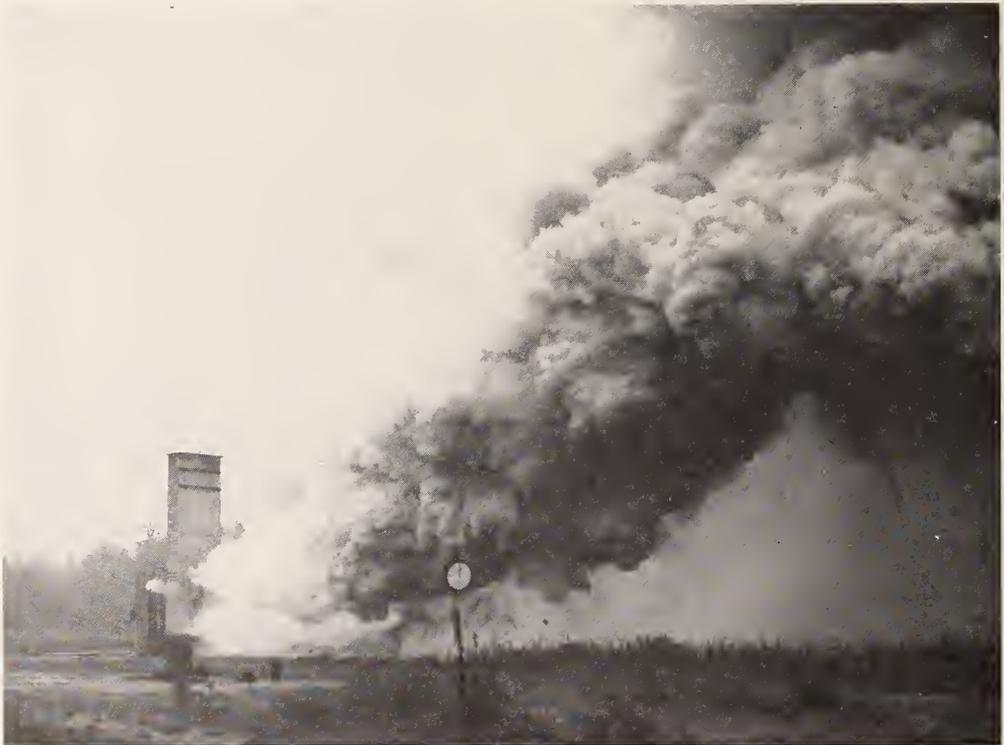
FIGURE 12. *Discharge of very dense fumes from horizontal vent just as ignition of fumes initiated at vent, experiment 9.*

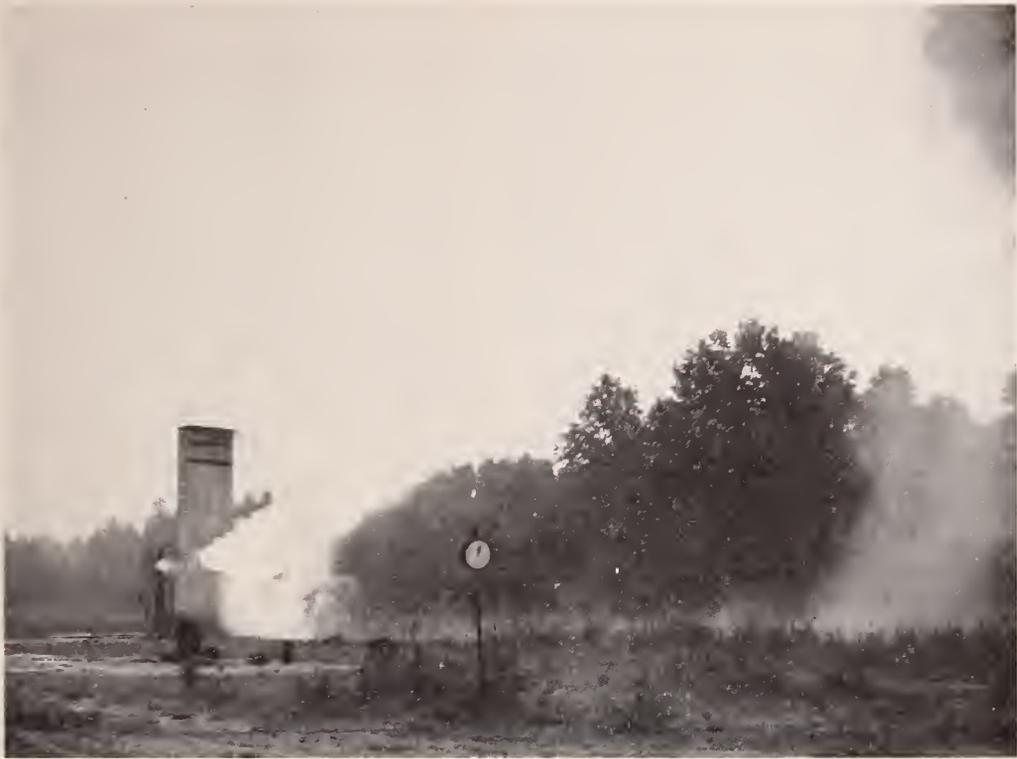
FIGURE 13. *Appearance during experiment 9 about 10 sec after that in figure 11, showing that dense fumes were almost completely burned.*

All the film in the vault was burned. Film was blown through the vent to distances up to 350 ft from the vault and flame length was at least 100 ft. The maximum recorded pressure was 3.0 lb/in.² and the maximum recorded temperature exceeded 2,192° F (1,200° C), the full scale of the potentiometer, for a period of 40 sec. Figure 13 shows the discharge of flames and film during this experiment.

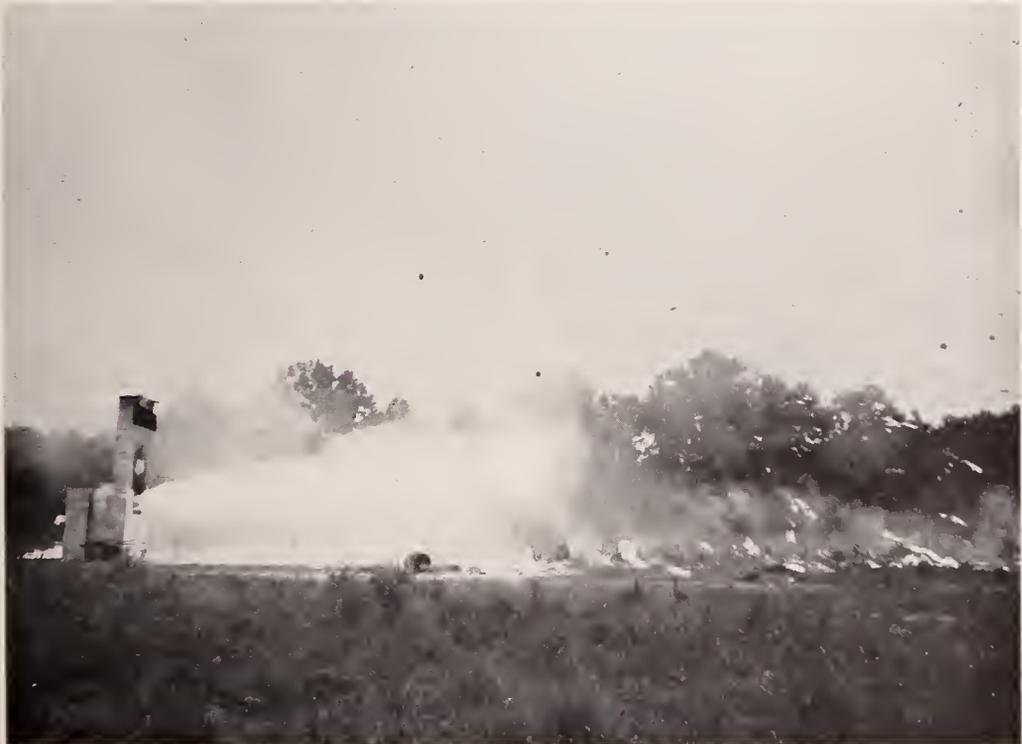
FIGURE 14. *Violent discharge of flames, film cans, and film from horizontal vent during experiment 12.*

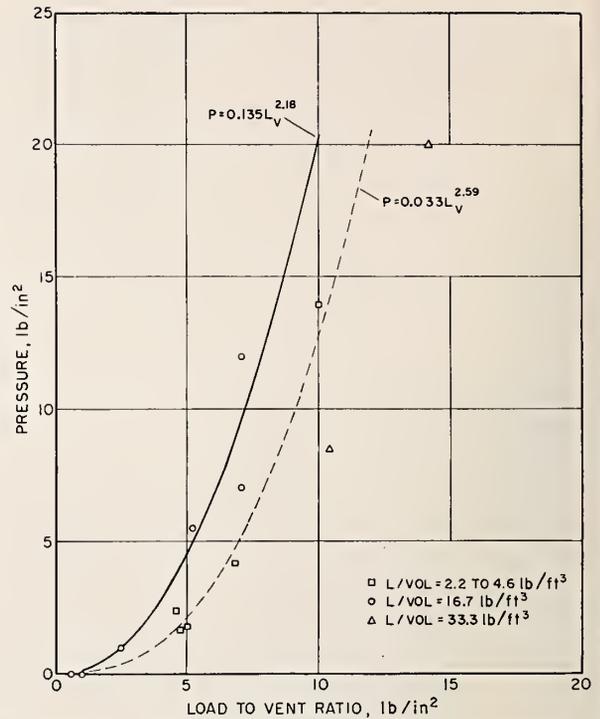
FIGURE 15. Pressure as function of load-to-vent ratio for film not in containers.

Figure 15 is a plot of the data obtained from experiments with film on bare reels or loose film. It includes data from NBS experiments and Stewart's [5] experiments except two of the latter in which extreme pressures of short duration were

attributed to temporary reduction of vent area through partial obstruction by film. The curves were plotted from formulas derived by least-squares analyses of the data. The solid curve represents the relationship

It should be borne in mind that the formulas and curves are intended to apply to only those cases in which the cellulose nitrate film is loose or on open reels, is stored without automatic sprinklers or equivalent protection, and is so placed in the vault or chamber that the vent will not be even partially obstructed at any time. The formulas do not include any extra margin of factor of safety.
